Inspection reference: 25029

## Confidential Inspection Report

16428 Estella Ave  
Cerritos CA 90703

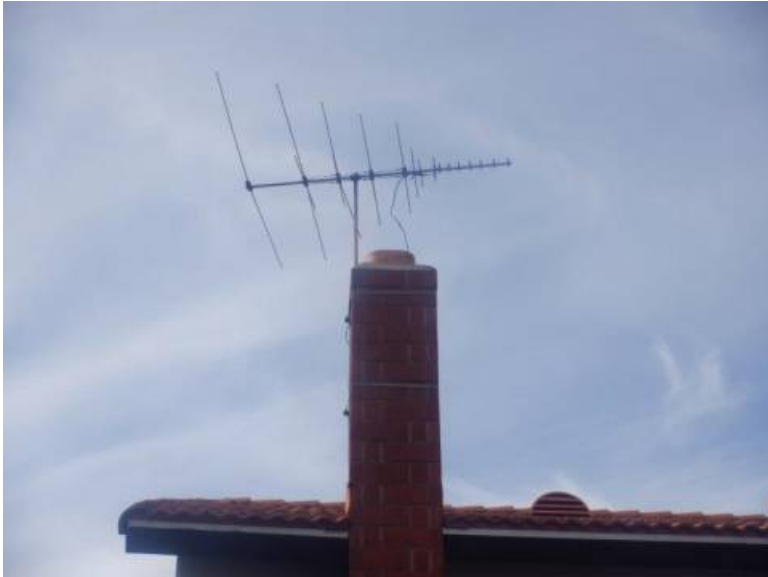
**3.5 Chimney Comments:**

The chimney does not have a spark arrester installed. A spark arrester (sometimes spark arrestor) is any device which prevents the emission of flammable debris from combustion sources, such as internal combustion engines, fireplaces, and wood burning stoves.

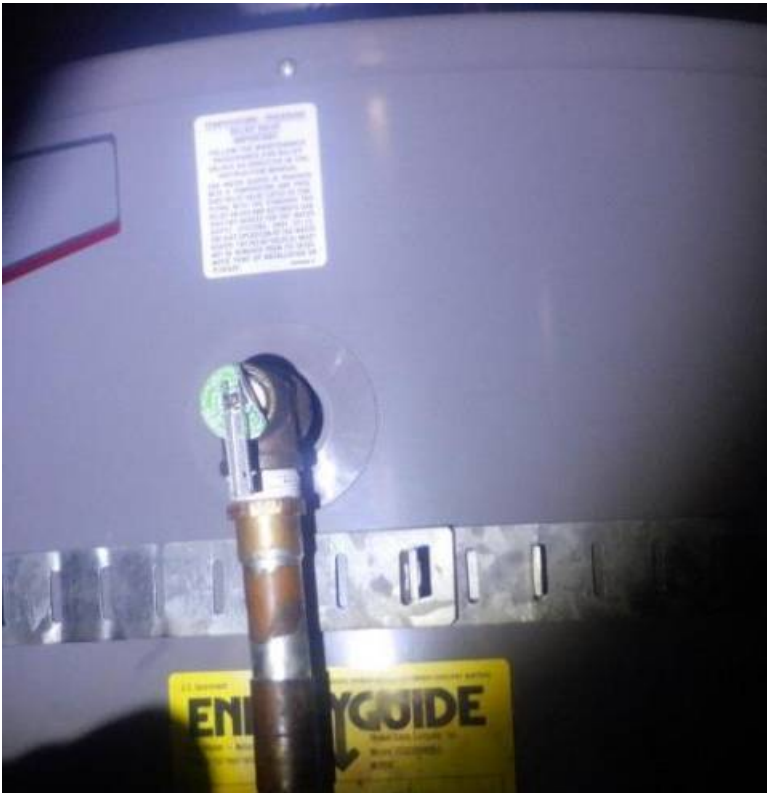
#### 8.5 Pressure Relief Valve/ Discharge Line:

Temperature/pressure-relief or TPR valves are safety devices installed on water heating appliances, such as boilers and domestic water supply heaters. TPRs are designed to automatically release water in the event that pressure or temperature in the water tank exceeds safe levels. The pressure relief valve is intact with the required discharge piping.

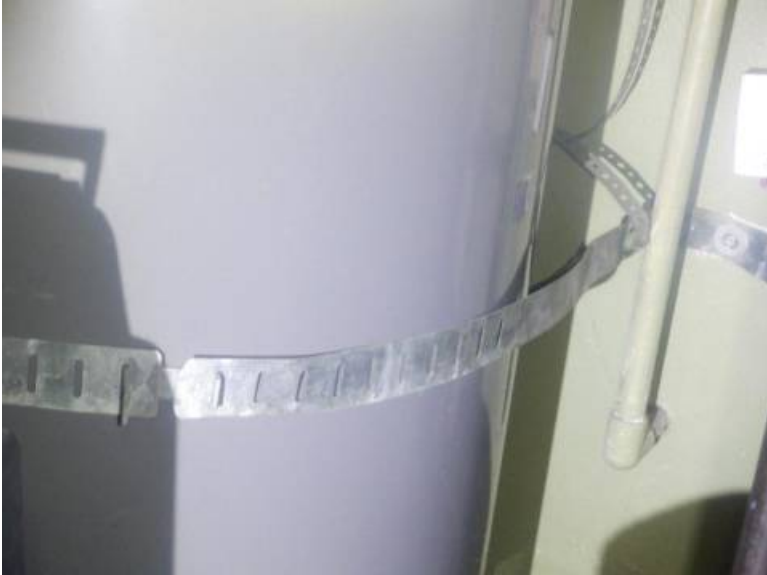
#### 8.6 Earthquake Strapping:

Earthquake strapping of water heaters is required in California residences. The water heater is properly earthquake strapped.

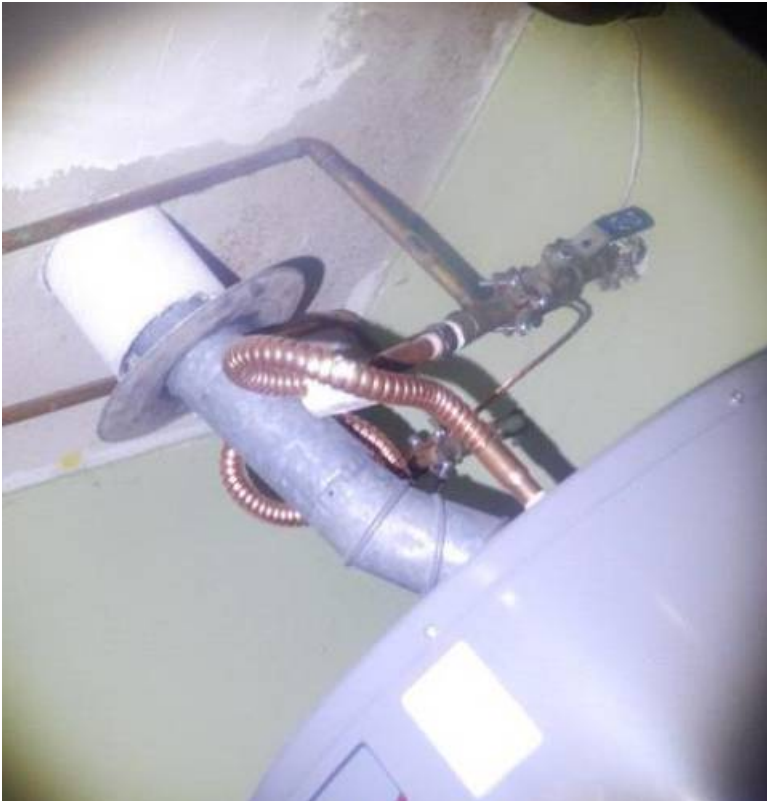
**8.7 Venting:**

The water heater vent is in serviceable condition, no defects noted.

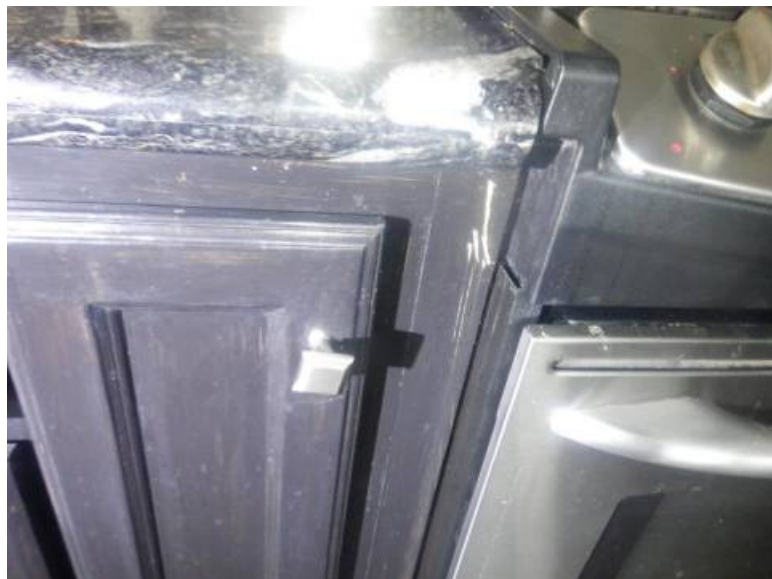
#### 9.3 Cabinetry/ Countertops Comments:

No defects noted at kitchen cabinetry.

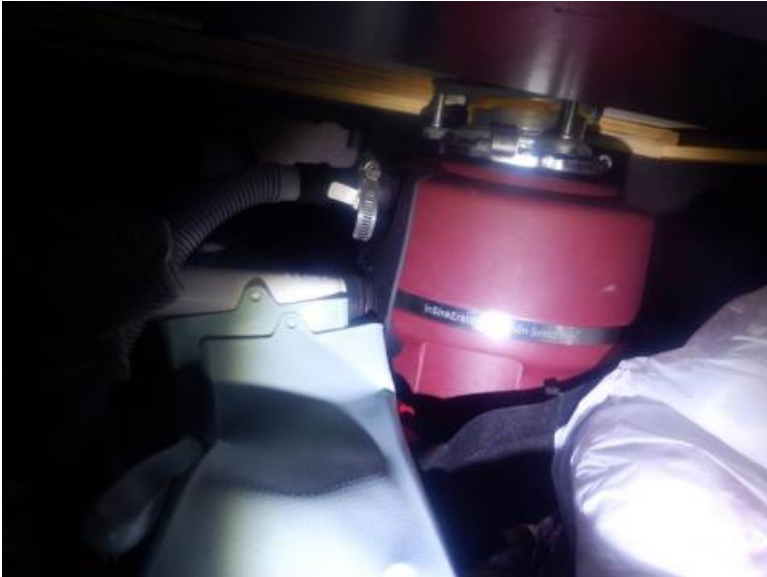
#### 9.7 Garbage Disposal Comments:

The garbage disposal operated properly with no visible defects.

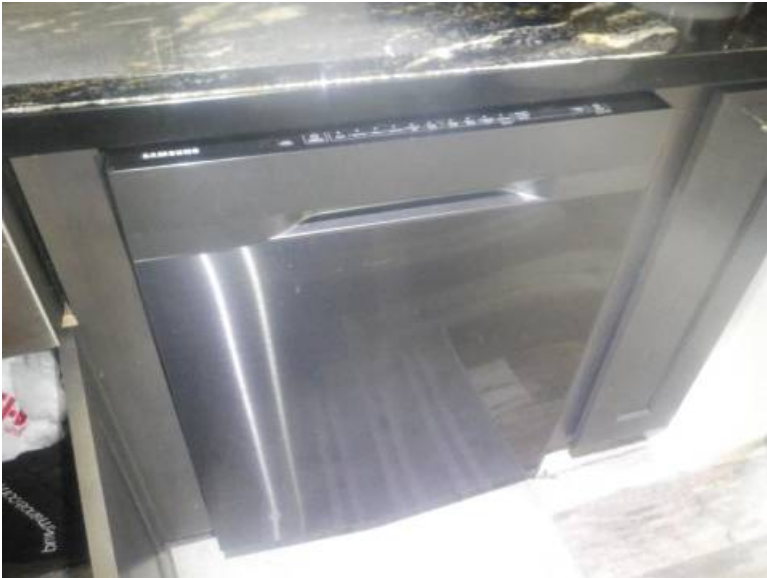
**9.8 Dishwasher Comments:**

The dishwasher operated properly.

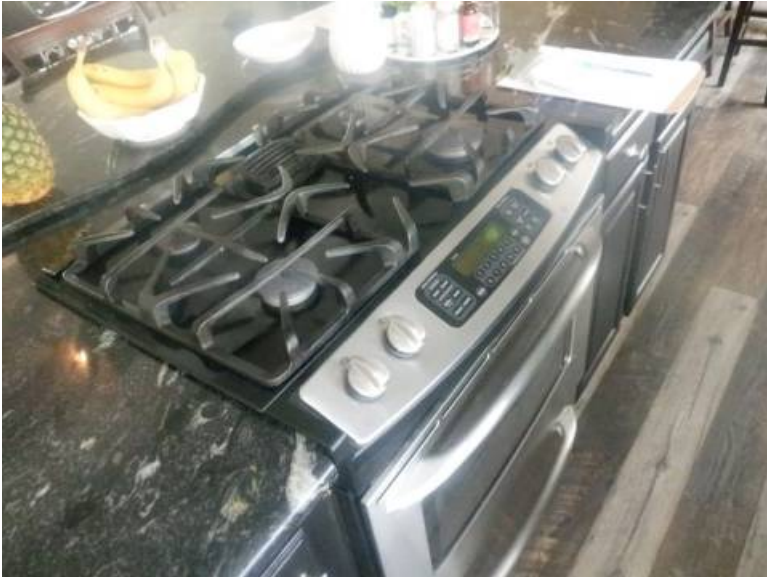
**9.9 Oven/ Cooktop Type:**

The cooktop is gas burning; The oven is gas burning.

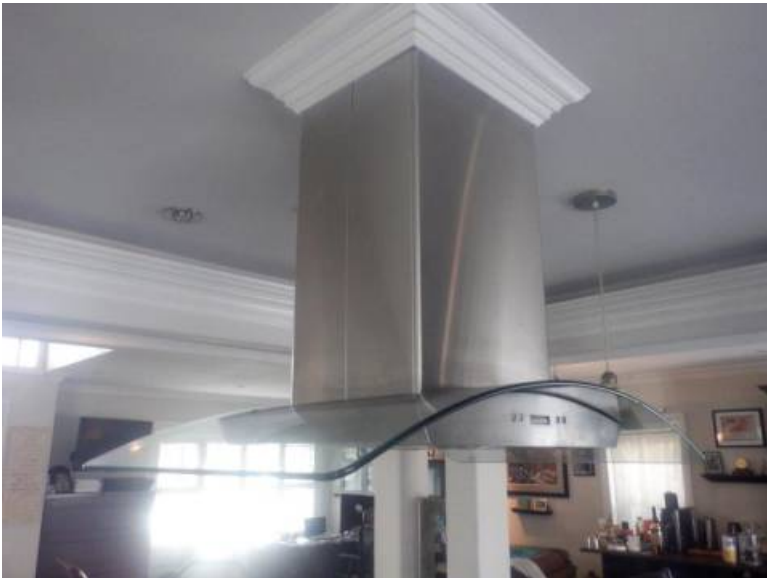
**9.11 Exhaust Fan Comments:**

No defects noted at exhaust fan.

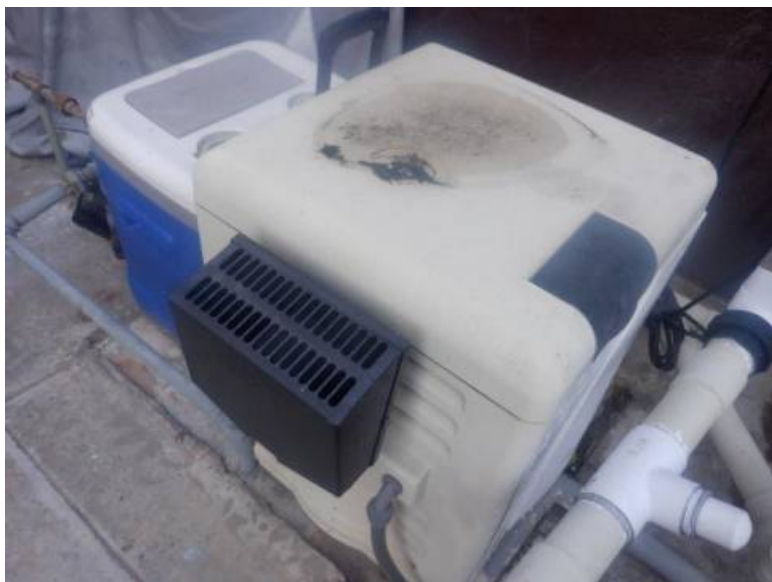
### 13.4 Heater:

The heater uses natural gas for fuel; The heater was operating when tested at time of inspection, seasonal maintenance is suggested to extend useful life.

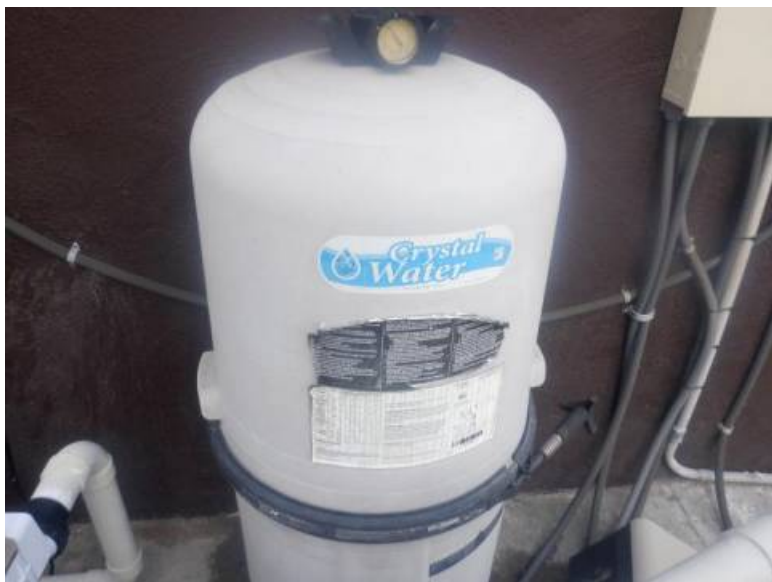
### 13.5 Filter:

DE Filter; DE filters use diatomaceous earth as a filter media. The DE filter has plastic grids covered with a plastic type of fabric. A layer of filter powder called Diatomaceous Earth covers the grids and does the filtering. As the water passes through the filter powder, any debris down to 5-8 microns is filtered out. Because the DE is much finer than sand, it is able to filter much more finely than a sand filter. DE powder needs to be added every time you vacuum and then backwashed afterwards. No visible defects noted at filter at time of inspection.

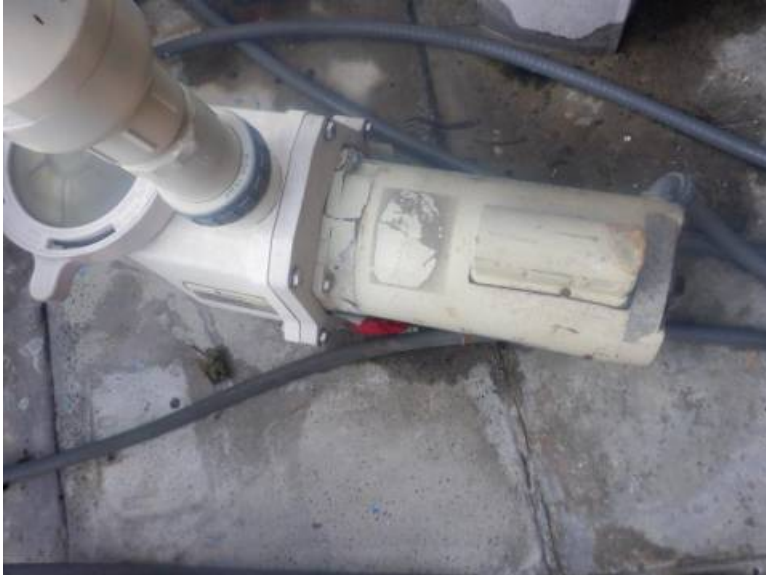
**13.6 Pumps:**

The heart of your circulation system, your pool pump pulls water from one or more suction ports (skimmers and main drain), and pushes it through the filtering, heating and sanitizing equipment, and back to the pool through the wall or floor returns, pressure cleaners or water features. Pool pump motors typically last about 8-10 years before needing either rebuilding or replacing. Noisy, screeching front and/ or rear bearings will let you know when you need to do something. No visible defects noted at pump(s).

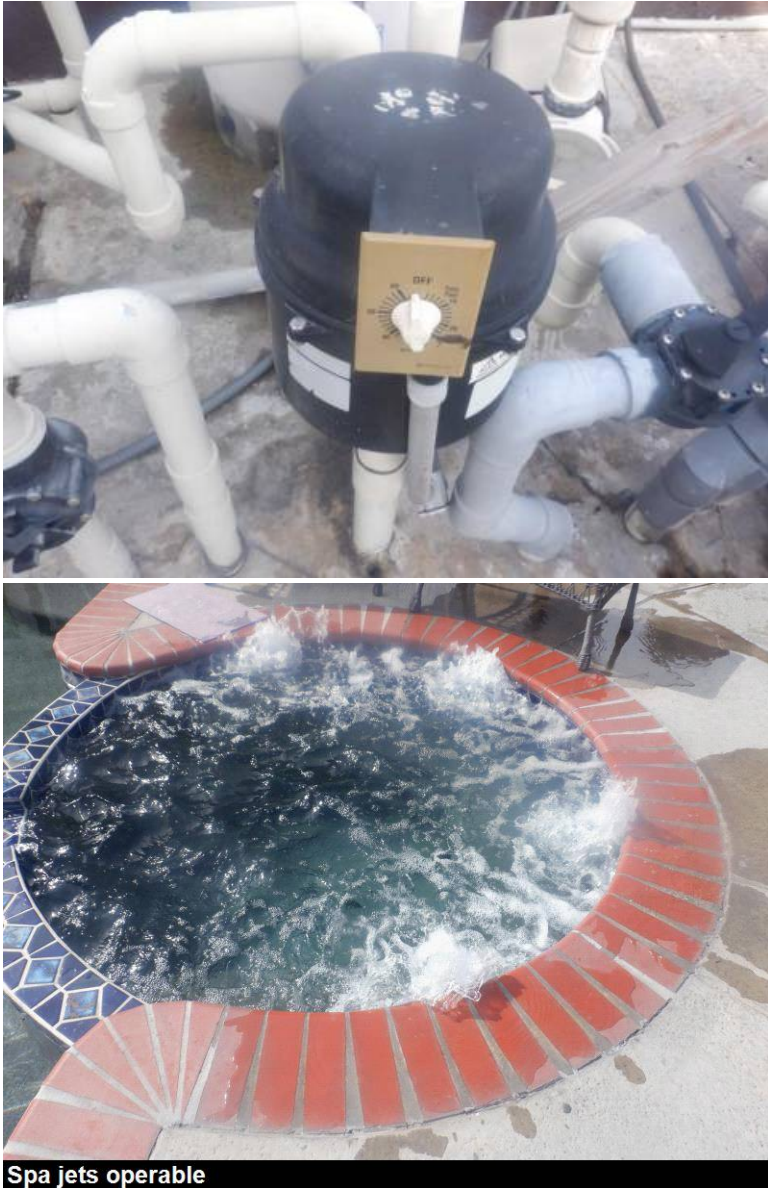
**13.8 Blower:**

The blower was operating properly when tested. A hot tub blower is a unit that uses a fan to create air flow and then channels that air through the jets in a hot tub or spa. It is sometimes referred to as an air pump or a bubbler because it creates bubbling in the water (different from a hot tub jet).
