### *Inspection Report*

Address: 267 Montana Way Los Osos, CA 93402

10/05/2026

Inspector: Taylor Vreeken, CCI

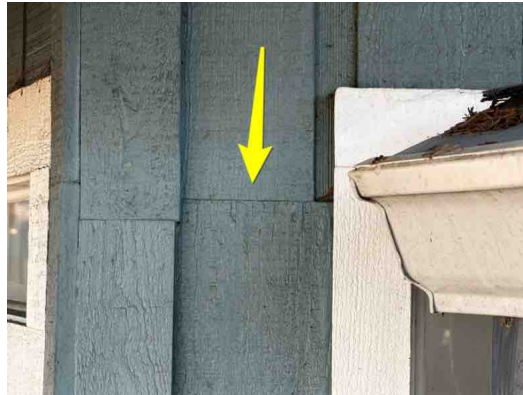
**FI 29: Disclosure:** No visible water shed / "Z" bar flashing at areas of some past exterior plywood wood siding repairs. Areas will need to be sealed and maintained regularly or removed and replaced with appropriate Z-bar flashing to help ensure water tightness.

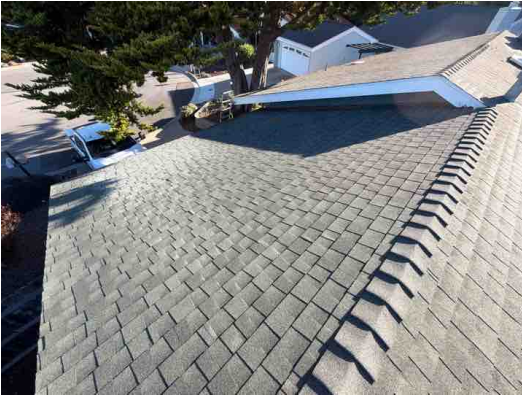
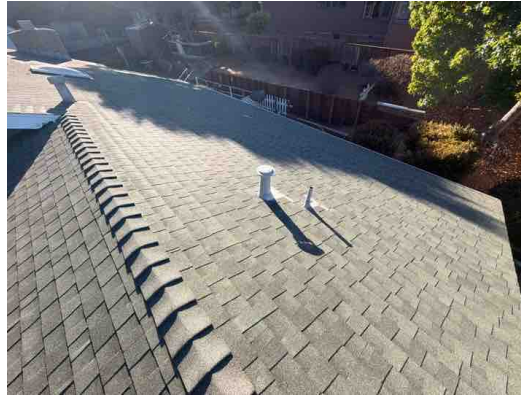
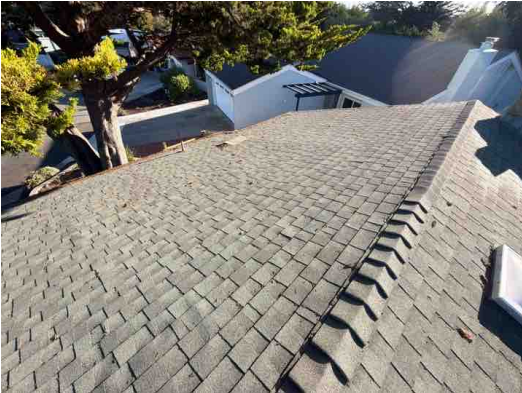
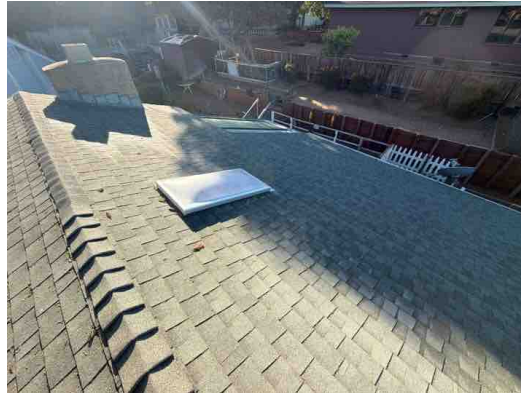
**45: Gable**

**46: Roof was walked**

**47: Number of Visible Layers of Roofing: 1**

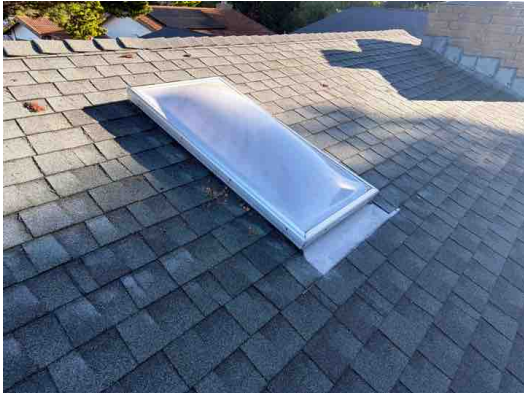
**MR 53:** Skylight(s) appears to be in good physical condition - *Skylights are not water tested, visual inspection only.*

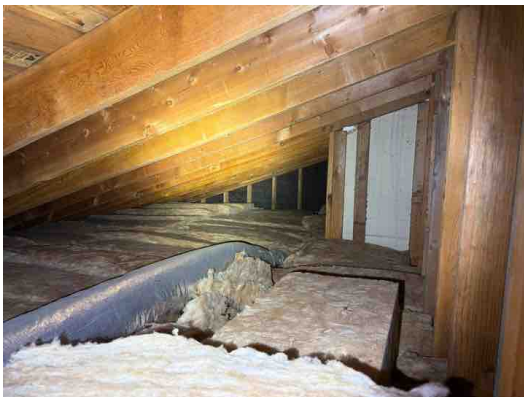
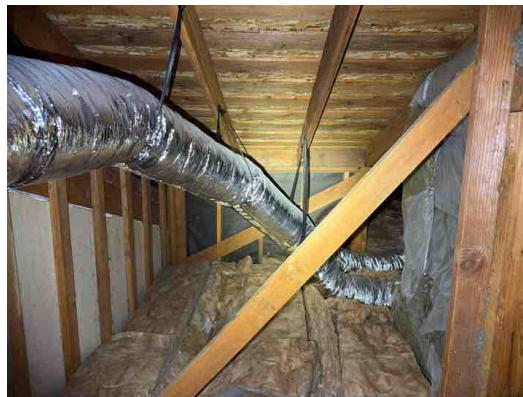
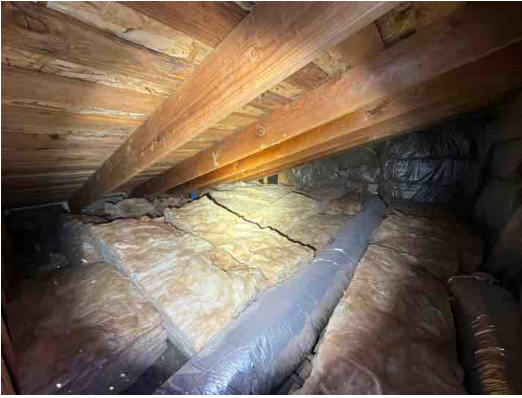
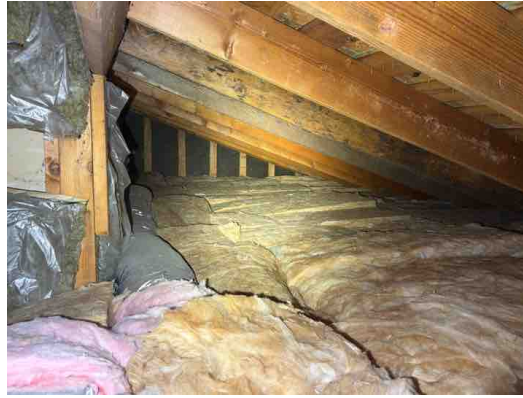
### 61: Attic Photographs

**SU DS 60:** The current attic framing is older and does not meet current structural or seismic standards; however, it appears to be in generally serviceable condition at the time of inspection for its age.

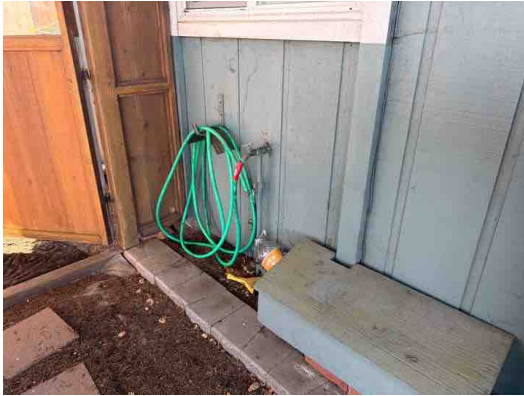
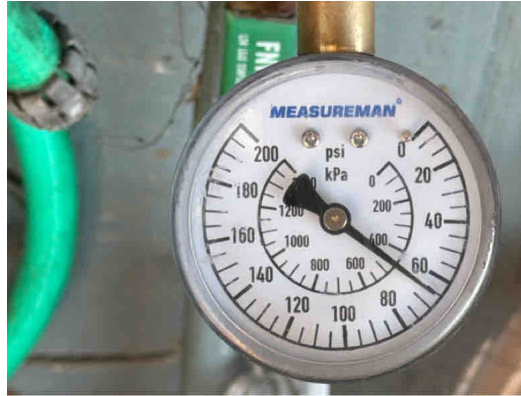
**Water Pressure** - Is At Approx. **66 +/- PSI.** *Optimal water pressure is between 40 and 80 PSI.*

1. *Pressure Regulator Installed:* **NO**
2. *An Automatic Leak Detection Device installed on the main water supply:* **NO.**

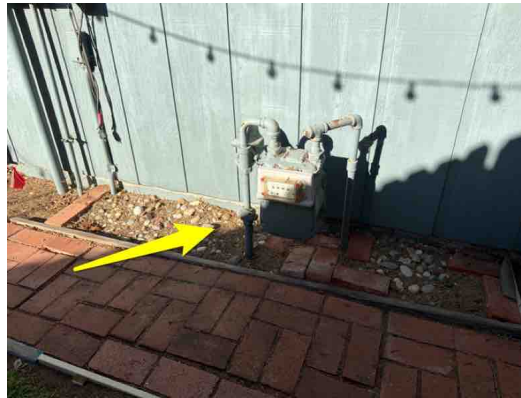
**76:** Gas shut-off appears serviceable.

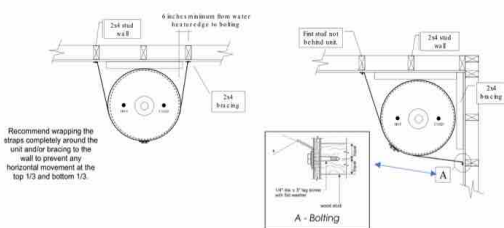
Water heater strapping and blocking recommendations

**E&C 80:** The Water heater is loosely strapped & not secured well - moves when pushed . Recommend adding BRACING OR BLOCKING to the wall to properly secure the tank per Uniform Plumbing Code and State Architect Requirements.

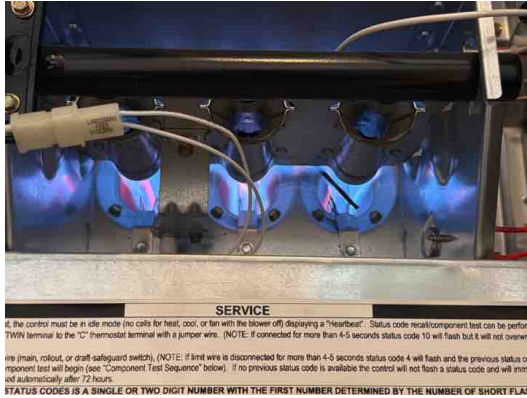
**168: HEATING SYSTEM CONDITION:** The heating system operated when tested.

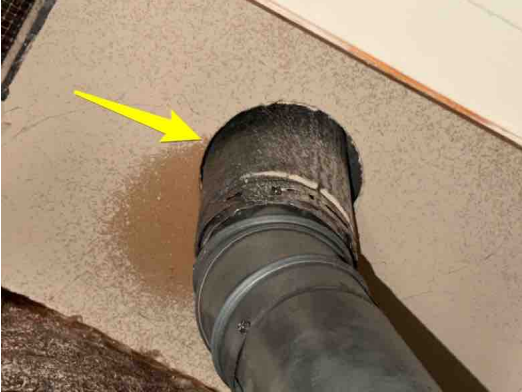
**E&C 172:** Furnace vent pipe lacks proper clearance to combustible material through the drywall ceiling. A minimum of 1 inch of space between the vent pipe and combustibles is needed per minimum standards.

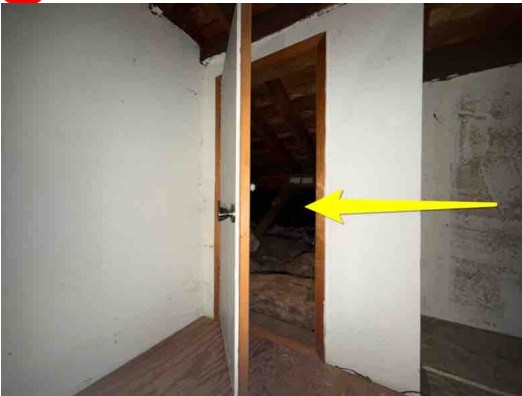
**SC 201:** Door from garage into the ATTIC space is NOT a fire rated door per standards.

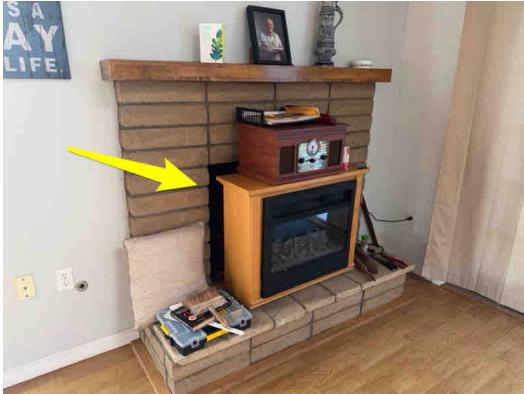
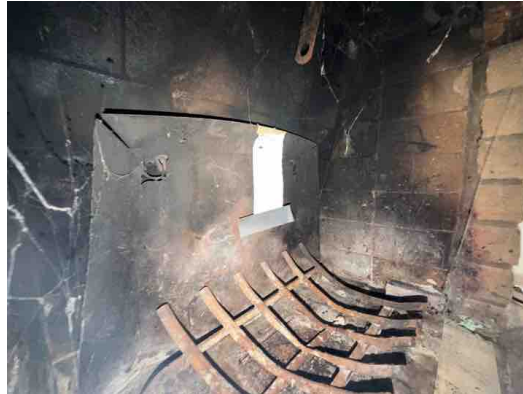
210: **LIVING ROOM**

**DS 211:** Level two camera chimney inspections are recommended for masonry fireplaces due to unknown and potentially hazardous conditions not visible inside the chimney flue or throat.

**DS 212:** Unable to fully inspect the fireplace due to occupant's belongings. Recommend Evaluation once area has been made available.

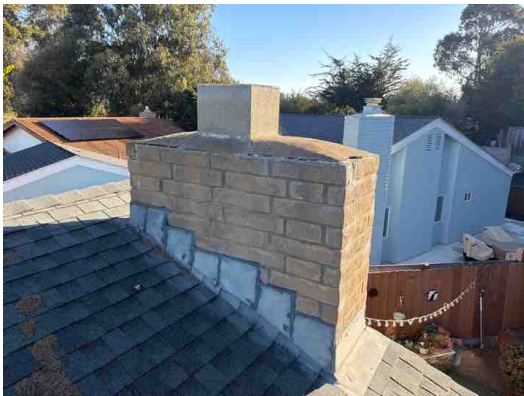
214: Photo of the LIVING ROOM Masonry Chimney

**SC 215:** An improper and unsafe use of a flat screen atop the fireplace chimney. Recommend the installation of a proper screen chimney cap for safety per standards.
