Shawn Foster Inspections

Confidential Inspection Report 3844 E. 15th St. Long Beach CA 90804

February 29, 2024

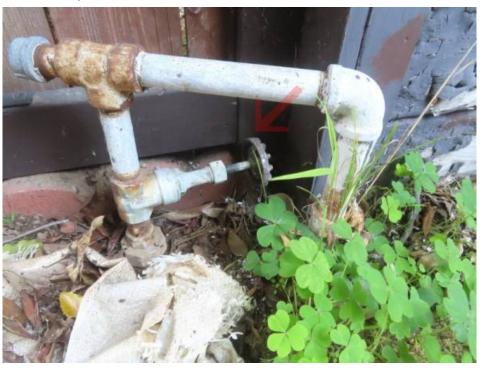
Galvanized steel. Supply line material was based on the visible portion at the main shutoff valve. Water meters are not inspected.

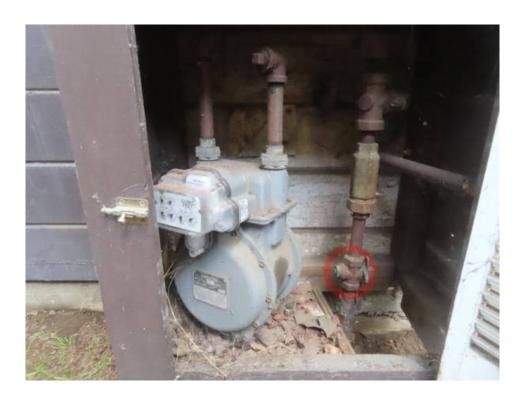
SAFETY: No seismic shutoff valve. We recommend installing a seismic shutoff valve on the gas meter for protection against fire loss in the event of a damaging earthquake. (A seismic shutoff valve is required to be installed on the gas system of residences in the City of Los Angeles prior to the transfer of title.)

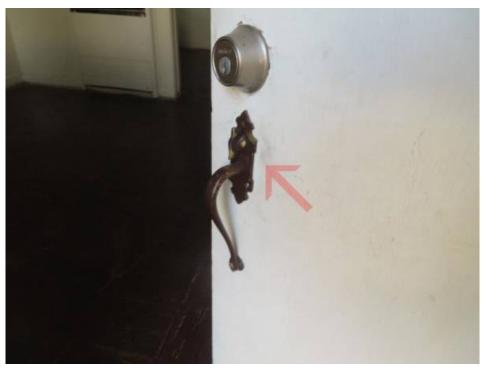
Main entry door

DEFERRED: No handle present, only deadbolt. Recommend adding a handle.

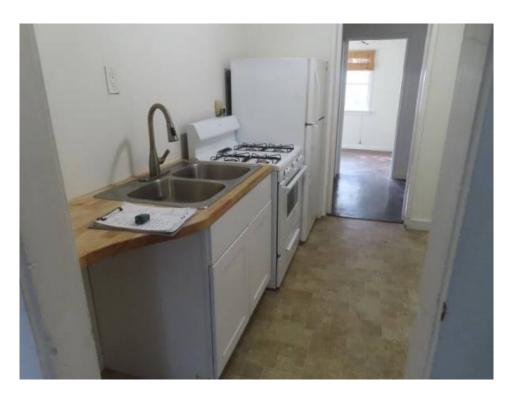
SAFETY: One or more receptacles are not GFCI protected. We recommend installing and maintaining GFCI protection at all kitchen counter receptacles.

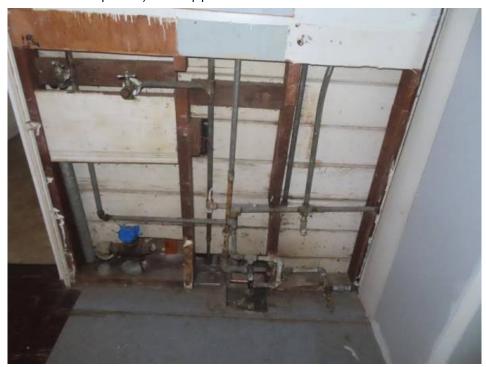
DEFECTIVE: Active drip leak in line. Recommend repairs at this time. SAFETY: 120 volt electrical outlet is an non grounded type receptacle. We recommend installing a grounded receptacle at this location or properly grounding the washer and dryer to the cold water pipes as per the appliance manufacturer's instructions to protect against electric shock or electrocution.
