# Inspection Report

**Property Address:**  
1642 Havemeyer Ln  
Redondo Beach CA 90278

## Professional Inspection Network

<b>Property Address</b> 1642 Havemeyer Ln Redondo Beach CA 90278	<b>Date of Inspection</b> 11/4/2022	<b>Report ID</b> 20221104-1642-Havemeyer-Ln
<b>Customer(s)</b> Sylvia Pulido Richard Colin	<b>Time of Inspection</b> 09:00 AM	<b>Real Estate Agent</b> Joe Safranek Beach City Brokers
<b>Inspection Details</b>		
<b>In Attendance:</b> Seller and Seller's Agent	<b>Type of building:</b> Single Family (2 story)	<b>Approximate age of building(s):</b> 55 Years Old
<b>Building(s) Faces:</b> North	<b>Temperature:</b> Over 60 (F) = 15.5 (C)	<b>Weather:</b> Clear
<b>Ground/Soil surface condition:</b> Dry	<b>Rain in last 3 days:</b> No	<b>Radon Test:</b> No
<b>Water Test:</b> No

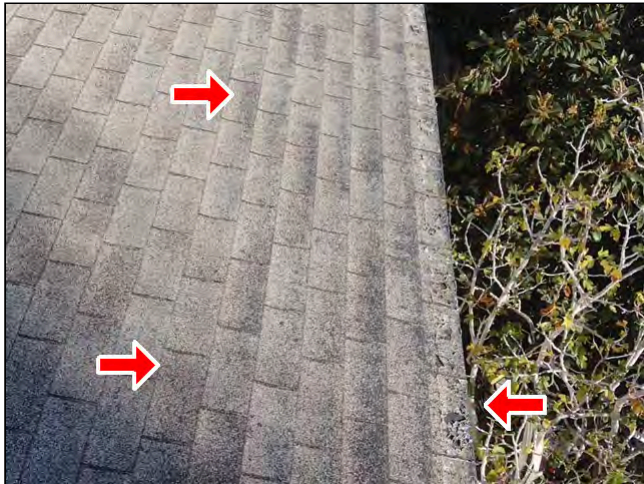
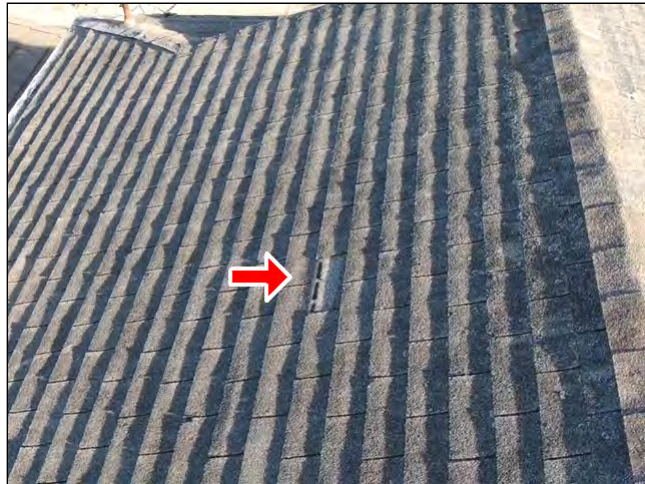
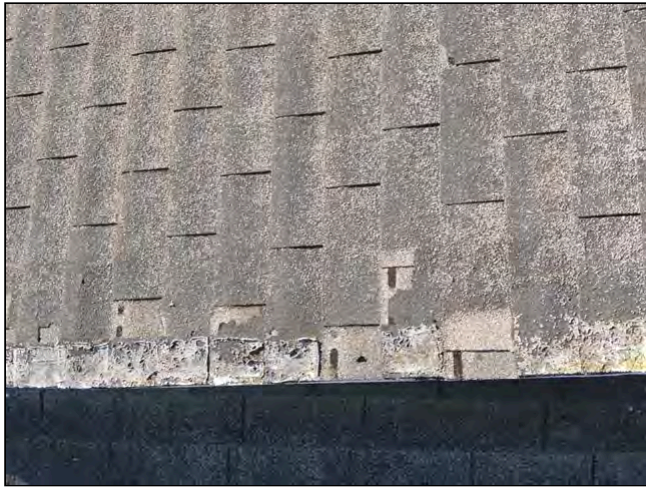
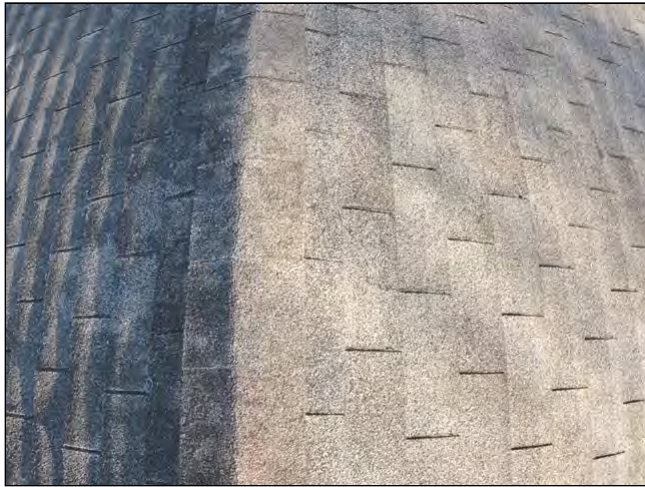
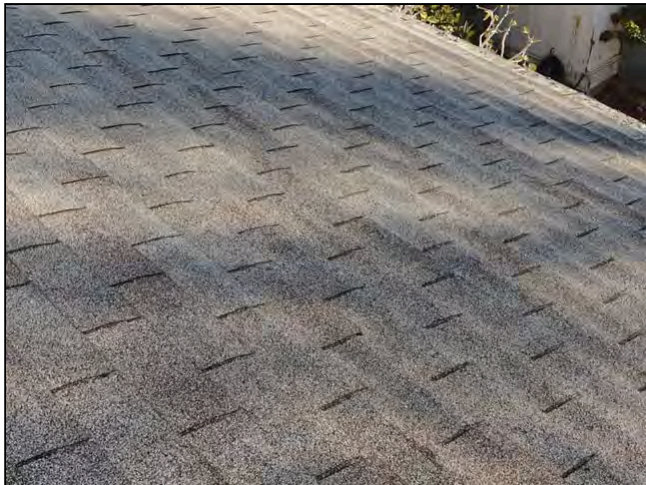
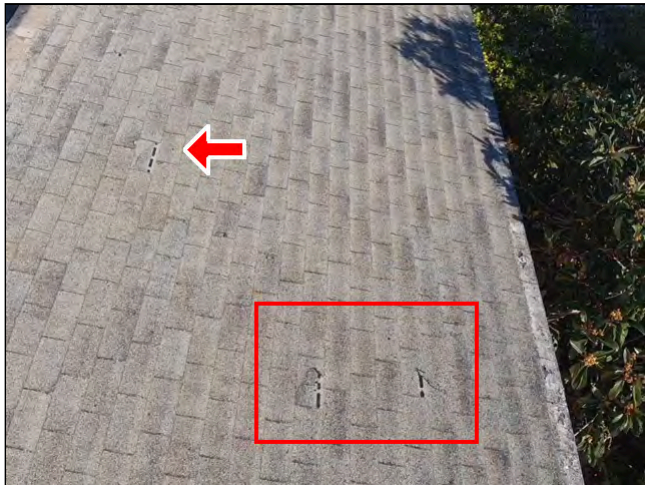
1. (1) **Major Concern:** The composition shingle roofing is wearing at uneven rates. The sides of the roofing that are more exposed to the sun's light are wearing more quickly than other areas. Also, there are missing/torn shingles in many locations. The composition asphalt shingle roof is at the end of its service life. It is in need of replacement. Suggest further review by a qualified roofing contractor to provide replacement options and cost.

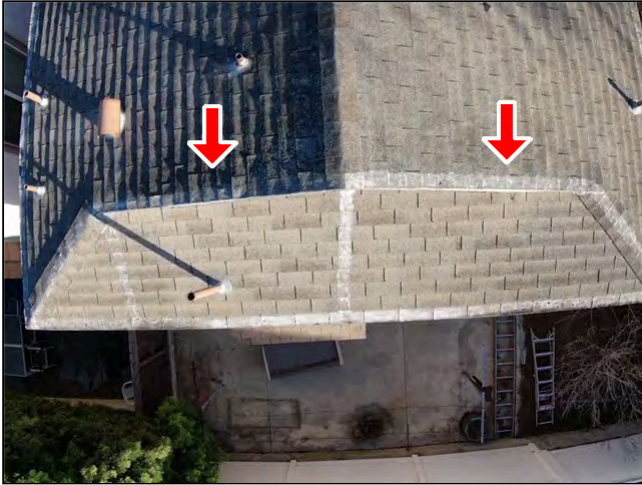
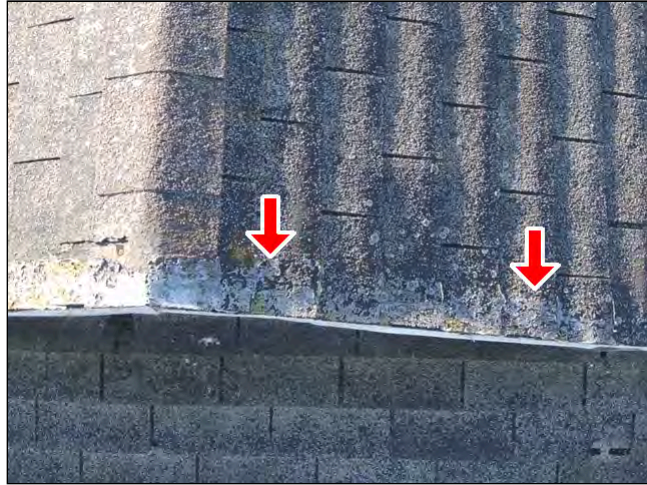
- 2. (2) **Monitor:** The edge of the roof is covered with paint/mastic throughout. This is an indication of a past problem and note that these areas could not be properly viewed and will require ongoing maintenance. Leaks can be difficult to repair, as the source of the leakage can be far removed from the water stains that shows up on the interior.

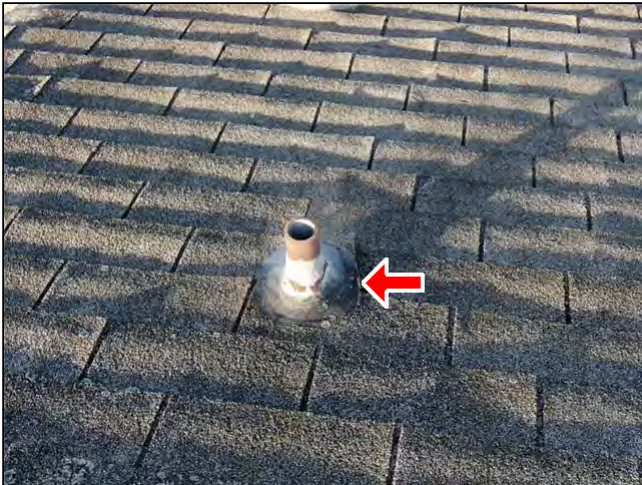
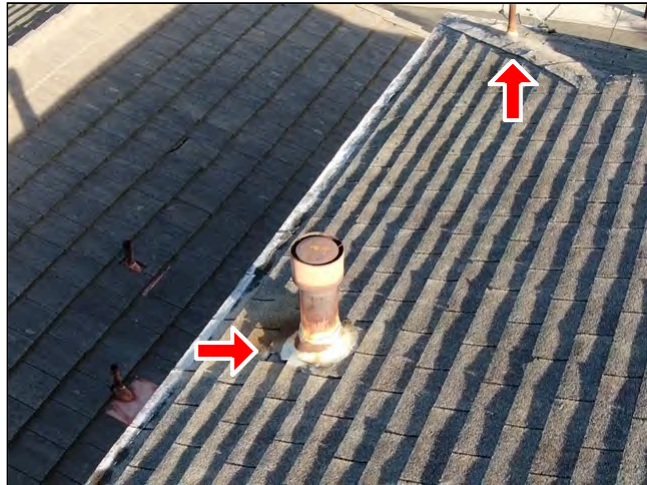
3. **Repair or Replace:** The mastic at all rooftop vents and penetrations is weathered and cracked. It is suggested that all vent and penetrations be examined and sealed with approved material by a qualified professional.

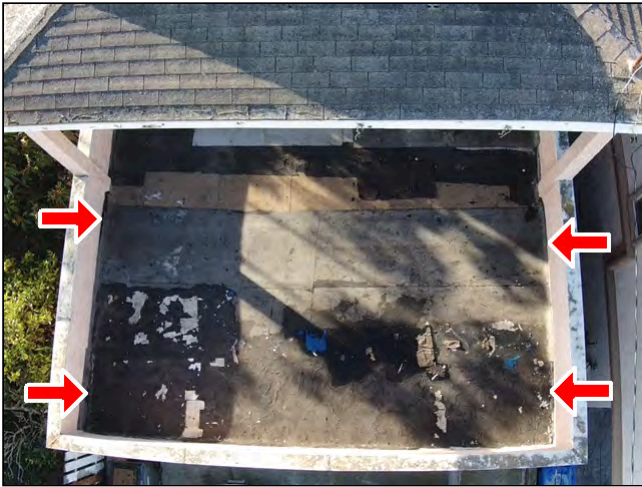
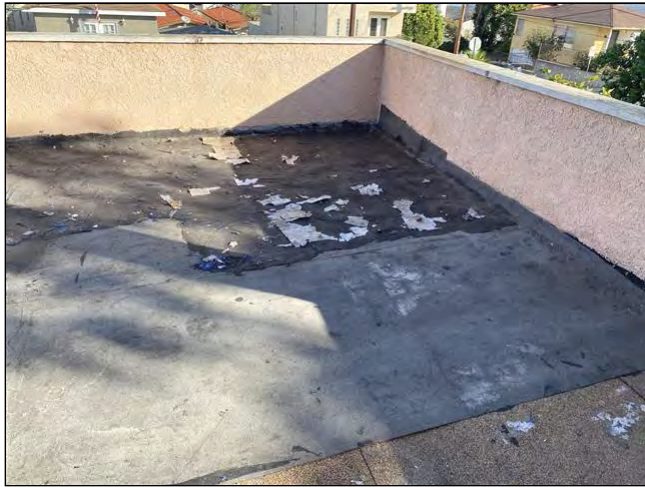
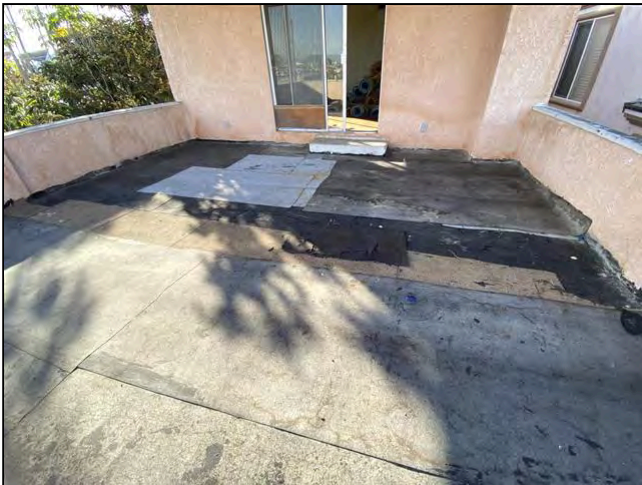
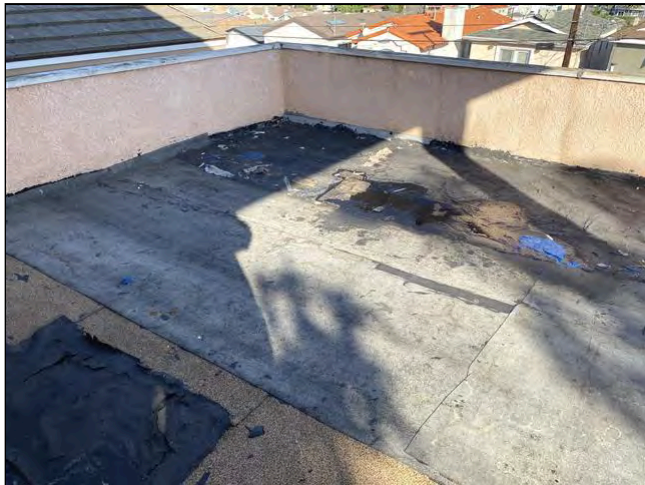
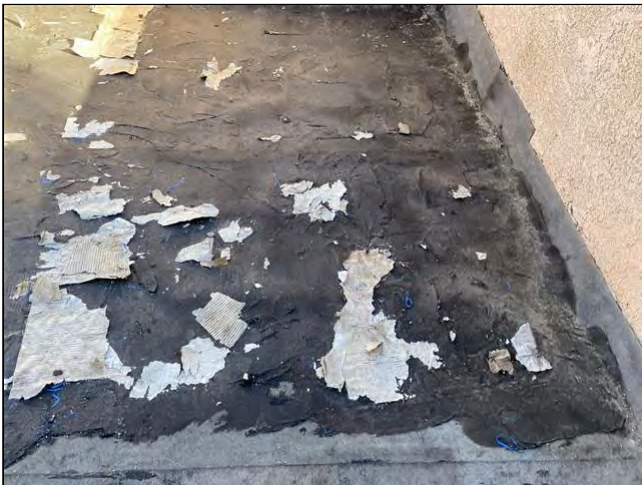
5. (1) **Major Concern:** The repairs performed at the front wall balcony are non-conforming. The repairs performed at the front balcony appear to have been done by a non-professional. They are not in accordance with industry standards. We suggest that the entire balcony and structure should be evaluated by a qualified contractor to provide replacement options and cost.

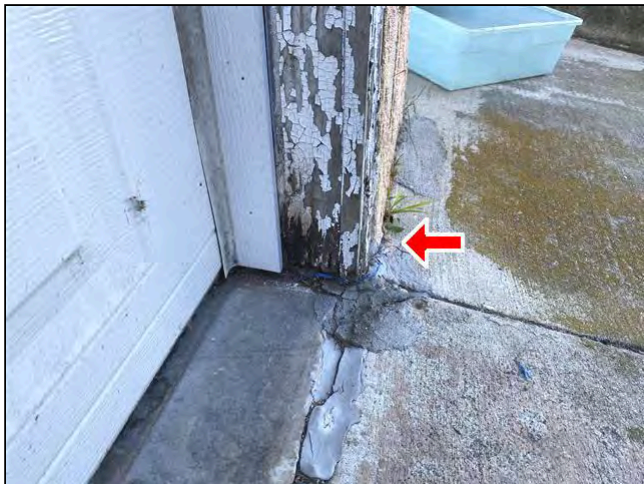
Item 8 - Item 1(Picture) Exterior

8. (4) **Repair or Replace:** Wood deterioration was observed at the base of the garage overhead door frame. The wood frame is in contact with the ground. This configuration is prone to rot and insect activity. If the home inspection reveals signs of damage you should have a pest control company inspect further for activity and possible hidden damage. Suggest repair/replacement of all deteriorated wood by a licensed contractor.

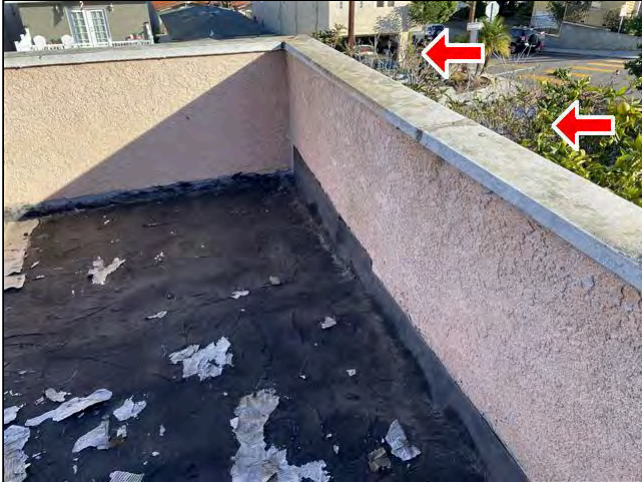
Item 9 - Item 1(Picture) Exterior

9. (6) **Safety Issue:** The height of the front wall balcony rail/wall does not comply with today's building standards. We suggest the wall should be repaired or replaced by a qualified technician to conform to standard trade practices.

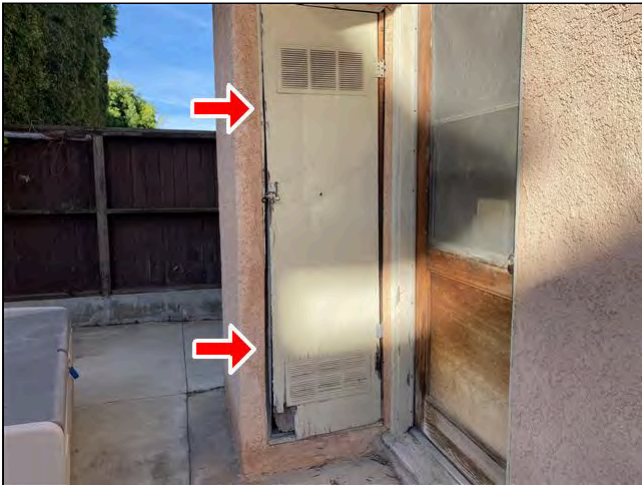
Item 10 - Item 1(Picture) Exterior

10. **Repair or Replace:** The rear exterior wall water heater closet door is deteriorated. The door and frame are in need of replacement. Suggest replacement by a qualified contractor.

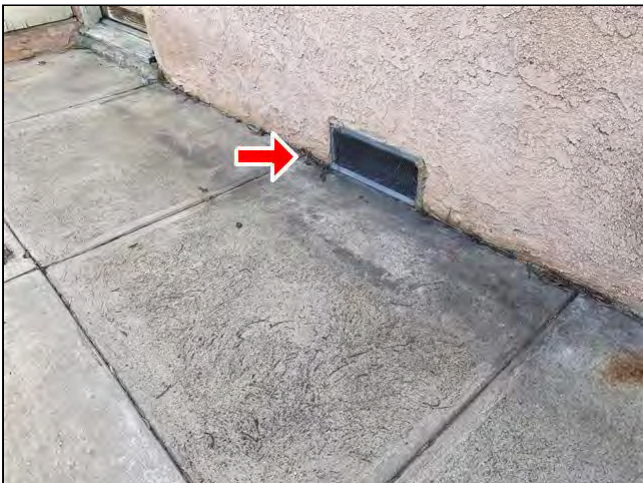
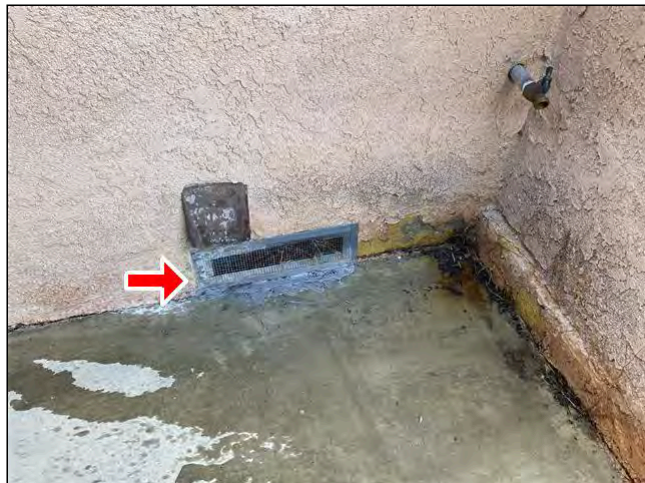
13. (3) **Improve:** The crawl space vent openings are at grade level in many locations. This configuration can allow water to enter the crawl space and cause damage. Suggest further review by a qualified contractor to provide drainage options and cost.

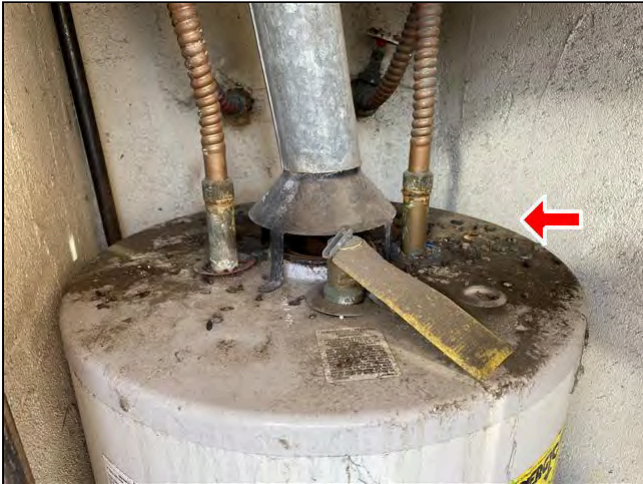
Item 14 - Item 1(Picture) Exterior

14. **Safety Issue:** Evidence of rodents was found in the form of feces was observed at the water heater. A qualified person should make repairs to seal openings in the structure, set traps, and clean rodent waste as necessary. Future costs could be incurred from prior rodent damage not visible at time of inspection.

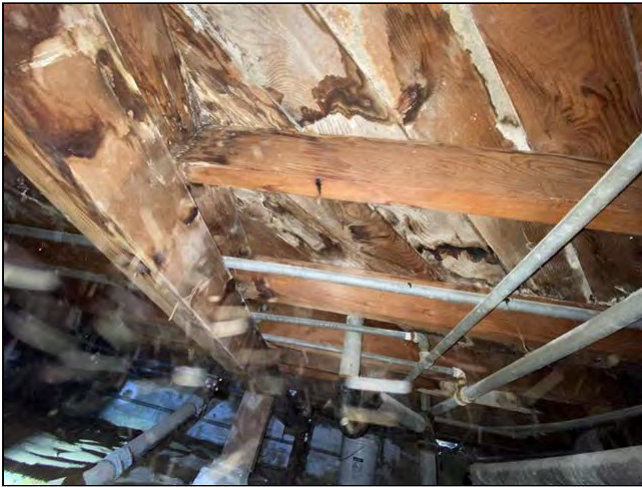
Item 16 - Item 1(Picture) Structural Components

16. (1) **Repair or Replace:** Water staining, wood deterioration and possible fungus was observed at the first floor bathroom subfloor. It is suggested that the subfloor below bathrooms be further evaluated by a qualified contractor to determine if wood subfloors or in need of repair and or replacement.

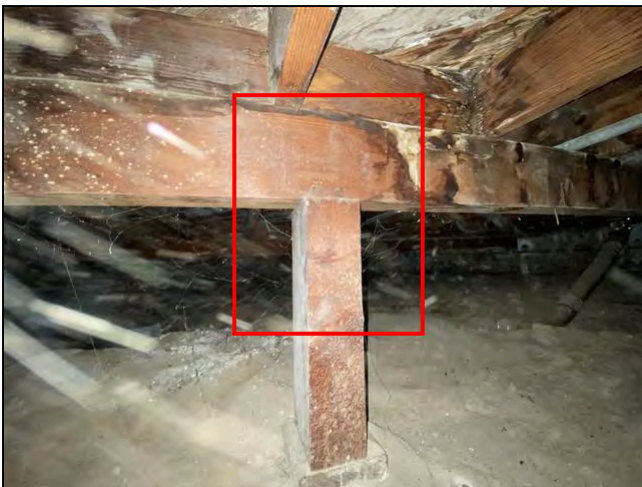
Item 17 - Item 1(Picture) Structural Components

17. (2) **Improve/Monitor:** The girder and post connections are not reinforced according to modern standard building practice. No adverse effects resulting from this condition are noted. We suggest as an up-grading these connections would be considered optional.

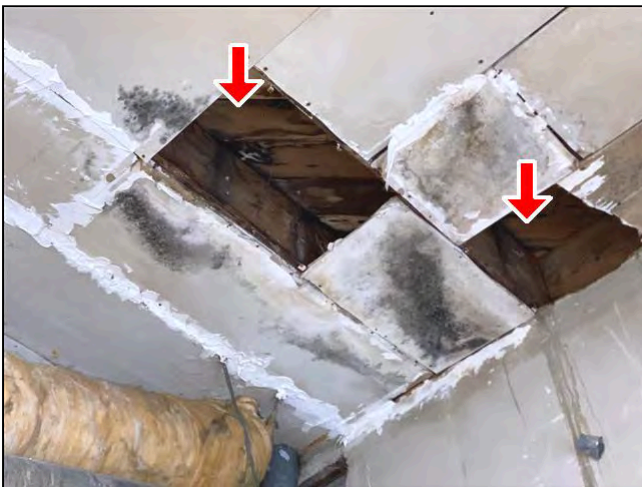
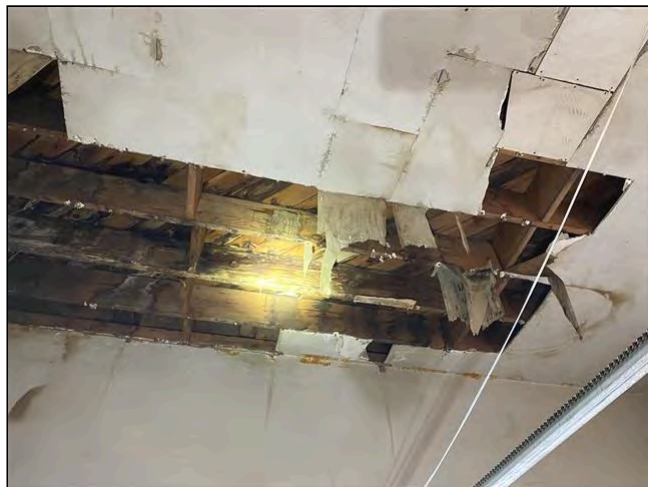
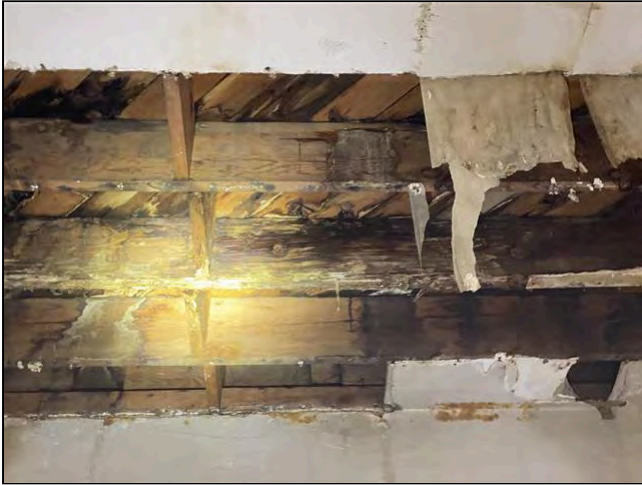
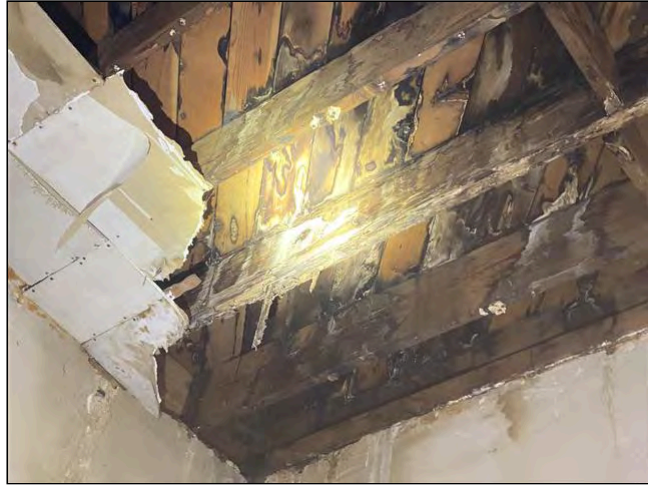
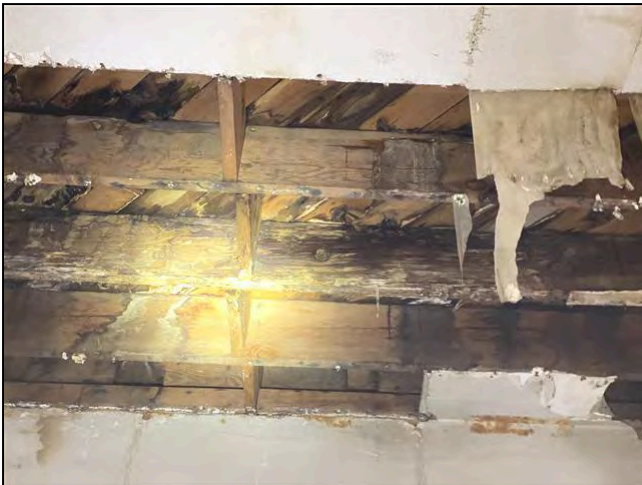
18. (1) **Major Concern:** A significant amount of water damage was observed at the exposed structure at the garage ceiling. The balcony deck above this location appears to have been leaking for sometime causing a considerable amount of damage to the structure. There is an extra risk of hidden damage at areas beyond view. Suggest further review by a qualified contractor and structural engineer to provide repair/replacement options and cost.

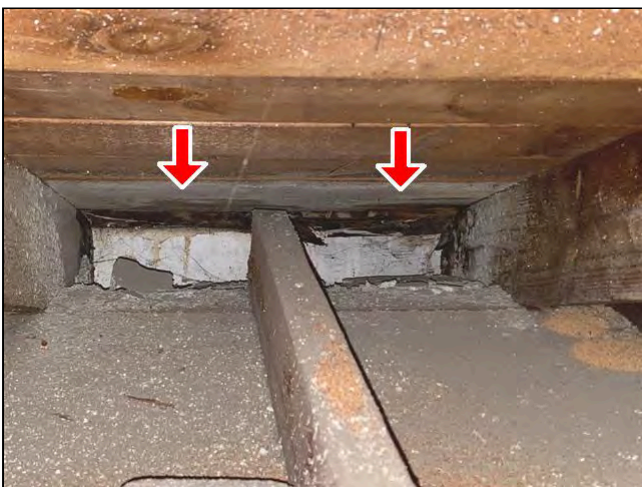
Item 19 - Item 1(Picture) Structural Components

19. (2) **Repair or Replace:** Wood deterioration was observed on the underside of the roof sheathing along the edge of the roof. Deterioration is possible due to the current condition of the roofing materials. If the home inspection reveals signs of damage you should have a pest control company inspect further for activity and possible hidden damage. Suggest repair/replacement of all deteriorated wood by a licensed contractor.

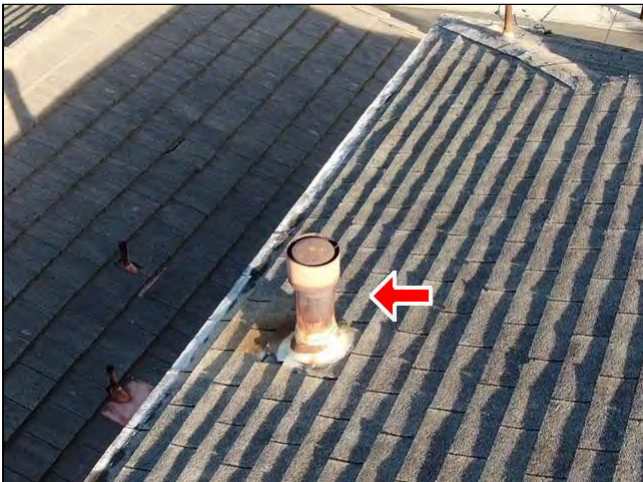
Item 22 - Item 1(Picture) Heating/Central Air

22. (1) **Repair or Replace:** The forced air heater metal exhaust vent is rusted. Suggest replacement of the venting system by a qualified HVAC contractor.

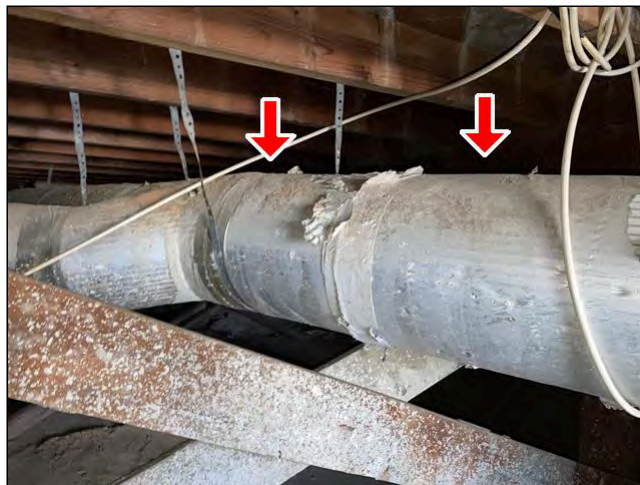
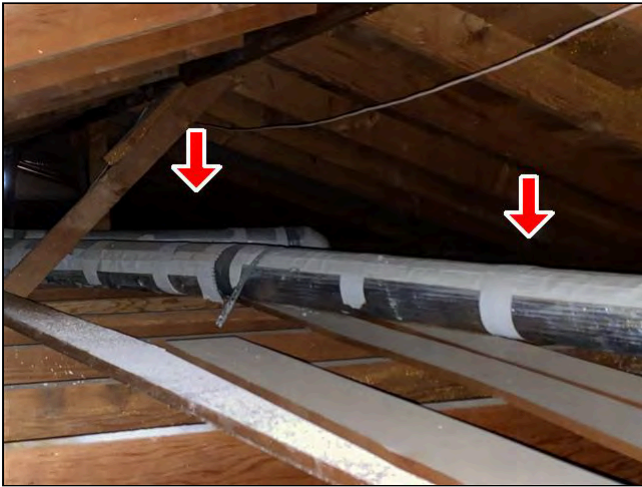
24. **Safety Issue:** The ducting for the forced air heater appears to be asbestos. The identification of Asbestos is outside the scope of this inspection. We suggest a qualified environmental specialist should be retained to evaluate the ducting and make further recommendations. Testing and remediation of Asbestos can only be accomplished by a qualified environmental specialist. If strict protocol is not followed, Asbestos can be released into the interior of the building and may create a health hazard. The ducting material shows signs of deterioration in many locations. The Environmental Protection Agency (E.P.A.) reports that asbestos represents a health hazard if "friable" (damaged, crumbling, or in any state that allows the release of fibers). Suggest further review, testing and removal by a qualified professional.

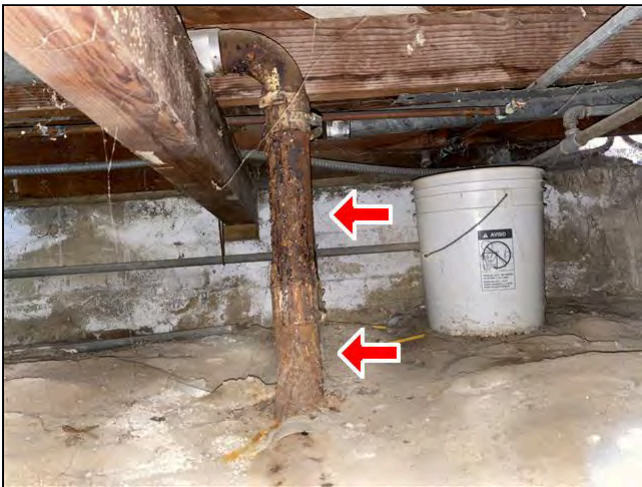
Item 25 - Item 1(Picture) Plumbing System

25. (1) **Repair or Replace:** The cast iron drain pipes at the rear area of the crawl space are corroded and leaking. The drain pipes are in need of replacement. Suggest further review and replacement by a qualified plumber.

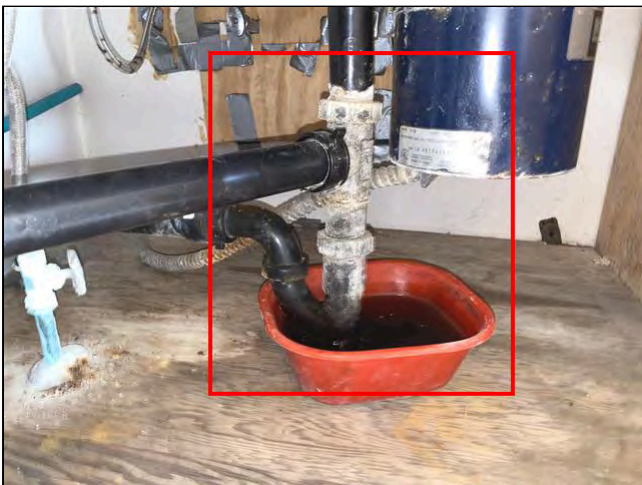
Item 26 - Item 1(Picture) Plumbing System

26. (2) **Repair or Replace:** The kitchen sink drain pipe is leaking. Suggest repair by a qualified professional.

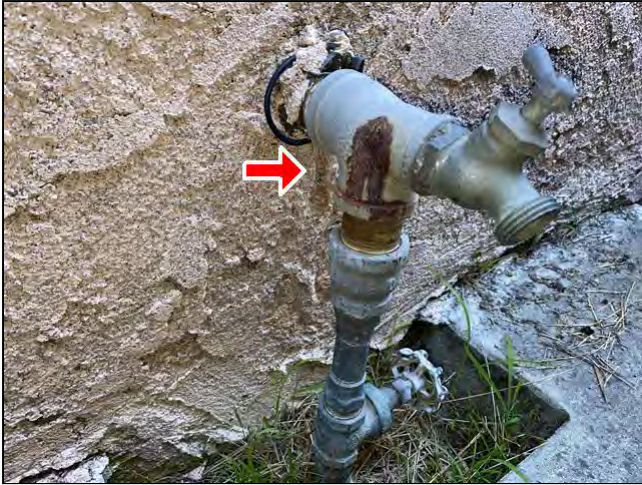
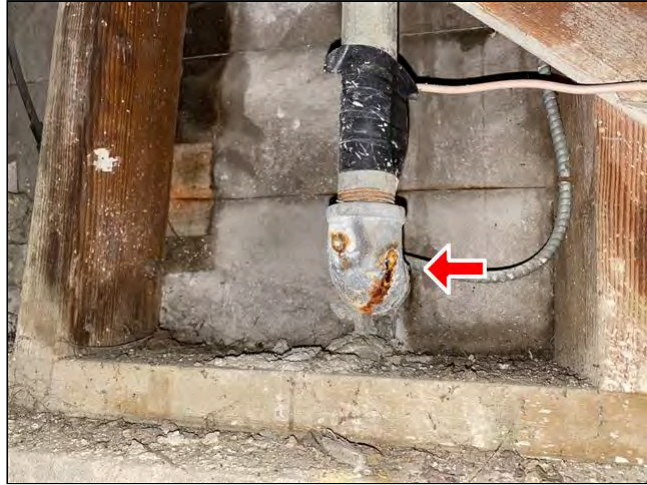
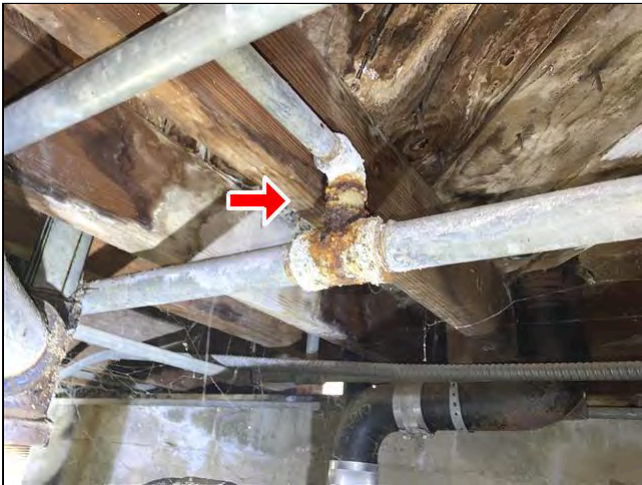
28. (1) **Major Concern:** Galvanized steel pipes are used in the interior water supply, and generally have a finite life span. The quality of the plating, installation methods, water temperature, water quality and water usage all factor into the actual serviceable life. Scale builds up inside the pipe which eventually restricts the flow of water to the fixtures. Corrosion eats away at the inside of the pipes, eventually causing leaks. Thirty to forty years is the average life of galvanized pipes. The exterior surfaces of the galvanized steel pipes are corroded/rusted in many locations. There is visible debris, and possible metal flakes, when water is run to the sinks in the home. The makeup of this debris is unknown. The galvanized steel pipes are in need of replacement. Suggest further review by a qualified plumber to provide replacement options and cost.

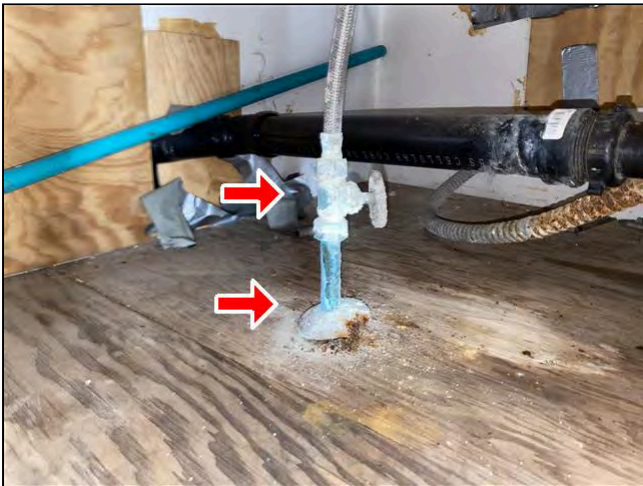
Item 30 - Item 1(Picture) Plumbing System

30. (3) **Repair or Replace:** The water supply pipe at the kitchen sink cabinet floor is corroded. It is suggested that it be replaced by a qualified professional.

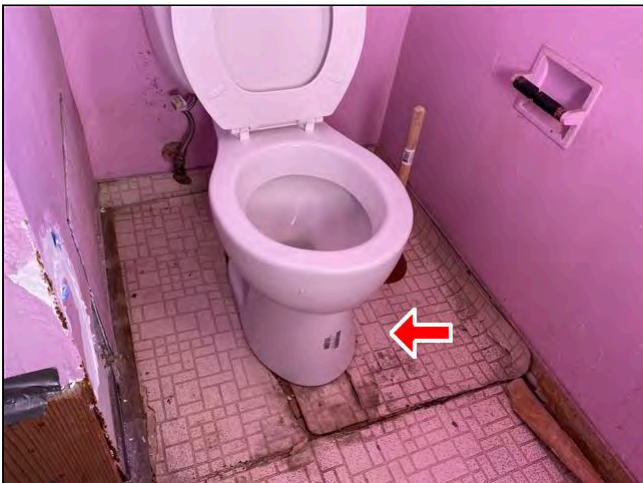
Item 31 - Item 1(Picture) Plumbing System

31. (6) **Repair or Replace:** The second floor bathroom toilet is not securely attached at the floor. This could allow leaks at or into the floor. We suggest if no leaks are evident, the bolts can often simply be tightened with a wrench. We strongly recommend that these toilets be removed and reset by a qualified plumber. At the time the toilet is removed, and before it is reset, the floor in the vicinity of the toilet should be carefully inspected for damage, rot or other deterioration caused by water seeping past the seal at the base of the toilet.

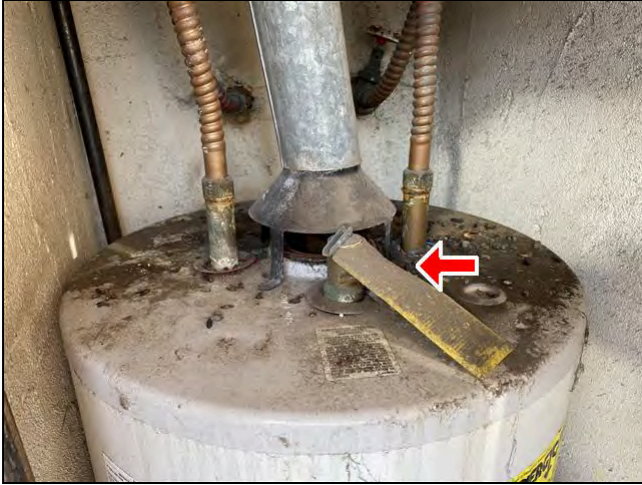
Item 32 - Item 1(Picture) Plumbing System

32. (1) **Safety Issue:** The Temperature and Pressure Relief valve at the water heater needs a 3/4 pipe to extend within 6 to 24 inches of floor for safety, the current building standards require that the discharge pipe be routed to the exterior of the home and terminate in a safe location. (PVC is not approved for hot water use). Recommend repair by a qualified person.

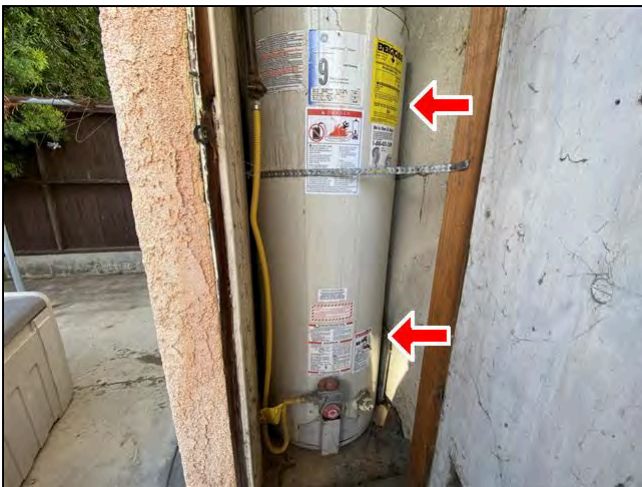
Item 33 - Item 1(Picture) Plumbing System

33. (2) **Safety Issue:** The water heater lacks seismic straps. The water heater is in need of seismic straps to prevent movement during earthquakes. Suggest further review and repairs by a licensed plumber.

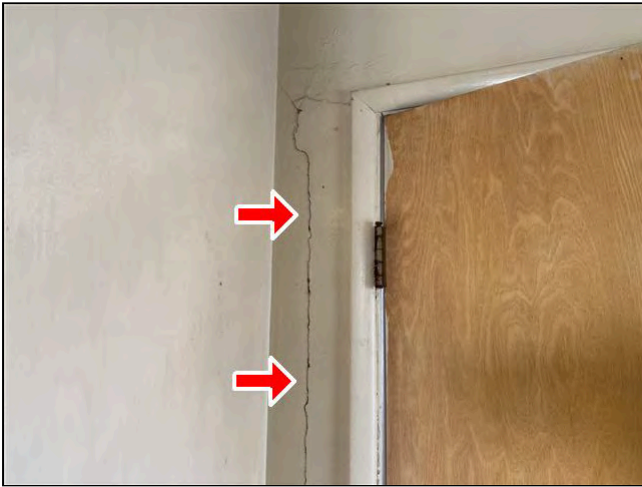
Item 41 - Item 1(Picture) Interiors

41. (3) **Repair/Replace/Monitor:** Evidence of settlement was observed on the interior wall/ceiling finishes. The interior wall and ceiling finishes are cracked in various locations within the home. This appears to be common settlement and/or movement with older homes. It is suggested that these areas be repaired and patched by a qualified professional and monitored for additional movement to determine if additional repairs to the home will be required.

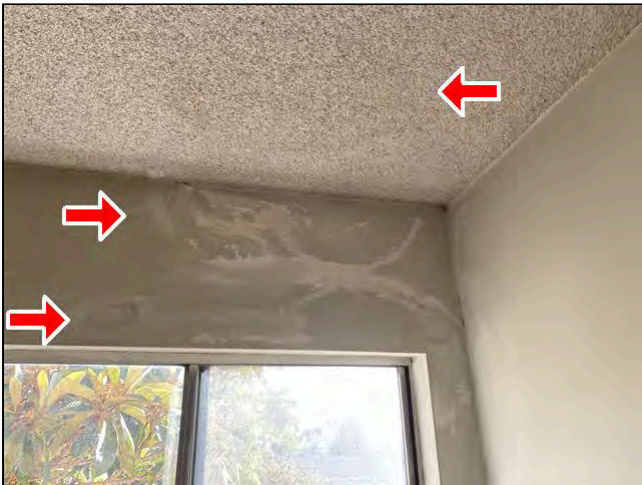
Item 42 - Item 1(Picture) Interiors

42. (4) **Repair or Replace:** Water damage was observed at the second floor front bedroom East interior wall and ceiling. The source of the leak(s) should be identified and repairs performed as necessary. Areas of past and present moisture are favorable for growing many fungal like organisms. There is an extra risk of hidden damage/fungus/mold to be present in this location. The identification of molds, fungus and other microbial organisms is outside the scope of this inspection.

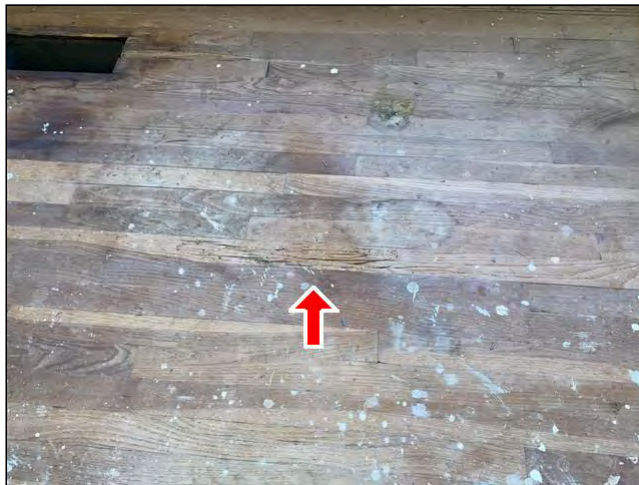
Item 43 - Item 2(Picture) Interiors

43. (1) **Repair or Replace:** Wood deterioration was observed at the living room floor boards in various locations. If the home inspection reveals signs of damage you should have a pest control company inspect further for activity and possible hidden damage. Suggest repair/replacement of all deteriorated wood by a licensed contractor.

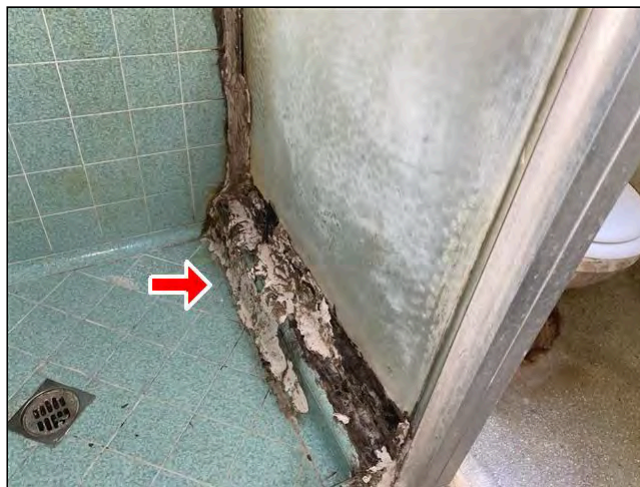
Item 47 - Item 2(Picture) Interiors

47. (1) **Safety Issue:** There is surface growth and fungal like growth observed at the first floor bathroom in many locations. This may indicate the presence of mold, fungus or other microbial organisms. Areas of past and present moisture are favorable for growing many fungal like organisms. The identification of molds, fungus and other microbial organisms is outside the scope of this inspection. We suggest a qualified environmental specialist should be retained to evaluate the surfaces and make further recommendations. Testing and remediation of mold growth can only be accomplished by a qualified environmental specialist. If strict protocol is not followed, spores can be released into the interior of the building and may create a health hazard for those with low tolerances to such organisms.

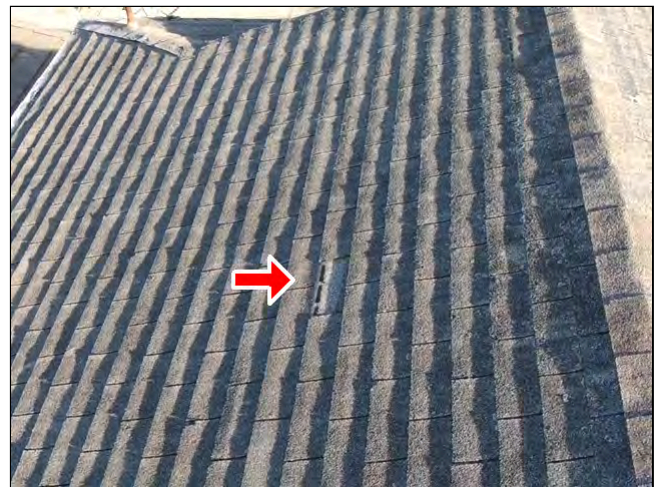
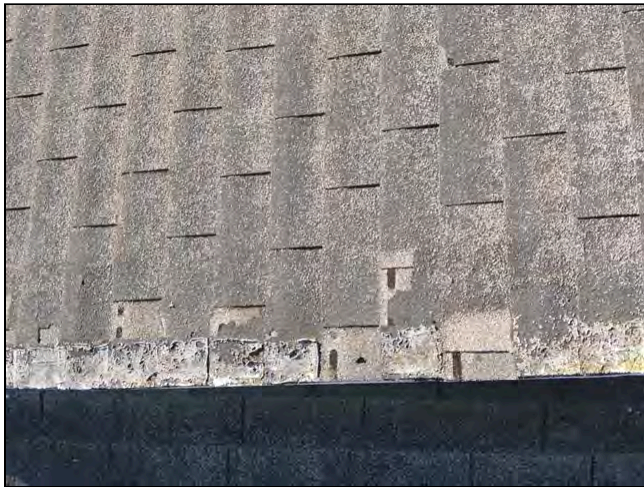
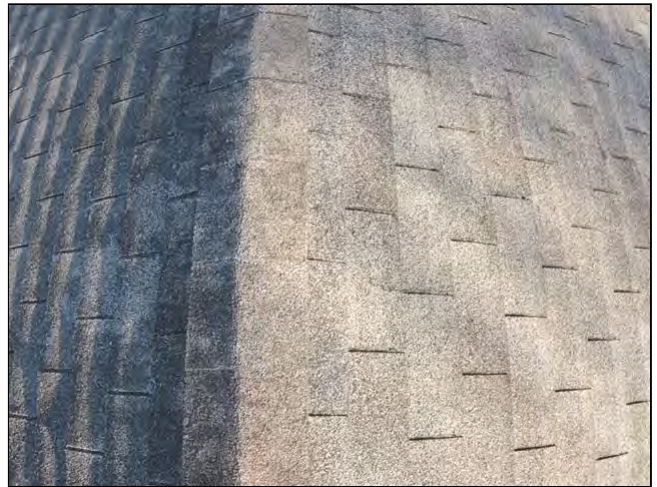
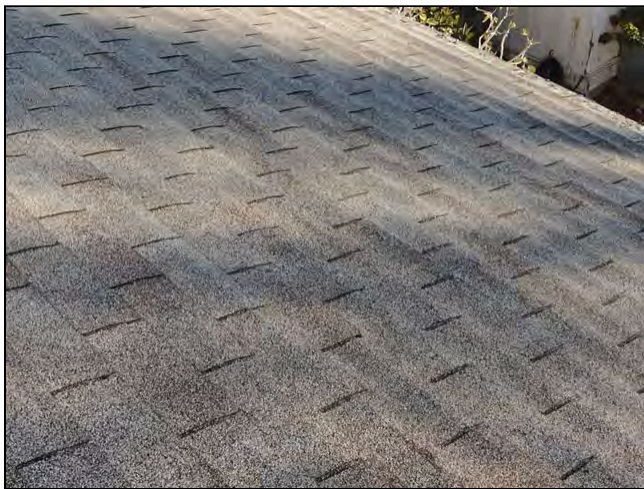
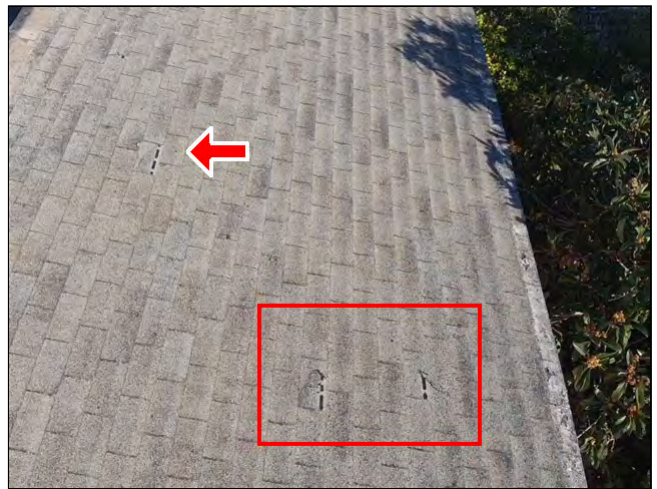
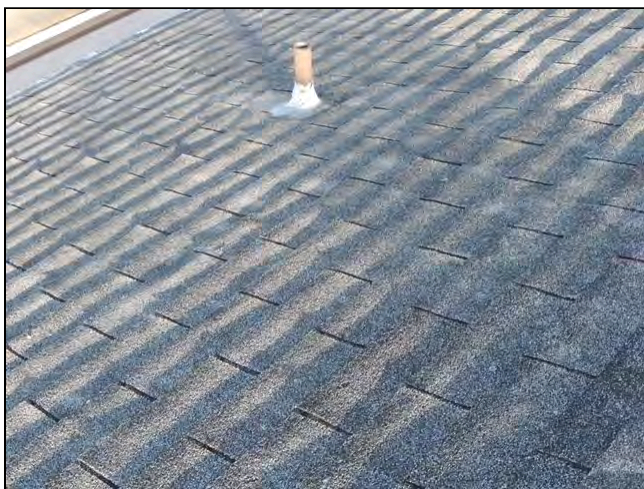
(1) **Major Concern:** The composition shingle roofing is wearing at uneven rates. The sides of the roofing that are more exposed to the sun's light are wearing more quickly than other areas. Also, there are missing/torn shingles in many locations. The composition asphalt shingle roof is at the end of its service life. It is in need of replacement. Suggest further review by a qualified roofing contractor to provide replacement options and cost.

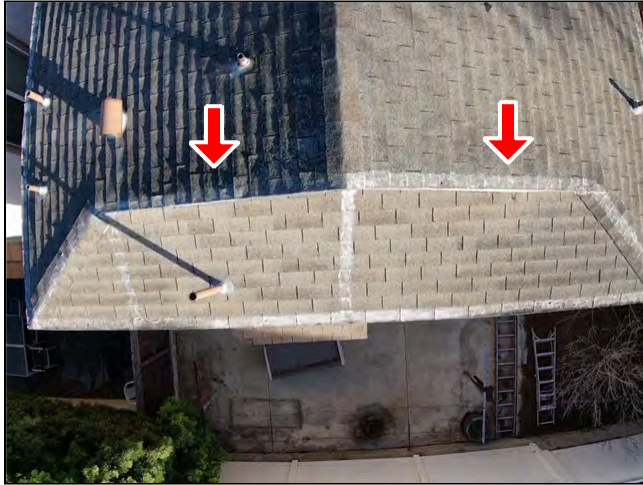
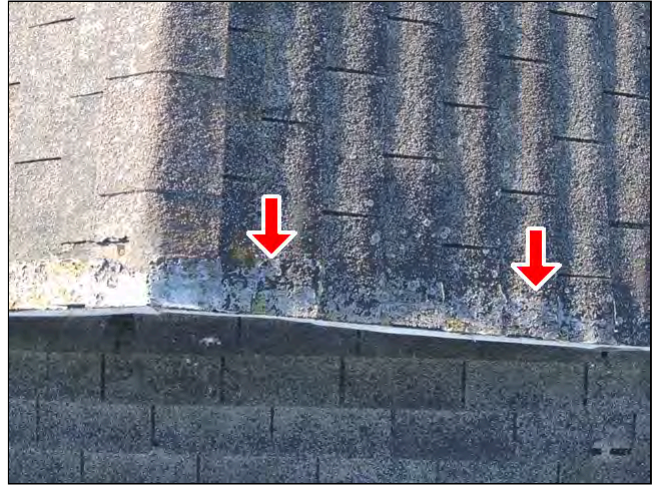
(2) **Monitor:** The edge of the roof is covered with paint/mastic throughout. This is an indication of a past problem and note that these areas could not be properly viewed and will require ongoing maintenance. Leaks can be difficult to repair, as the source of the leakage can be far removed from the water stains that shows up on the interior.

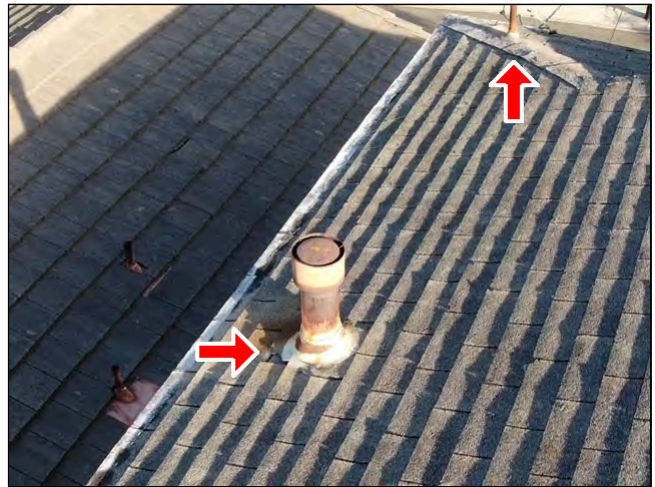
1.1 Item 2(Picture) Roofing

**Repair or Replace:** The mastic at all rooftop vents and penetrations is weathered and cracked. It is suggested that all vent and penetrations be examined and sealed with approved material by a qualified professional.

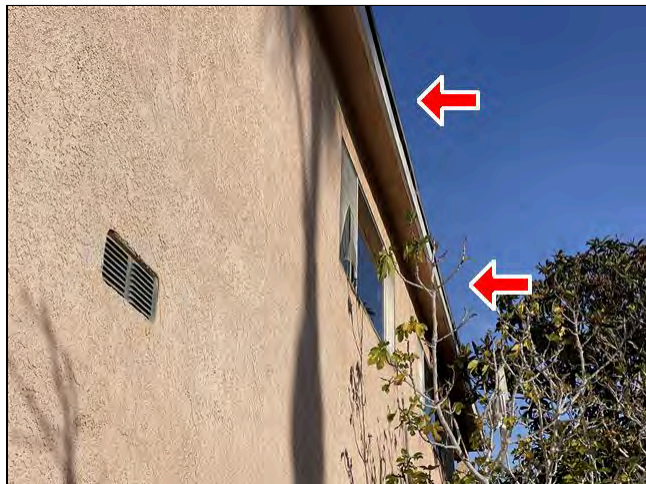
1.3 Item 1(Picture) Roofing

**Improve:** It is suggested that gutters and downspouts be installed throughout the roofing to prevent damage/deterioration to the foundation and exterior walls.

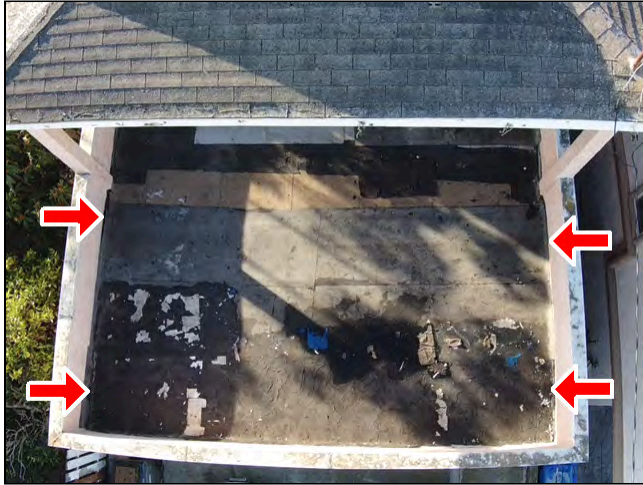
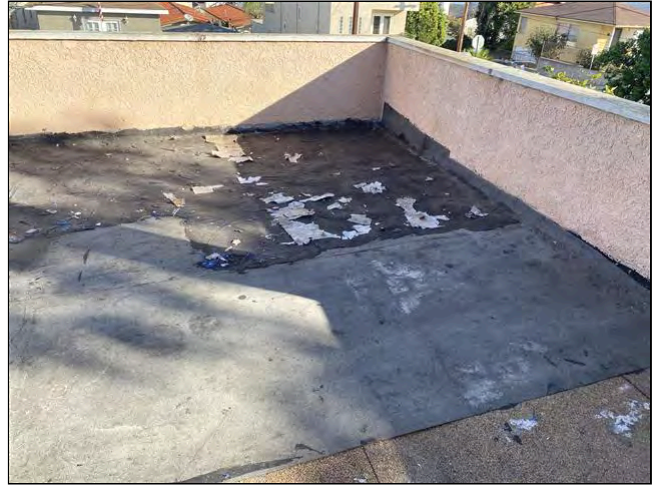
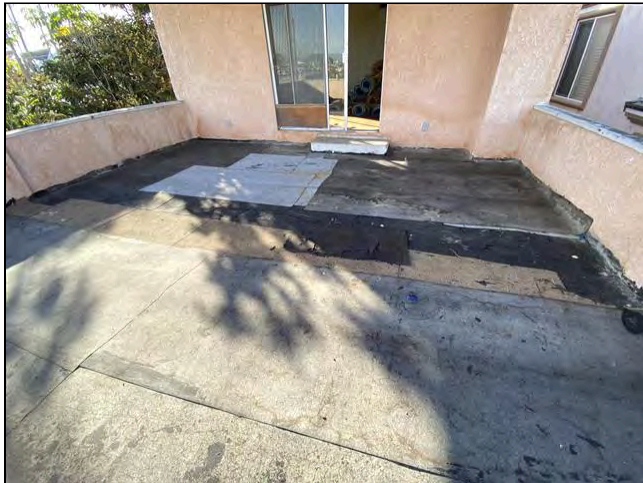
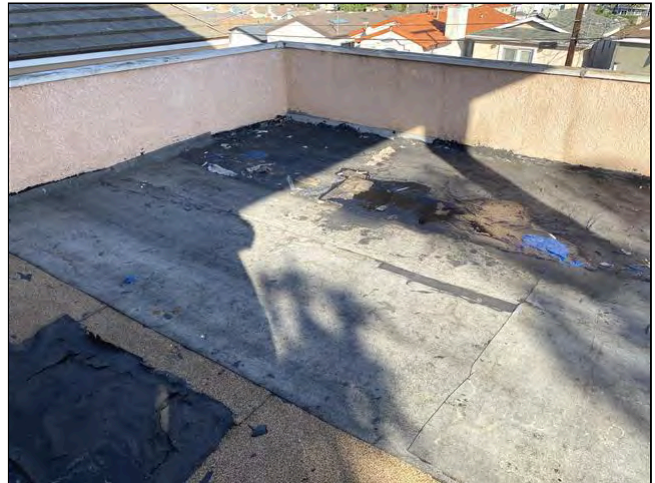
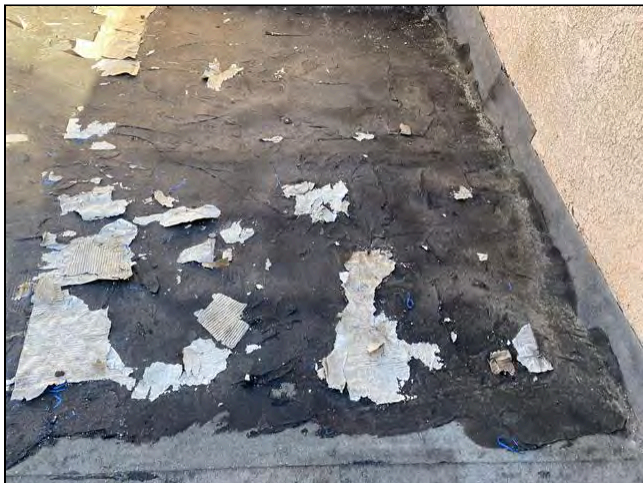
(1) **Major Concern:** The repairs performed at the front wall balcony are non-conforming. The repairs performed at the front balcony appear to have been done by a non-professional. They are not in accordance with industry standards. We suggest that the entire balcony and structure should be evaluated by a qualified contractor to provide replacement options and cost.

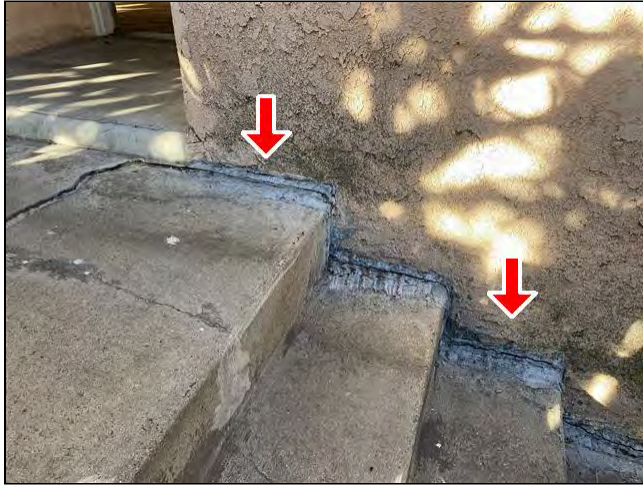
2.0 Item 6(Picture) Exterior

(2) **Repair or Replace:** The steps at the East exterior wall of the home have been installed directly to the

exterior wall. No visible flashing was observed between the exterior wall and steps. Possible seepage can occur. This area shows signs of settlement and previous repair. This would suggest that water and/or moisture has entered the home and structure. Recommend further evaluation and repairs by a qualified contractor.
