# Inspection Report

**Property Address:**  
1642 Havemeyer Ln  
Redondo Beach CA 90278

## Professional Inspection Network

<b>Property Address</b> 1642 Havemeyer Ln Redondo Beach CA 90278	<b>Date of Inspection</b> 11/4/2022	<b>Report ID</b> 20221104-1642-Havemeyer-Ln
<b>Customer(s)</b> Sylvia Pulido Richard Colin	<b>Time of Inspection</b> 09:00 AM	<b>Real Estate Agent</b> Joe Safranek Beach City Brokers
<b>Inspection Details</b>		
<b>In Attendance:</b> Seller and Seller's Agent	<b>Type of building:</b> Single Family (2 story)	<b>Approximate age of building(s):</b> 55 Years Old
<b>Building(s) Faces:</b> North	<b>Temperature:</b> Over 60 (F) = 15.5 (C)	<b>Weather:</b> Clear
<b>Ground/Soil surface condition:</b> Dry	<b>Rain in last 3 days:</b> No	<b>Radon Test:</b> No
<b>Water Test:</b> No

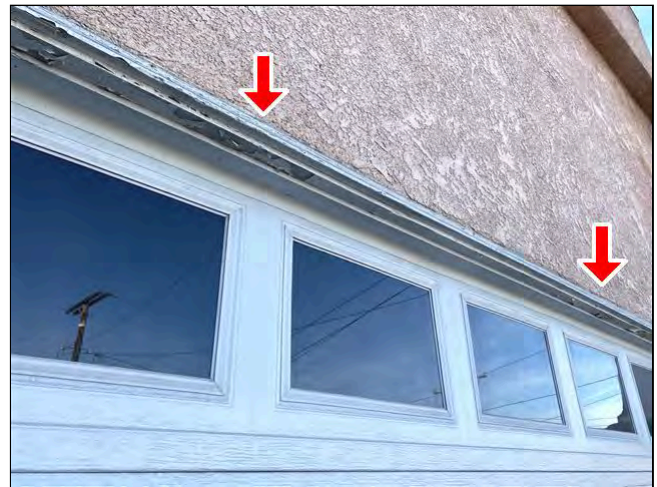
2.0 Item 8(Picture) Exterior

(3) **Repair or Replace:** The exterior wooden elements throughout the exterior of the home have not been maintained for some time. The wooden trims, doors, fascia boards, eaves, rafters and etc require (in various degrees) repair, replacement, sanding and painting. Suggest further evaluation by a qualified trades person determination, evaluation and or corrective repairs and replacement.

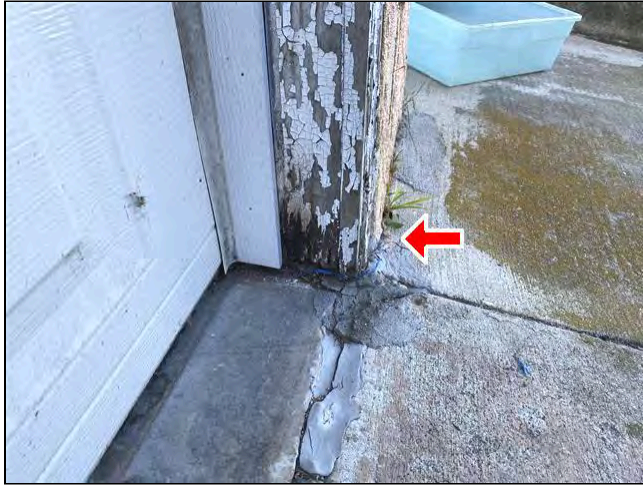
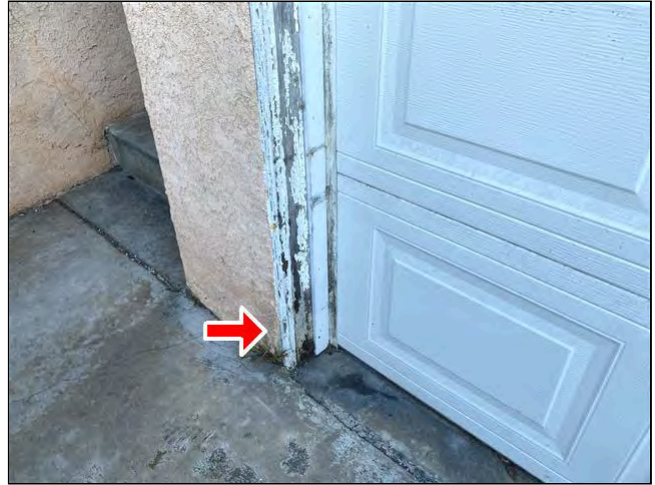
(4) **Repair or Replace:** Wood deterioration was observed at the base of the garage overhead door frame. The wood frame is in contact with the ground. This configuration is prone to rot and insect activity. If the home inspection reveals signs of damage you should have a pest control company inspect further for activity and possible hidden damage. Suggest repair/replacement of all deteriorated wood by a licensed contractor.

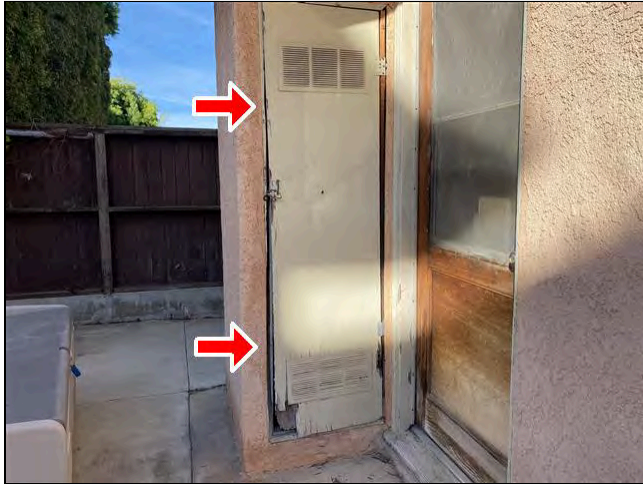
2.1 Item 1(Picture) Exterior

**Repair or Replace:** The rear exterior wall water heater closet door is deteriorated. The door and frame are in need of replacement. Suggest replacement by a qualified contractor.

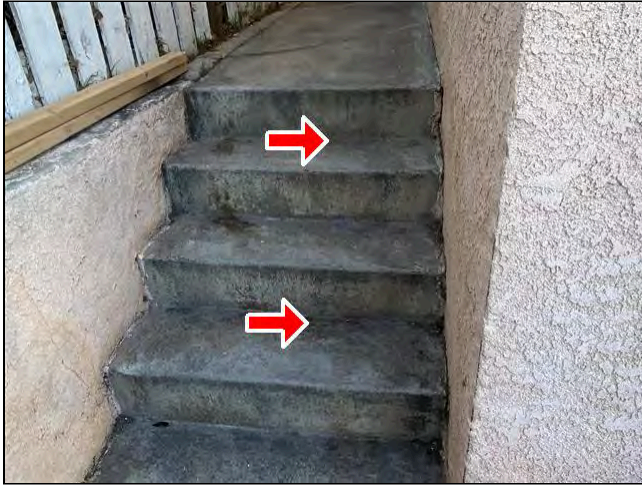
2.4 Item 2(Picture) Exterior

(2) **Repair or Replace:** There is a negative slope towards the home at the front East wall. This configuration can cause or contribute to water intrusion or deterioration of the foundation. Water can be detrimental to the integrity of the foundation of the house. It is important to prevent or minimize standing water around the house. Recommend further evaluation by a qualified grading contractor to determine corrections needed.

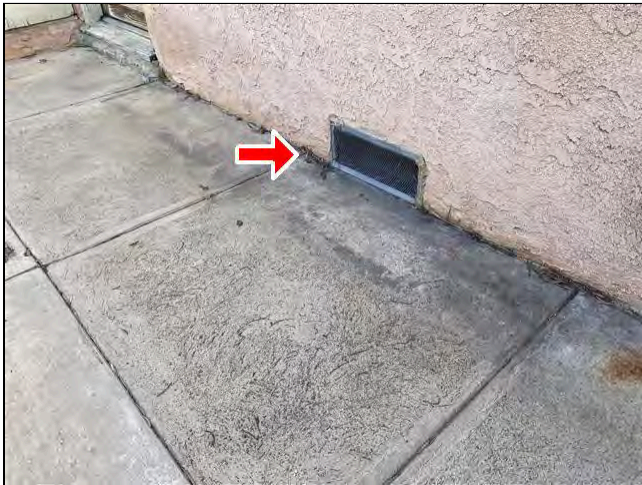
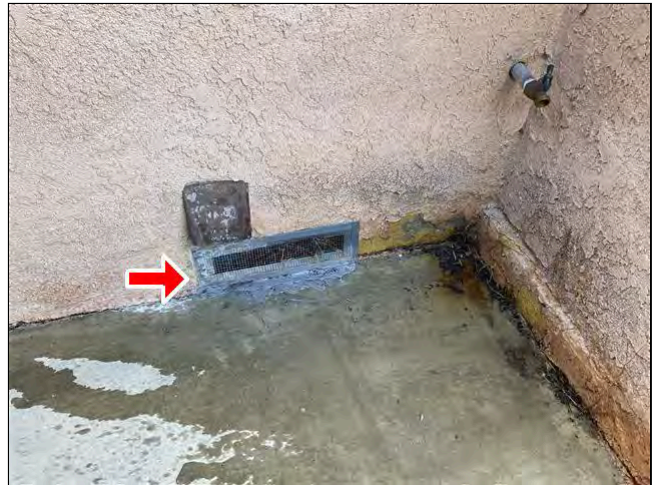
(3) **Improve:** The crawl space vent openings are at grade level in many locations. This configuration can allow water to enter the crawl space and cause damage. Suggest further review by a qualified contractor to provide drainage options and cost.

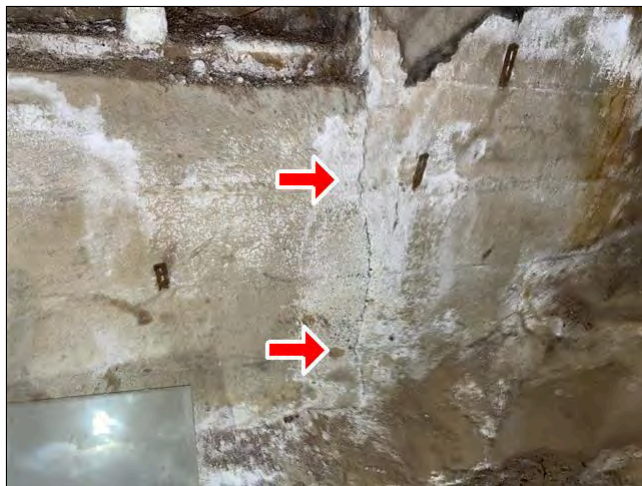
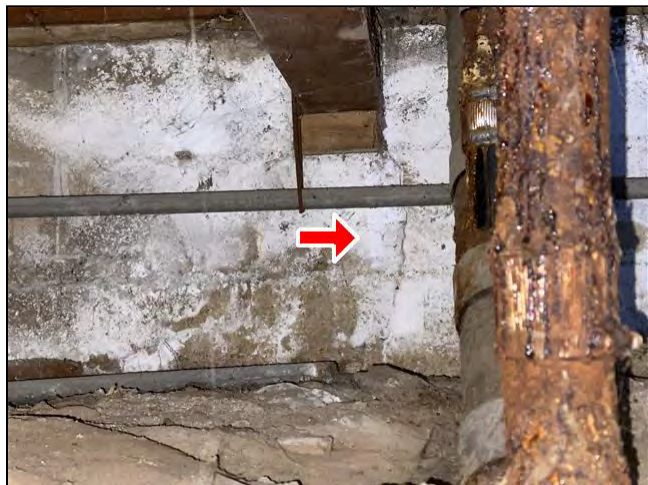
(2) **Repair or Replace:** Signs of cracking and movement were visible in portions of the foundation at more than one location. Although the cracking is isolated to these areas, we feel this could affect the performance of the entire foundation, especially during seismic activity. We suggest a qualified foundation contractor or structural engineer should evaluate the foundation, and determine what repairs are needed.

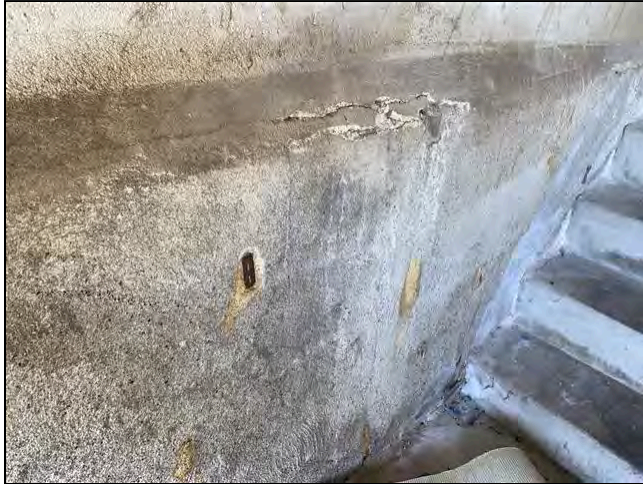
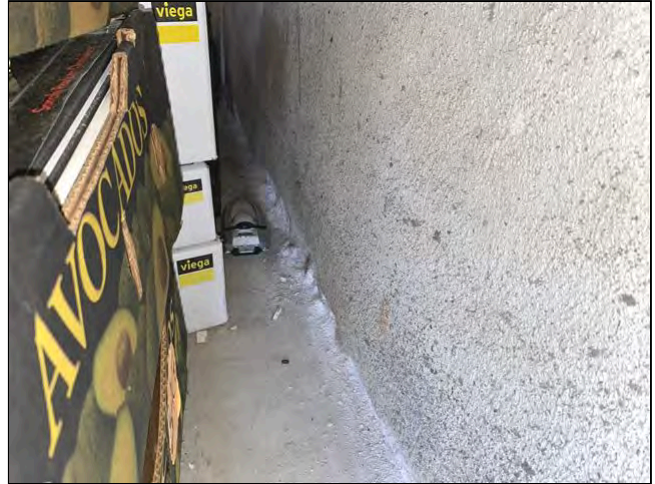
(4) **Improve/Monitor:** A condition known as efflorescence is evident on portions of the garage foundation walls or slab. This whitish, fuzzy material is a mineral deposit left when moisture in the concrete evaporates. The presence of efflorescence often indicates an occasional surplus of moisture on the outside of the foundation. We suggest to keep the exterior moisture to a minimum, exterior surface drainage, including downspout water, should be directed as far away from the building as possible. Landscape watering should always be directed away from the building and limited to short durations.

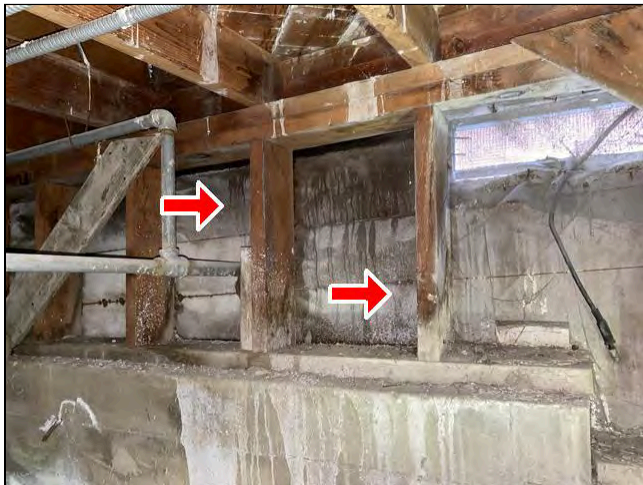
3.0 Item 7(Picture) Structural Components

(5) **Improve:** The cripple walls have not been reinforced and/or lack adequate support from movement. It is suggested that the cripple walls be reinforced by a qualified professional. The primary purpose of earthquake retrofitting is to keep your home/cripple walls from movement - making the building safer and less prone to major structural damage during an earthquake. Existing homes need to be retrofitted because our understanding of the effects of earthquakes as well as construction techniques have improved after the homes were built.

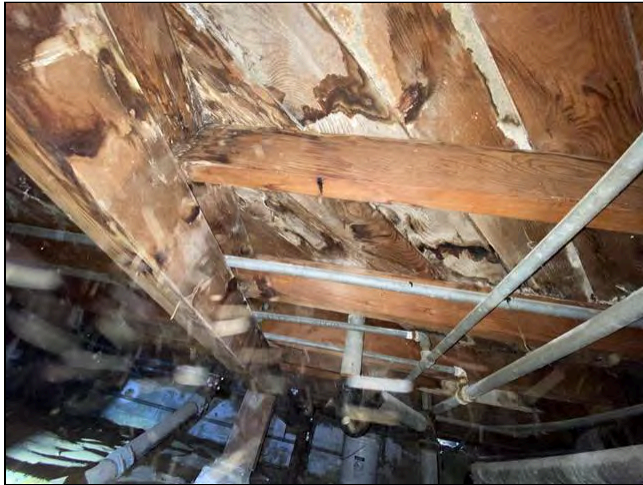
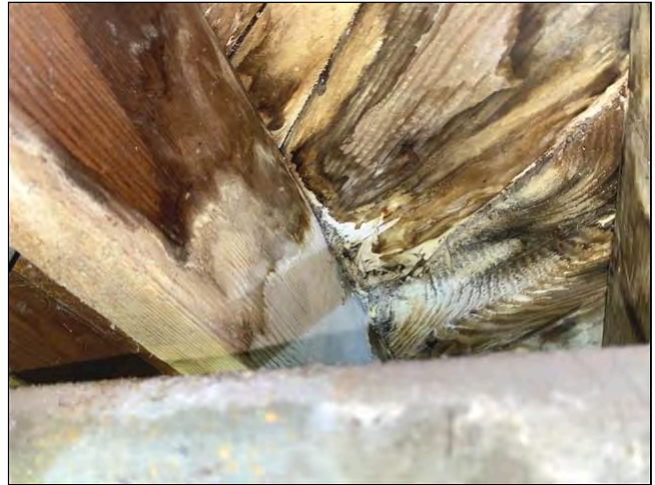
(1) **Repair or Replace:** Water staining, wood deterioration and possible fungus was observed at the first floor bathroom subfloor. It is suggested that the subfloor below bathrooms be further evaluated by a qualified contractor to determine if wood subfloors or in need of repair and or replacement.

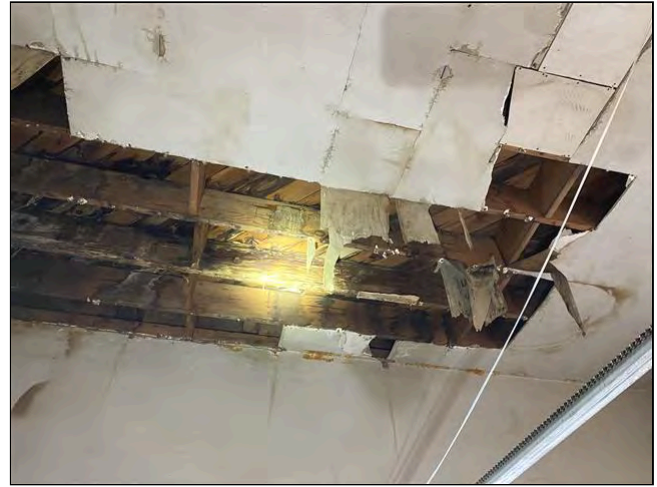
3.5 Item 2(Picture) Structural Components

(1) **Major Concern:** A significant amount water damage was observed at the exposed structure at the garage ceiling. The balcony deck above this location appears to have been leaking for sometime causing a considerable amount damage to the structure. There is an extra risk of hidden damage at areas beyond view. Suggest further review by a qualified contractor and structural engineer to provide repair/replacement options and cost.

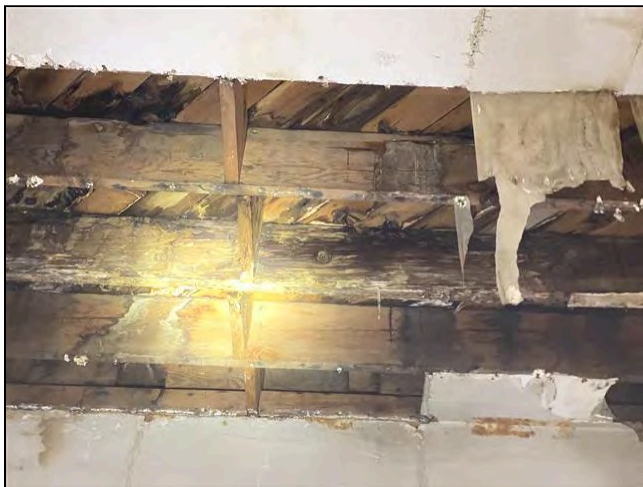
3.5 Item 5(Picture) Structural Components

(2) **Repair or Replace:** Wood deterioration was observed on the underside of the roof sheathing along the edge of the roof. Deterioration is possible due to the current condition of the roofing materials. If the home inspection reveals signs of damage you should have a pest control company inspect further for activity and possible hidden damage. Suggest repair/replacement of all deteriorated wood by a licensed contractor.

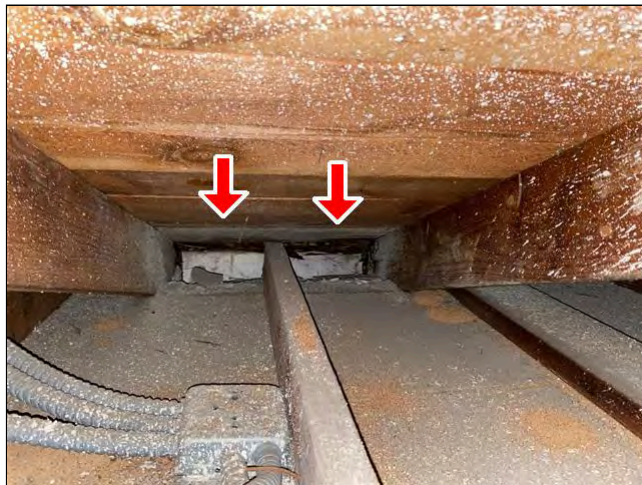
3.5 Item 7(Picture) Structural Components

(3) **Monitor:** Water staining was observed on the underside of the roof sheathing and structure in various locations. The source of the leak(s) should be identified and repairs performed as necessary.

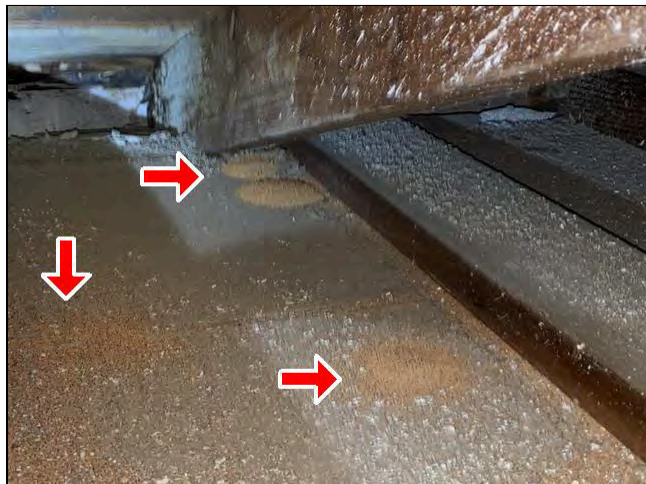
3.5 Item 9(Picture)

(4) **Monitor:** Signs of insect activity (possible wood destroying) was observed at the attic space of the home in many locations.

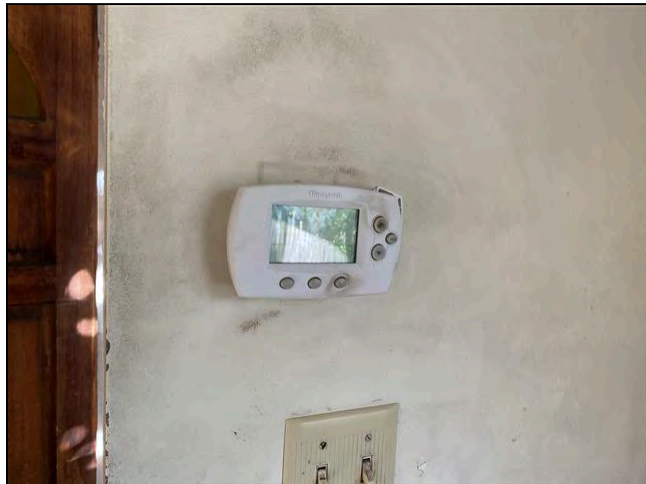
4.2 Item 1(Picture) Heating/Central Air

**Repair or Replace:** The thermostat for the forced air heater is inoperative. Unable to test and operate the forced air heater during the inspection.

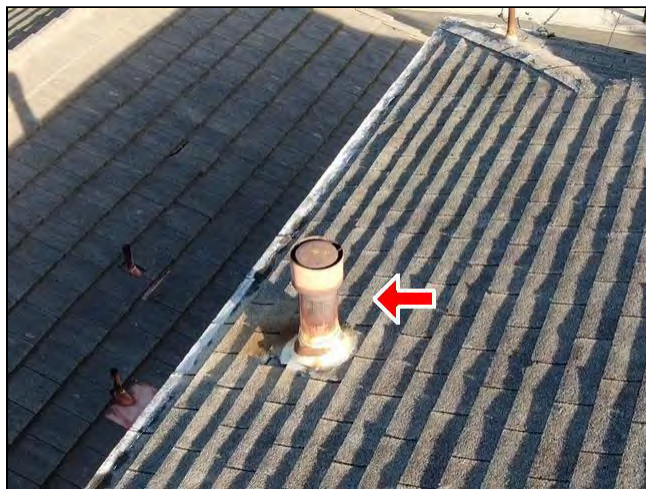
4.3 Item 1(Picture) Heating/Central Air

(1) **Repair or Replace:** The forced air heater metal exhaust vent is rusted. Suggest replacement of the venting system by a qualified HVAC contractor.

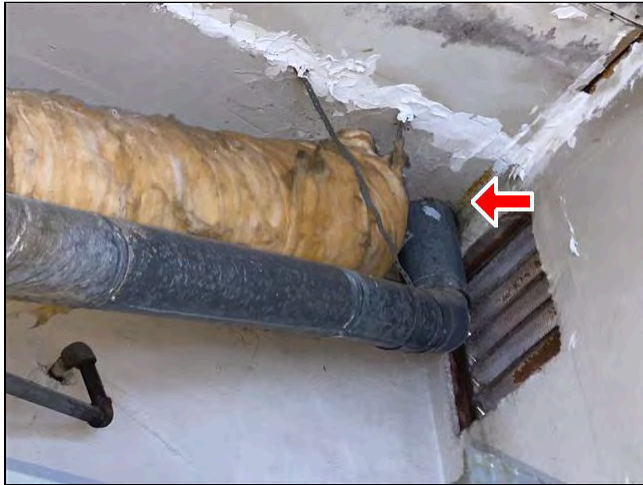
4.3 Item 2(Picture) Heating/Central Air

(2) **Safety Issue:** The forced air heater vent passes through a ceiling or wall without the use of an approved thimble or spacer. This could be a fire hazard. We suggest a qualified technician should install an approved, listed thimble or spacer.

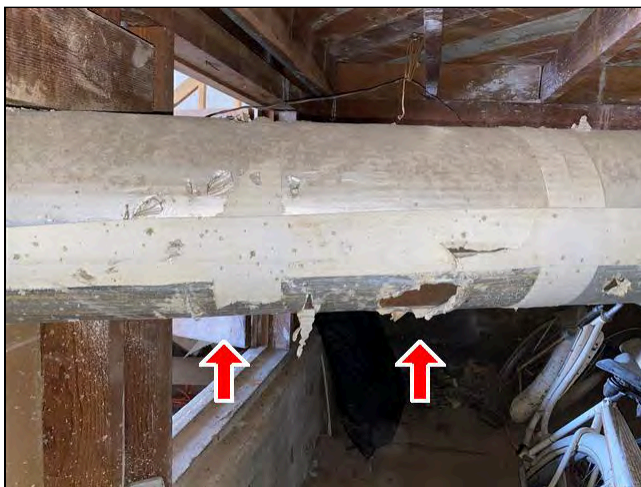
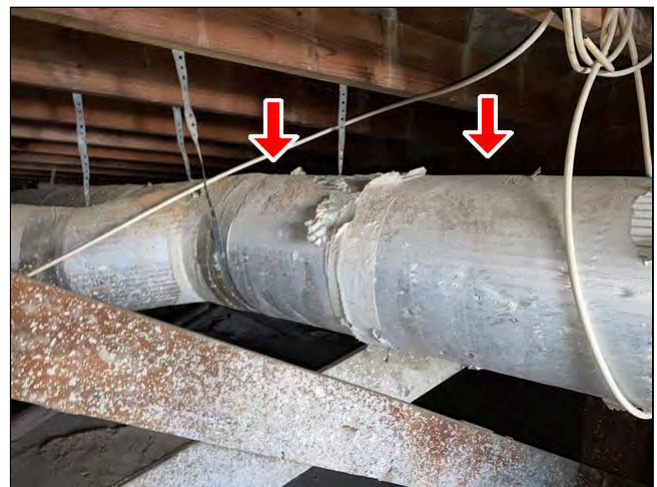
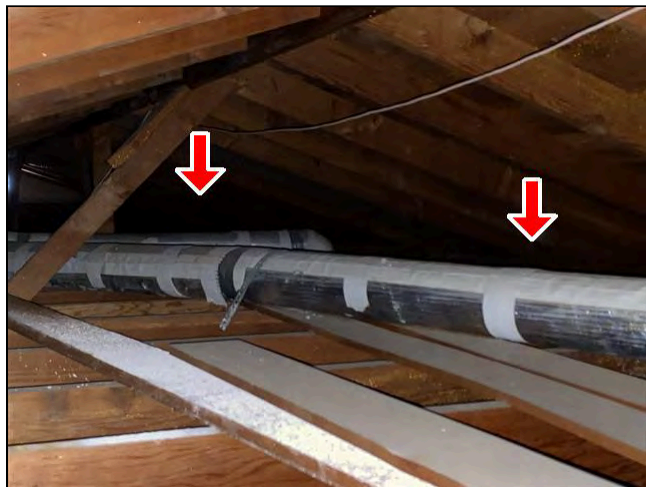
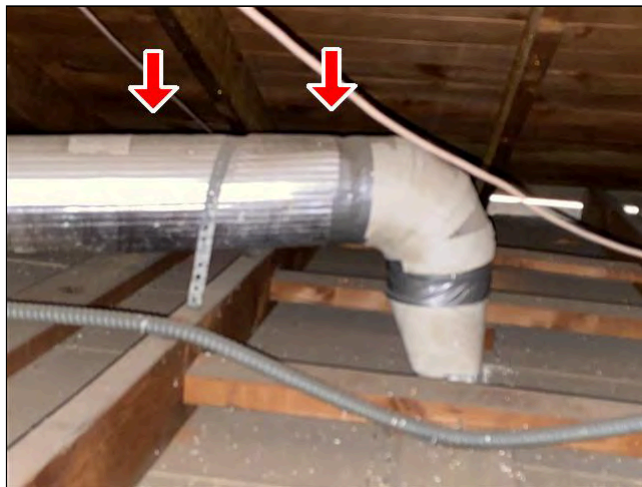
**Safety Issue:** The ducting for the forced air heater appears to be asbestos. The identification of Asbestos is outside the scope of this inspection. We suggest a qualified environmental specialist should be retained to evaluate the ducting and make further recommendations. Testing and remediation of Asbestos can only be accomplished by a qualified environmental specialist. If strict protocol is not followed, Asbestos can be released into the interior of the building and may create a health hazard. The ducting material shows signs of deterioration in many locations. The Environmental Protection Agency (E.P.A.) reports that asbestos represents a health hazard if "friable" (damaged, crumbling, or in any state that allows the release of fibers). Suggest further review, testing and removal by a qualified professional.

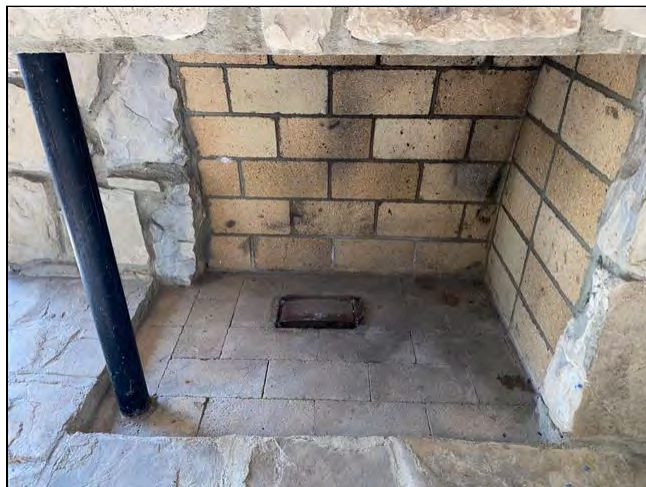
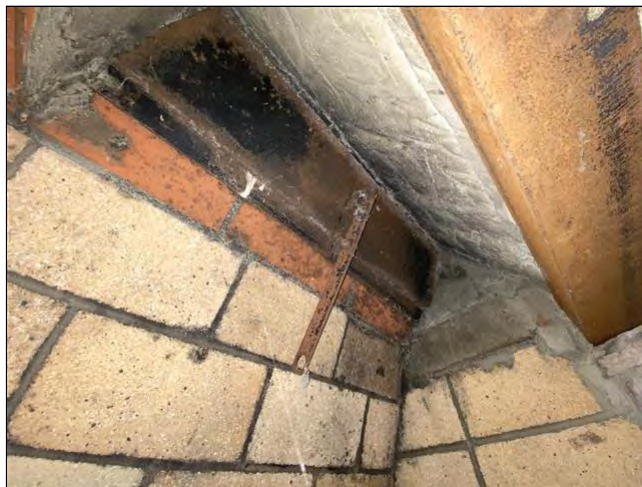
**Monitor:** The NFPA (National Fire Protection Association) 211 standards state that upon a sale or transfer of property a Level II inspection should be conducted on a fireplace and chimney. Please note that a change in burning habits can result in a fire loss or personal injury if the system does not meet or exceed the industry standards and/or manufacturers requirements. This means that a change in operation or use, such as a property resale, is a time of higher risk. We suggest a Level II inspection by a qualified F.I.R.E. and CSIA Certified Fireplace Inspector.

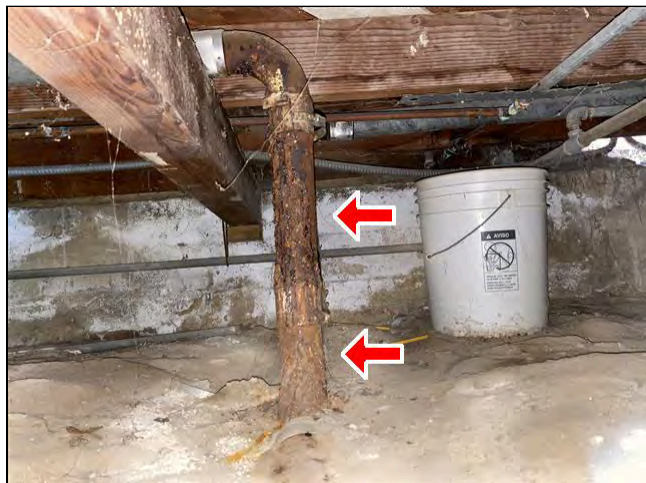
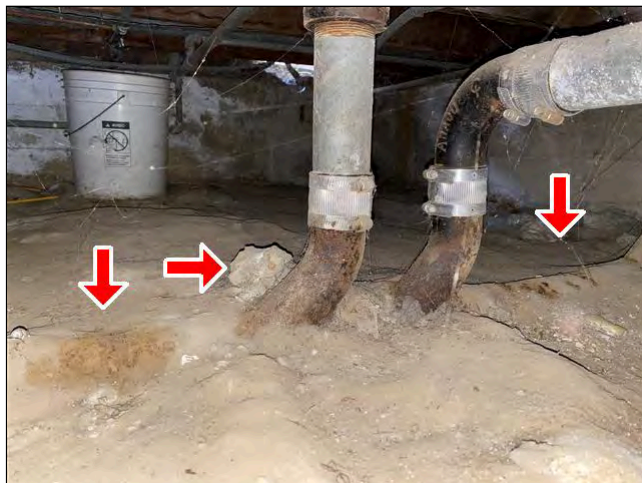
(1) **Repair or Replace:** The cast iron drain pipes at the rear area of the crawl space are corroded and leaking. The drain pipes are in need of replacement. Suggest further review and replacement by a qualified plumber.

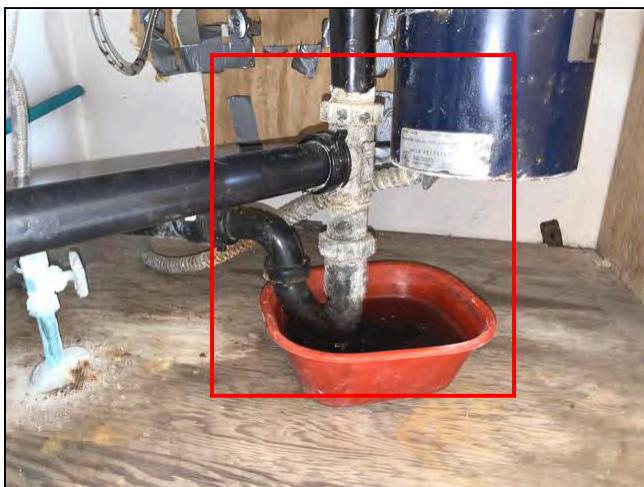
5.0 Item 3(Picture) Plumbing System

(2) **Repair or Replace:** The kitchen sink drain pipe is leaking. Suggest repair by a qualified professional.

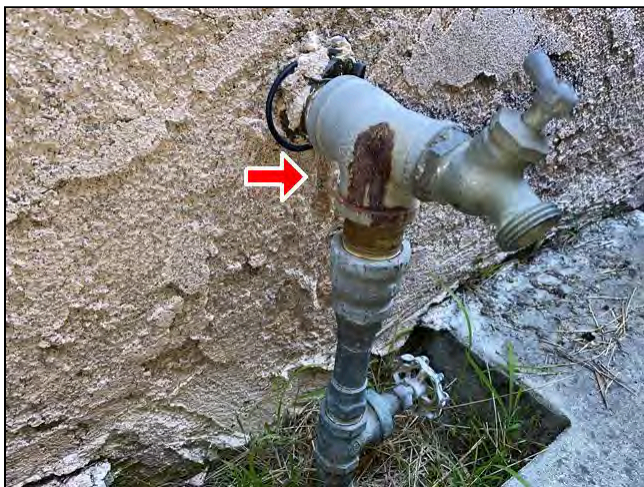
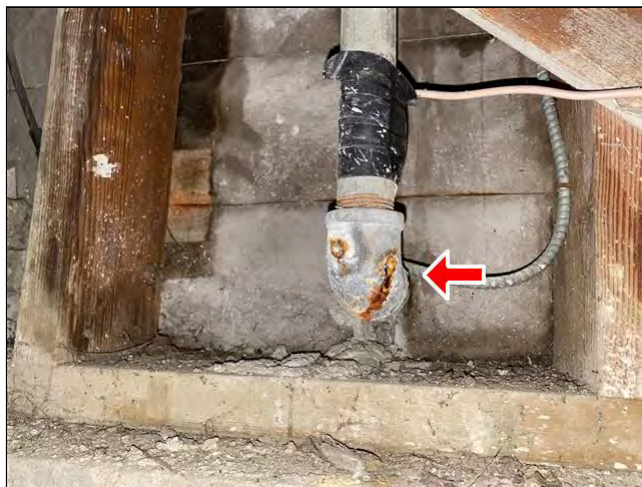
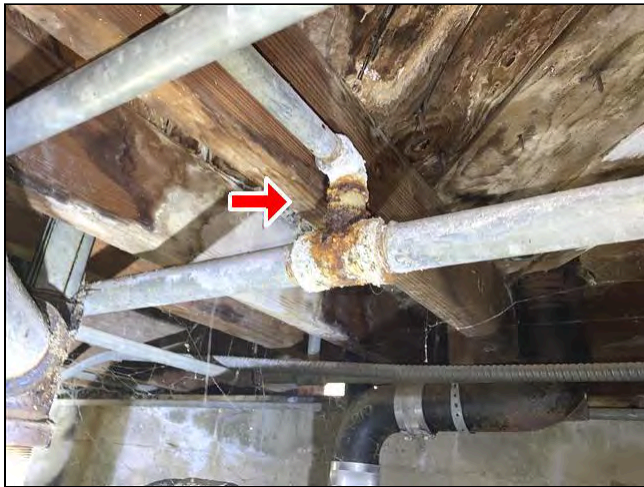
(1) **Major Concern:** Galvanized steel pipes are used in the interior water supply, and generally have a finite life span. The quality of the plating, installation methods, water temperature, water quality and water usage all factor into the actual serviceable life. Scale builds up inside the pipe which eventually restricts the flow of water to the fixtures. Corrosion eats away at the inside of the pipes, eventually causing leaks. Thirty to forty years is the average life of galvanized pipes. The exterior surfaces of the galvanized steel pipes are corroded/rusted in many locations. There is visible debris, and possible metal flakes, when water is run to the sinks in the home. The makeup of this debris is unknown. The galvanized steel pipes are in need of replacement. Suggest further review by a qualified plumber to provide replacement options and cost.

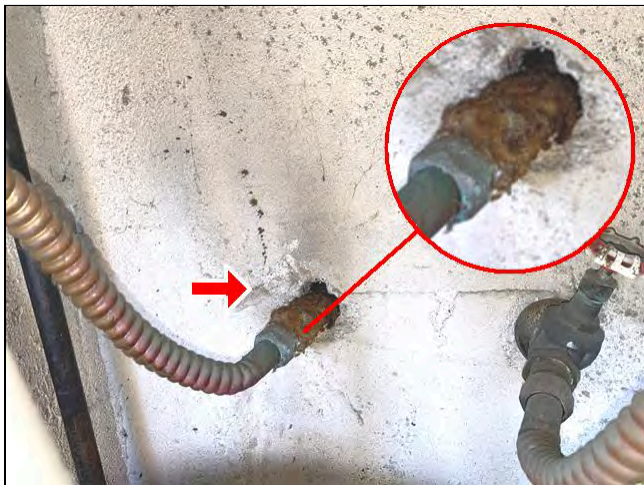
5.1 Item 4(Picture) Plumbing System

(2) **Repair or Replace:** The water supply pipe at the rear wall the water heater is corroded. Although the valve is not leaking it is suggested that it be replaced by a qualified professional.

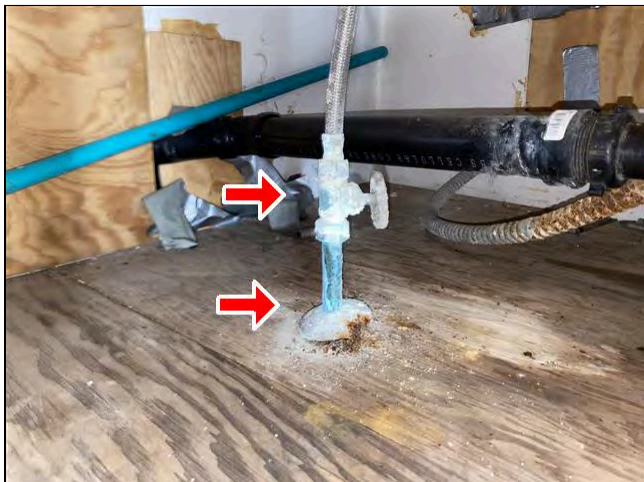
5.1 Item 5(Picture) Plumbing System

(3) **Repair or Replace:** The water supply pipe at the kitchen sink cabinet floor is corroded. It is suggested that it be replaced by a qualified professional.

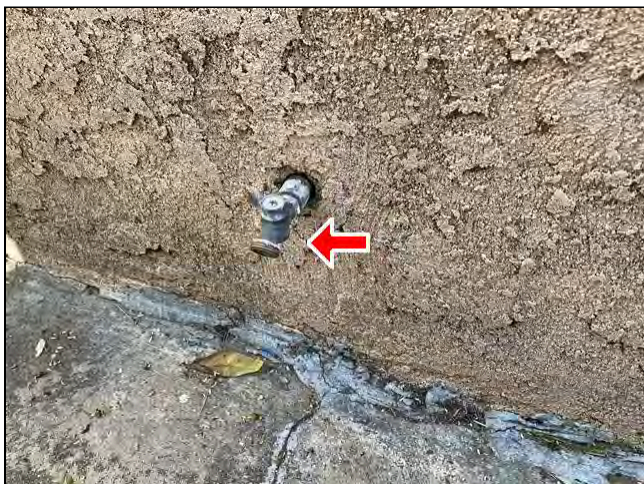
5.1 Item 6(Picture) Plumbing System

(4) **Improve:** All exterior hose bibs should provided vacuum breakers to prevent hose water from being drawn back into the home's water supply system.

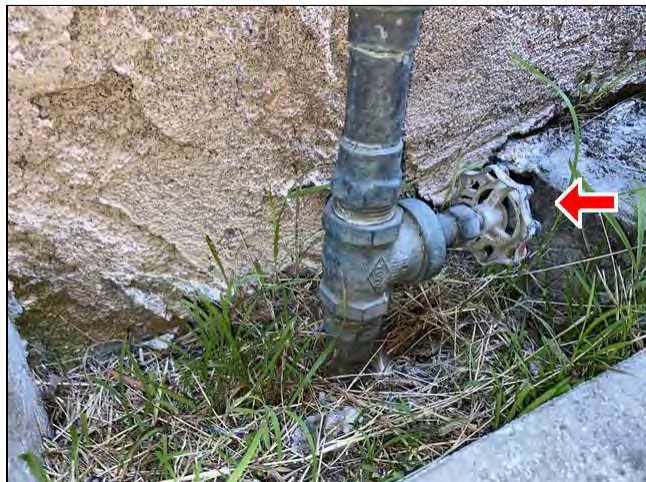
5.1 Item 7(Picture) Plumbing System

(5) **Improve:** It is suggested that the older main water shut off valve at the front exterior wall of the home replaced with a quarter turn ball valve type by a licensed plumber.

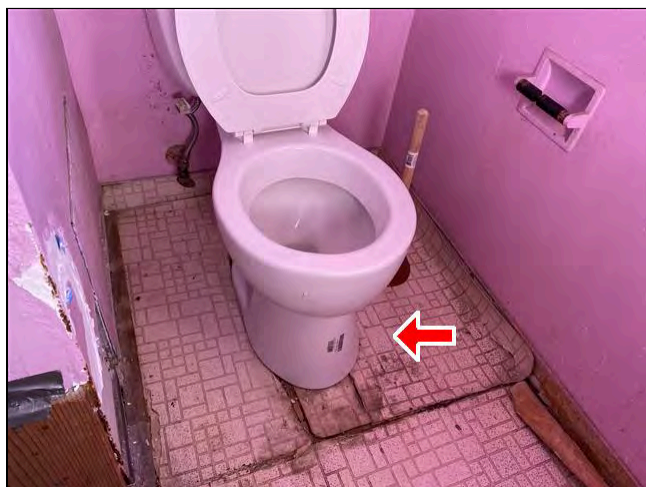
5.1 Item 8(Picture) Plumbing System

(6) **Repair or Replace:** The second floor bathroom toilet is not securely attached at the floor. This could allow leaks at or into the floor. We suggest if no leaks are evident, the bolts can often simply be tightened with a wrench. We strongly recommend that these toilets be removed and reset by a qualified plumber. At the time the toilet is removed, and before it is reset, the floor in the vicinity of the toilet should be carefully inspected for damage, rot or other deterioration caused by water seeping past the seal at the base of the toilet.

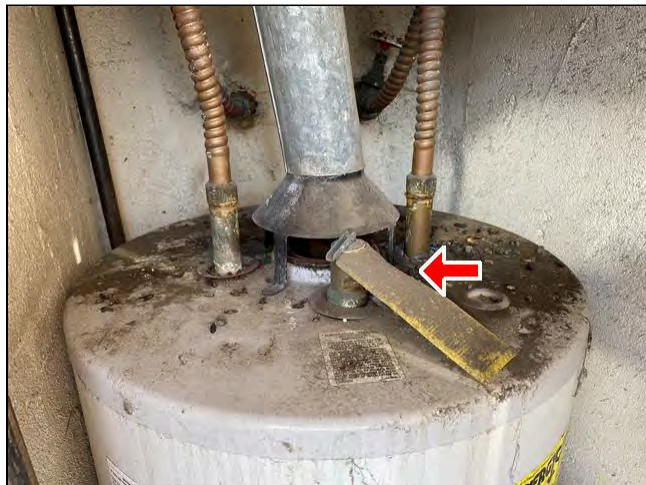
5.2 Item 1(Picture) Plumbing System

(1) **Safety Issue:** The Temperature and Pressure Relief valve at the water heater needs a 3/4 pipe to extend within 6 to 24 inches of floor for safety, the current building standards require that the discharge pipe be routed to the exterior of the home and terminate in a safe location. (PVC is not approved for hot water use). Recommend repair by a qualified person.

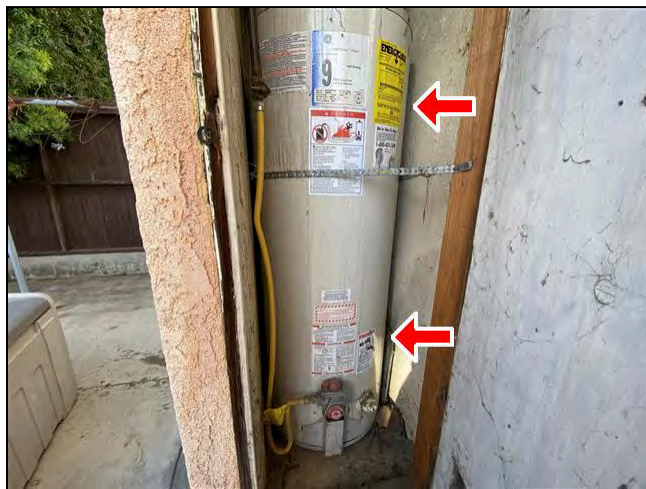
5.2 Item 2(Picture) Plumbing System

(2) **Safety Issue:** The water heater lacks seismic straps. The water heater is in need of seismic straps to prevent movement during earthquakes. Suggest further review and repairs by a licensed plumber.

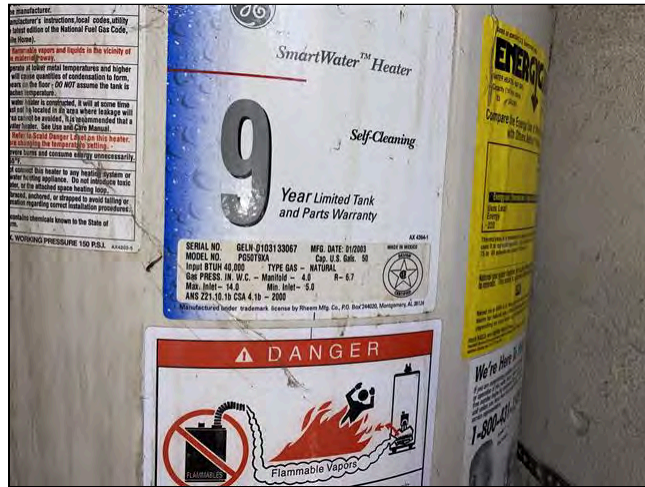
5.2 Item 3(Picture)

(3) **Repair/Replace:** The water heater is an older unit. The water heater is at the end of its service life. Typical life expectancy of water heaters is 7 to 12 years. The existing unit is 20 years old. Suggest replacement of the water heater by a licensed and qualified plumber.

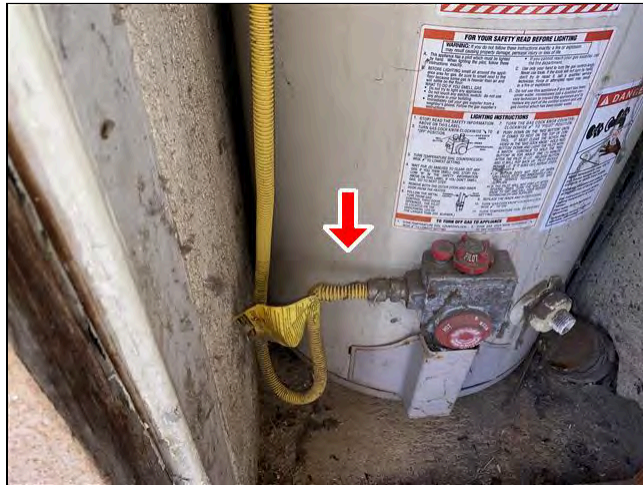
5.4 Item 1(Picture) Plumbing System

**Improve:** The gas supply pipe at the water heater lacks a sediment trap. It is suggested that one be installed by a licensed plumber.

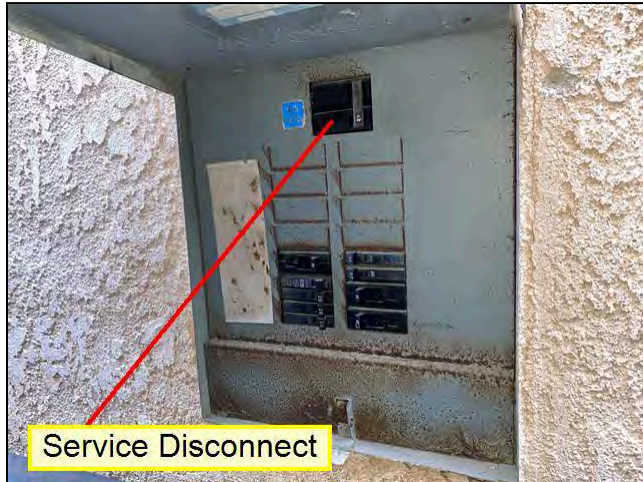
6.0 Item 1(Picture) Electrical System

(1) **Improve/Monitor:** The size of the electrical service supplied to the home (40-Amps) may not be sufficient depending on the lifestyle of the occupants. Most older homes were constructed with a generic 100-amp electrical panel that could provide all of the home's electricity, but as times have changed, so have homes and their electrical needs. Today, a 40-amp electrical panel will struggle or fail to get the job done and you will have to upgrade to a larger service/panel. Calculate your homes wattage needs to determine exactly what size your home requires. Look out for a few common and obvious signs such as your lights flickering, appliances that aren't performing to their full potential, using multiple appliances in your home will trip the breakers, or the panel has begun to simply malfunction. Having an old or undersized electrical panel in your home can not only cause quite the inconvenience but it can also become dangerous. It's important to know the signs to look out for when your panel has become insufficient for your home's wattage needs. A qualified electrician can inspect the system and provide you with replacement options and costs within the inspection contingency period.

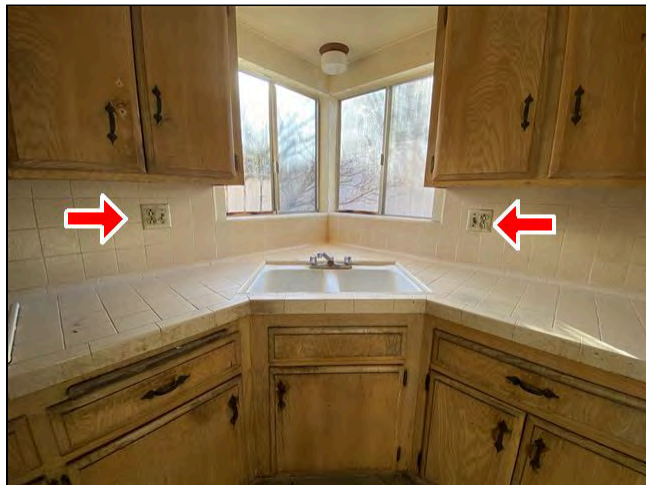
6.2 Item 1(Picture) Electrical System

(1) **Safety Issue:** The installation of ground fault circuit interrupter (GFCI) devices is advisable at all kitchen outlets within 3 to 6- feet of the sink. GFCI's are strongly recommended at the disposal unit & dishwasher. A ground fault circuit interrupter (GFCI) offers protection from shock or electrocution; suggest repairs by a licensed electrical contractor

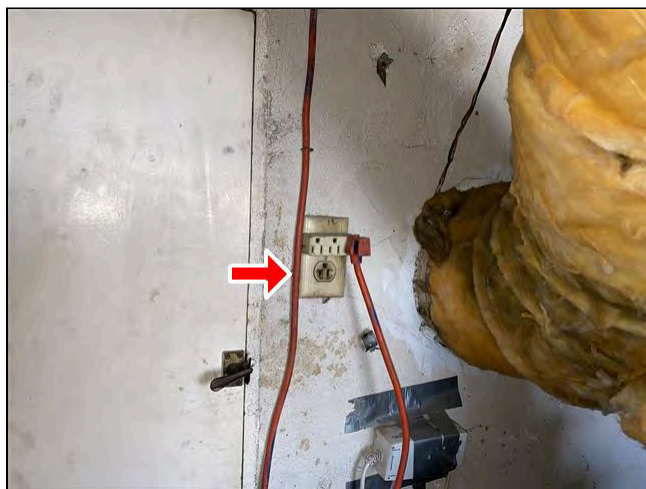
6.2 Item 2(Picture) Electrical System

(3) **Safety Issue:** The installation of ground fault circuit interrupter (GFCI) devices is advisable at all exterior and garage outlets. GFCI's are strongly recommended. A ground fault circuit interrupter (GFCI) offers protection from shock or electrocution; suggest repairs by a licensed electrical contractor.

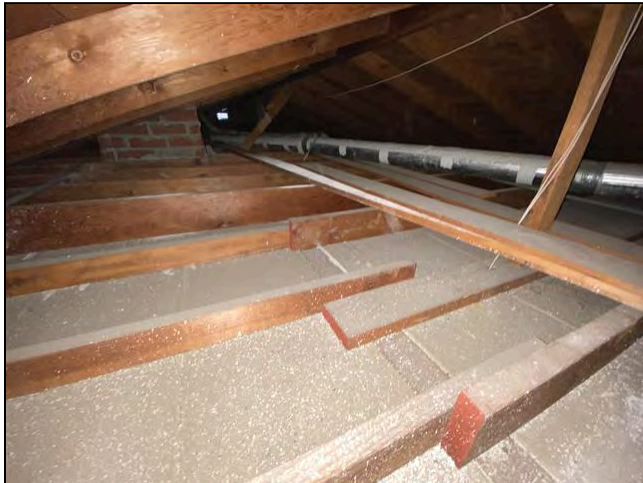
7.0 Item 1(Picture) Insulation & Ventilation

**Improve:** The attic space of the home lacks insulation.

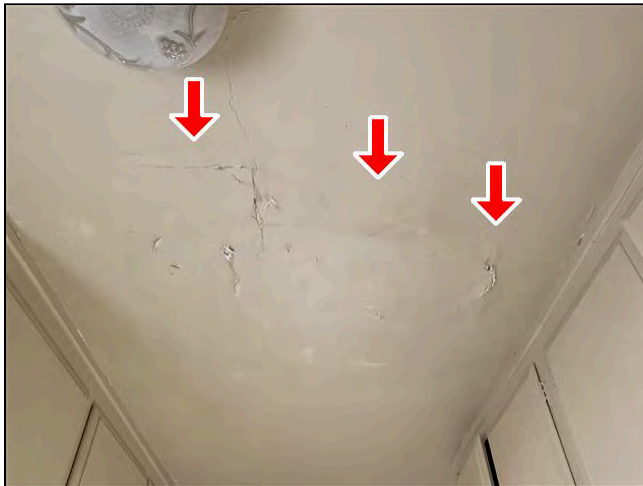
8.1 Item 1(Picture) Interiors

(1) **Major Concern:** Evidence of water damage was observed at the laundry room ceiling. A bathroom is located above this area. This damage would suggest that an active leak(s) is present in this location. Areas of past and present moisture are favorable for growing many fungal like organisms. There is an extra risk of hidden damage/fungus/mold to be present in this location. The identification of molds, fungus and other microbial organisms is outside the scope of this inspection. We suggest a qualified environmental specialist should be retained to evaluate the surfaces and make further recommendations. Testing and remediation of mold growth can only be accomplished by a qualified environmental specialist. If strict protocol is not followed, spores can be released into the interior of the building and may create a health hazard for those with low tolerances to such organisms. Suggest further investigations and repairs by a qualified contractor.

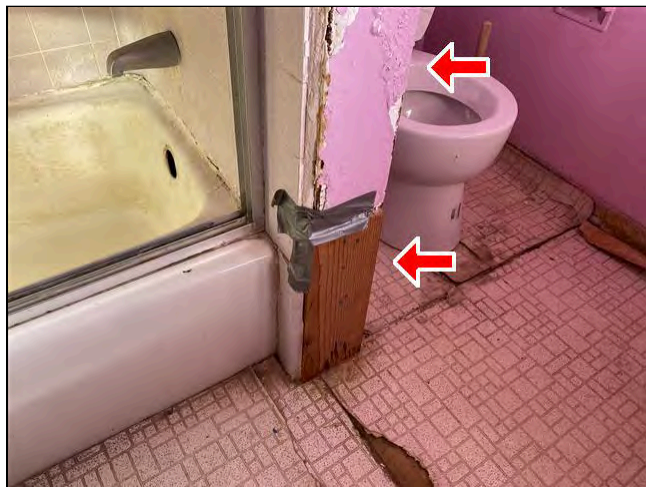
8.1 Item 2(Picture) Interiors

(2) **Major Concern:** Water damage was observed at the interior walls in the second floor bathroom. Areas of past and present moisture are favorable for growing many fungal like organisms. There is an extra risk of hidden damage/fungus/mold to be present in this location. The identification of molds, fungus and other microbial organisms is outside the scope of this inspection. We suggest a qualified environmental specialist should be retained to evaluate the surfaces and make further recommendations. Testing and remediation of mold growth can only be accomplished by a qualified environmental specialist. If strict protocol is not followed, spores can be released into the interior of the building and may create a health hazard for those with low tolerances to such organisms. Suggest further investigations and repairs by a qualified contractor.

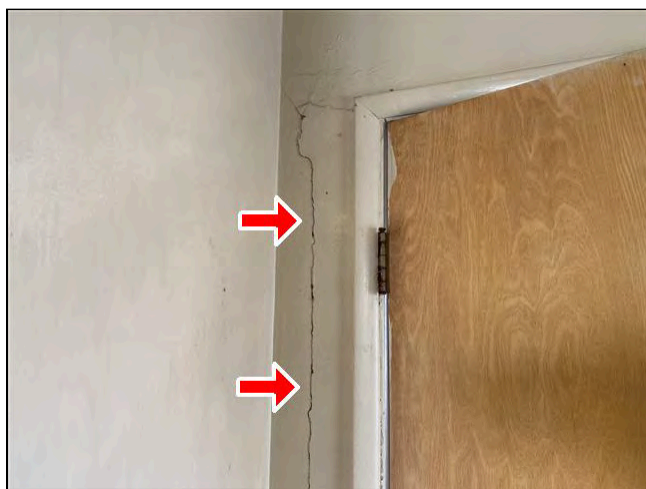
8.1 Item 3(Picture) Interiors

(3) **Repair/Replace/Monitor:** Evidence of settlement was observed on the interior wall/ceiling finishes. The interior wall and ceiling finishes are cracked in various locations within the home. This appears to be common settlement and/or movement with older homes. It is suggested that these areas be repaired and patched by a qualified professional and monitored for additional movement to determine if additional repairs to the home will be required.

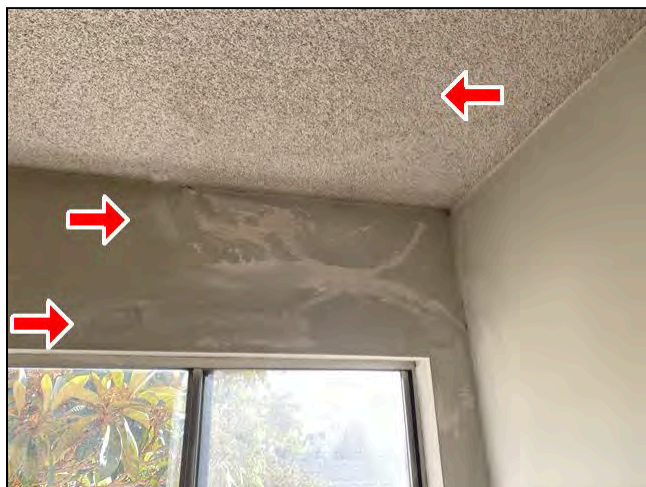
8.1 Item 4(Picture) Interiors

(4) **Repair or Replace:** Water damage was observed at the second floor front bedroom East interior wall and ceiling. The source of the leak(s) should be identified and repairs performed as necessary. Areas of past and present moisture are favorable for growing many fungal like organisms. There is an extra risk of hidden damage/fungus/mold to be present in this location. The identification of molds, fungus and other microbial

organisms is outside the scope of this inspection.

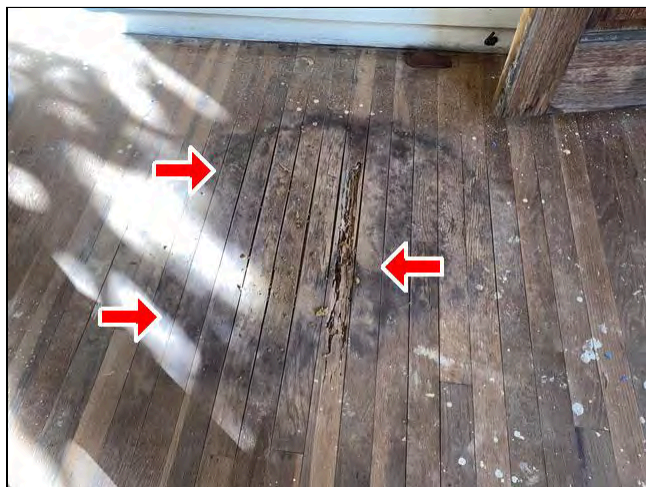
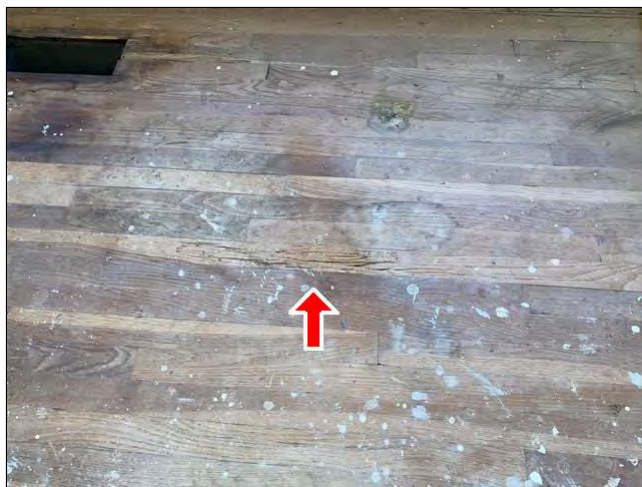
(1) **Repair or Replace:** Wood deterioration was observed at the living room floor boards in various locations. If the home inspection reveals signs of damage you should have a pest control company inspect further for activity and possible hidden damage. Suggest repair/replacement of all deteriorated wood by a licensed contractor.

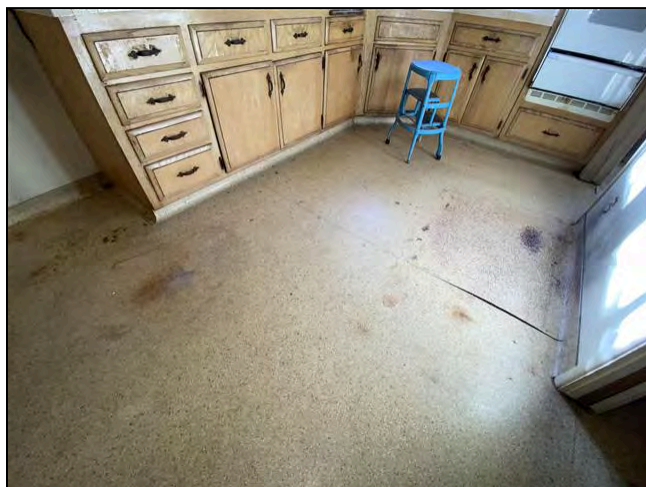
8.2 Item 3(Picture) Interiors

(2) **Repair or Replace:** The kitchen vinyl floor is in need of replacement

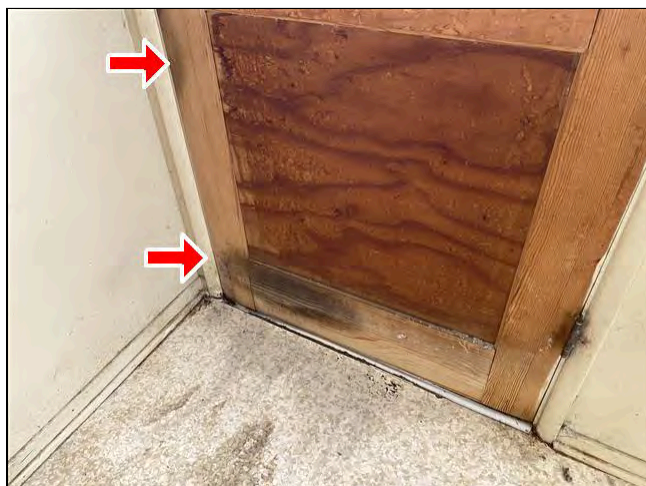
8.4 Item 1(Picture) Interiors

**Repair or Replace:** The laundry room rear wall door is in need of replacement.

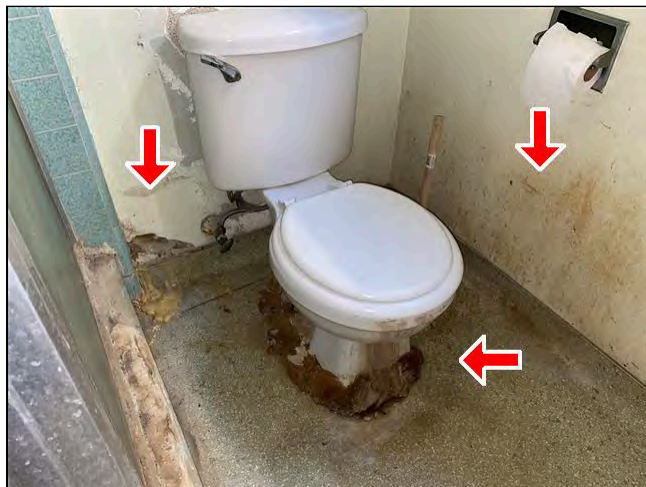
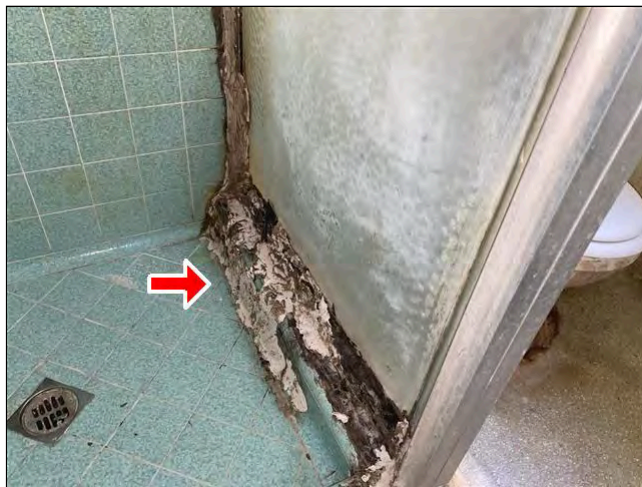
(1) **Safety Issue:** There is surface growth and fungal like growth observed at the first floor bathroom in many locations. This may indicate the presence of mold, fungus or other microbial organisms. Areas of past and present moisture are favorable for growing many fungal like organisms. The identification of molds, fungus and other microbial organisms is outside the scope of this inspection. We suggest a qualified environmental specialist should be retained to evaluate the surfaces and make further recommendations. Testing and remediation of mold growth can only be accomplished by a qualified environmental specialist. If strict protocol is not followed, spores can be released into the interior of the building and may create a health hazard for those with low tolerances to such organisms.
