# Inspection Report

**Property Address:**  
1642 Havemeyer Ln  
Redondo Beach CA 90278

## Professional Inspection Network

<b>Property Address</b> 1642 Havemeyer Ln Redondo Beach CA 90278	<b>Date of Inspection</b> 11/4/2022	<b>Report ID</b> 20221104-1642-Havemeyer-Ln
<b>Customer(s)</b> Sylvia Pulido Richard Colin	<b>Time of Inspection</b> 09:00 AM	<b>Real Estate Agent</b> Joe Safranek Beach City Brokers
<b>Inspection Details</b>		
<b>In Attendance:</b> Seller and Seller's Agent	<b>Type of building:</b> Single Family (2 story)	<b>Approximate age of building(s):</b> 55 Years Old
<b>Building(s) Faces:</b> North	<b>Temperature:</b> Over 60 (F) = 15.5 (C)	<b>Weather:</b> Clear
<b>Ground/Soil surface condition:</b> Dry	<b>Rain in last 3 days:</b> No	<b>Radon Test:</b> No
<b>Water Test:</b> No

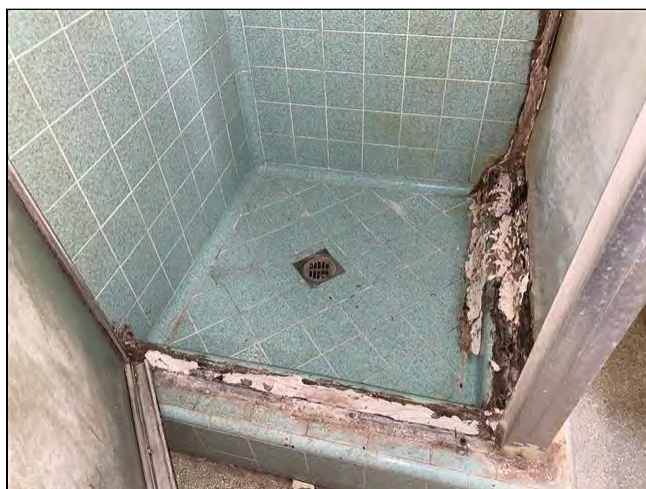
8.9 Item 3(Picture) Interiors

(2) **Monitor:** The testing of shower pan systems are beyond the scope of this inspection. A shower pan is a waterproof barrier that is made of various materials. Typically, they are placed under the tiles of a shower or tub so that they can catch the water and direct it to the drain. It is suggested that all shower pan systems throughout the home be further investigated by a qualified plumber to verify the presence of any leaks that will require repair within the inspection contingency period.

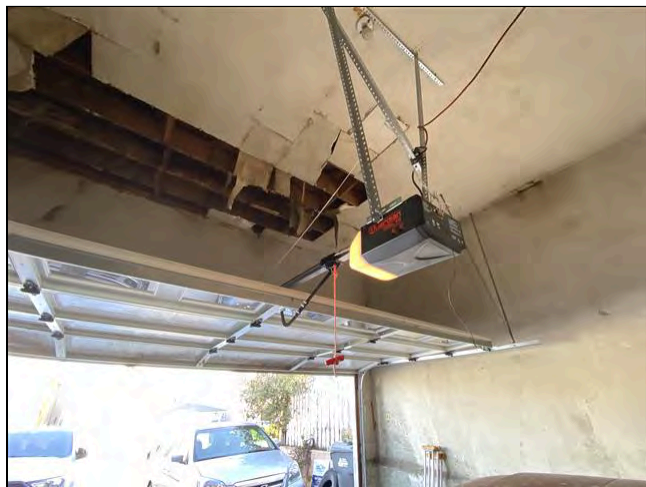
9.2 Item 1(Picture) Garage

**Monitor:** The garage door and opener were functional and opened and closed the door. The light beams responded when tested and caused the door(s) to stop and auto reverse. Testing of the downward force (pressure test) was not performed as this can damage the door and is outside the scope of this inspection. Proper operation of the reversing mechanism should be verified prior to the close of the inspection contingency period. Information on garage door openers is available from the Consumer Product Safety Commission at [www.cpsc.gov](http://www.cpsc.gov).

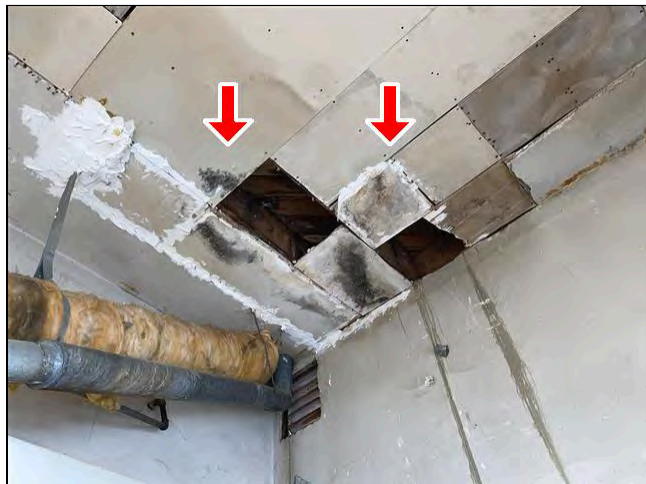
9.4 Item 1(Picture) Garage

(1) **Safety Issue:** There is surface growth at the garage ceiling. This may indicate the presence of mold, fungus or other microbial organisms. The identification of molds, fungus and other microbial organisms is outside the scope of this inspection. We suggest a qualified environmental specialist should be retained to evaluate the surfaces and make further recommendations. Testing and remediation of mold growth can only be accomplished by a qualified environmental specialist. If strict protocol is not followed, spores can be released into the interior of the building and may create a health hazard for those with low tolerances to such organisms.

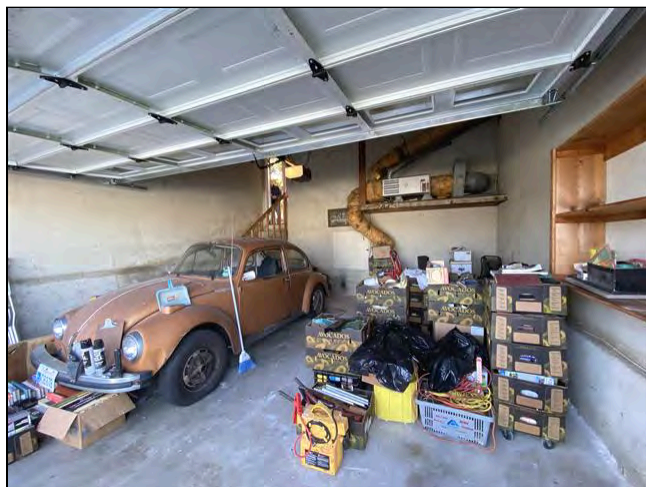
9.4 Item 2(Picture) Garage

(2) **Monitor:** The occupants belongings at the garage prevents full view.

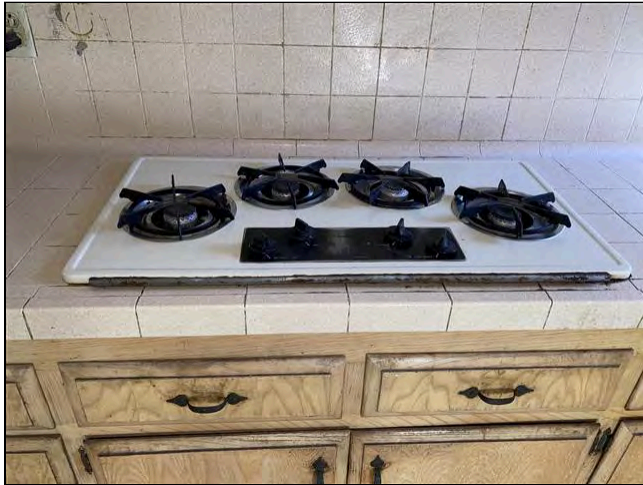
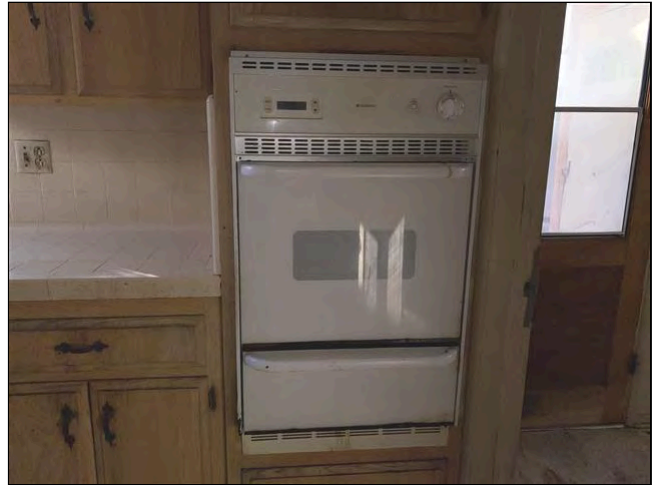
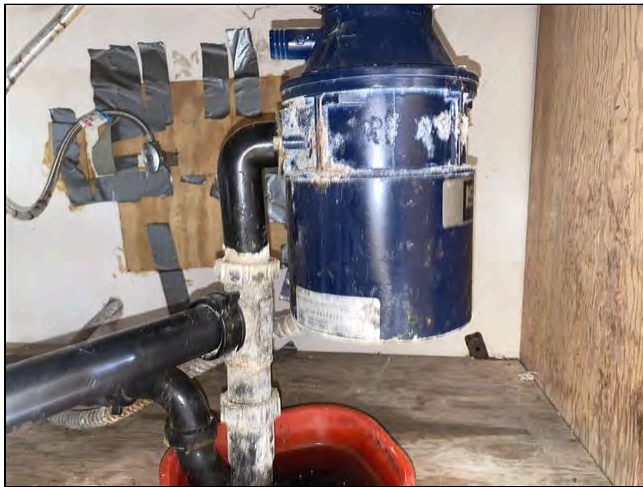
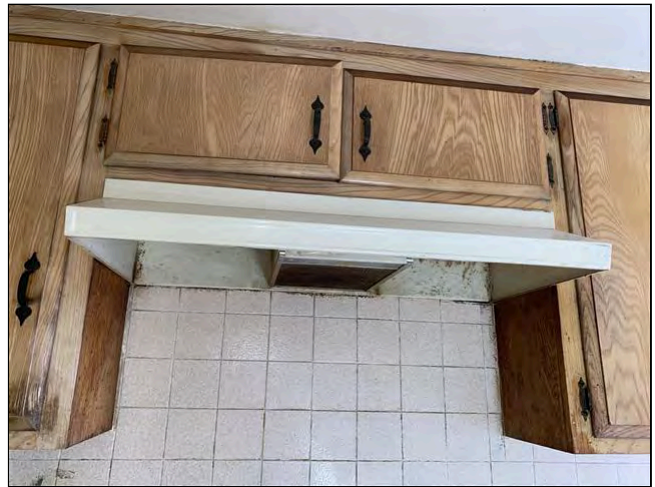
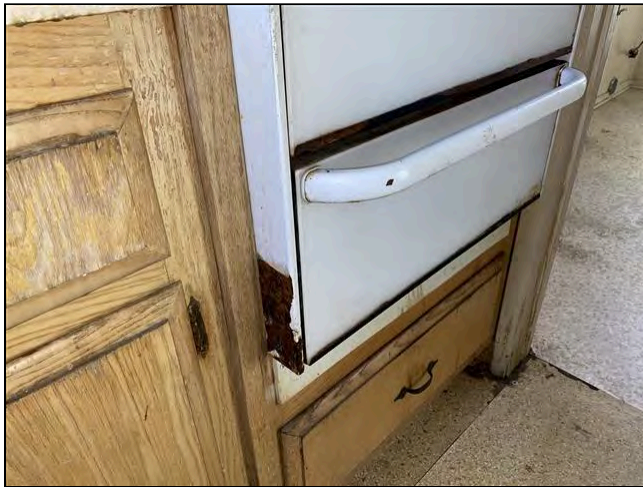
**Repair/Replace/Monitor:** The kitchen appliances are at the end of there service life.
