# Premier Home Inspection, Inc.

**Kelly Bowers  
2953 Floral Ave., Riverside CA**

**Date: 01/12/2024**

**Report # 2240106**

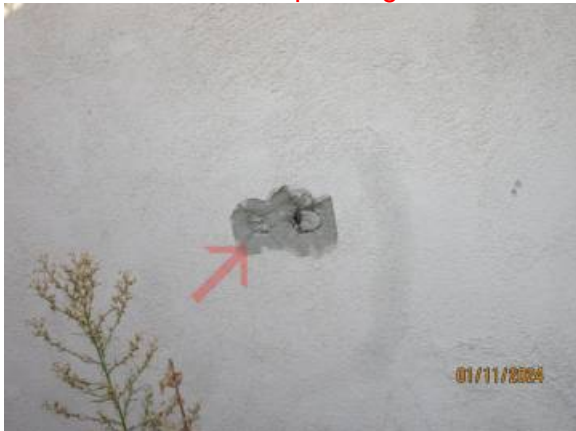
The stucco around the house is deteriorated and damaged in several areas around the house. We recommend it be removed and replaced in all of the affected areas as needed. There is damaged or deteriorated wood siding noted in several areas. We recommend repair or replacement as needed. The exterior surfaces are in fair condition due to weathering and age. We recommend repainting and/or refinishing in the near future to maximize the service.

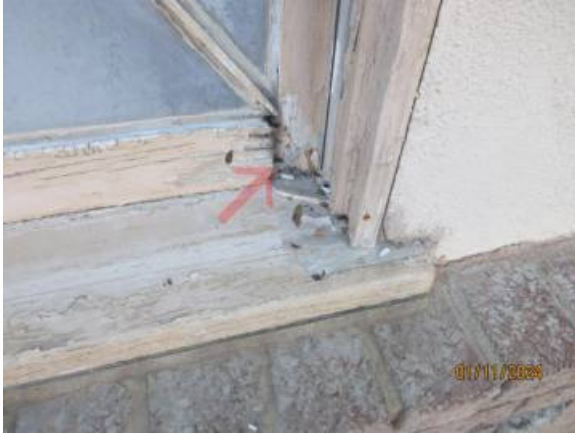
There is broken glass at one or more windows. We recommend it be replaced or repaired as needed. Several of the window frames are damaged from moisture in the joints. We recommend they be repaired or replaced.

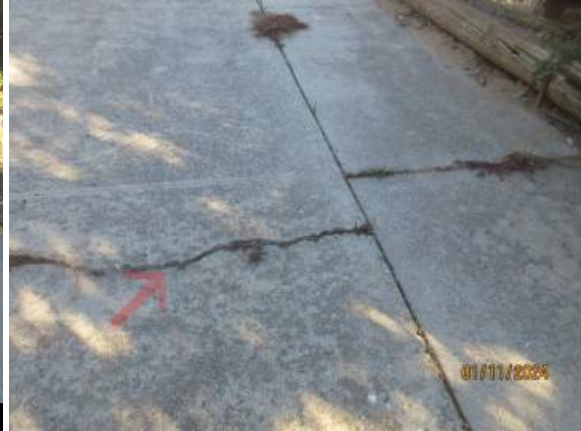
Concrete. The driveway drainage is sloped toward the house and garage. We recommend this condition be monitored and if necessary, a drainage system be installed to ensure surface water does not flow into the building. There is not any drainage visible in this area. There are large cracks and heaving or settling of the driveway. While vehicles can still be driven over it, replacement should be budgeted for and the trip hazards corrected.

Slopes towards the house.

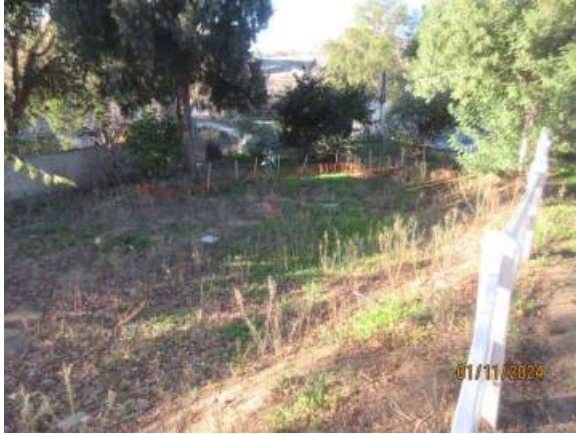
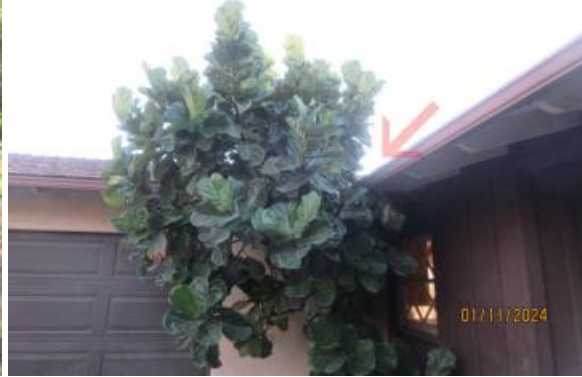
This yard and property has not been well maintained. The grass and grounds are dead and dying in many areas. Repairs needed to the landscaping in the yard as needed. Tree(s) are planted too close to the structure. Removal should be considered as trees continue to grow in size and damage may occur to the foundation and/or roof structures. Trees are touching or overhanging the roof. We recommend they be trimmed to prevent damage to the roofing surface, and allow free flow of roof runoff. The trees, bushes and plant growth are overgrown in many areas of the yard. These areas need to be cut back. These areas of the yard and house are not completely visible or accessible to inspector due to this overgrowth to these areas. Repair as needed.

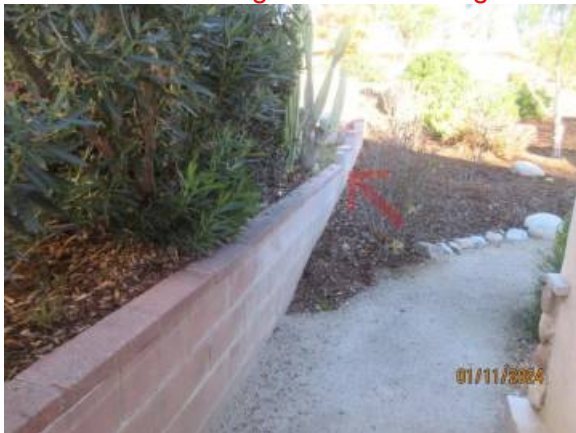
The retaining walls have developed major cracks and/or leaning. This is on the left side of the house and in the front yard area as well. There are missing blocks and loose blocks in several areas. The rebar is exposed and not properly installed in these areas. While the walls are still standing, in our opinion they have failed as intended and should be removed and replaced. There are no weep holes or drains at the base of the retaining wall to aid in the drainage behind the wall. This should be corrected to prevent excessive pressures against the wall and allow for drainage to occur through these areas. Repair and add as needed.

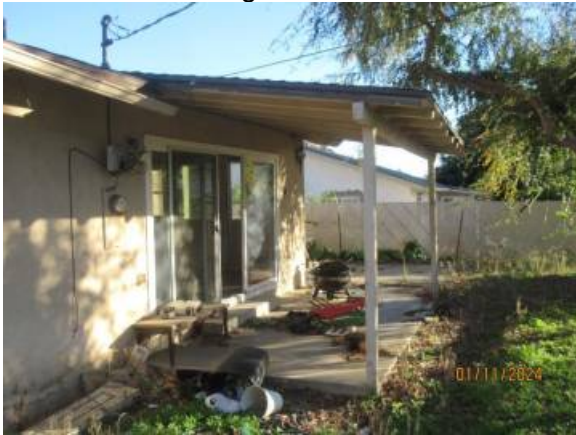
There is damaged wood to the beams and posts in several areas. Repair the damaged wood as needed. Check the termite report for all damaged wood to this structure and repair or replace the damaged wood in these areas as needed. The posts are not properly secured and supported in these areas. There are not any brackets and footings to properly support the posts in these areas. One post is leaning and off of the concrete slab in this area. The posts also need to be properly secured and strapped to the header beam as well. Repairs needed to the structure as needed. Patio cover is not stable as it is currently installed. Additional support and repairs needed to the patio cover structure for proper support of structure. This structure appears to have been an addition done to the property. Check for signed off permits on this addition.

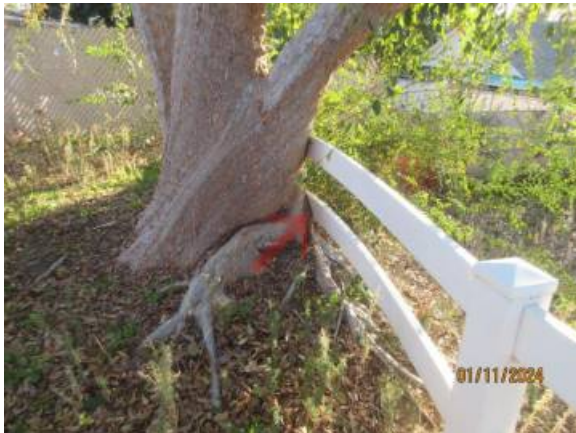
The chain link fencing is in good condition in the visible and accessible areas. **The tree in the backyard is moving the vinyl fencing in this area. Remove the tree and repair the damaged fence as needed. The gate(s) needs adjustment or minor repairs to restore proper operation and function.**

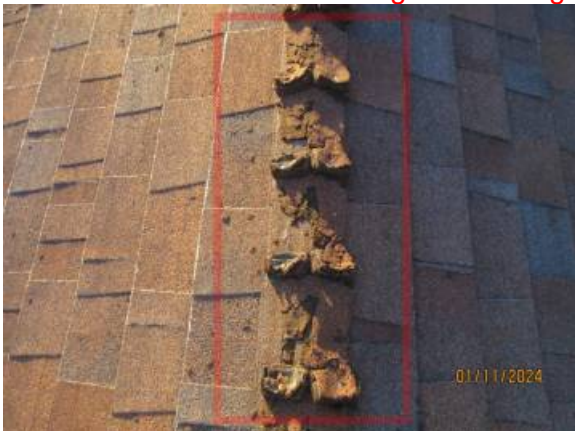
The roof shingles have extensive granulation loss, erosion and cracking throughout the shingled surface. The nail fasteners are exposed in many areas. There is also exposed felt paper on the roofs surface as well. These conditions indicate the end of the useful life of this type of roofing. This cannot be repaired and replacement is needed. The ridge cap shingles are damaged and deteriorated in many areas of the roof and need to be replaced. There is debris accumulating on the roof. This is likely to cause roof damage and drain blockages. We recommend the debris be removed and the roof inspected regularly to keep the drains clear. Portions of the shingles have been installed over a surface with a pitch of less than 2 in 12 and is subject to leakage due to poor drainage for the roof over the patio cover area. The surface should be monitored for signs of leakage and repaired if necessary.

The roof is in poor condition. The conditions noted create the opportunity for leakage, and the roof can not be effectively patched. We recommend the roof be replaced.

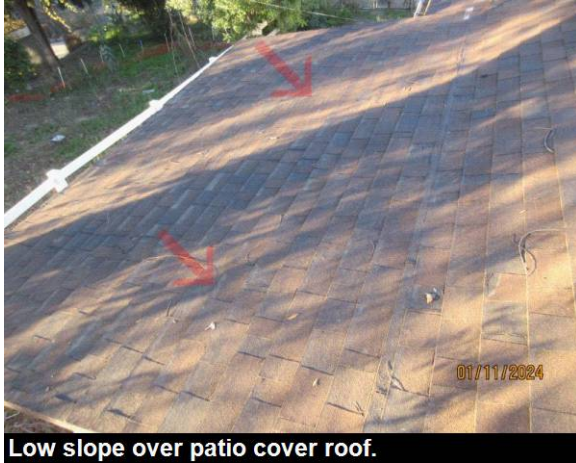
Low slope over patio cover roof.

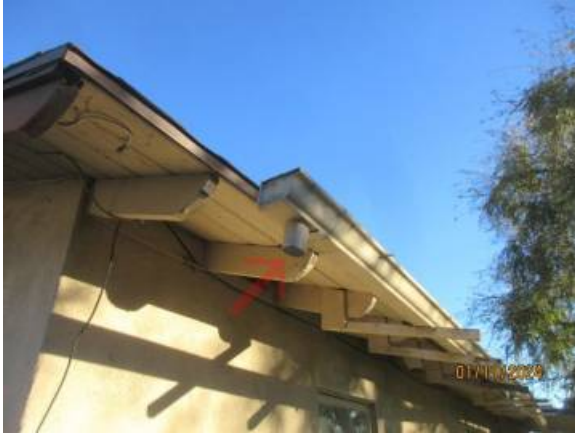
One or more downspouts is missing. We recommend they be replaced.

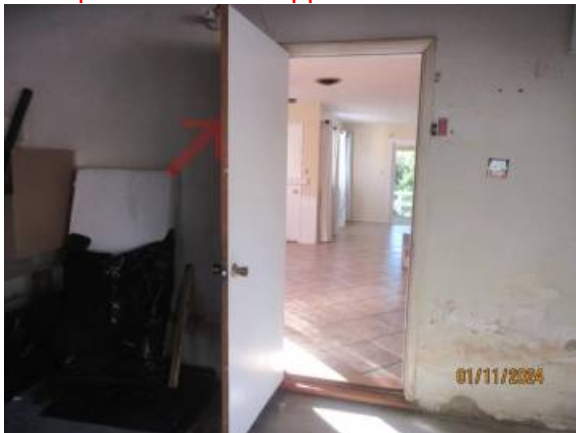
Standards require the door between the garage and living space to be a solid core door that is approximately 1 3/4" thickness or greater or a properly rated and approved fire door with an automatic closer. This door is a 1 1/4" thick door. We recommend the existing door be replaced with an approved fire door for increased safety.

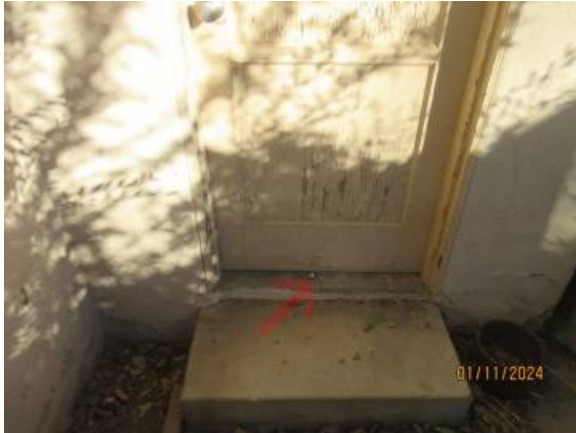
There is some damage to the wood on this door. Repair or replace this door as needed. There is not a threshold on the area under this door. Repair and add a proper threshold to close and seal off the area under this door.

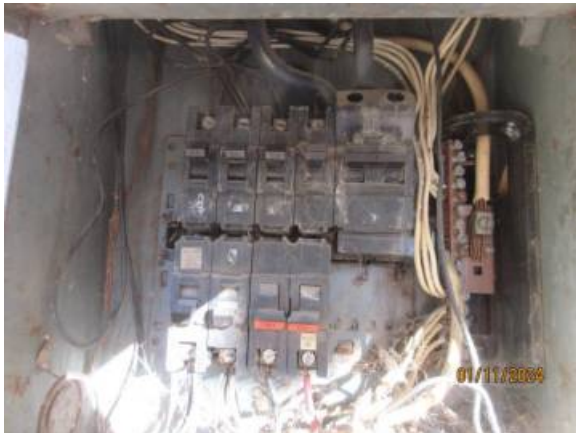
There are a minimal amount of breakers in this panel and not adequate to properly service this house effectively. Additional breakers and circuits are needed in this panel for safety and functional use as needed.

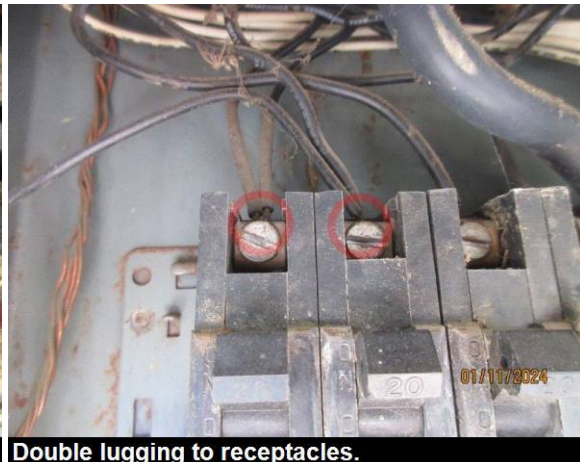
Multiple wires are connected to a single lug on several circuit breakers where only one wire should be connected. This "double lugging" and "triple lugging" is not permitted because a positive connection for all wires is not assured. We recommend the circuitry be reconfigured and additional breakers be installed as needed. Have a licensed electrician make further evaluation and corrections as needed.

Double lugging to receptacles.

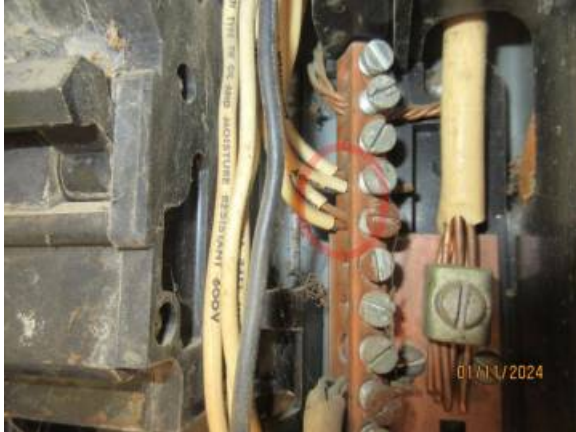
Multiple wires are connected to a single lug on the grounding bar area(s) where only one wire should be connected. This "double lugging" is not permitted because a positive connection for all wires is not assured. We recommend the circuitry be reconfigured so each wire has its own terminal to be properly installed as needed.

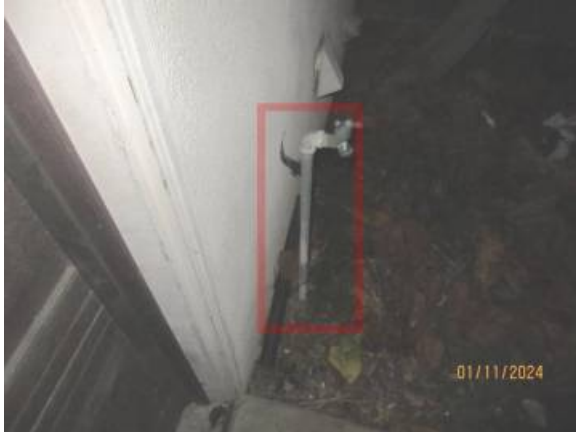
A sample were operated, and were in serviceable condition. The added hose bibs in the yard are not secured with a metal stake on the added water lines for these hose bibs. Repair and properly secure and support the water pipes in these areas as needed.

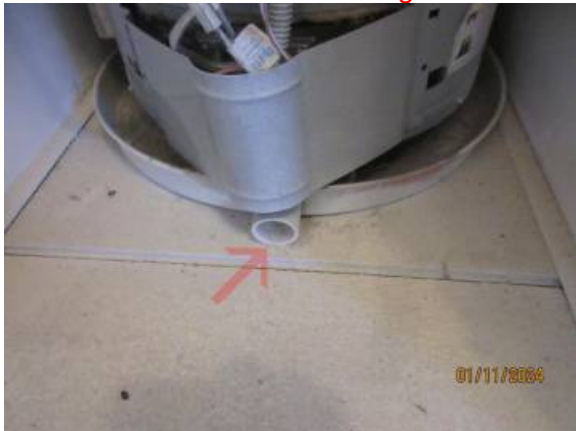
The water heater tank rumbles while the water is heating up. Check for any sediment build-up inside of the tank. Water heaters need to be drained on a regular basis to remove hard water deposits out of the water heater tank. There is a drain pan under the water heater. This should tie into a drain line and drain away from the stand to prevent any damage to the stand if there is a leak in this area. This does not appear to have any drainage to drain properly away from the stand in the visible areas of the stand. Repair and add a drain pipe to the drain pan to properly drain away from this area as needed. This water heater system does not have an expansion tank system installed. This is required on water heaters that have a closed plumbing system. Repair and add as needed. The water heater system is not properly bonded with a bare bonding wire to complete the bonding of this unit and system. Repair and bond properly on the water lines and the gas line for safety as needed.

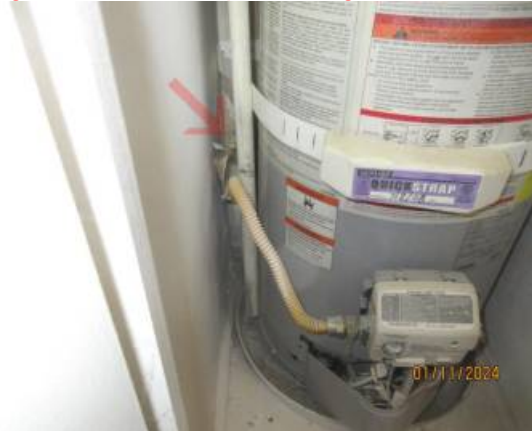
## 807 GAS SUPPLY:

The gas valve is present and the flexible gas connector is an approved type. **There is not a gas sediment trap on the gas line at the gas valve area. Repair and add as needed.**

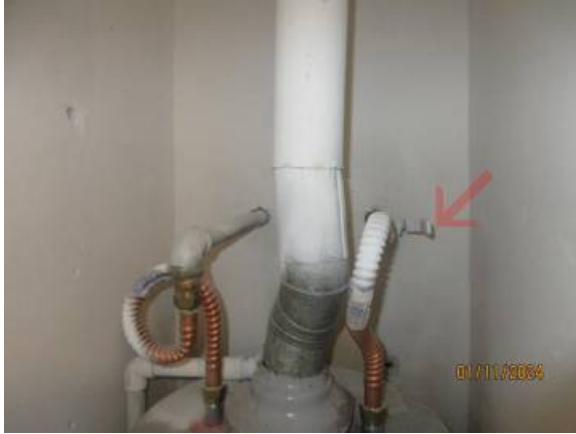
## 810 WATER CONNECTIONS:

A water shutoff valve is installed but was not tested.

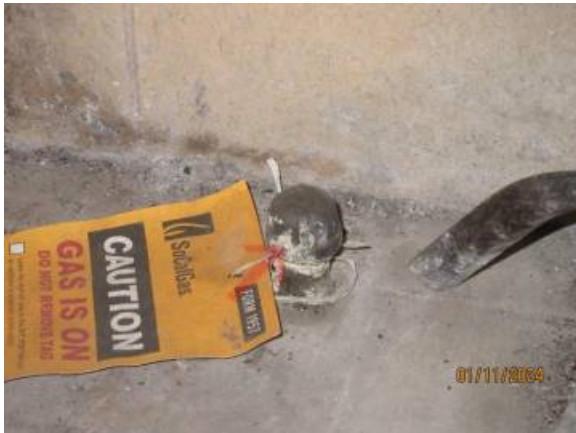
## 908 FIREPLACE - FIREBOX:

Mortar joints are intact. Damper is operational. **The gas line is capped off and it is not in use. Check for proper use and function and repair as needed.**

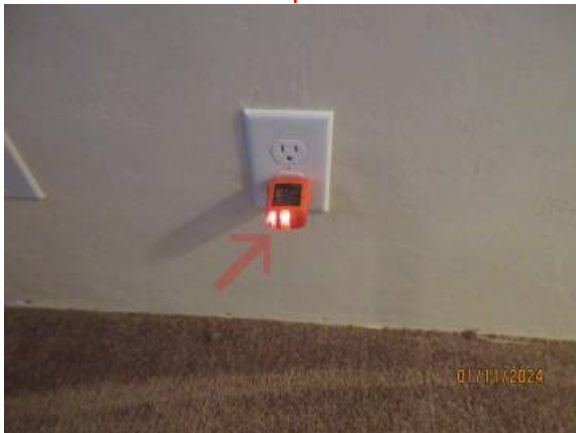
### 1048 ELECTRICAL:

There is reverse polarity to two of the receptacles in the back left side secondary bedroom. Repair the wiring to these areas as needed. Missing cover plate on a switch in the back right side bedroom. Repair and add as needed.

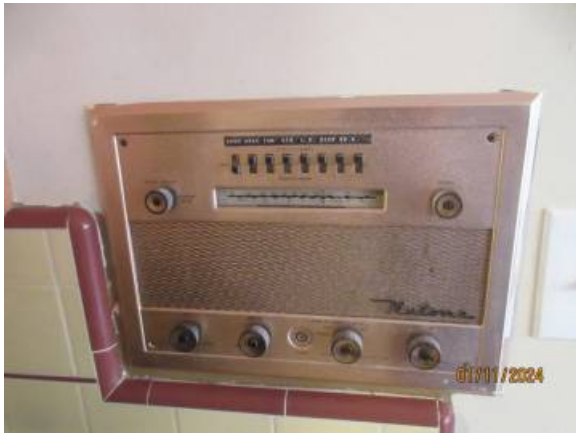
### 1098 GENERAL COMMENTS:

There is an intercom system for this property. This unit and its system is not tested as part of this inspection. No testing is done to this unit and system. Contact a specialist for a further review as needed.

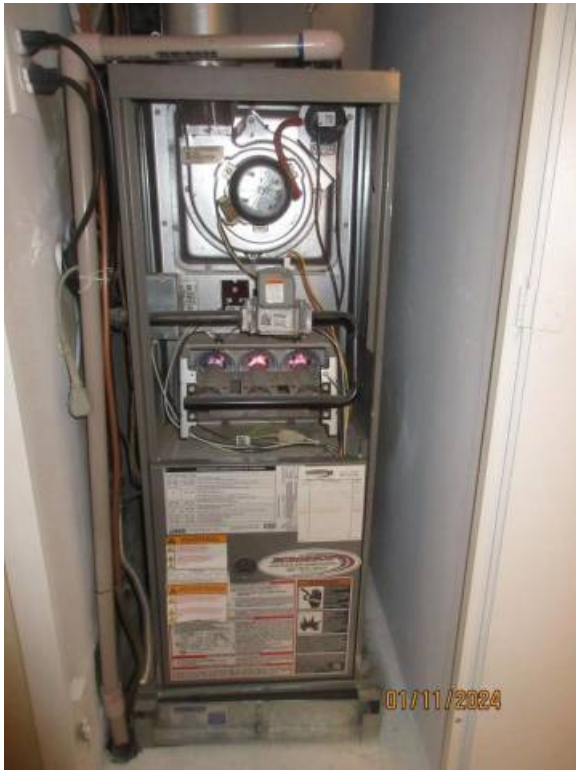
#### 1101 LOCATION & TYPE OF UNIT:

Hall closet. Forced Air unit.

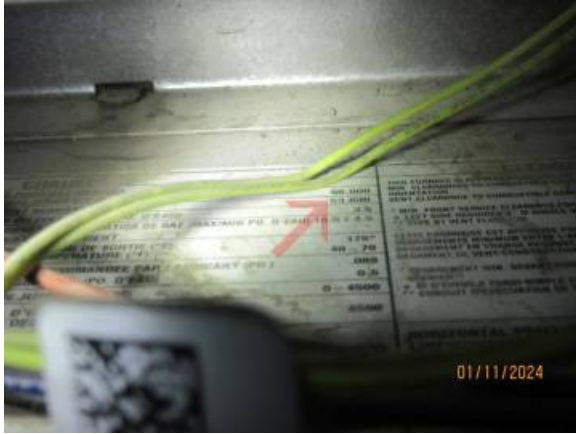
## 1102 CAPACITY OF UNIT:

66,000 btu. Could not determine the age of this unit.

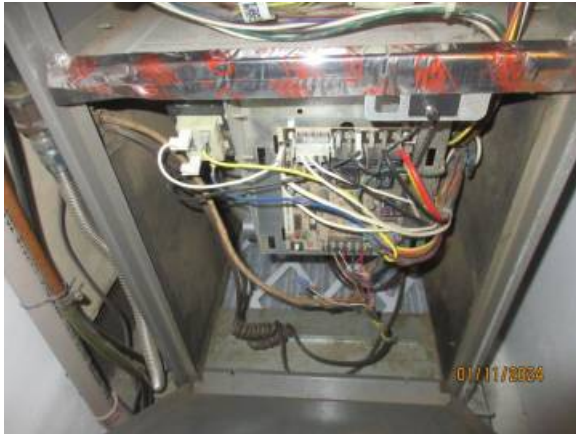
## 1109 BLOWER AND FILTER:

The filter installed is clean at this time. All filters need regular service or replacement at regular intervals.

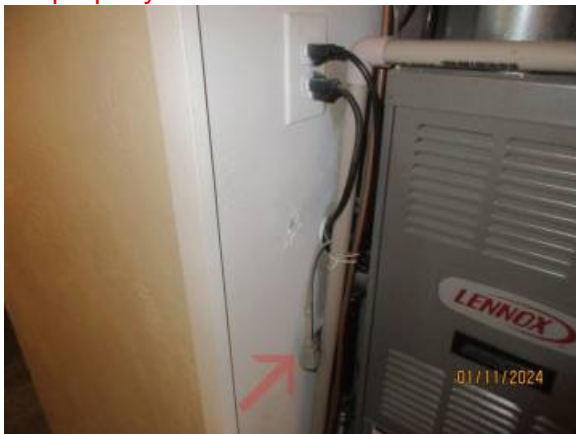
## 1112 GENERAL SUGGESTIONS:

The unit is plugged in with an extension cord and not directly into its own receptacle to be properly installed.

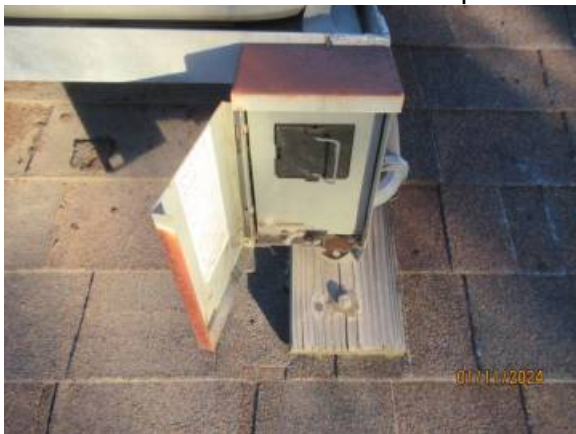
### 1302 POWER SOURCE:

220 Volt. Electrical disconnect present as required for service personal.

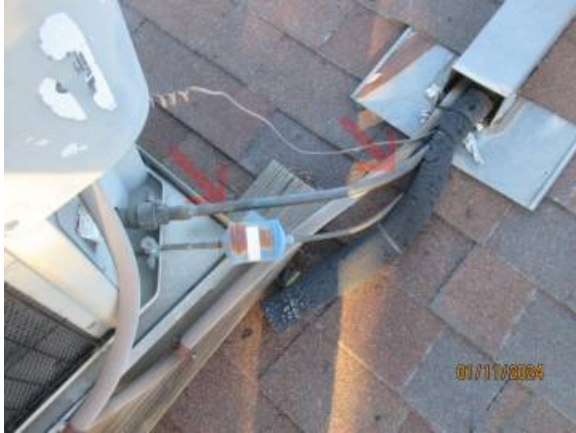
## 1305 SYSTEM CONDITION:

Outside air temperature was below 65 degrees. Unable to test system at this time. The refrigeration line has missing or damaged insulation at the condenser. We recommend the insulation be replaced to increase the energy efficiency.

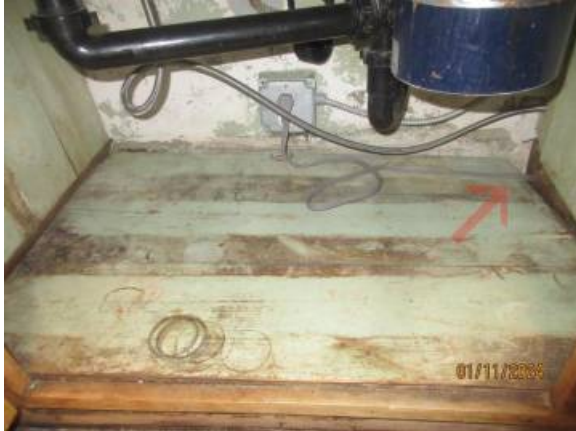
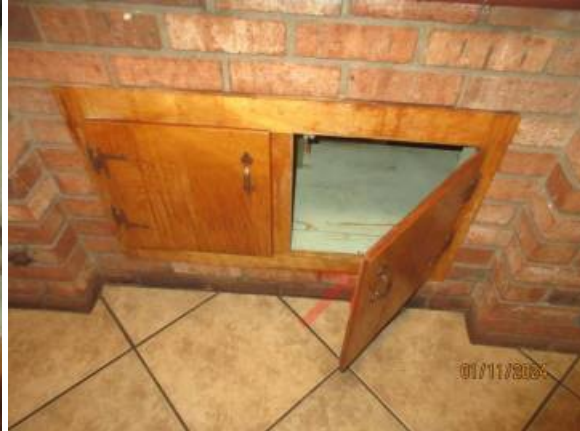
### **1436 COUNTERTOPS AND CABINETS:**

The countertops show typical minor wear or cracking. The cabinets and drawers show moderate to heavy wear. We recommend repair and/or refinishing to maximize their service life. The cabinets have minor wear and need minor adjustment of the hinges. Missing or damaged drawer front in one area as well. The sink base cabinet shelf is damaged from moisture. We recommend it be replaced or repaired as needed.

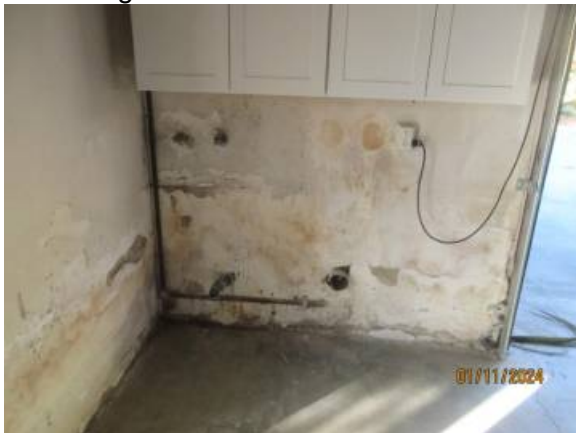
### 1451 LOCATION:

Garage.

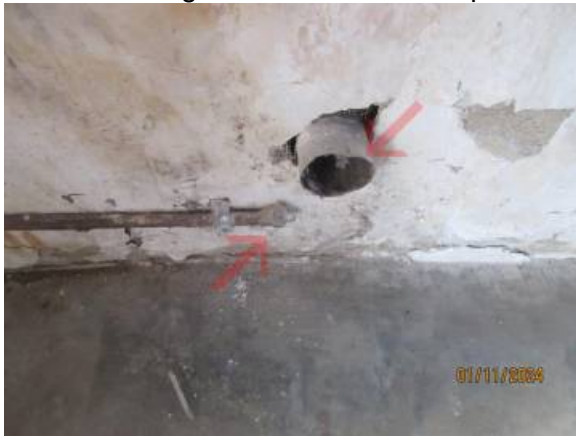
## 1452 DRYER CONNECTIONS:

The dryer hookup is intended for a gas unit only. Dryer venting is provided that appears to be terminating to the exterior as required.

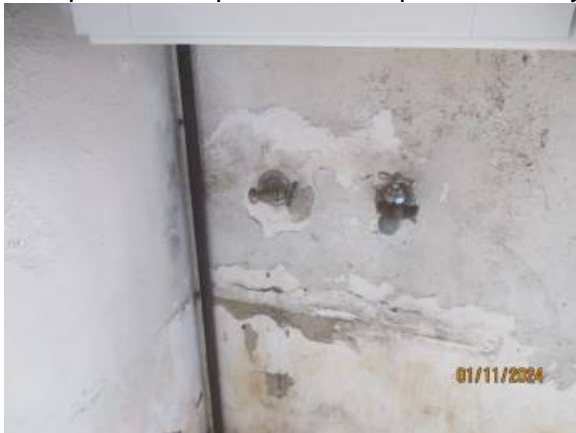
## 1453 WASHER HOOKUP VALVES:

The visible plumbing appears serviceable. The washer hookup valves are not tested or operated as part of this inspection. They may leak if they are turned and operated.

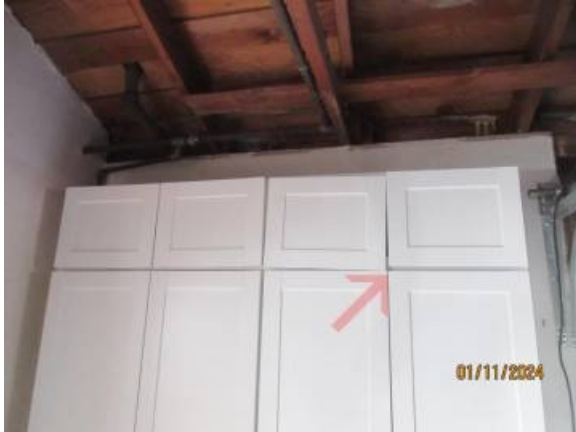
## 1462 CABINET(S):

The cabinet doors do not all operate properly. Repair the doors and hinges as needed.

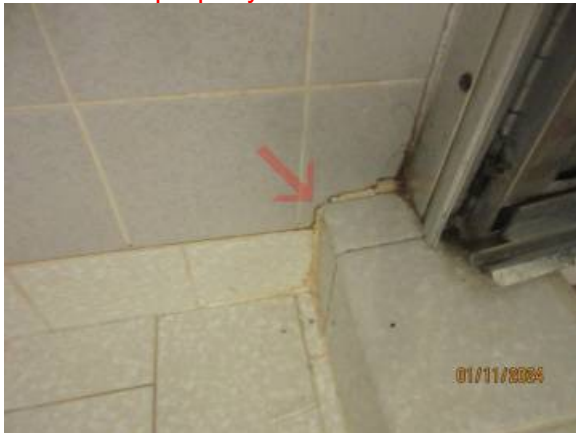
## 1506 TUB/SHOWER WALLS:

Caulking and/or re-grouting is needed to prevent water intrusion in these areas. Repair and seal off properly as needed.

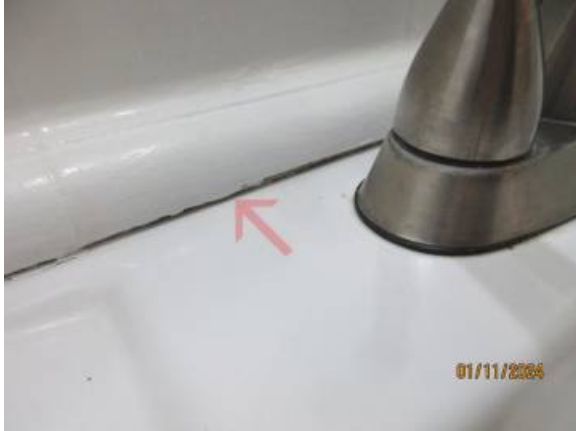
### 1502 CONDITION OF SINK:

Drainage from the sink emptied in a reasonable amount of time. **The sink faucet stopper valve is not operational. Repair as needed. The sink needs to be caulked at the counter top area.** Counters/cabinets appear serviceable.

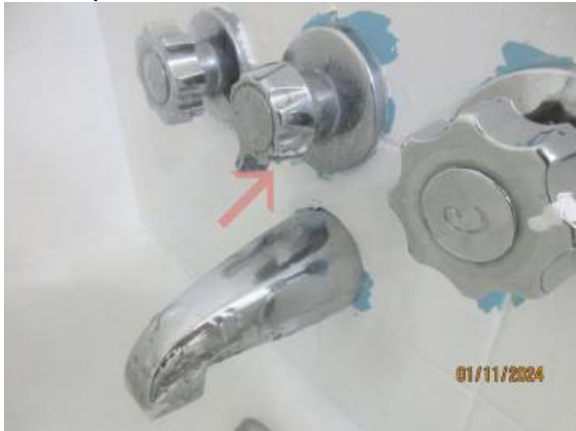
### 1505 TUB/SHOWER PLUMBING FIXTURES:

**Minor leakage is noted at faucet handles and/or the tub diverter. We recommend new valve stems be installed or faucets be replaced. The shower head leaks or sprays improperly. We recommend it be replaced. The following item(s) were noted at the tub/shower drain: Mechanical drain stopper is not operational at tub.** This shower head has a low flow rating of 2.5 gallons per minute or less. This is indicated by the label rating on the faucet. This is not verified only to determine the faucet has this rating on it. The drain appears serviceable and emptied in a reasonable amount of time.

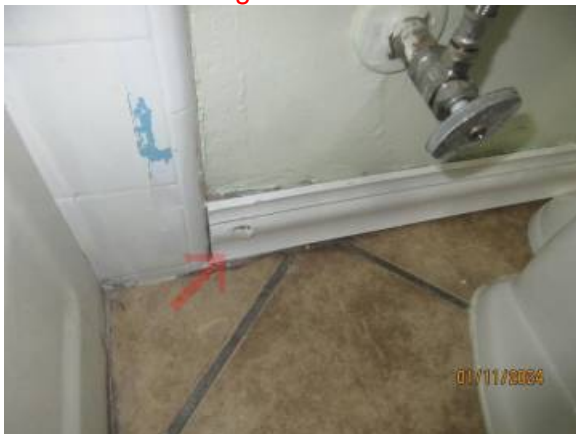
## 1507 BATHROOM WALLS/FLOORS:

Moisture damage is noted at the wall or floor outside the tub/shower area. The source of the moisture should be identified and corrected. Repairs may reveal further damage into the wall or floor framing.

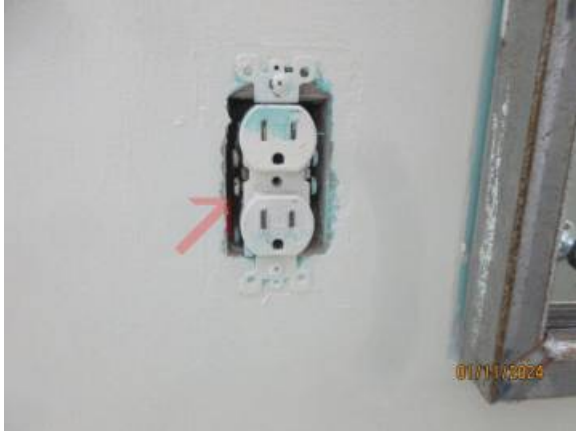
## 1512 ELECTRICAL:

There is not a GFCI circuit for this outlet. This was not required when the property was originally built. This would be a good upgrade for safety. There is a missing cover plate for the receptacle and/or the switch in this area.
