# **Cornerstone Inspection**

## **Property Inspection Report**

**1556 Gulf St, San Luis Obispo, CA 93405**

**Date of Inspection: 10/7/2025 Time: 1:00 PM**

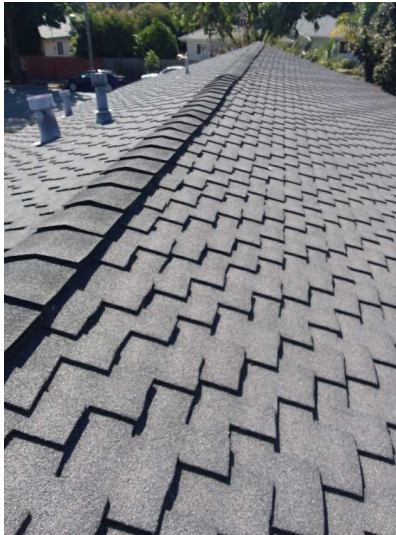
The roof needs to be cleaned and any foliage trimmed away to promote and insure proper drainage.

The composition shingle roof is in acceptable condition, but it will need to be kept clean and should be inspected annually. However, our service does not include any guarantee against leaks. For a guarantee, a roofing company would have to perform a water-test and issue a roof certification.

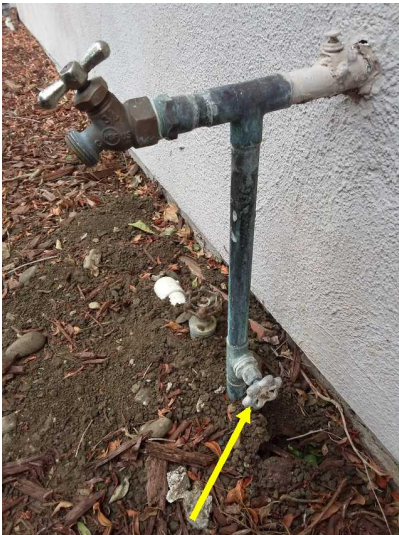
1.5. The main water valve is leaking or dripping and should be repaired.

1.6. The pressure inside the residence exceeds 80psi, which is too strong and will stress components of the system, and a regulator should be installed. Most regulators come factory pre-set at 60psi.

The main water shut-off valve is located at the front of the house.

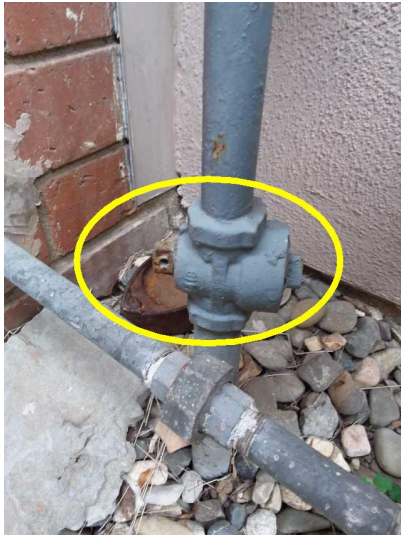
2.4. Some of the gas lines at the meter are rusted and should be painted to prevent further corrosion.

The gas main shut-off is located on left side of the home, unit or building.

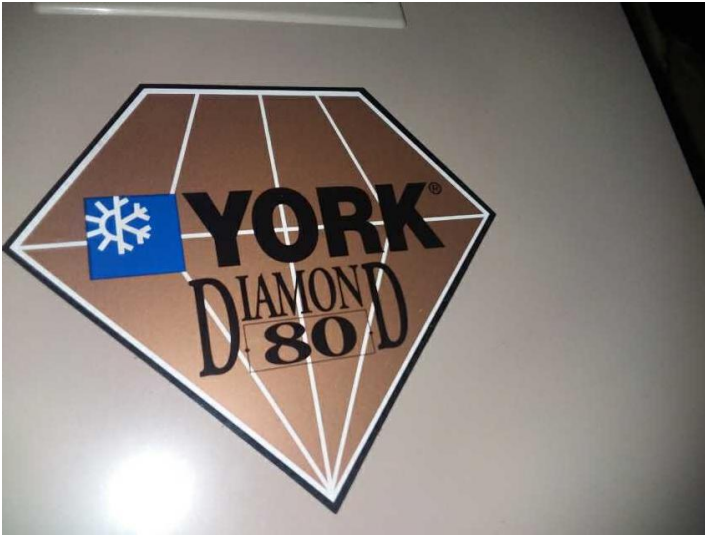
1.14. The furnace is functional. However, it is beyond the commonly accepted design life of twenty years, and will need to be monitored more closely for evidence of metal fatigue. We recommend that you have it serviced and evaluated by an HVAC contractor prior to the close of the inspection period.

Central heat is provided by a forced-air furnace that is located in the attic.
