### *Inspection Report*

**Address: 1229 Mill St San Luis Obispo, CA 93401**

**07/29/2025**

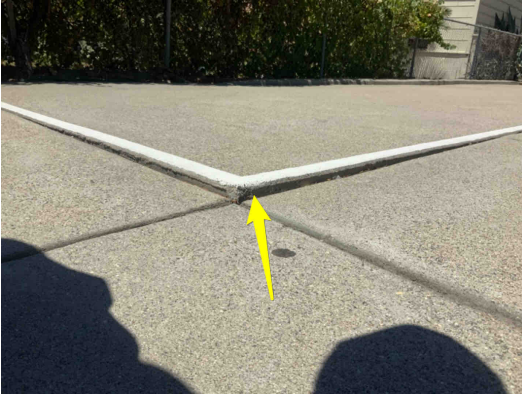
Example

**SU 17:** Areas of the driveway are uneven with potential trip hazards. Upgrades recommended.

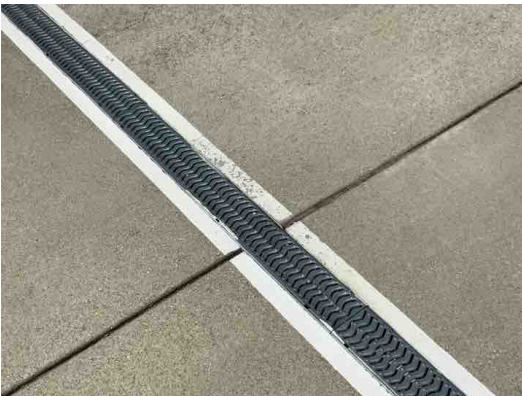
**MR DS 18:** Surface drains and boxes noted in areas of the driveway. Drains are not tested, conditions of the underground piping and terminations are unknown. Recommend having drains cleaned and tested to determine proper flow and termination. Keep drains clean and free of debris regularly.

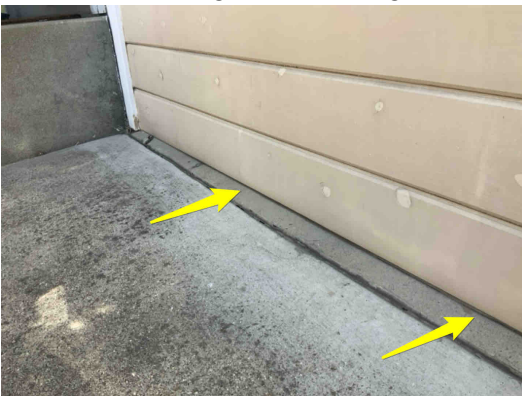
Example

**UPG DS 20:** Disclosure: Due to the height of the DUPLEX driveway at the exterior wall at the garage conversion / living space at UNIT 1225 some water intrusion into the building may occur during certain weather. No visible watershed flashing at the building exterior and driveway connection. Upgrades recommended.

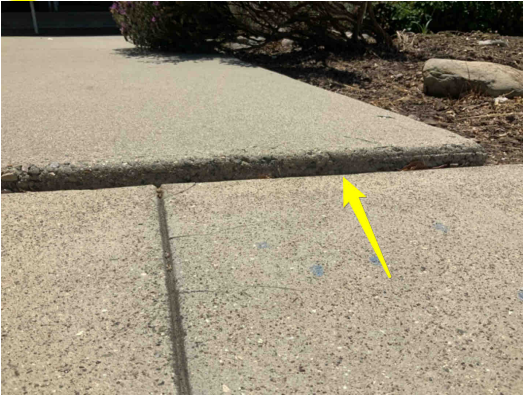
Example

**SU** 24: Areas of the walkways are uneven with potential trip hazards.

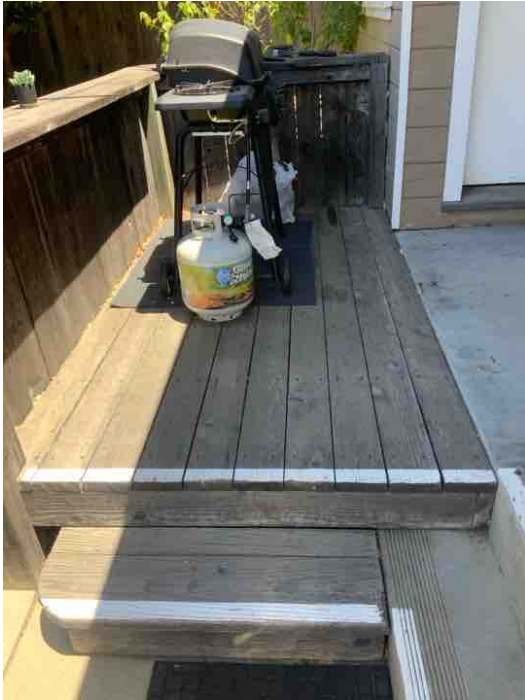
48: DECK LOCATION: **UNIT 1227 FRONT ENTRY DECK**

**E&C 49:** Some moisture and/or bug-type damage and deterioration found at areas of the wood decking and/or wood deck railings: UNIT 1227 FRONT ENTRY DECK. *Refer to the termite report for additional comments and recommendations.*

**E&C 52:** A broken 2 x 12 top rail found at the UNIT 1227 FRONT ENTRY DECK railing.

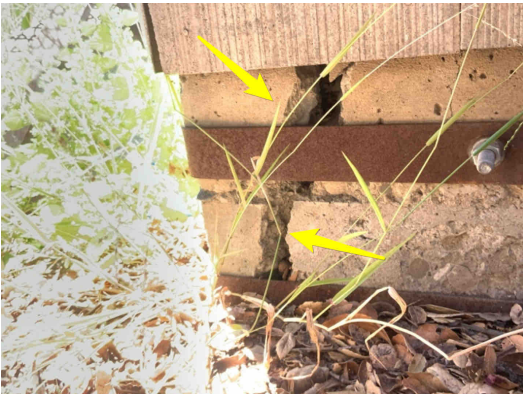
**FI 73:** Some moderate cracks with displacement found at areas of the concrete perimeter foundation stem walls at areas of the DUPLEX FOUNDATION. Evidence of **some** past repairs noted. Unable to verify if the repairs are adequate. Refer to sellers disclosures, or have areas evaluated in appropriate engineer. Recommend additional review by qualified and licensed engineer to evaluate cause, the current conditions and potential future issues.

cracks and displacement at foundation stem wall

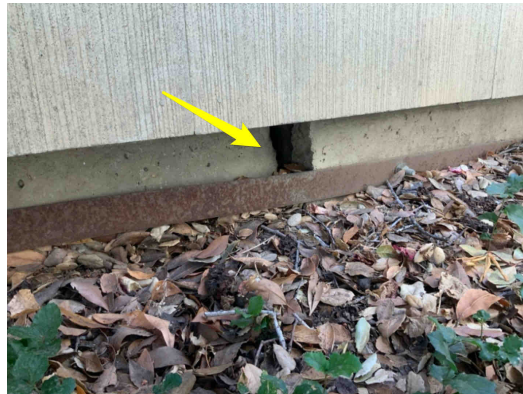
cracks and displacement at foundation stem wall

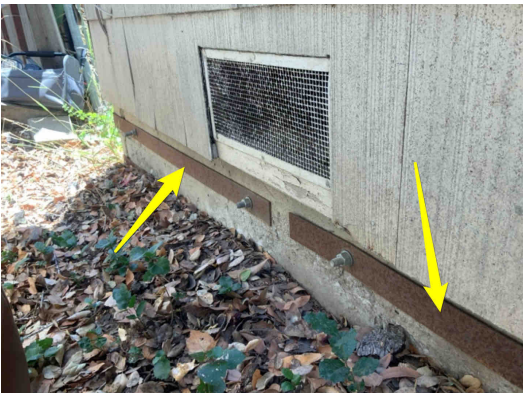
Past repair straps

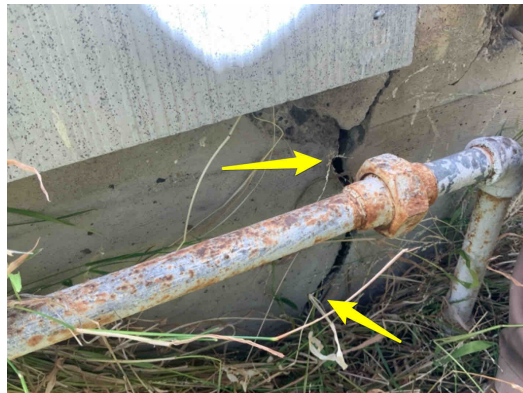
Some moderate cracks not repaired

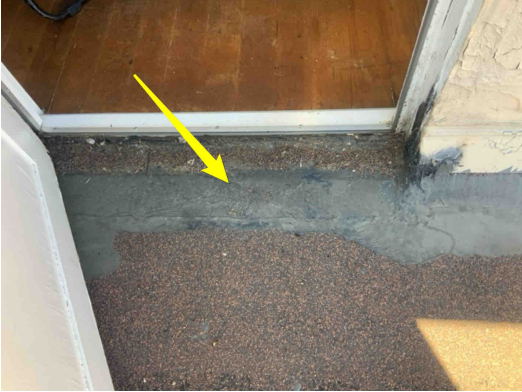
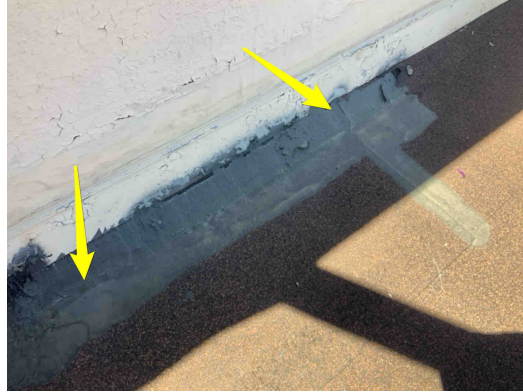
Example

**MR** **UPG** **88:** Areas of past improper or incomplete past repairs found at areas of the UPSTAIRS FLAT ROOF ROLLED COMPOSITION ROOFING. Areas of exposed mastic found not covered by aggregate found deteriorated.

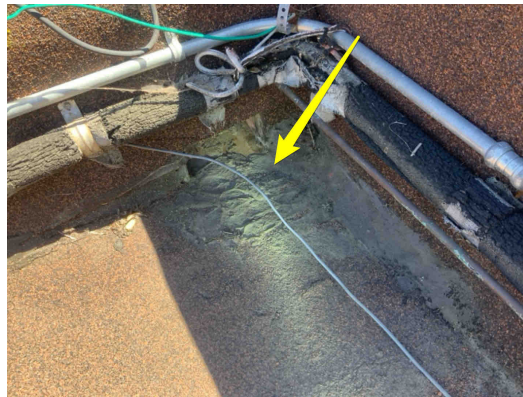
Around the scupper

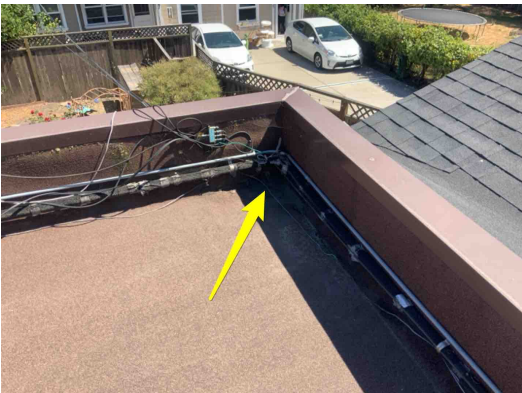
Around the scupper

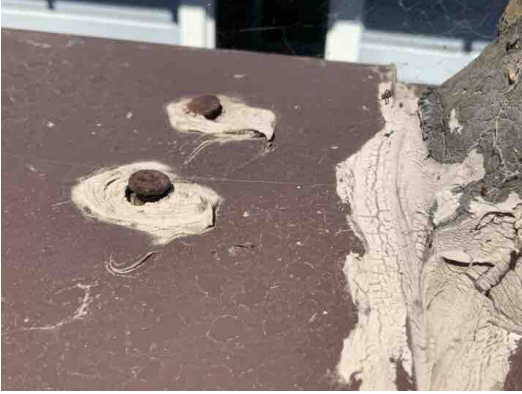
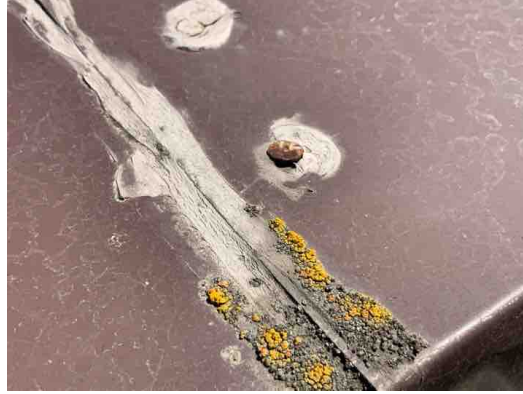
**E&C** **MR** **94:** Deteriorated sealant, Exposed, Loose / Lifting nails at areas of the FRONT UNIT - FLAT ROOF PARAPET CAP FLASHINGS.

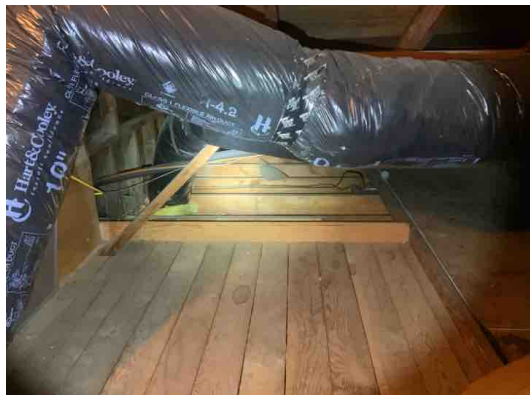
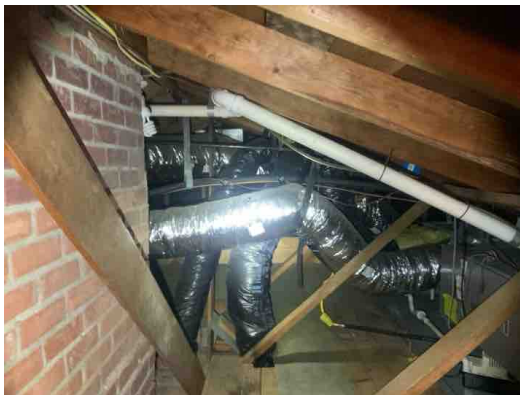
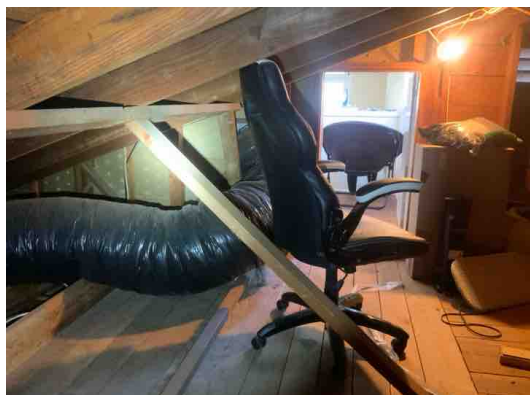
**96: ATTIC ACCESS LOCATION:** Upstairs Bedroom Hallway- FRONT UNIT.

**SU DS 97:** Attic framing does not meet current standards and is sagging in some areas. However, appears to be in good condition. Upgrades recommended.

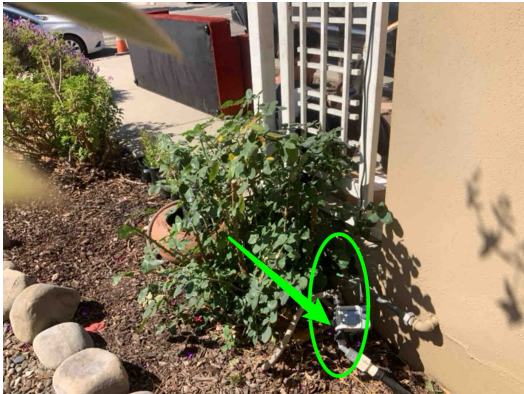
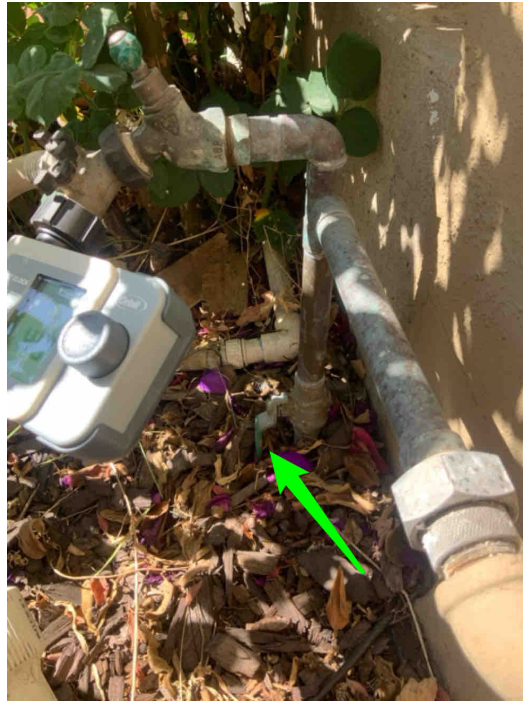
**101:** Main water supply shut-off location: ON THE FRONT OF THE FRONT HOUSE. *Main water shut-off valve not tested.*

Main water shut off valve

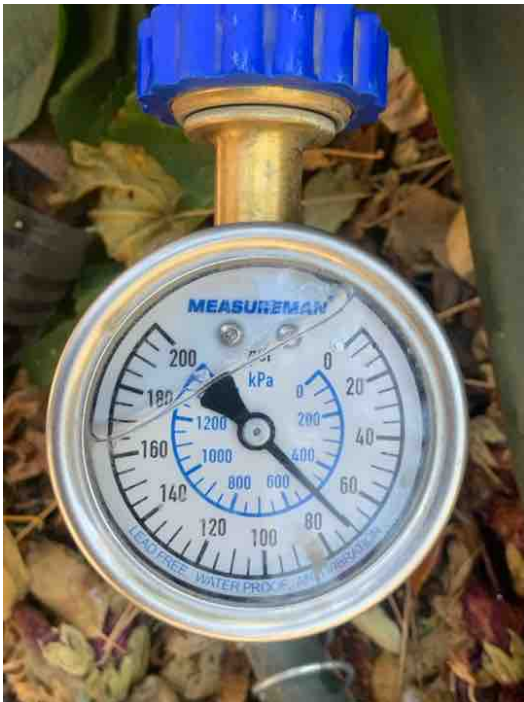
**102: WATER PRESSURE - Is Within Standards:** At Approx. 70 +/- PSI . *Optimal water pressure is between 40 and 80 PSI.*

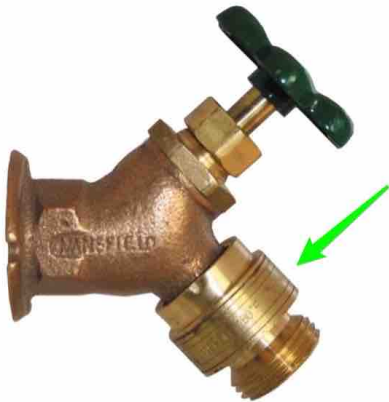
Example of an anti-siphon valve on a hose faucet

**UPG 109:** Anti-siphon valves recommended on exterior hose faucets where not installed.

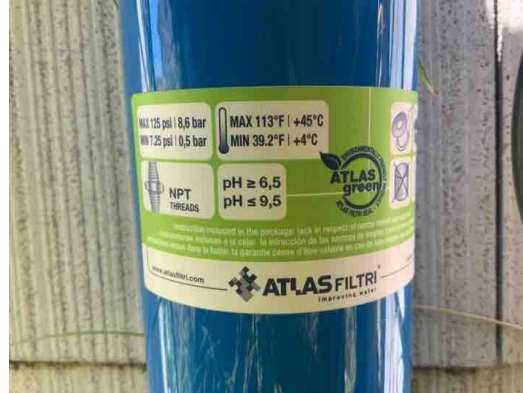
**MR DS 110:** Water filter installed on the EAST SIDE - Exterior at the DUPLEX. *Water quality and filter not inspected or tested. Water filters require continuous and ongoing maintenance. Please read owner's manual for recommendations.*

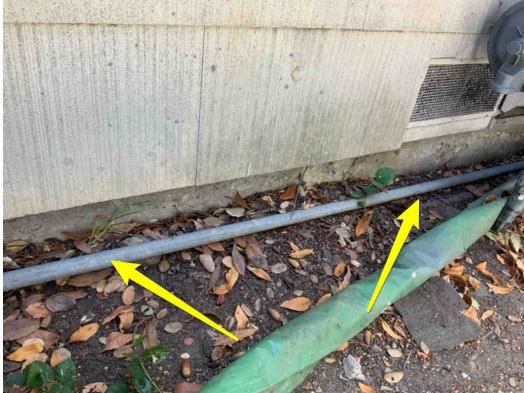
Example. UNIT 1227

**E&C MR 119:** An improper installation of unprotected / unwrapped metal Gas pipe in contact or close to the dirt at the exterior at UNIT 1227.

All gas piping which runs under ground or **within 6 inches off the ground** must be protected from physical contact with the soil to prevent rust and corrosion. Contact a qualified plumber to evaluate the current condition and replace the unprotected gas piping if/as needed.

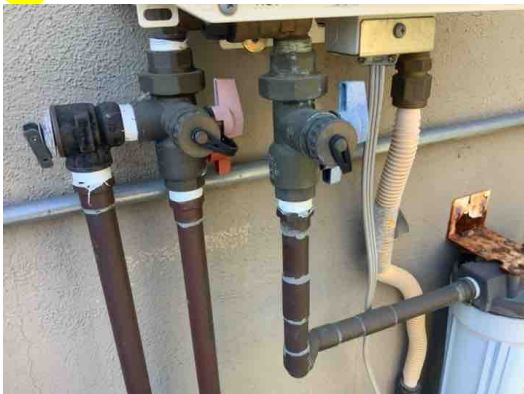
**MR 129:** The Tankless Water Heater shutoff and flush valves are installed. *Valve not tested.*

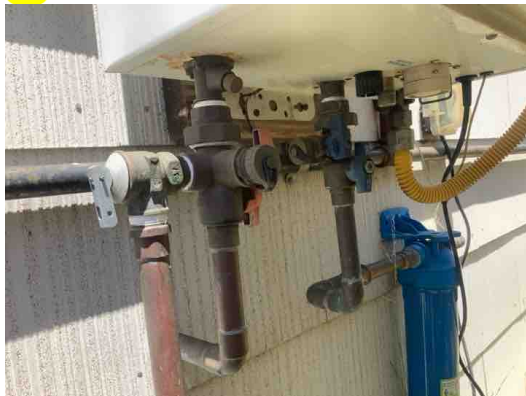
**MR 139:** The Tankless Water Heater shutoff and flush valves are installed. *Valve not tested.*

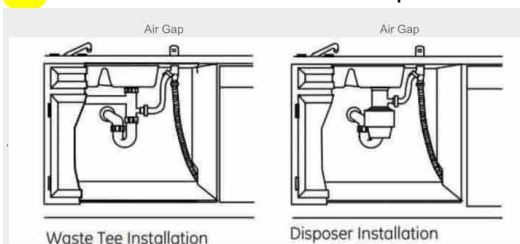
**SU 147:** Recommend an Air Gap Device at the dishwasher drain.

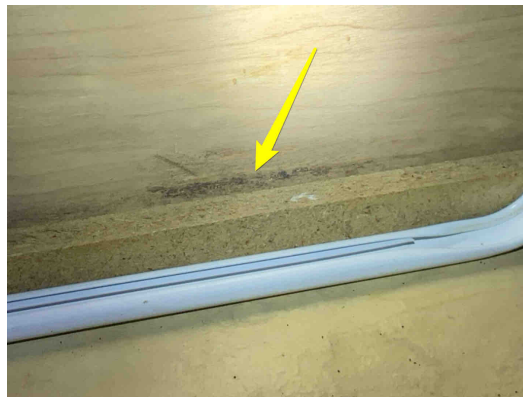
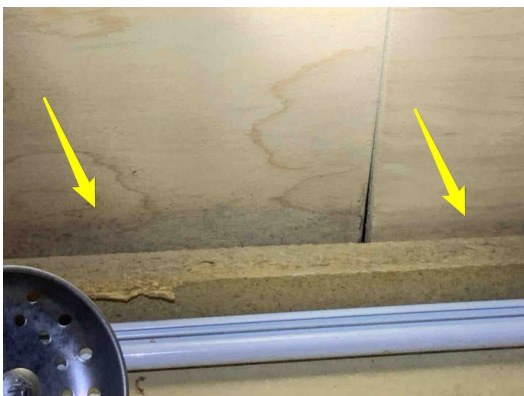
UNIT 1225

**FI 160:** Some corrosion found at waste pipe connections under the kitchen sink / evidence of past leaking.

**FI 161:** Some dry moisture stains and damage in the cabinetry below the UNIT-1225 kitchen sink.

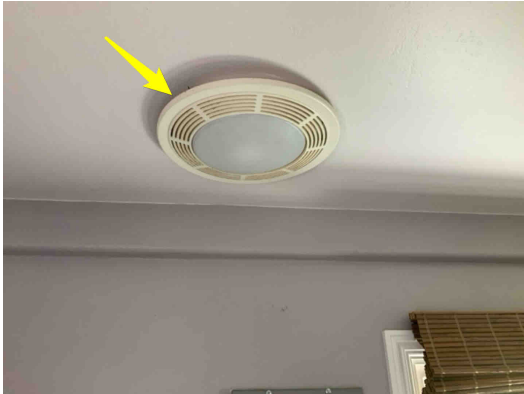
Fan cover found loose ceiling. Maintenance or upgrade recommended

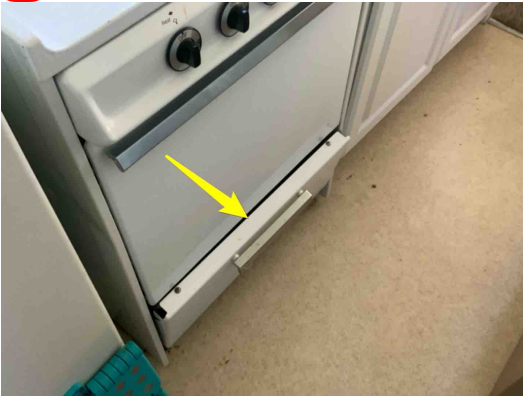
**E&C 170:** The broiler door does not properly open or close at UNIT-1225 kitchen range.

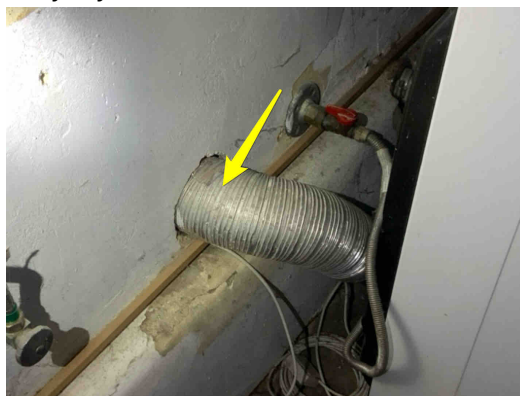
**SC 191:** An improper use of a non-fire rated / flexible laundry dryer vent pipe through the FRONT UNIT GARAGE FIRE WALL and CRAWLSPACE. Replacement recommended for fire safety. Contact a qualified, HVAC contractor. The maximum length of a flexible laundry dryer flex connector is 6 feet.

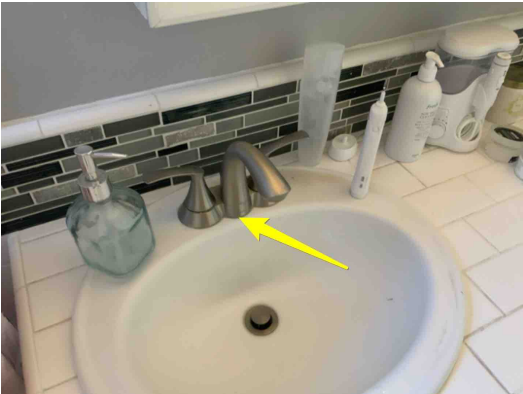
**E&C** 199: Active leaking, dripping water into the cabinet below, from the sink faucet to sink connection in the UNIT 1225 BATHROOM

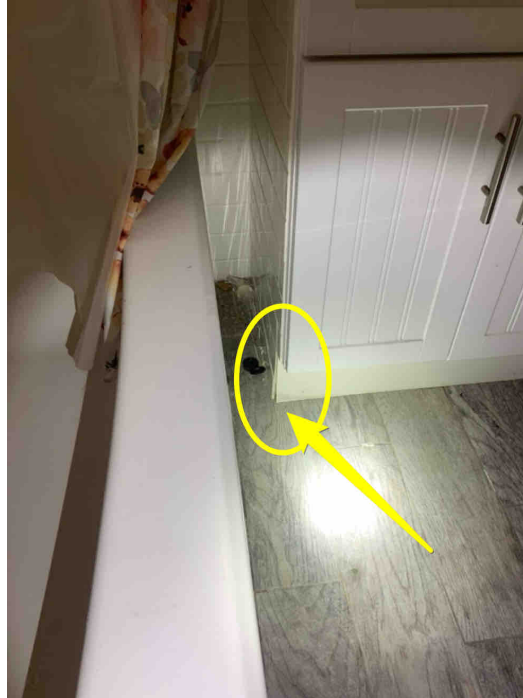
**E&C** **204:** Moisture stains and damage to wood cabinet outside tub: UNIT 1225 BATHROOM

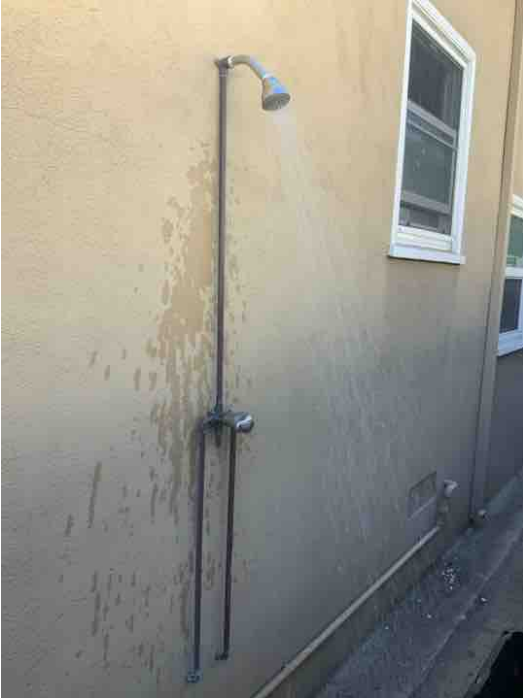
**MR 206:** OUTDOOR SHOWER operated properly when tested. (1.75 GPM shower head)

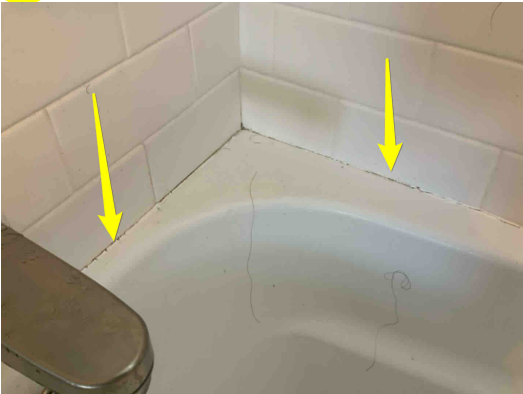
**MR 207:** Some deteriorated caulking in the UNIT 1225 BATHROOM shower area. Maintenance Recommended

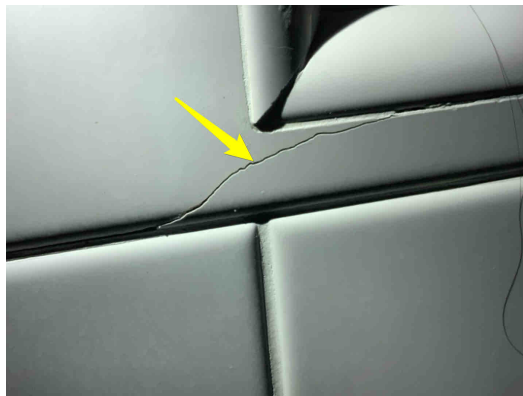
**FI 208:** Some cracked tiles found in areas of UNIT 1225 BATHROOM shower enclosure.

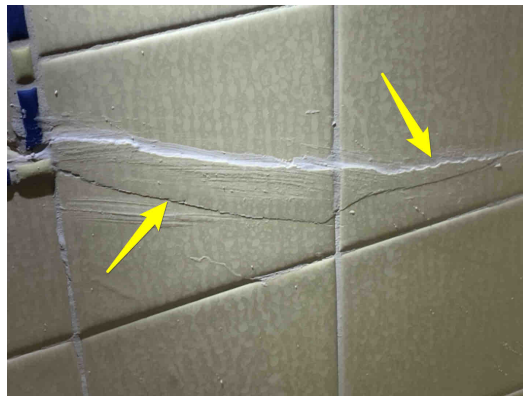
**FI 209:** Some cracked tiles found in areas of UNIT 1227 BATHROOM shower enclosure.

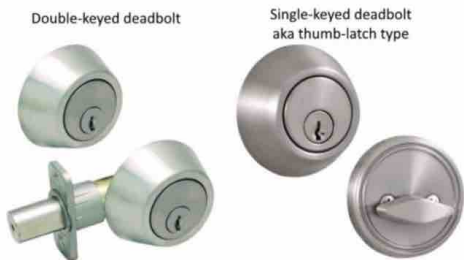
Example. UPSTAIRS WOOD EXTERIOR DOOR

**E&C 220:** Moisture deterioration / damage at the UPSTAIRS WOOD EXTERIOR DOOR

**SC 222:** It is considered unsafe to use of a double-keyed deadbolt at exterior doors which may be used as and exit in an emergency: FRONT HOUSE UPSTAIRS ROOF ACCESS DOOR

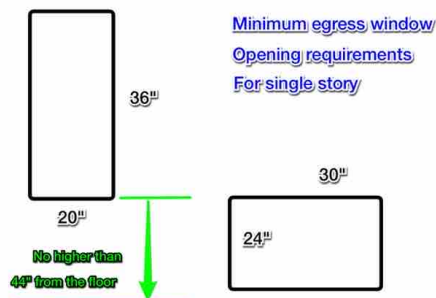
**SC 253:** Windows in the **UNIT-1225 bedroom** are too small and too high off the floor and do not meet the current minimum fire egress standards. Upgrades recommended for safety.

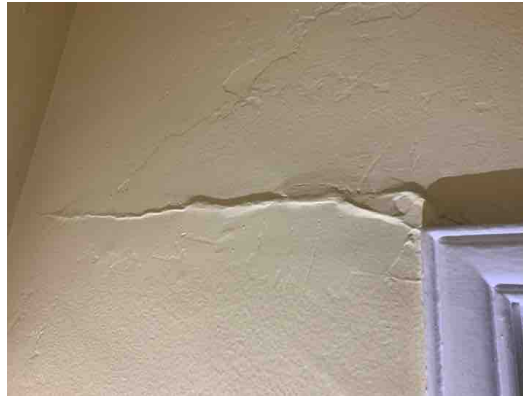
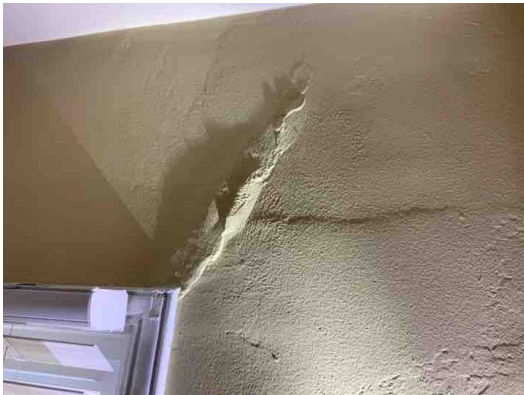
**FI 265:** Evidence of some unusual cracks and/or tearing of the drywall. The visible movement appears more than normal: UNIT 1227. This appears to be from some type of movement or settlement of the framing and/or foundation system. It is advised to have a licensed engineer evaluate the cause, current condition and potential future issues.

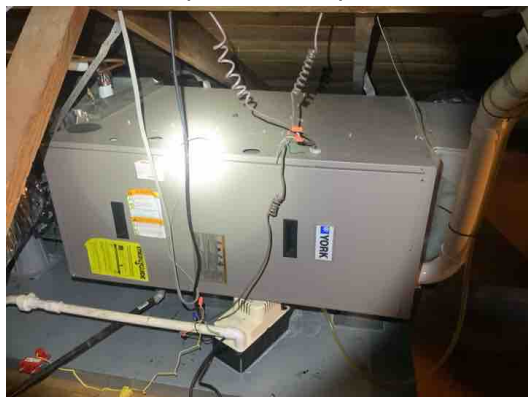
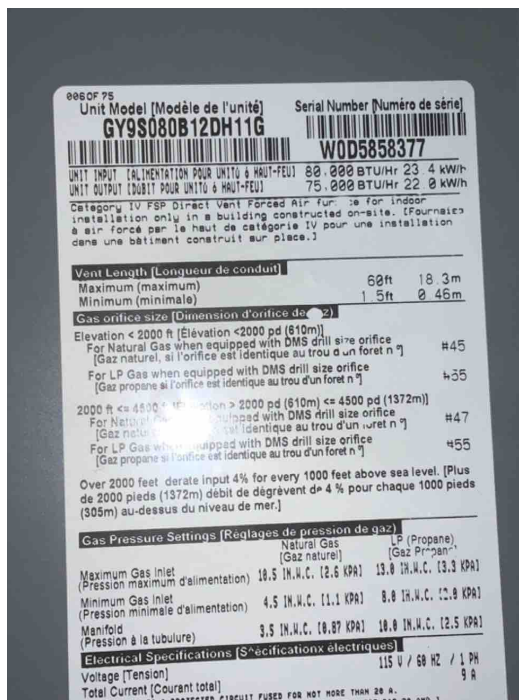
**FI** **MR** 269: Some minor moisture stains inside at furnace enclosure. Suspected condensation leak from the vent pipe.

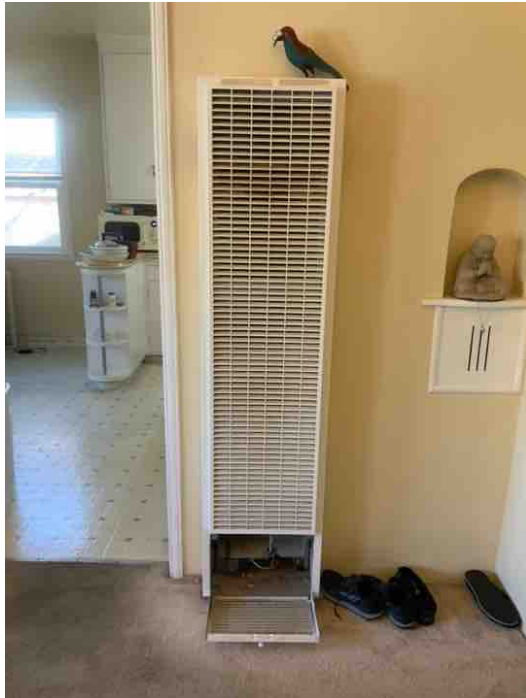
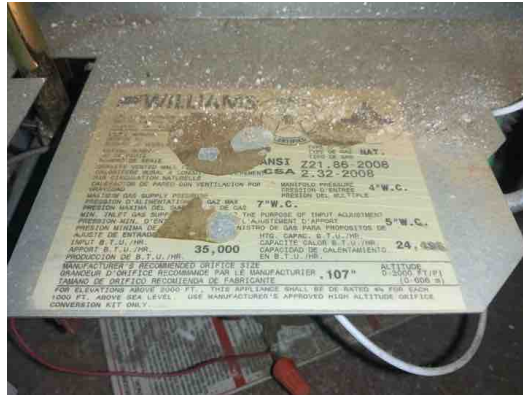
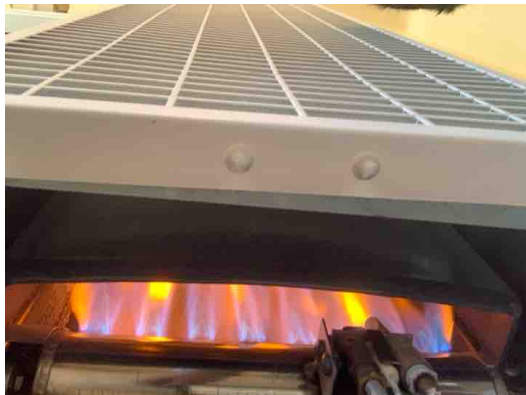
**MR SU** 275: Recommend cleaning the controller compartment under the gas wall furnace. Maintenance needed / recommended.

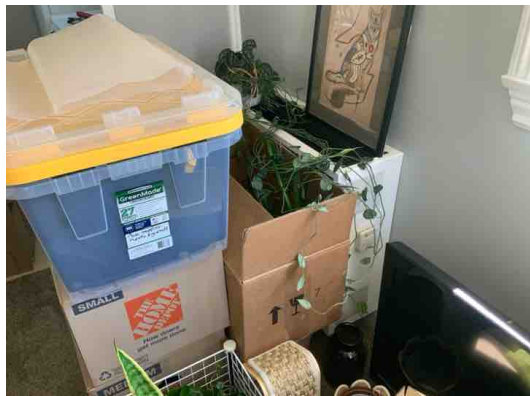
**FI 281: FURNACE CONDITION:** **The Furnace in UNIT 1227 did not respond to normal controls and was not fully accessible due to the occupant's belongings.** *Recommend further review, cleaning, servicing and certification by a licensed HVAC contractor.*

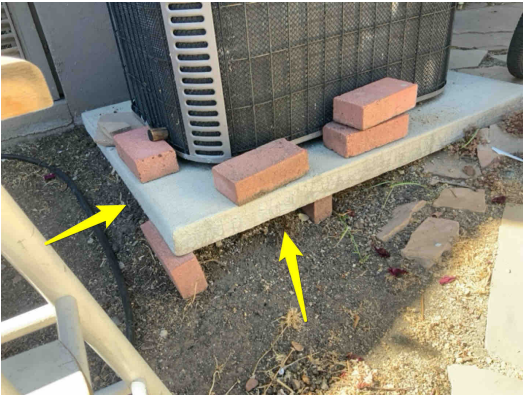
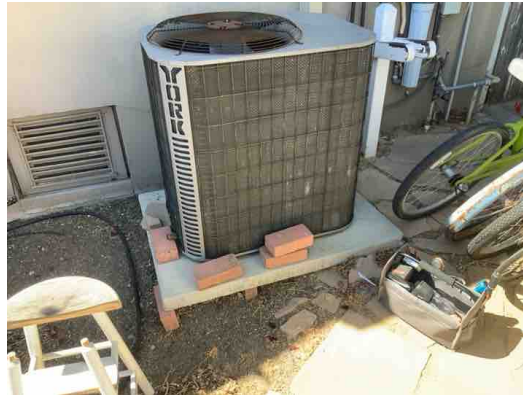
Example

**E&C 287:** Some unusual and/or excessive soil erosion found around the base of the air conditioner condenser concrete pad which can cause settlement and tilting of the unit. Correction Recommended.

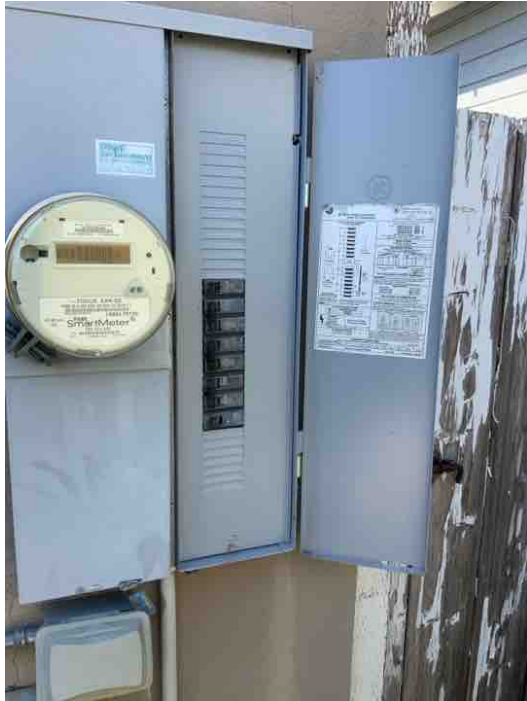
**SU 289:** Breaker panel is not fully or properly labeled per standards: MAIN ELECTRICAL PANEL.

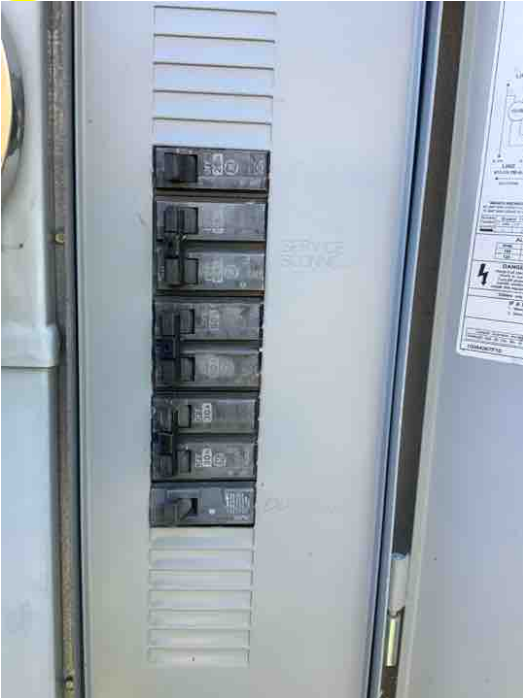
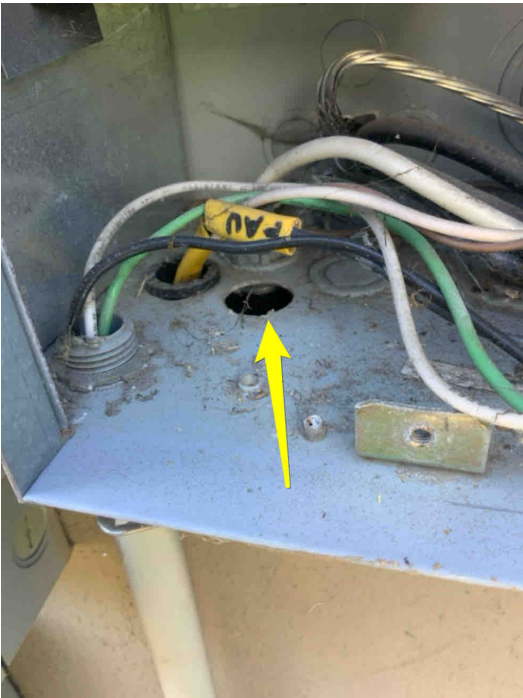
Example FRONT HOUSE

**SU 290:** Unprotected / unused opening(s) through the BOTTOM of the FRONT HOUSE MAIN ELECTRICAL PANEL needing to be sealed for safety per standards. This will help prevent critter intrusion into the electrical panel.

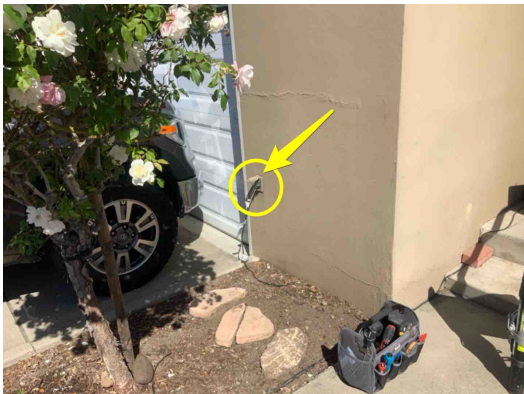
**SC 294:** Miswired electrical outlet (Reverse polarity) found AT THE EXTERIOR OUTLET ON THE FRONT OF THE FRONT HOUSE GARAGE. Have electrician check all outlets and correct as needed.

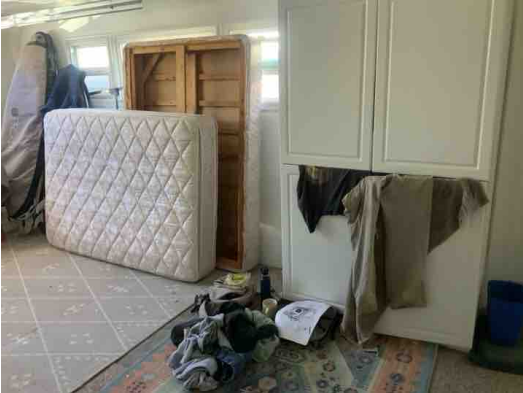
**DS 303:** The FRONT UNIT garage floor and walls are not fully visible due to carpeting, occupants' belongings and/or cabinetry. Areas of the garage is not accessible, visible nor inspected. A re-inspection is recommended once full access is made available.

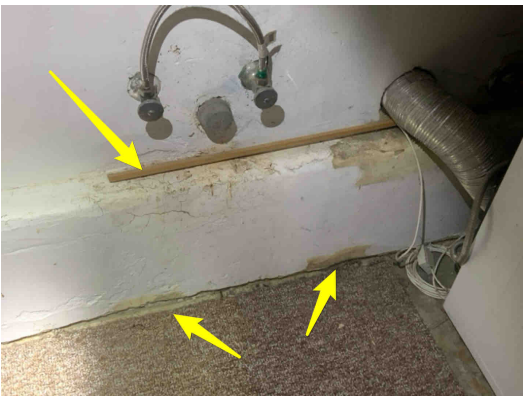
**FI 307:** Moisture stains found on areas of the garage wall. Recommend further review to determine cause, current condition and if repairs are needed. Areas found dry today.

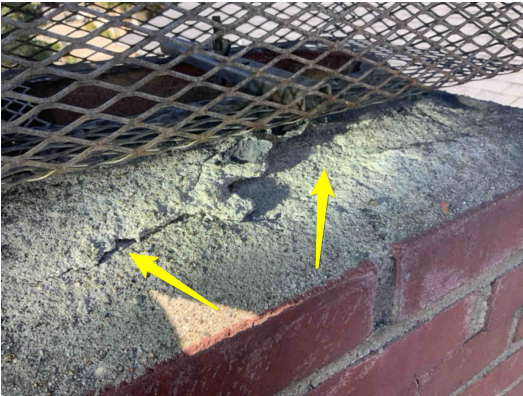
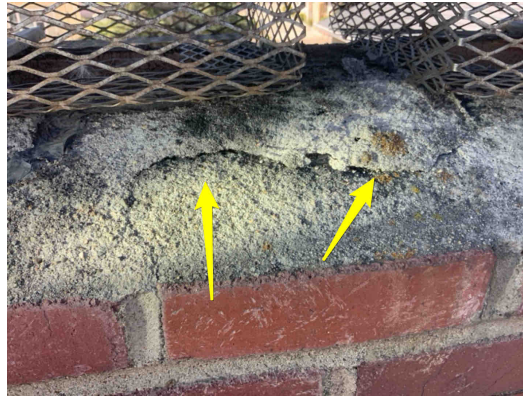
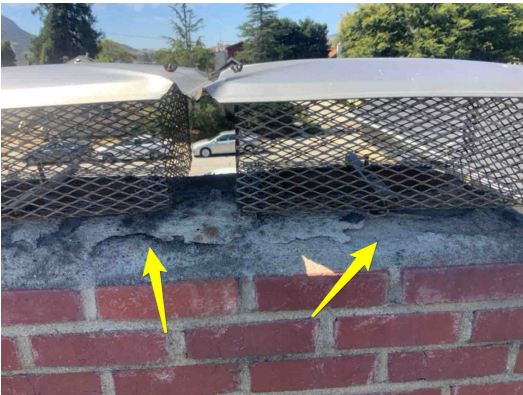
**MR 328:** Visible cracks found in the mortar crown located at the top of the LIVING ROOM fireplace chimney. Maintenance / caulking or sealing is recommended to help prevent water intrusion into the confined spaces within the masonry chimney.

**MR 329:** Heavily deteriorated mortar crown located at the top of the LIVING ROOM and BEDROOM fireplace chimney. Maintenance / repairs recommended to help prevent water intrusion into the confined spaces within the masonry chimney.
