Inspection Report

Property Address:
447 E Hullett St
Long Beach CA 90805

Ferguson Home Inspections

Date: 3/23/2024	Time: 09:00 AM	Report ID: 20240323-447-E-Hullett-St
Property: 447 E Hullett St Long Beach CA 90805	Customer: Kimberly Stewart	Real Estate Professional: Sue Freeman

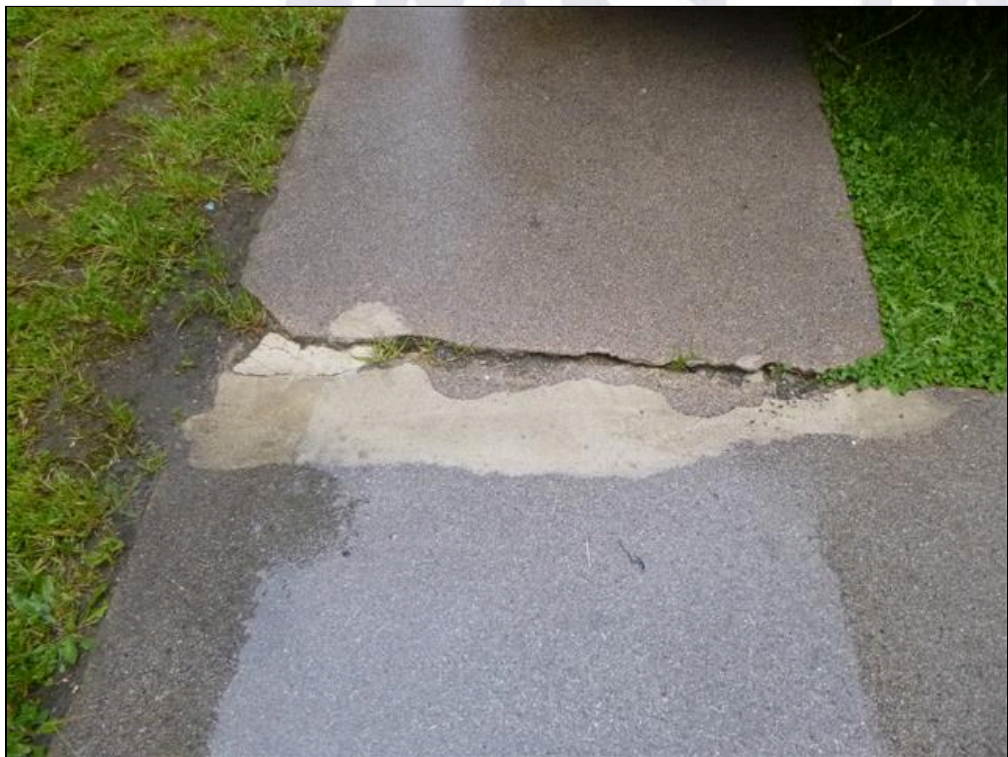
1.0 Item 2(Picture)

1.0 Settling, expansion cracks and heaving noted at various areas, this is a potential trip hazard. Suggest review with a licensed contractor for repair/replacement costs as needed.

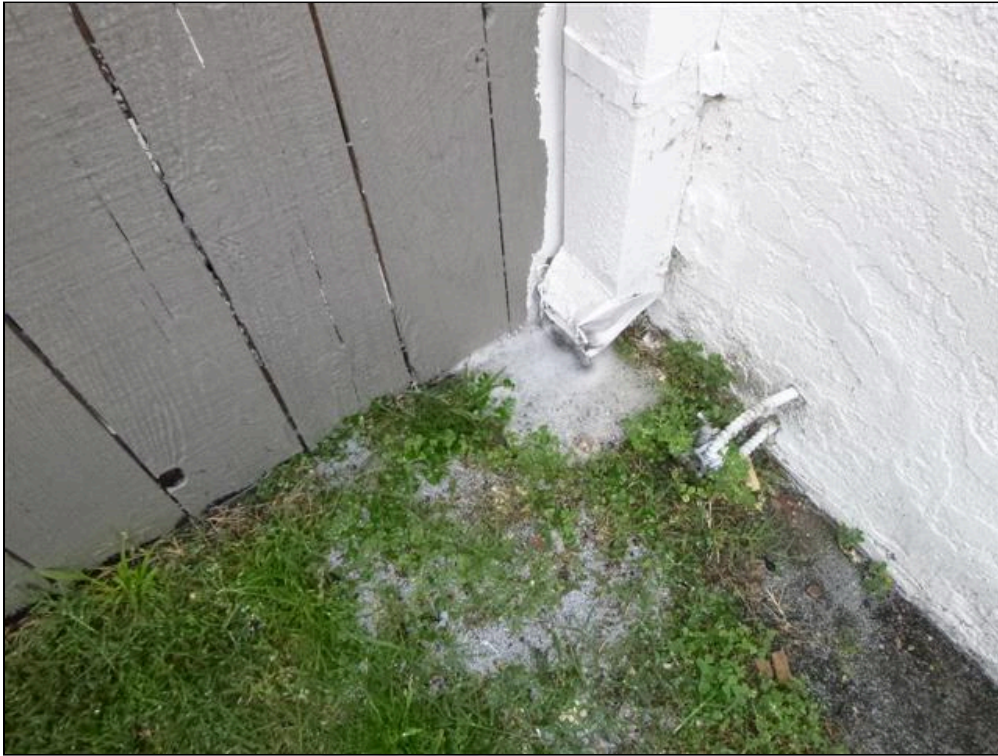
1.9 Item 1(Picture)

1.9 (1) Suggest review by a licensed contractor for possible installation of an area drainage system to

divert drainage away from the foundation.

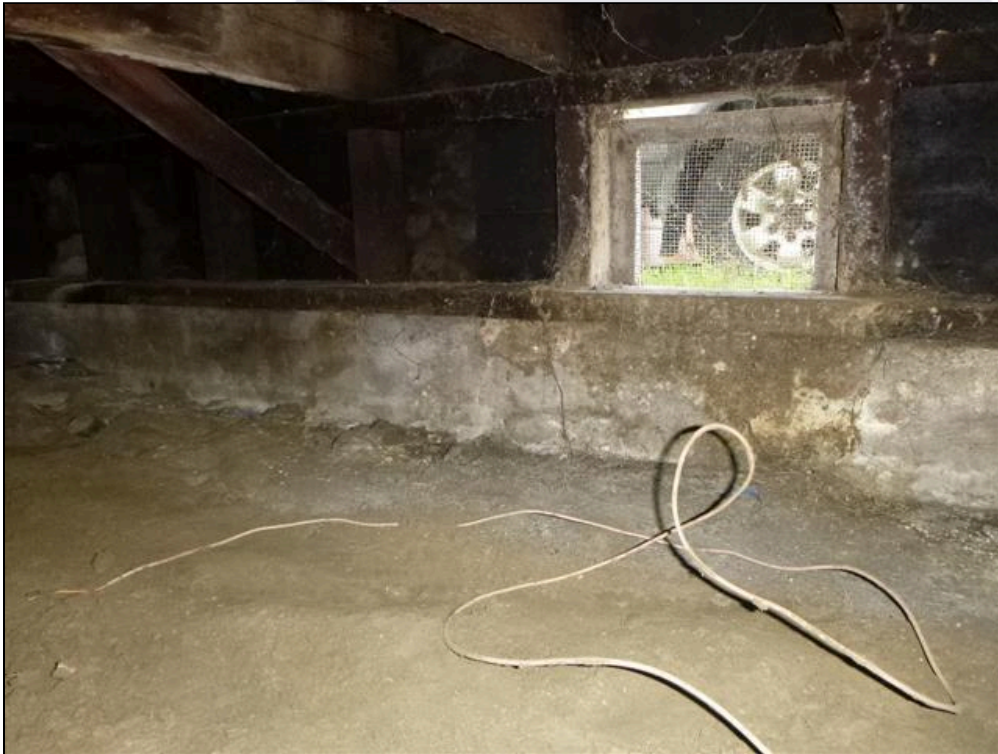
2.0 Item 1(Picture)

2.0 Re-grading where needed is recommended to assure all water drains away from the home's foundation. The inadequate drainage has caused the excessive moisture buildup at the foundation and intrusion into the crawl area. Suggest review with a licensed contractor for installation of concrete walkways/barriers, water proofing membranes, rain gutters and an area drainage/sump pump system to divert all the water away from the foundation/structure.

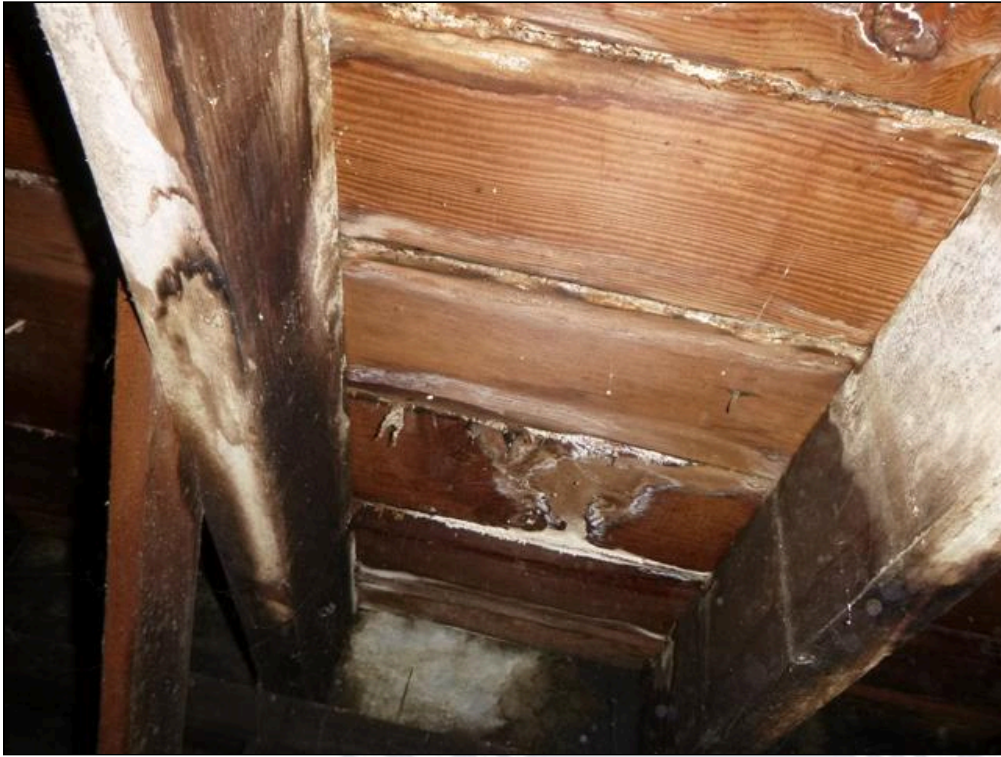
3.1 Item 2(Picture)

3.1 (1) Stains and deterioration noted at various flooring and supports from prior leaks. Suggest review with a termite company and/or a licensed contractor for any repair/replacement costs as needed.

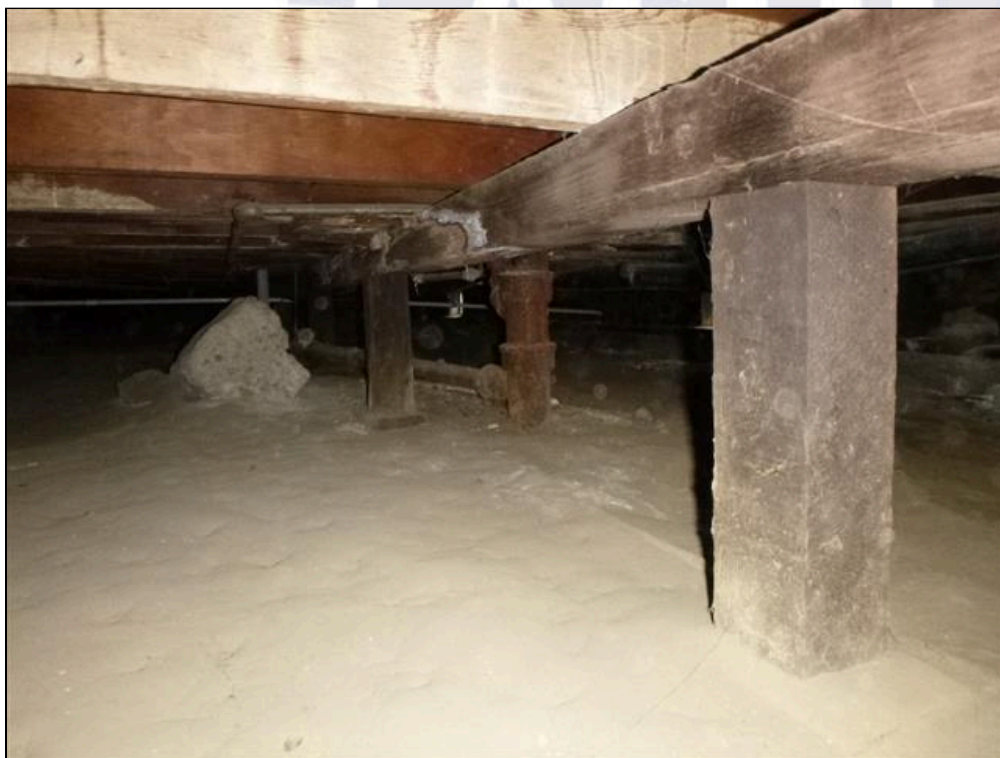
3.1 Item 5(Picture)

3.1 (2) Inadequate support noted at various girder beams due to the excessive span and inadequate support posts, common for the original age of the dwelling. Suggest review by a licensed contractor for costs to add additional supports to prevent possible future structural and floor movement as needed.

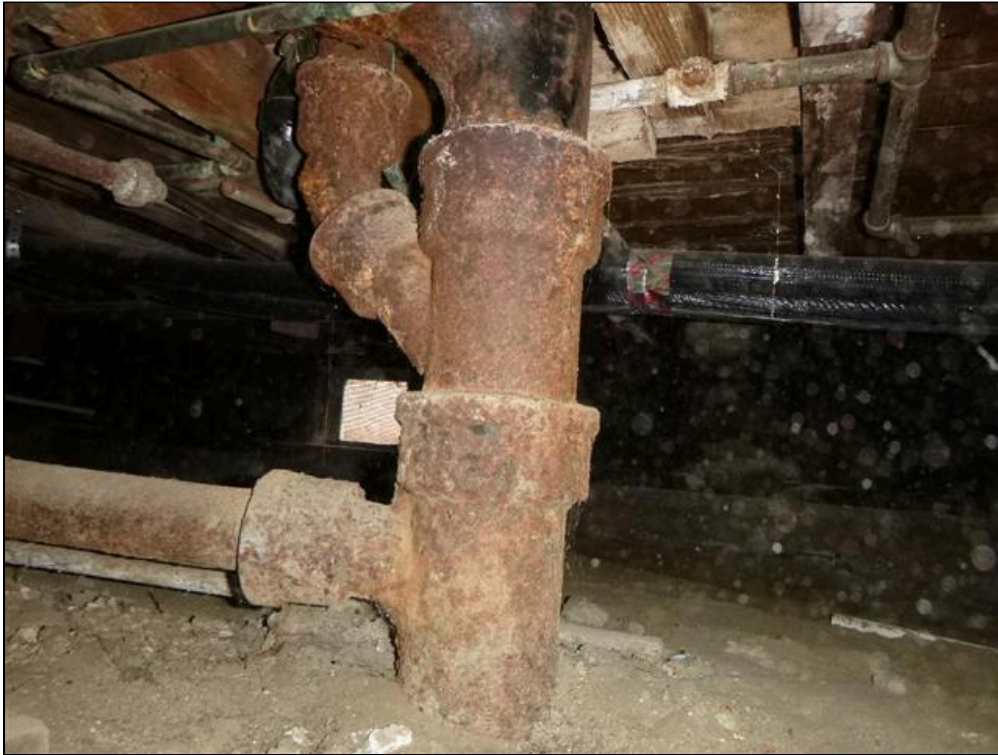
4.3 Item 1(Picture)

4.3 (1) Excessive rust, seepage and corrosion noted at various cast iron drain lines within the crawl space. Suggest review by a licensed plumbing contractor for replacement costs as needed to prevent future leakage at the crawl area.

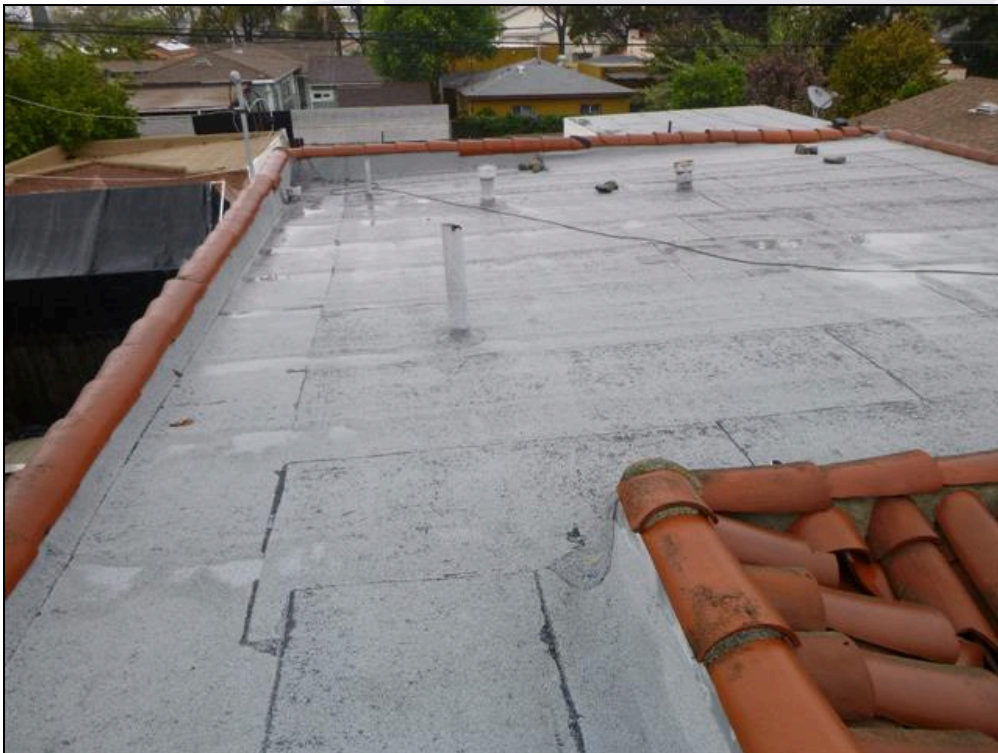
5.0 Item 1(Picture)

5.0 (1) The sloped roof covering is old and deteriorated. It is nearing the end of its useful life and the covering will need to be replaced. While it could last a year or so, some areas may need patching/repairs as leaks develop. Please review with a licensed roofer to determine the remaining life expectancy and for costs to repair/remove and replace the existing roofing material as needed.

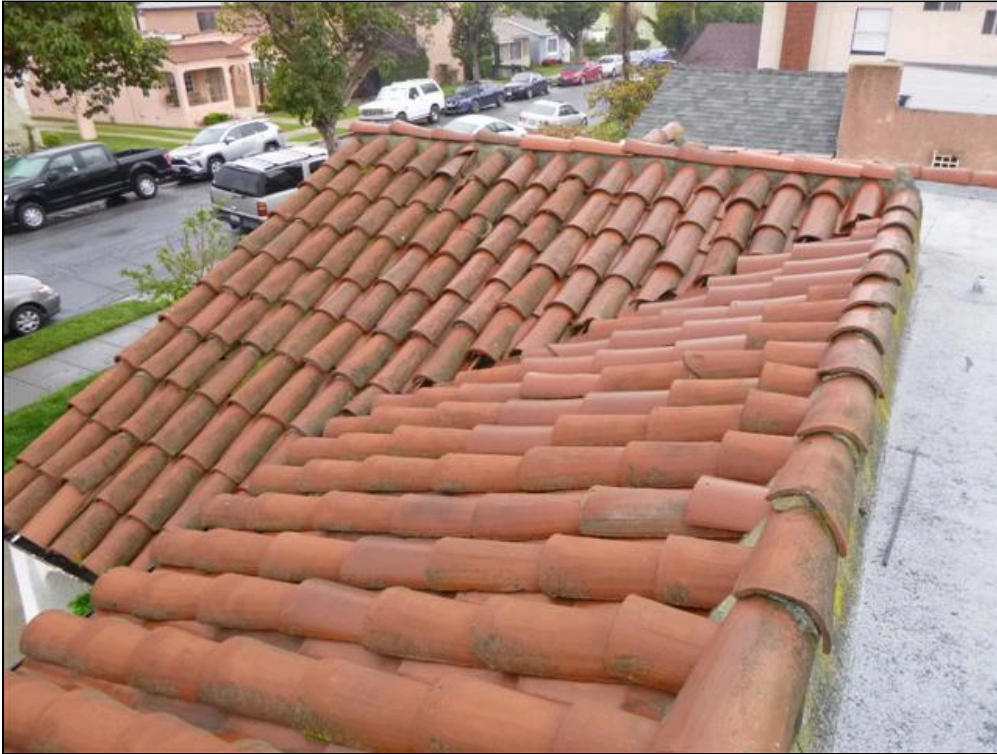
5.0 Item 8(Picture)

5.0 (5) Deteriorated, cracked, loose and missing sections of the roof tiles was noted, suggest review by a licensed roofer for repair/replacement costs as needed to prevent any future leakage during the rainy season.

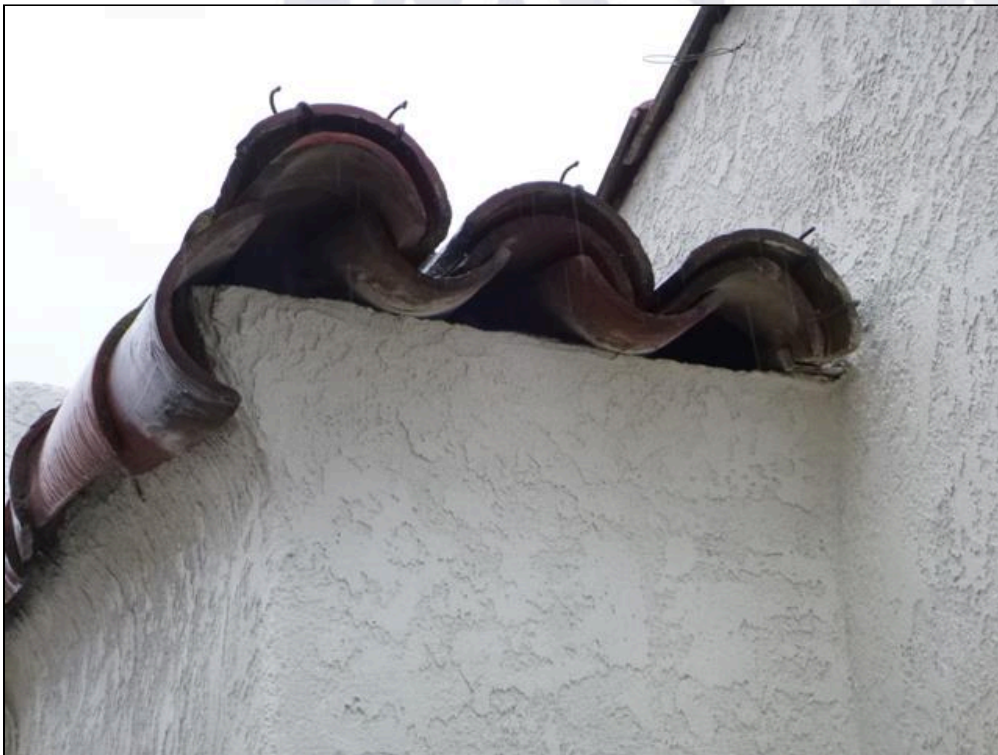
5.0 Item 16(Picture)

5.0 (6) No 'bird stops' were installed at the tile roof time of the inspection. Suggest review with a licensed roofer for installation costs as needed.

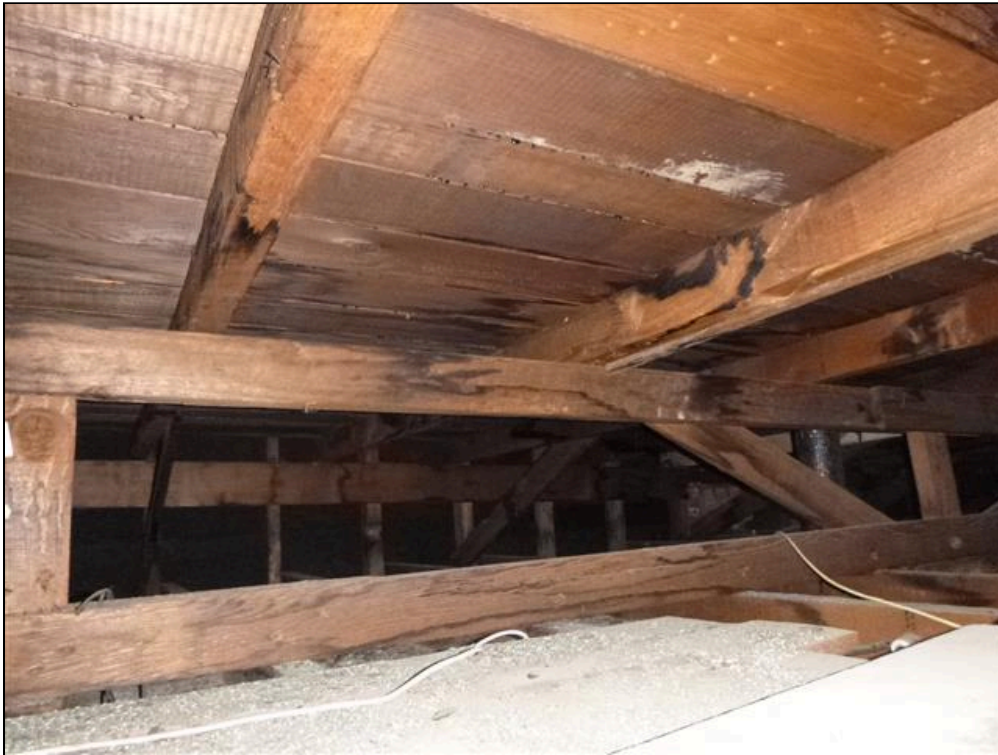
6.0 Item 1(Picture)

6.0 Moisture stains noted at various areas of the attic sheathing/framing, see roof comments and repair as needed.

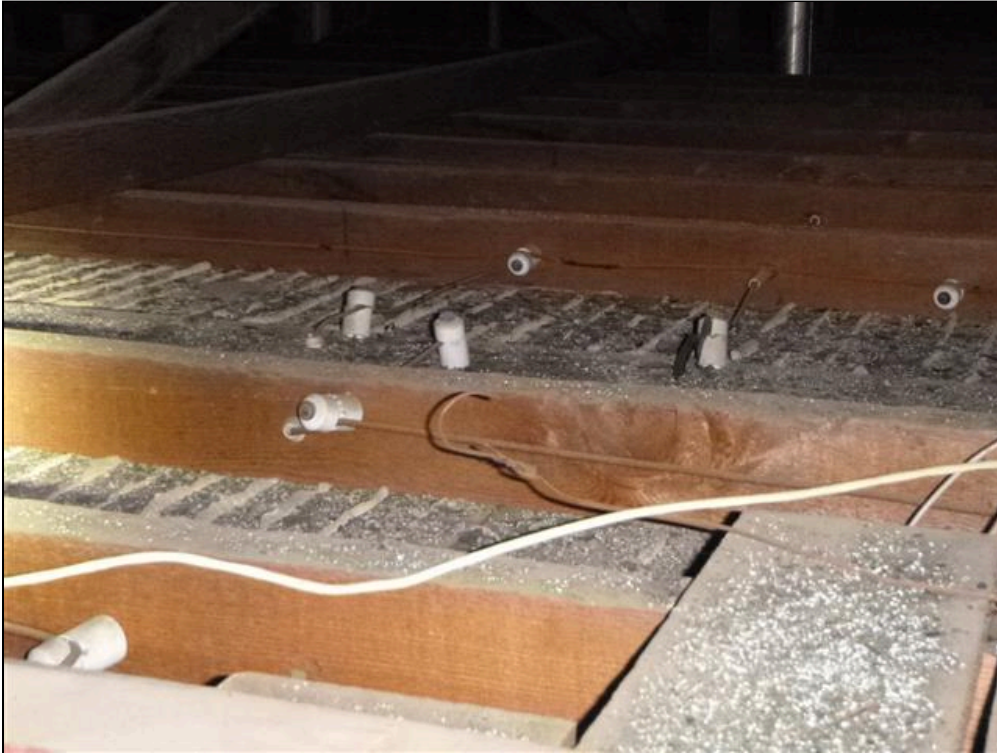
6.3 Item 1(Picture)

6.3 Knob & Tube wiring noted throughout the attic area, this is common for the original age of the dwelling. Suggest review by a licensed electrician for replacement costs to upgrade the wiring to todays standards for safety.

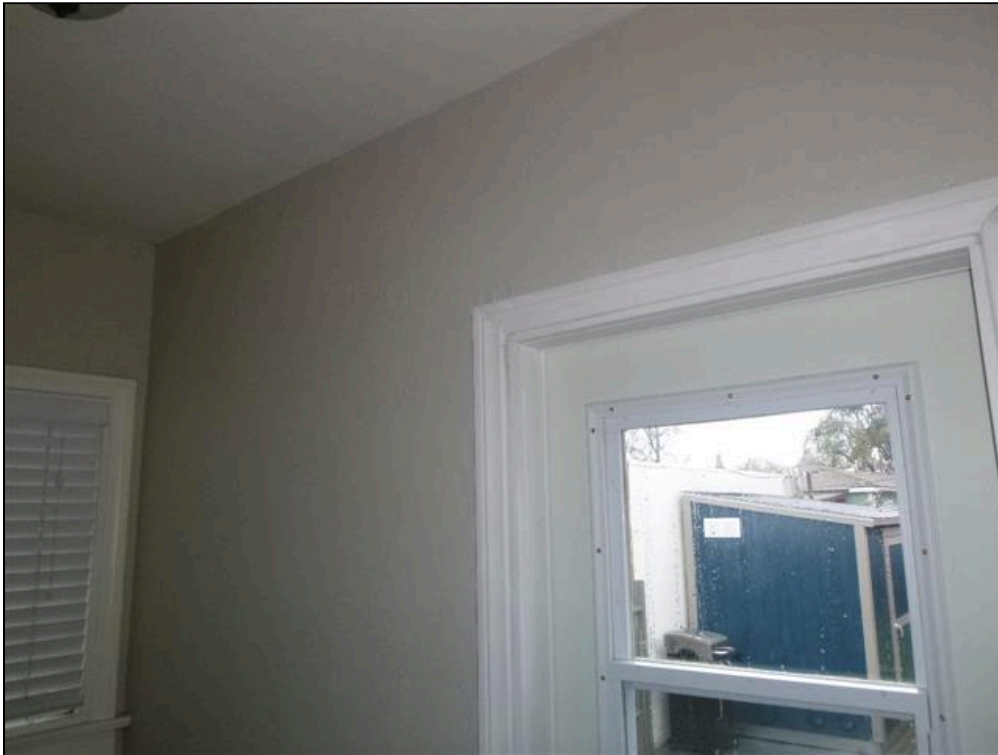
7.1 Item 1(Picture)

7.1 Patched areas of the walls was noted, suggest review with the seller for the cause and any repairs needed. Suggest repair as needed.

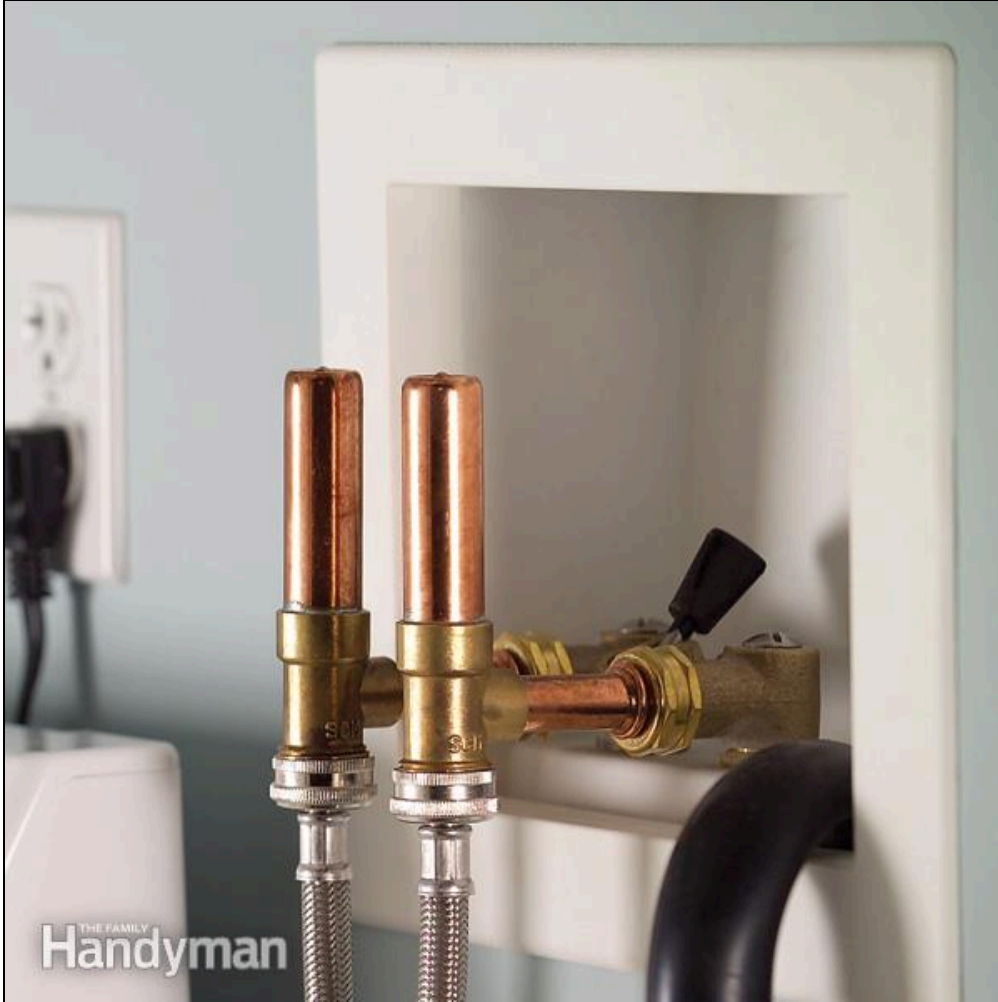
7.7 Item 1(Picture) HV

7.7 Suggest upgrading with 'hammer valve' plumbing supply systems if a water sensor/efficient/smart washing machine is to be installed at this area.

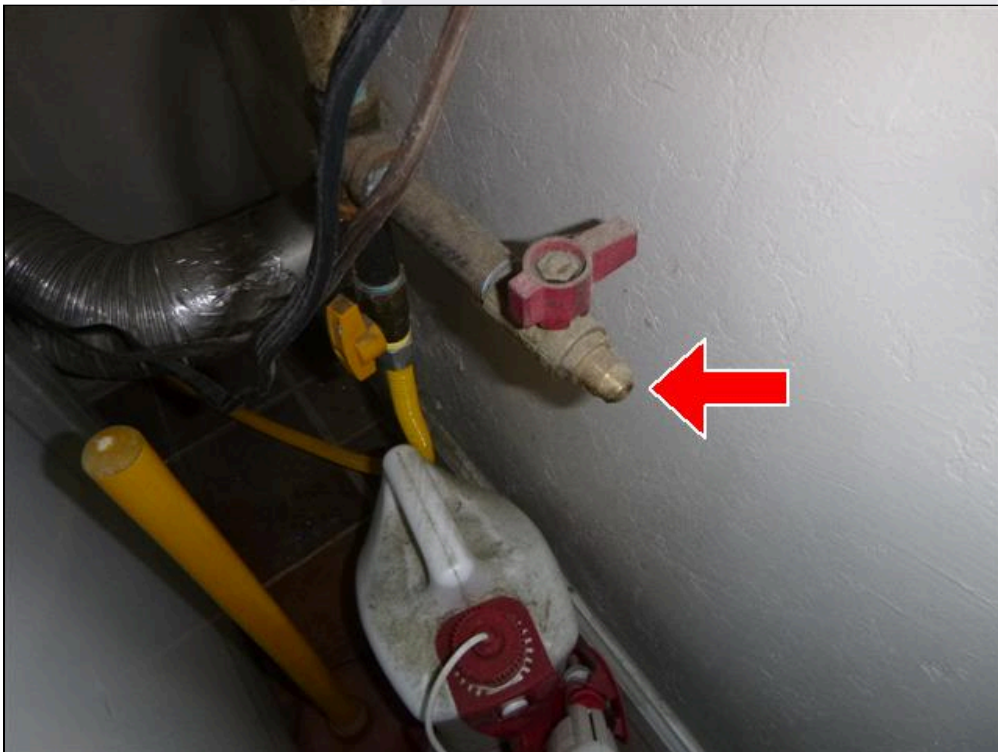
7.8 Item 1(Picture)

7.8 (1) Suggest periodic cleaning of dryer vent to exterior to prevent blockages, which can result in extended drying times and leakage.

7.8 (2) Suggest capping the unused gas line/valve as required for safety.

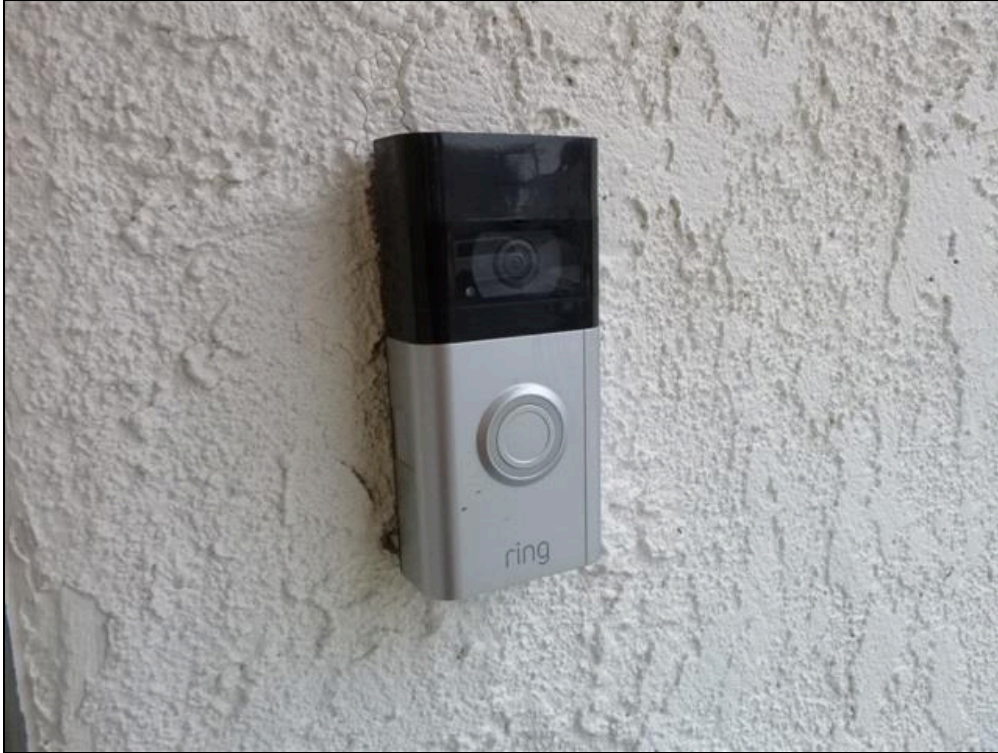
8.7 Item 1(Picture)

8.7 A 'Ring' door bell was noted at the front door. Suggest review with the seller to confirm if this unit is remaining with the property/dwelling, confirm correct operation and request operational manual.

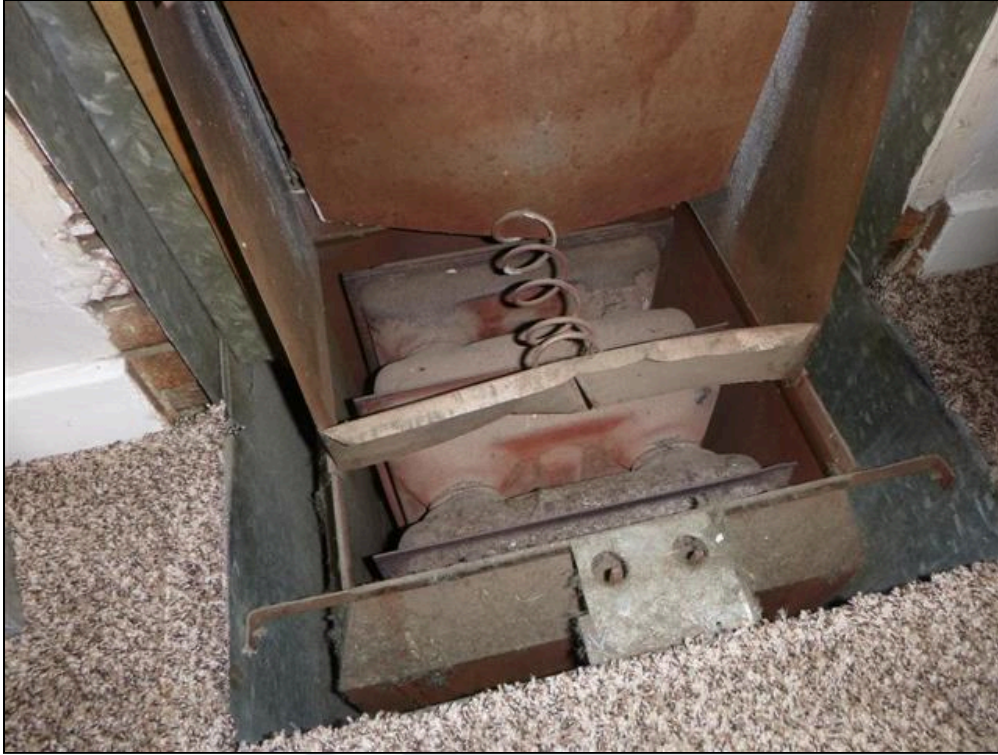
10.0 Item 3(Picture)

10.0 (2) A potential fire spread hazard was noted due to the excessive hair and debris at the base of the heating unit, suggest cleaning/removal as needed.

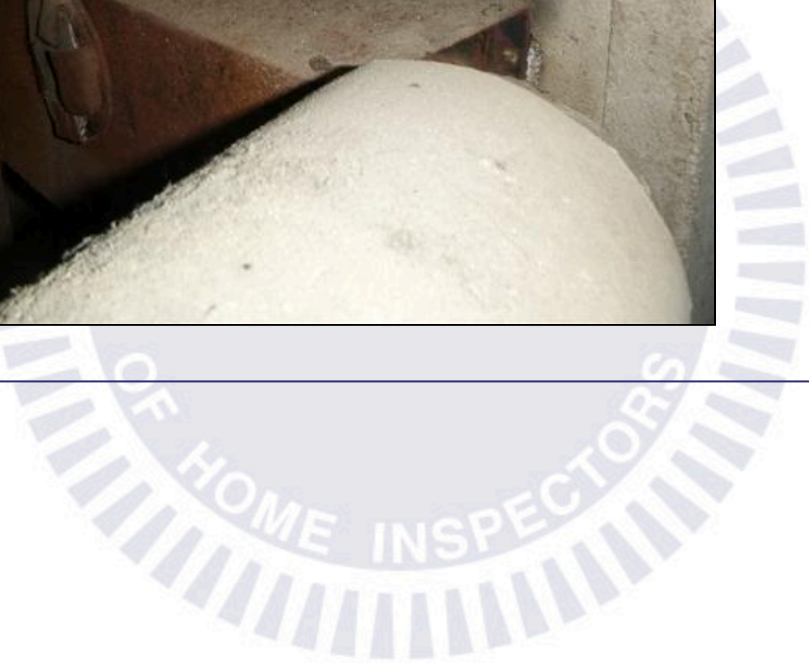
10.1 Item 1(Picture)

10.1 Potential safety hazard due to the heater draft diverter is rusted, deteriorated and large holes were noted. This will allow heater fumes/carbon monoxide to escape into the crawl area and possibly into the dwelling. Suggest review with a licensed heater company for replacement costs as required for safety.

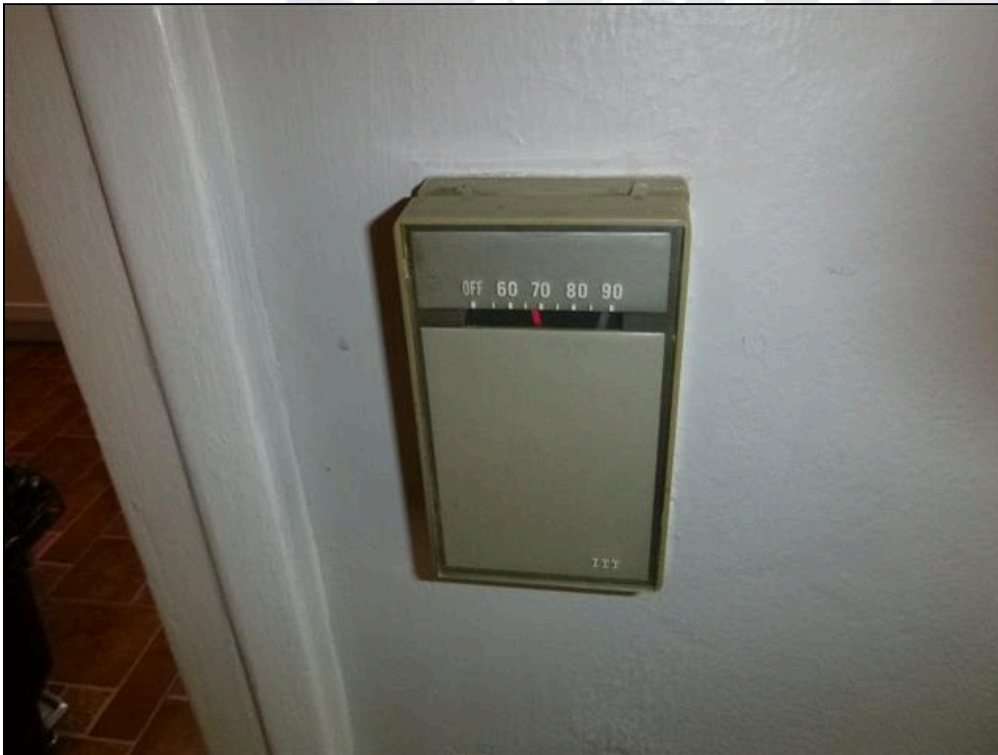
10.2 Item 1(Picture)

10.2 Suggest upgrading with digital programmable thermostat as needed.

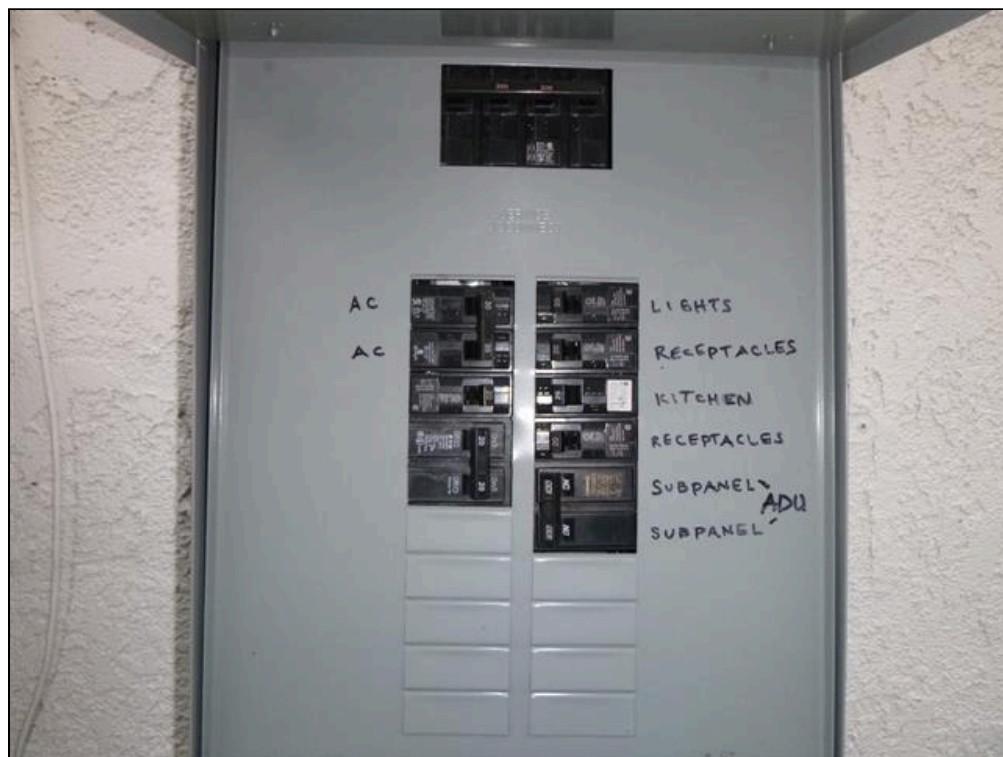
12.1 Item 1(Picture)

12.1 Suggest adding correct/complete indexing/labelling to all breakers for identification of each circuit for safety.

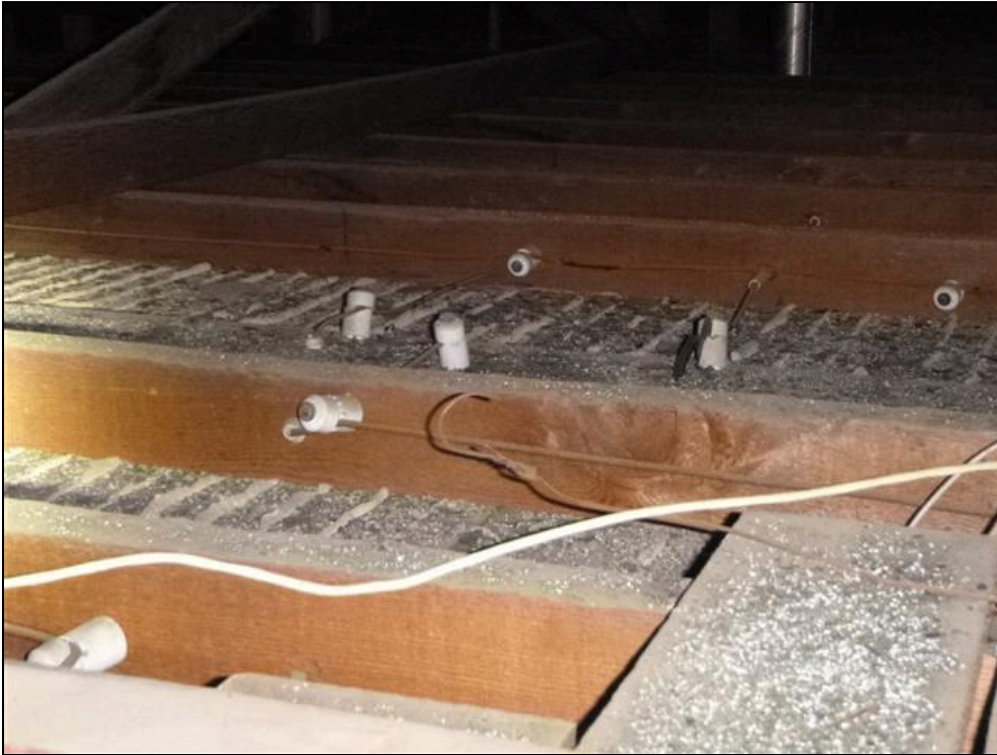
12.2 Item 2(Picture)

12.2 (3) Knob & Tube wiring noted throughout the attic area, this is common for the original age of the dwelling. Suggest review by a licensed electrician for replacement costs to upgrade the wiring to todays standards for safety.

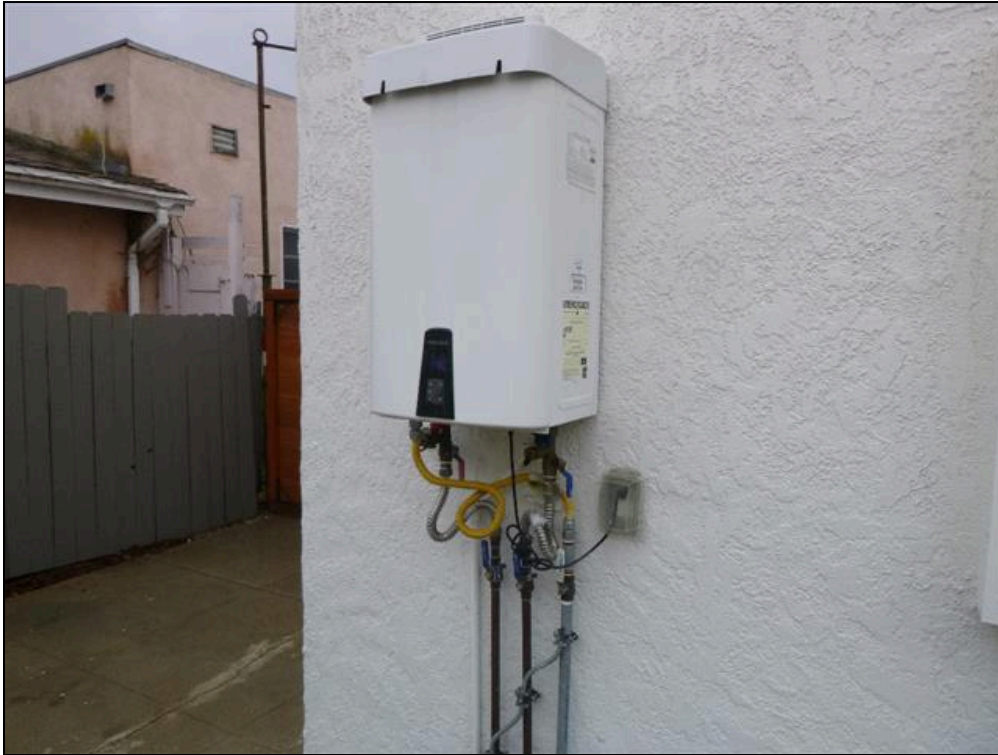
15.0 Item 1(Picture)

15.0 (1) The water heater was operational at the time of the inspection.

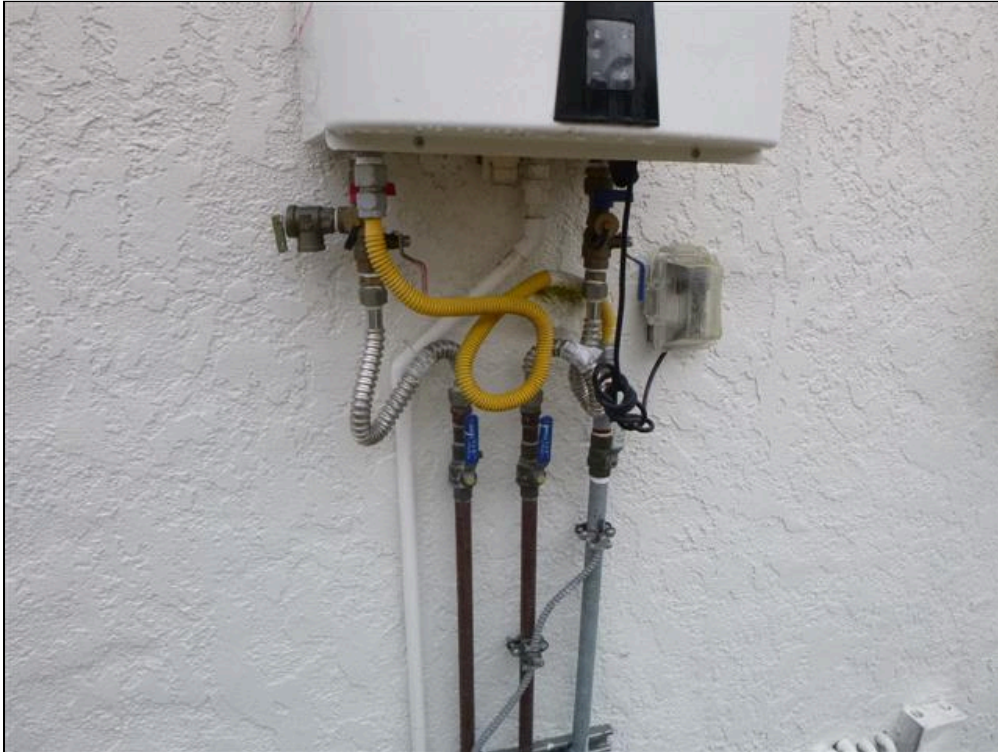
15.0 Item 2(Picture)

15.0 (3) The current water heater does not have a "Thermal Expansion tank" which is generally installed to prevent a possible leak at the T&P or "pop-off" valve and/or excessive pressure build-up at the internal plumbing, fixtures and joints. Recent changes (2012) require one when a new water heater is installed, but various cities do not enforce this installation for multiple reasons (the home is not on a closed system and various tankless units do not require it) . There were no leaks or drips at the T&P valve during inspection. If your water heater does begin to drip or leak, then a thermal expansion tank may be needed. Suggest review with the city and/or a licensed plumber to determine if this installation is required and install as needed.

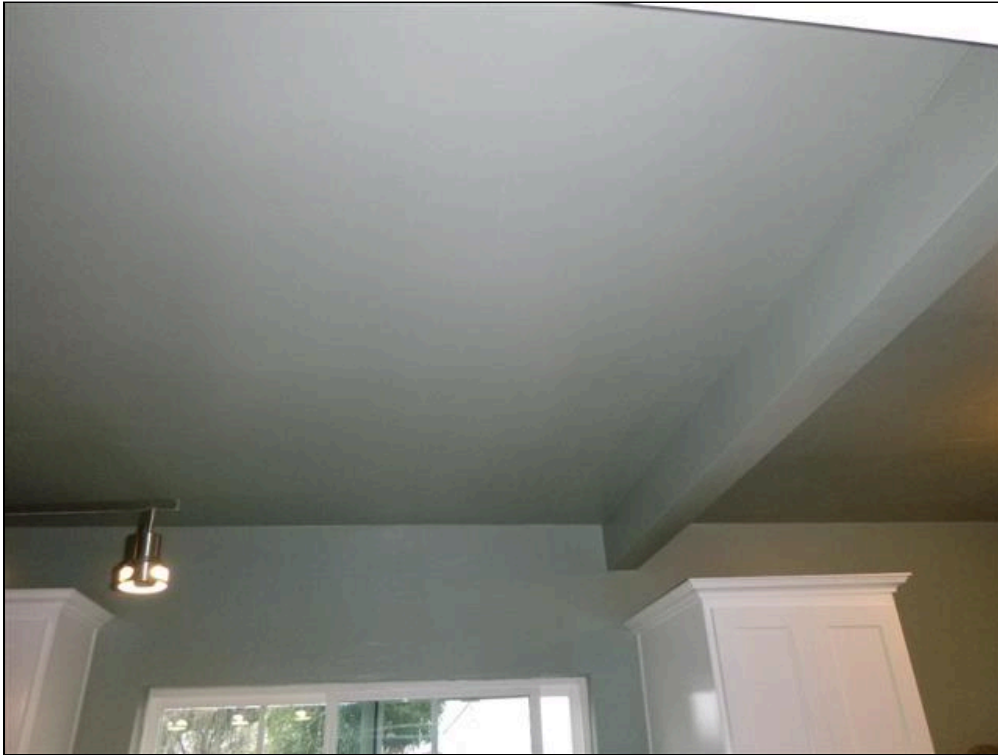
16.2 Item 1(Picture)

16.2 Patched and uneven areas of the ceiling was noted, suggest review with the seller on the cause and any repairs needed. Suggest review with a licensed contractor for any repair/removal/replacement costs as needed.

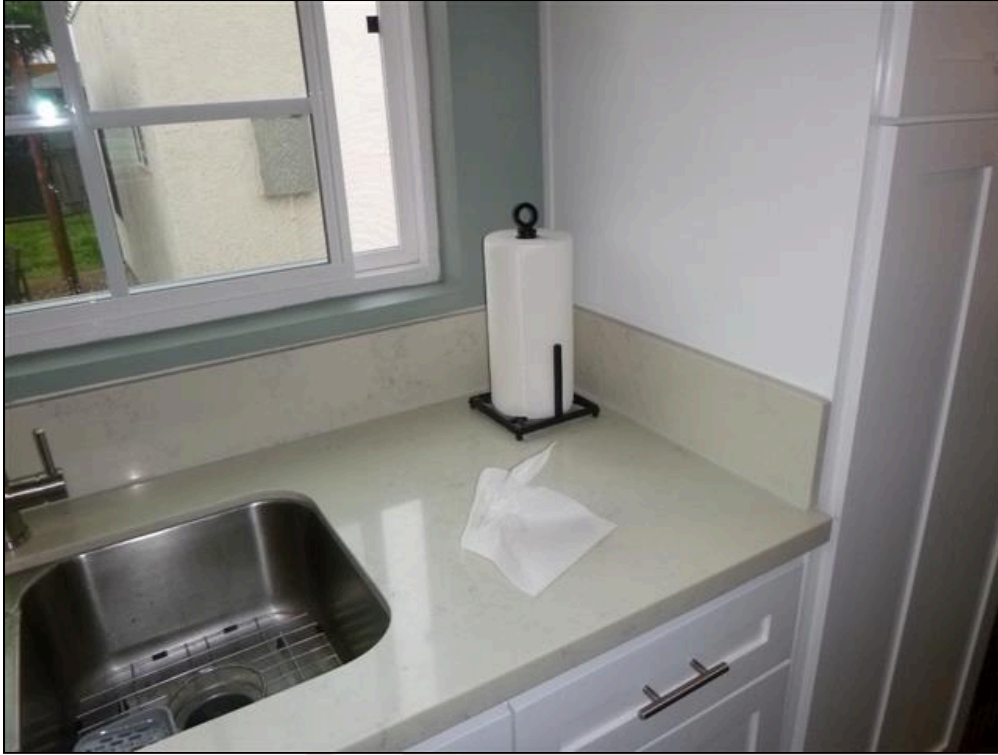
16.7 Item 1(Picture)

16.7 (1) Inadequate/incorrectly installed countertop/appliance outlets/circuits were noted, suggest review with a licensed electrician for installation costs as needed/required.

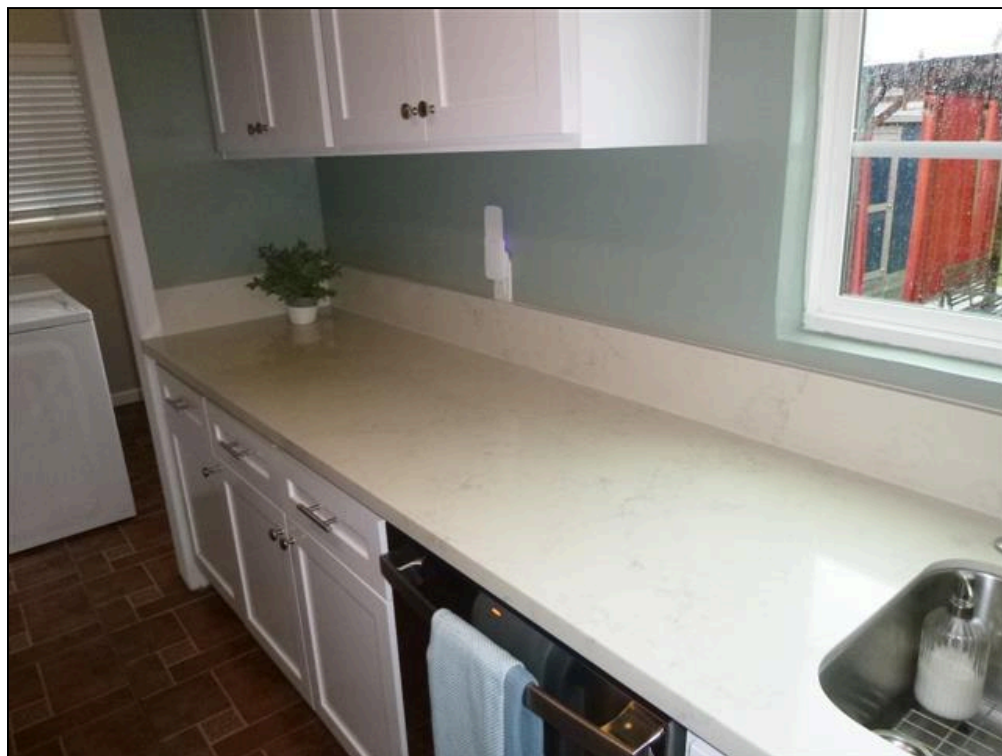
16.7 Item 2(Picture)

16.7 (2) A minimum number of outlets were installed at this area at the time of the inspection, this is common for the original age of dwelling. Suggest review by a licensed electrician for installation costs for additional outlets if desired as an upgrade.

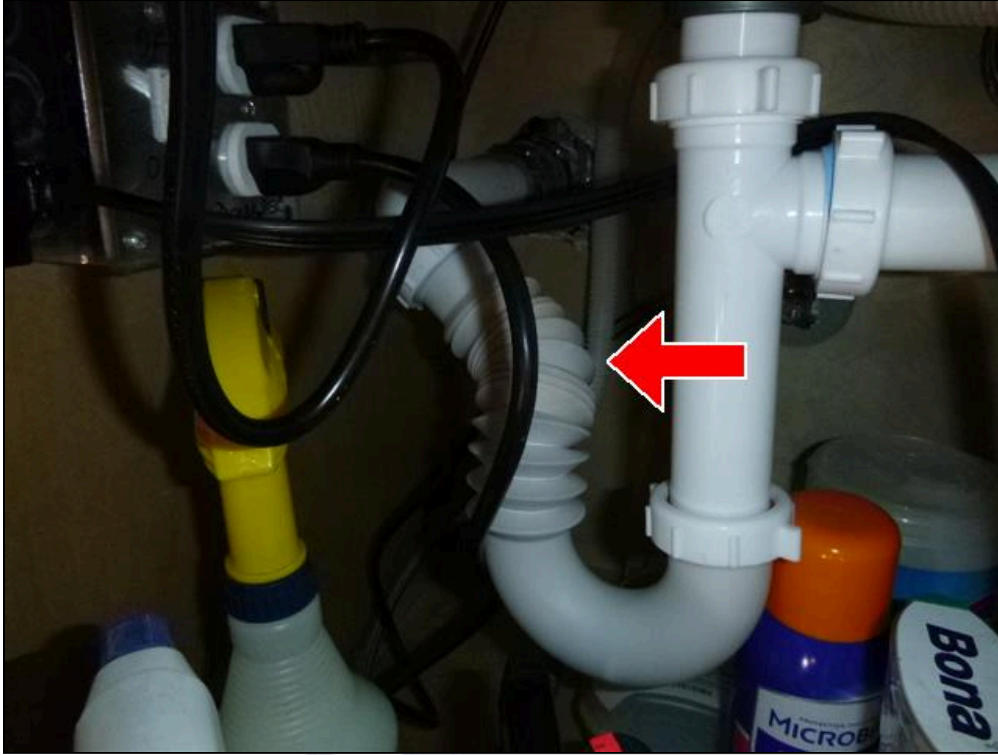
16.10 Item 1(Picture)

16.10 Suggest review by a licensed plumber for costs to replace the sink flex drain(s) with the appropriate materials as required.

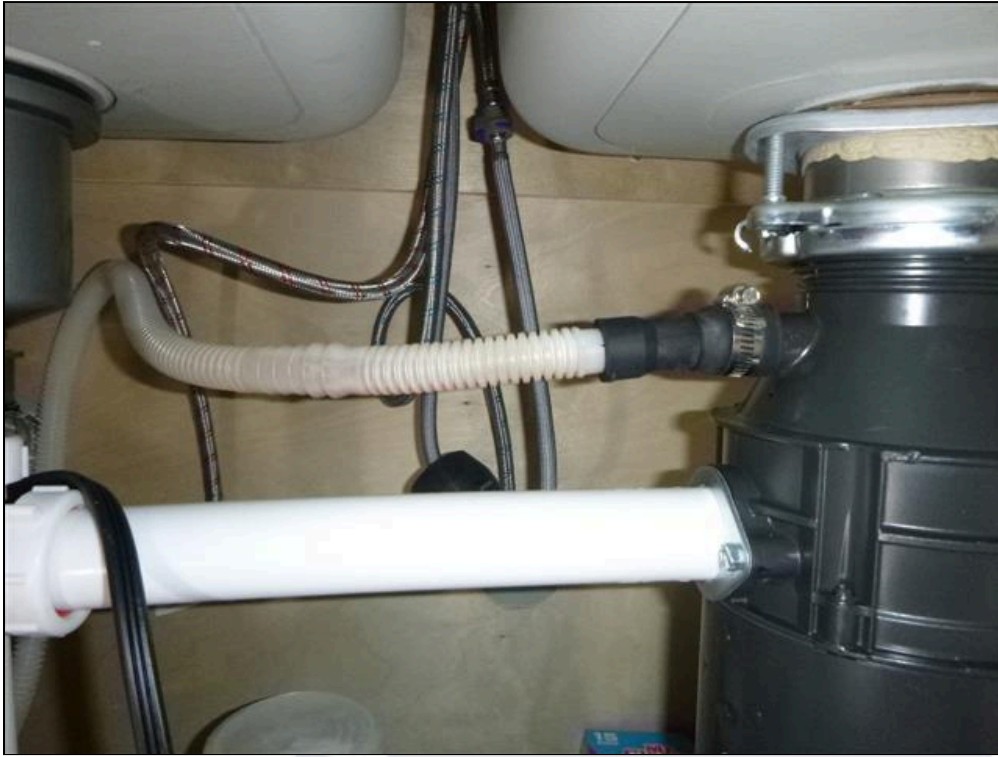
16.11 Item 1(Picture)

16.11 There is no air gap installed for the dishwasher as required, the system currently drains directly into the disposal. Suggest review by a licensed plumber for costs to install the air gap and drain as required by the State of California.

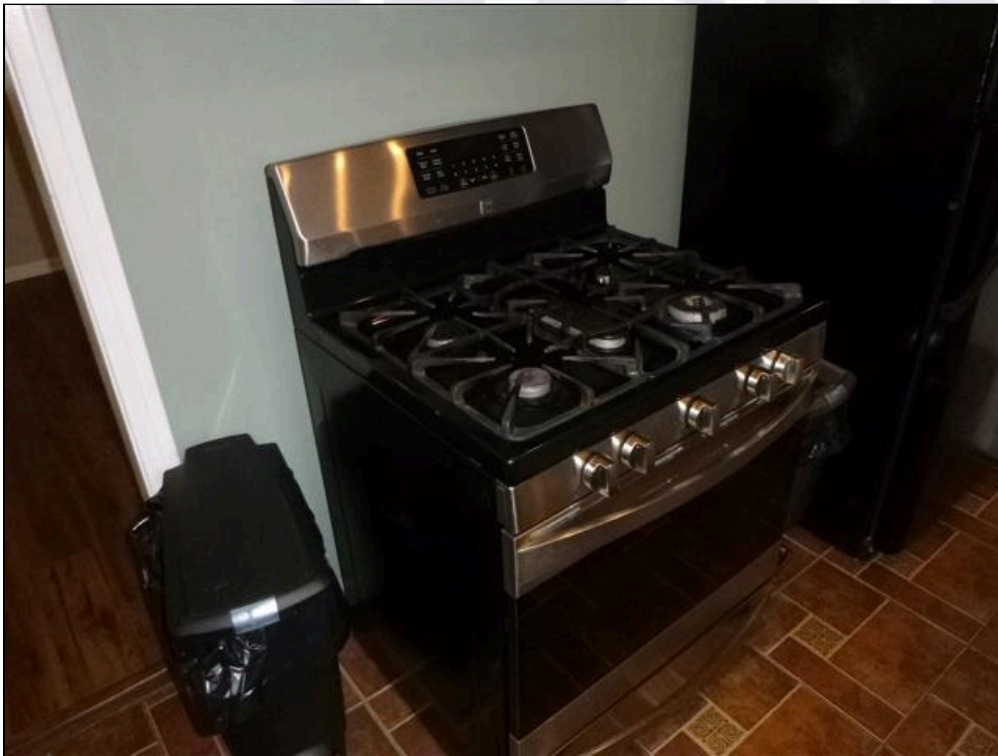
16.13 Item 2(Picture)

16.13 (1) The anti-tip bracket/chain is not currently installed. An anti-tip bracket is usually installed on the floor and against the wall (towards the back of the stove) for one of the rear legs to slide into.
