Inspection Report

Property Address:
447 E Hullett St
Long Beach CA 90805

Ferguson Home Inspections

Date: 3/23/2024	Time: 09:00 AM	Report ID: 20240323-447-E-Hullett-St
Property: 447 E Hullett St Long Beach CA 90805	Customer: Kimberly Stewart	Real Estate Professional: Sue Freeman

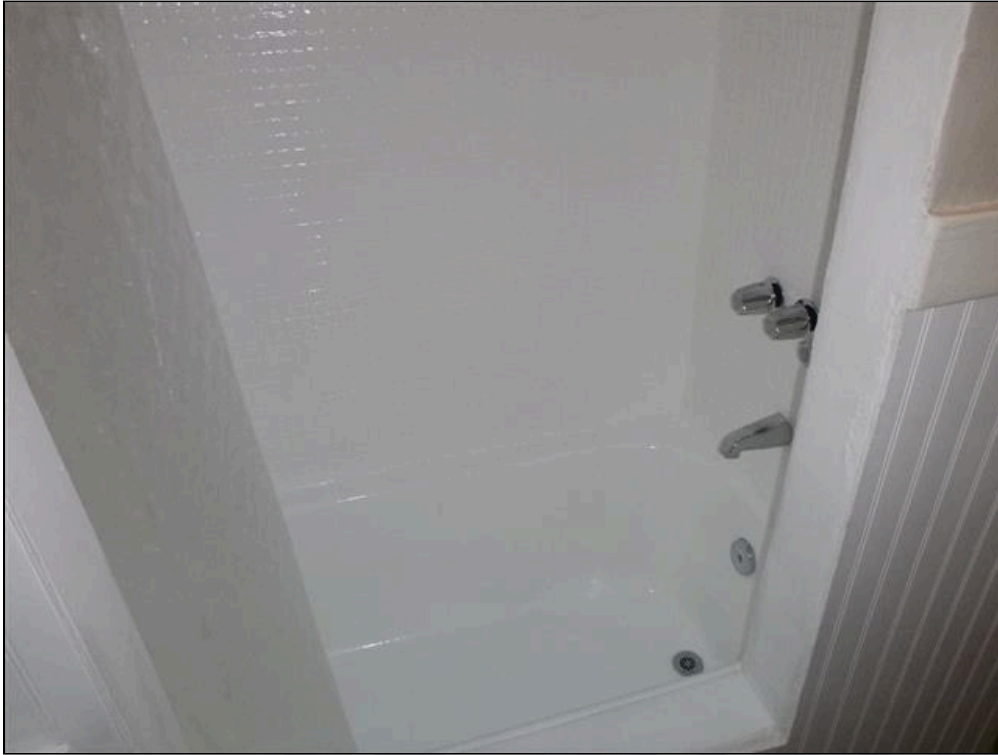
17.8 Item 1(Picture)

17.8 The tub has been re-glazed, suggest review with the seller and/or installation company for care and maintenance requirements.

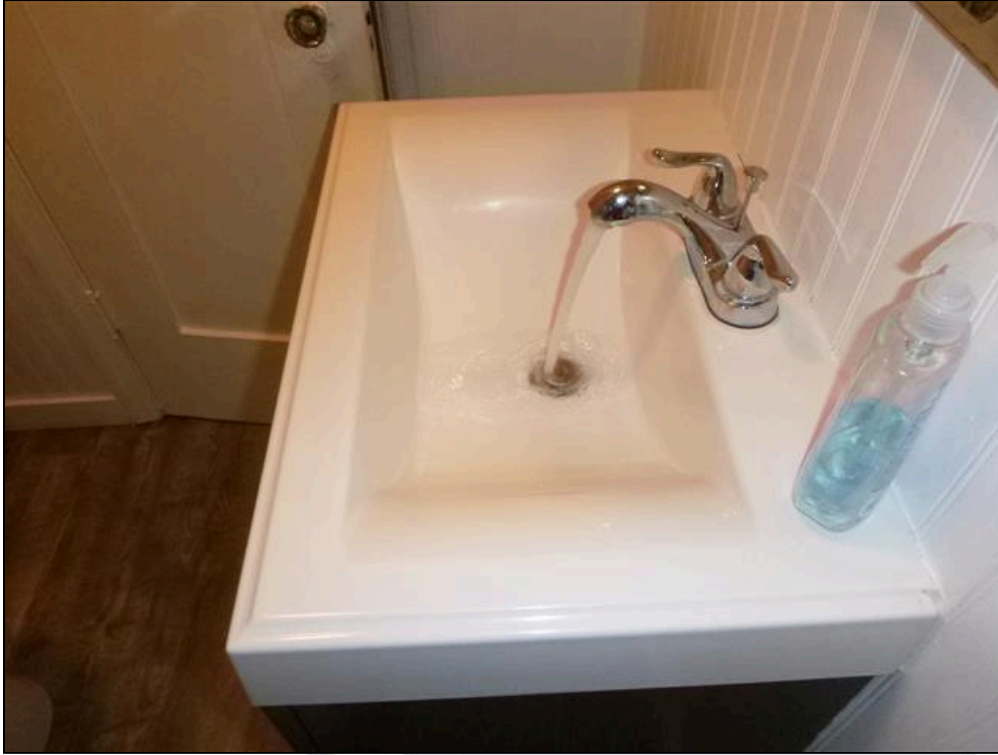
17.13 Item 1(Picture)

17.13 No drainage overflow system installed at the sink(s) as required, suggest review with a licensed plumber for repair/replacement costs as required.

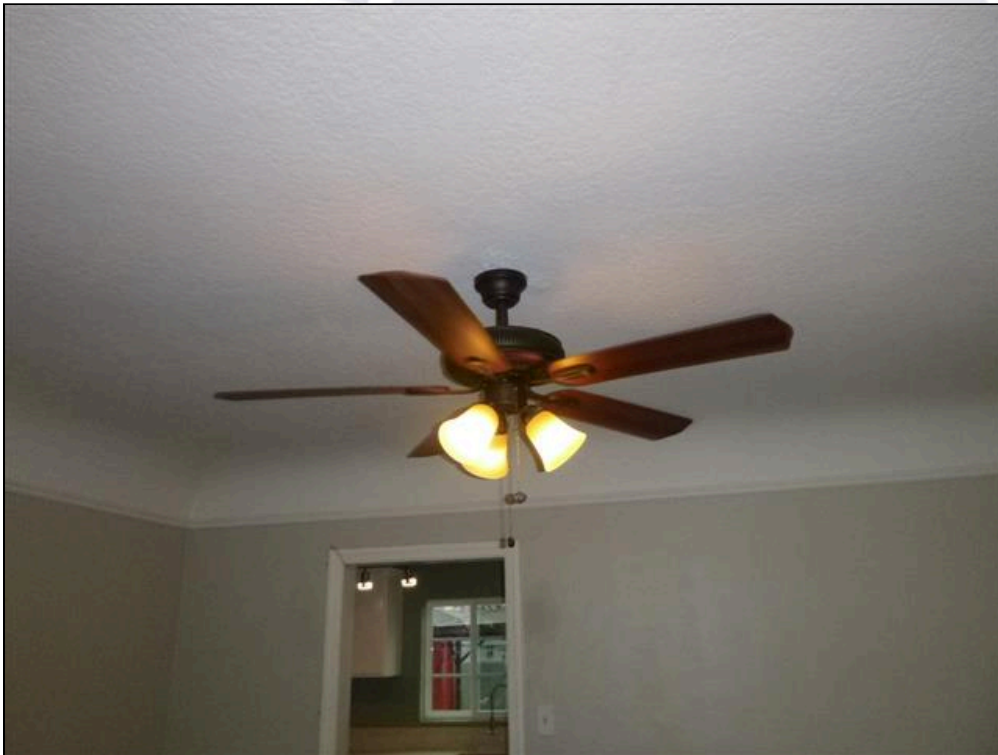
20.6 Item 1(Picture)

20.6 The ceiling fan system was operational at the time of the inspection.

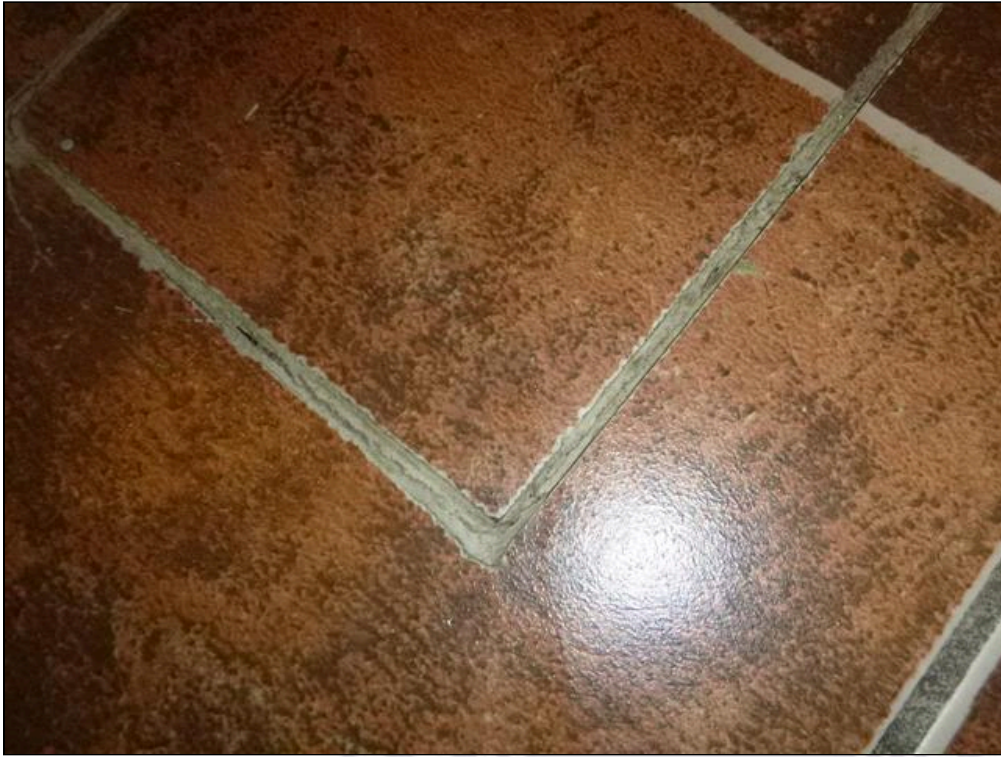
21.0 Item 2(Picture)

21.0 Patched repaired areas of the tile flooring was noted (this appears to be from a removed wall). Suggest review with the seller and/or a licensed contractor on this item as needed.

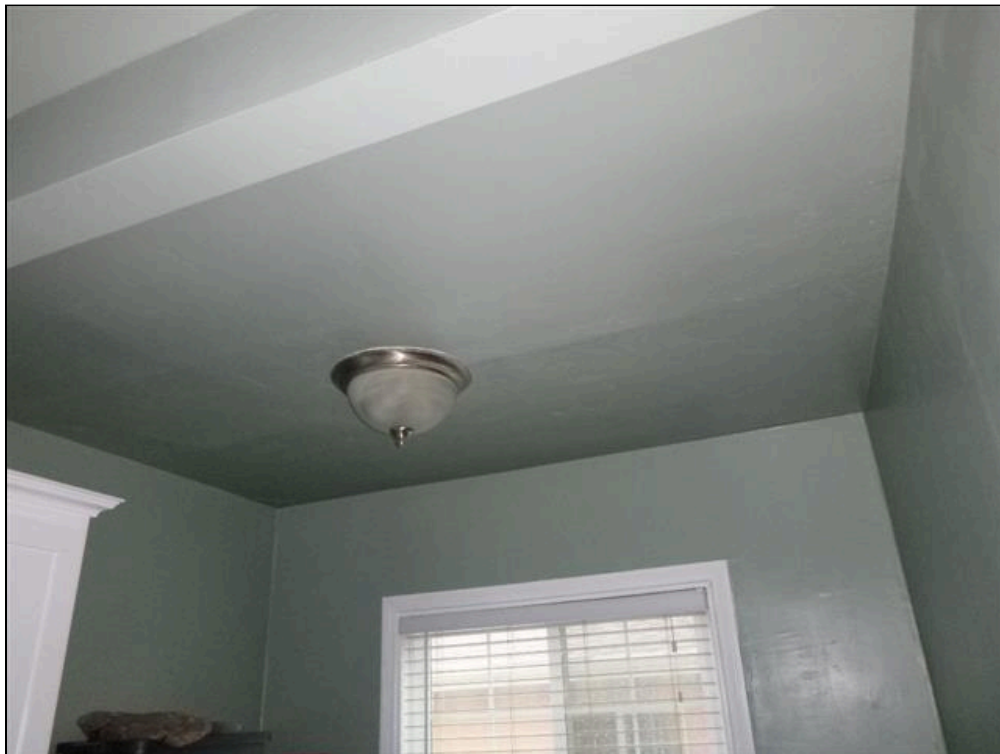
21.2 Item 1(Picture)

21.2 Patched and uneven areas of the ceiling was noted, suggest review with the seller on the cause and any repairs needed. Suggest review with a licensed contractor for any repair/removal/replacement costs as needed.

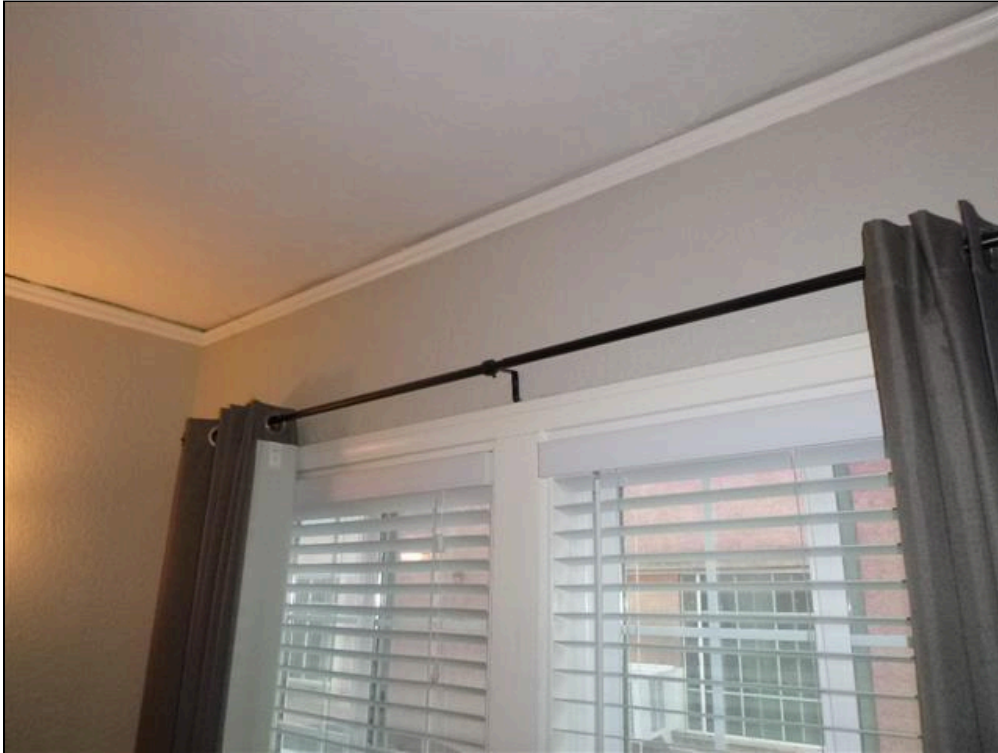
24.1 Item 1(Picture)

24.1 (1) Patched areas of the walls was noted, suggest review with the seller for the cause and any repairs needed. Suggest repair as needed.

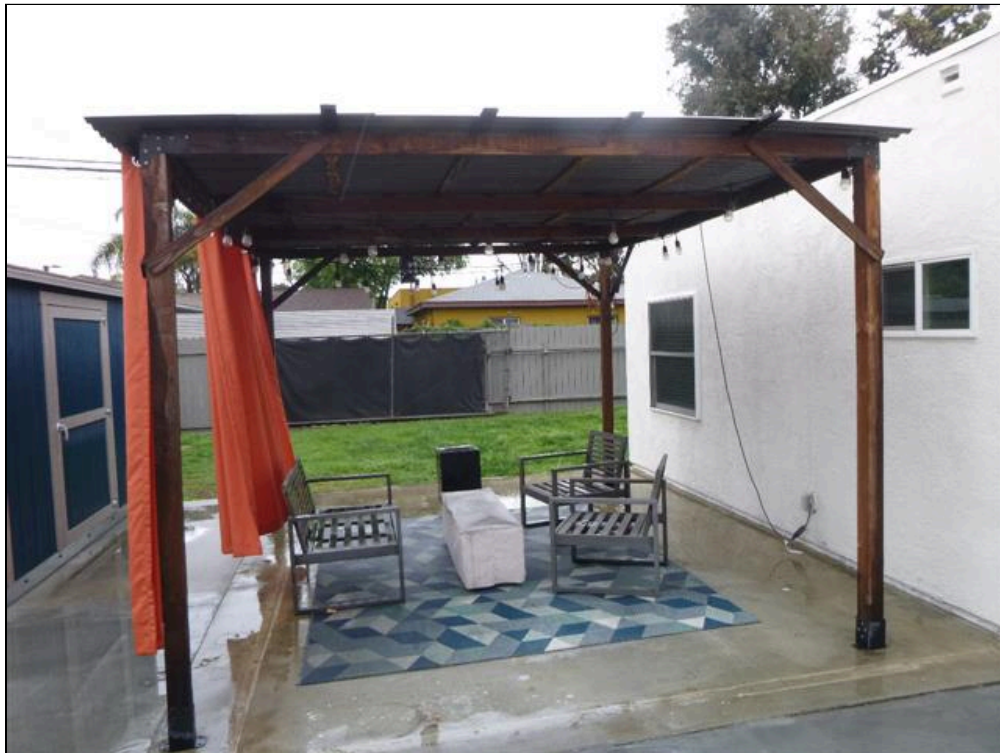
25.6 Item 1(Picture)

25.6 The wood awning at the left side is not currently bolted/secured to the concrete slab. Suggest review with the seller and/or a licensed contractor for costs to bolt/secure the awning as needed.

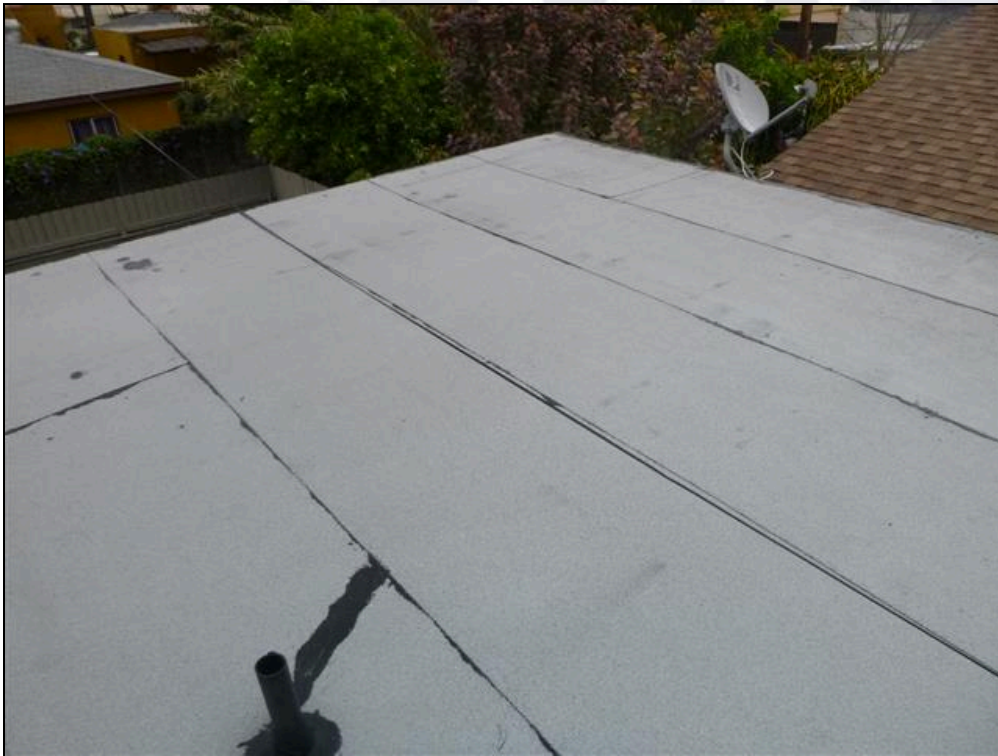
27.0 Item 1(Picture)

27.0 Patched and repaired areas of the roofing was noted. Suggest review with a licensed roofing contractor for any repair/replacement costs as needed and to determine the remaining life expectancy of the roof.

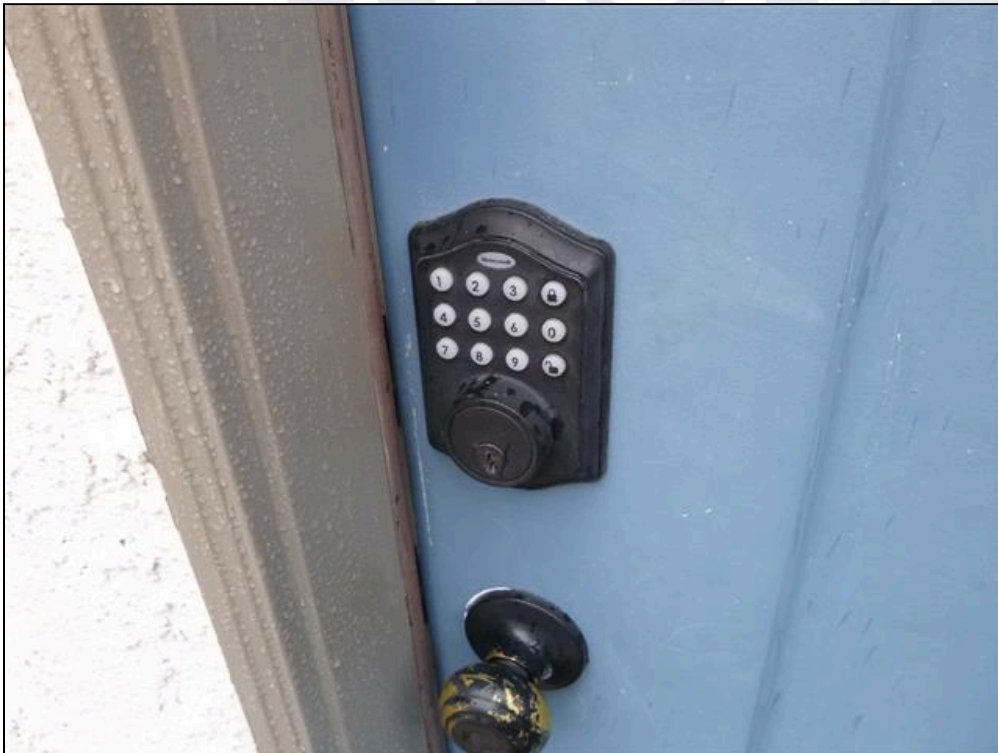
28.3 Item 1(Picture)

28.3 (1) A keypad door lock system was noted. Suggest review with seller for operational brochure, codes for operation and confirm correct operation as needed.

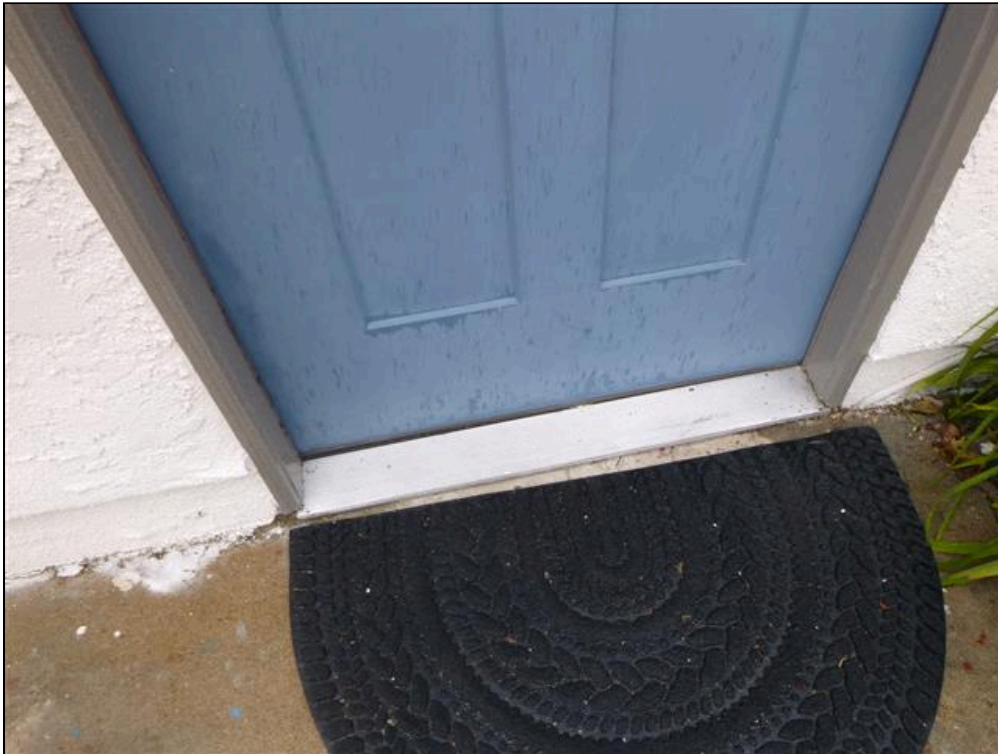
28.3 Item 2(Picture)

28.3 (2) The existing threshold for the doorway is set at/below the deck level. Water entry may occur at these areas and cause damaged within the structure. Current requirements for doorway/thresholds are two inches minimum height above the hard deck or exterior surface/grade. Suggest review with a licensed contractor for repair/replacement costs needed to eliminate water entry into the structure.

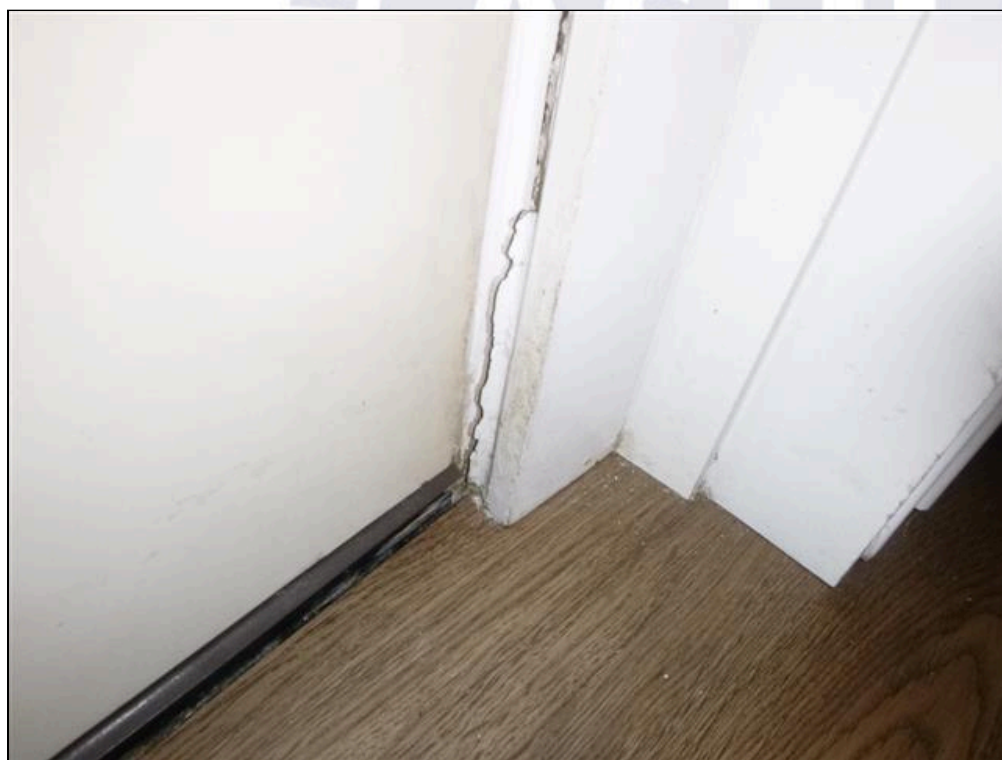
28.3 Item 4(Picture)

28.3 (3) Evidence of previous and ongoing water intrusion noted at the door(s) to the interior. Deteriorated and loose door trim/casings were noted. Suggest review with a licensed contractor for any repair/replacement costs as needed to prevent further and future water intrusion at this area.

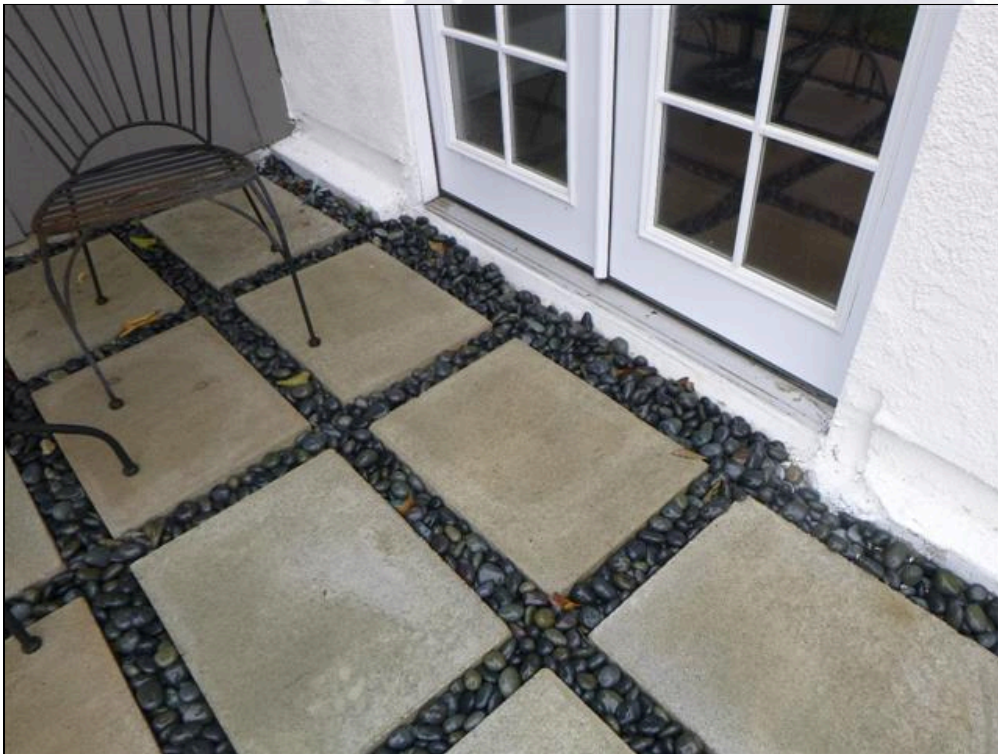
29.0 Item 1(Picture)

29.0 An inadequate/incomplete sized deck/landing was noted at the exterior doorway. Generally a 36' formed landing is required at an exterior door. Suggest review with the seller/city and/or a licensed contractor for installation costs as needed.

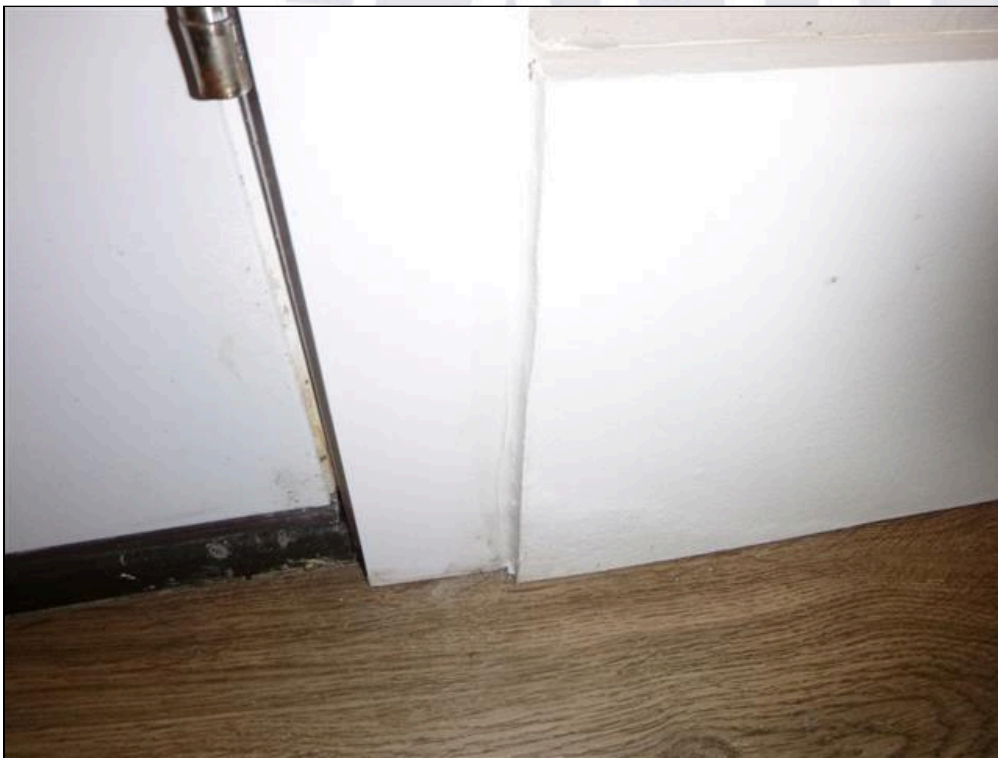
29.2 Item 2(Picture)

29.2 Evidence of previous and ongoing water intrusion noted at the door(s) to the interior. Deteriorated and stained flooring/baseboards noted. Suggest review with a licensed contractor for any repair/replacement costs as needed to prevent further and future water intrusion at this area.

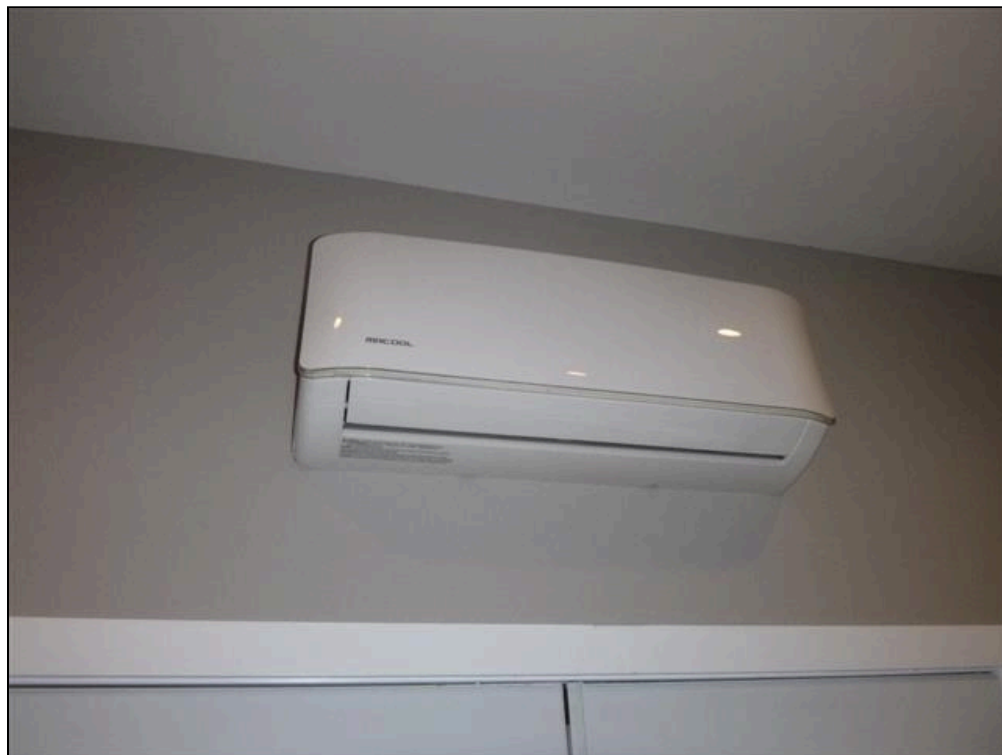
30.0 Item 1(Picture)

30.0 (1) The combination heating-A/C unit was tested and was operational at the time of the inspection.

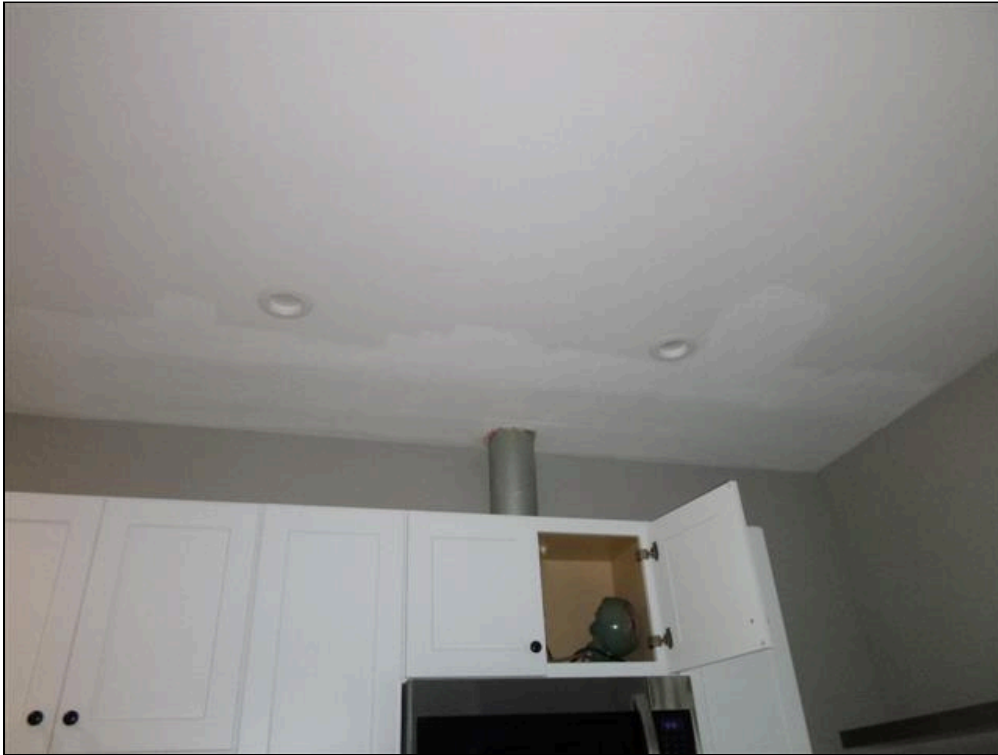
33.2 Item 1(Picture)

33.2 Patched and repaired areas of the ceiling was noted, suggest review with the seller on the cause and any repairs needed. Suggest review with a licensed contractor for any repair/removal/replacement costs as needed.

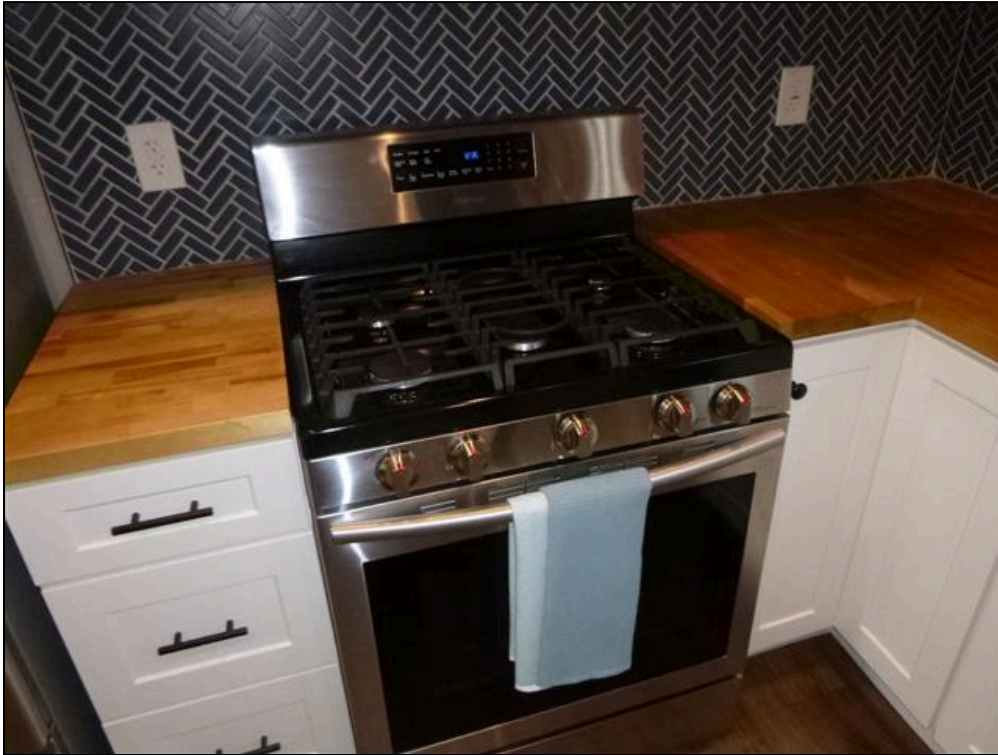
33.7 Item 1(Picture)

33.7 Suggest review with the seller/city and/or a licensed contractor on the installation of the wood block countertop due to the proximity to the gas fueled stove.

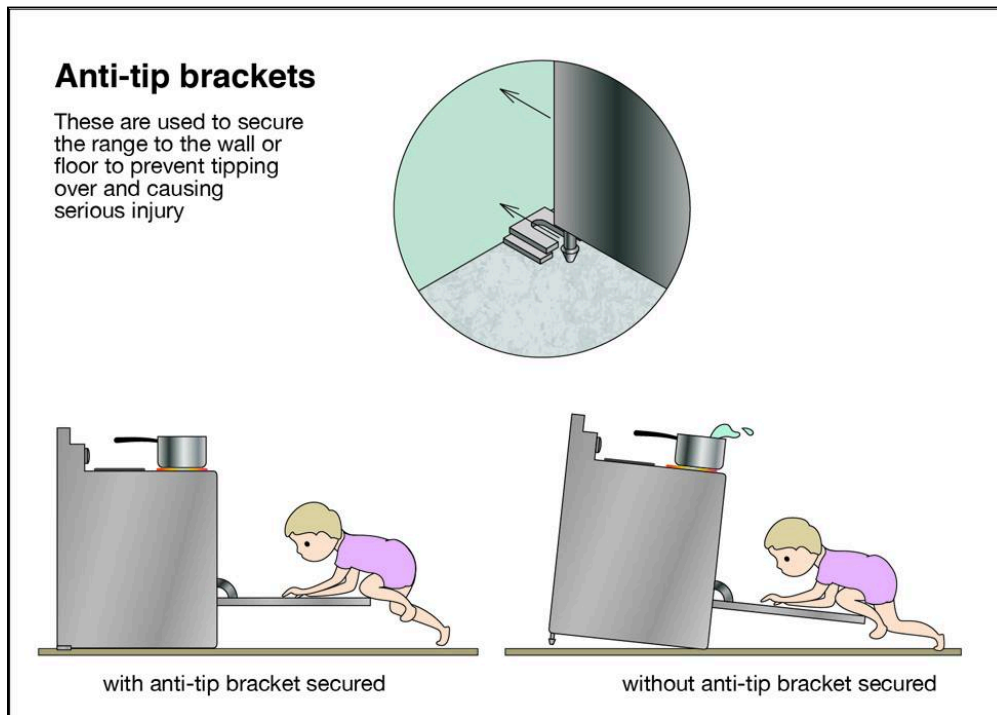
33.13 Item 1(Picture)

33.13 (1) The anti-tip bracket/chain is not currently installed. An anti-tip bracket is usually installed on the floor and against the wall (towards the back of the stove) for one of the rear legs to slide into. Its purpose is to prevent the stove from tipping when a heavy load is placed on the door (possible child) or slide-out racks upsetting the center of gravity. Suggest installation for safety as required since 1991.

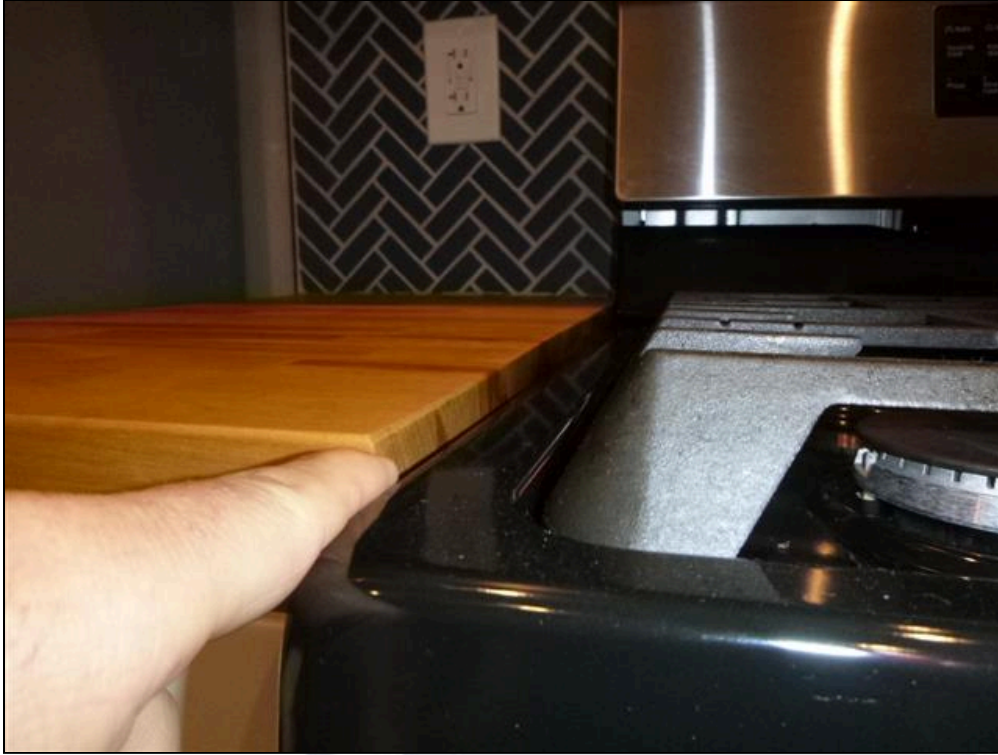
33.13 Item 3(Picture)

33.13 (2) Potential fire spread hazard due to the stove is currently below the countertop height.

Suggest review with a licensed contractor for cost to raise and level the stove to above the countertop height as required for safety.

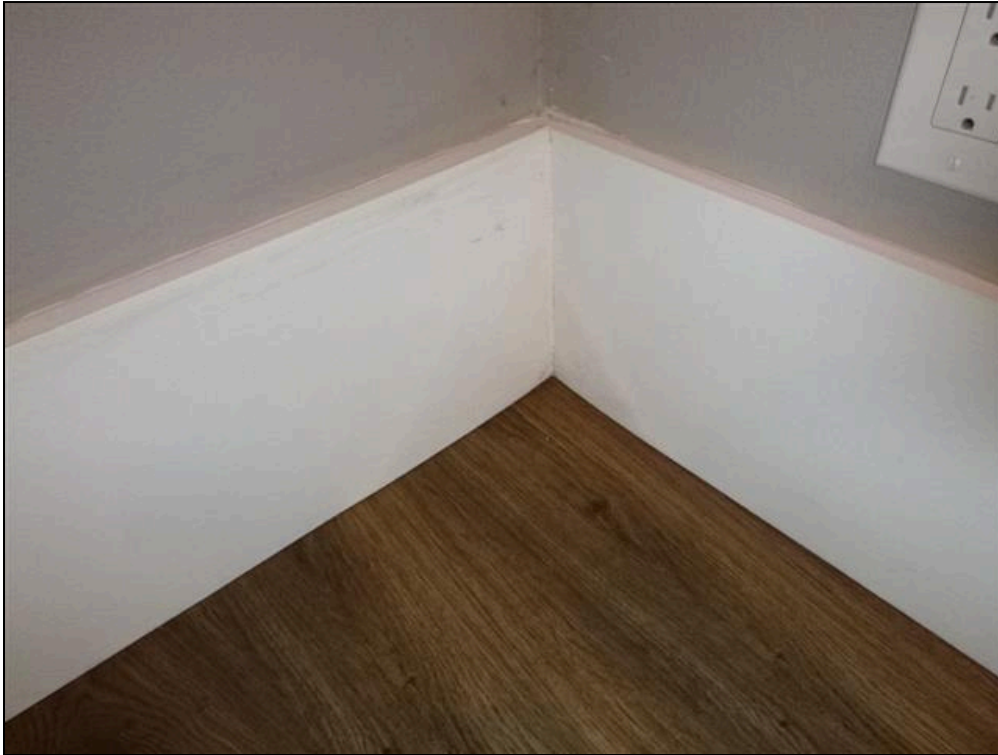
35.1 Item 1(Picture)

35.1 Stains, deterioration and water damage noted at the walls (this area tested positive for moisture at the time of the inspection). Suggest review with the seller and/or a licensed contractor to determine/verify the source of the leak and any repairs needed. Suggest review with a licensed contractor for repair/removal/replacement costs as needed.

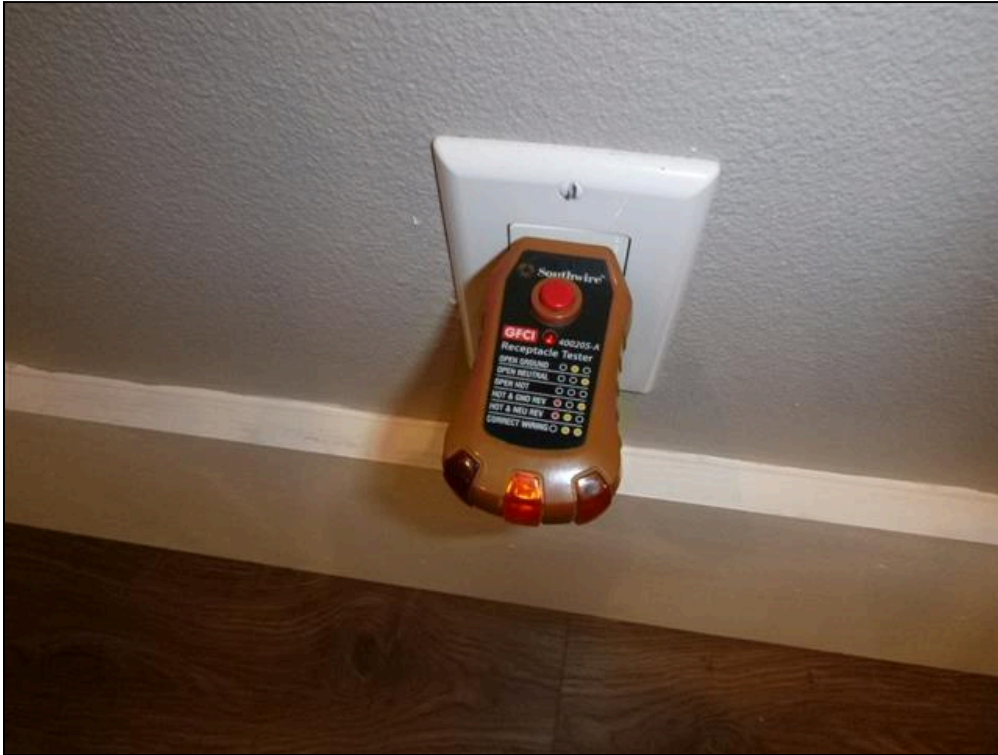
35.6 Item 1(Picture)

35.6 Ungrounded three prong outlets noted at this area. Suggest review with a licensed electrician for costs to ground the outlets as needed as an upgrade and/or protect the outlet(s) on a GFCI circuit where recommended.

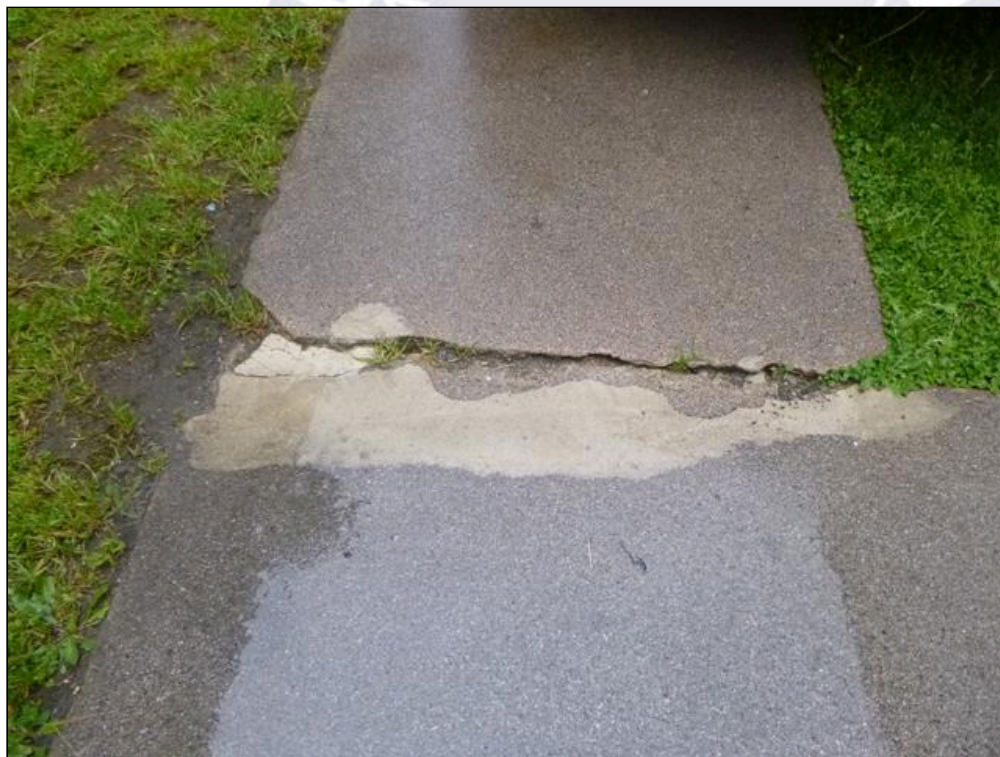
1.0 Item 2(Picture)

Settling, expansion cracks and heaving noted at various areas, this is a potential trip hazard. Suggest review with a licensed contractor for repair/replacement costs as needed.

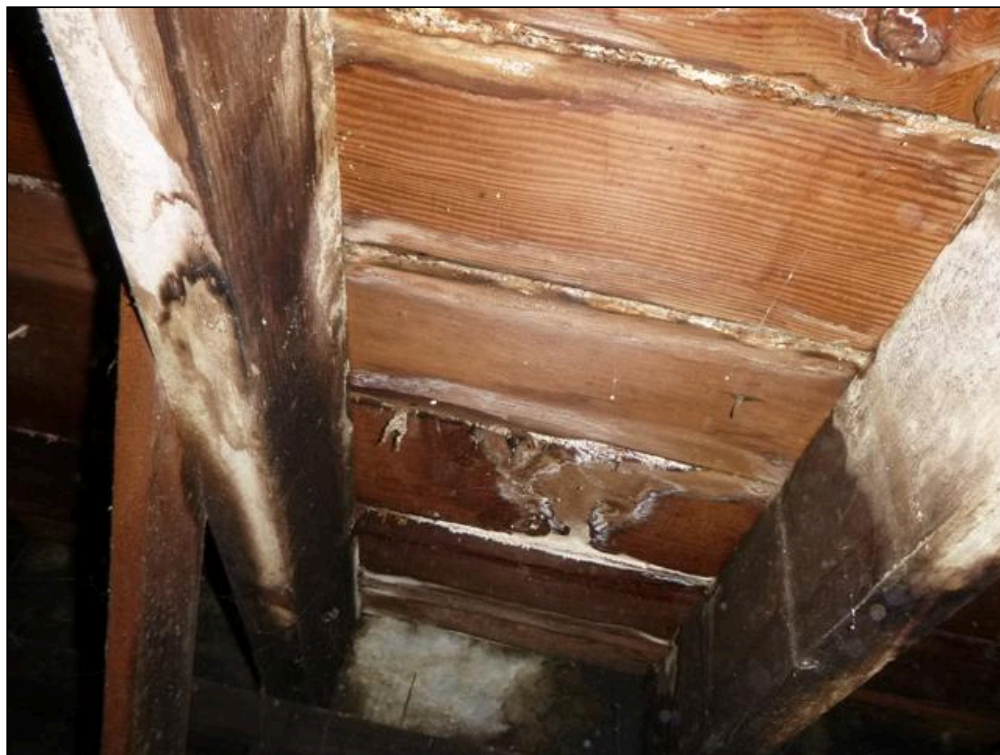
3.1 Item 2(Picture)

(1) Stains and deterioration noted at various flooring and supports from prior leaks. Suggest review with a termite company and/or a licensed contractor for any repair/replacement costs as needed.

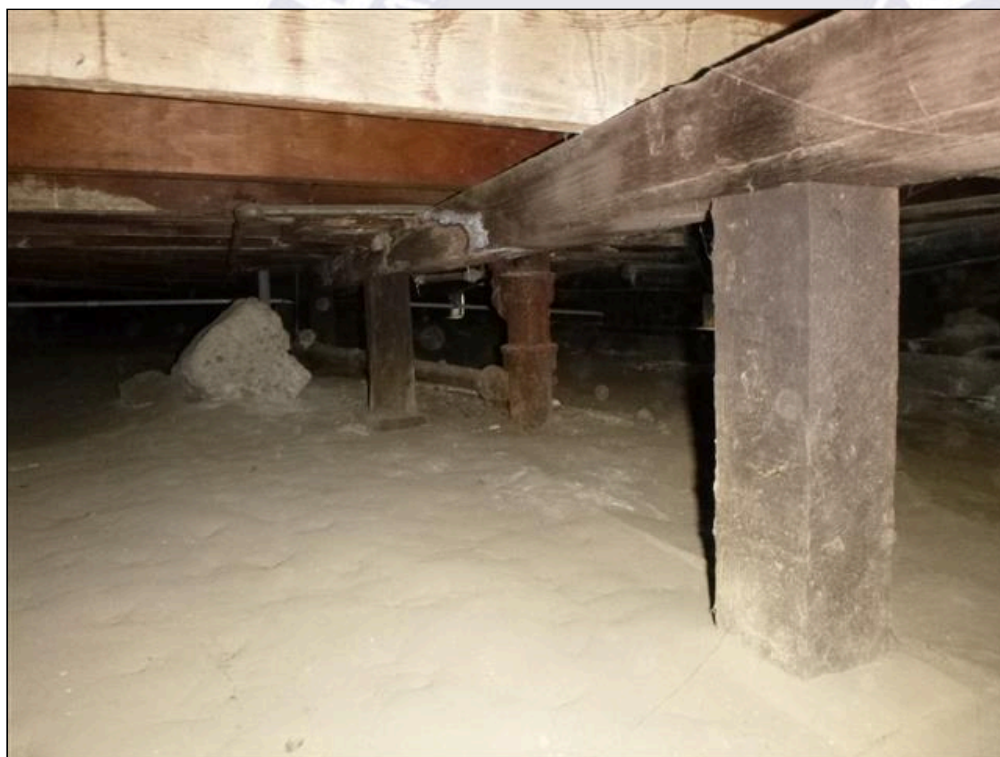
3.1 Item 5(Picture)

(2) Inadequate support noted at various girder beams due to the excessive span and inadequate support posts, common for the original age of the dwelling. Suggest review by a licensed contractor for costs to add additional supports to prevent possible future structural and floor movement as needed.

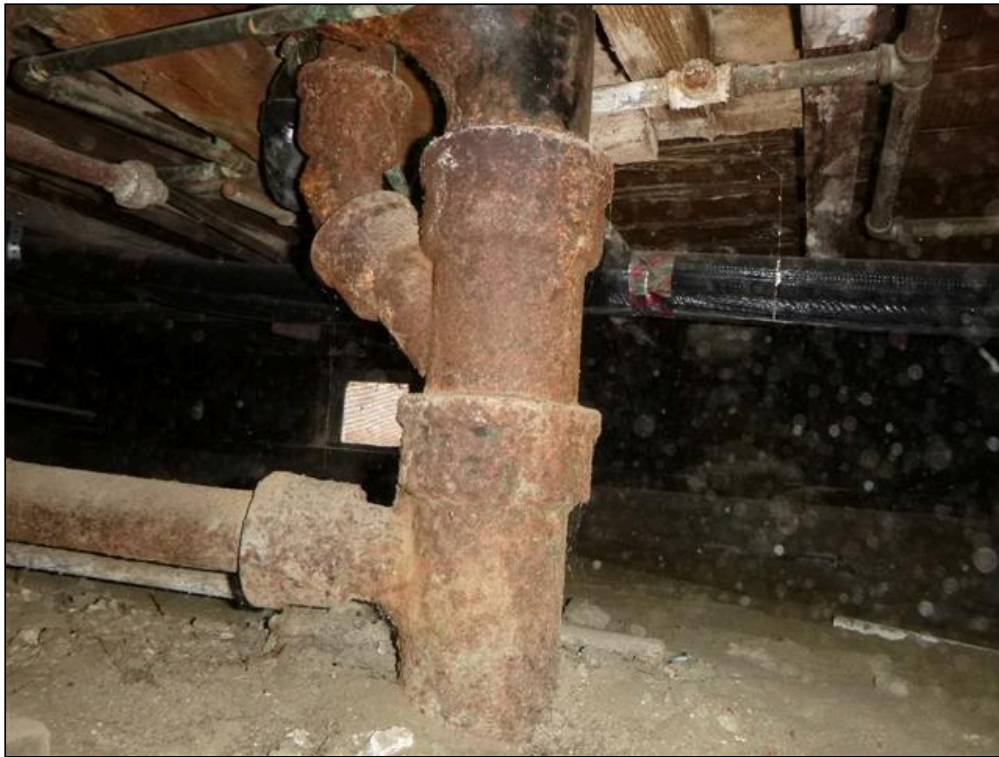
4.3 Item 1(Picture)

(1) Excessive rust, seepage and corrosion noted at various cast iron drain lines within the crawl space. Suggest review by a licensed plumbing contractor for replacement costs as needed to prevent future

leakage at the crawl area.

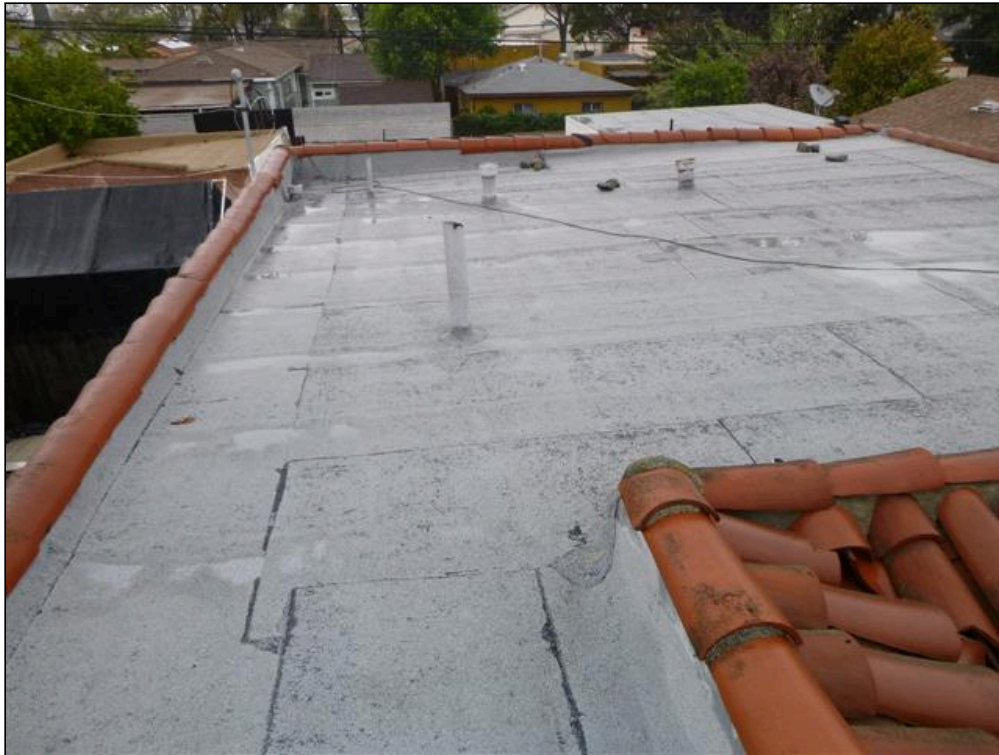
5.0 Item 1(Picture)

(1) The sloped roof covering is old and deteriorated. It is nearing the end of its useful life and the covering will need to be replaced. While it could last a year or so, some areas may need patching/repairs as leaks develop. Please review with a licensed roofer to determine the remaining life expectancy and for costs to repair/remove and replace the existing roofing material as needed.

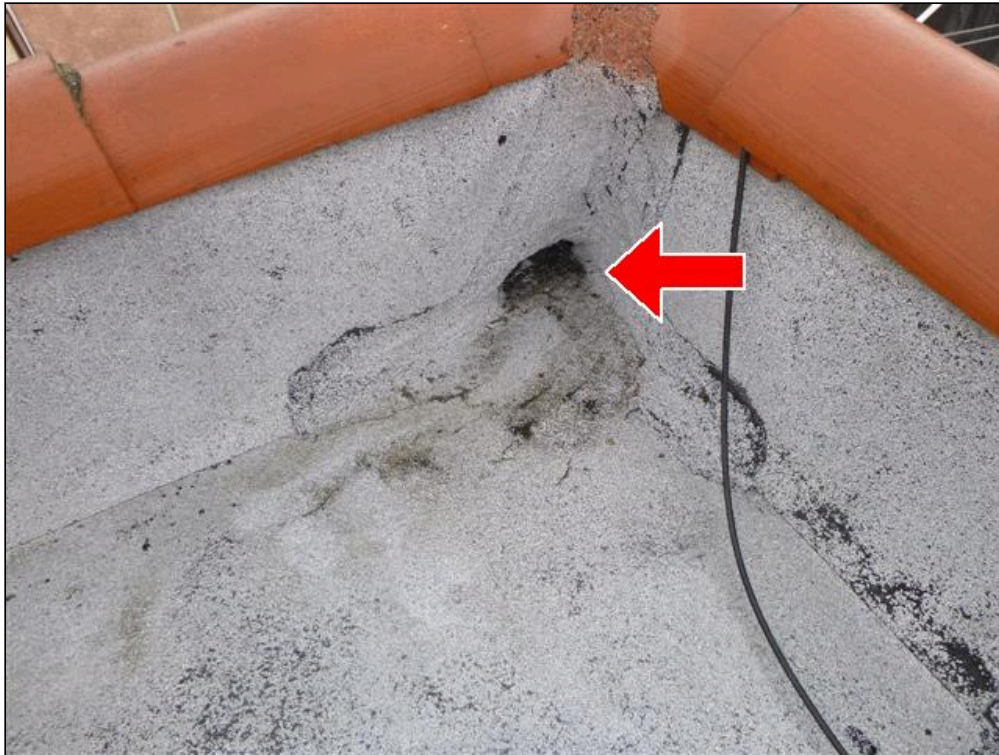
5.0 Item 7(Picture)

(2) Suggest review with a licensed roofer for installation costs for a scupper/over flow drain to the roof as an upgrade. Any blockages to the roof drain will result in excessive water ponding/flooding at the roof area.

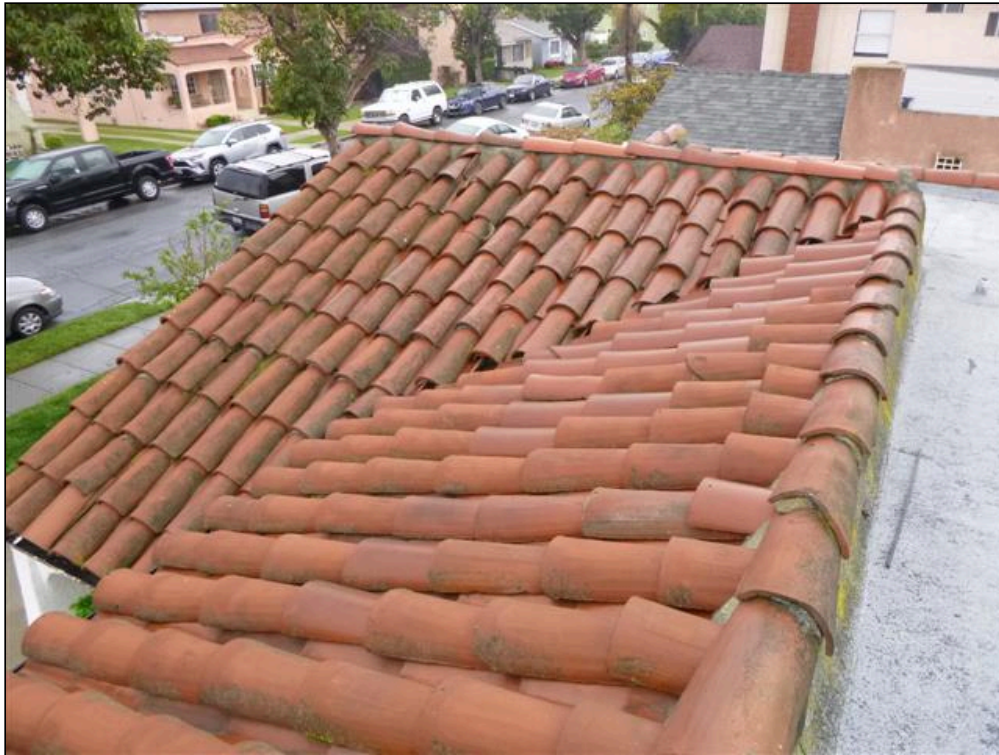
5.0 Item 8(Picture)

(3) Multiple layers of roof covering exist on the current roof, generally two layers of roofing is the maximum allowable. Additional layers of roofing causes a lot of excessive weight on the roof support structure. Suggest review with a licensed roofer to determine the remaining life expectancy and for costs to remove and replace the existing roofing material as needed.

(4) Excessive 'Ramping', lifting/inadequately/incorrectly installed areas of the sloped roof was noted. Suggest review with a licensed roofer for repair/removal/replacement costs as needed.

(5) Deteriorated, cracked, loose and missing sections of the roof tiles was noted, suggest review by a licensed roofer for repair/replacement costs as needed to prevent any future leakage during the rainy season.

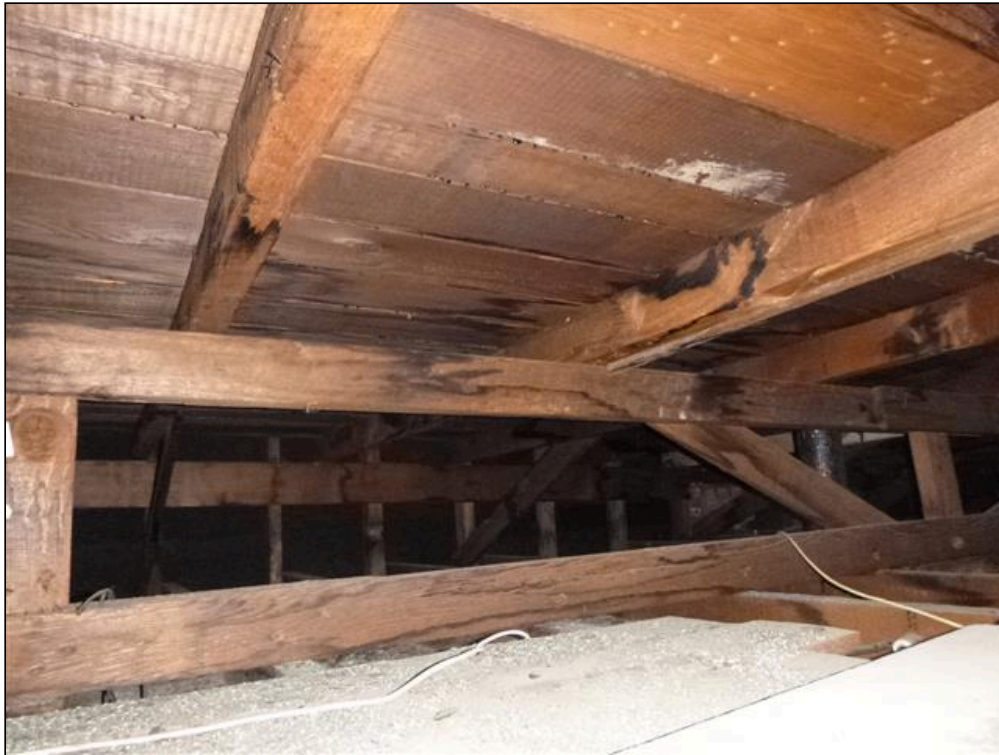
6.0 Item 1(Picture)

Moisture stains noted at various areas of the attic sheathing/framing, see roof comments and repair as needed.
