Inspection Report

Property Address:
447 E Hullett St
Long Beach CA 90805

Ferguson Home Inspections

Date: 3/23/2024	Time: 09:00 AM	Report ID: 20240323-447-E-Hullett-St
Property: 447 E Hullett St Long Beach CA 90805	Customer: Kimberly Stewart	Real Estate Professional: Sue Freeman

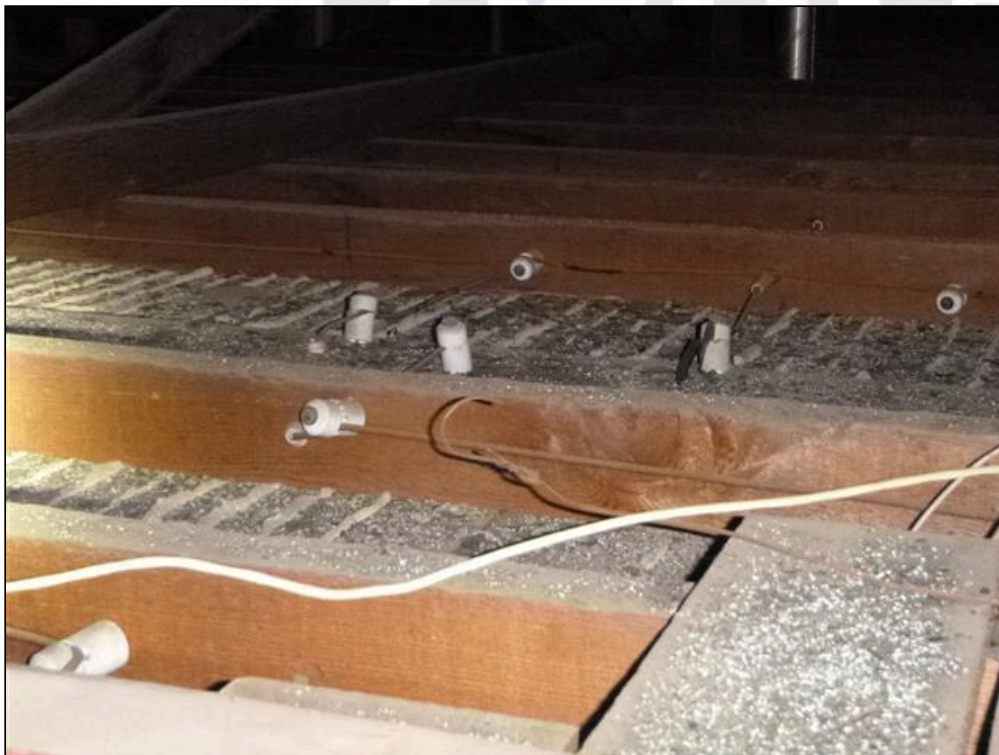
6.3 Item 1(Picture)

Knob & Tube wiring noted throughout the attic area, this is common for the original age of the dwelling. Suggest review by a licensed electrician for replacement costs to upgrade the wiring to todays standards for safety.

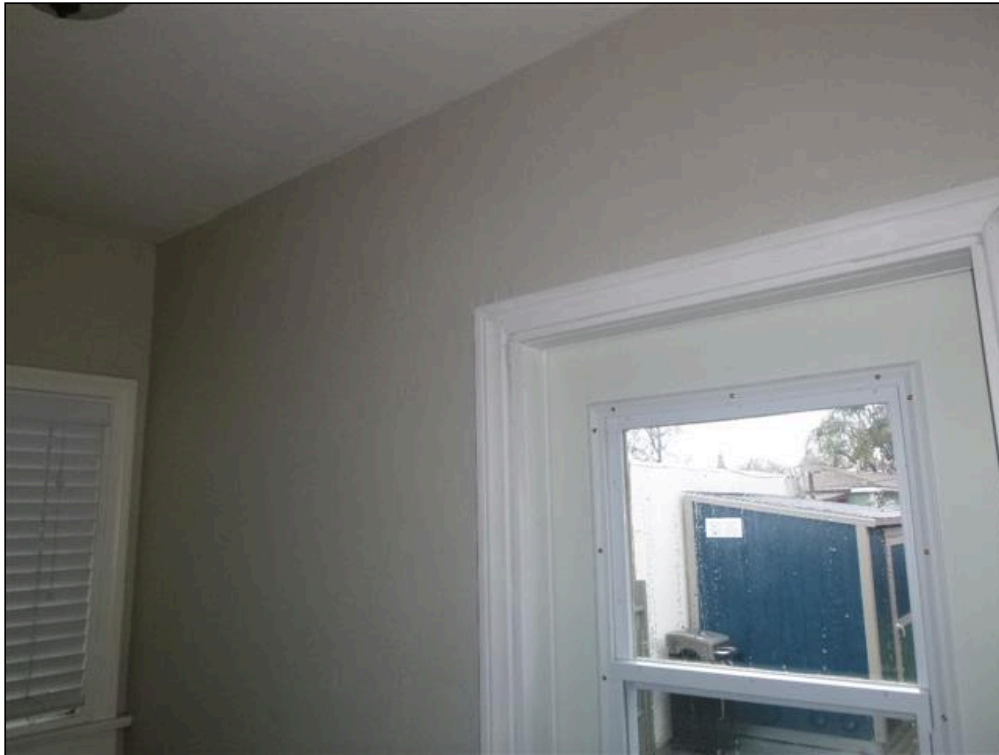
7.1 Item 1(Picture)

Patched areas of the walls was noted, suggest review with the seller for the cause and any repairs needed. Suggest repair as needed.

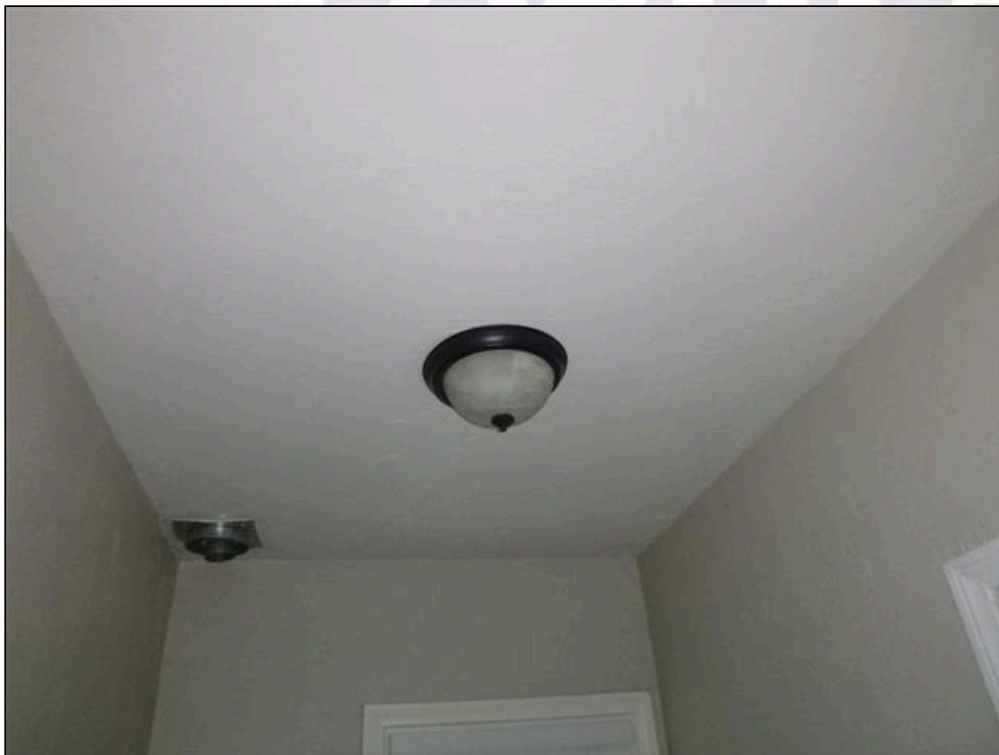
7.2 Item 1(Picture)

Patched and uneven areas of the ceiling was noted, suggest review with the seller on the cause and any repairs needed. Suggest review with a licensed contractor for any repair/removal/replacement costs as needed.

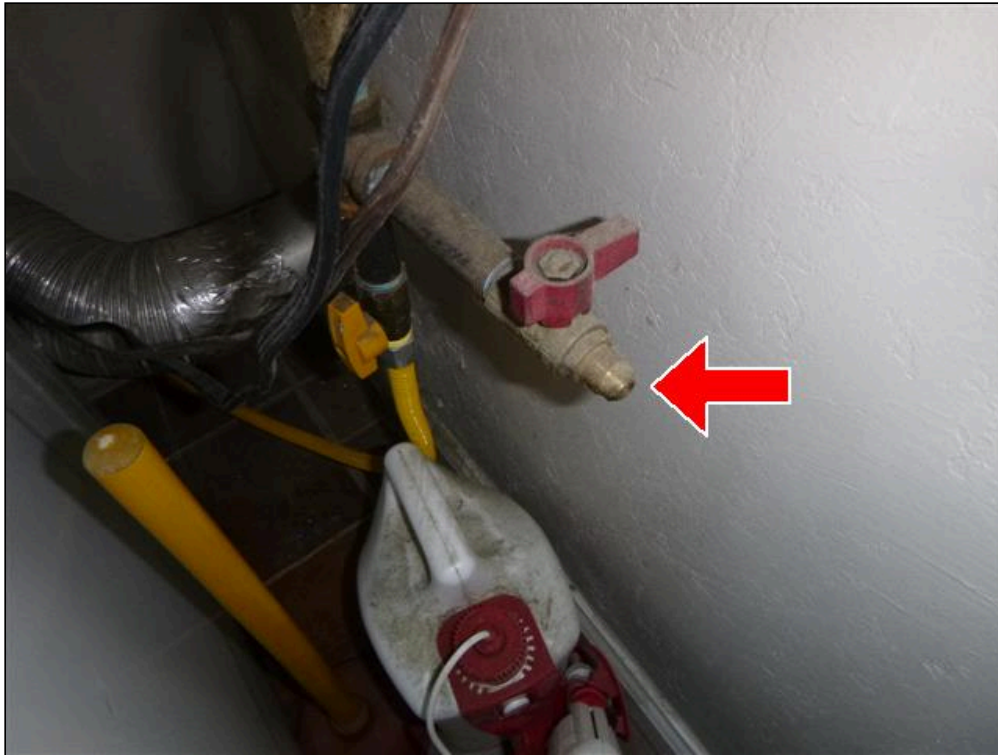
7.8 Item 1(Picture)

(2) Suggest capping the unused gas line/valve as required for safety.

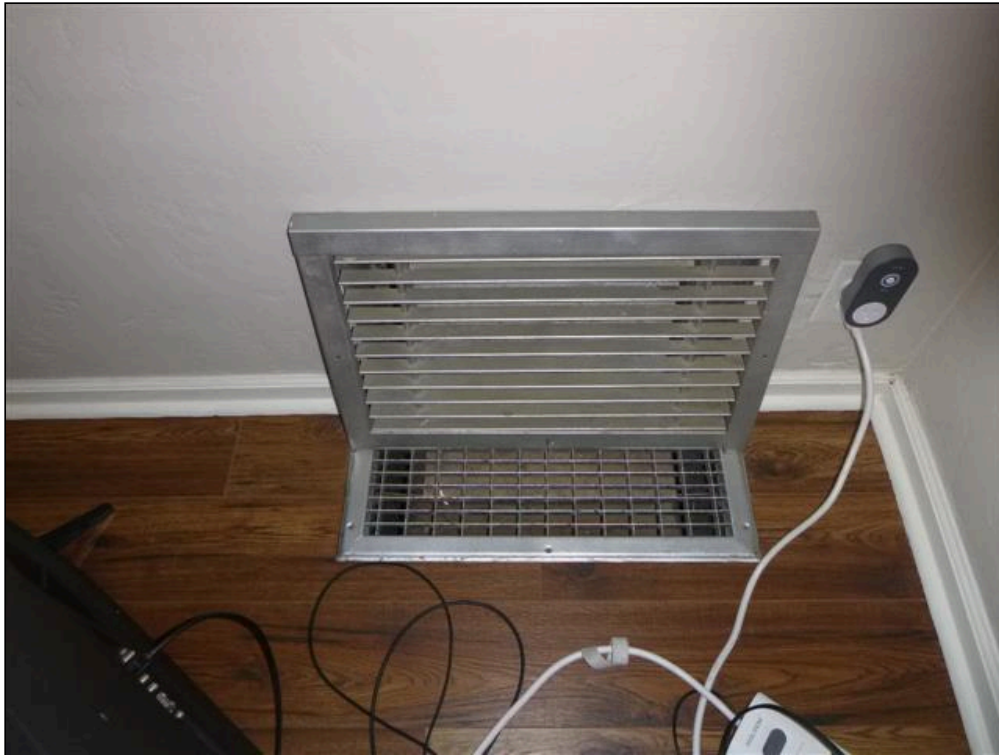
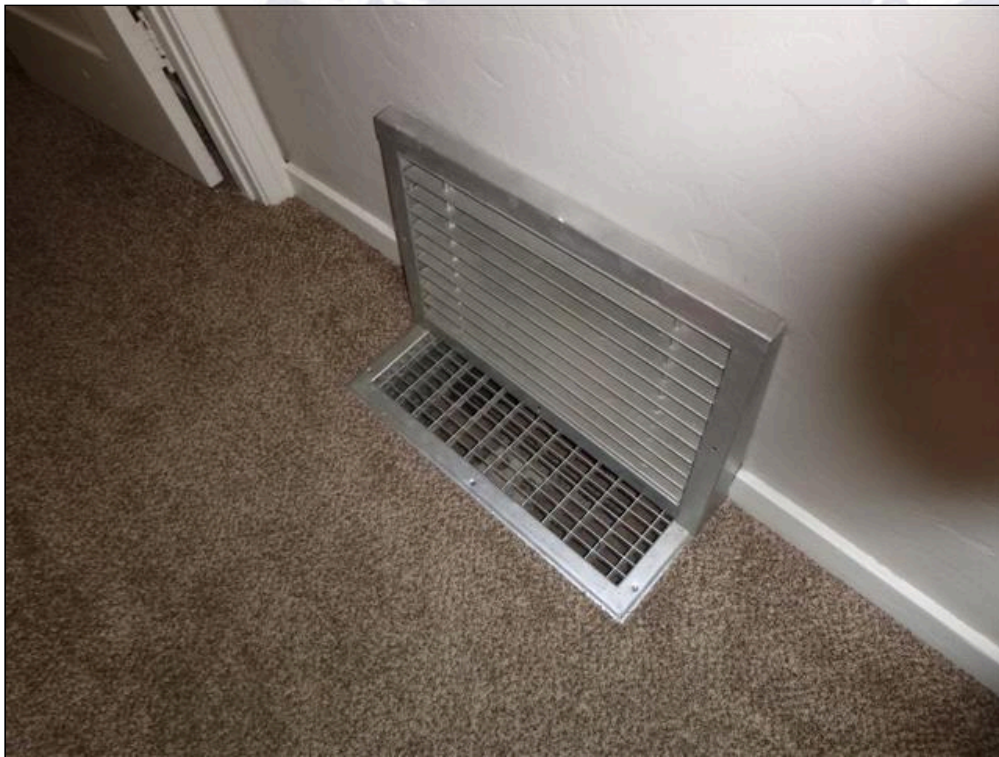
(1) The heater/furnace is very old but did work at the time of inspection. The inspector is unable to determine remaining life expectancy of this system. Due to the age and style of this system, suggest review with the Gas company and/or a licensed heating company for further review to determine the remaining life expectancy of the unit and any repair/replacements costs as needed

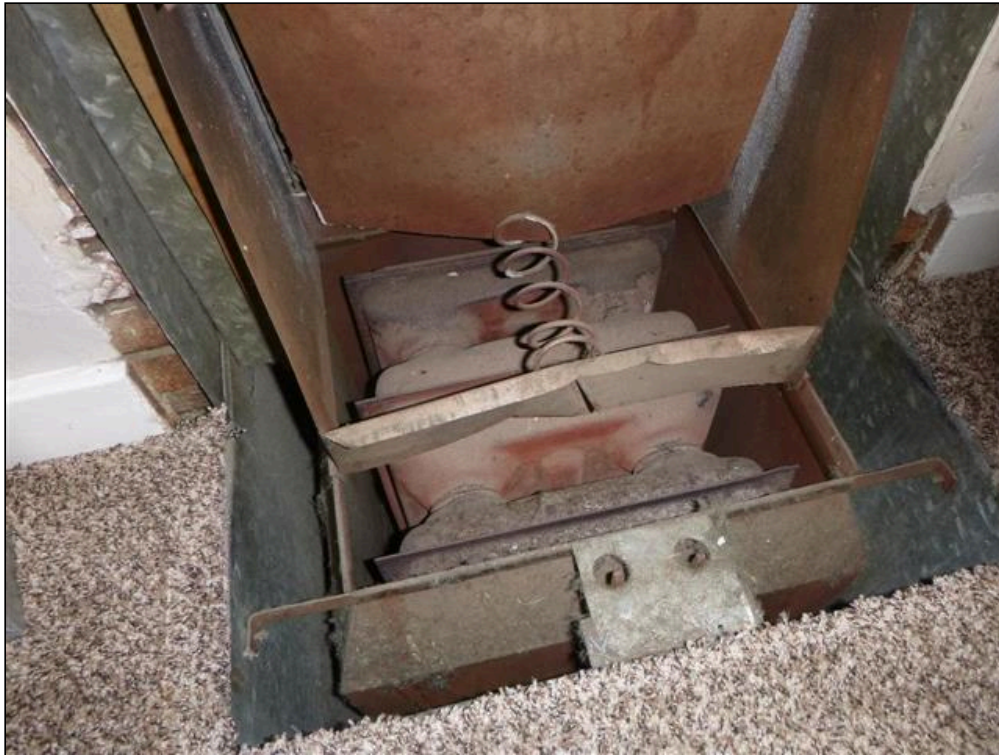
10.0 Item 3(Picture)

(2) A potential fire spread hazard was noted due to the excessive hair and debris at the base of the heating unit, suggest cleaning/removal as needed.

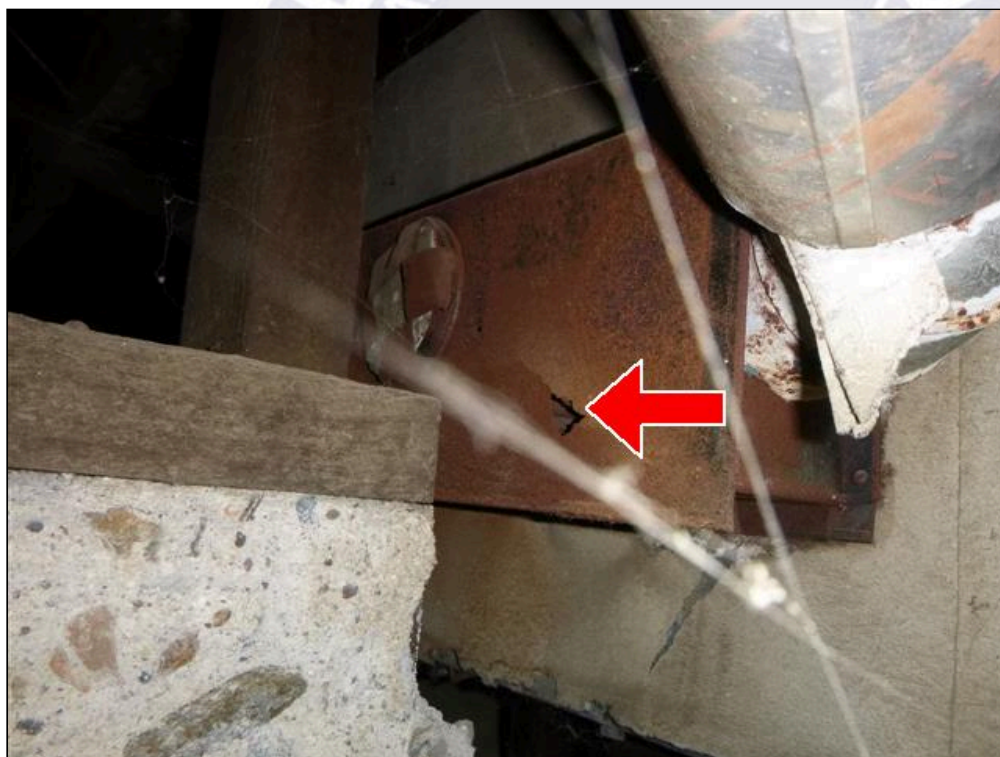
10.1 Item 2(Picture)

Potential safety hazard due to the heater draft diverter is rusted, deteriorated and large holes were noted. This will allow heater fumes/carbon monoxide to escape into the crawl area and possibly into the dwelling. Suggest review with a licensed heater company for replacement costs as required for safety.

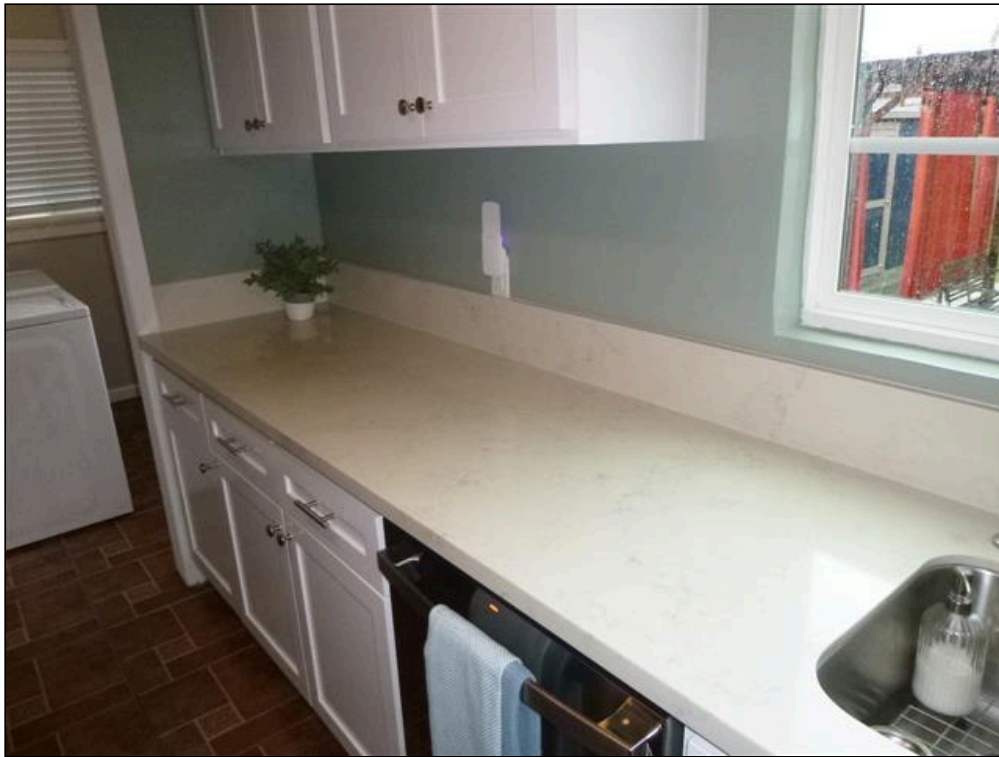
16.7 Item 2(Picture)

(2) A minimum number of outlets were installed at this area at the time of the inspection, this is common for the original age of dwelling. Suggest review by a licensed electrician for installation costs

for additional outlets if desired as an upgrade.

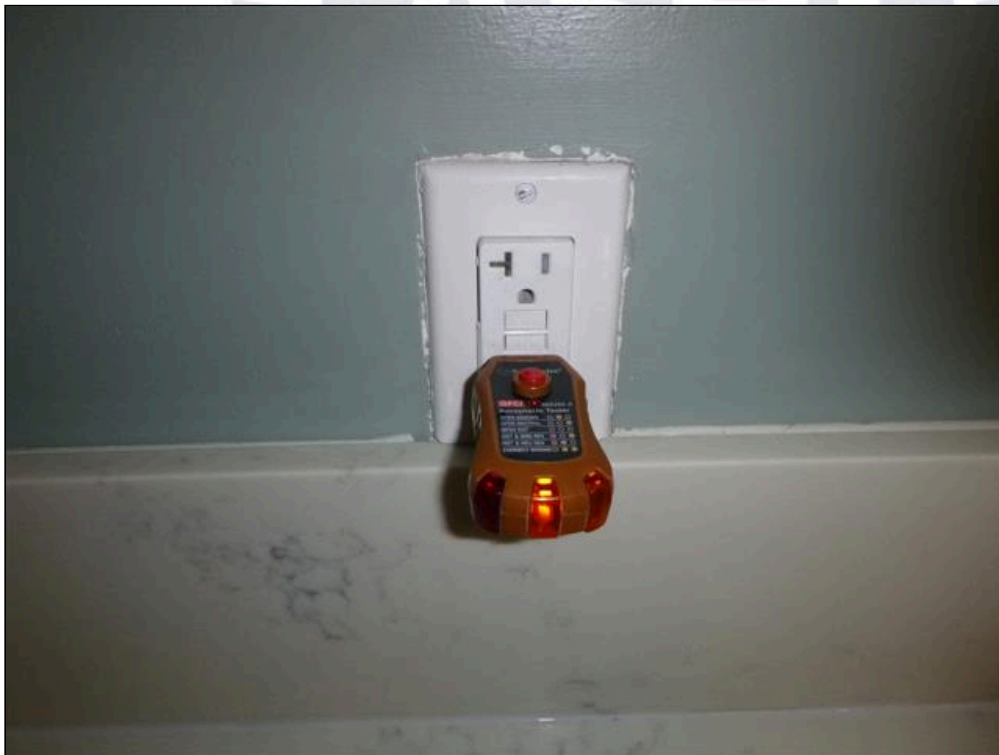
16.7 Item 3(Picture)

(3) The GFCI outlet(s) at this area are not grounded. The GFCI should still provide GFCI protection but the outlet should generally be grounded. Suggest review by a licensed electrician for repair/grounding cost as needed and required for safety.

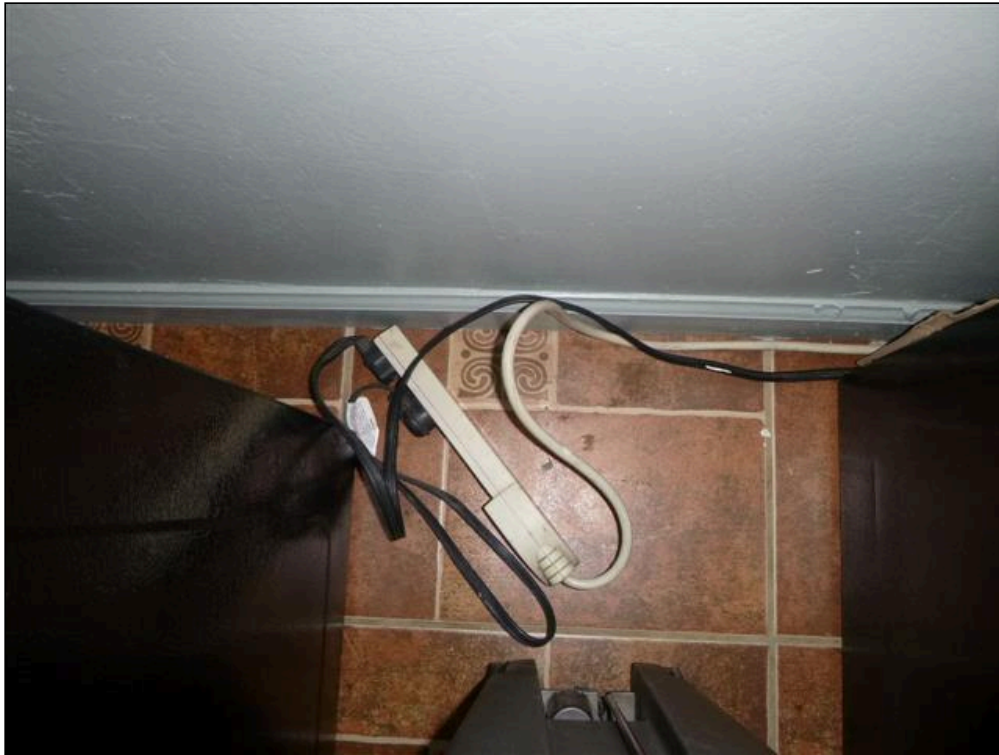
16.7 Item 4(Picture)

(4) Excessive use of electrical plugs strips/extension cords used at this area, this is a potential fire safety hazard. Suggest review with a licensed electrician for additional electrical circuits/outlets costs as needed for safety.

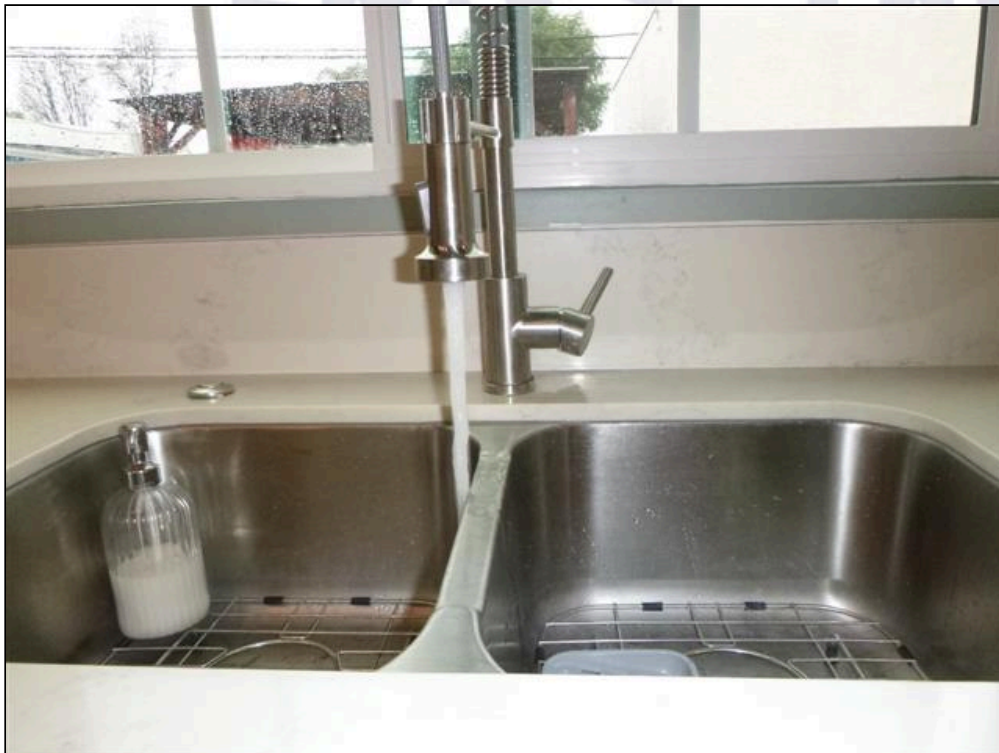
16.9 Item 1(Picture)

The sink faucet is loose at the countertop, suggest repair as needed.

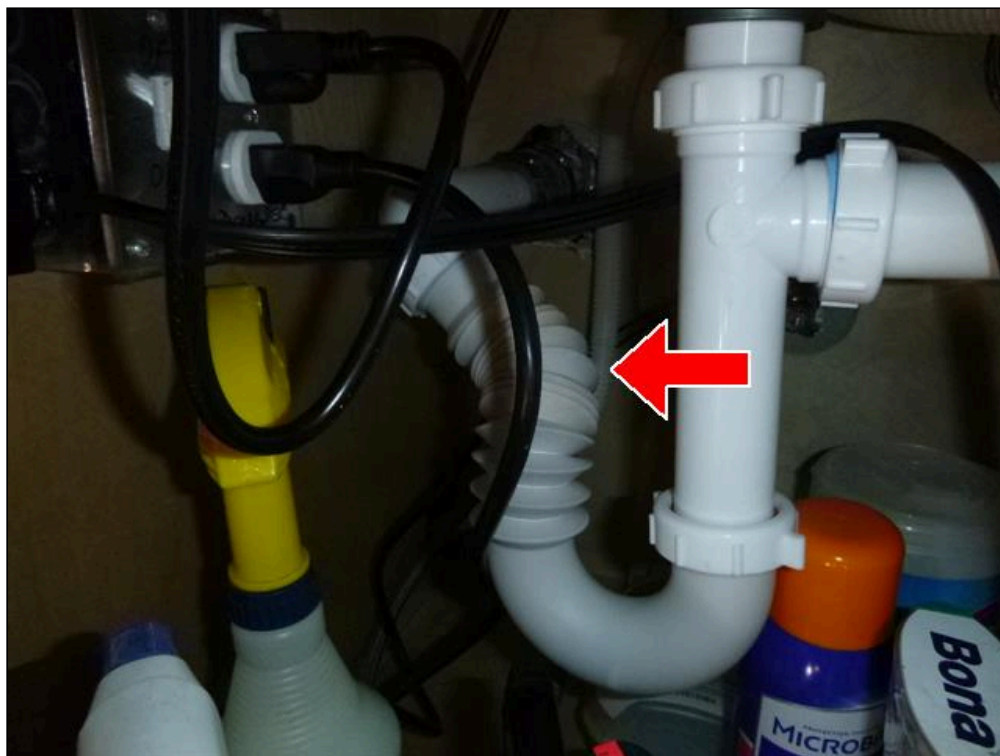
16.10 Item 1(Picture)

Suggest review by a licensed plumber for costs to replace the sink flex drain(s) with the appropriate materials as required.

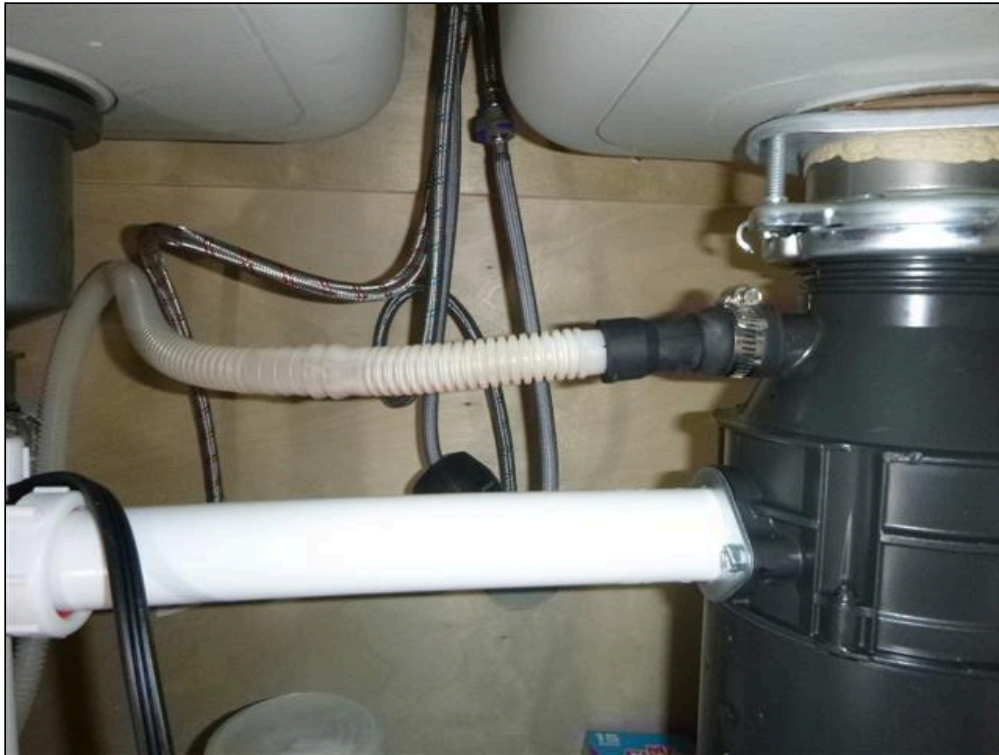
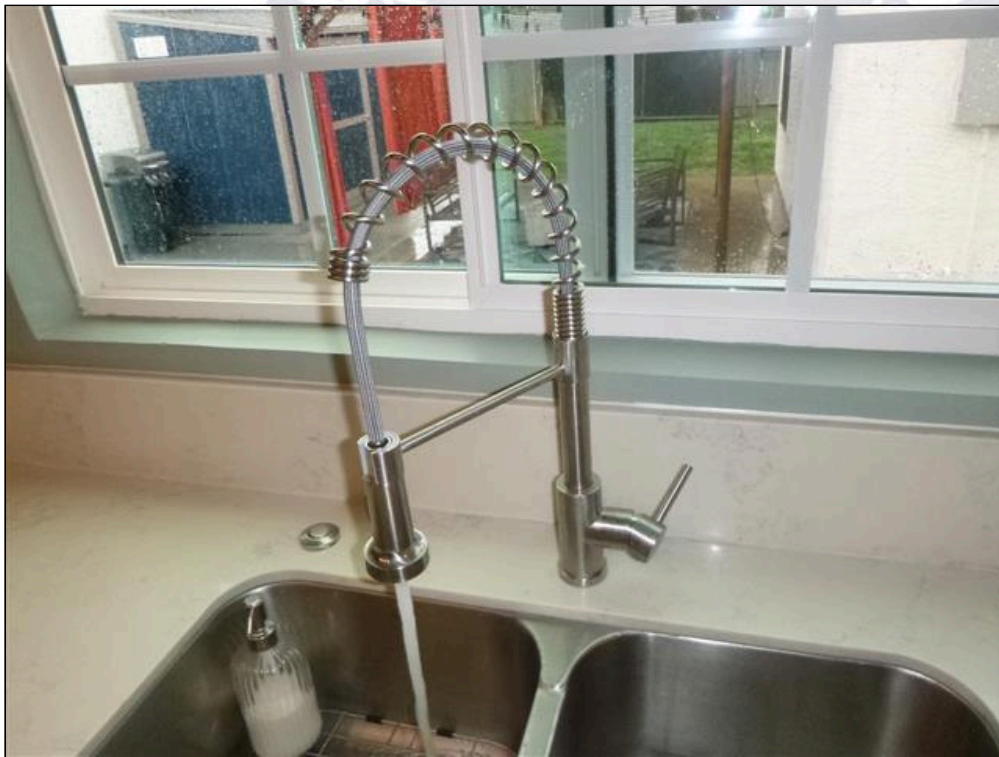
There is no air gap installed for the dishwasher as required, the system currently drains directly into the disposal. Suggest review by a licensed plumber for costs to install the air gap and drain as required by the State of California.

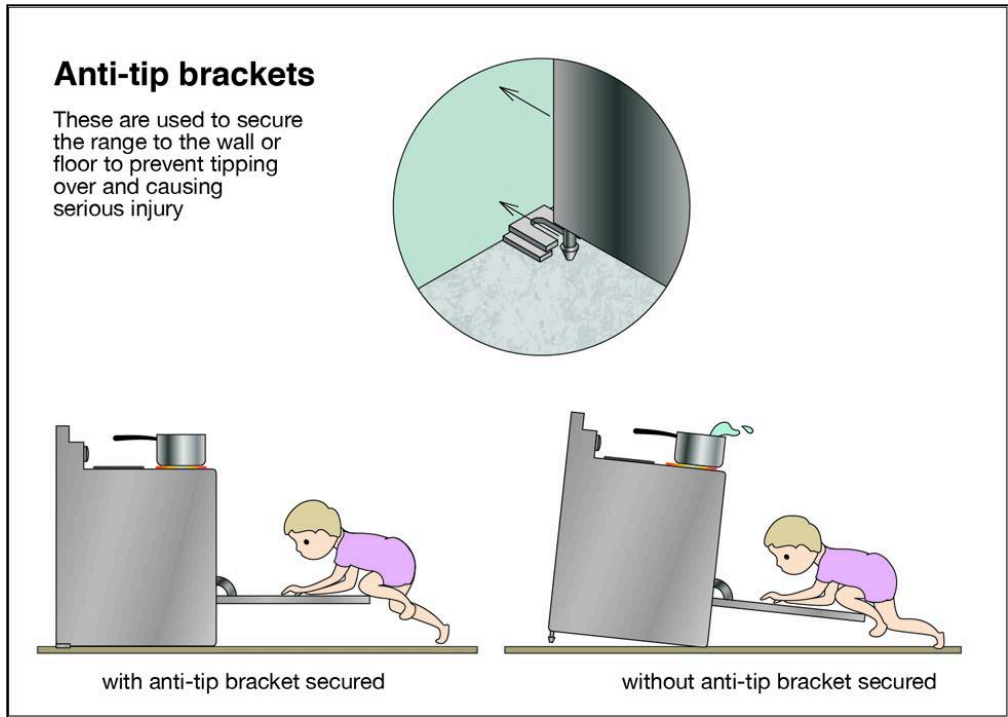
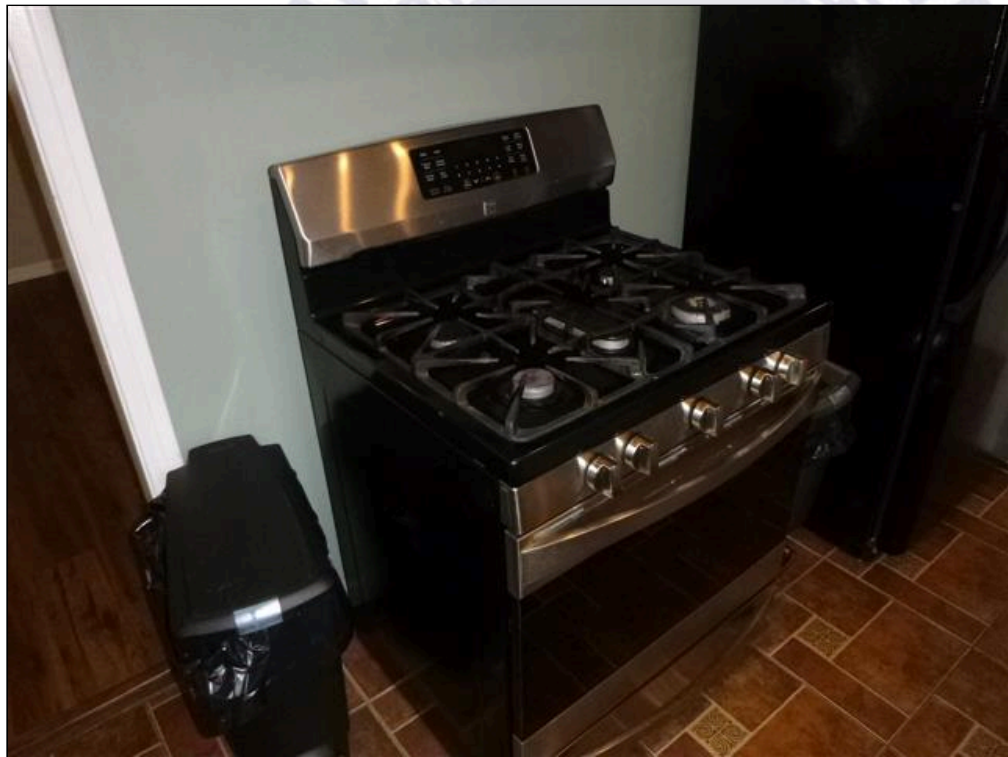
(1) The anti-tip bracket/chain is not currently installed. An anti-tip bracket is usually installed on the floor and against the wall (towards the back of the stove) for one of the rear legs to slide into. Its purpose is to prevent the stove from tipping when a heavy load is placed on the door (possible child) or slide-out racks upsetting the center of gravity. Suggest installation for safety as required since 1991.

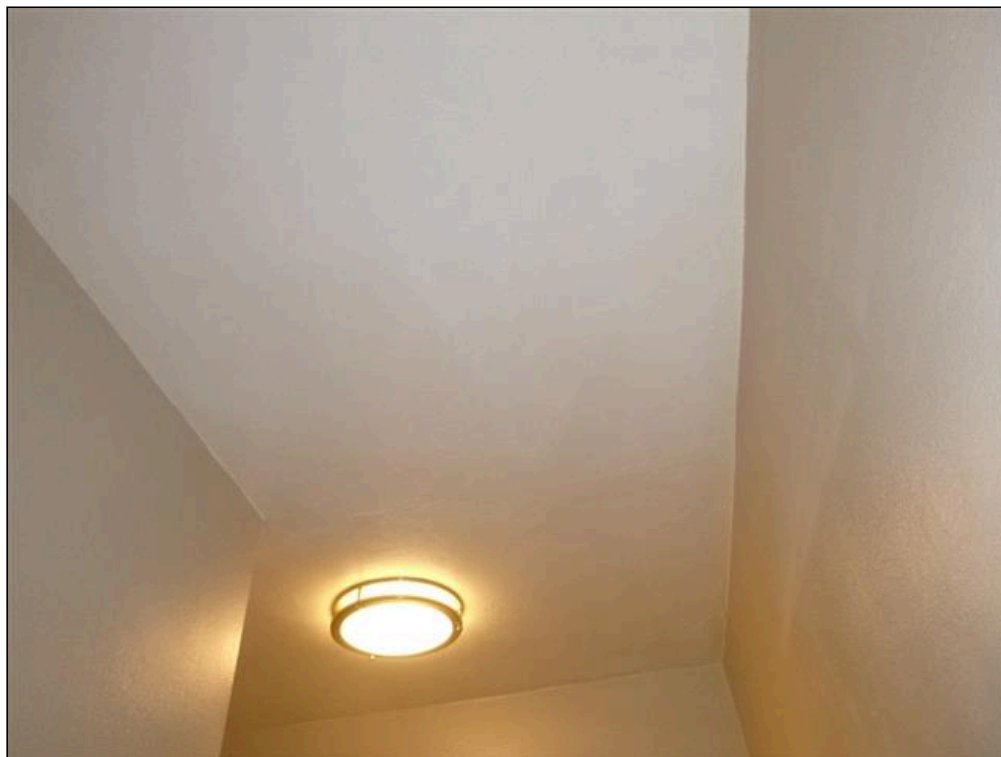
17.2 Item 1(Picture)

Patched and uneven areas of the ceiling was noted, suggest review with the seller on the cause and any repairs needed. Suggest review with a licensed contractor for any repair/removal/replacement costs as needed.

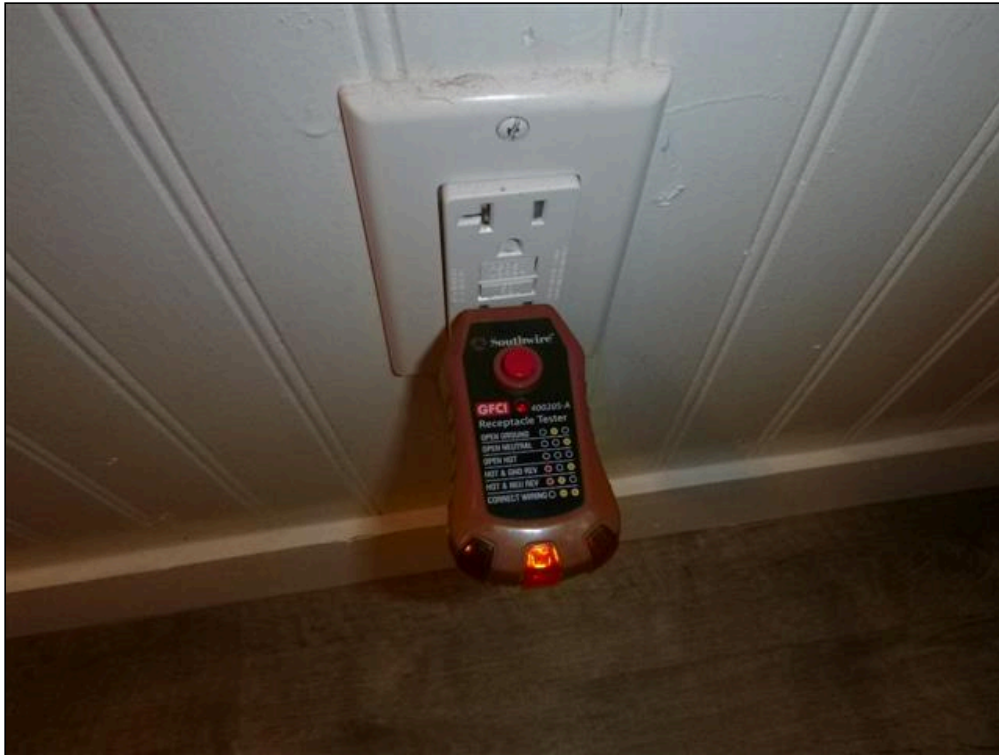
17.6 Item 1(Picture)

The GFCI outlet(s) at this area are not grounded. The GFCI should still provide GFCI protection but the outlet should generally be grounded. Suggest review by a licensed electrician for repair/grounding cost as needed and required for safety.

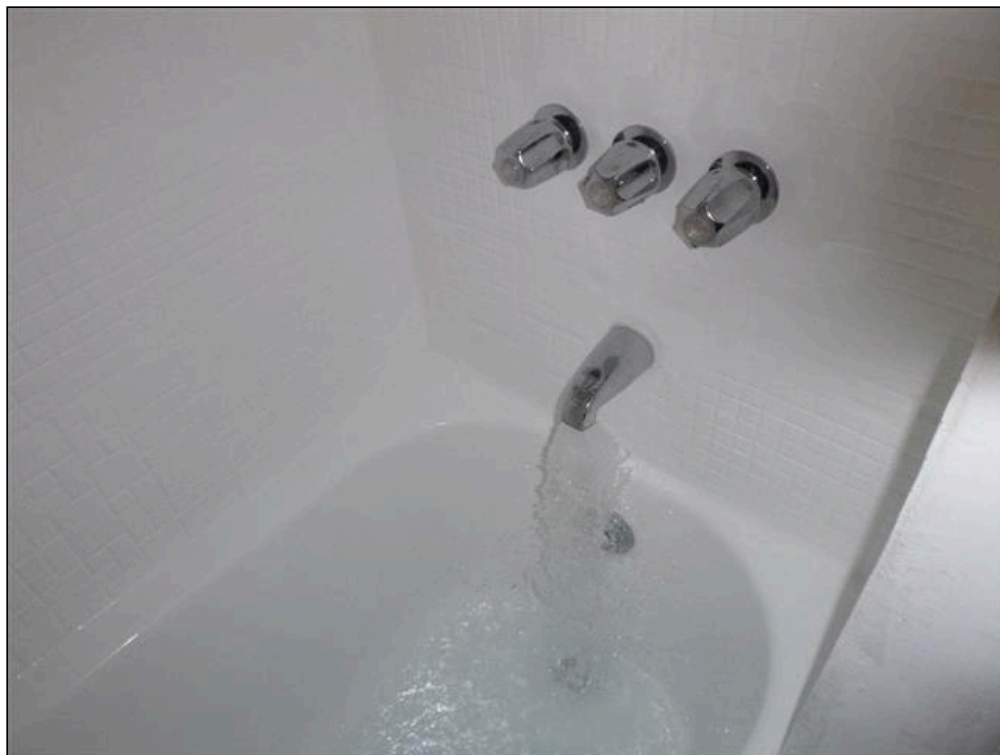
17.9 Item 1(Picture)

(1) The existing tub faucet is not a low-flow system as required. Suggest review with a licensed plumber for costs to replace the existing tub faucet with a low flow faucet (2.2 gallons per minute) as required by the State of California as of January 1st, 2017. See the plumbing system comments for further details and a link to the State of California plumbing ordinance. Most retrofit companies/cities do not enforce the low flow tub faucet requirements due to it can take an excessive amount of time to fill the tub (you will use the same amount of water irrelevant of how long it takes to fill the tub).

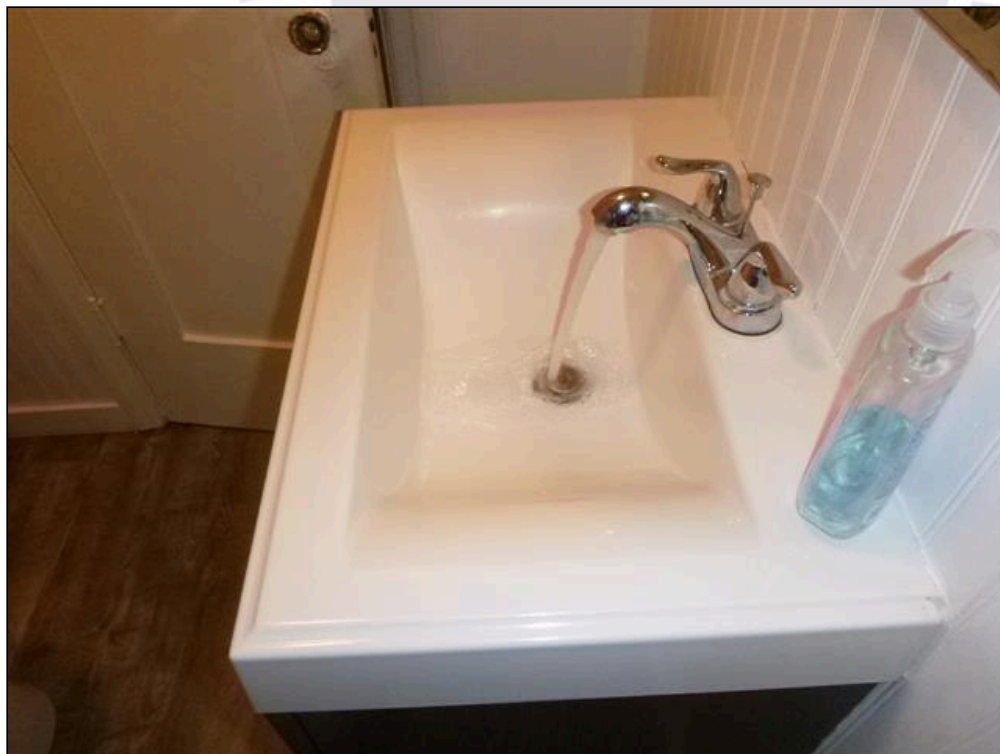
17.13 Item 1(Picture)

No drainage overflow system installed at the sink(s) as required, suggest review with a licensed plumber for repair/replacement costs as required.

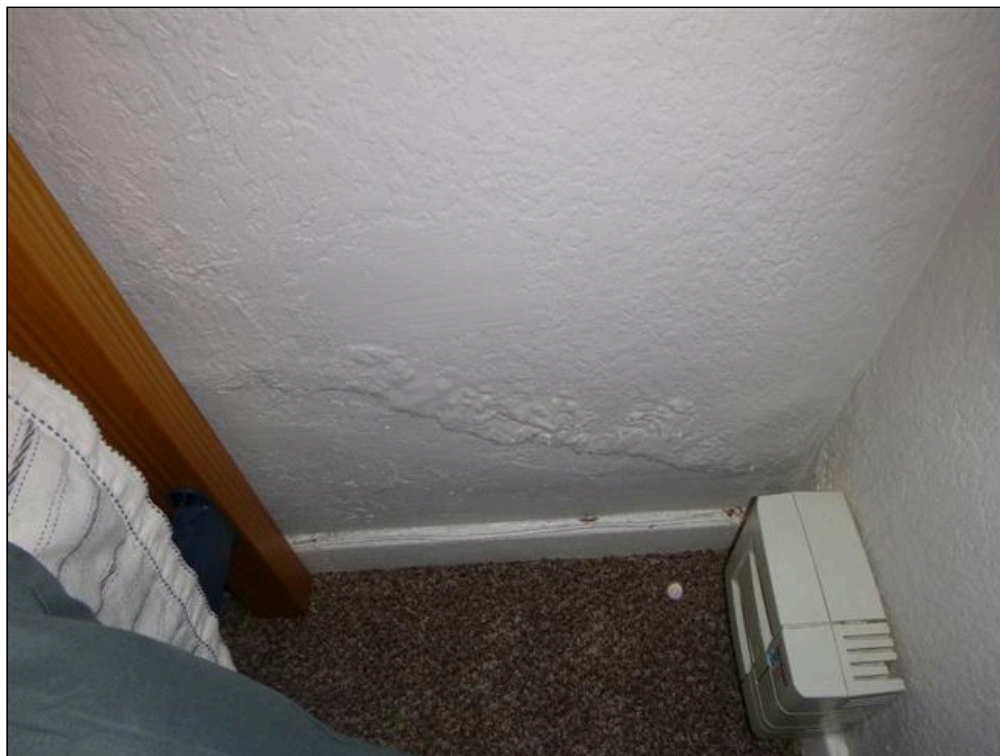
17.18 Item 1(Picture)

Excessive deterioration/damaged areas of the wall in bedroom #2 was noted noted which is adjacent to the tub/shower area. Suggest review with the seller and/or a licensed contractor for any repair/removal/replacement costs as needed.

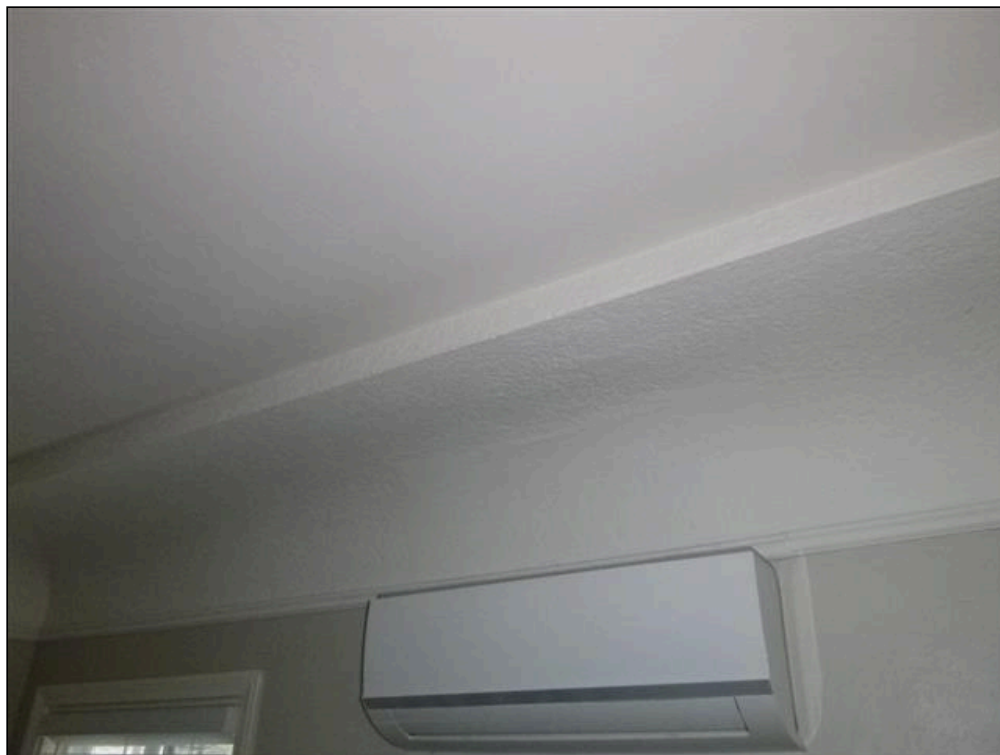
19.1 Item 1(Picture)

Patched areas of the walls was noted, suggest review with the seller for the cause and any repairs needed. Suggest repair as needed.

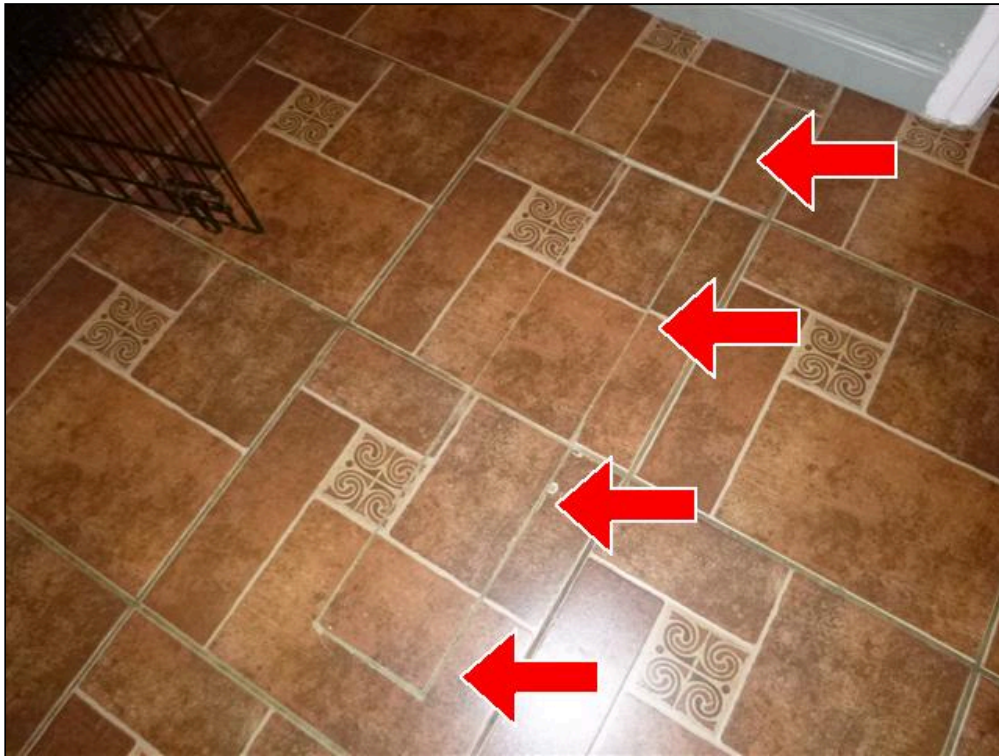
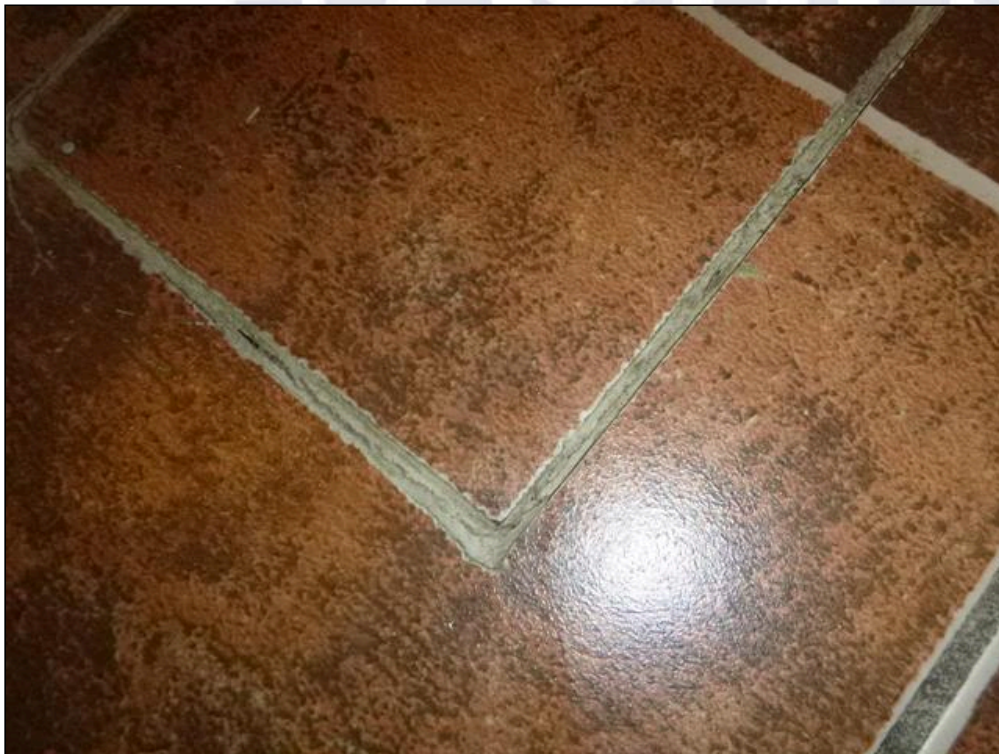
Patched repaired areas of the tile flooring was noted (this appears to be from a removed wall).
Suggest review with the seller and/or a licensed contractor on this item as needed.

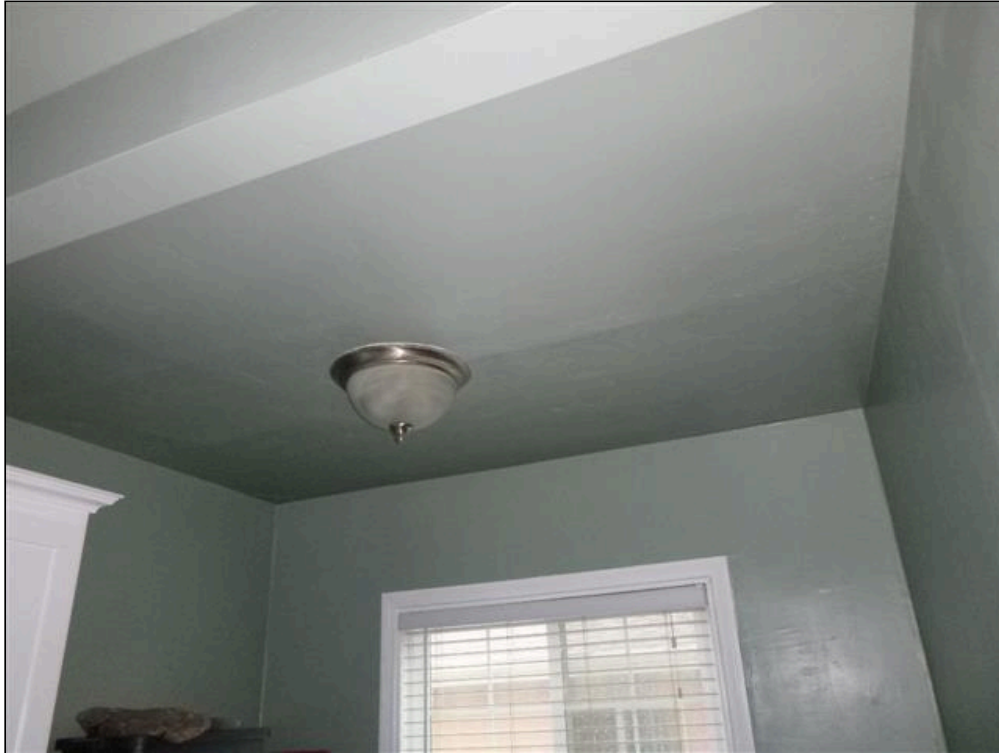
21.2 Item 1(Picture)

Patched and uneven areas of the ceiling was noted, suggest review with the seller on the cause and any repairs needed. Suggest review with a licensed contractor for any repair/removal/replacement costs as needed.

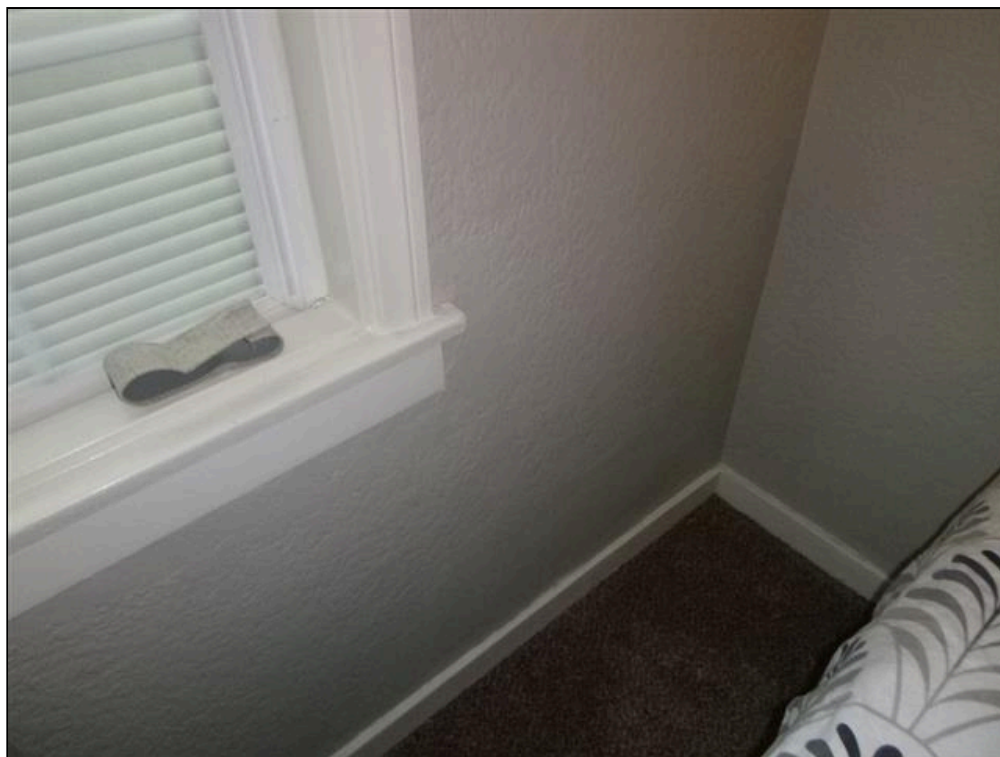
23.1 Item 1(Picture)

Patched areas of the walls was noted, suggest review with the seller for the cause and any repairs needed. Suggest repair as needed.

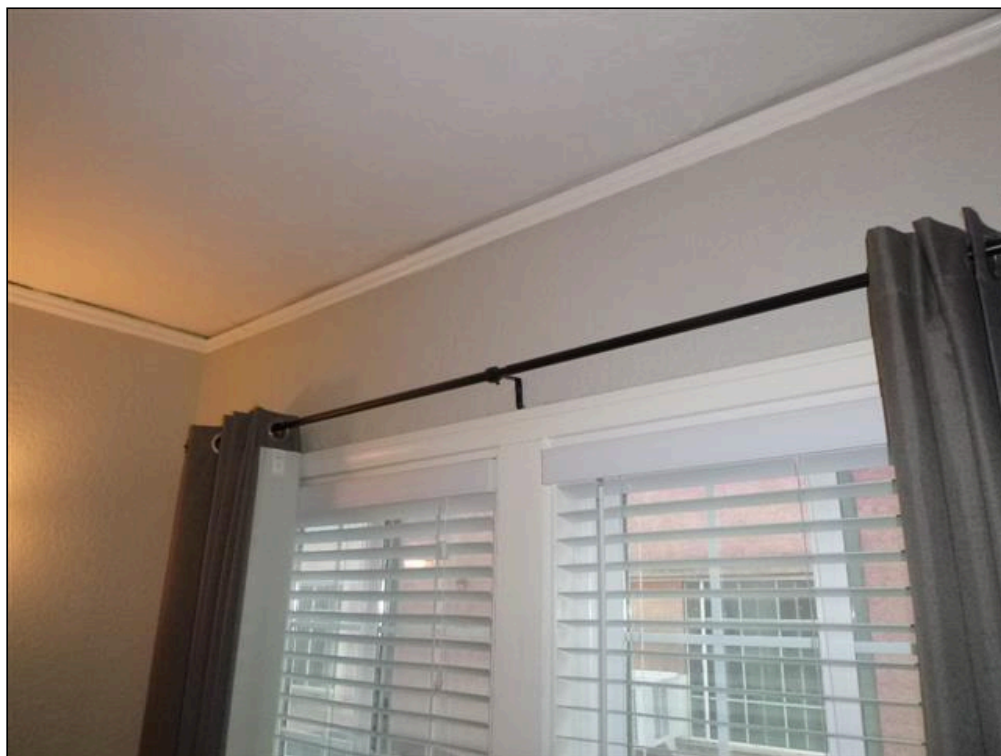
24.1 Item 1(Picture)

(1) Patched areas of the walls was noted, suggest review with the seller for the cause and any repairs needed. Suggest repair as needed.
