Inspection Report

Property Address:
447 E Hullett St
Long Beach CA 90805

Ferguson Home Inspections

Date: 3/23/2024	Time: 09:00 AM	Report ID: 20240323-447-E-Hullett-St
Property: 447 E Hullett St Long Beach CA 90805	Customer: Kimberly Stewart	Real Estate Professional: Sue Freeman

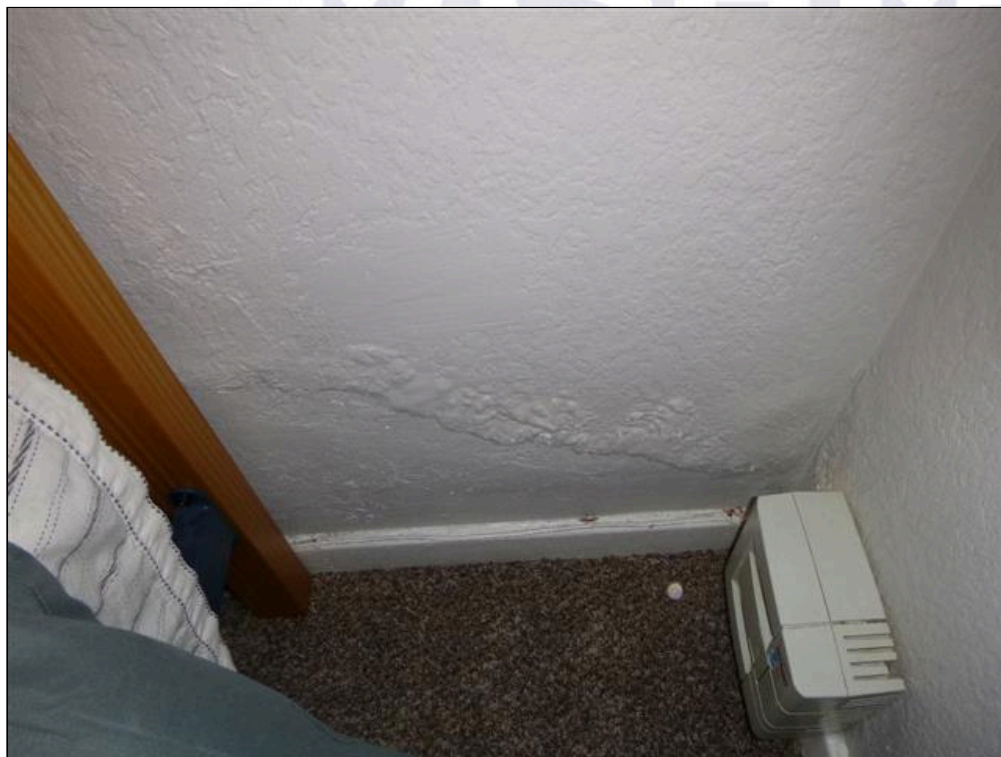
24.1 Item 2(Picture)

(2) Deteriorated/blistered/damaged areas of the front wall were noted (this area tested dry at the time of the inspection). This area is adjacent to the bathroom tub/shower area. Suggest review with the seller and/or a licensed contractor for any repair/removal/replacement costs as needed.

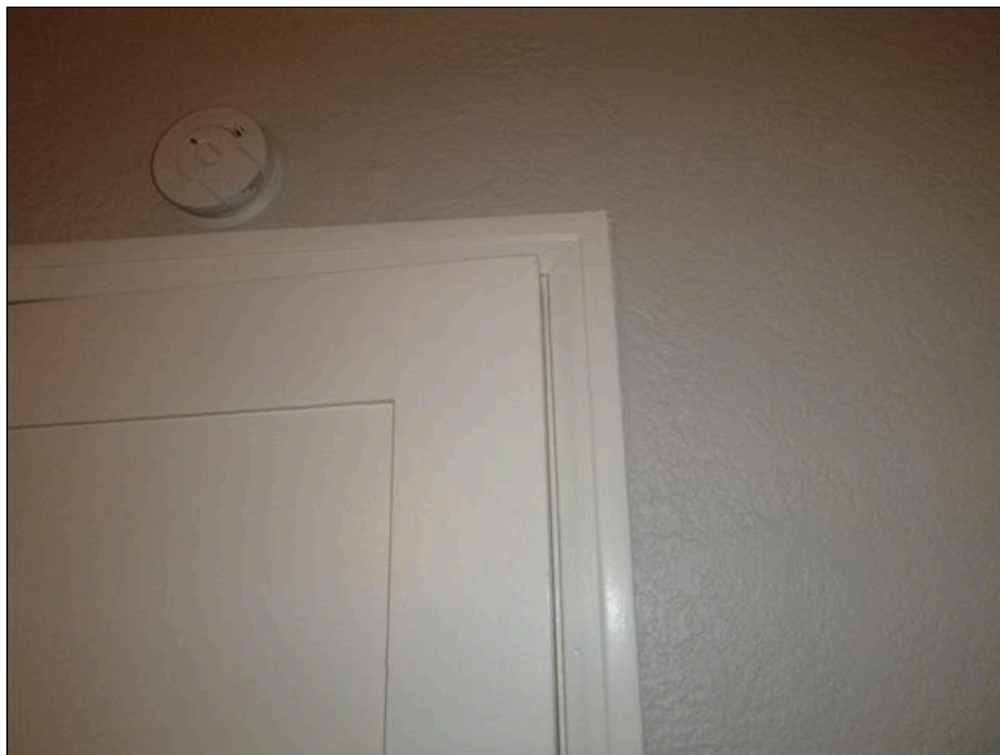
24.3 Item 1(Picture)

The door sticks/impacts on the jamb when operating, suggest repair as needed.

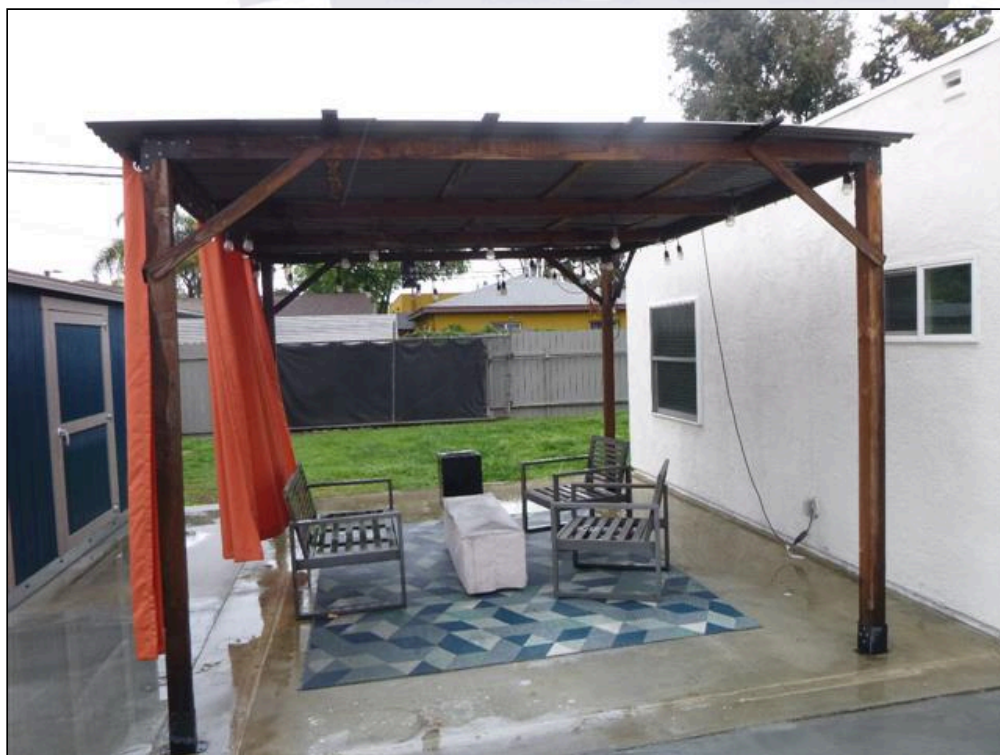
25.6 Item 1(Picture)

The wood awning at the left side is not currently bolted/secured to the concrete slab. Suggest review with the seller and/or a licensed contractor for costs to bolt/secure the awning as needed.

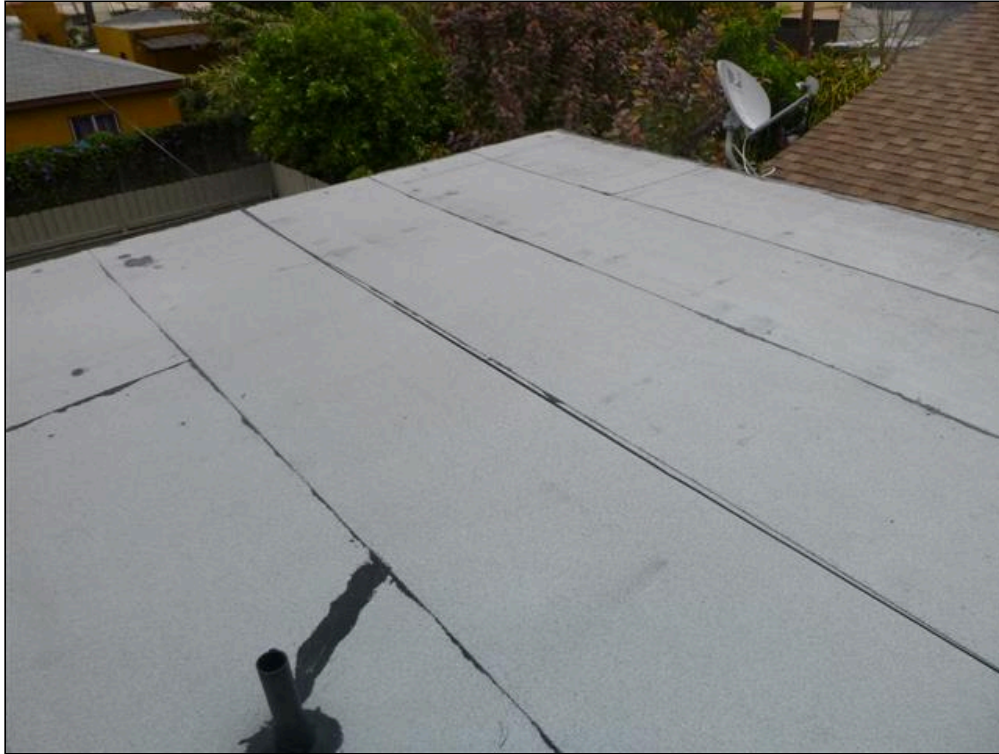
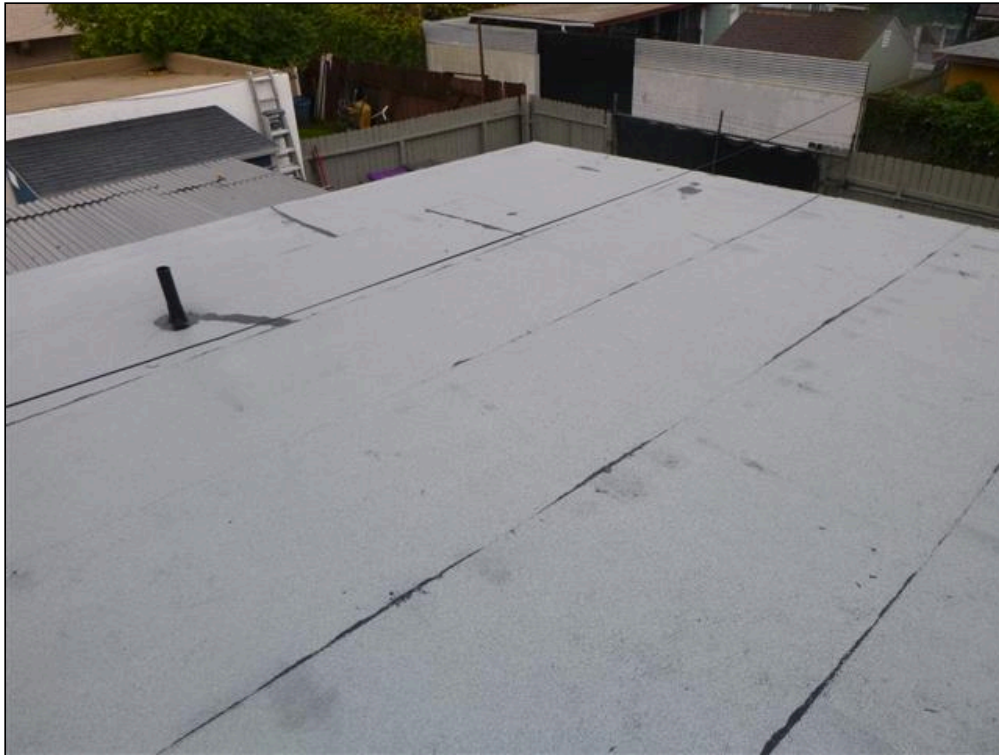
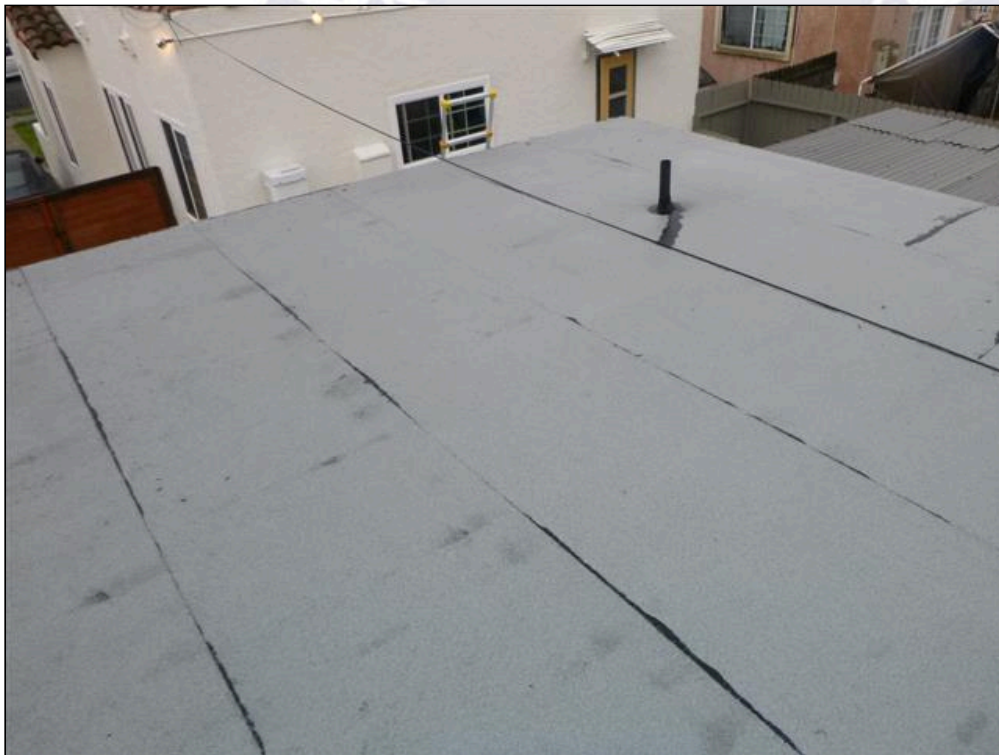
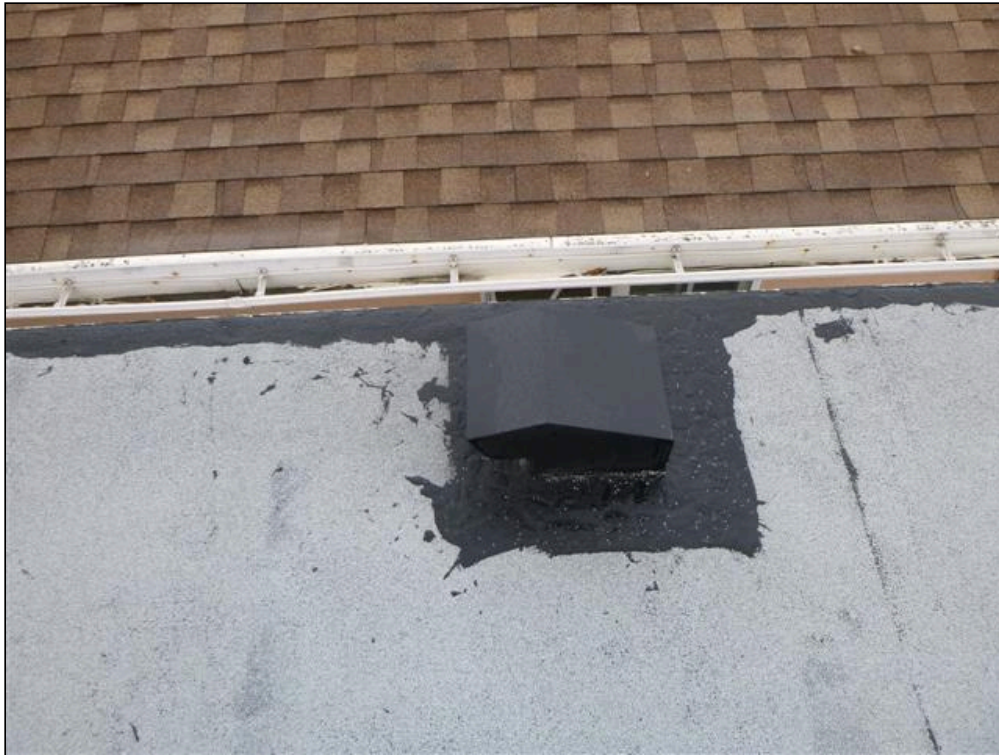
Patched and repaired areas of the roofing was noted. Suggest review with a licensed roofing contractor for any repair/replacement costs as needed and to determine the remaining life expectancy of the roof.

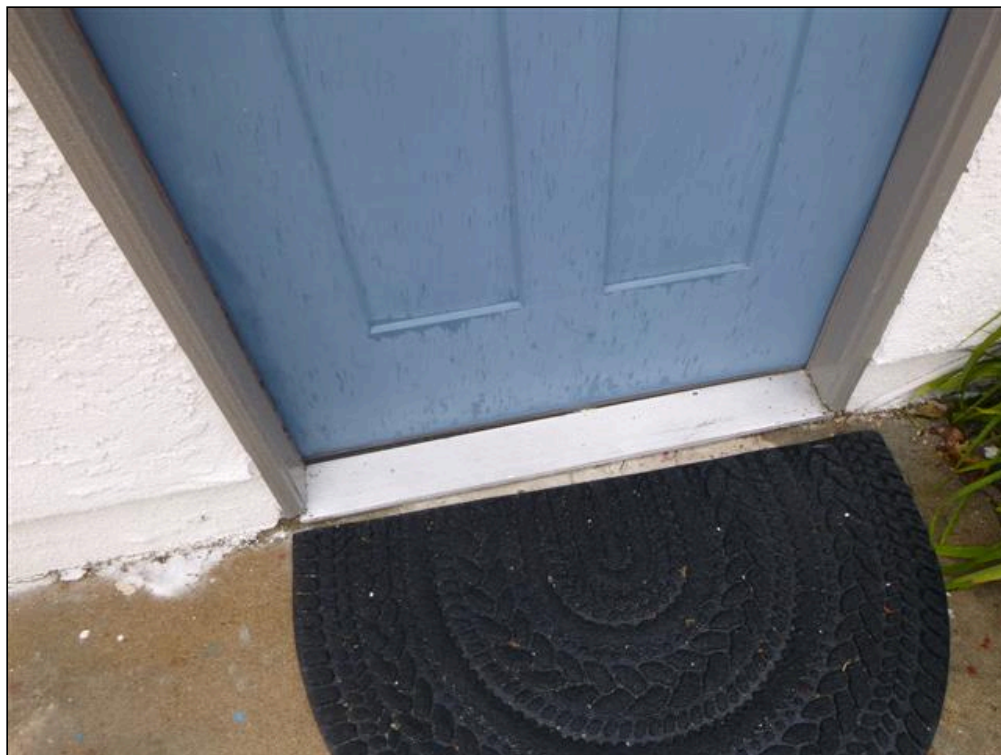
28.3 Item 2(Picture)

(2) The existing threshold for the doorway is set at/below the deck level. Water entry may occur at these areas and cause damaged within the structure. Current requirements for doorway/thresholds are two inches minimum height above the hard deck or exterior surface/grade. Suggest review with a licensed contractor for repair/replacement costs needed to eliminate water entry into the structure.

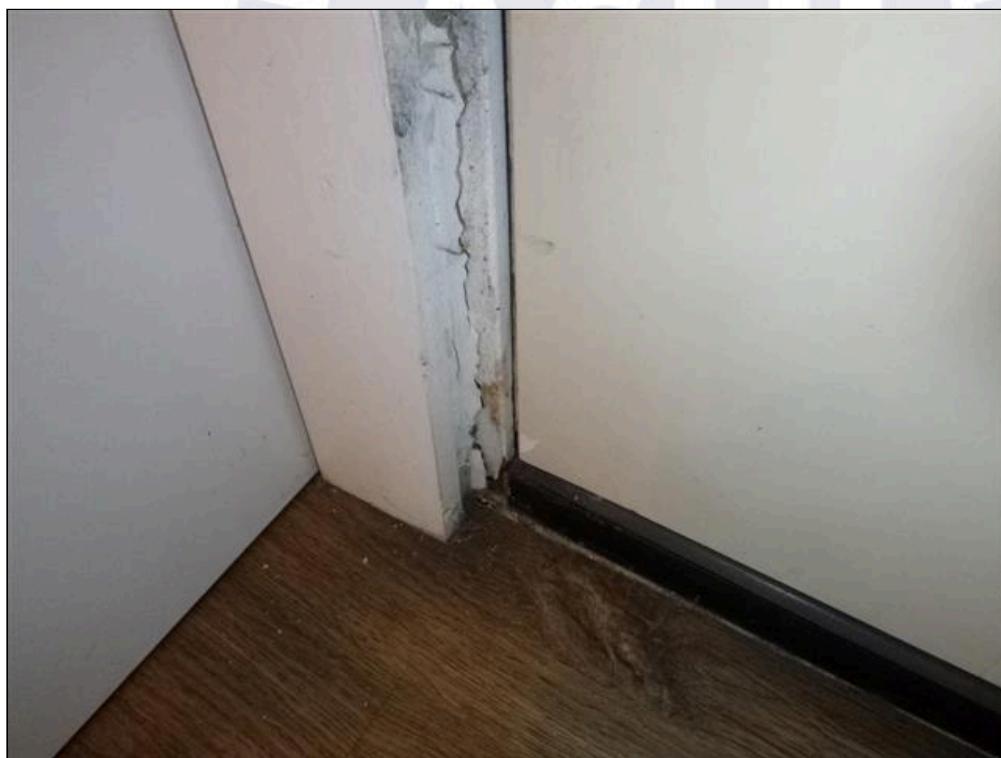
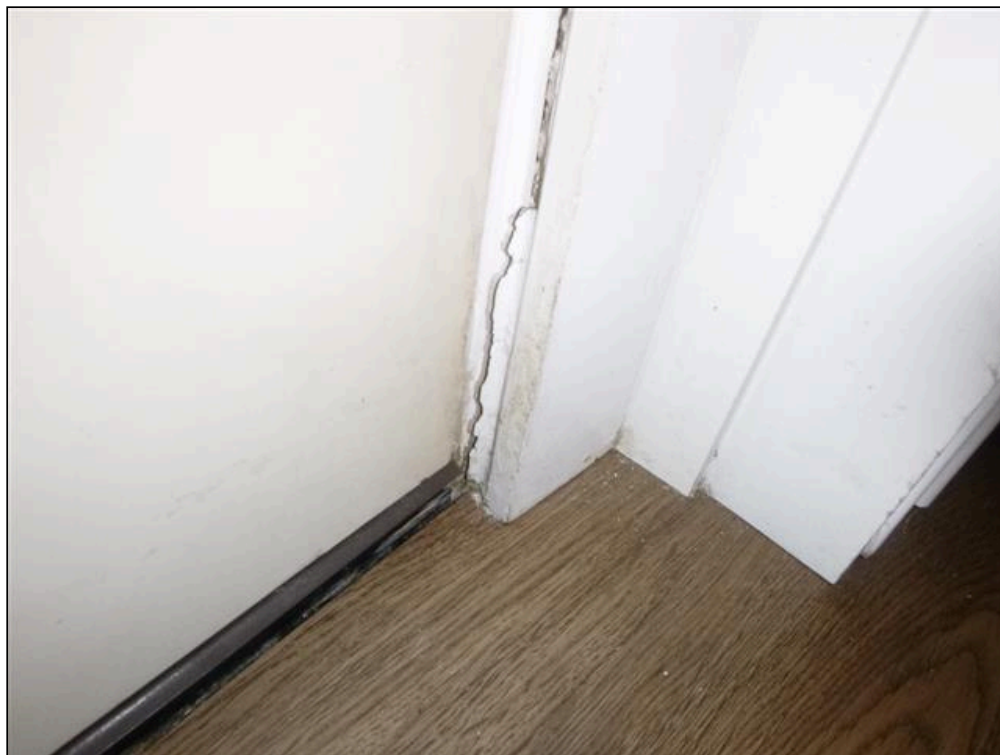
(3) Evidence of previous and ongoing water intrusion noted at the door(s) to the interior. Deteriorated and loose door trim/casings were noted. Suggest review with a licensed contractor for any repair/ replacement costs as needed to prevent further and future water intrusion at this area.

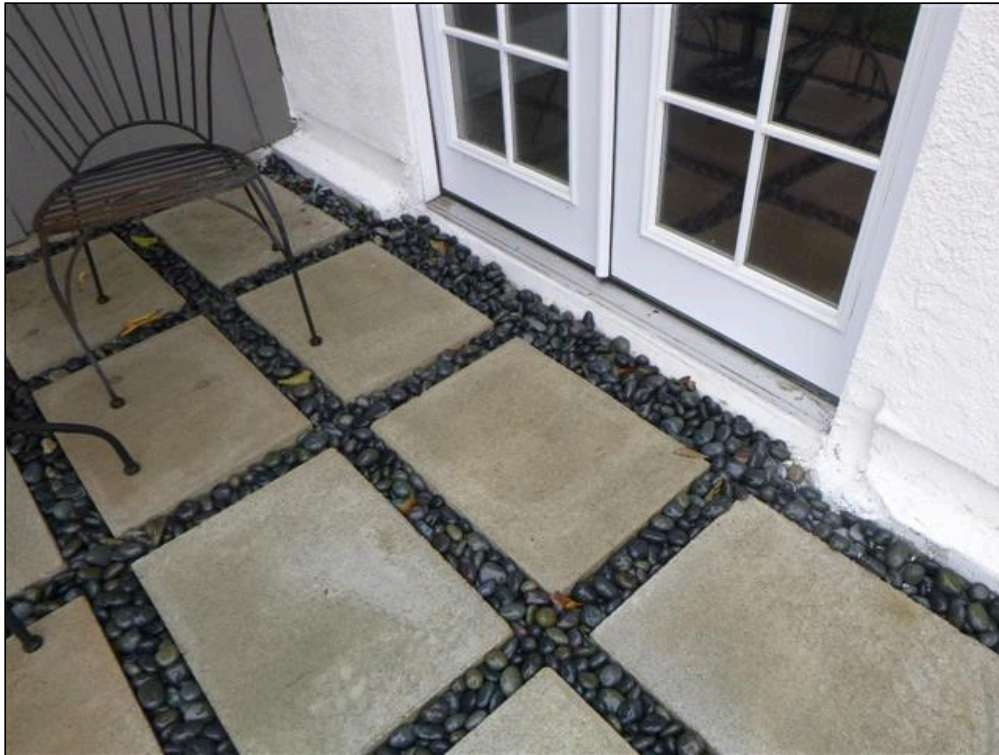
29.0 Item 1(Picture)

An inadequate/incomplete sized deck/landing was noted at the exterior doorway. Generally a 36' formed landing is required at an exterior door. Suggest review with the seller/city and/or a licensed contractor for installation costs as needed.

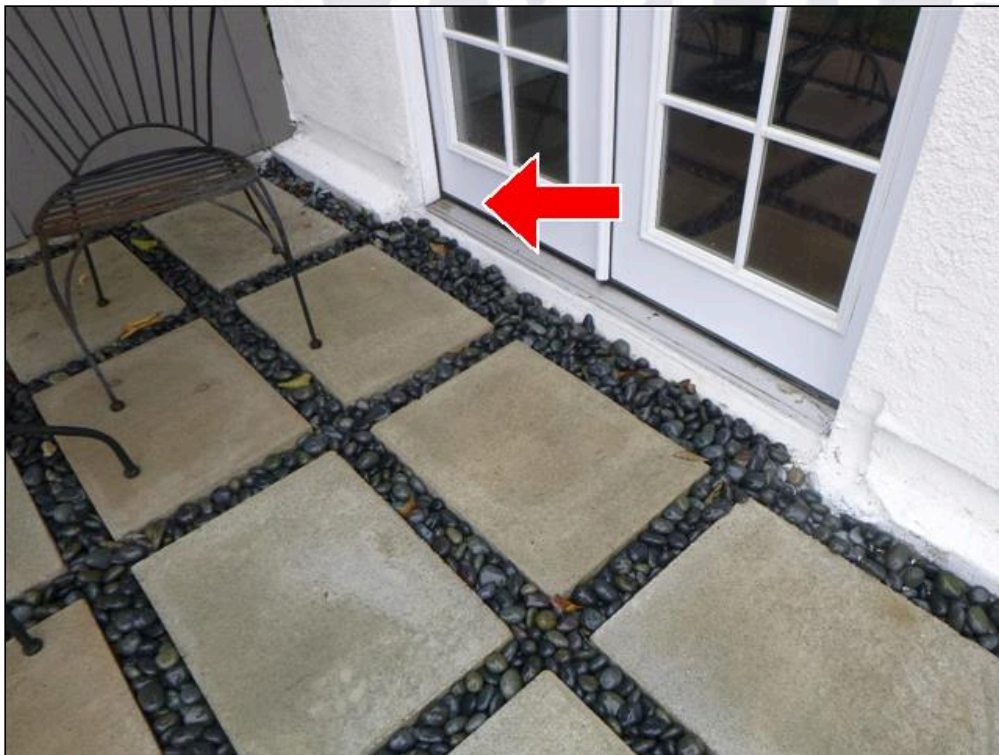
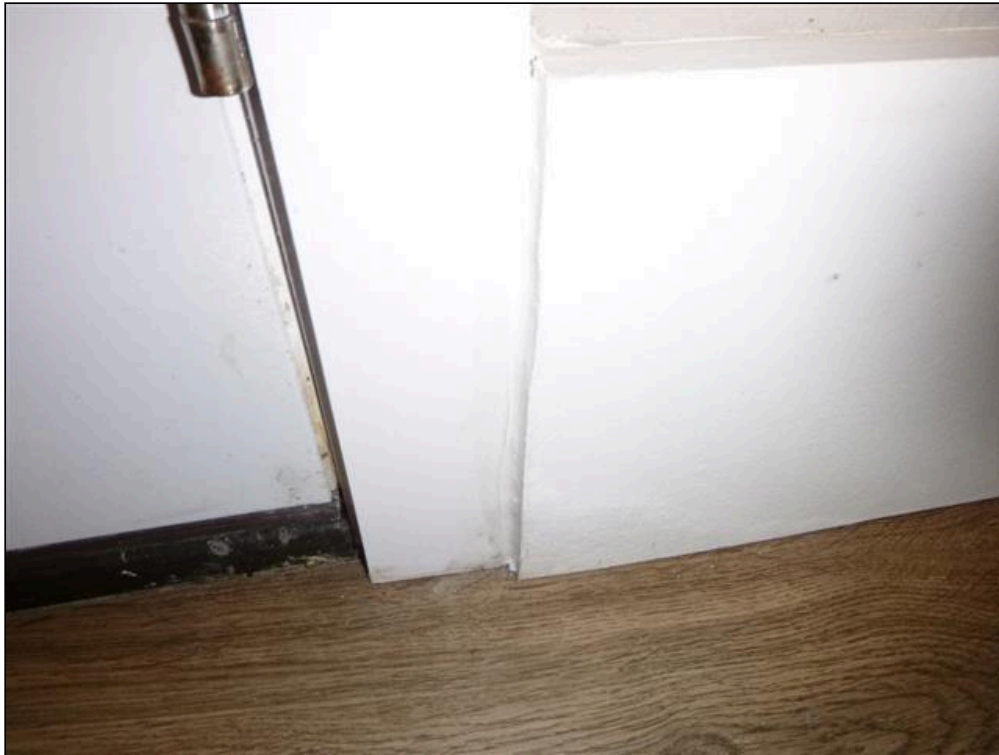
Evidence of previous and ongoing water intrusion noted at the door(s) to the interior. Deteriorated and stained flooring/baseboards noted. Suggest review with a licensed contractor for any repair/ replacement costs as needed to prevent further and future water intrusion at this area.

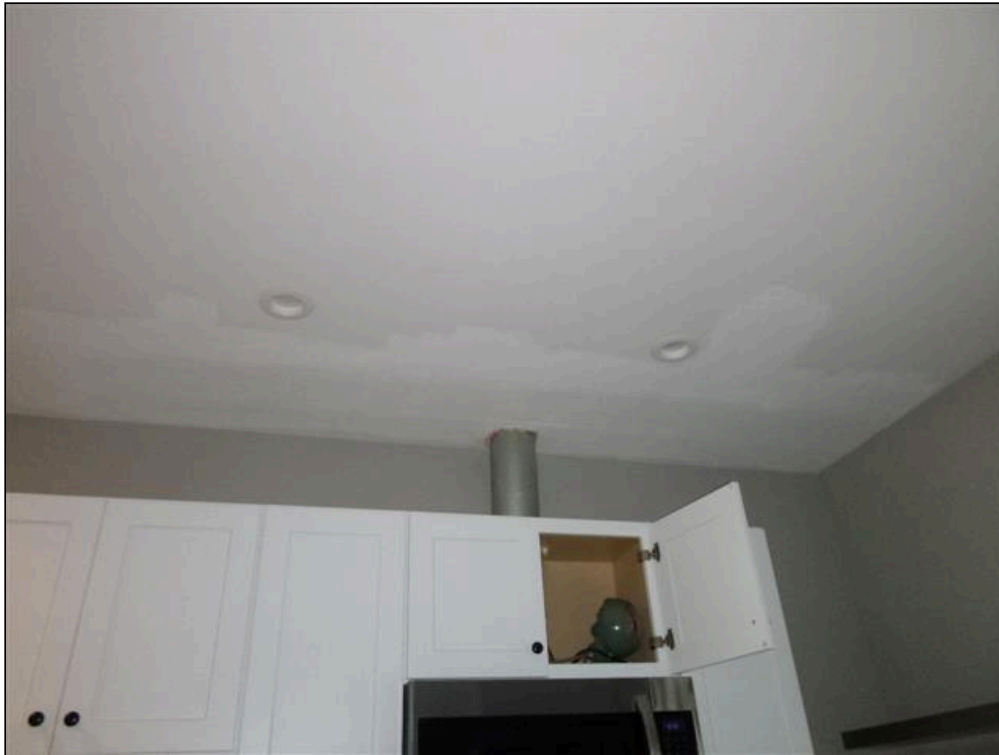
33.2 Item 1(Picture)

Patched and repaired areas of the ceiling was noted, suggest review with the seller on the cause and any repairs needed. Suggest review with a licensed contractor for any repair/removal/replacement costs as needed.

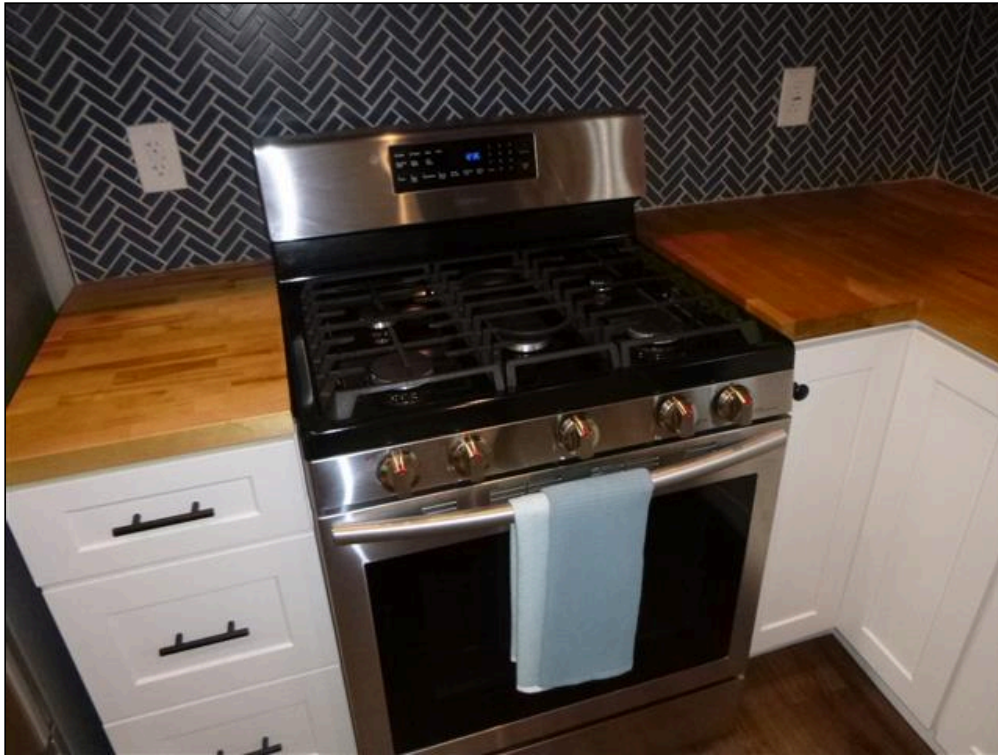
33.7 Item 1(Picture)

Suggest review with the seller/city and/or a licensed contractor on the installation of the wood block countertop due to the proximity to the gas fueled stove.

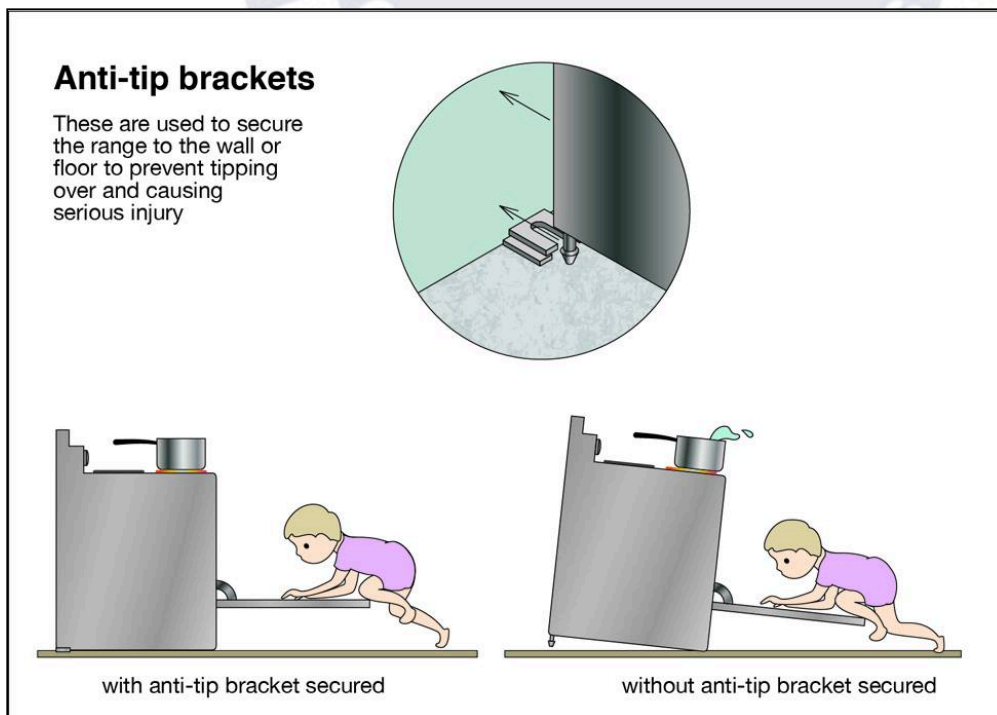
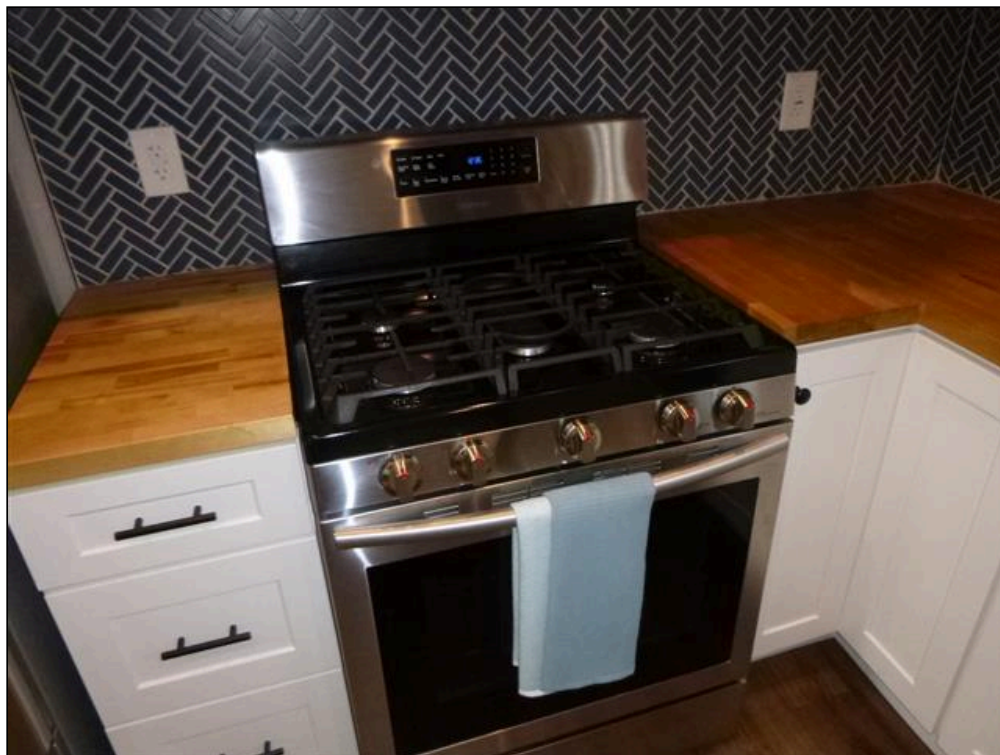
(1) The anti-tip bracket/chain is not currently installed. An anti-tip bracket is usually installed on the floor and against the wall (towards the back of the stove) for one of the rear legs to slide into. Its purpose is to prevent the stove from tipping when a heavy load is placed on the door (possible child) or slide-out racks upsetting the center of gravity. Suggest installation for safety as required since 1991.

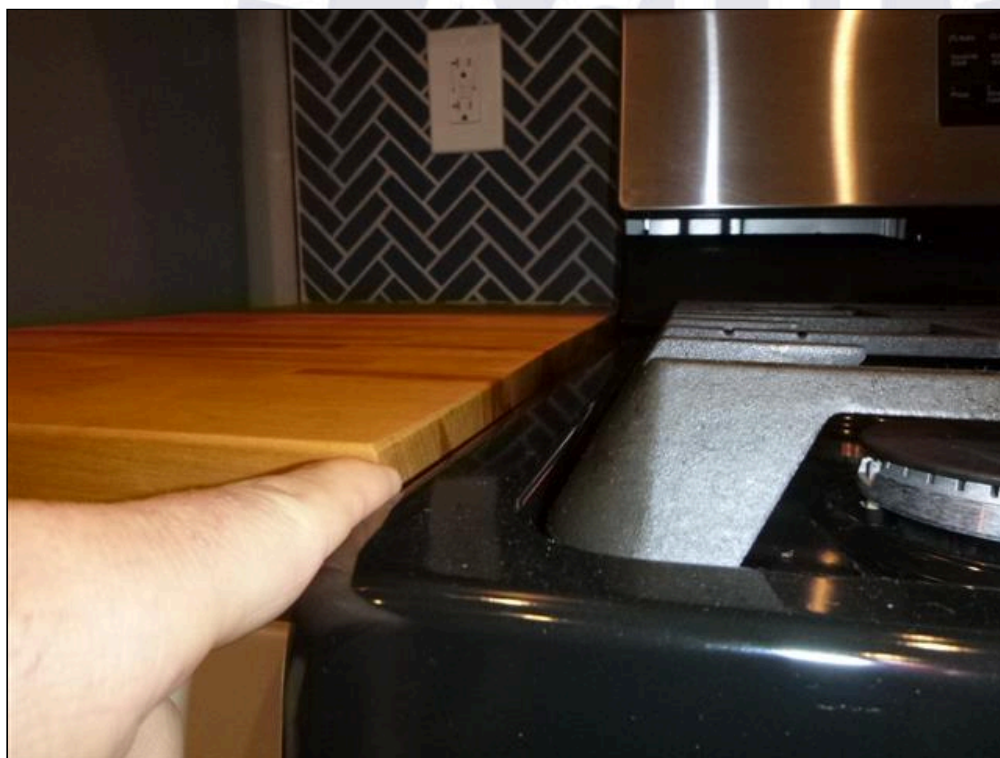
33.13 Item 3(Picture)

(2) Potential fire spread hazard due to the stove is currently below the countertop height. Suggest review with a licensed contractor for cost to raise and level the stove to above the countertop height as required for safety.

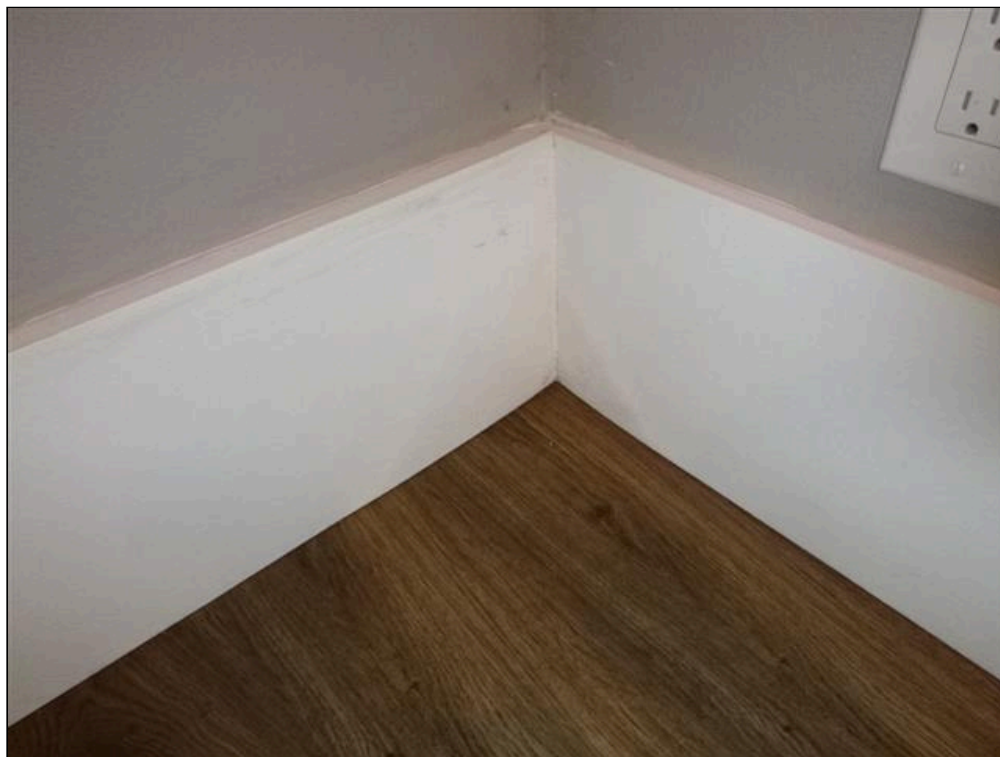
35.1 Item 1(Picture)

Stains, deterioration and water damage noted at the walls (this area tested positive for moisture at the time of the inspection). Suggest review with the seller and/or a licensed contractor to determine/verify the source of the leak and any repairs needed. Suggest review with a licensed contractor for repair/removal/replacement costs as needed.

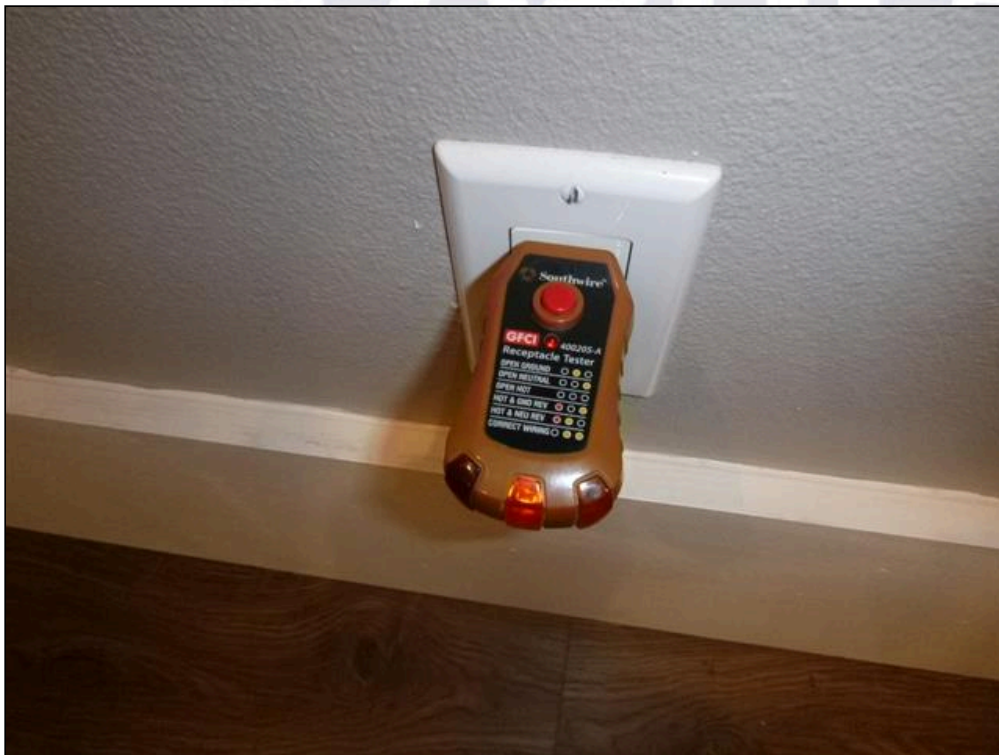
35.6 Item 1(Picture)

Ungrounded three prong outlets noted at this area. Suggest review with a licensed electrician for costs to ground the outlets as needed as an upgrade and/or protect the outlet(s) on a GFCI circuit where recommended.
