**Archive Property Inspection**

**Report ID# :**

**06182026-276-32**

**29619 Camino Pepita**

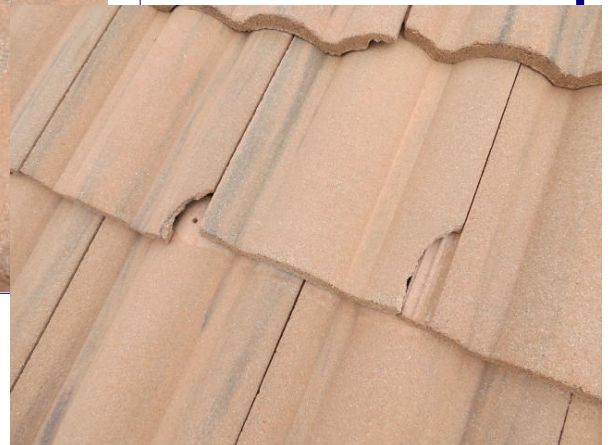
Broken corners noted at multiple roof tiles in various areas, primarily the south facing roof line. Small gaps can allow for water intrusion. Recommend further evaluation and correction by a licensed roofer.

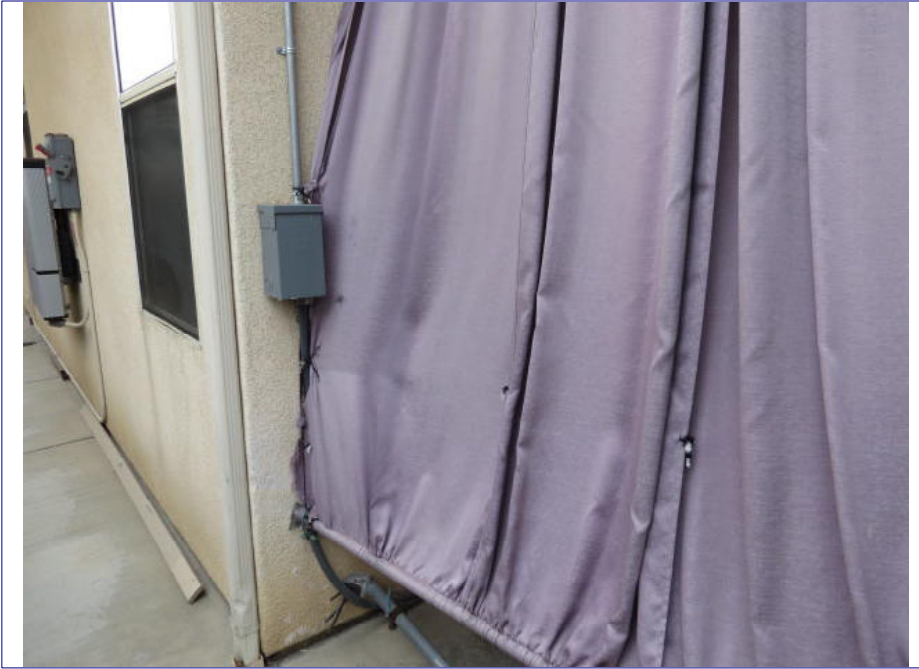
**Picture 31**

The electrical disconnect to the hottub is too close the spa body. The minimum distance is 5ft to prevent anyone sitting in the hottub from reaching the disconnect. Consult with a licensed electrician for appropriate correction.

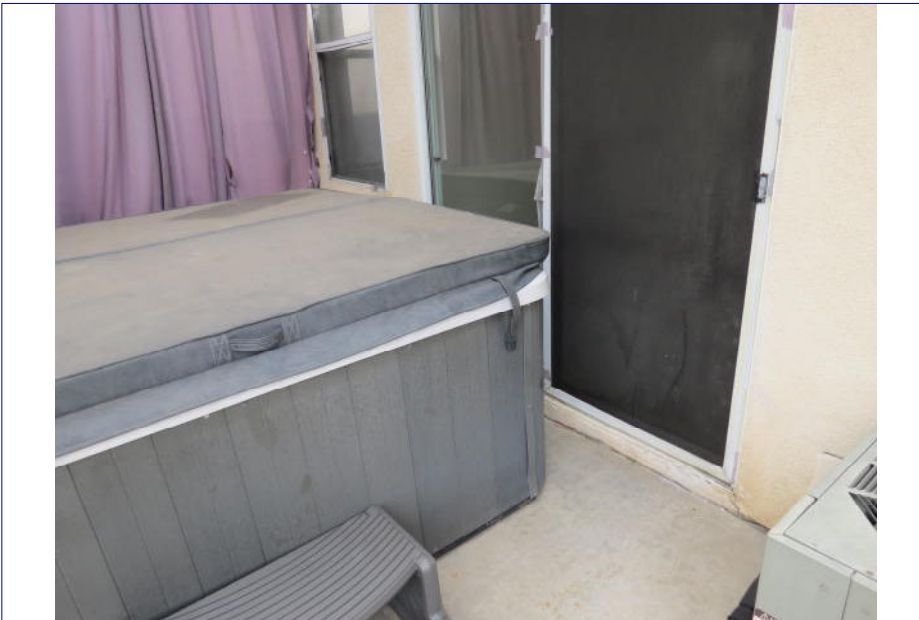
**Picture 32**

The hottub partially blocks egress from the primary bedroom exit. Consult with a licensed contractor for appropriate correction.

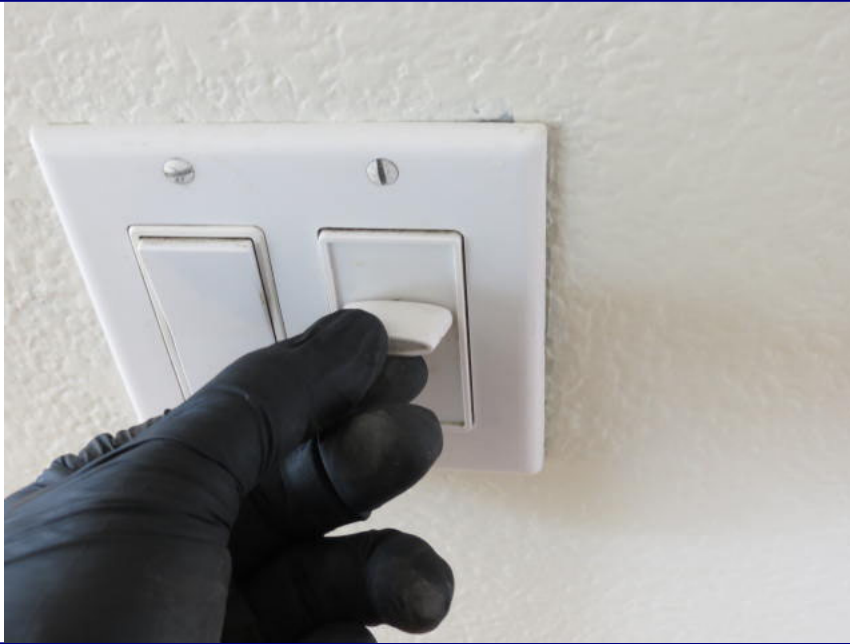
**Picture 3**

The dimmer switch (this photo) to the lights over the kitchen (lower photo) may not be compatible for the light bulbs installed. The lights were flickering then would shut off when the dimmer was fully on. Recommend further evaluation and correction by a licensed electrician.

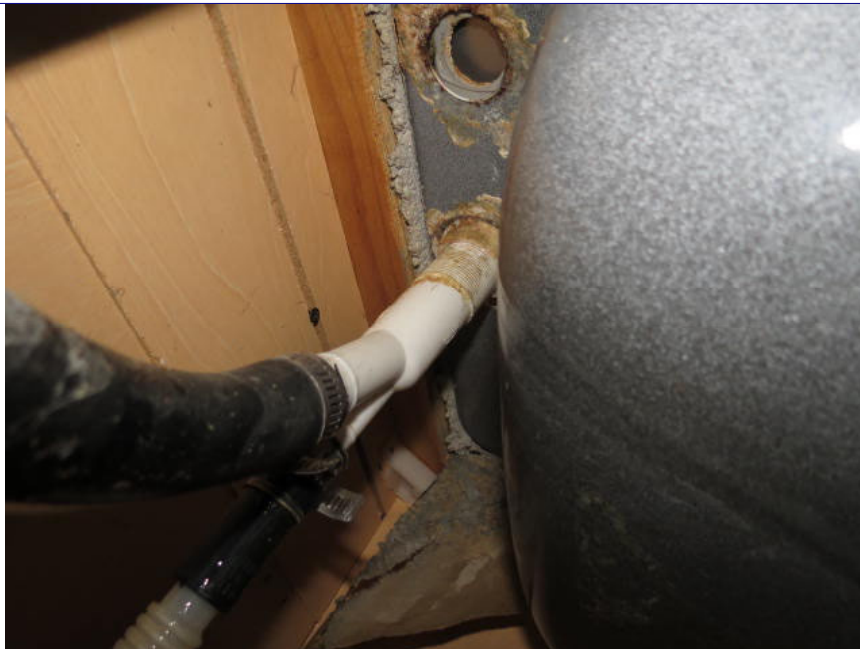
**Picture 16**

Leaks noted from the airgap device, a result of the water discharge noted above. Recommend further evaluation and correction by a licensed plumber.

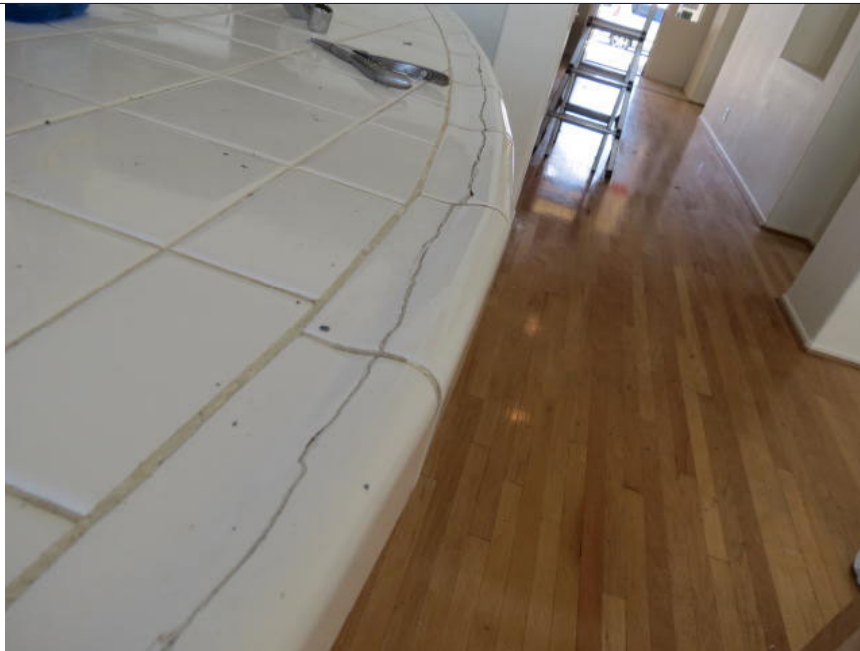
**Picture 20**

Crack noted running across the edge of the kitchen island tile. Consult with a tile professional for potential corrections.

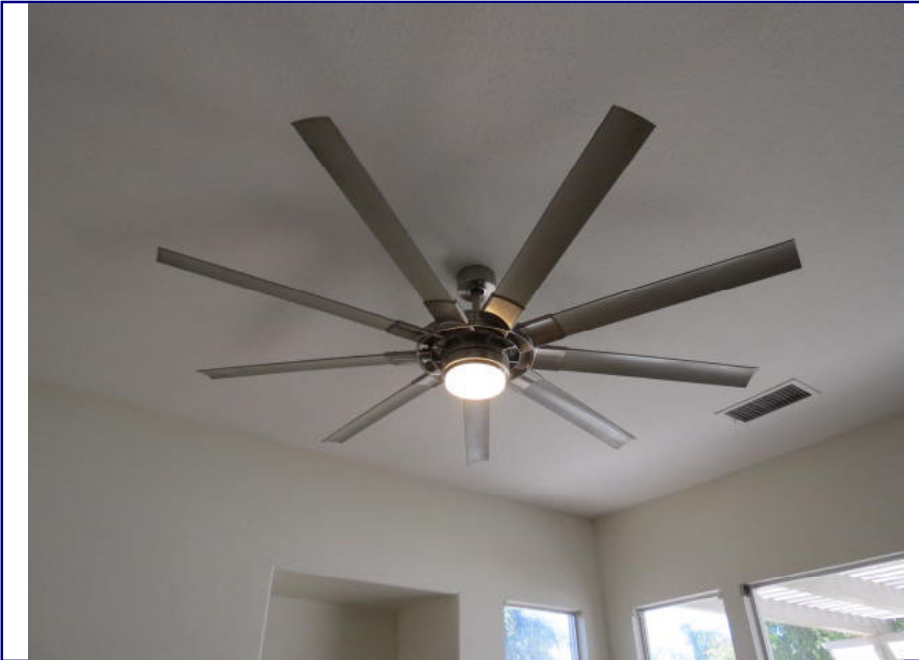
**Picture 1**

Unable to determine operation of the ceiling fan in the family room. The fan did not respond to the wall switch and there was no remote control located. Check with homeowner for proper operation or have evaluated by a licensed electrician.

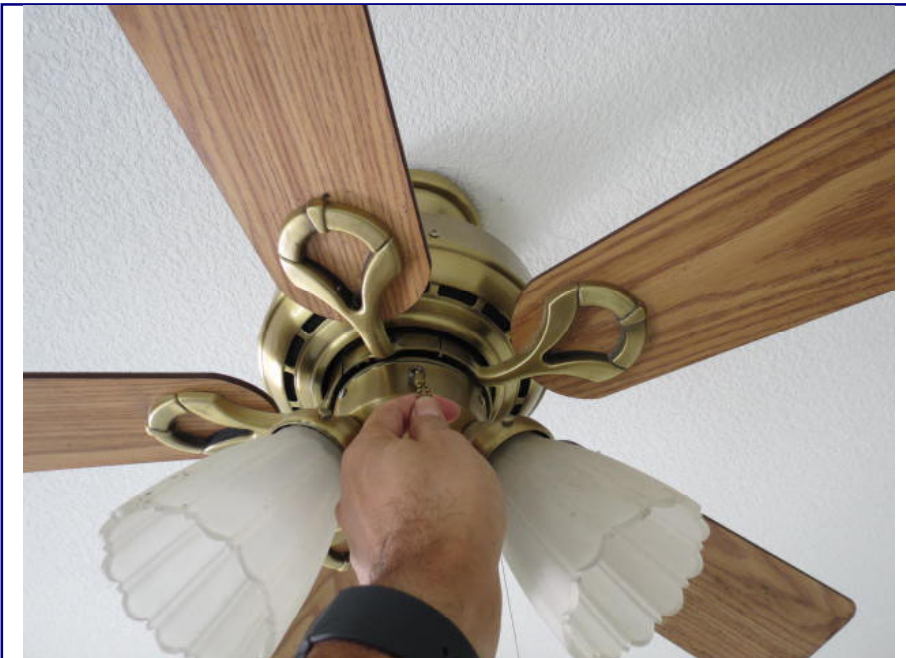
**Picture 2**

Unable to determine operation of the ceiling fan/light assembly in the primary bedroom. The unit did not respond to the wall switch nor the pull chains and there was no remote control located. Check with homeowner for proper operation or have evaluated by a licensed electrician.

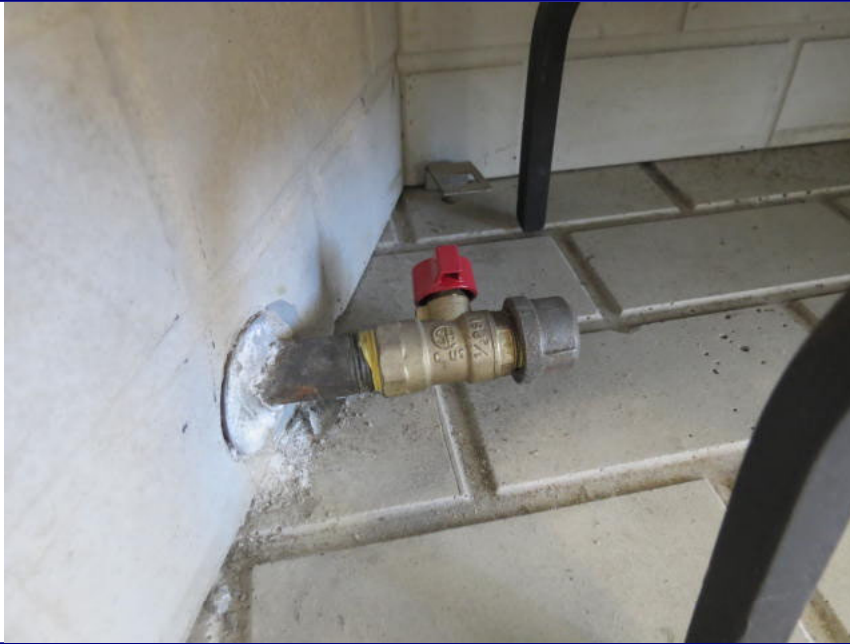
**Picture 3**

Secondary gas shut off valve noted inside the firebox of the living room fireplace. This is subject to damage and is not necessary, as there is a primary shut off outside the fireplace. Recommend further evaluation and correction by a fireplace professional.
