# Inspection Report

**Property Address:**  
6402 Seabryn  
Rancho Palos Verdes CA 90275

**Home Inspection Detection Services**

<b>Date:</b> 3/26/2025	<b>Time:</b> 11:00 AM	<b>Report ID:</b> KI032625-116-116
<b>Property:</b> 6402 Seabryn Rancho Palos Verdes CA 90275	<b>Customer:</b> Carol Manligas-Kishler Kevin Kishler	<b>Real Estate Professional:</b> Steve Gutierrez-Kovner John Hart Real Estate

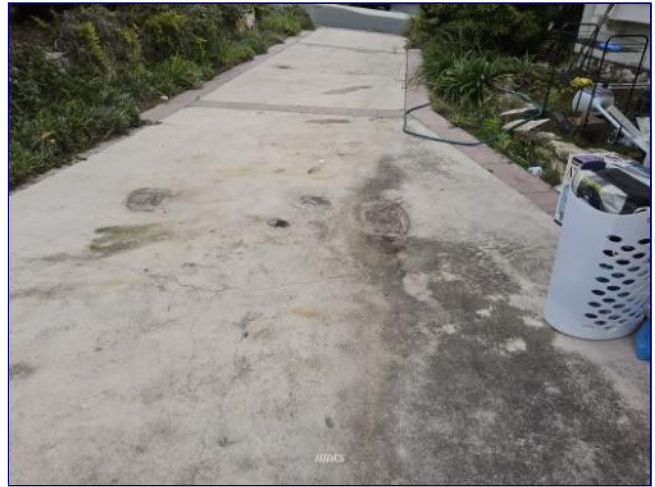
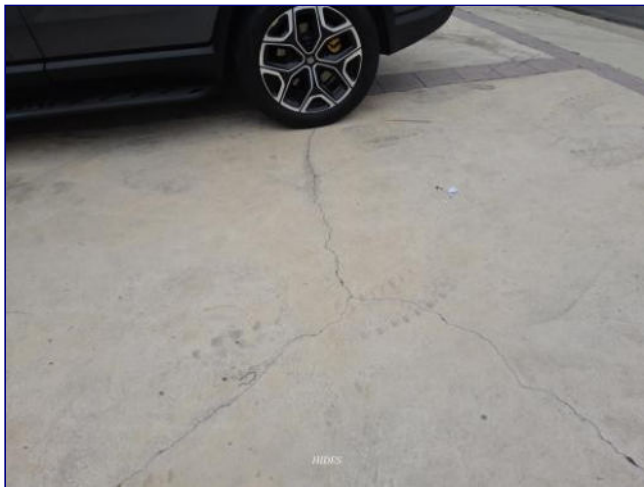
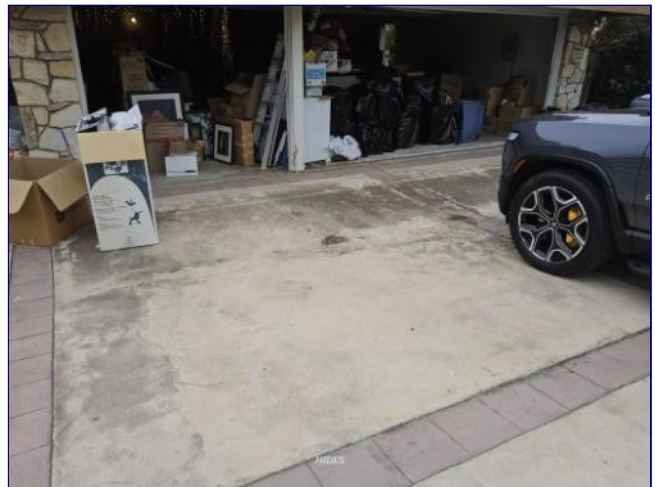
Moderate to large size cracks were noted to the driveway. Regular maintenance and or inspection is advised. Driveway show evidence of inadequate drainage and or ponding. Regular maintenance and or inspection is advised. Driveway appears to be sloped towards the home / garage. Further evaluation is recommended by a licensed general contractor.

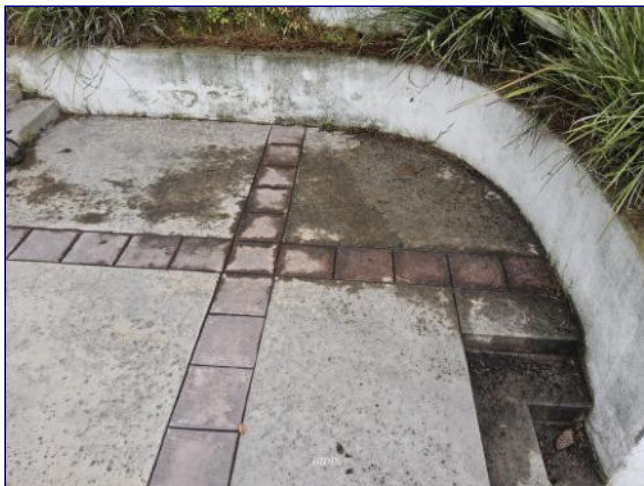
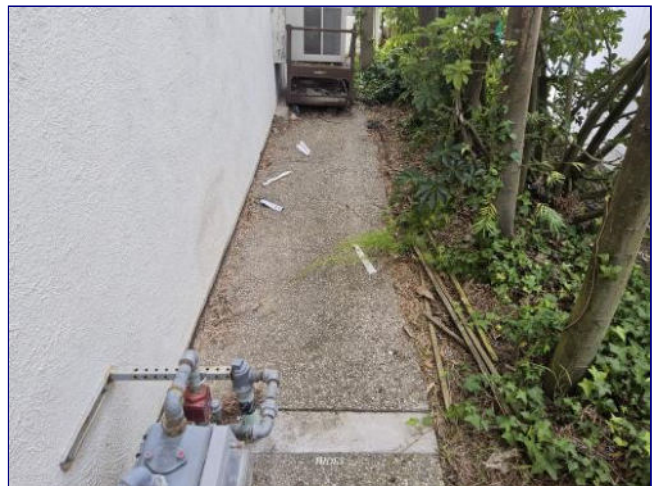
Common to moderate cracks as well as evidence of ponding and or inadequate drainage was noted to the sidewalks. Regular maintenance and or inspection is advised. Uneven areas were noted to the sidewalks. Regular maintenance and or inspection is advised. Trip hazards were noted to the sidewalks. This is a safety hazard and correction is needed. Further evaluation is recommended by a licensed general contractor.

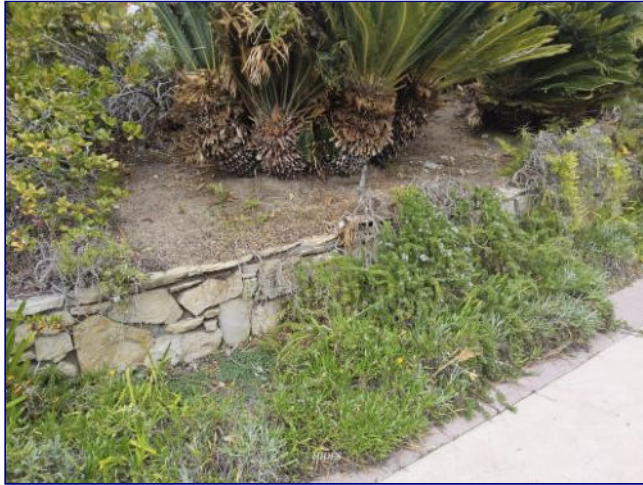
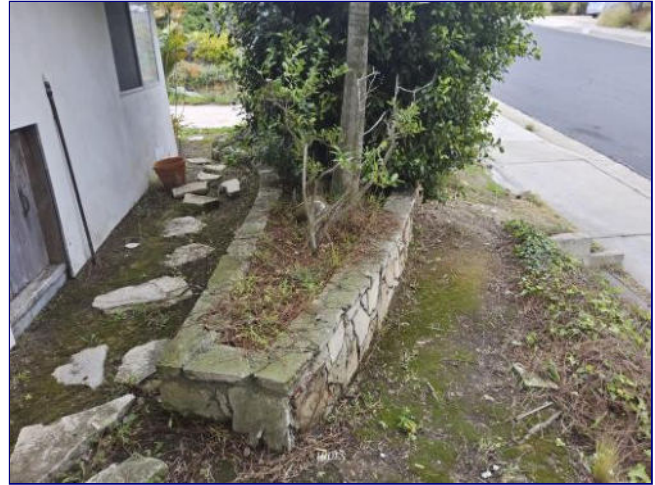
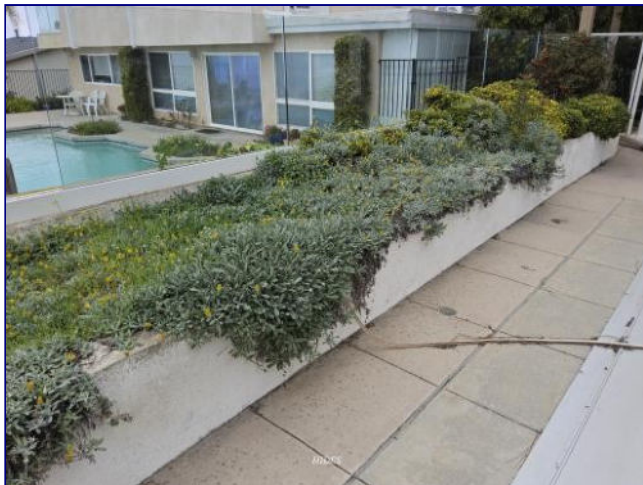
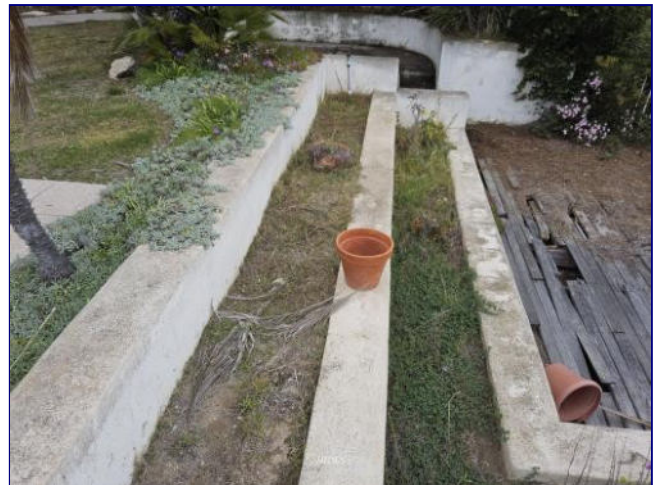
- 🔧 No evidence of drainage openings were noted to the retaining walls. Regular maintenance and or inspection is advised. Evidence of moisture penetration was noted to the retaining walls. Regular maintenance and or inspection is advised. Evidence of movement / displacement was noted to the retaining walls. Further evaluation is recommended by a licensed general contractor or landscaper.

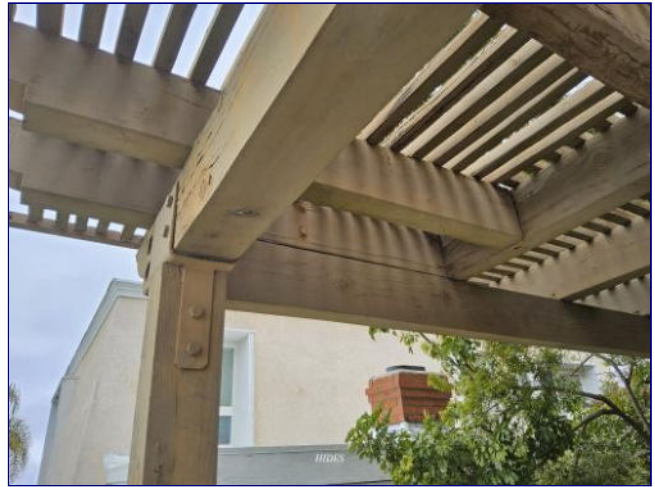
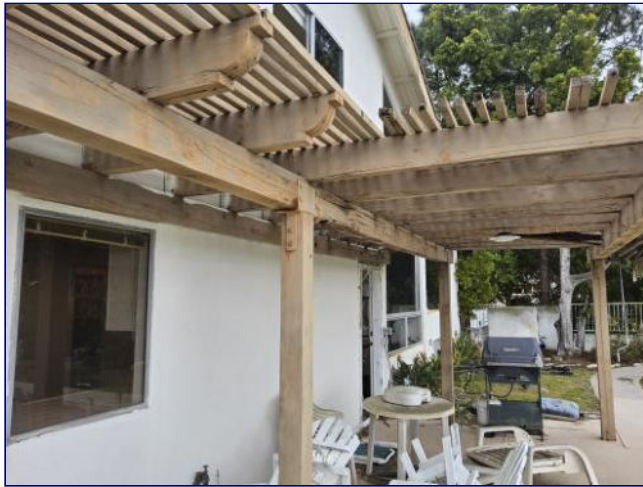
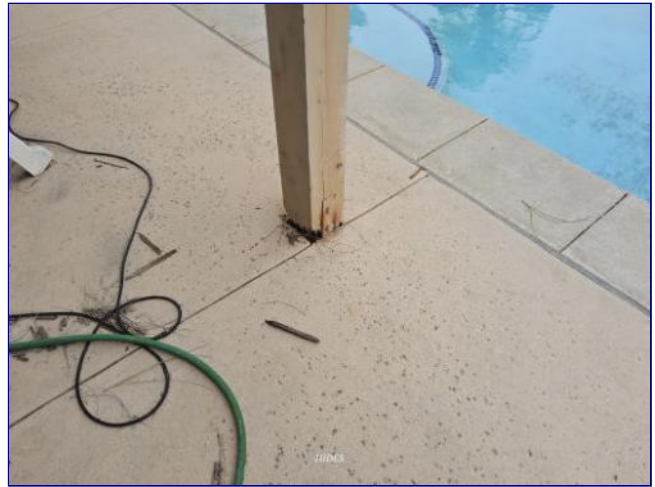
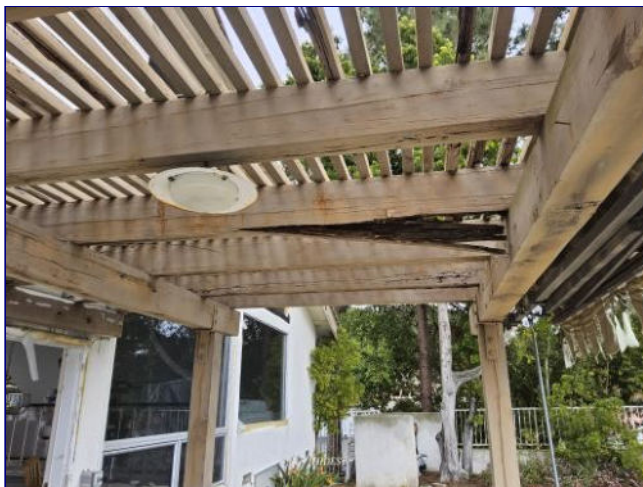
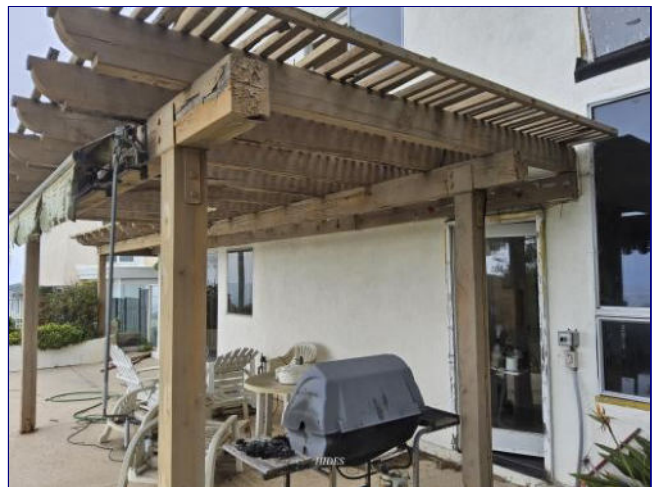
- 🔧 Substandard / non professional installation, support methods used along with heavy moisture stains were noted to the patio area structure. Further evaluation, consultation, and inspect, is recommended by a licensed general contractor. Extensive moisture damage and dry rot was noted to the open design patio covers. Further evaluation, consultation, and inspection, is highly recommended by a licensed pest control / termite company and or licensed general contractor.

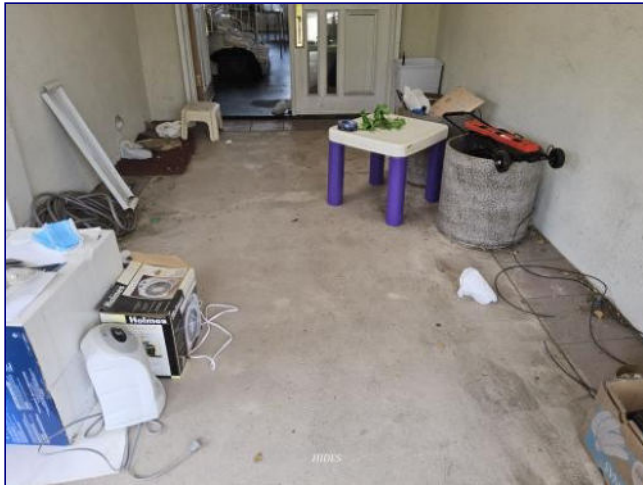
1.5 Item 1(Picture)

Common cracks were noted to the patio and or porch area. Regular maintenance and or inspection is advised.

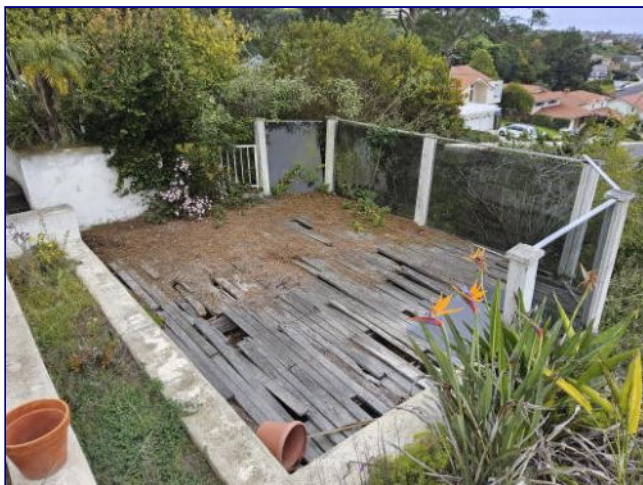
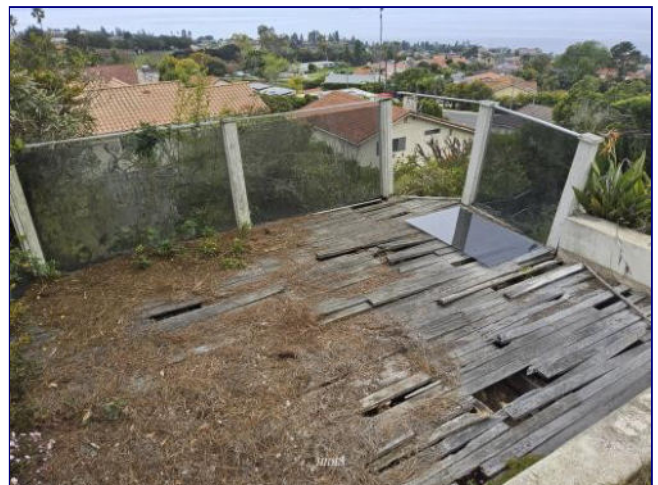
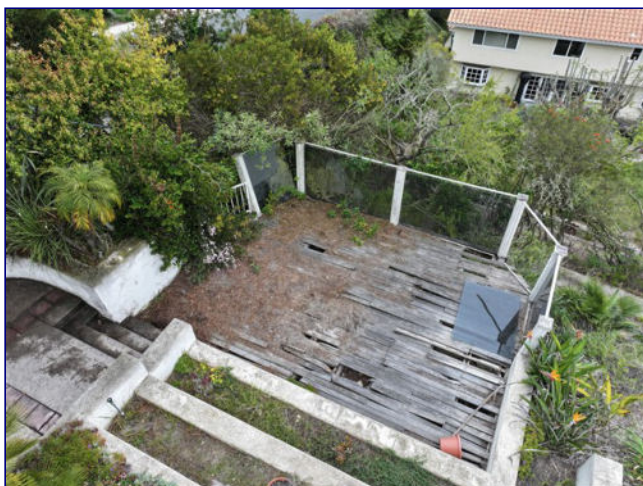
🔨 Deck has major moisture damage, major dry rot and or termite damage, is not structurally sound and has damaged glass railings. Considering the location of the deck, its damage, and the lack of structural integrity, this is an extreme safety hazard. Deck should not be walked on. Immediate attention is needed. Further evaluation, consultation, and inspection, is highly recommended by a licensed general contractor, structural engineer, and possibly a geo-technical contractor.

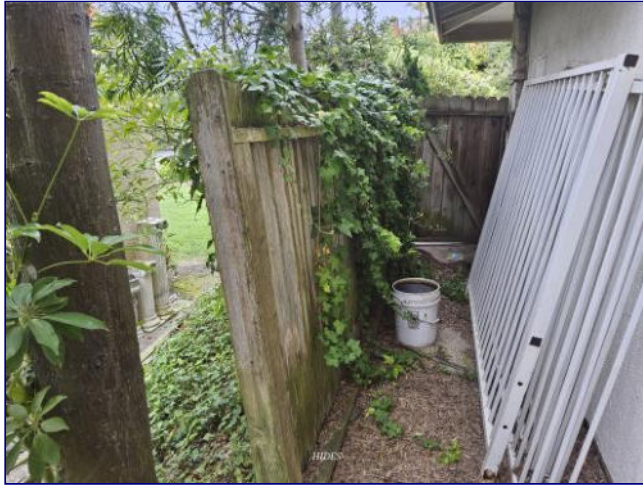
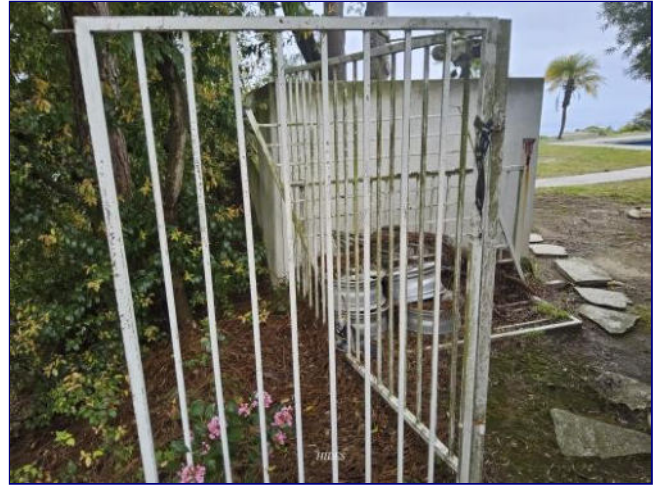
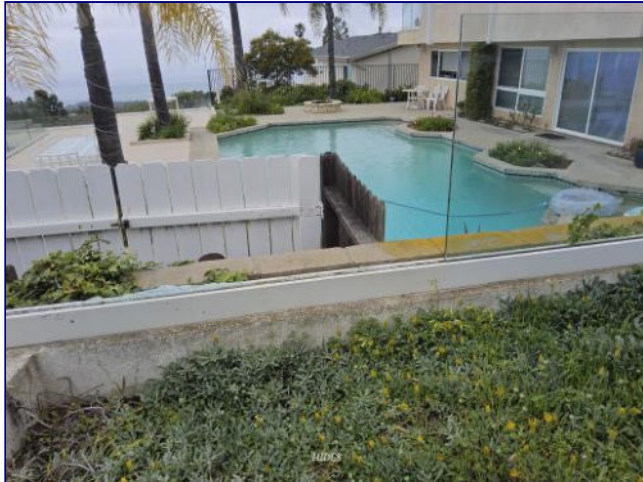
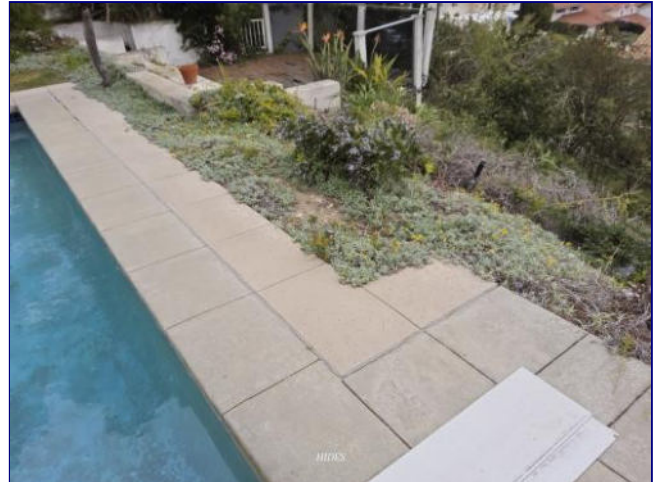
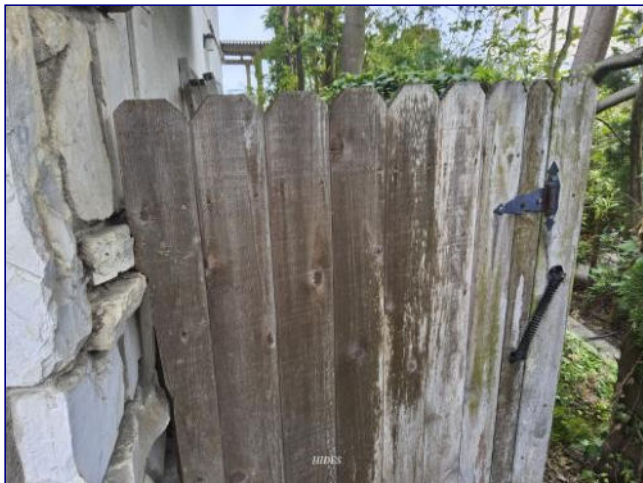
🔧 Perimeter fencing and gates are worn, rusted, deteriorated. Also, gates leading to the pool area are in need of self closing device and or device is not functional. The self closing device issue is a safety hazard. Further evaluation, consultation, and inspection, is highly recommended by a licensed gate installation company / contractor.

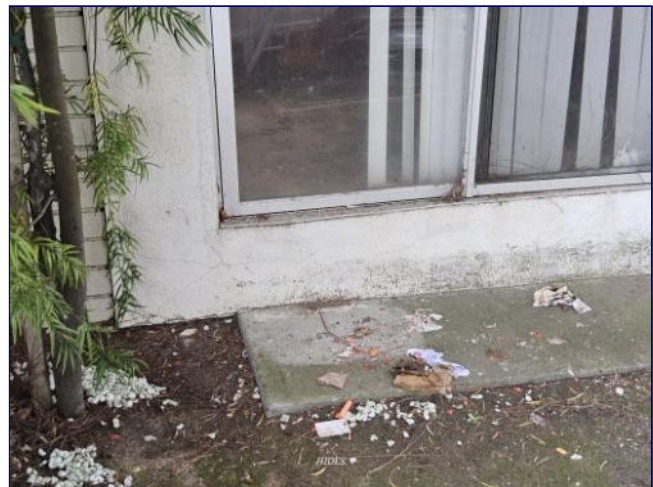
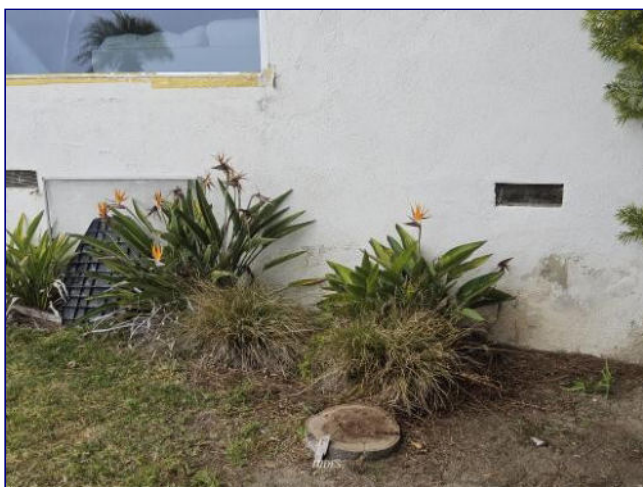
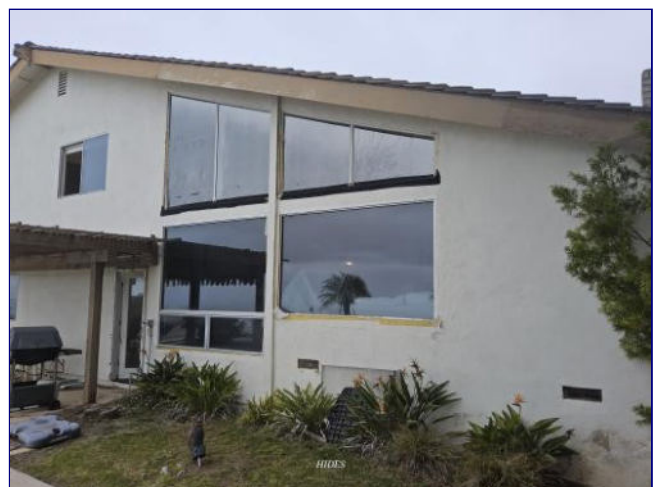
- Moderate cracks were noted to the exterior walls. Regular maintenance and or inspection is advised. Large size cracks were noted to the exterior walls. Regular maintenance and or inspection is advised. Stucco to the exterior walls is worn / deteriorated. Regular maintenance and or inspection is advised. Moisture stains were noted to the exterior walls. Although stains are dry, regular maintenance and or inspection is advised. Holes, openings, and or exposed framing was noted to the exterior walls. These holes, openings, and or exposed framing areas must be sealed / patched to help eliminate any moisture intrusion and or penetration. Further evaluation is recommended by a licensed general contractor.

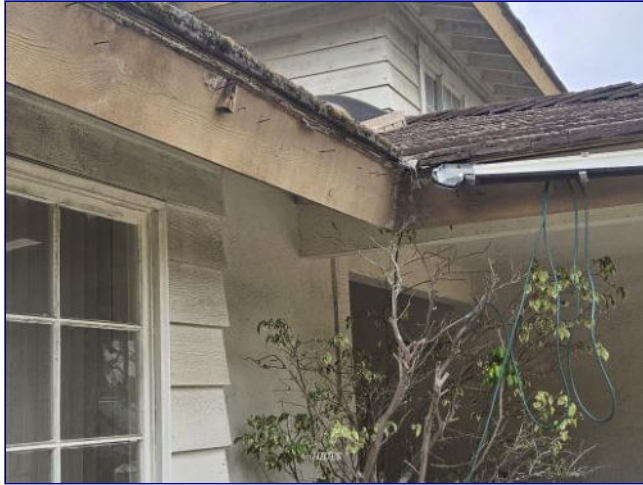
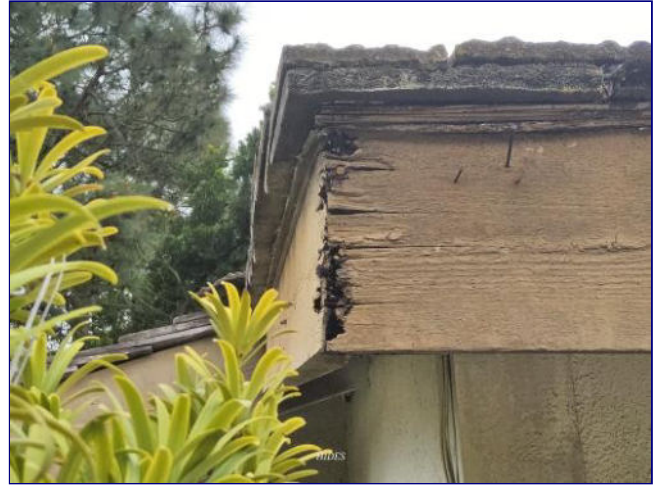
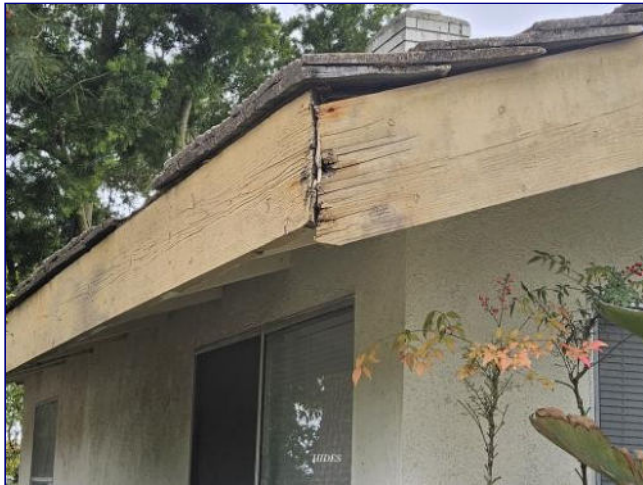
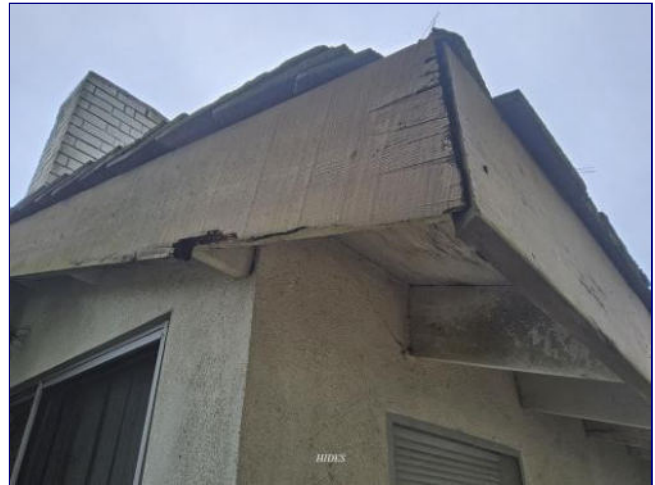
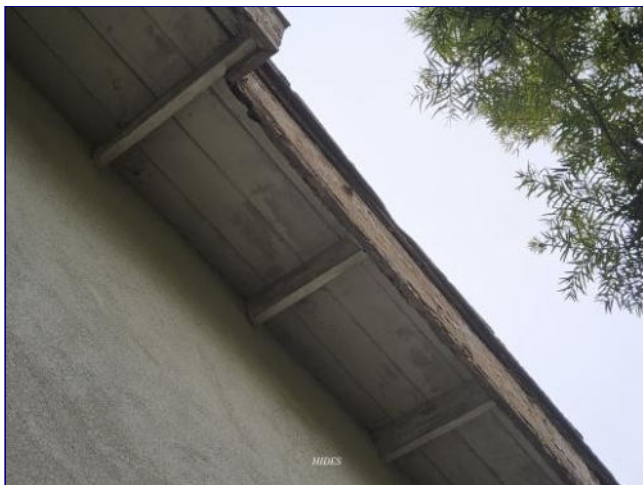
- Moisture stains were noted to the exterior trim at various locations. Regular maintenance and or inspection is advised. Wear / deterioration was noted to the exterior trim at various locations. Regular maintenance and or inspection is advised. Extensive dry rot, moisture damage and or possible termite damage was noted to the exterior trim at various locations. Further evaluation is highly recommended by a pest control / termite company and or a licensed general contractor.

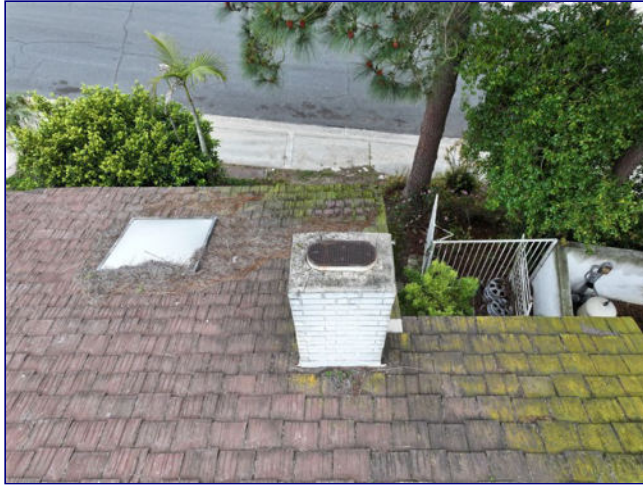
2.3 Item 1(Picture)

Spark screen was missing to the chimney. Correction is needed. Further evaluation is recommended by a licensed fireplace / chimney contractor. Raincap was missing to the chimney. Correction is recommended by a licensed fireplace / chimney contractor. Separation of flashing was noted at chimney to roof unions. Correction is recommended by a licensed fireplace / chimney contractor and or licensed roofer. Moderate cracks were noted to the chimney brick and or mortar. Correction is recommended by a licensed fireplace / chimney contractor and or licensed roofer.

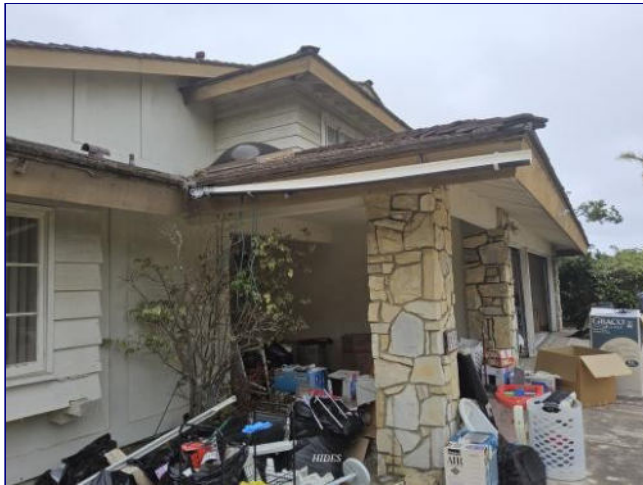
2.5 Item 1(Picture)

Downspout and or gutter was damaged. Correction is recommended by a licensed gutter / downspout contractor.

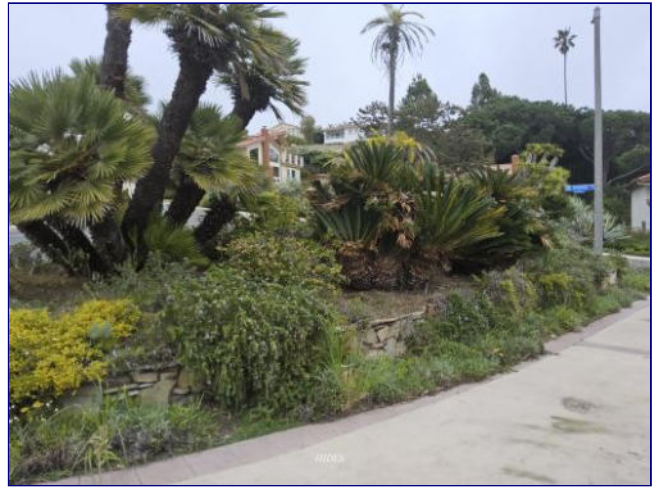
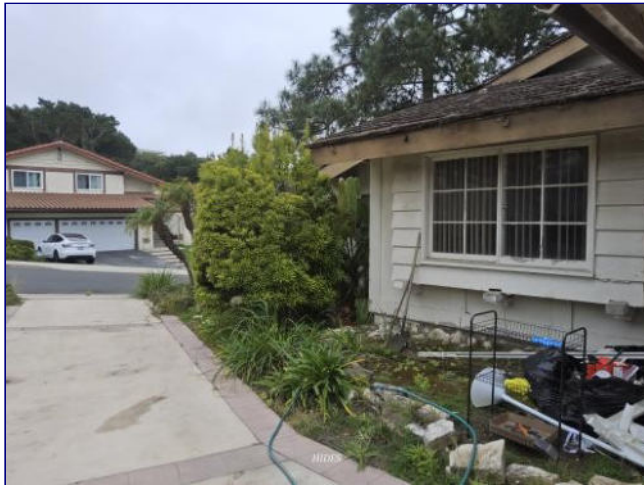
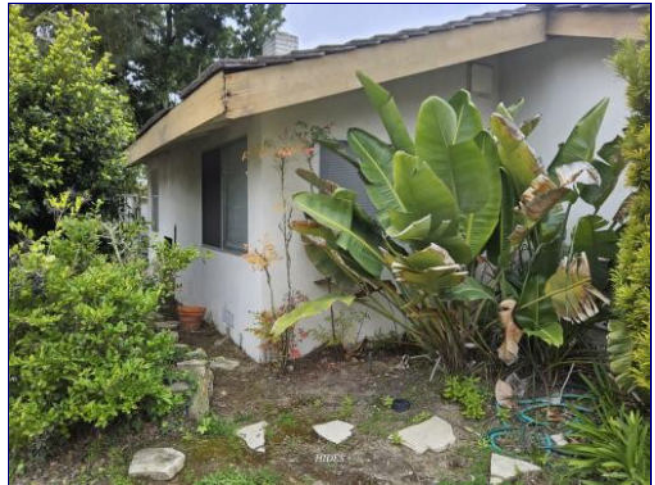
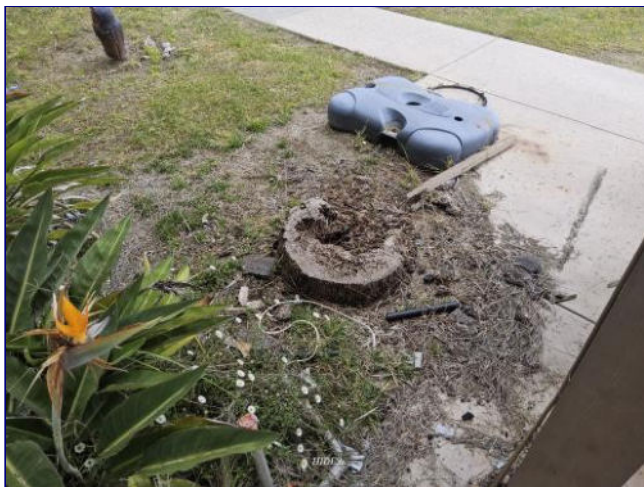
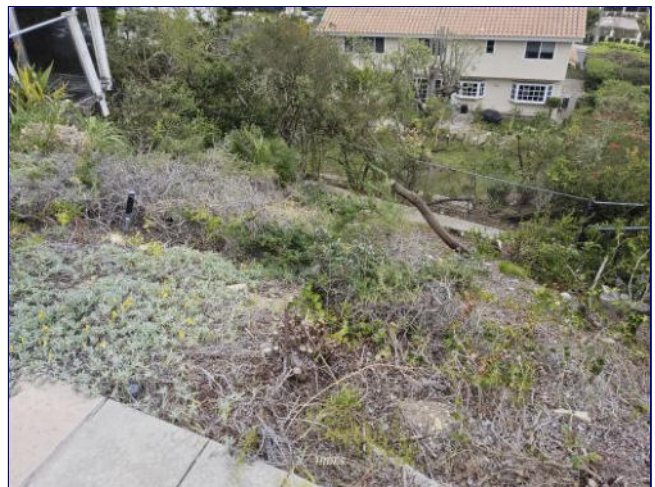
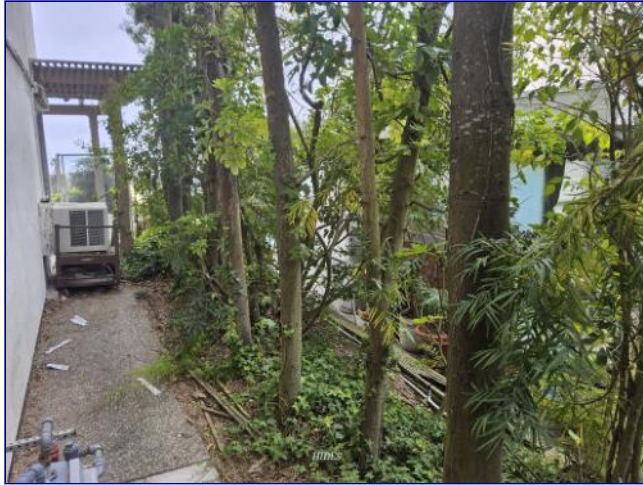
Large size trees and or tree trunks were planted on the property. Regular maintenance and or inspection is advised as large size trees can pose issues with various aspects of construction. The tree limbs that are in contact with the roof or hanging near roof should be trimmed. Overgrown vegetation was noted. Removal of overgrown vegetation is recommended as this can pose issues with various aspects of construction. Evidence of inadequate drainage / ponding was noted around the perimeter of the home near foundation. Regular maintenance and or inspection is advised. Due to the overgrown vegetation, many perimeter block walls were not visible for inspection. Use caution High soil level was noted at exterior walls at various perimeter locations. Regular maintenance and or inspection is advised.

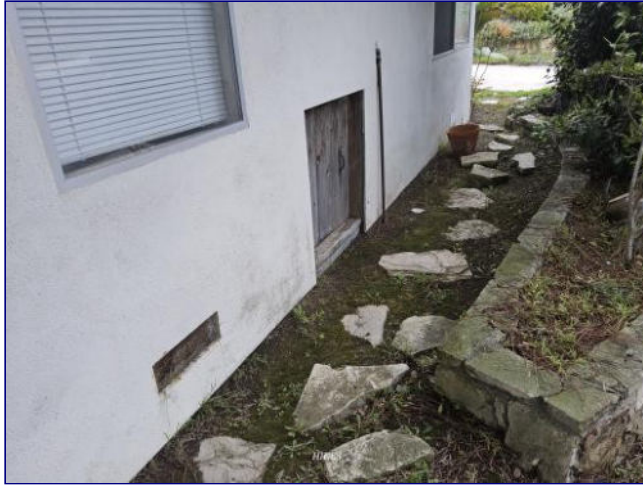
3.2 Item 1(Picture)

A portion of the raised foundation was not accessible due to the installation of indoor spa at the left side of the home. Raised foundation portion inspection is limited. The other access point inside the home (downstairs office area) to the raised foundation shows evidence of possible moisture intrusion and or penetration along with inadequate ventilation. Further evaluation, consultation, and inspection, is highly recommended by a licensed general contractor.

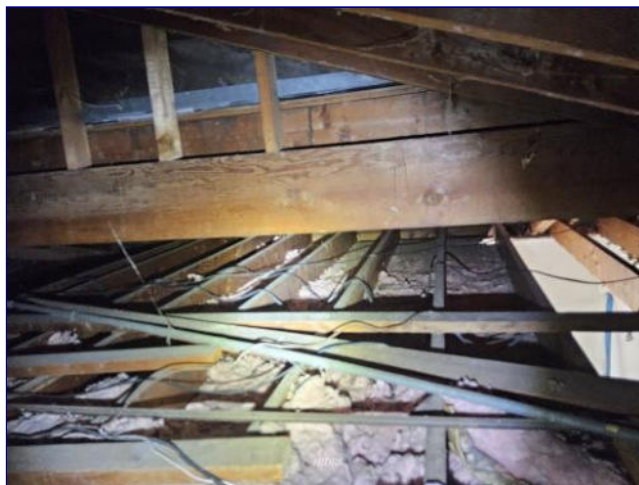
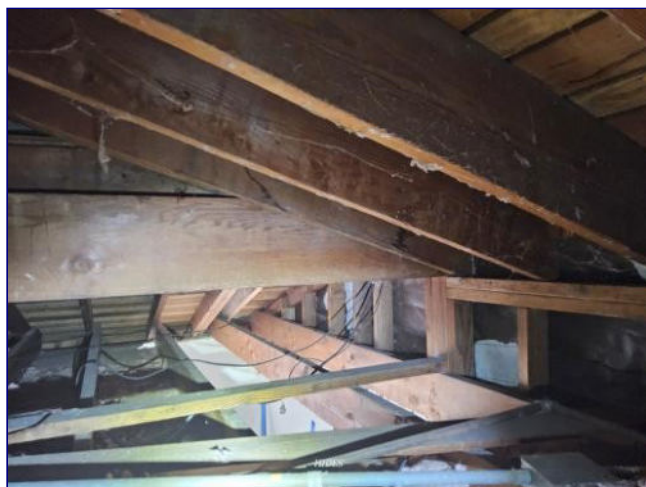
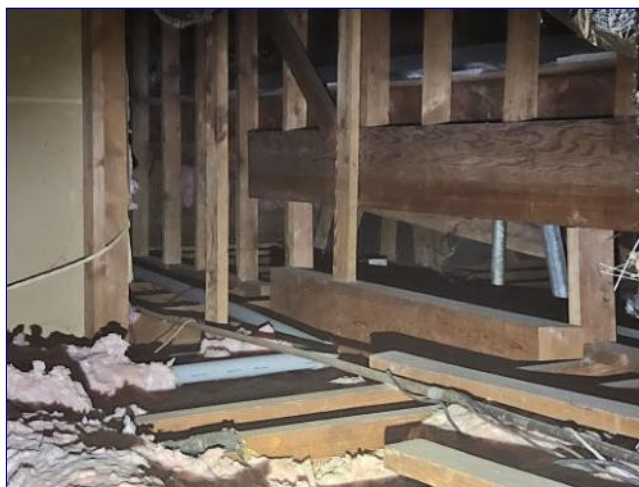
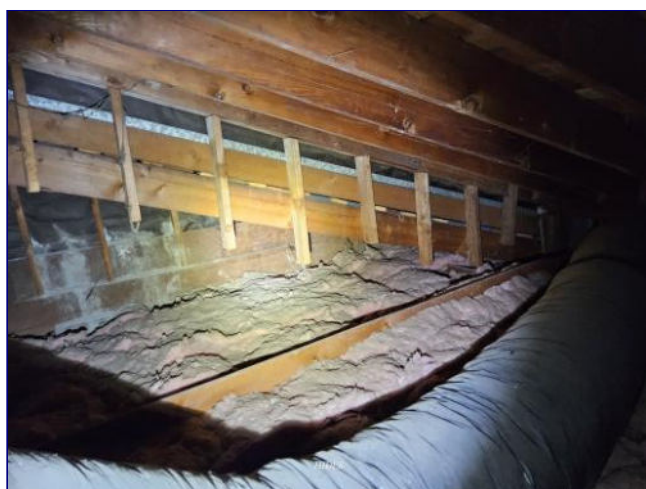
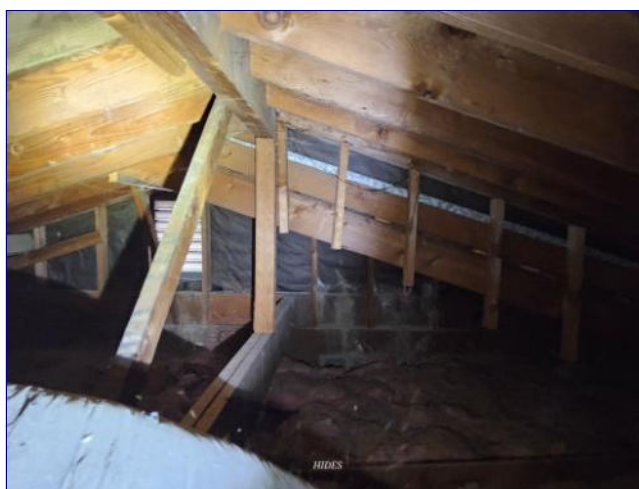
Moisture stains were noted in the attic area at various locations. Although stains are dry, regular maintenance and or inspection is advised. Evidence of possible rodent droppings were noted all throughout the attic area. Further evaluation is recommended by a licensed pest control company. Attic access hatch remains partially open is damaged / defective. Correction is needed. Further evaluation is recommended by a licensed drywall contractor. Asbestos type materials was installed in the attic. Further evaluation is recommended by a licensed general contractor. Poor insulation coverage was noted in the attic. Further evaluation is recommended by a licensed general contractor.

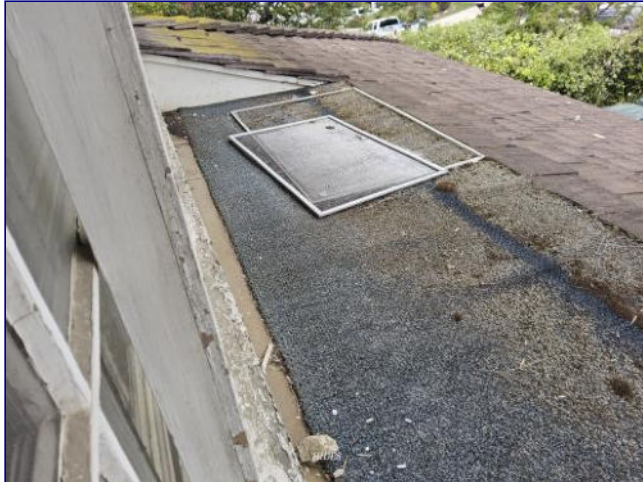
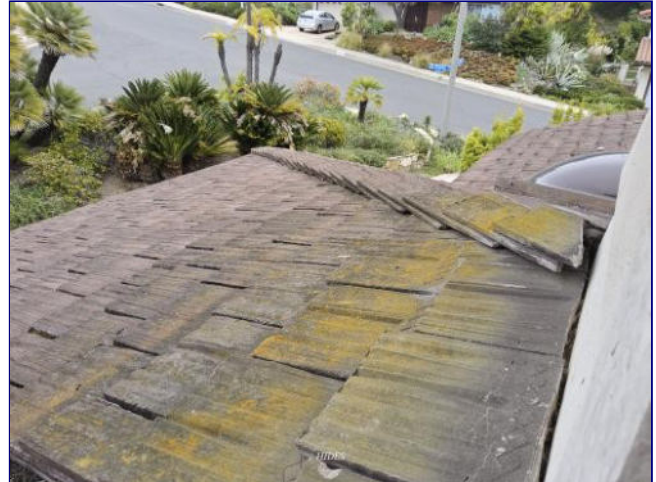
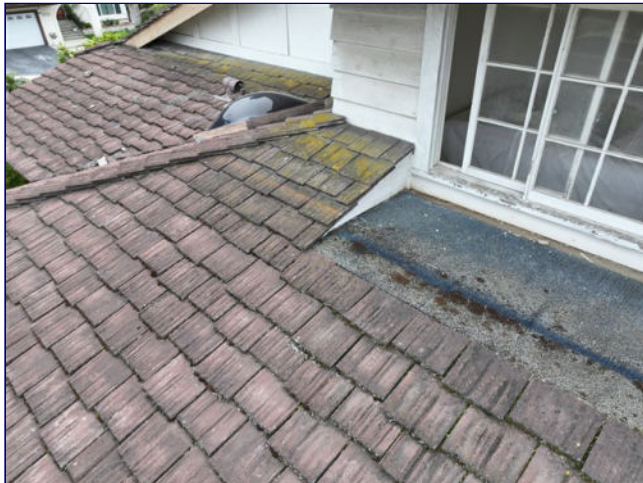
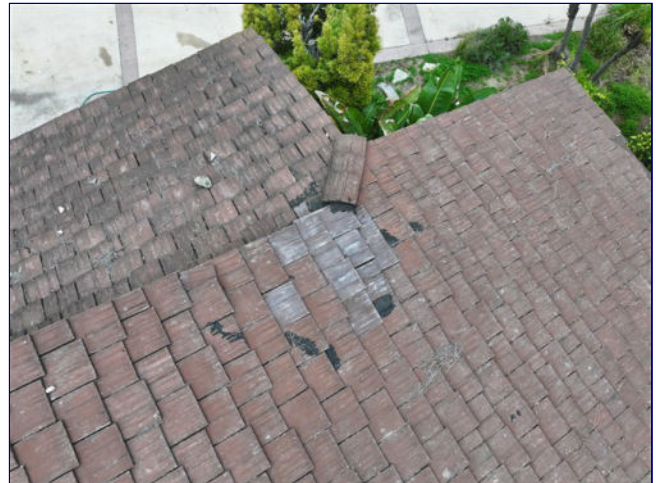
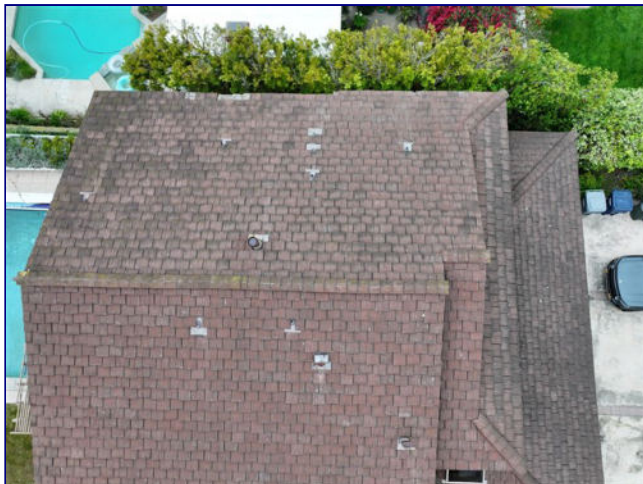
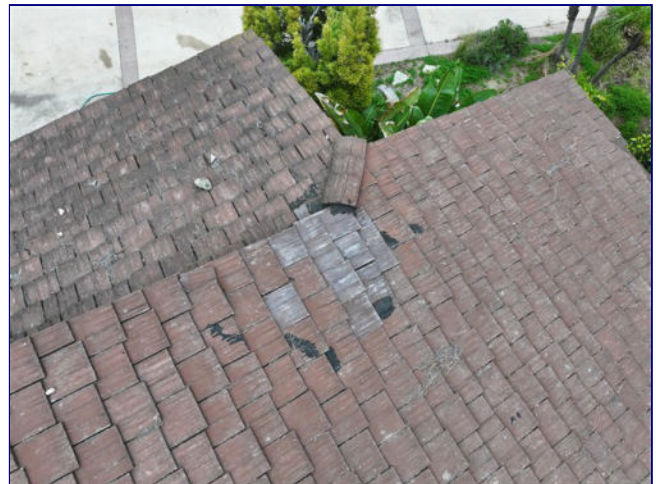
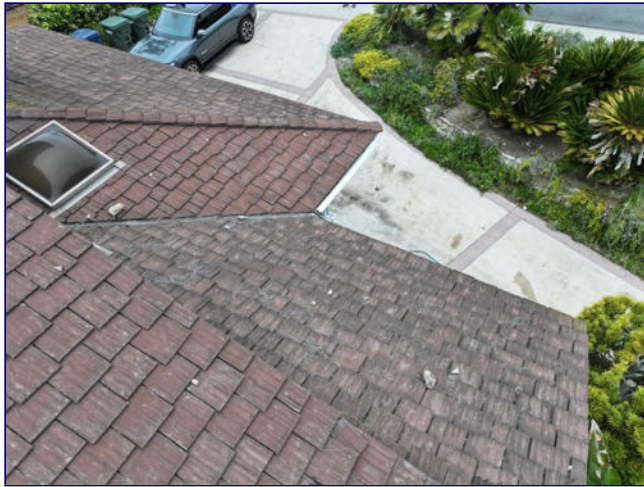
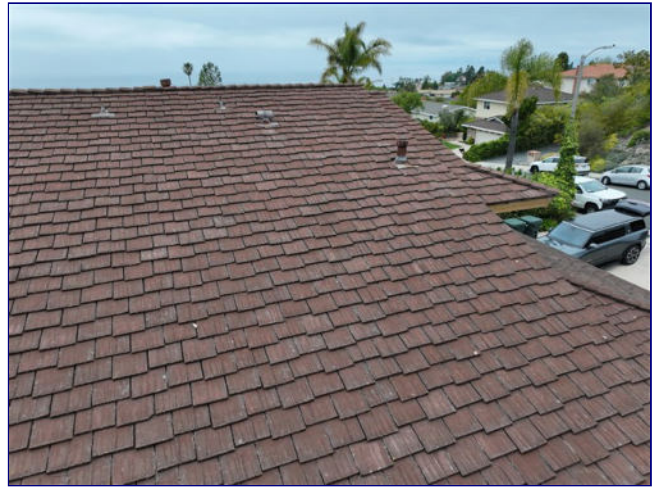
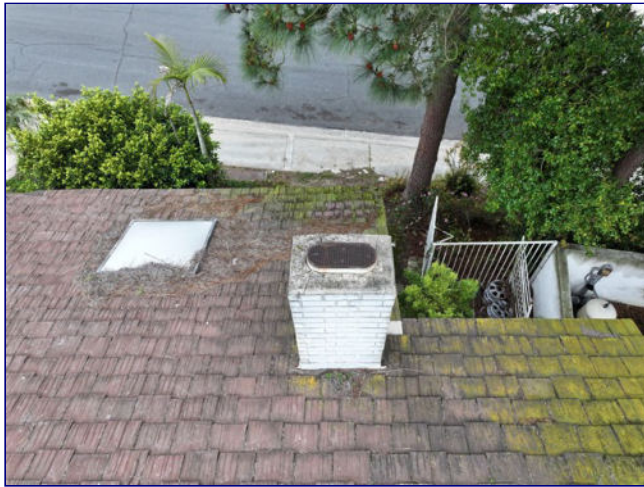
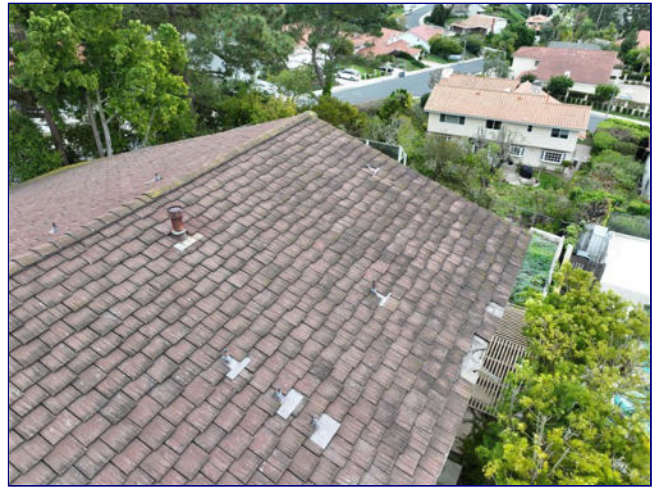
- The roofing system is in a heavily worn / deteriorated condition, and quite simply is approaching the end of its lifespan with improper installation of flashing, rusted flashing, cracked tiles, loose tiles,

dislodged tiles, and no roof underlayment noted. Further evaluation, consultation, and inspection, is highly recommended by a licensed roofer.

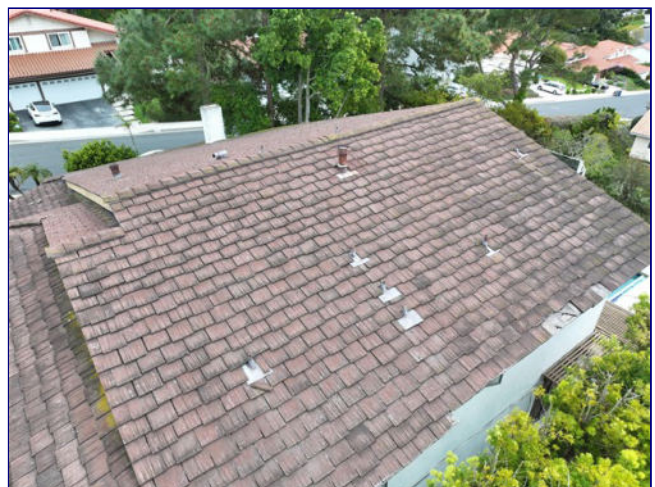
4.1 Item 2(Picture)

The roofing system is in a heavily worn / deteriorated condition, and quite simply is approaching the end of its lifespan with improper installation of flashing, rusted flashing, cracked tiles, loose tiles, dislodged tiles, and no roof underlayment noted. Further evaluation, consultation, and inspection, is highly recommended by a licensed roofer.

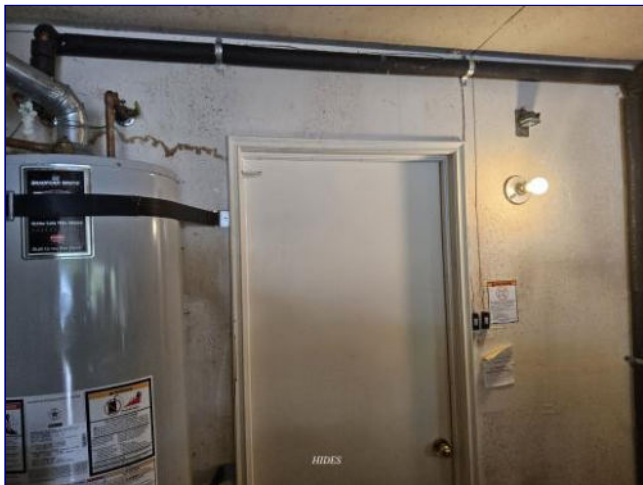
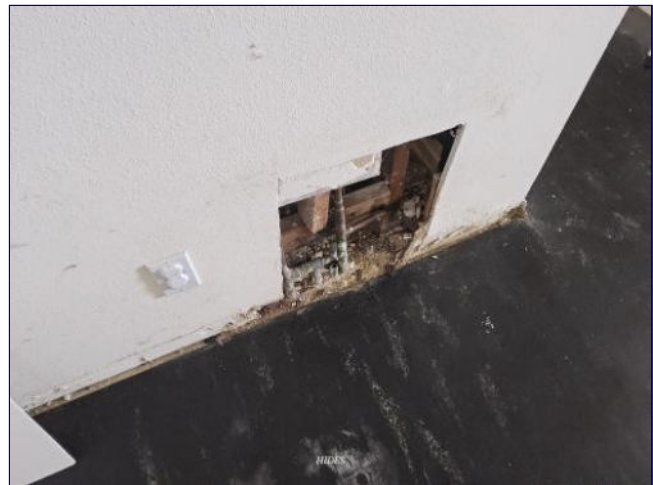
- Please note that the supply lines have moderate major restriction of water pressure and or volume primarily when using multiple fixtures. Further evaluation, consultation, and inspection is highly recommended by a licensed plumber. Please note that the downstairs supply lines leading to the kitchen area and laundry room area have been capped / no water provided in this area, as told to the inspector by the client. As a result, supply lines and drain lines as well as components and systems related to the supply lines were unable to be inspected. Further evaluation, consultation, and inspection, is highly recommended by a licensed plumber. Substandard, non-professional installations and routing methods used was noted to the supply lines. Further evaluation is recommended by a licensed plumber. There is an active leak to the supply lines and or waste / drain lines st upstairs hallway bathroom resulting in the extensive moisture damage, mold like substance to the ceiling below at family room. Further evaluation, consultation, and inspection, is highly recommended by a licensed plumber for the leak issues and subsequent general contractor, drywall contractor, mold abatement company, and possibly a structural engineer.

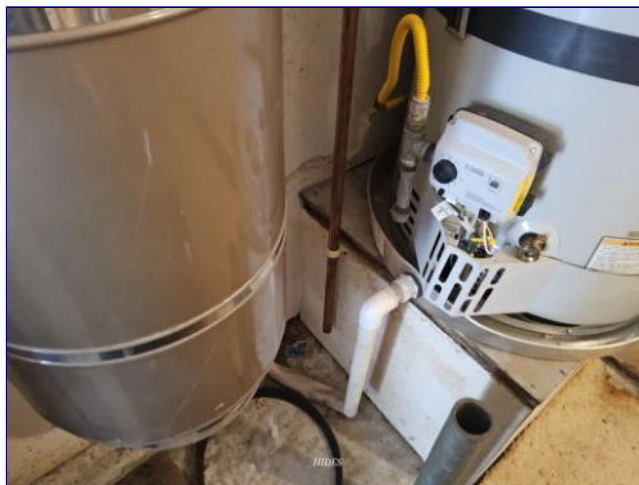
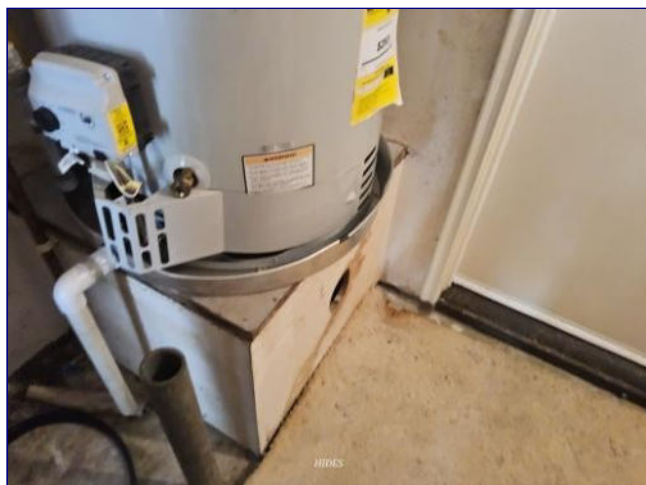
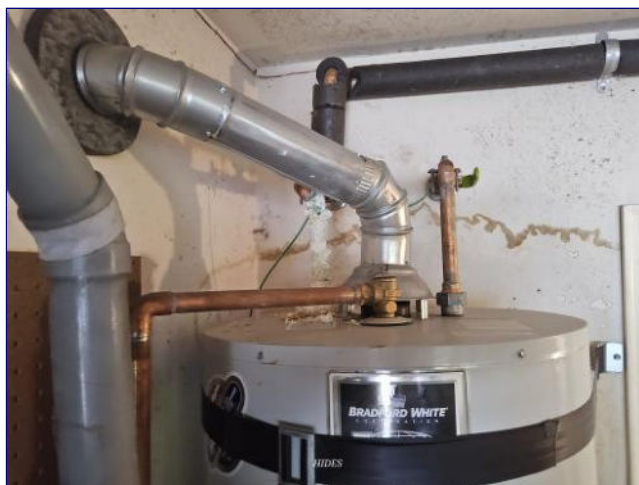
Please note that the supply lines have moderate major restriction of water pressure and or volume primarily when using multiple fixtures. Further evaluation, consultation, and inspection is highly recommended by a licensed plumber. Please note that the downstairs supply lines leading to the kitchen area have been capped / no water provided in this area, as told to the inspector by the client. As a result, supply lines and drain lines as well as components and systems related to the supply lines were unable to be inspected. Further evaluation, consultation, and inspection, is highly recommended by a licensed plumber. Substandard, non-professional installations and routing methods used was noted to the supply lines. Further evaluation is recommended by a licensed plumber. Improper installation of seismic straps, improper termination of TPR overflow pipe, and major corrosion to the outlet line and or connector, were all deficiencies noted to the water heater. Further evaluation, consultation, and inspection, is highly recommended by a licensed plumber. Please note that the water heater platform has a hole / opening and has been compromised and as a result, adjacent garage firewall has been compromised. This is a safety hazard and correction is needed. Further evaluation is recommended by a licensed general contractor and or licensed drywall contractor.

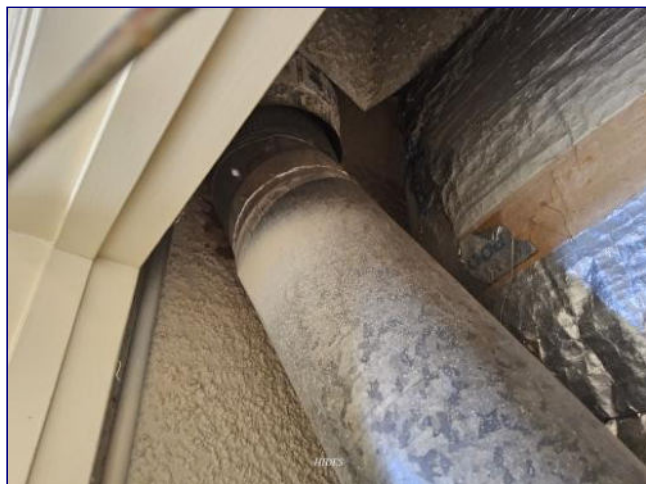
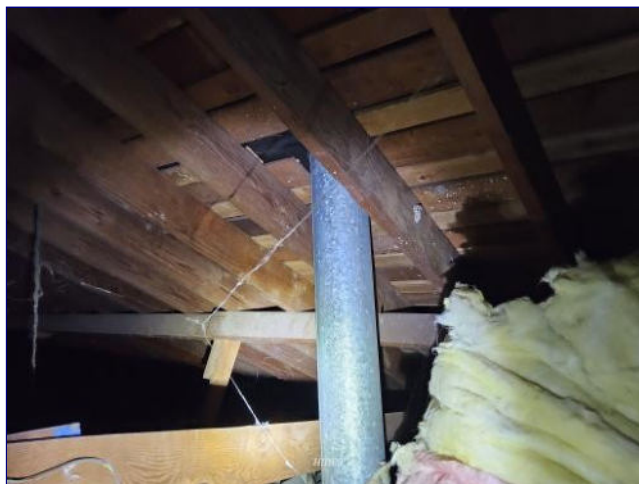
- 🔧 Heating system turns on and off sporadically, had detached vent at ceiling collar, vent is in contact with combustible material in the attic area, has low air volume to its distribution system (due to damaged and disconnected ducting in the attic). These deficiencies are safety hazards and correction is needed. Further evaluation, consultation, and inspection, is highly recommended by a licensed HVAC contractor.
