# Inspection Report

**Property Address:**  
6402 Seabryn  
Rancho Palos Verdes CA 90275

**Home Inspection Detection Services**

<b>Date:</b> 3/26/2025	<b>Time:</b> 11:00 AM	<b>Report ID:</b> KI032625-116-116
<b>Property:</b> 6402 Seabryn Rancho Palos Verdes CA 90275	<b>Customer:</b> Carol Manligas-Kishler Kevin Kishler	<b>Real Estate Professional:</b> Steve Gutierrez-Kovner John Hart Real Estate

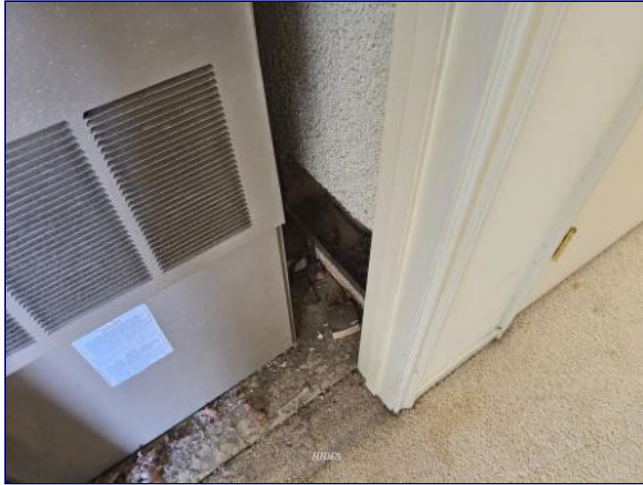
6.4 Item 1(Picture)

- 🔧 Heating system turns on and off sporadically, had detached vent at ceiling collar, vent is in contact with combustible material in the attic area, has low air volume to its distribution system (due to damaged and disconnected ducting in the attic). These deficiencies are safety hazards and correction is needed. Further evaluation, consultation, and inspection, is highly recommended by a licensed HVAC contractor. Combustion air supply are missing their respective screens inside the heating system enclosure. Correction is needed. Further evaluation is recommended by a licensed HVAC contractor.

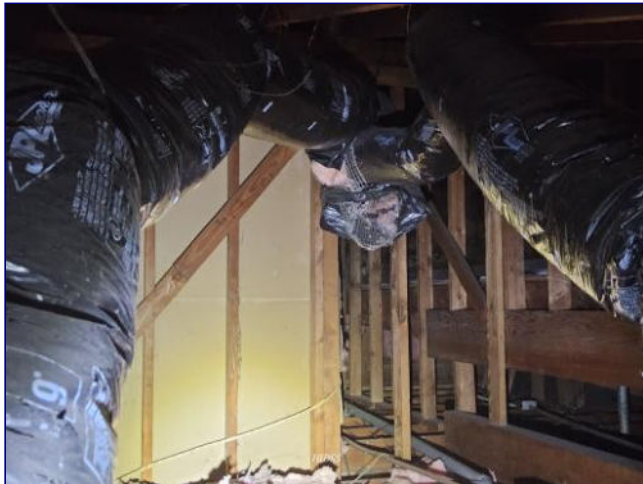
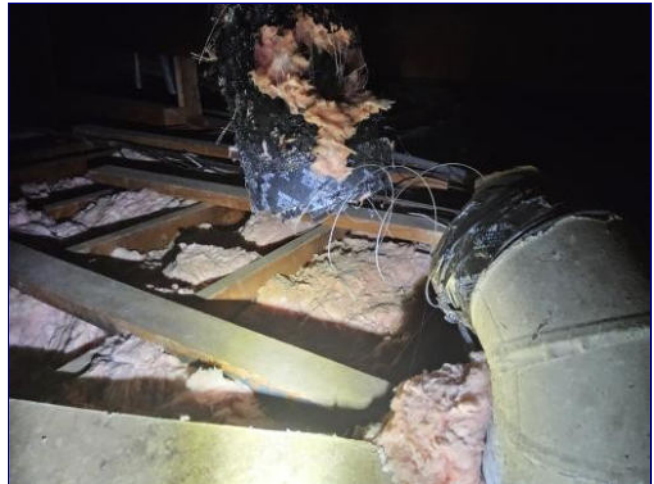
- 🔧 Heating system turns on and off sporadically, had detached vent at ceiling collar, vent is in contact with combustible material in the attic area, has low air volume to its distribution system (due to damaged and disconnected ducting in the attic). These deficiencies are safety hazards and correction is needed. Further evaluation, consultation, and inspection, is highly recommended by a licensed HVAC contractor.

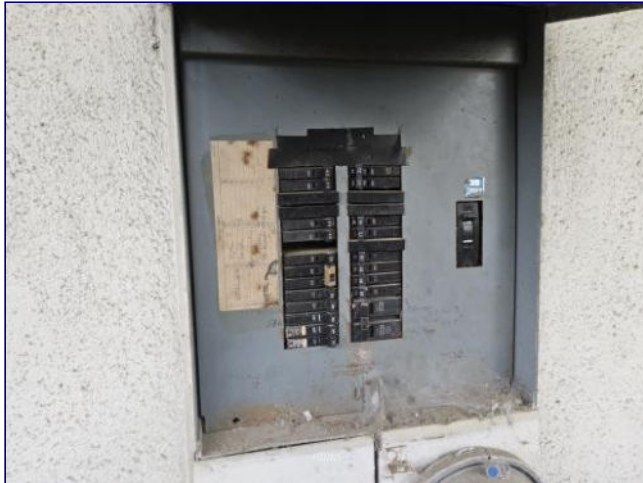
7.2 Item 1(Picture)

- 🔧 Main electrical panel has unprotected openings. Further evaluation, consultation, and inspection, is recommended by a licensed electrician. Breakers are not fully labeled for circuit designation. This is a safety hazards and correction is needed. Further evaluation, consultation, and inspection, is recommended by a licensed electrician. Improper wiring / two wires connected to a breaker was noted

to the main electrical panel. This is a safety hazard and correction is needed by a licensed electrician. The 125 amp main electrical may be undersized by today's electrical standards due to the size of the home as well as the pool installation. Further consultation is recommended by a electrician.

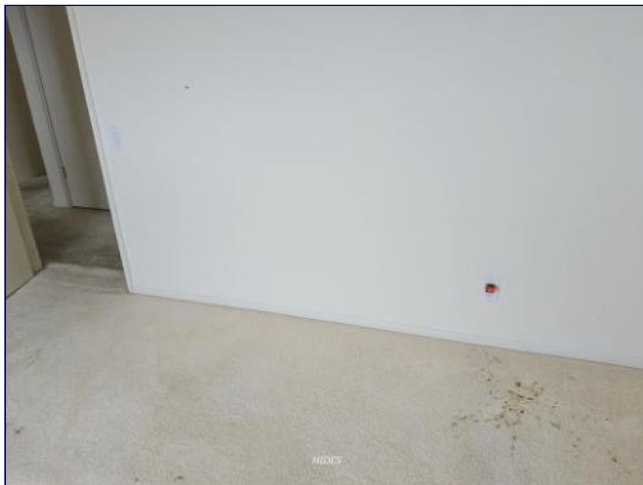
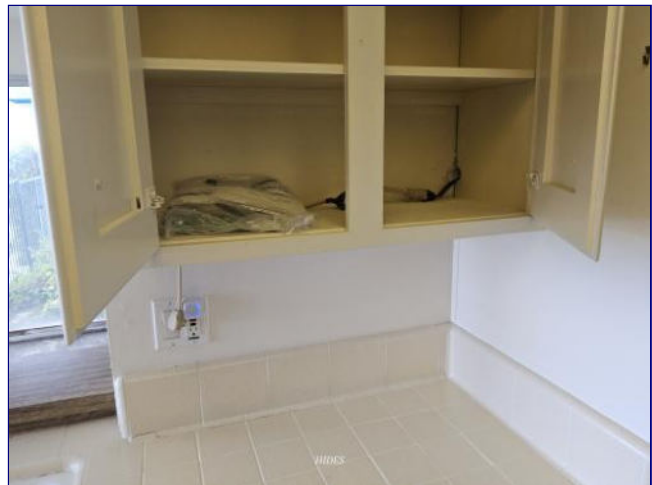
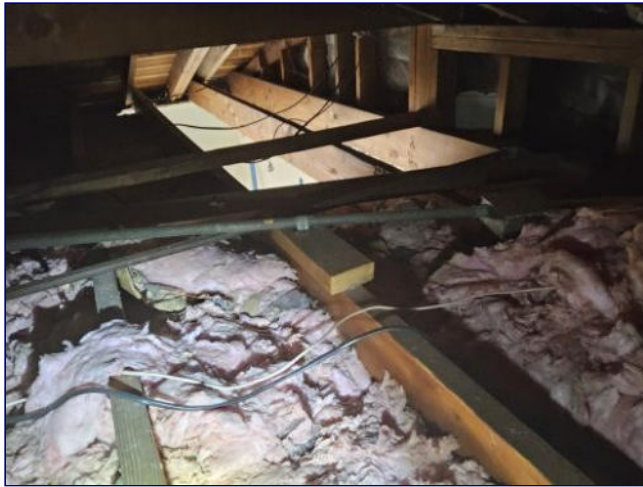
Wall switch powers / controls both the upper and lower receptacles at all bedrooms. Switch should on power / control lower receptacle. This is a wiring deficiency and correction is needed. Further evaluation is recommended by a licensed electrician. Improper wiring / splicing / extension cord use as permanent wiring, were all electrical deficiencies noted in the kitchen inside cabinetry. This is a safety hazard and correction is needed. Further evaluation is recommended by a licensed electrician.

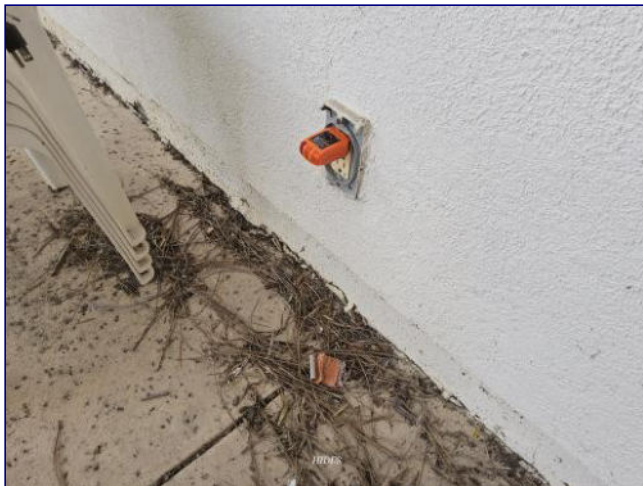
7.4 Item 1(Picture)

- Various exterior outlets were not grounded and GFCI not functional as well as missing exterior rated cover plates. These deficiencies are safety hazards and correction is needed. Further evaluation is recommended by a licensed electrician. Pool equipment GFCI is missing its exterior rated cover plates as well as various other outlets throughout the property. This is a safety hazard and correction is needed. Further evaluation is recommended by a licensed electrician.

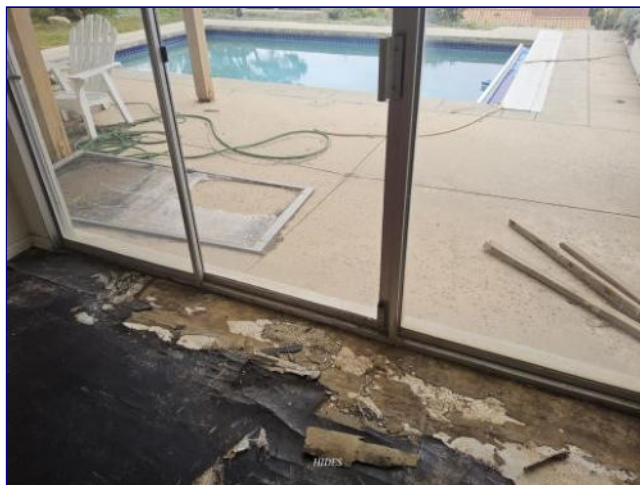
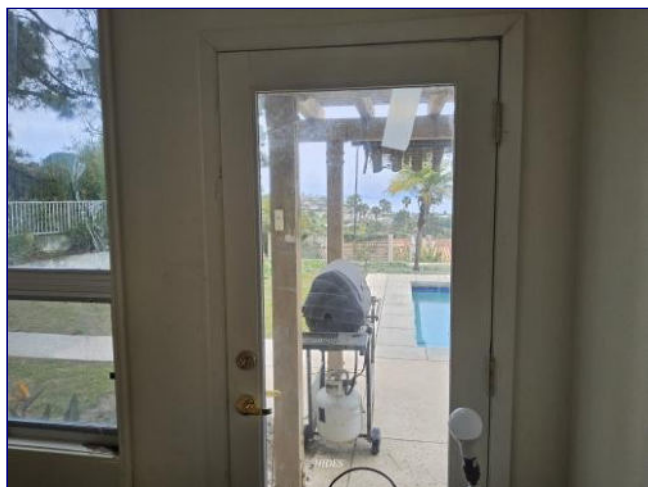
- Rear exterior sliding door does not have a landing. This is a safety hazard and correction is needed. Further evaluation is recommended by a licensed door contractor. All exterior sliding doors were difficult to operate, in need of adjustment / lubrication, have damaged or missing exterior sliding screen doors and do not appear to be tempered. Further evaluation, consultation, and inspection, is highly recommended by a licensed door contractor and or licensed general contractor. Please note that many interior doors had some sort of defect (missing hardware, non functional hardware, trim damage, door damage, doors not square to frame). Further evaluation, consultation, and inspection, is highly recommended by a licensed door contractor.

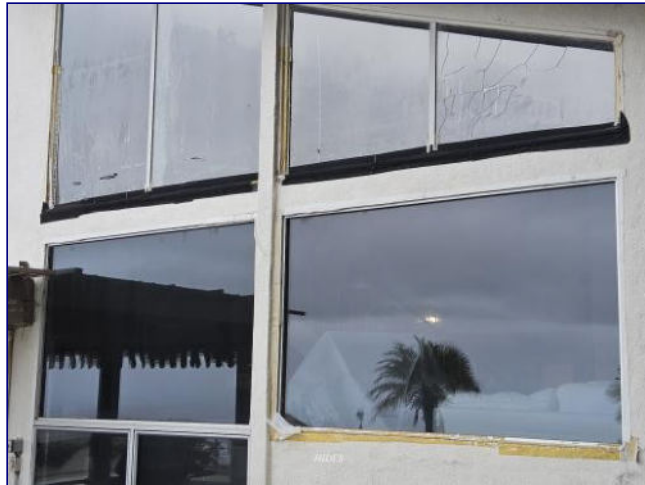
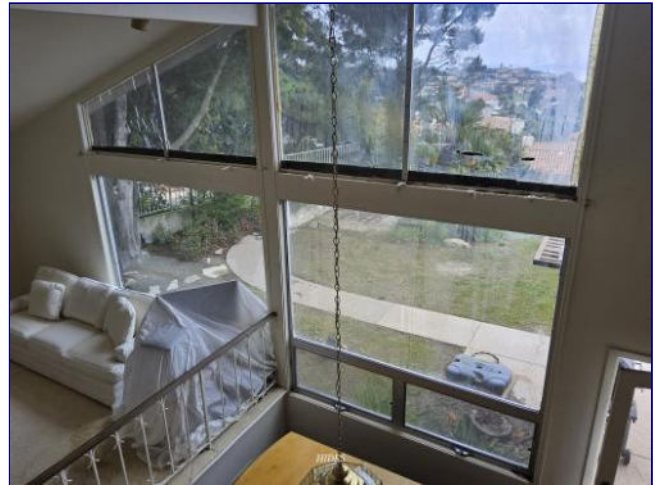
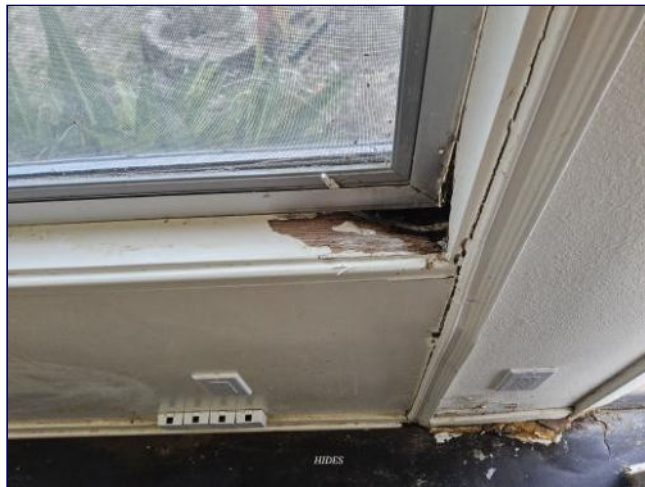
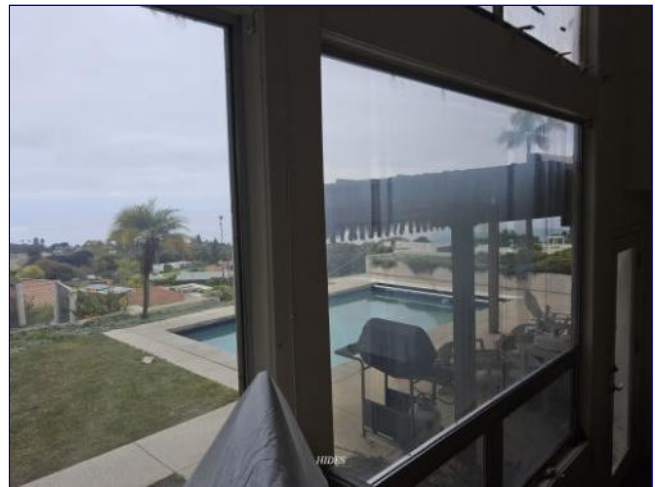
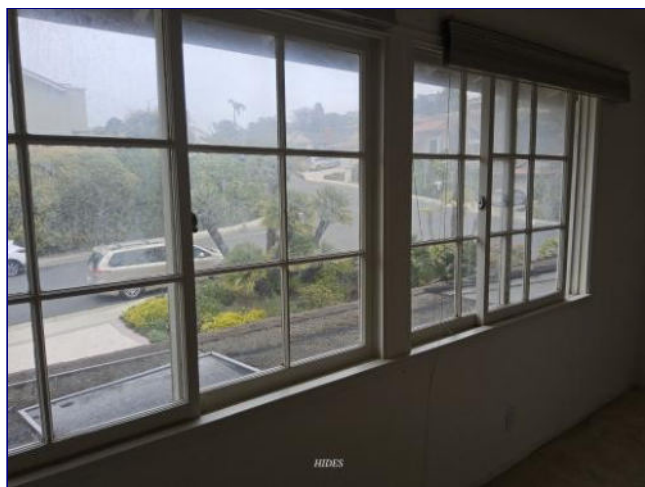
- 🔧 Window has cracked glass at various locations. This is a safety hazard and correction is needed. Further evaluation is highly recommended by a licensed window contractor. Please note that there is evidence of moisture intrusion to various windows throughout the home resulting in moisture damage to window sills, interior walls, etc.. There is also evidence of moisture intrusion to rear facing windows. All of the rear facing windows are not sealed to exterior wall unions and interior wall unions. Also, many windows screens were damaged or missing. Wood casement windows were moisture damaged, difficult to operate and or painted shut with defective hardware. Further evaluation, consultation, and inspection, is highly recommended by a licensed window contractor.

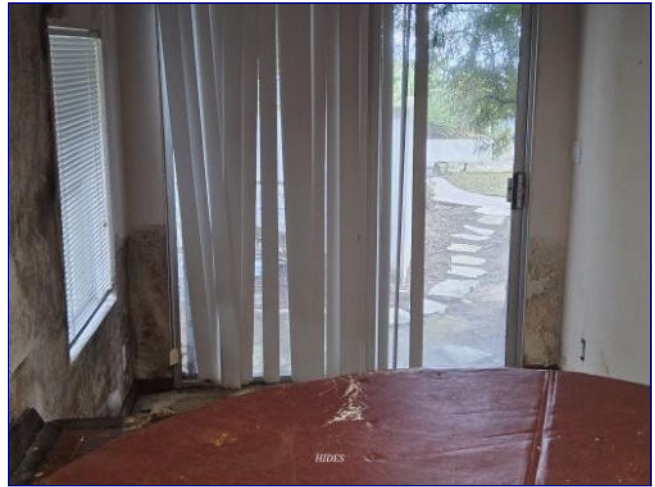
8.2 Item 2(Picture)

Due to the many areas of excessive moisture stains, excessive moisture damage, excessive mold like substance, holes, openings / exposed framing noted all throughout the property, the structural integrity of the walls and ceilings and possible slab / floors may and or have been compromised. Further evaluation, consultation, and inspection, is highly recommended by a licensed general contractor, drywall contractor, mold abatement company, and a structural engineer.

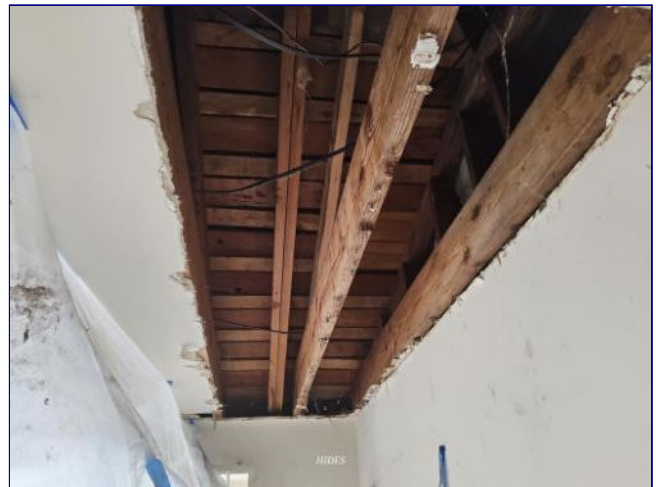
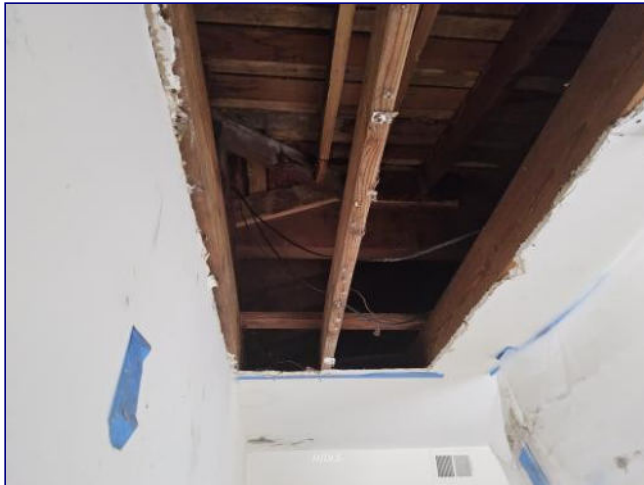
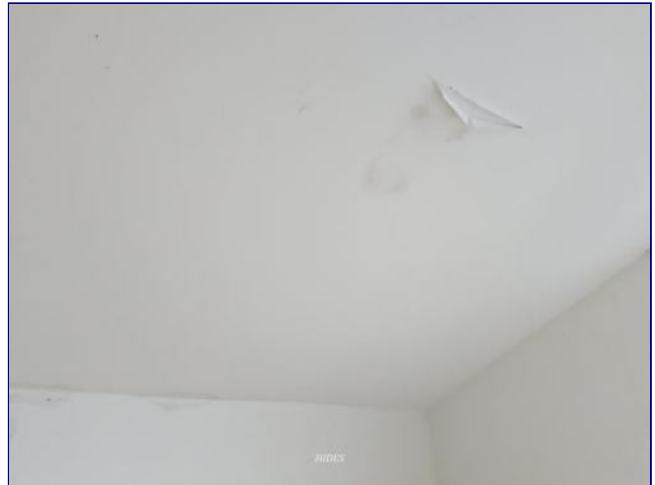
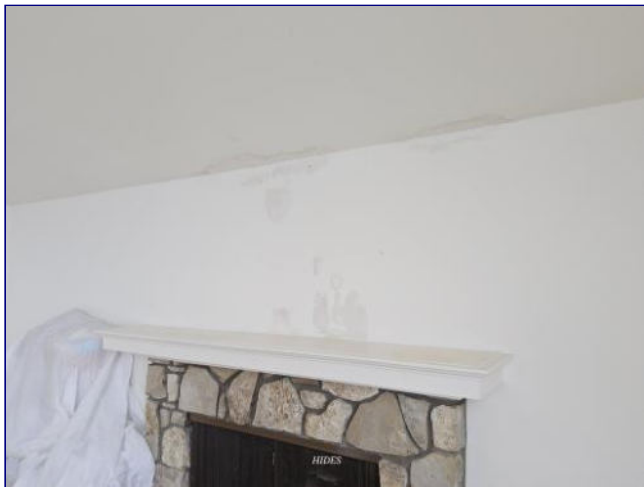
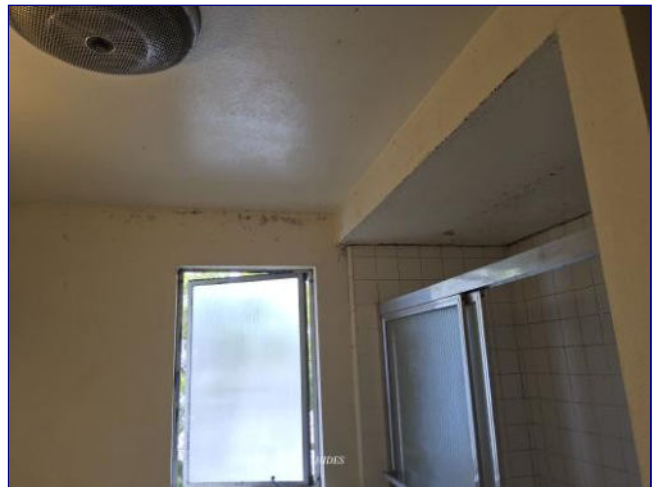
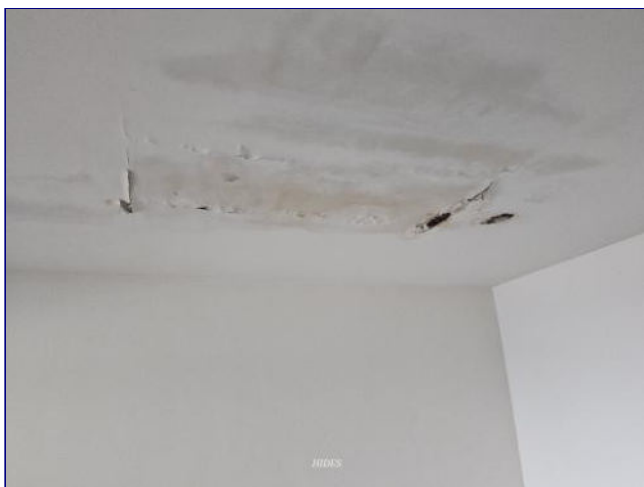
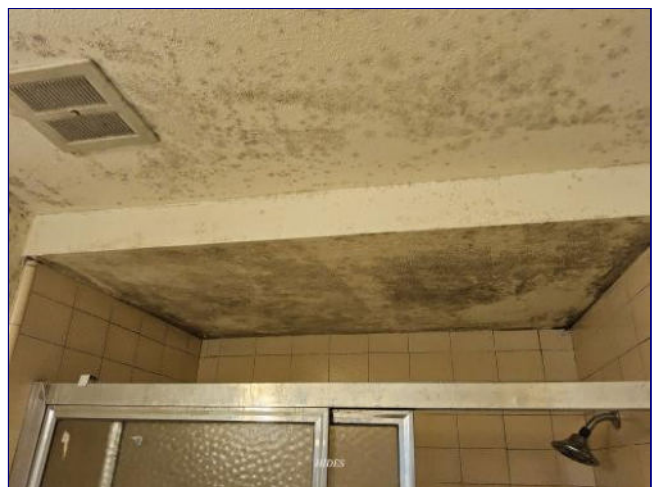
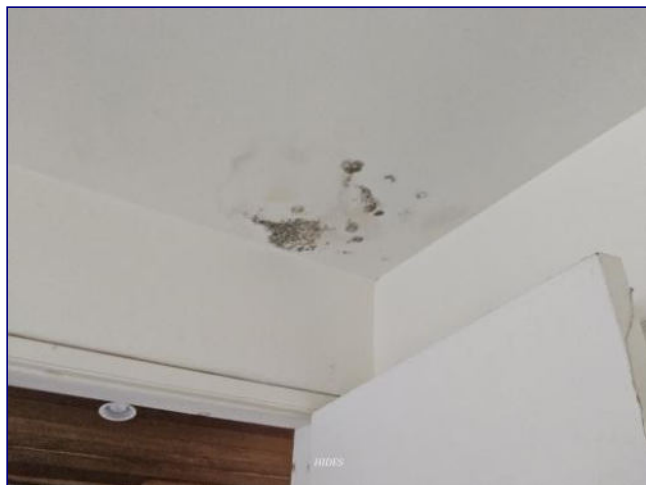
Due to the many areas of excessive moisture stains, excessive moisture damage, excessive mold like substance, holes, openings / exposed framing noted all throughout the property, the structural integrity of the walls and ceilings and possible slab / floors may and or have been compromised. Further evaluation, consultation, and inspection, is highly recommended by a licensed general contractor, drywall contractor, mold abatement company, and a structural engineer. There is an active leak to the supply lines and or waste / drain lines st upstairs hallway bathroom resulting in the extensive moisture damage, mold like substance to the ceiling below at family room. Further evaluation, consultation, and inspection, is highly recommended by a licensed plumber for the leak issues and subsequent general contractor, drywall contractor, mold abatement company, and possibly a structural engineer.

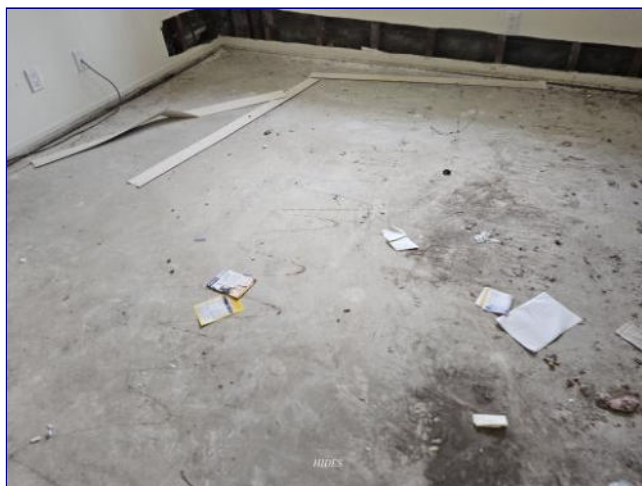
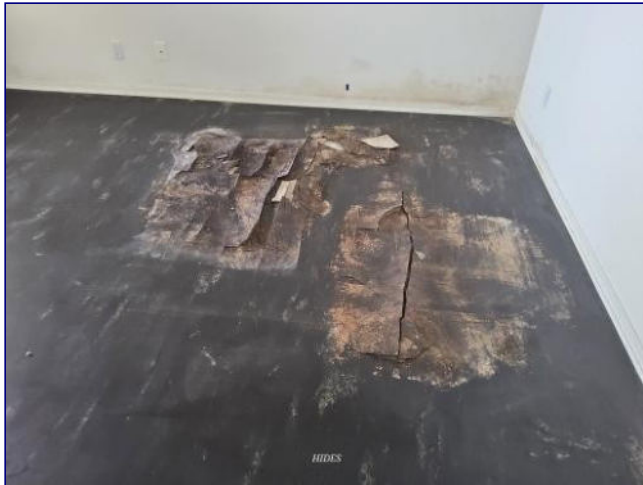
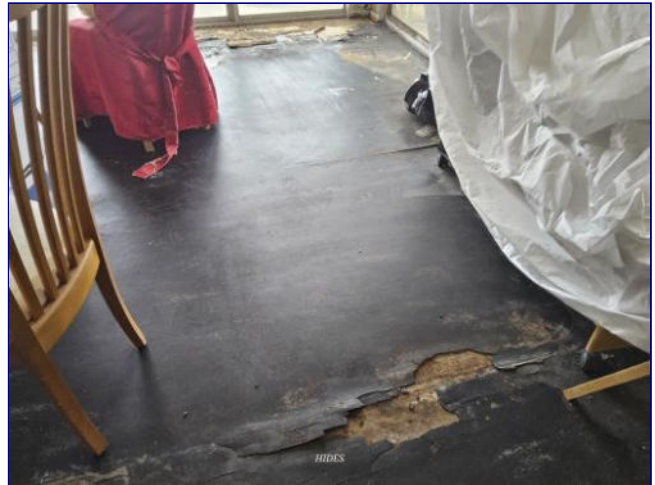
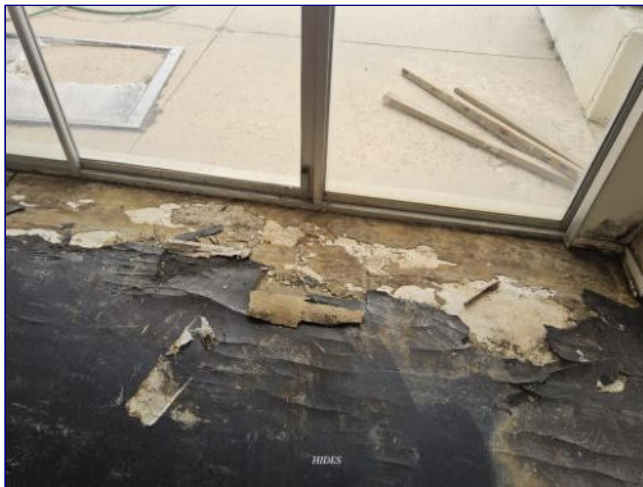
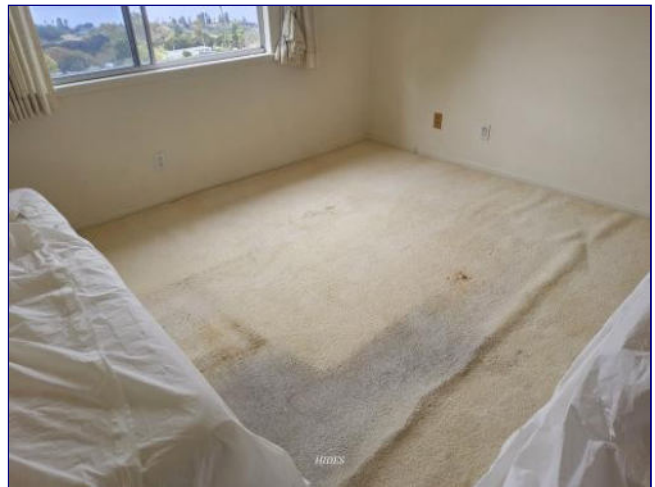
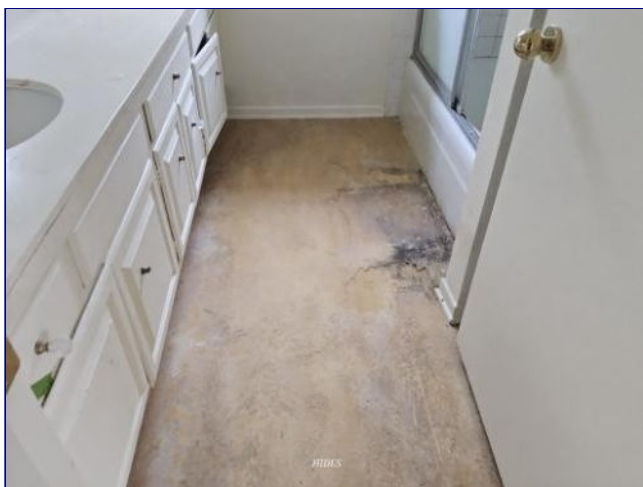
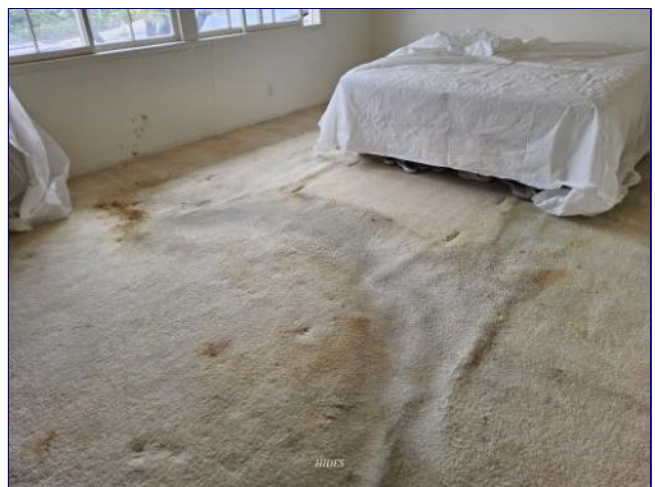
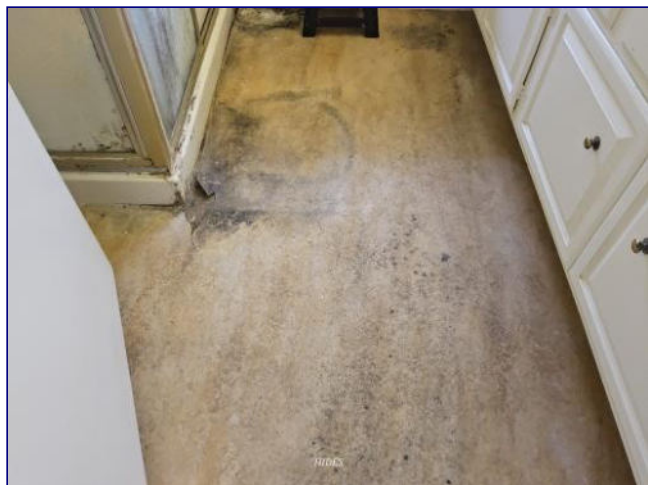
Due to the many areas of excessive moisture stains, excessive moisture damage, excessive mold like substance, holes, openings / exposed framing noted all throughout the property, the structural integrity of the walls and ceilings and possible slab / floors may and or have been compromised. Further evaluation, consultation, and inspection, is highly recommended by a licensed general contractor, drywall contractor, mold abatement company, and a structural engineer. There is an active leak to the supply lines and or waste / drain lines st upstairs hallway bathroom resulting in the extensive moisture damage, mold like substance to the ceiling below at family room. Further evaluation, consultation, and inspection, is highly recommended by a licensed plumber for the leak issues and subsequent general contractor, drywall contractor, mold abatement company, and possibly a structural engineer. Missing floor coverings were noted at many locations with heavy stains and damage to floor coverings. Further evaluation is highly recommended by a licensed flooring contractor.

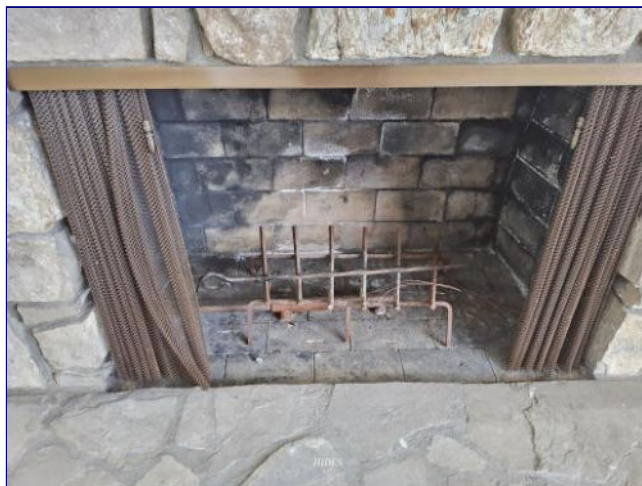
8.5 Item 2(Picture)

Gas entry line inside the fireplace is not sealed and line has excessive rust / corrosion. The rust / corrosion to the gas line inside the firebox is a direct result of moisture intrusion and or penetration of the chimney / fireplace. This is a safety hazard and correction is needed. Further evaluation is recommended by a licensed general or licensed fireplace / chimney contractor. Fireplace appears to have not been serviced or swept for some time. Further evaluation, consultation, and inspection, is highly recommended by a licensed fireplace / chimney contractor.

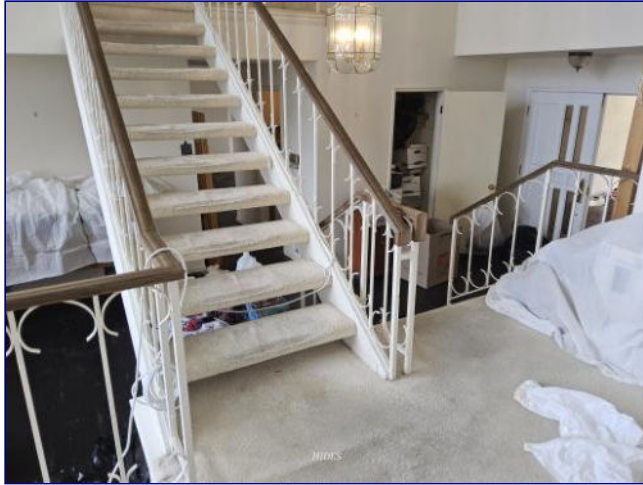
8.6 Item 1(Picture)

A staircase railings and balusters are too wide by today's construction / safety standards. This is a safety hazard and correction is recommended by a licensed general contractor.

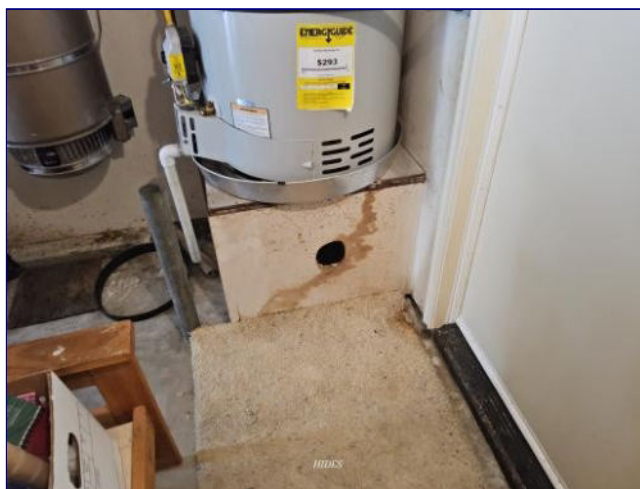
10.1 Item 2(Picture)

- 🔧 Moisture stains were noted to the garage wall(s). Although stains are dry, regular maintenance and or inspection is advised. Holes, openings were noted to to the garage firewall / firewall ceiling. This is a safety hazard and correction is needed. Further evaluation is recommended by a licensed drywall contractor. Please note that the water heater platform has a hole / opening and has been compromised and as a result, adjacent garage firewall has been compromised. This is a safety hazard and correction is needed. Further evaluation is recommended by a licensed general contractor and or licensed drywall contractor.

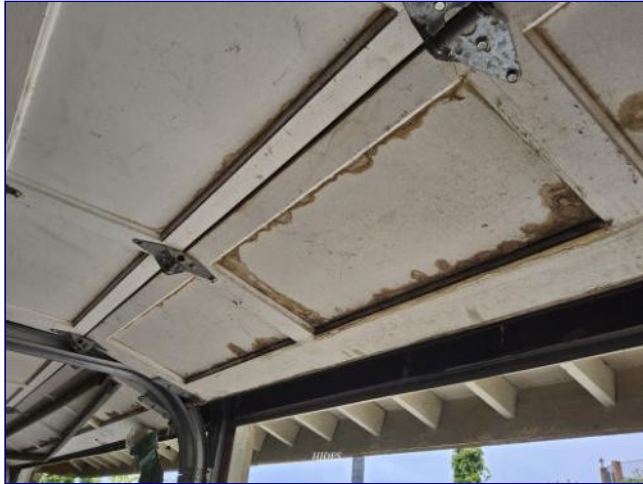
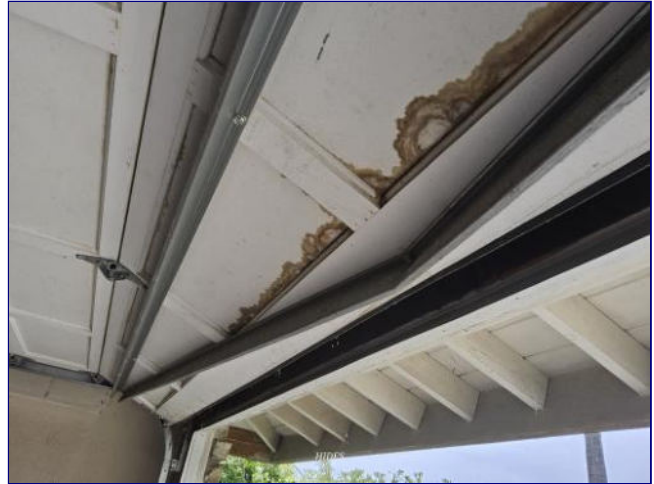
- 🔧 Garage vehicle doors have moisture stains and some moisture damage at base of doors (moisture intrusion / penetration). Correction is needed. Further evaluation is recommended by a licensed garage vehicle door installation company / contractor.

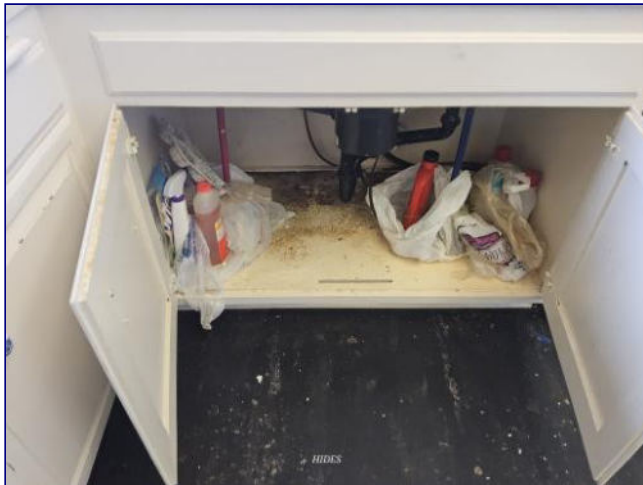
11.1 Item 1(Picture)

- Moisture damage was noted to cabinetry / platform underneath the kitchen sink. Further evaluation is recommended by a licensed cabinetry contractor and or licensed pest control / termite company.

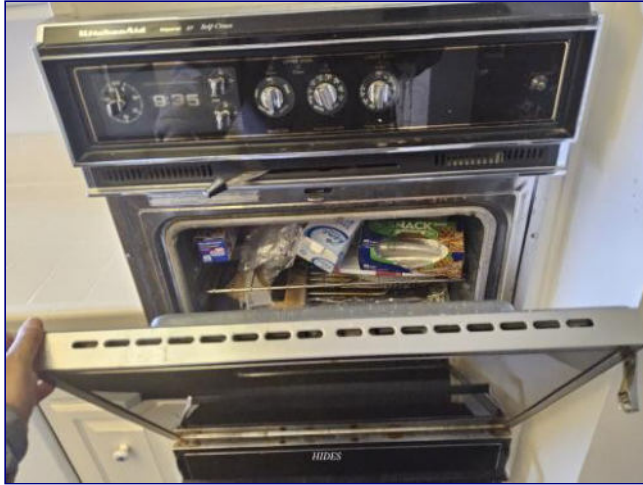
11.3 Item 1(Picture)

- Ovens were being used as storage. Inspector was unable to inspect and therefore verify functionality.

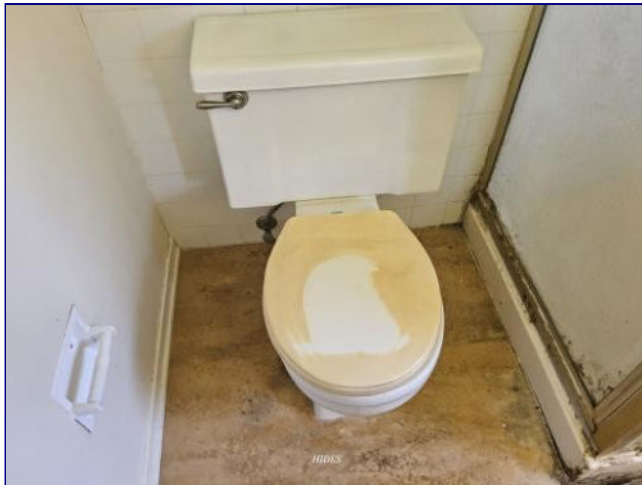
12.0.A Item 1(Picture)

- 🔧 Master bathroom toilet takes a long time to flush indicating possible stoppage issues. Further evaluation is recommended by a licensed plumber.

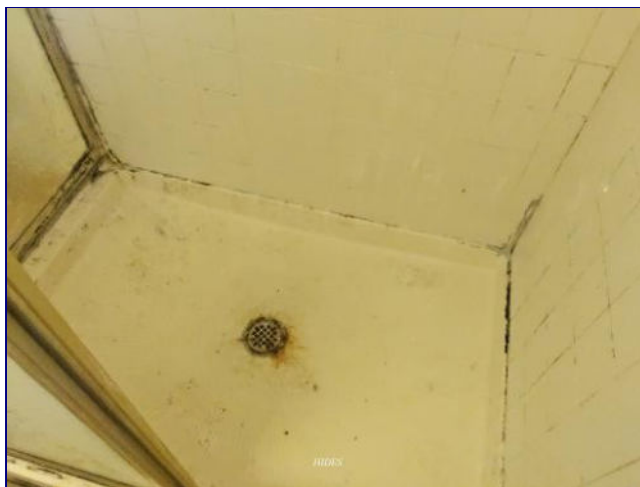
12.4.A Item 2(Picture)

- Extremely low water pressure was observed to master bathroom sinks and shower. Correction is needed. Further evaluation is recommended by a licensed plumber.

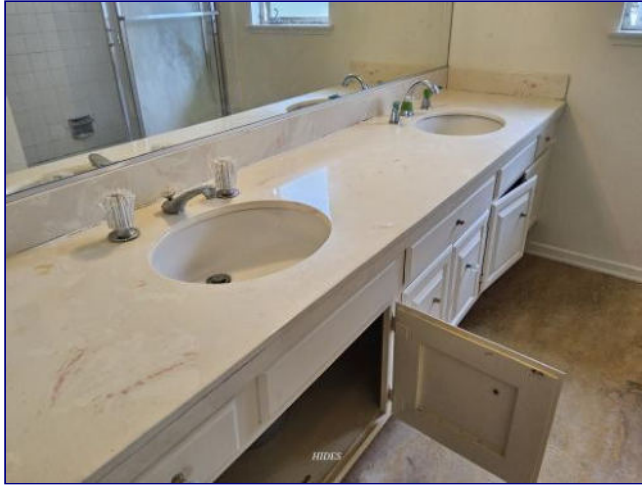
12.1.B Item 1(Picture)

- Right side upstairs hallway bathroom right side sink is not functional and left side sink drain line leaks as well as faucet. Correction is needed. Further evaluation is recommended by a licensed plumber.

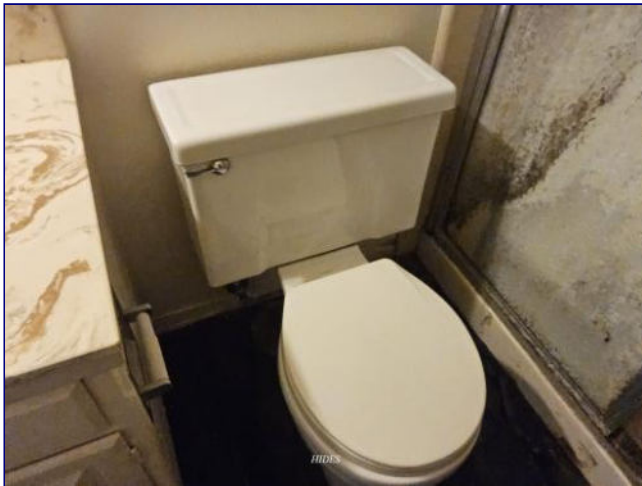
12.0.C Item 1(Picture)

- Downstairs bathroom toilet does not flush / has defective / not functional flushing lever.

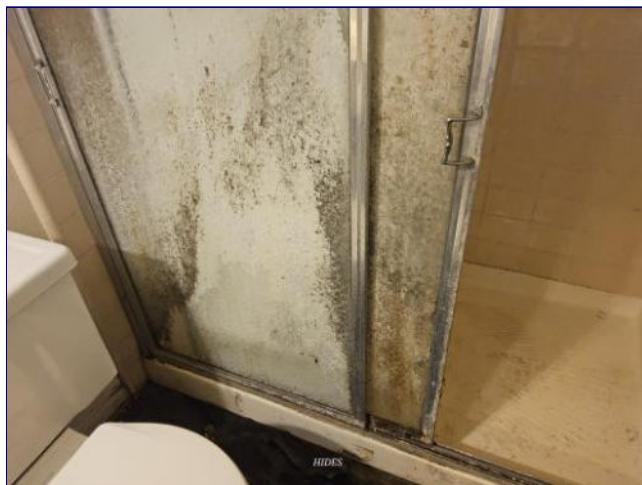
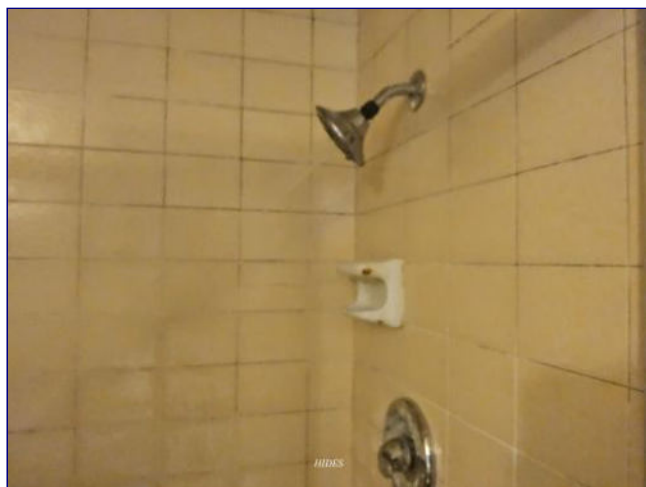
- Heavy deterioration, mildew, and possible mold like substance was observed at downstairs bathroom, shower enclosure. Further evaluation is highly recommended by a licensed mold abatement company. Downstairs bathroom shower head leaks. Correction is recommended by a licensed plumber.

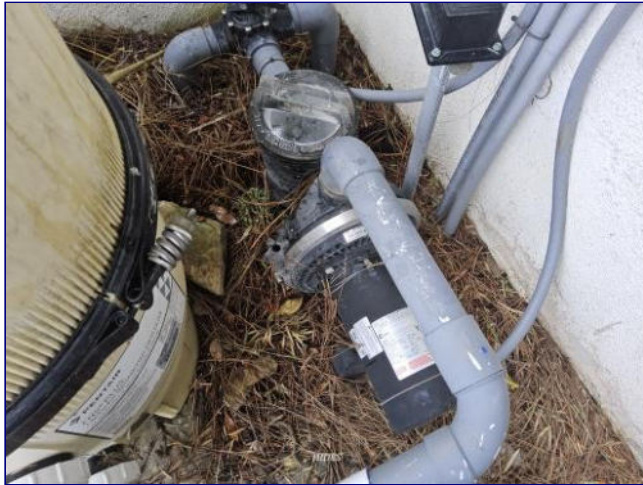
13.3 Item 1(Picture)

- 🔧 Pool circulation pump leaking and has no body bond. Correction is needed. Further evaluation is recommended by a licensed pool contractor.

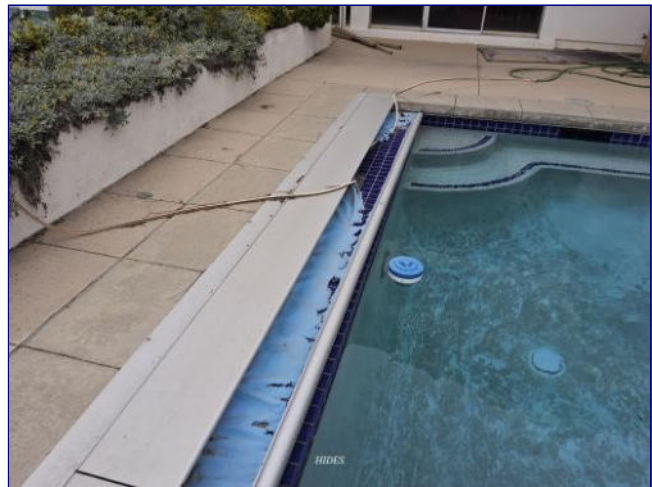
13.5 Item 2(Picture)

- 🔧 Pool equipment GFCI is missing its exterior rated cover plates as well as various other outlets throughout the property. This is a safety hazard and correction is needed. Further evaluation is recommended by a licensed electrician. Pool time box is heavily corroded and replacement is needed. Further evaluation is recommended by a licensed pool contractor and or licensed electrician. Electronic pool cover is not functional, as mentioned to the inspector from client. Further evaluation is recommended by a licensed pool contractor as to its functionality and issues.

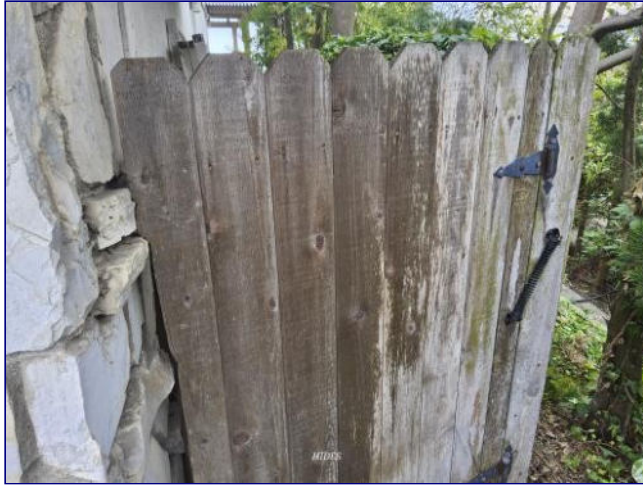
13.6 Item 1(Picture)

- 🔧 Perimeter gates are in need of self closing devices or devices are not functional due to pool / spa installation. This is a safety hazard and correction is needed. Further evaluation is recommended by a licensed gate installation company / contractor. Common to moderate cracks were noted to the pool surrounding deck areas. Further evaluation is recommended by a licensed pool contractor. Surface deterioration was noted to the pool. Regular maintenance and or inspection is advised. Please note that the edge of the pool towards the rear of the property is quite close to an embankment and may have inadequate support of adjacent soil and embankment. This may also and or is impacting the adjacent deck as well. Further evaluation, consultation, and inspection, is highly recommended by a licensed geo-technical contractor as to soil in this area.

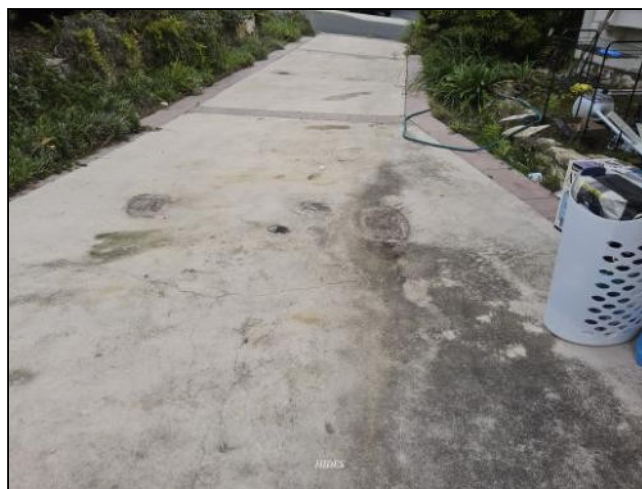
1.0 Item 2(Picture)

🔧 **1.0** Moderate to large size cracks were noted to the driveway. Regular maintenance and or inspection is advised. Driveway show evidence of inadequate drainage and or ponding. Regular maintenance and or inspection is advised. Driveway appears to be sloped towards the home / garage. Further evaluation is recommended by a licensed general contractor.

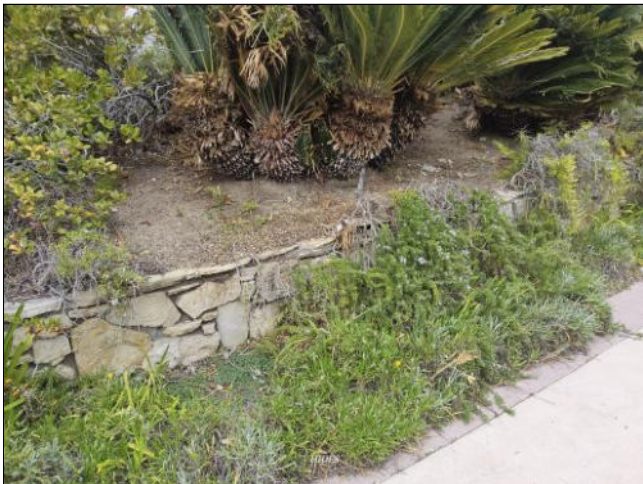
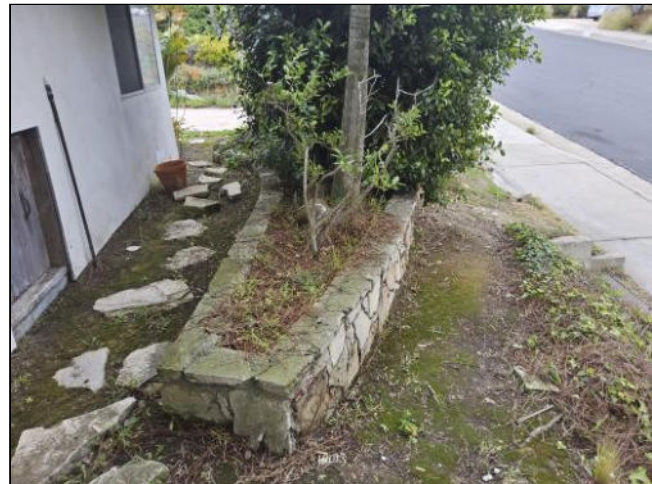
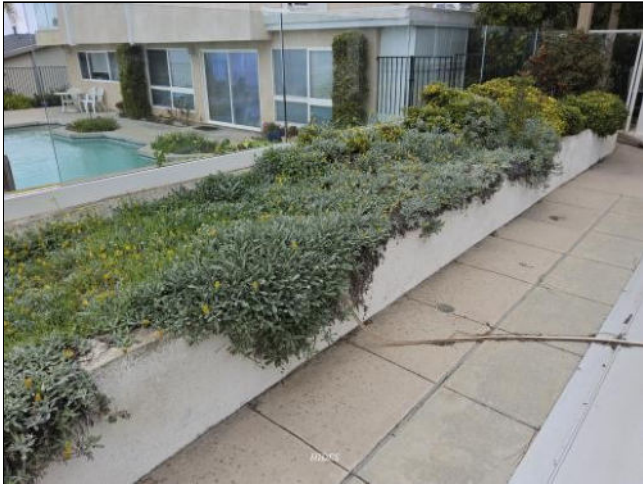
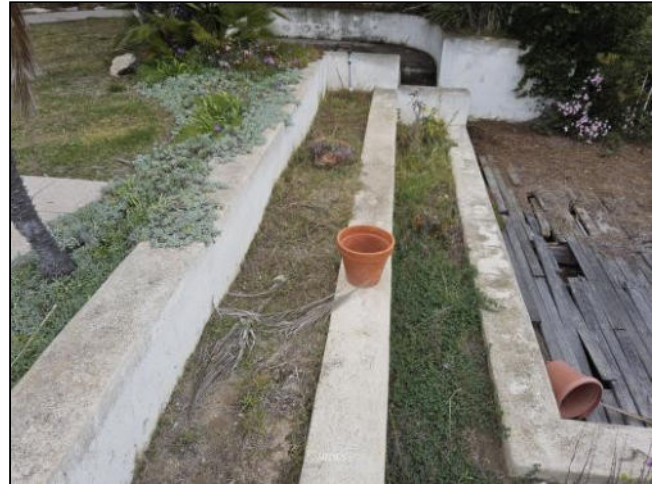
**1.2** No evidence of drainage openings were noted to the retaining walls. Regular maintenance and or inspection is advised. Evidence of moisture penetration was noted to the retaining walls. Regular maintenance and or inspection is advised. Evidence of movement / displacement was noted to the retaining walls. Further evaluation is recommended by a licensed general contractor or landscaper.

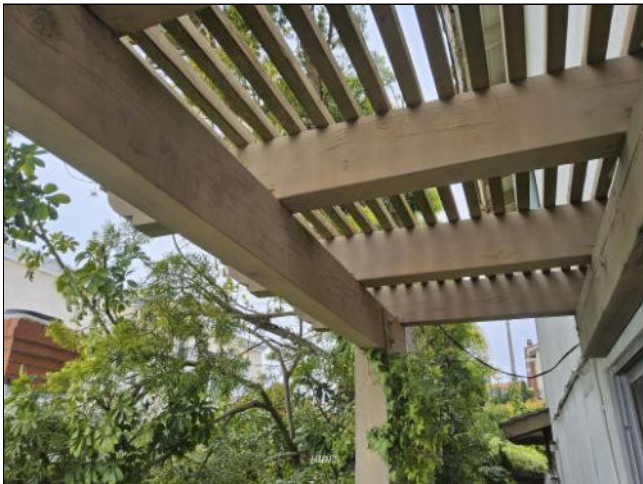
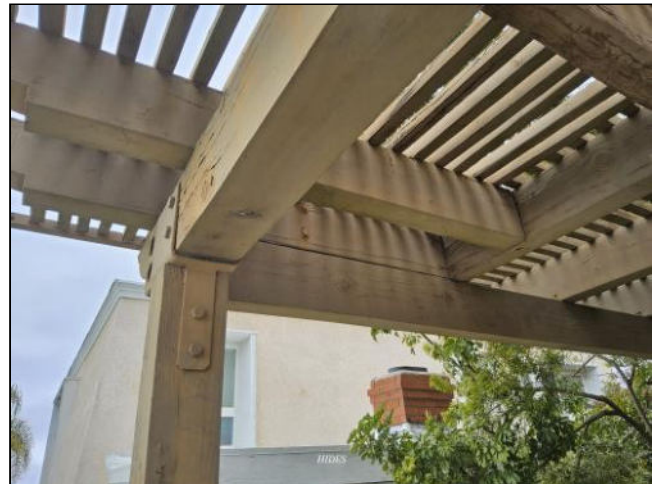
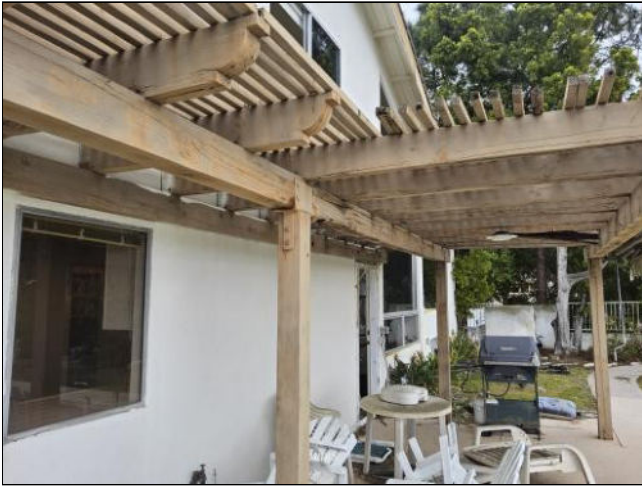
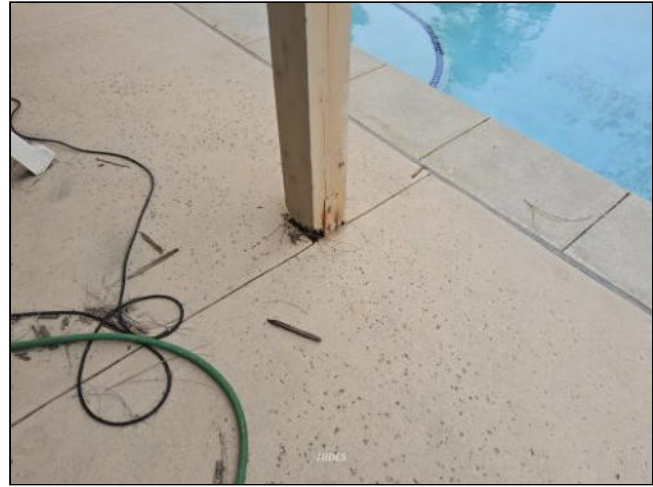
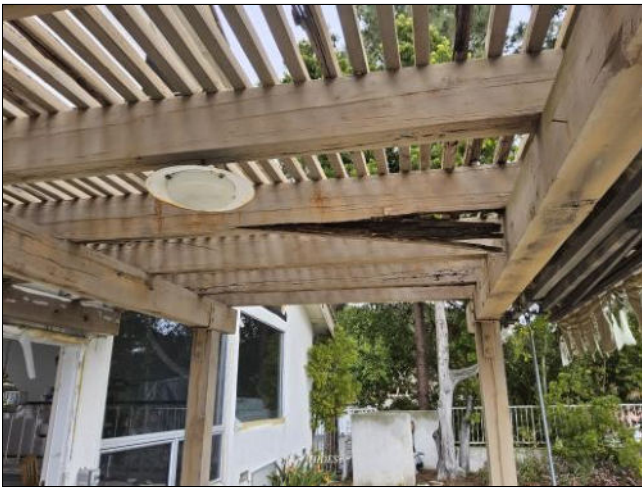
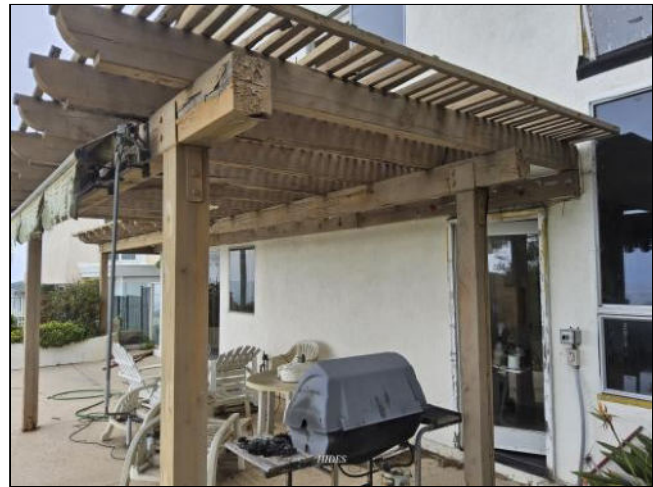
**1.4** Substandard / non professional installation, support methods used along with heavy moisture stains were noted to the patio area structure. Further evaluation, consultation, and inspect, is recommended by a licensed general contractor. Extensive moisture damage and dry rot was noted to the open design patio covers. Further evaluation, consultation, and inspection, is highly recommended by a licensed pest control / termite company and or licensed general contractor.

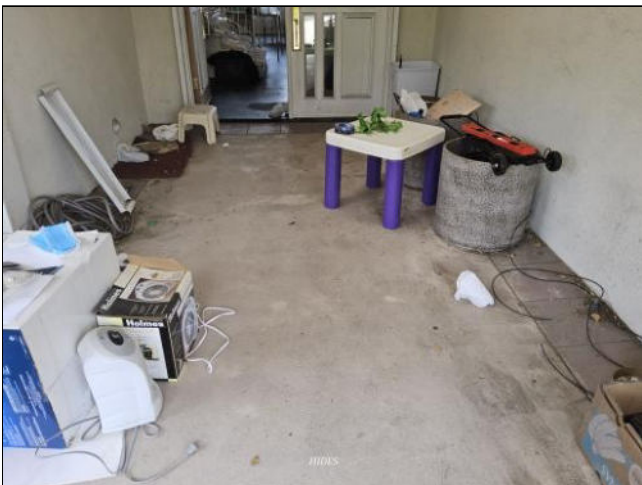
1.5 Item 1(Picture)

**1.5** Common cracks were noted to the patio and or porch area. Regular maintenance and or inspection is advised.
