# Inspection Report

**Property Address:**  
6402 Seabryn  
Rancho Palos Verdes CA 90275

**Home Inspection Detection Services**

<b>Date:</b> 3/26/2025	<b>Time:</b> 11:00 AM	<b>Report ID:</b> KI032625-116-116
<b>Property:</b> 6402 Seabryn Rancho Palos Verdes CA 90275	<b>Customer:</b> Carol Manligas-Kishler Kevin Kishler	<b>Real Estate Professional:</b> Steve Gutierrez-Kovner John Hart Real Estate

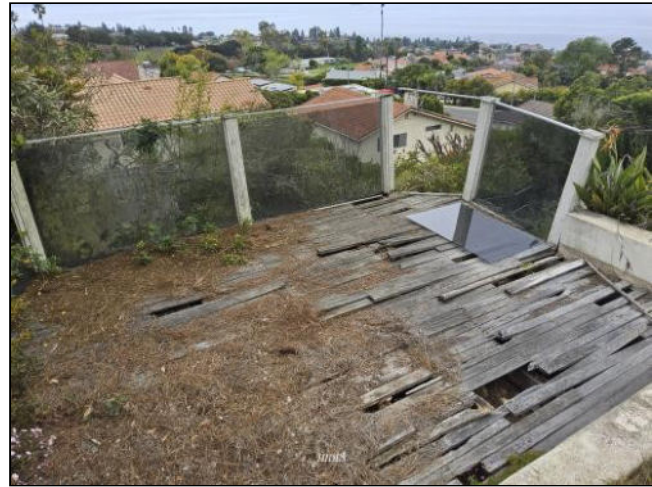
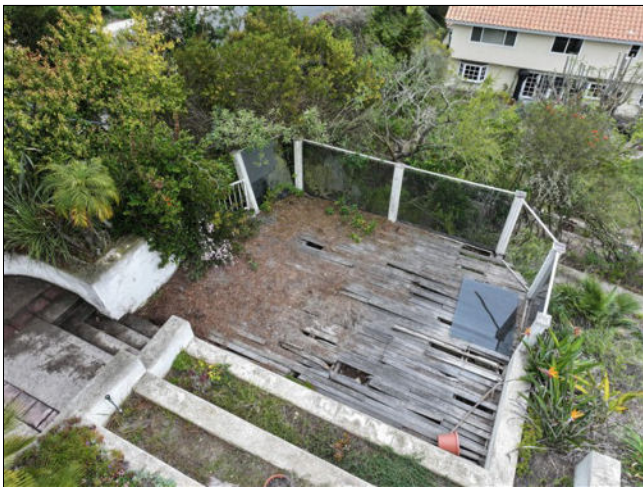
**1.7** Deck has major moisture damage, major dry rot and or termite damage, is not structurally

sound and has damaged glass railings. Considering the location of the deck, its damage, and the lack of structural integrity, this is an extreme safety hazard. Deck should not be walked on. Immediate attention is needed. Further evaluation, consultation, and inspection, is highly recommended by a licensed general contractor, structural engineer, and possibly a geo-technical contractor.

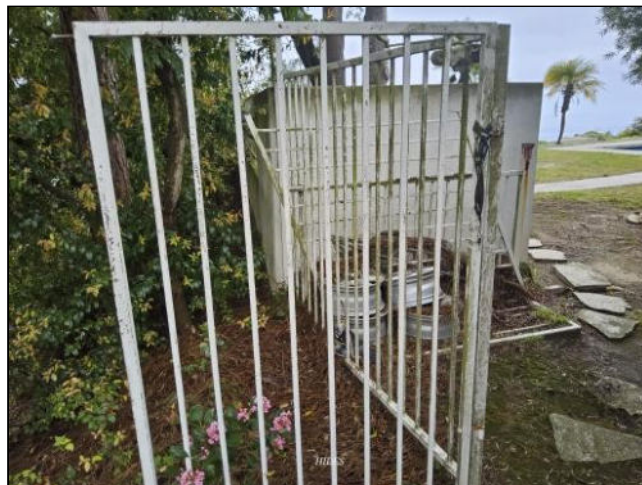
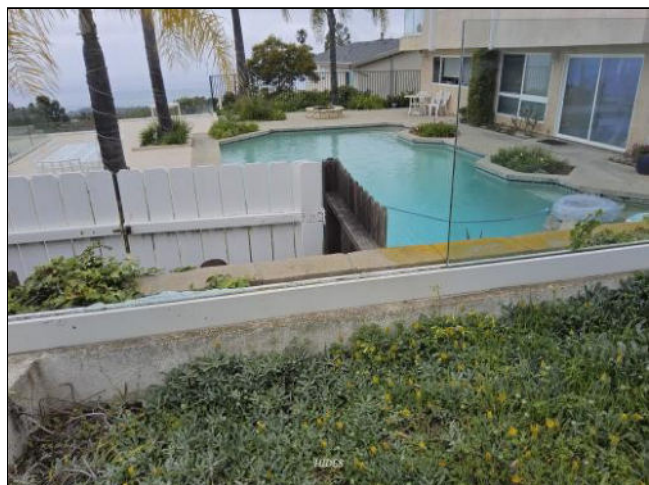
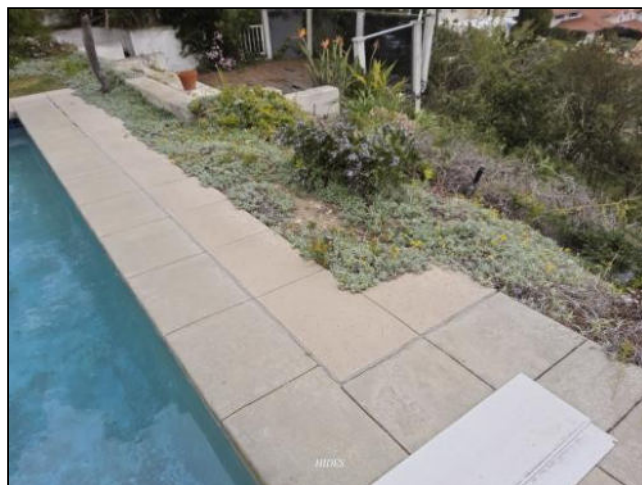
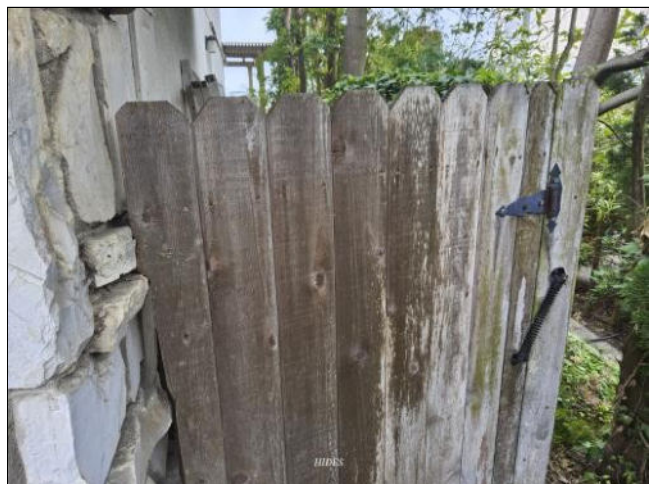
**1.8** Perimeter fencing and gates are worn, rusted, deteriorated. Also, gates leading to the pool area are in need of self closing device and or device is not functional. The self closing device issue is a safety hazard. Further evaluation, consultation, and inspection, is highly recommended by a licensed gate installation company / contractor.

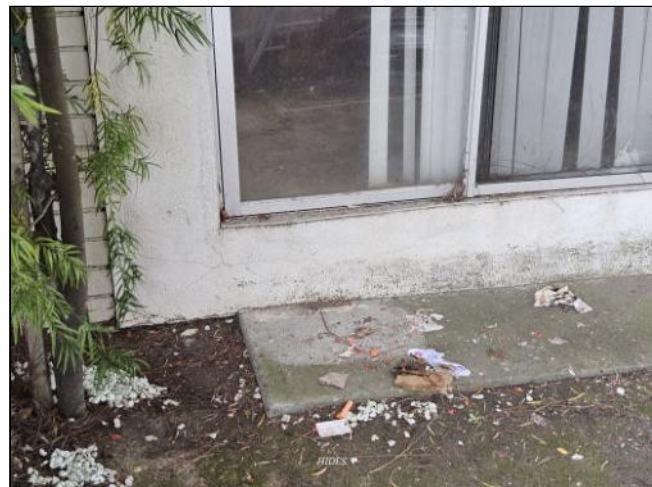
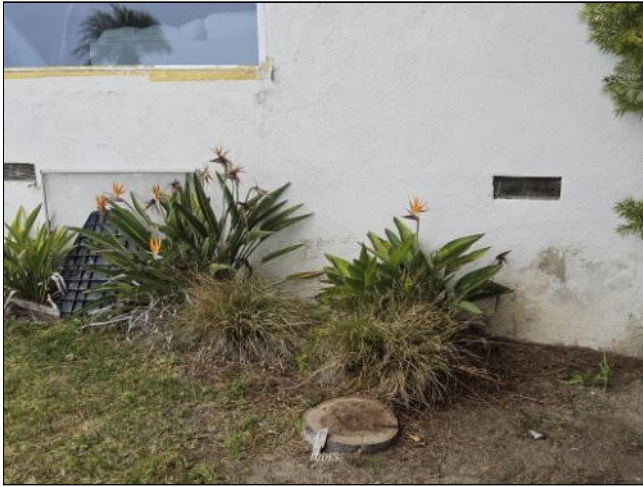
**2.1** Moderate cracks were noted to the exterior walls. Regular maintenance and or inspection is advised. Large size cracks were noted to the exterior walls. Regular maintenance and or inspection is advised. Stucco to the exterior walls is worn / deteriorated. Regular maintenance and or inspection is advised. Moisture stains were noted to the exterior walls. Although stains are dry, regular maintenance and or inspection is advised. Holes, openings, and or exposed framing was noted to the exterior walls. These holes, openings, and or exposed framing areas must be sealed / patched to help eliminate any moisture intrusion and or penetration. Further evaluation is recommended by a licensed general contractor.

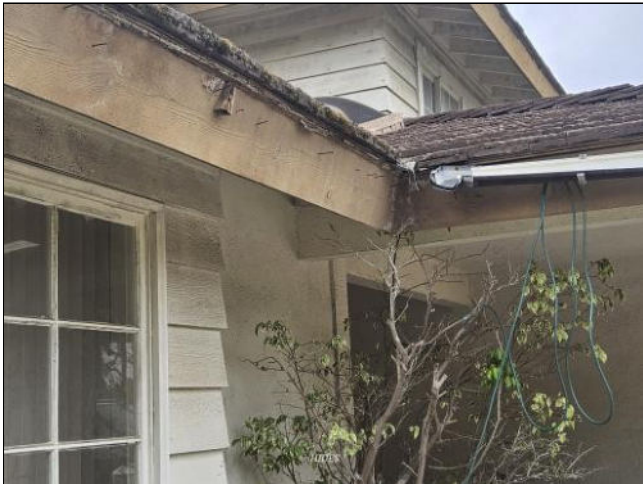
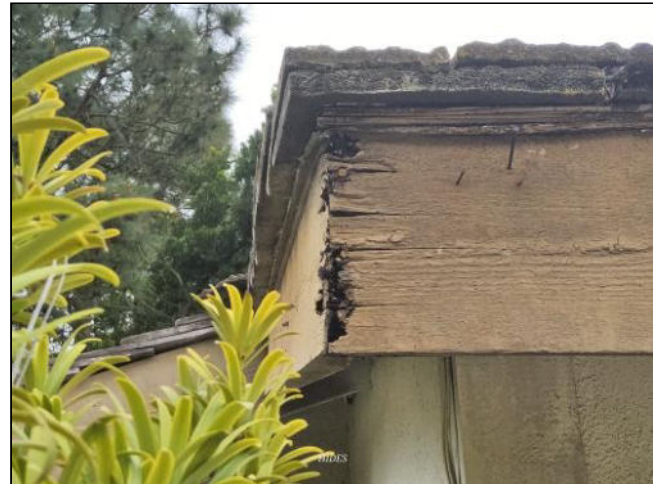
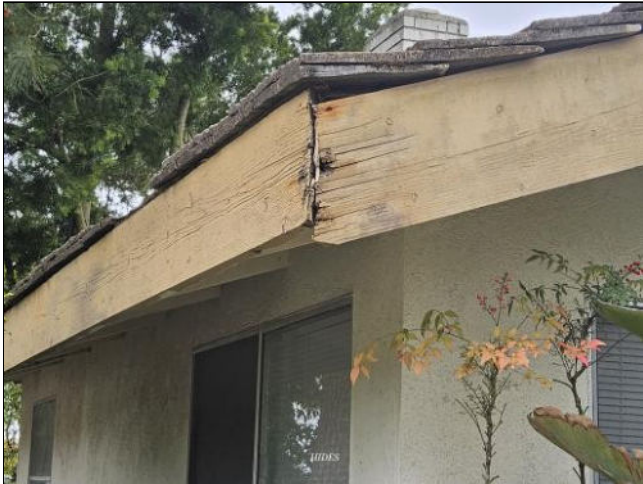
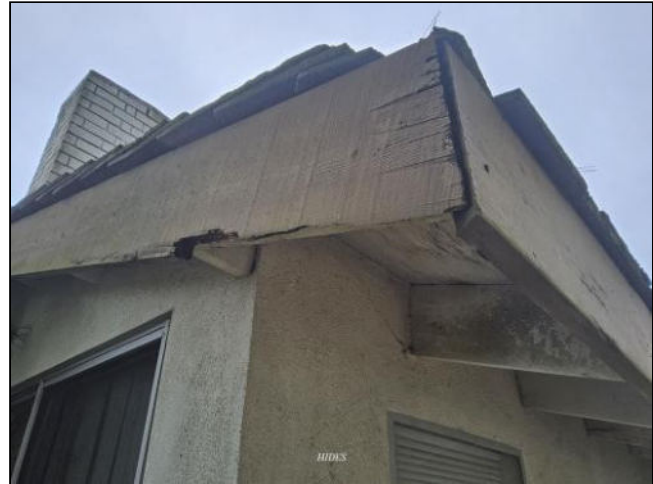
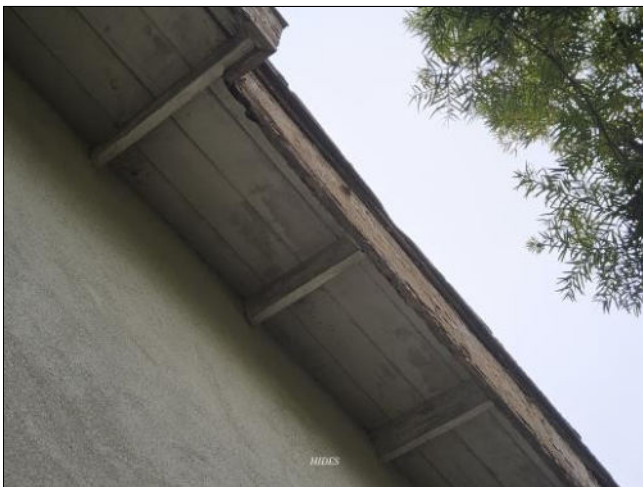
**2.2** Moisture stains were noted to the exterior trim at various locations. Regular maintenance and or inspection is advised. Ware / deterioration was noted to the exterior trim at various locations. Regular maintenance and or inspection is advised. Extensive dry rot, moisture damage and or possible termite damage was noted to the exterior trim at various locations. Further evaluation is highly recommended by a pest control / termite company and or a licensed general contractor.

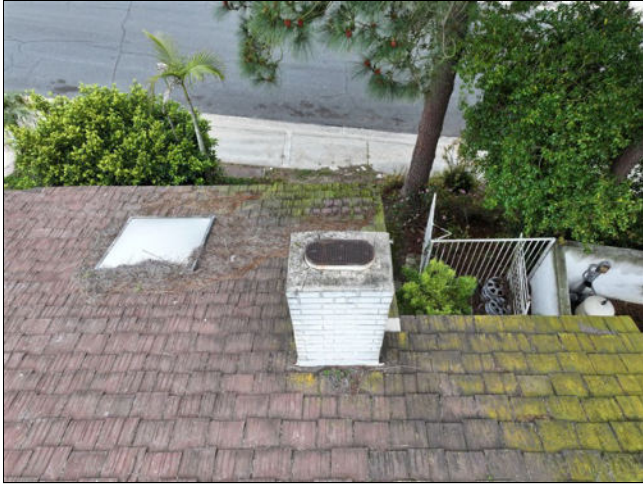
2.3 Item 1(Picture)

**2.3** Spark screen was missing to the chimney. Correction is needed. Further evaluation is recommended by a licensed fireplace / chimney contractor. Raincap was missing to the chimney. Correction is recommended by a licensed fireplace / chimney contractor. Separation of flashing was noted at chimney to roof unions. Correction is recommended by a licensed fireplace / chimney contractor and or licensed roofer. Moderate cracks were noted to the chimney brick and or mortar. Correction is recommended by a licensed fireplace / chimney contractor and or licensed roofer.

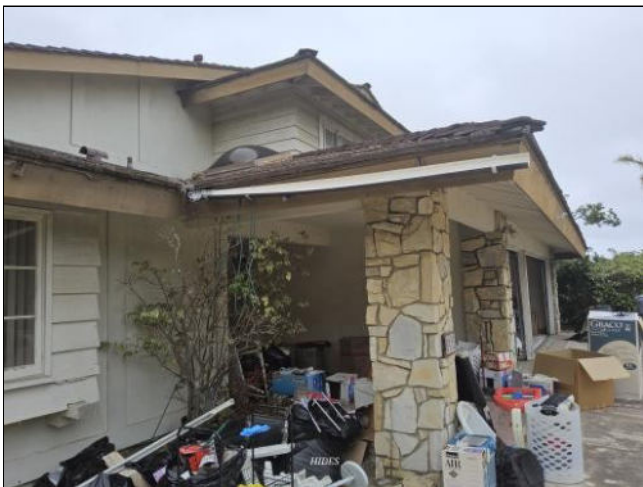
2.5 Item 1(Picture)

**2.5** Downspout and or gutter was damaged. Correction is recommended by a licensed gutter / downspout contractor.

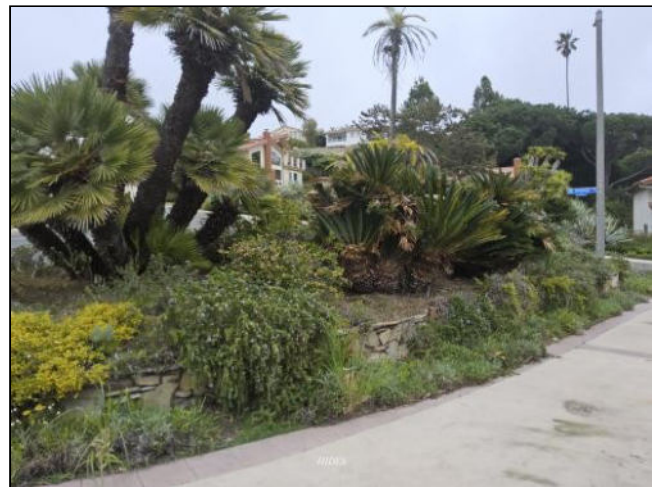
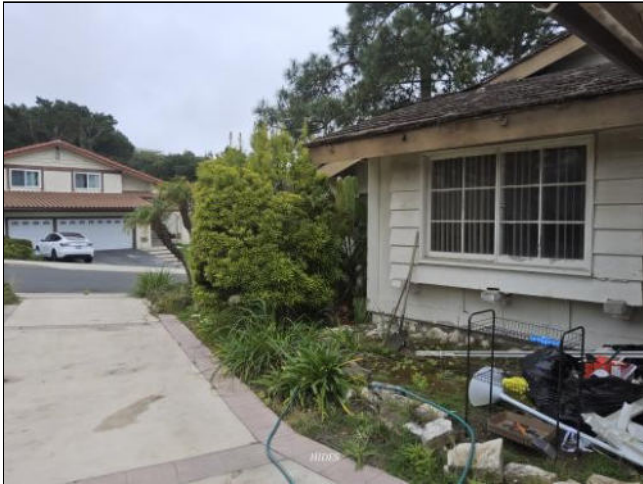
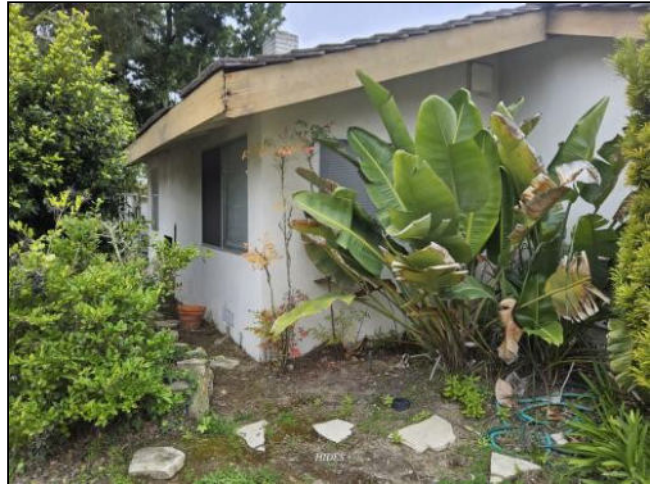
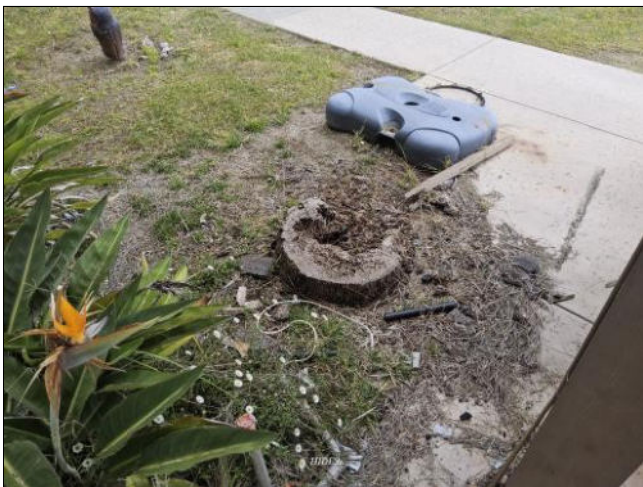
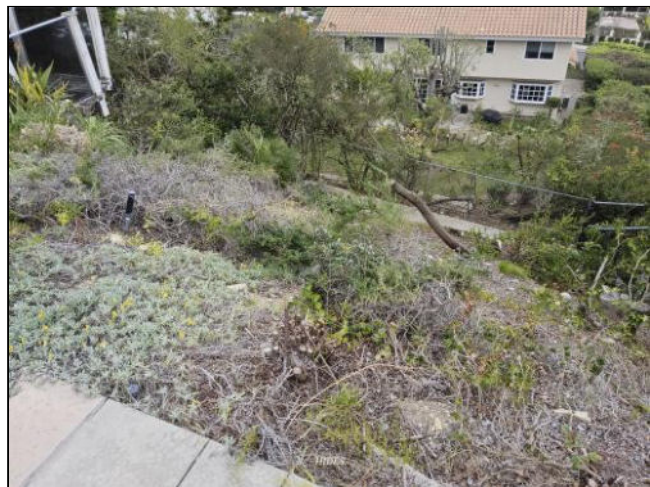
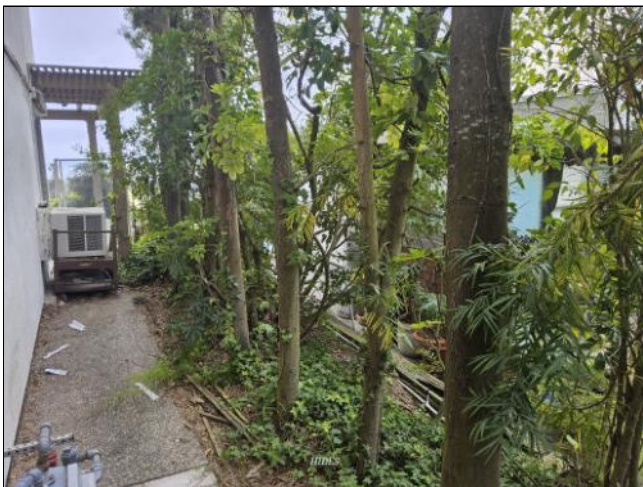
**3.0** Large size trees and or tree trunks were planted on the property. Regular maintenance and or inspection is advised as large size trees can pose issues with various aspects of construction. The tree limbs that are in contact with the roof or hanging near roof should be trimmed. Overgrown vegetation was noted. Removal of overgrown vegetation is recommended as this can pose issues with various aspects of construction. Evidence of inadequate drainage / ponding was noted around the perimeter of the home near foundation. Regular maintenance and or inspection is advised. Due to the overgrown vegetation, many perimeter block walls were not visible for inspection. Use caution High soil level was noted at exterior walls at various perimeter locations. Regular maintenance and or inspection is advised.

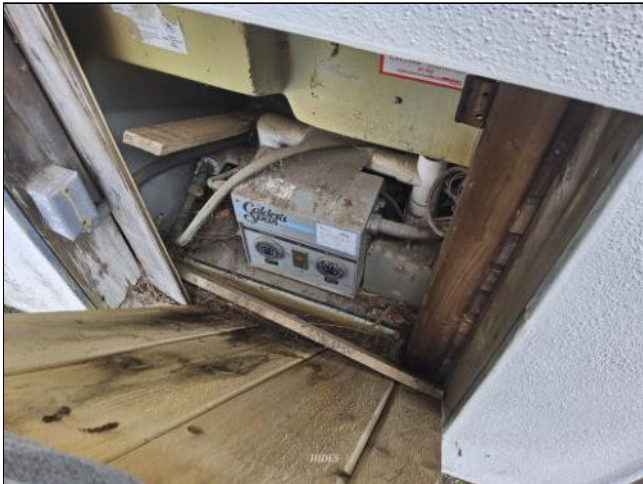
3.1 Item 1(Picture)

**3.1** A portion of the raised foundation was not accessible due to the installation of indoor spa at the left side of the home. Raised foundation portion inspection is limited. The other access point inside the home (downstairs office area) to the raised foundation shows evidence of possible moisture intrusion and or penetration along with inadequate ventilation. Further evaluation, consultation, and inspection, is highly recommended by a licensed general contractor. There is an active leak to the supply lines and

or waste / drain lines st upstairs hallway bathroom resulting in the extensive moisture damage, mold like substance to the ceiling below at family room. Further evaluation, consultation, and inspection, is highly recommended by a licensed plumber for the leak issues and subsequent general contractor, drywall contractor, mold abatement company, and possibly a structural engineer.

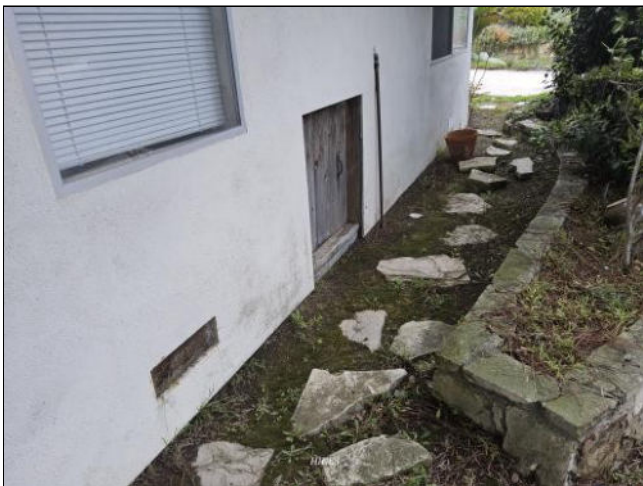
3.2 Item 1(Picture)

**3.2** A portion of the raised foundation was not accessible due to the installation of indoor spa at the left side of the home. Raised foundation portion inspection is limited. The other access point inside the home (downstairs office area) to the raised foundation shows evidence of possible moisture intrusion and or penetration along with inadequate ventilation. Further evaluation, consultation, and inspection, is highly recommended by a licensed general contractor.

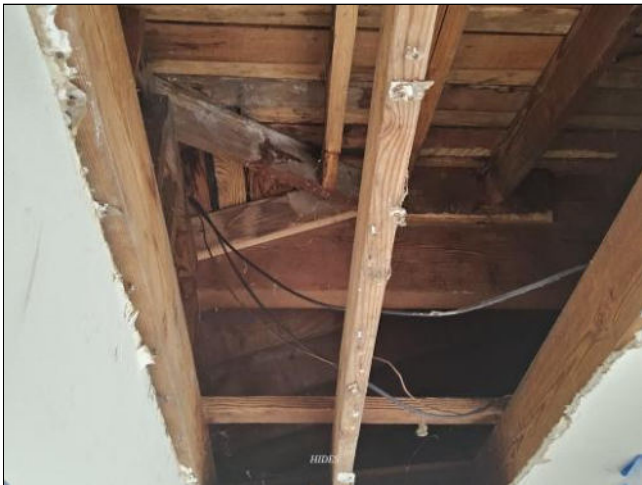
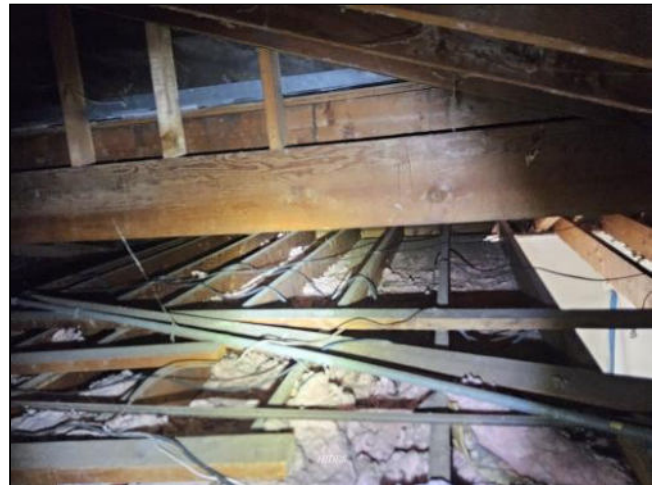
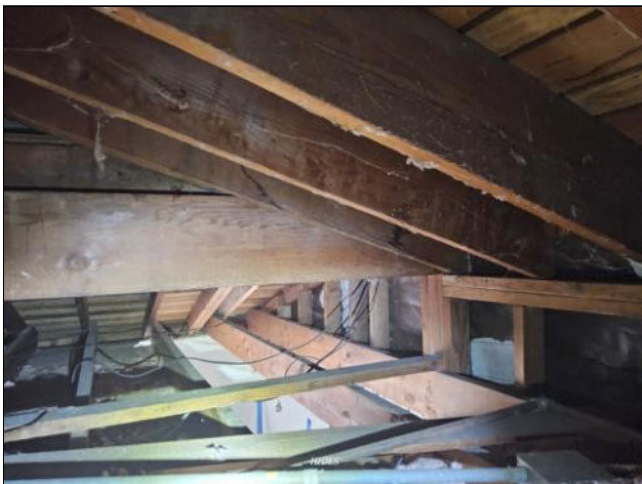
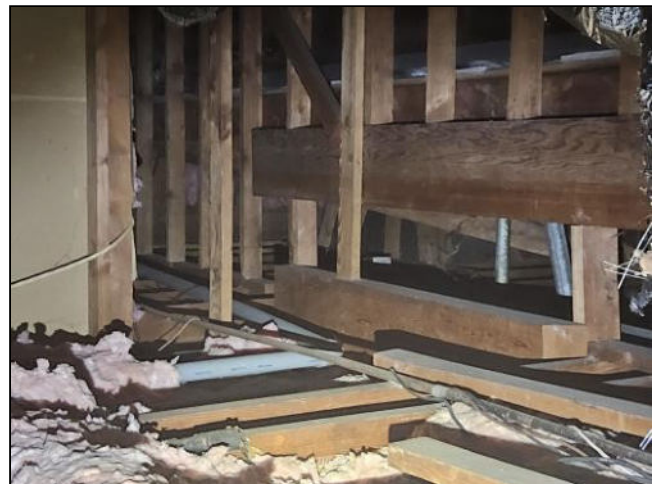
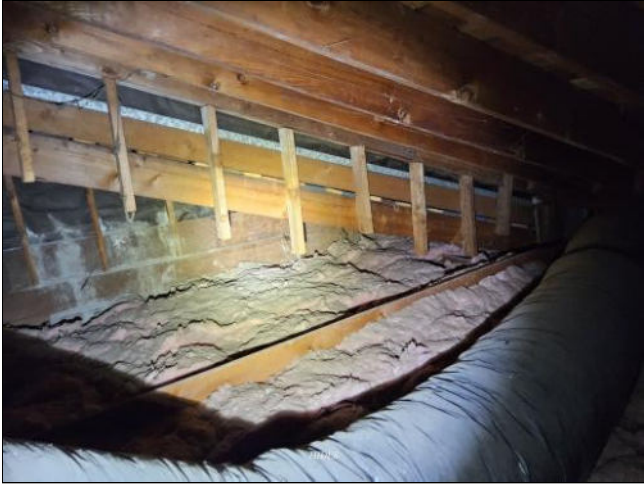
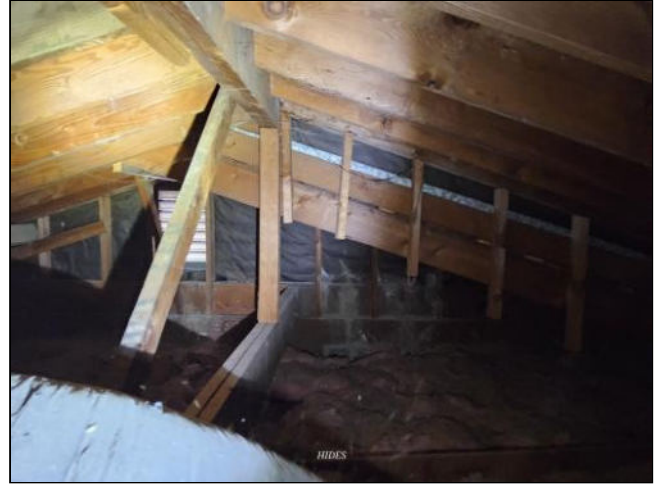
**3.6** Moisture stains were noted in the attic area at various locations. Although stains are dry, regular maintenance and or inspection is advised. Evidence of possible rodent droppings were noted all throughout the attic area. Further evaluation is recommended by a licensed pest control company. Attic access hatch remains partially open is damaged / defective. Correction is needed. Further evaluation is recommended by a licensed drywall contractor. Asbestos type materials was installed in the attic. Further evaluation is recommended by a licensed general contractor. Poor insulation coverage was noted in the attic. Further evaluation is recommended by a licensed general contractor.

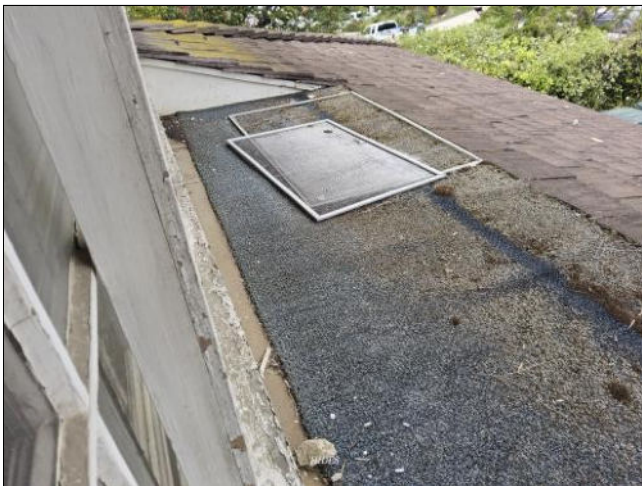
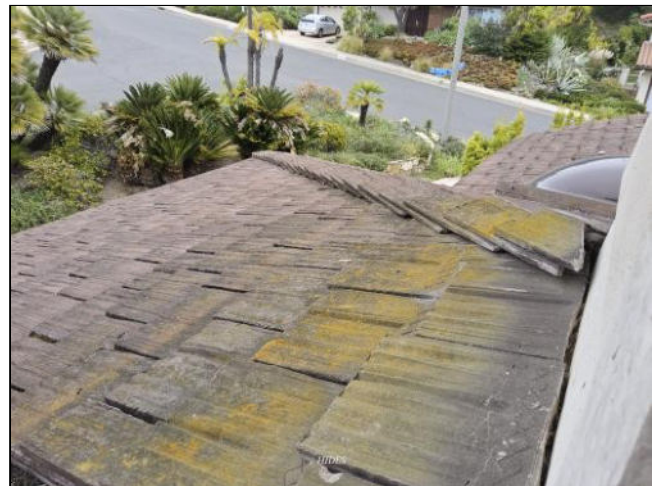
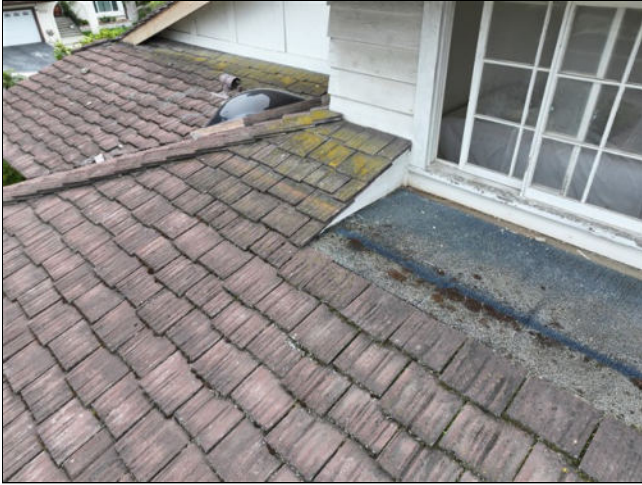
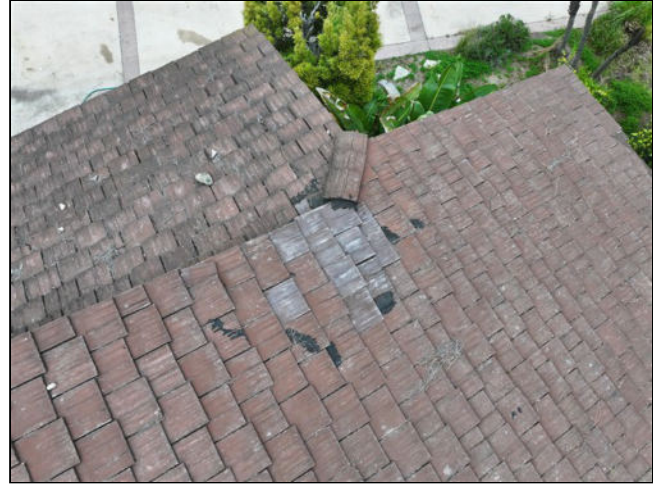
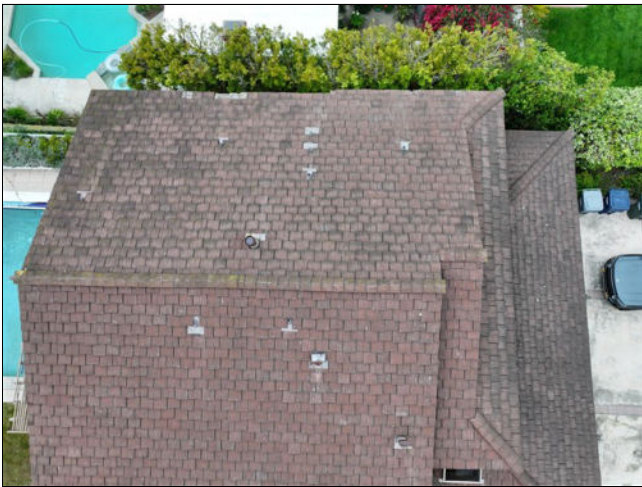
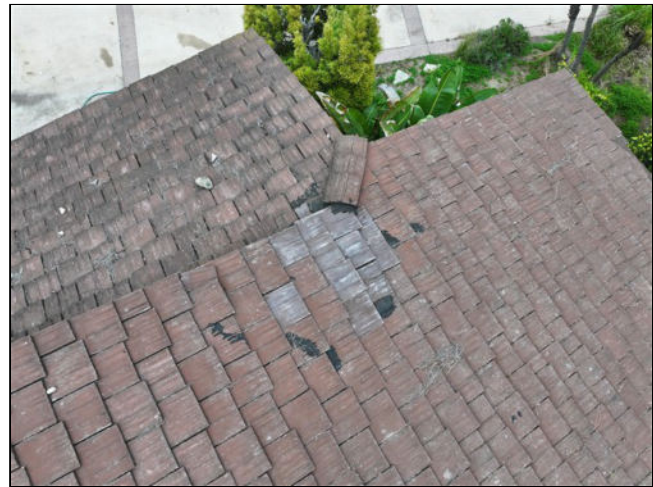
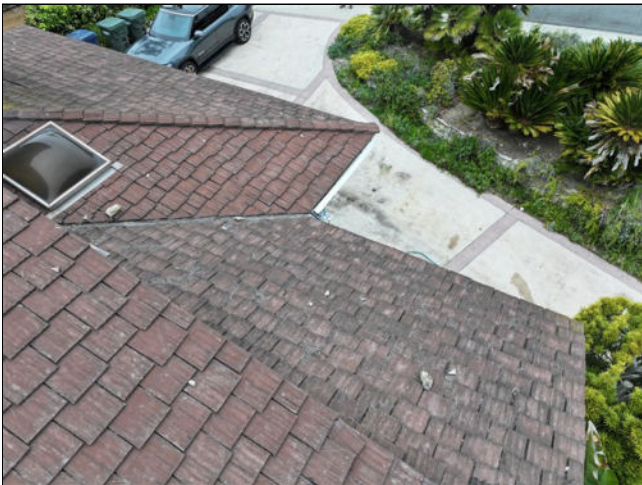
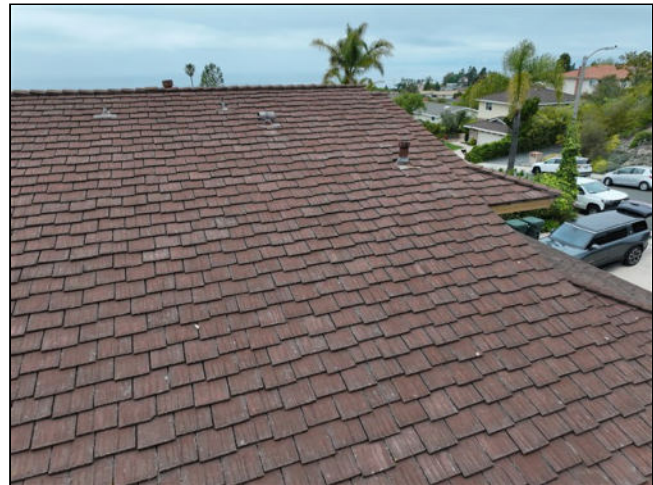
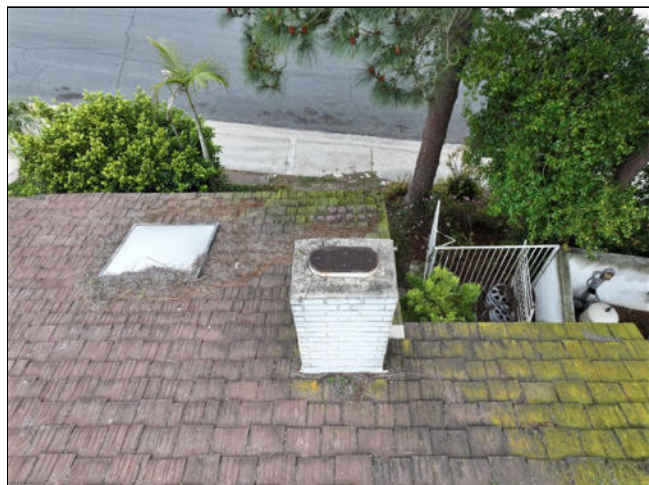
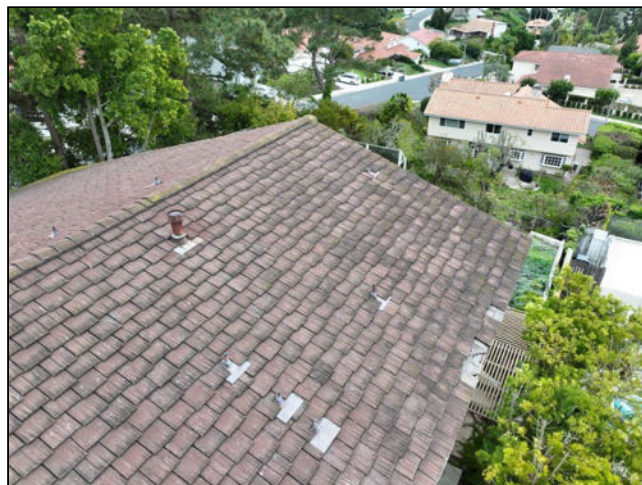
**4.0** The roofing system is in a heavily worn / deteriorated condition, and quite simply is approaching the end of its lifespan with improper installation of flashing, rusted flashing, cracked tiles, loose tiles, dislodged tiles, and no roof underlayment noted. Further evaluation, consultation, and inspection, is highly recommended by a licensed roofer.

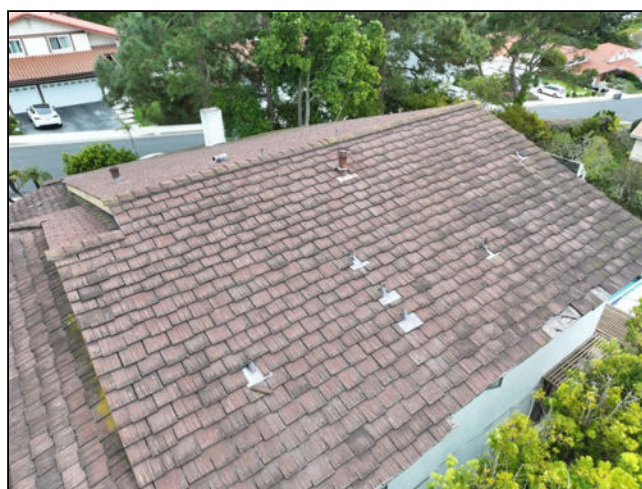
4.1 Item 2(Picture)

**4.1** The roofing system is in a heavily worn / deteriorated condition, and quite simply is approaching the end of its lifespan with improper installation of flashing, rusted flashing, cracked tiles, loose tiles, dislodged tiles, and no roof underlayment noted. Further evaluation, consultation, and inspection, is highly recommended by a licensed roofer.

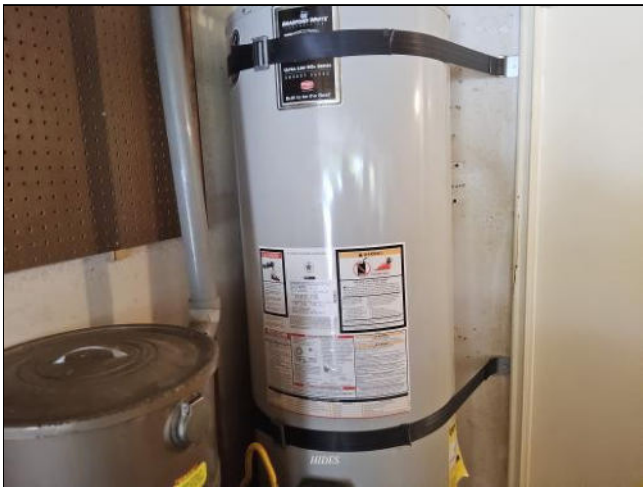
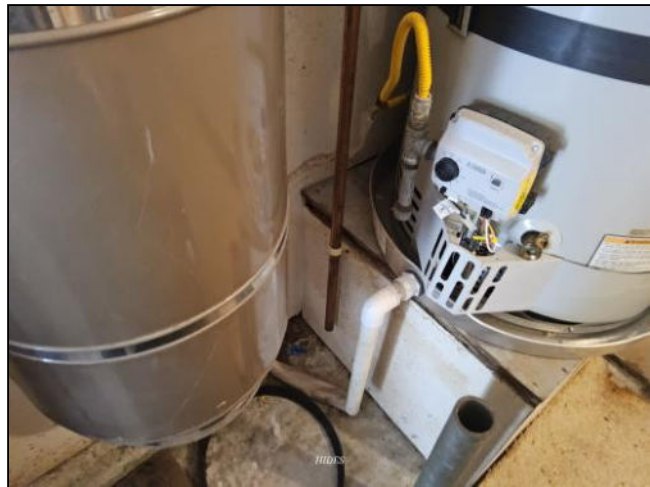
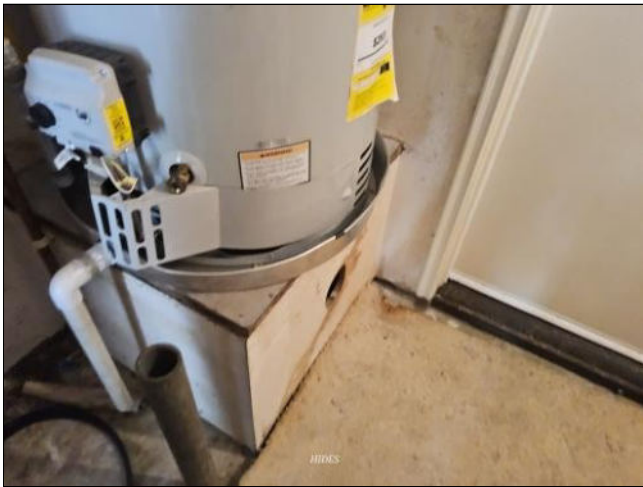
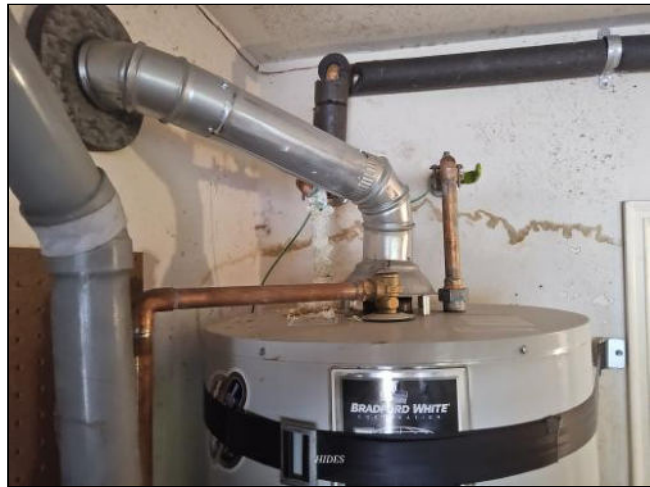
5.5 Please note that the supply lines have moderate major restriction of water pressure and or volume primarily when using multiple fixtures. Further evaluation, consultation, and inspection is highly recommended by a licensed plumber. Please note that the downstairs supply lines leading to the kitchen area have been capped / no water provided in this area, as told to the inspector by the client. As a result, supply lines and drain lines as well as components and systems related to the supply lines were unable to be inspected. Further evaluation, consultation, and inspection, is highly recommended by a licensed plumber. Substandard, non-professional installations and routing methods used was noted to the supply lines. Further evaluation is recommended by a licensed plumber. Improper installation of seismic straps, improper termination of TPR overflow pipe, and major corrosion to the outlet line and or connector, were all deficiencies noted to the water heater. Further evaluation, consultation, and inspection, is highly recommended by a licensed plumber. Please note that the water heater platform has a hole / opening and has been compromised and as a result, adjacent garage firewall has been compromised. This is a safety hazard and correction is needed. Further evaluation is recommended by a licensed general contractor and or licensed drywall contractor.

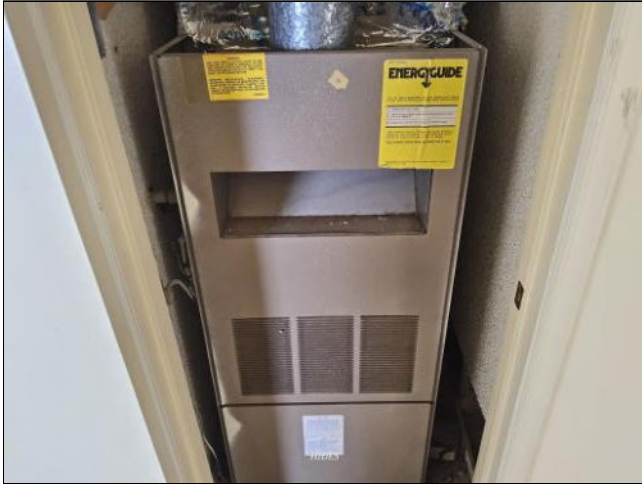
6.0 Item 1(Picture)

🔧 **6.0** Heating system turns on and off sporadically, had detached vent at ceiling collar, vent is in contact with combustible material in the attic area, has low air volume to its distribution system (due to damaged and disconnected ducting in the attic). These deficiencies are safety hazards and correction is needed. Further evaluation, consultation, and inspection, is highly recommended by a licensed HVAC contractor.

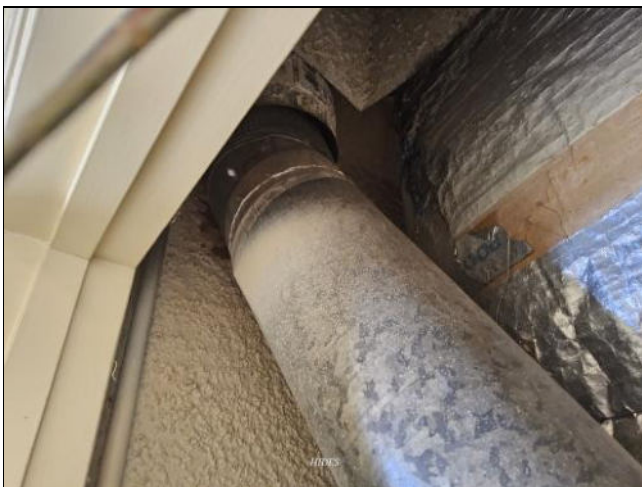
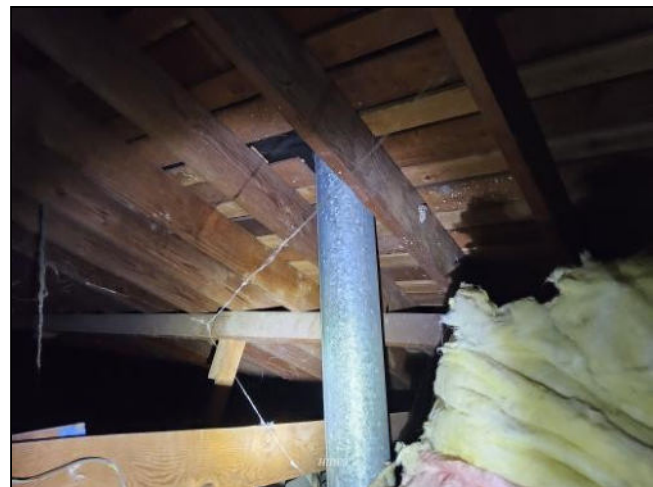
🔧 **6.3** Heating system turns on and off sporadically, had detached vent at ceiling collar, vent is in contact with combustible material in the attic area, has low air volume to its distribution system (due to damaged and disconnected ducting in the attic). These deficiencies are safety hazards and correction is needed. Further evaluation, consultation, and inspection, is highly recommended by a licensed HVAC contractor.

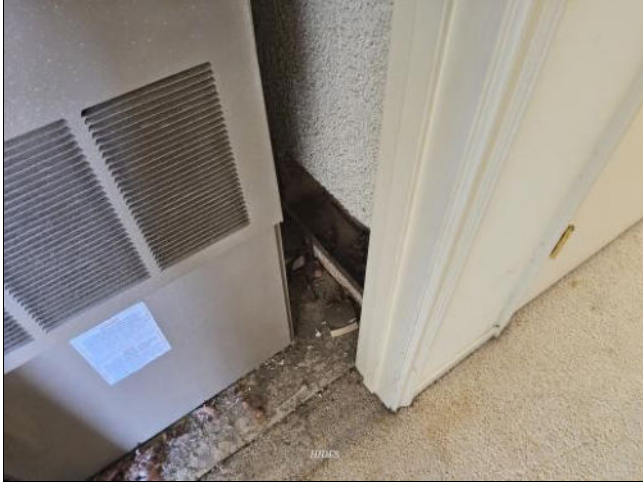
6.4 Item 1(Picture)

🔧 **6.4** Heating system turns on and off sporadically, had detached vent at ceiling collar, vent is in contact with combustible material in the attic area, has low air volume to its distribution system (due to damaged and disconnected ducting in the attic). These deficiencies are safety hazards and correction is needed. Further evaluation, consultation, and inspection, is highly recommended by a licensed HVAC contractor. Combustion air supply are missing their respective screens inside the heating system enclosure. Correction is needed. Further evaluation is recommended by a licensed HVAC contractor.

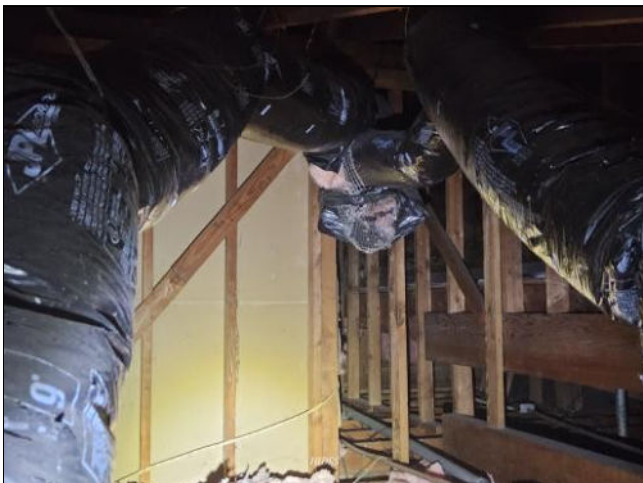
6.6 Item 1(Picture)

🔧 **6.6** Heating system turns on and off sporadically, had detached vent at ceiling collar, vent is in contact with combustible material in the attic area, has low air volume to its distribution system (due to damaged and disconnected ducting in the attic). These deficiencies are safety hazards and correction is needed. Further evaluation, consultation, and inspection, is highly recommended by a licensed HVAC contractor.

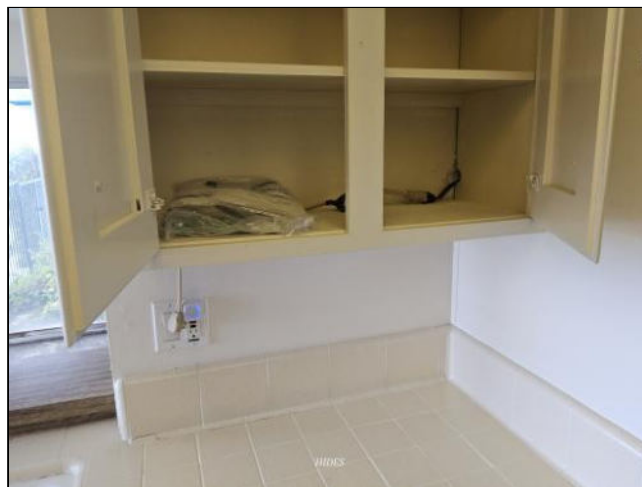
7.3 Item 2(Picture)

**7.3** Wall switch powers / controls both the upper and lower receptacles at all bedrooms. Switch should on power / control lower receptacle. This is a wiring deficiency and correction is needed. Further evaluation is recommended by a licensed electrician. Improper wiring / splicing / extension cord use as permanent wiring, were all electrical deficiencies noted in the kitchen inside cabinetry. This is a safety hazard and correction is needed. Further evaluation is recommended by a licensed electrician.

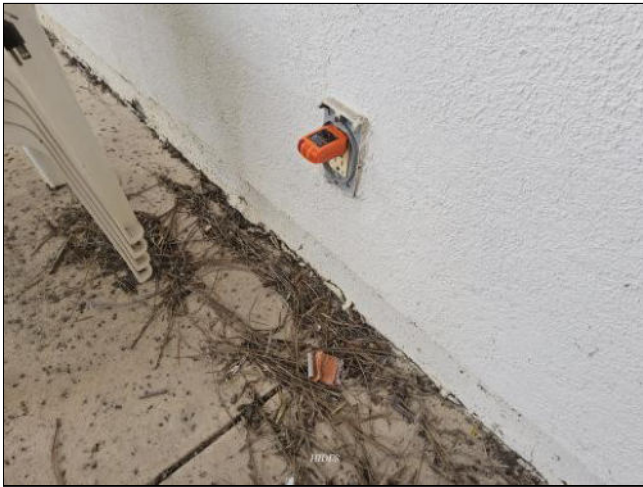
7.4 Item 1(Picture)

**7.4** Various exterior outlets were not grounded and GFCI not functional as well as missing exterior rated cover plates. These deficiencies are safety hazards and correction is needed. Further evaluation is recommended by a licensed electrician. Pool equipment GFCI is missing its exterior rated cover plates as well as various other outlets throughout the property. This is a safety hazard and correction is needed. Further evaluation is recommended by a licensed electrician.

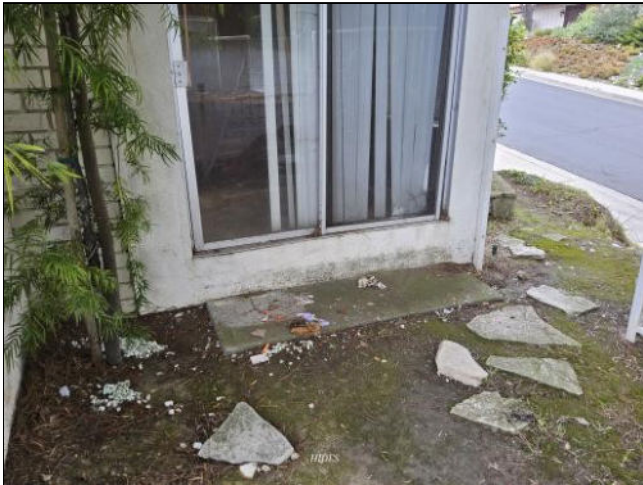
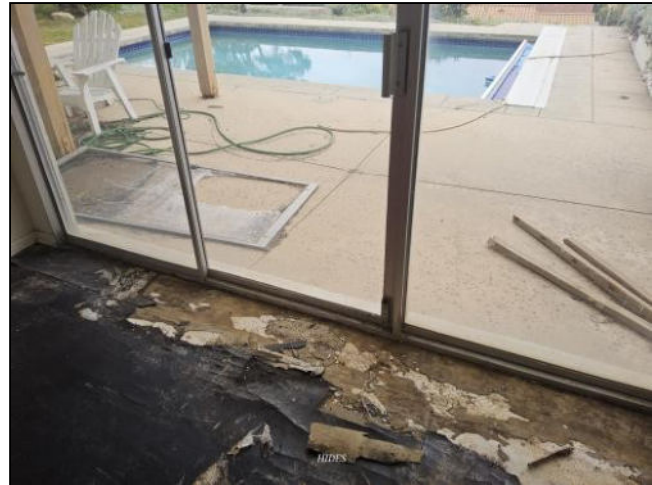
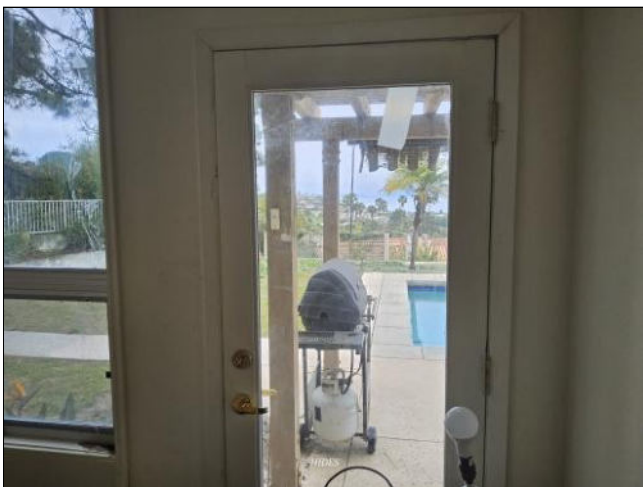
🔧 **8.0** Rear exterior sliding door does not have a landing. This is a safety hazard and correction is needed. Further evaluation is recommended by a licensed door contractor. All exterior sliding doors were difficult to operate, in need of adjustment / lubrication, have damaged or missing exterior sliding screen doors and do not appear to be tempered. Further evaluation, consultation, and inspection, is highly recommended by a licensed door contractor and or licensed general contractor. Please note that many interior doors had some sort of defect (missing hardware, non functional hardware, trim damage, door damage, doors not square to frame). Further evaluation, consultation, and inspection, is highly recommended by a licensed door contractor.

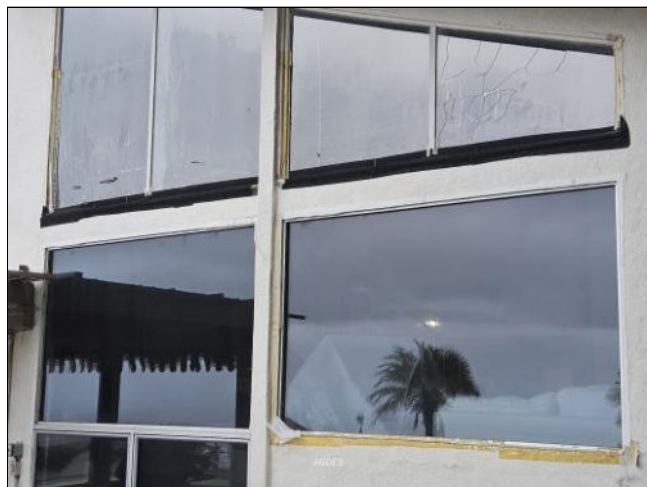
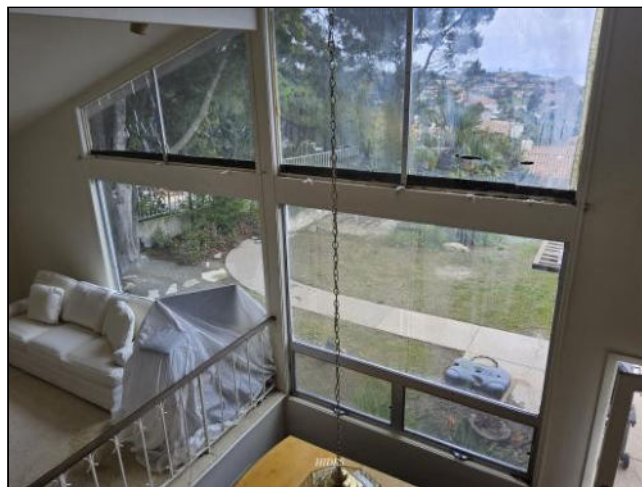
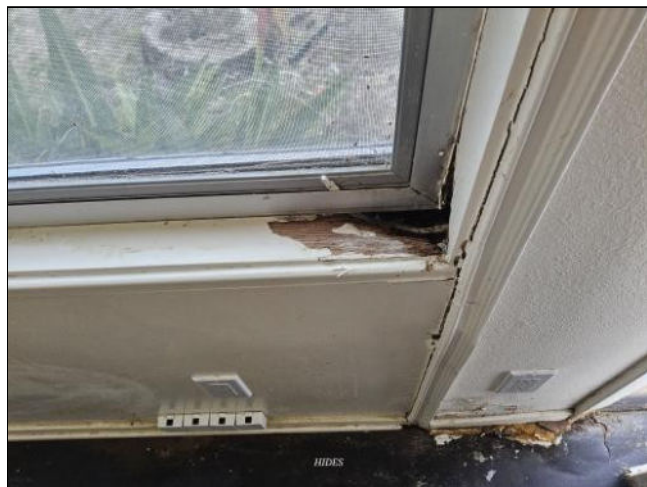
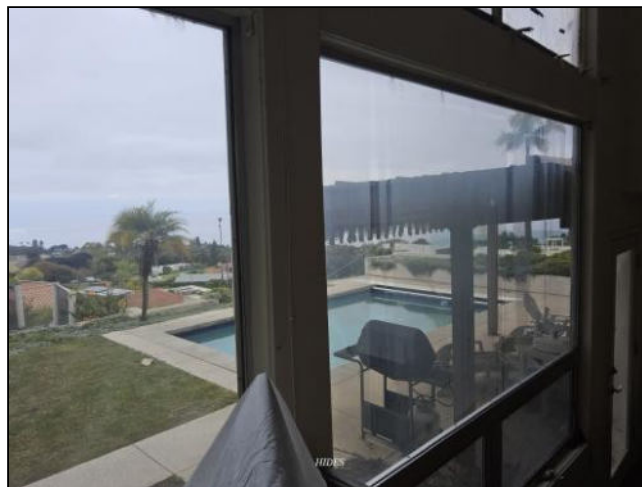
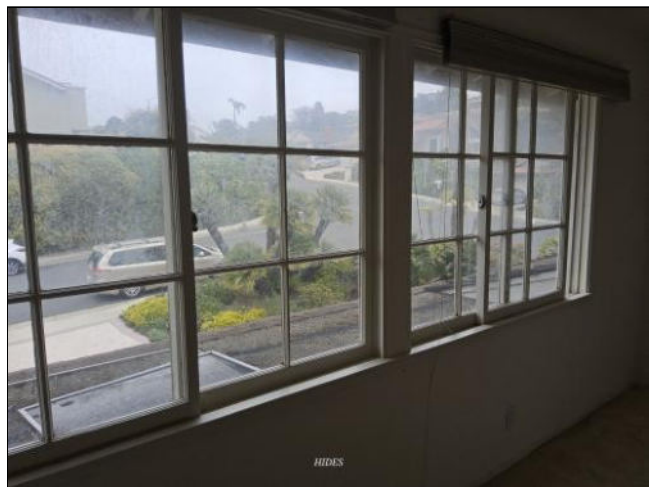
**8.1** Window has cracked glass at various locations. This is a safety hazard and correction is needed. Further evaluation is highly recommended by a licensed window contractor. Please note that there is evidence of moisture intrusion to various windows throughout the home resulting in moisture damage to window sills, interior walls, etc.. There is also evidence of moisture intrusion to rear facing windows. All of the rear facing windows are not sealed to exterior wall unions and interior wall unions. Also, many windows screens were damaged or missing. Wood casement windows were moisture damaged, difficult to operate and or painted shut with defective hardware. Further evaluation, consultation, and inspection, is highly recommended by a licensed window contractor.
