# Inspection Report

**Property Address:**  
6402 Seabryn  
Rancho Palos Verdes CA 90275

**Home Inspection Detection Services**

<b>Date:</b> 3/26/2025	<b>Time:</b> 11:00 AM	<b>Report ID:</b> KI032625-116-116
<b>Property:</b> 6402 Seabryn Rancho Palos Verdes CA 90275	<b>Customer:</b> Carol Manligas-Kishler Kevin Kishler	<b>Real Estate Professional:</b> Steve Gutierrez-Kovner John Hart Real Estate

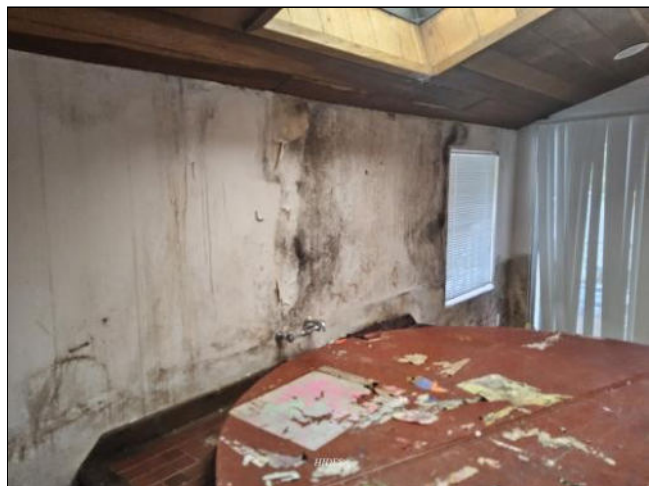
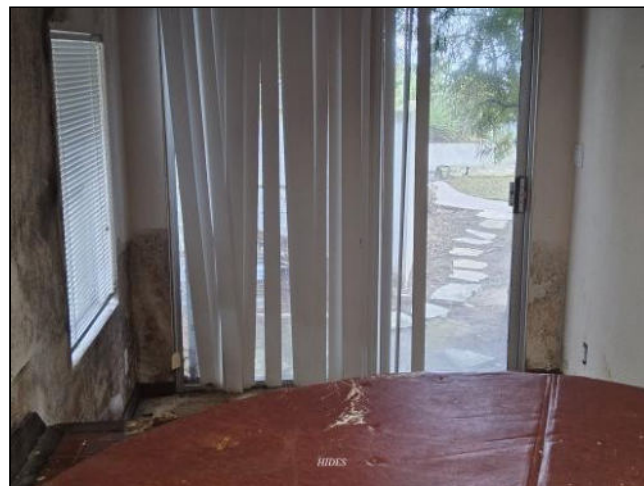
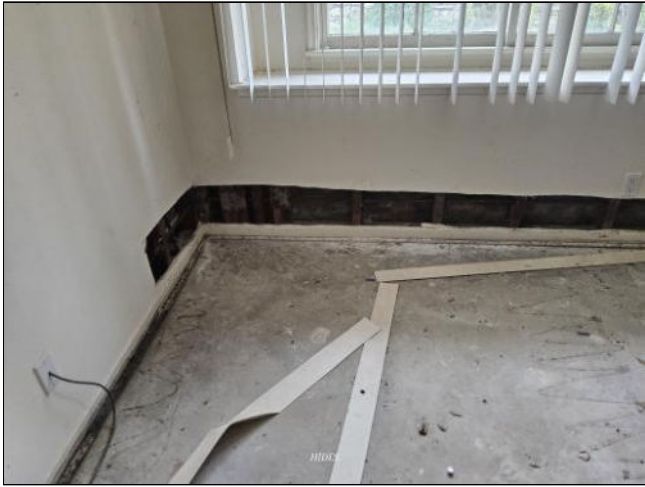
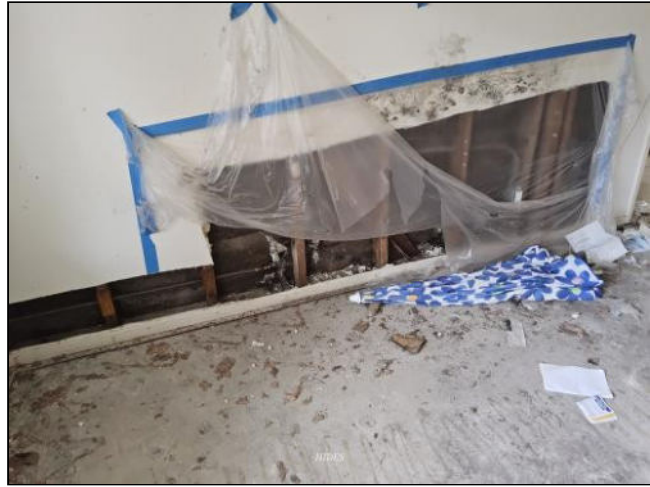
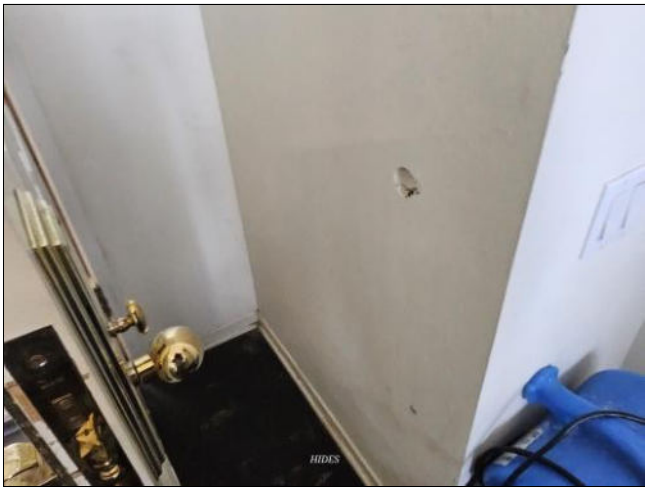
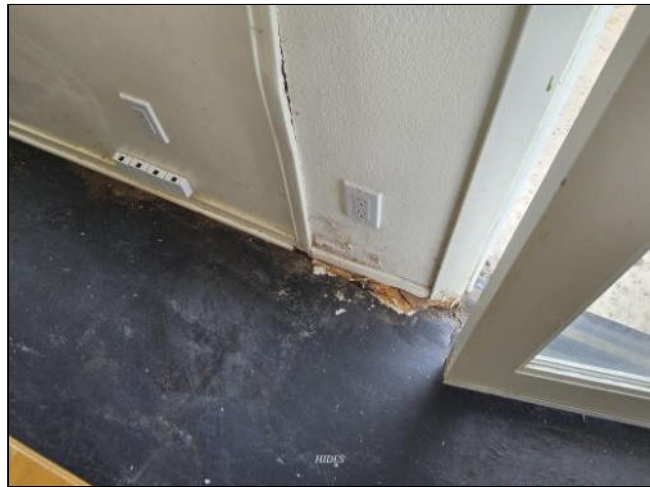
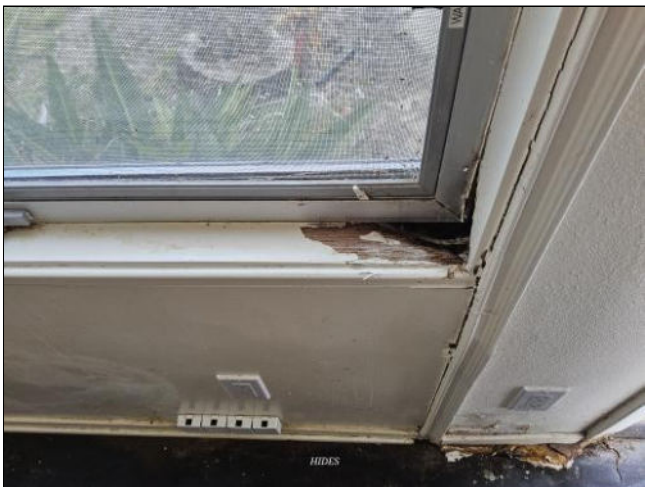
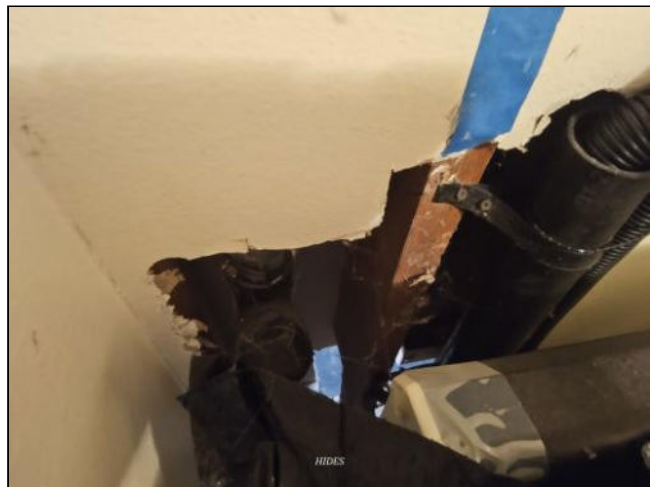
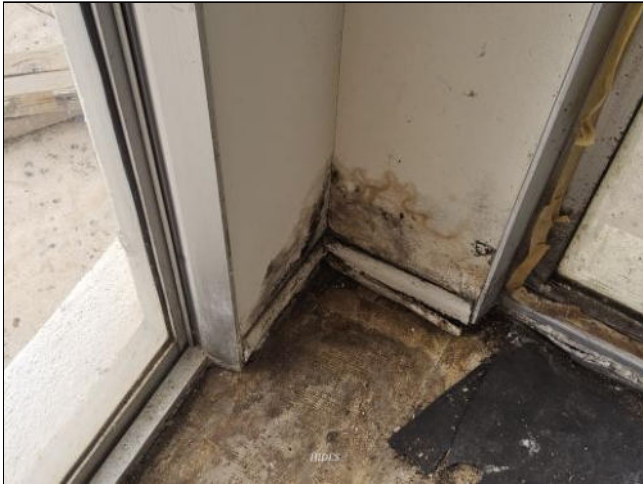
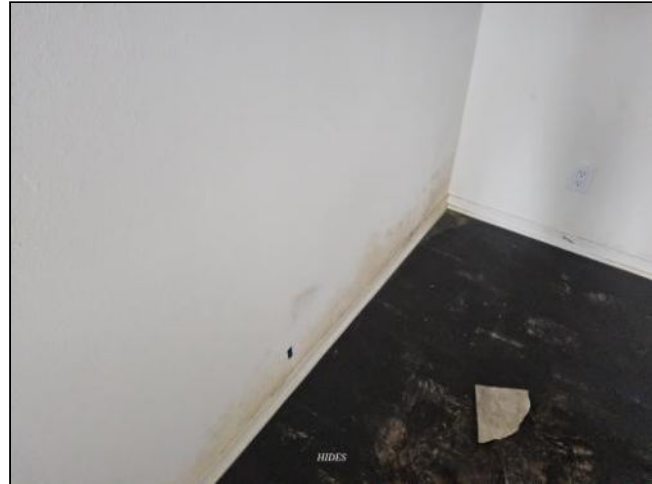
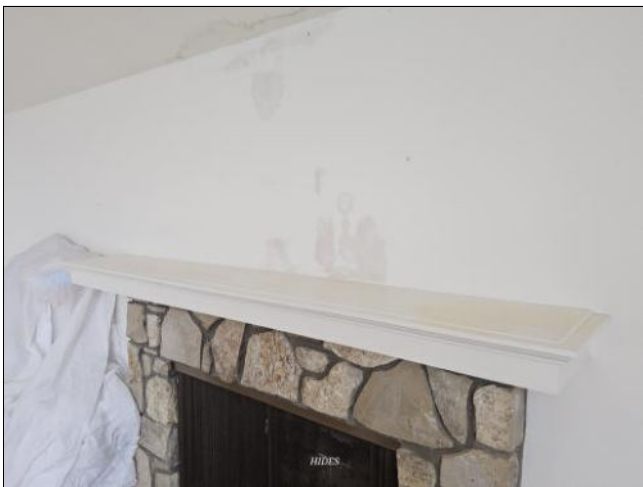
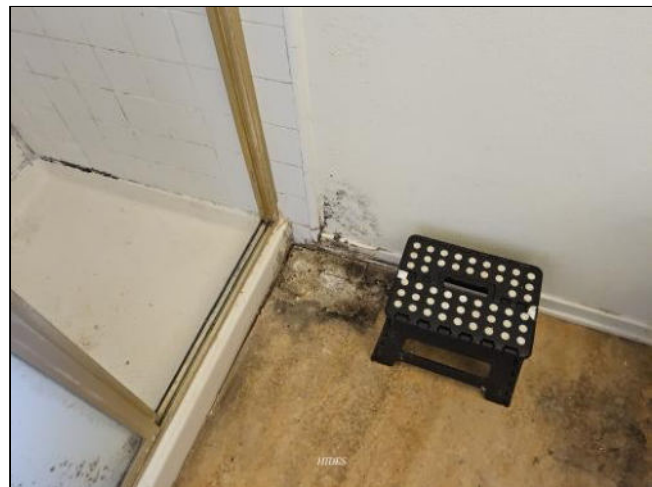
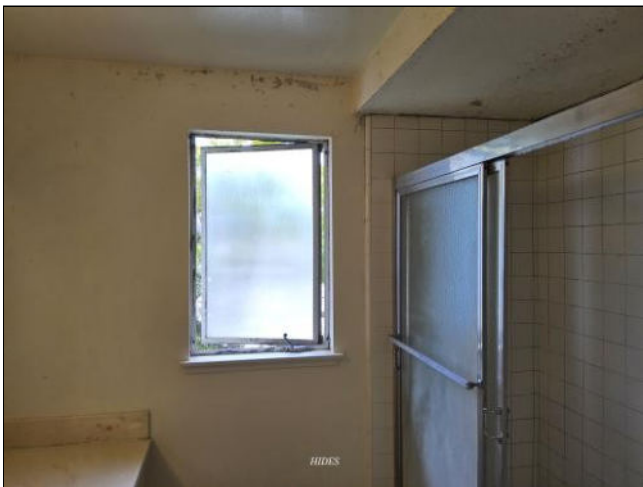
**8.2** Due to the many areas of excessive moisture stains, excessive moisture damage, excessive mold like substance, holes, openings / exposed framing noted all throughout the property, the structural integrity of the walls and ceilings and possible slab / floors may and or have been compromised. Further evaluation, consultation, and inspection, is highly recommended by a licensed general contractor, drywall contractor, mold abatement company, and a structural engineer.

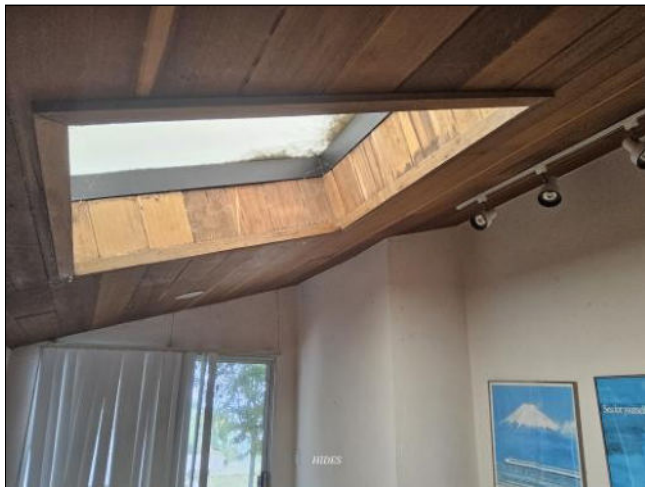
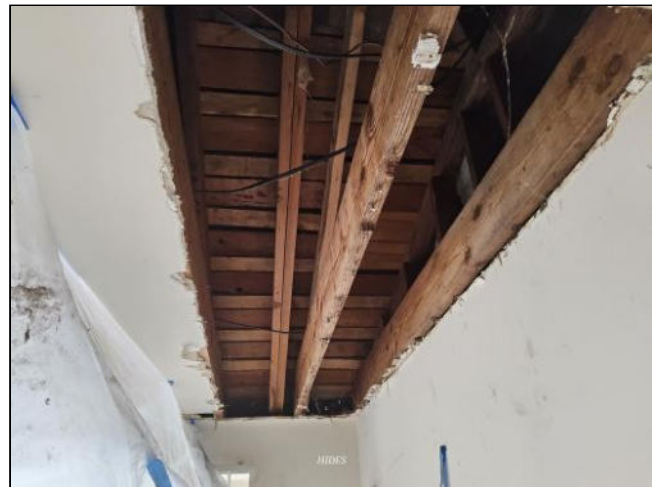
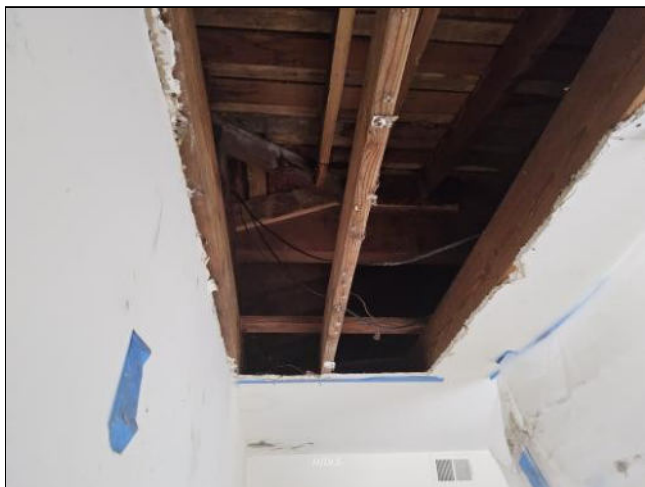
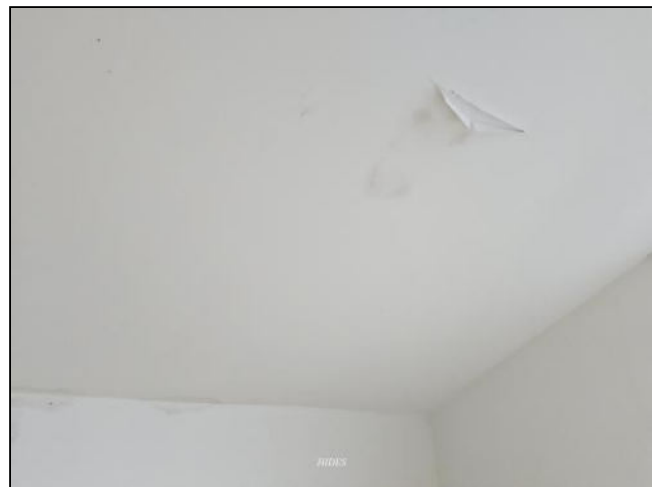
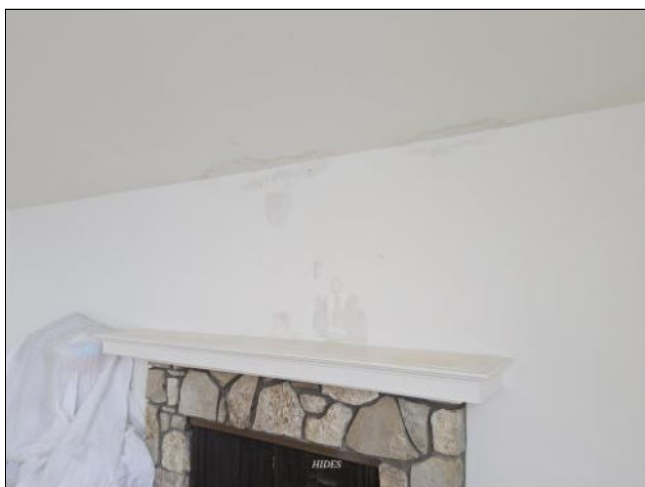
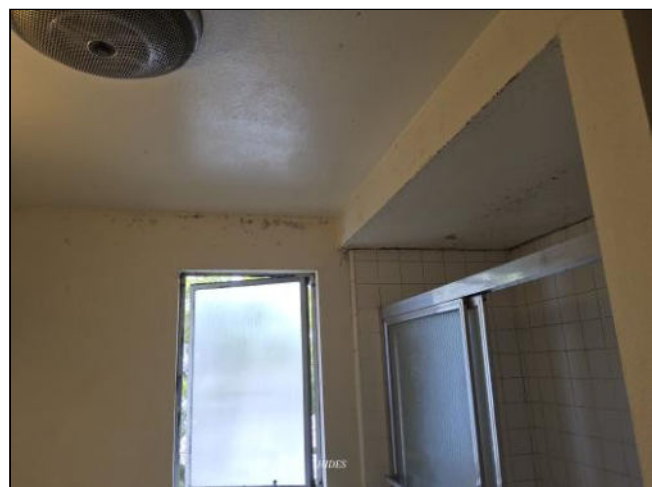
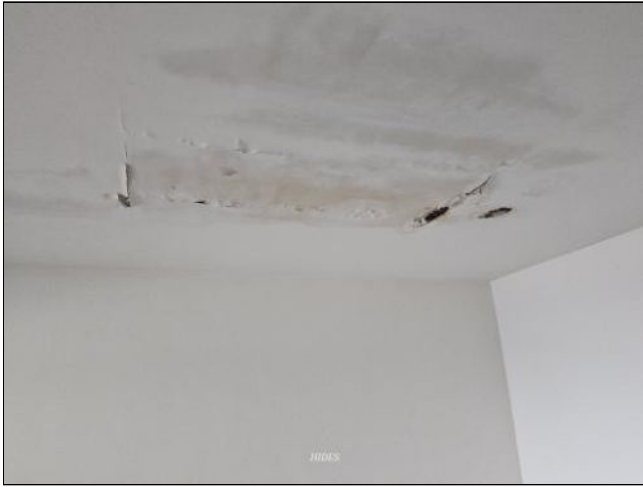
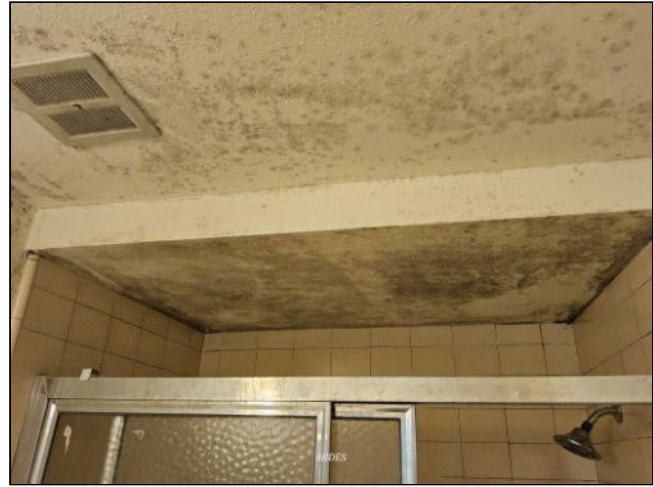
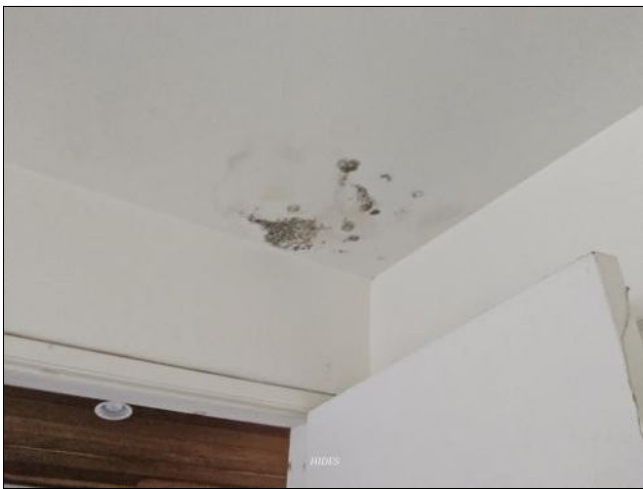
**8.3** Due to the many areas of excessive moisture stains, excessive moisture damage, excessive mold like substance, holes, openings / exposed framing noted all throughout the property, the structural integrity of the walls and ceilings and possible slab / floors may and or have been compromised. Further evaluation, consultation, and inspection, is highly recommended by a licensed general contractor, drywall contractor, mold abatement company, and a structural engineer. There is

an active leak to the supply lines and or waste / drain lines st upstairs hallway bathroom resulting in the extensive moisture damage, mold like substance to the ceiling below at family room. Further evaluation, consultation, and inspection, is highly recommended by a licensed plumber for the leak issues and subsequent general contractor, drywall contractor, mold abatement company, and possibly a structural engineer.

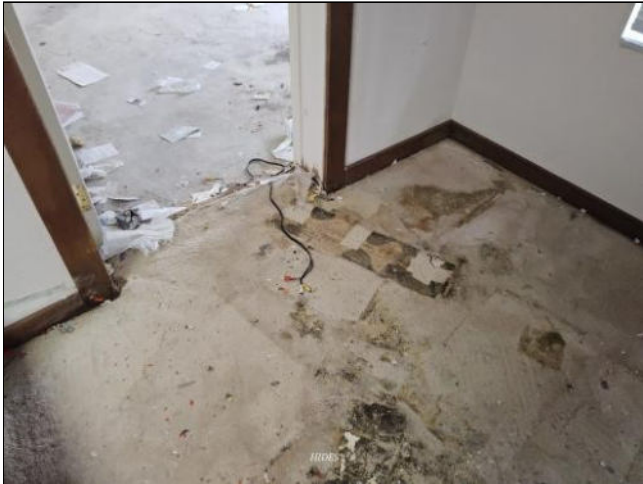
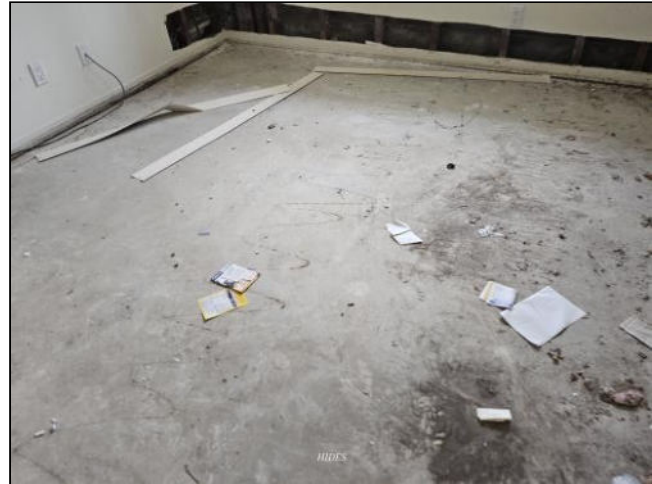
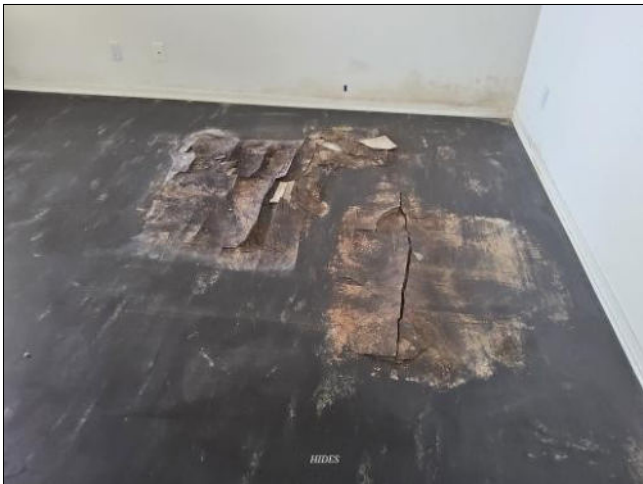
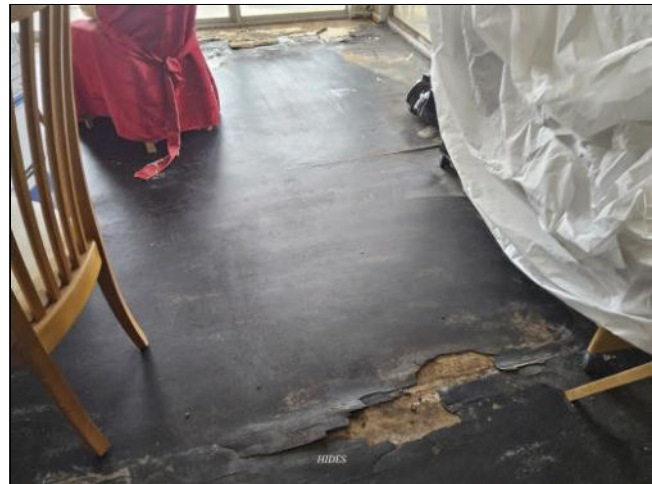
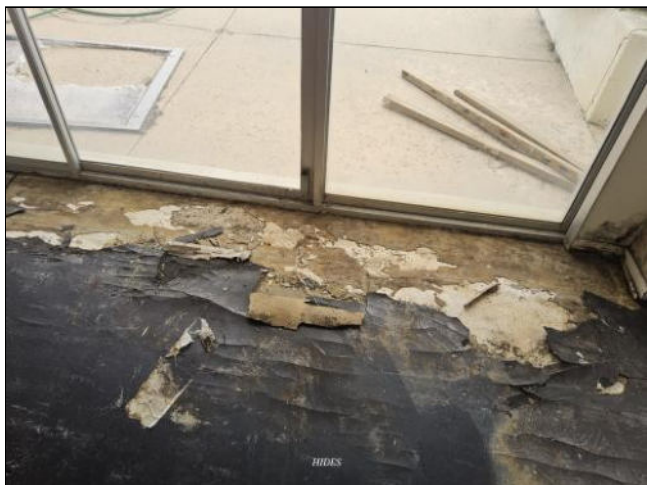
**8.4** Due to the many areas of excessive moisture stains, excessive moisture damage, excessive mold like substance, holes, openings / exposed framing noted all throughout the property, the structural integrity of the walls and ceilings and possible slab / floors may and or have been compromised. Further evaluation, consultation, and inspection, is highly recommended by a licensed general contractor, drywall contractor, mold abatement company, and a structural engineer. There is an active leak to the supply lines and or waste / drain lines st upstairs hallway bathroom resulting in the extensive moisture damage, mold like substance to the ceiling below at family room. Further evaluation, consultation, and inspection, is highly recommended by a licensed plumber for the leak issues and subsequent general contractor, drywall contractor, mold abatement company, and possibly a structural engineer. Missing floor coverings were noted at many locations with heavy stains and damage to floor coverings. Further evaluation is highly recommended by a licensed flooring contractor.

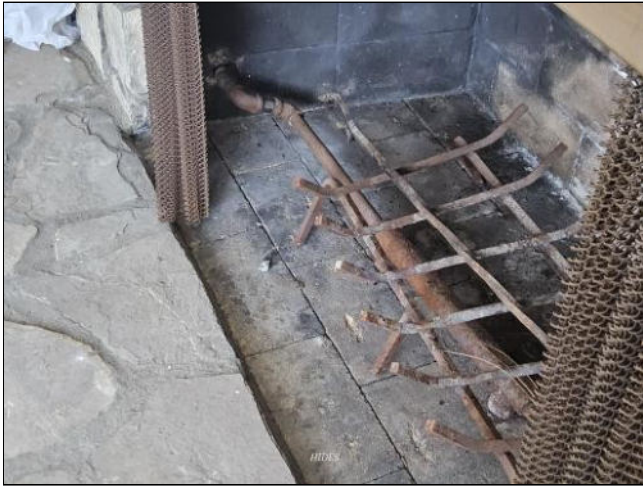
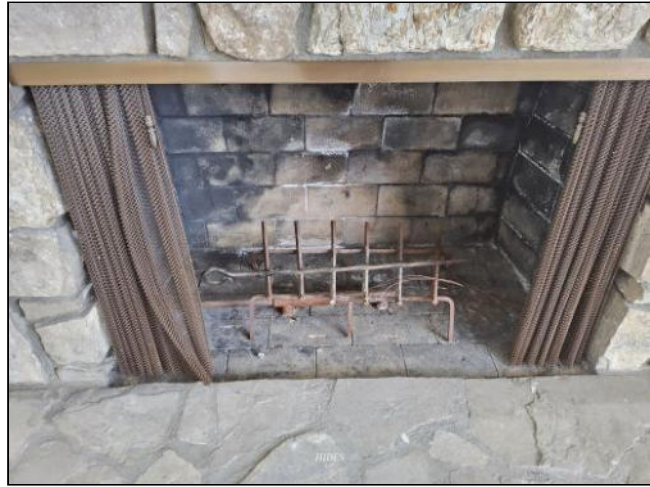
**8.5** Gas entry line inside the fireplace is not sealed and line has excessive rust / corrosion. The rust / corrosion to the gas line inside the firebox is a direct result of moisture intrusion and or penetration of the chimney / fireplace. This is a safety hazard and correction is needed. Further evaluation is recommended by a licensed general or licensed fireplace / chimney contractor. Fireplace appears to have not been serviced or swept for some time. Further evaluation, consultation, and inspection, is

highly recommended by a licensed fireplace / chimney contractor.

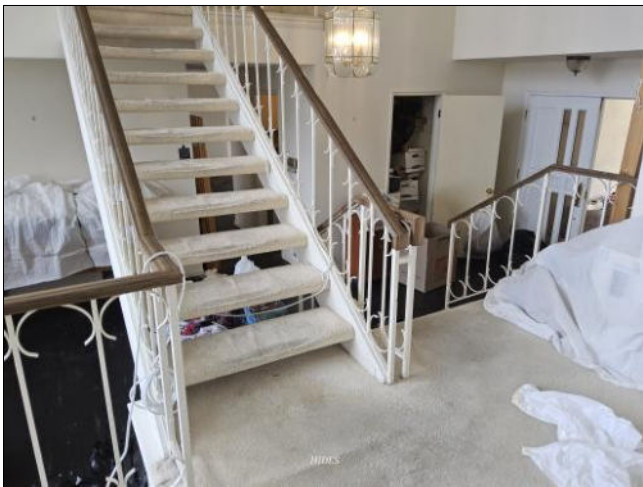
8.6 Item 1(Picture)

**8.6** A staircase railings and balusters are too wide by today's construction / safety standards. This is a safety hazard and correction is recommended by a licensed general contractor.

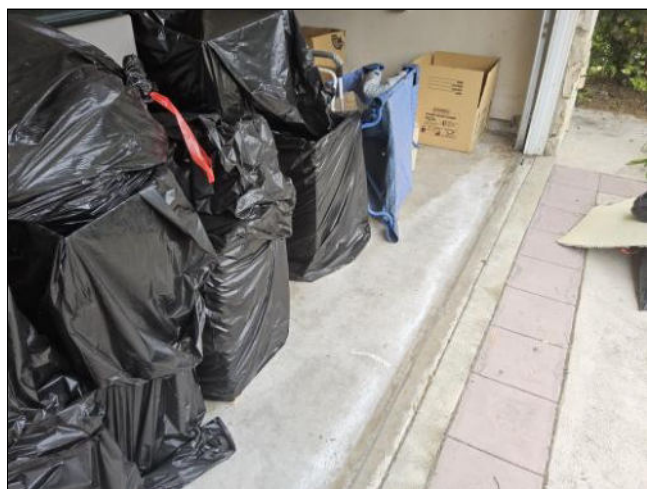
10.0 Item 1(Picture)

**10.0** Moderate cracks were noted to the garage floor / slab. Regular maintenance and or inspection is advised. Evidence of moisture intrusion and or penetration was noted to the garage floor, resulting in efflorescence, was noted. Further evaluation is recommended by a licensed general contractor.

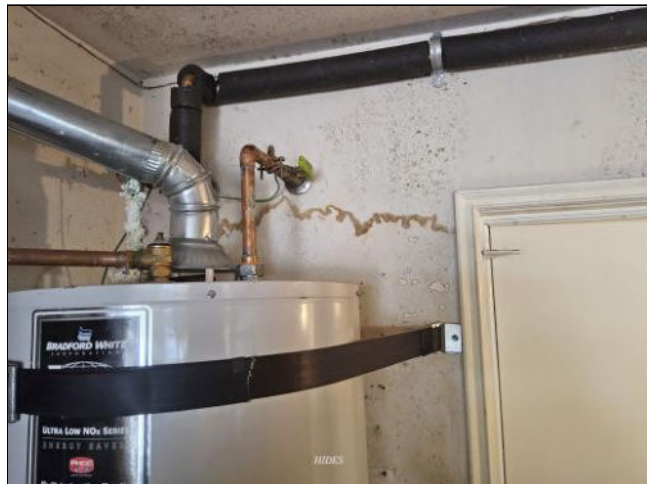
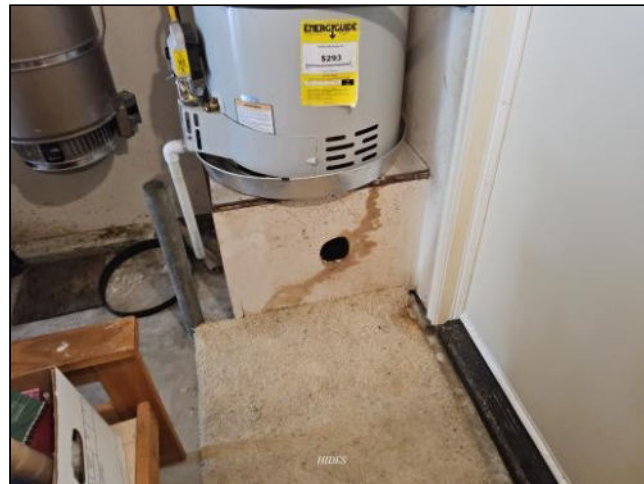
**10.1** Moisture stains were noted to the garage wall(s). Although stains are dry, regular maintenance and or inspection is advised. Holes, openings were noted to to the garage firewall / firewall ceiling. This is a safety hazard and correction is needed. Further evaluation is recommended by a licensed drywall contractor. Please note that the water heater platform has a hole / opening and has been compromised and as a result, adjacent garage firewall has been compromised. This is a safety hazard and correction is needed. Further evaluation is recommended by a licensed general contractor and or licensed drywall contractor.

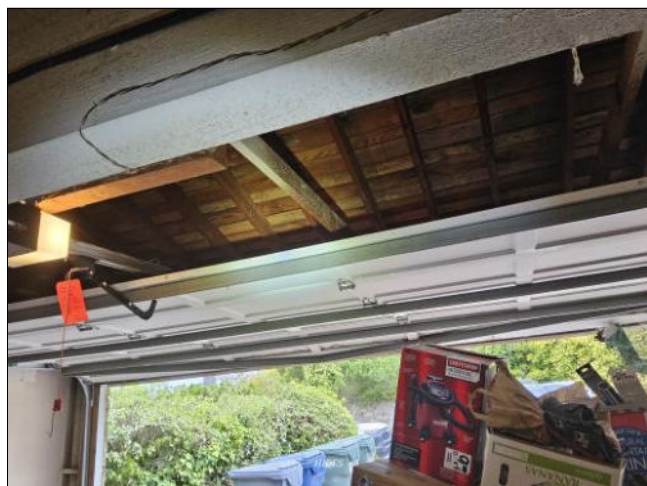
10.2 Item 1(Picture)

**10.2** Moisture stains were noted to the garage ceiling(s). Although stains are dry, regular maintenance and or inspection is advised.

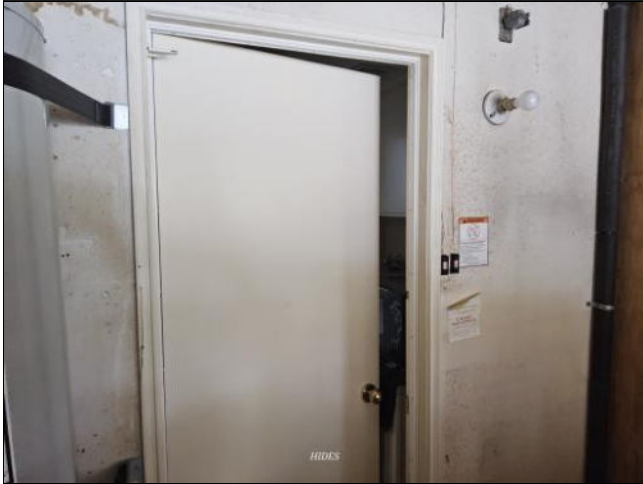
10.4 Item 1(Picture)

**10.4** The garage door to living space is missing its self closing device. This is a safety hazard and correction is needed. Further evaluation is recommended by a licensed door contractor.

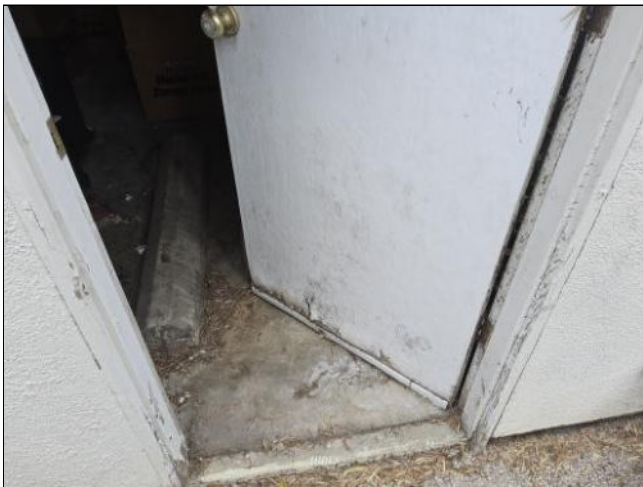
10.5 Item 1(Picture)

**10.5** Garage exterior door is moisture damaged. Correction is needed. Further evaluation is recommended by a licensed door contractor and or licensed pest control / termite company.

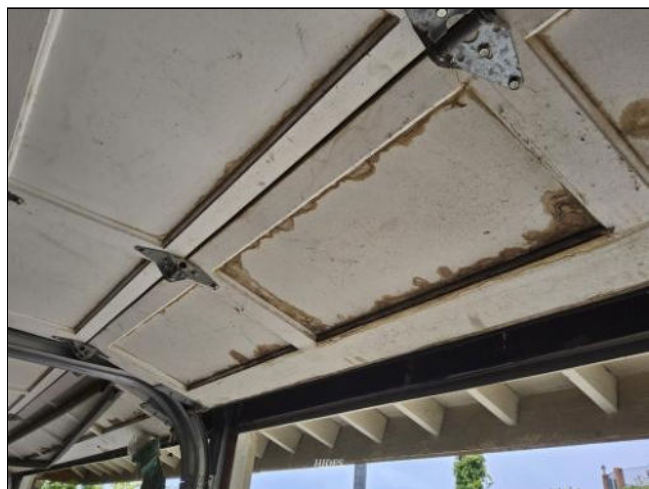
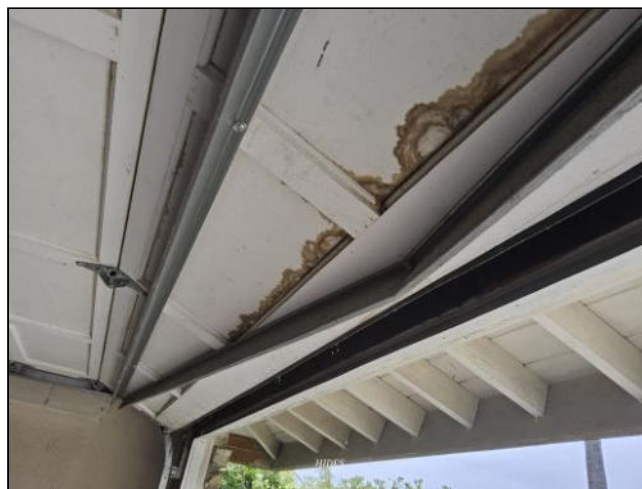
**10.6** Garage vehicle doors have moisture stains and some moisture damage at base of doors (moisture intrusion / penetration). Correction is needed. Further evaluation is recommended by a licensed garage vehicle door installation company / contractor.

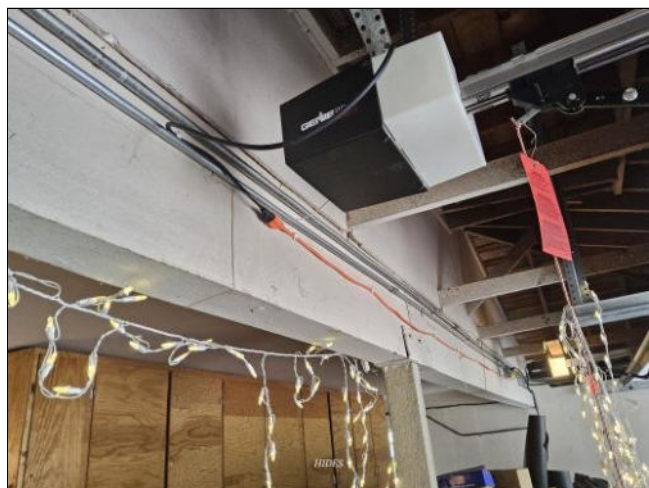
10.8 Item 1(Picture)

**10.8** Improper light fixture wiring noted in the garage. This is as a safety hazard and correction is needed. Further evaluation is recommended by a licensed electrician. Missing outlet and or switch covert plates were noted in the garage. This is a safety hazard and correction is needed. Further evaluation is recommended by a licensed electrician. Unprotected / exposed wiring was noted in the garage. This is a safety hazard and correction is needed. Further evaluation is recommended by a licensed electrician.

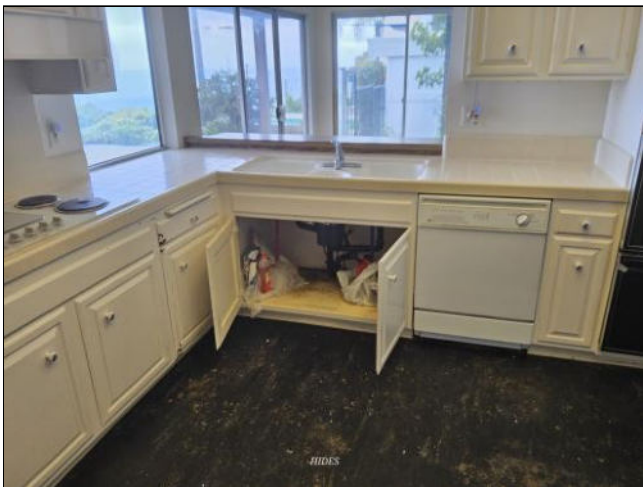
11.0 Item 1(Picture)

🔧 **11.0** Please note that the supply lines have moderate major restriction of water pressure and or volume primarily when using multiple fixtures. Further evaluation, consultation, and inspection is highly recommended by a licensed plumber. Please note that the downstairs supply lines leading to the kitchen area and laundry room area have been capped / no water provided in this area, as told to the inspector by the client. As a result, supply lines and drain lines as well as components and systems related to the supply lines were unable to be inspected. Further evaluation, consultation, and inspection, is highly recommended by a licensed plumber. Substandard, non-professional installations and routing methods used was noted to the supply lines. Further evaluation is recommended by a licensed plumber. There is an active leak to the supply lines and or waste / drain lines st upstairs hallway bathroom resulting in the extensive moisture damage, mold like substance to the ceiling below at family room. Further evaluation, consultation, and inspection, is highly recommended by a licensed plumber for the leak issues and subsequent general contractor, drywall contractor, mold abatement company, and possibly a structural engineer.

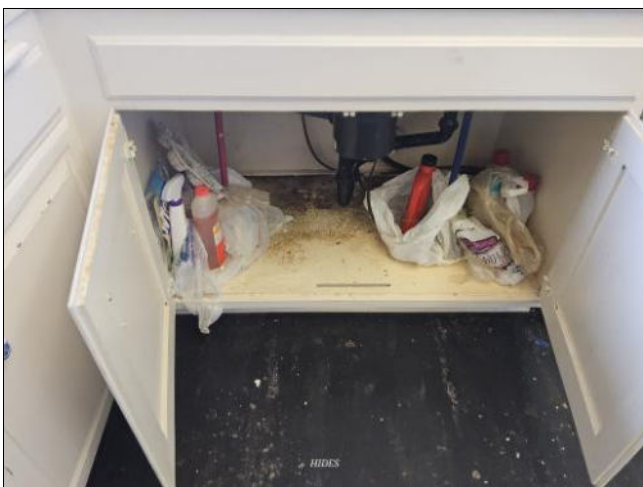
11.1 Item 1(Picture)

🔧 **11.1** Moisture damage was noted to cabinetry / platform underneath the kitchen sink. Further evaluation is recommended by a licensed cabinetry contractor and or licensed pest control / termite company.

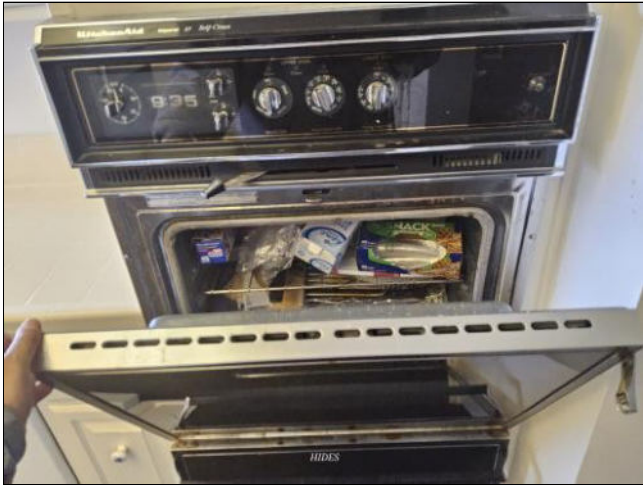
11.3 Item 1(Picture)

**11.3** Ovens were being used as storage. Inspector was unable to inspect and therefore verify functionality.

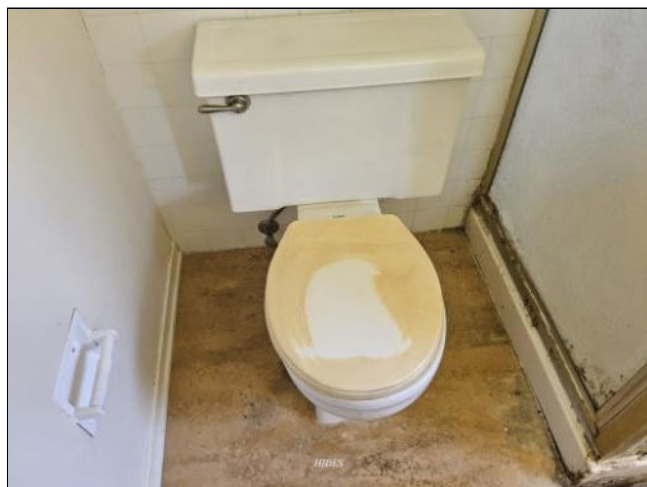
12.0.A Item 1(Picture)

**12.0.A** Master bathroom toilet takes a long time to flush indicating possible stoppage issues. Further evaluation is recommended by a licensed plumber.

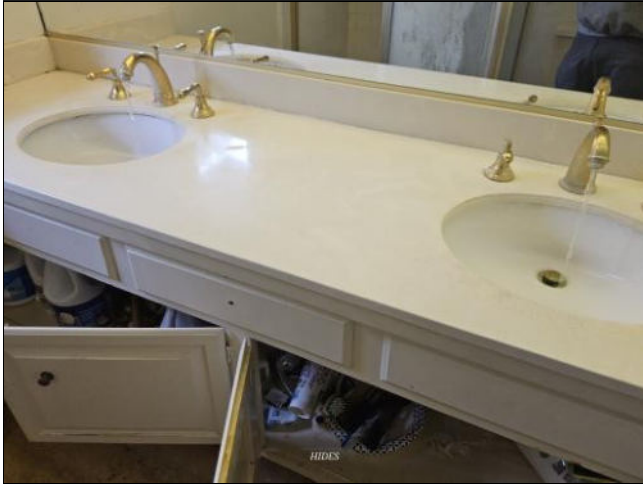
12.1.A Item 1(Picture)

**12.1.A** Extremely low water pressure was observed to master bathroom sinks and shower. Correction is needed. Further evaluation is recommended by a licensed plumber.

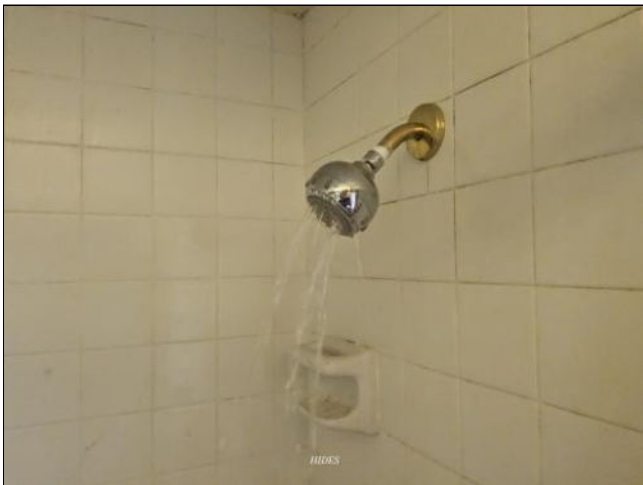
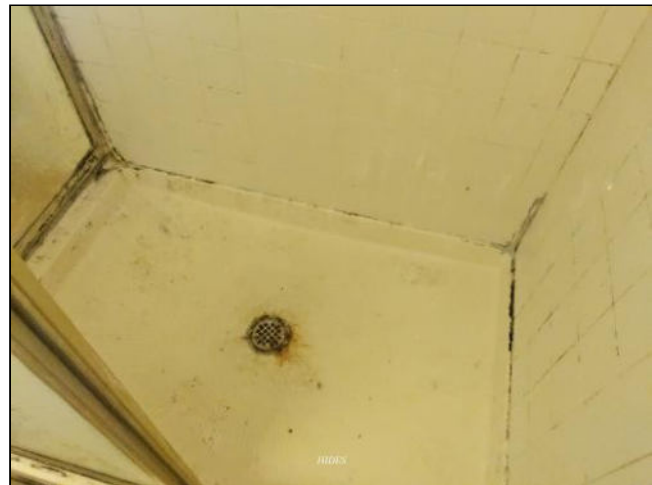
**12.4.A** Extremely low water pressure was observed to master bathroom sinks and shower. Correction is needed. Further evaluation is recommended by a licensed plumber.

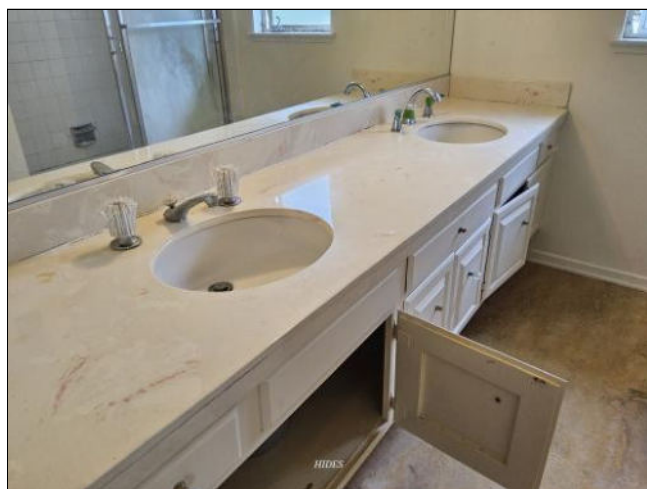
12.1.B Item 1(Picture)

**12.1.B** Right side upstairs hallway bathroom right side sink is not functional and left side sink drain line leaks as well as faucet. Correction is needed. Further evaluation is recommended by a licensed plumber.

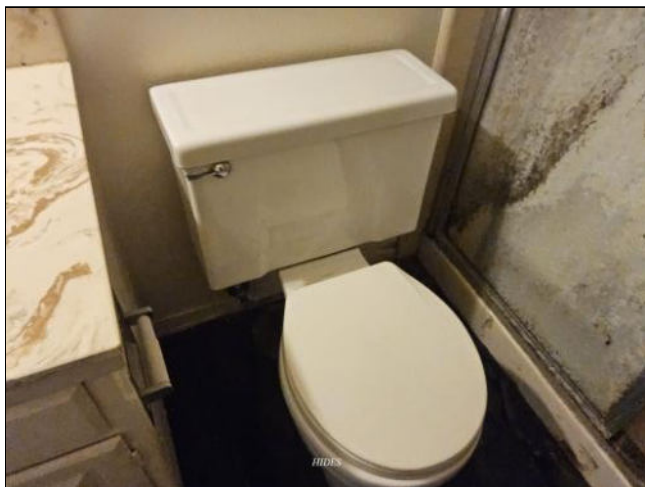
12.0.C Item 1(Picture)

**12.0.C** Downstairs bathroom toilet does not flush / has defective / not functional flushing lever.

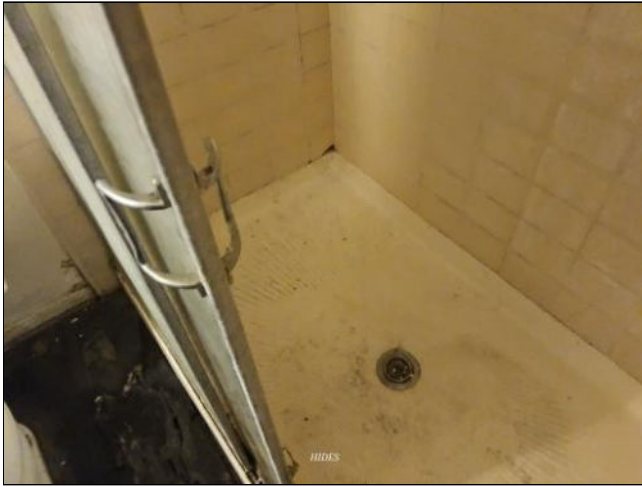
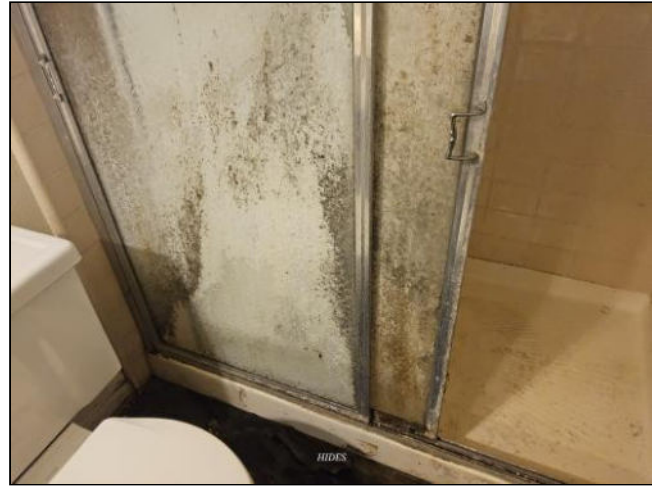
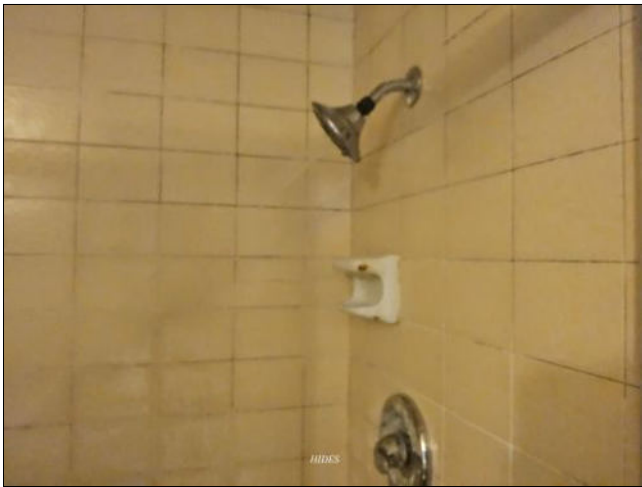
**12.4.C** Heavy deterioration, mildew, and possible mold like substance was observed at downstairs bathroom, shower enclosure. Further evaluation is highly recommended by a licensed mold abatement company. Downstairs bathroom shower head leaks. Correction is recommended by a licensed plumber.

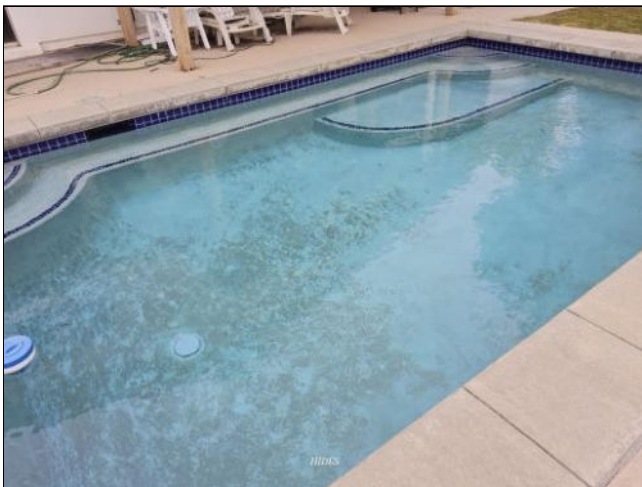
13.0 Item 1(Picture)

**13.0** Surface deterioration was noted to the pool. Regular maintenance and or inspection is advised. Please note that the edge of the pool towards the rear of the property is quite close to an embankment and may have inadequate support of adjacent soil and embankment. This may also and or is impacting the adjacent deck as well. Further evaluation, consultation, and inspection, is highly recommended by a licensed geo-technical contractor as to soil in this area.

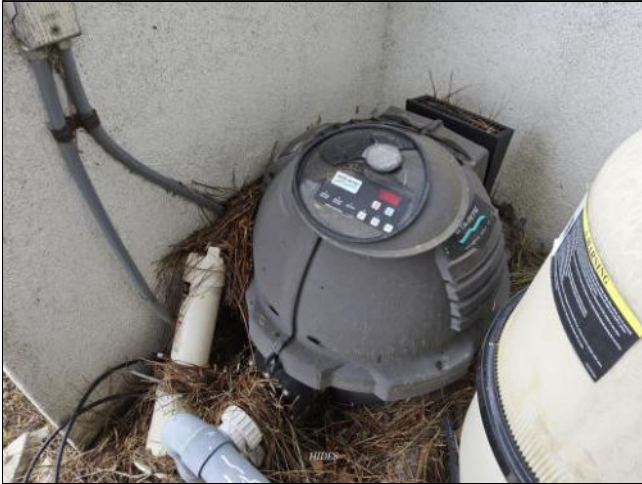
13.1 Item 1(Picture)

**13.1** Pool heater was not responsive / currently functional. Further evaluation is recommended by a licensed pool contractor.

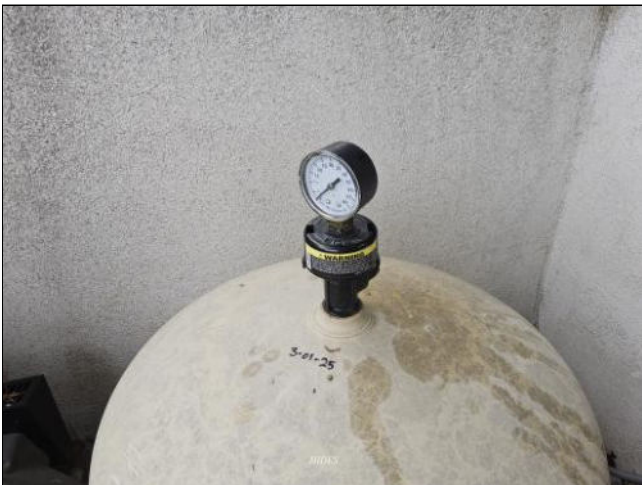
13.2 Item 1(Picture)

**13.2** Diatomaceous pool filter pressure gage shows no reading when in operation. Correction is needed. Further evaluation is recommended by a licensed pool contractor.

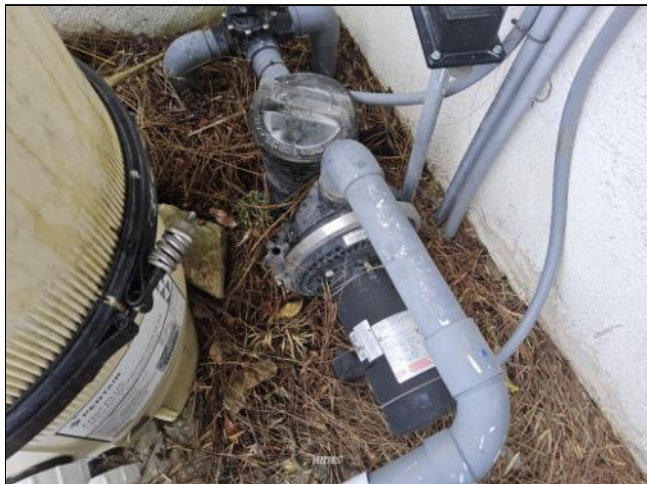
13.3 Item 1(Picture)

**13.3** Pool circulation pump leaking and has no body bond. Correction is needed. Further evaluation is recommended by a licensed pool contractor.

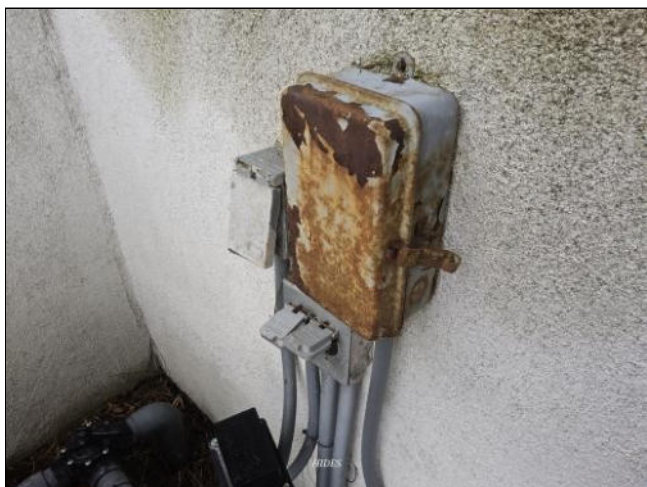
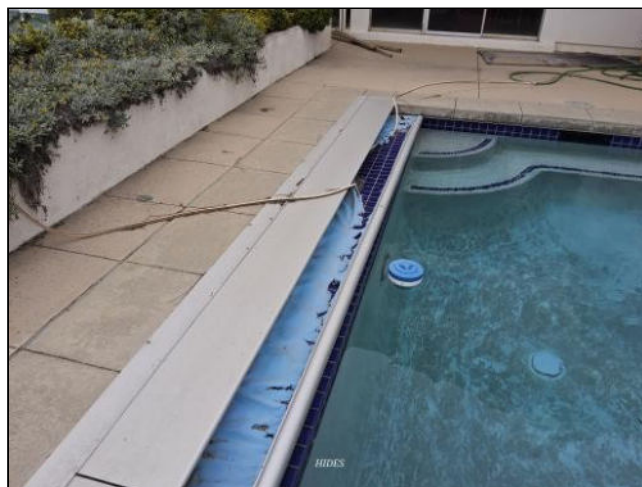
**13.5** Pool equipment GFCI is missing its exterior rated cover plates as well as various other outlets throughout the property. This is a safety hazard and correction is needed. Further evaluation is recommended by a licensed electrician. Pool time box is heavily corroded and replacement is needed. Further evaluation is recommended by a licensed pool contractor and or licensed electrician. Electronic pool cover is not functional, as mentioned to the inspector from client. Further evaluation is recommended by a licensed pool contractor as to its functionality and issues.

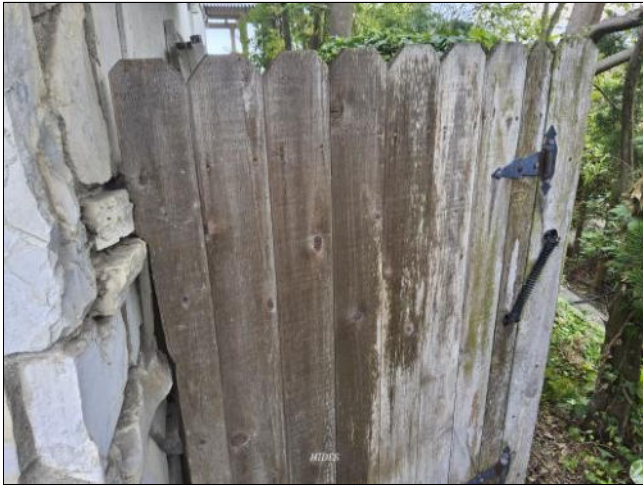
13.6 Item 1(Picture)

**13.6** Perimeter gates are in need of self closing devices or devices are not functional due to pool / spa installation. This is a safety hazard and correction is needed. Further evaluation is recommended by a licensed gate installation company / contractor. Common to moderate cracks were noted to the pool surrounding deck areas. Further evaluation is recommended by a licensed pool contractor. Surface deterioration was noted to the pool. Regular maintenance and or inspection is advised. Please note that the edge of the pool towards the rear of the property is quite close to an embankment and may have inadequate support of adjacent soil and embankment. This may also and or is impacting the adjacent deck as well. Further evaluation, consultation, and inspection, is highly recommended by a licensed geo-technical contractor as to soil in this area.
