### *Inspection Report*

Address: 2649 Vine St Paso Robles, CA 93446

2/11/23

Inspector: Keith Vreeken, MCI, FCI  
P.O. Box 415 Templeton, CA 93465 O: 805.462.1978 C: 805.440.5050

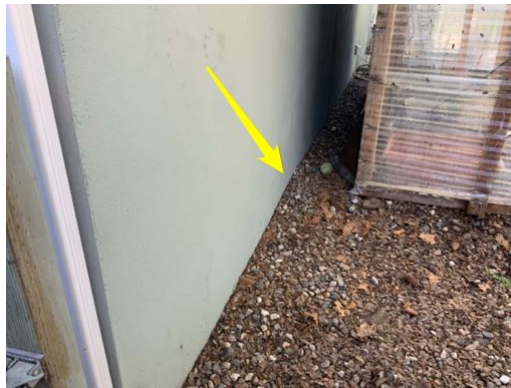
Example at house

**MR 41:** Soil level found high at areas of the exterior. Soil should be a minimum of 6 inches from the top of the garage and house concrete stem wall to the exterior dirt, rock, mulch or wood chips.

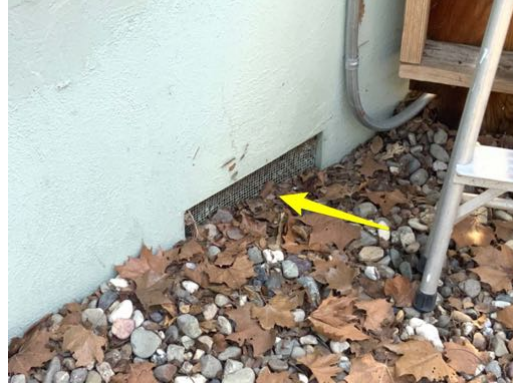
Example

**MR 44:** Areas of the surrounding soil areas found higher or above the crawlspace ventilation opening. This can allow water to flow unrestricted into the crawlspace. Upgrades recommended.

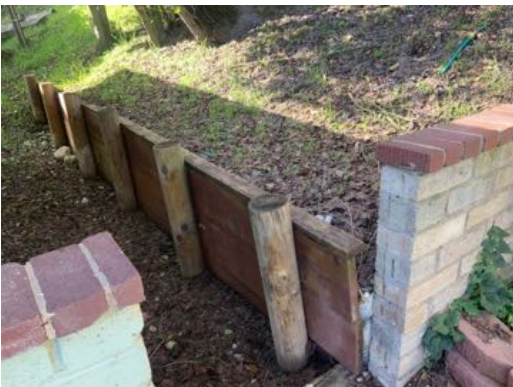
### 46: Wood

**Disclosure:** Wood retaining walls have a limited lifespan and will eventually need to be repaired or replaced. Client is advised to continue to monitor and repair or replace as needed.

**E&C 47:** Some moisture damage, deterioration, and/or leaning of the wood retaining walls. *Be aware that wood retaining walls have a limited lifespan and will warrant eventual replacement. Monitor all wood walls and upgrade or repair as needed.*

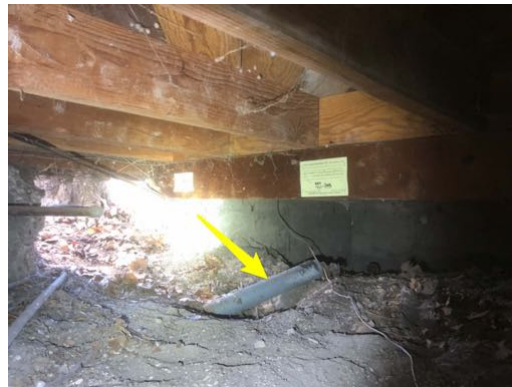
**E&C SU 58:** Many of the posts under the home at the foundation system found to be leaning with one post that had fallen over near the crawlspace opening. Recommend further review of all piers, posts and girder connections with Upgrades and Repairs by qualified contractor.

A Structural support post had fallen over

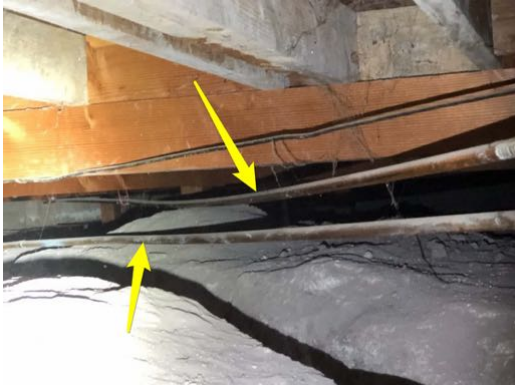
Example

**E&C 79:** Some water supply pipes lack proper support, strapping or fastening in areas of the crawlspace.

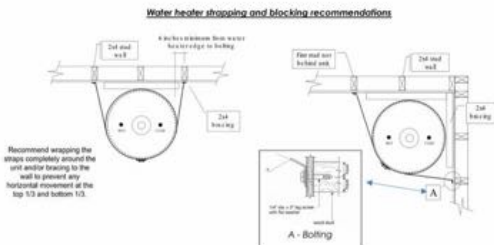
**E&C 87: The Water heater is loosely strapped & not secured well - moves when pushed .** Recommend adding **BRACING OR BLOCKING** to the wall to properly secure the tank per Uniform Plumbing Code and State Architect Requirements.

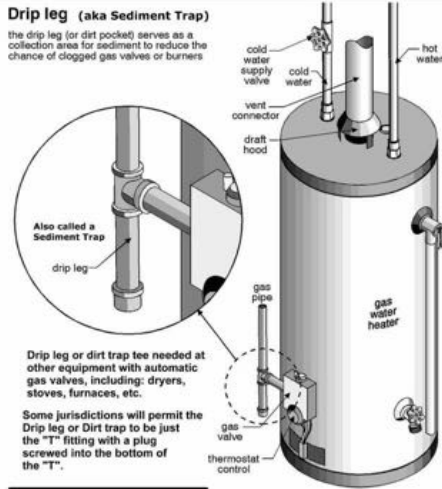
FIGURE 1212.8  
METHOD OF INSTALLING A  
TEE FITTING SEDIMENT TRAP  
[NFPA 54: FIGURE 9.6.7]

**E&C 91:** Recommend the installation of the missing sediment trap / drip leg at the WATER HEATER gas piping at flex connection by a certified or licensed plumbing professional familiar with minimum requirements.

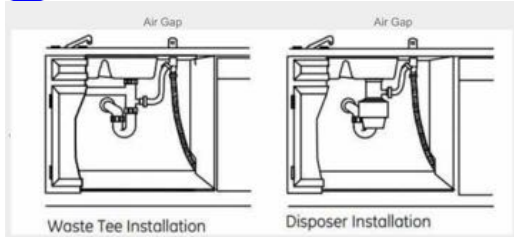
**SU 97:** Recommend an Air Gap Device at the dishwasher drain.

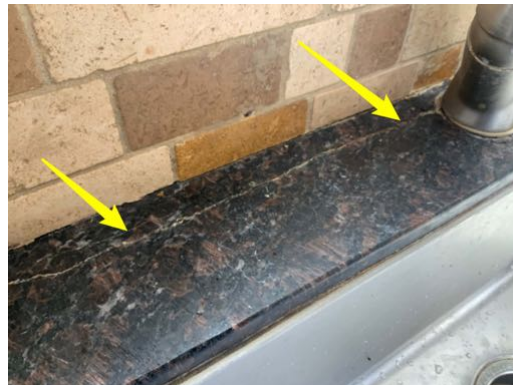
**FI 102: Disclosure:** Some cracks noted at the kitchen counter: Ex. Behind the kitchen sink faucet.

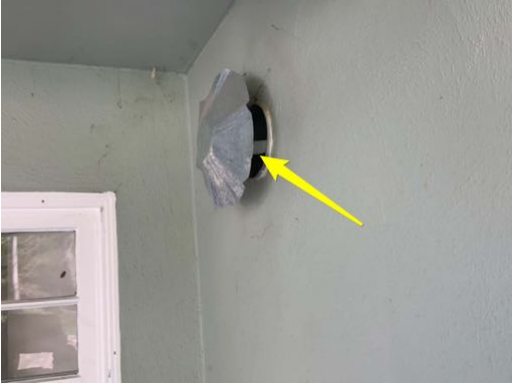
**E&C 108:** Recommend a proper screen at the kitchen cooktop exhaust vent termination cap. A proper screen is recommended per standards to help prevent critter intrusion.

A proper screen cap is recommended to prevent critter intrusion

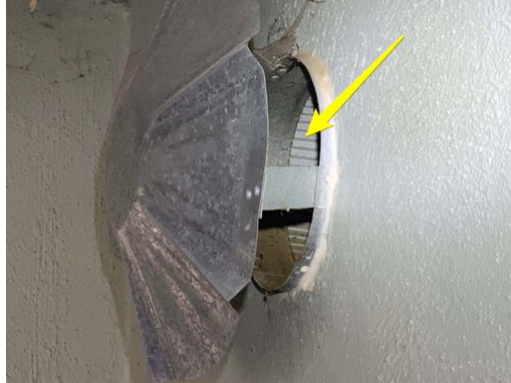
A proper screen cap is recommended to prevent critter intrusion

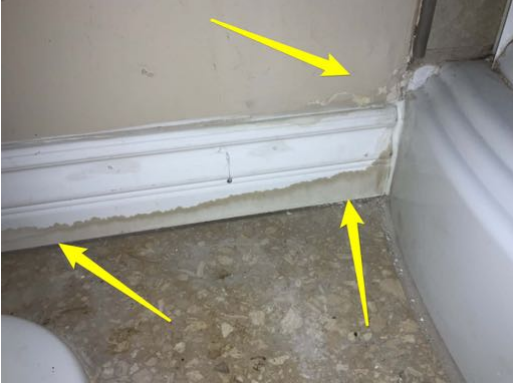
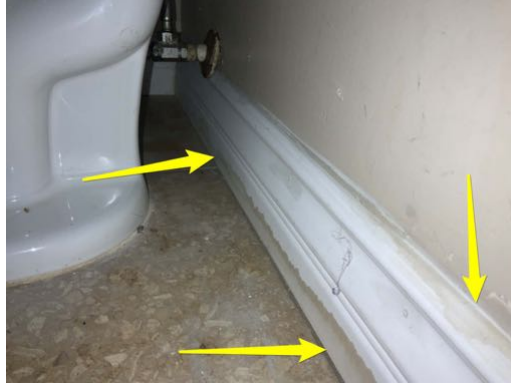
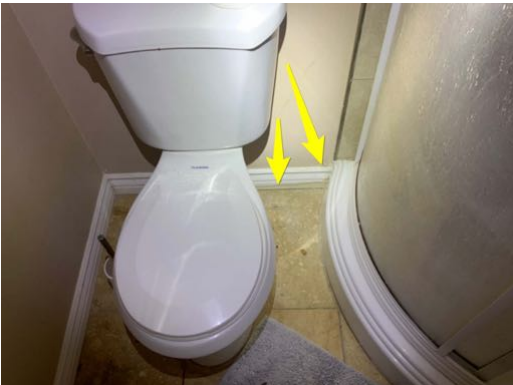
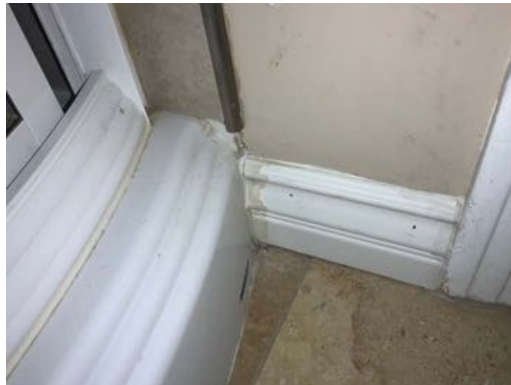
**FI 132:** Moisture stains & damage to walls, baseboards and/or floor outside shower: LAUNDRY BATHROOM

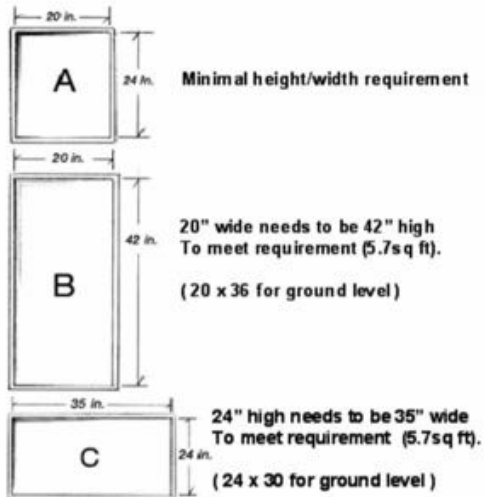
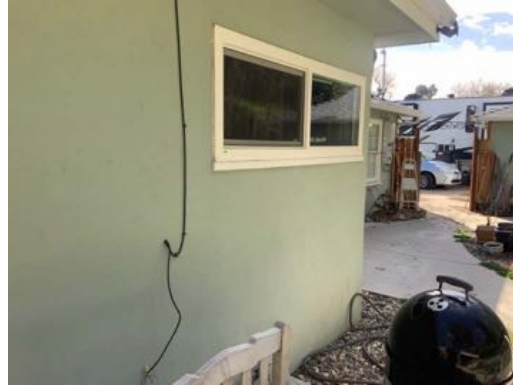
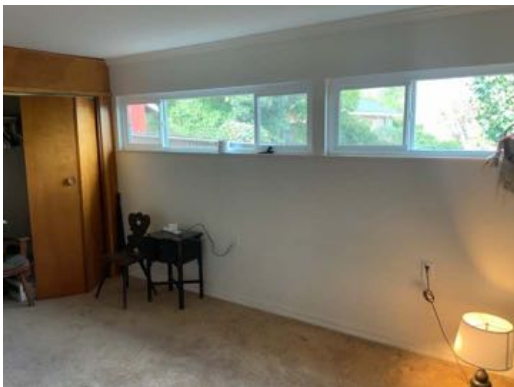
**SC 148:** The newer windows in the BEDROOMS do not meet the current fire egress standards. Windows are too small and too high off the ground. Upgrades recommended for fire safety.

Total window area needs to be 5.7 sq ft  
(5.0 for ground level)

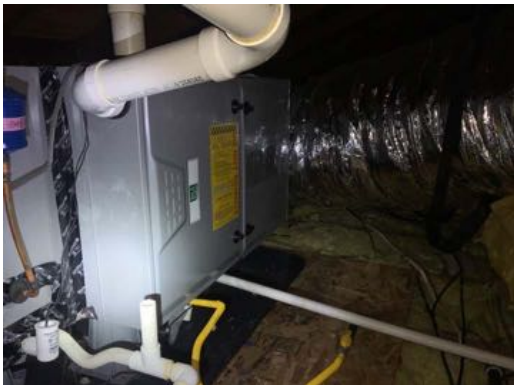
**SC 162:** Furnace found not operating properly. Furnace appears to turn off and on prematurely prior to reaching the appropriate desired temperature set at the thermostat. Recommend additional review by licensed HVAC contractor.

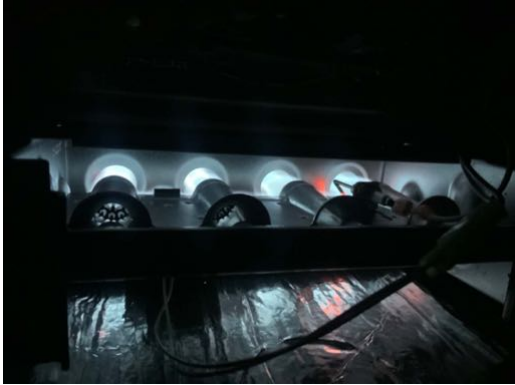
163: The Furnace flame appears serviceable.

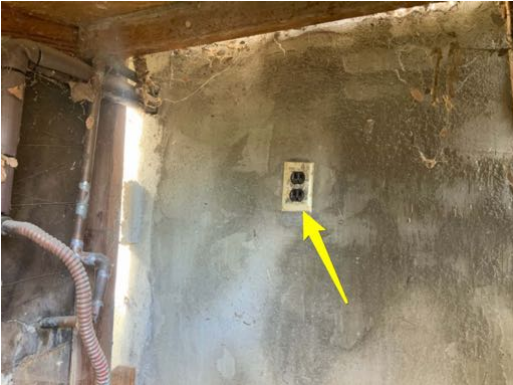
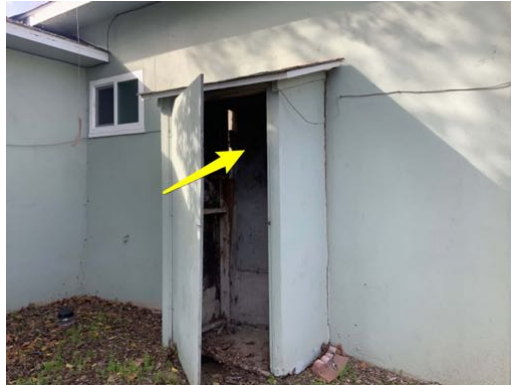
**SC 181:** Missing the required exterior electrical outlet weather tight cover: At an exterior outlet inside the front yard storage closet located on the northeast corner

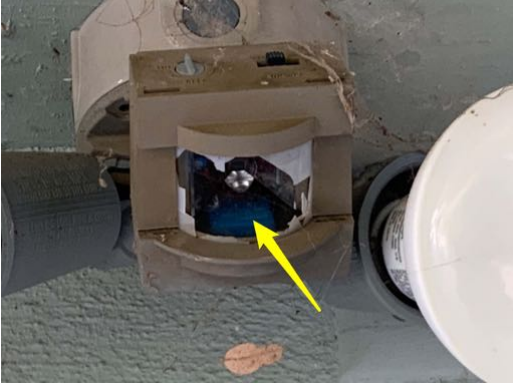
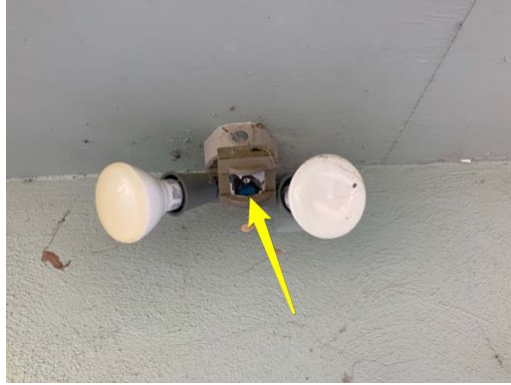
**MR 184:** Damaged motion sensor screen at the exterior light at the added exterior light fixture on the back of the house.

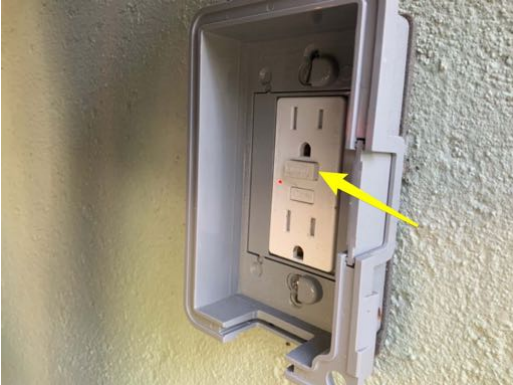
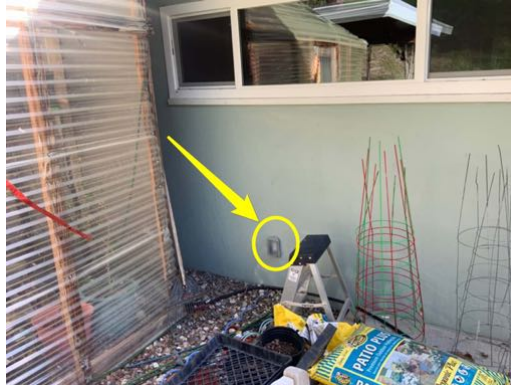
**E&C 185:** A newer GFCI outlet found tripped off and will not reset: On the back of the house. Recommend additional review and correction by licensed electrical contractor.

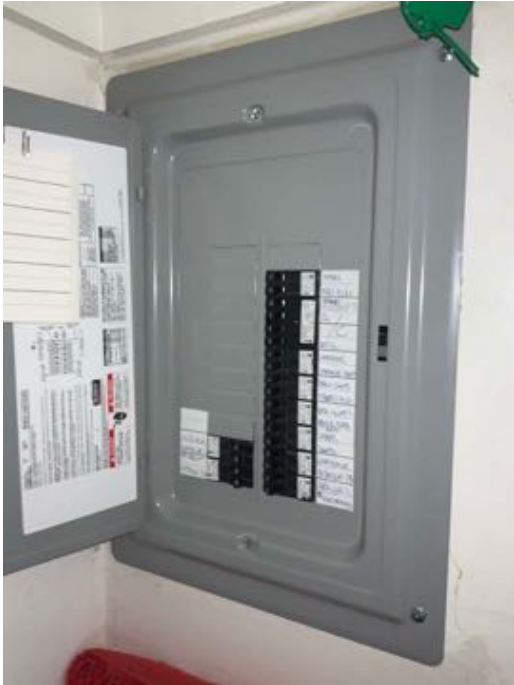
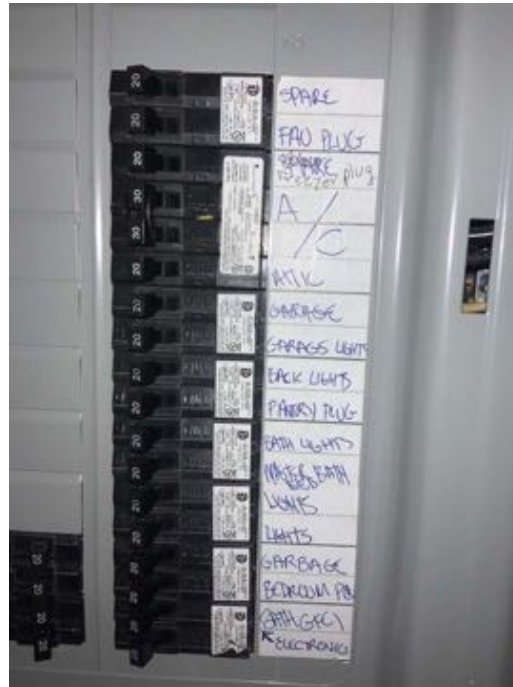
**SC 187:** A couple of unused wires in the ELECTRICAL SUB PANEL found missing proper wire nuts. Repairs are recommended for safety to help prevent a short or shock. Contact a qualified professional.

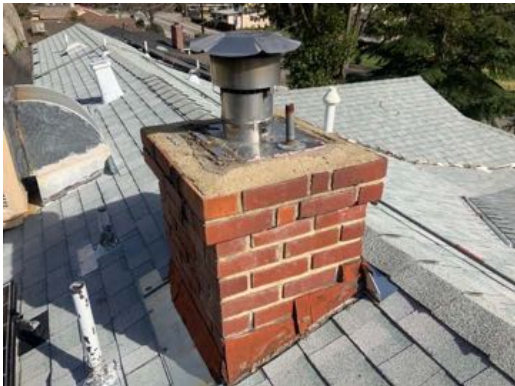
**209:** Photo of the LIVING ROOM fireplace metal chimney termination.
