## Home Inspection Report

26584 Oak Terrace Pl  
Stevenson Ranch, CA 91381

Inspected On Thu, Oct 1, 2026 at 10:00 AM

Secure Home And Property Inspections LLC

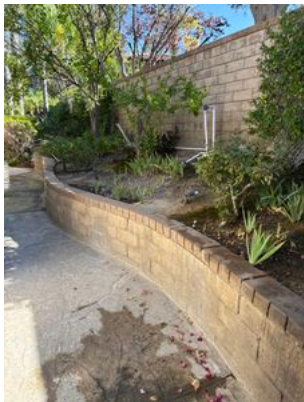
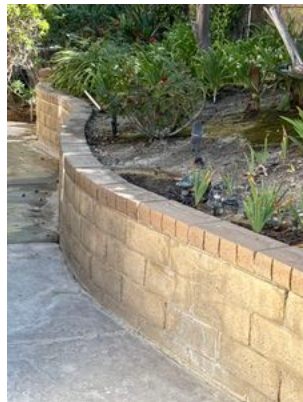
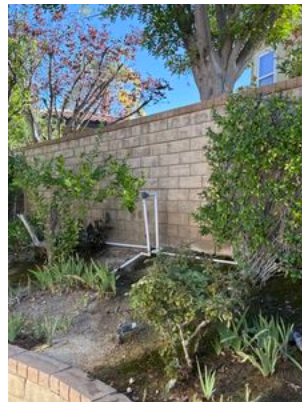
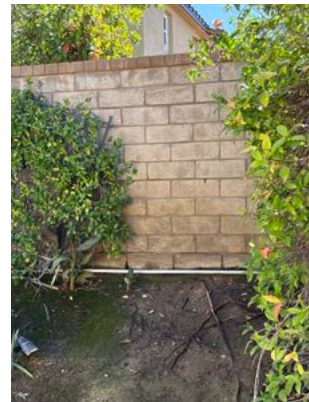
Efflorescence was observed on many sections of the masonry block retaining walls and property block walls. This appears to be a cosmetic issue only at this time. Recommend monitoring for changes.

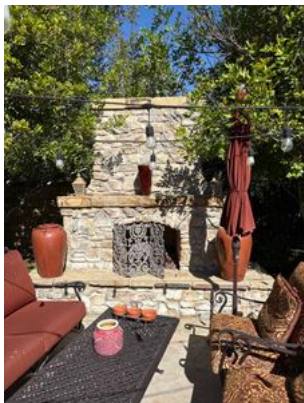
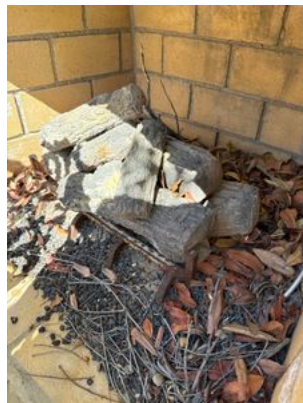
**Comment 3**  
**Deficiency**

Rear patio natural gas burning fireplace should be cleaned. A large buildup of flammable debris has accumulated inside of the burn box.

Recommend further evaluation and repair by a qualified licensed contractor.

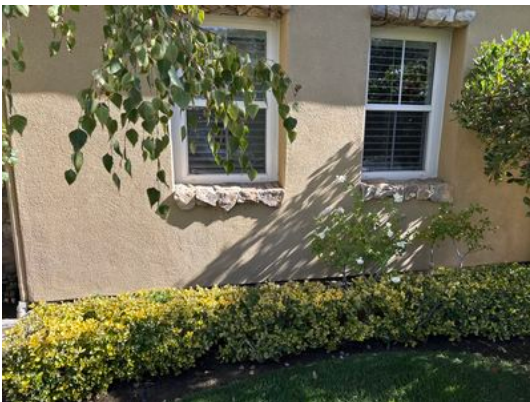
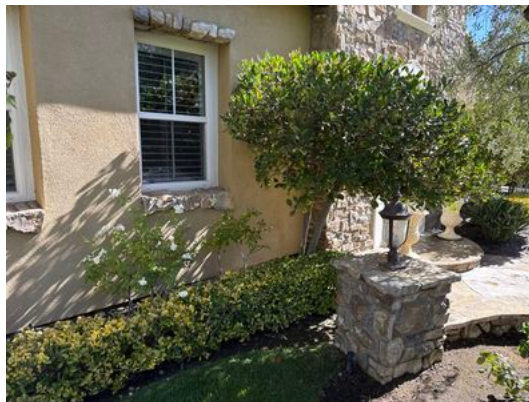
Sprinkler over spray was noted around the exterior of the home in many areas. Soil is built up against and above the weep screed. Damaged and rusted sections of the stucco weep screeds were observed.

Recommend adjustment of sprinklers

Recommend further evaluation and repair by a qualified licensed contractor.

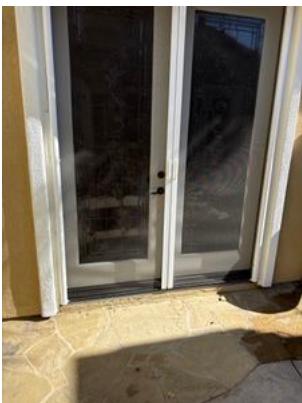
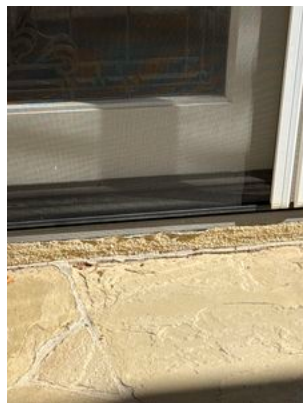
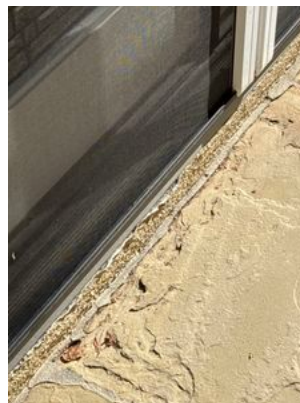
**Comment 6**

Peeling paint was observed beneath the front patio french doors.

Recommend further evaluation and repair by a qualified licensed contractor.

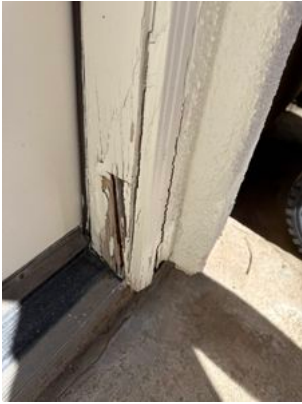
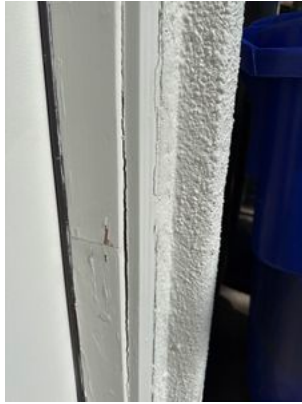
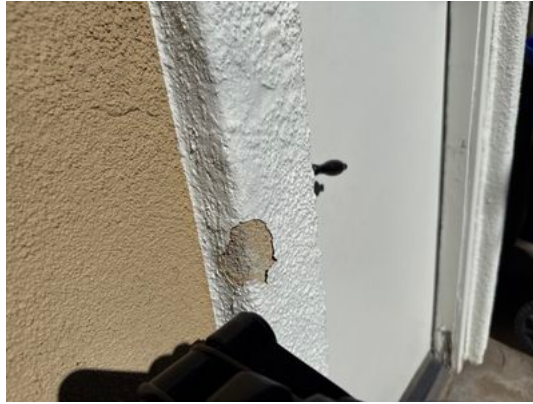
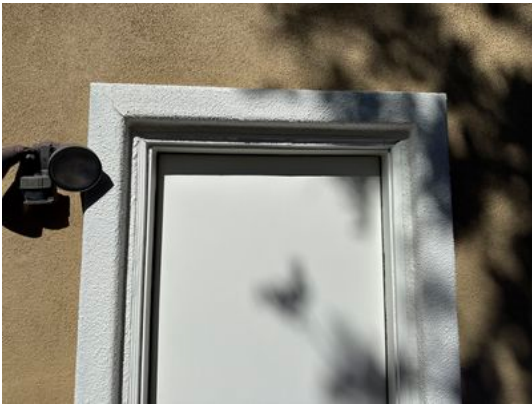
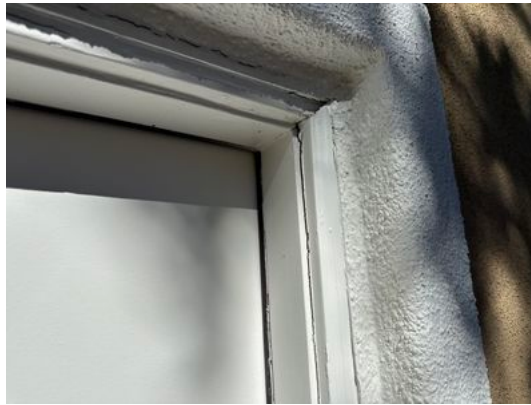
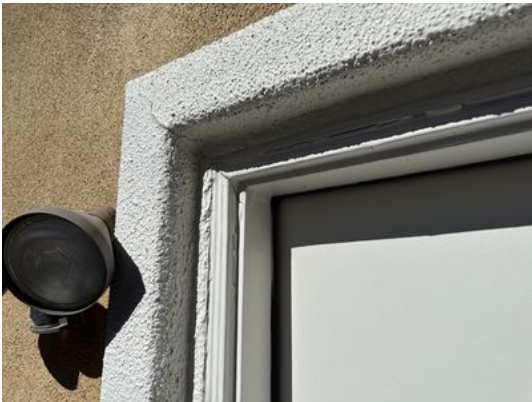
Peeling paint and stucco was observed around the side pedestrian garage door frame and casing.

Recommend further evaluation and repair by a qualified licensed contractor.

Recommend further evaluation by a qualified licensed termite contractor.

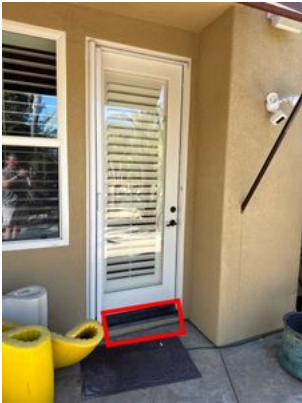
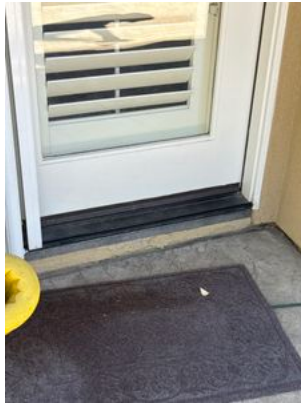
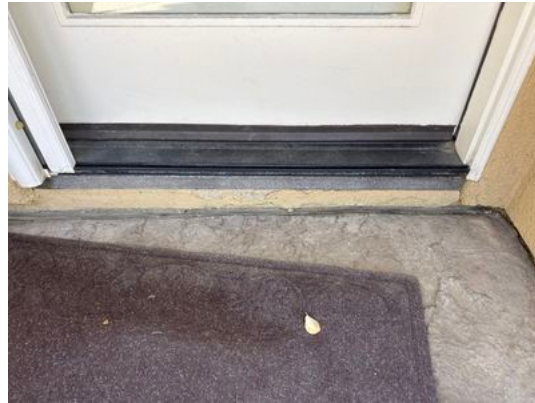
**Comment 9**

Peeling paint was observed beneath the rear patio master door.

Recommend further evaluation and repair by a qualified licensed contractor.

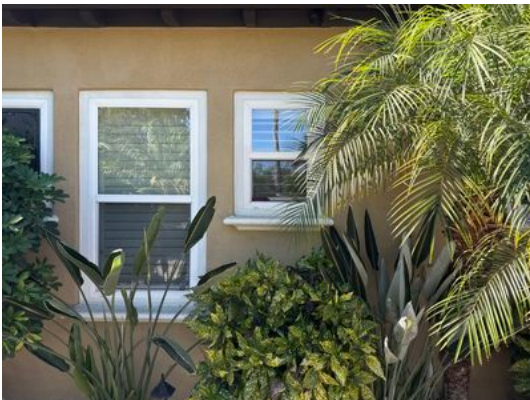
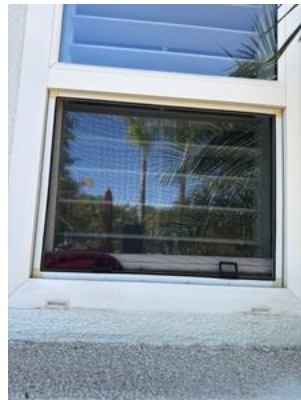
**Comment 10**

A towel was noted in the window frame to keep the window opened at the rear of the home. When on the interior was noted to have broken springs.

Recommend further evaluation and repair by a qualified licensed contractor.

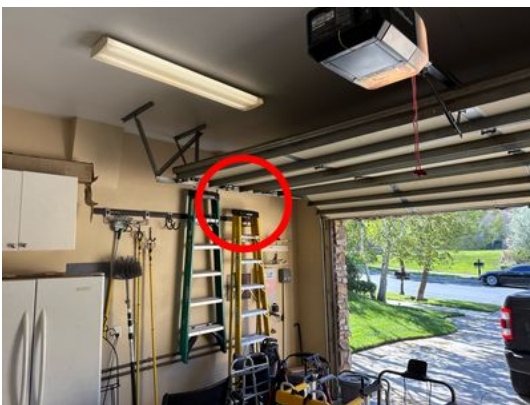
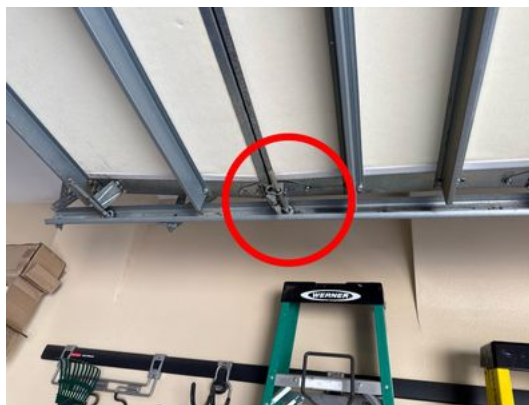
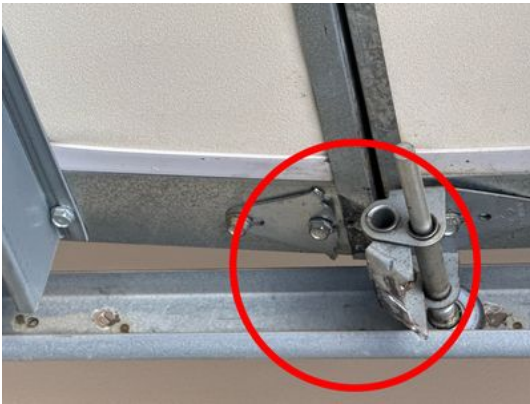
A garage rollup door bracket on the left side was noted to be damaged and separated.

Recommend further evaluation and repair by a qualified licensed contractor.

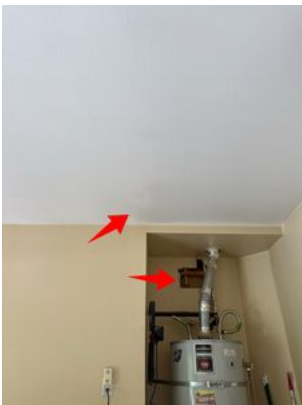
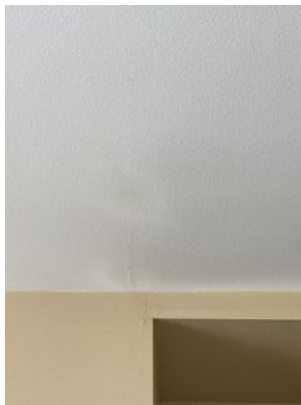
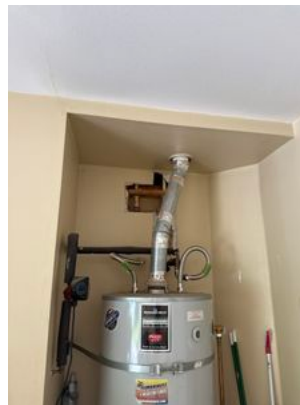
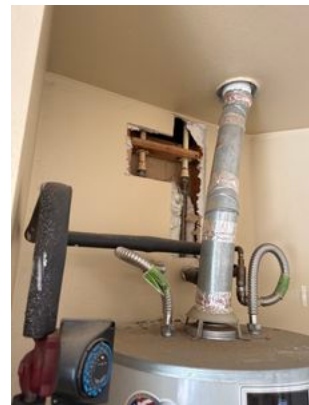
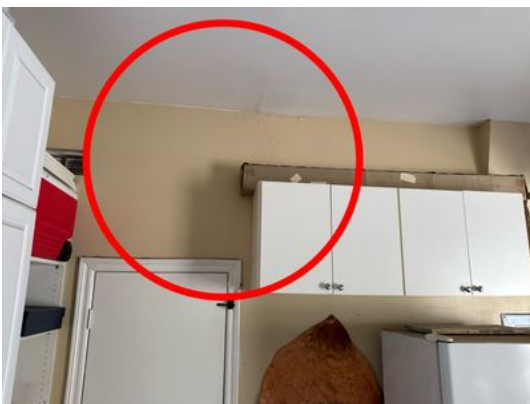
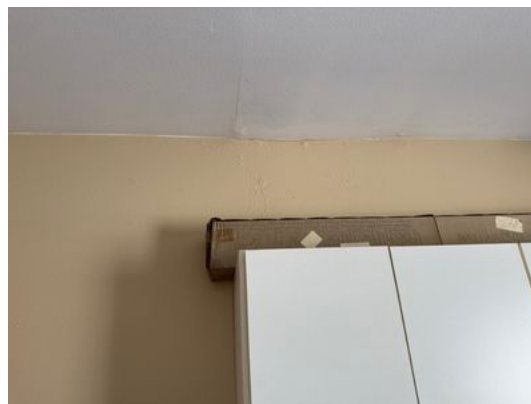
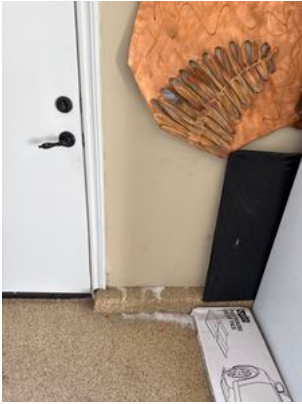
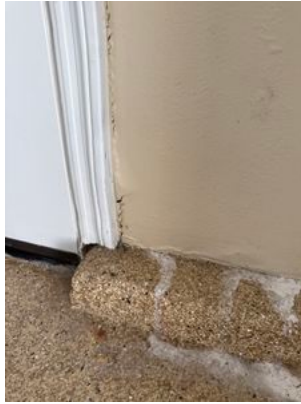
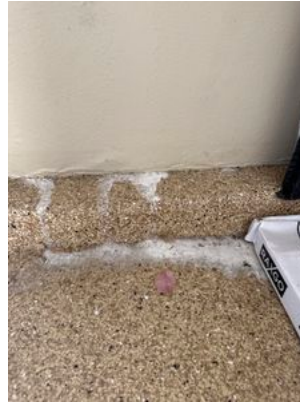
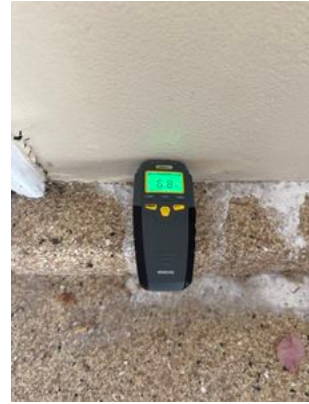
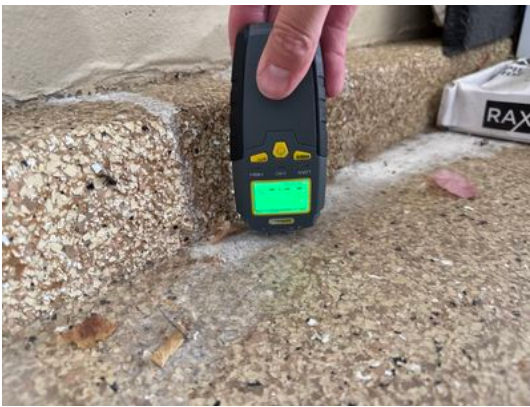
**Comment 12**

Damaged drywall repair was noted in the garage . Behind water heater drywall was found removed. Damaged drywall above side garage pedestrian door. Staining and efflorescence with swollen drywall was noted next to the door frame.

Recommend further evaluation and repair by a qualified licensed contractor.

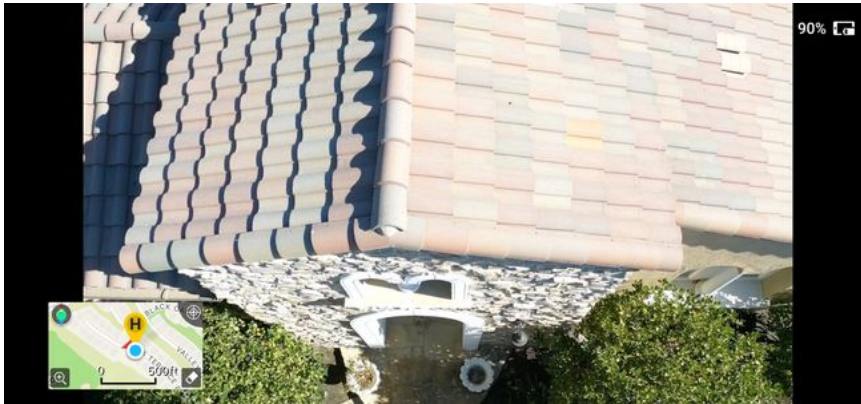
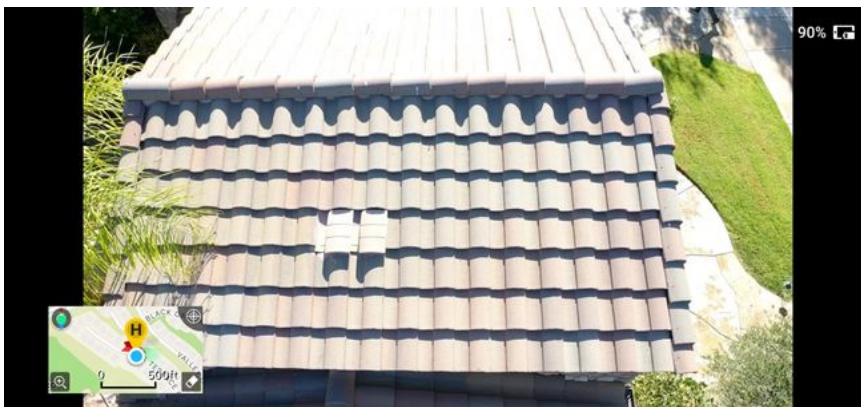
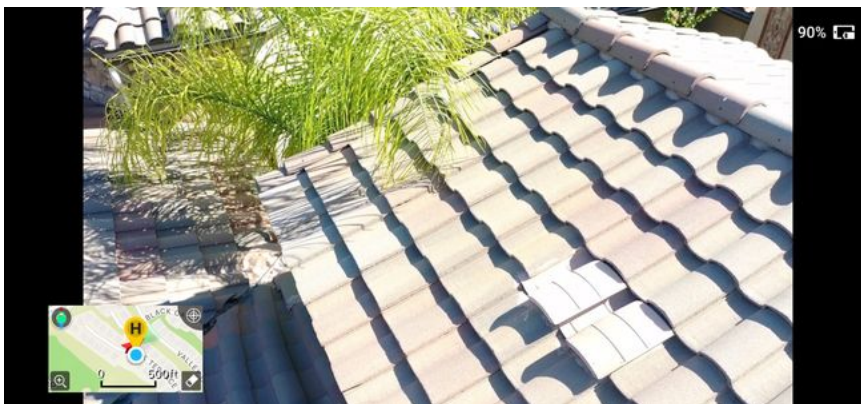
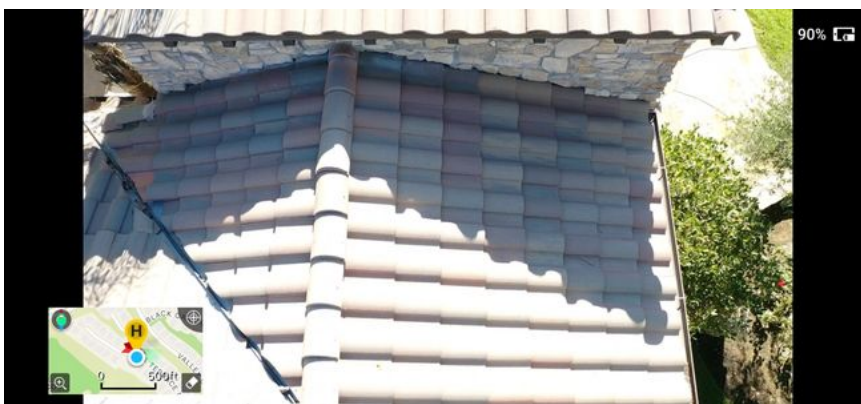
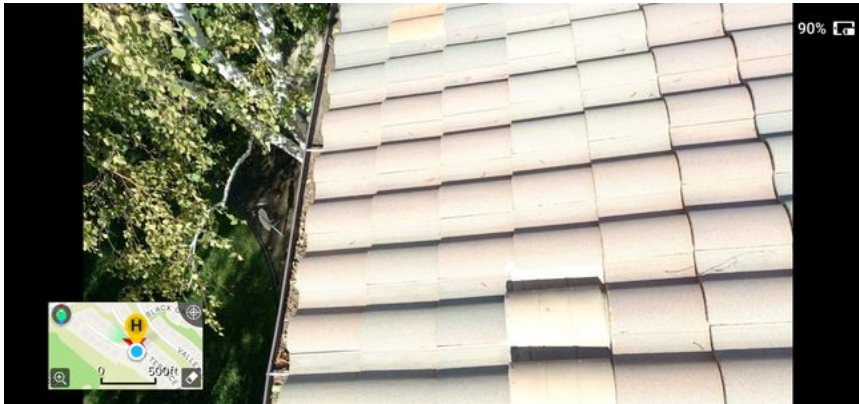
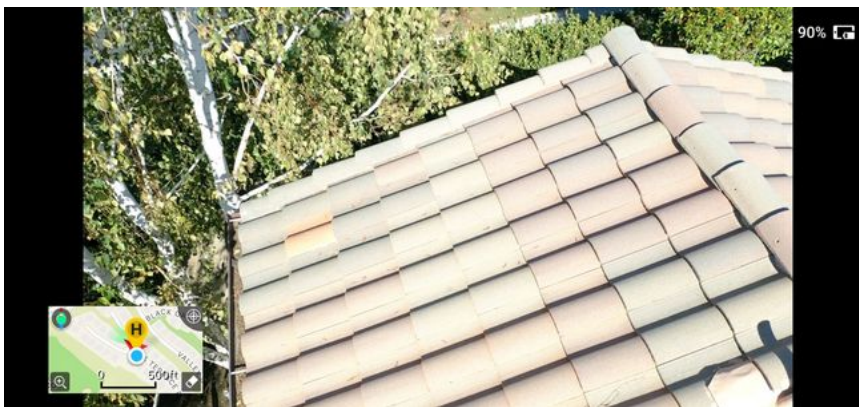
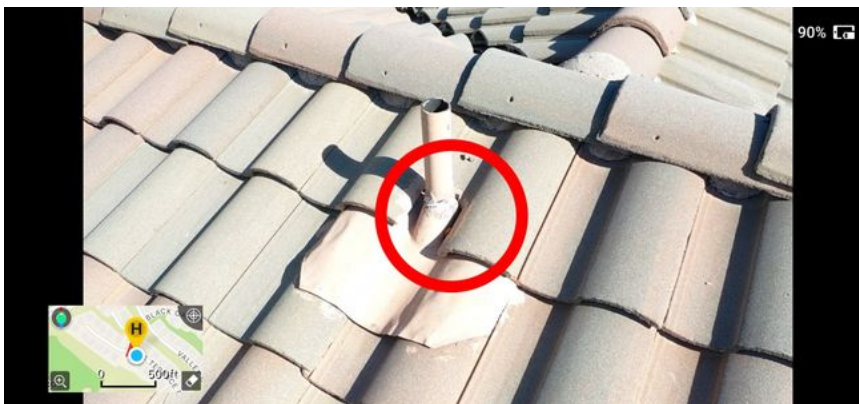
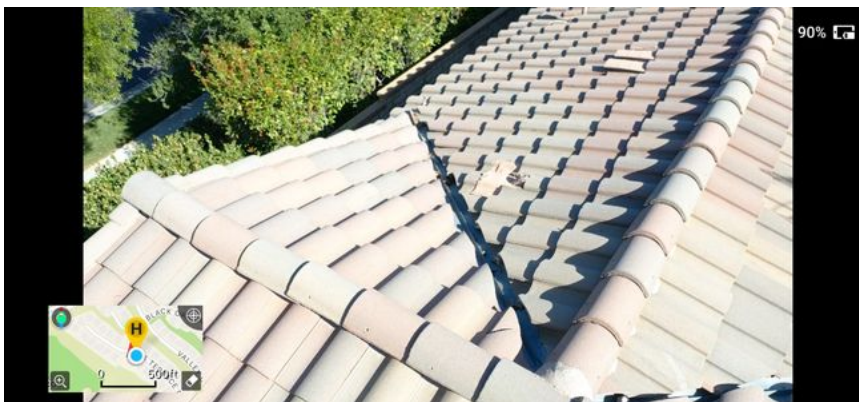
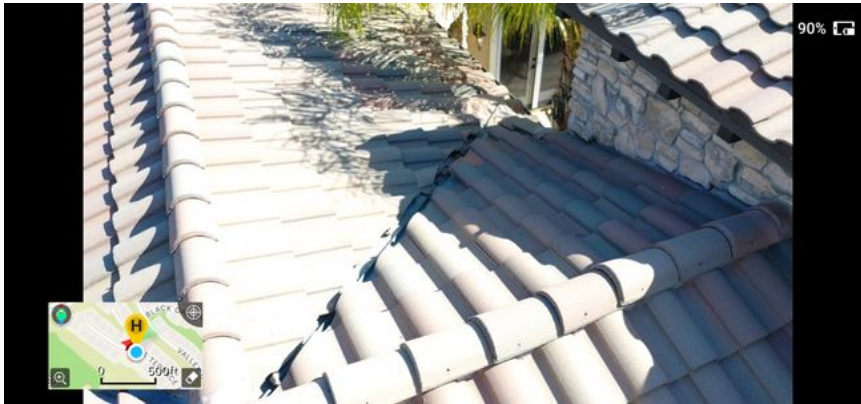
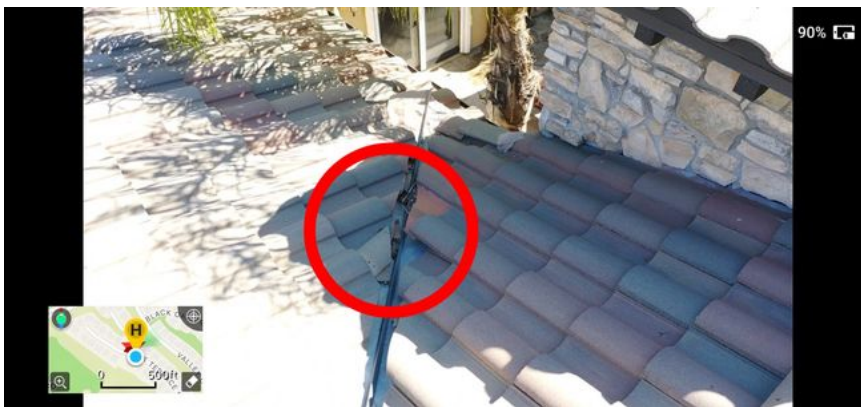
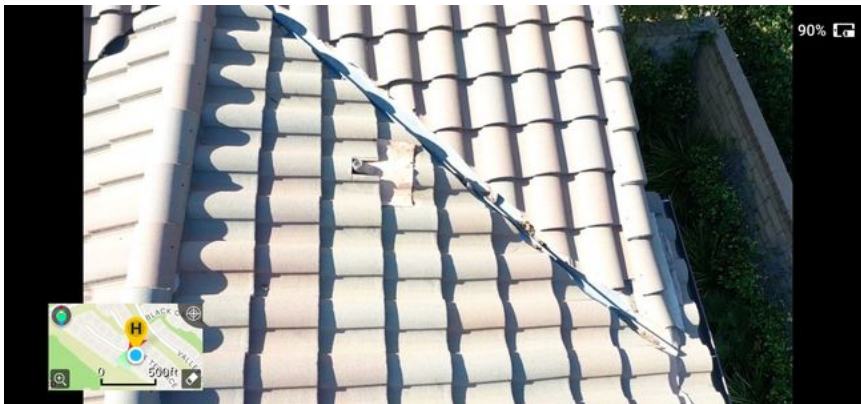
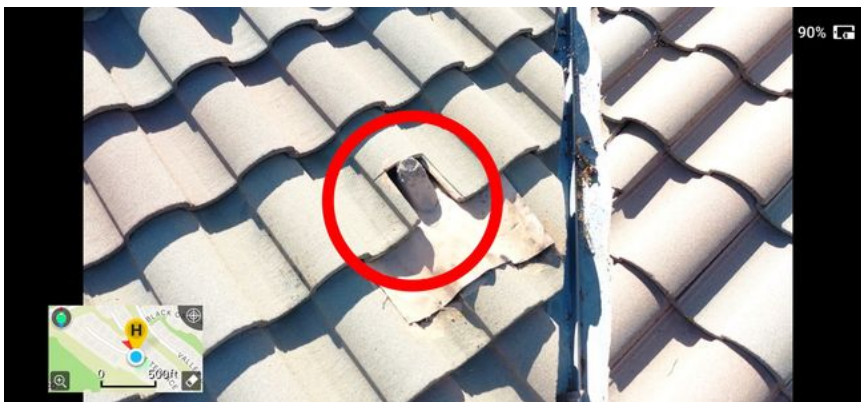
Cracked and slipped tiles were observed during the roofing inspection. Previously repaired and or replaced tiles were noted in some locations. Vent flashing sealant in a few locations is in need of maintenance work, gaps and cracks are beginning to form. Valleys and rain gutters were noted to have a buildup of debris and should be cleaned.

Recommend further evaluation and repair by a qualified licensed roofing contractor.

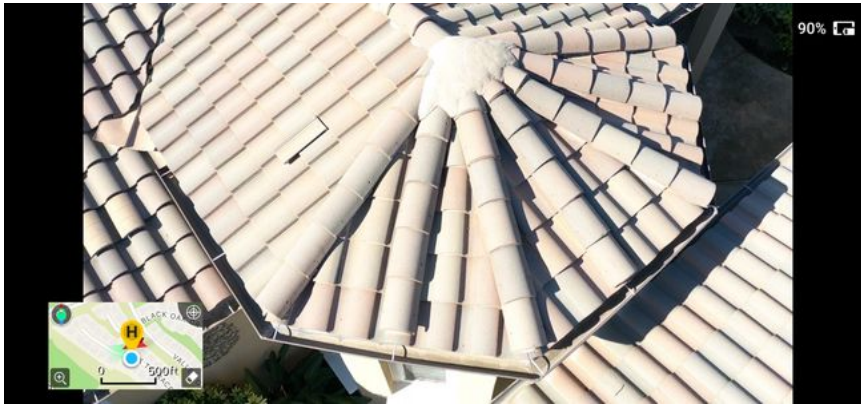
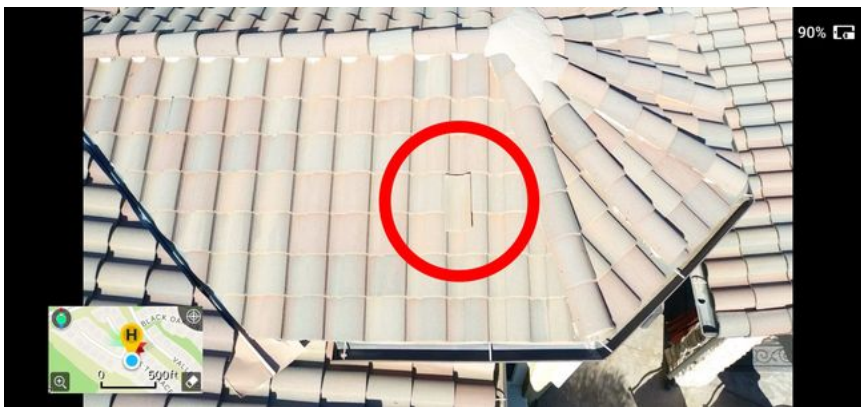
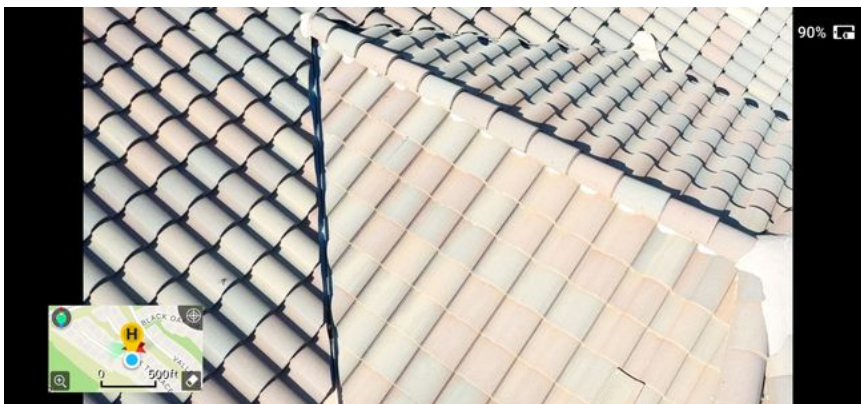
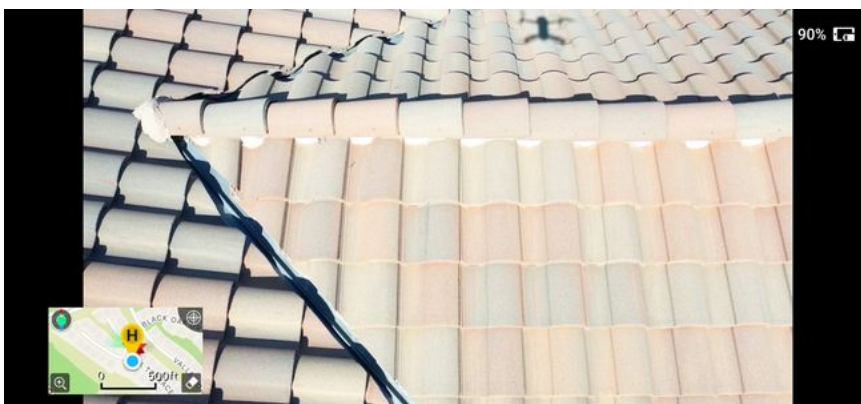
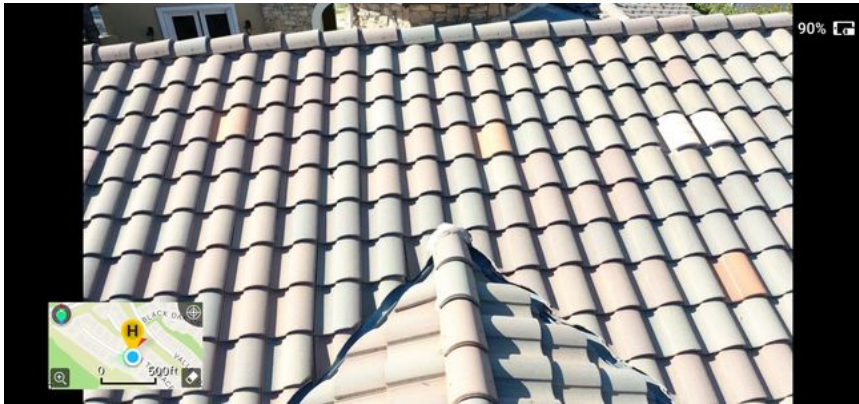
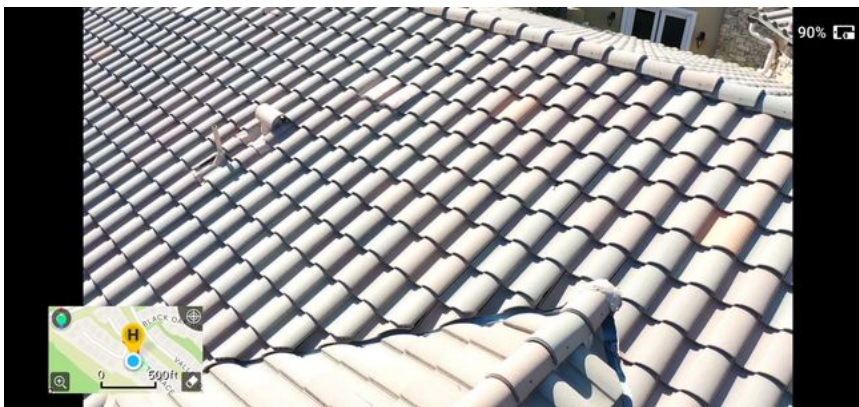
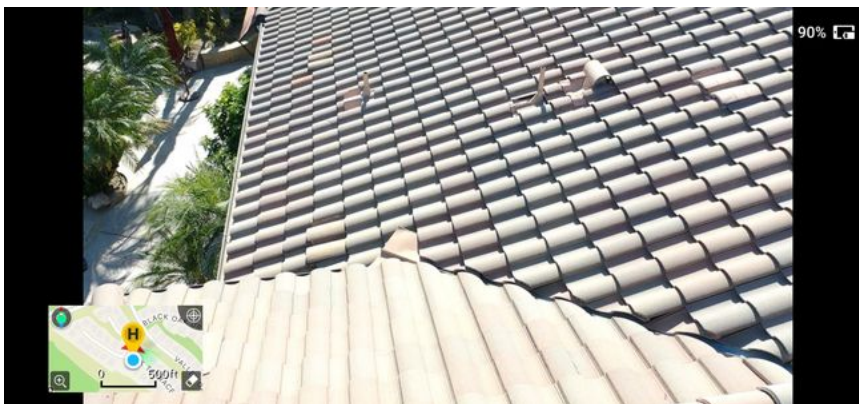
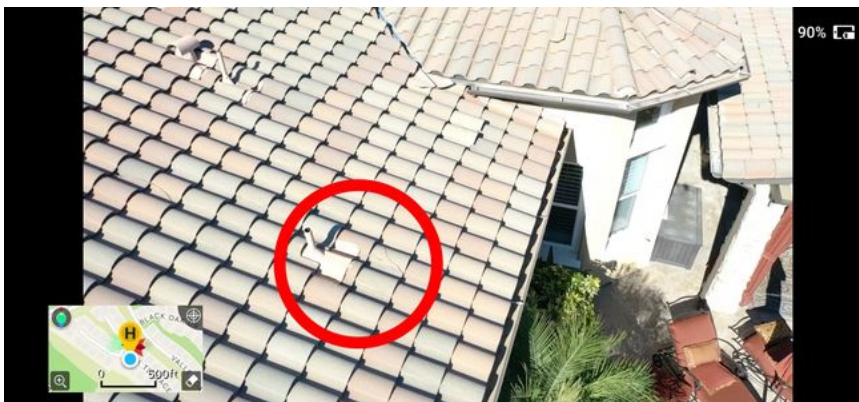
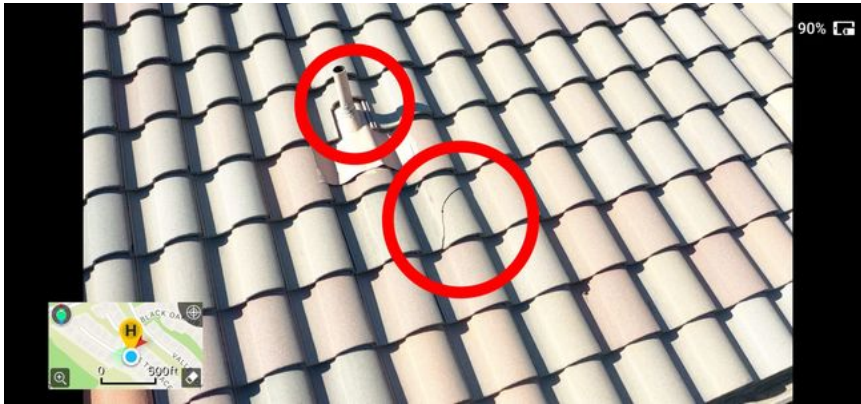
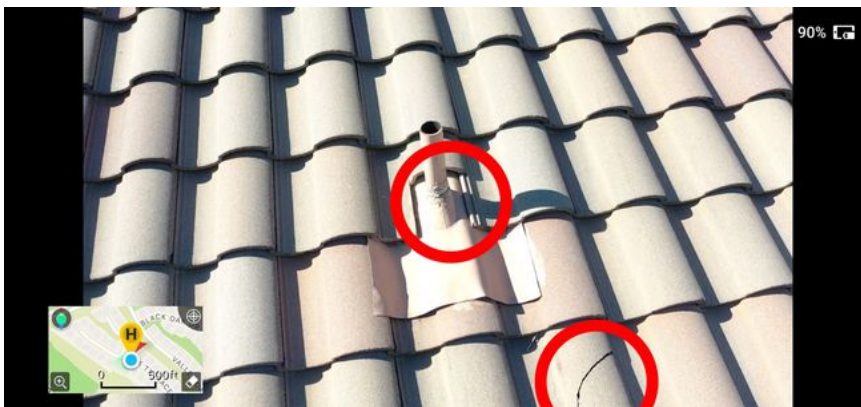
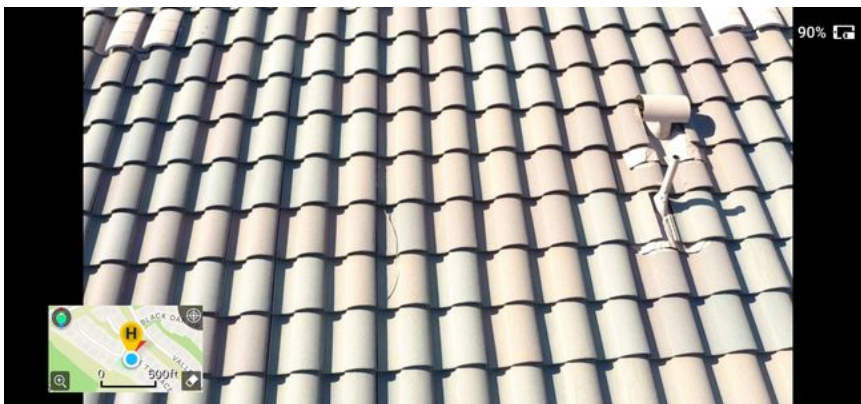
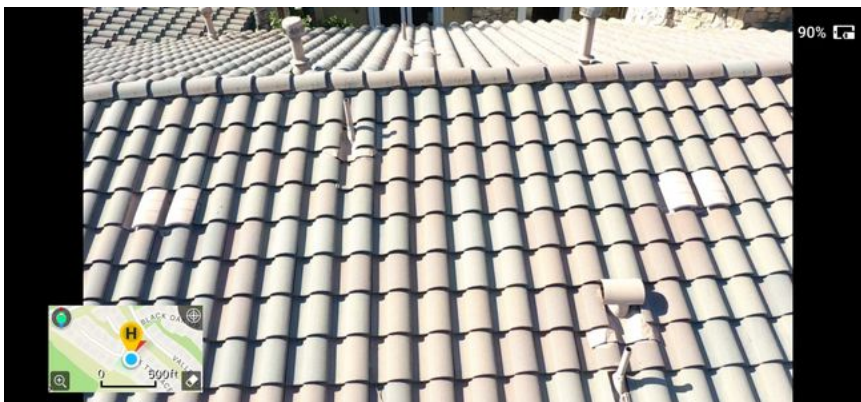
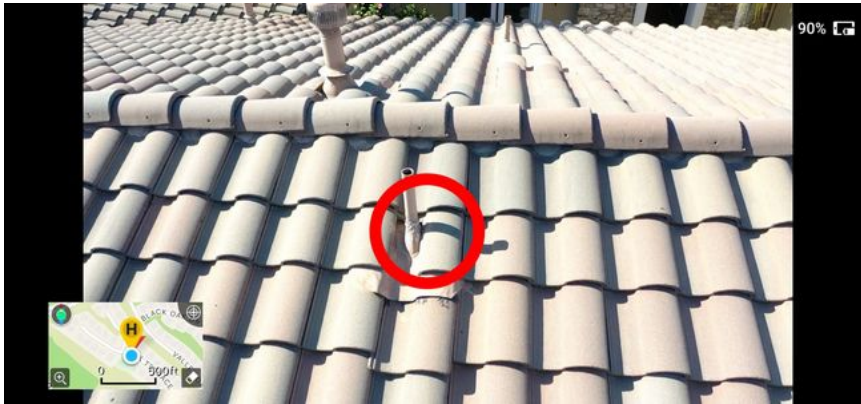
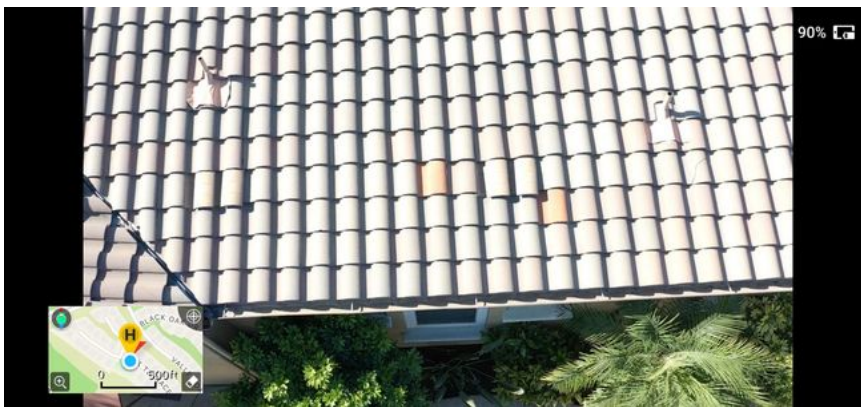
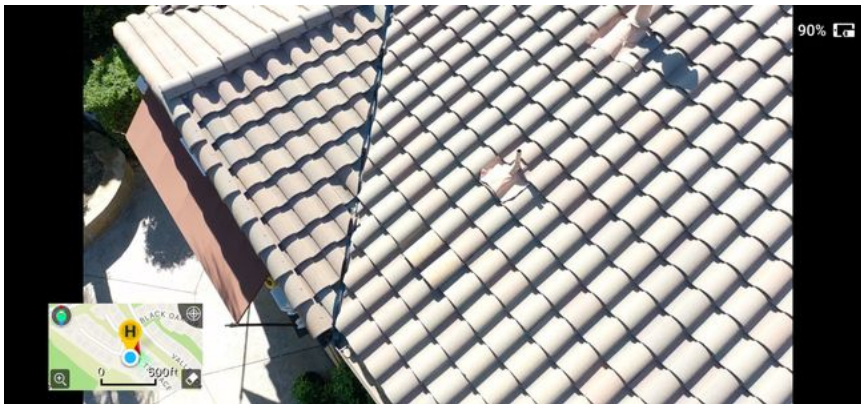
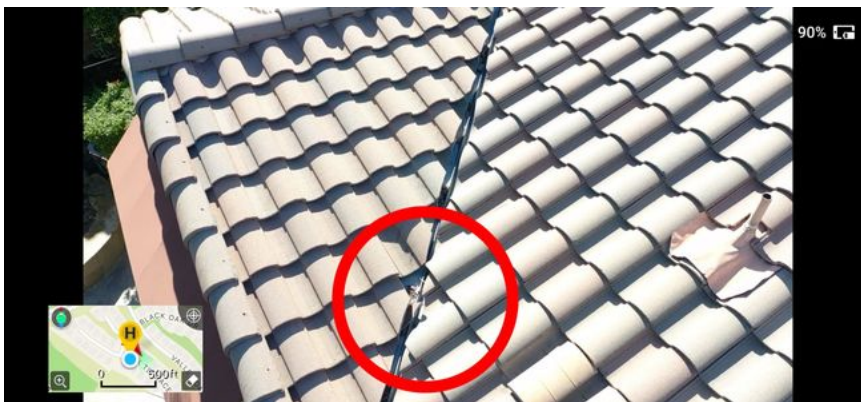
**Comment 14**

Continuation of roofing pictures.

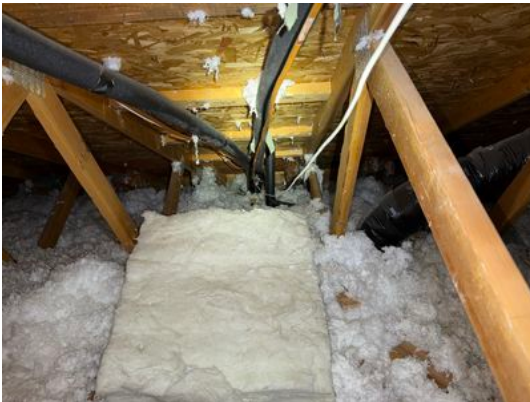
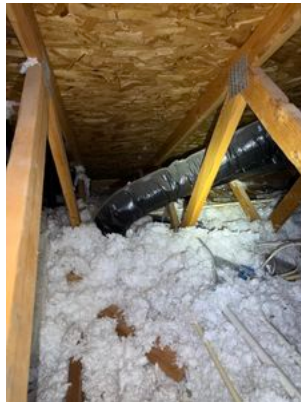
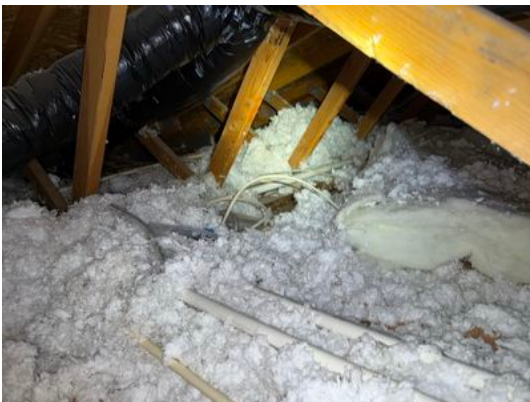
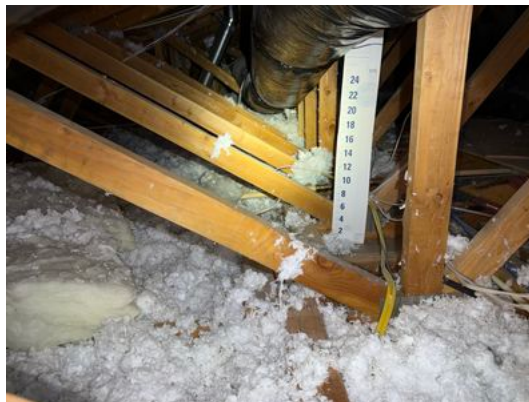
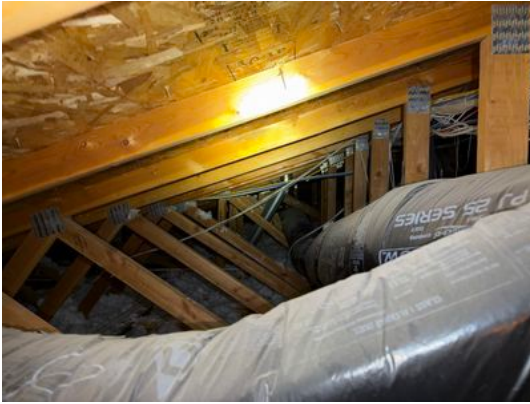
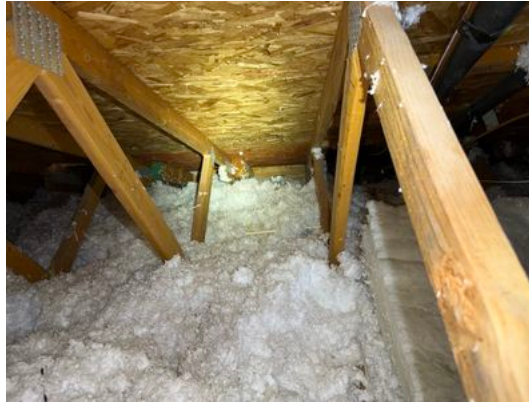
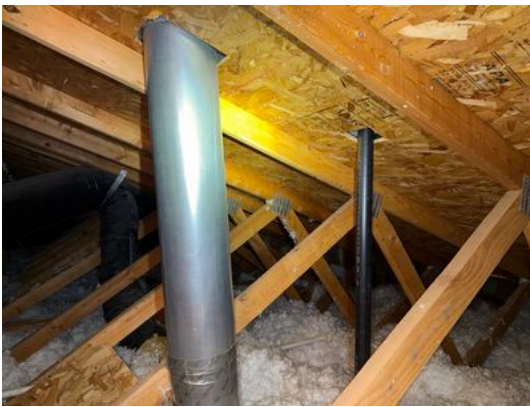
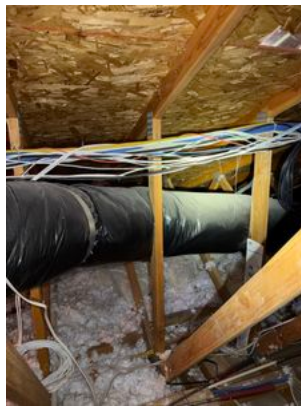
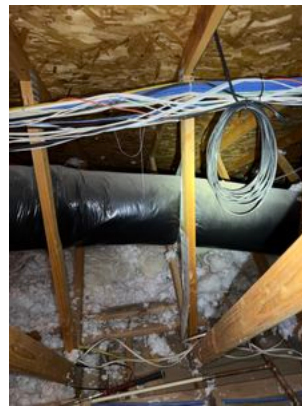
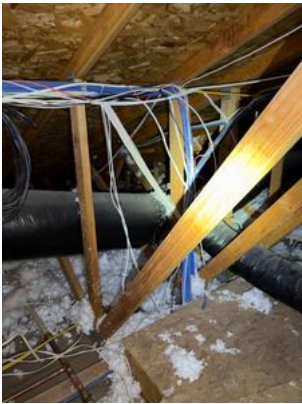
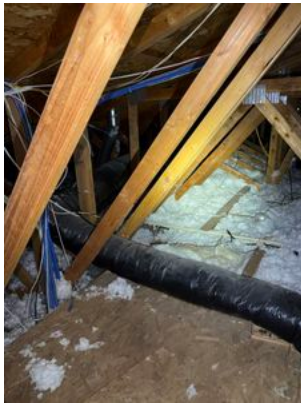
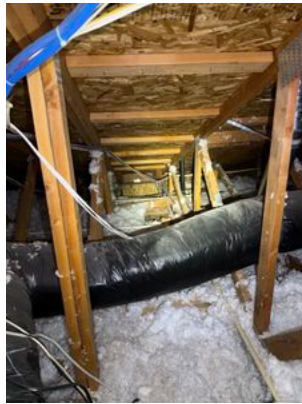
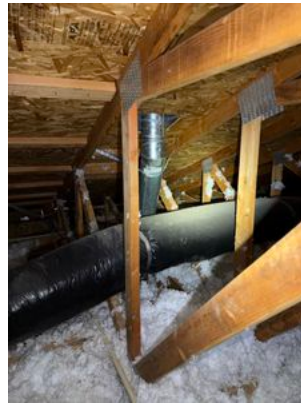
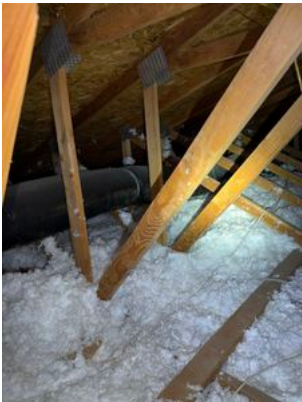
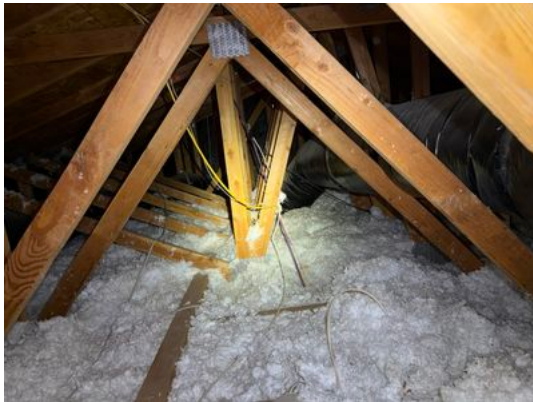
Information only, attic pictures.

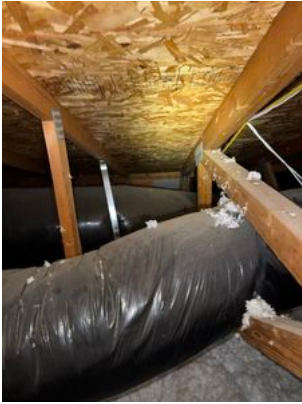
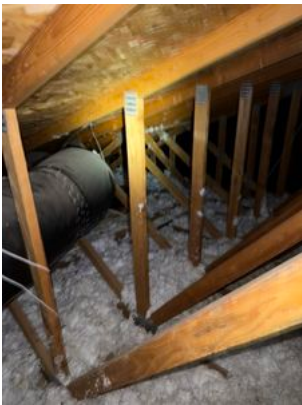
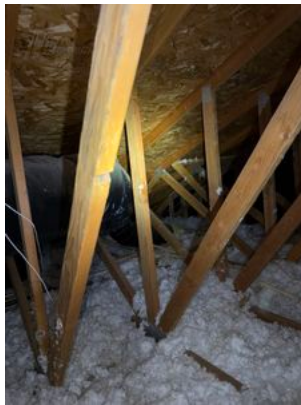
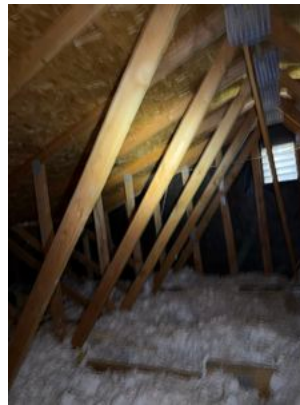
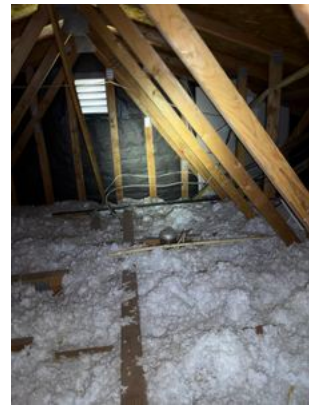
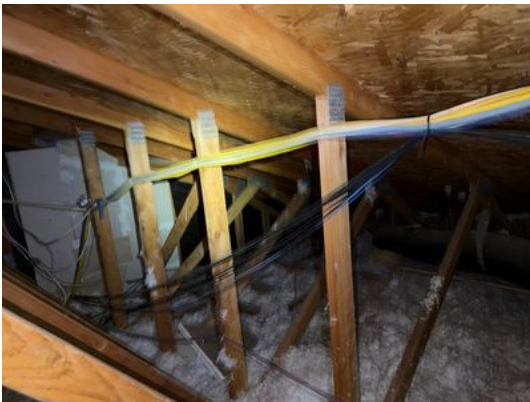
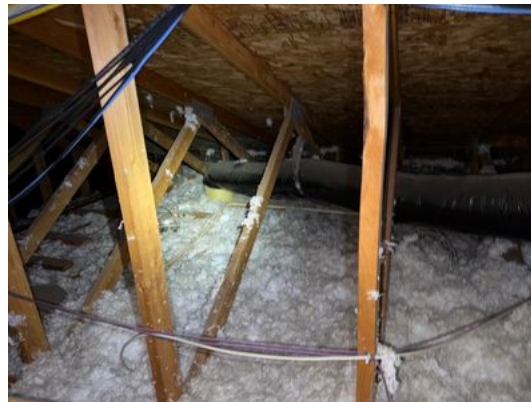
**Comment 17**  
**Information**

Continuation of attic pictures.

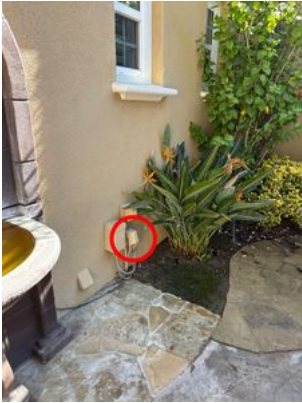
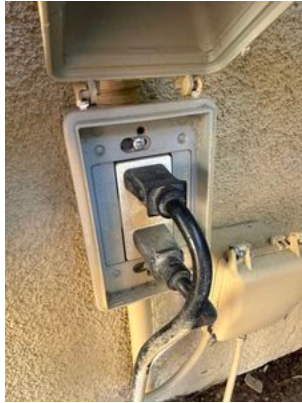
The front patio electrical outlet is not protected with a GFCI.

Recommend further evaluation and repair by a qualified licensed contractor.

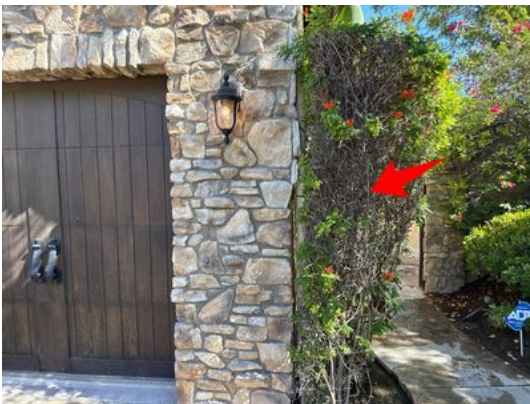
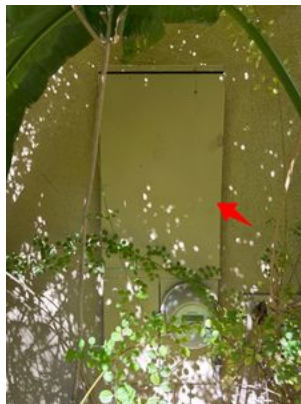
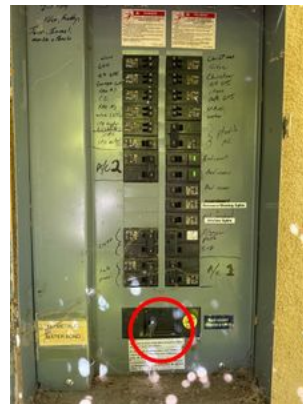
**Comment 21**

Main power shut off breaker is in the red circle. Pictures of the electrical service panel. Informational only.

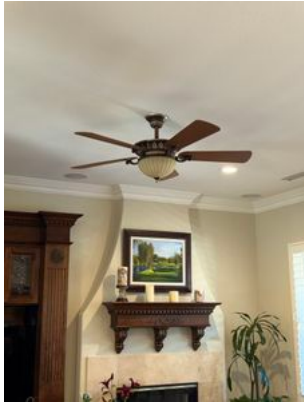
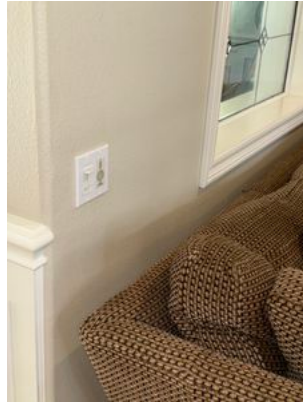
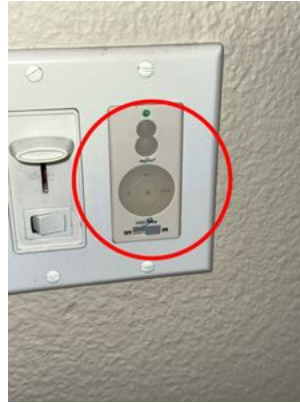
Family room ceiling fan/lighting fixture did not turn on.

Recommend further evaluation and repair by a qualified licensed contractor.

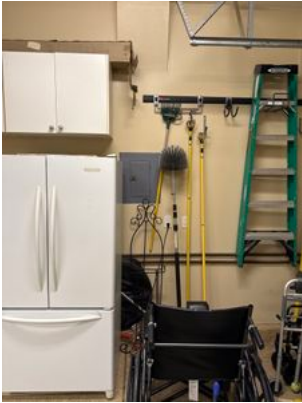
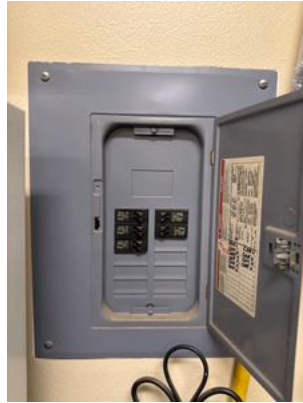
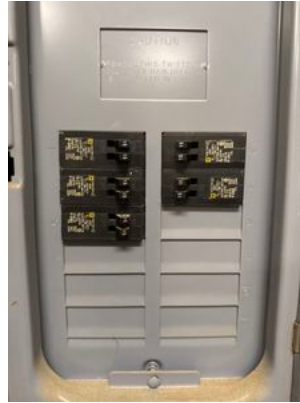
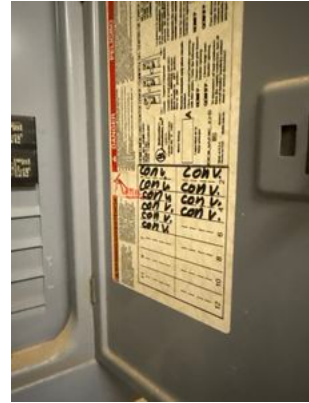
#### Comment 26 Information

Pictures of the garage sub panel. Panel cover could not be safely removed due to the refrigerator blocking access. informational only.

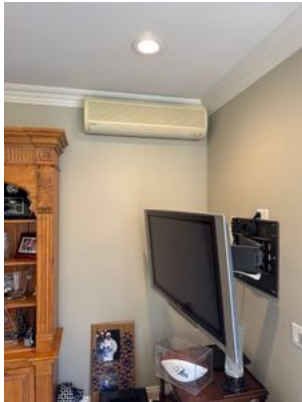
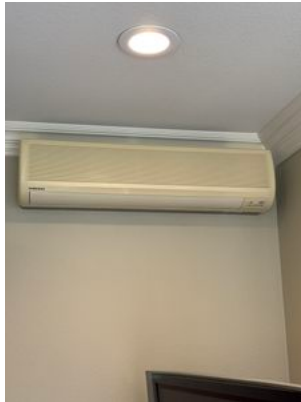
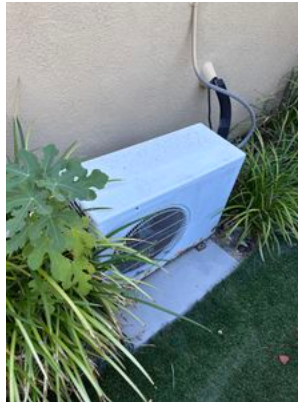
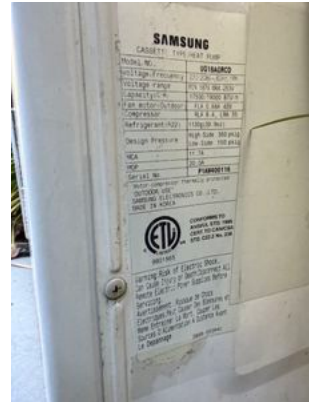
### Comment 27 Information

A mini split HVAC unit is installed in the front detached office. Remote control for the unit was not located during the inspection. Recommend confirming with the current owner the functionality of this item prior to the close of escrow.

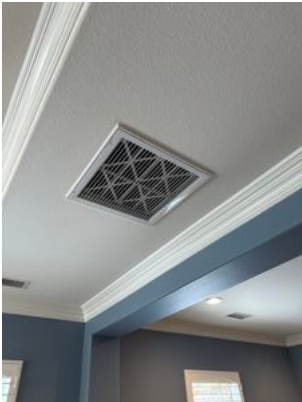
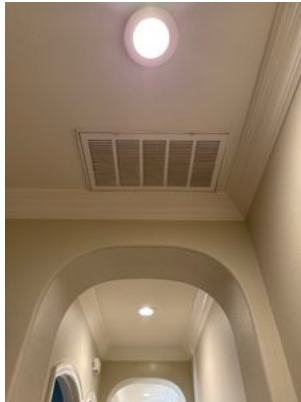
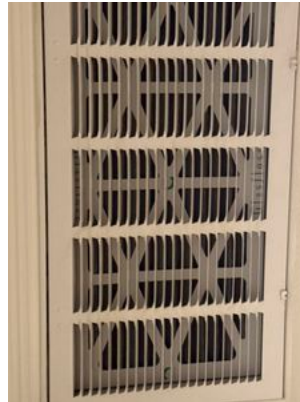
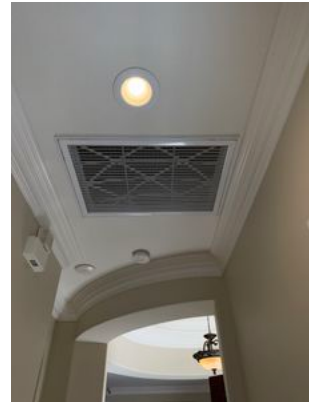
Recommend replacement of the HVAC system filters.

Recommend further evaluation and repair by a qualified licensed contractor.

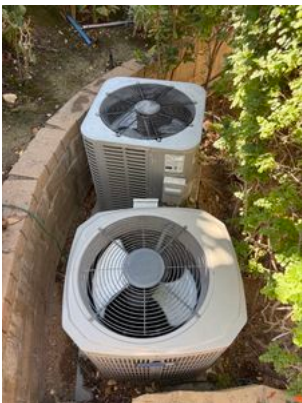
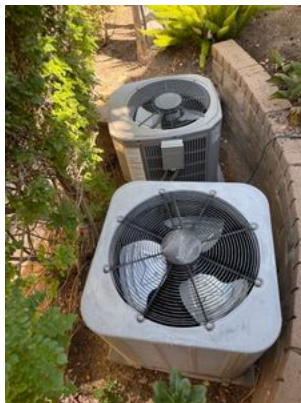
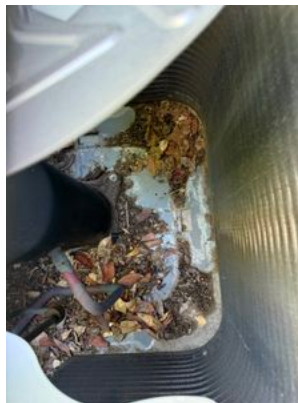
The master bedroom side air-conditioning system was only lowering the incoming air temperature by approximately 10°.

Dirt, dust, and debris are noted inside both of the air conditioning condensers.

Due to the age and build up of debris inside, recommend servicing/cleaning by a qualified licensed HVAC contractor.
