## Home Inspection Report

26584 Oak Terrace Pl  
Stevenson Ranch, CA 91381

Inspected On Thu, Oct 1, 2026 at 10:00 AM

Secure Home And Property Inspections LLC

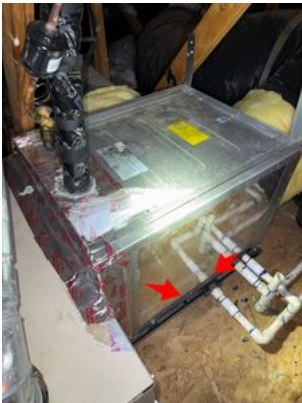
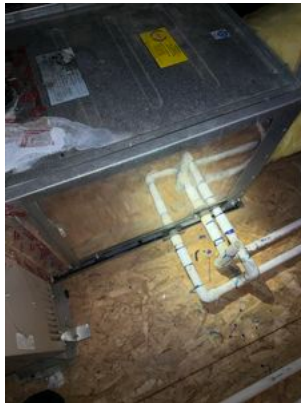
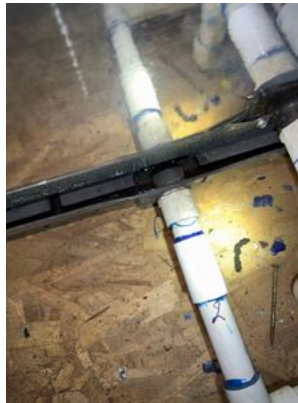
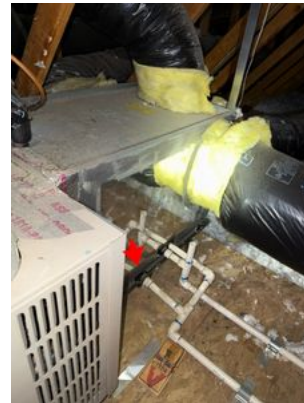
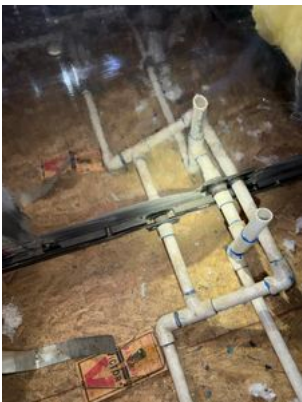
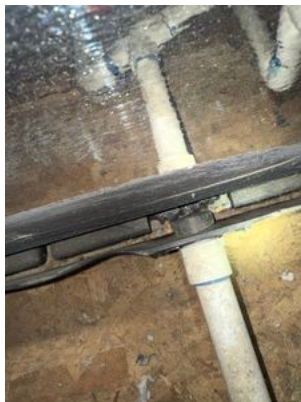
Both air-conditioning condensation catch pans or noted to have water built up.

Recommend further evaluation and repair by a qualified licensed HVAC contractor.

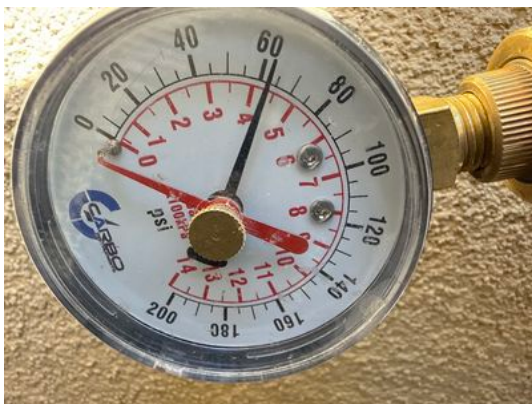
### Comment 37

House water pressure is at approximately 62psi and is within normal range. Residential water pressure should be between 60 and 80 psi.

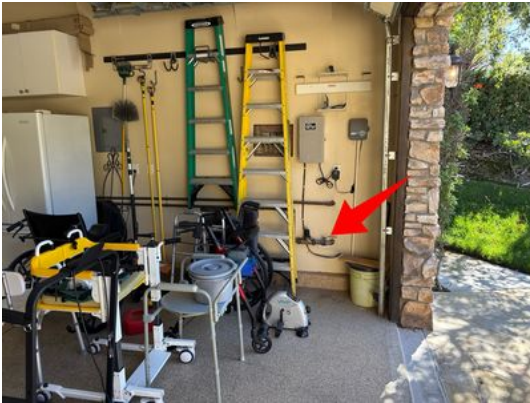
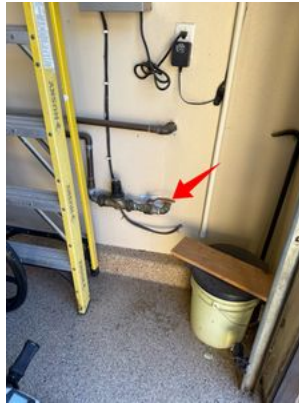
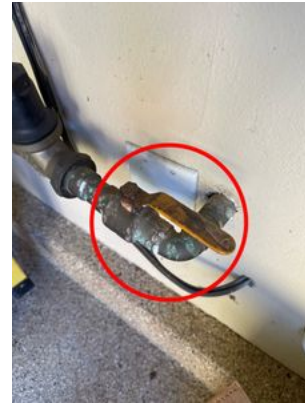
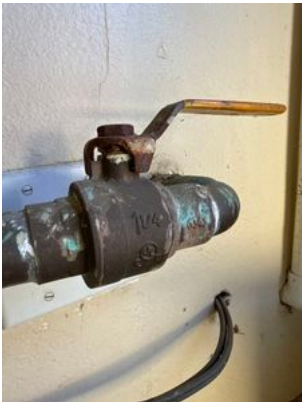
### Comment 38

Rust and corrosion is built up on and around the water main shut off valve handle. Valve may be unreliable and event of an emergency in the water must be turned off. Recommend installation of a new valve.

Recommend further evaluation and repair by a qualified licensed contractor.

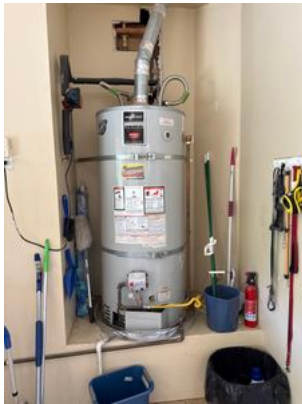
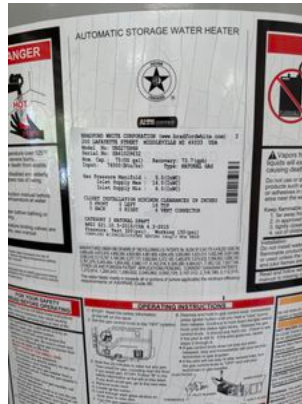
Informational only, water heater is producing hot water.

If small children are living in the home, recommend adjusting the water heater temperature to or below 120° to prevent scalds/burns.

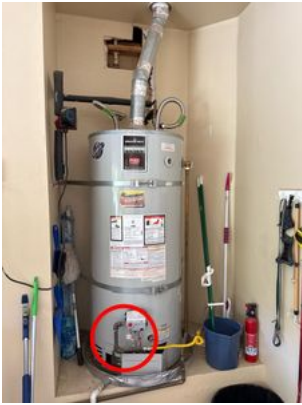
#### Comment 40

Grounding wires and a gas sediment trap, have not been installed on the water heater unit.

Recommend further evaluation and repair by a qualified licensed contractor.

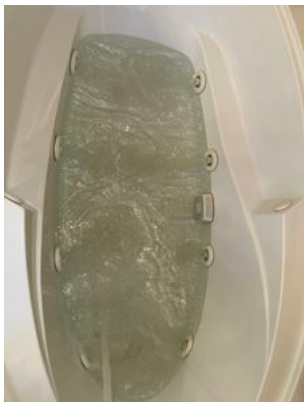
#### Comment 41 Information

Master bathroom bathtub has a recirculating pump installed. Unit was functioning at the time of the inspection. Before first use, recommend filling tub and adding 2 cups of bleach. Run motor for approximately two minutes. Drain and refill with water. Run for approximately five minutes and drain. This procedure sanitizes the plumbing and motor assembly.

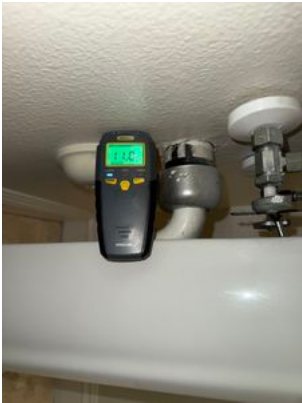
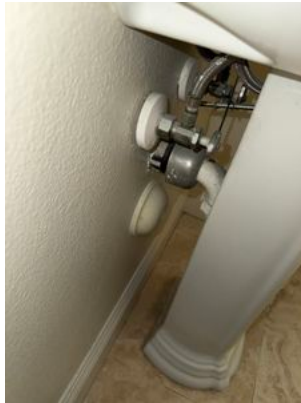
The drywall under the hallway bathroom sink was tested for moisture. Moisture was noted at 11.0%

Drywall under 15% moisture in this area is considered normal.

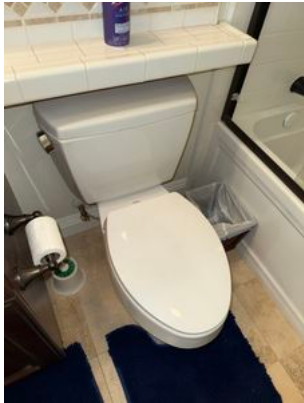
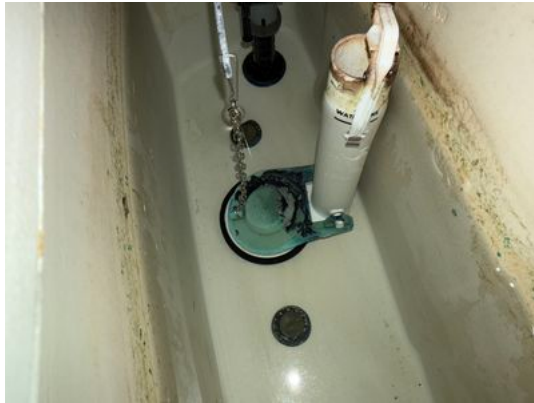
Bathroom toilet flapper appears to be in need of replacement. Water leaks past the flapper.

Recommend further evaluation and repair by a qualified licensed contractor.

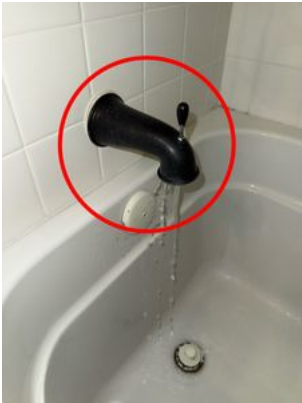
Recommend replacement of the tub/shower diverter valve. When the shower valve is in the up position water is still flowing through to the tub spout.

Recommend replacement by a qualified licensed plumber.

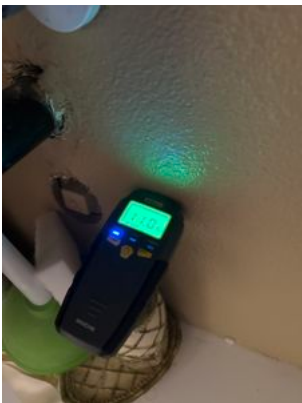
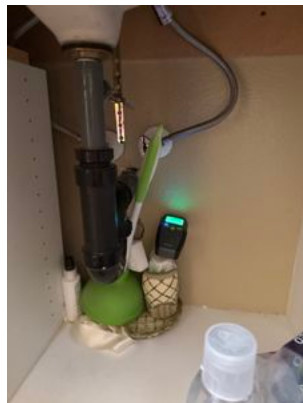
The drywall under the first bedroom bathroom sink was tested for moisture. Moisture was noted at 11.0%

Drywall under 15% moisture in this area is considered normal.

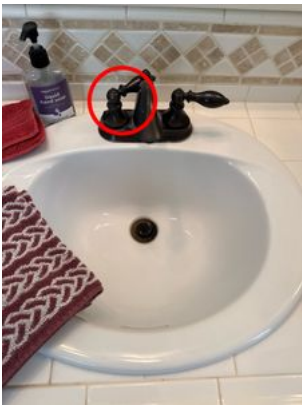
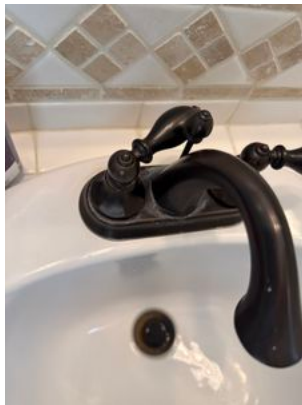
The end hallway bedroom bathroom sink faucet hot side water valve is installed in the wrong direction.

Recommend further evaluation and repair by a qualified licensed contractor.

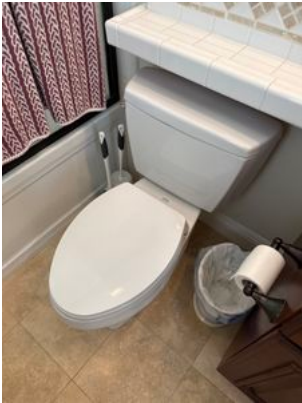
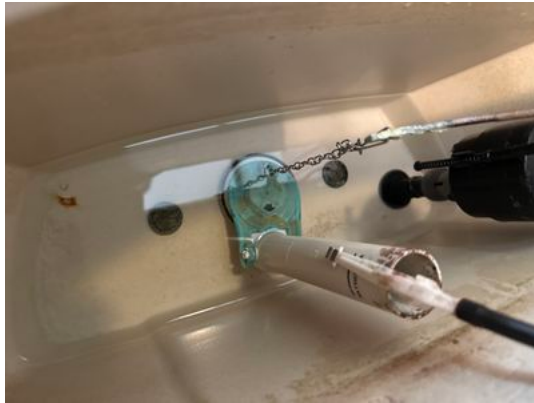
Bathroom toilet flapper appears to be in need of replacement. Water leaks past the flapper.

Recommend further evaluation and repair by a qualified licensed contractor.

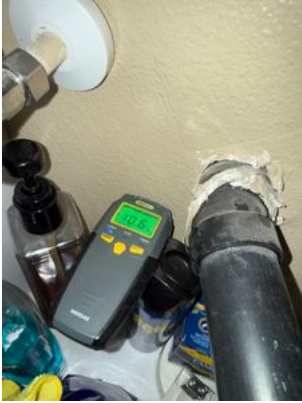
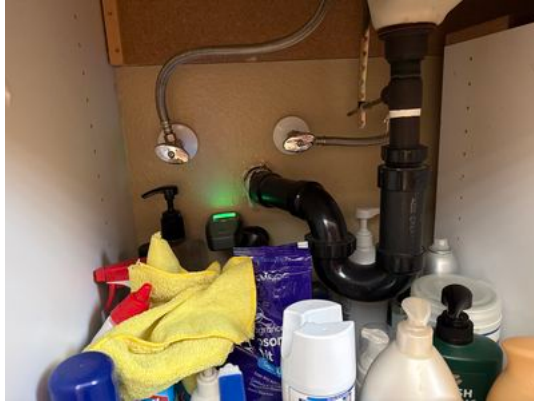
The drywall under the end hallway bedroom bathroom sink was tested for moisture. Moisture was noted at 1.06%

Drywall under 15% moisture in this area is considered normal.

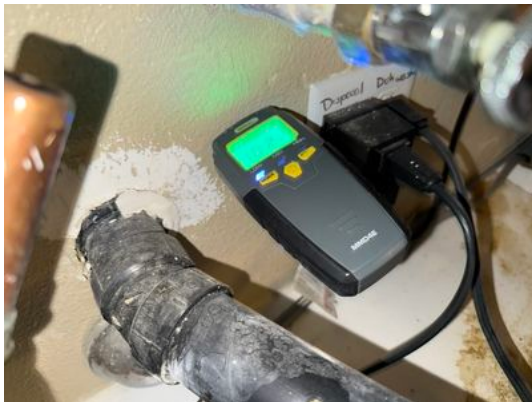
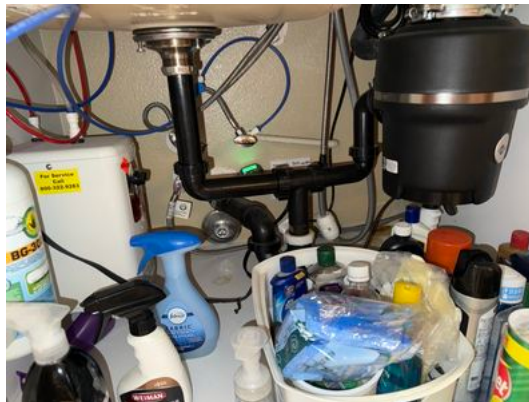
Moisture was tested under the kitchen sink. Moisture was noted at 10.2%. Normal moisture in this area is under 15%

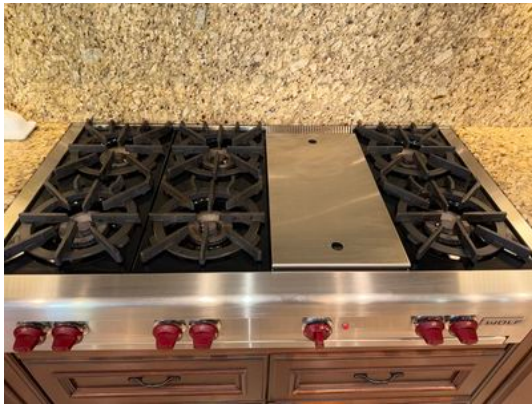
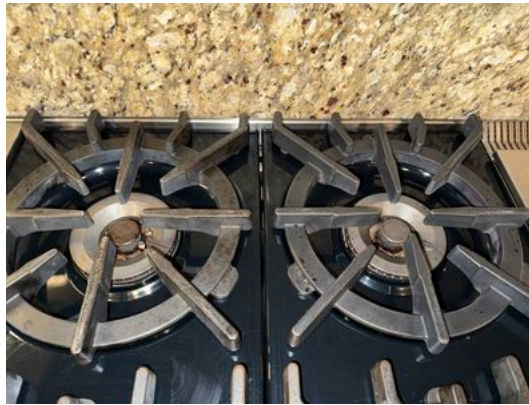
Left rear two burners did not ignite.

Recommend further evaluation and repair by a qualified licensed contractor.

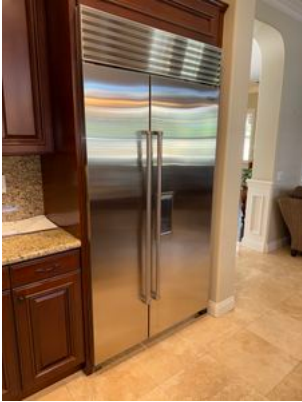
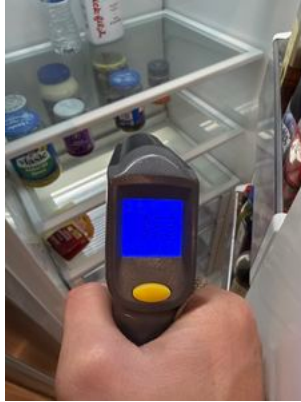
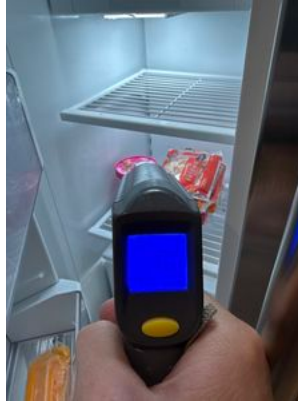
Refrigerator and freezer temperatures. Informational only.

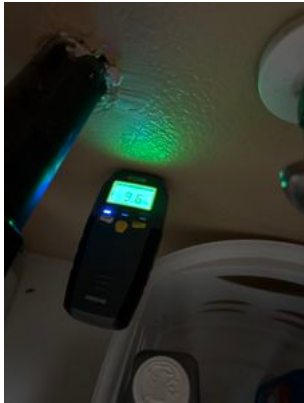
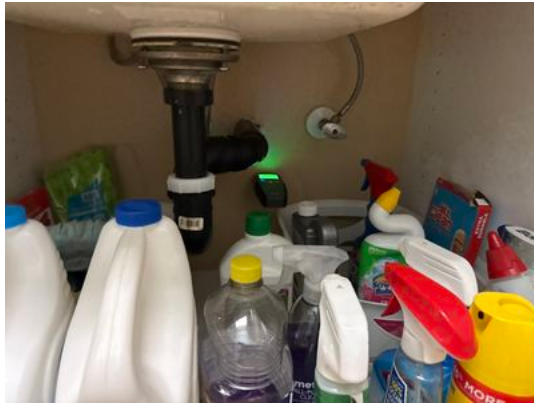
Moisture was tested in the drywall under the laundry room sink. Moisture was noted at 8.8%.

Normal drywall moisture in this area is under 15%

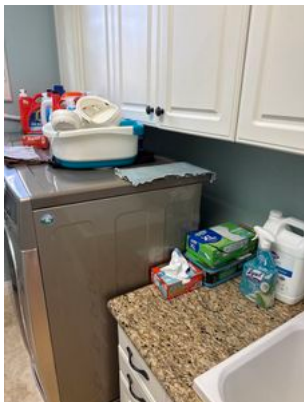
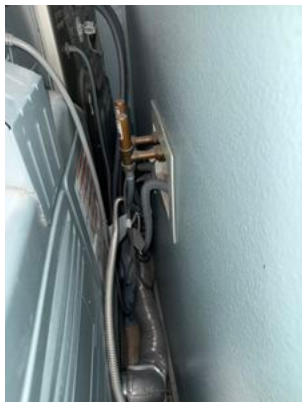
Informational only, unable to test the drywall moisture under the washing machine hook up valves/drain. Cabinets and units are blocking access. No evidence of water leaks/moisture at the time of the inspection.

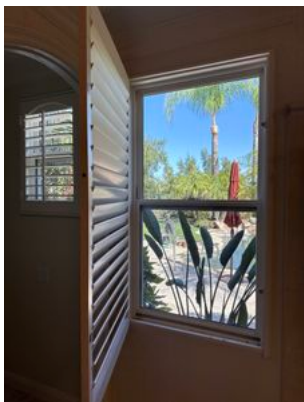
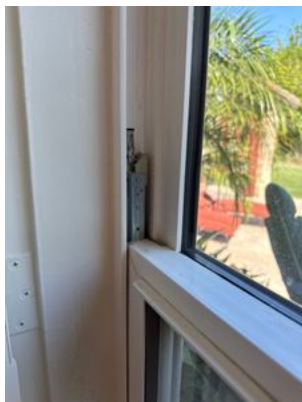
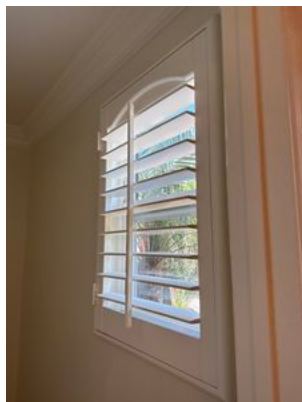
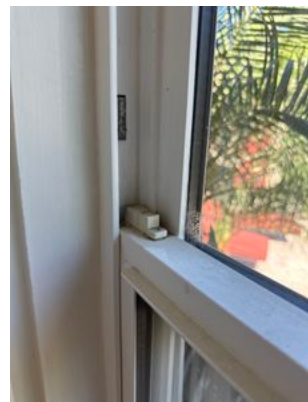
Broken window springs were noted throughout the master bedroom and bathroom, laundry room, pantry, hallway bathroom, bedroom hallway, center and front bedroom bathrooms.

Recommend further evaluation and repair by a qualified licensed contractor.

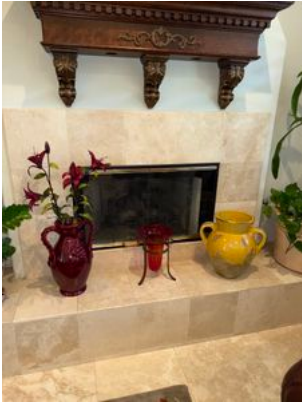
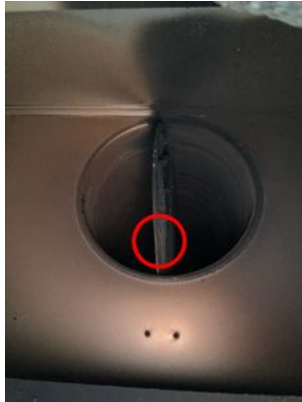
Visible areas of the chimney in the family room appear to be clean and clear; however, a flue clamp is missing.

Recommend installing a flue clamp to keep the flue open since the unit is set up for gas only.

Recommend further evaluation and repair by a qualified licensed contractor.

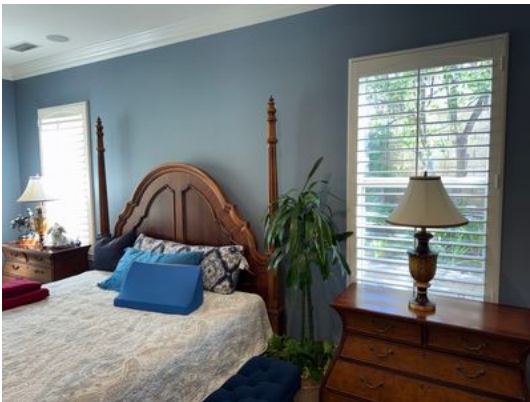
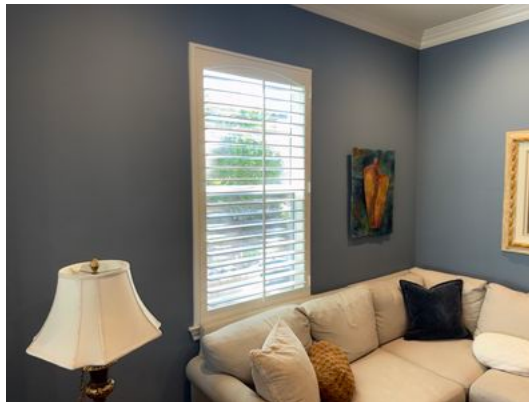
##### **Comment 62** **Information**

Informational only, unable to access three of the windows in the master bedroom. First lines are blocking access.

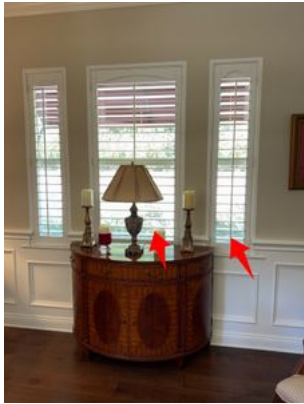
**Comment 63**  
**Information**

Unable to access a window in the home. Informational only.

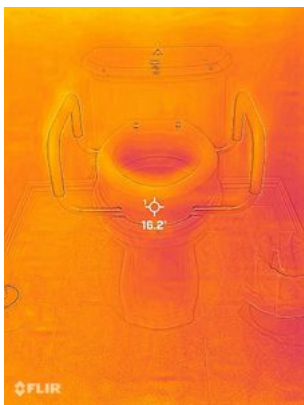
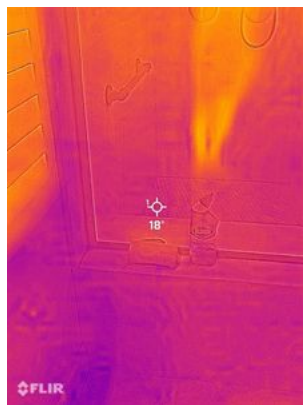
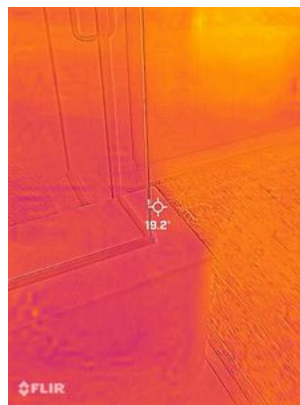
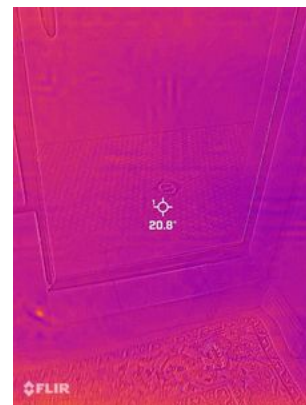
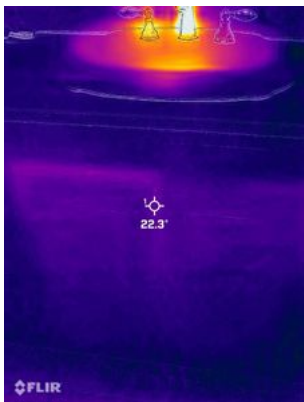
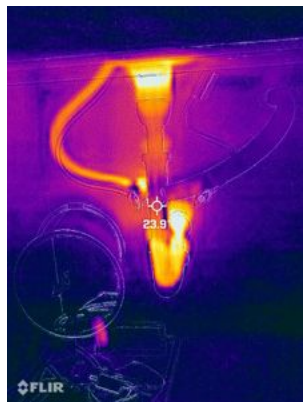
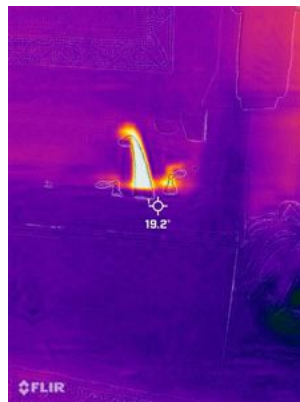
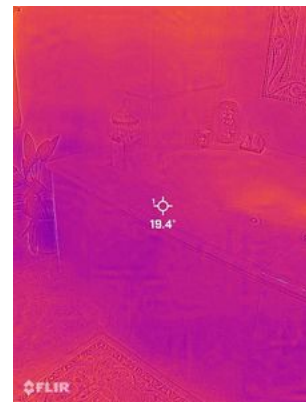
**Comment 64**  
**Information**

Walls and ceilings throughout the home were observed using a FLIR infrared camera. No abnormalities noted at this time.

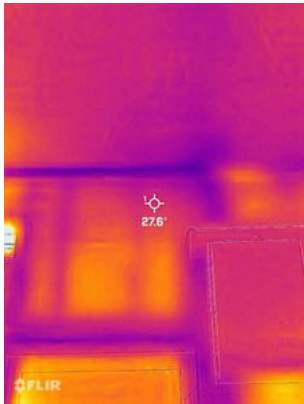
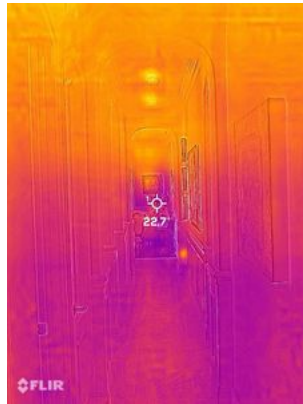
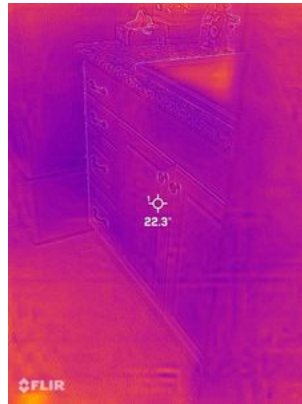
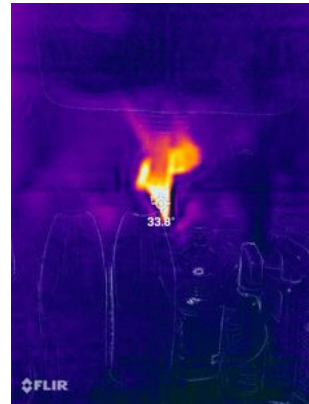
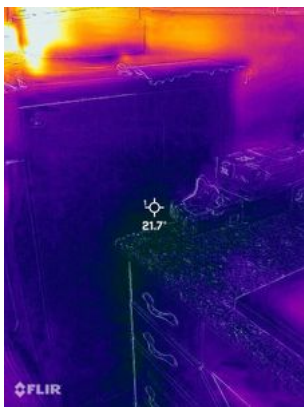
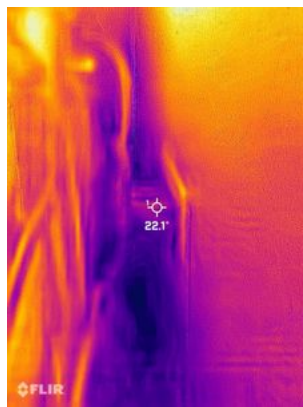
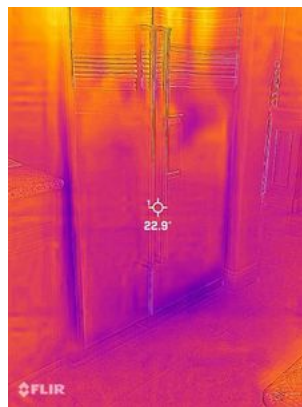
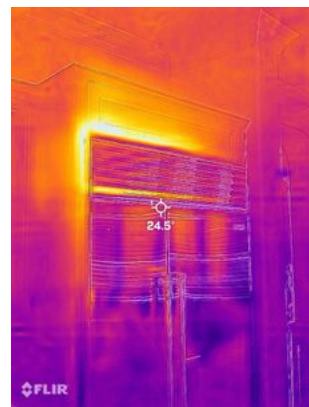
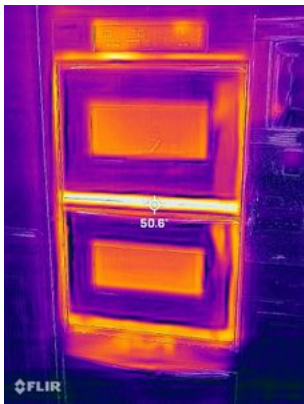
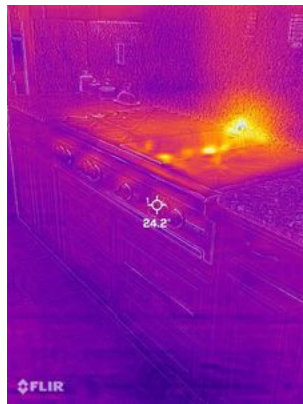
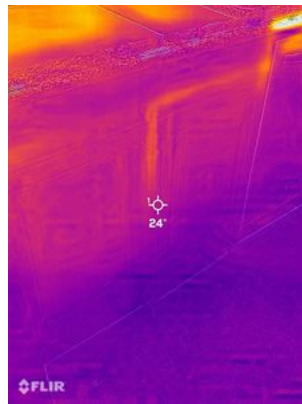
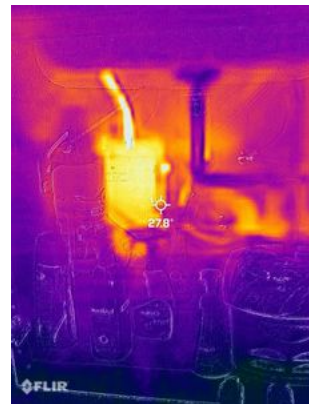
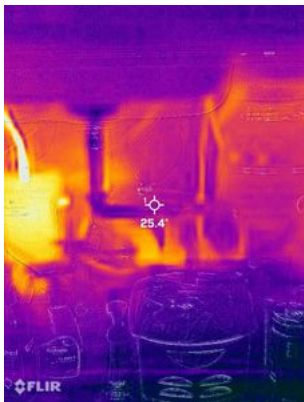
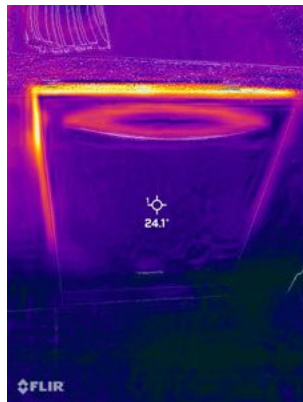
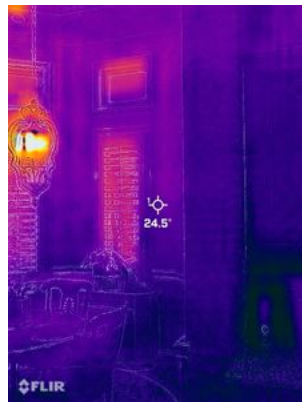
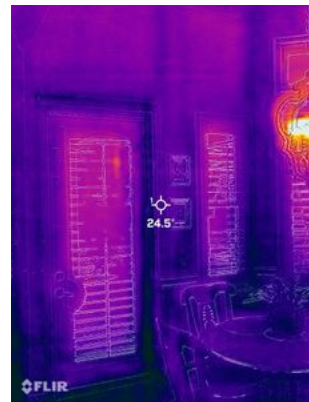
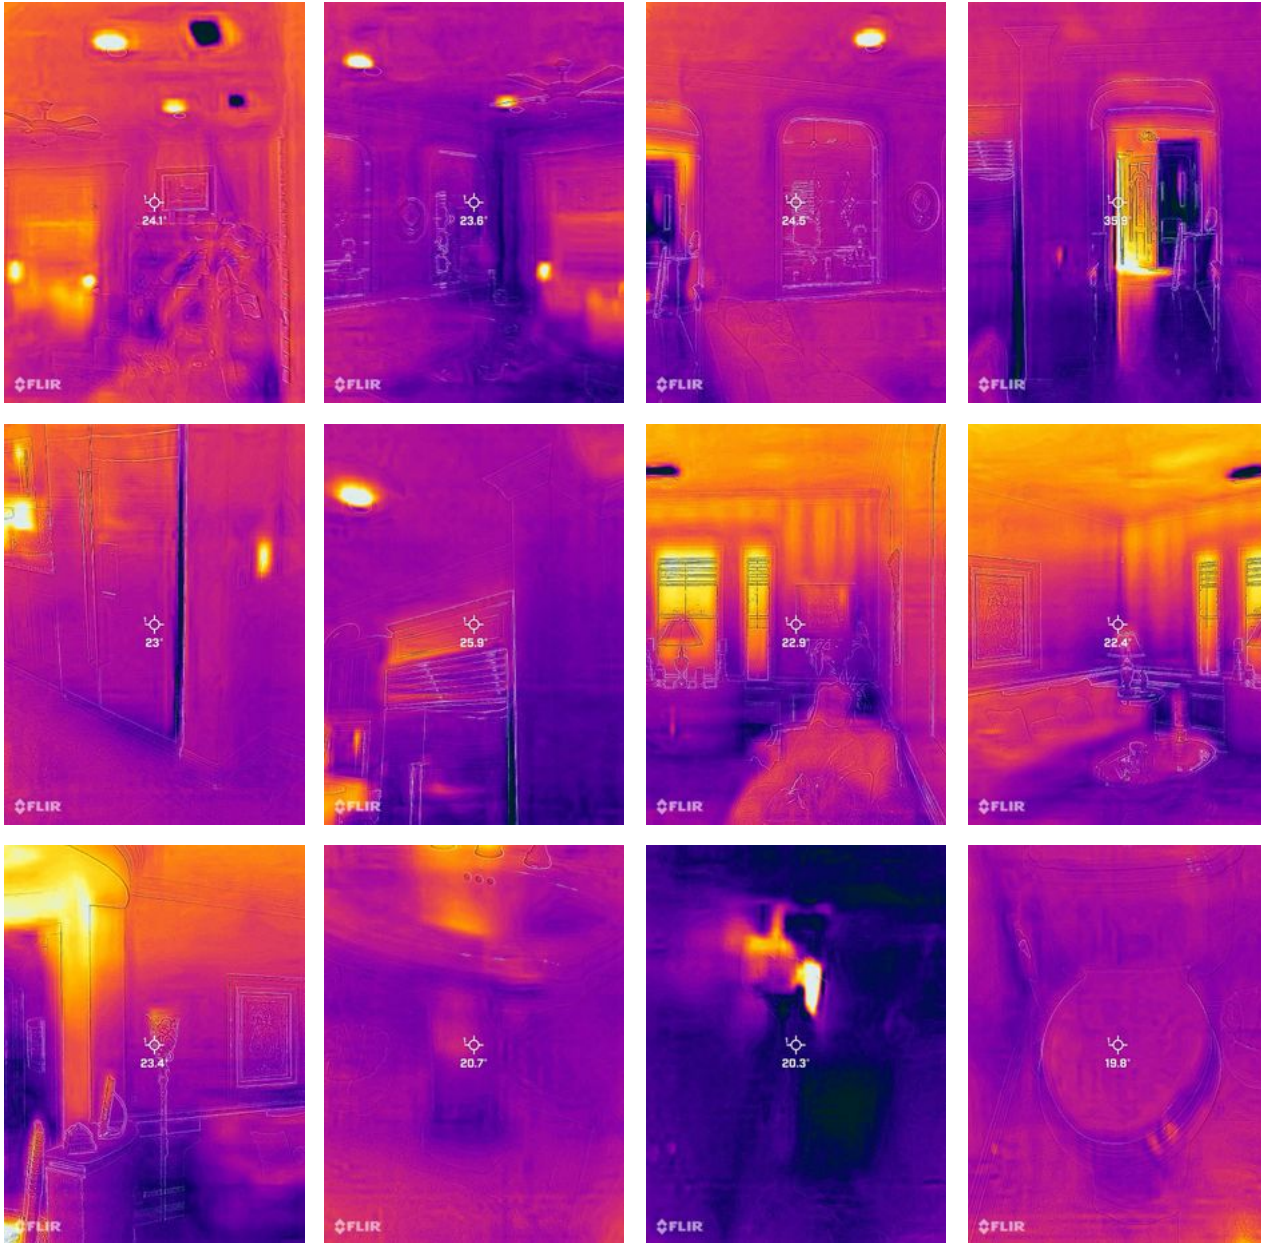
**Comment 65**  
**Information**

Continuation of FLIR pictures.

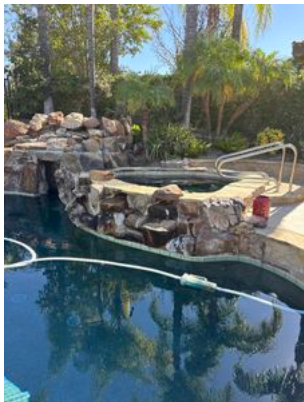
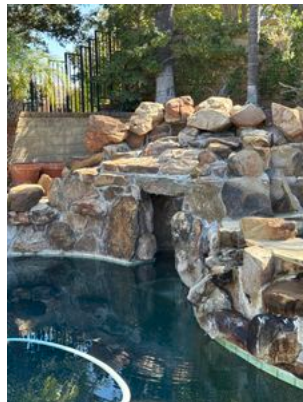
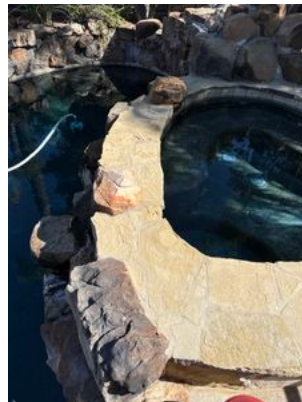
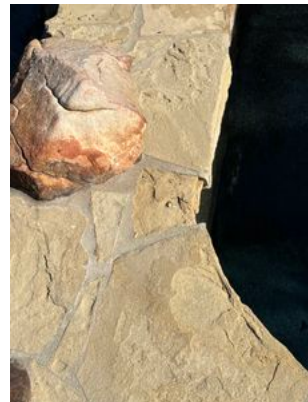
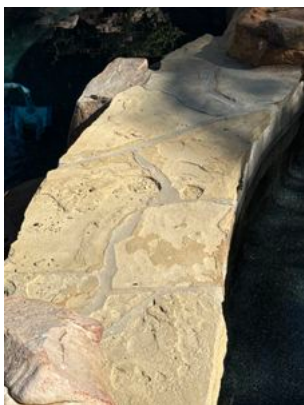
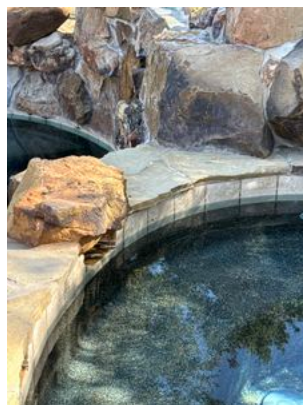
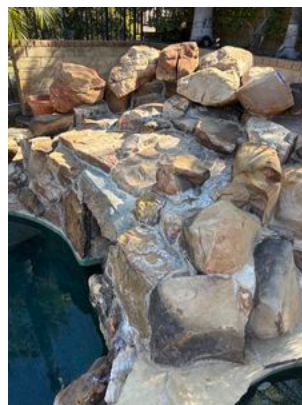
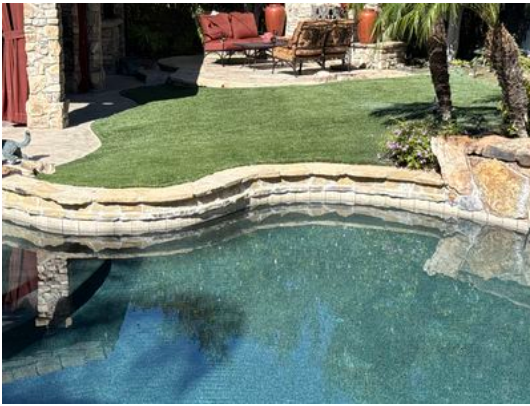
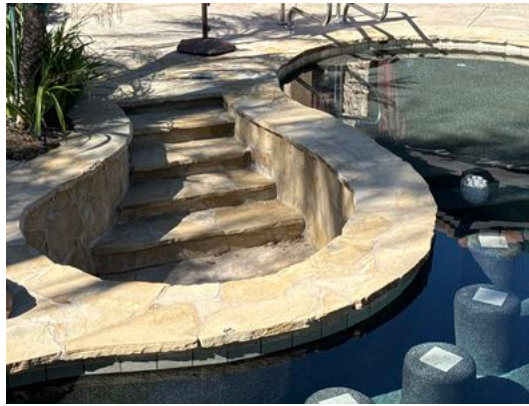
Efflorescence buildup is noted on the stone surrounding the pool, spa and waterfall. Sandstone above the spa spillway and some areas of the coping are beginning to flake and separate. Loose sections of the stone were observed in several areas. Maintenance work/stone sealant is needed to prevent further deterioration.

Recommend further evaluation and repair by a qualified licensed pool contractor.

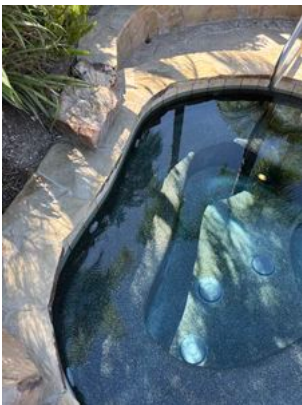
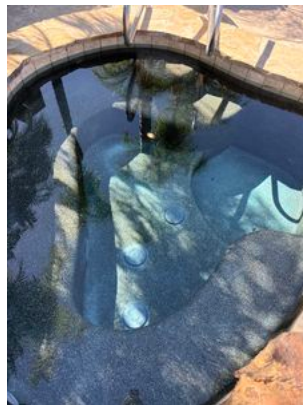
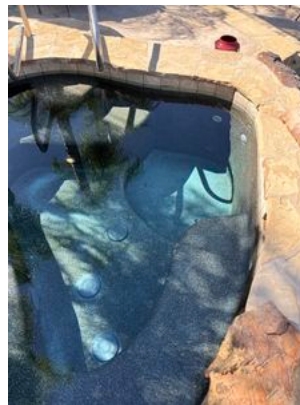
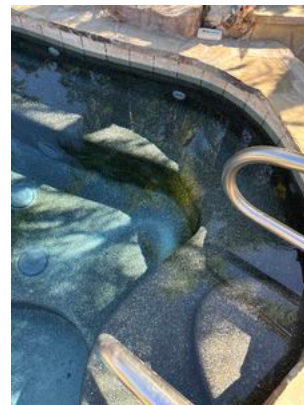
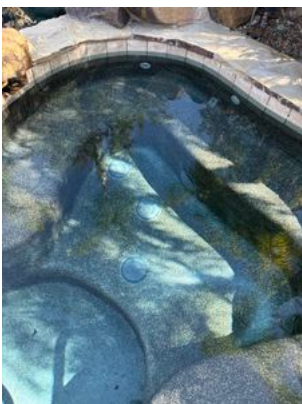
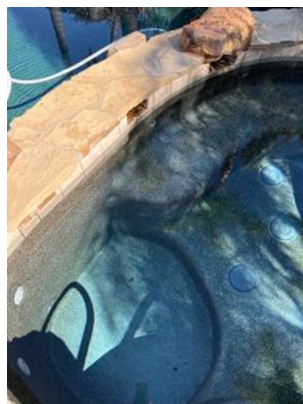
**Comment 67**

Spa interior finish appears to be in generally good condition. A buildup of material was observed on the steps and bottom of the spa which appears to be related to the degrading stone surrounding the coping.

Recommend further evaluation and repair by a qualified licensed pool contractor.

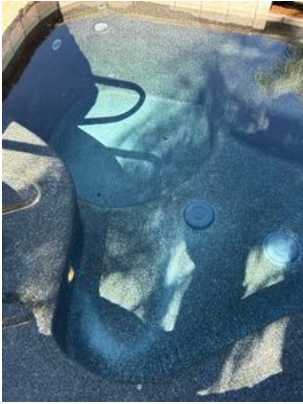
**Comment 68**

One of the spa intake covers is cracked.

Recommend further evaluation and repair by a qualified licensed contractor.

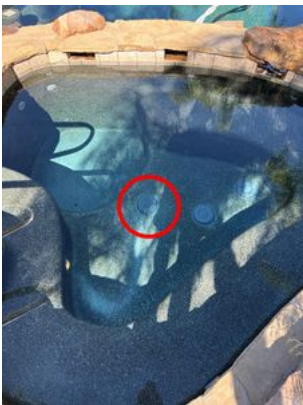
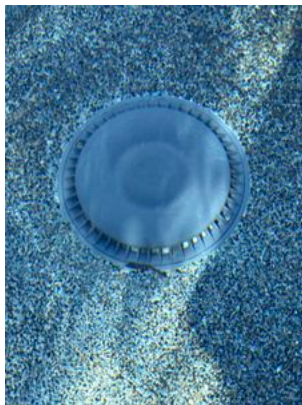
**Comment 69**

Pool interior finish appears to be in generally good condition. Normal wear and tear is noted in some areas pool mostly around the swim step and seat areas. Complete observation/access of the grotto cannot be made at the time of the inspection.

Recommend monitoring for changes over time.

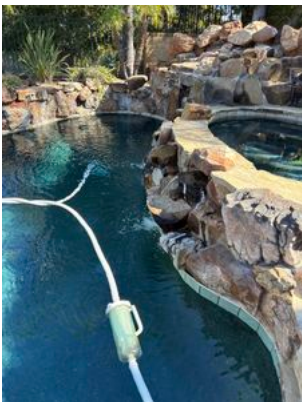
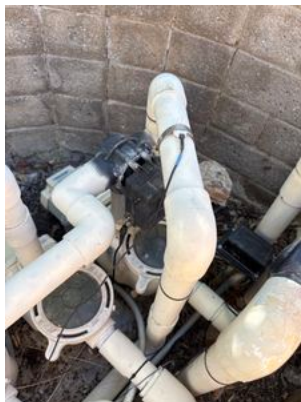
### Comment 70 Information

Information only, pool/spa filtration pump turned on and is functional.

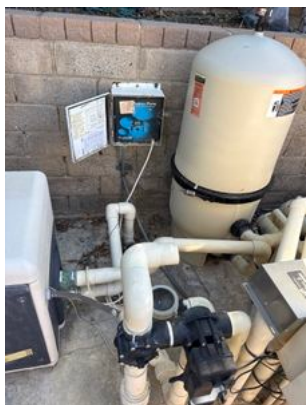
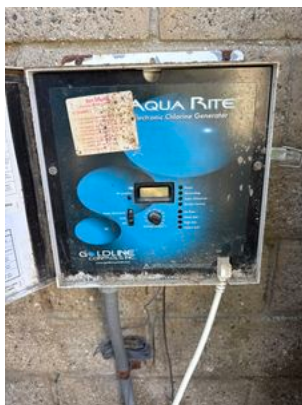
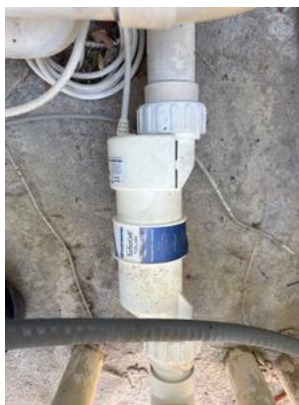
### Comment 71

Salt water chlorine generator does not appear to be functional. Recommend further evaluation and repair by a qualified licensed pool contractor or serviceman.

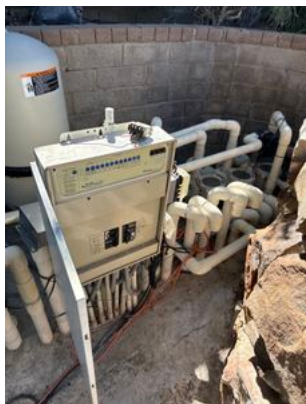
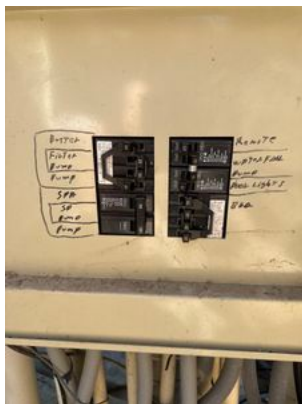
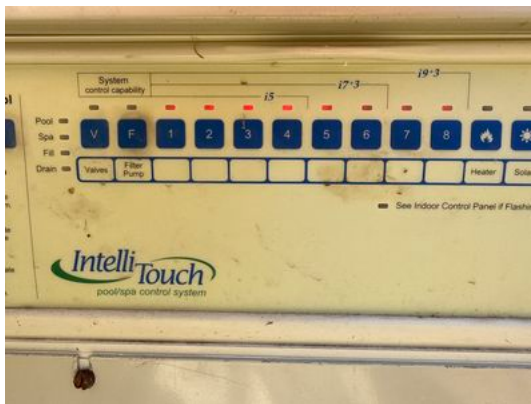
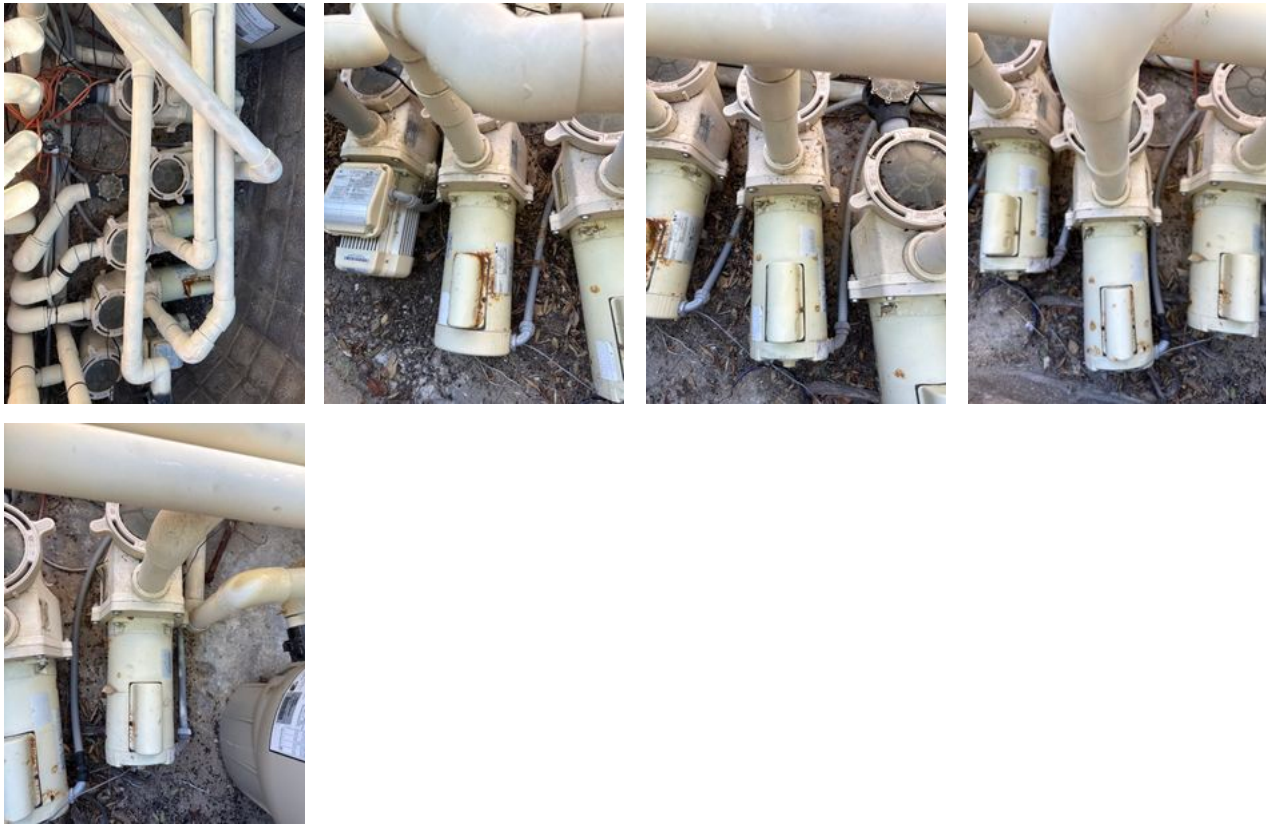
### Comment 72

Only the main filtration pump turned on during the inspection. Breakers were found tripped on the panel. Also a relay switch was found abandoned on top of the control box. GFCI outlets on the sides of the panel were found in the tripped position. Booster pumps and the waterfall pump were noted to have large amounts of rust buildup.

Recommend further evaluation and repair by a qualified licensed pool contractor.

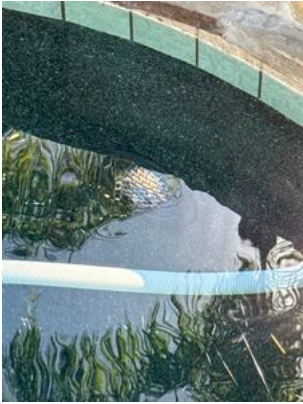
**Comment 73**

The spa and pool lights were functional however the GFCI outlet attached to the control panel was found in the tripped position at the start of the inspection. GFCI outlet was reset to allow for testing. GFCI outlet appears to be in need of replacement. Outlet appeared to be corroded.

Recommend further evaluation and repair by a qualified licensed pool contractor.

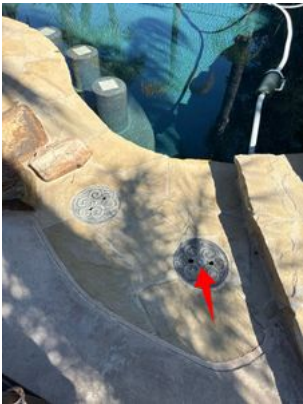
**Comment 74**

Float valve assembly appears to have been removed from the skimmer basket intake piping. Recommend further evaluation and repair by a qualified licensed pool contractor.

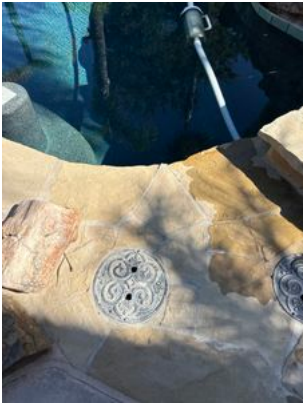
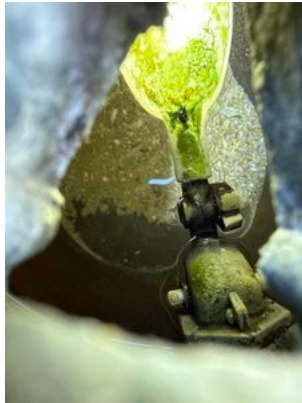
**Comment 75**

Automatic float valve that fills the pool with water was functional.

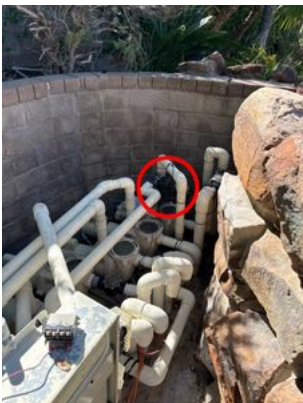
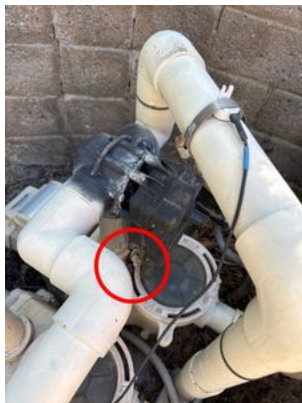
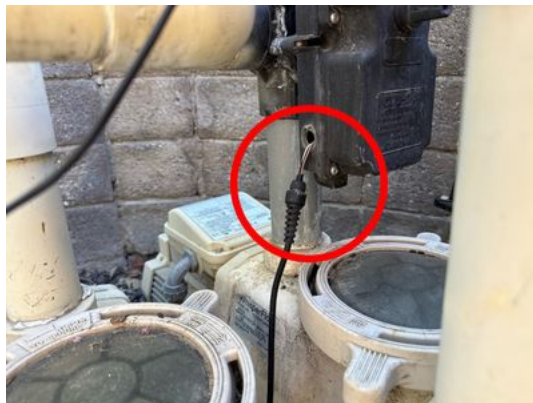
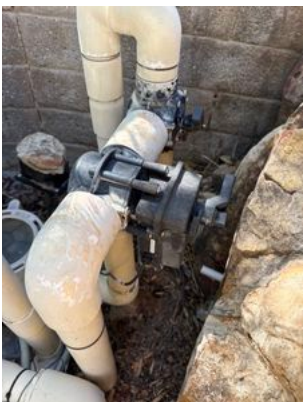
#### Comment 76

Automatic actuator valves were functional however one of the units controllers has separated from the wire housing.

Recommend further evaluation and repair by a qualified licensed pool contractor.

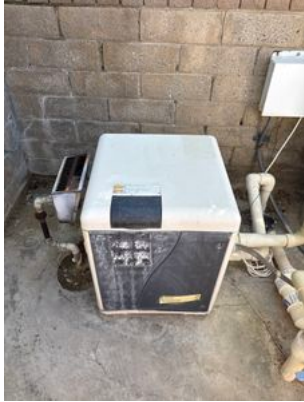
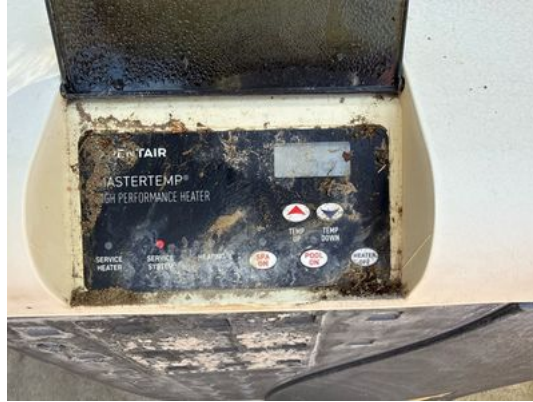
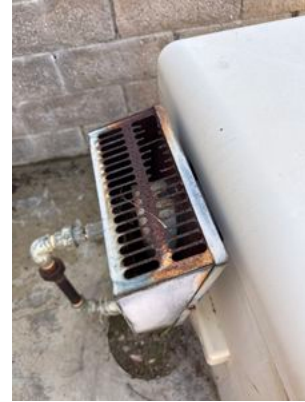
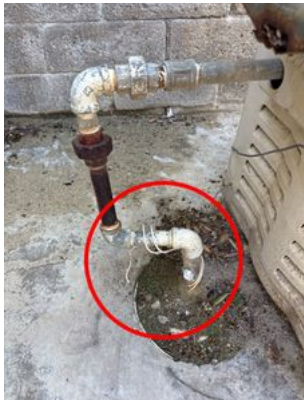
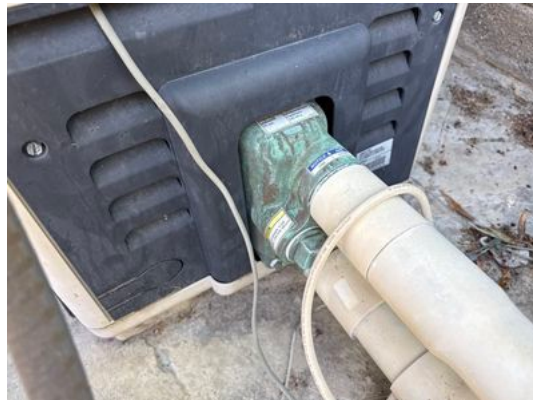
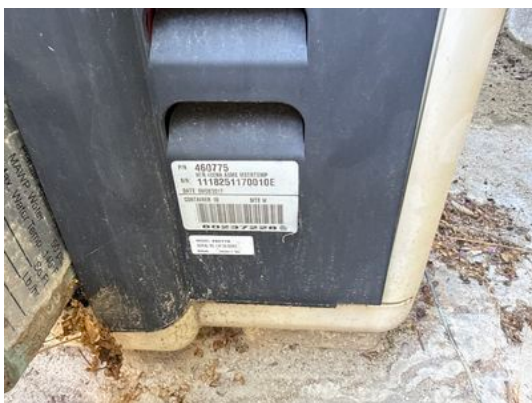
**Comment 77**

The pool/spa heater did not turn on during the inspection. Unit produced a series of cooking sounds than the service light illuminated. Unit was found to be rusted/corroded. Also the natural gas piping valve is deteriorated.

Recommend further evaluation and repair by a qualified licensed pool contractor.

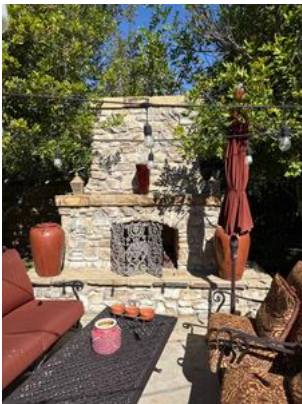
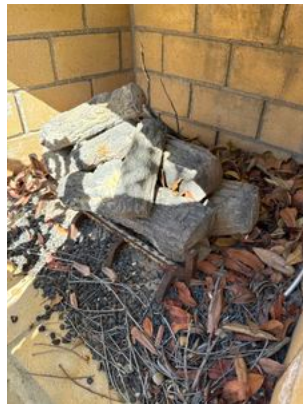
Rear patio natural gas burning fireplace should be cleaned. A large buildup of flammable debris has accumulated inside of the burn box.

Recommend further evaluation and repair by a qualified licensed contractor.

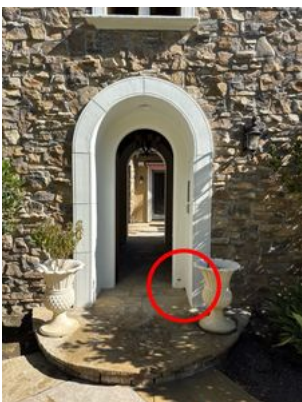
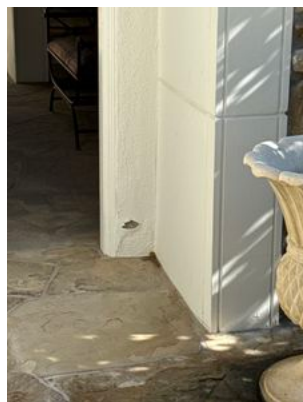
Peeling paint and stucco was noted on the right exterior side of the front door.

Recommend further evaluation and repair by a qualified licensed contractor.

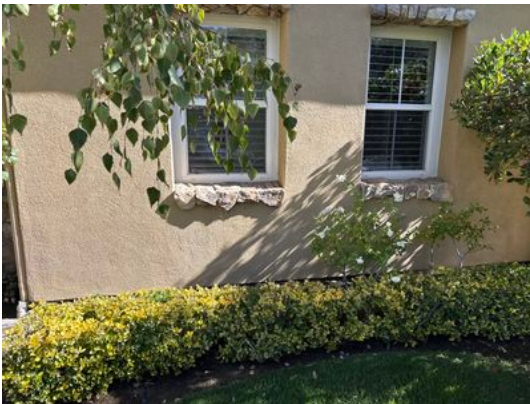
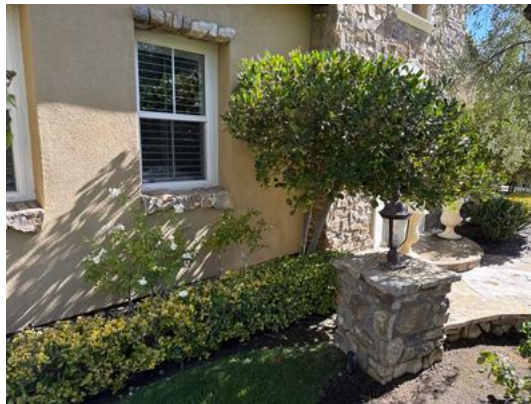
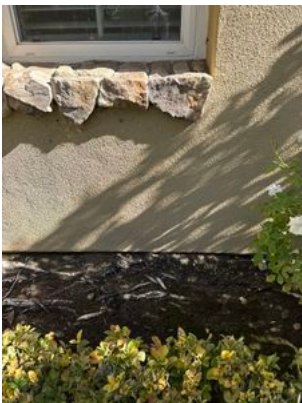
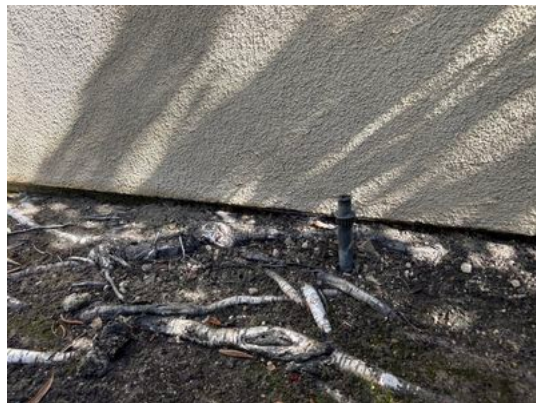
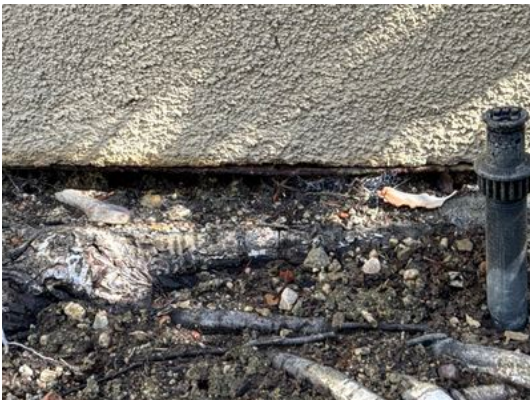
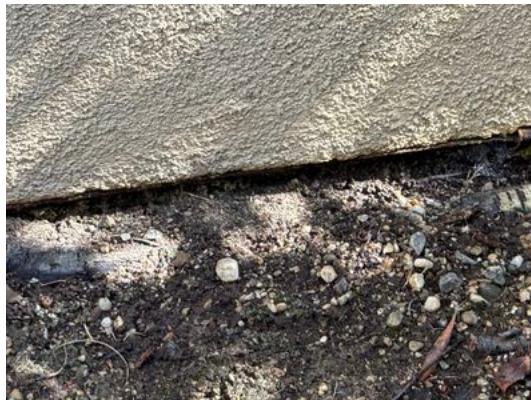
Sprinkler over spray was noted around the exterior of the home in many areas. Soil is built up against and above the weep screed. Damaged and rusted sections of the stucco weep screeds were observed.

Recommend adjustment of sprinklers

Recommend further evaluation and repair by a qualified licensed contractor.

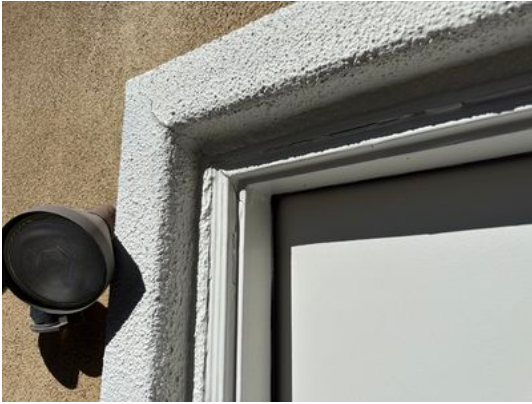
Peeling paint was observed beneath the rear patio master door.

Recommend further evaluation and repair by a qualified licensed contractor.
