## Home Inspection Report

26584 Oak Terrace Pl  
Stevenson Ranch, CA 91381

Inspected On Thu, Oct 1, 2026 at 10:00 AM

Secure Home And Property Inspections LLC

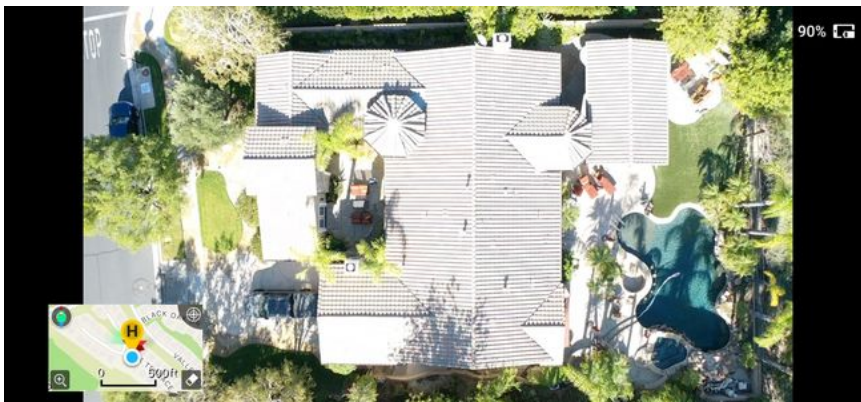
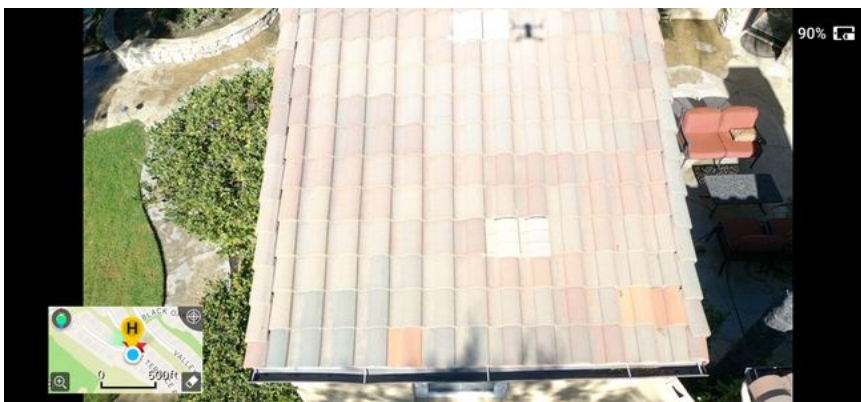
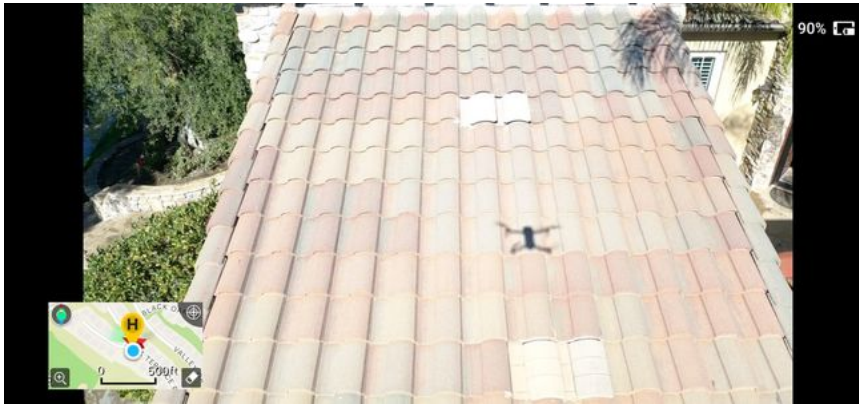
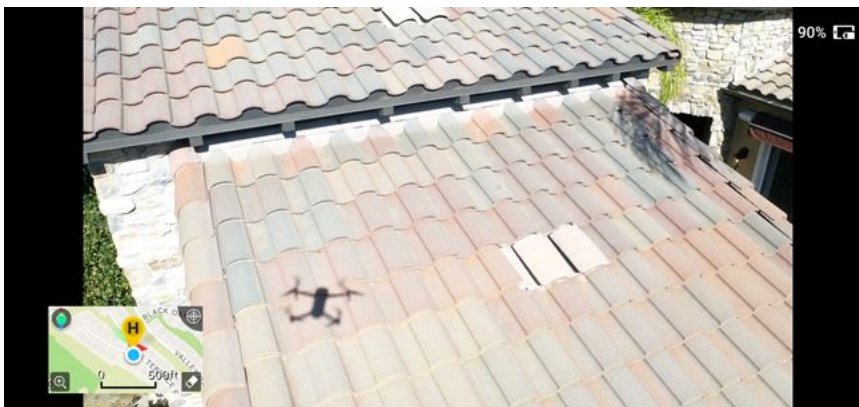
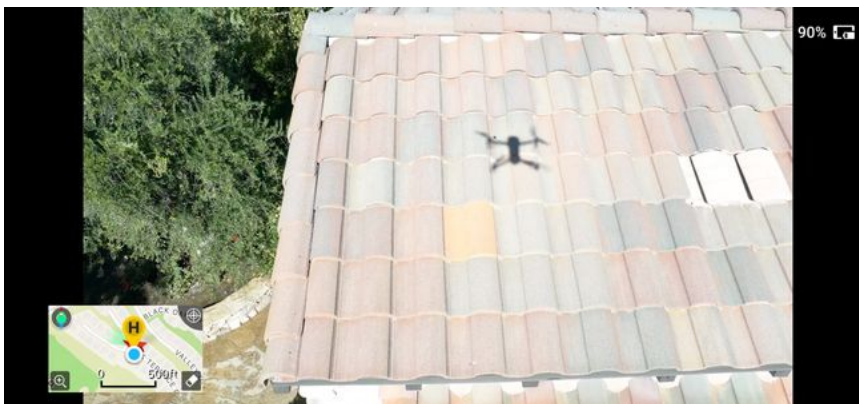
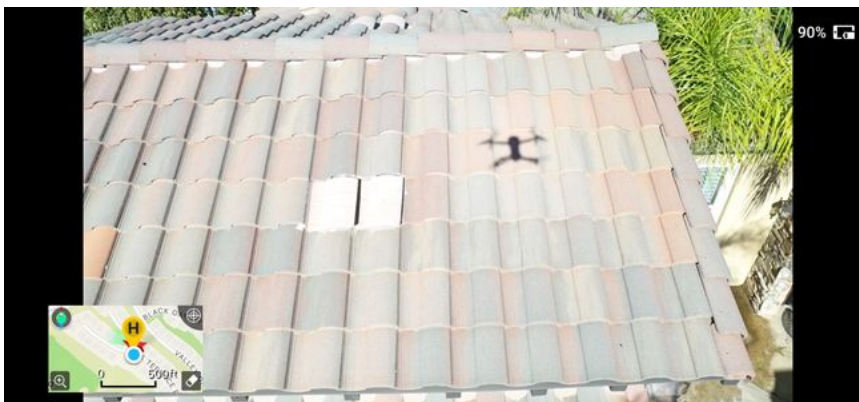
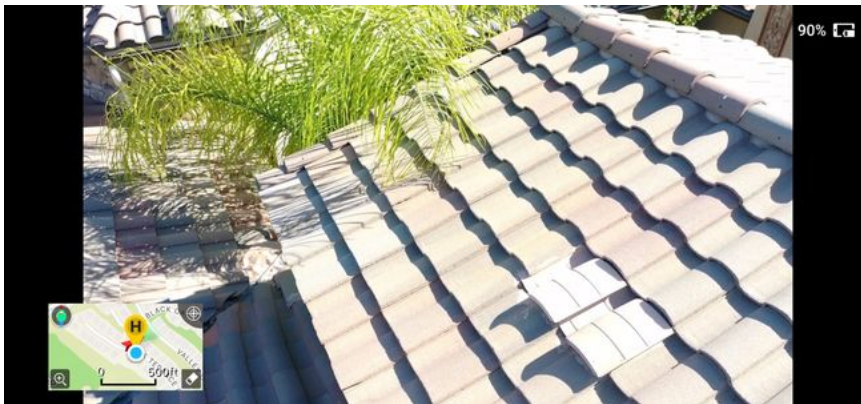
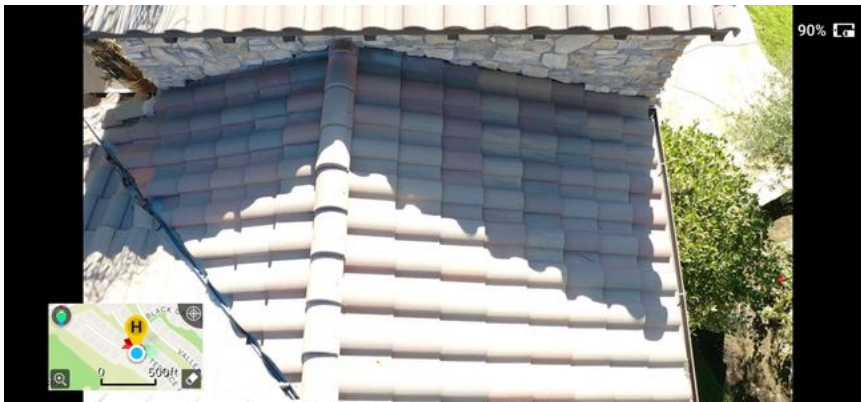
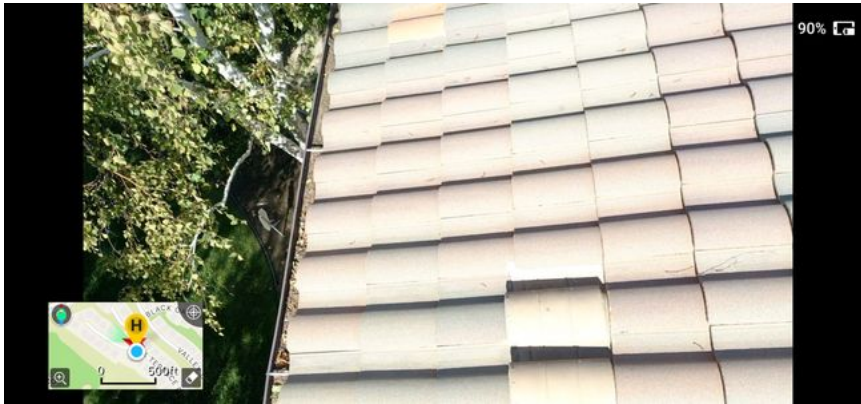
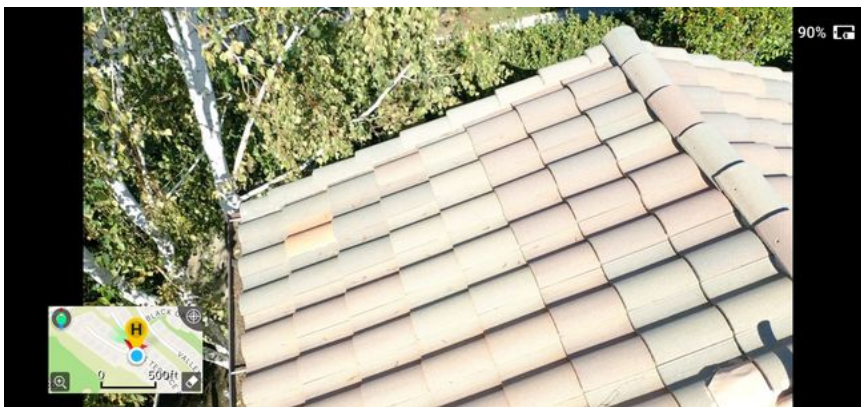
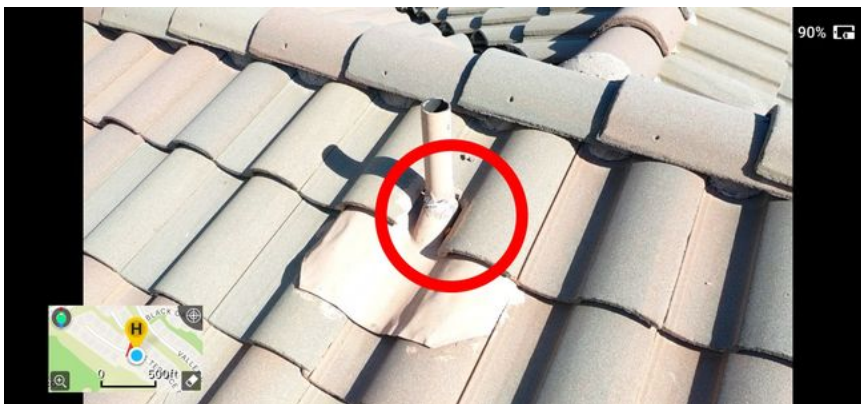
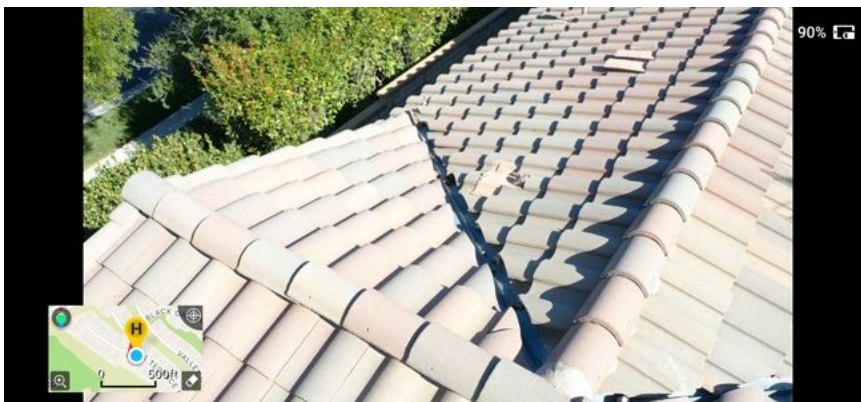
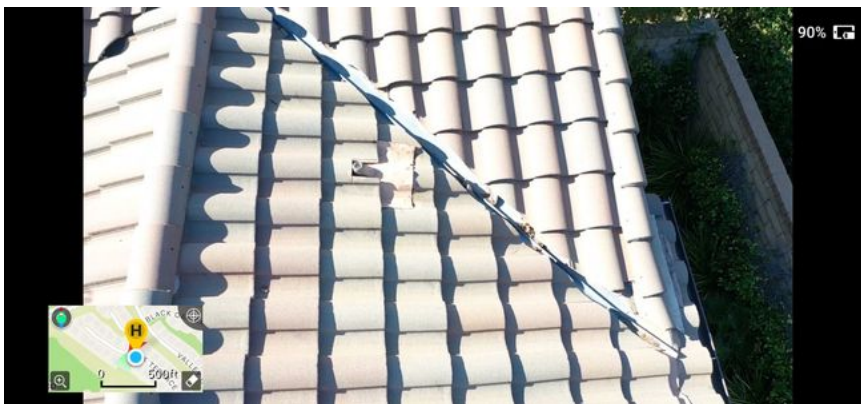
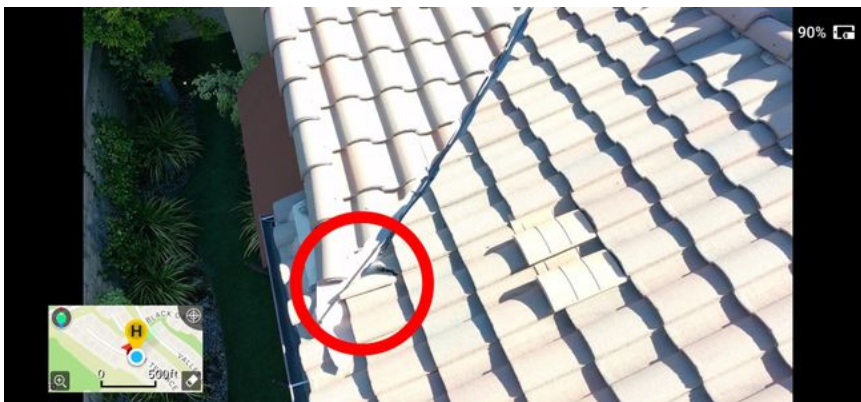
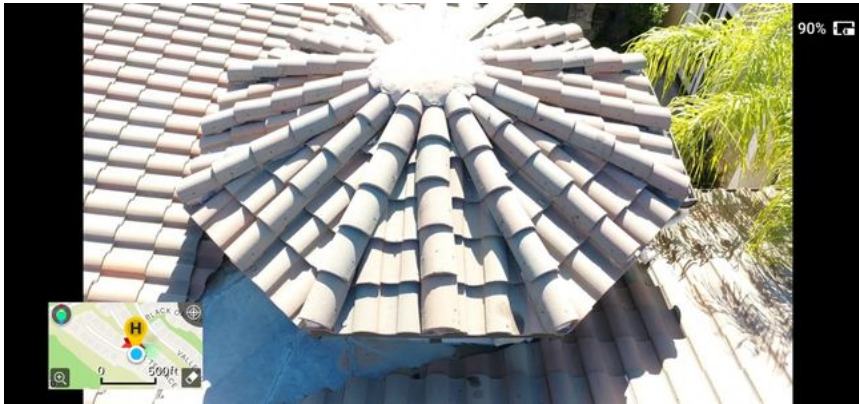
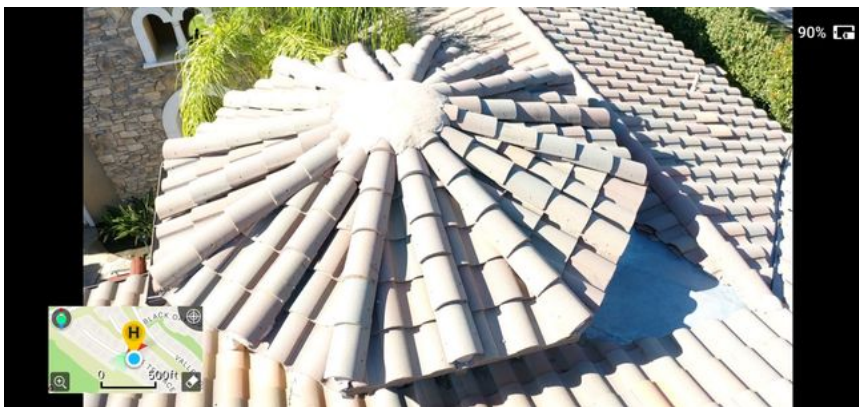
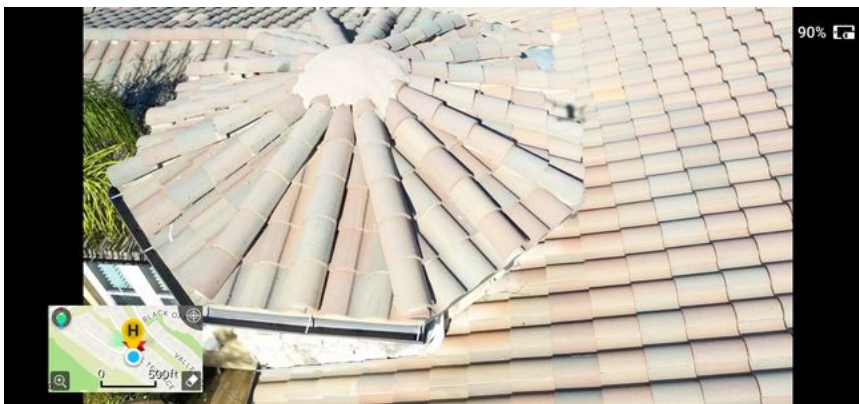
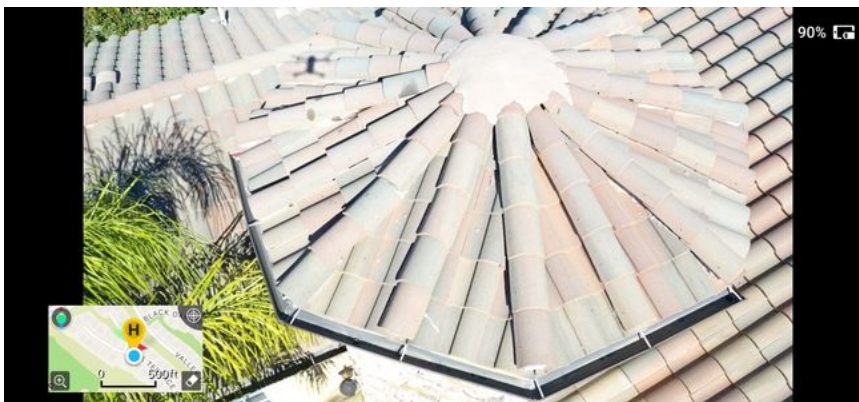
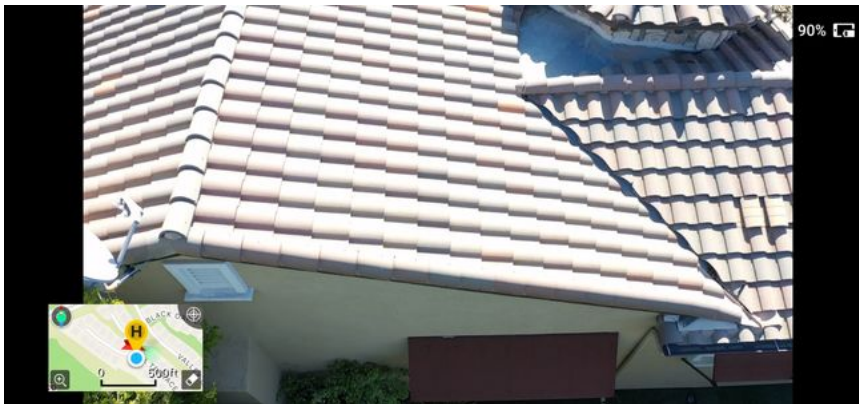
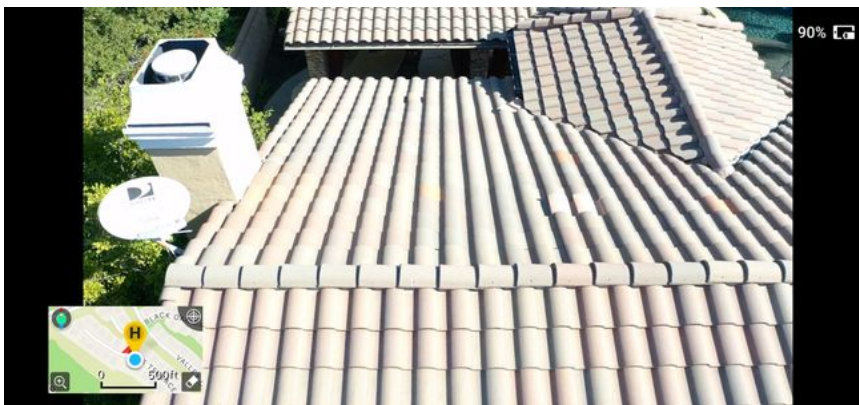
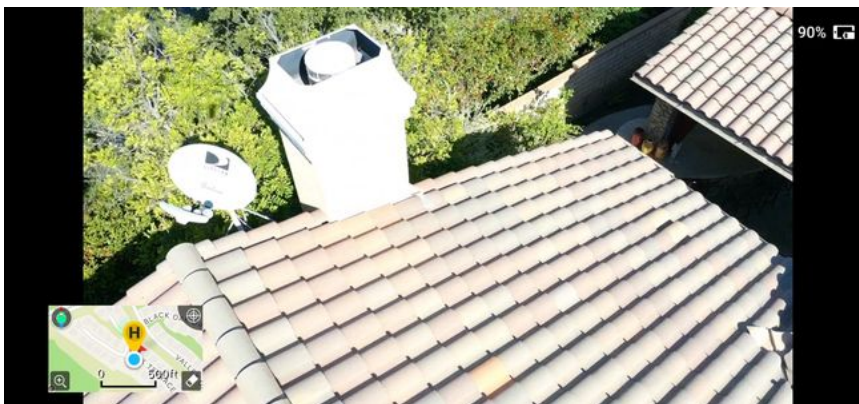
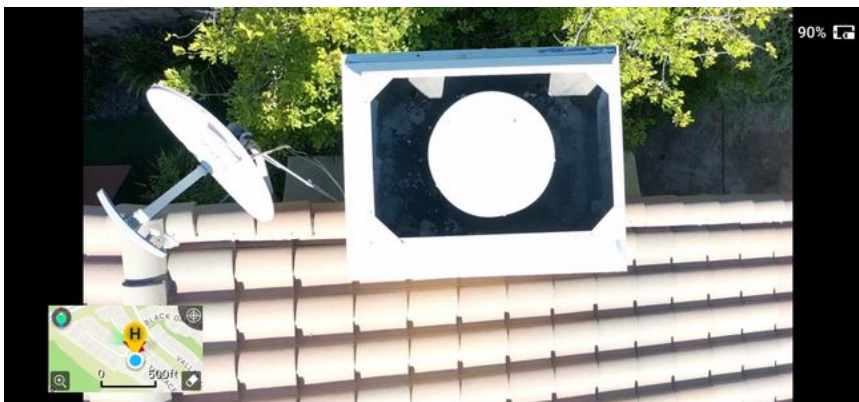
Cracked and slipped tiles were observed during the roofing inspection. Previously repaired and or replaced tiles were noted in some locations. Vent flashing sealant in a few locations is in need of maintenance work, gaps and cracks are beginning to form. Valleys and rain gutters were noted to have a buildup of debris and should be cleaned.

See attached pictures for locations. Many additional pictures continue onto the next section of the report below.

Recommend further evaluation and repair by a qualified licensed roofing contractor.

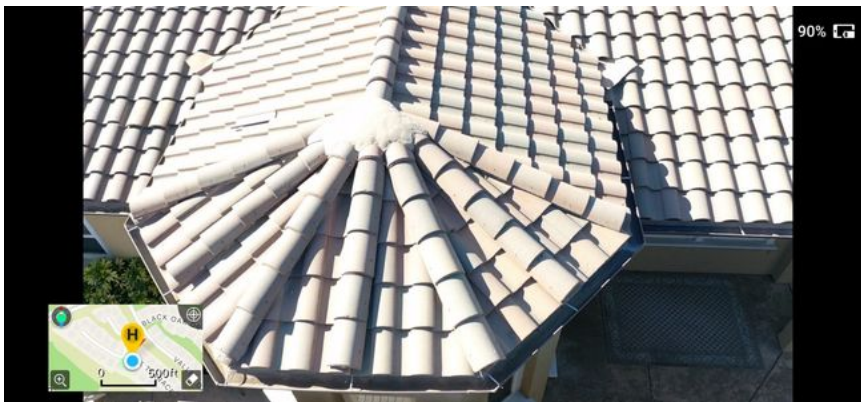
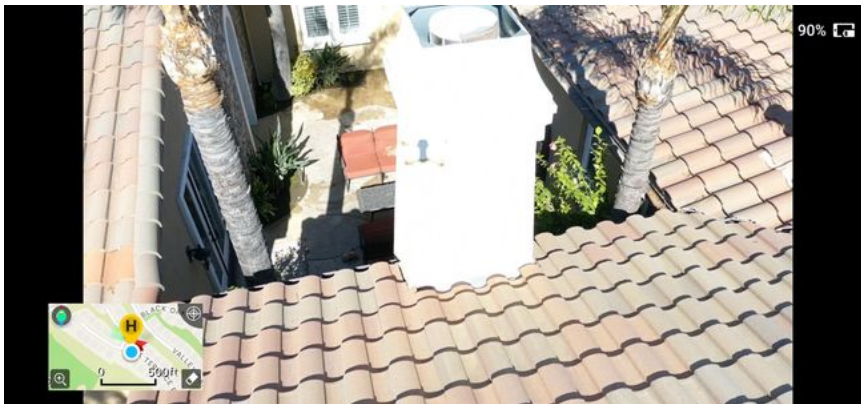
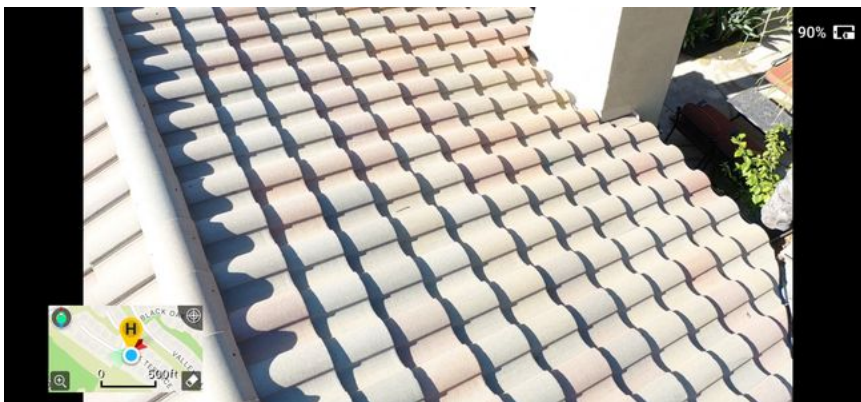
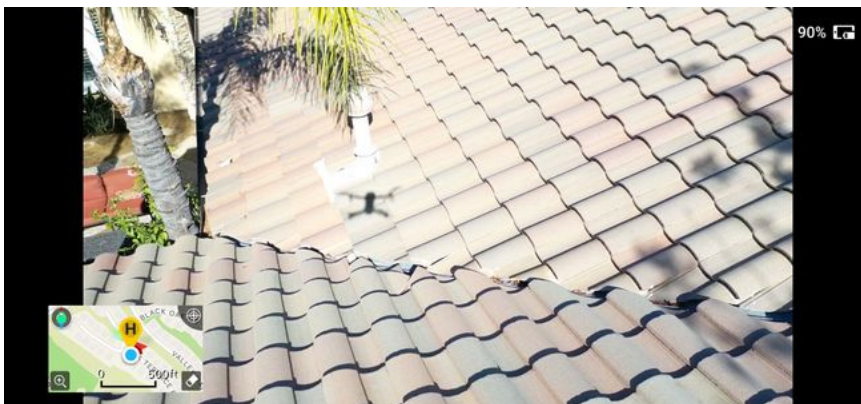
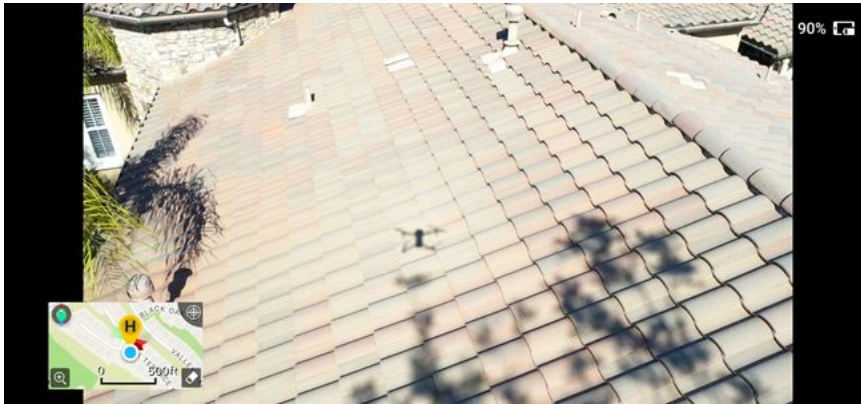
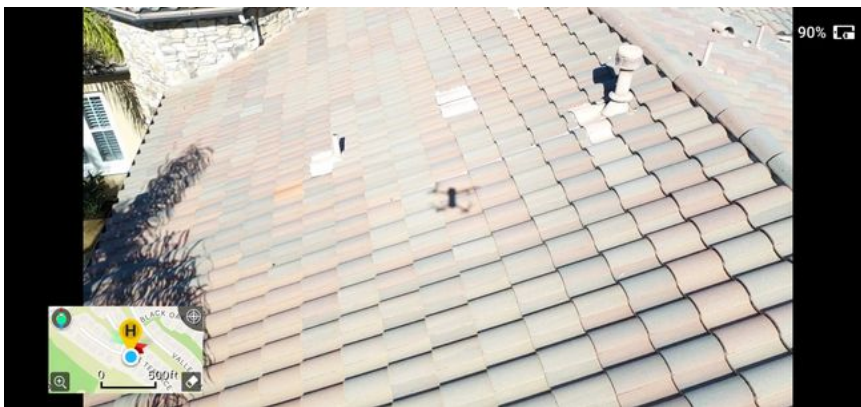
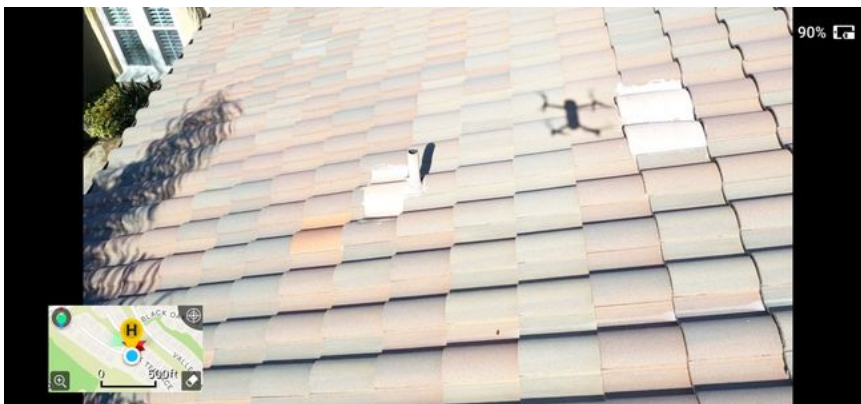
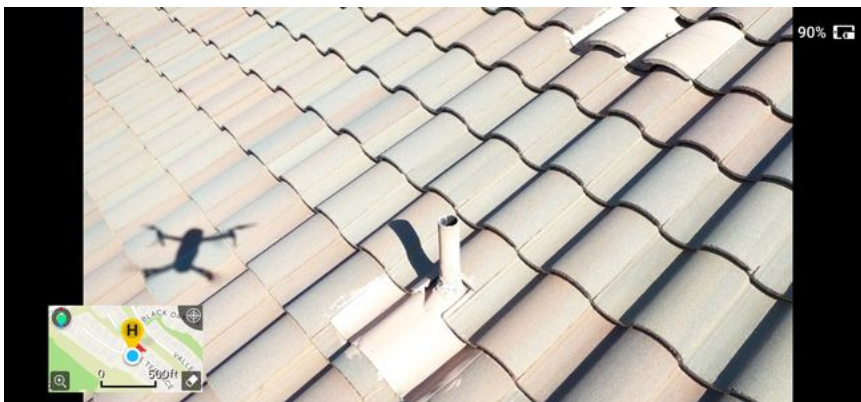
Continuation of roofing pictures.

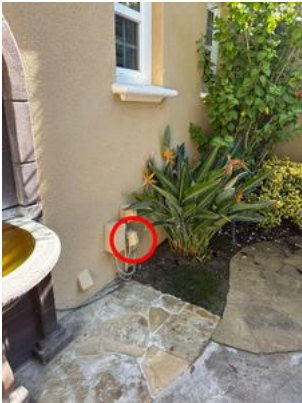
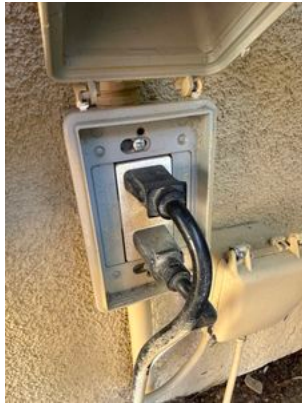
Electrical outlet on the left rear side of the home did not reset. Outlet appears to be corroded.

Recommend further evaluation and repair by a qualified licensed contractor.

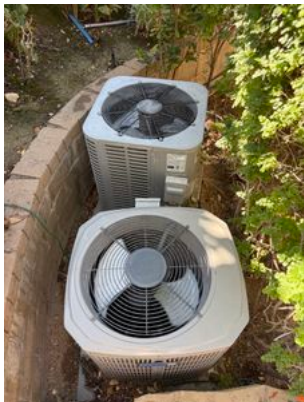
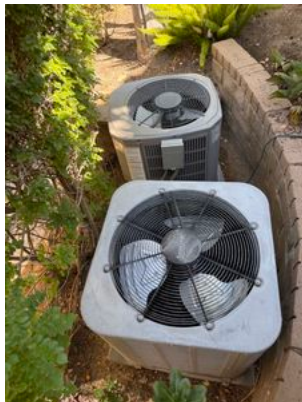
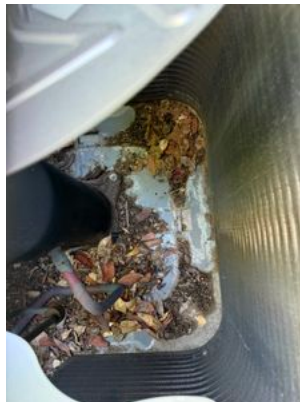
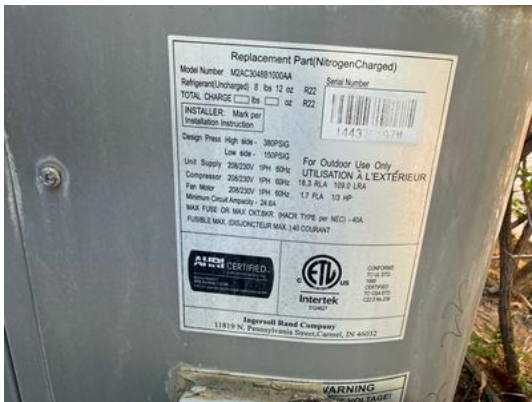
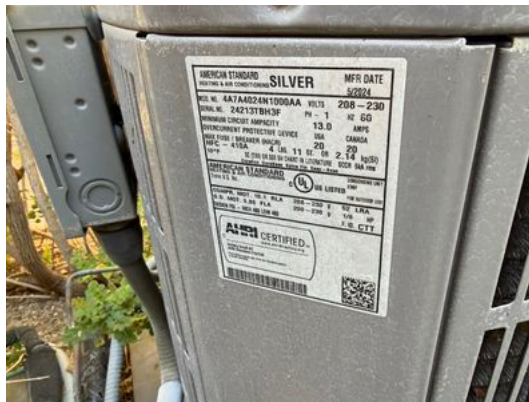
### HVAC: Cooling: Type of Equipment

The master bedroom side air-conditioning system was only lowering the incoming air temperature by approximately 10°.

Dirt, dust, and debris are noted inside both of the air conditioning condensers.

Due to the age and build up of debris inside, recommend servicing/cleaning by a qualified licensed HVAC contractor.

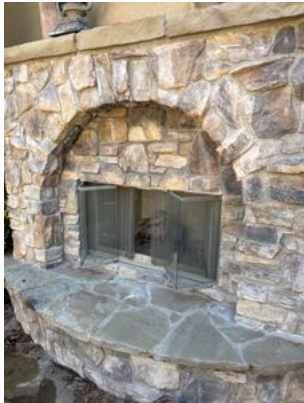
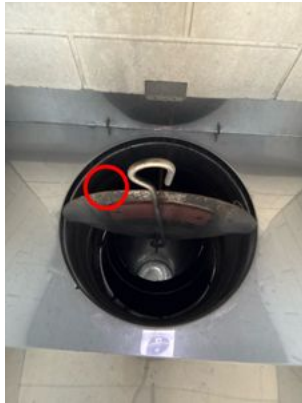
### Interior: Fireplace

Visible areas of the chimney in the family room appear to be clean and clear; however, a flue clamp is missing.

Recommend installing a flue clamp to keep the flue open since the unit is set up for gas only.

Recommend further evaluation and repair by a qualified licensed contractor.

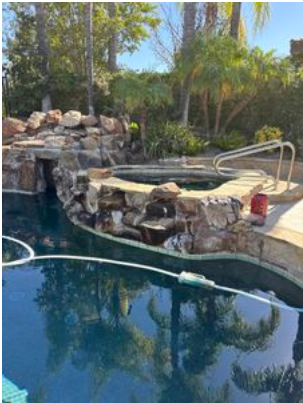
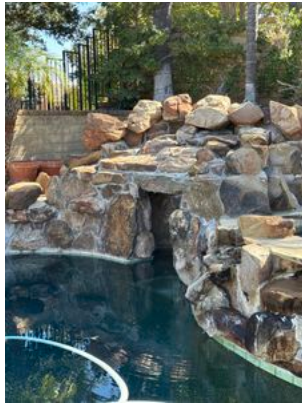
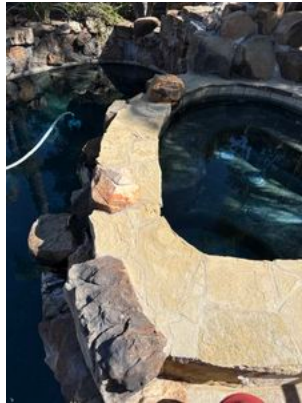
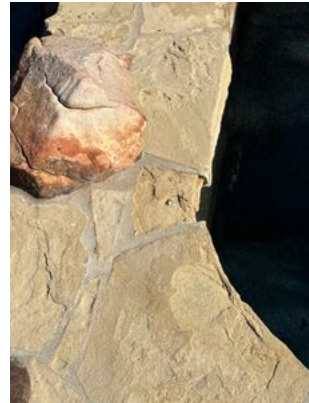
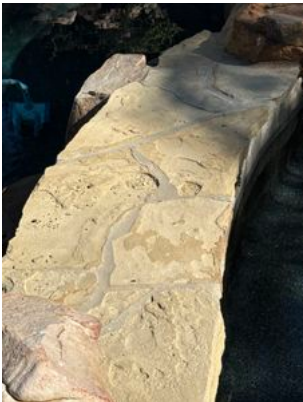
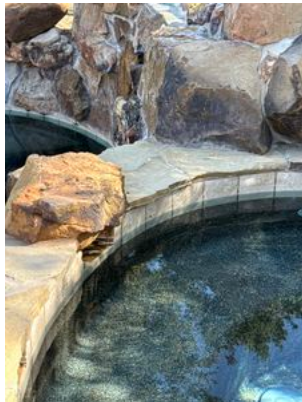
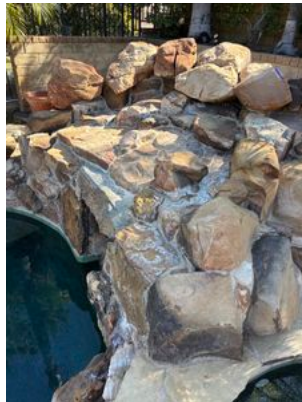
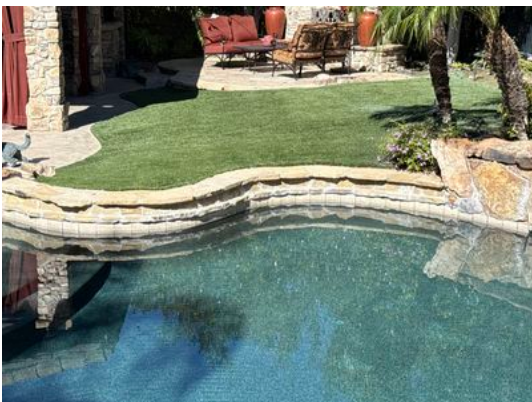
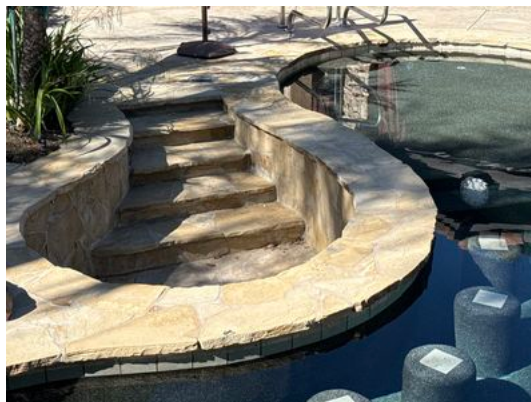
#### Pool/Spa: Interior Finish

Spa interior finish appears to be in generally good condition. A buildup of material was observed on the steps and bottom of the spa which appears to be related to the degrading stone surrounding the coping.

Recommend further evaluation and repair by a qualified licensed pool contractor.

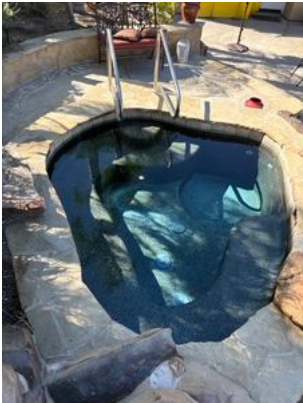
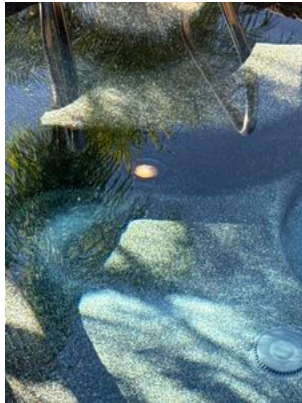
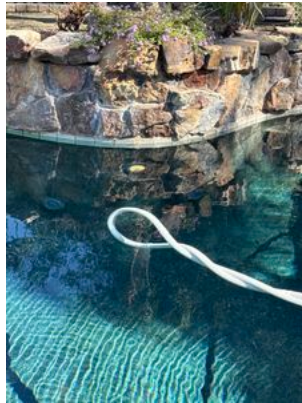
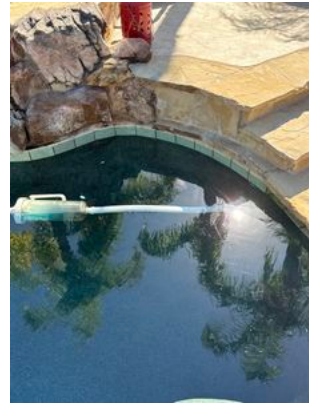
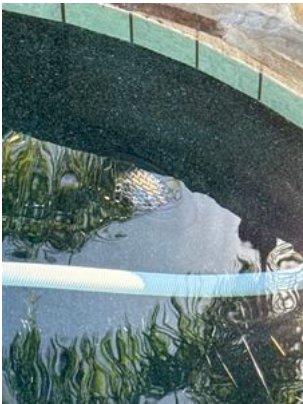
The spa and pool lights were functional however the GFCI outlet attached to the control panel was found in the tripped position at the start of the inspection. GFCI outlet was reset to allow for testing. GFCI outlet appears to be in need of replacement. Outlet appeared to be corroded.

Recommend further evaluation and repair by a qualified licensed pool contractor.

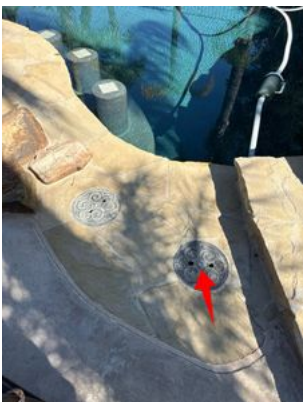
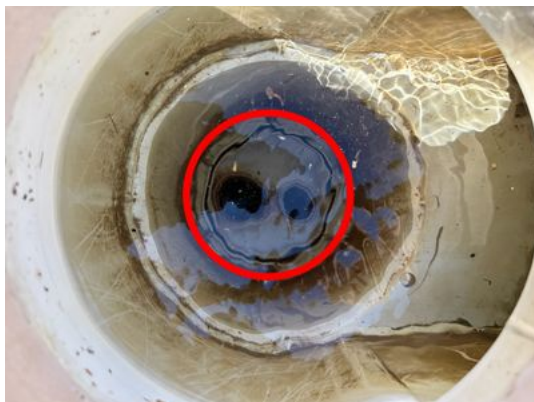
Float valve assembly appears to have been removed from the skimmer basket intake piping. Recommend further evaluation and repair by a qualified licensed pool contractor.

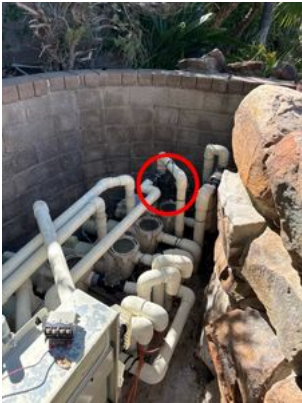
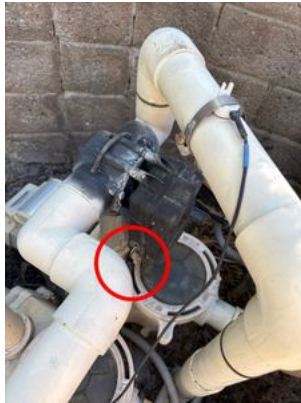
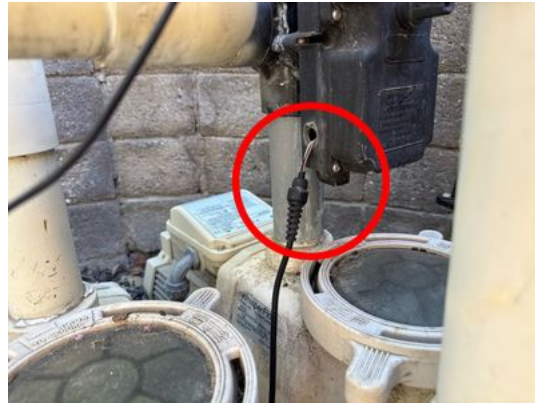
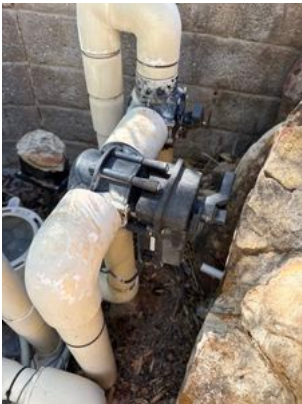
Automatic actuator valves were functional however one of the units controllers has separated from the wire housing.

Recommend further evaluation and repair by a qualified licensed pool contractor.

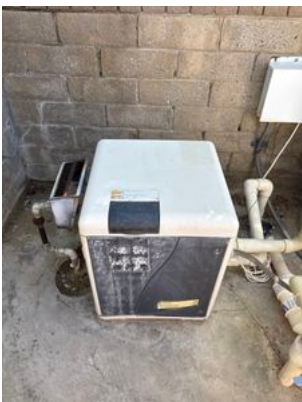
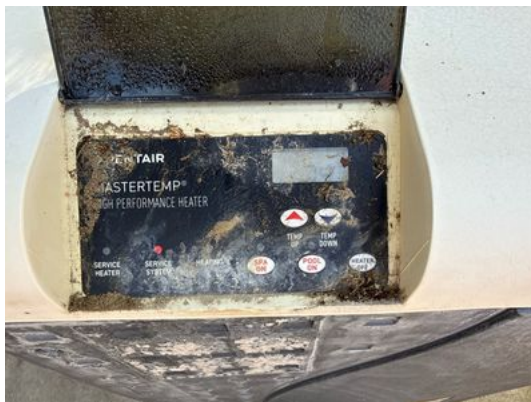
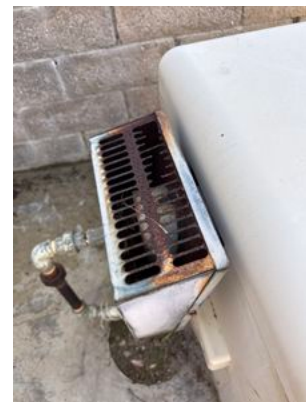
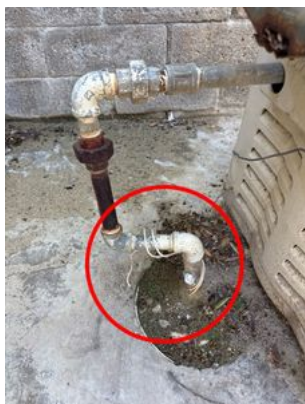
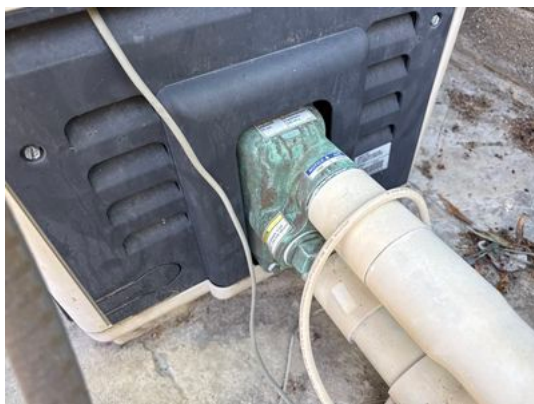
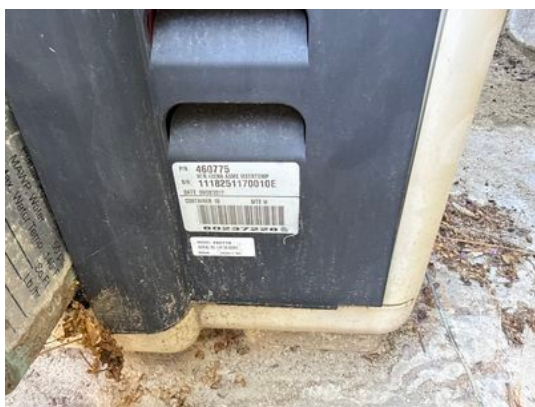
The pool/spa heater did not turn on during the inspection. Unit produced a series of cooking sounds than the service light illuminated. Unit was found to be rusted/corroded. Also the natural gas piping valve is deteriorated.

Recommend further evaluation and repair by a qualified licensed pool contractor.
