## Inspection Services

### *Inspection Report*

Address: 2015 Calle Pattito Templeton, CA 93465

09/26/2025

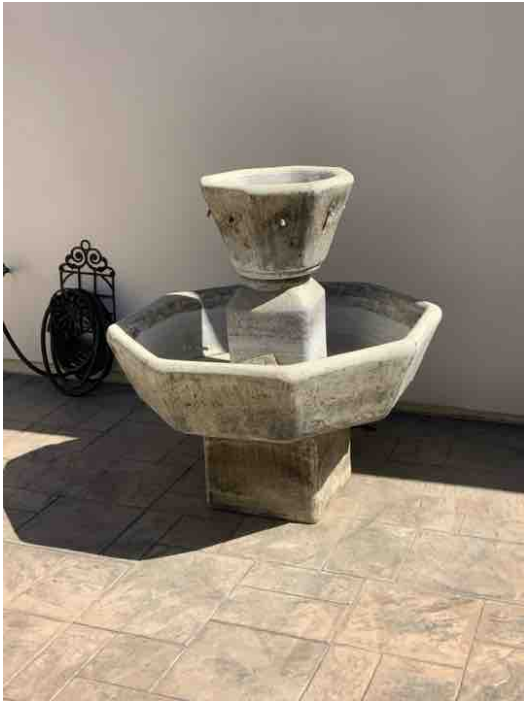
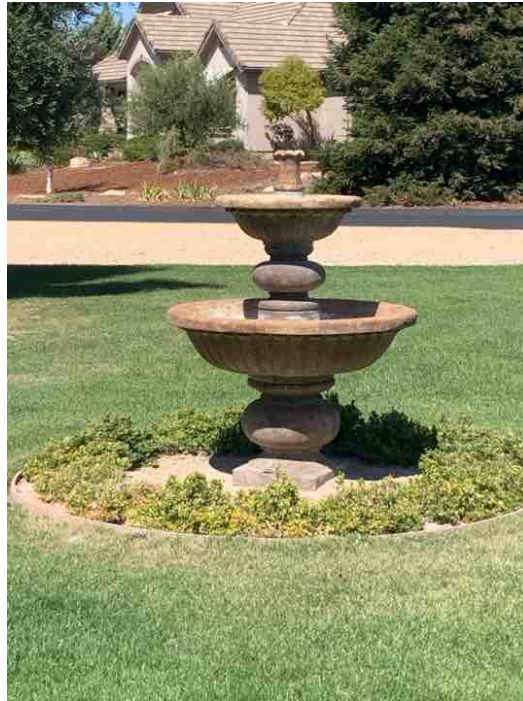
**13: Water Features such as Ponds, Waterfalls, Fountains, etc.**

Note: All water features can be considered a potential drowning hazard. Client should take appropriate measures to ensure safety.

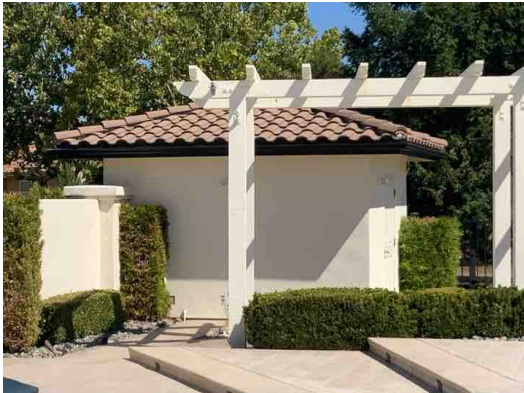
**14: The Pool house**

Client is advised to have the pool professionally inspected.

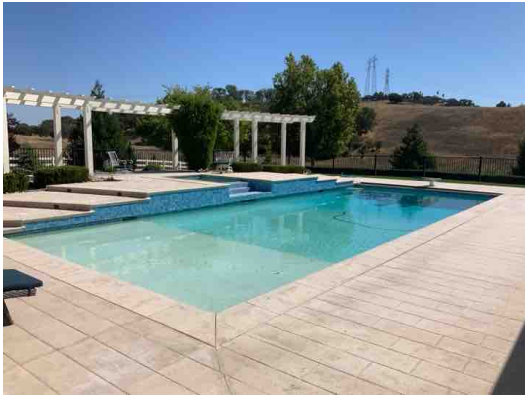
**15: Pool and Spa / and all equipment, systems and components.**

*Client is advised to have the pool, spa, it's associated electrical systems, and all pool / spa safety devices professionally inspected.*

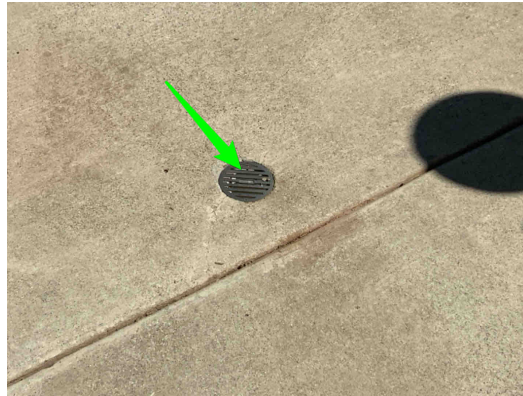
**MR DS 29: Disclosure:** Some surface drains noted in areas of the patio. Drains not tested. The condition of the underground piping and terminations are unknown. Recommend having drains and terminations cleaned, tested and inspected by a qualified landscape contractor to determine the proper flow. Keep drains clean and free of debris regularly.

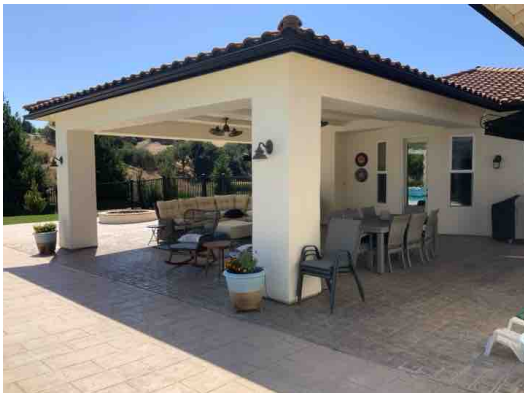
**30: BACKYARD PATIO COVER:** Appears serviceable and in good condition.

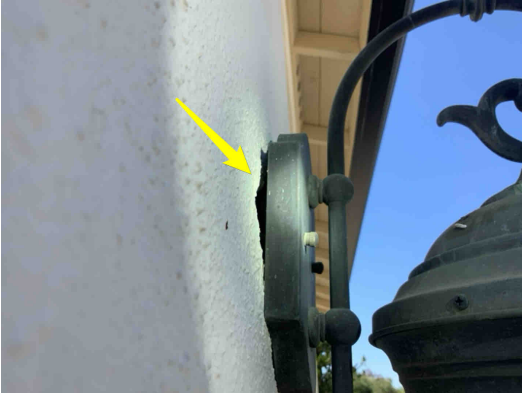
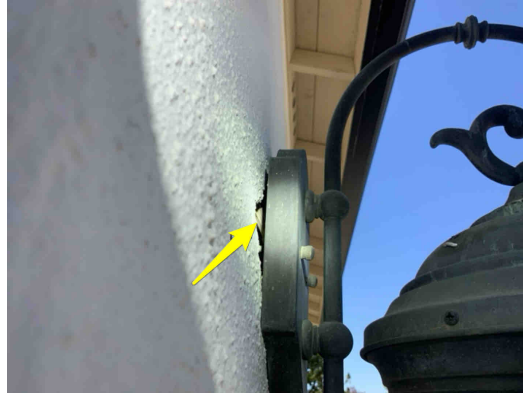
**MR 37:** Recommend sealing around the exterior light fixtures making sure they are sealed tight to the wall to help prevent water and/or critter intrusion per installation requirements. Contact the qualified painter or other licensed professional to evaluate all exterior light fixtures and upgrade, or correct as needed.

Exposed electrical wires, subject to water intrusion deterioration

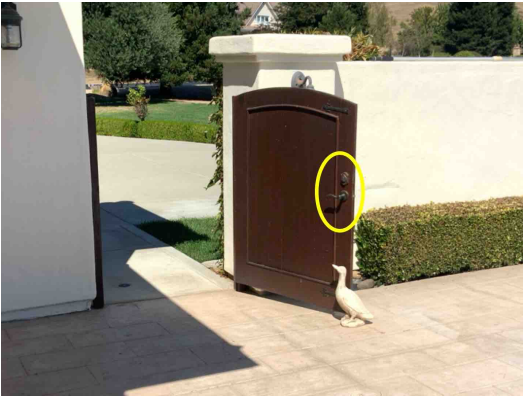
#1. A proper non-climbable fence . However, the gate from the driveway to the backyard pool area does not meet minimum standards. Improper latch.

#2. Missing a second drowning prevention device or system.

*A pool should have the minimum of TWO of the following drowning prevention or notification devices such as: a proper ASTM pool cover, a proper non-climbable fence with self-closing gates with approved latches, alarms on the exit doors from the house and/or garage with access to the pool area, proper splash alarms installed in the pool, proper self-closing doors on all the exit doors, including sliding glass doors, from the house and/or garage with access to the pool area or an ASTM approved temporary net-type fencing along the perimeter of the pool edge with an appropriate gate and latch. Recommend further review, upgrades and/or repairs by a certified and/or licensed swimming pool professional familiar with the minimum current standards.*

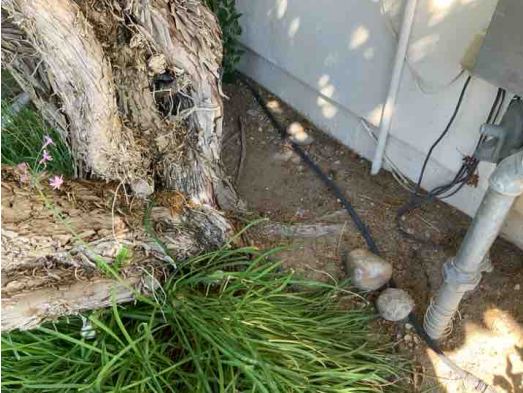
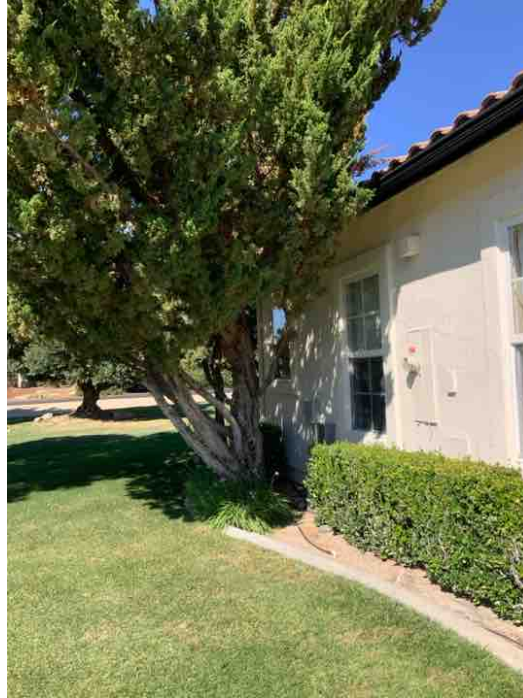
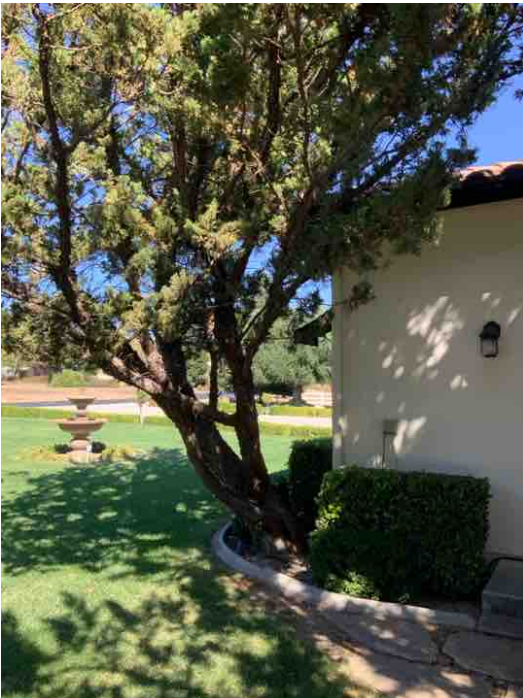
**E&C 43:** Recommend some proper landscape grading and maintenance along areas of the exterior. This should help ensure the proper flow of site water away from the building(s) and off the property. This will also help prevent an excessive moisture condition and help maintain the proper clearances from the interior floor level, and/or the exterior stucco, wood or other siding to the top of soil. Trim trees and bushes that are making contact with areas of the exterior siding, trim and/or roof.

**MR 44:** Plants and/or trees touch the buildings exterior and/or the roof. Proper landscape maintenance needed.

**MR 45:** **NOTE:** Be aware that large bushes and/or trees planted too close to the building and foundation system can negatively impact the exterior, roof, foundation, underground utilities, interior floors or other components. Client should take measures to ensure that the tree and foliage and its root system has or cannot cause deterioration or damage to the house or its systems. Recommend contacting a qualified arborist to evaluate and make recommendations.

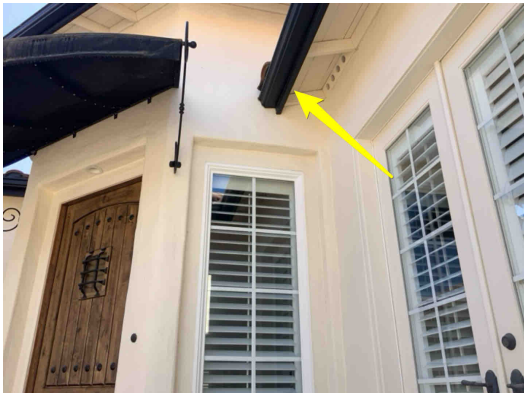
**FI 53:** Evidence of some roof leakage with visible moisture stains and/or damage at areas of the roof overhang: OVER THE FRONT ENTRY AREA WHERE A TILE HAS IMPROPERLY SLIPPED OUT OF POSITION. Recommend further review of the roof by qualified roofer to determine the cause, the current conditions and to determine if other areas of concern exist. Proper repairs are recommended.

A loose and displaced roof tile above the water damaged area.

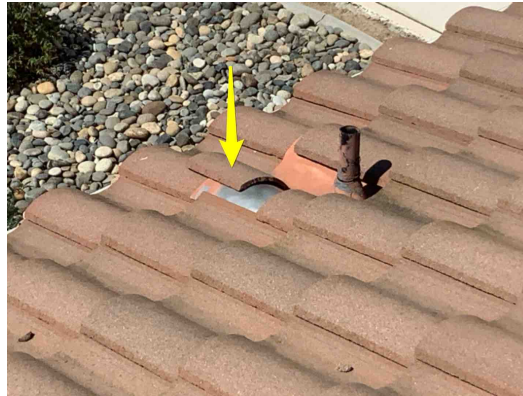
**E&C 54:** Multiple cracked, damaged roof tiles needing repair or replacement. Contact a licensed roofing contractor for further evaluation of the roof and to determine location(s) and quantity of the roof tiles needing repair or replacement.

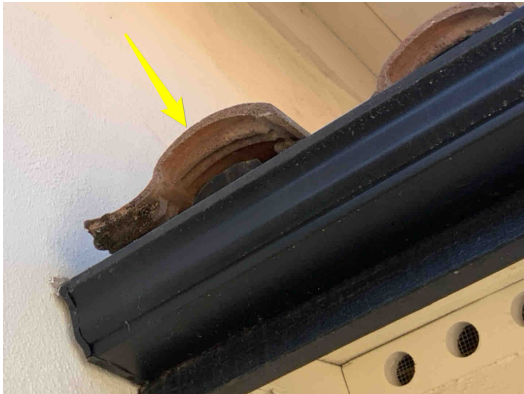
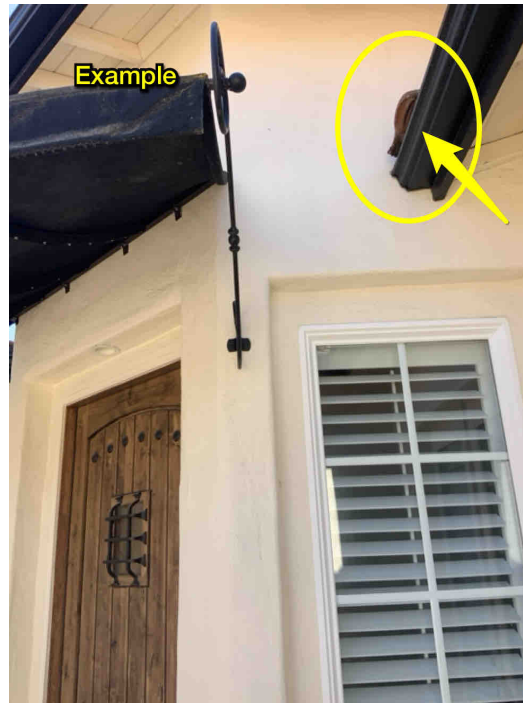
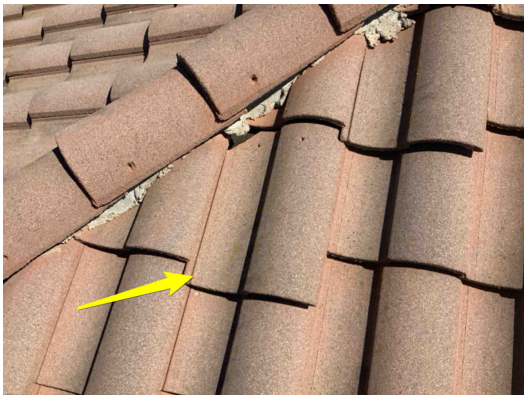
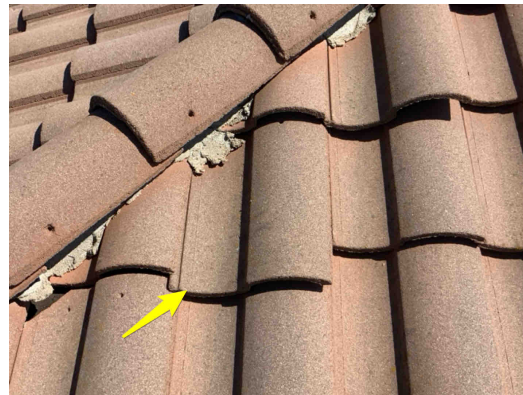
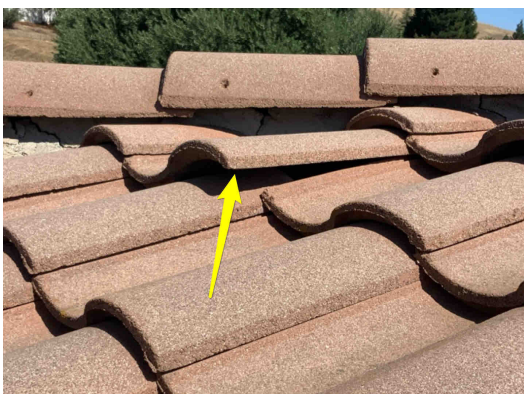
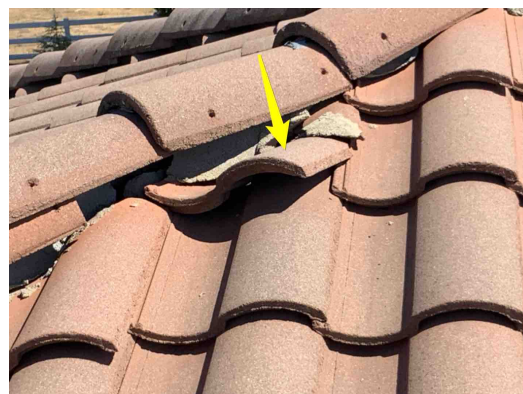
**E&C MR 55:** Some loose roof tiles needing repair or maintenance found missing the required approved fastener, nail, or batten extender at areas of the tile roof. Recommend further review of the roof by a qualified / licensed roofing contractor to determine quantity of repair or maintenance needed.

Above the front entry door area

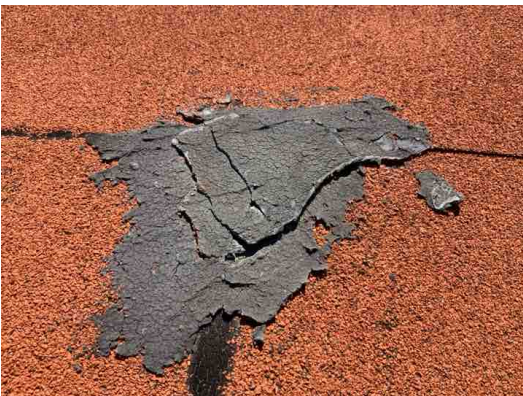
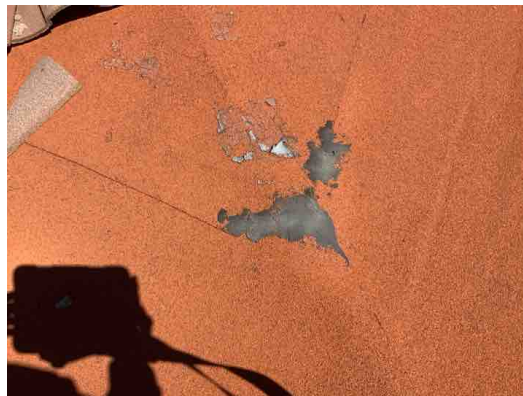
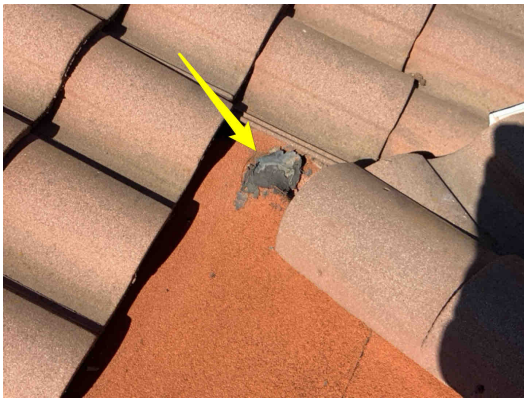
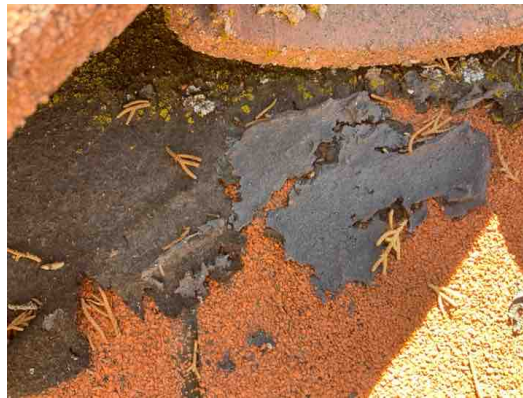
**FI 58:** Areas of past improper or incomplete past repairs found at areas of the ROLLED COMPOSITION ROOFING. Areas of exposed mastic found not covered by aggregate found deteriorated. These areas covered by mastic may be indicative of previous roof, deterioration or roof leakage. Recommend additional review with maintenance or repair by a licensed roofer.

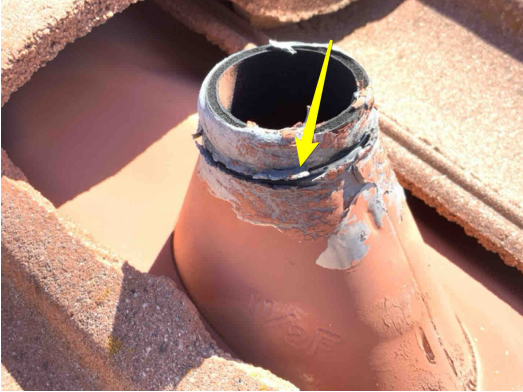
**MR 61:** Deteriorated sealant at some roof flashings, around the roof penetrations. Maintenance recommended to help prevent water intrusion into areas of the attic. Have roofer evaluate the roof flashings and correct as needed.

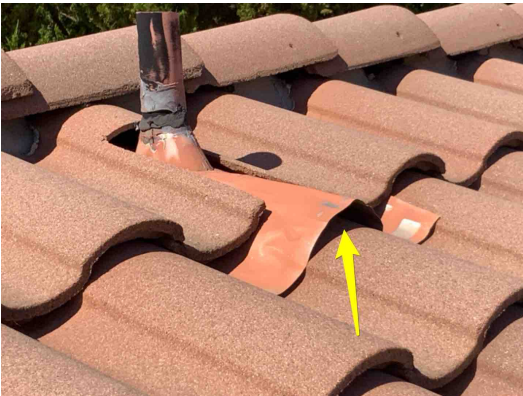
**E&C MR 62:** Some lifting roof flashings. Corrections, maintenance or repairs are recommended to help prevent water intrusion and/or roof leakage from windy, wet weather.

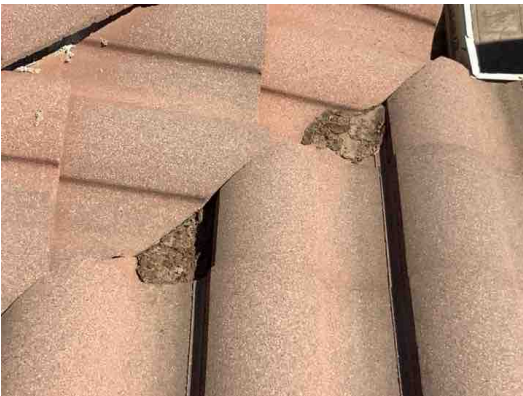
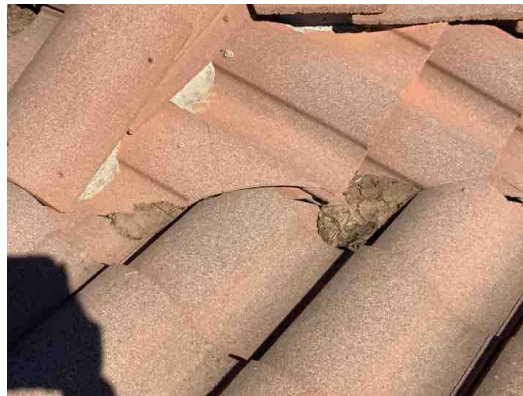
**MR 63:** Some debris buildup on areas of the roof and/or roof valley flashings. Areas not fully visible. Continuous maintenance / cleaning warranted to help prevent roof leakage.

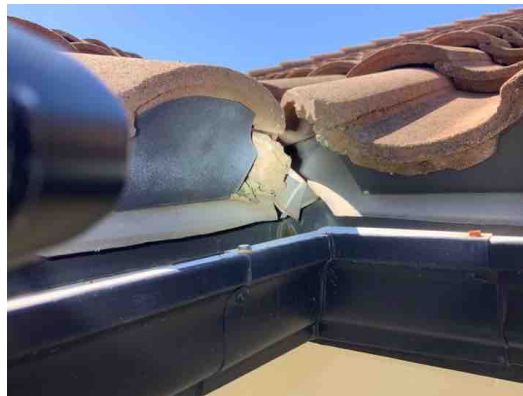
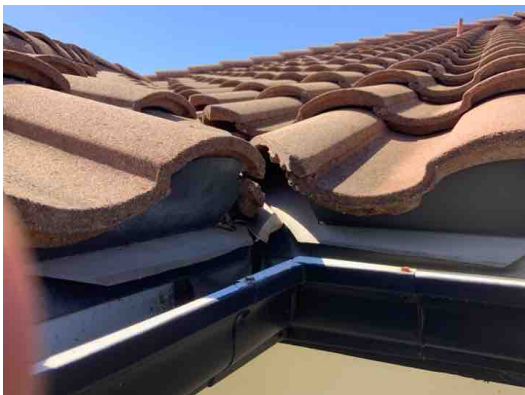
**E&C 66:** Evidence of some loose roof tiles improperly installed in the roof valley flashings (Missing the required batten extenders with the use of a single crown valley flashing). This allows the tile to drop onto the valley flashing causing damming of the water and may create a roof leak.

Tiles are lifted and separated

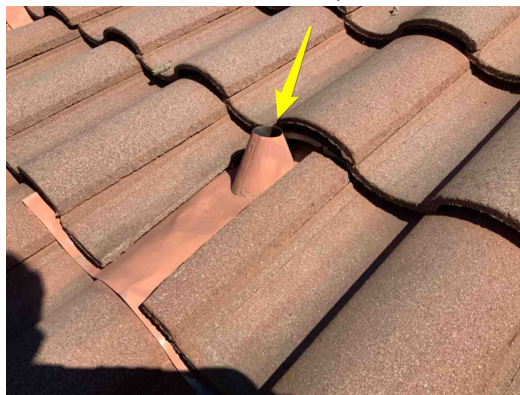
**FI 67:** Plumbing vent pipe has slipped or is improperly installed and does not properly pass through the roof. Jack flashing over the primary bedroom bathroom area. Recommend a licensed plumber to evaluate and correct.

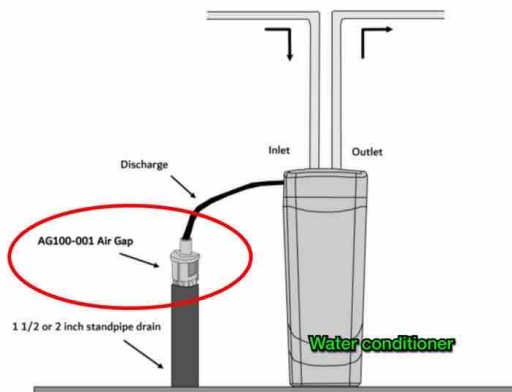
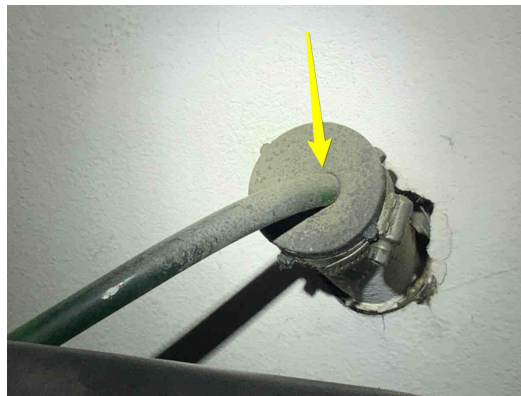
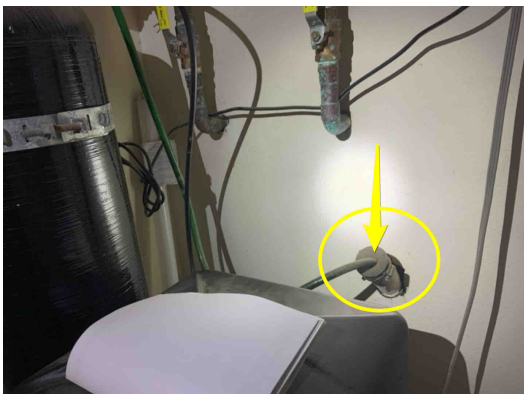
**SC 89:** Improper installation of the water softener drain hose. Missing the required air gap at water softener drain hose at waste connection. Refer to the manufacturer's installation requirements and plumbing code.

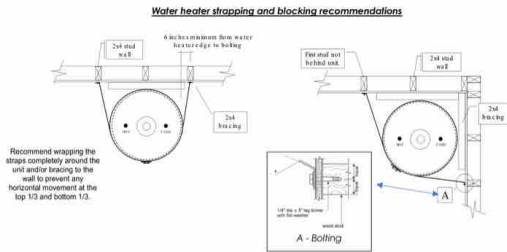
**E&C 99:** Water heater is improperly and loosely strapped & not secured well - moves when pushed. Recommend adding the proper STRAPPING which wraps at least once completely around the tank and/or adding BRACING OR BLOCKING to the wall to properly secure the tank per Uniform Plumbing Code and State Architect Requirements. Recommended further review and repairs by a certified or licensed professional familiar with the minimum installation requirements.

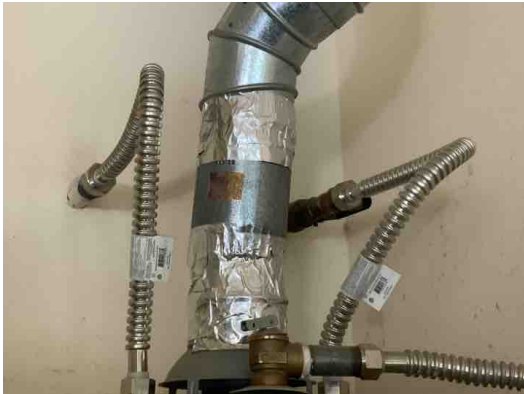
**SC 101:** Areas of the water heater vent pipe were improperly installed. Some of the Water heater vent connector pipe (single wall) is not properly fastened at all connections with the required 3 fasteners at each connection, including the draft hood per standards. The use of Aluminum tape is not an acceptable alternative to using screws.

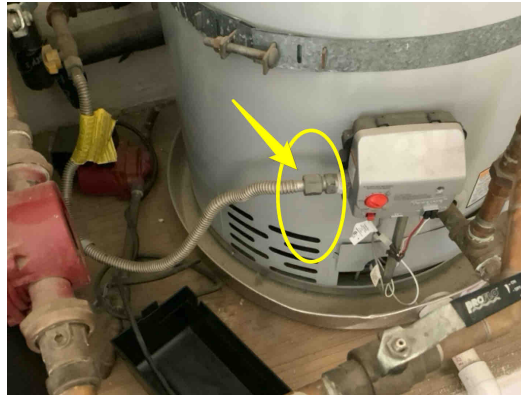
**UPG 105:** Recommend the installation of the missing sediment trap / drip leg at the gas TANKLESS WATER HEATER gas piping at flex connection by a certified or licensed plumbing professional familiar with minimum requirements.

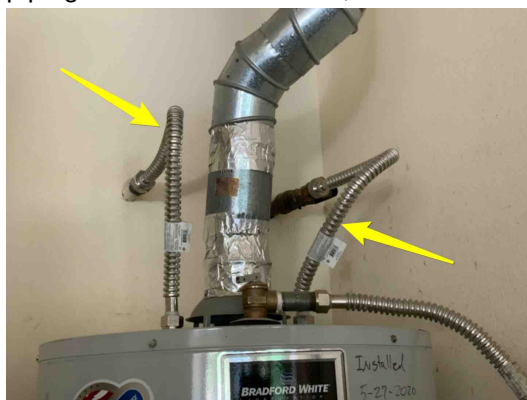
**MR 106:** Recommend insulation on the HOT and COLD water supply pipes at the water heater per minimum codes and standards.

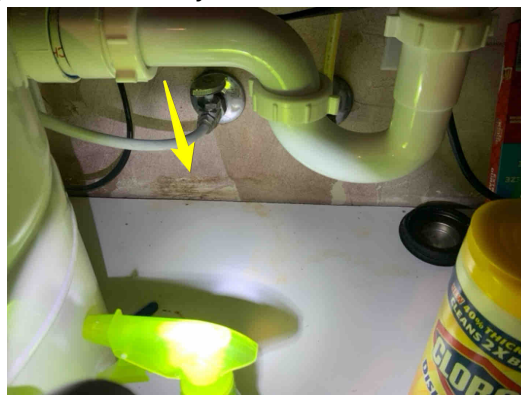
**FI** 114: Some dry moisture stains and damage in the cabinetry below the kitchen sink.

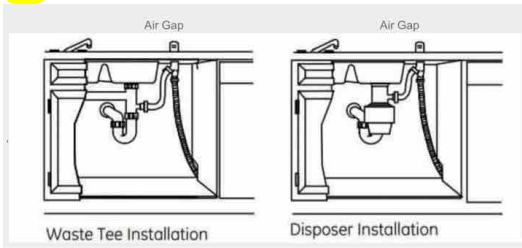
**SU 117:** Recommend an Air Gap Device at the dishwasher drain.

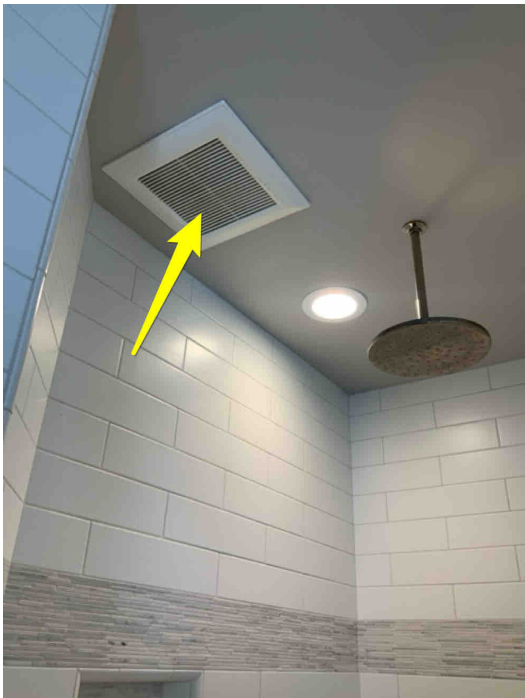
**SC** 152: The bathroom exhaust fan installed inside the PRIMARY BEDROOM BATHROOM shower enclosure is not GFCI protected as required when installed inside the shower enclosure.

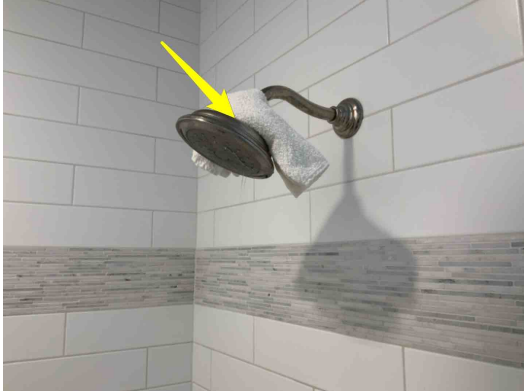
**E&C 155:** Showerhead leaks & drips at pipe connection: PRIMARY BEDROOM BATHROOM

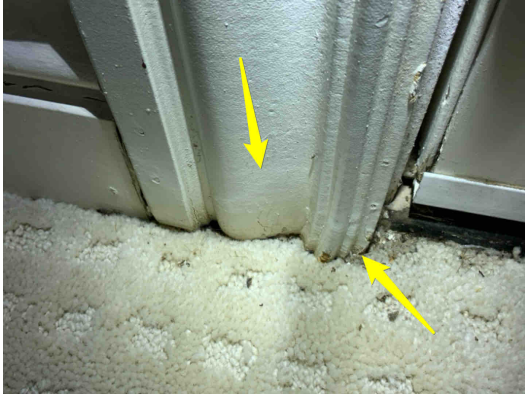
**FI 159:** Evidence of past water intrusion from around the OFFICE exterior door with stains and damage on the interior.

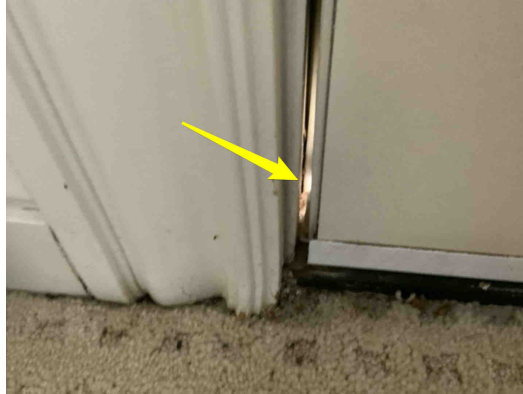
Some water damage at the door trim

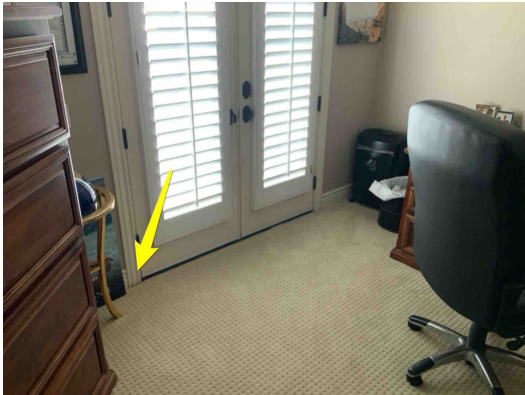
Some visible daylight between the door and the door jam

**MR 161:** Visible daylight noted around some of the exterior doors. Adjustment and/or repair of the weather stripping is recommended to help prevent water and critter intrusion.

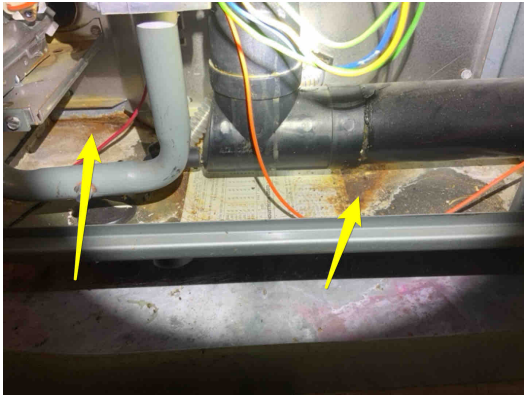
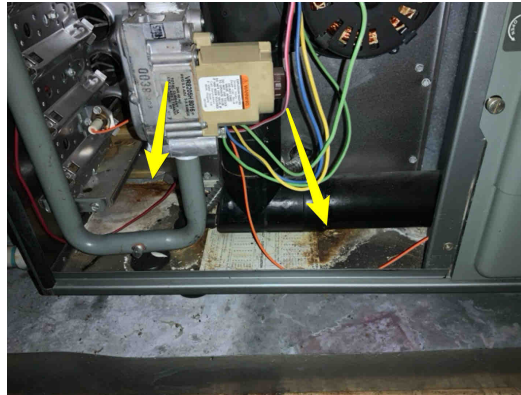
**FI 184:** Some water stains with visible rust found inside the Hall 1/2 Bathroom Hallway ATTIC furnace cabinet due to condensation leakage from the high efficiency furnace exhaust vent system. Recommend additional review and repair by a licensed HVAC contractor.

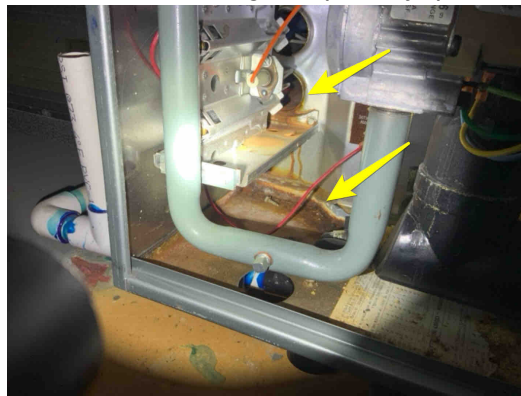
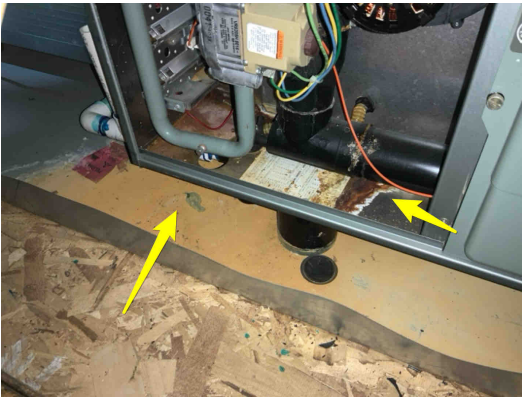
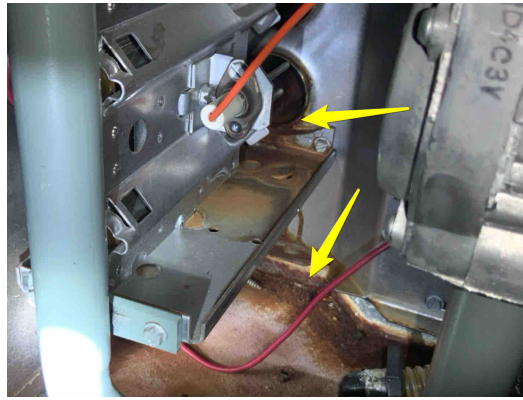
**FI MR 189:** Evidence of past dripping and leaking of condensation at the BEDROOM-2 CLOSET ATTIC high efficiency furnace vent system. Recommend further review, servicing or repairs by qualified HVAC professional.

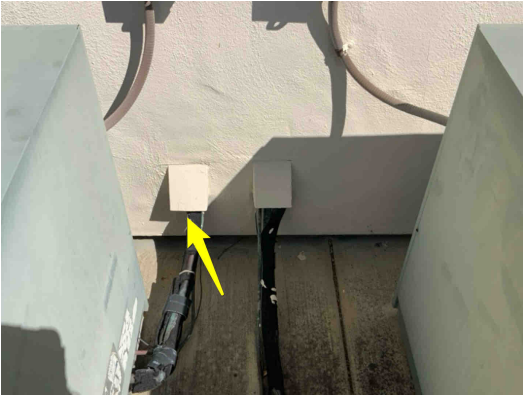
**SU 198:** Recommend sealing the hole or opening through the exterior wall where the Air Conditioner's refrigeration pipes enter the building. This will help prevent rodent, bug and /or water intrusion through this area as need per standards. Recommend filling the opening with rodent resistant expandable foam in a can, which can be purchased at most local hardware store stores.

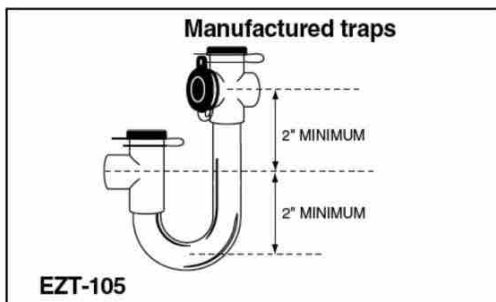
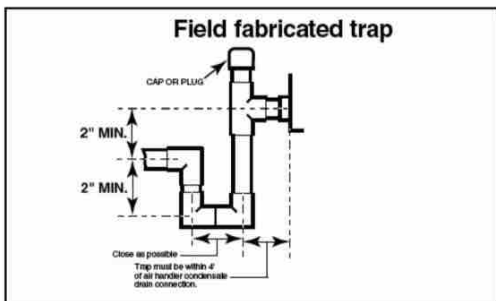
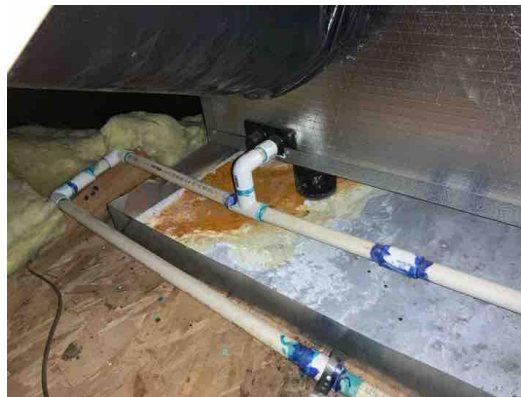
**E&C 200:** Missing the vent/clean-out and trap at the Air Conditioner's condensate drip pipe at the coil. Upgrades / repairs recommended per minimum installation standards.

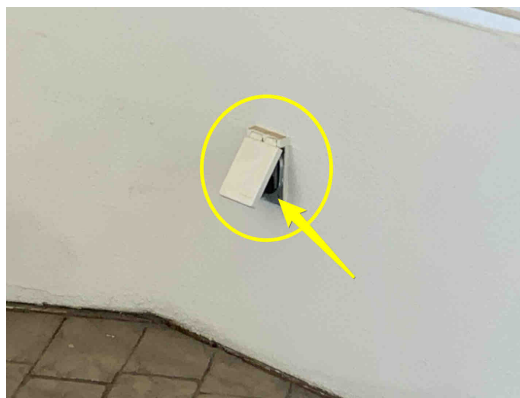
**SC 217:** GFCI protection at a GFCI outlet found defective / non-operational. Recommend replacement of the defective outlet: EXTERIOR OUTLET ON THE EAST SIDE OF THE HOUSE OFF THE KITCHEN EXTERIOR DOOR

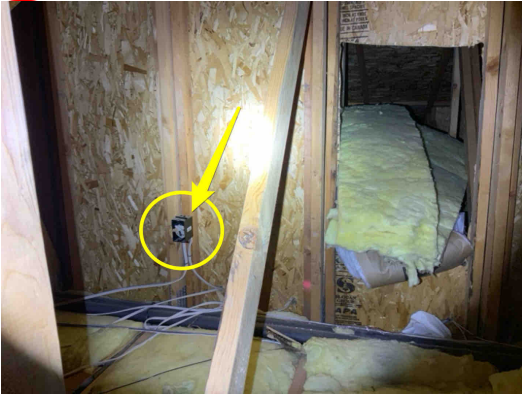
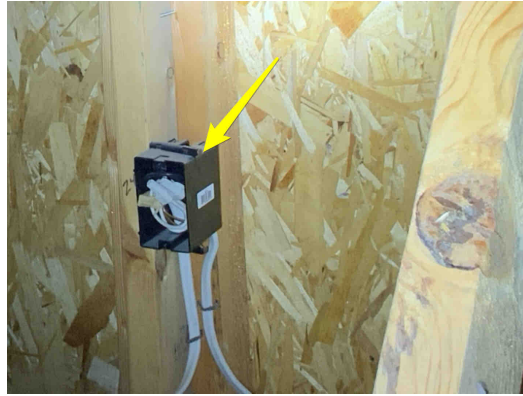
**SC 218:** Missing electrical cover plate at a junction box in the garage attic.

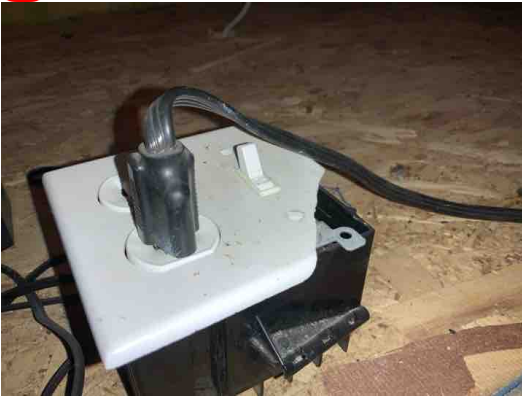
**SC 219:** Damaged electrical cover plate: BEDROOM-2 CLOSET ATTIC LIGHT SWITCH

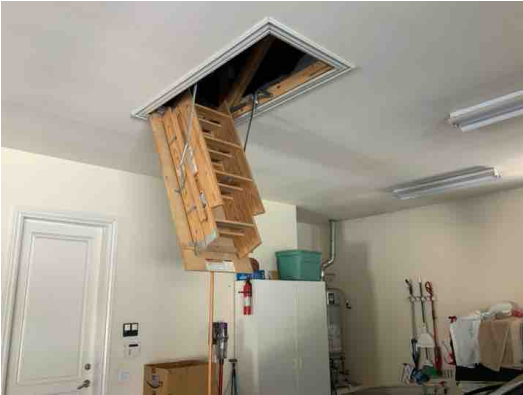
**SC 229:** The added ceiling attic access ladder in garage is not rated for firewall penetration and does not meet minimum firewall safety standards. Upgrades are recommended for fire safety. Any door or openable access through the garage firewall walled ceiling should be self-closing, fully weatherstripped, self latching, with a proper 20 minute fire rated access cover or door.

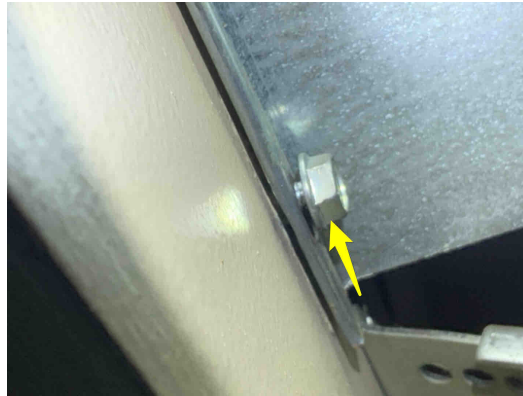
Example

**MR SU 236:** Some loose nuts and bolts noted at the wood roll-up door hinges. Maintenance recommended.

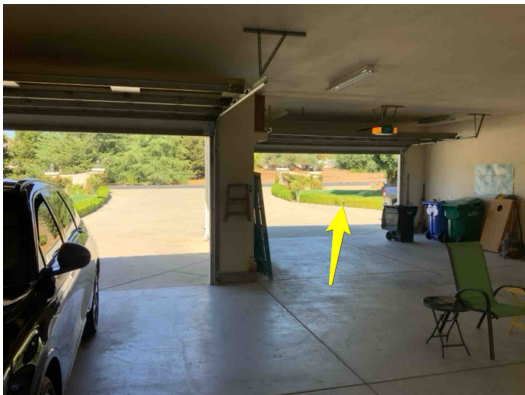
**SC MR 237:** The garage vehicle door auto opener safety reverse did not operate properly, it appears if the electric eyes may not be aligned properly at the EAST end door. Adjustment or Repair warranted.

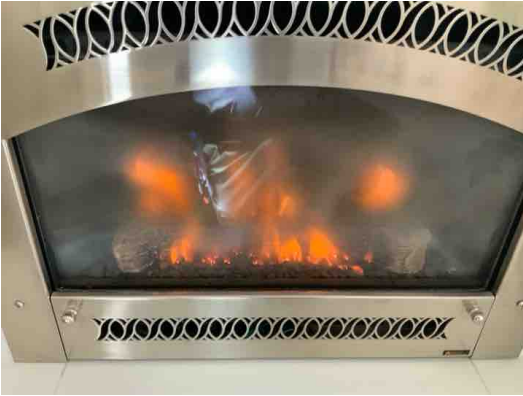
247: **GAS FIREPLACE CONDITION:** The PRIMARY BEDROOM GAS fireplace operated when tested.
