# Inspection Report

**Ellen Nelson & Charlie Cote**  
**2249 Inyo Street**  
**Los Osos, CA 93402**

Report Date: 9/29/2025

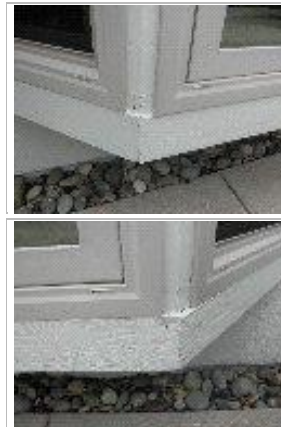
1.) There is some minor moisture damage to the wood trim below the bay window at the SE bedroom.

Moisture damage to the wood trim below the bay window.
