Inspection Report

Property Address:
1619 Armour Ln
Redondo Beach CA 90278

Ferguson Home Inspections

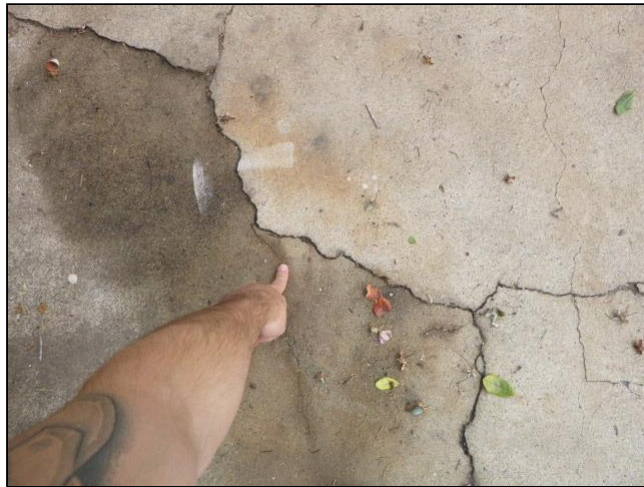
1.0 Item 1 (Picture)

1.0 Settling and heaving noted at various areas, this is a potential trip hazard. Suggest review with a licensed contractor for repair/replacement costs as needed.

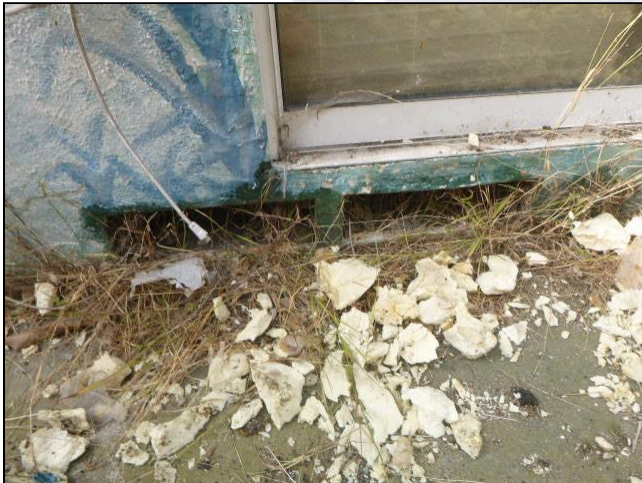
1.1 Item 1 (Picture)

1.1 (1) Settling and heaving noted at various areas, this is a potential trip hazard. Suggest review with a licensed contractor for repair/replacement costs as needed.

1.1 (2) Suggest lowering the exterior walkway/grade and/or installation of exterior sub-surface drains at the rear and left side as needed to prevent the excessive/ongoing water intrusion into the crawlspace. Re-grading where needed is recommended to assure all water drains away from the home's foundation.

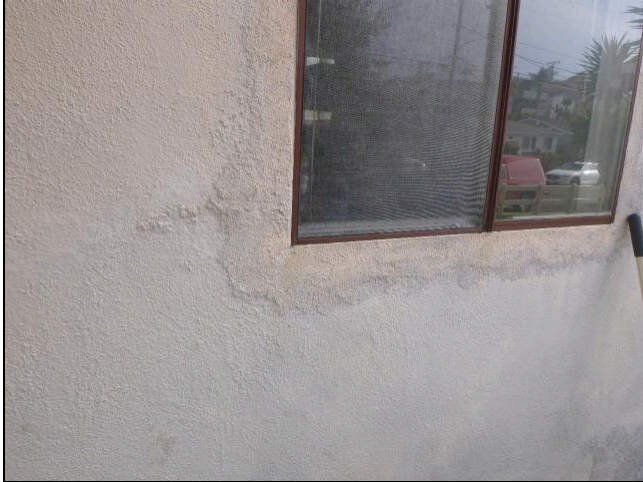
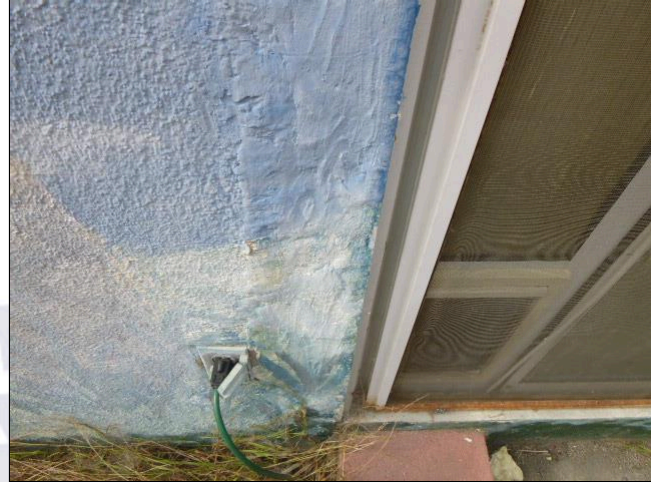
1.4 (1) Various areas of the siding have been patched, suggest review with the seller on the cause and any repairs needed.

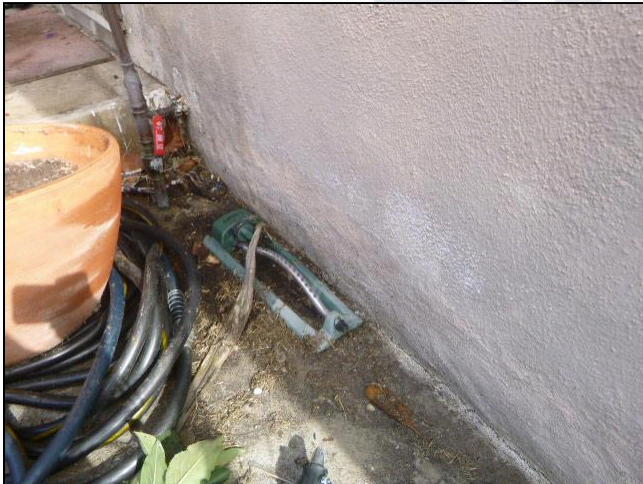
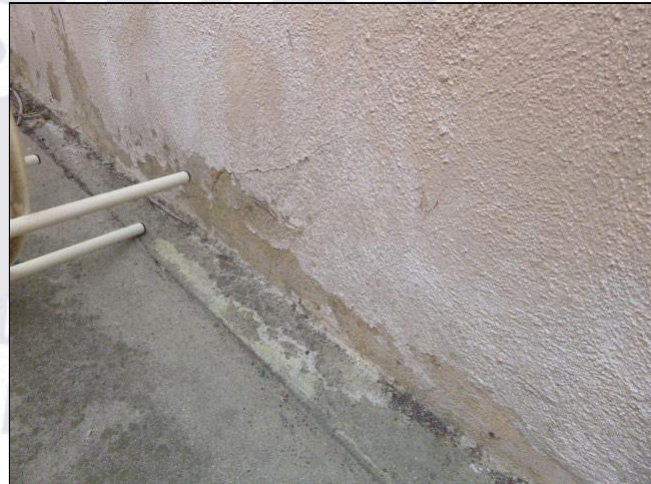
1.4 (2) Deteriorated and blistering stucco noted at various areas. See the Lot/Drainage comments and review with a licensed contractor to repair as needed and divert water away from the foundation areas.

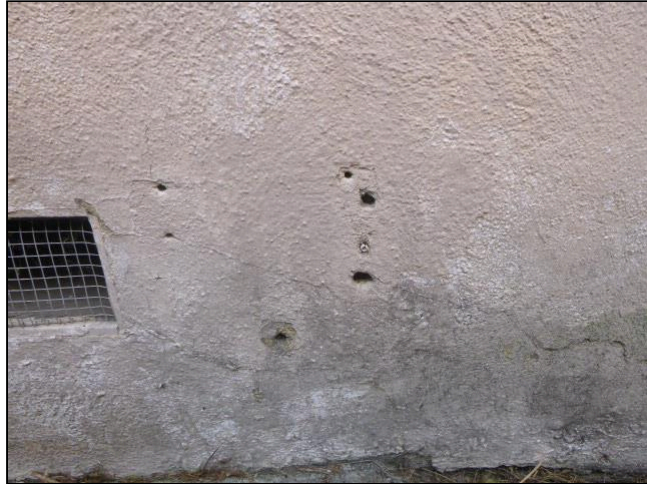
1.4 Item 5 (Picture)

1.4 (3) The holes in siding needs closing off with sealant, stucco or liquid foam at the right side.

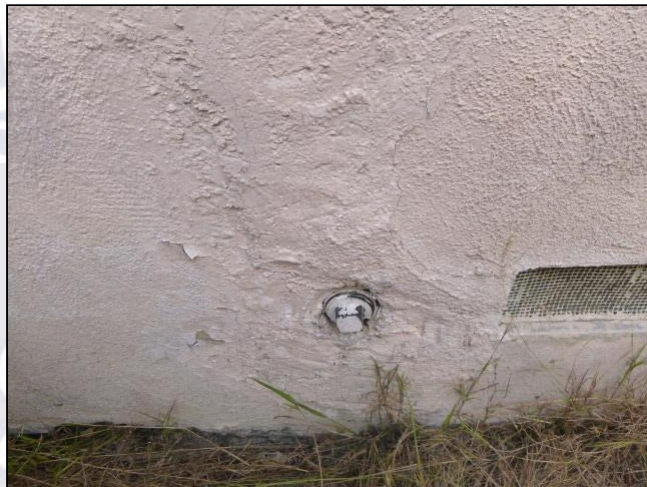
1.4 Item 6 (Picture)

1.4 (4) Excessive stucco deterioration/ blistering and possible wood framing deterioration (not visible due to the exterior stucco finish) noted at the exterior of the kitchen, likely due from the leaking drain line(s). Suggest review with a licensed contractor for removal/ repair/replacement costs as needed.

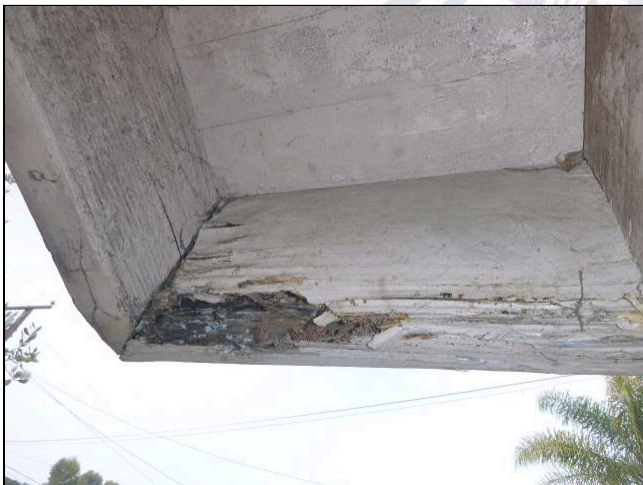
1.5 Item 1 (Picture)

1.5 (1) Paint blistering, peeling and wood deterioration noted at various trim areas. Suggest review with a termite company and/or a licensed contractor and repair/replace as needed.

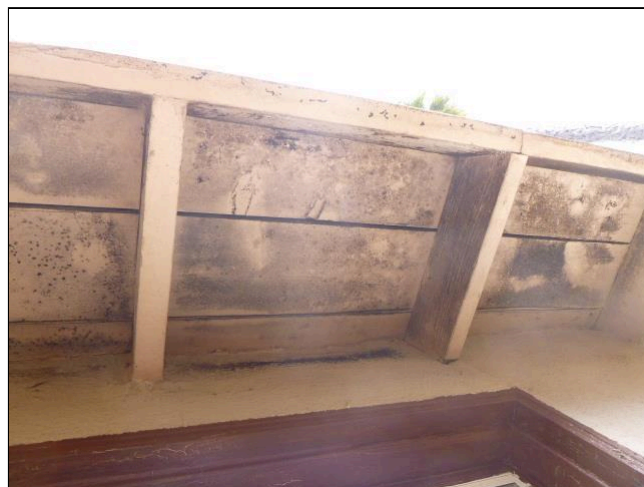
1.5 Item 4 (Picture)

1.5 (2) Excessive black staining noted at the roof line/eaves, suggest review with a licensed contractor for repairs as

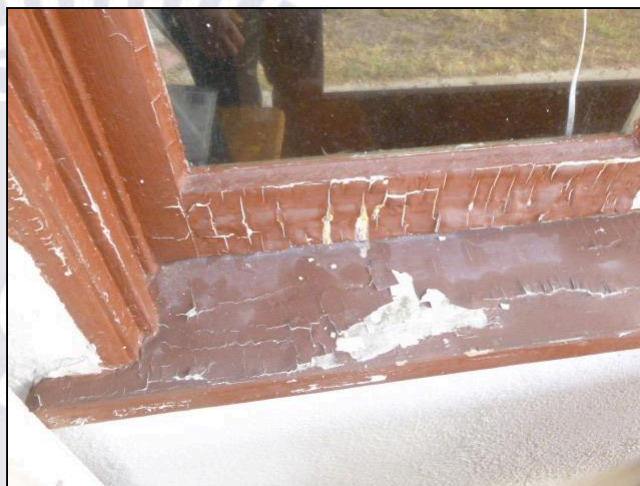
1.6 Item 1 (Picture)

1.6 (1) The wood window frames are peeling paint at most wood windows, further deterioration may occur if not repaired. Suggest review by a licensed contractor and repair/replace as needed.

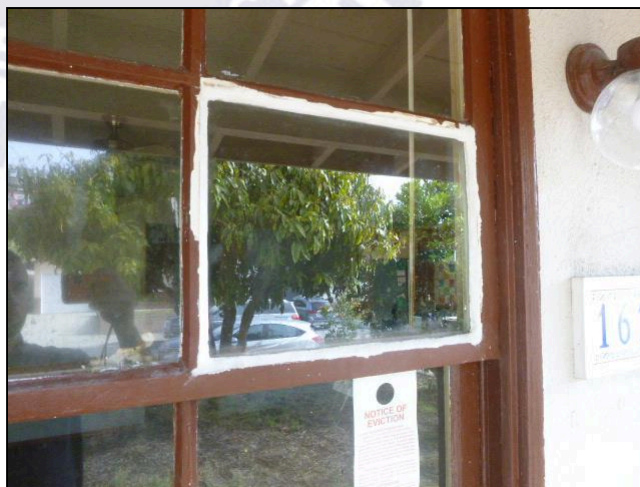
1.6 Item 2 (Picture)

1.6 (2) The glazing/wood frame is deteriorated at the wood windows, this is a potential safety hazard. Suggest review by a licensed contractor and repair/replace as needed.

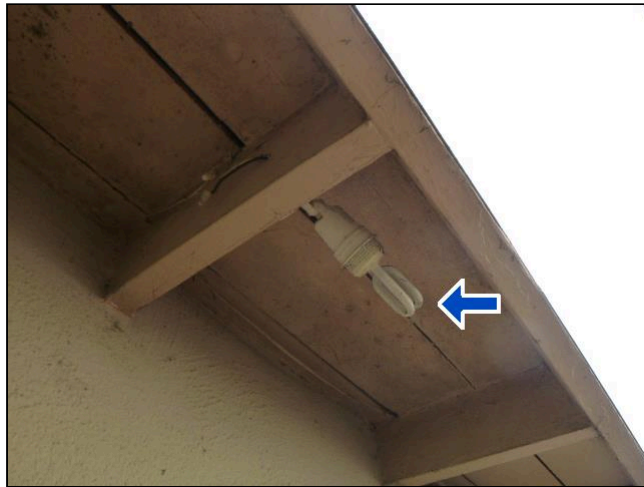
1.8 Item 1 (Picture)

1.8 (1) The cover globe was missing at the light fixture at the time of the inspection. Suggest replacing the missing cover globes for safety.

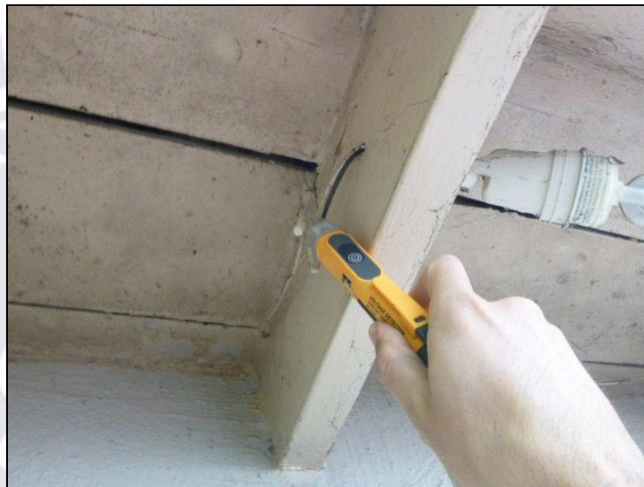
1.8 Item 2 (Picture)

1.8 (2) Open splices were noted, this is a safety concern. Whenever an electrical wire is cut and re-connected, the 'splice' should be encased in a covered junction box to prevent shocks and separation of the splice. Suggest review by licensed electrician and repair as needed.

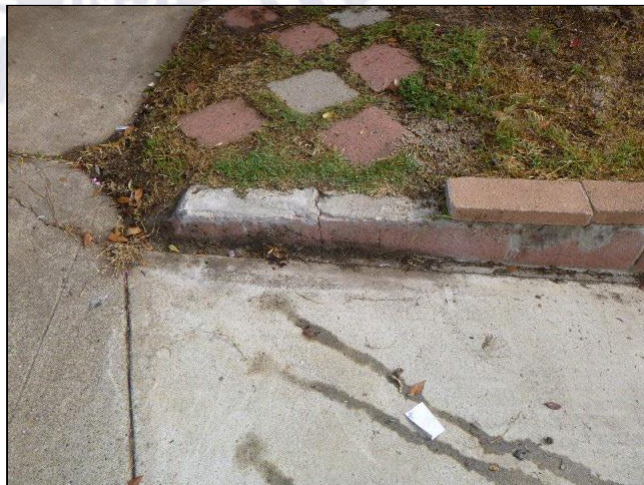
1.10 Item 1 (Picture)

1.10 (1) The front retaining wall is missing several top caps, suggest repairs as needed.

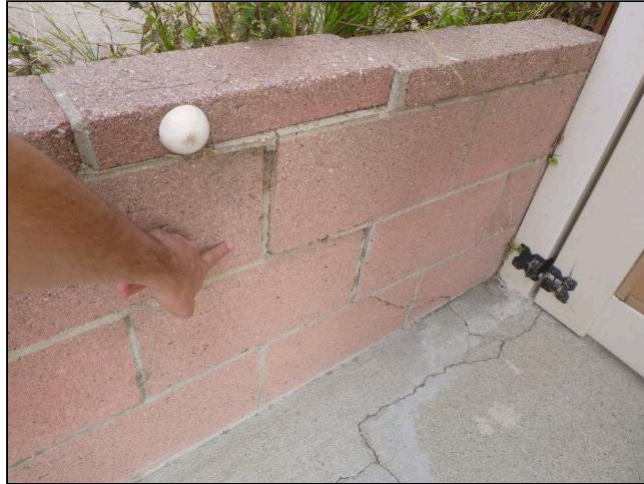
1.10 Item 2 (Picture)

1.10 (2) The retaining walls show some settlement and movement cracks, but appears stable. Suggest review with a licensed contractor for repair/ replacement costs as needed.

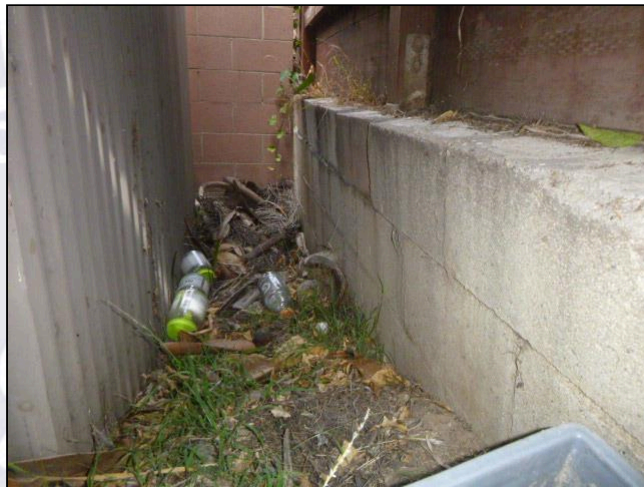
1.10 Item 3 (Picture)

1.10 (3) Minor leaning noted at the rear retaining wall, suggest review with a licensed contractor as needed.

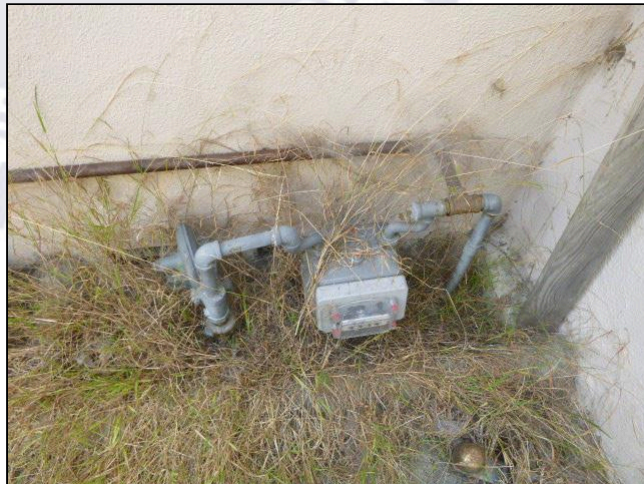
1.12 Item 1 (Picture)

1.12 Suggest removing/trimming the vegetation away from the gas meter to allow for correct accessed as required.

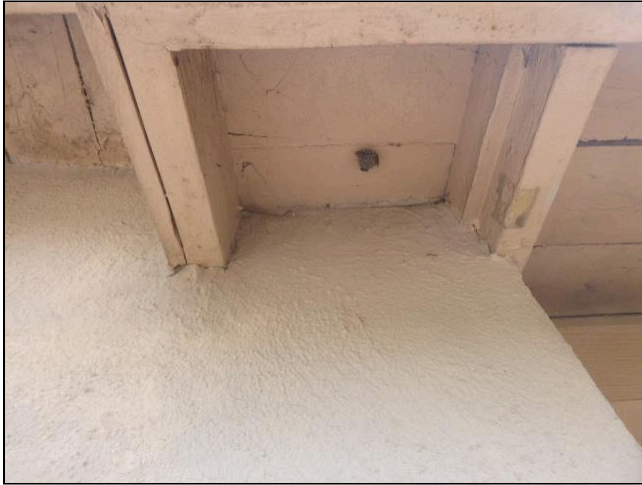
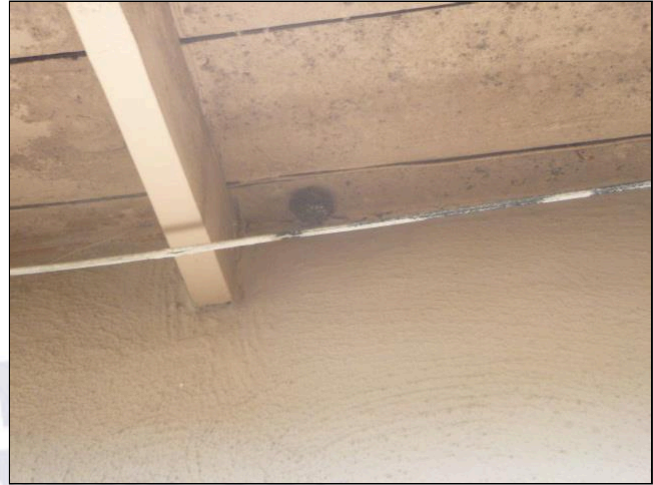
1.13 (2) Several wasp/bee nests were noted at various eave areas, suggest review with a pest control company for removal costs as needed.

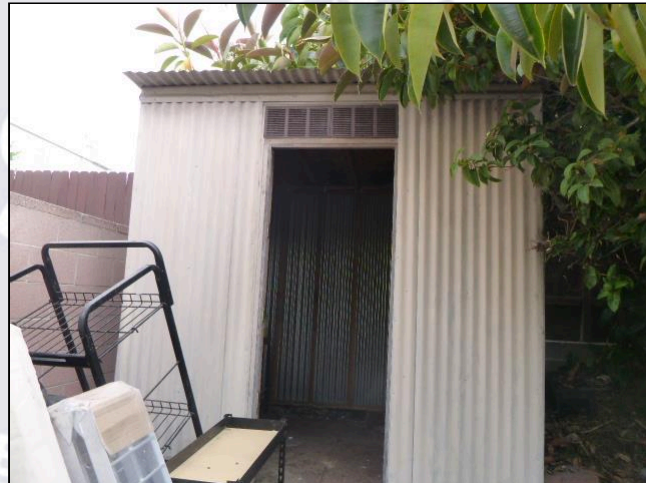
1.13 Item 3 (Picture)

1.13 (3) The sheds and covered areas at the rear yard are beyond the scope of the inspection and were not inspected.

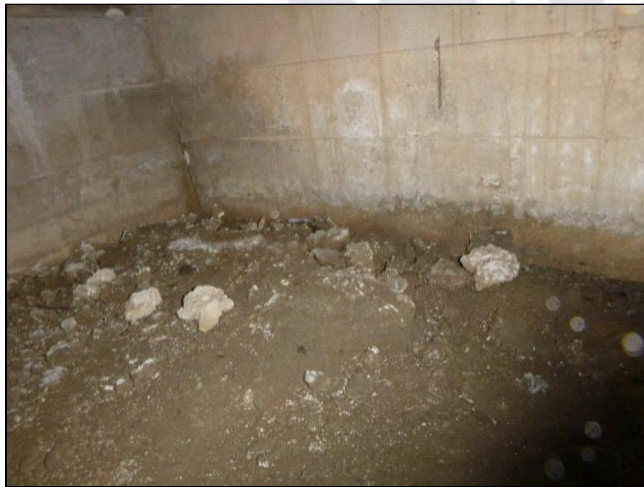
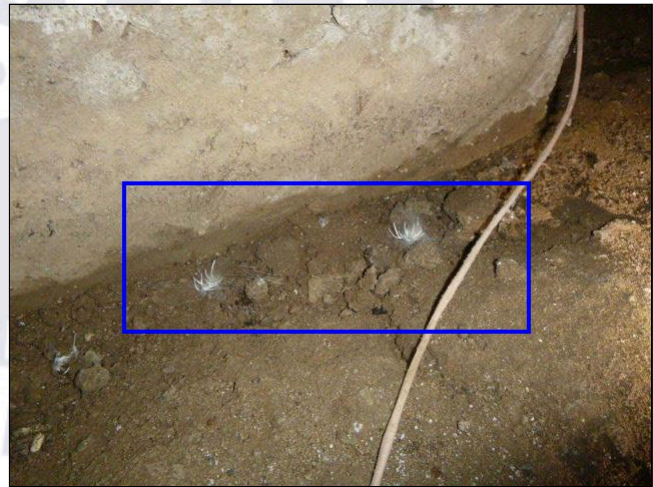
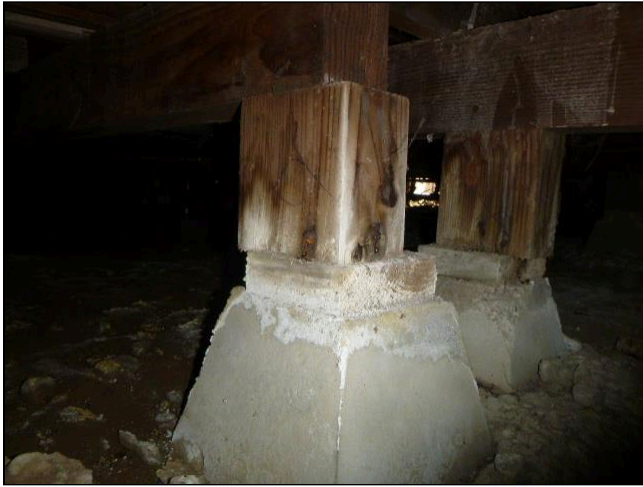
2.0 (2) Re-grading where needed is recommended to assure all water drains away from the home's foundation. The inadequate drainage has caused the excessive moisture buildup at the foundation and intrusion into the crawl area, suggest review with a licensed contractor for foundation repairs and installation of rain gutters and an area drainage system to divert all the water away from the foundation.

2.0 (1) Suggest installation of gutters throughout all eave areas and installation of an area drainage system to divert the water away from the foundation to the street as an upgrade.

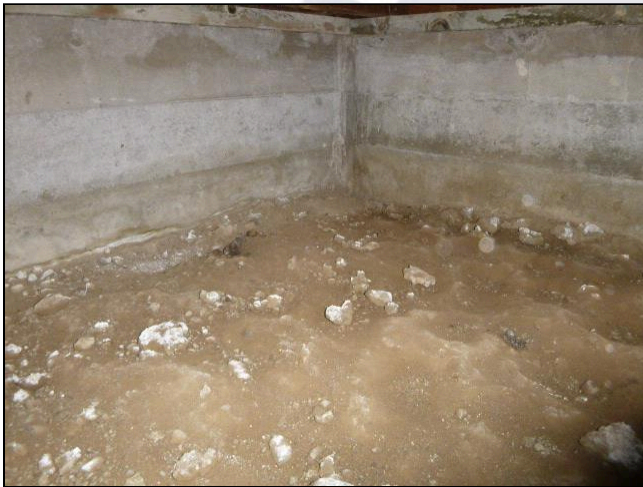
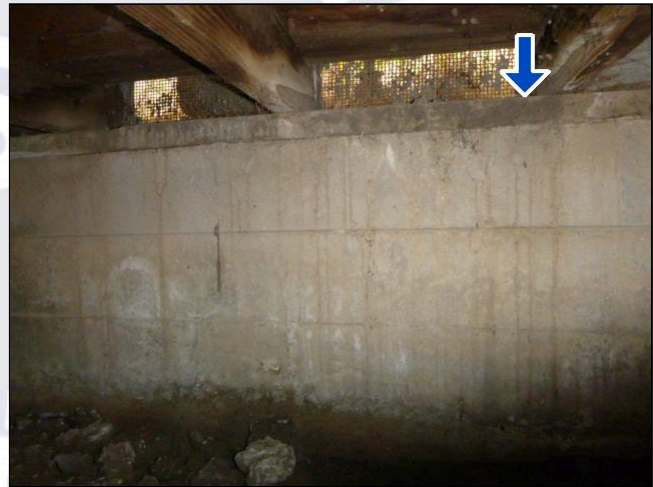
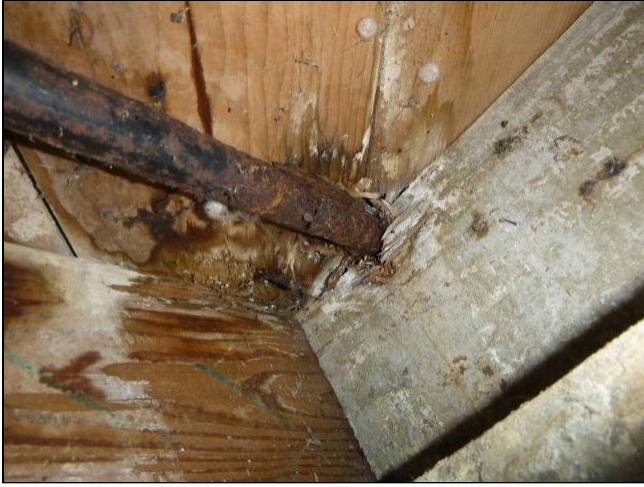
2.0 (4) Suggest lowering the exterior walkway/grade and/or installation of exterior sub-surface drains at the rear and left side as needed to prevent the excessive/ongoing water intrusion into the crawlspace. Re-grading where needed is recommended to assure all water drains away from the home's foundation.

2.0 (3) Suggest review by a licensed contractor for possible installation of an area drainage system to divert drainage away from the foundation.

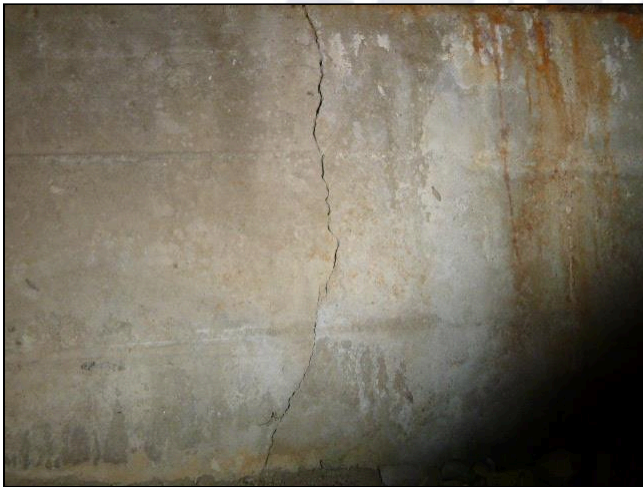
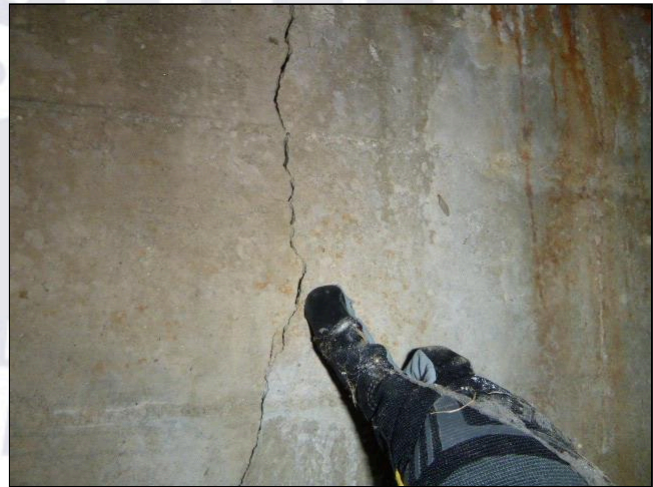
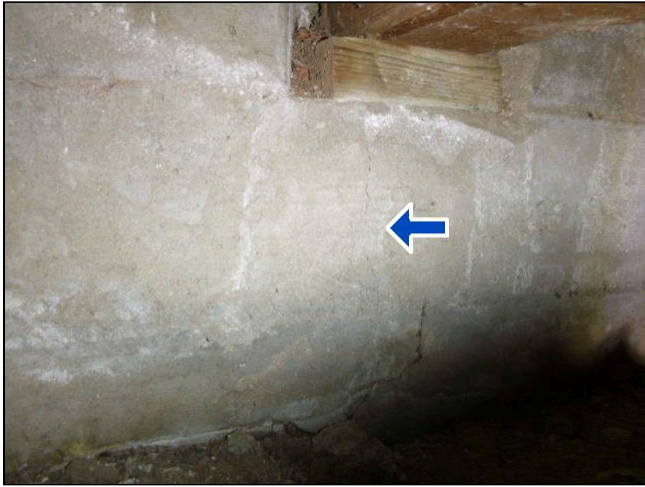
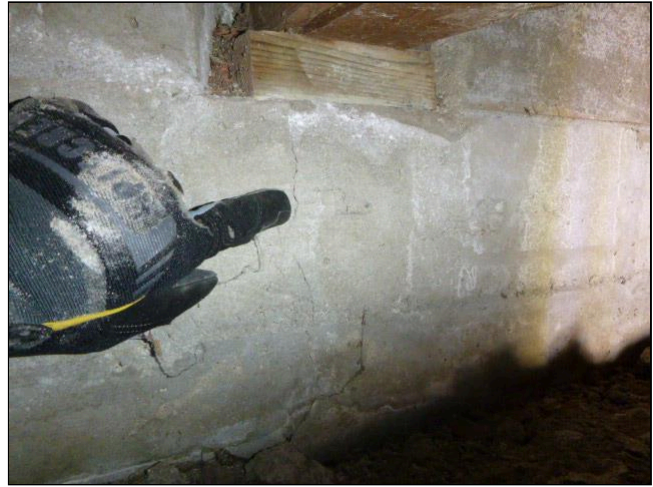
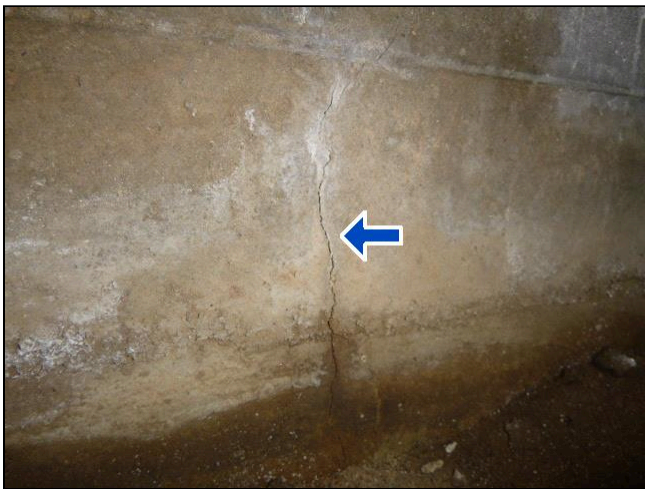
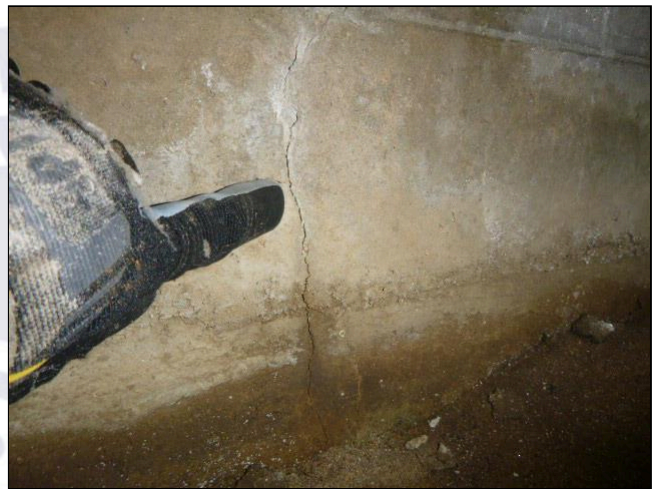
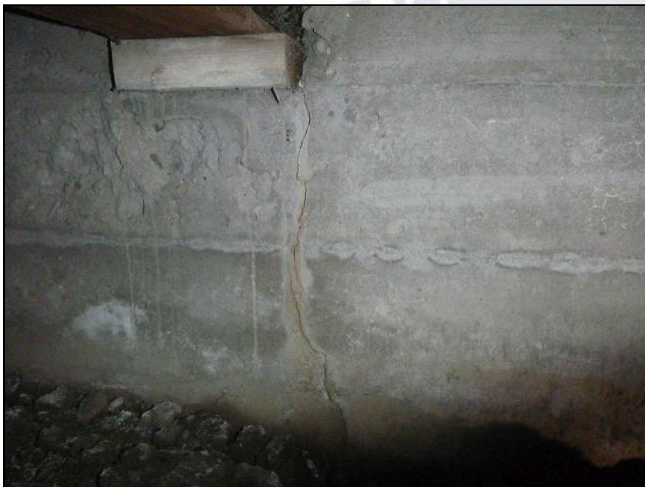
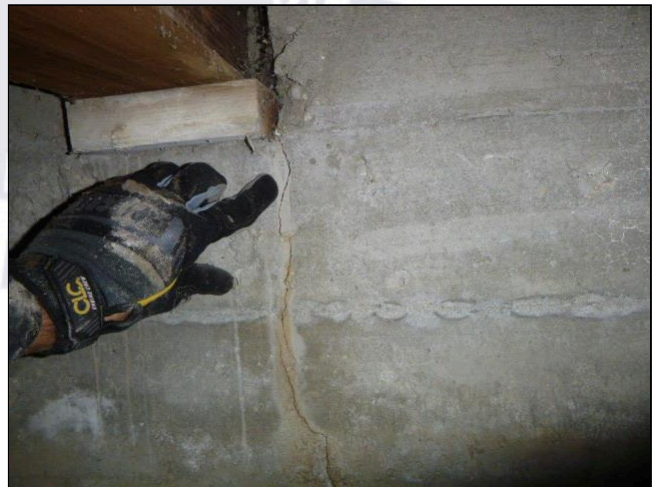
3.0 (1) Re-grading where needed is recommended to assure all water drains away from the home's foundation. The inadequate drainage has caused minor settling/cracking/movement to the foundation, suggest review with a licensed contractor for installation of perimeter concrete walkways/barriers, rain gutters and an area drainage system to divert all the water away from the foundation.

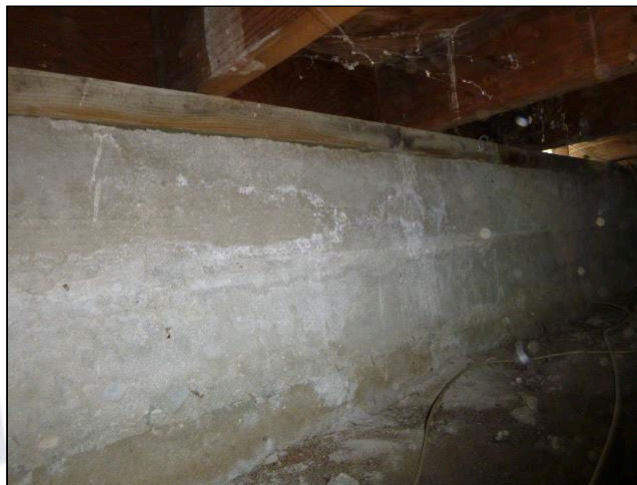
3.0 Item 9 (Picture)

3.0 (2) Re-grading where needed is recommended to assure all water drains away from the home's foundation. The inadequate drainage has caused the excessive moisture buildup at the foundation and intrusion into the crawl area, suggest review with a licensed contractor for foundation repairs and installation of rain gutters and an area drainage system to divert all the water away from the foundation.

3.0 (3) White efflorescence (powder substance) on foundation footings indicates prior, and possibly ongoing, excessive moisture build up at the exterior of the foundation. Ongoing water intrusion at the foundations can, in some cases, cause the steel in the foundations to rust, called spalling, which can lead to horizontal cracking of the foundation (currently there are no major cracks visible at the foundation). Any future cracking/damaged can be an expensive repair as the foundation is now structurally weak and susceptible to horizontal movement. Suggest review of the Lot/Grade and drainage systems, including rain gutters, to reduce and prevent further and future water buildup at the exterior of the dwellings foundations.

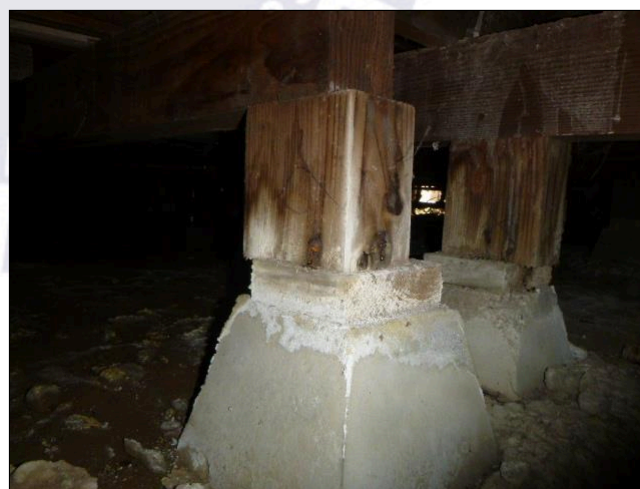
3.0 Item 11 (Picture)

3.0 (5) Evidence of settling/movement was noted at the internal pier and post flooring supports (due to the excessive water intrusion) which has resulted in the interior floor slope and settling cracks at the walls and ceilings. Suggest review with a licensed foundation contractor for repair/re-leveling/shimming costs as needed.

3.0 (6) Evidence of ongoing flooding of the crawl area was noted. See Lot Grade/Drainage and the sewer drain comments and repair as needed. Failure to prevent ongoing water intrusion will result in ongoing settling of the foundation and additional cracking of the walls and ceilings.

3.0 (7) Undermining of the foundation/ concrete piers noted at the front/right crawl areas. Suggest review by a licensed contractor for costs required to re-install the dirt or other means to prevent possible future movement of the foundation and/or structure.

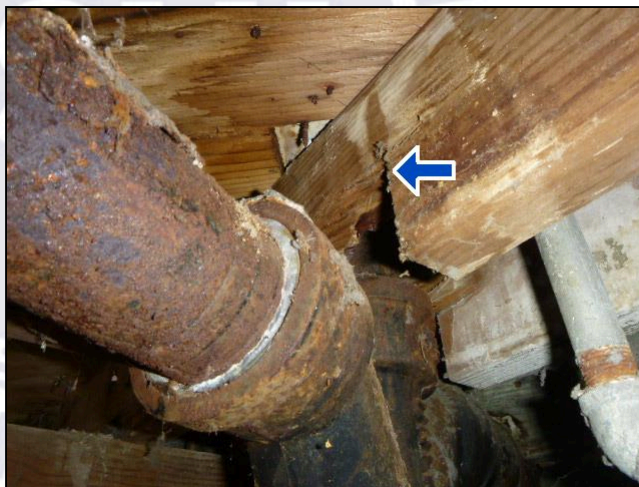
3.1 Item 1 (Picture)

3.1 (1) Excessive cutting and notching of various floor joists due to drainage installation. Suggest review by a licensed contractor for repair costs as needed.

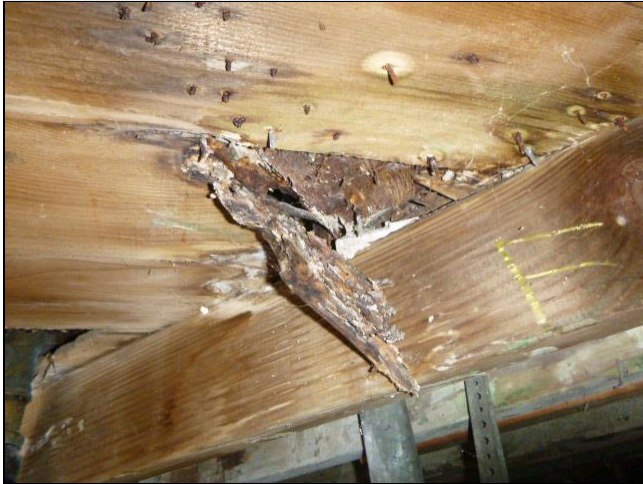
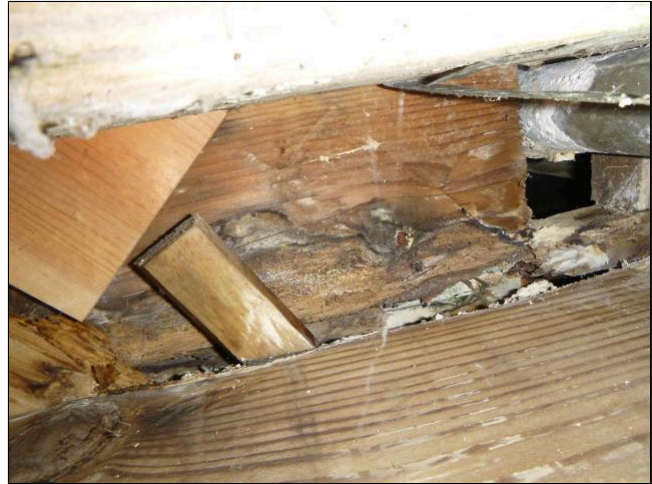
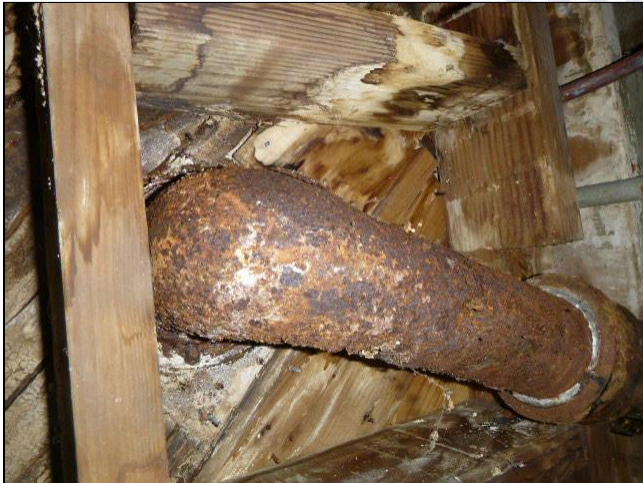
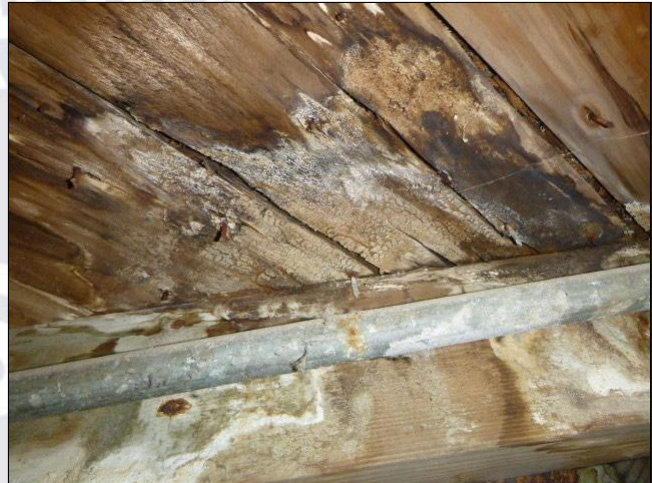
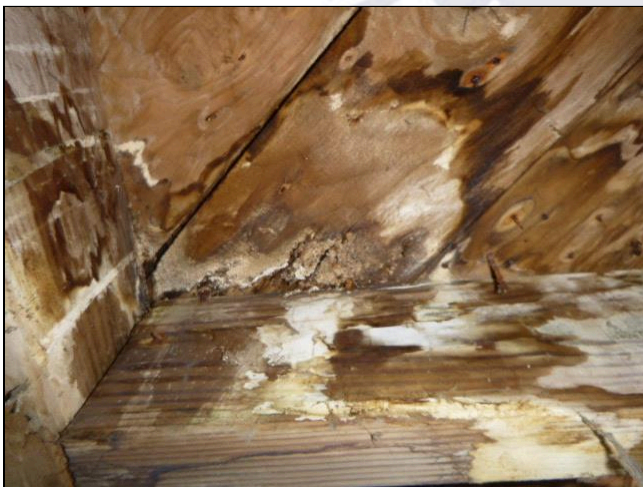
3.1 (2) Stains and deterioration noted at various flooring and supports from prior and ongoing leaks. Suggest review with a termite company and/or a licensed contractor and repair/replace as needed.

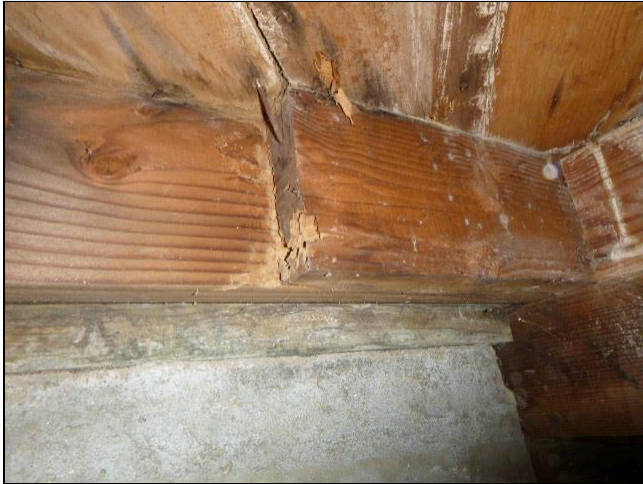
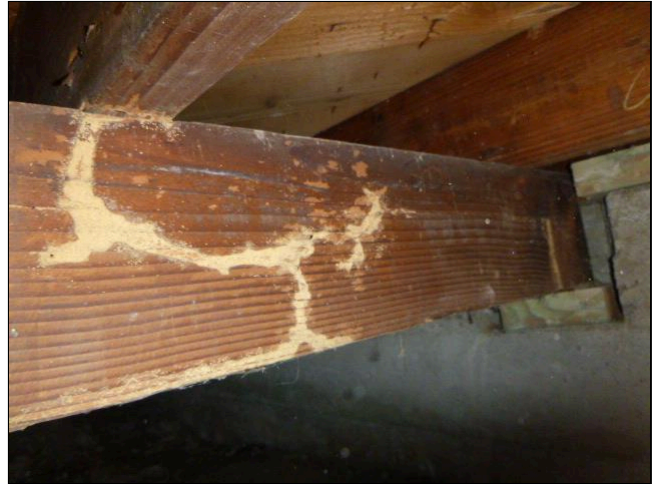
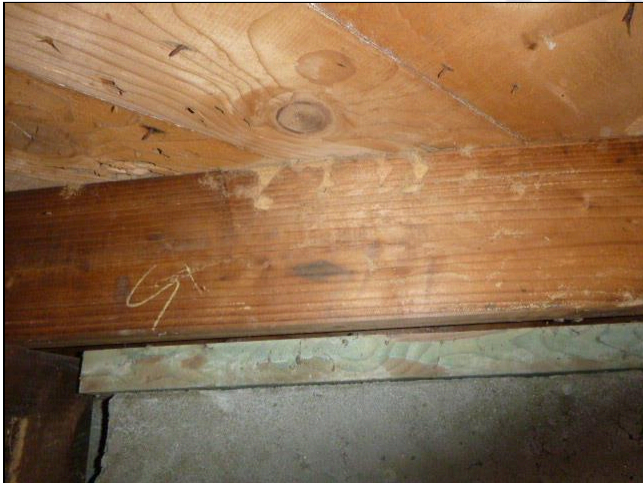
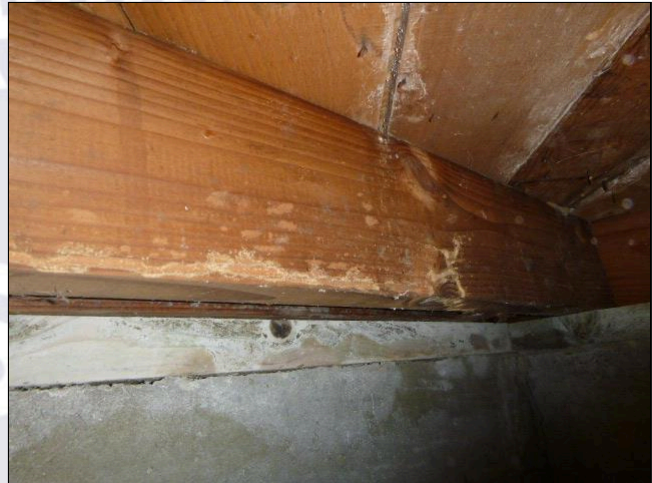
3.1 (3) Wood deterioration noted at various flooring and supports. Suggest review with a termite company and/or a licensed contractor and repair/replace as needed.

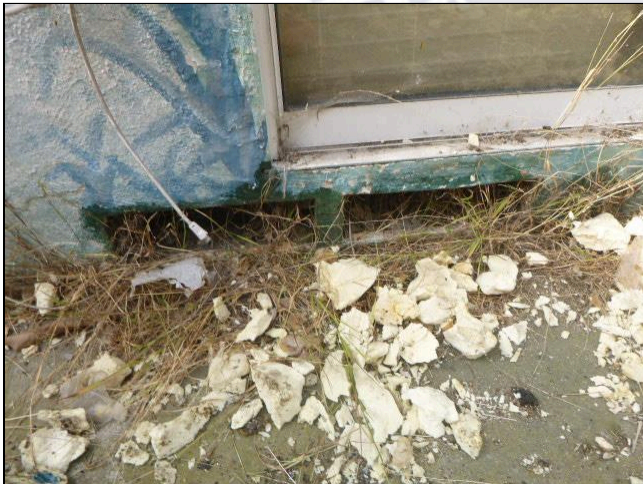
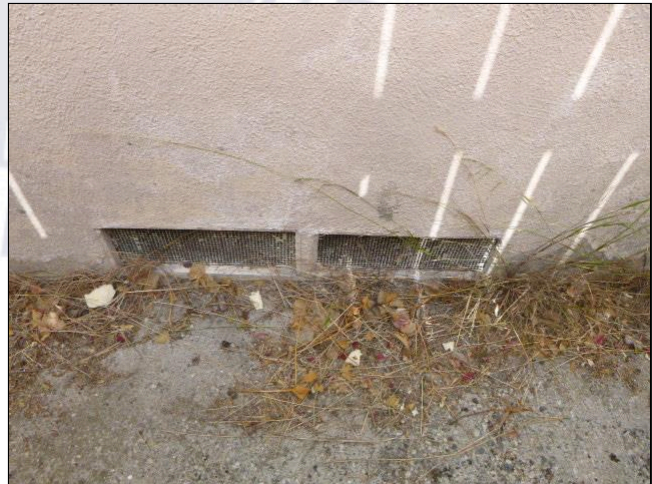
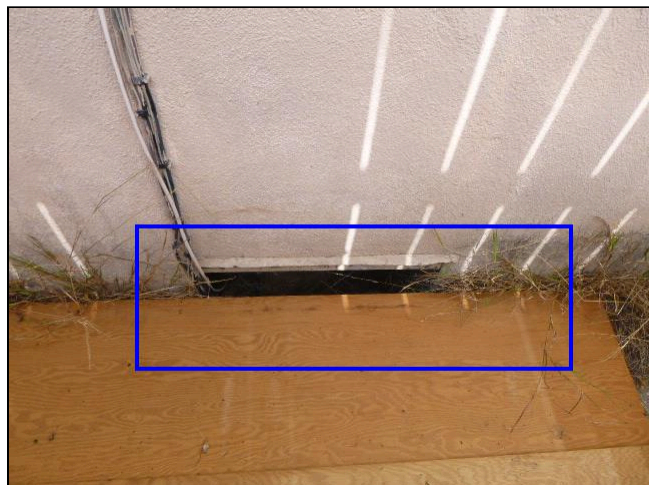
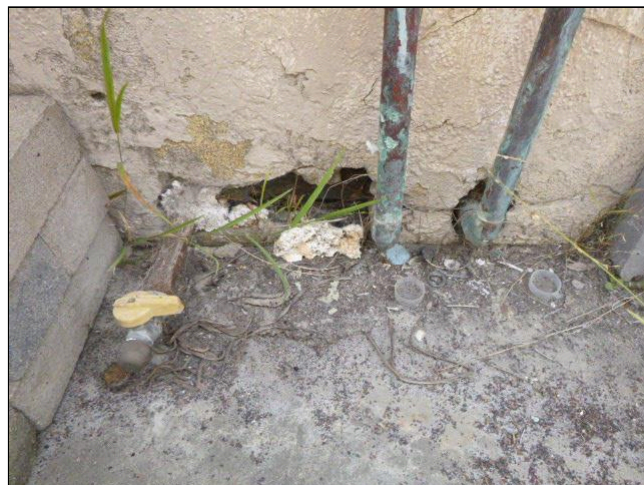
4.0 (1) The crawl space access port(s) and vent screens are below grade and evidence of water entry into the crawl space was noted. Suggest lowering the exterior grade or installing a brick or concrete berm to eliminate water entry into the crawl space. Suggest review by a licensed contractor for possible installation of an area drainage system to divert drainage away from the foundation.

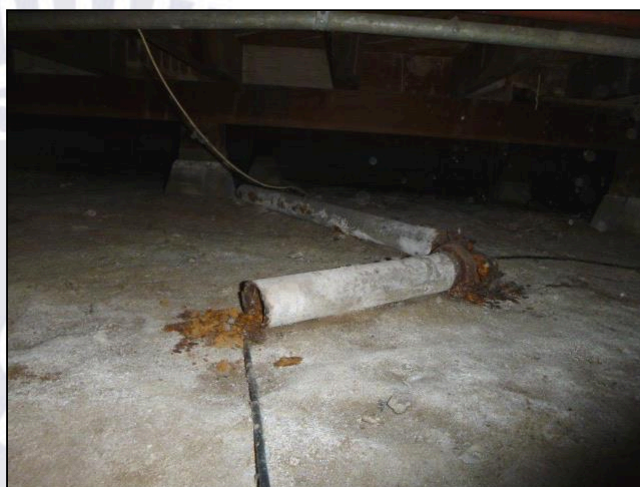
4.0 Item 5 (Picture)

4.0 (2) Suggest removal of debris and construction items from the crawl area.

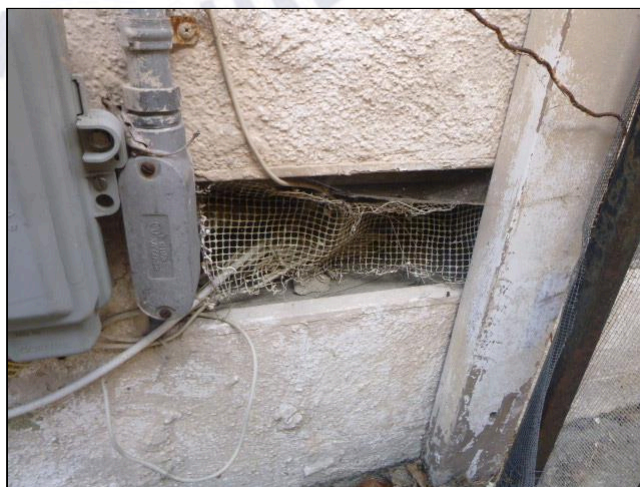
4.1 Item 1 (Picture)

4.1 Loose, missing or deteriorated vent screens noted. Suggest re-screening missing and/or deteriorated vent screens as needed to prevent rodent and insect intrusion.

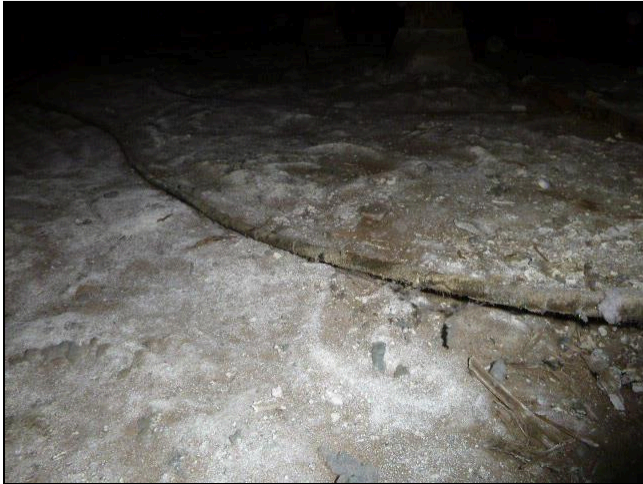
4.2 Item 1 (Picture)

4.2 The electrical wiring is frayed/deteriorated and in contact with the wet ground within areas of the crawl areas, this is potential safety hazard. Suggest review with a licensed electrician for repair/replacement costs as needed.

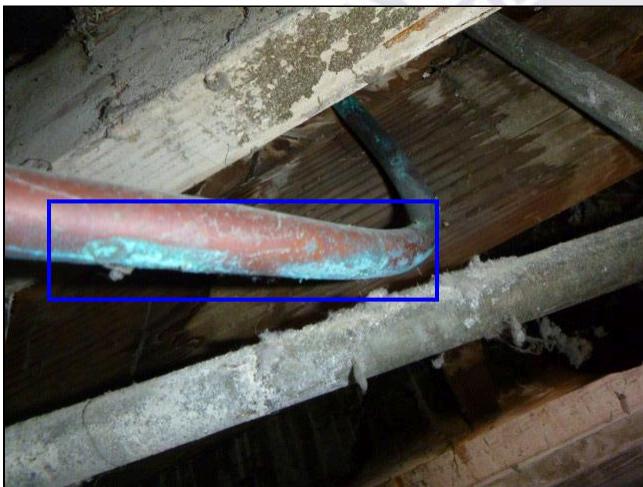
4.3 Item 1 (Picture)

4.3 (1) Corroded areas of the copper plumbing was noted throughout the crawl area, this can be a pre-cursor to 'pin hole' leaks. Suggest review with a licensed plumber for repair/replacement costs as needed.

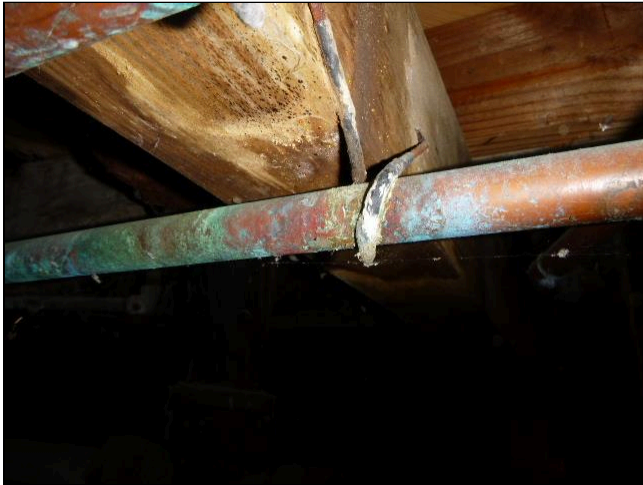
4.3 Item 3 (Picture)

4.3 (2) The copper plumbing lines are inadequately and improperly secured with straps that are causing excessive deterioration of the copper. Suggest replacing the deteriorated areas of the copper plumbing lines as well as replacing the straps with approved materials to prevent electrolysis and future leaks.

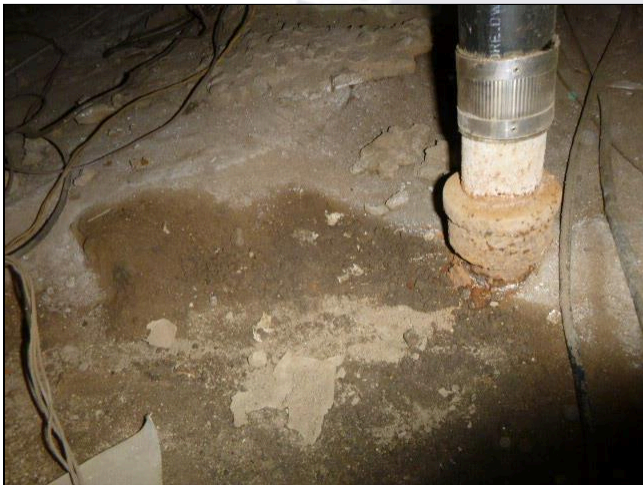
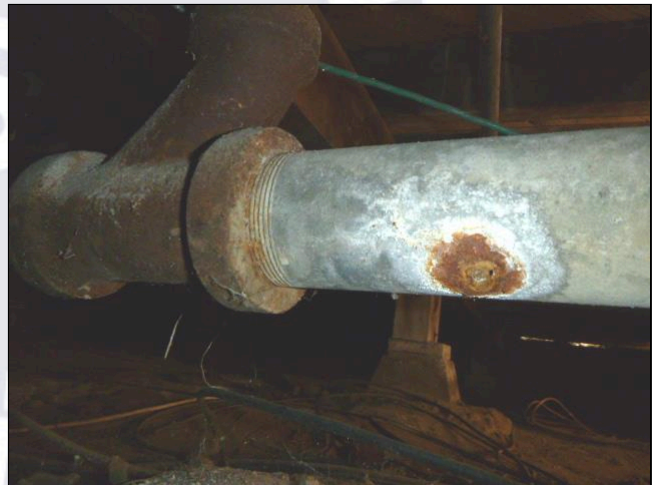
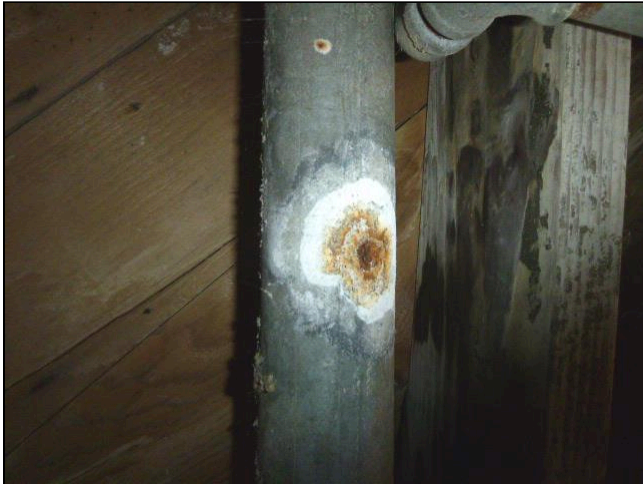
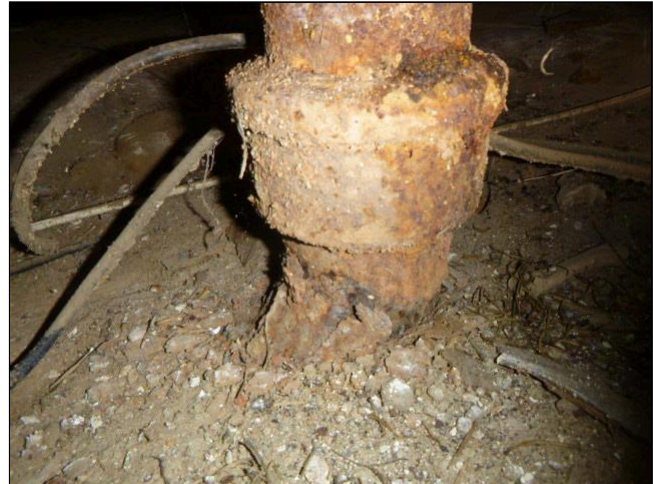
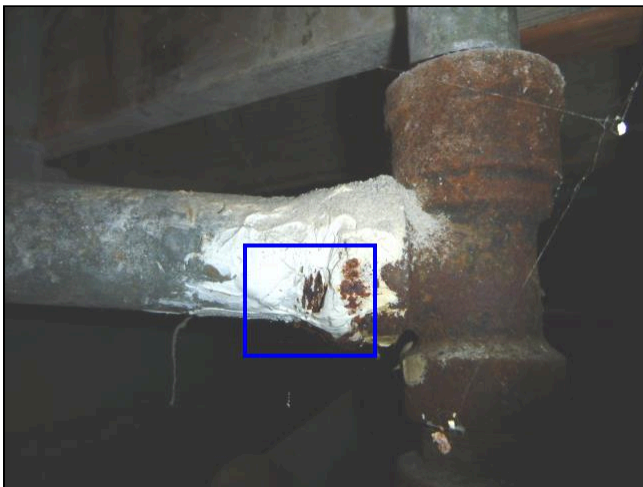
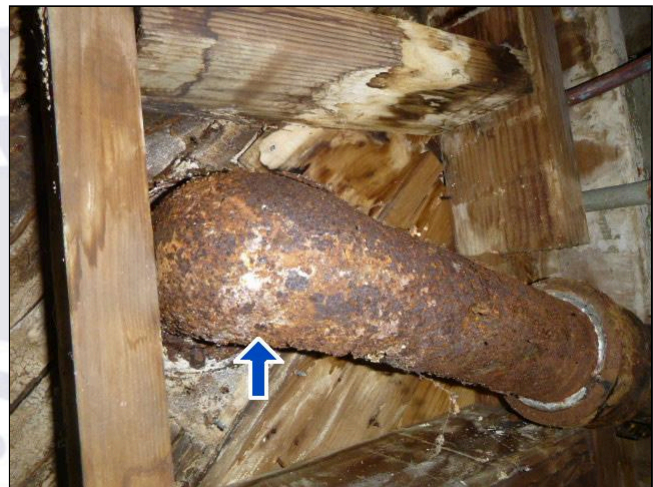
4.3 (3) Excessive rust, leaking and seepage/deterioration noted at various cast iron/galvanized drain lines within the crawl space. The excessive deterioration of the drain lines have caused leaking and saturation of the soil in the crawl area. Suggest review by a licensed plumbing contractor for replacement costs as needed to prevent on-going leakage at the crawl area.

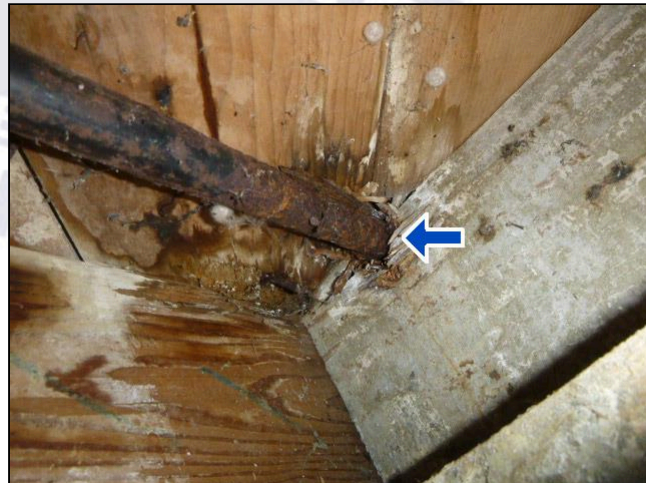
4.3 Item 11 (Picture)

4.3 (4) Excessive rust and corrosion was noted at the gas line at the left side due to the water intrusion. Suggest review with a licensed plumber for replacement costs as needed.

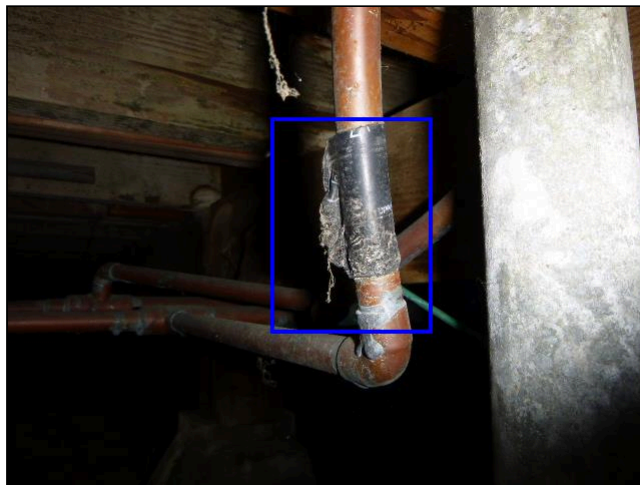
4.3 Item 12 (Picture)

4.3 (5) Non-typical and sporadic taping of the copper lines were noted, unable to determine if the tape/wrap is a temporary repair concealing deterioration, suggest review with a licensed plumber for replacement/repair as needed.
