Inspection Report

Property Address:
1619 Armour Ln
Redondo Beach CA 90278

Ferguson Home Inspections

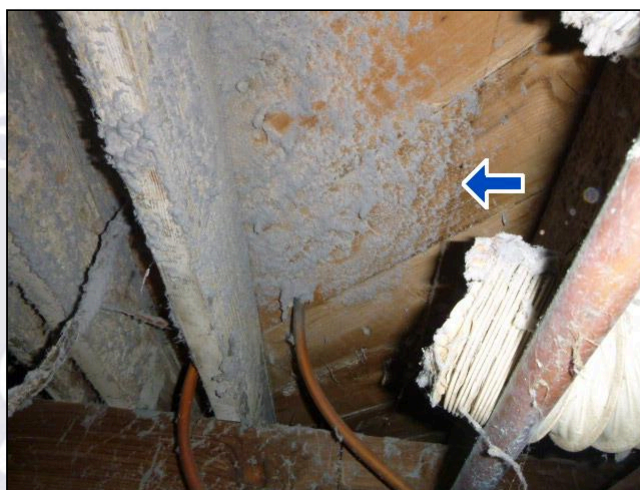
4.4 Item 1 (Picture)

4.4 Excessive lint was noted in the crawl area from the laundry dryer vent, this is a potential fire spread hazard. Suggest review with a licensed contractor for costs to repair and remove all of the lint from the crawl area as required for safety.

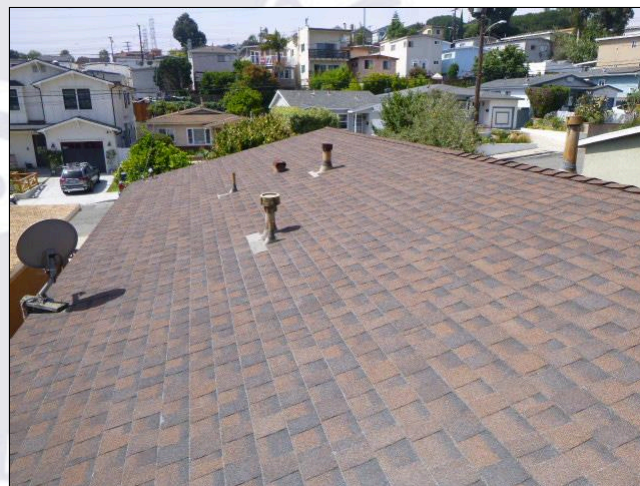
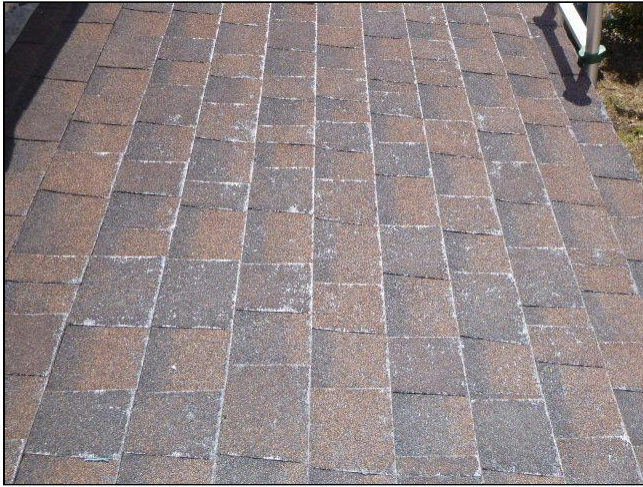
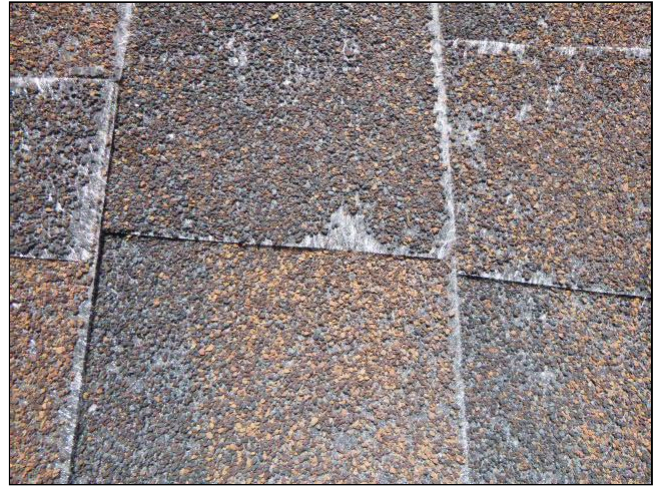
5.0 (1) Worn areas and deterioration of the roofing was noted, suggest review with a licensed roofing contractor for repairs, periodic maintenance and to determine the remaining life expectancy of the roof.

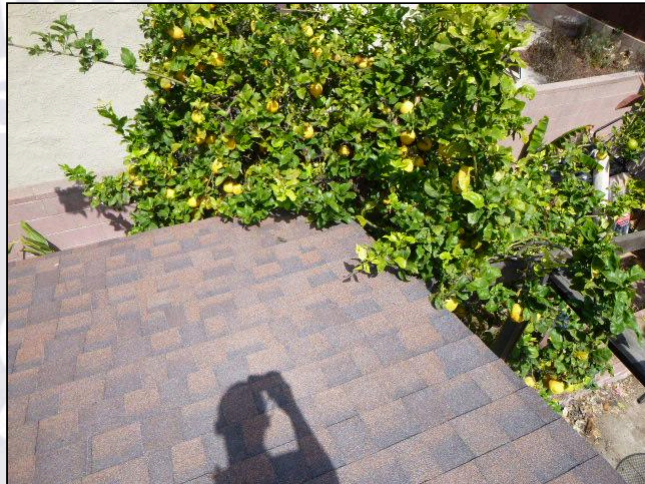
5.0 Item 5 (Picture)

5.0 (2) The tree limbs that are in contact with the roof or hanging near the roof should be trimmed to prevent damaging the roof. Suggest trimming as needed.

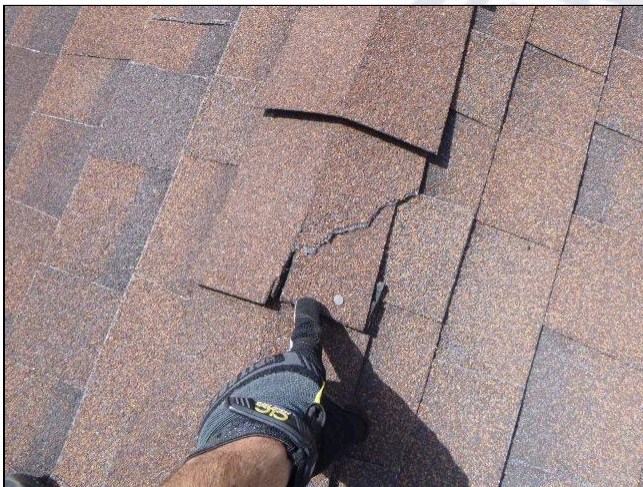
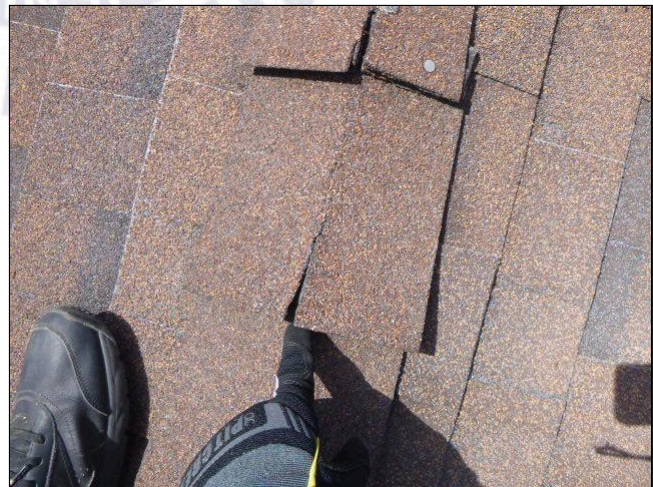
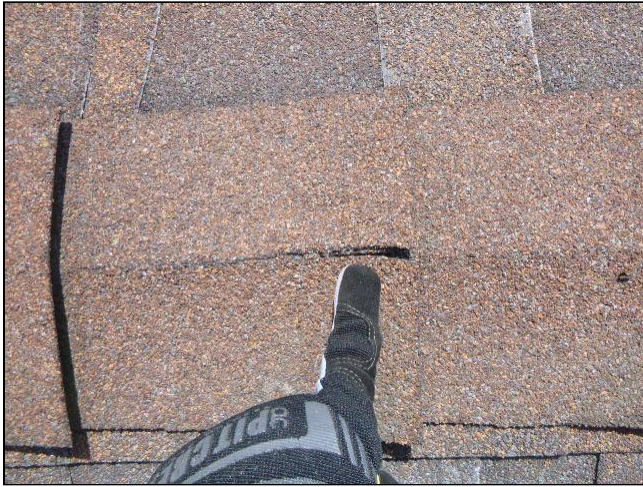
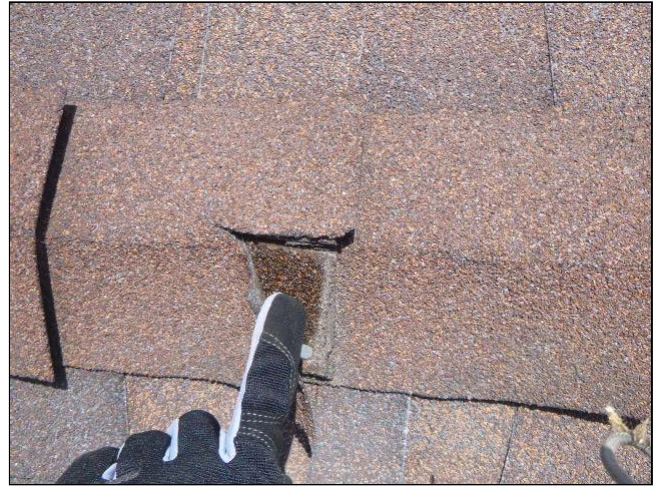
5.0 (3) Deteriorated ridge caps noted at the pitched roof, suggest review by licensed roofer for replacement costs and replace as needed.

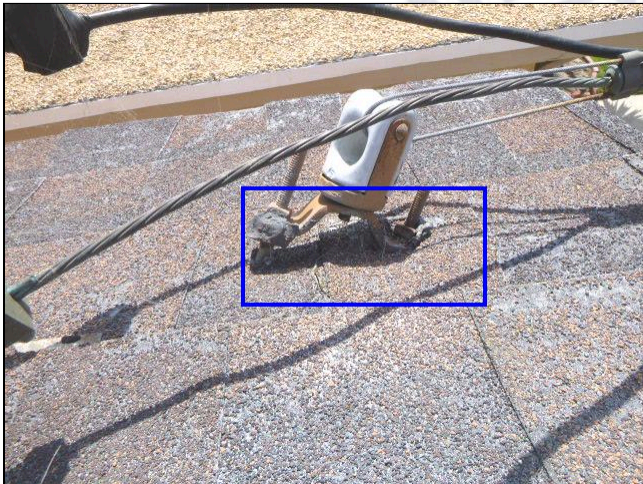
5.1 Item 1 (Picture)

5.1 (1) Loose/incorrect flashings/roof attachments were noted at various areas, suggest review with a licensed roofer for repairs as needed.

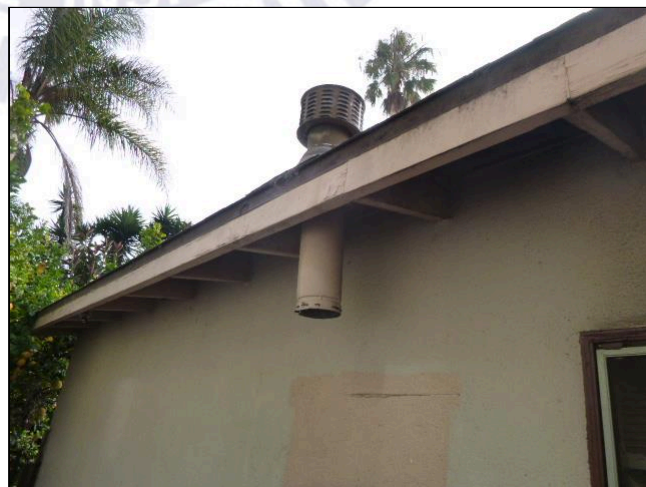
5.1 Item 3 (Picture)

5.1 (2) Suggest removal of the old/abandoned flashings/old vent pipes as needed.

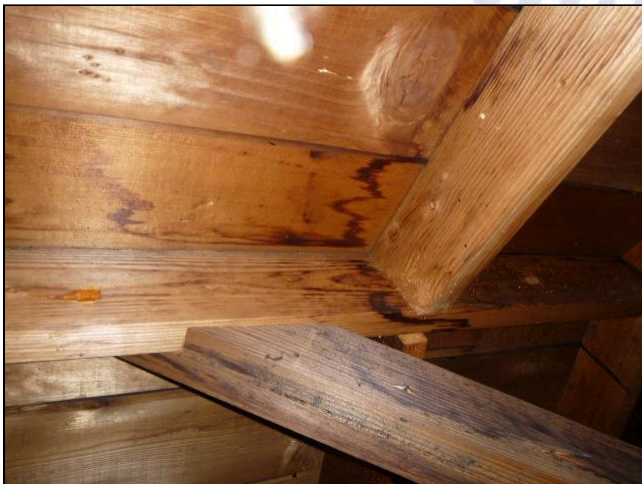
6.0 Item 1 (Picture)

6.0 (1) Minor wood deterioration noted at various areas of the roof framing, suggest review with a termite company and/or a licensed contractor for repairs as needed.

6.0 (2) Moisture stains noted at various areas of the attic sheathing/framing, see roof comments and repair as needed.

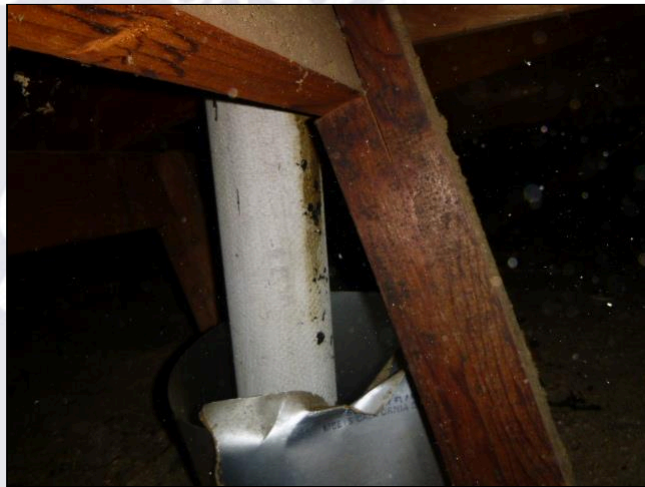
6.5 Item 1 (Picture)

6.5 Abandoned asbestos vent pipes noted in the attic area, suggest review with a licensed contractor for removal costs as needed.

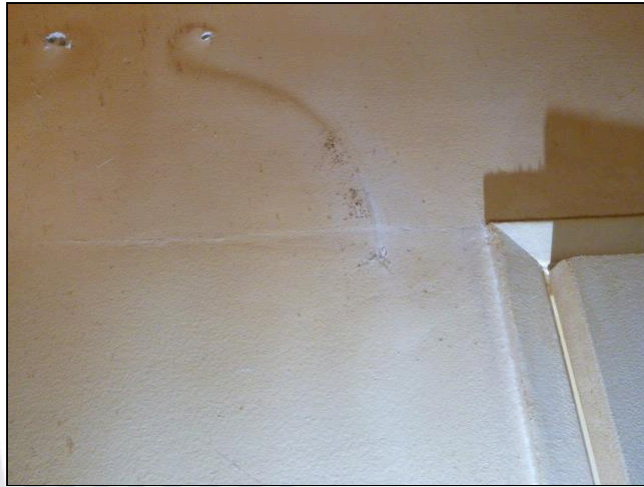
7.1 Item 1 (Picture)

7.1 (1) Settling cracks and patching was noted, suggest repair as needed.

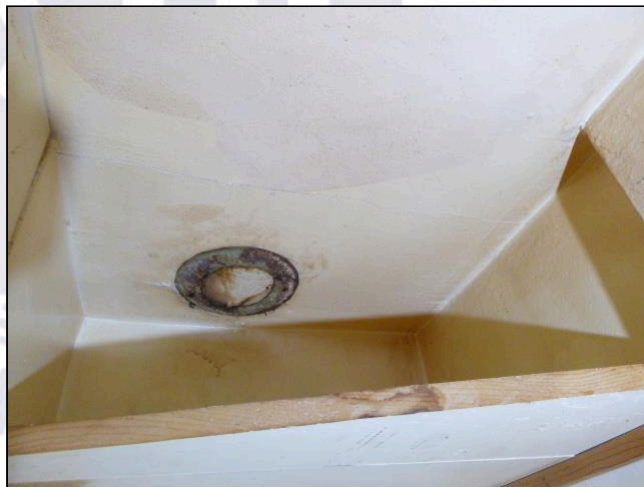
7.2 Item 1 (Picture)

7.2 (2) An old transite asbestos style vent pipe was noted at the ceiling of this area, suggest removal as needed.

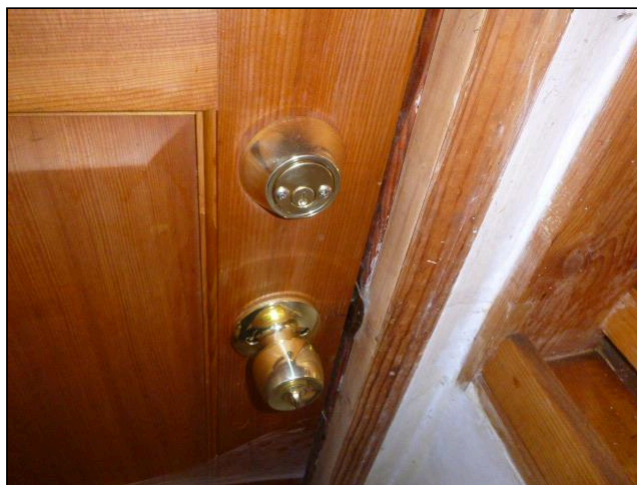
7.3 Item 1 (Picture)

7.3 A keyed interior lock is installed at the exterior door, suggest installing a thumb turn dead-bolt to enhance safety as an upgrade.

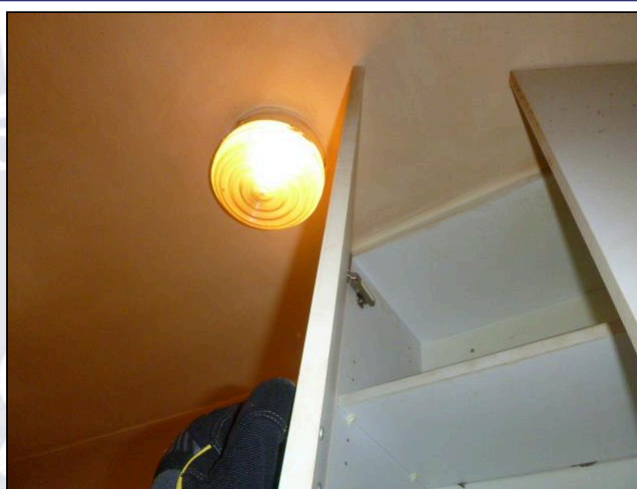
7.4 Item 1 (Picture)

7.4 (1) The cabinet door strikes the light fixture, suggest repairs as needed for safety.

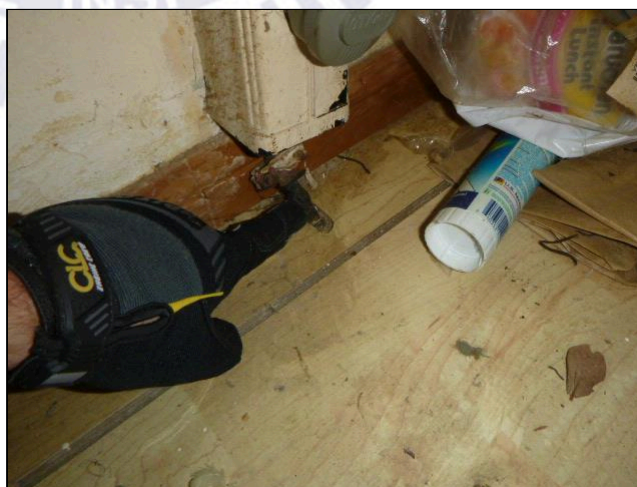
7.4 Item 2 (Picture)

7.4 (3) Exposed romex wiring located in accessible areas. This is a safety concern as it could be subject to physical damage. Romex wiring is allowed in inaccessible areas such as attics, crawl spaces and within walls provided that all proper protective materials and required tie-downs are in place. Suggest review by a licensed electrician for repair/ replacement costs as needed.

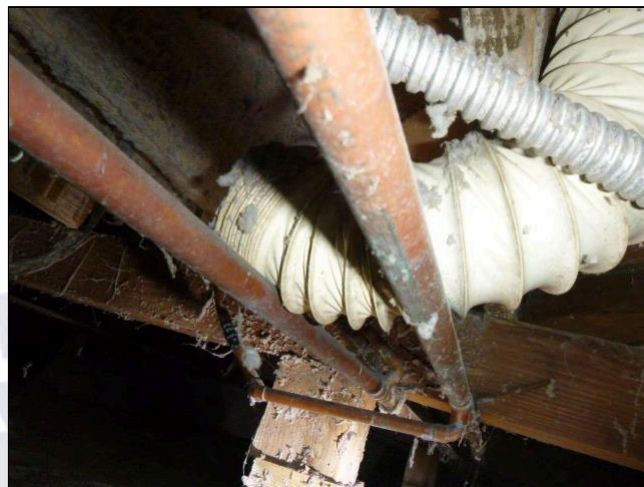
7.6 Item 2 (Picture)

7.6 (2) Improper vinyl flex vent installed to the crawl space (not installed to the exterior as required). Suggest removal of the existing material and install a rigid vent pipe to the exterior as required. Excessive lint noted was noted in the crawl area due to the incomplete installation, this is a potential fire hazard. Suggest review by licensed contractor for costs to remove the lint form the crawl area as required for safety.

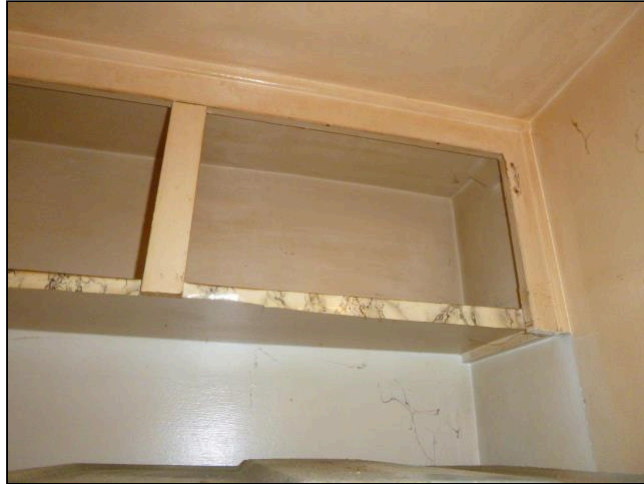
7.7 Item 1 (Picture)

7.7 Various cabinet doors are damaged, missing or loose on the hinges. Suggest repair/replace as needed.

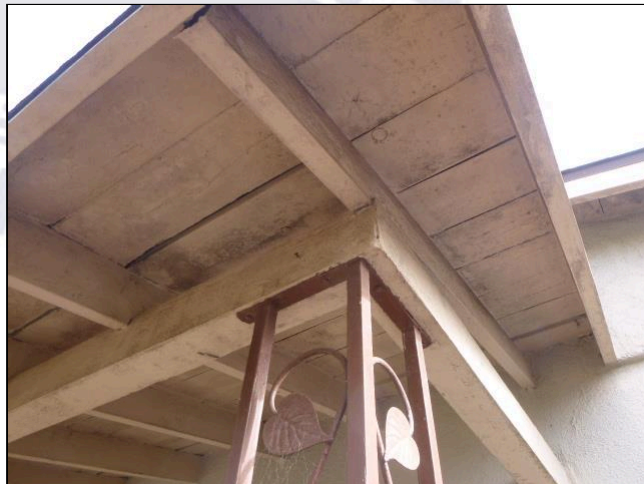
8.0 Item 1 (Picture)

8.0 (1) Paint blistering, peeling and wood deterioration noted at various trim areas. Suggest review with a termite company and/or a licensed contractor and repair/replace as needed.

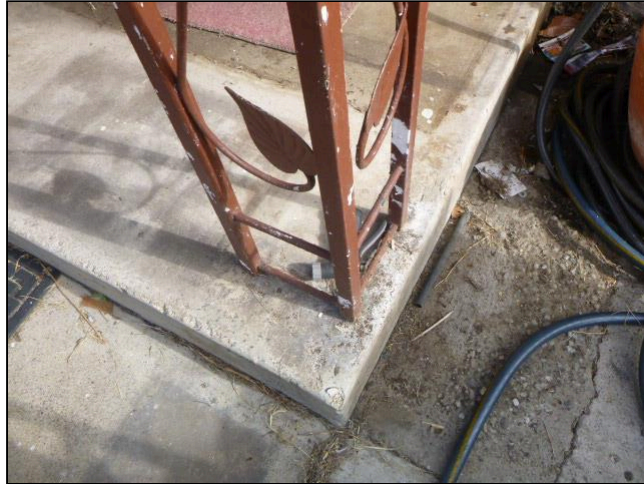
8.0 Item 2 (Picture)

8.0 (2) Rust/deterioration and loose areas noted at the corner roof post support, suggest review with a licensed contractor for repair/replacement costs as needed.

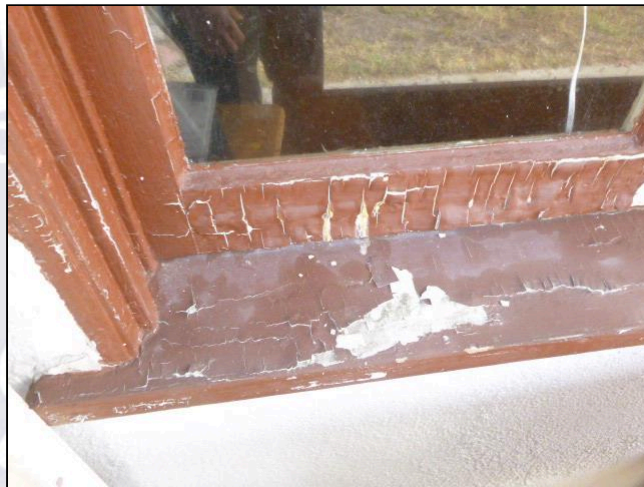
8.4 Item 1 (Picture)

8.4 Wood deterioration noted at various windows. Suggest review with termite company and/or a licensed contractor and repair/replace as needed.

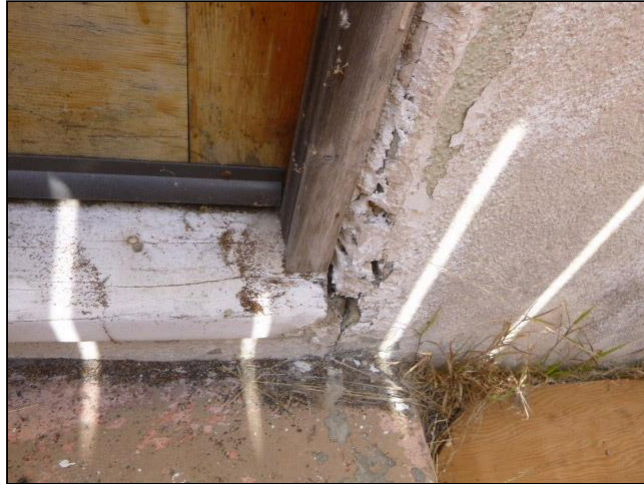
9.5 Item 1 (Picture)

9.5 Excessive wood deterioration noted at the door, door frame and threshold. Suggest review by a licensed contractor for repair/replacement costs as needed.

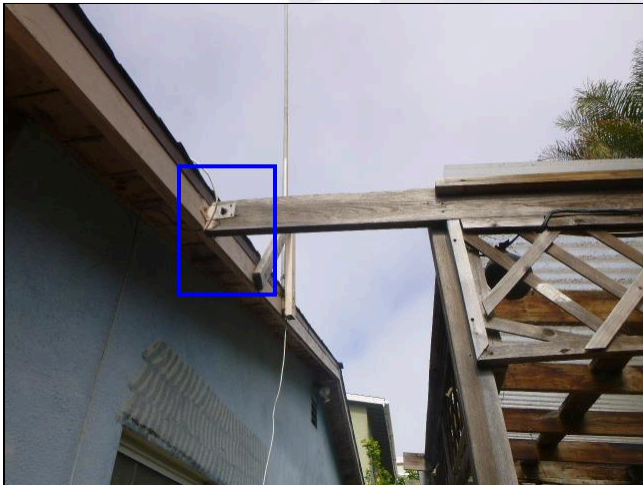
10.0 Item 1 (Picture)

10.0 (2) The rear patio has been incorrectly secured back to the structure, suggest removal as needed.

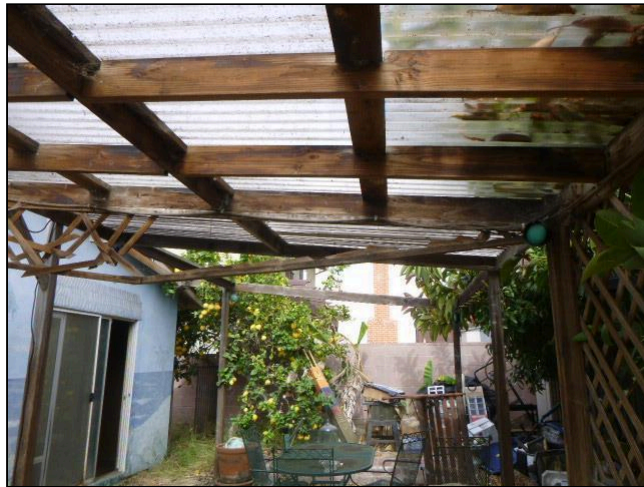
10.0 Item 3 (Picture)

10.0 (3) Excessive wood deterioration noted at the rear patio structure, suggest removal as needed.

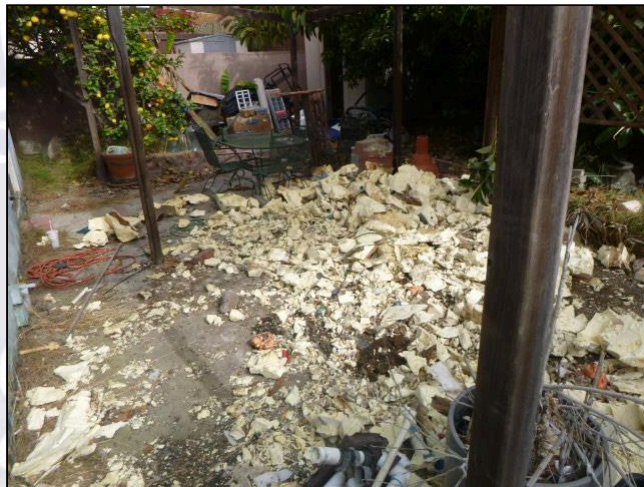
10.1 Item 1 (Picture)

10.1 Excessive debris was noted throughout this area, suggest removal as it poses a potential trip hazard. The inspector was unable to visually inspect this area as a result.

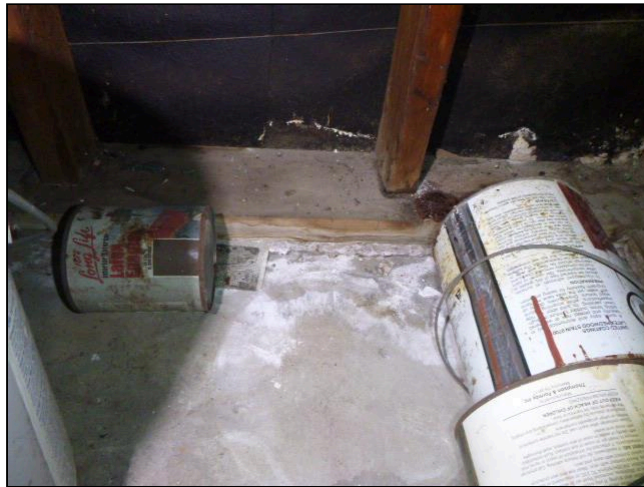
11.0 Item 2 (Picture)

11.0 (2) White efflorescence (powder substance) on foundation footings indicates prior, and possibly ongoing, excessive moisture build up at the exterior of the foundation. Ongoing water intrusion at the foundations can, in some cases, cause the steel in the foundations to rust, called spalling, which can lead to horizontal cracking of the foundation (currently there are no major cracks visible at the foundation). Any future cracking/damaged can be an expensive repair as the foundation is now structurally weak and susceptible to horizontal movement. Suggest review of the Lot/Grade and drainage systems, including rain gutters, to reduce and prevent further and future water buildup at the exterior of the dwellings foundations.

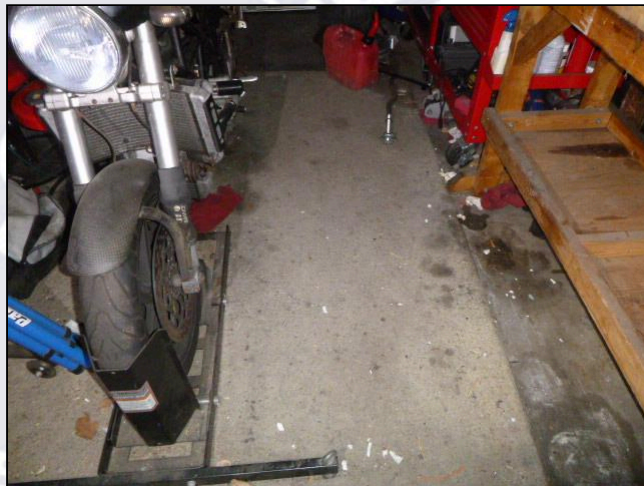
11.0 Item 3 (Picture)

11.0 (3) Suggest removal of the carpet if vehicles are to be parked in the garage. Non fire rated flooring at the garage area is a potential fire safety hazard. Suggest review with a licensed contractor for repair/replacement costs as needed.

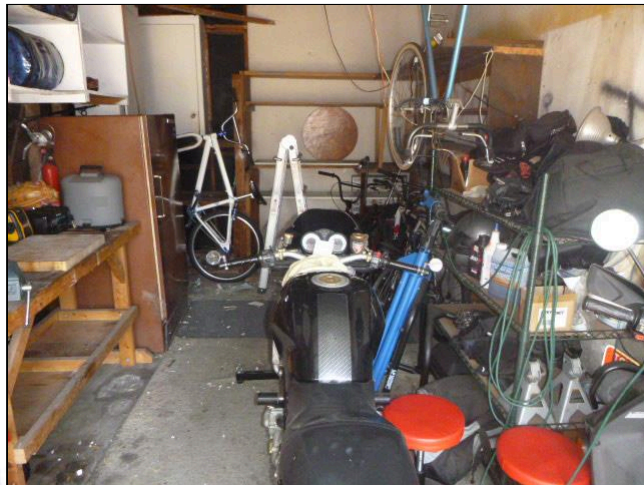
11.3 Item 1 (Picture)

11.3 (1) Unable to make a complete inspection of firewall due to a large concentration of personal effects. Suggest review of firewall once area has been cleared. If any breaches or damage to firewall is found, suggest patching and repair with 5/8 drywall as needed to complete firewall.

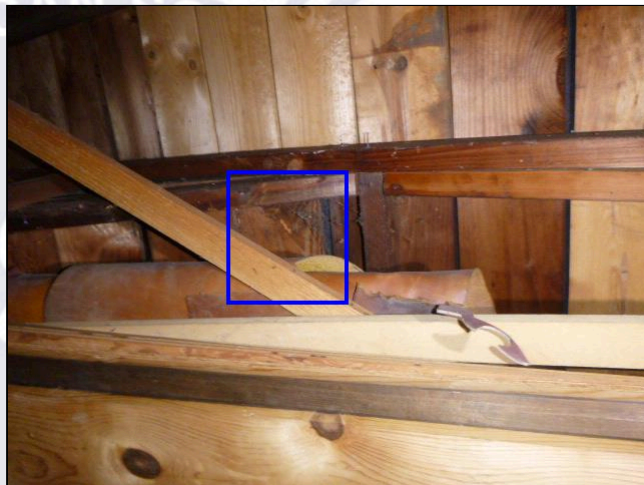
11.3 Item 2 (Picture)

11.3 (2) Wood deterioration noted at various areas of the garage framing, suggest review with a termite company and/or a licensed contractor for repairs as needed.

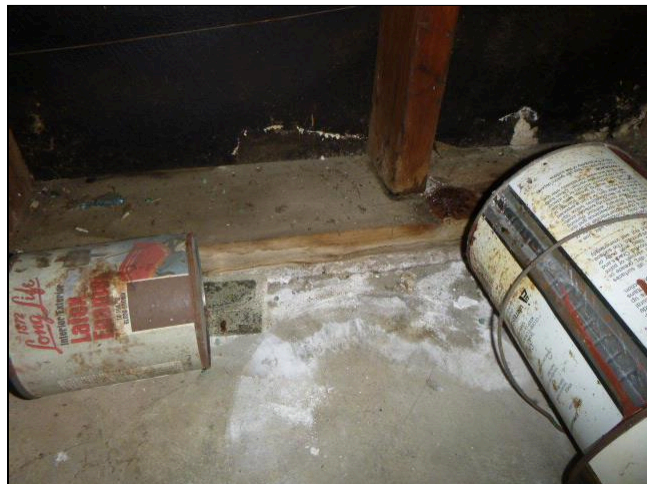
11.3 Item 3 (Picture)

11.3 (3) Water stains and deterioration noted at the lower section of the walls due to water intrusion. Suggest repair/replace as needed.

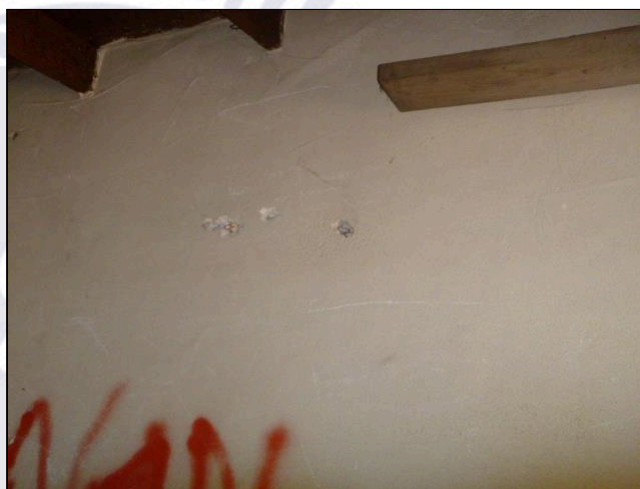
11.3 Item 5 (Picture)

11.3 (4) Holes and unfinished sections of firewall and ceiling were noted, this is a potential fire spread hazard. 5/8 inch sheetrock may be installed as a minimum standard material and as a requirement for a one hour burn through rating for firewall. Suggest review by licensed contractor for repair/installation costs as needed.

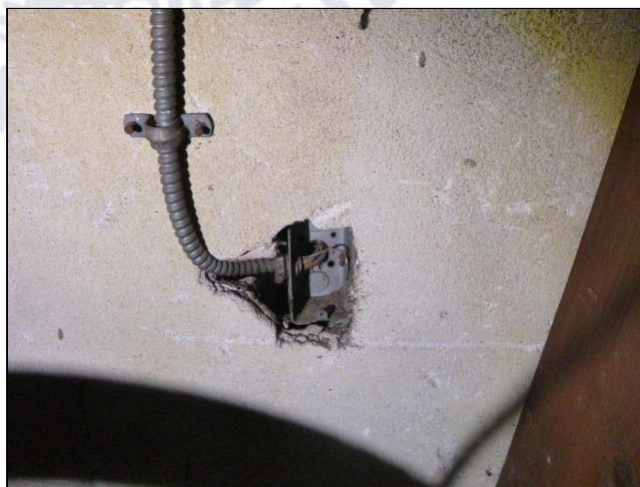
11.4 Item 1 (Picture)

11.4 (1) Open junction boxes were noted, this is a potential safety hazard. Whenever an electrical wire is cut and re-connected, the 'splice' should be encased in a covered junction box to prevent shocks and separation of the splice. Suggest review by a licensed electrician for repair/replacement costs as needed.

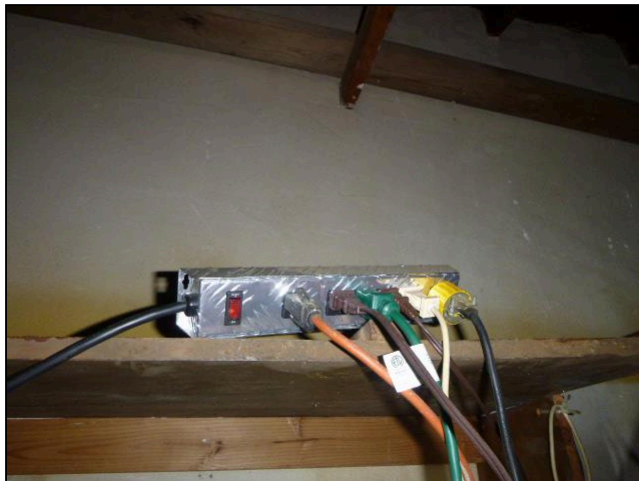
11.4 Item 2 (Picture)

11.4 (3) Excessive use of electrical plugs strips/extension cords used at this area, this is a potential fire safety hazard. Suggest review with a licensed electrician for additional electrical circuits/outlets costs as needed for safety.

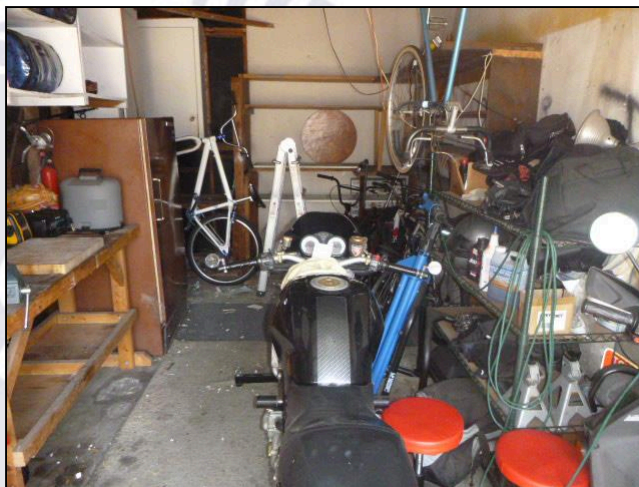
11.5 Item 1 (Picture)

11.5 (1) Access within this area was blocked or severely limited at the time of the inspection. An inspection of this area can be performed by appointment and at an additional cost when the area is made accessible.

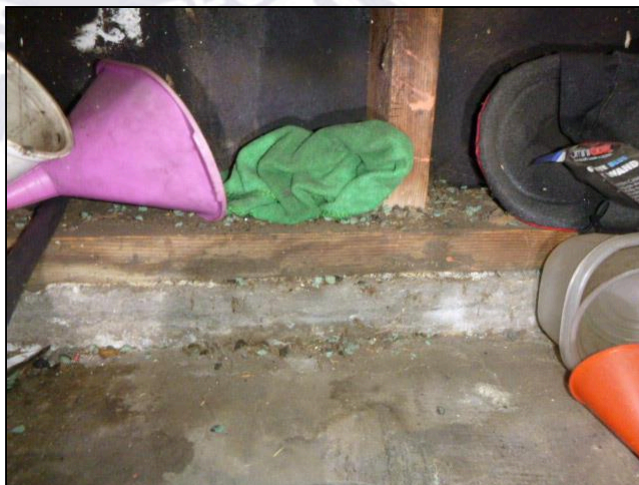
11.5 Item 2 (Picture)

11.5 (2) Pest droppings noted within the garage area. Suggest review with a qualified pest control company and/or a licensed contractor for removal costs of the droppings as needed.

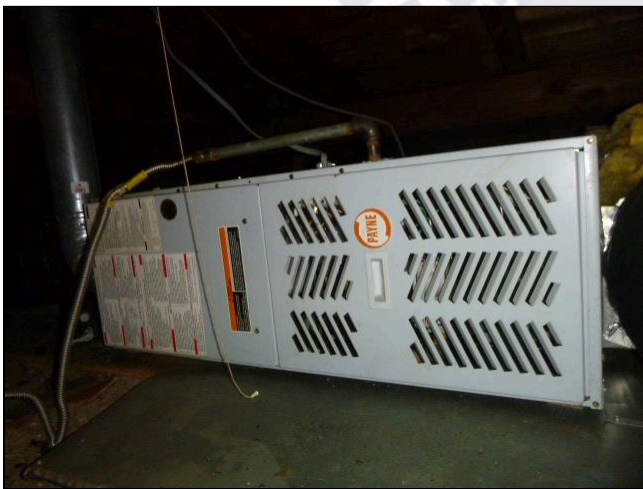
12.0 Item 1 (Picture)

12.0 (1) The heating unit was tested and was operational at the time of the inspection.

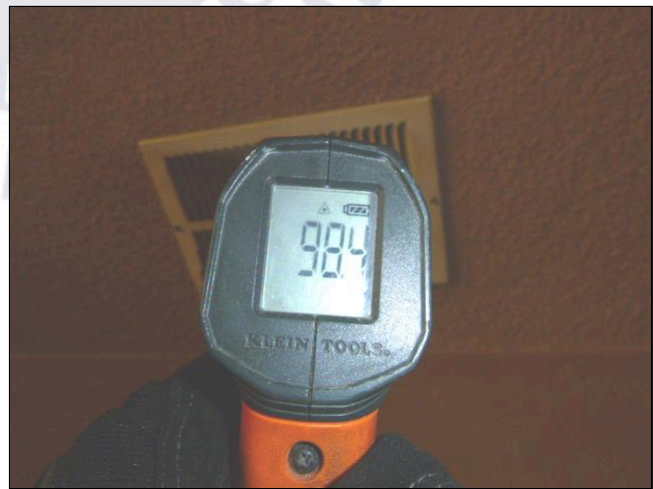
12.0 Item 2 (Picture)

12.0 (2) Suggest replacing/cleaning the filter(s) as needed.

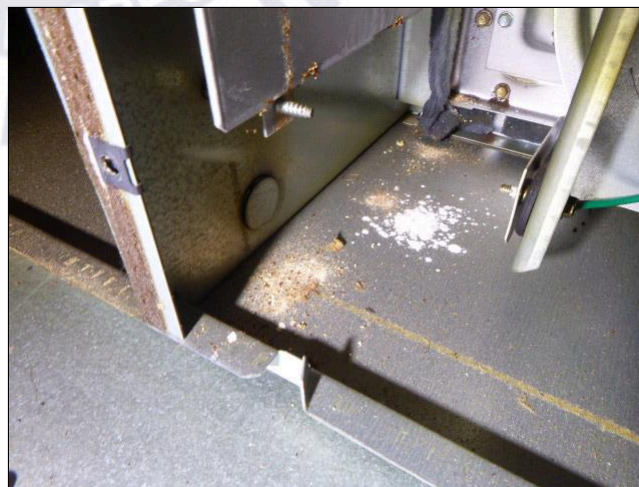
12.0 Item 6 (Picture)

12.0 (4) Deterioration/possible condensation debris/build-up was noted at the base of the exhaust vent manifold, suggest review with a licensed heating contractor for maintenance/repairs as needed.

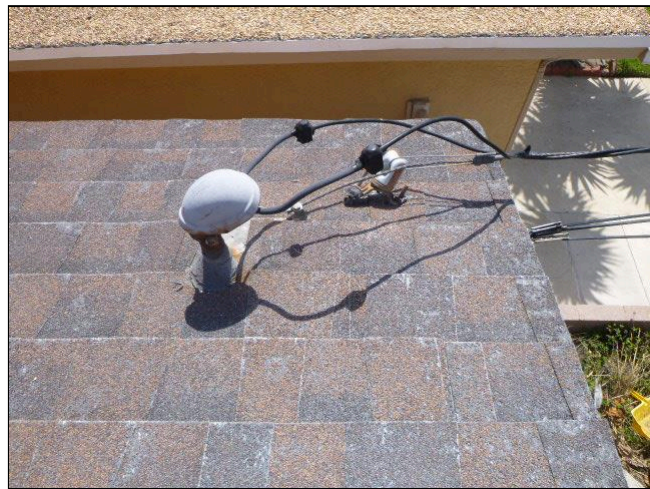
13.0 Item 3 (Picture)

13.0 (2) Inadequate drip loop was noted, suggest review with a licensed electrician for repairs as needed.

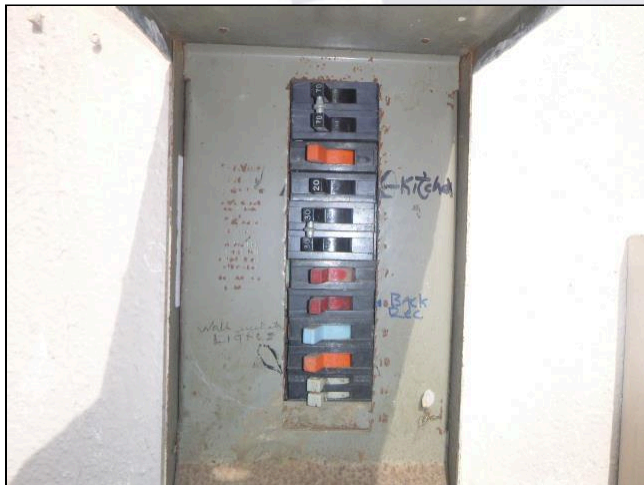
13.1 Item 1 (Picture)

13.1 (1) The main electrical panel is a Zinsco brand panel box, a product that hasn't been manufactured for many years. There are problems with these panels that can, in some cases, be serious. Some Zinsco panels have aluminum bus bars (the bars that run down the middle of the panel to which the breakers connect). Over a period of years, oxide forms on the aluminum causing a poor connection with the breakers and leading to arcing, overheating, and, eventually, breaker failure. Other problems with Zinsco panels include circuit breakers (depending on the vintage) with a dismal performance record and the possibility of unbalanced multi-wire circuits. Also, please be aware that various insurance companies will not insure homes with this style of electrical panel. Suggest review by a licensed electrician for replacement costs as needed.

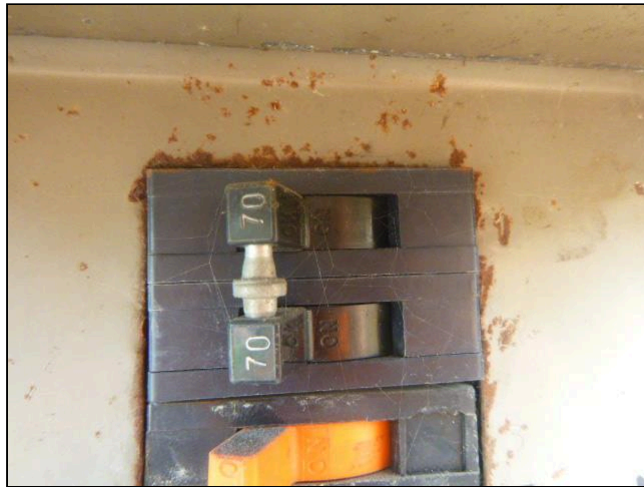
13.1 Item 3 (Picture)

13.1 (2) Due to the age and size/overall amperage of this system relative to the square footage of the dwelling, suggest review with a licensed electrician for replacement cost to upgrade the electrical panel, increase the overall amperage and install additional circuits to the interior of the dwelling as needed/desired.

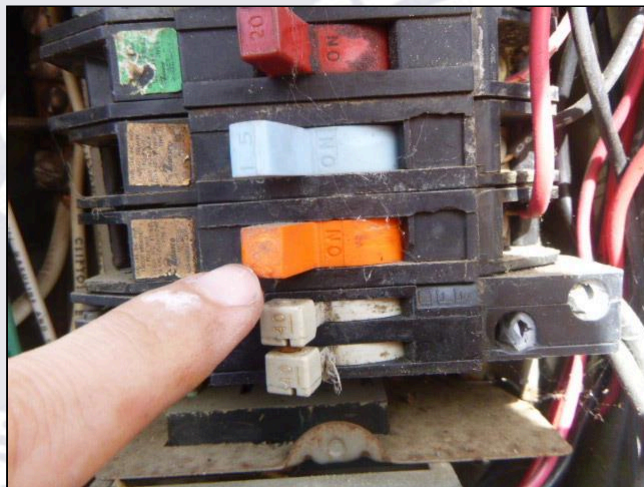
13.2 Item 1 (Picture)

13.2 (2) A damaged breaker was noted, suggest replacement as needed.

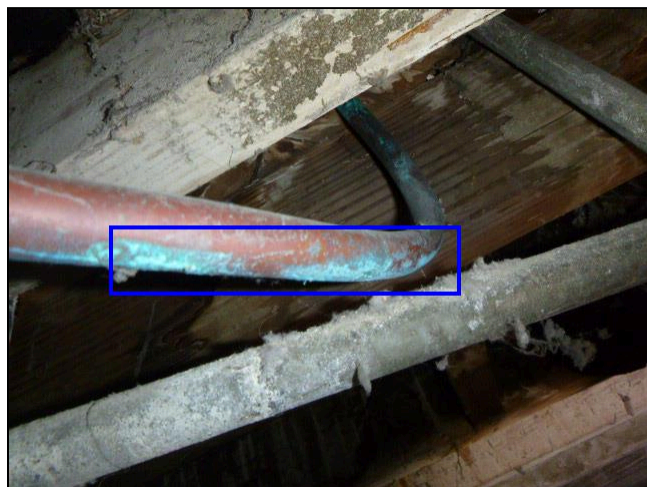
14.0 Item 2 (Picture)

14.0 (2) See the crawl space comments and repair as needed.

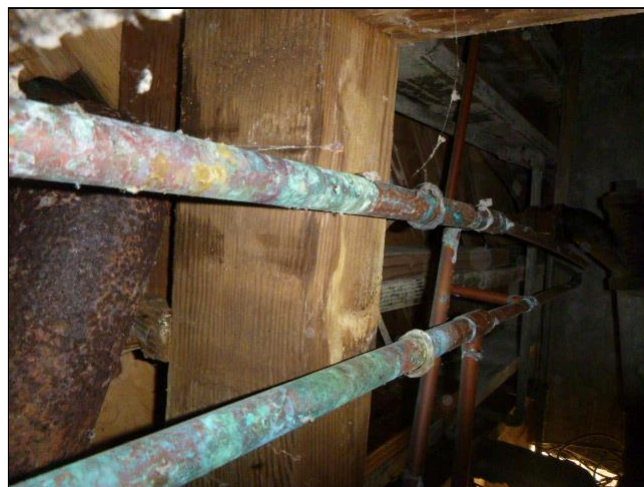
14.0 Item 3 (Picture)

14.0 (3) Corroded plumbing and fittings noted at various areas within the dwelling/crawl space. Suggest further review by a licensed plumber for repair/replacement costs as needed to prevent future leakage, pin hole leaks and possible stains/damage to the interior of the dwelling/foundation.

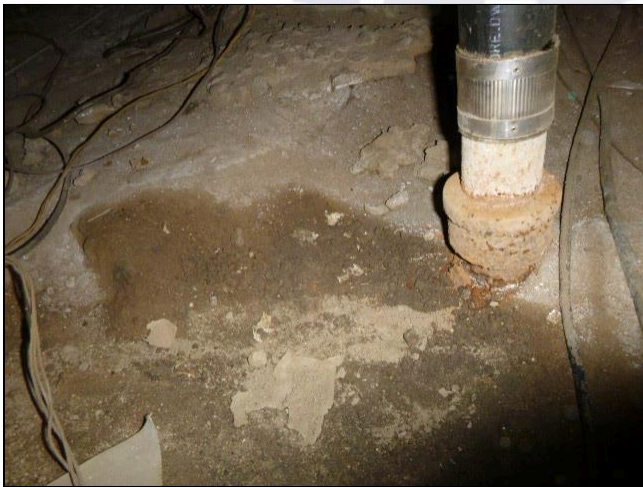
15.0 Item 1 (Picture)

15.0 (1) See the crawl space comments due to multiple cracks and leaking drains. Suggest review by licensed plumber for repair/replacement costs.

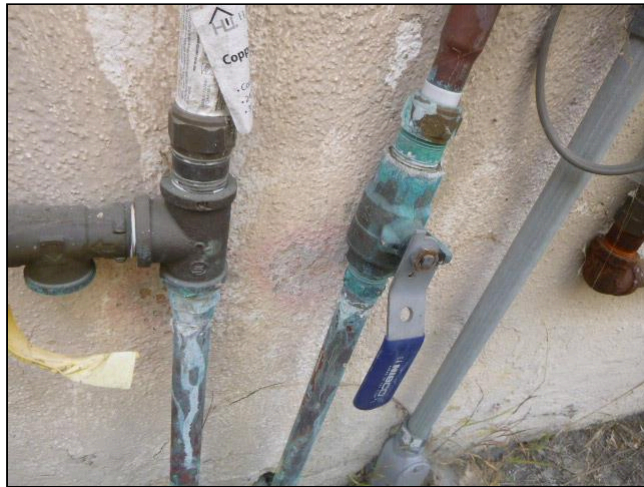
16.0 Item 2 (Picture)

16.0 (2) Rust and corrosion was noted at the cold water shut off, no leaking was visible at the time of the inspection. Suggest review by a licensed plumber for repair/replacement costs as needed.

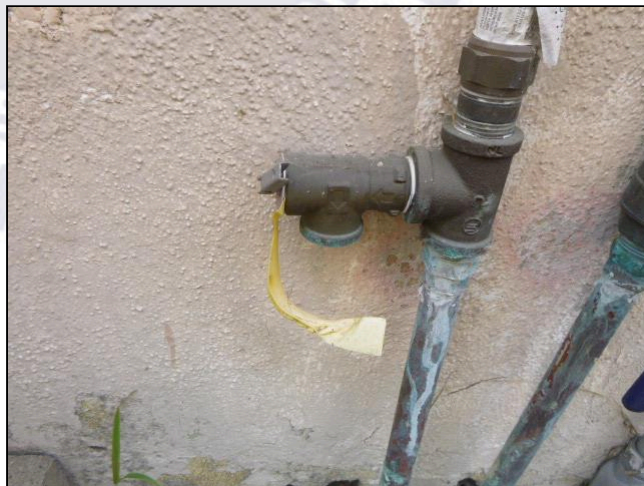
16.0 Item 4 (Picture)

16.0 (4) No discharge pipe connected to the TP&R valve, this is a potential safety hazard. Suggest review by a licensed plumber for costs to install the TP discharge drain down to within 4-6 inches of the exterior grade/deck as required for safety.

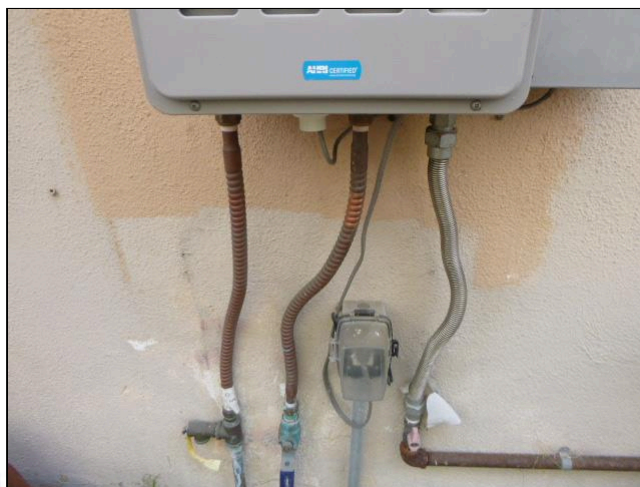
16.0 Item 5 (Picture)

16.0 (6) The current water heater does not have a "Thermal Expansion tank" which is generally installed to prevent a possible leak at the T&P or "pop-off" valve and/or excessive pressure build-up at the internal plumbing, fixtures and joints. Recent changes (2012) require one when a new water heater is installed, but various cities do not enforce this installation for multiple reasons (the home is not on a closed system and various tankless units do not require it) . There were no leaks or drips at the T&P valve during inspection. If your water heater does begin to drip or leak, then a thermal expansion tank may be needed. Suggest review with the city and/or a licensed plumber to determine if this installation is required and install as needed.

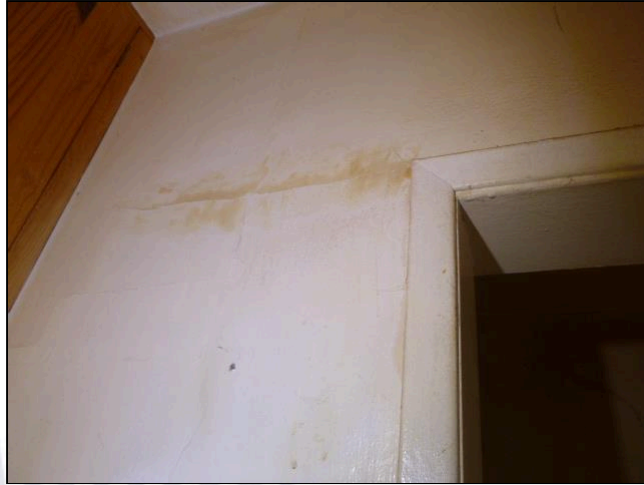
17.1 Item 1 (Picture)

17.1 (1) Settling cracks and patching was noted, suggest repair as needed.

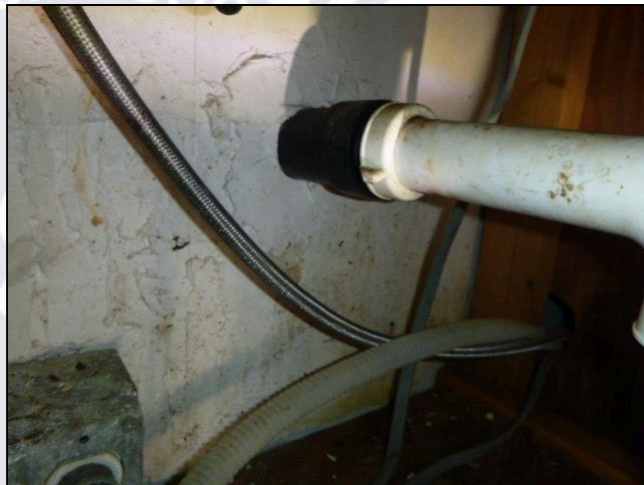
17.1 Item 2 (Picture)

17.1 (2) Patched areas of the walls was noted, suggest review with the seller for the cause and any repairs needed. Suggest repair as needed.

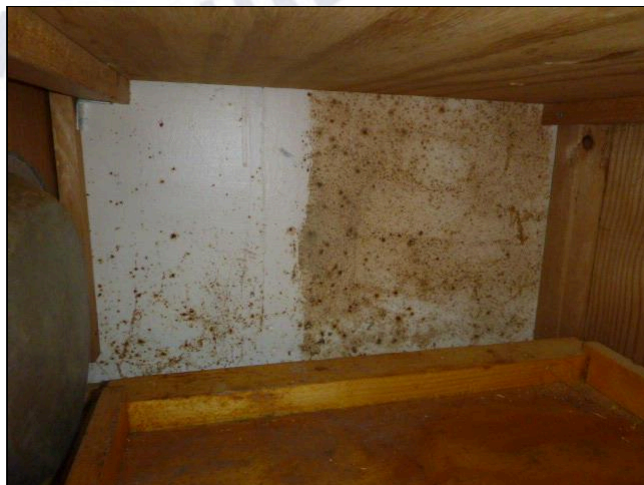
17.1 Item 3 (Picture)

17.1 (3) Excessively stained wall(s) noted in the cabinetry. Suggest review with the seller and a licensed contractor for removal/repair/replacement costs as needed.

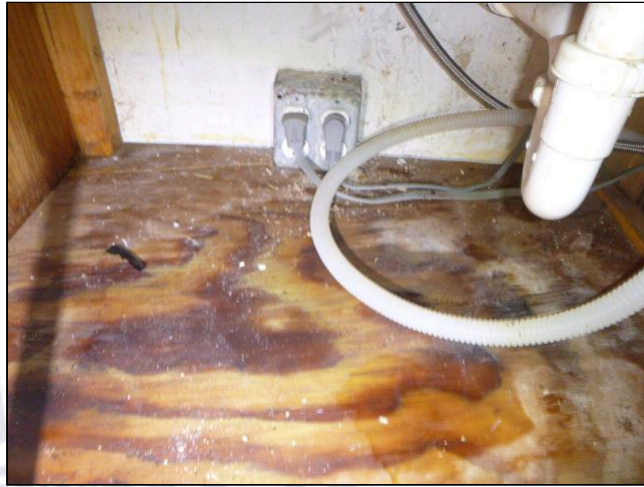
17.5 Item 1 (Picture)

17.5 (1) The base cabinet under the sink is deteriorated/stained from previous leaks, suggest repair/replace as needed.

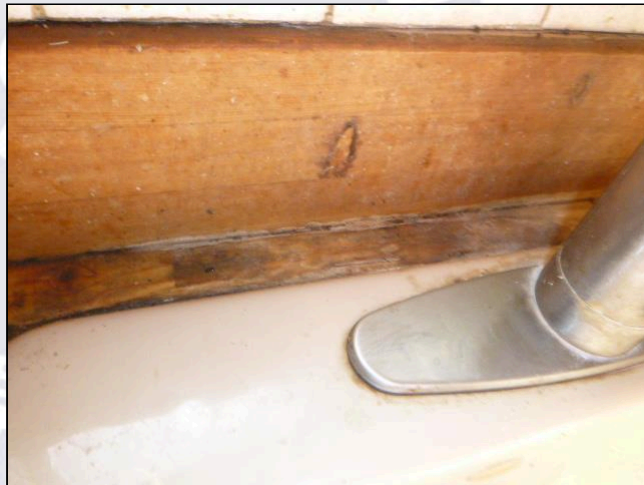
17.6 Item 1 (Picture)

17.6 Deterioration noted at various areas, suggest repair/replace as needed.

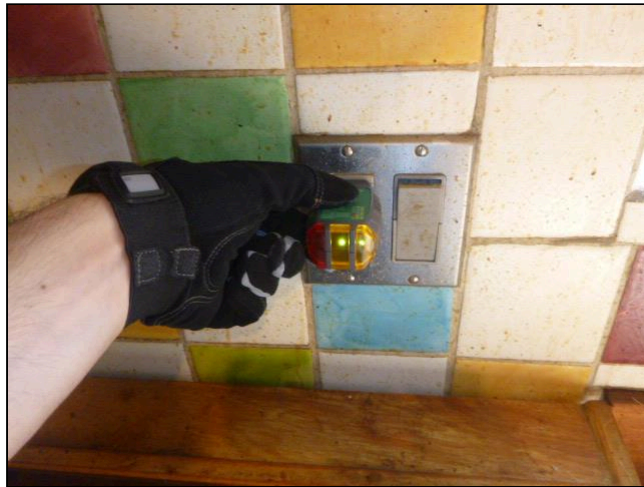
17.7 Item 1 (Picture)

17.7 Various countertop outlets are not GFCI protected as required. Countertop GFCI outlet(s)/protection has been required within six feet of the sink since 1987 and all countertop outlets since 1996. Suggest review by a licensed electrician for installation costs as required for safety.

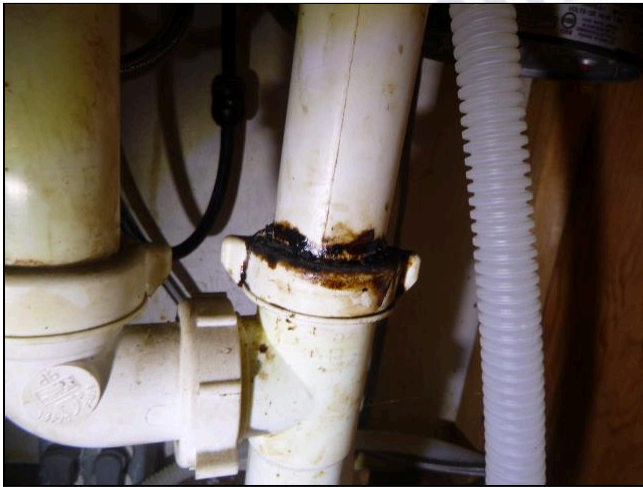
17.10 Item 1 (Picture)

17.10 Corrosion noted at the sink drain and angle valve(s), no leaking noted at the time of the inspection. Suggest review by a licensed plumber and repair/replace as needed.

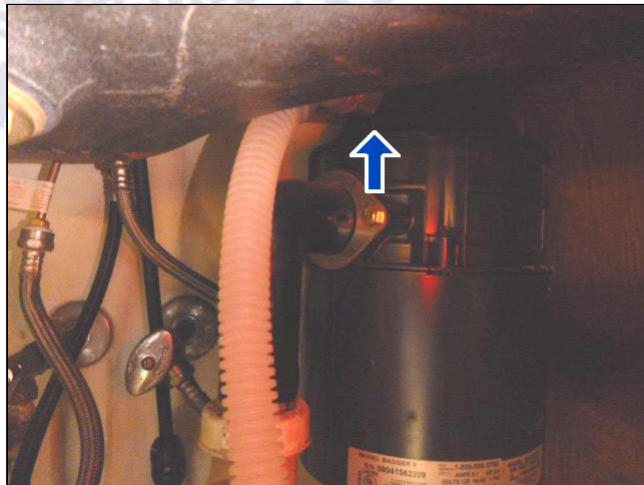
17.11 Item 1 (Picture)

17.11 (1) There is no air gap installed for the dishwasher as required, the system currently drains directly into the disposal. Suggest review by a licensed plumber for costs to install the air gap and drain as required.

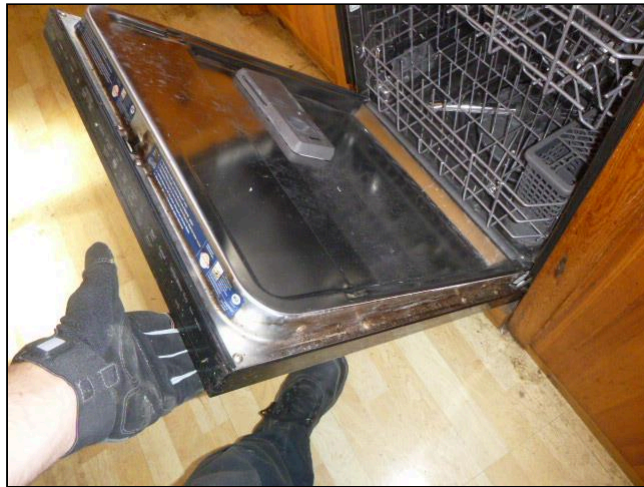
17.11 Item 2 (Picture)

17.11 (2) The dishwasher door spring is broken/disconnected, suggest repair or replace as needed.

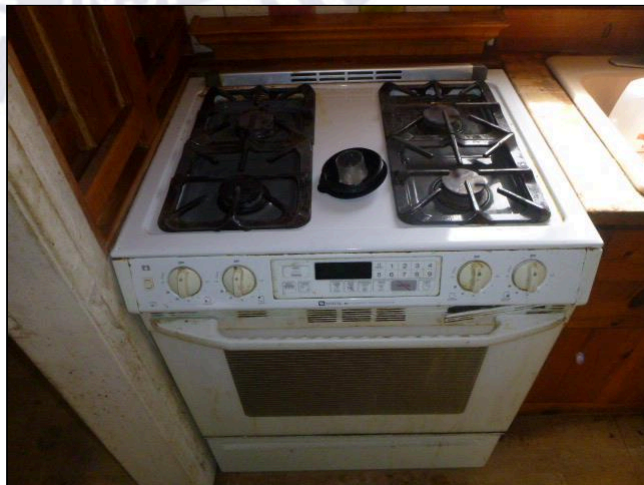
17.13 Item 1 (Picture)

17.13 (1) The oven is in disrepair and has a faulty ignition system, suggest replacement as needed.

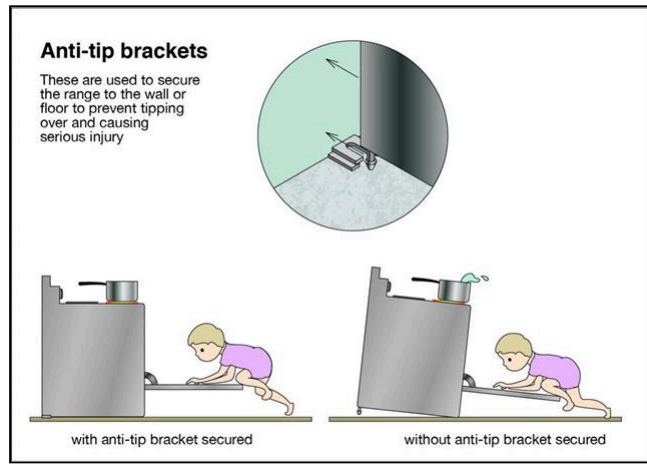
17.13 Item 2 (Picture)

17.13 (2) The anti-tip bracket is not currently installed. An anti-tip bracket is usually installed on the floor and against the wall (towards the back of the stove) for one of the rear legs to slide into. Its purpose is to prevent the stove from tipping when a heavy load is placed on the door (possible child) or slide-out racks upsetting the center of gravity. Suggest installation for safety as required since 1991.
