Inspection Report

Property Address:
1619 Armour Ln
Redondo Beach CA 90278

Ferguson Home Inspections

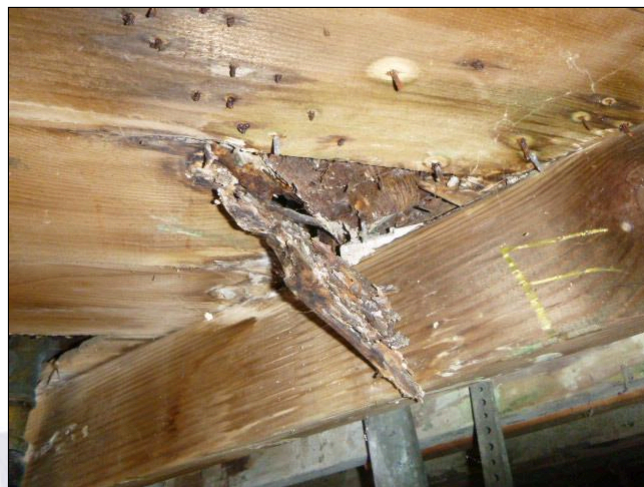
18.0 Item 2 (Picture)

18.0 Wet areas noted under the sink (likely due to the leaking drain), has caused sub floor damage. See the foundation comments and make repairs as needed.

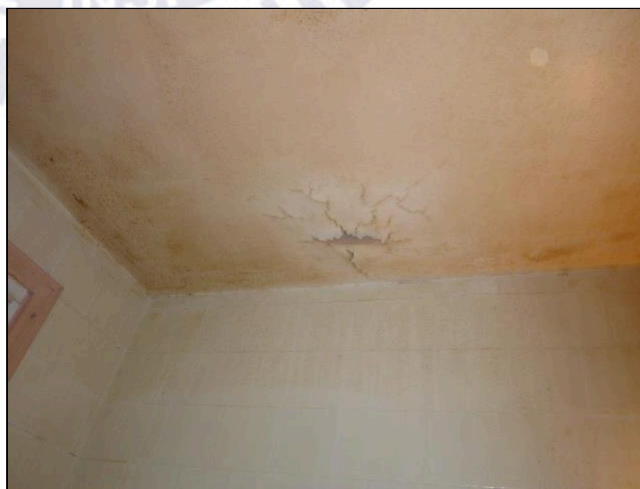
18.2 Item 1 (Picture)

18.2 (1) Blistering and excessive deterioration noted at the ceiling due to inadequate ventilation. See the exhaust fan comment and repair/install as needed.

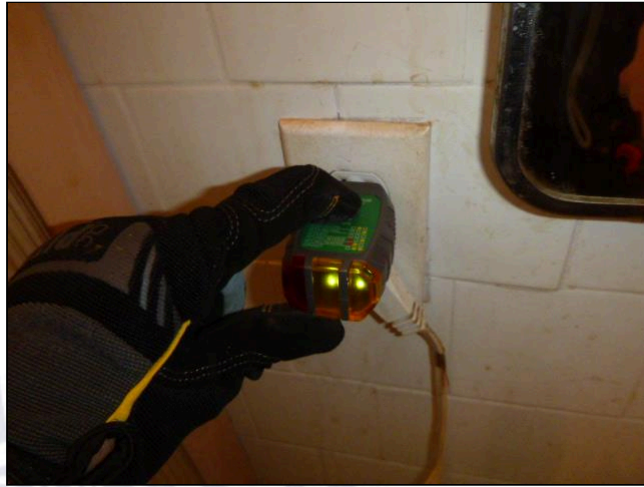
18.6 Item 1 (Picture)

18.6 No GFCI outlet or protection installed in this bathroom. GFCI protection has been required in bathrooms since 1975, suggest review by a licensed electrician for installation as required for safety.

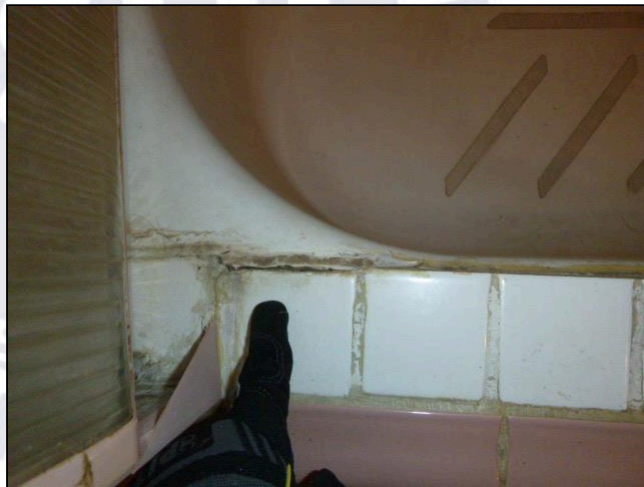
18.8 Item 1 (Picture)

18.8 Suggest caulking or re-grout as needed. The edges of the tub walls should be caulked to prevent moisture penetration. Failure to keep walls sealed can cause deterioration and extensive moisture damage to the interior walls, which is not always visible.

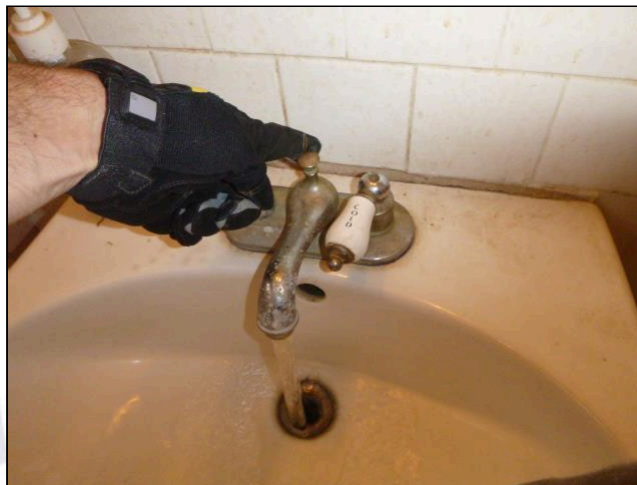
18.12 Item 1 (Picture)

18.12 The sink stopper is faulty/inoperable, suggest repair/replace as needed.

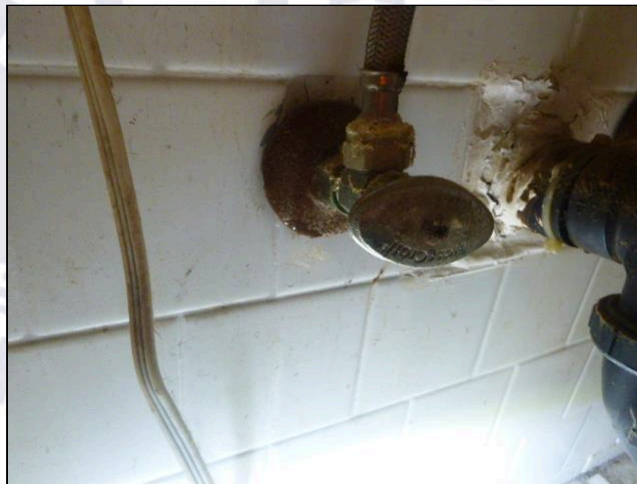
18.14 Item 1 (Picture)

18.14 (1) Corrosion noted at the sink angle valve(s), no leaking noted at the time of the inspection. Suggest review with a licensed plumber and repair/replace as needed.

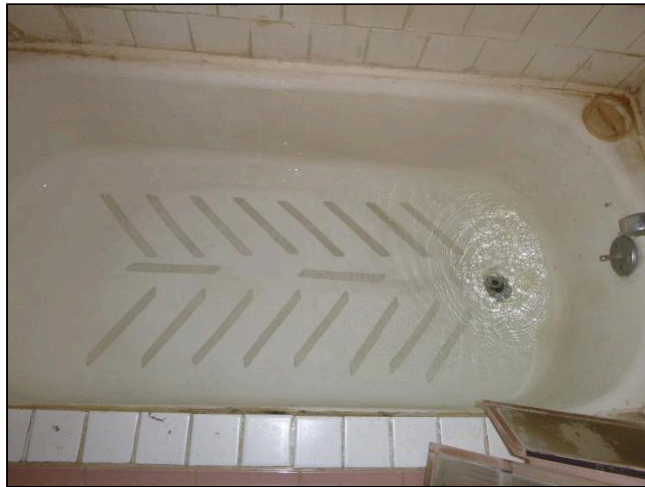
18.14 Item 2 (Picture)

18.14 (2) The tub drains slowly, suggest review with a licensed plumber for costs to clear the trap or drain as needed and confirm correct drainage as needed.

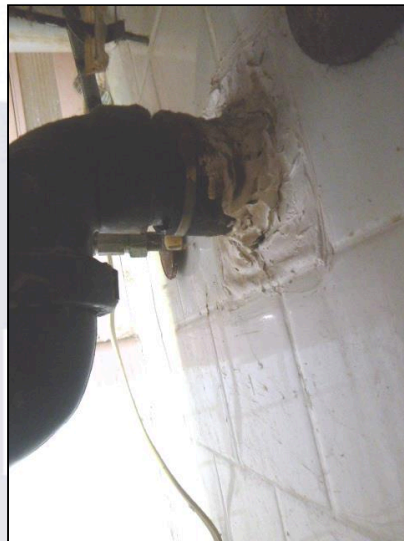
18.14 Item 3 (Picture)

18.14 (3) The sink drain appears to be rusted/deteriorated and leaking, suggest review with a licensed plumber for replacement costs as needed.

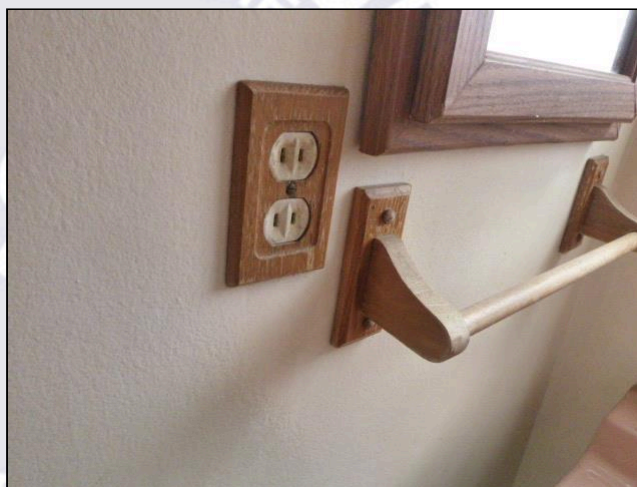
19.6 Item 1 (Picture)

19.6 (1) No GFCI outlet or protection installed in this bathroom. GFCI protection has been required in bathrooms since 1975, suggest review by a licensed electrician for installation as required for safety.

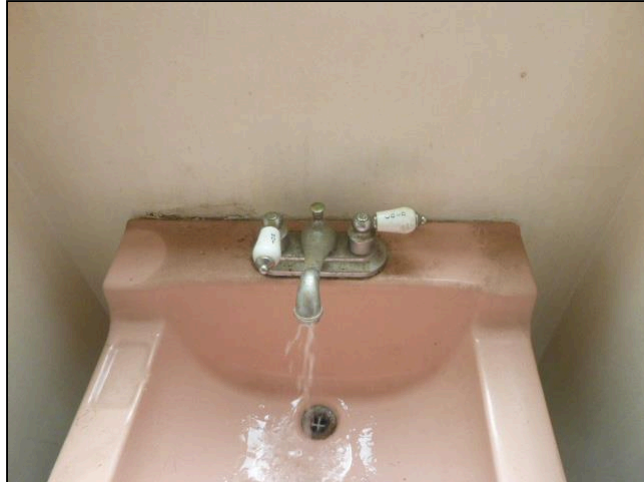
19.8 Item 1 (Picture)

19.8 Poor water flow noted at the faucet, suggest review with a licensed plumber for repair/replacement costs as needed.

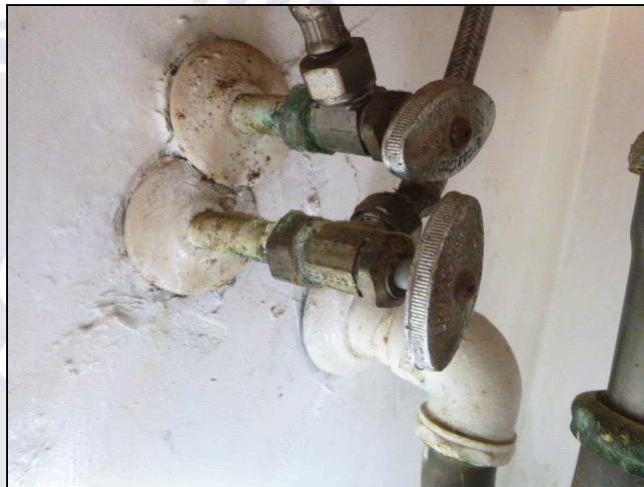
19.9 Item 1 (Picture)

19.9 Corrosion noted at the sink angle valve(s), no leaking noted at the time of the inspection. Suggest review with a licensed plumber and repair/replace as needed.

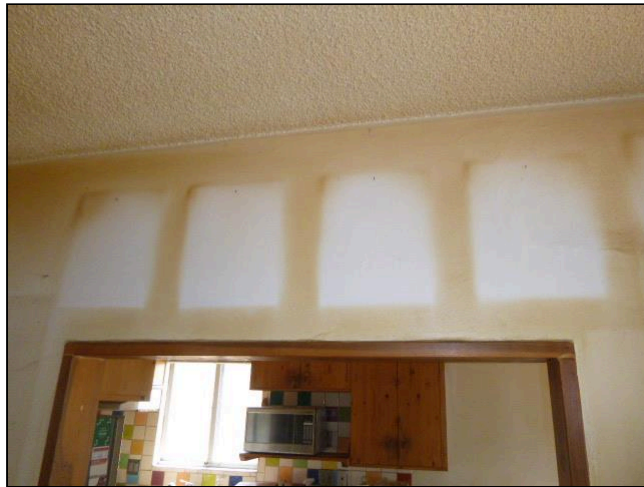
20.1 Item 2 (Picture)

20.1 (2) Excessive stains and smoke odor was noted due to potentially/likely excessive interior smoking, suggest review with the seller and a licensed contractor on this item as needed.

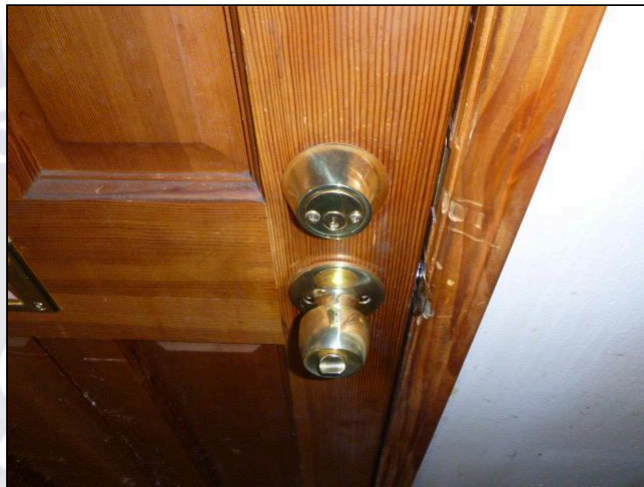
20.3 Item 1 (Picture)

20.3 (1) A keyed interior lock is installed at the exterior door, suggest installing a thumb turn dead-bolt to enhance safety as an upgrade.

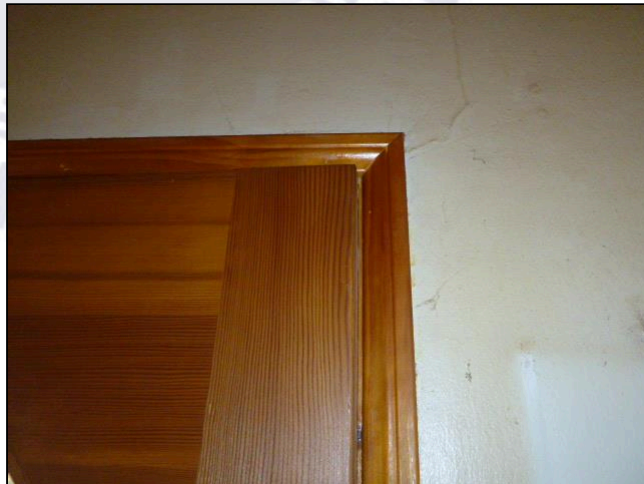
20.3 Item 2 (Picture)

20.3 (2) The door sticks/impacts on the jamb when operating due to settling, suggest repair as needed.

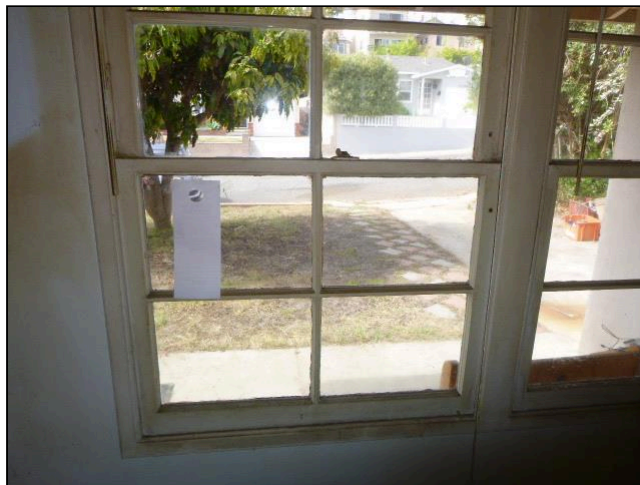
20.4 Item 1 (Picture)

20.4 (1) The window(s) are stuck/painted shut at the time of the inspection, maintenance or repair as needed is suggested to allow for emergency exit and ventilation.

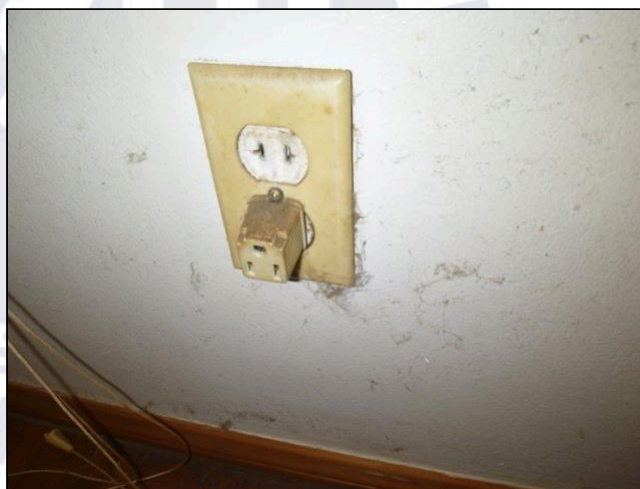
20.6 Item 1 (Picture)

20.6 (1) Ungrounded three prong outlets noted at this area. Suggest review with a licensed electrician for costs to ground the outlets as needed as an upgrade and/or protect the outlet(s) on a GFCI circuit where recommended.

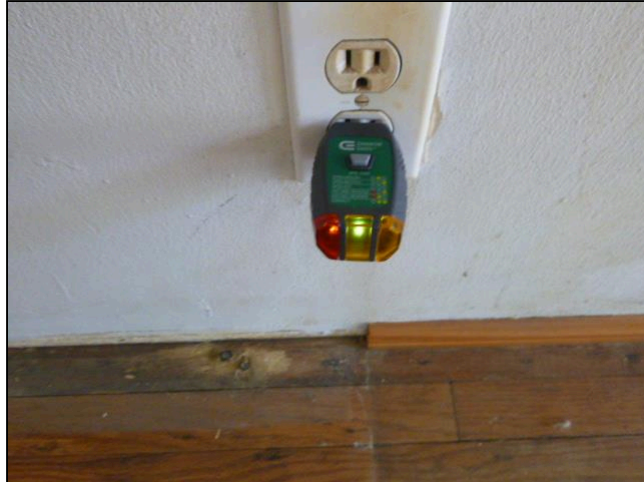
20.6 Item 2 (Picture)

20.6 (2) Two wire and two prong electrical receptacles noted. At the time of the original construction this type of system was the acceptable standard and appears to be intact. If three prong and GFCI receptacles are desired a ground source is required. Suggest review with a licensed electrician for costs to ground the outlets as needed as an upgrade and/or protected the outlet(s) on a GFCI circuit where recommended.

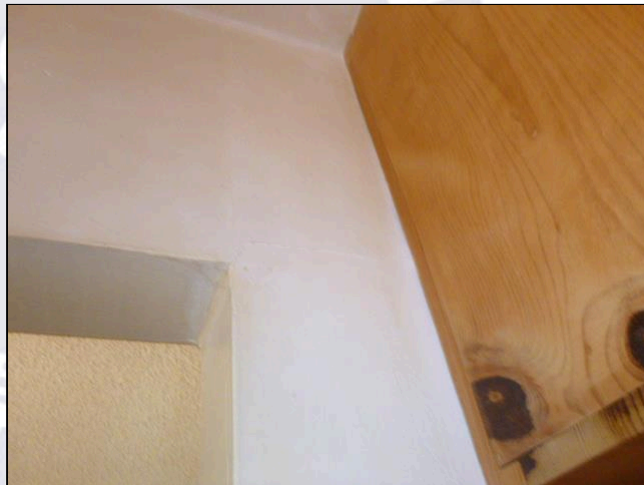
21.1 Item 1 (Picture)

21.1 (1) Settling cracks and patching was noted, suggest repair as needed.

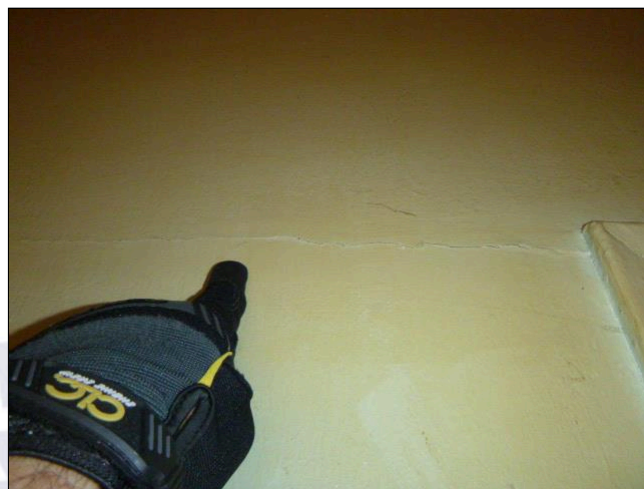
23.1 Item 2 (Picture)

23.1 (1) Excessive settling cracks noted, see the foundation and Lot/Drainage comments. Suggest review with a licensed contractor for repair/replacement costs as needed.

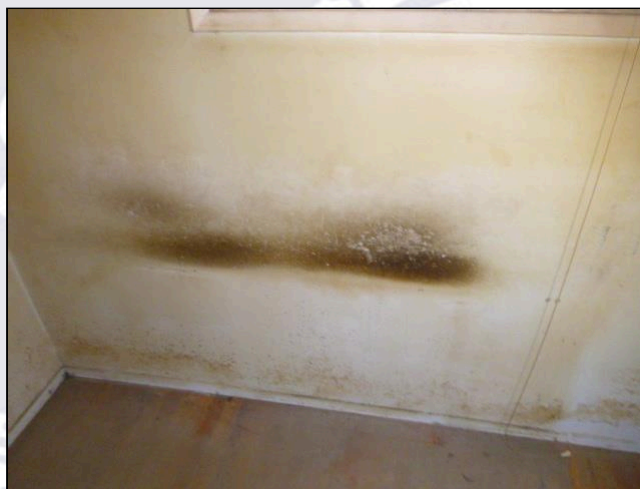
23.1 Item 3 (Picture)

23.1 (2) Excessive stains and smoke odor was noted due to potentially/likely excessive interior smoking, suggest review with the seller and a licensed contractor on this item as needed.

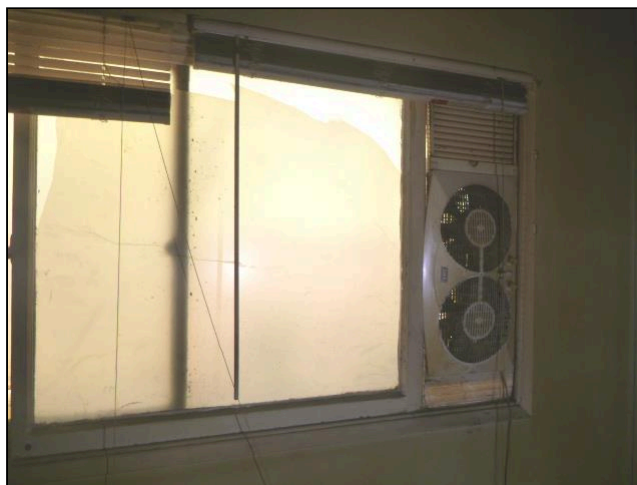
23.4 Item 1 (Picture)

23.4 (1) Unable to test the window due to the fan unit, suggest removal and make repairs as needed.

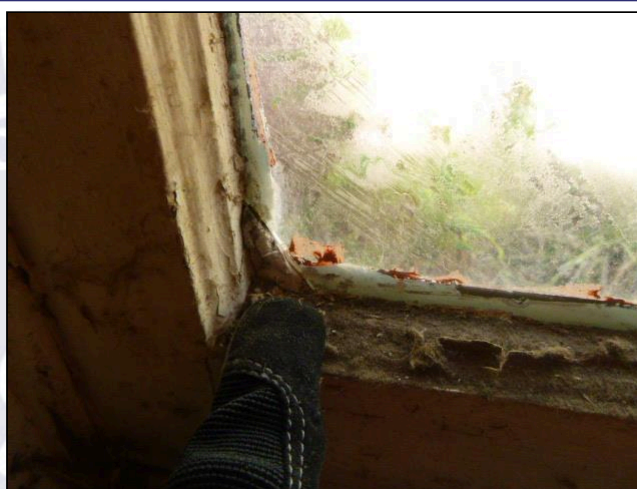
23.4 Item 2 (Picture)

23.4 (2) Cracked/broken glass noted at the window(s), this is a potential safety hazard. Suggest review with a licensed contractor/glazing company for replacement costs as required for safety.

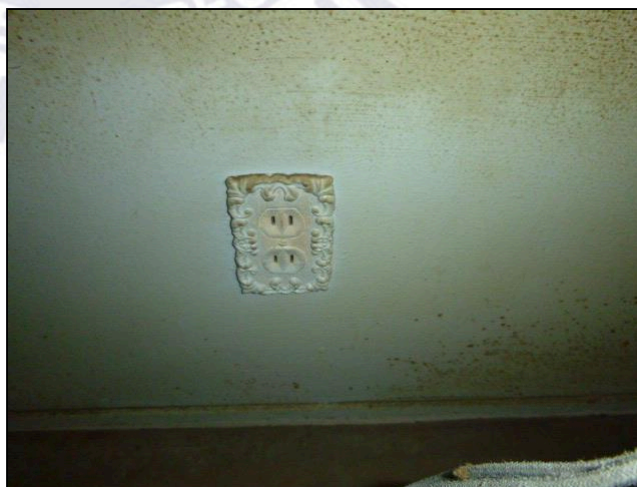
23.6 Item 1 (Picture)

23.6 (1) Two wire and two prong electrical receptacles noted. At the time of the original construction this type of system was the acceptable standard and appears to be intact. If three prong and GFCI receptacles are desired a ground source is required. Suggest review with a licensed electrician for costs to ground the outlets as needed as an upgrade and/or protected the outlet(s) on a GFCI circuit where recommended.

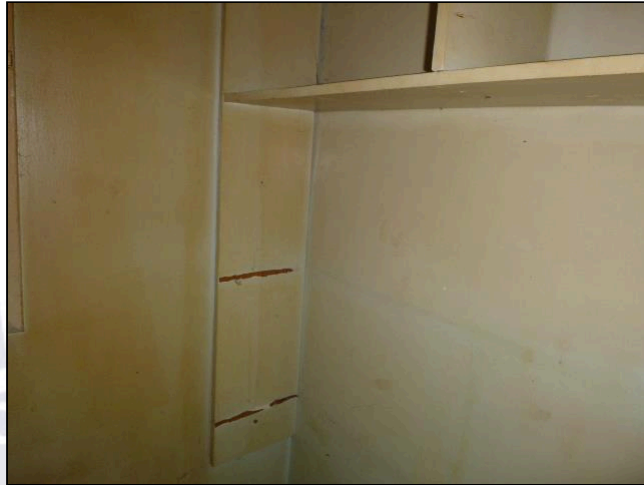
23.7 Item 1 (Picture)

23.7 Damaged/missing areas noted at the wall cabinetry, suggest repair/replace as needed.

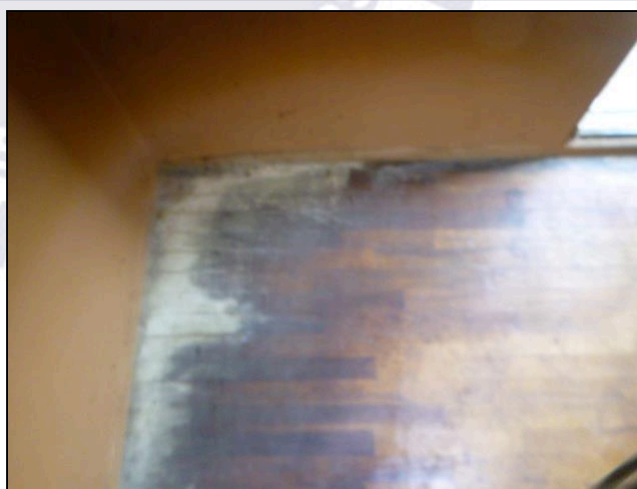
24.0 Item 1 (Picture)

24.0 (1) Floor slope and uneven flooring noted.

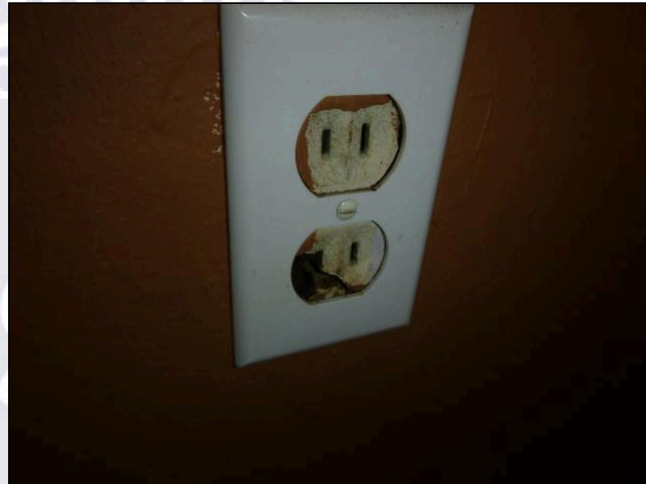
24.5 Item 1 (Picture)

24.5 (1) Two wire and two prong electrical receptacles noted. At the time of the original construction this type of system was the acceptable standard and appears to be intact. If three prong and GFCI receptacles are desired a ground source is required. Suggest review with a licensed electrician for costs to ground the outlets as needed as an upgrade and/or protected the outlet(s) on a GFCI circuit where recommended.

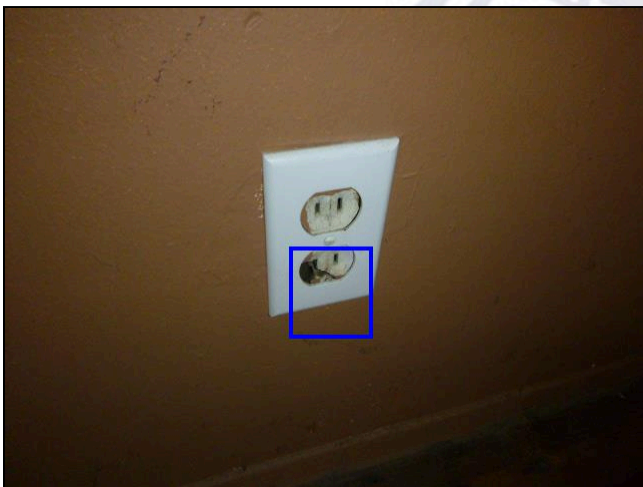
24.5 Item 2 (Picture)

24.5 (2) The outlets are deteriorated and loose. Suggest repair or replace as needed for safety.

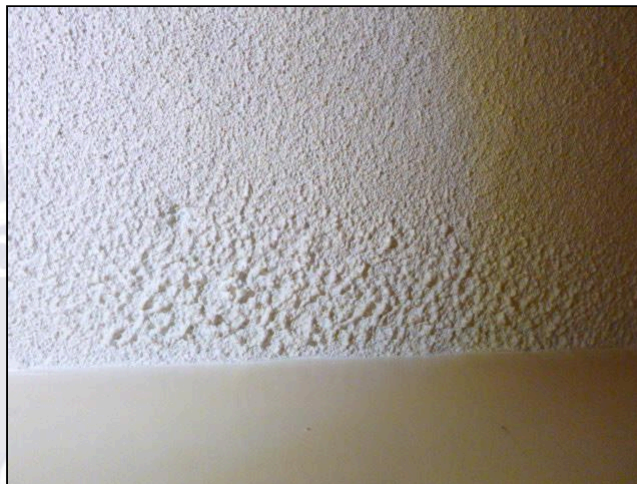
25.2 Item 1 (Picture)

25.2 Patched and uneven areas of the ceiling noted, suggest review with the seller on the cause and any repairs needed. Suggest repair as needed.

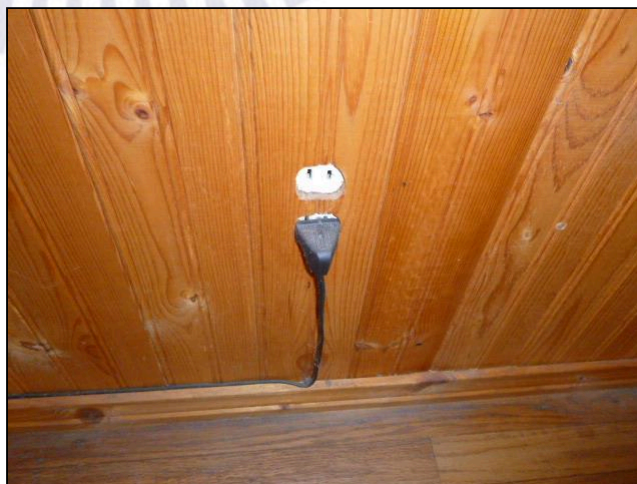
25.5 Item 1 (Picture)

25.5 (1) Two wire and two prong electrical receptacles noted. At the time of the original construction this type of system was the acceptable standard and appears to be intact. If three prong and GFCI receptacles are desired a ground source is required. Suggest review with a licensed electrician for costs to ground the outlets as needed as an upgrade and/or protected the outlet(s) on a GFCI circuit where recommended.

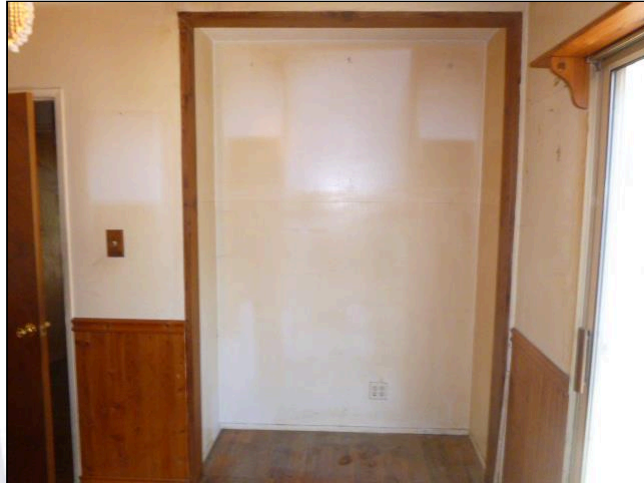
25.6 Item 1 (Picture)

25.6 (1) The closet doors were missing from this area at the time of the inspection, suggest replacing as needed.

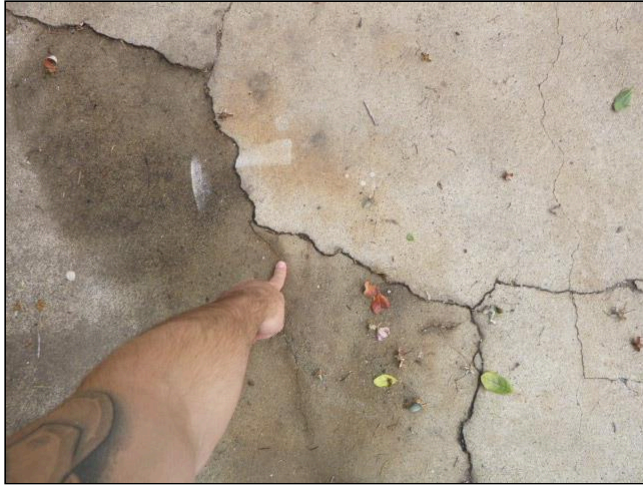
1.0 Item 1 (Picture)

Settling and heaving noted at various areas, this is a potential trip hazard. Suggest review with a licensed contractor for repair/replacement costs as needed.

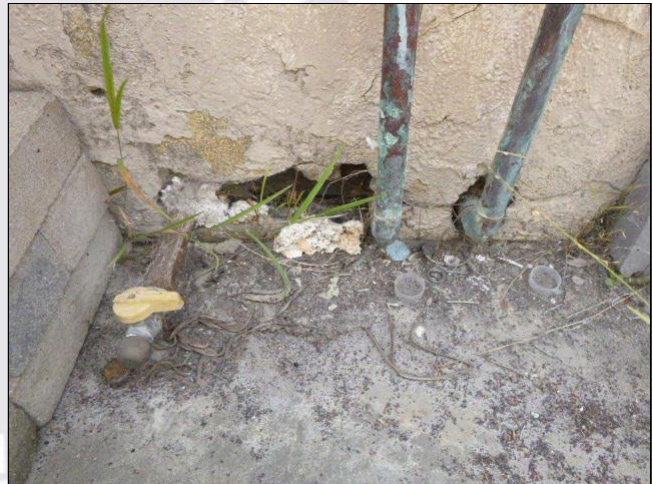
1.1 Item 2 (Picture)

(2) Suggest lowering the exterior walkway/grade and/or installation of exterior sub-surface drains at the rear and left side as needed to prevent the excessive/ongoing water intrusion into the crawlspace. Re-grading where needed is recommended to assure all water drains away from the home's foundation.

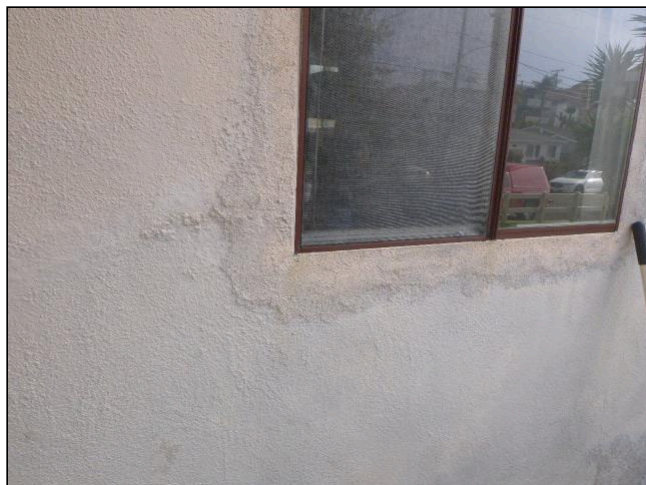
1.4 Item 1 (Picture)

(1) Various areas of the siding have been patched, suggest review with the seller on the cause and any repairs needed.

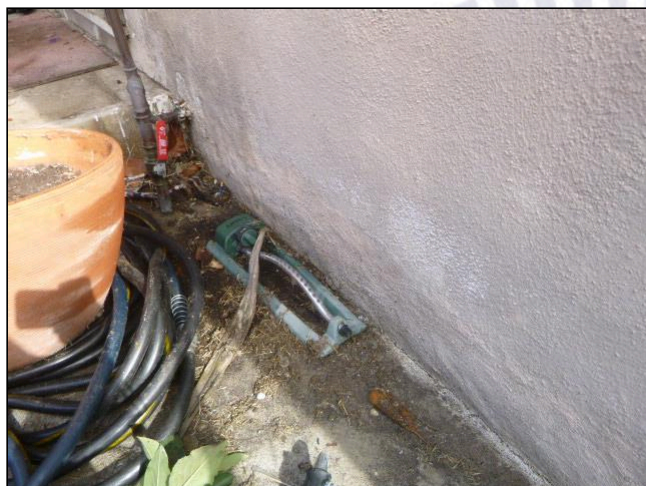
1.4 Item 3 (Picture)

(2) Deteriorated and blistering stucco noted at various areas. See the Lot/Drainage comments and review with a licensed contractor to repair as needed and divert water away from the foundation areas.

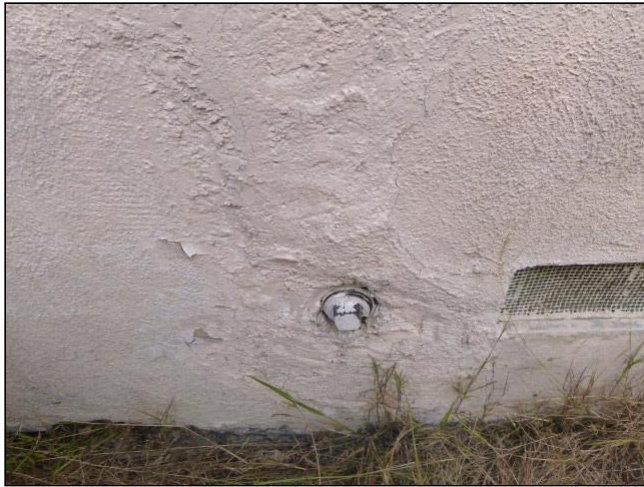
1.4 Item 6 (Picture)

(4) Excessive stucco deterioration/blistering and possible wood framing deterioration (not visible due to the exterior stucco finish) noted at the exterior of the kitchen, likely due from the leaking drain line(s). Suggest review with a licensed contractor for removal/repair/replacement costs as needed.

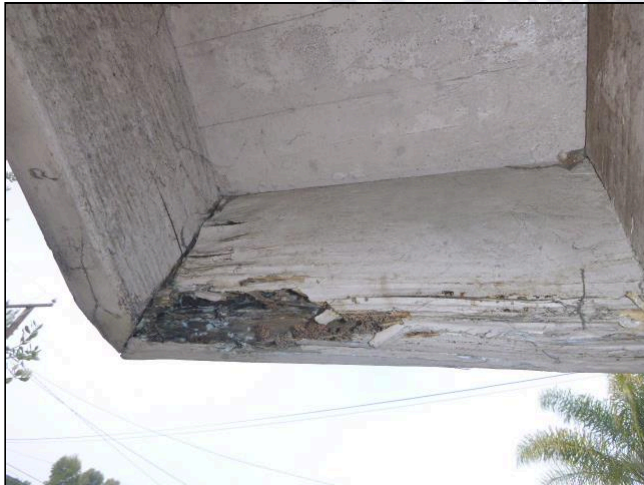
1.5 Item 1 (Picture)

(1) Paint blistering, peeling and wood deterioration noted at various trim areas. Suggest review with a termite company and/or a licensed contractor and repair/replace as needed.

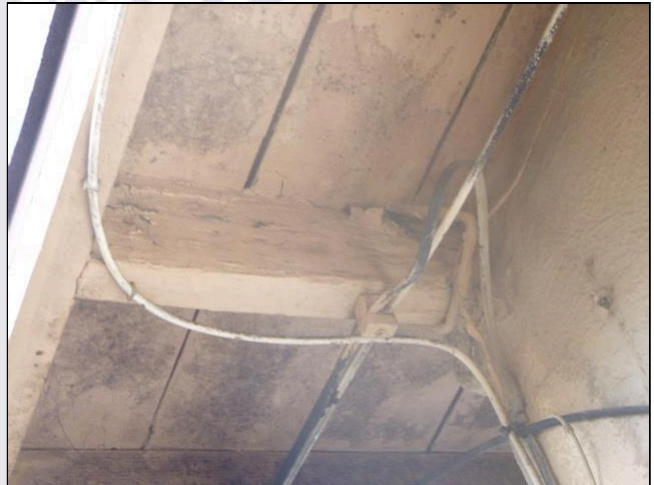
1.5 Item 2 (Picture)

(2) Excessive black staining noted at the roof line/eaves, suggest review with a licensed contractor for repairs as needed.

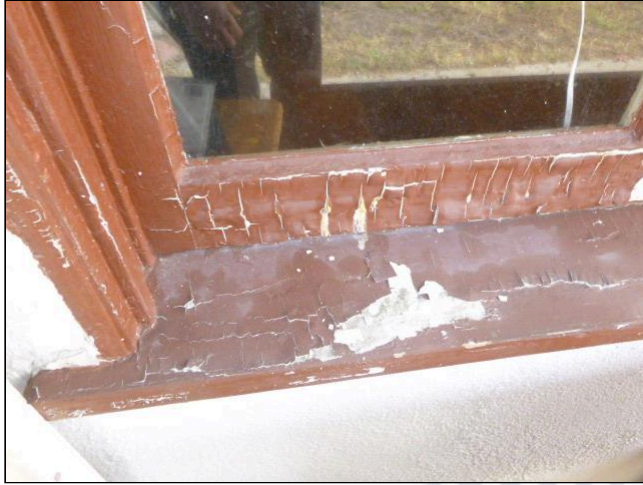
1.6 Item 1 (Picture)

(1) The wood window frames are peeling paint at most wood windows, further deterioration may occur if not repaired. Suggest review by a licensed contractor and repair/replace as needed.

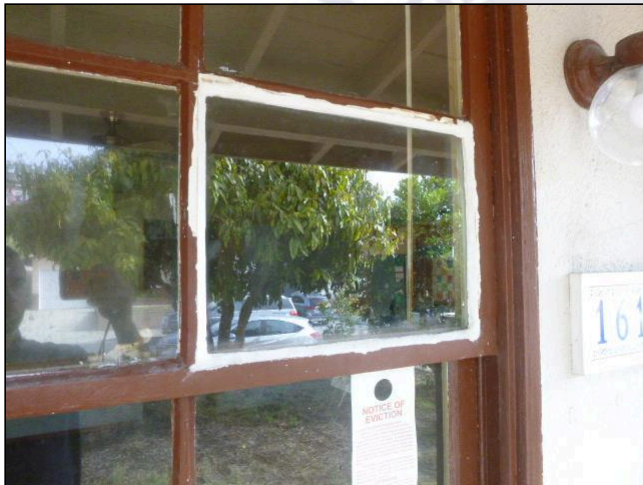
1.6 Item 2 (Picture)

(2) The glazing/wood frame is deteriorated at the wood windows, this is a potential safety hazard. Suggest review by a licensed contractor and repair/replace as needed.

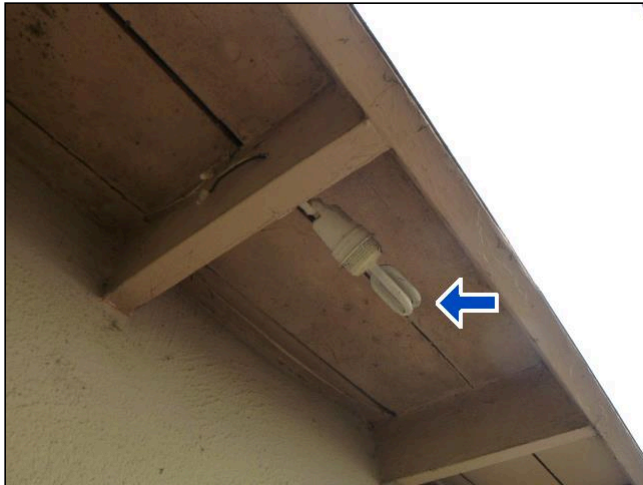
1.8 Item 1 (Picture)

(1) The cover globe was missing at the light fixture at the time of the inspection. Suggest replacing the missing cover globes for safety.

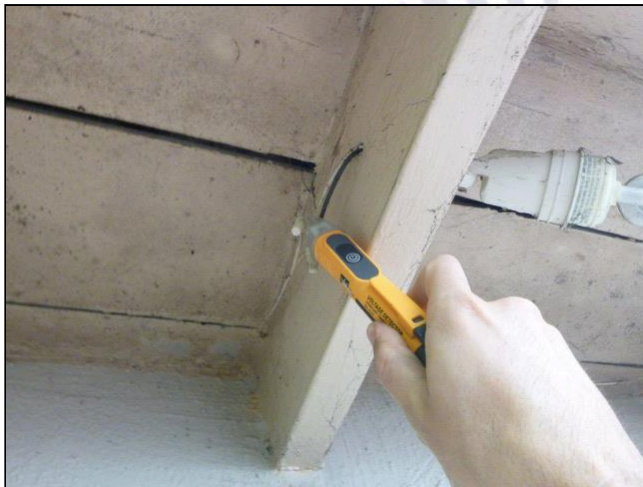
1.8 Item 2 (Picture)

(2) Open splices were noted, this is a safety concern. Whenever an electrical wire is cut and re-connected, the 'splice' should be encased in a covered junction box to prevent shocks and separation of the splice. Suggest review by licensed electrician and repair as needed.

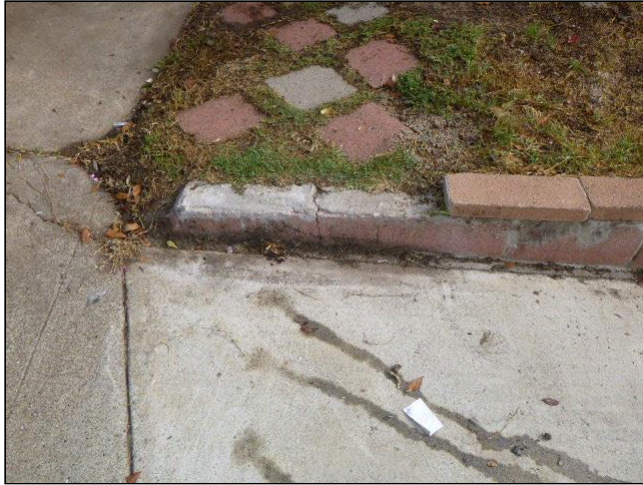
1.10 Item 1 (Picture)

(1) The front retaining wall is missing several top caps, suggest repairs as needed.

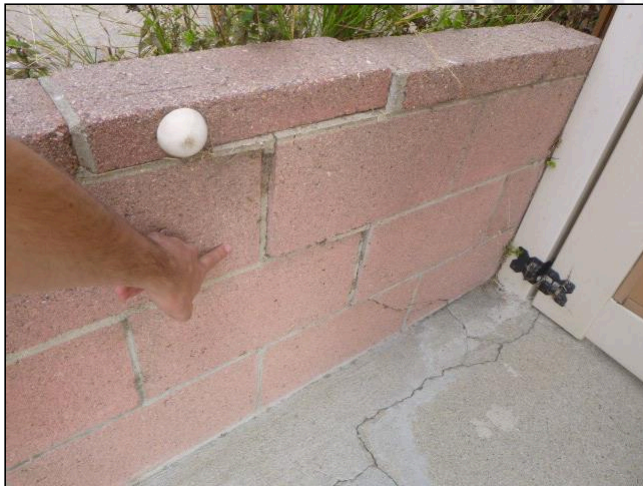
1.10 Item 2 (Picture)

(2) The retaining walls show some settlement and movement cracks, but appears stable. Suggest review with a licensed contractor for repair/replacement costs as needed.

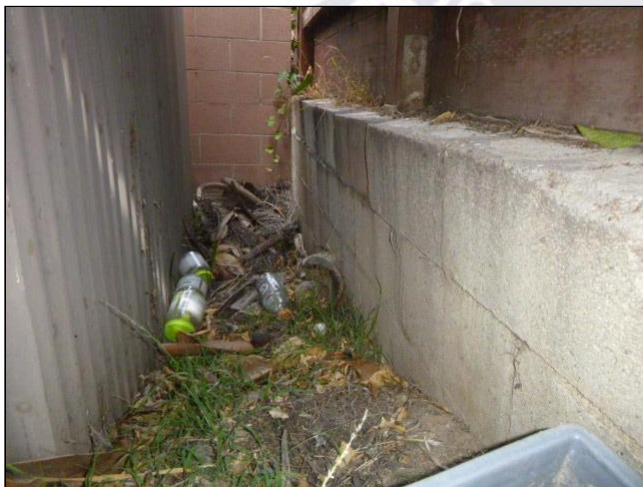
1.10 Item 3 (Picture)

(3) Minor leaning noted at the rear retaining wall, suggest review with a licensed contractor as needed.

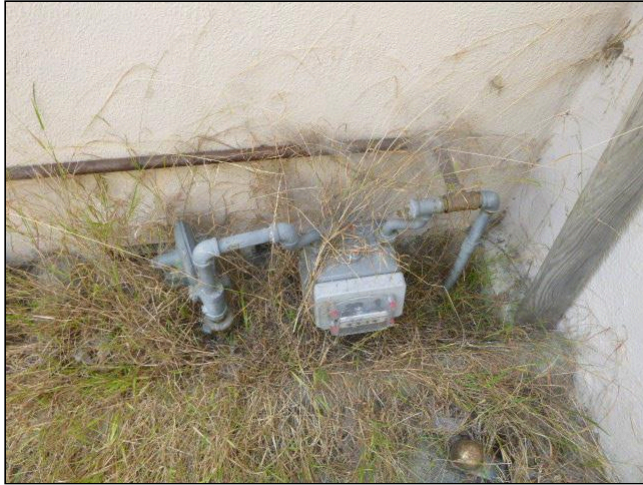
1.12 Item 1 (Picture)

Suggest removing/trimming the vegetation away from the gas meter to allow for correct accessed as required.

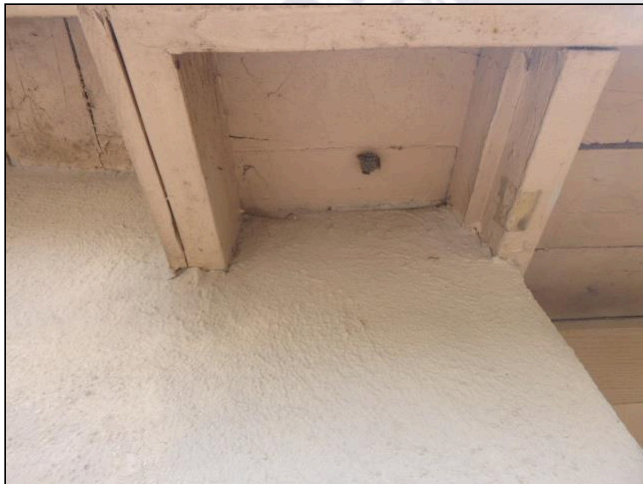
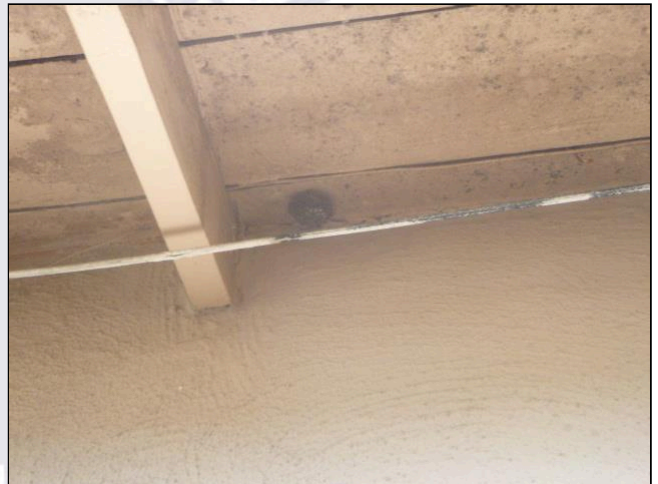
- (1) Suggest review of trees and root structures to prevent future damage to the property, drainage systems and structures.
- (2) Several wasp/bee nests were noted at various eave areas, suggest review with a pest control company for removal costs as needed.

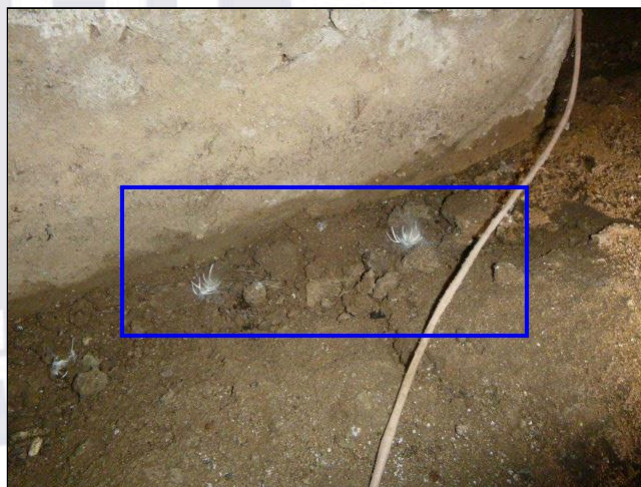
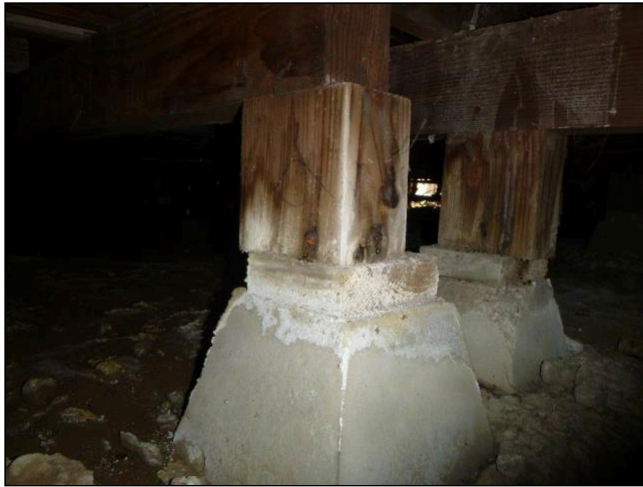
(2) Re-grading where needed is recommended to assure all water drains away from the home's foundation. The inadequate drainage has caused the excessive moisture buildup at the foundation and intrusion into the crawl area, suggest review with a licensed contractor for foundation repairs and installation of rain gutters and an area drainage system to divert all the water away from the foundation.

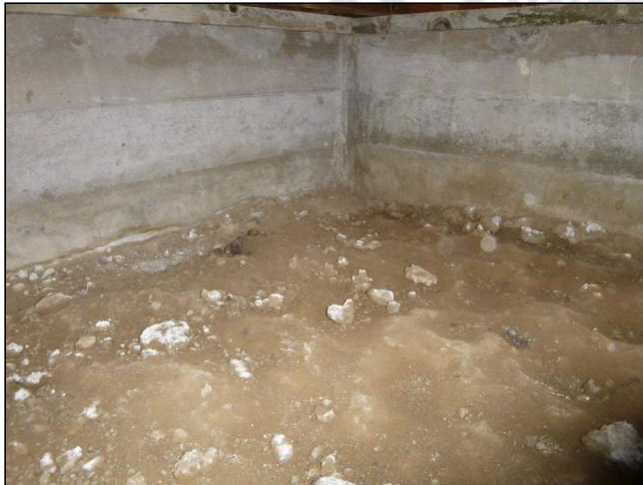
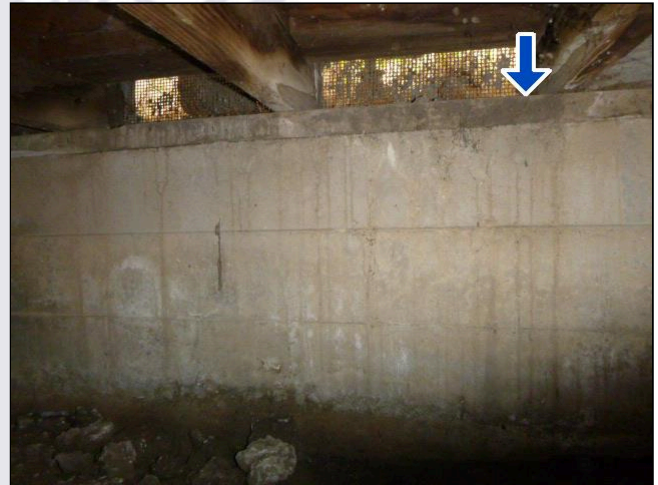
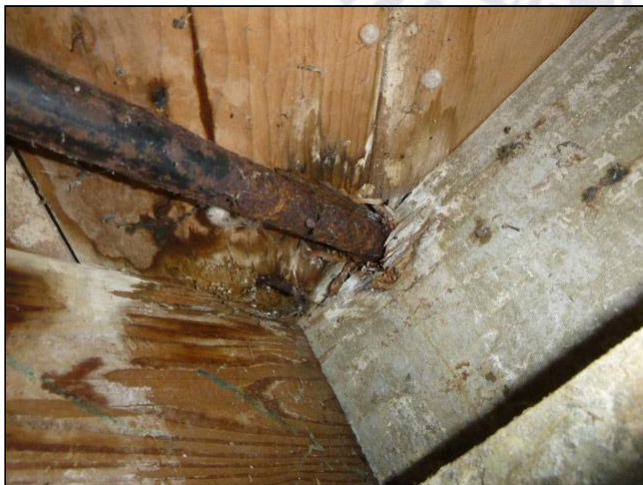
(4) Suggest lowering the exterior walkway/grade and/or installation of exterior sub-surface drains at the rear and left side as needed to prevent the excessive/ongoing water intrusion into the crawlspace. Re-grading where needed is recommended to assure all water drains away from the home's foundation.

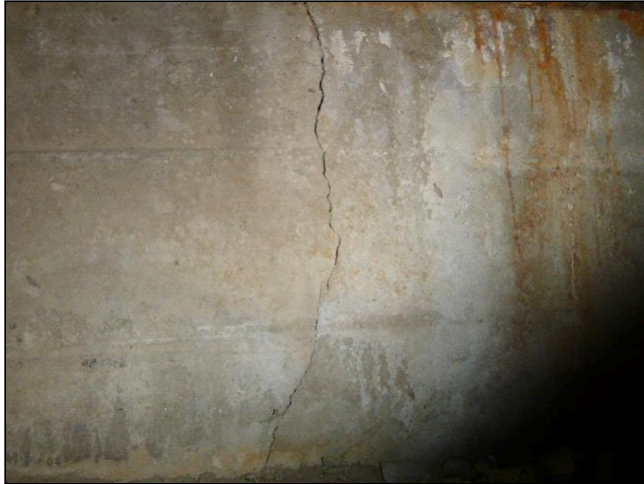
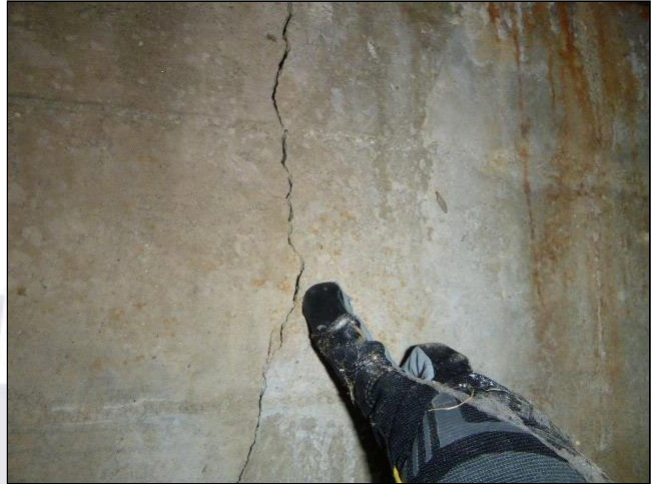
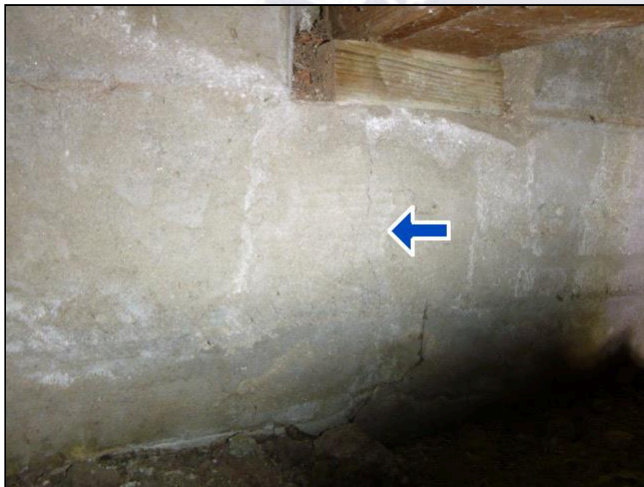
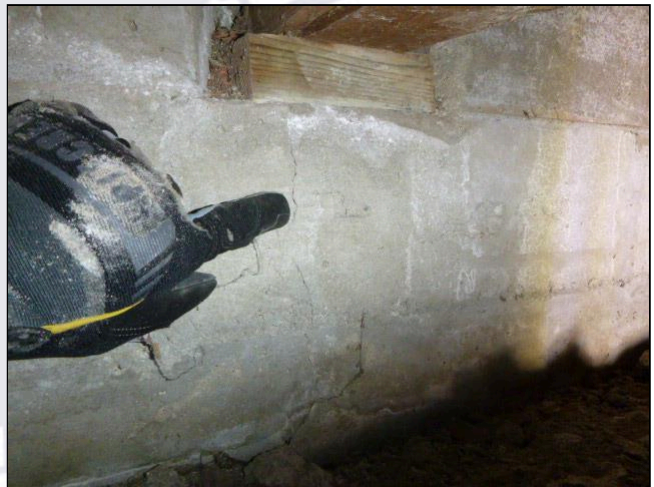
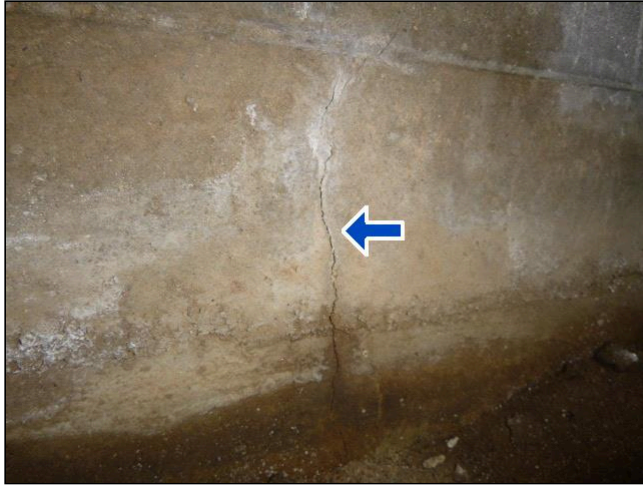
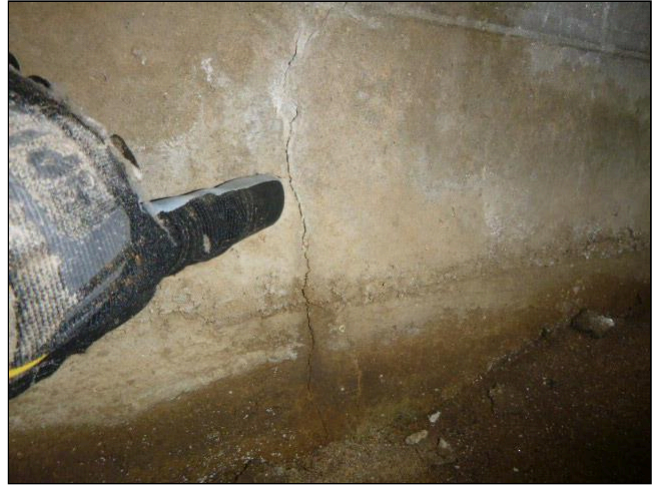
(1) Re-grading where needed is recommended to assure all water drains away from the home's foundation. The inadequate drainage has caused minor settling/cracking/movement to the foundation, suggest review with a licensed contractor for installation of perimeter concrete walkways/barriers, rain gutters and an area drainage system to divert all the water away from the foundation.

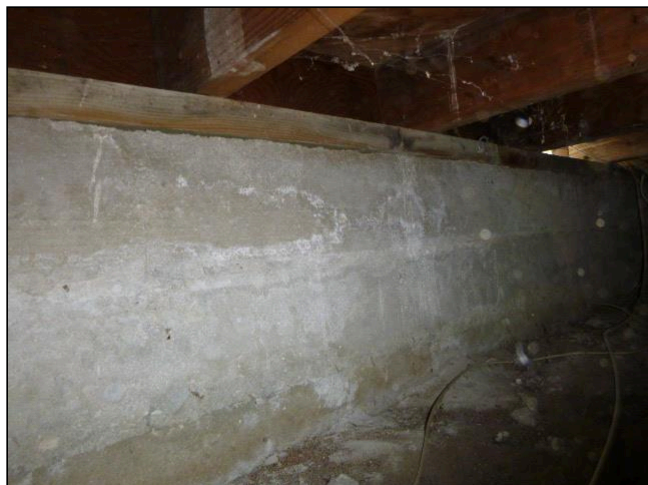
3.0 Item 9 (Picture)

(3) White efflorescence (powder substance) on foundation footings indicates prior, and possibly ongoing, excessive moisture build up at the exterior of the foundation. Ongoing water intrusion at the foundations can, in some cases, cause the steel in the foundations to rust, called spalling, which can lead to horizontal cracking of the foundation (currently there are no major cracks visible at the foundation). Any future cracking/damaged can be an expensive repair as the foundation is now structurally weak and susceptible to horizontal movement. Suggest review of the Lot/ Grade and drainage systems, including rain gutters, to reduce and prevent further and future water buildup at the exterior of the dwellings foundations.

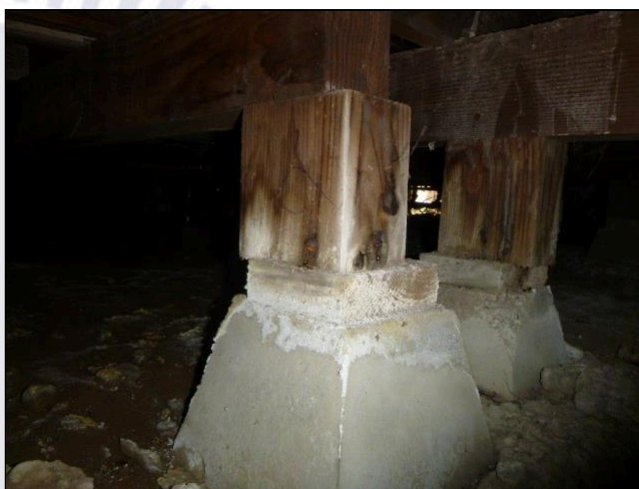
3.0 Item 11 (Picture)

(4) Excessive staining/saturation/deterioration of internal wood support members was noted due to excessive and ongoing water intrusion. Suggest review with a licensed foundation contractor for repair/replacement costs needed to prevent any future movement to the foundation and/or structure.

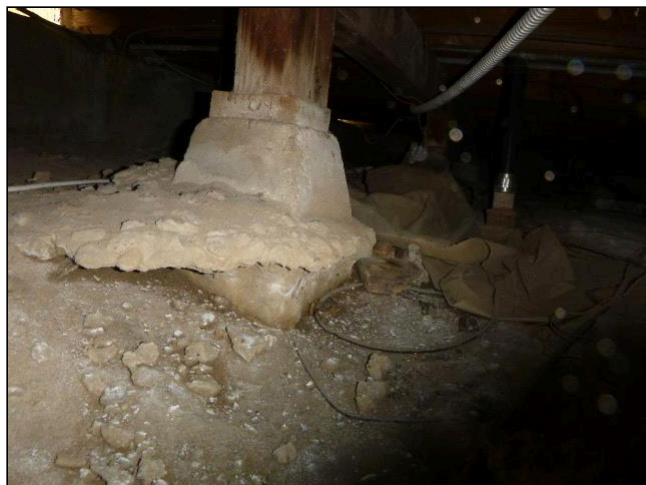
3.0 Item 12 (Picture)

(7) Undermining of the foundation/concrete piers noted at the front/right crawl areas. Suggest review by a licensed contractor for costs required to re-install the dirt or other means to prevent possible future movement of the foundation and/or structure.

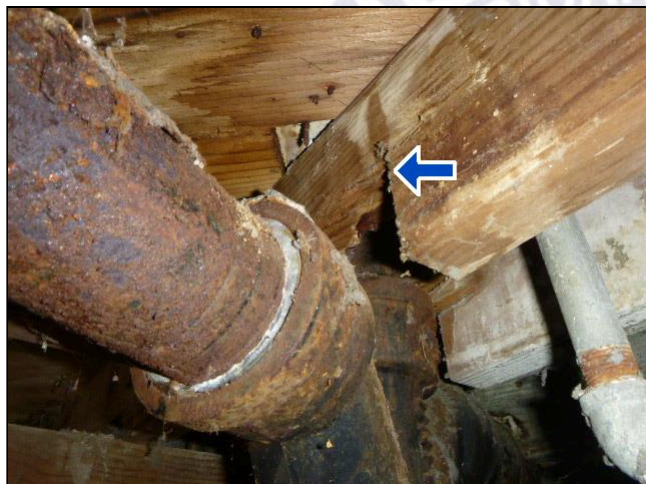
3.1 Item 1 (Picture)

(1) Excessive cutting and notching of various floor joists due to drainage installation. Suggest review by a licensed contractor for repair costs as needed.
