Inspection Report

Property Address:
1619 Armour Ln
Redondo Beach CA 90278

Ferguson Home Inspections

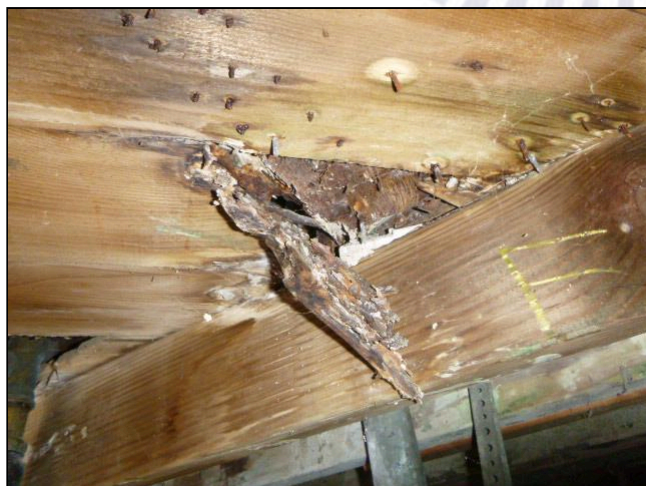
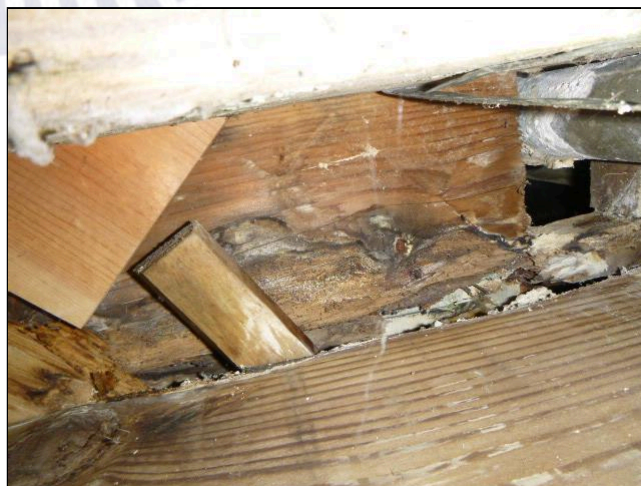
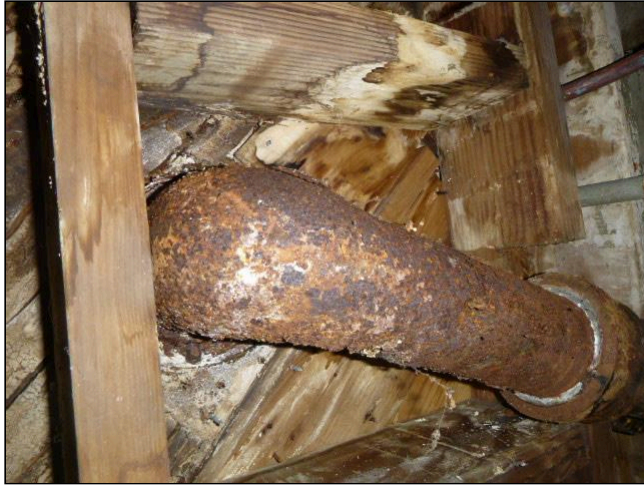
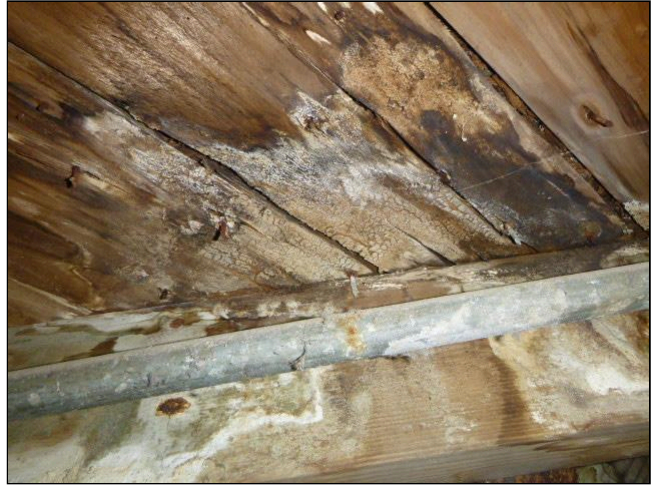
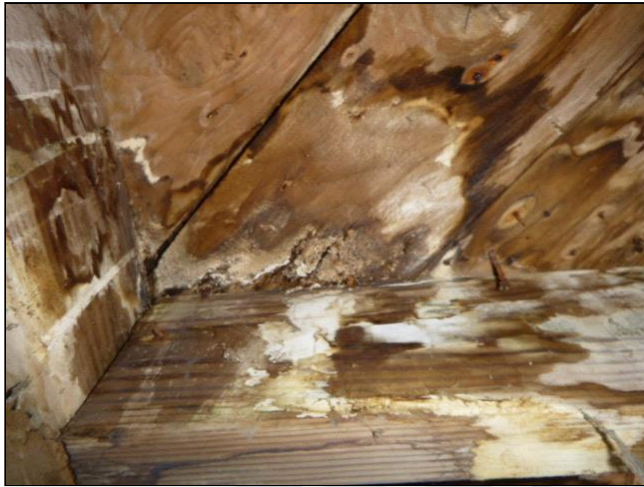
(2) Stains and deterioration noted at various flooring and supports from prior and ongoing leaks. Suggest review with a termite company and/or a licensed contractor and repair/replace as needed.

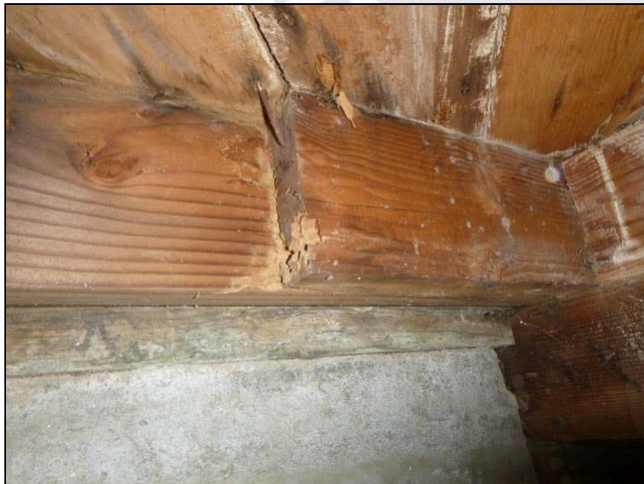
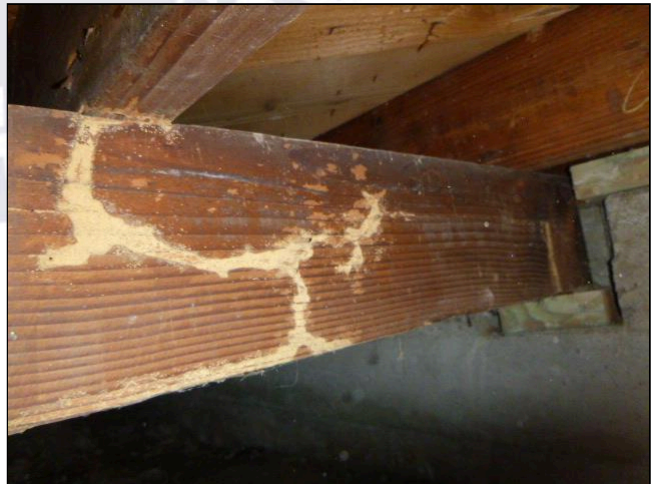
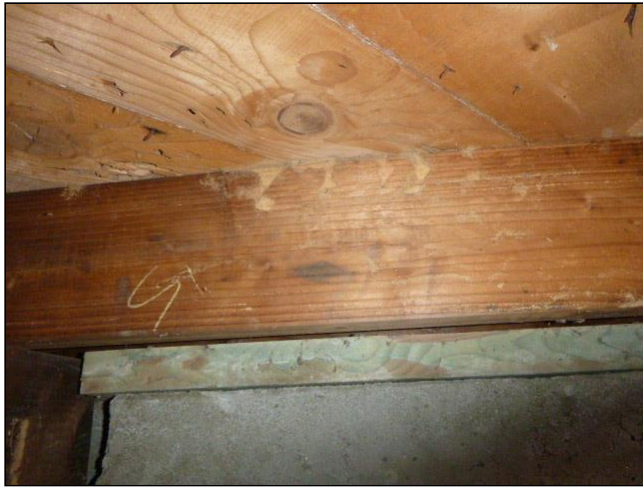
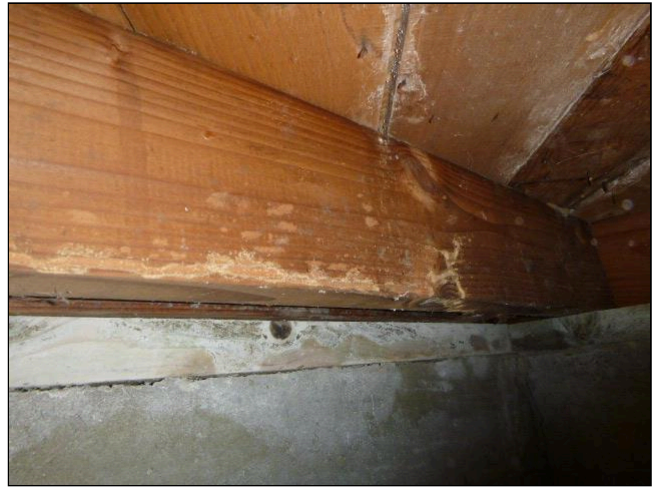
(3) Wood deterioration noted at various flooring and supports. Suggest review with a termite company and/or a licensed contractor and repair/replace as needed.

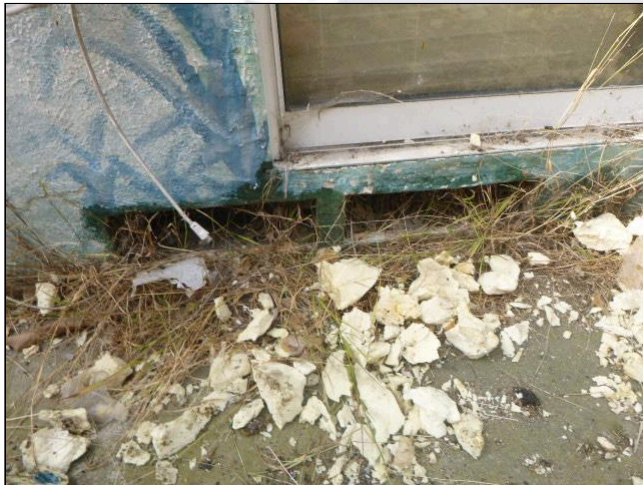
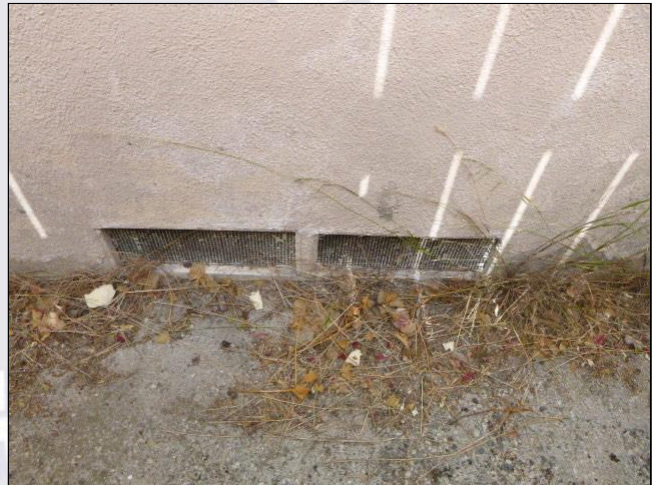
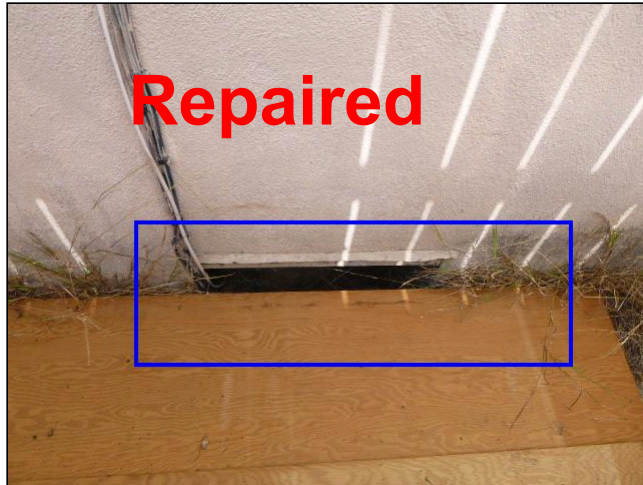
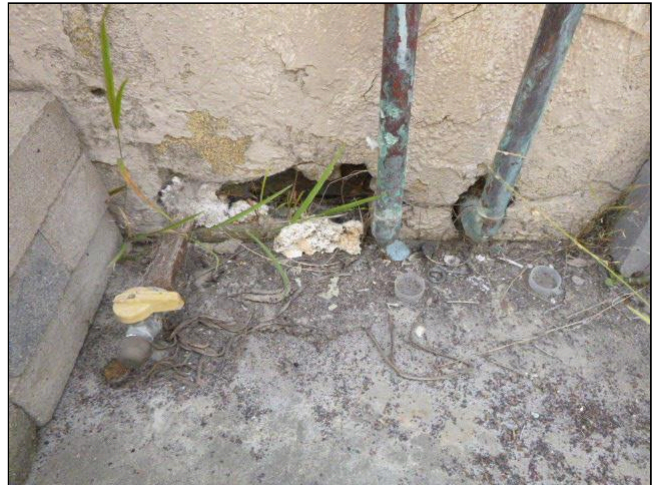
(1) The crawl space access port(s) and vent screens are below grade and evidence of water entry into the crawl space was noted. Suggest lowering the exterior grade or installing a brick or concrete berm to eliminate water entry into the crawl space. Suggest review by a licensed contractor for possible installation of an area drainage system to divert drainage away from the foundation.

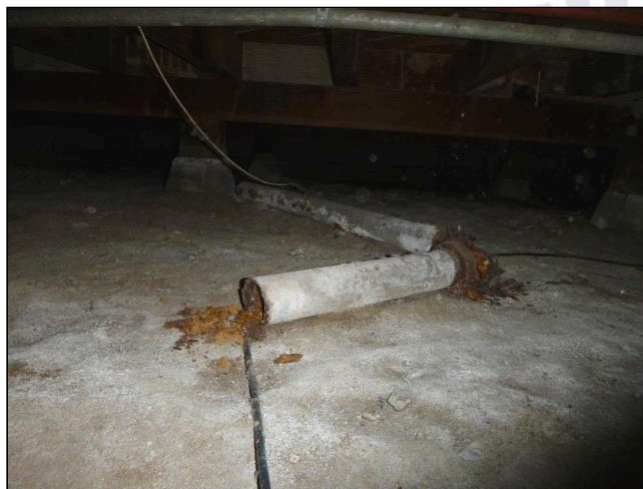
4.0 Item 5 (Picture)

(2) Suggest removal of debris and construction items from the crawl area.

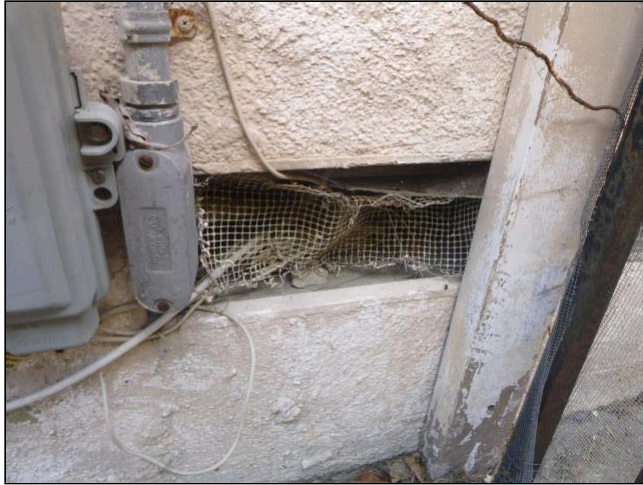
4.1 Item 1 (Picture)

Loose, missing or deteriorated vent screens noted. Suggest re-screening missing and/or deteriorated vent screens as needed to prevent rodent and insect intrusion.

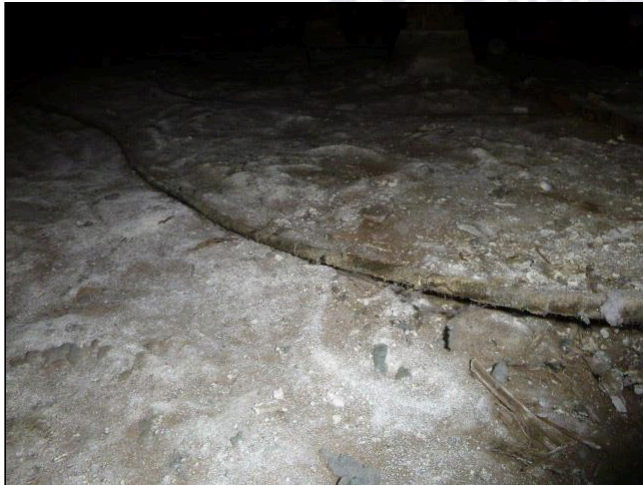
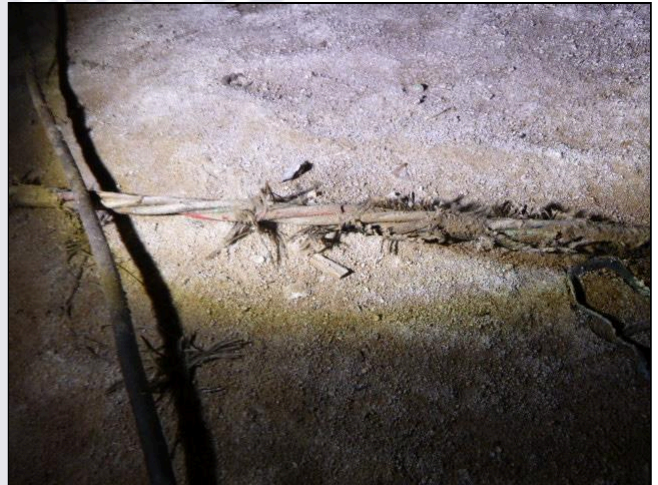
The electrical wiring is frayed/deteriorated and in contact with the wet ground within areas of the crawl areas, this is potential safety hazard. Suggest review with a licensed electrician for repair/replacement costs as needed.

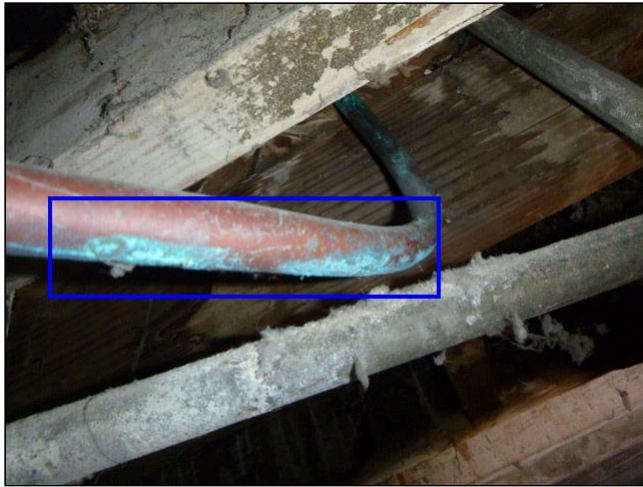
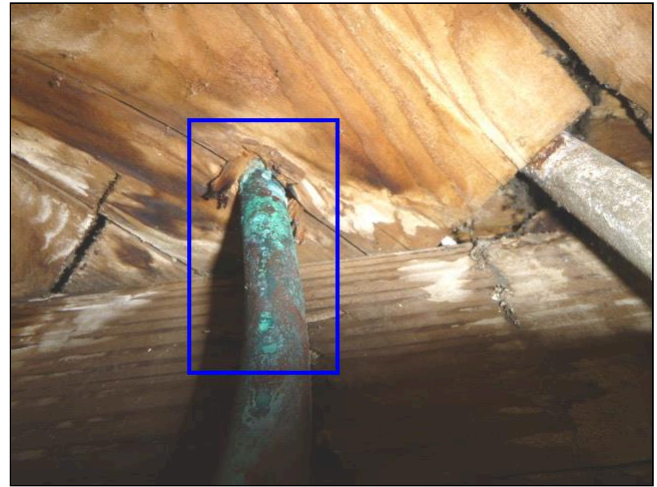
(1) Corroded areas of the copper plumbing was noted throughout the crawl area, this can be a pre-cursor to 'pin hole' leaks. Suggest review with a licensed plumber for repair/replacement costs as needed.

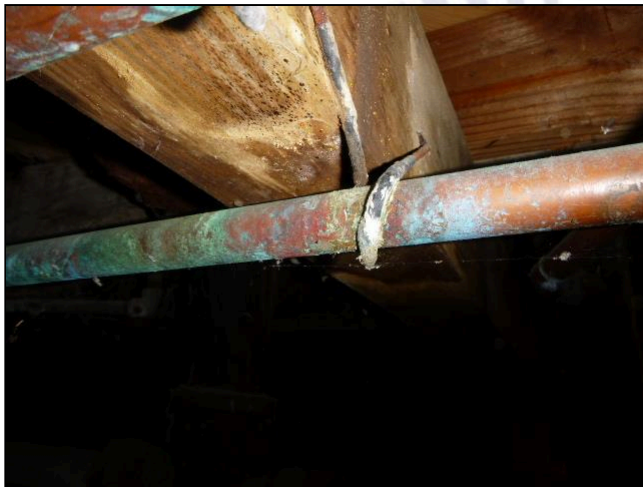
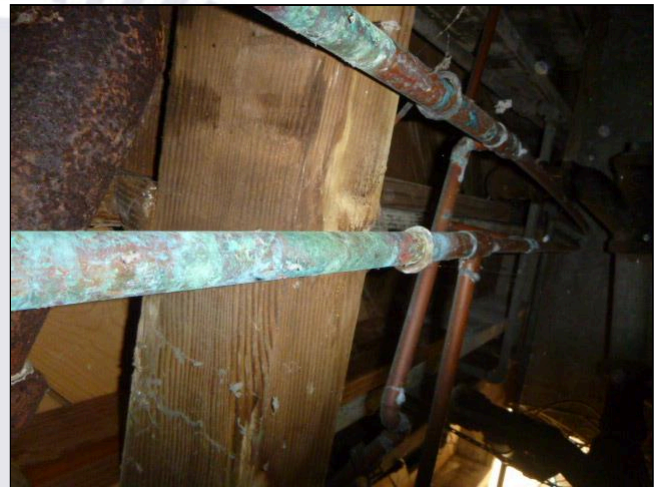
(2) The copper plumbing lines are inadequately and improperly secured with straps that are causing excessive deterioration of the copper. Suggest replacing the deteriorated areas of the copper plumbing lines as well as replacing the straps with approved materials to prevent electrolysis and future leaks.

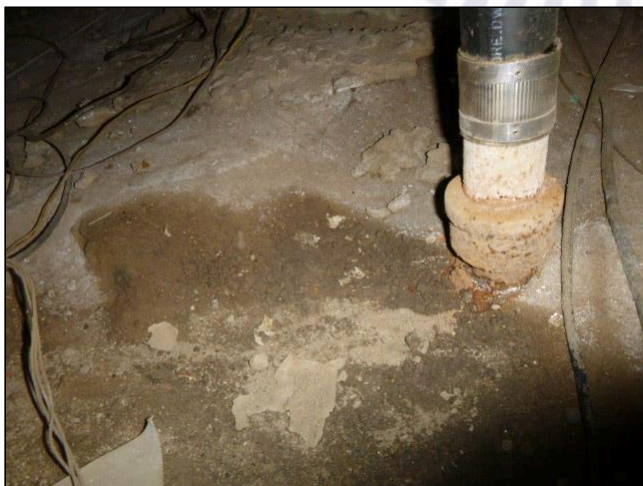
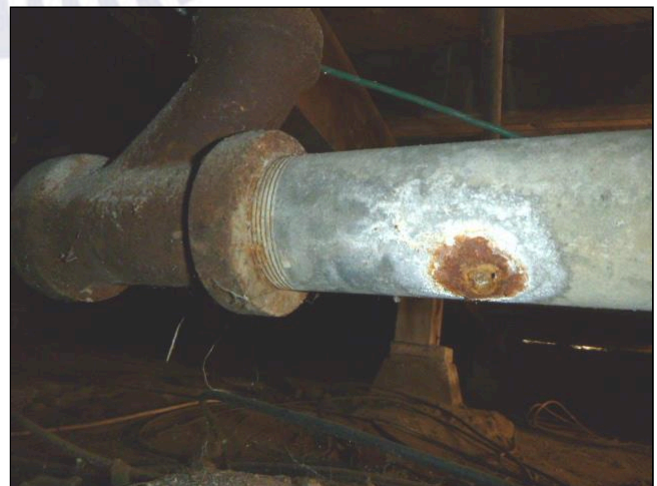
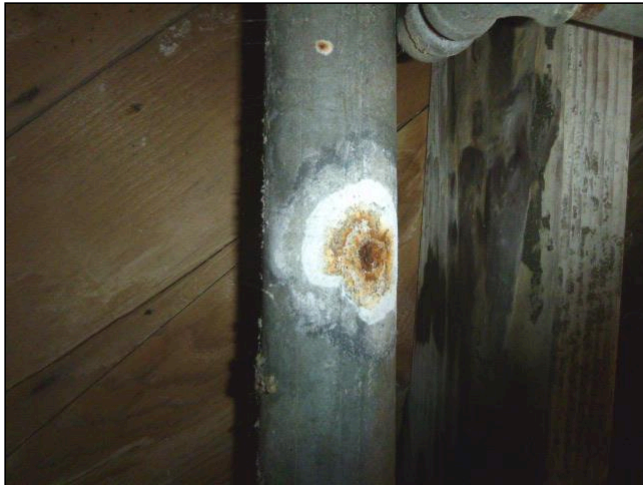
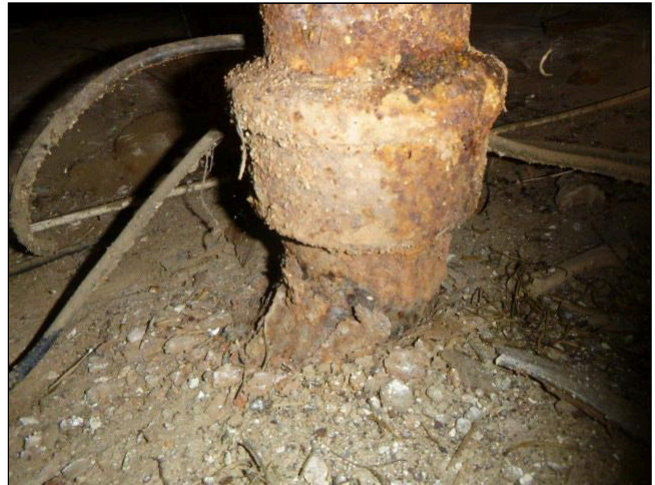
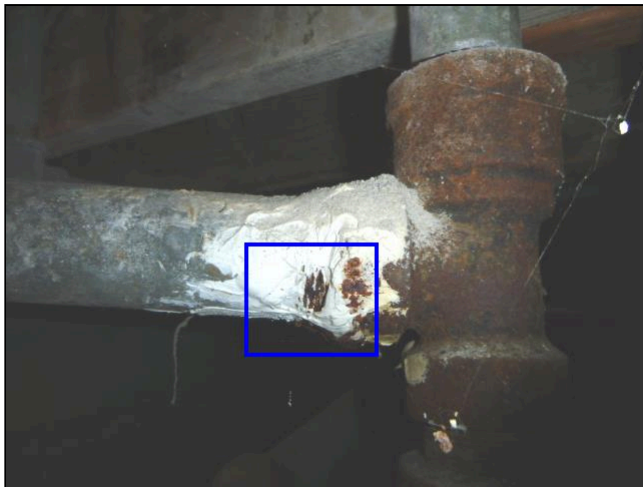
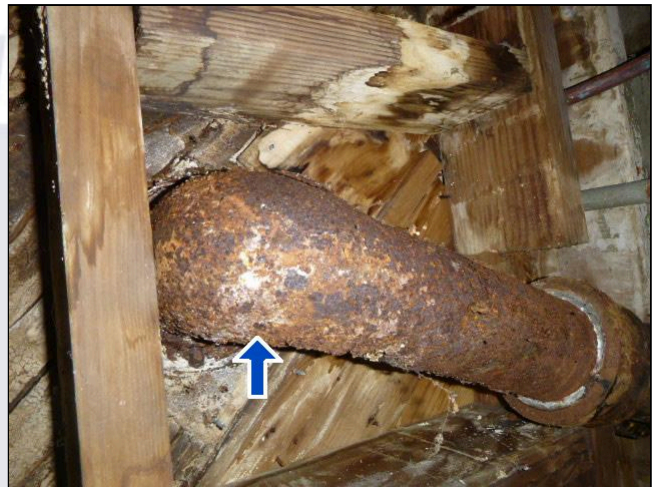
(3) Excessive rust, leaking and seepage/deterioration noted at various cast iron/galvanized drain lines within the crawl space. The excessive deterioration of the drain lines have caused leaking and saturation of the soil in the crawl area. Suggest review by a licensed plumbing contractor for replacement costs as needed to prevent on-going leakage at the crawl area.

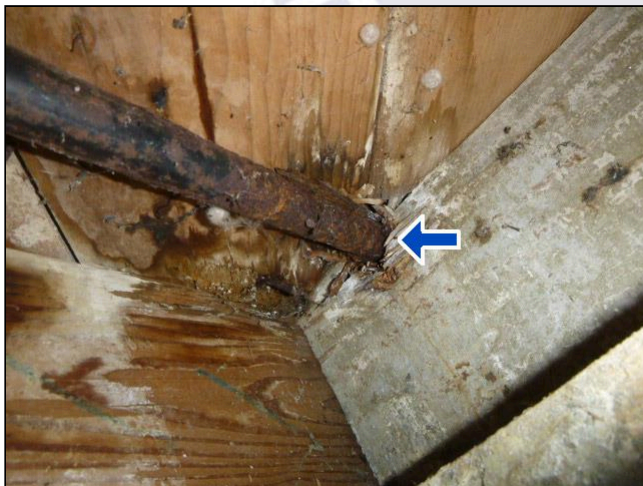
4.3 Item 11 (Picture)

(4) Excessive rust and corrosion was noted at the gas line at the left side due to the water intrusion. Suggest review with a licensed plumber for replacement costs as needed.

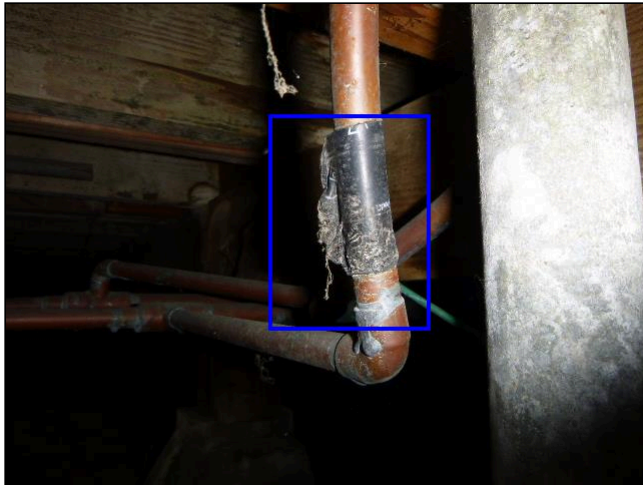
4.3 Item 12 (Picture)

(5) Non-typical and sporadic taping of the copper lines were noted, unable to determine if the tape/wrap is a temporary repair concealing deterioration, suggest review with a licensed plumber for replacement/repair as needed.

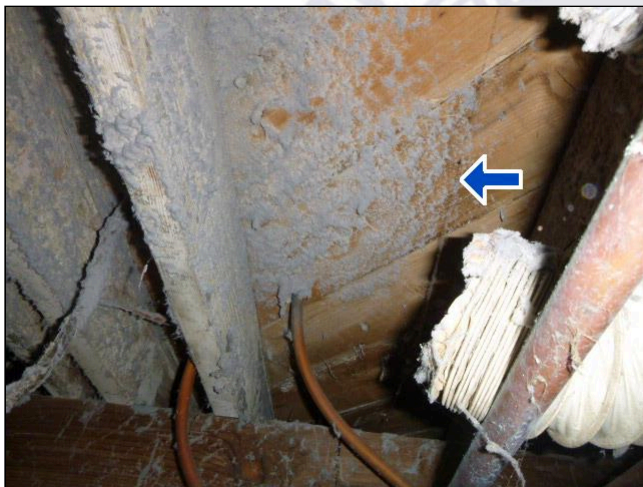
4.4 Item 1 (Picture)

Excessive lint was noted in the crawl area from the laundry dryer vent, this is a potential fire spread hazard. Suggest review with a licensed contractor for costs to repair and remove all of the lint from the crawl area as required for safety.

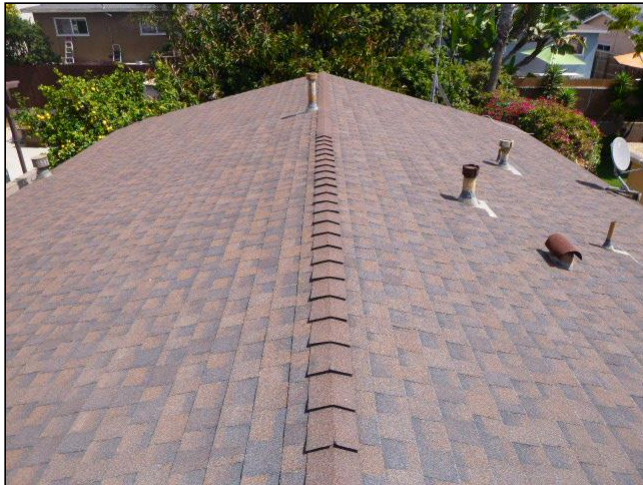
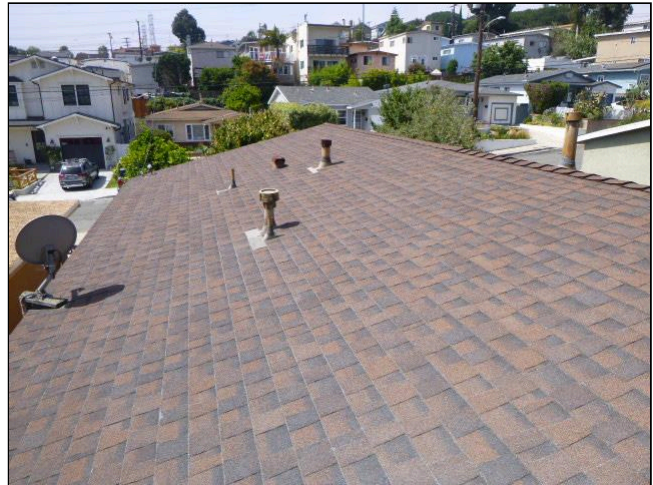
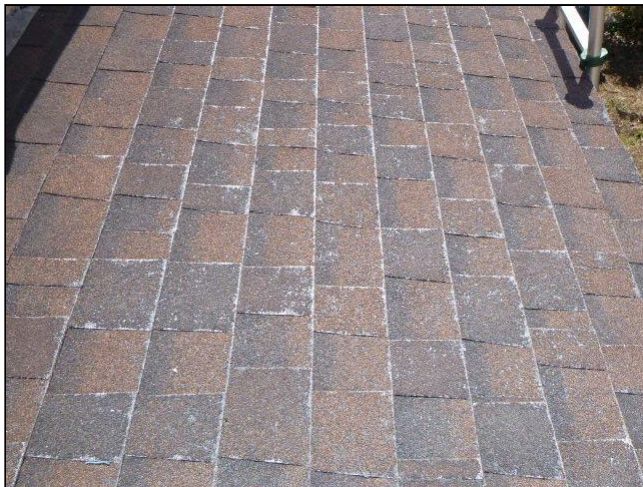
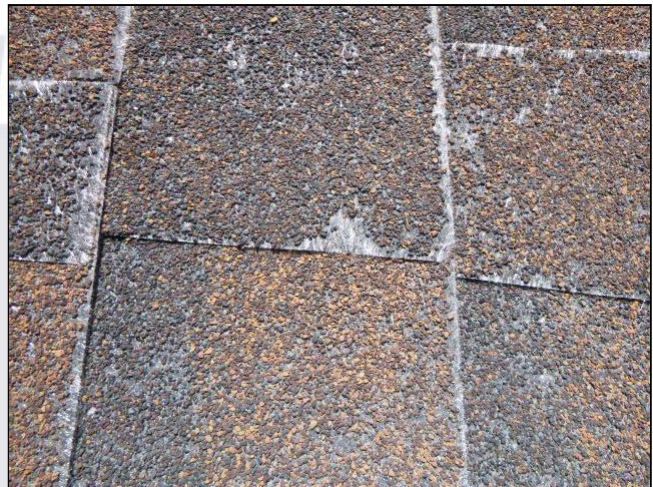
(1) Worn areas and deterioration of the roofing was noted, suggest review with a licensed roofing contractor for repairs, periodic maintenance and to determine the remaining life expectancy of the roof.

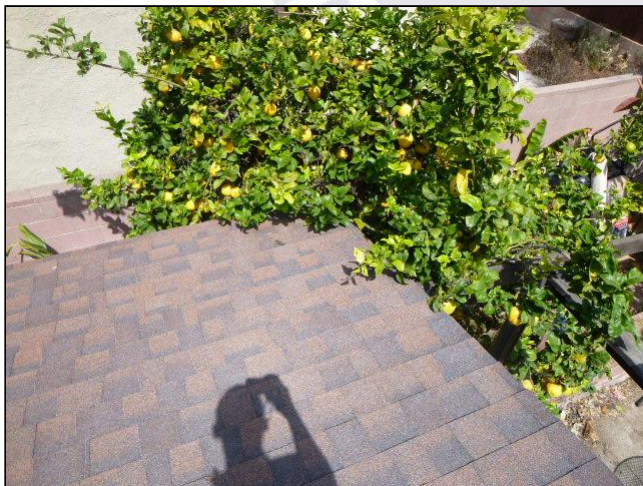
5.0 Item 5 (Picture)

(2) The tree limbs that are in contact with the roof or hanging near the roof should be trimmed to prevent damaging the roof. Suggest trimming as needed.

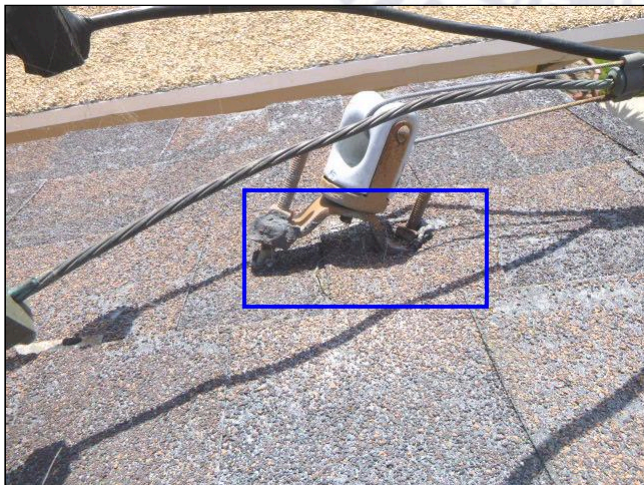
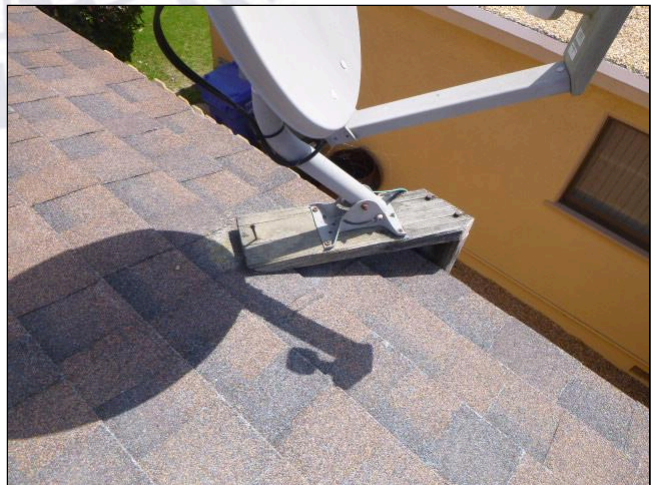
(1) Loose/incorrect flashings/roof attachments were noted at various areas, suggest review with a licensed roofer for repairs as needed.

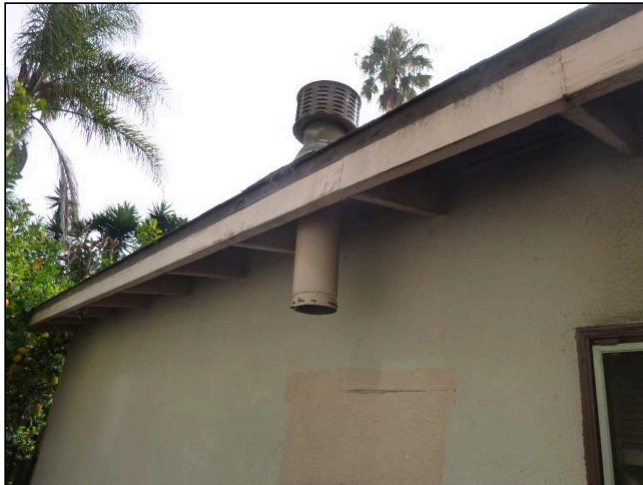
5.1 Item 3 (Picture)

(2) Suggest removal of the old/abandoned flashings/old vent pipes as needed.

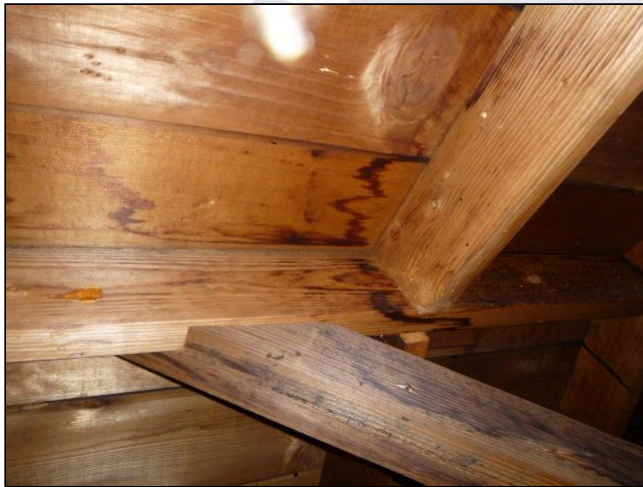
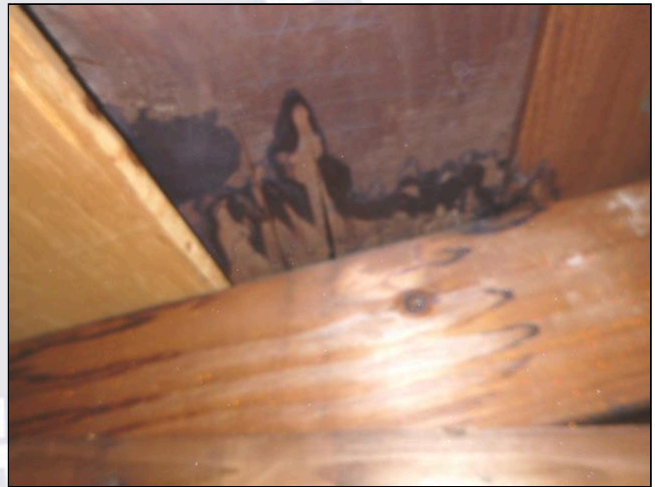
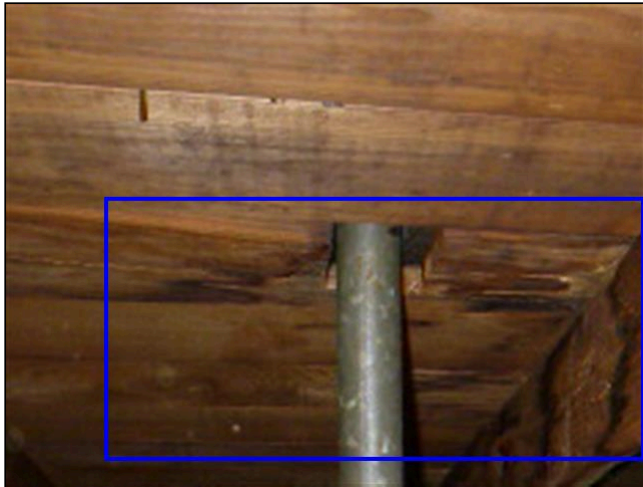
- (1) Minor wood deterioration noted at various areas of the roof framing, suggest review with a termite company and/or a licensed contractor for repairs as needed.
- (2) Moisture stains noted at various areas of the attic sheathing/framing, see roof comments and repair as needed.

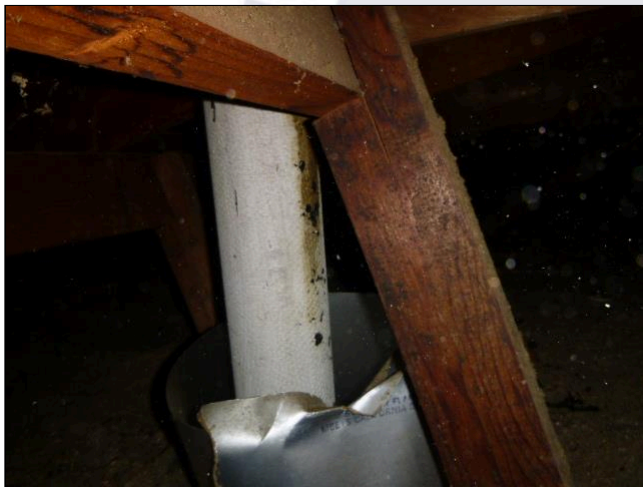
6.5 Item 1 (Picture)

Abandoned asbestos vent pipes noted in the attic area, suggest review with a licensed contractor for removal costs as needed.

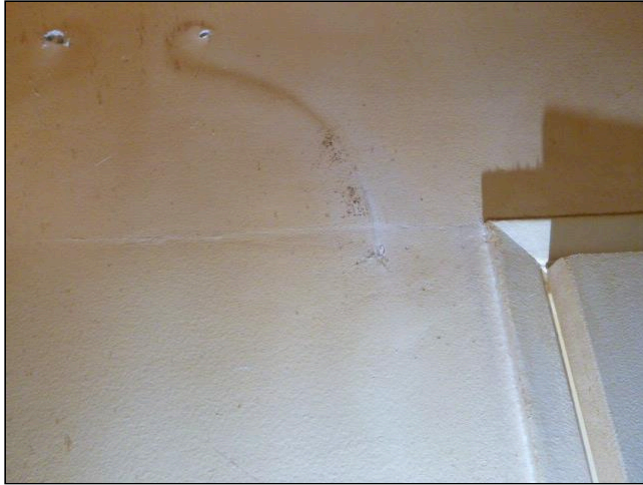
7.1 Item 1 (Picture)

(1) Settling cracks and patching was noted, suggest repair as needed.

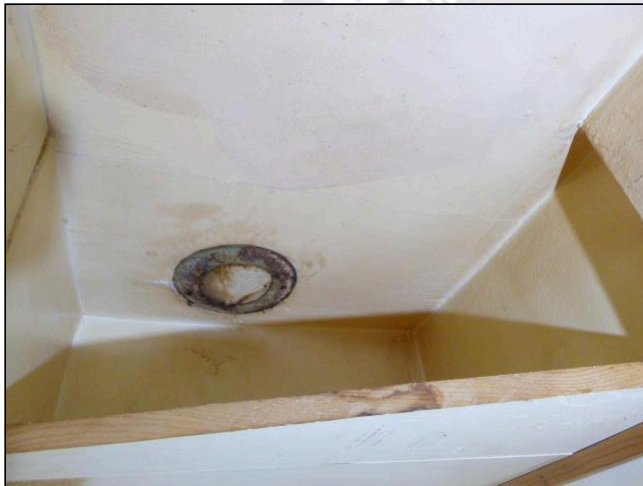
7.2 Item 1 (Picture)

(1) Settling cracks and patching noted, suggest repair as needed.

(2) An old transite asbestos style vent pipe was noted at the ceiling of this area, suggest removal as needed.

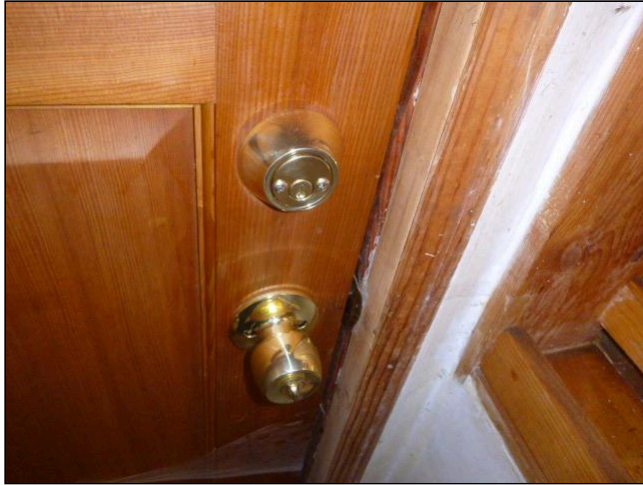
7.3 Item 1 (Picture)

A keyed interior lock is installed at the exterior door, suggest installing a thumb turn dead-bolt to enhance safety as an upgrade.

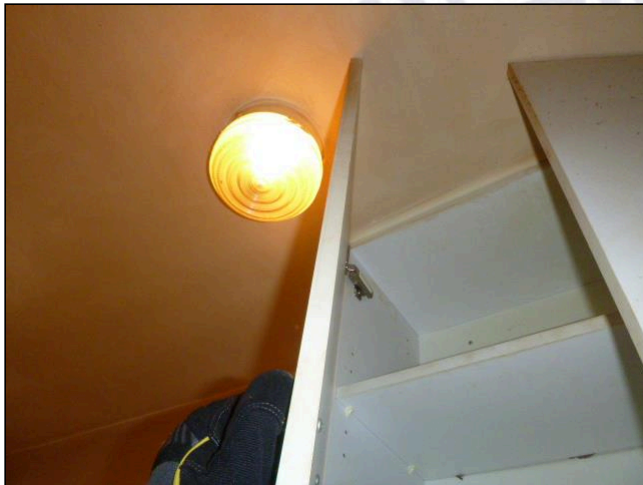
7.4 Item 1 (Picture)

(1) The cabinet door strikes the light fixture, suggest repairs as needed for safety.

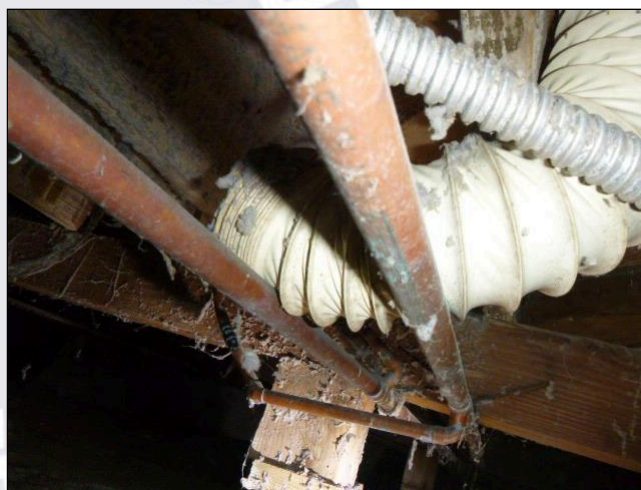
7.6 Item 2 (Picture)

(2) Improper vinyl flex vent installed to the crawl space (not installed to the exterior as required). Suggest removal of the existing material and install a rigid vent pipe to the exterior as required. Excessive lint noted was noted in the crawl area due to the incomplete installation, this is a potential fire hazard. Suggest review by licensed contractor for costs to remove the lint form the crawl area as required for safety.

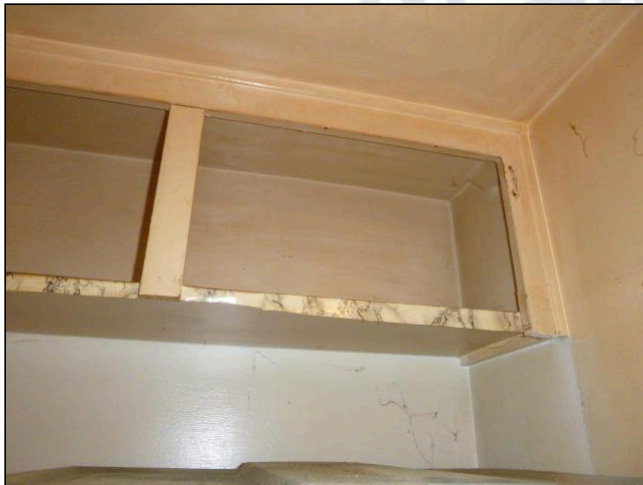
7.7 Item 1 (Picture)

Various cabinet doors are damaged, missing or loose on the hinges. Suggest repair/replace as needed.

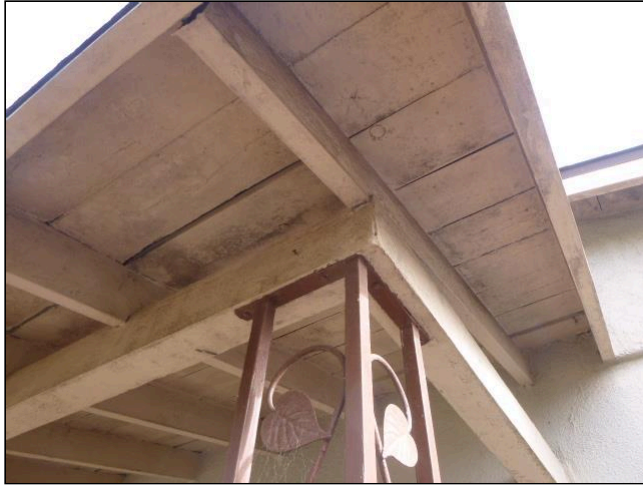
8.0 Item 1 (Picture)

(1) Paint blistering, peeling and wood deterioration noted at various trim areas. Suggest review with a termite company and/or a licensed contractor and repair/replace as needed.

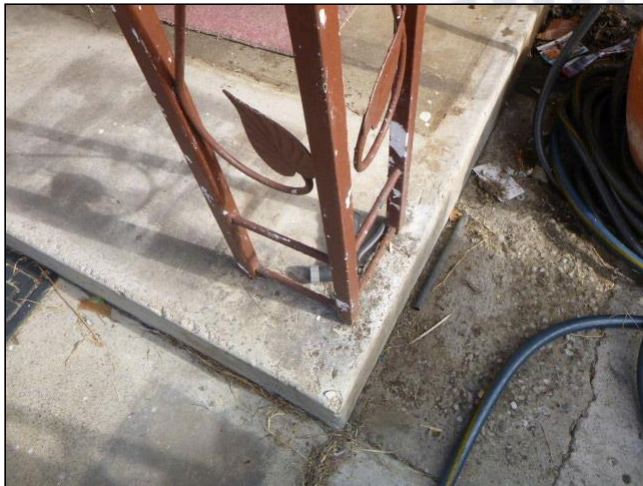
8.0 Item 2 (Picture)

(2) Rust/deterioration and loose areas noted at the corner roof post support, suggest review with a licensed contractor for repair/replacement costs as needed.

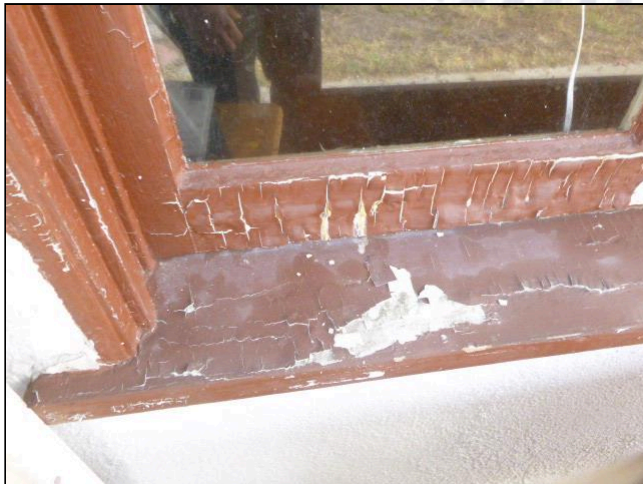
8.4 Item 1 (Picture)

Wood deterioration noted at various windows. Suggest review with termite company and/or a licensed contractor and repair/replace as needed.

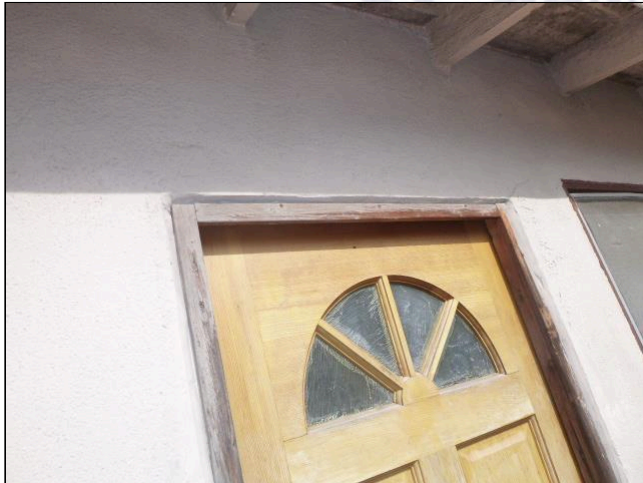
9.3 Item 1 (Picture)

No light fixture installed at this area as required, this is a possible safety hazard. Suggest review with a licensed electrician for installation costs for a light fixture to enhance safety.

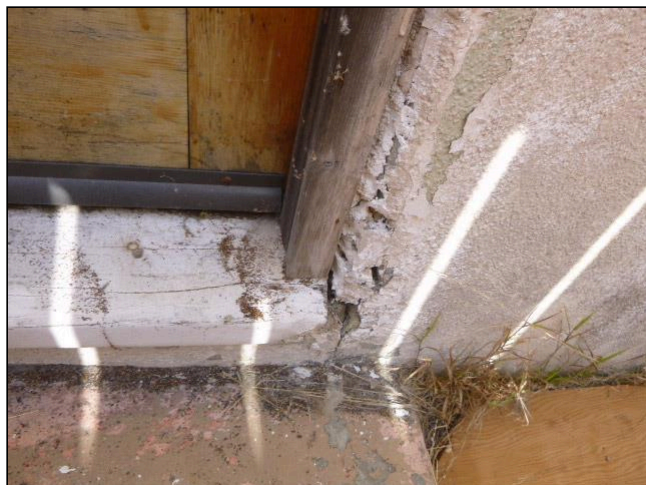
9.5 Item 1 (Picture)

Excessive wood deterioration noted at the door, door frame and threshold. Suggest review by a licensed contractor for repair/replacement costs as needed.

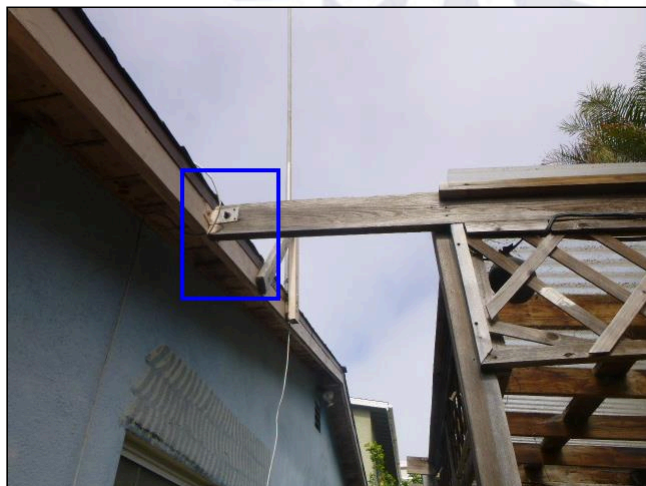
10.0 Item 1 (Picture)

(1) Paint blistering, peeling and wood deterioration noted at various trim areas. Suggest review with a termite company and/or a licensed contractor and repair/replace as needed.

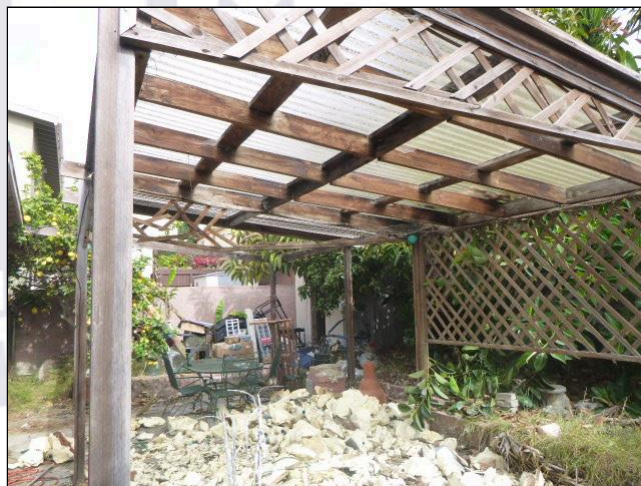
10.0 Item 2 (Picture)

(2) The rear patio has been incorrectly secured back to the structure, suggest removal as needed.

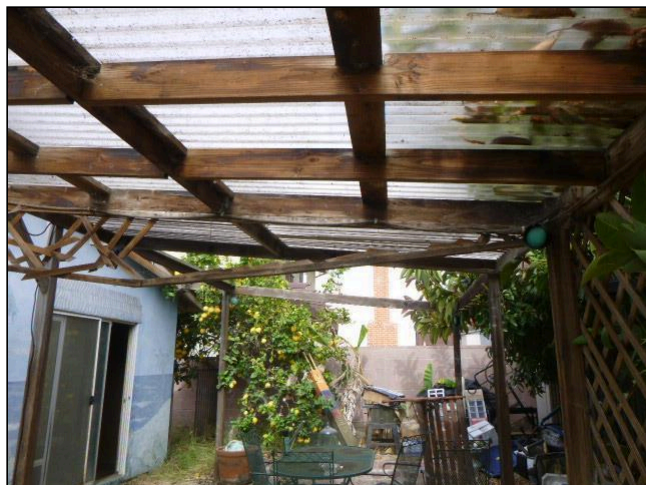
10.0 Item 3 (Picture)

(3) Excessive wood deterioration noted at the rear patio structure, suggest removal as needed.

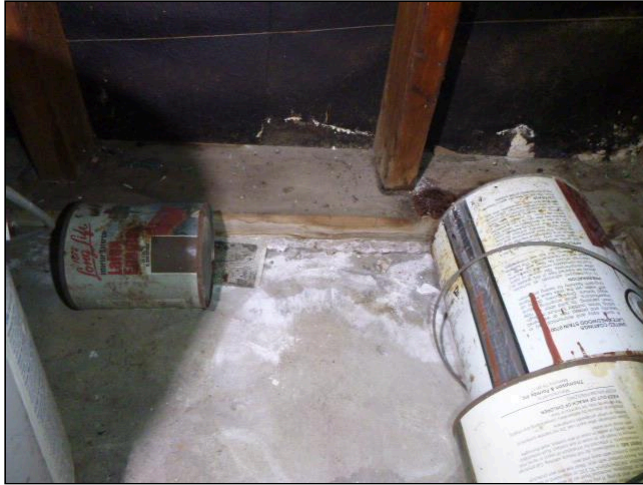
11.0 Item 2 (Picture)

(2) White efflorescence (powder substance) on foundation footings indicates prior, and possibly ongoing, excessive moisture build up at the exterior of the foundation. Ongoing water intrusion at the foundations can, in some cases, cause the steel in the foundations to rust, called spalling, which can lead to horizontal cracking of the foundation (currently there are no major cracks visible at the foundation). Any future cracking/damaged can be an expensive repair as the foundation is now structurally weak and susceptible to horizontal movement. Suggest review of the Lot/ Grade and drainage systems, including rain gutters, to reduce and prevent further and future water buildup at the exterior of the dwellings foundations.

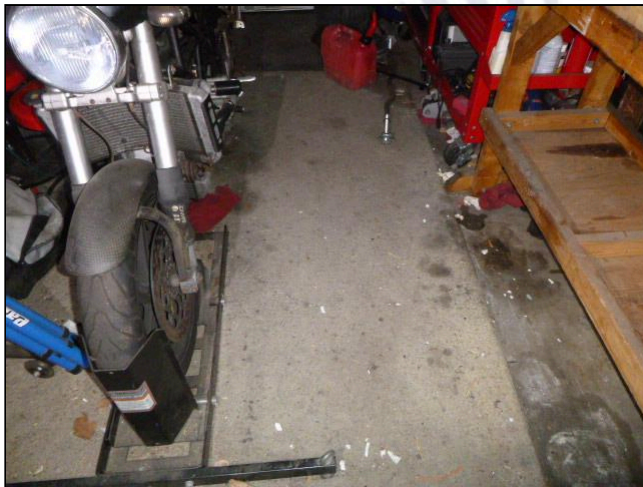
11.0 Item 3 (Picture)

(3) Suggest removal of the carpet if vehicles are to be parked in the garage. Non fire rated flooring at the garage area is a potential fire safety hazard. Suggest review with a licensed contractor for repair/replacement costs as needed.

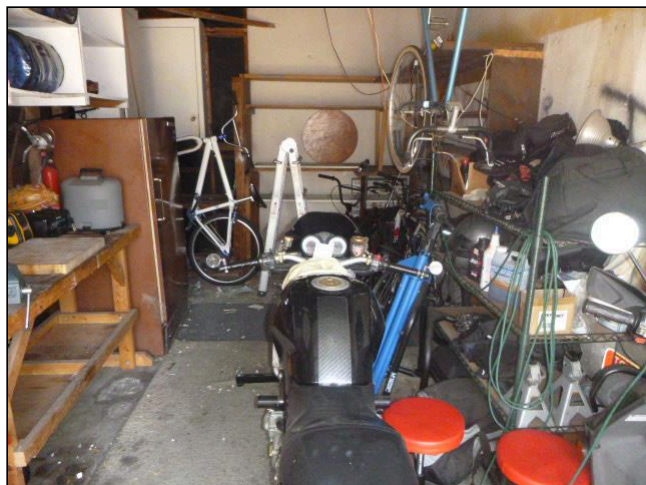
11.3 Item 1 (Picture)

(1) Unable to make a complete inspection of firewall due to a large concentration of personal effects. Suggest review of firewall once area has been cleared. If any breaches or damage to firewall is found, suggest patching and repair with 5/8 drywall as needed to complete firewall.

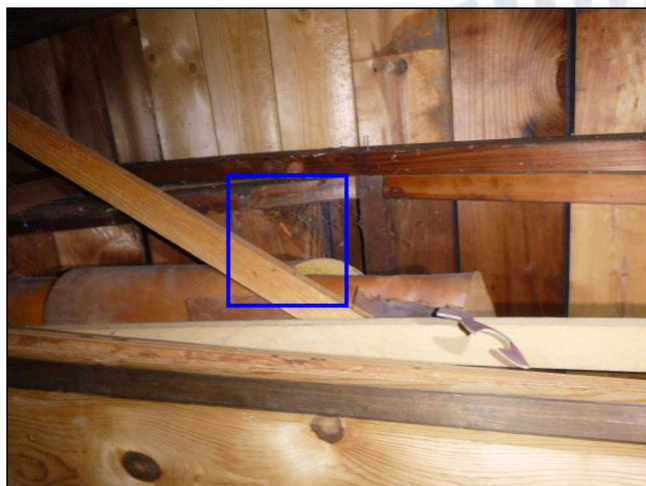
11.3 Item 2 (Picture)

(2) Wood deterioration noted at various areas of the garage framing, suggest review with a termite company and/or a licensed contractor for repairs as needed.

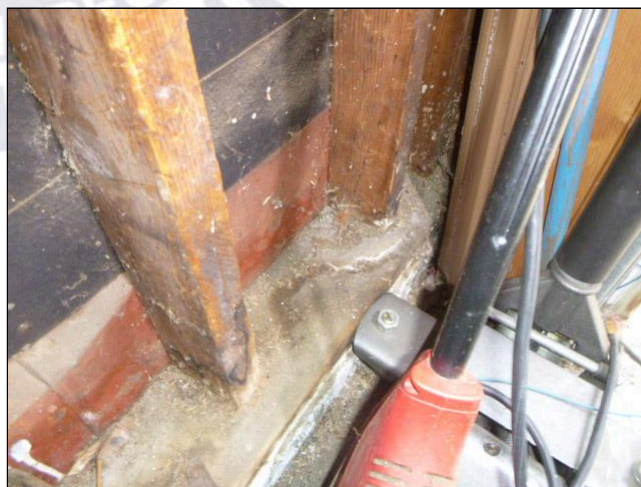
11.3 Item 4 (Picture)

(3) Water stains and deterioration noted at the lower section of the walls due to water intrusion. Suggest repair/replace as needed.

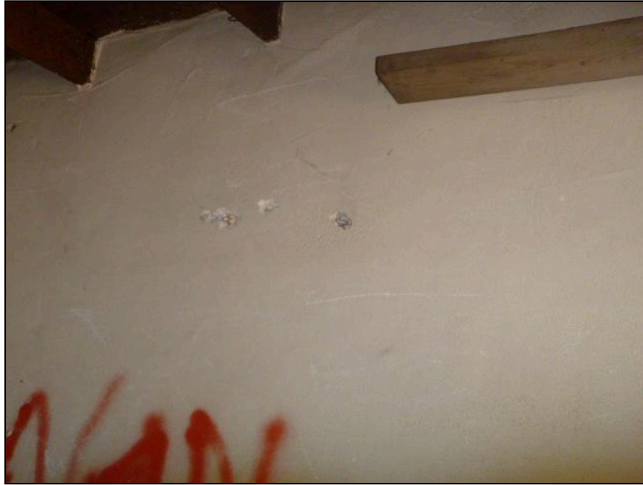
11.3 Item 5 (Picture)

(4) Holes and unfinished sections of firewall and ceiling were noted, this is a potential fire spread hazard. 5/8 inch sheetrock may be installed as a minimum standard material and as a requirement for a one hour burn through rating for firewall. Suggest review by licensed contractor for repair/installation costs as needed.

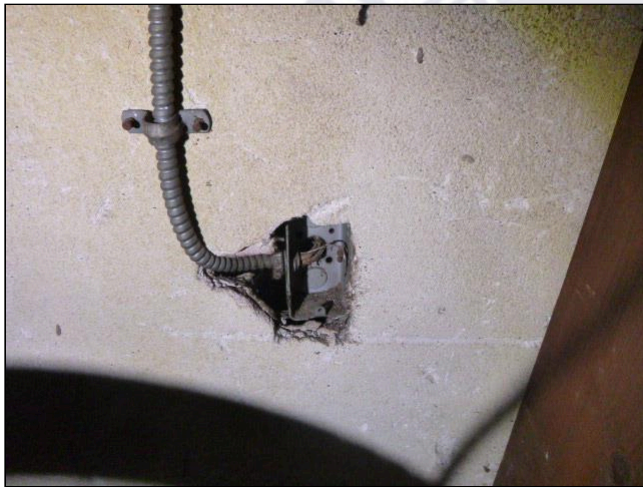
11.4 Item 1 (Picture)

(1) Open junction boxes were noted, this is a potential safety hazard. Whenever an electrical wire is cut and re-connected, the 'splice' should be encased in a covered junction box to prevent shocks and separation of the splice. Suggest review by a licensed electrician for repair/replacement costs as needed.

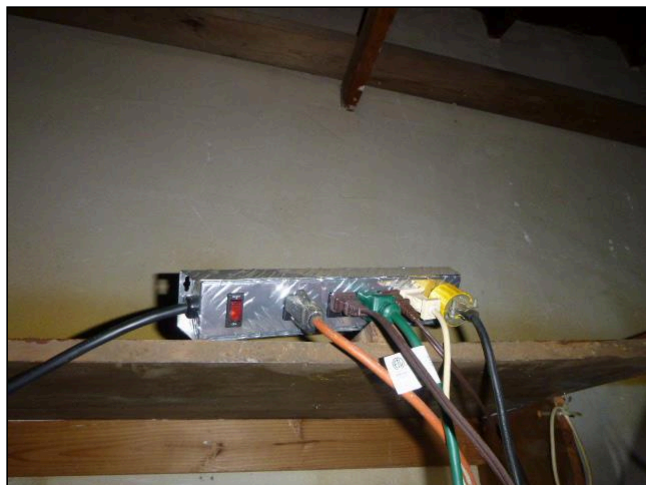
11.4 Item 2 (Picture)

(3) Excessive use of electrical plugs strips/extension cords used at this area, this is a potential fire safety hazard. Suggest review with a licensed electrician for additional electrical circuits/outlets costs as needed for safety.

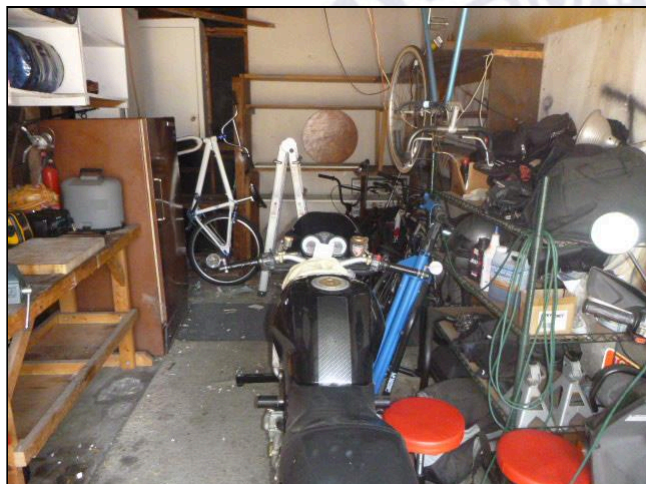
11.5 Item 1 (Picture)

(1) Access within this area was blocked or severely limited at the time of the inspection. An inspection of this area can be performed by appointment and at an additional cost when the area is made accessible.
