Inspection Report

Property Address:
1619 Armour Ln
Redondo Beach CA 90278

Ferguson Home Inspections

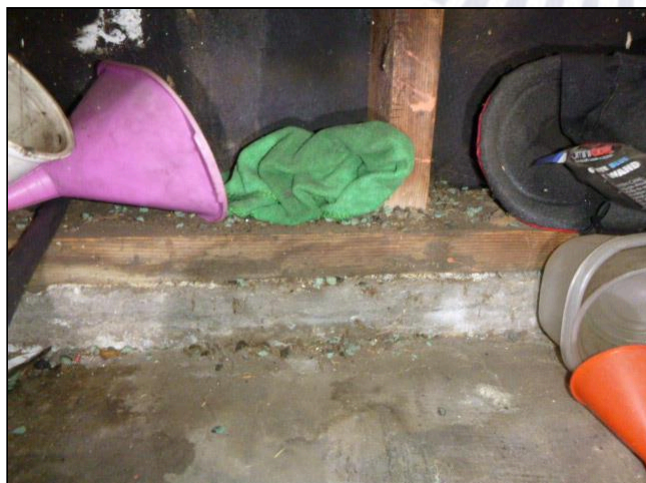
11.5 Item 2 (Picture)

(2) Pest droppings noted within the garage area. Suggest review with a qualified pest control company and/or a licensed contractor for removal costs of the droppings as needed.

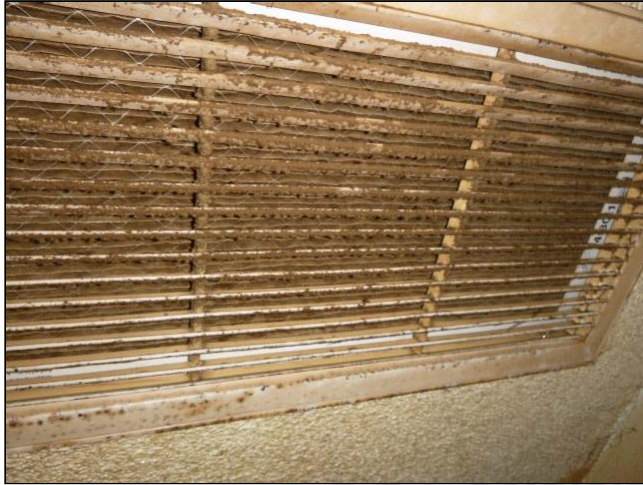
12.0 Item 3 (Picture)

(2) Suggest replacing/cleaning the filter(s) as needed.

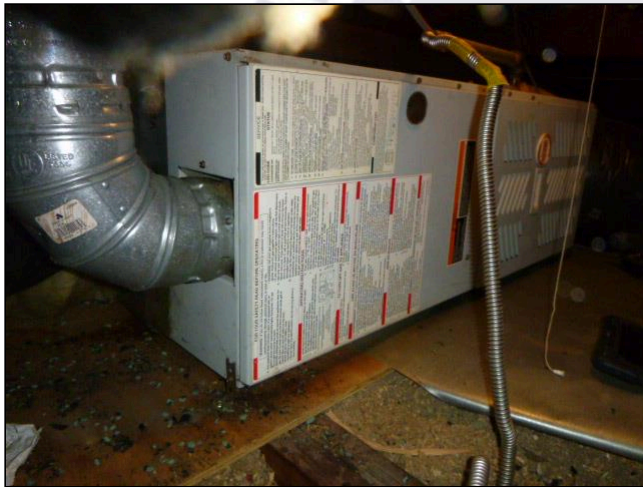
12.0 Item 4 (Picture)

(3) The heating unit has been installed on a plywood base, suggest review by a licensed heating contractor for installation on non-combustible stands as required.

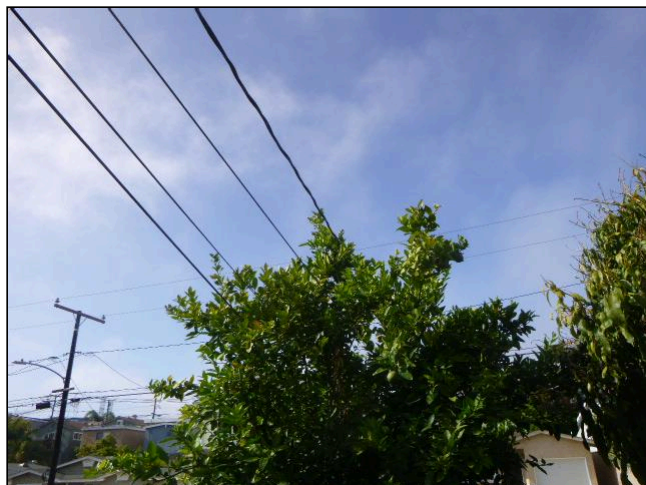
13.0 Item 1 (Picture)

(1) Utility wires are contacting foliage/tree limbs. When utility company wires coming into the service mast are sagging, frayed, strung through trees, they present a potential hazard, the utility company should be contacted to correct the condition.

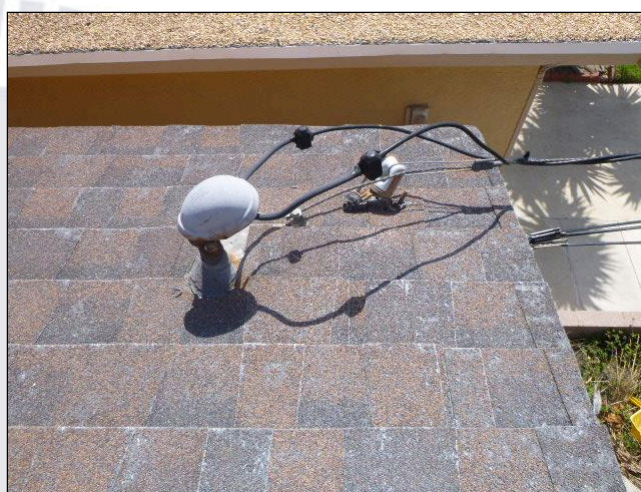
13.0 Item 3 (Picture)

(2) Inadequate drip loop was noted, suggest review with a licensed electrician for repairs as needed.

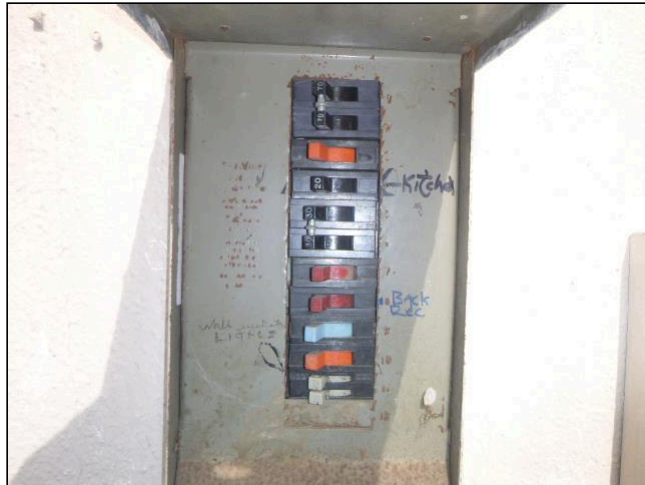
13.1 Item 1 (Picture)

(1) The main electrical panel is a Zinsco brand panel box, a product that hasn't been manufactured for many years. There are problems with these panels that can, in some cases, be serious. Some Zinsco panels have aluminum bus bars (the bars that run down the middle of the panel to which the breakers connect). Over a period of years, oxide forms on the aluminum causing a poor connection with the breakers and leading to arcing, overheating, and, eventually, breaker failure. Other problems with Zinsco panels include circuit breakers (depending on the vintage) with a dismal performance record and the possibility of unbalanced multi-wire circuits. Also, please be aware that various insurance companies will not insure homes with this style of electrical panel. Suggest review by a licensed electrician for replacement costs as needed.

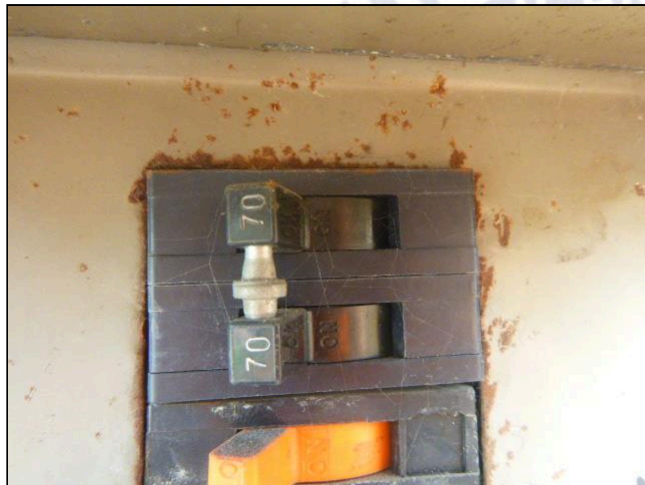
13.1 Item 3 (Picture)

(2) Due to the age and size/overall amperage of this system relative to the square footage of the dwelling, suggest review with a licensed electrician for replacement cost to upgrade the electrical panel, increase the overall amperage and install additional circuits to the interior of the dwelling as needed/desired.

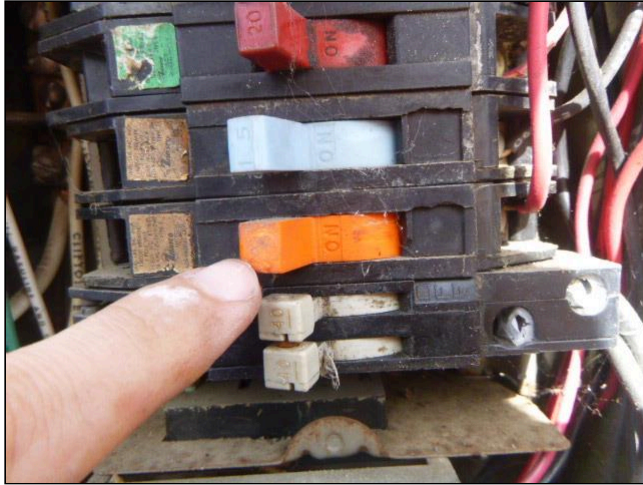
13.2 Item 1 (Picture)

(2) A damaged breaker was noted, suggest replacement as needed.

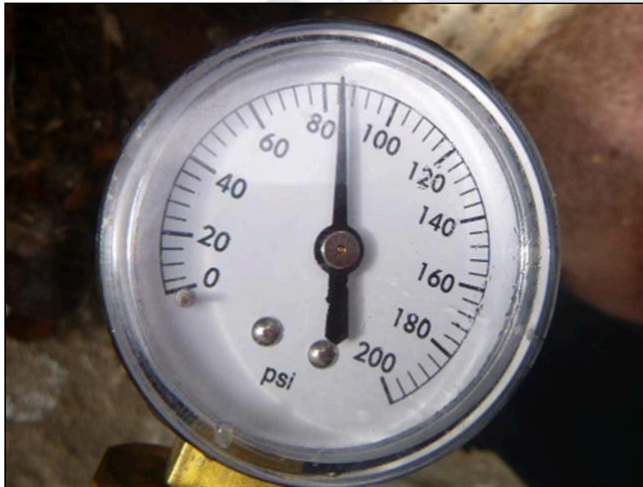
14.0 Item 1 (Picture)

(1) Suggest installation of a pressure regulator to reduce water pressure below 80 PSI to relieve stress on all plumbing joints and fittings.

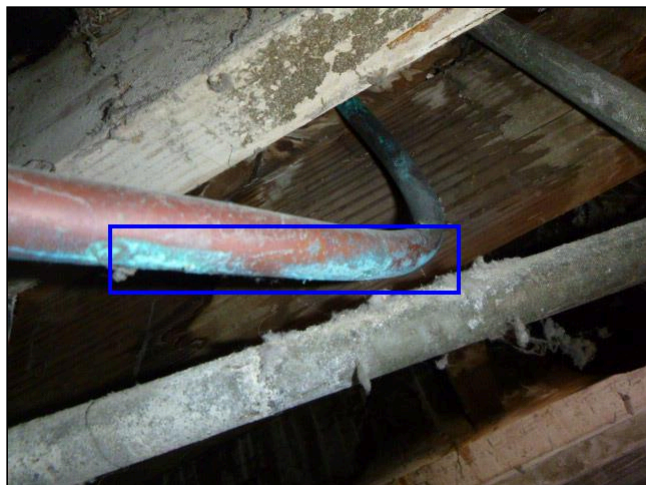
14.0 Item 2 (Picture)

(2) The copper plumbing lines are inadequately and improperly secured with straps that are causing excessive deterioration of the copper. Suggest replacing the deteriorated areas of the copper plumbing lines as well as replacing the straps with approved materials to prevent electrolysis and future leaks.

(2) See the crawl space comments and repair as needed.

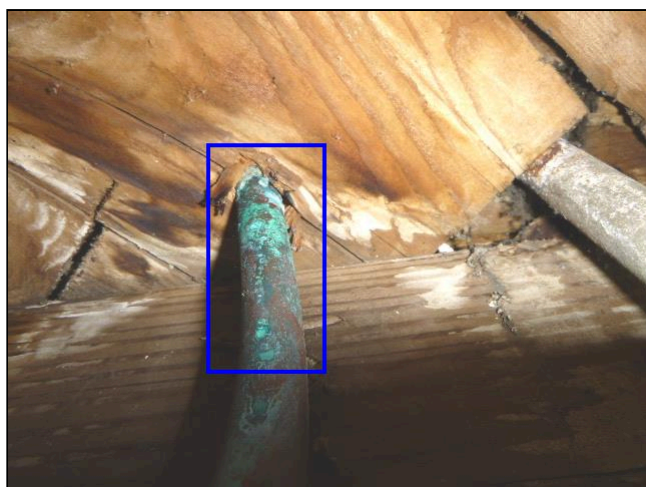
14.0 Item 4 (Picture)

(5) Non-typical and sporadic taping of the copper lines were noted, unable to determine if the tape/wrap is a temporary repair concealing deterioration, suggest review with a licensed plumber for replacement/repair as needed.

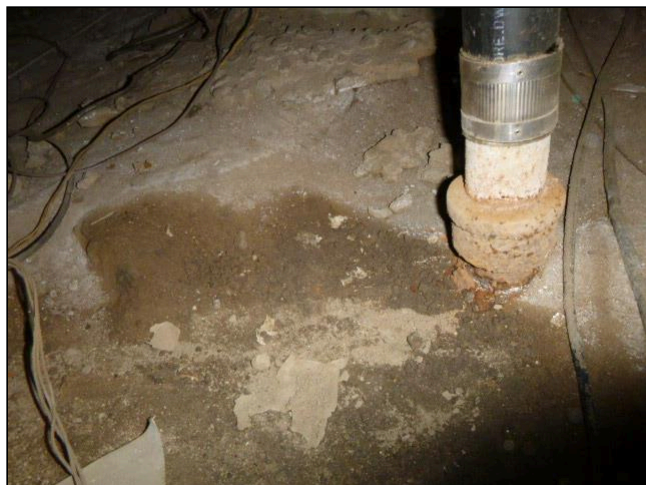
15.0 Item 1 (Picture)

(1) See the crawl space comments due to multiple cracks and leaking drains. Suggest review by licensed plumber for repair/replacement costs.

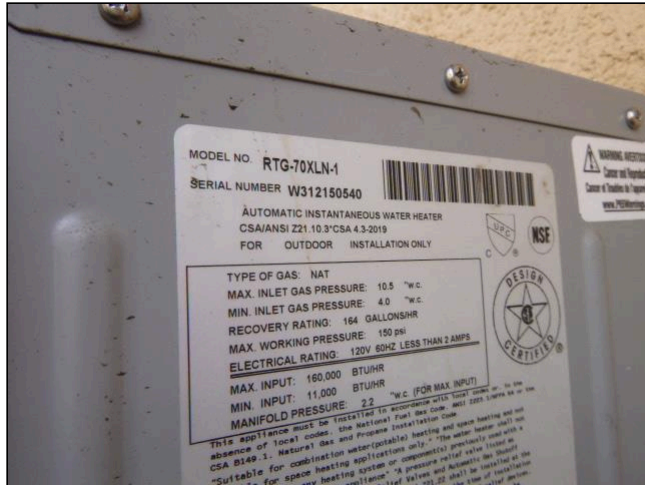
16.0 Item 1 (Picture)

(1) The water heater was operational at the time of the inspection.

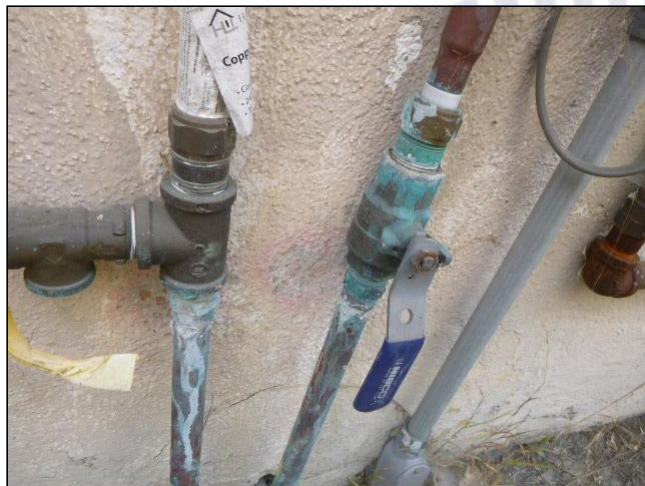
16.0 Item 2 (Picture)

(2) Rust and corrosion was noted at the cold water shut off, no leaking was visible at the time of the inspection. Suggest review by a licensed plumber for repair/replacement costs as needed.

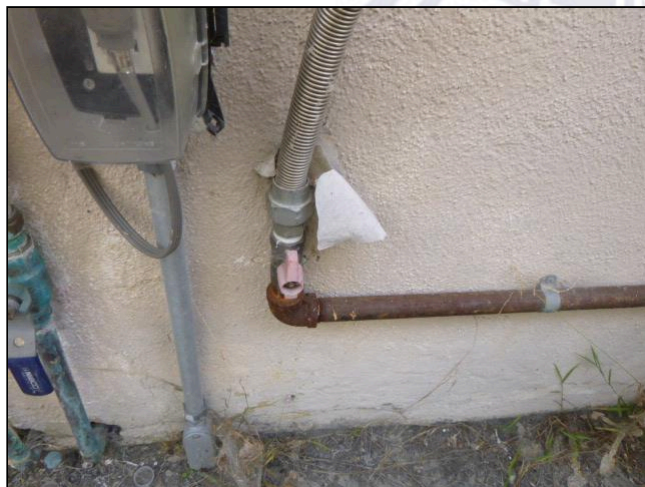
16.0 Item 3 (Picture)

(3) Currently no gas supply line drip leg/sediment trap is installed, please be aware that various cities do not enforce/require this installation. Suggest review with the local City Building Department and/or with a licensed plumbing contractor for installation costs as needed.

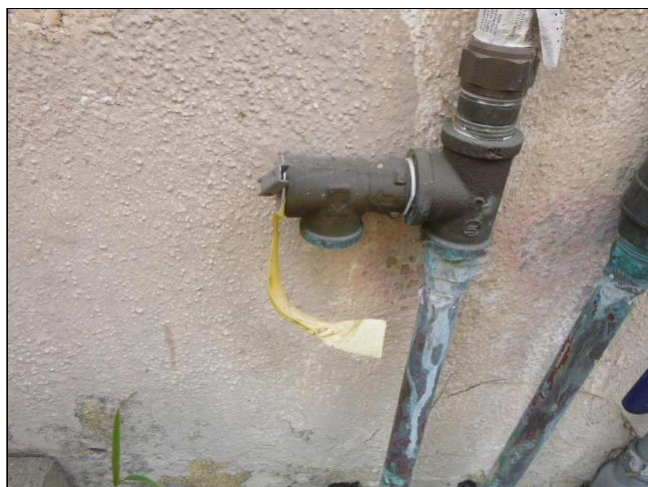
16.0 Item 4 (Picture)

(4) No discharge pipe connected to the TP&R valve, this is a potential safety hazard. Suggest review by a licensed plumber for costs to install the TP discharge drain down to within 4-6 inches of the exterior grade/deck as required

for safety.

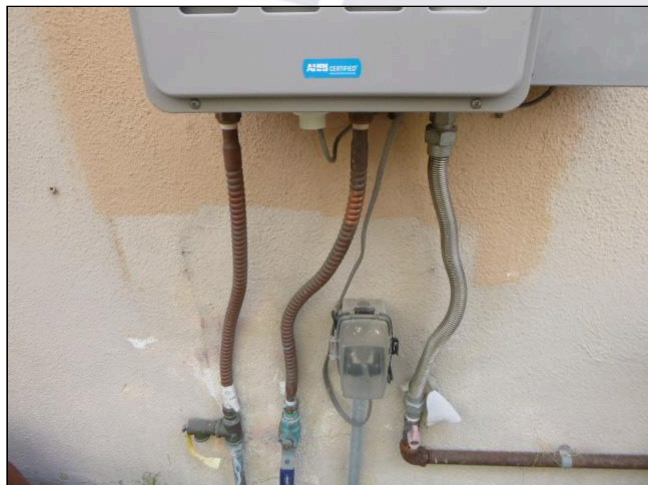
16.0 Item 5 (Picture)

(5) Suggest review of the operational and installation manual to determine/confirm any installation and/or regular maintenance/De-Scaling required for this style water heater.

(6) The current water heater does not have a "Thermal Expansion tank" which is generally installed to prevent a possible leak at the T&P or "pop-off" valve and/or excessive pressure build-up at the internal plumbing, fixtures and joints. Recent changes (2012) require one when a new water heater is installed, but various cities do not enforce this installation for multiple reasons (the home is not on a closed system and various tankless units do not require it). There were no leaks or drips at the T&P valve during inspection. If your water heater does begin to drip or leak, then a thermal expansion tank may be needed. Suggest review with the city and/or a licensed plumber to determine if this installation is required and install as needed.

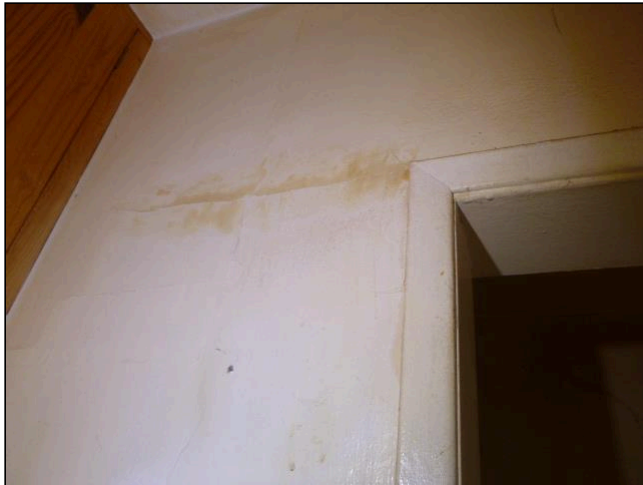
17.1 Item 1 (Picture)

(1) Settling cracks and patching was noted, suggest repair as needed.

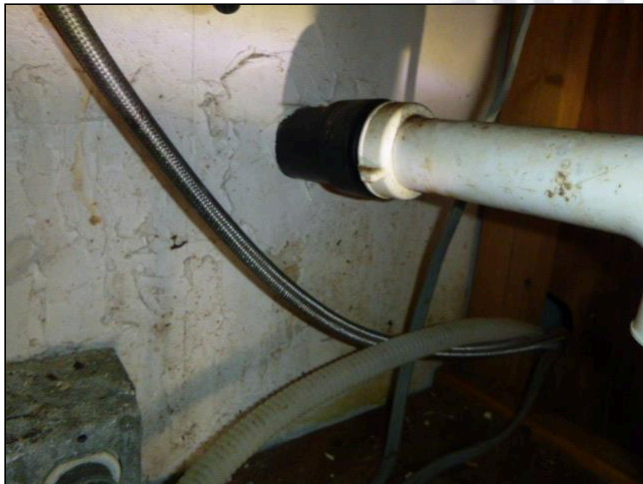
17.1 Item 2 (Picture)

(2) Patched areas of the walls was noted, suggest review with the seller for the cause and any repairs needed. Suggest repair as needed.

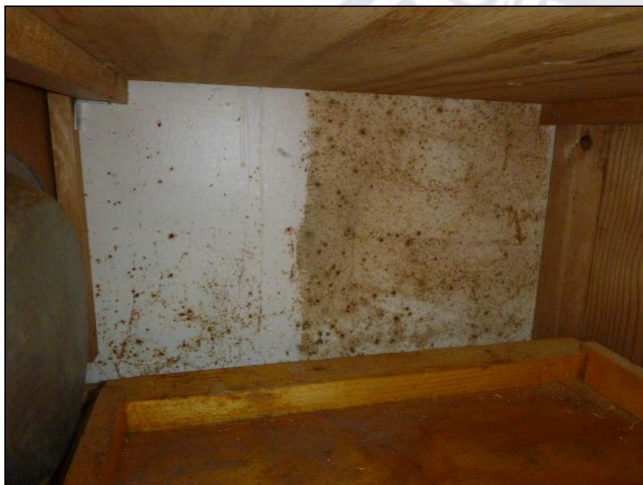
17.1 Item 3 (Picture)

(3) Excessively stained wall(s) noted in the cabinetry. Suggest review with the seller and a licensed contractor for removal/repair/replacement costs as needed.

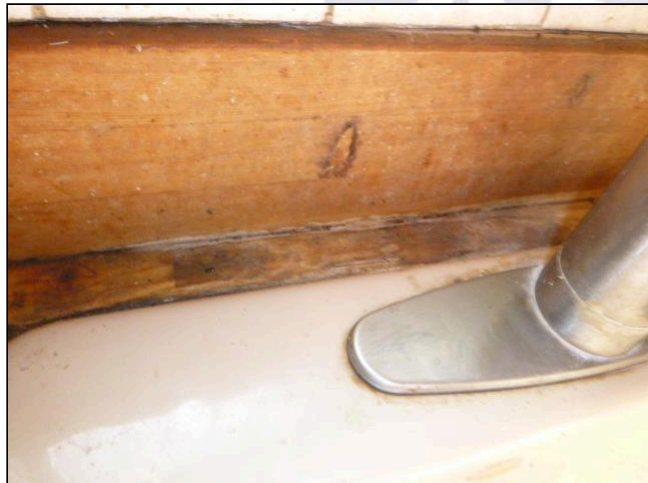
17.6 Item 1 (Picture)

Deterioration noted at various areas, suggest repair/replace as needed.

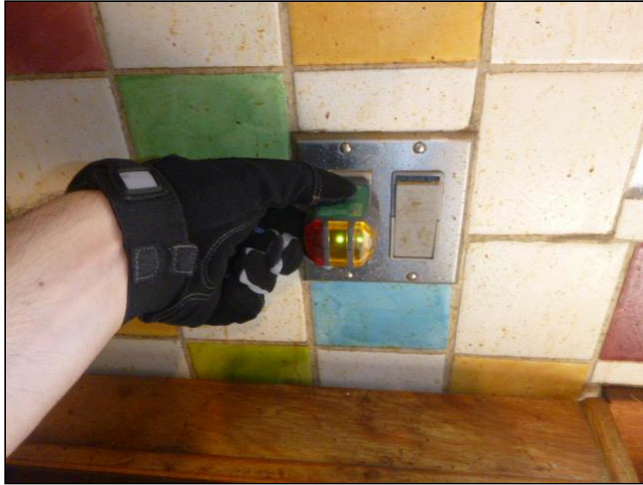
17.7 Item 1 (Picture)

Various countertop outlets are not GFCI protected as required. Countertop GFCI outlet(s)/protection has been required within six feet of the sink since 1987 and all countertop outlets since 1996. Suggest review by a licensed electrician for installation costs as required for safety.

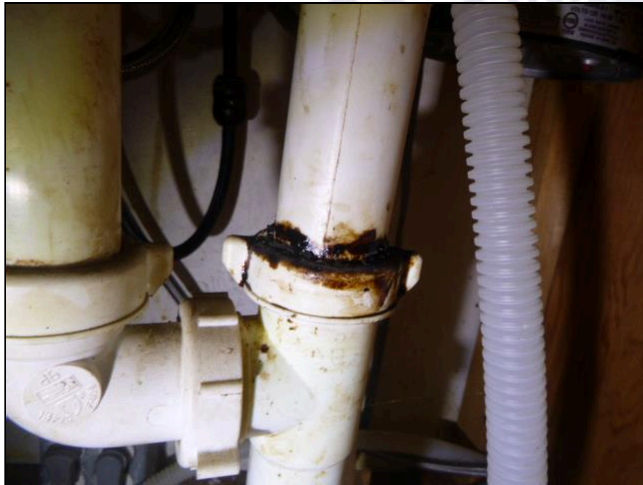
17.10 Item 1 (Picture)

Corrosion noted at the sink drain and angle valve(s), no leaking noted at the time of the inspection. Suggest review by a licensed plumber and repair/replace as needed.

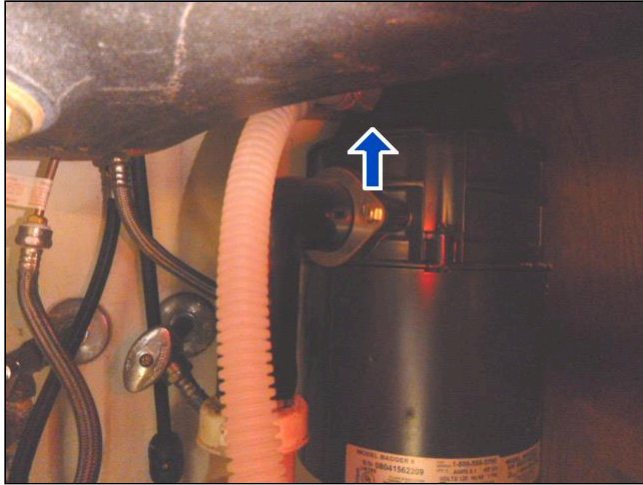
17.11 Item 1 (Picture)

(1) There is no air gap installed for the dishwasher as required, the system currently drains directly into the disposal. Suggest review by a licensed plumber for costs to install the air gap and drain as required.

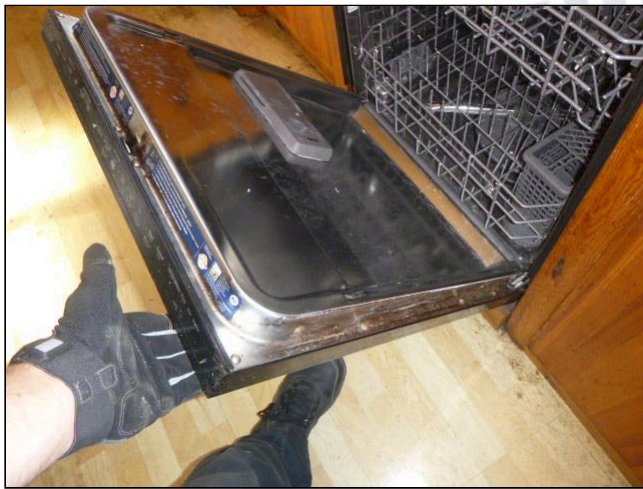
17.11 Item 2 (Picture)

(2) The dishwasher door spring is broken/disconnected, suggest repair or replace as needed.

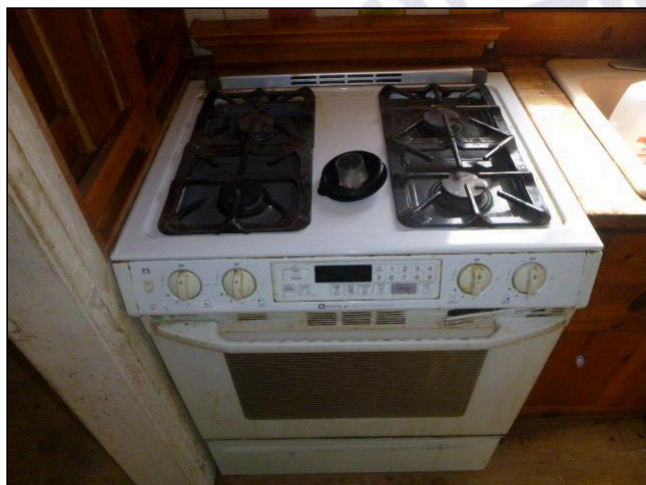
17.13 Item 1 (Picture)

(1) The oven is in disrepair and has a faulty ignition system, suggest replacement as needed.

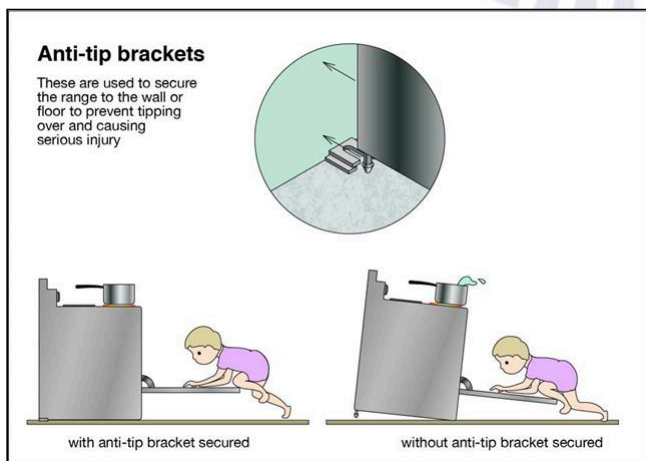
17.13 Item 2 (Picture)

(2) The anti-tip bracket is not currently installed. An anti-tip bracket is usually installed on the floor and against the wall (towards the back of the stove) for one of the rear legs to slide into. Its purpose is to prevent the stove from tipping when a heavy load is placed on the door (possible child) or slide-out racks upsetting the center of gravity. Suggest installation for safety as required since 1991.

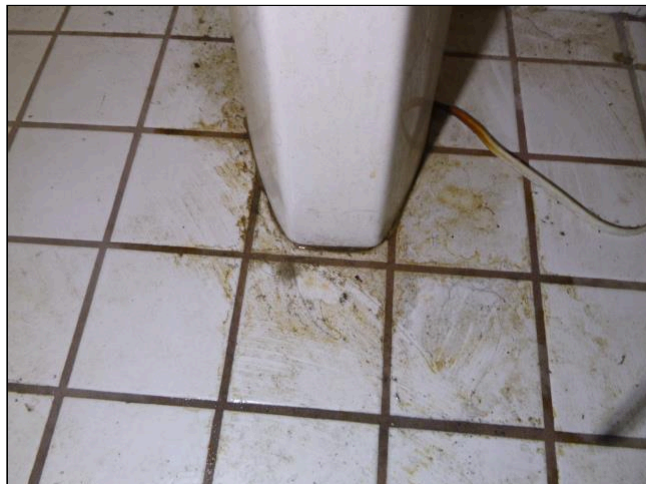
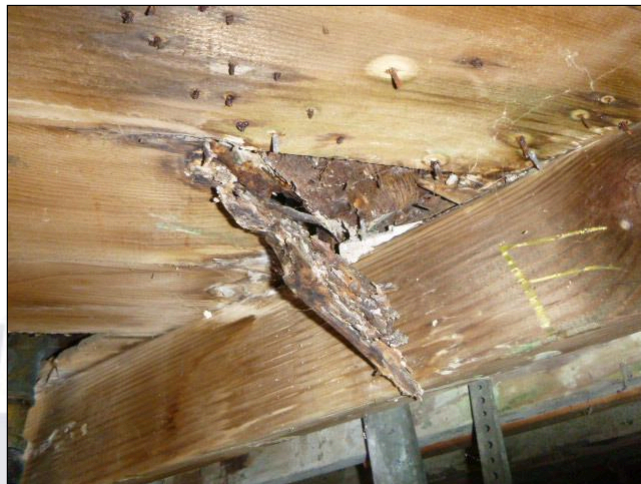
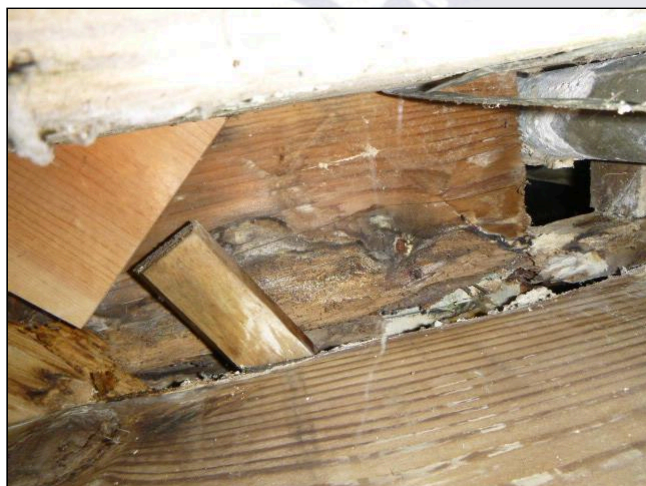
Wet areas noted under the sink (likely due to the leaking drain), has caused sub floor damage. See the foundation comments and make repairs as needed.

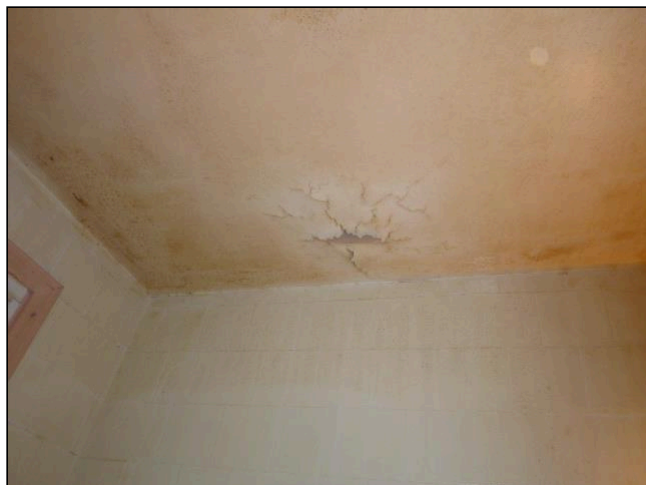
18.2 Item 1 (Picture)

(1) Blistering and excessive deterioration noted at the ceiling due to inadequate ventilation. See the exhaust fan comment and repair/install as needed.

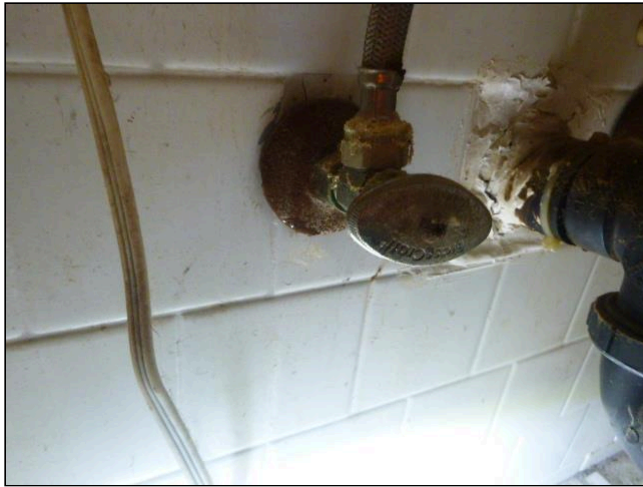
18.14 Item 1 (Picture)

(1) Corrosion noted at the sink angle valve(s), no leaking noted at the time of the inspection. Suggest review with a licensed plumber and repair/replace as needed.

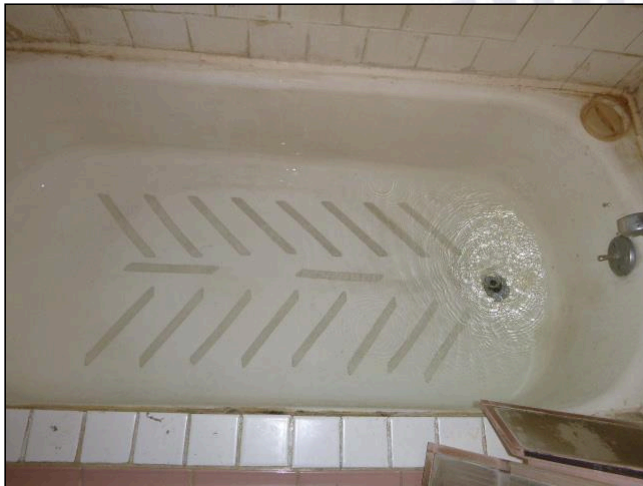
18.14 Item 2 (Picture)

(2) The tub drains slowly, suggest review with a licensed plumber for costs to clear the trap or drain as needed and confirm correct drainage as needed.

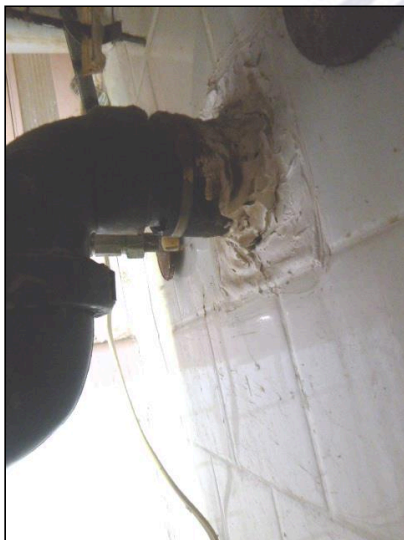
18.14 Item 3 (Picture)

(3) The sink drain appears to be rusted/deteriorated and leaking, suggest review with a licensed plumber for replacement costs as needed.

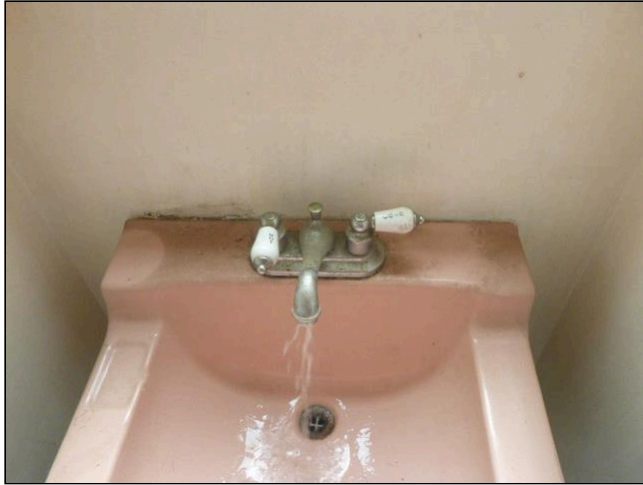
19.8 Item 1 (Picture)

Poor water flow noted at the faucet, suggest review with a licensed plumber for repair/replacement costs as needed.

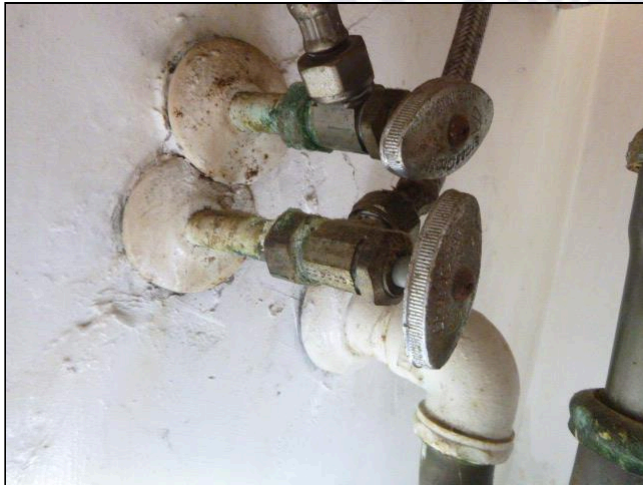
19.9 Item 1 (Picture)

Corrosion noted at the sink angle valve(s), no leaking noted at the time of the inspection. Suggest review with a licensed plumber and repair/replace as needed.

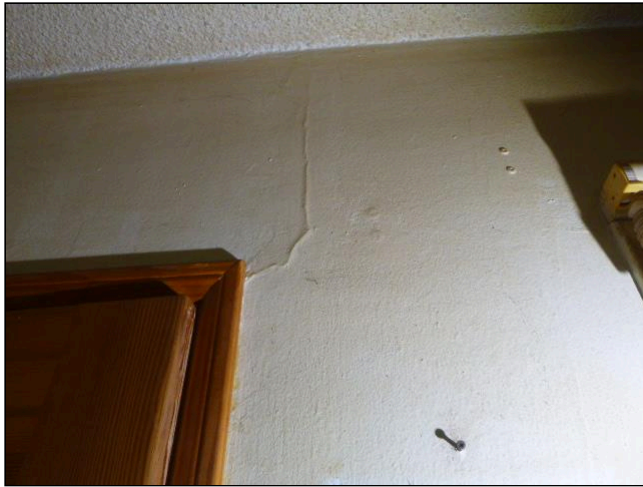
20.1 Item 1 (Picture)

(1) Settling cracks and patching was noted, suggest repair as needed.

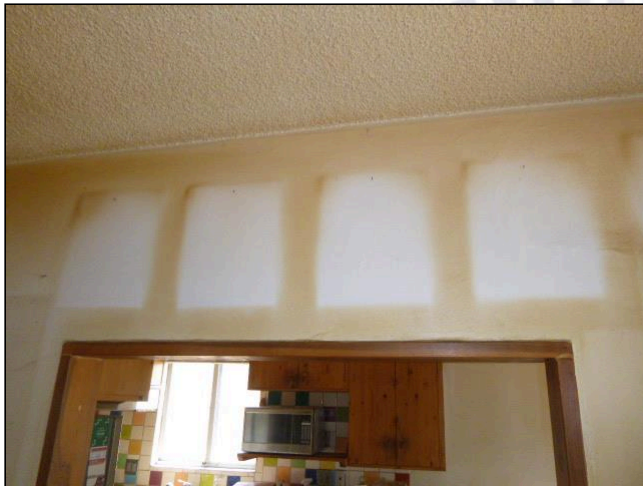
20.1 Item 2 (Picture)

(2) Excessive stains and smoke odor was noted due to potentially/likely excessive interior smoking, suggest review with the seller and a licensed contractor on this item as needed.

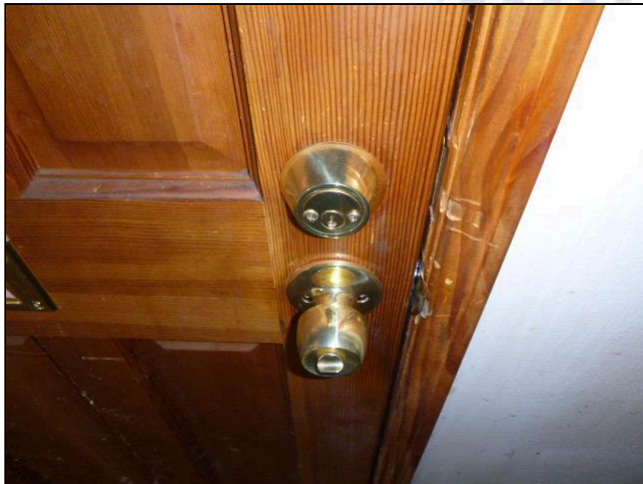
20.3 Item 1 (Picture)

(1) A keyed interior lock is installed at the exterior door, suggest installing a thumb turn dead-bolt to enhance safety as an upgrade.

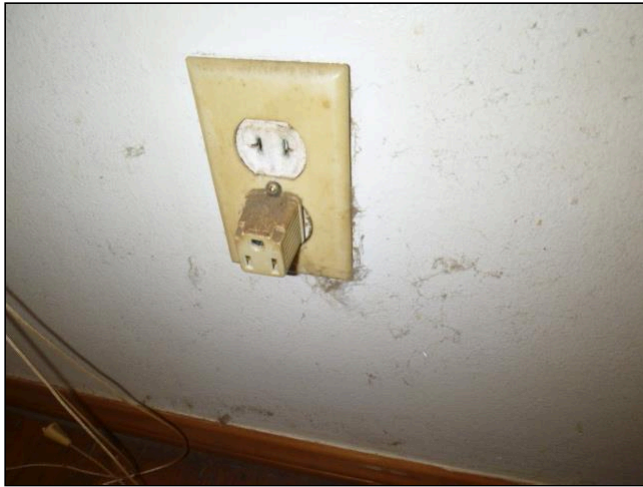
20.6 Item 1 (Picture)

(1) Ungrounded three prong outlets noted at this area. Suggest review with a licensed electrician for costs to ground the outlets as needed as an upgrade and/or protect the outlet(s) on a GFCI circuit where recommended.

(2) Two wire and two prong electrical receptacles noted. At the time of the original construction this type of system was the acceptable standard and appears to be intact. If three prong and GFCI receptacles are desired a ground source is required. Suggest review with a licensed electrician for costs to ground the outlets as needed as an upgrade and/or protected the outlet(s) on a GFCI circuit where recommended.

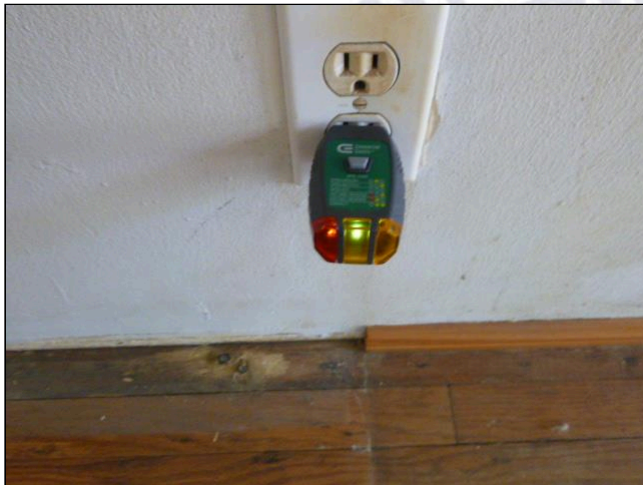
20.6 Item 2 (Picture)

(3) The front outlet is deteriorated and loose. Suggest repair or replace as needed.

(4) Reversed polarity noted at various outlets. Reversed polarity, hot and neutral are reversed, typically these issues for the electric outlets are usually easily corrected by minor wiring adjustments at the specified item. Suggest review with a licensed electrician for repair/replacement costs and confirm correct operation as needed.

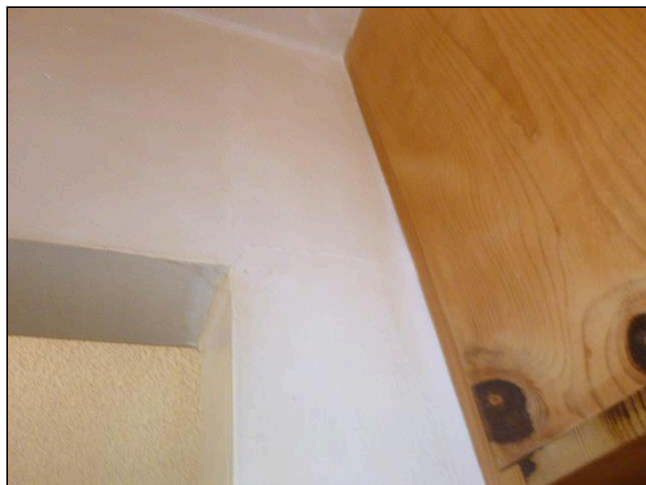
21.1 Item 1 (Picture)

(1) Settling cracks and patching was noted, suggest repair as needed.

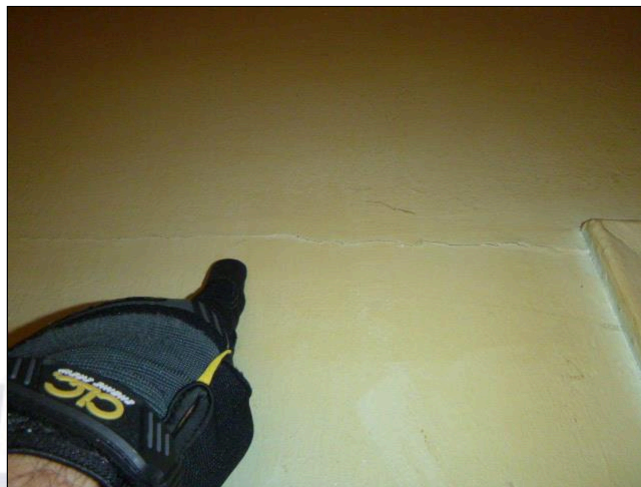
23.1 Item 2 (Picture)

(1) Excessive settling cracks noted, see the foundation and Lot/Drainage comments. Suggest review with a licensed contractor for repair/replacement costs as needed.

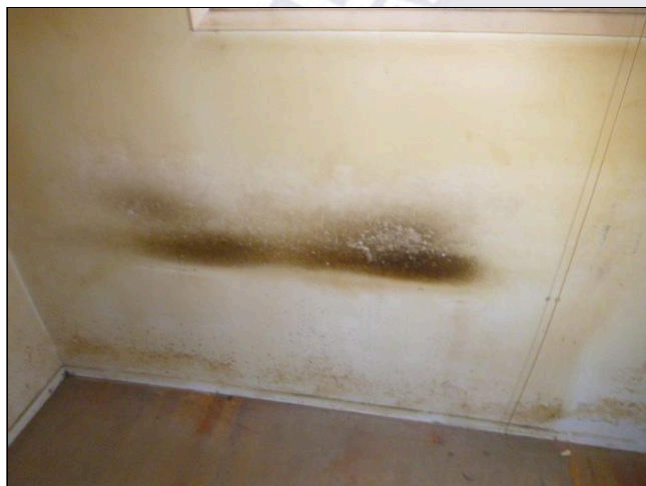
23.1 Item 3 (Picture)

(2) Excessive stains and smoke odor was noted due to potentially/likely excessive interior smoking, suggest review with the seller and a licensed contractor on this item as needed.

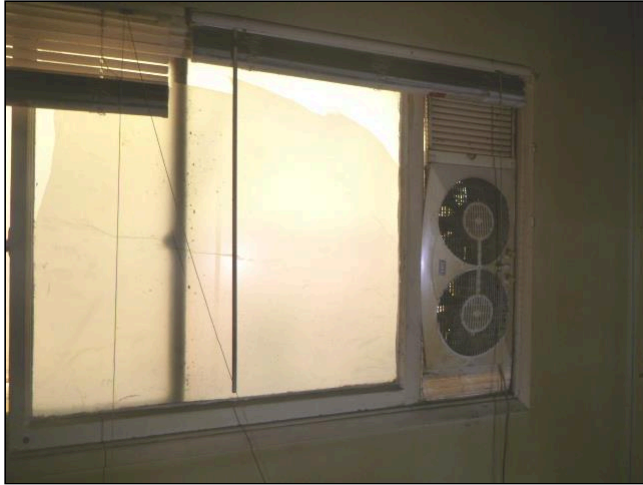
23.4 Item 1 (Picture)

(1) Unable to test the window due to the fan unit, suggest removal and make repairs as needed.

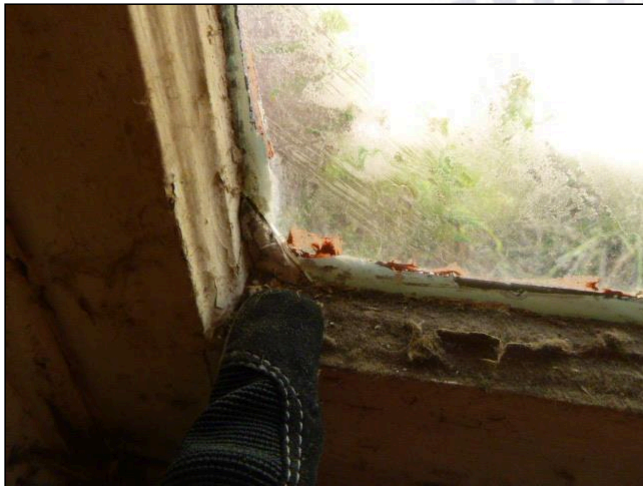
23.4 Item 2 (Picture)

(2) Cracked/broken glass noted at the window(s), this is a potential safety hazard. Suggest review with a licensed contractor/glazing company for replacement costs as required for safety.

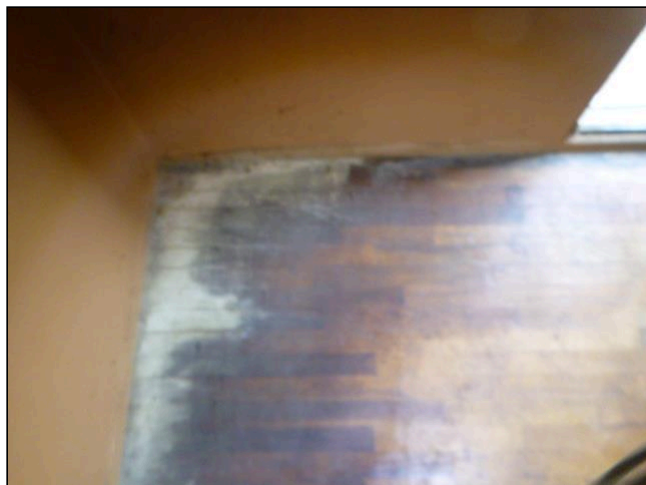
24.0 Item 1 (Picture)

(2) Worn and deteriorated areas of the flooring were noted, suggest repair/refinish as needed.

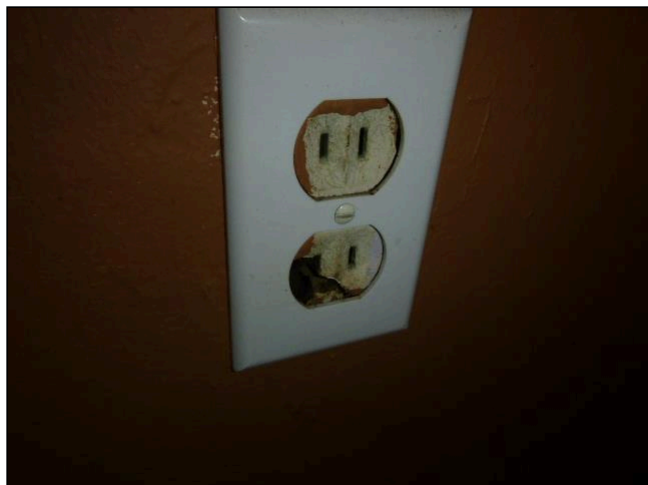
24.5 Item 1 (Picture)

(1) Two wire and two prong electrical receptacles noted. At the time of the original construction this type of system was the acceptable standard and appears to be intact. If three prong and GFCI receptacles are desired a ground source is required. Suggest review with a licensed electrician for costs to ground the outlets as needed as an upgrade and/or protected the outlet(s) on a GFCI circuit where recommended.

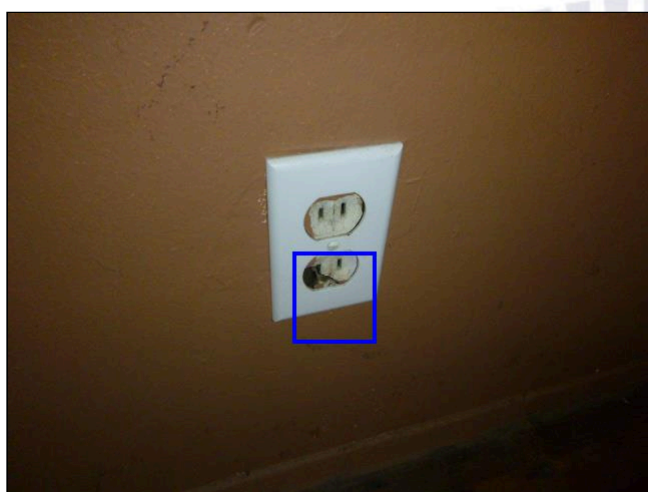
24.5 Item 2 (Picture)

(2) The outlets are deteriorated and loose. Suggest repair or replace as needed for safety.

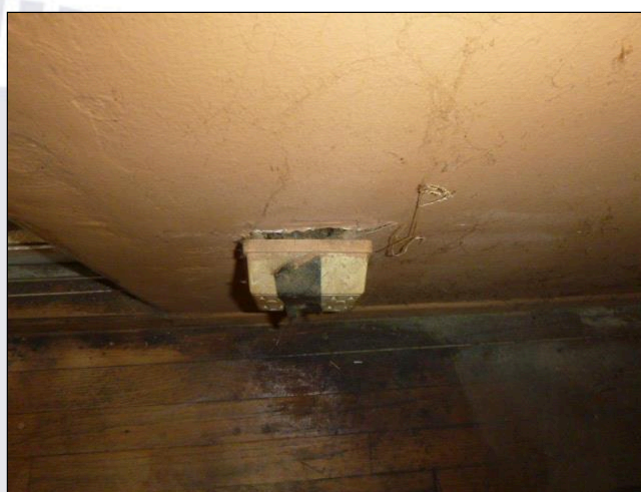
24.5 Item 3 (Picture)

(3) A minimum number of outlets were installed at this area at the time of the inspection, this is common for the original age of dwelling. Suggest review by a licensed electrician for installation costs for additional outlets if desired as an upgrade.

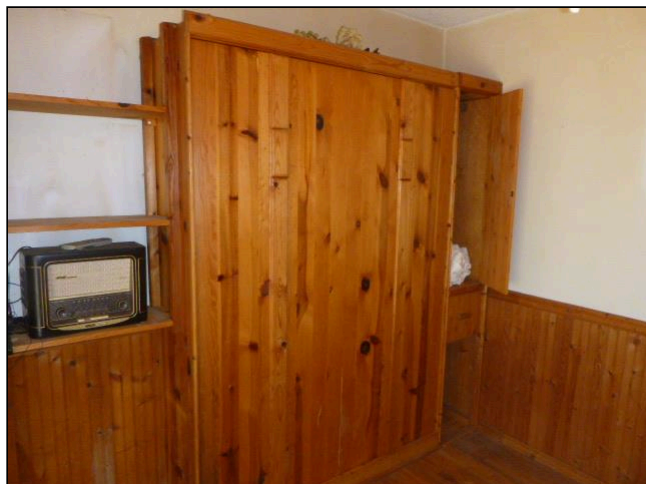
25.7 Item 1 (Picture)

The 'Murphy Bed' system is beyond the scope of the inspection and was not tested/inspected.
