Key Findings Report

Property Address: 221 Tall Oak
Irvine CA 92603

Date of inspection: 2/11/2022 **Inspector:** Reid Anderson

Home Inspection Report

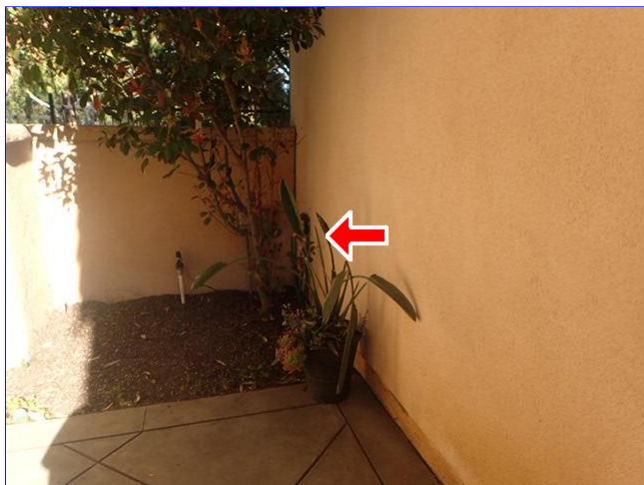
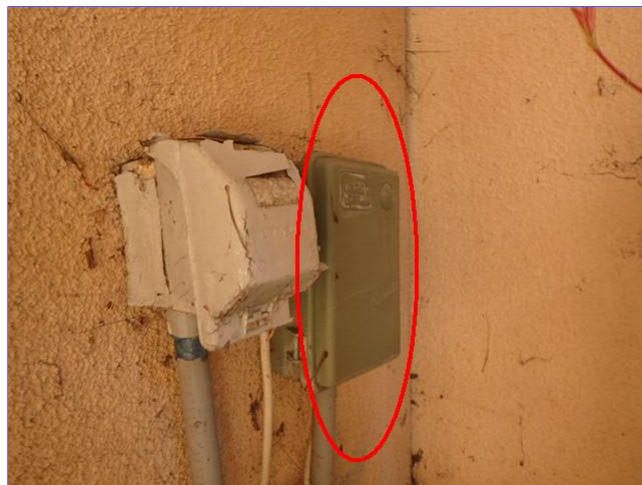
10. Testing of irrigation (yard sprinklers) systems is beyond the scope of this inspection.
- We suggest that you have the seller, or a qualified sprinkler specialist, demonstrate the irrigation system and any related timer controls.

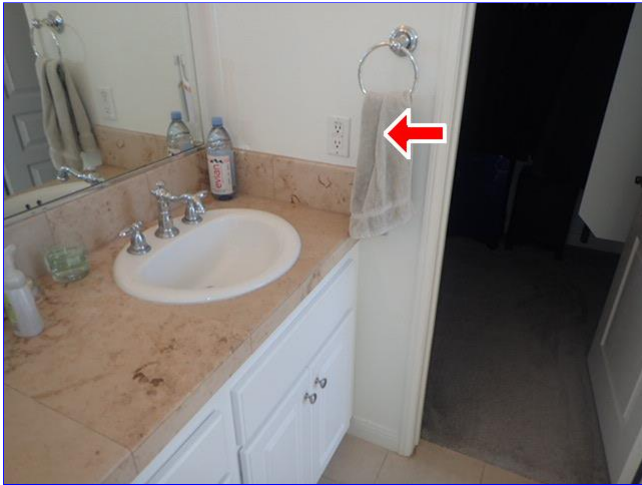
Item 16 - Item 1(Picture)

16. NOTE: When tested, the GFCI receptacle providing protection for the bathrooms tripped and shut off power, as designed. This GFCI device is located in the Master Bathroom.
 - To restore power to the bathrooms if the device trips off, reset the button on the GFCI.

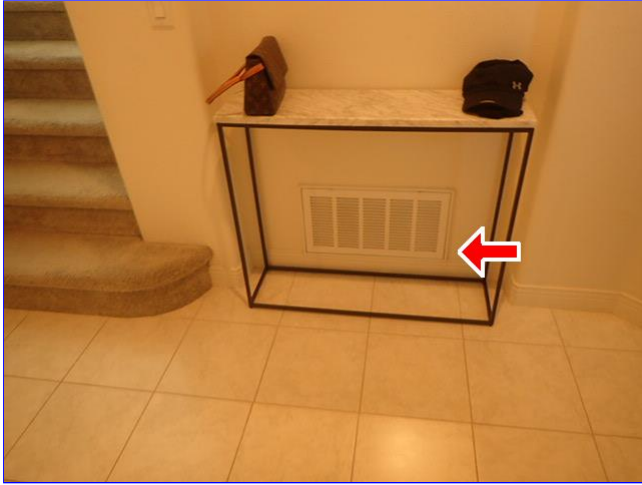
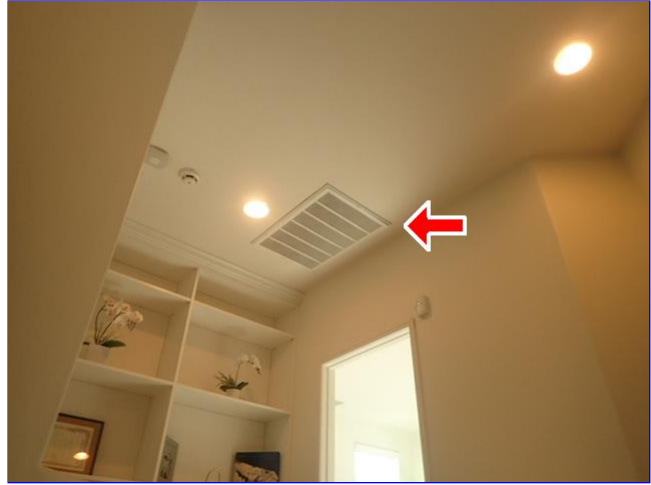
18. Filters should be changed (or cleaned if washable) regularly, depending on how often the blower is running. This is the most important maintenance item for the long-term operation of your HVAC system. Dirty filters will decrease system efficiency, and cause accelerated wear and tear on the system.

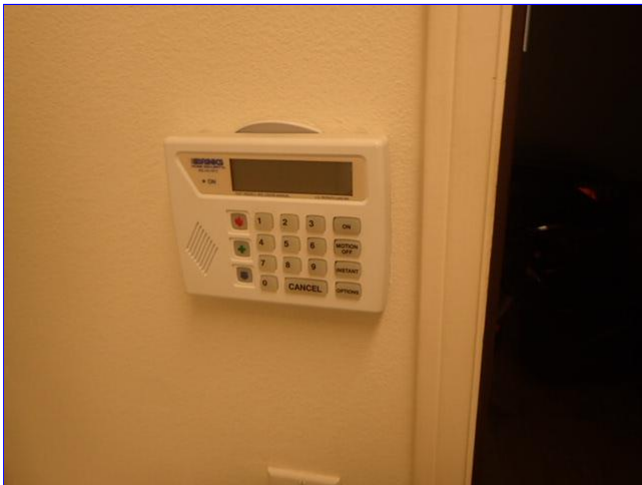
Item 21 - Item 1(Picture)

21. (1) A security system has been installed. Security systems are beyond the scope of this inspection.
- We suggest consultation with the owner and/or an alarm company regarding the operation and maintenance of this system.

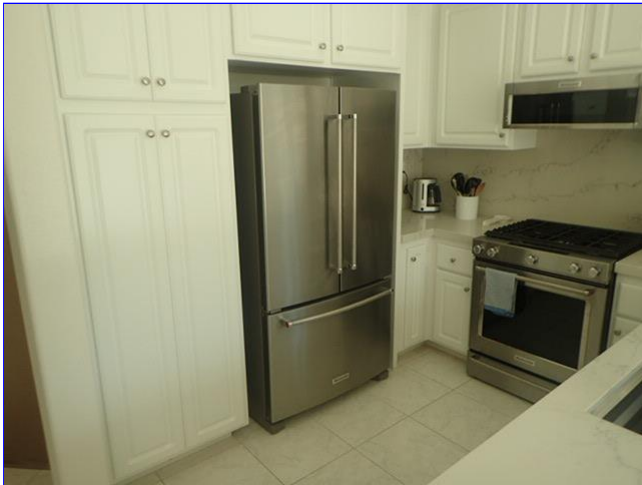
Item 24 - Item 1(Picture)

24. Tip: Inspection and evaluation of the refrigerator is beyond the scope of this inspection. Periodic cleaning of the refrigerator coils is recommended to keep the unit operating at peak efficiency. Referral to the owner's manual is recommended for information on access and cleaning of the coils.

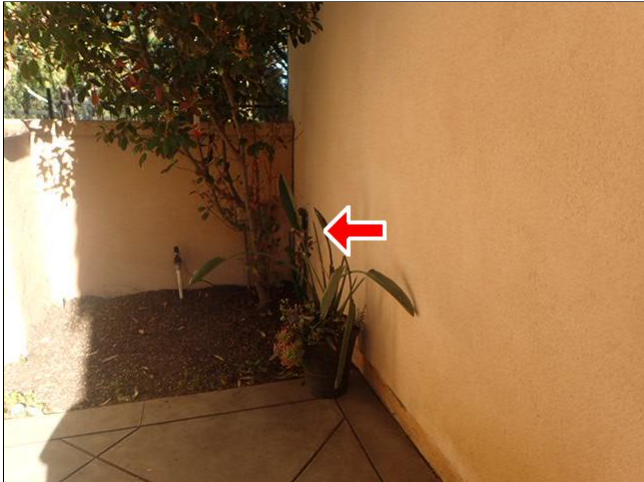
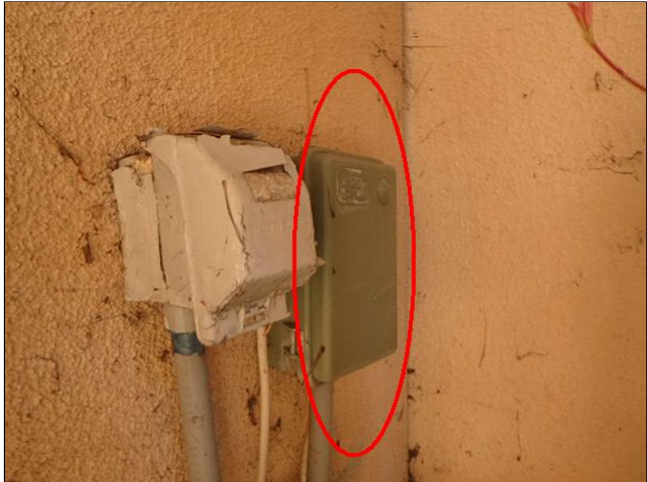
Testing of irrigation (yard sprinklers) systems is beyond the scope of this inspection.

- We suggest that you have the seller, or a qualified sprinkler specialist, demonstrate the irrigation system and any related timer controls.

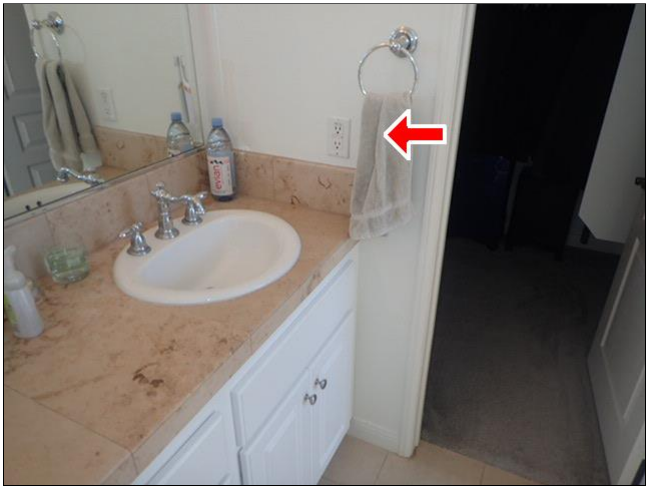
5.3 Item 1(Picture)

**NOTE:** When tested, the GFCI receptacle providing protection for the bathrooms tripped and shut off power, as designed. This GFCI device is located in the Master Bathroom.
- To restore power to the bathrooms if the device trips off, reset the button on the GFCI.

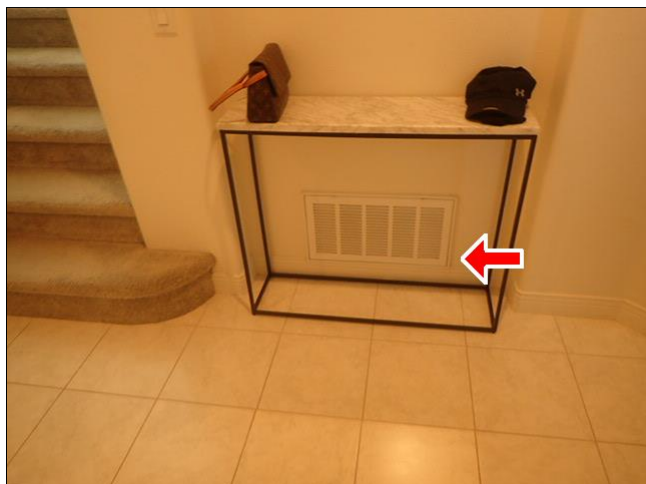
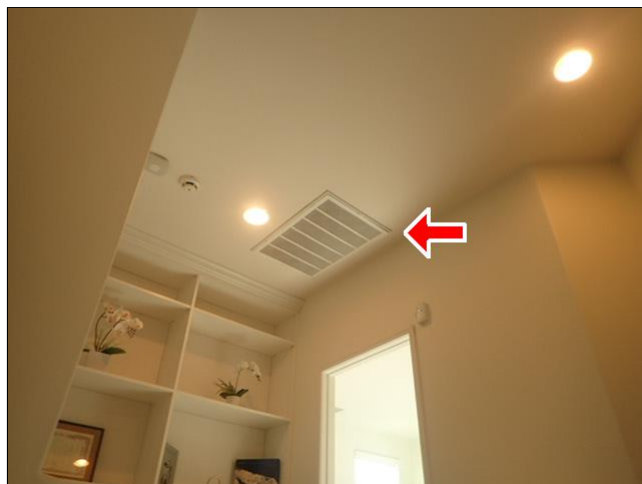
Filters should be changed (or cleaned if washable) regularly, depending on how often the blower is running. This is the most important maintenance item for the long-term operation of your HVAC system. Dirty filters will decrease system efficiency, and cause accelerated wear and tear on the system.

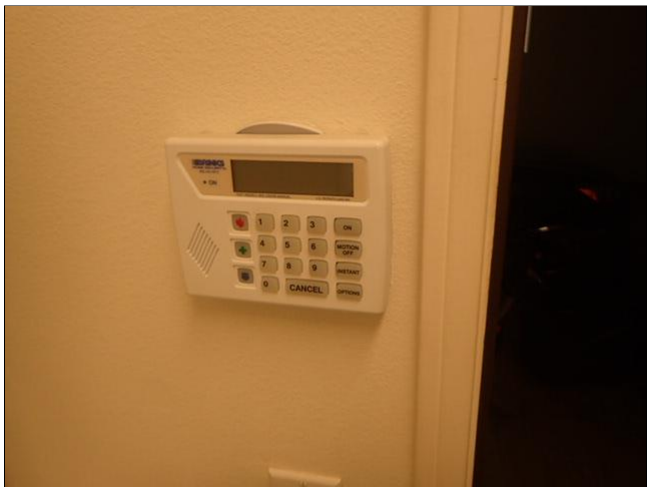
9.0 Item 1(Picture)

(1) A security system has been installed. Security systems are beyond the scope of this inspection.
- We suggest consultation with the owner and/or an alarm company regarding the operation and maintenance of this system.

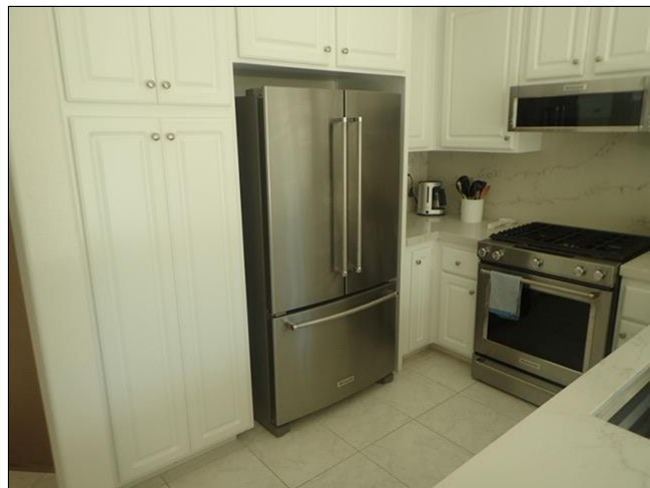
10.7 Item 1(Picture)

**Tip:** Inspection and evaluation of the refrigerator is beyond the scope of this inspection. Periodic cleaning of the refrigerator coils is recommended to keep the unit operating at peak efficiency. Referral to the owner's manual is recommended for information on access and cleaning of the coils.
