Superior Home Inspections

Inspection reference: 2885

Confidential Inspection Report

201 E Platt St

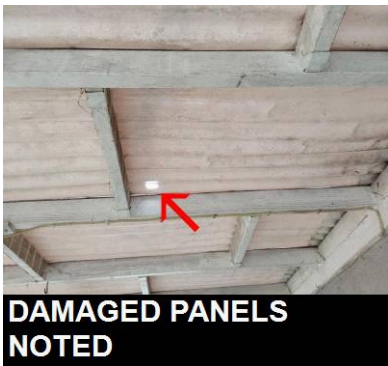
P2

Patio Cover Condition:

Attention Needed - The patio cover needs repair to function properly. Damaged patio cover panels noted. Please see additional pictures.

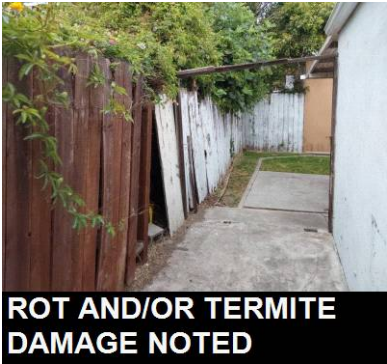
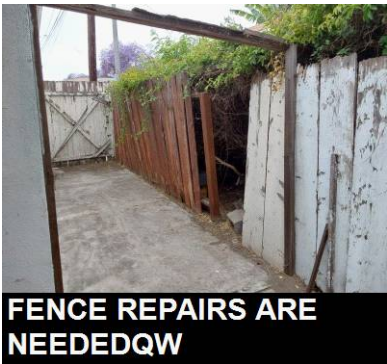
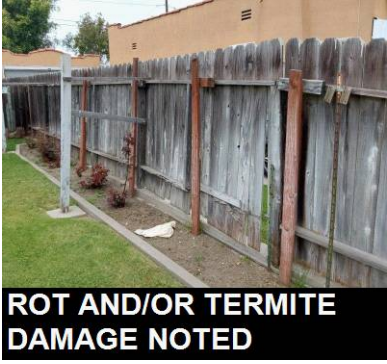
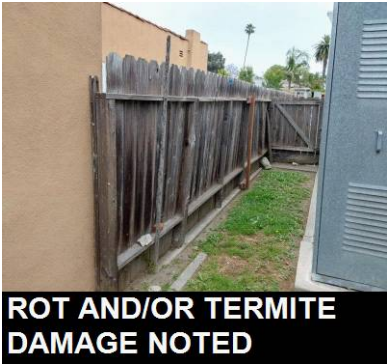
Fence Materials Condition:

Action Necessary - The fencing is not performing its intended function. Repair or replacement is suggested. The wood fence located on the East and North sides of the house is in a condition that warrants replacement. Please note that this is a common wall and typically the repairs expenses can be split between the two neighbors. See additional pictures.

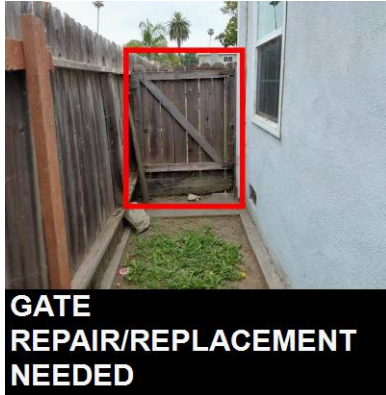
P10

Gates and Latches:

Action Necessary - The gate is not functional or is deteriorated to the degree that replacement is indicated.

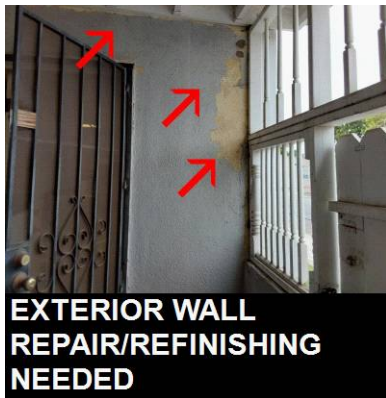
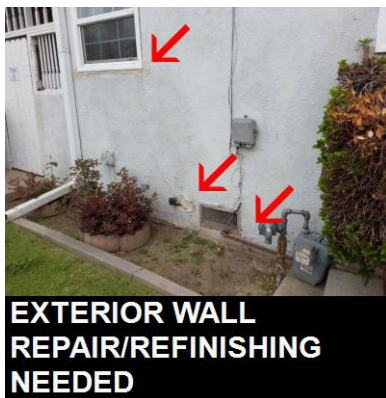
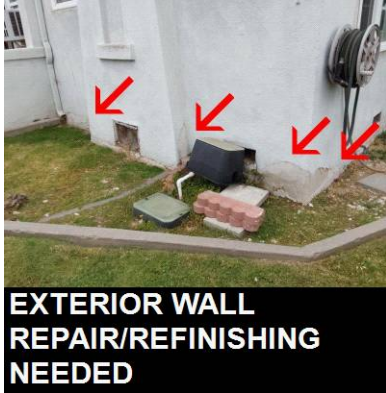
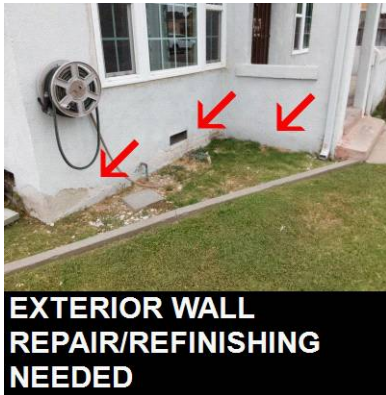
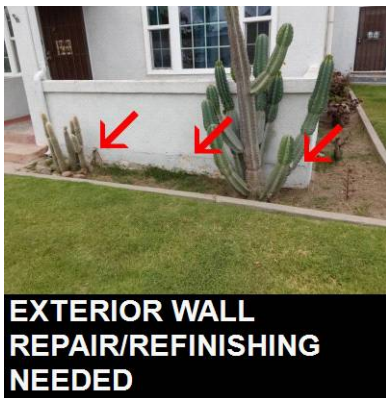
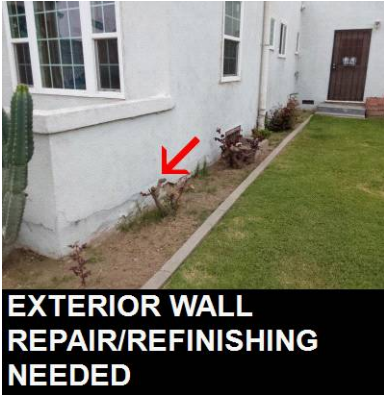
Siding Condition:

Action Necessary - Some portion of the exterior siding material or finish is in a deteriorated condition that requires repair or replacement.

Flaking off stucco noted on several areas of the house, we are suggesting to have the noted areas

repaired/refinished to prevent from further deterioration.
Please note: These are cosmetic repairs and not a safety concern.
See additional pictures.

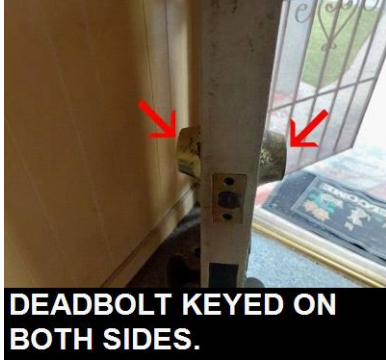
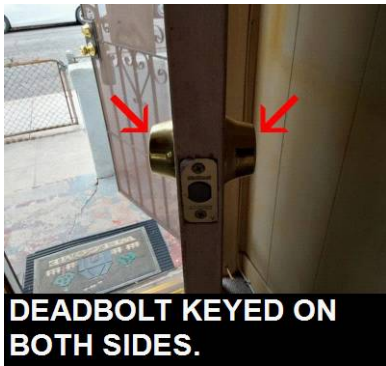
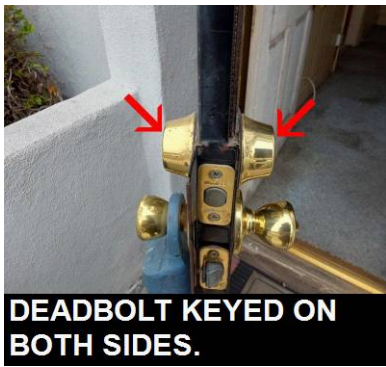
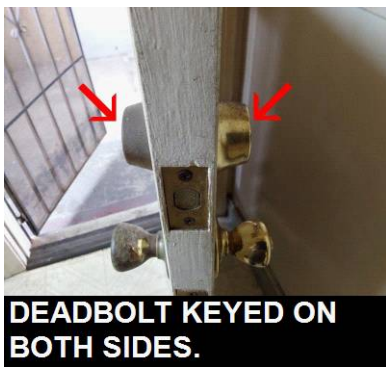
Action Necessary - The outside entry door is in need of repair or replacement.

The deadbolt is keyed on both sides. This is a potential safety hazard if you need to exit the house quickly and there is no key readily available.

This conditions were noted on all of the exterior doors
See additional pictures.

The door locking hardware needs to be repaired/replaced.

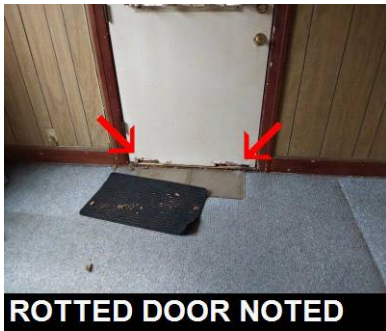
P27

Rotted door noted, this is the exterior door located on the bedroom located on the Northeast corner of the house.

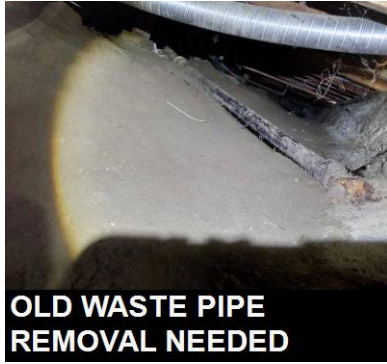
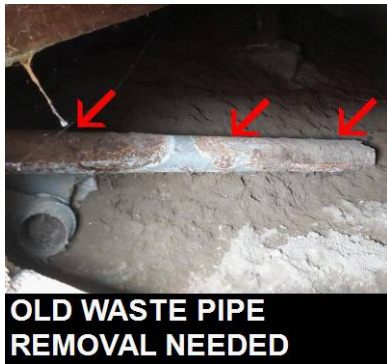
Please note: The inspector noted that the old cast iron sewer pipes were replaced with plastic pipes and the old pipes were left behind in the crawlspace, the inspector is strongly suggesting to have the old pipes removed and properly dispose off.

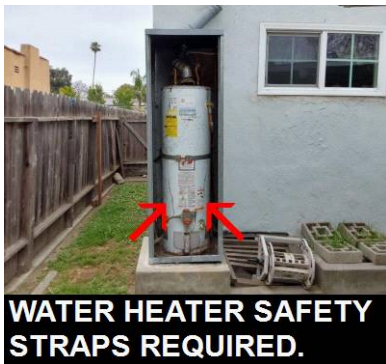
P36

The water heater needs to have the required safety straps installed, currently there is only one strap installed and two straps are required.

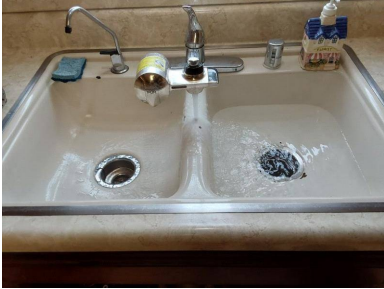
P38

Damaged sink finish noted.

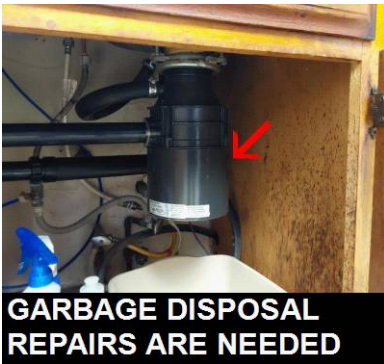
P40

The food waste disposal is stuck.

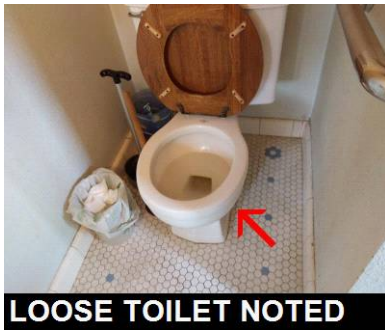
P45

Action Necessary - The toilet in this bathroom needs repair. The toilet is not secure to the floor, allowing it to wobble and possibly leak. Action should be taken to re-secure it to the floor.

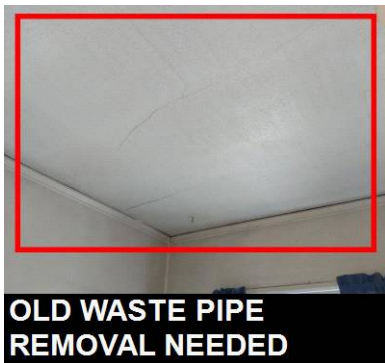
P49

Action Necessary - There is deterioration in the ceiling of this room that needs to be repaired.

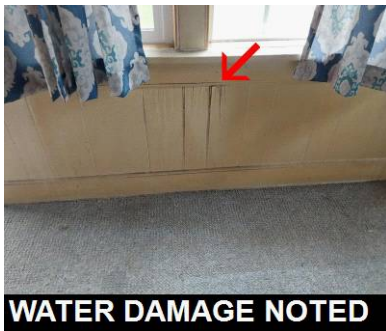
P58

Action Necessary - There is a condition in the wall sheeting that needs to be repaired.

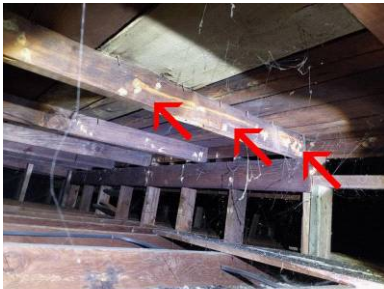
Action Necessary - A condition exists that calls for repairs. Termite damage noted on one of the roof rafters.

Termite damage noted on one of the roof rafters.

TERMITE DAMAGE NOTED

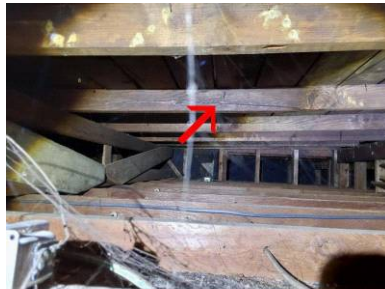
A cracked roof rafter was noted, we are suggesting to have the roof rafter repaired/reinforced to prevent from further damage.

CRACKED ROOF RAFTER NOTED

A cracked roof rafter was noted, we are suggesting to have the roof rafter repaired/reinforced to prevent from further damage.

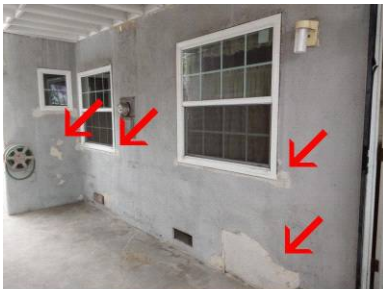
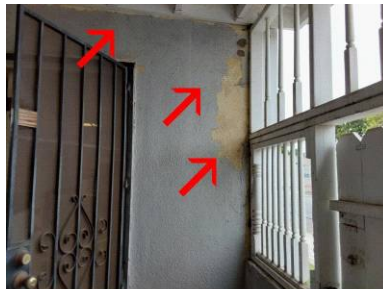
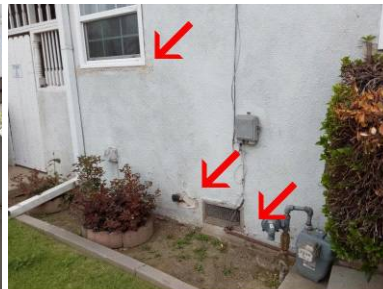
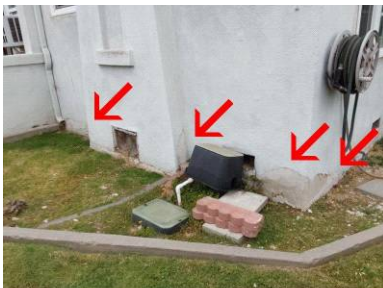
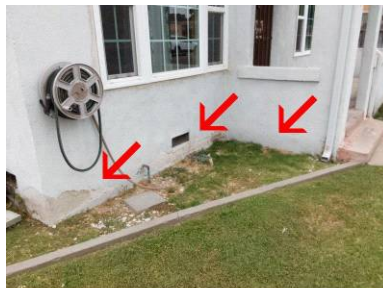
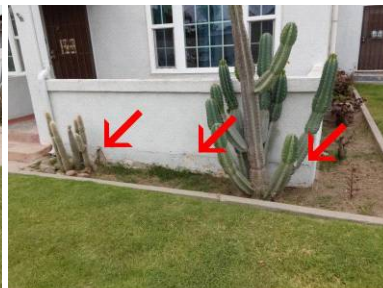
Please note: These are cosmetic repairs and not a safety concern.

EXTERIOR WALL REPAIR/REFINISHING NEEDED

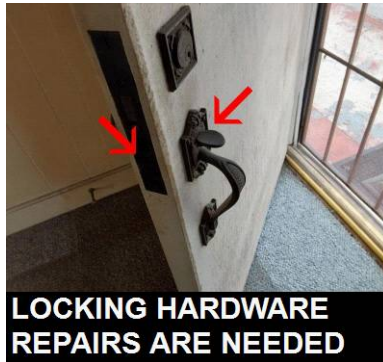
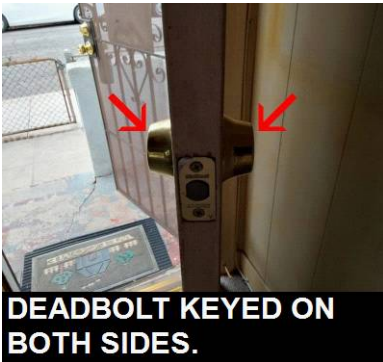
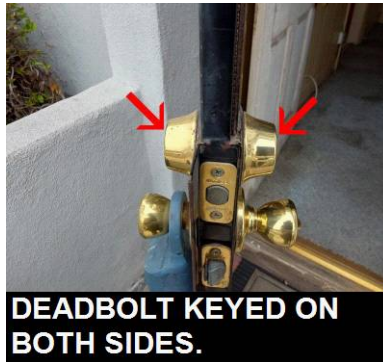
Action Necessary - The outside entry door is in need of repair or replacement.

The deadbolt is keyed on both sides. This is a potential safety hazard if you need to exit the house quickly and there is no key readily available.

This conditions were noted on all of the exterior doors
See additional pictures.

Rotted door noted, this is the exterior door located on the bedroom located on the Northeast corner of the house.

The door locking hardware needs to be repaired/replaced.

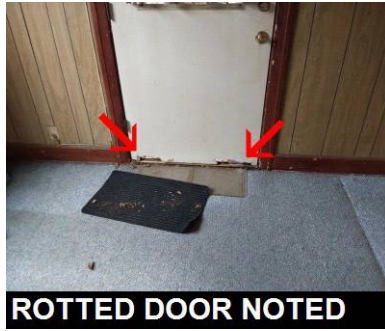
ROTTED DOOR NOTED

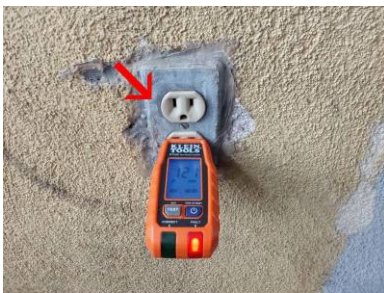
Reverse polarity is noted,
This is the electrical outlet located on the exterior wall of the garage.

REVERSED POLARITY NOTED

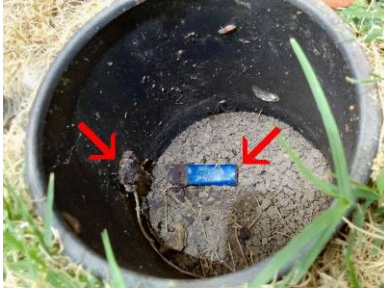
Please note: The water shutoff valve handle is broken and needs to be replaced.

CUTOFF VALVE REPLACEMENT NEEDED

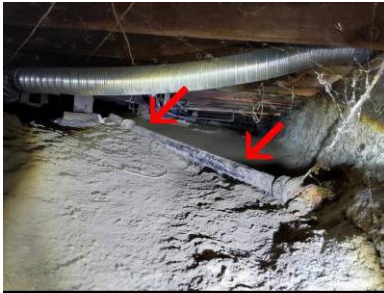
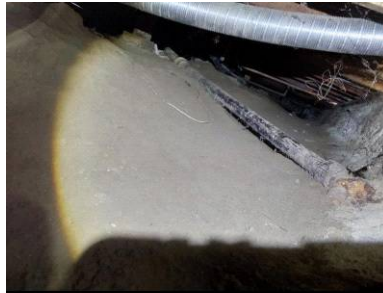
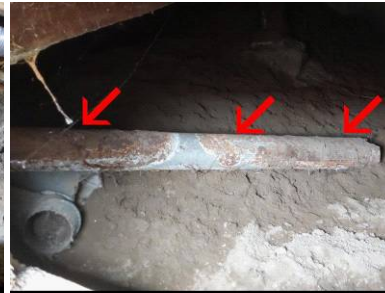
Please note: The inspector noted that the old cast iron sewer pipes were replaced with plastic pipes and the old pipes were left behind in the crawlspace, the inspector is strongly suggesting to have the old pipes removed and properly dispose off.

**OLD WASTE PIPE
REMOVAL NEEDED**

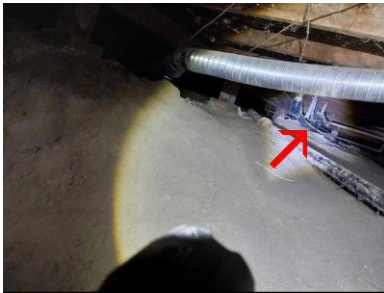
Attention Needed - Of the existing support straps and hangers, at least one loose or broken support exists and needs to be repaired or replaced.

The sewer pipes need to have additional hangers needed, the inspector noted sagging on the pipes and is strongly suggesting to have additional hangers installed.

**ADDITIONAL PIPE
HANGERS ARE NEEDED**

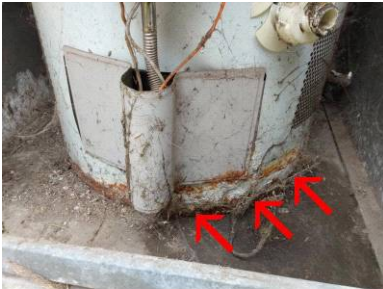
Action Necessary - There is evidence of deterioration due to rust or leakage. Replacement is recommended.

ROTTED WATER HEATER NOTED

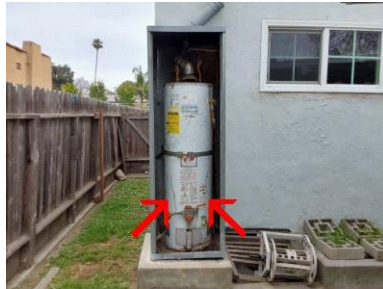
The water heater needs to have the required safety straps installed, currently there is only one strap installed and two straps are required.

WATER HEATER SAFETY STRAPS REQUIRED.

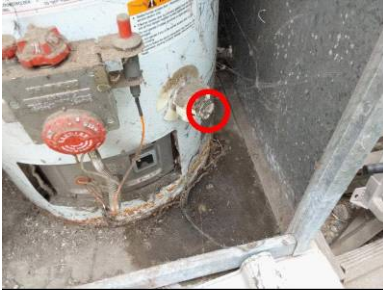
Yes - There is a drain valve installed on the lower side of the water heater. Please note: The drain valve is leaking.

LEAKING DRAIN VALVE NOTED

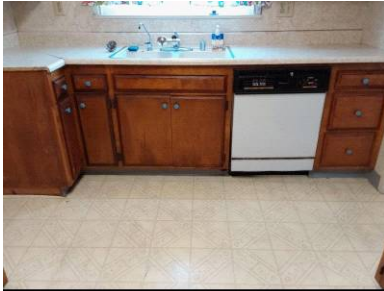
There are some areas of the cabinet finish that need attention.

**CABINET FINISH
REPAIR/REFINISHING
NEEDED**

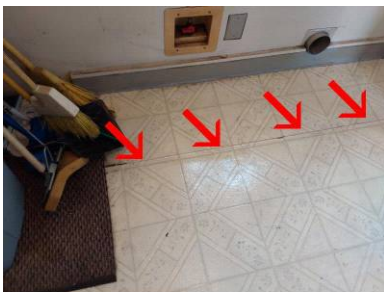
Action Necessary - The floor in the laundry room needs some repair or replacement. The floor covering material is vinyl.

**FLOOR COVERING
REPAIRS ARE NEEDED**

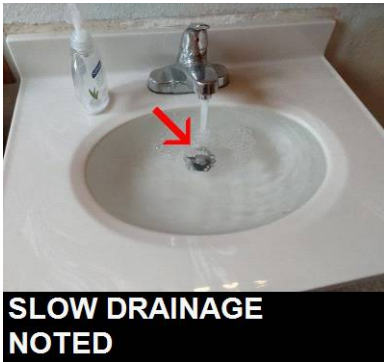
Attention Needed - The basin or drainage fixture needs attention. The lavatory drains slowly. There may be some blockage either in the fixture or the drain line.

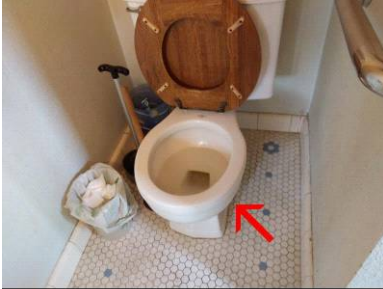
Action Necessary - The toilet in this bathroom needs repair. The toilet is not secure to the floor, allowing it to wobble and possibly leak. Action should be taken to re-secure it to the floor.

**LOOSE TOILET NOTED****Tub:**

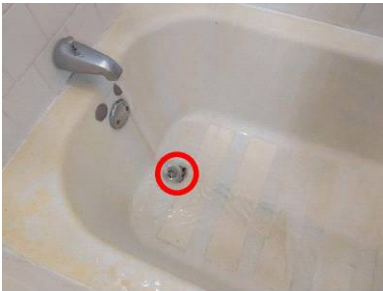
Action Necessary - The finish on the bathtub is damaged. It is not a leak now. However, when the finish on a steel tub is damaged, it will eventually rust causing a leak. Repair of the damaged area can delay further deterioration.

**DAMAGED TUB FINISH NOTED****Tub Mixing Valve & Stopper:**

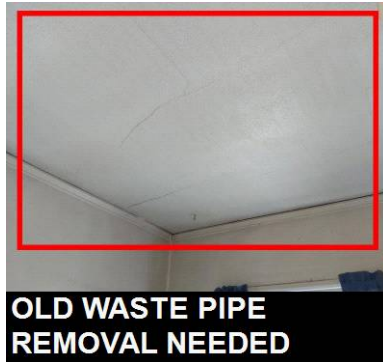
Action Necessary - There is deterioration in the ceiling of this room that needs to be repaired.

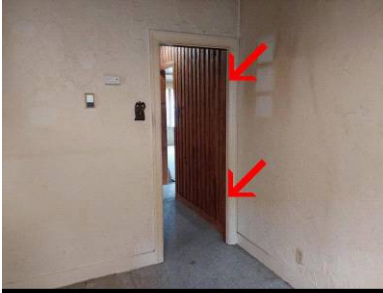
The door needs to be replaced.

**DOOR REPLACEMENT
NEEDED**

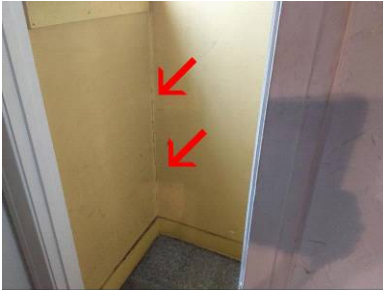
Attention Needed - The closet walls need minor repair/refinishing.

**COSMETIC REPAIRS
ARE NEEDED**

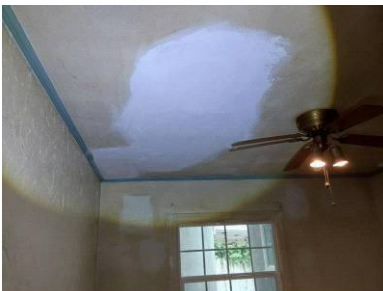
Evidence of previous repairs noted.

**EVIDENCE OF
PREVIOUS REPAIRS
NOTED**

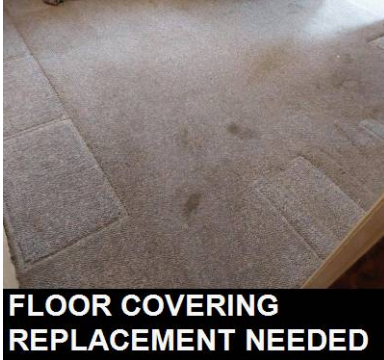
The floor covering is in a condition that warrants replacement.

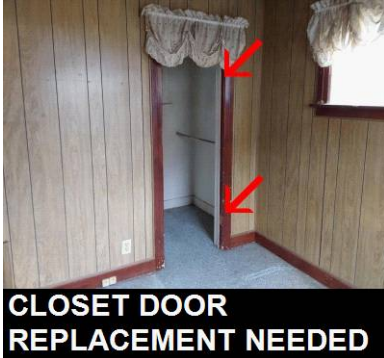
The closet door needs to be replaced.

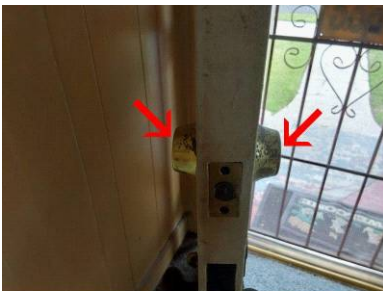
There is a deadbolt installed on the main entry door, and it is operational. This is a recommended safety feature. The deadbolt is keyed on both sides. This is a potential safety hazard if you need to exit the house quickly and there is no key readily available.

DEADBOLT KEYED ON BOTH SIDES.

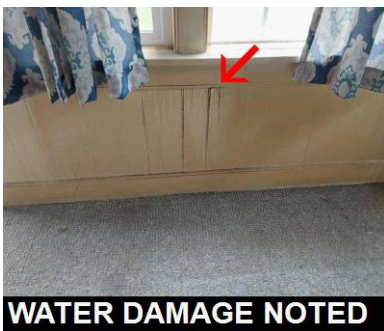
Action Necessary - There is a condition in the wall sheeting that needs to be repaired.

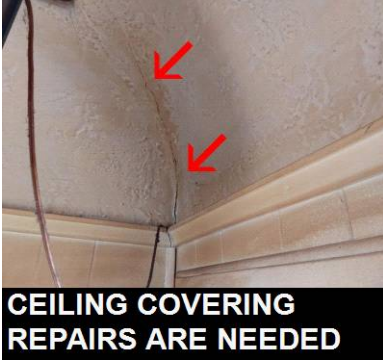
Action Necessary - There is deterioration in the ceiling of this room that needs to be repaired.

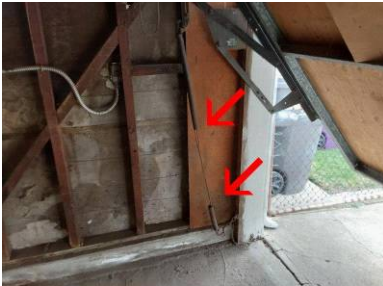
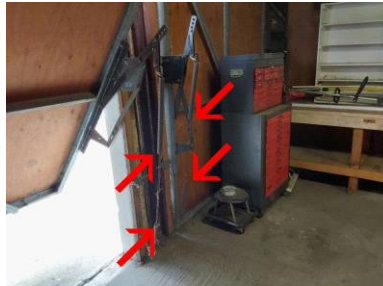
Action Necessary - The overhead door needs repair or replacement. The overhead door springs or hardware needs some repair or replacement parts.

BROKEN DOOR SPRINGS NOTED

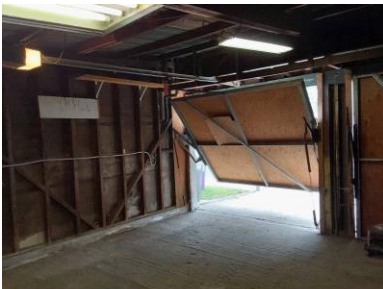
The garage door opener needs to be properly adjusted, currently the door opener does not fully open as it is supposed to.

GARAGE DOOR OPENER ADJUSTMENTS NEEDED

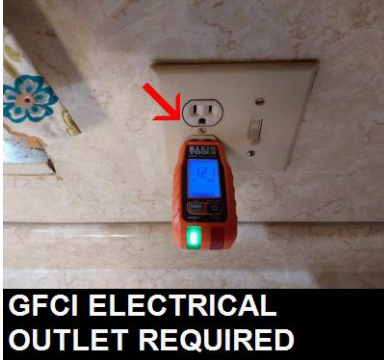
The outlets tested in the kitchen are correctly wired and grounded. As a whole, outlets throughout the room are in serviceable condition. This kitchen does not have Ground Fault Circuit Interrupt outlets installed within 6 feet of water sources. The age of the structure may pre-date the required installation; however, for safety considerations, it is strongly suggested that one be installed at any location within 6 feet of a water source.
