Inspection Report

Address: 246 16th St Paso Robles, CA 93446

3/20/23

Inspector: Keith Vreeken, MCI, FCI
P.O. Box 415 Templeton, CA 93465 O: 805.462.1978 C: 805.440.5050

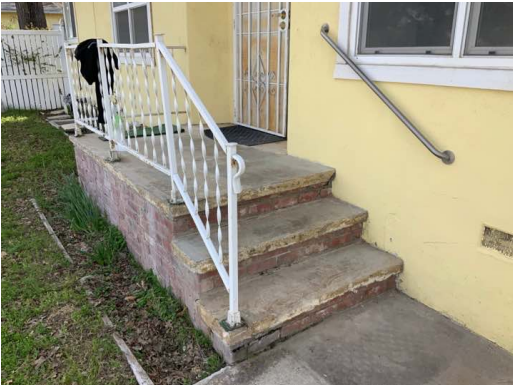
33: Type: Concrete exterior stairway: OFF THE FRONT ENTRY

SC 34: Loose and damaged stairway railings at the OFF THE FRONT ENTRY. Corrections needed for safety.

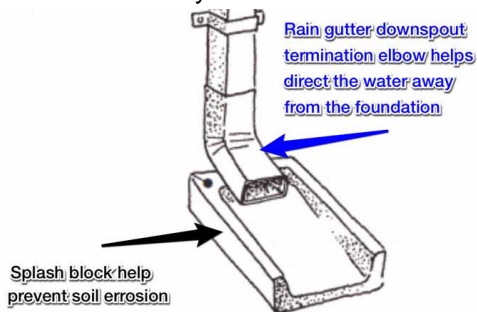
E&C MR 63: Some Loose and/or disconnected rain gutter downspouts.

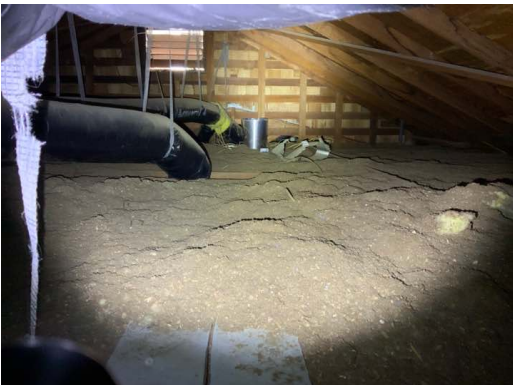
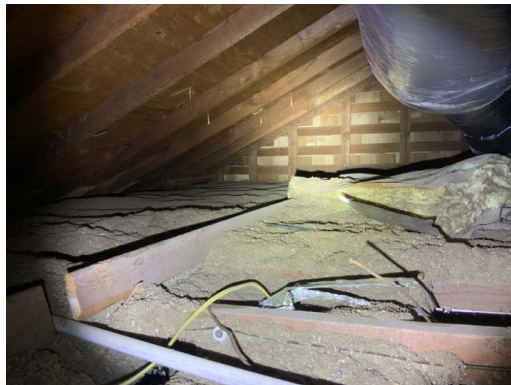
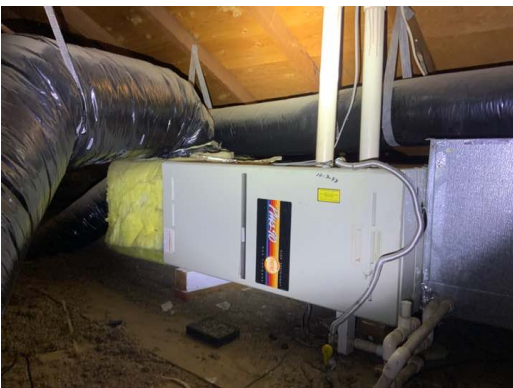
64: ATTIC ACCESS LOCATION: Bedroom Hallway

65: ATTIC CONDITION: No noted framing defects found in the accessible and visible areas of the attic.

66: ATTIC VENTING: Appears Adequate. *However, attic ventilation was not calculated but visually observed.*

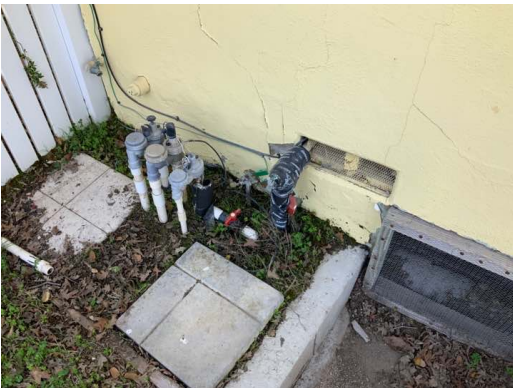
72: APPROX. WATER PRESSURE: 60-65 +/- PSI . *Optimal water pressure is between 40 and 80 PSI.*

E&C 73: Active water leak noted at the MAIN WATER SUPPLY pipe or valve.

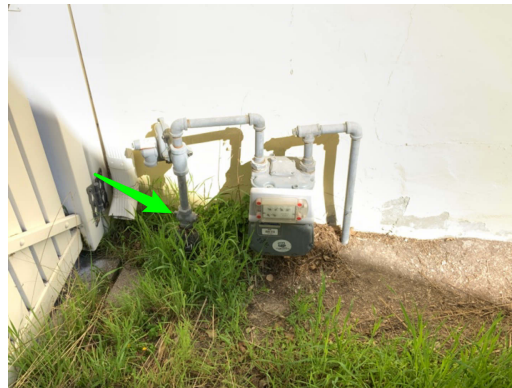
Main gas shut off valve

89: Gas shut-off appears serviceable.

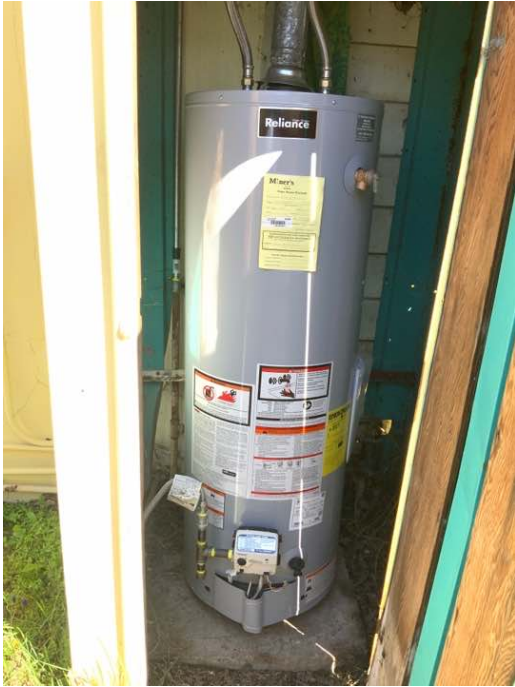
SC 91: The Water heater operated but found to be improperly installed or not installed well. Recommend further review and repairs by a licensed plumbing professional familiar with minimum installation requirements. See details in the report for specific comments as to the defective installation. Refer to the water heater, section for specific comments and defects.

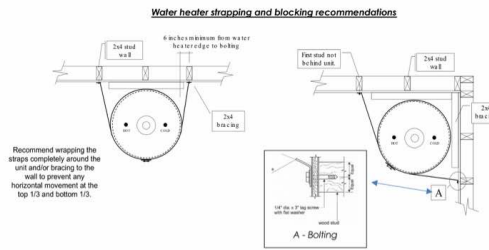
SC 94: Water heater TPR (temperature pressure relief) pipe is missing / not installed.

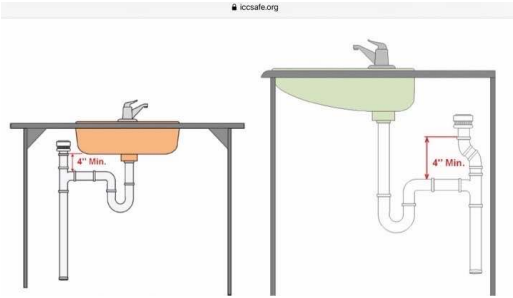
E&C 102: Improper drain piping, improper S-type trap system installed under Kitchen sink. Simple corrections are needed for safety.

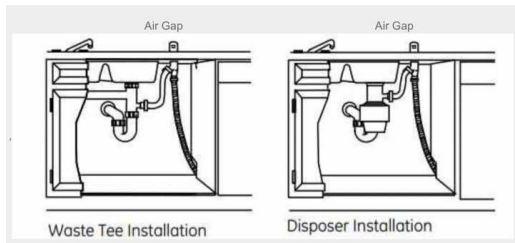
E&C 104: Improper installation of the dishwasher drain hose. Missing the Air Gap Device at the dishwasher drain per minimum codes and standards (California does not allow for high-loop methods or direct waste connections). {CPC 801.2}

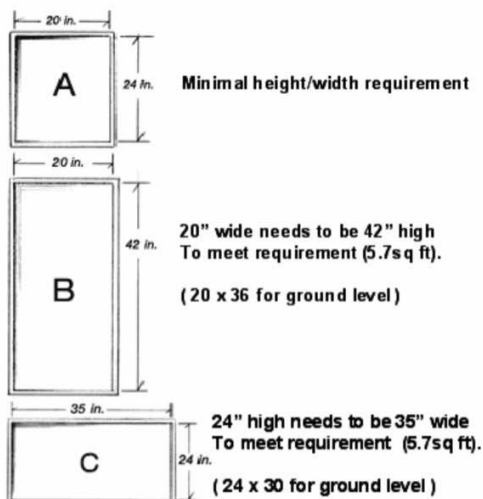
SU 141: The newer windows in the BEDROOMS do not meet the current fire egress standards. Windows are too small and/or too high off the floor.

Total window area needs to be 5.7 sq ft
(5.0 for ground level)

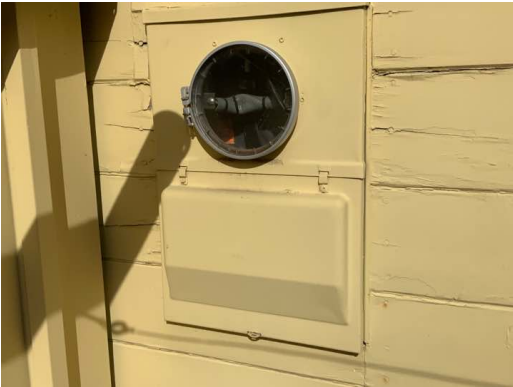
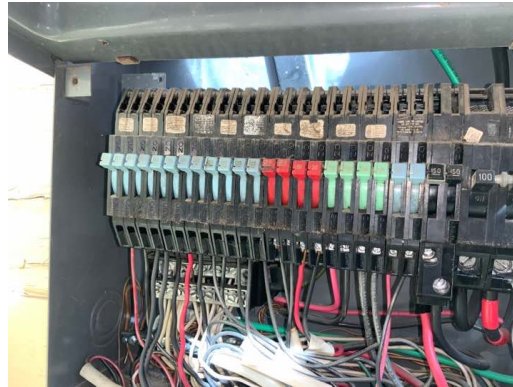
SC 181: Breaker panel not fully or properly labeled per standards: **MAIN HOUSE ELECTRICAL SUB PANEL**
