# HOME INSPECTION REPORT

8534 Bothwell Road, Northridge

679847

June 30, 2026

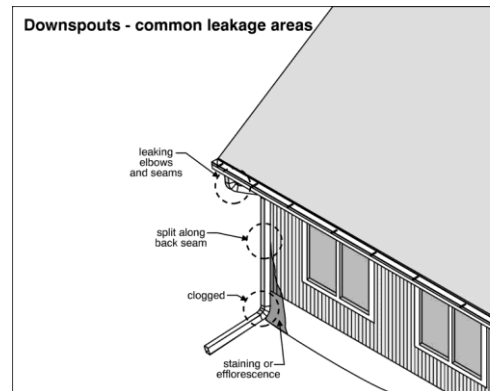
Illustration 2D

- ! 4. Leaks were noted in the downspouts and/or gutters at the rear. During wet weather conditions these areas are more obvious and during dry weather conditions they are noted from the stains at the areas where the leaks have occurred. We recommend all leaks be repaired.  
([See Illustration 2D](#)) ([See Photo 22](#))

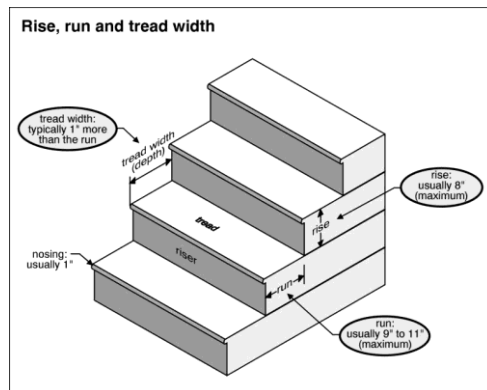
Illustration 3R

- ! 11. The steps at the rear appear to be non-conforming. This could create a potential fall hazard. We recommend the services of a licensed general contractor.  
(See Illustration 3R) (See Photo 21)

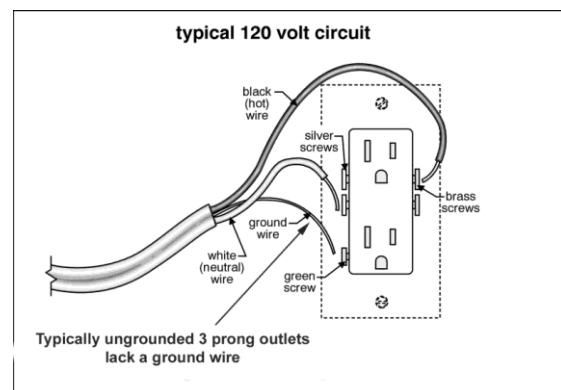
Illustration 4O

- ! 1. The loose light fixtures in the exterior front and hallway should be repaired or replaced.  
([See Photo 15](#)) ([See Photo 41](#))
- ! 2. Ungrounded "3-prong" outlets at the addition should be improved. A grounded cable or ground wire could be installed at these outlets, the outlet labeled as ungrounded or the original "2-prong" receptacle could be reinstalled. Based upon our inspection of a representative number of outlets, we recommend testing of every outlet. Repairs or rewiring are recommended at all deficient locations. For additional information we recommend a licensed electrician be consulted.  
([See Illustration 4O](#)) ([See Photo 44](#))

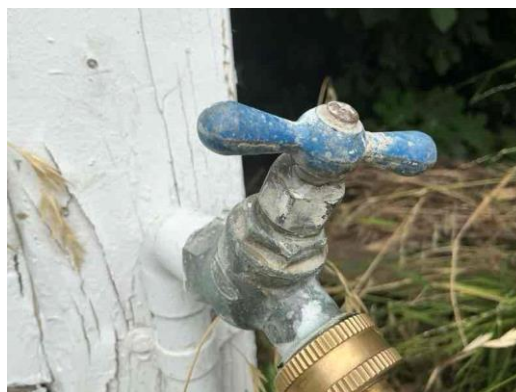
Photo 10

- ! 8. The exterior hose bib at the front and left side is leaking. We recommend all leaks be repaired.**  
[\(See Photo 10\)](#)
- ! 9. Evidence of water stains to the hot water heater stand was observed. We recommend the services of a licensed contractor and/or structural pest control operator.**  
[\(See Photo 28\)](#)

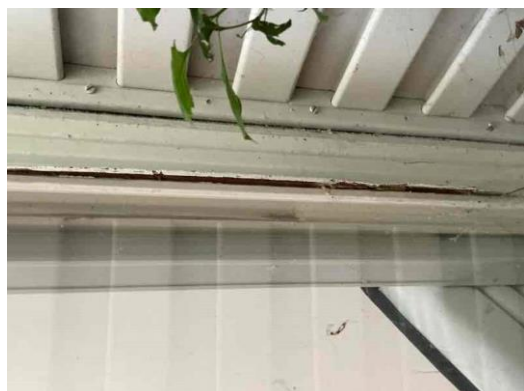
Photo 11

2. The drywall or wall finish in the garage is damaged, cracked or blemished in one or more areas. We recommend repair or refinishing
- ! 3. Damaged or non-functional exterior window hardware at the right side should be repaired as necessary.  
[\(See Photo 11\)](#)

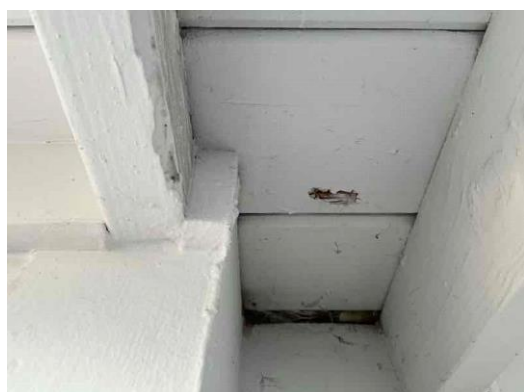
Photo 13

- ! 5. The wood fencing at the rear of the property is in need of repairs.  
[\(See Photo 19\)](#) [\(See Photo 20\)](#)
- ! 6. Water damage was observed to the roof eaves/sheathing at the front and rear. We recommend the services of a licensed general contractor and/or structural pest control company.  
[\(See Photo 13\)](#) [\(See Photo 23\)](#)

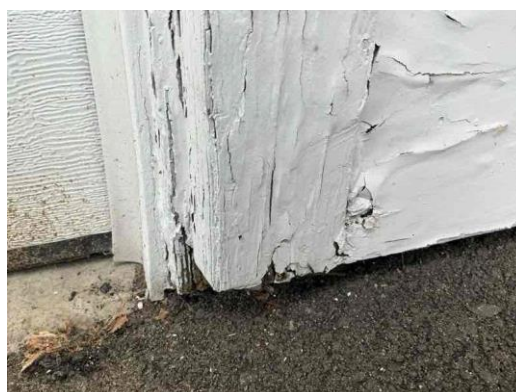
Photo 14

- ! 7. Water damage was observed to the exterior trim at the front. We recommend the services of a licensed general contractor and/or structural pest control company.  
[\(See Photo 14\)](#)

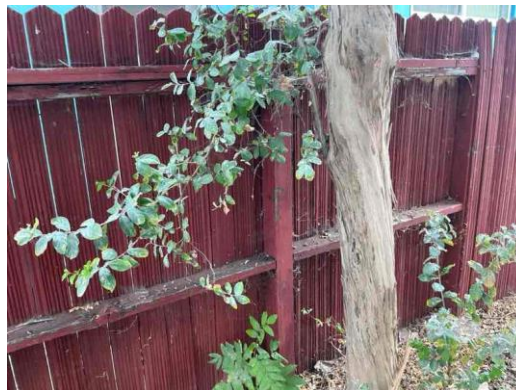
Photo 16

- ! 9. Various fence posts are loose. We recommend all loose, damaged or deteriorated posts be reinforced or replaced as necessary.  
[\(See Photo 16\)](#)

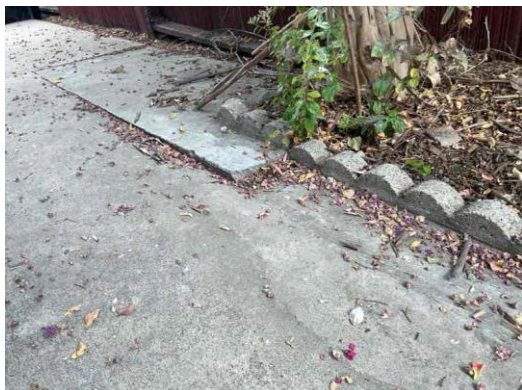
Photo 17

- ! 4. The cracked, heaved, or uneven walkway sections at the exterior pose a potential trip hazard. We recommend corrective action to improve safety and reduce the risk of injury. A qualified contractor should assess the affected areas and perform necessary repairs to ensure a level walking surface.  
[\(See Photo 17\)](#) [\(See Photo 24\)](#)

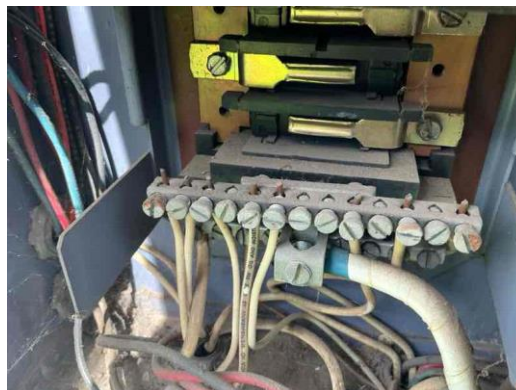
Photo 18

- ! 7. Evidence of periodic moisture entry/rust were noted in the interior of the main electrical panel. We recommend further evaluation and improvement of the panel by a licensed electrical contractor.  
([See Photo 18](#))

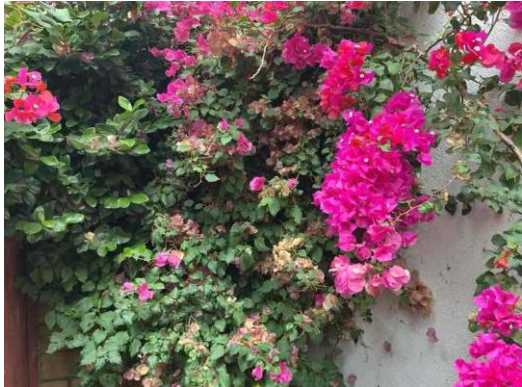
Photo 25

Heavy foliage/vegetation was noted at the right side of the structure or property, making this area inaccessible. Reportable conditions may be hidden from inspection. We recommend this area be cleared to allow for further inspection.  
[\(See Photo 25\)](#)

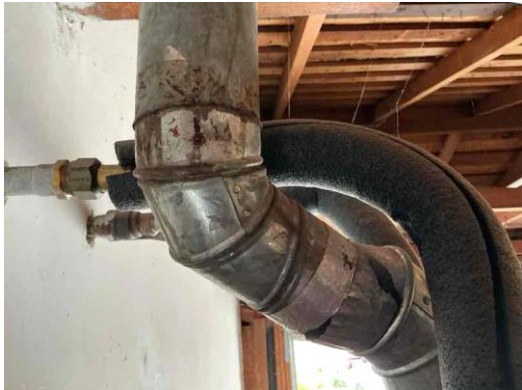
Photo 26

- ! 7. For enhanced safety, it is recommended that the loose or damaged connections of the water heater venting system be improved. A minimum of 3 screws at each section of the duct is recommended.**  
[\(See Illustration 8M\)](#) [\(See Photo 26\)](#)

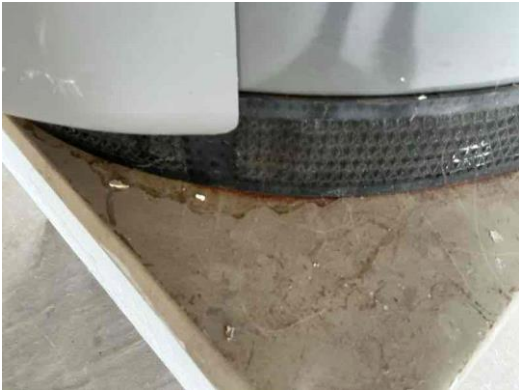
Photo 27

- ! 10. The water heater vent was noted to be corroded and leaking. This is a potential hazardous condition and we recommend repair.**  
[\(See Photo 27\)](#)

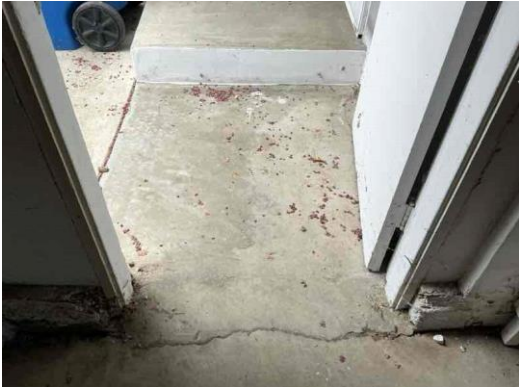
Photo 33

- ! 3. The window frame at the rear right bedroom is water damaged. We recommend it be repaired or replaced.  
(See Photo 39)
- ! 4. The wall at the garage and primary bathroom shows evidence of water stains. It is recommended that the source of the moisture be identified and corrected and the surface be repaired and refinished to restore its appearance.  
(See Photo 33) (See Photo 46)

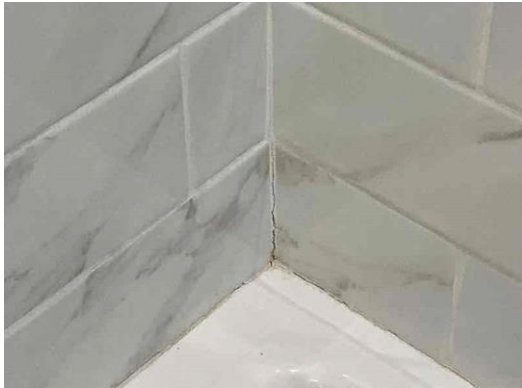
Photo 36

- ! 33. The tub walls at the hall bathroom are cracked or damaged and should be replaced. Water leaking through non-sealed areas can cause damage. Damage caused by water seepage cannot be determined by this visual observation.  
[\(See Photo 36\)](#)

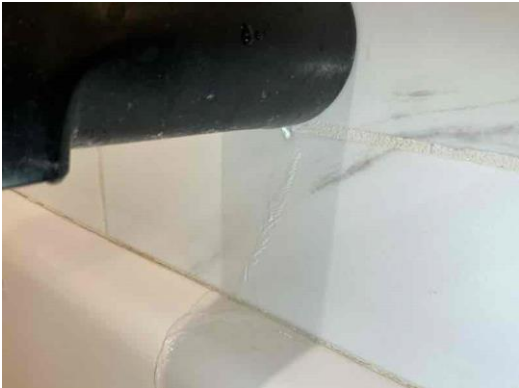
Photo 37

- ! 34. Cracked, deteriorated and/or missing grout and caulk should be replaced. Water leaking through non-sealed areas can cause damage. Damage caused by water seepage cannot be determined by this visual observation. A flexible caulking material is recommended rather than rigid cementitious grout.  
[\(See Photo 37\)](#)

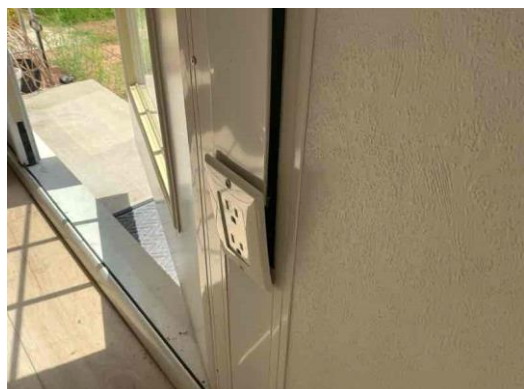
Photo 42

- ! 5. The conduit installed at the addition is damaged. We recommend that this conduit be repaired or replaced.  
([See Photo 42](#))
- ! 6. Tree limbs should be cut back from the electrical service entrance wires. This work should be done by or coordinated with the utility provider.  
([See Photo 4](#))

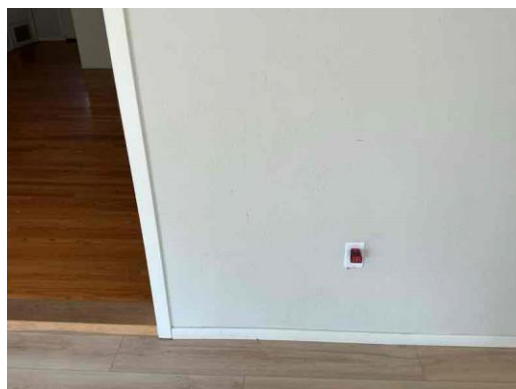
Photo 43

- ! 9. The outlet at the addition was noted to be loose and pulling out of the receptacle box. We recommend it be repaired.  
([See Photo 43](#))
10. Several of the interior outlets and/or switches are loose in their boxes. We recommend a general tightening and "tune-up" of all of the loose receptacles.
