# Confidential Inspection Report

522 Ave. F  
Redondo Beach CA 90277

July 24, 2025

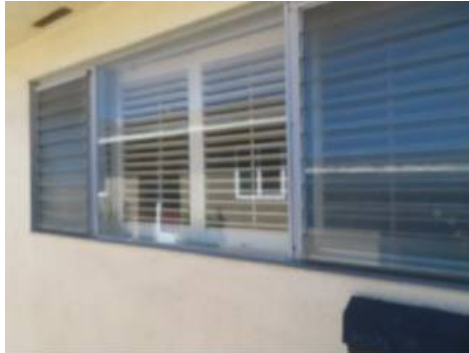
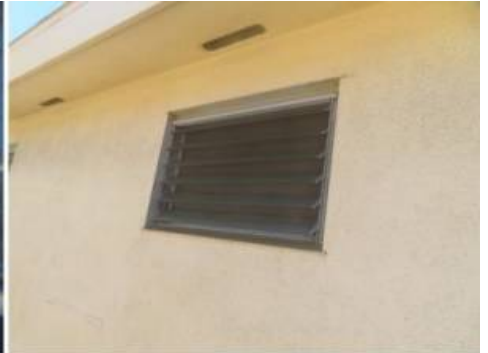
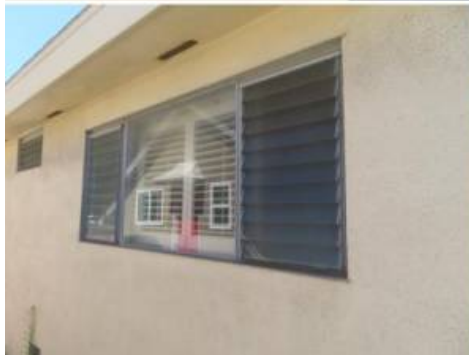
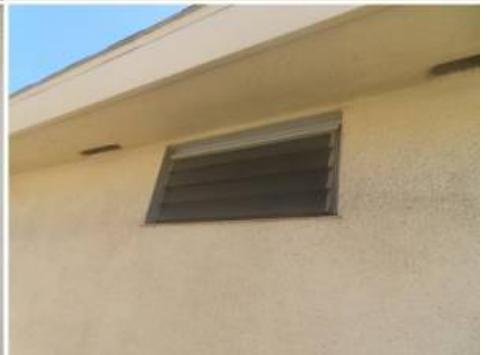
MAINTENANCE: Screen was damaged at one or more windows sampled.

MAINTENANCE: Metal frame is corroded at one or more windows sampled. We recommend further evaluation by a licensed window installer.

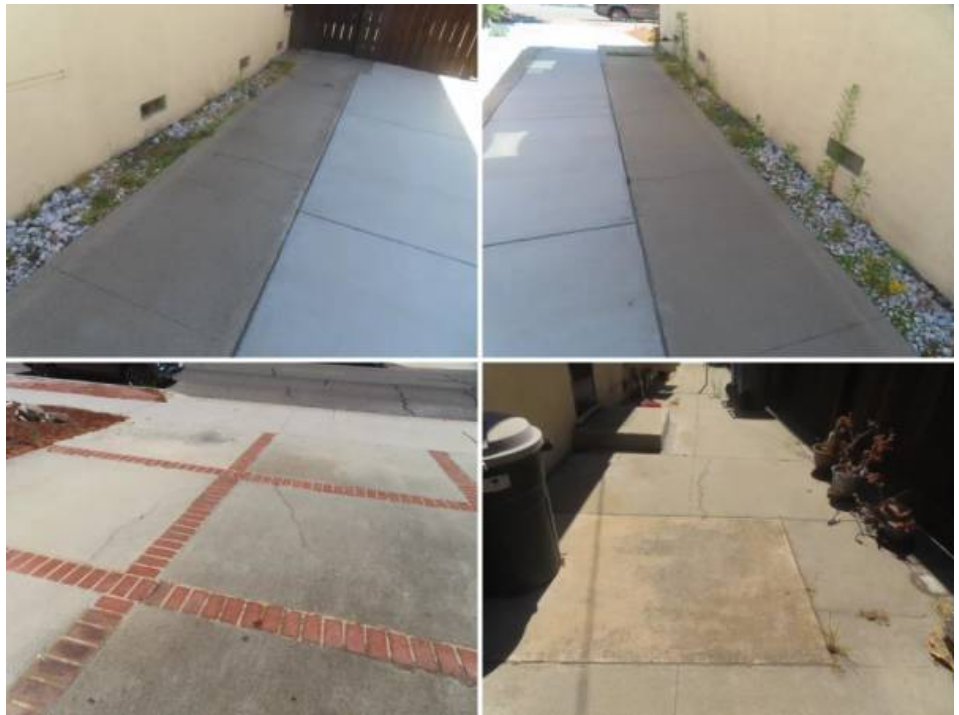
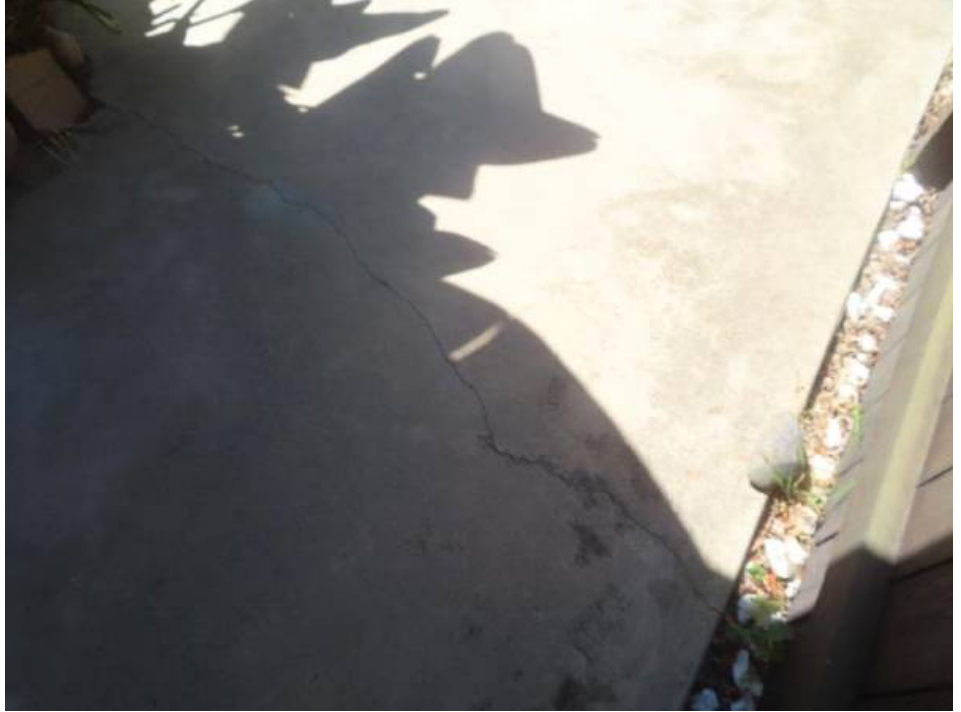
522 entry.

MONITOR: Small cracks viewed in the paving appear to be typical of settlement or shrinkage. We recommend monitoring cracks from time to time. Change in the size or number of cracks may be symptomatic of other conditions such as defective drainage, settlement or soil movement and should be further evaluated by a licensed concrete contractor.

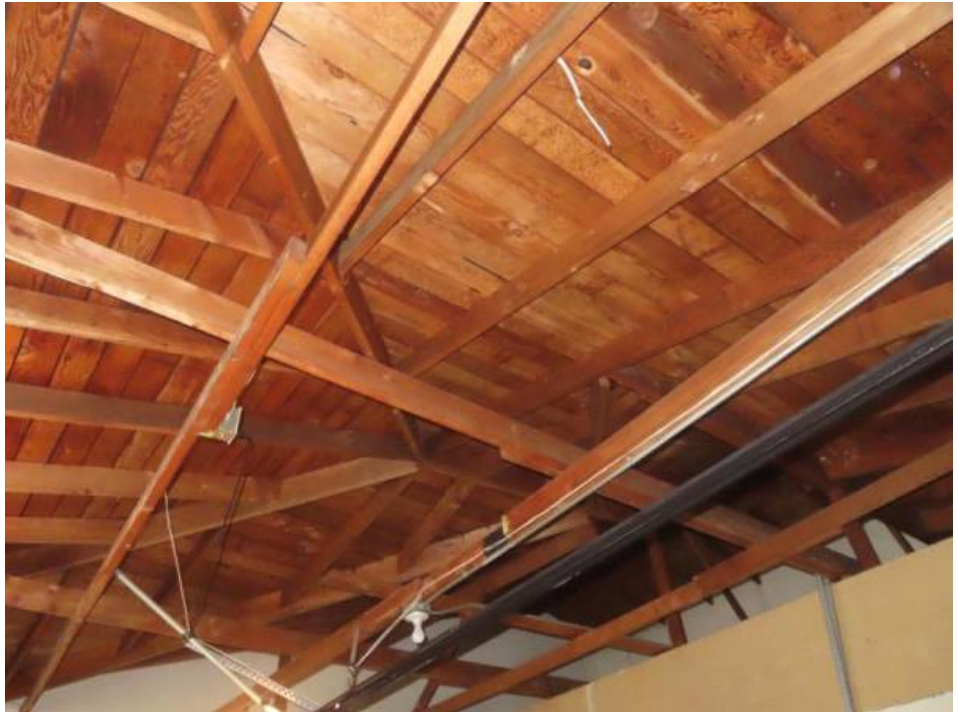
*Interior surfaces*

DEFERRED: Moisture stains noted at the ceiling/walls were dry at the time of our inspection. We could not determine if the stains are from an intermittent or repaired leak.

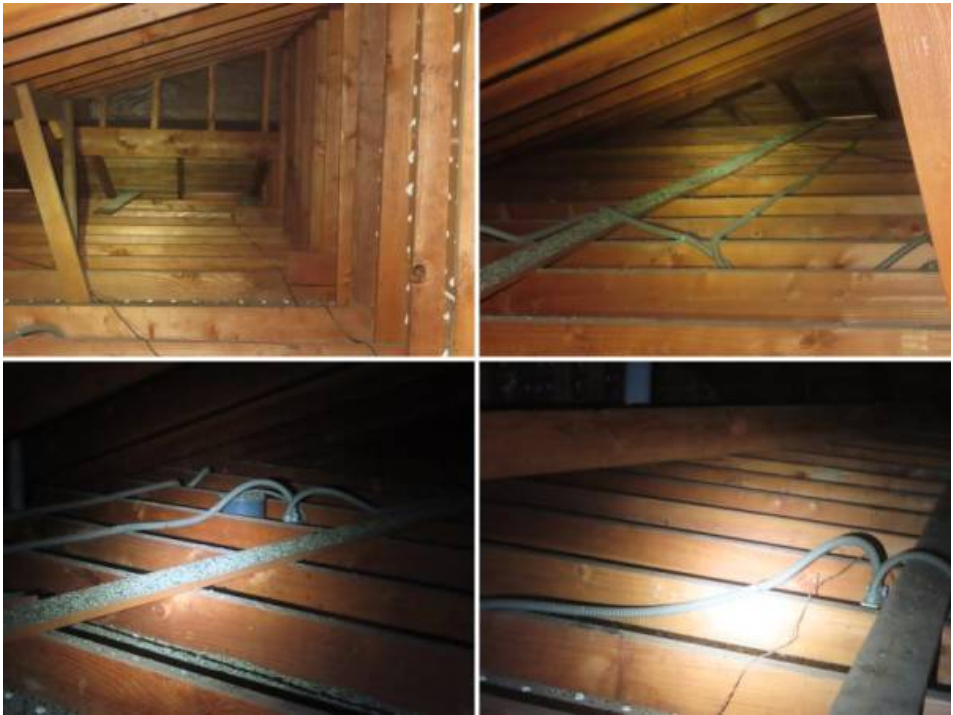
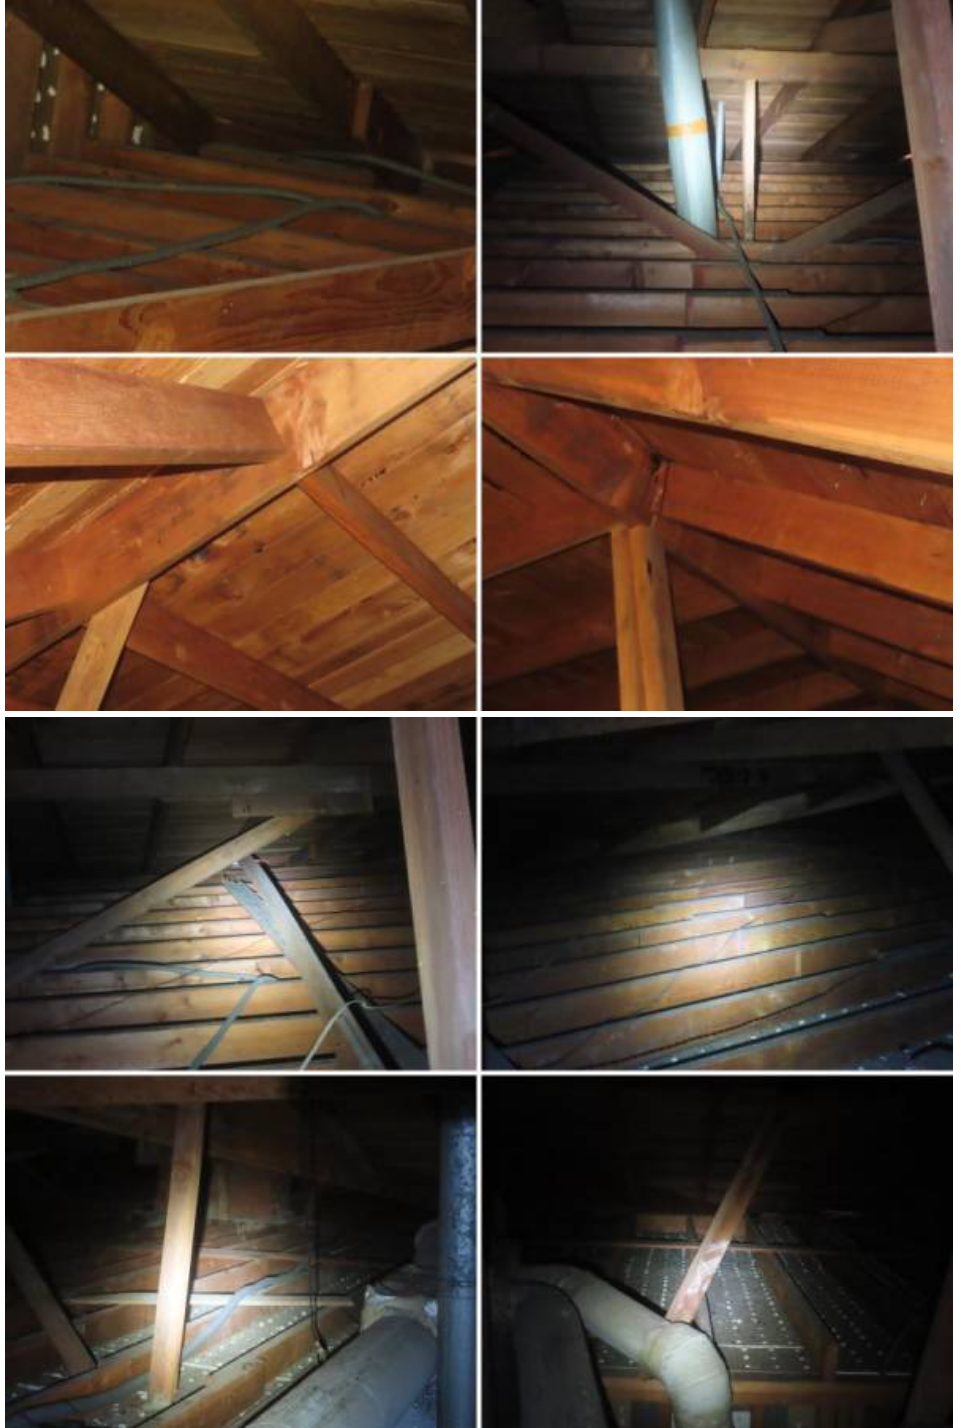
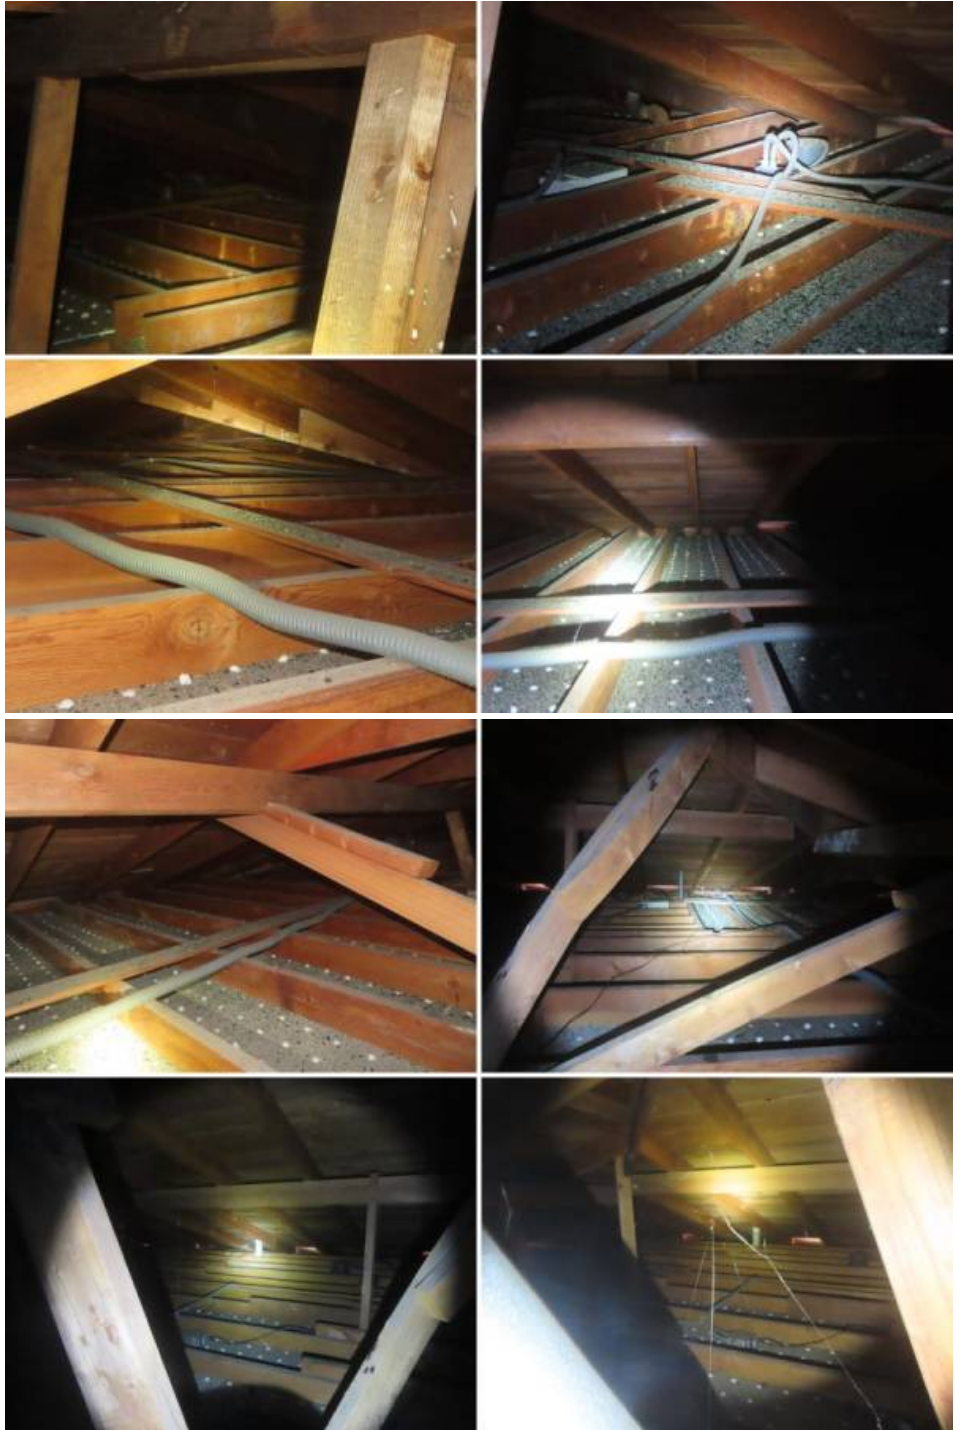
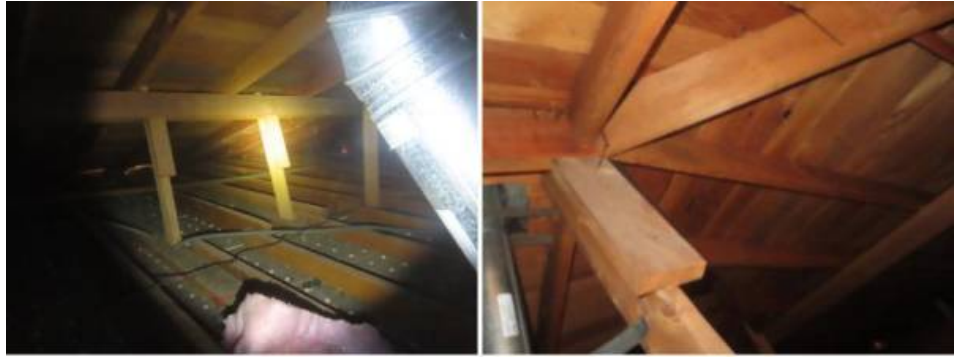
| Framing | SERVICEABLE.<br>Conventional framing.<br>1x6 sheathing.<br>DEFERRED: Water stains viewed. We can't tell the age of stains from appearance, or if they are from a previous leak or a current leak. Also see roof covering notes below for additional information. |

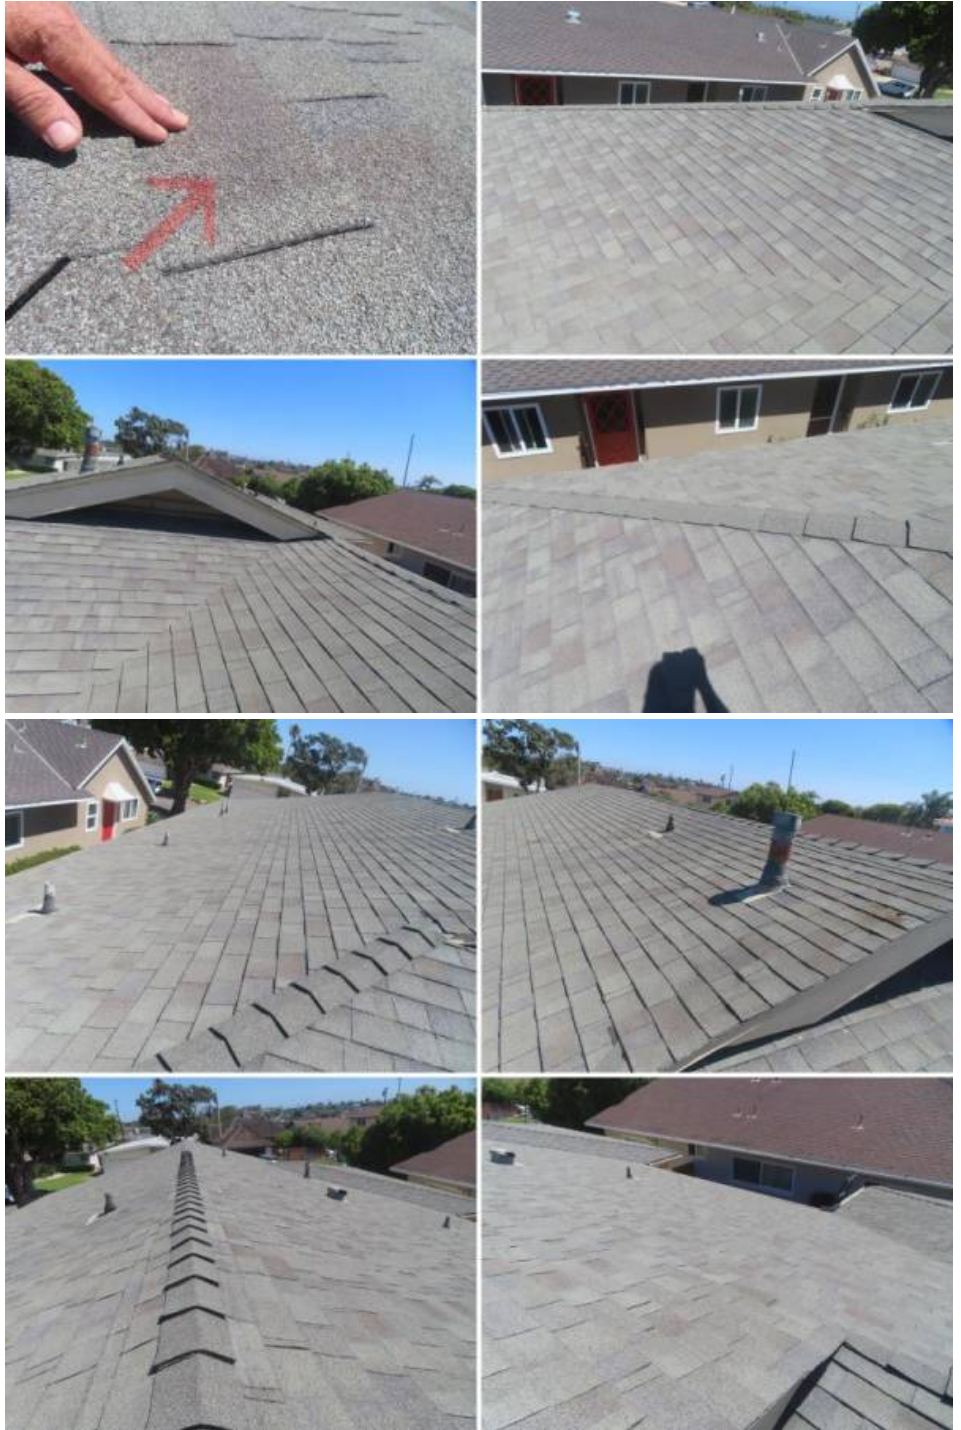
Roof is beginning to wear, roofing materials are washing into the gutters.

MONITOR: Older roof, appears to be at or near the end of its design life. We recommend further evaluation by a licensed roofer and suggest budgeting for a new roof in the near future.

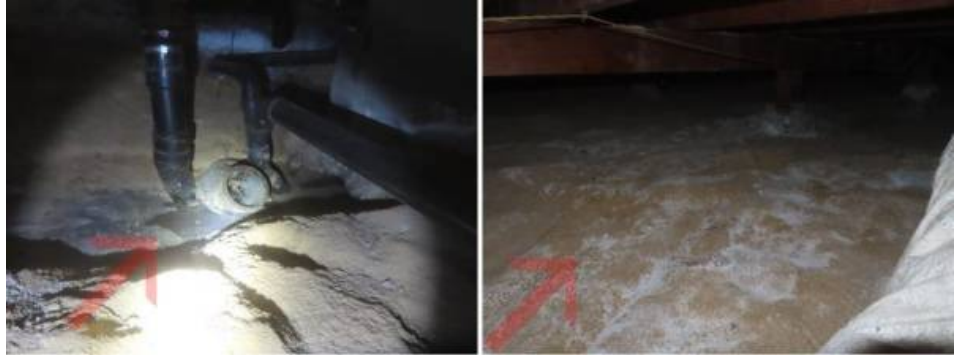
MAINTENANCE: Moisture noted in the sub area.

DEFERRED: Crystalline like substance viewed on the wet earth. This appears to be efflorescence, however, it may also be or contain microbial matter (mold, fungi, etc.). Environmental issues are beyond the scope of our physical inspection. You will need to consult with an environmentalist or industrial hygienist if you have concerns.

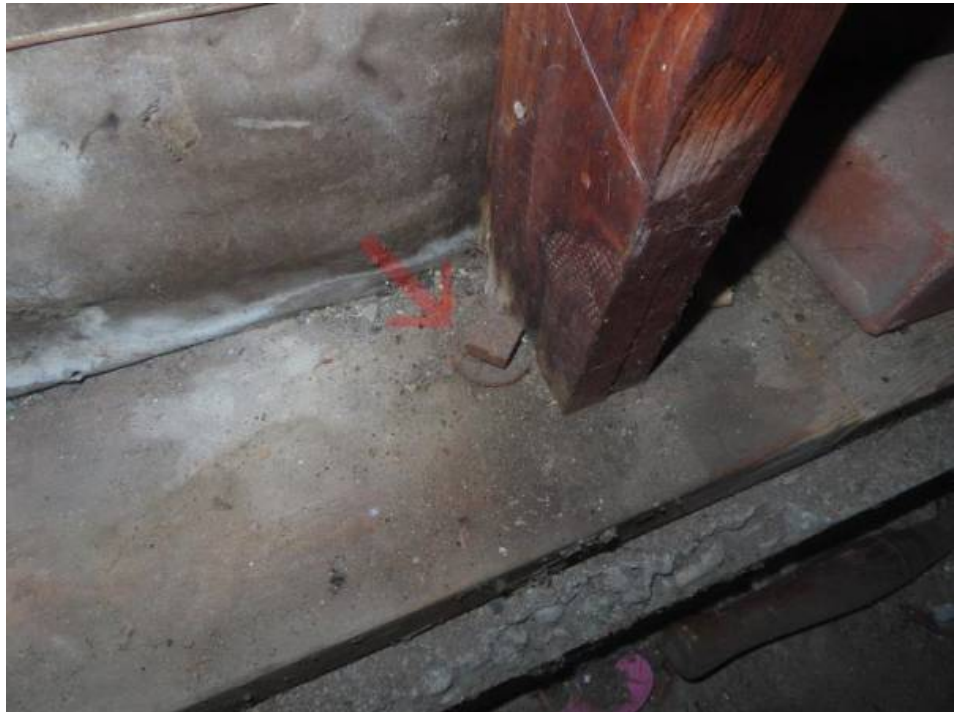
Likely from past plumbing issue.

DEFERRED: Efflorescence noted in the sub area. Efflorescence is a powdery crystalline substance caused by excessive moisture. In severe cases deterioration of the concrete and embedded structural steel products can result.

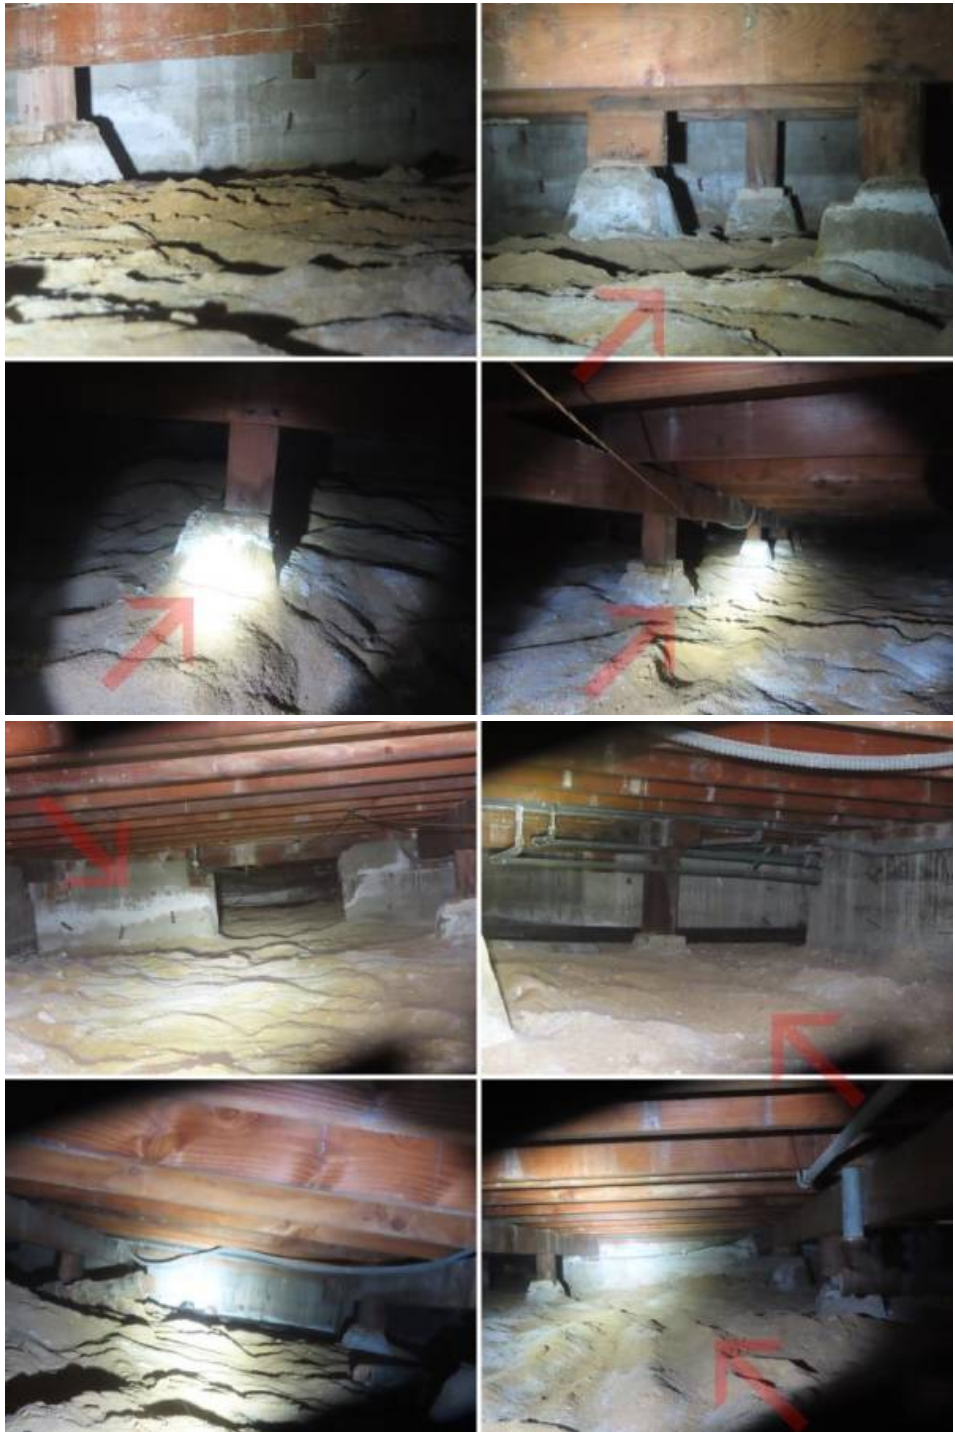
The piers are deteriorating from the moisture from drain line or past leaks.

DEFERRED: Light to moderate efflorescence noted in the sub area. Efflorescence is a powdery crystalline substance caused by excessive moisture. In severe cases deterioration of the concrete and embedded structural steel products can result.

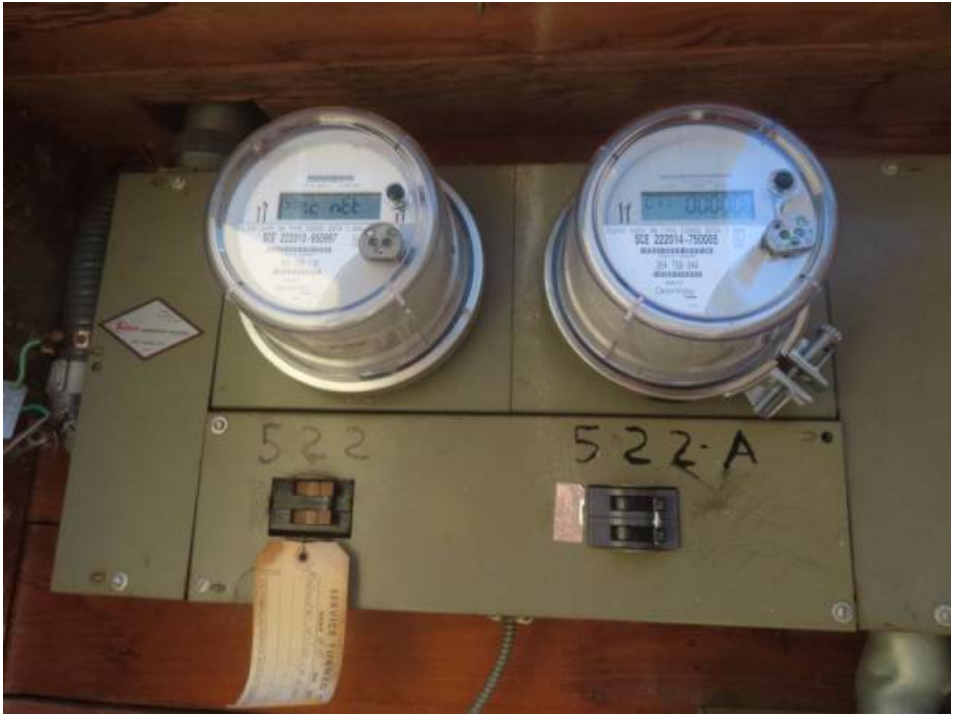
| <i>Panel observations, exterior</i> | SAFETY: Federal Pacific or Zinsco brand panel present. Electrical panels and circuit breakers are known to deteriorate with age. Many older panels have aluminum bus bars that are susceptible to oxidization, which can compromise the electrical connections. Also, older breakers have a higher failure rate than do modern breakers. Both of these conditions can lead to arcing and overheating, sometimes resulting in an electrical fire. |

A visual inspection cannot determine if these panels and breakers are performing to their original design specifications. Federal Pacific and Zinsco brands in particular are problematic and we routinely recommend replacing these panels as a safety upgrade.

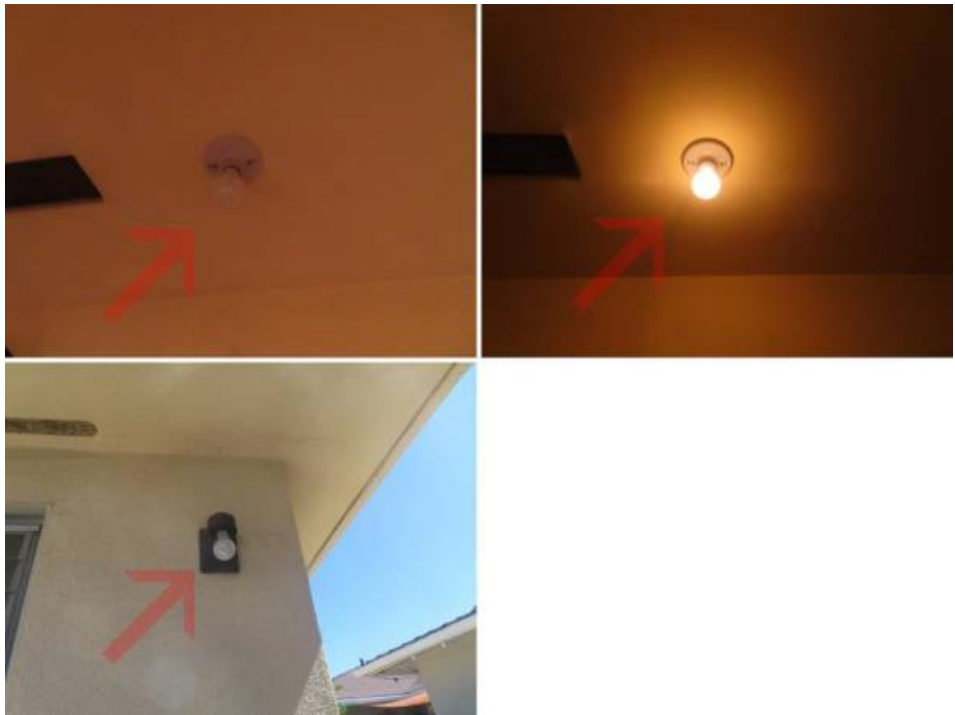
Recommend testing bulbs.  
DEFERRED: Some lights or switches were not working or we did not determine what some switches control. We recommend asking the seller if all switches are operational and to replace defective light bulbs so you can verify their operation prior to the close of this transaction.  
DEFECTIVE: Light fixture is broken, missing the globe, or is not installed at one or more locations.  
522A power is off.

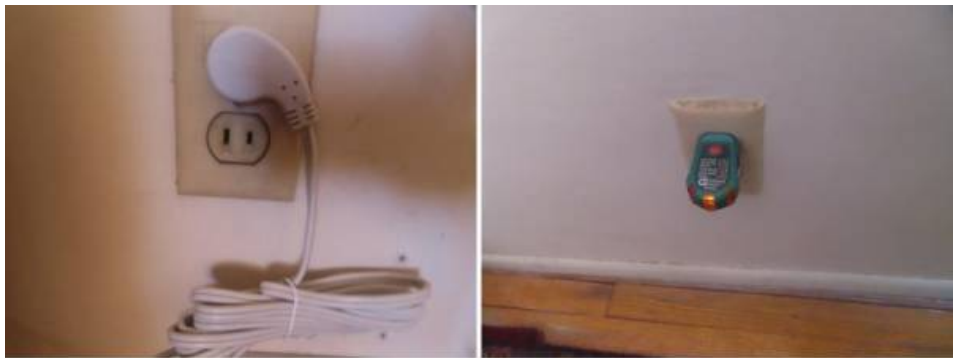
522.  
SAFETY: Two-pronged, ungrounded, polarized system. This type of system is common with similar structures of this age. Some plug-in devices, such as lamps and televisions, etc., may not require a grounded receptacle. However, we recommend upgrading to properly grounded three-pronged receptacles where needed, especially at receptacles for appliances, tools and electronic equipment including refrigerators, laundry machines, computers, and for all other appliances and equipment that are supplied with a three-prong grounded plug.  
DEFECTIVE: Many 3-prong grounded type receptacles sampled were not properly grounded. Original 2-prong receptacles appear to have been improperly replaced with grounded type receptacles.  
522A power is off and 3 pronged outlets not tested.

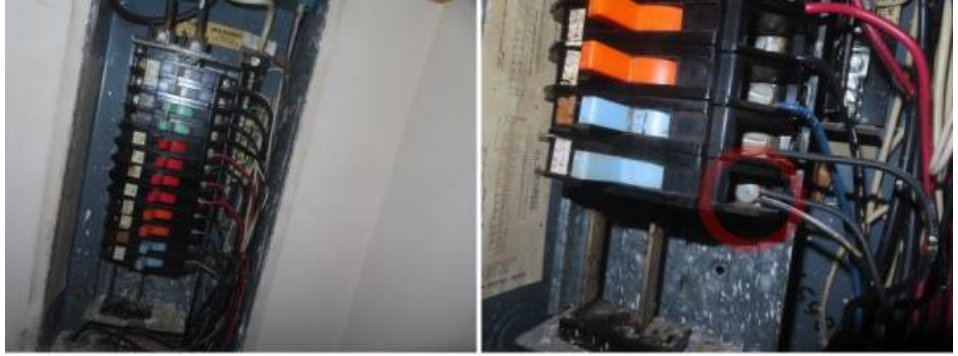
DEFECTIVE: Multiple wires are connected to a circuit breaker lug designed for a single wire only. This condition can compromise the electrical connection and lead to overheating of the wires and is a potential fire hazard.

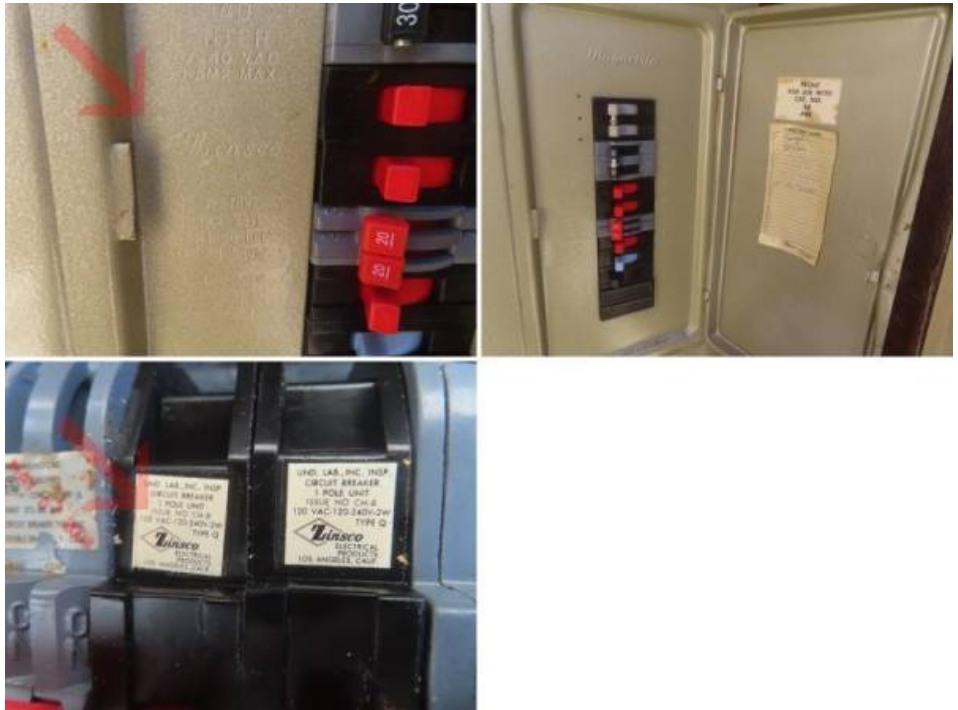
522A

SAFETY: Federal Pacific or Zinsco brand panel present. Electrical panels and circuit breakers are known to deteriorate with age. Many older panels have aluminum bus bars that are susceptible to oxidization, which can compromise the electrical connections. Also, older breakers have a higher failure rate than do modern breakers. Both of these conditions can lead to arcing and overheating, sometimes resulting in an electrical fire. A visual inspection cannot determine if these panels and breakers are performing to their original design specifications. Federal Pacific and Zinsco brands in particular are problematic and we routinely recommend replacing these panels as a safety upgrade.

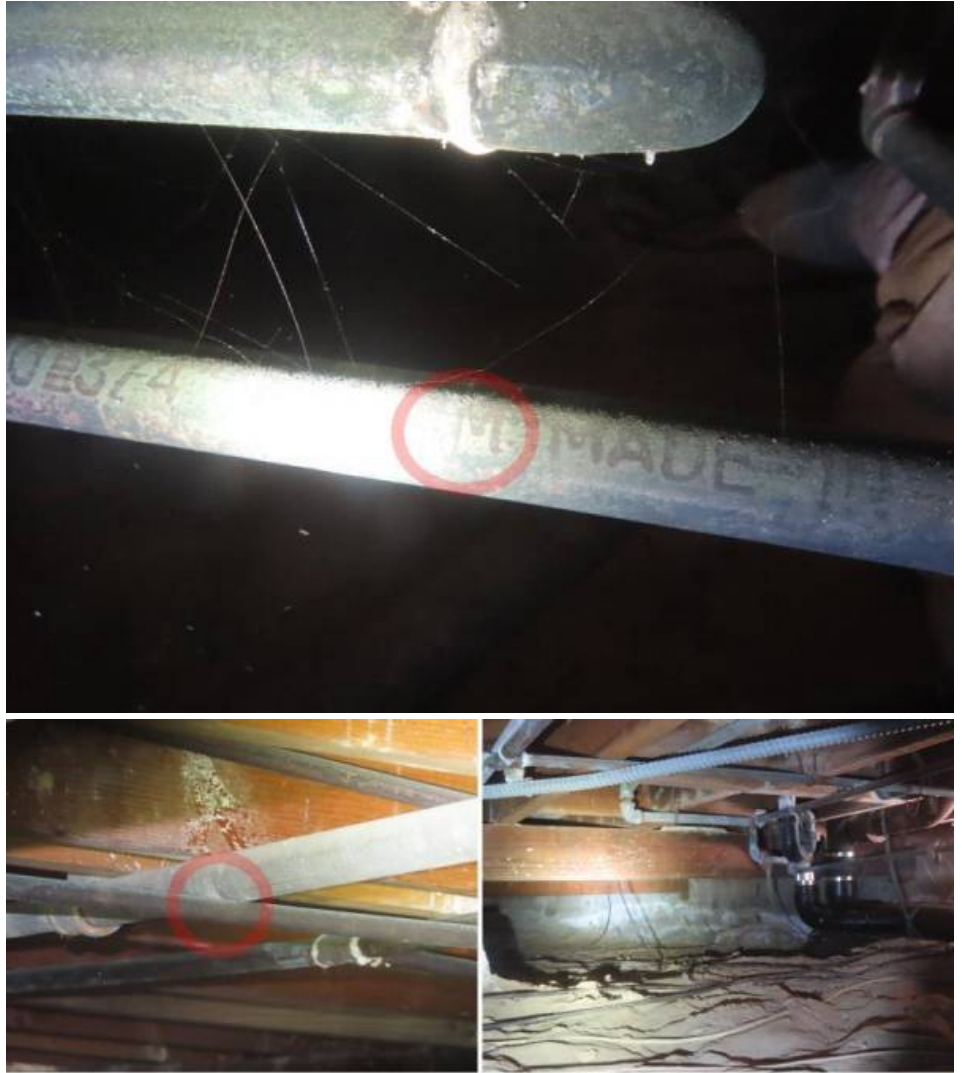
DEFECTIVE: Where copper and galvanized pipes are touching together a dielectric spacers, or section of brass pipe must be used to control galvanic corrosion and premature leakage.

DEFERRED: Appears to have been completely re-piped in copper; however, old galvanized lines were left in place as is common practice and we are unable to state with certainty that none of these pipes are currently in use.

Older copper is faded.

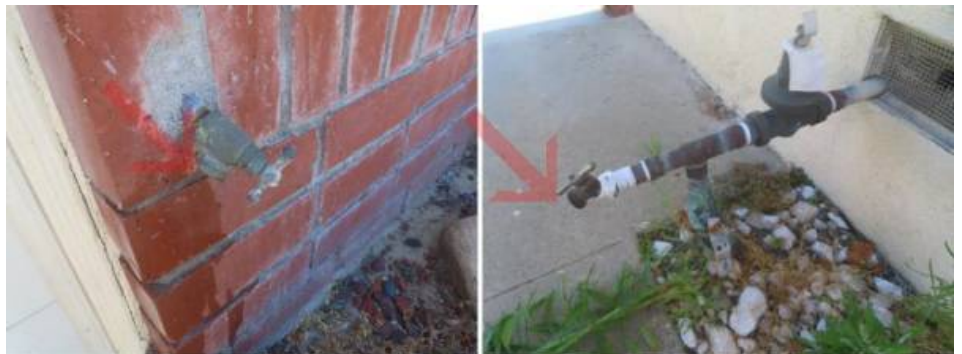
SAFETY: We recommend installing anti-siphon devices at all hose connections to protect the potable water supply from possible cross contamination. The common anti-siphon device for this purpose will screw onto the existing hose faucet. These are required on new construction and when replacing water pipes in older structures. They are available at most hardware stores in the plumbing department and can be easily installed by most homeowners with minimal or no tools.

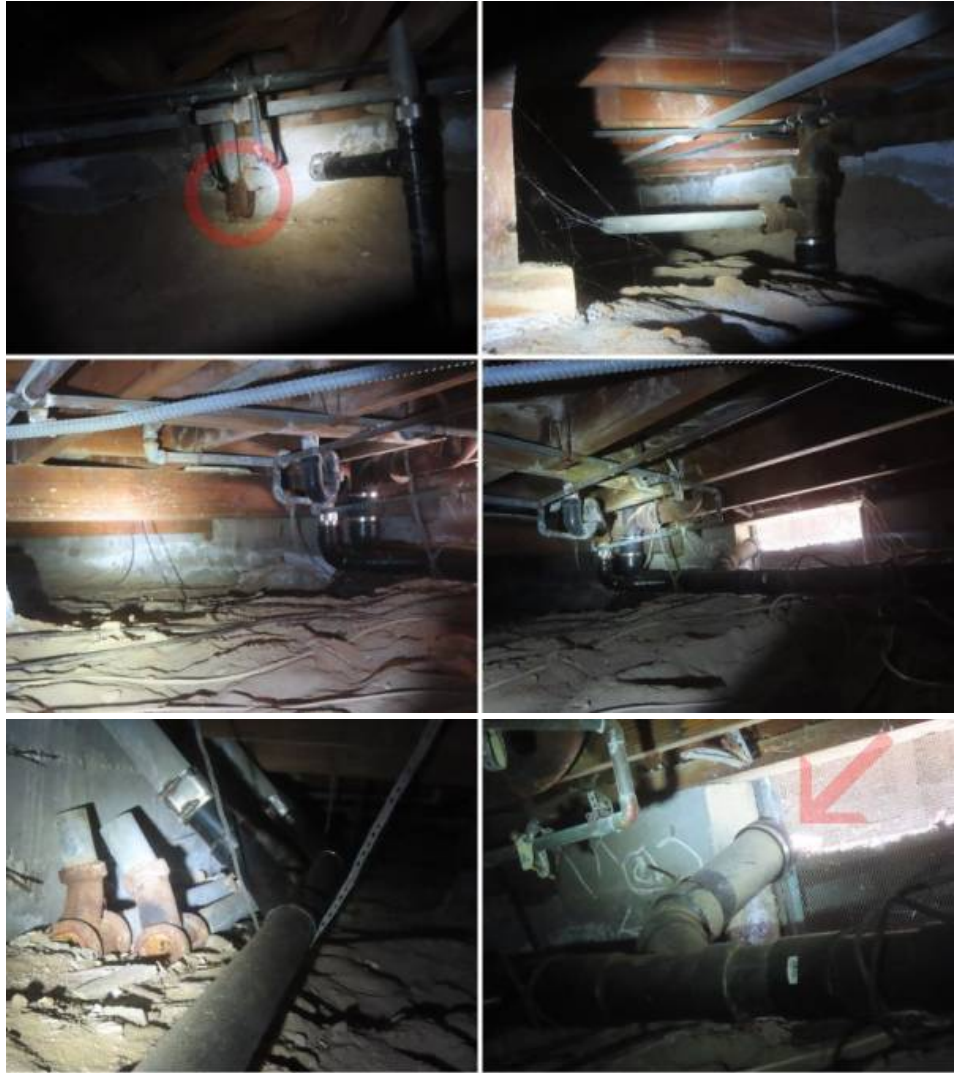
Plumbing fixtures drained well at the time of our inspection with limited use. We recommend asking the current owner for any history of drain blockage or repair.  
DEFECTIVE: Under 522 primary bedroom. Clean out is open and water is draining into the sub area when draining. Recommend a proper sized cap.  
DEFERRED: Metal straps on ABS, Plastic straps are to be used to prevent corrosion and sagging.  
522 Tub drain.  
MONITOR: Excessive corrosion observed on tub drain. Preventive maintenance repairs may be desirable at this time.

MAINTENANCE: While on the roof we noticed a groove in the transite vent pipe that was probably caused by a drain cleaning snake. This may indicate past or recurring blockage in the sewer line. We recommend asking the current owner if there is a history of sewer blockage. You may also wish to obtain a video scan to determine the interior condition of the sewer line (service provided by others).  
Clean out at foundation access.

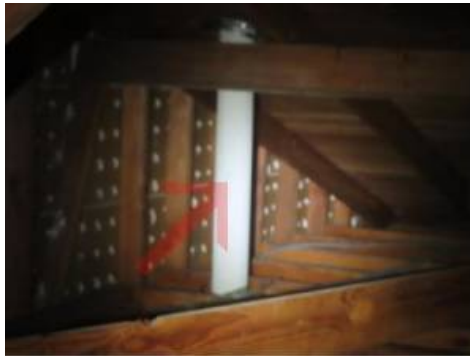
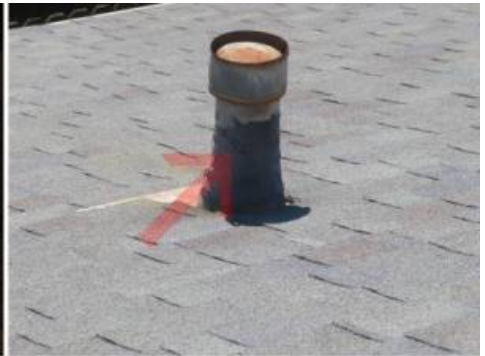
Top section from ceiling up.

SAFETY: Transite vent pipe(s) observed. Transite is known to contain asbestos and will need special handling if removed or repaired.

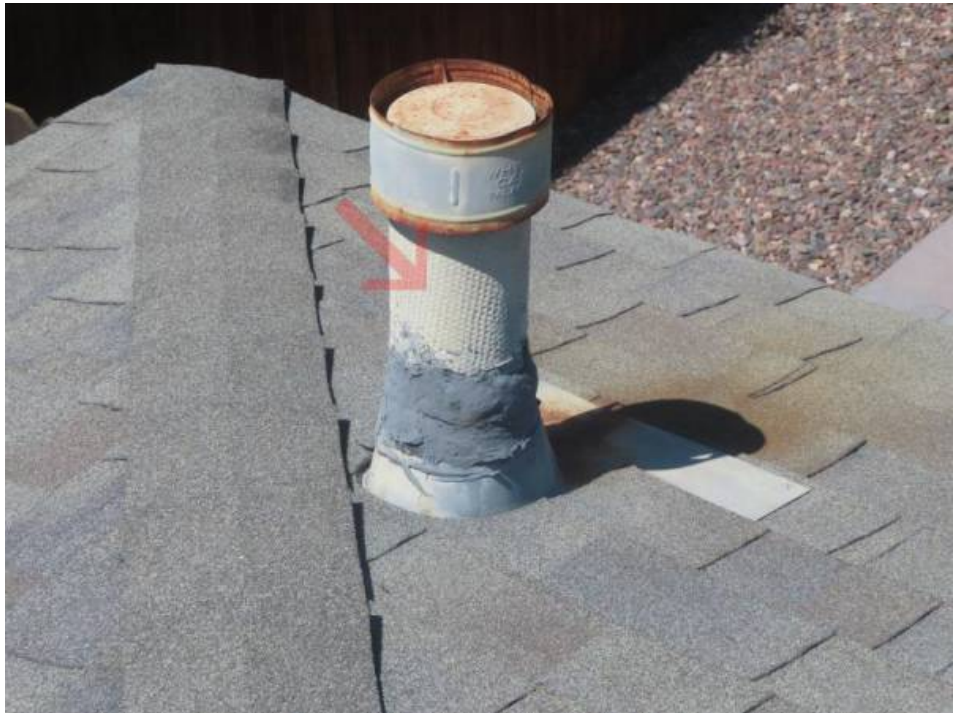
Top section from ceiling up.

SAFETY: Transite vent pipe(s) observed. Transite is known to contain asbestos and will need special handling if removed or repaired.

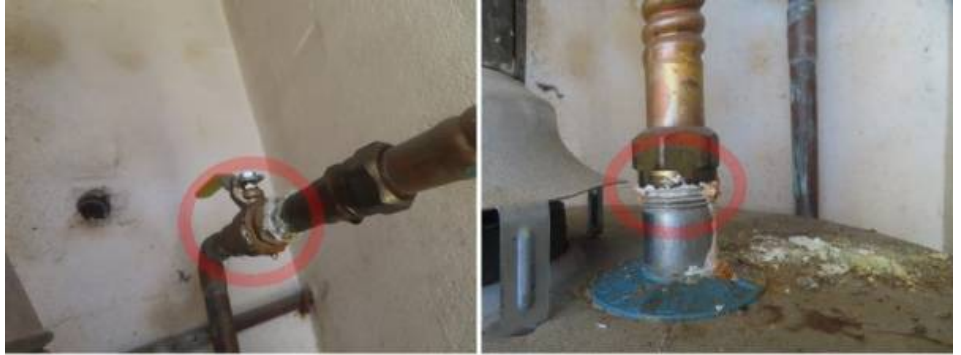
MAINTENANCE: Shutoff valve or connectors are corroded. We recommend replacing

corroded components when observed as preventative maintenance.

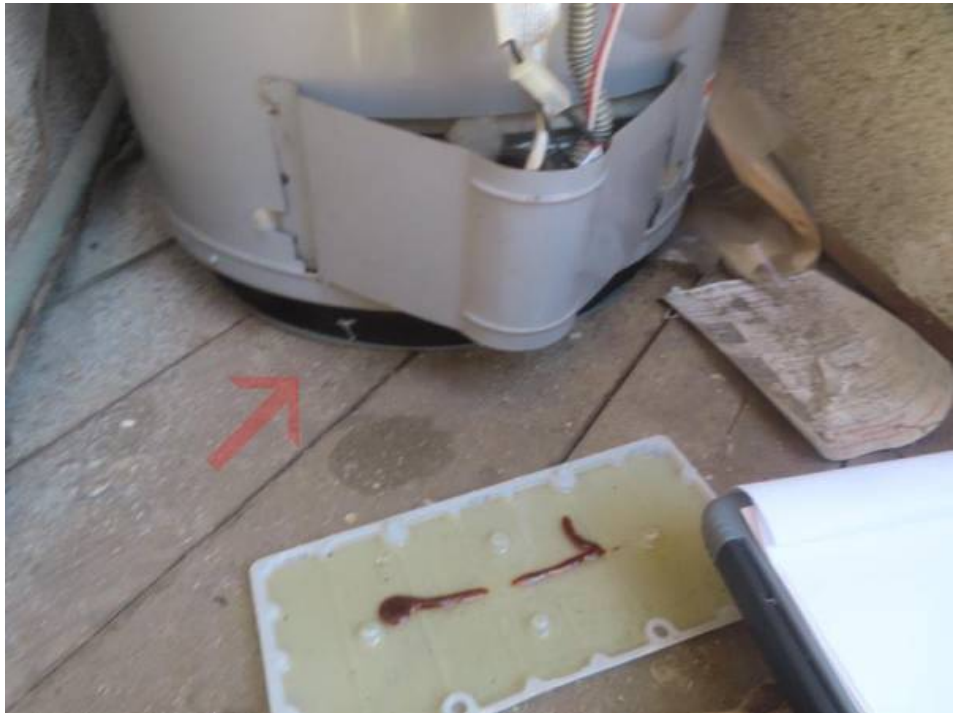
522A.

MAINTENANCE: We recommend installing a properly sized catch pan with a drain that terminates at the exterior of the building to prevent damage to structure/belongings in the event the water heater leaks.

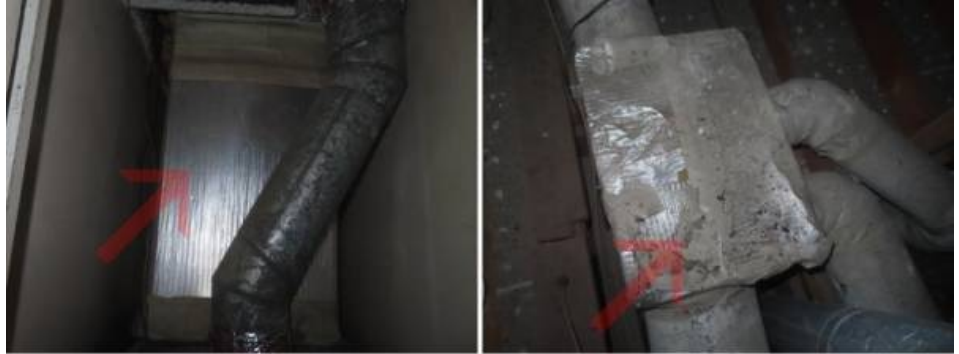
*Plenum*

SAFETY: Suspect asbestos insulating material visible on the plenum is in damaged condition. Removal or encapsulation is generally recommended when material is damaged and/or in friable condition. Positive identification of asbestos can only be made from samples sent to a certified laboratory. If you have any concerns we recommend further evaluation by a licensed asbestos assessor .

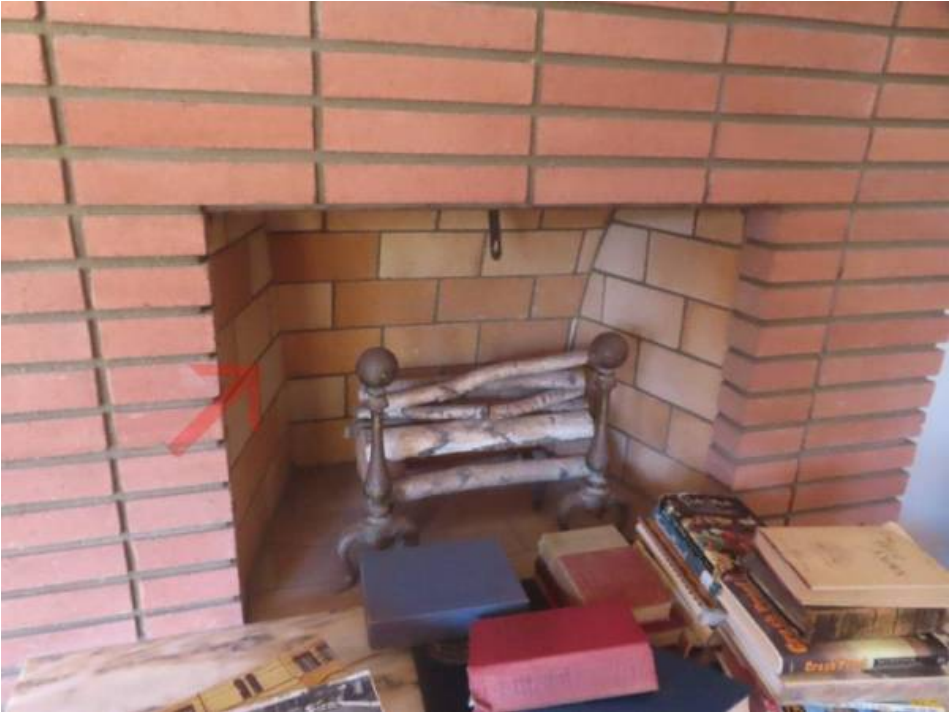
DEFECTIVE: No fire screen, or the fire screen is not attached to the fireplace and may be personal property. We recommend installing a fire screen or doors on the fireplace to contain hot embers and prevent items from coming into contact with the fire.

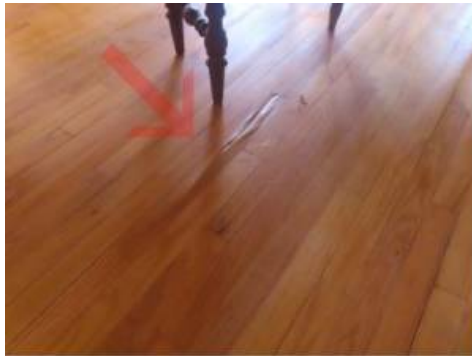
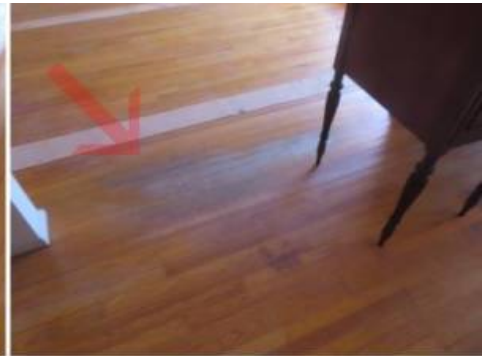
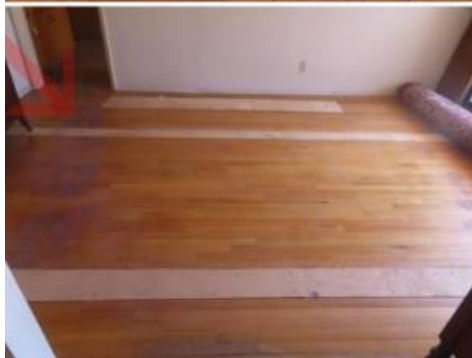
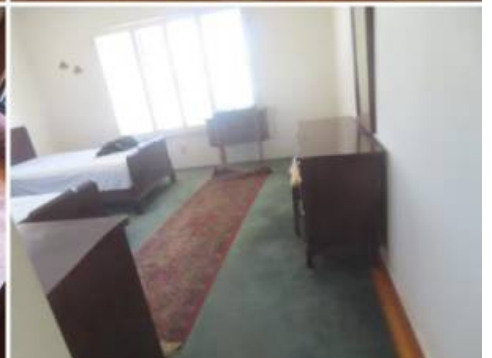
522.

DEFERRED: Insect damage viewed.

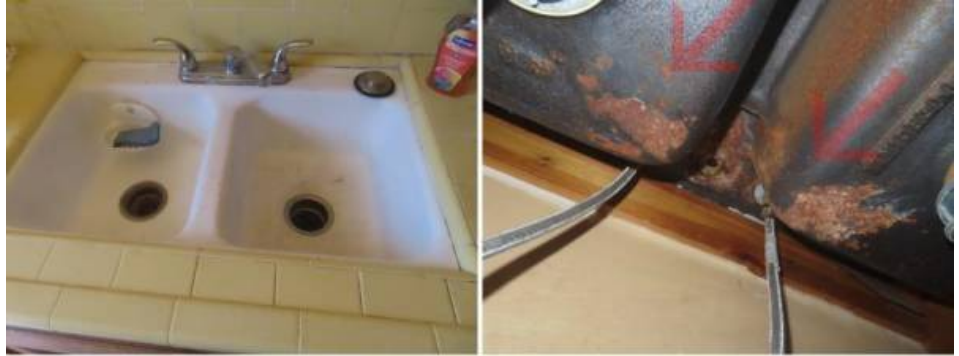
522.

MAINTENANCE: Stained, chipped, or heavy wear noted.

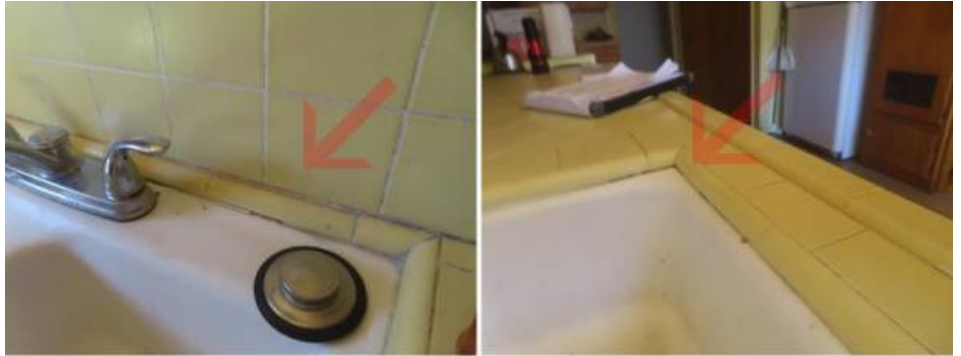
MAINTENANCE: Caulking is deteriorated. We recommend re-caulking backsplash as needed at this time to prevent water intrusion and subsequent damage.

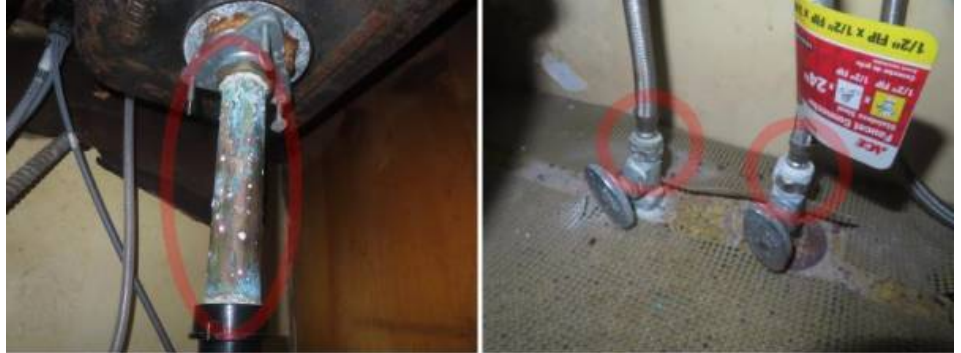
MAINTENANCE: Moderate corrosion on the drain line. We recommend replacing corroded components before they begin to leak.

MAINTENANCE: Shutoff valve or connector is corroded. Corroded components will eventually fail; we recommend replacing corroded components when observed.
