# Confidential Inspection Report

522 Ave. F  
Redondo Beach CA 90277

July 24, 2025

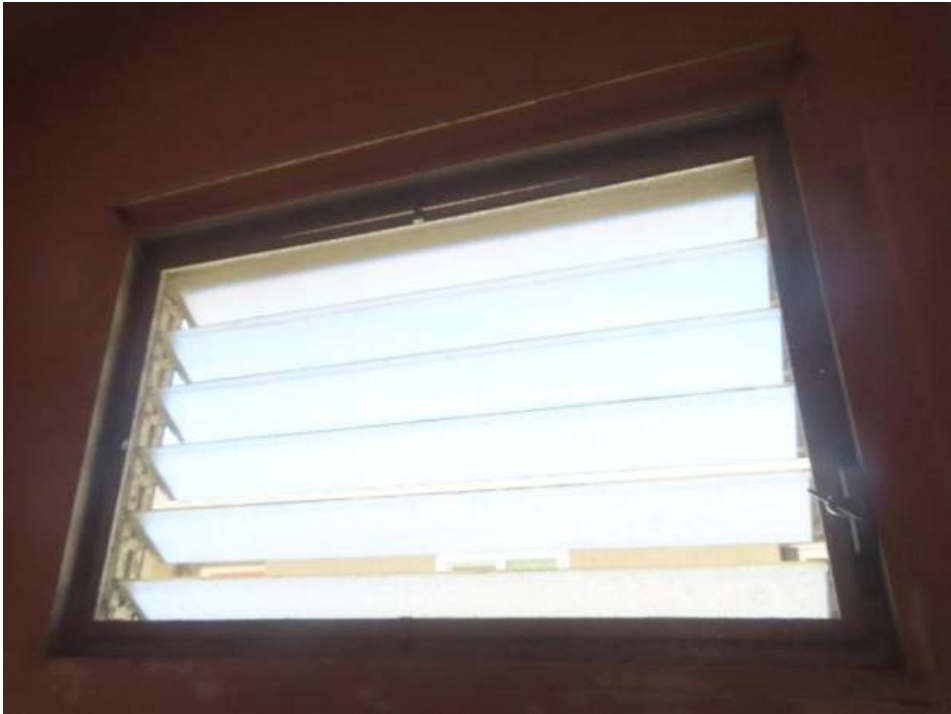
| Ventilation | 522<br>Louver window.<br>SAFETY: Safety glass label was not present or was not found. We could not determine if the window at the tub or shower is safety glass. Because slipping accidents are common at tubs and showers, we recommend installing safety glass at windows subject to human impact. |

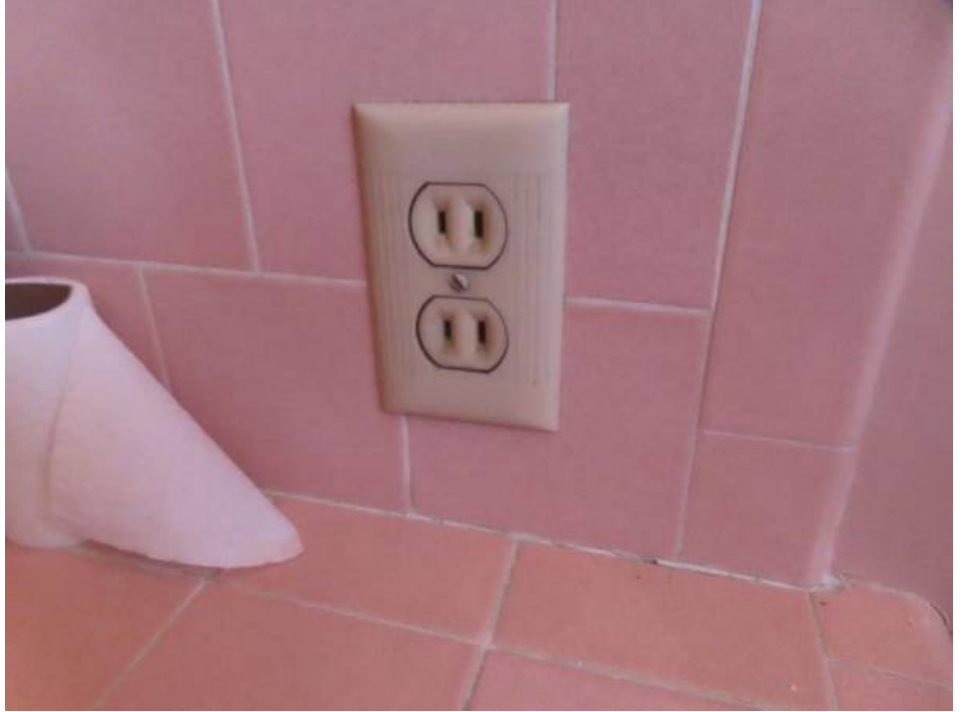
| Ground Fault Circuit Interrupters (GFCI) | 522.<br>SAFETY: One or more receptacles are not GFCI protected. We recommend installing and maintaining GFCI protection at all bathroom receptacles. |

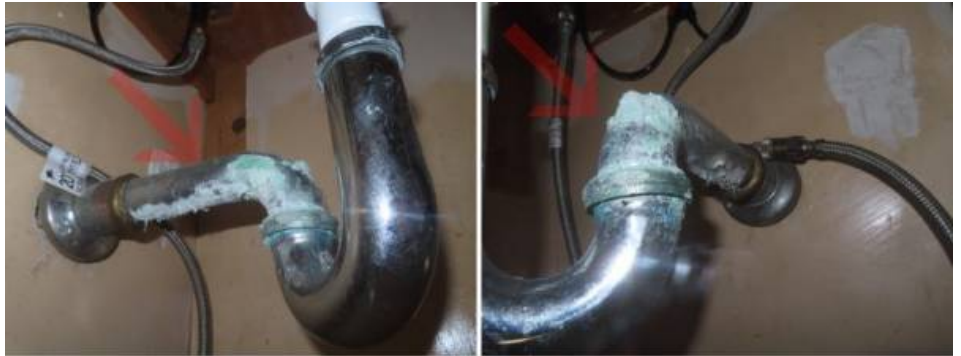
MAINTENANCE: Moderate corrosion on the drain line. We recommend replacing corroded components before they begin to leak.

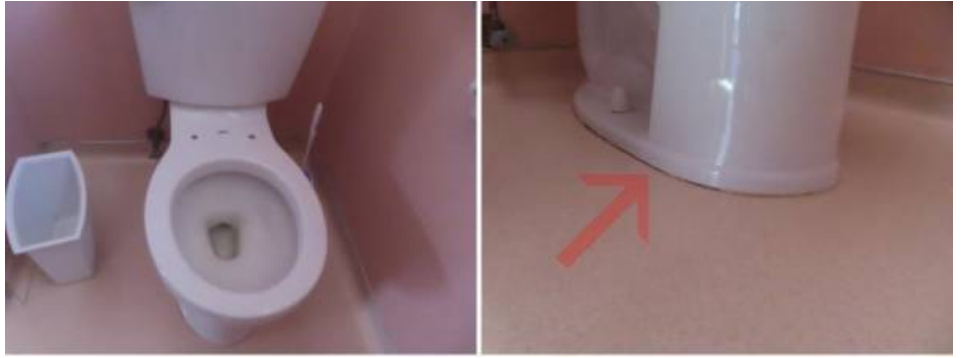
MAINTENANCE: Does not flush properly.  
DEFECTIVE: Seat is damaged or missing.

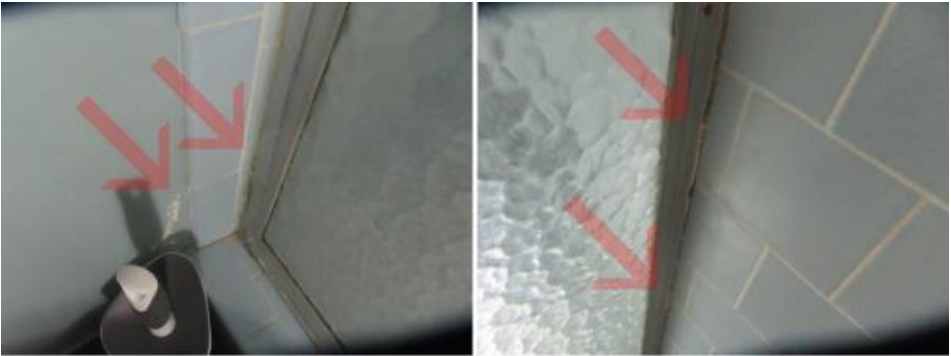
SERVICEABLE. Safety glazing label viewed.  
MAINTENANCE: Needs general re-caulking or the vinyl strip at the bottom of the door needs repair.

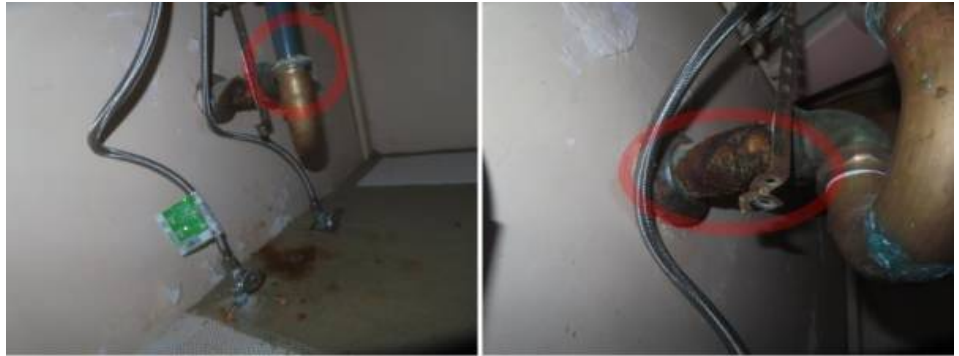
522A.

MAINTENANCE: Moderate corrosion on the drain line. We recommend replacing corroded components before they begin to leak.

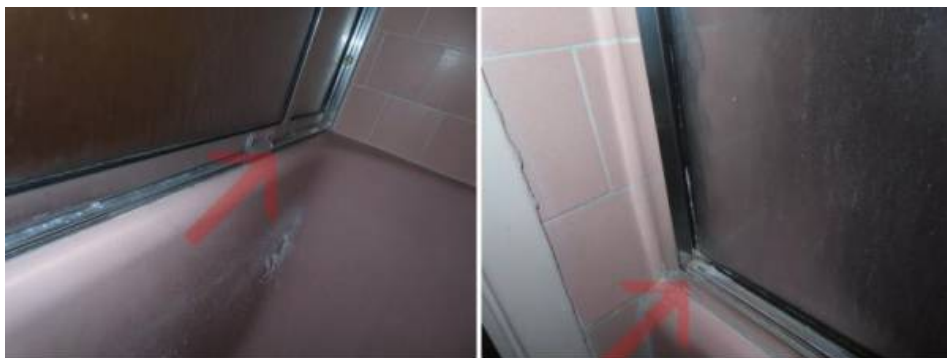
MAINTENANCE: Needs general re-caulking.

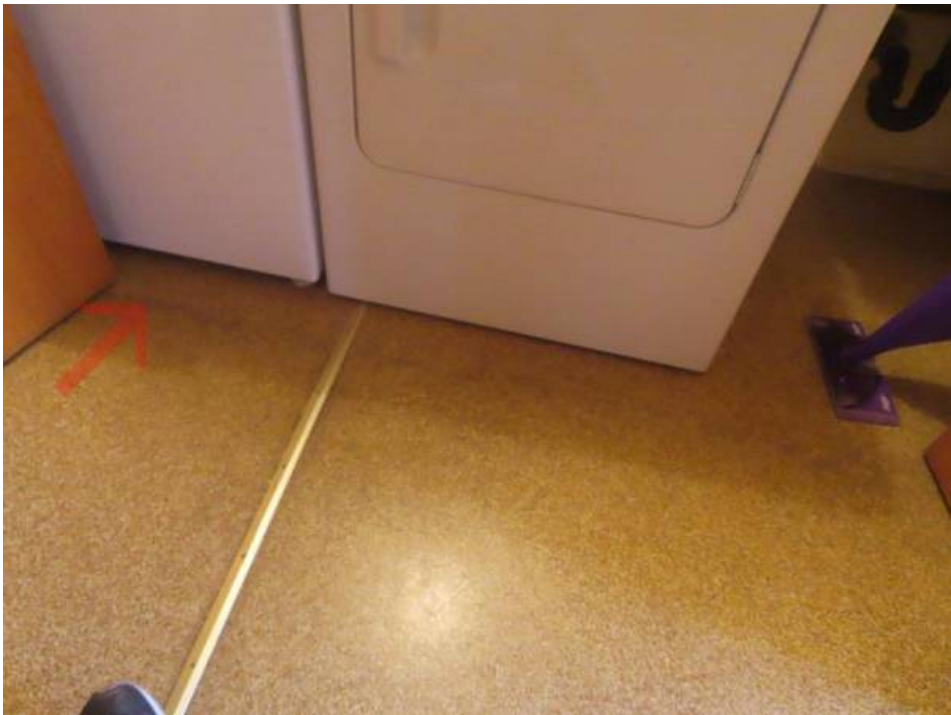
522  
DEFERRED: Laundry machines and appliances are not inspected or operated.  
DEFERRED: Gas service is capped and not tested.  
SAFETY: We suggest installing a catch pan with a drain to the exterior to prevent water damage in the event of a leak in the washing machine.
