General Summary

Ferguson Home Inspections

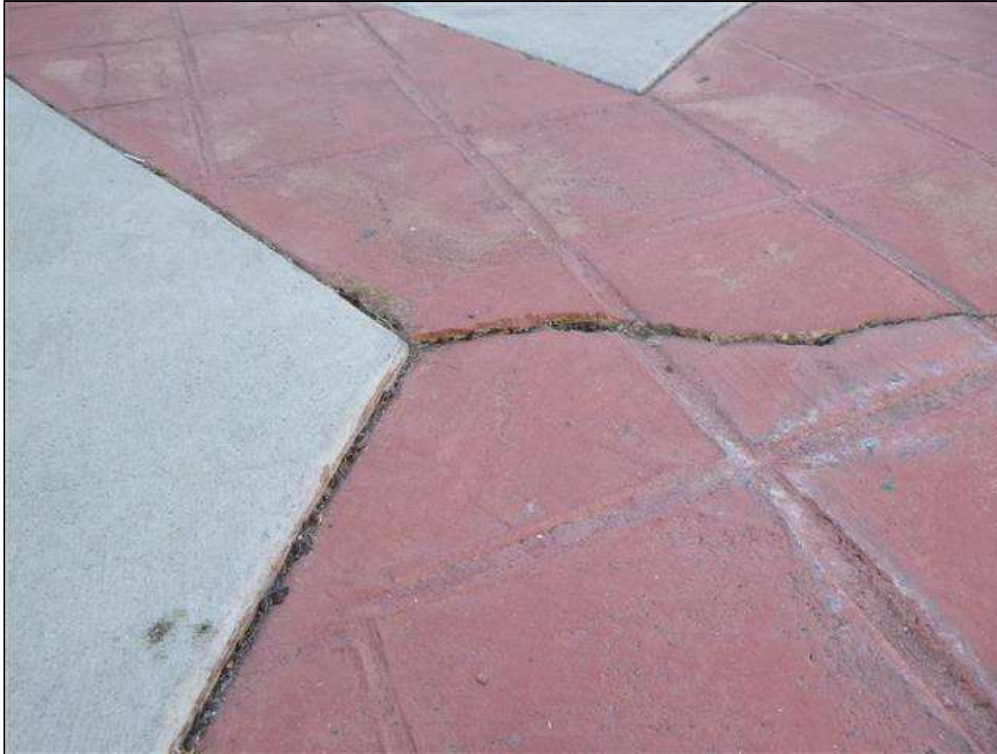
1.0 Item 1(Picture)

(1) Settling, expansion cracks and heaving noted at various areas, this is a potential trip hazard. Suggest review with a licensed contractor for any repair/replacement costs as needed.

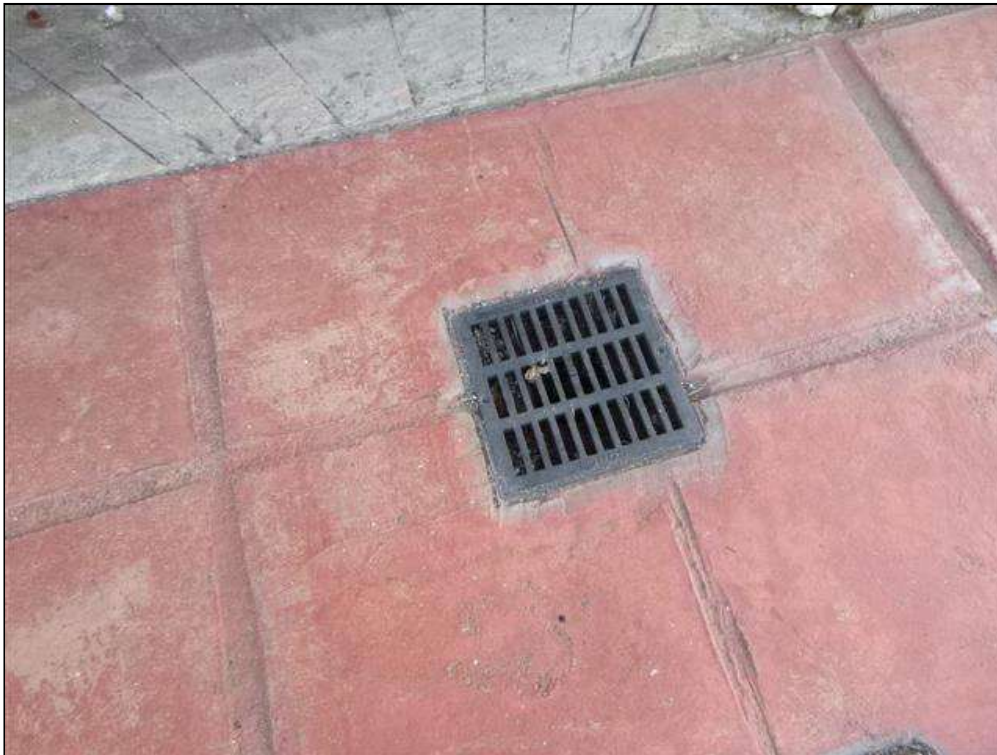
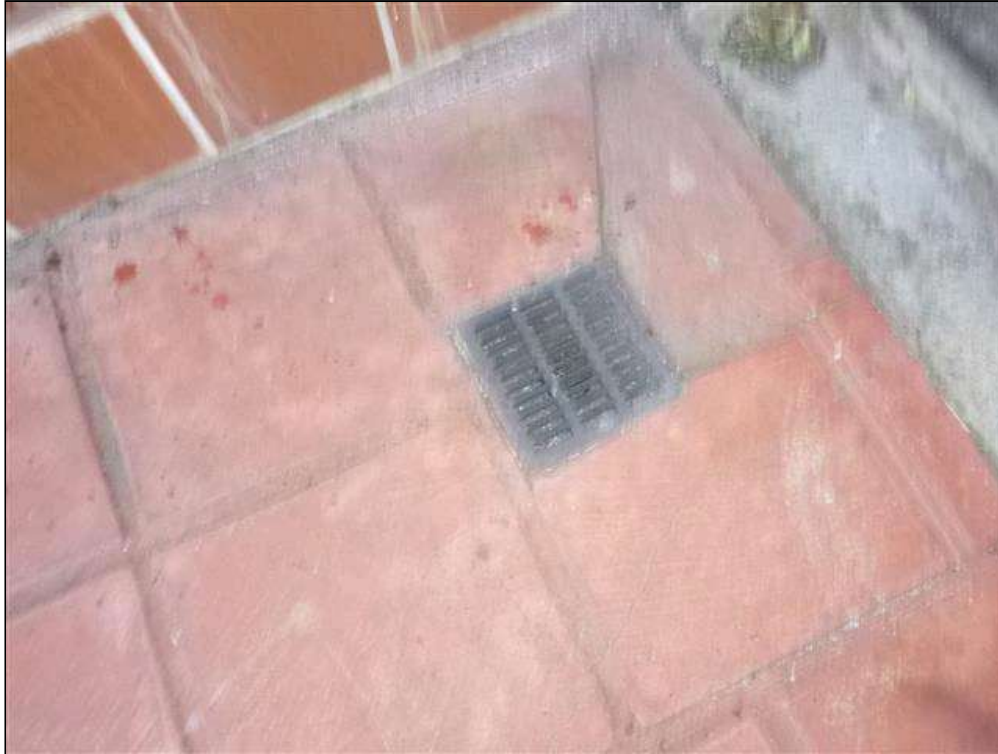
1.0 Item 2(Picture)

(2) Suggest cleaning the driveway drain and drain transition to street prior to the rainy season to prevent blockages which could result in water intrusion into the garage/dwelling.

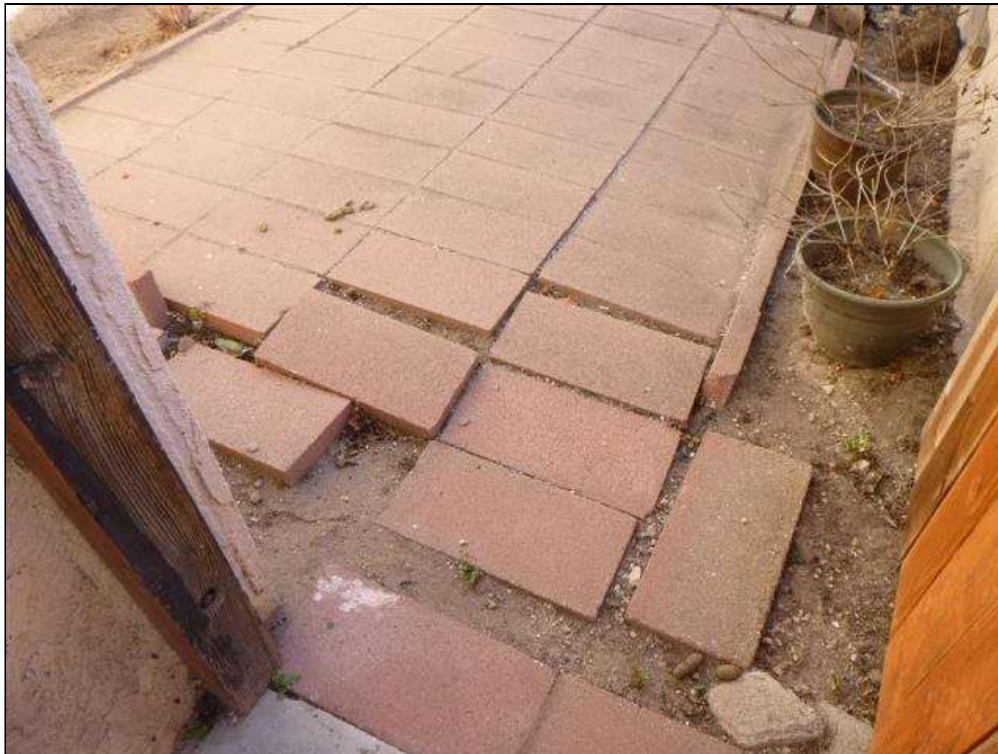
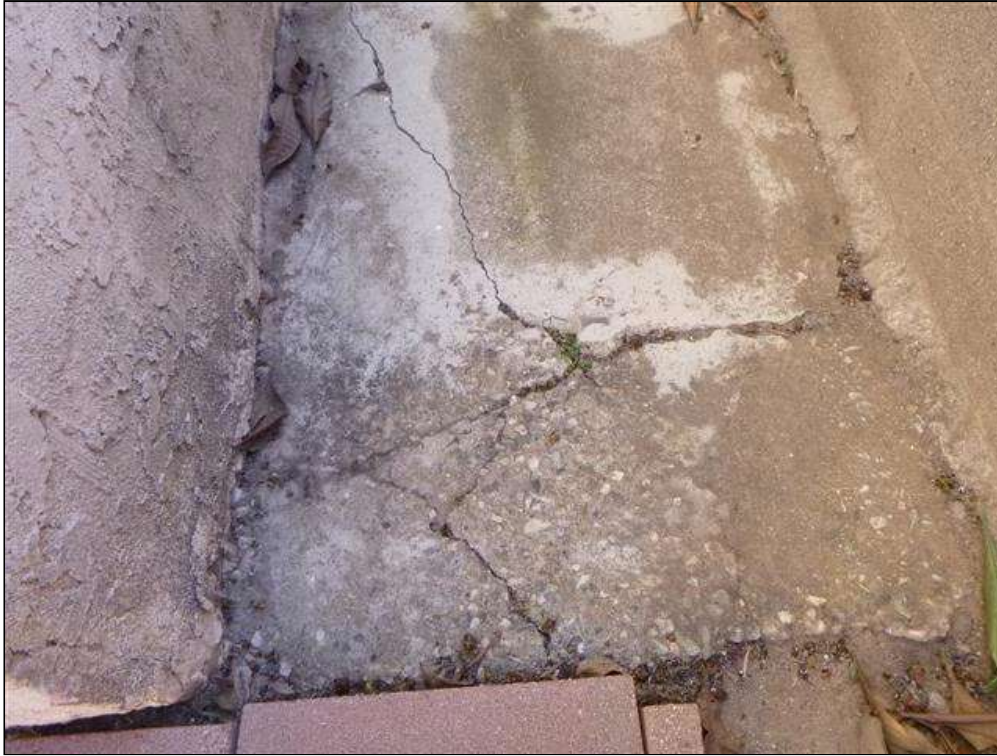
1.1 Item 1(Picture)

Settling, expansion cracks, loose and heaving noted at various areas, this is a potential trip hazard. Suggest review with a licensed contractor for any repair/replacement costs as needed.

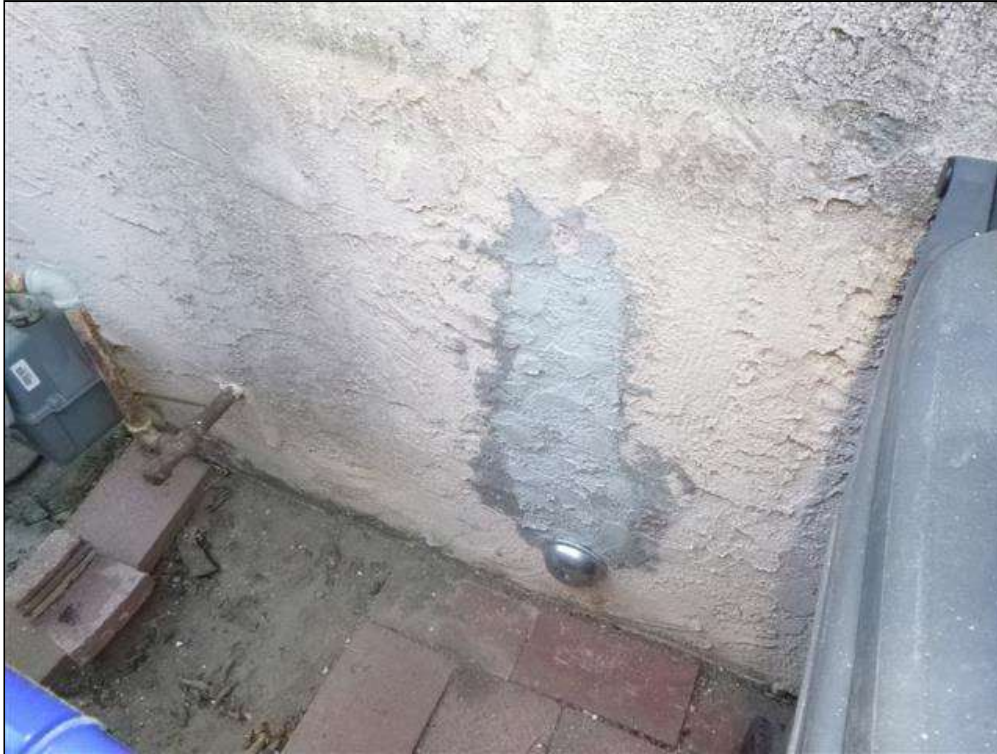
1.4 Item 1(Picture)

- (1) Deteriorated and blistering stucco noted at various areas. See the Lot/Drainage comments and review with a licensed contractor to repair as needed and divert water away from the foundation areas.
- (2) Multiple trees and bushes are in contact with the siding. Suggest trimming them away from the siding to prevent any future damage.
- (3) Various areas of the siding have been patched, suggest review with the seller on the cause and any repairs needed.

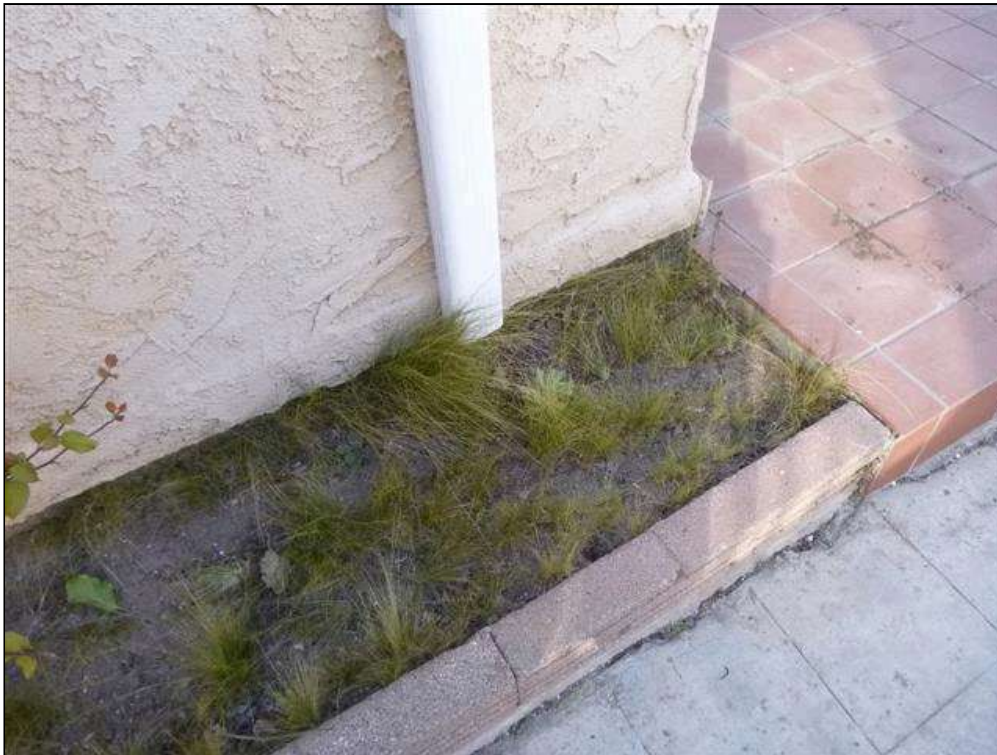
1.9 Item 2(Picture)

(1) Suggest installation of gutters throughout all eave areas and installation of an area drainage system to divert the water away from the foundation to the street as an upgrade.

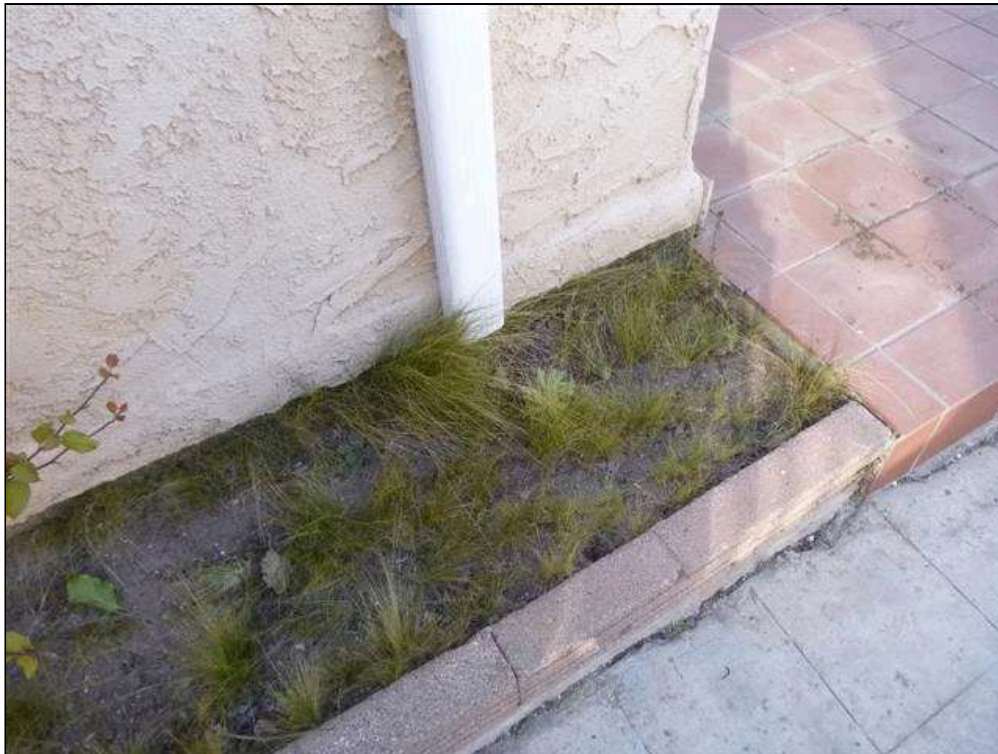
1.11 Item 1(Picture)

No drains and/or drain holes noted/visible at the planter(s). Suggest installing drains/weep holes to prevent ponding and/or excessive moisture buildup at the foundation during the rainy season.

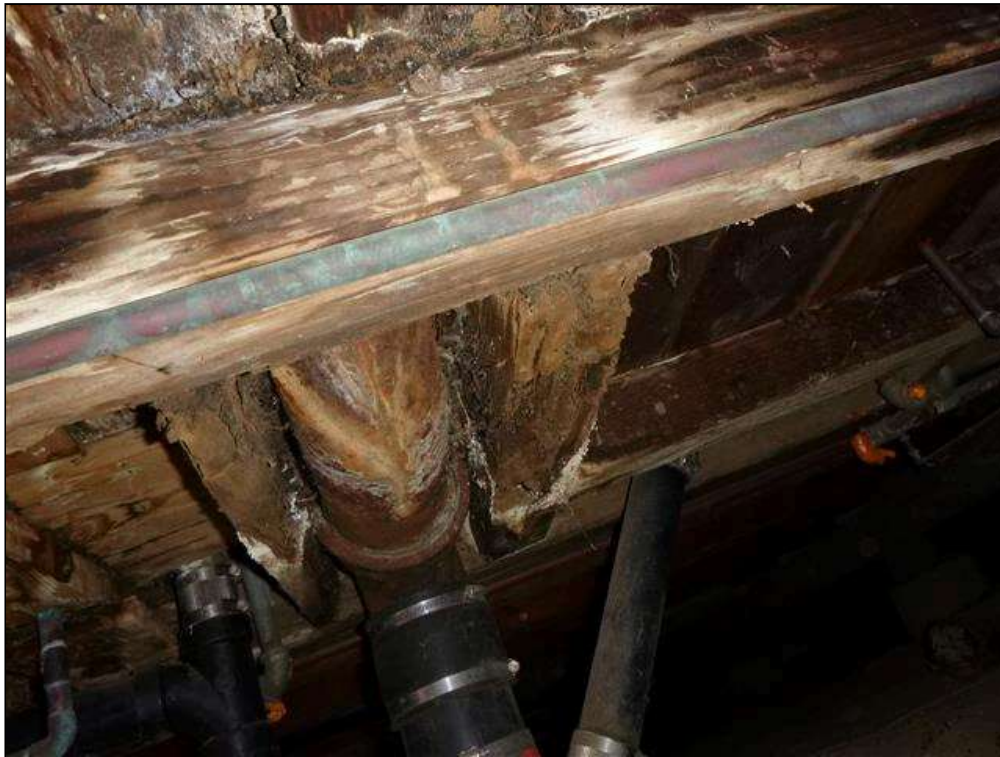
3.1 Item 2(Picture)

Excessive stains and deterioration noted at various flooring and supports from prior leaks. Suggest review with a termite company and/or a licensed contractor for any repair/replacement costs as needed.

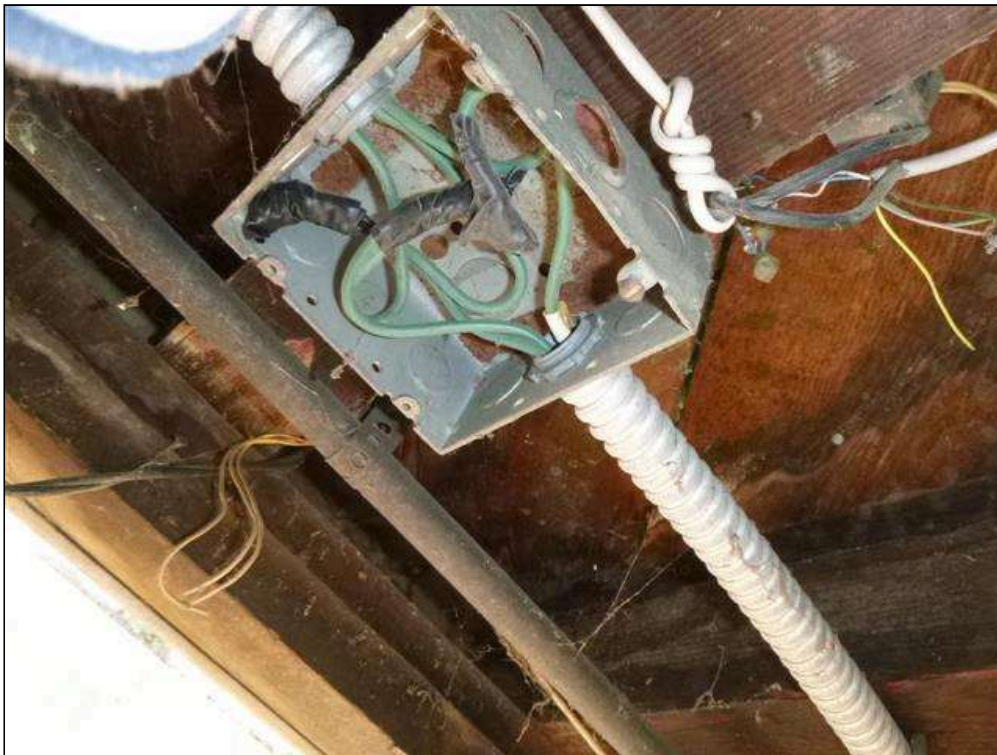
4.3 Item 1(Picture)

(1) Open junction boxes were noted. This is a safety concern. Whenever an electrical wire is cut and re-connected, the 'splice' should be encased in a covered junction box to prevent shocks and separation of the splice. Suggest review by a licensed electrician and repair as needed.

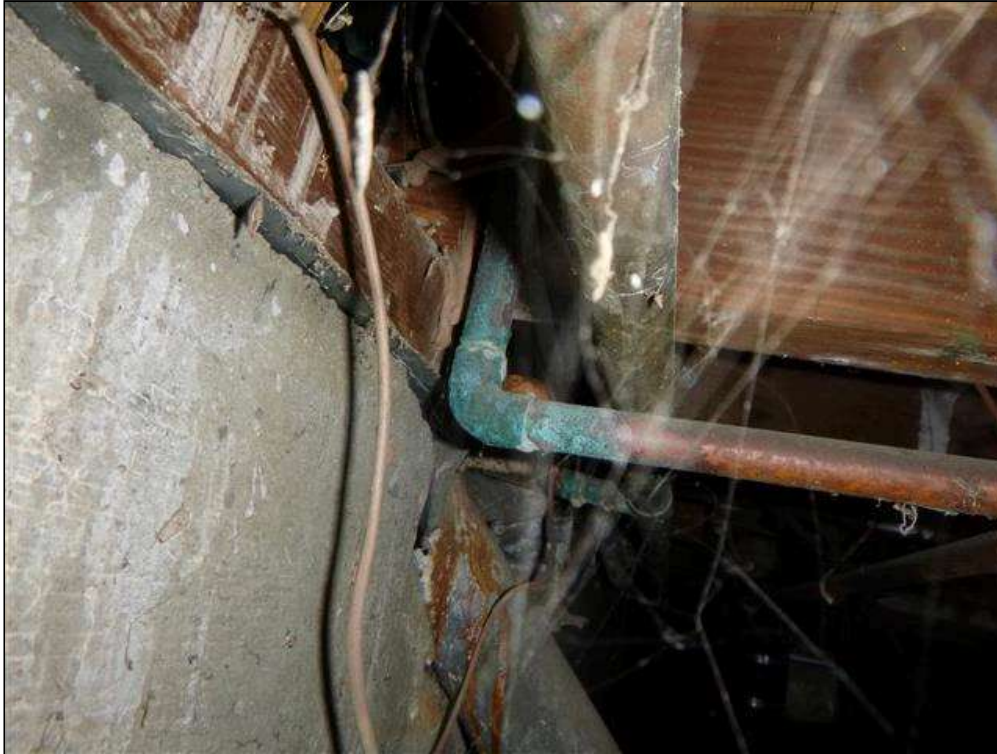
4.4 Item 1(Picture)

(1) Corroded areas of the copper plumbing was noted throughout the crawl area, this can be a pre-cursor to 'pin hole' leaks. Suggest review with a licensed plumber for any repair/replacement costs as needed.

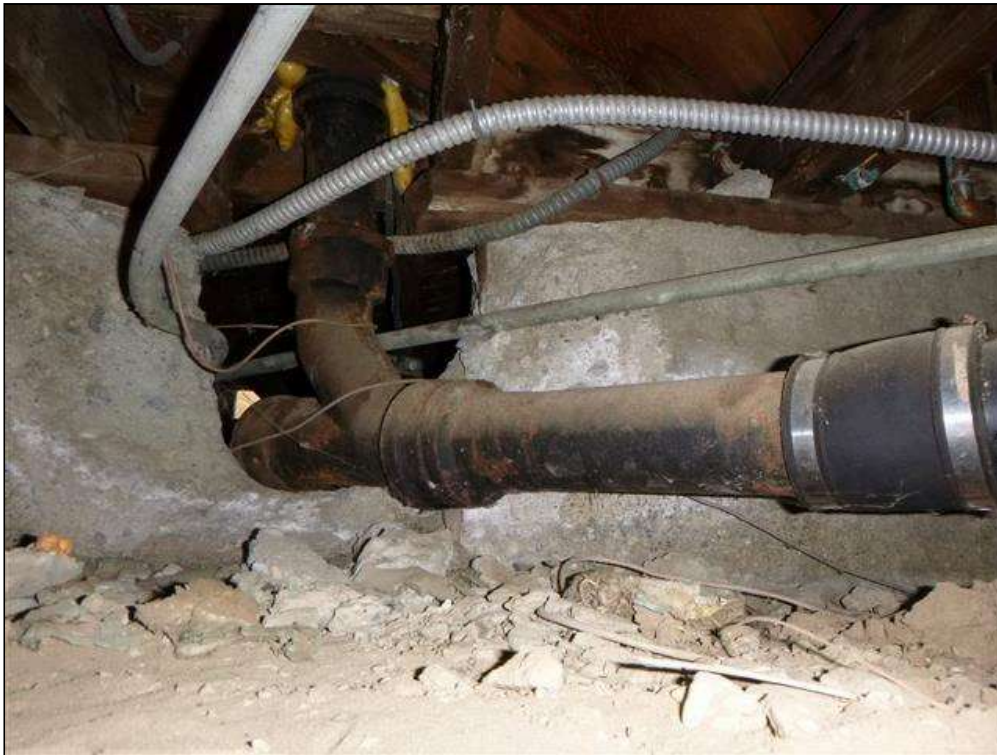
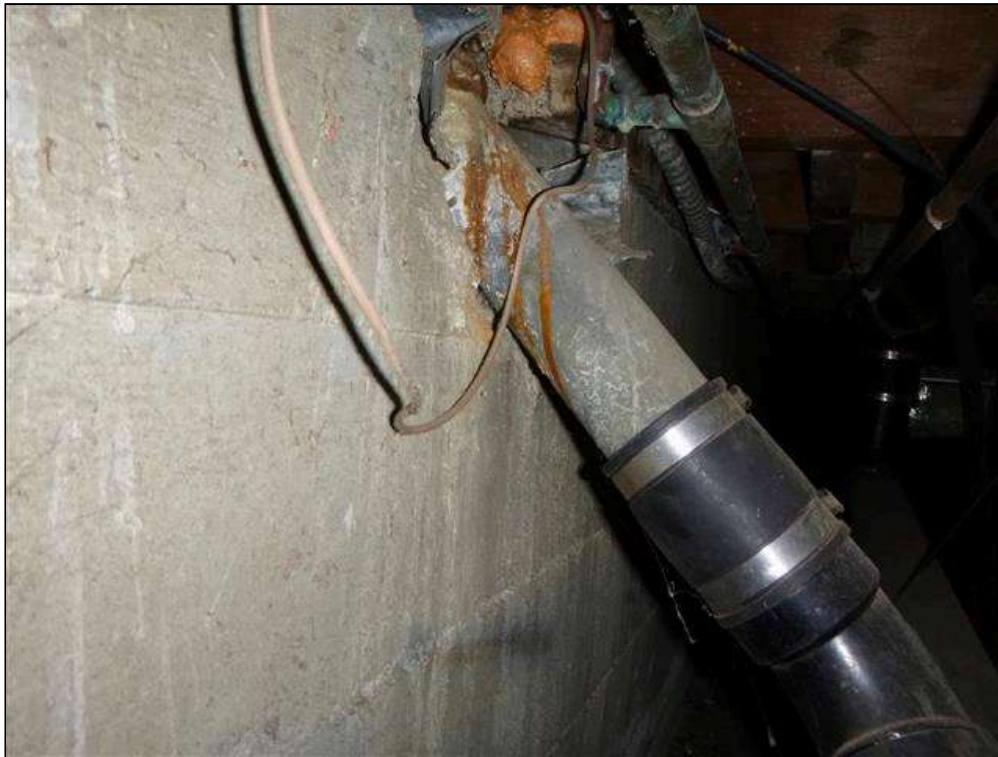
4.4 Item 2(Picture)

(2) Rust and corrosion noted at various cast iron drain lines within the crawl space, common for the age, no leaking visible at the time of the inspection. Suggest review by a licensed plumbing contractor for repair/replacement costs as needed.

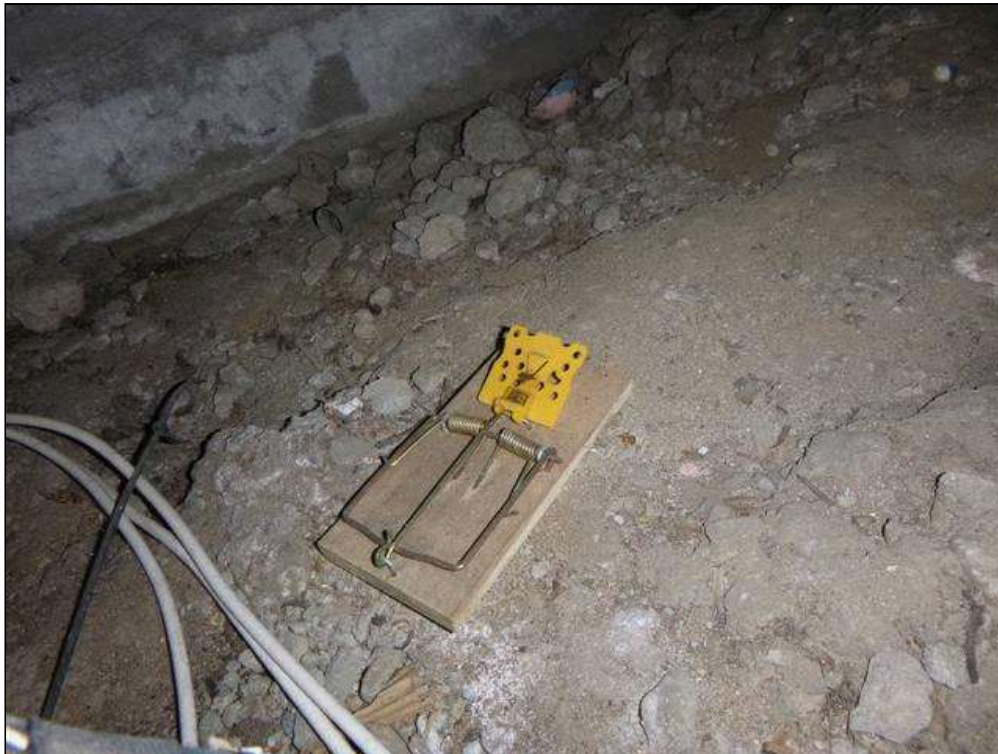
4.5 Item 1(Picture)

Excessive pest droppings and traps noted within the crawlspace. Suggest review with a qualified pest control company and/or a licensed contractor for removal costs of the droppings as needed.

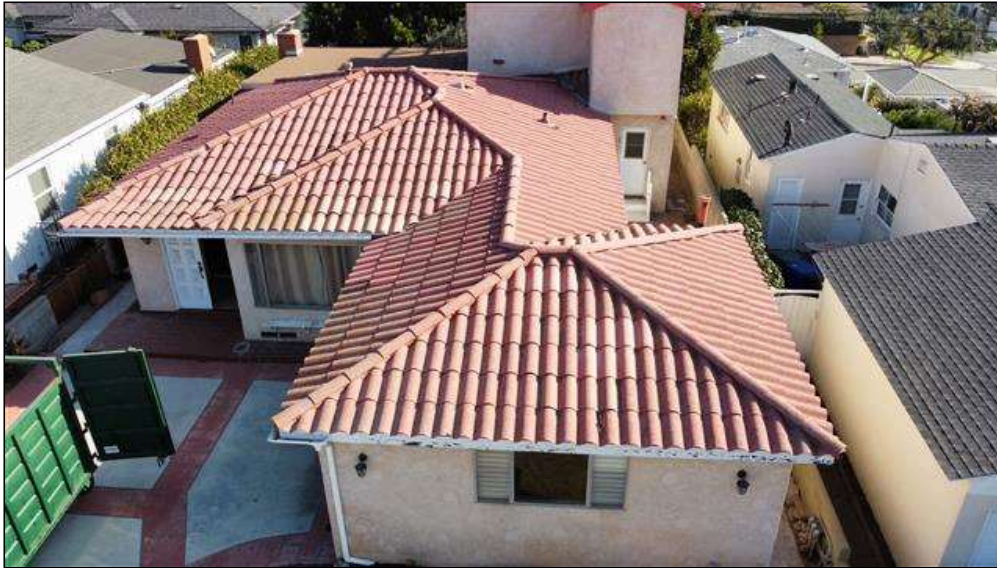
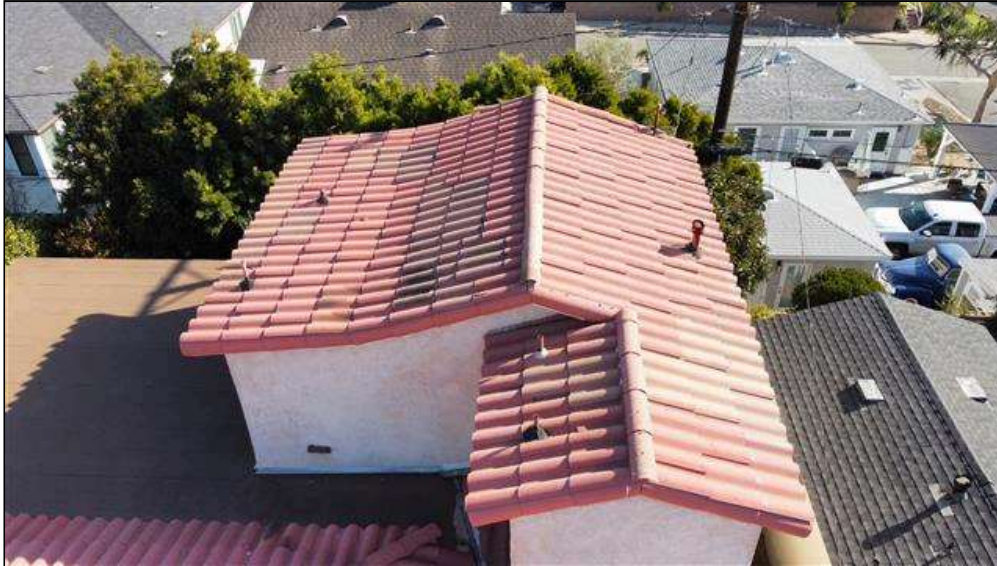
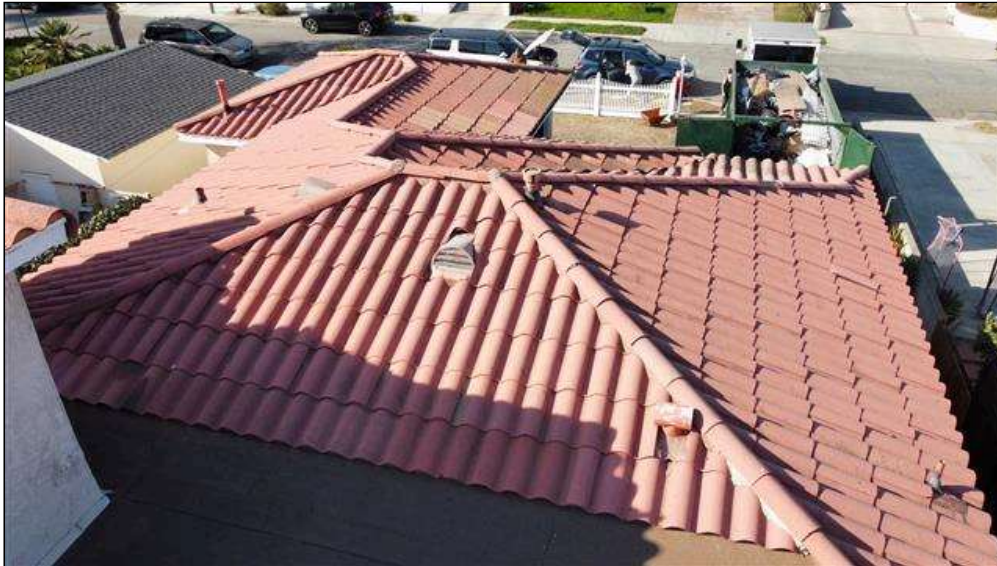
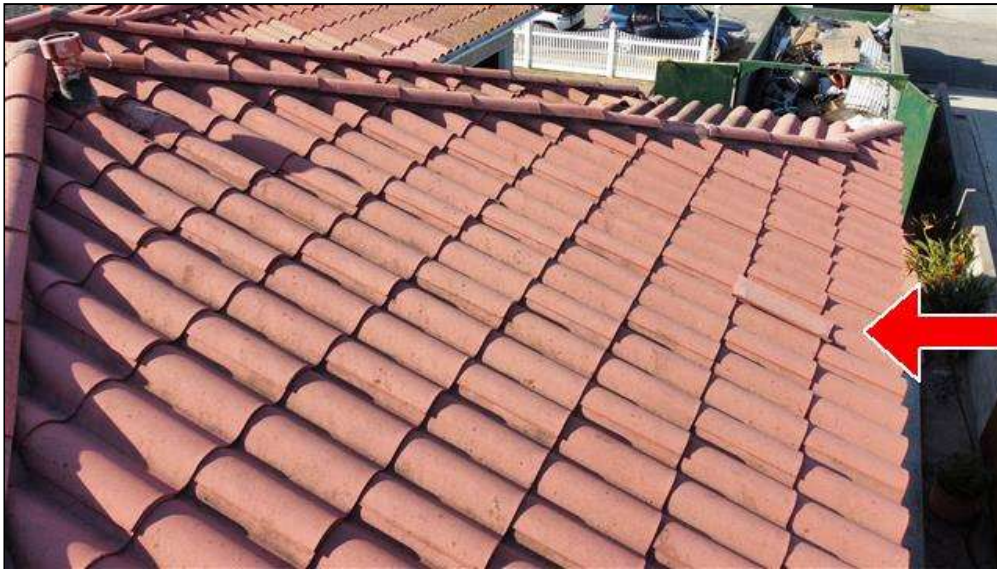
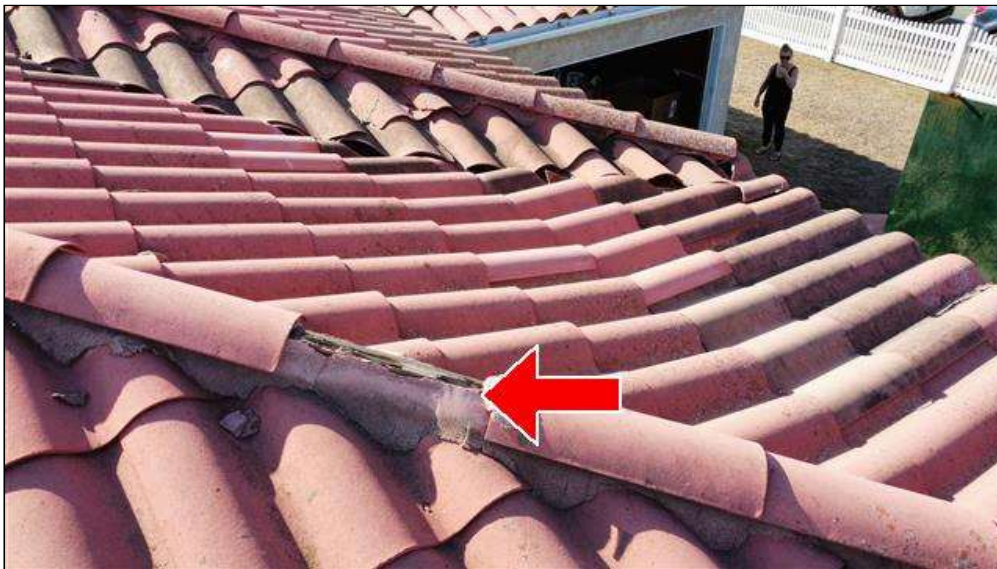
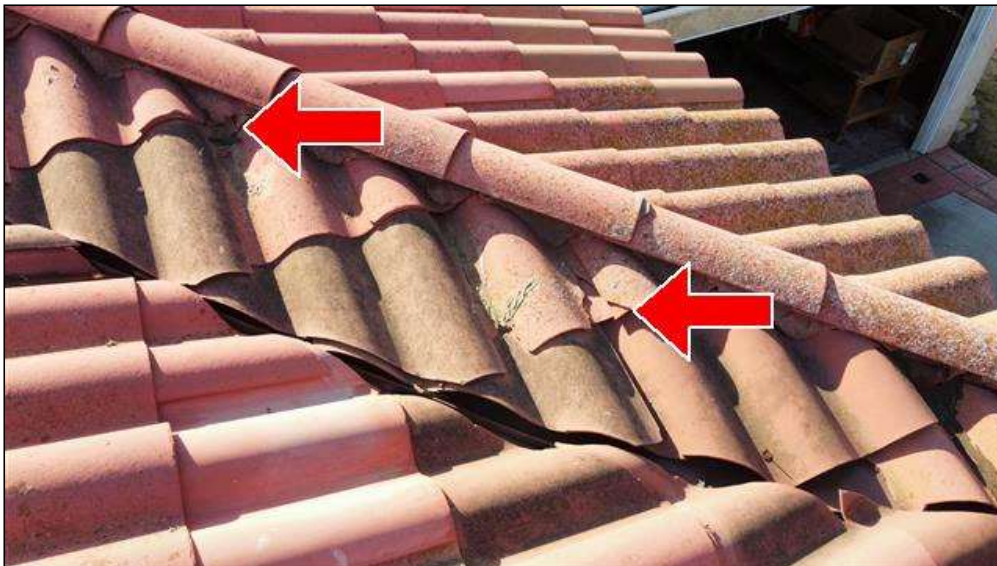
(1) Deteriorated, cracked, loose and missing sections of the roof tiles was noted. Suggest review by a licensed roofer for any repair/replacement costs as needed to prevent any future leakage during the rainy season.

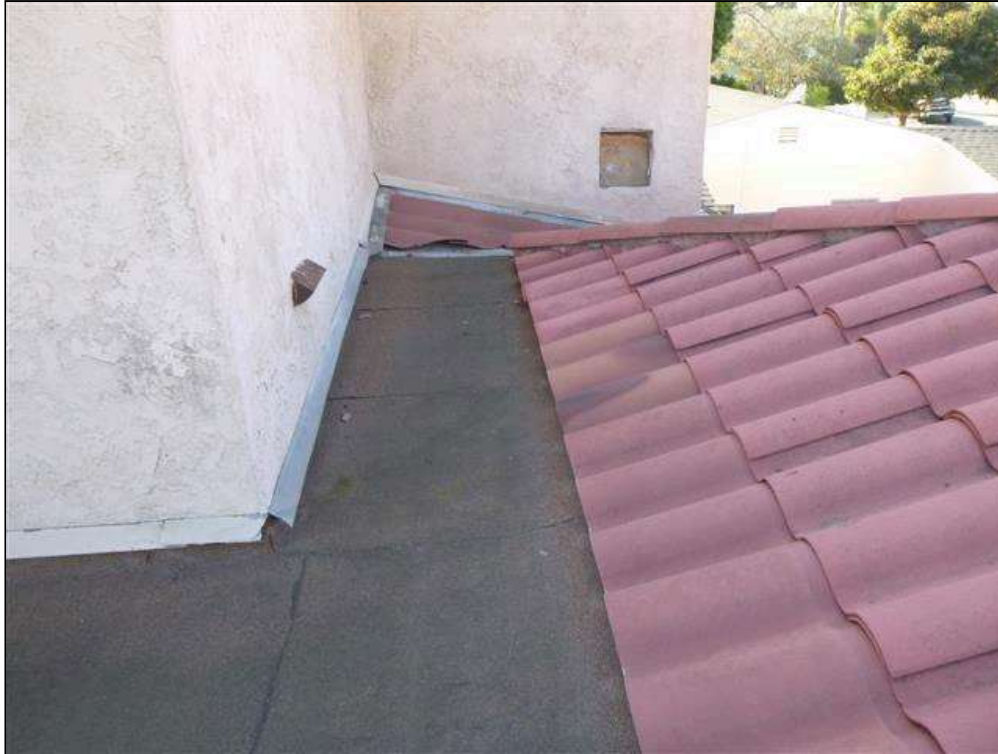
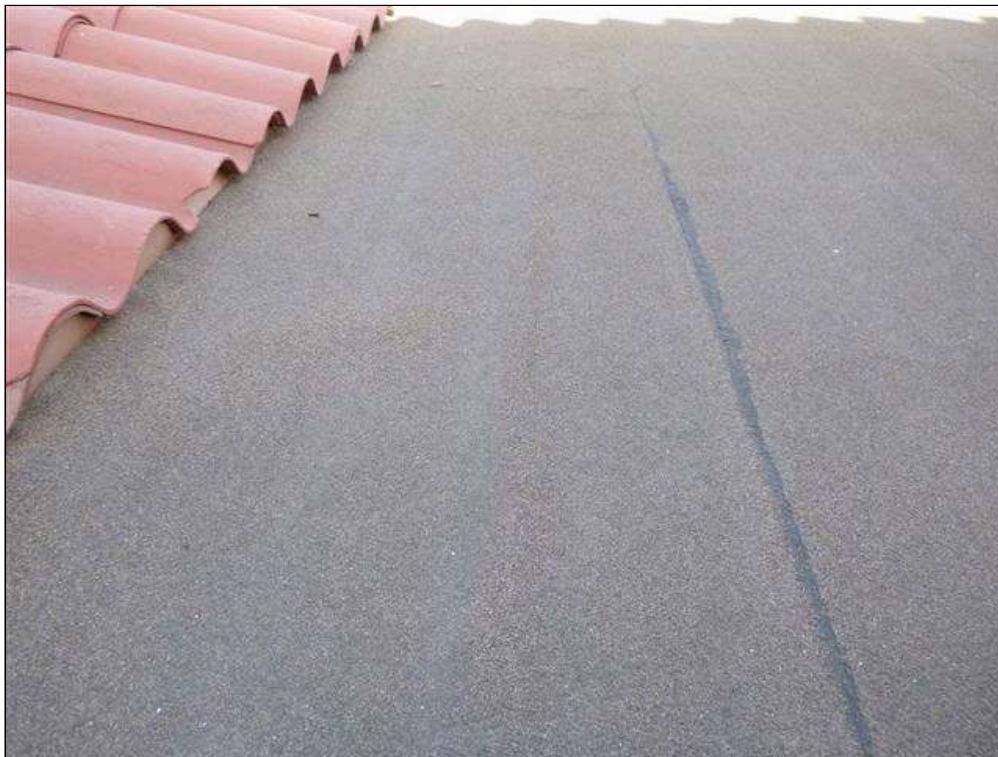
5.0 Item 8(Picture)

(2) Soft, uneven, wrinkling and worn areas of the sloped roof was noted. Suggest review with a licensed roofer for any repair/removal/replacement costs as needed.

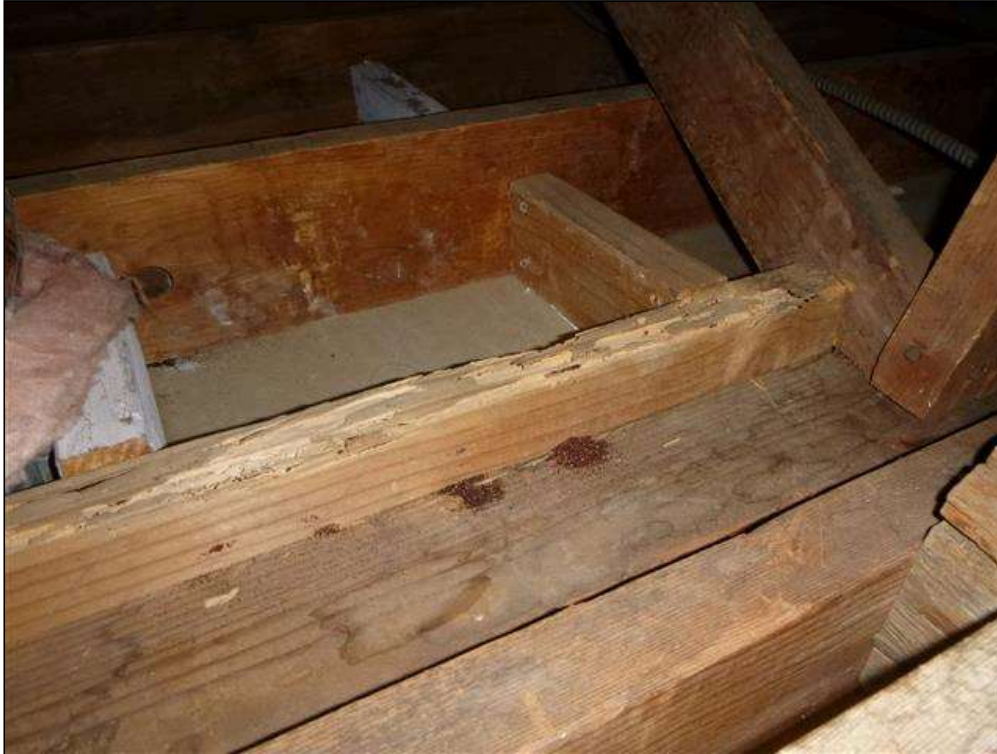
6.0 Item 2(Picture)

(2) Wood deterioration noted at various areas of the roof framing, suggest review with a termite company and/or a licensed contractor for repairs as needed.

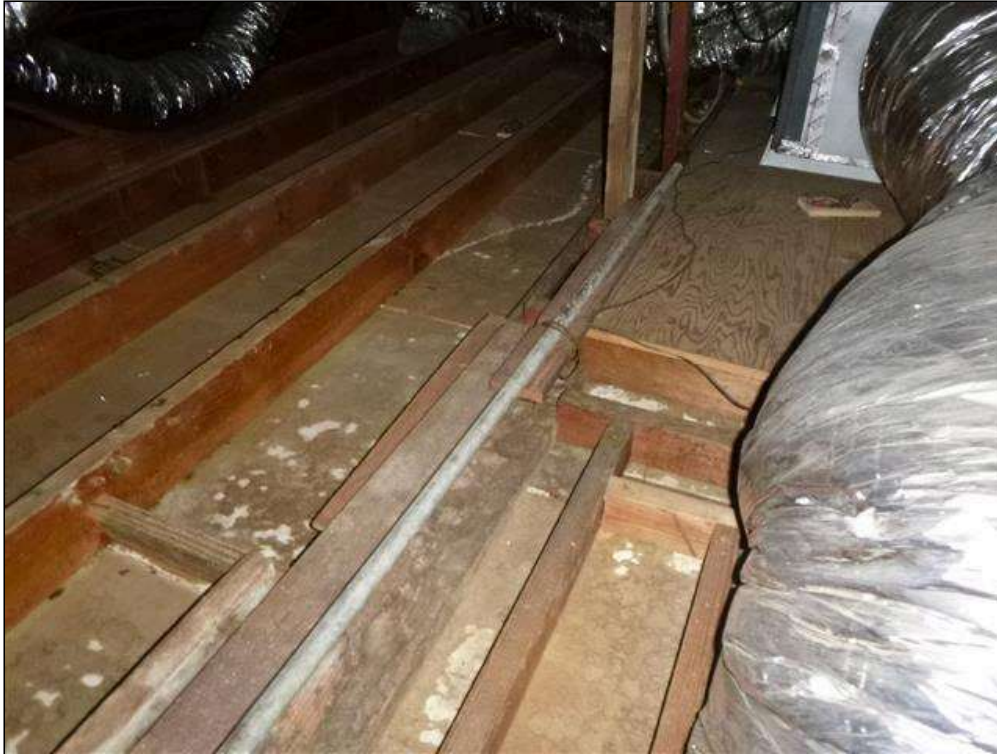
6.6 Item 1(Picture)

- (1) The attic access ladder is deteriorated/damaged, suggest replacing as needed.
- (2) No heater access platform is currently installed, suggest review with a licensed contractor for installation as required.

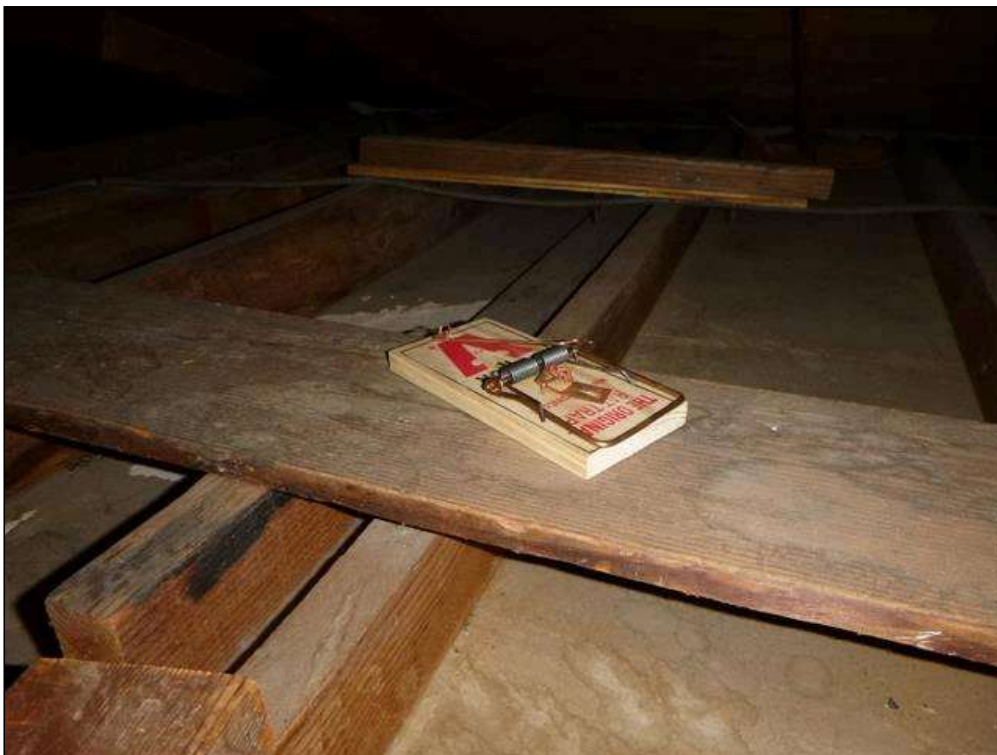
6.6 Item 2(Picture)

- (3) Pest traps were noted within the attic. Suggest review with a qualified pest control company and/or a licensed contractor for removal costs of the droppings, re-screening of the vents and any removal/replacement of the attic insulation as needed.

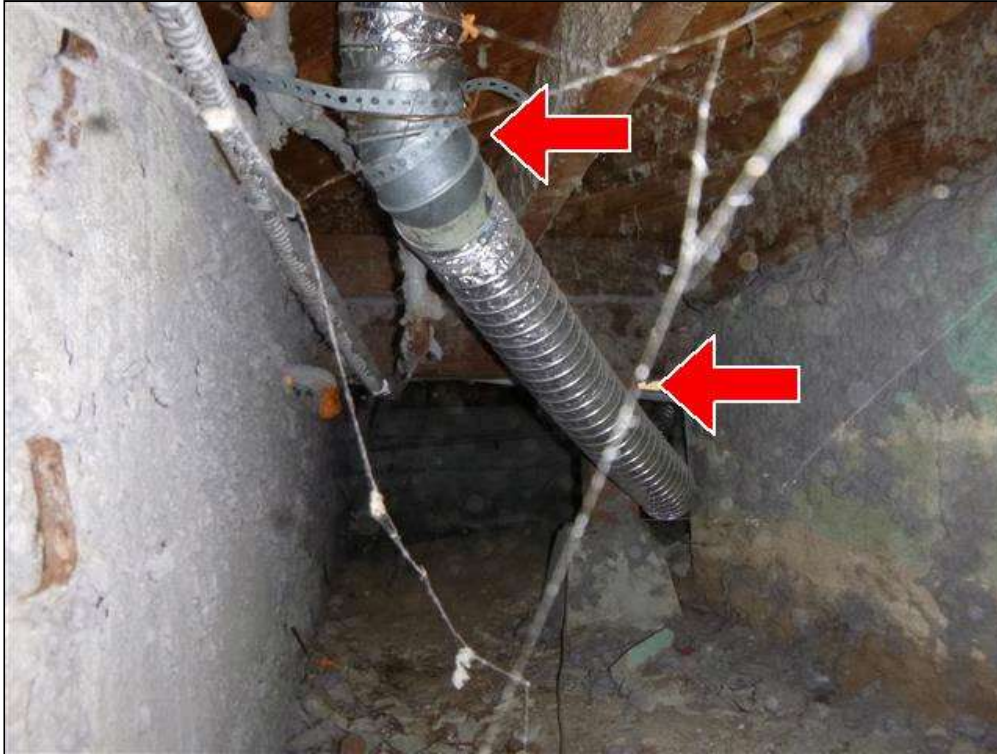
7.8 Item 2(Picture)

(1) Improper aluminum/vinyl flex vent installed to the exterior of the dwelling, this is a potential fire/safety hazard. Suggest remove the existing material and installation of a rigid metal vent pipe/duct and vent cap to the exterior as required.

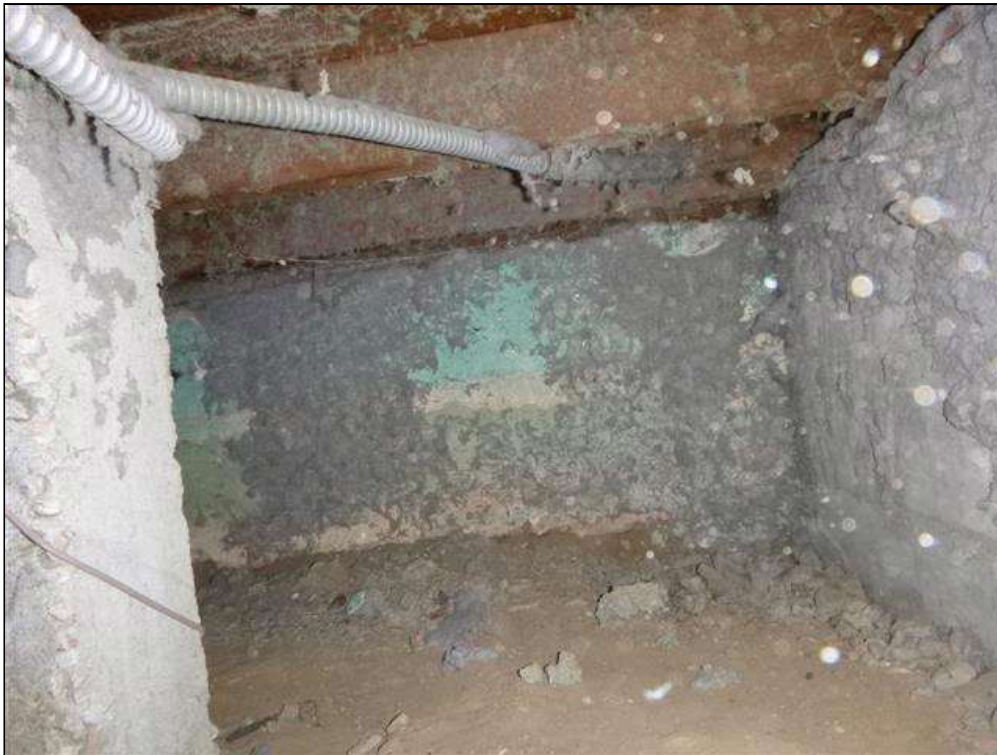
7.8 Item 3(Picture)

(2) The dryer vent is pulled apart/leaking within the crawl space, this is a potential fire safety hazard. Suggest repairs as needed and vent to the exterior of dwelling with approved rigid materials and removal of all lint from the crawl area.

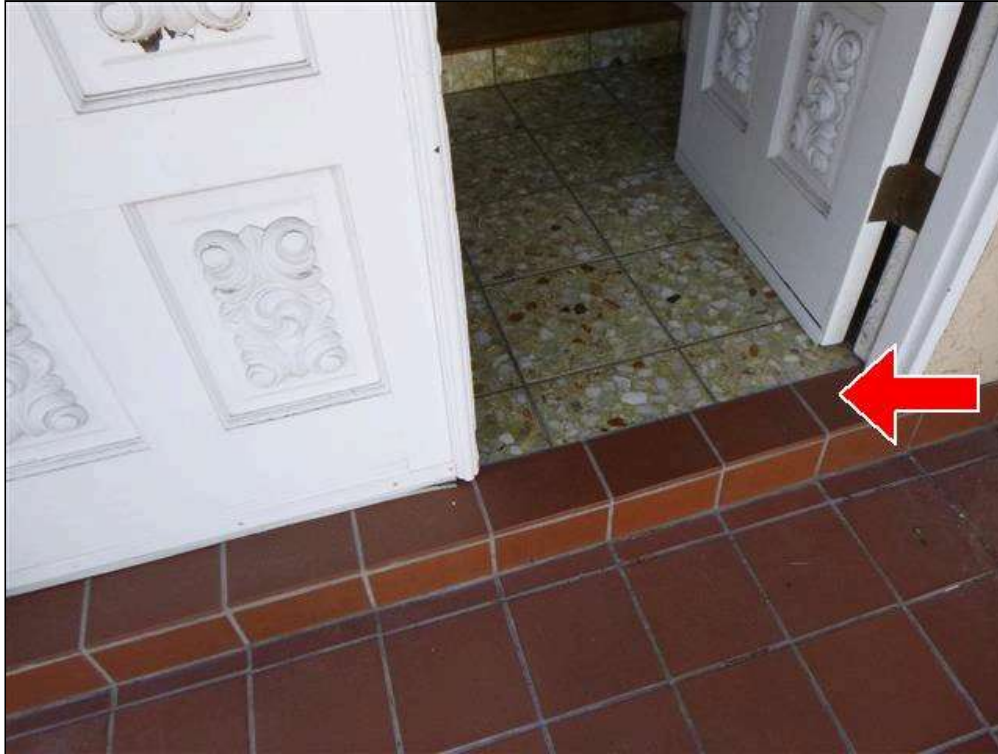
8.5 Item 2(Picture)

(2) Suggest review with a licensed contractor for costs to install a door threshold and weather seals as needed.

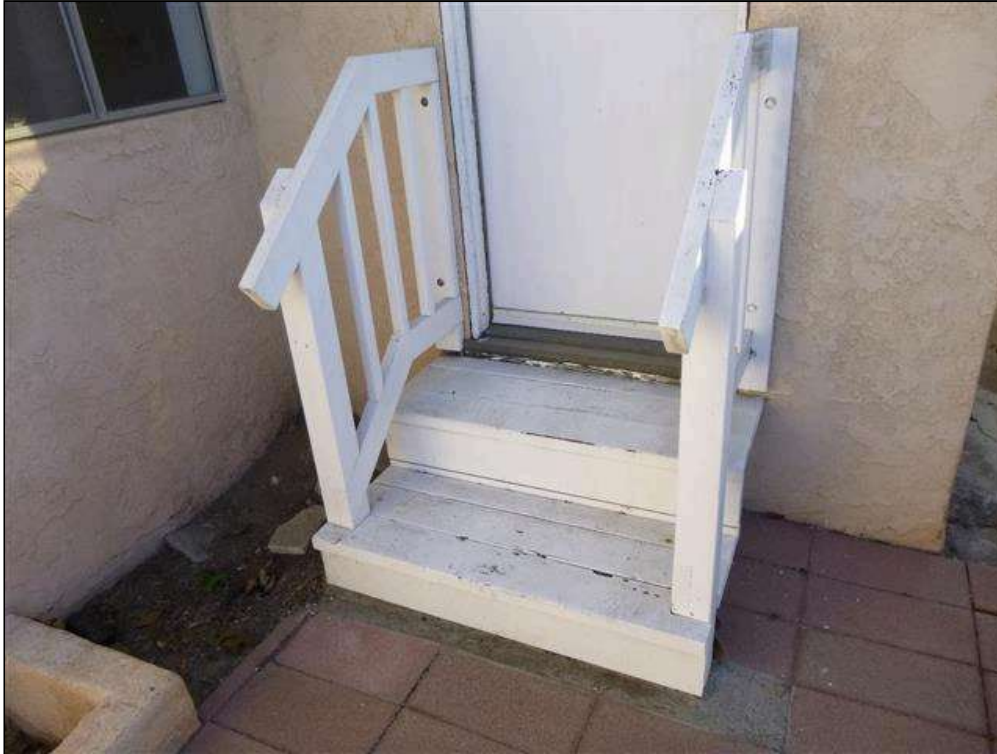
9.0 Item 1(Picture)

A potential trip/safety hazard was noted due an inadequate sized deck/landing prior to the step(s) (this is common for the age of the home/dwelling). Generally a 36" landing is required at any exterior door prior to any step(s). Suggest review by a licensed contractor for any repair/replacement costs as needed.

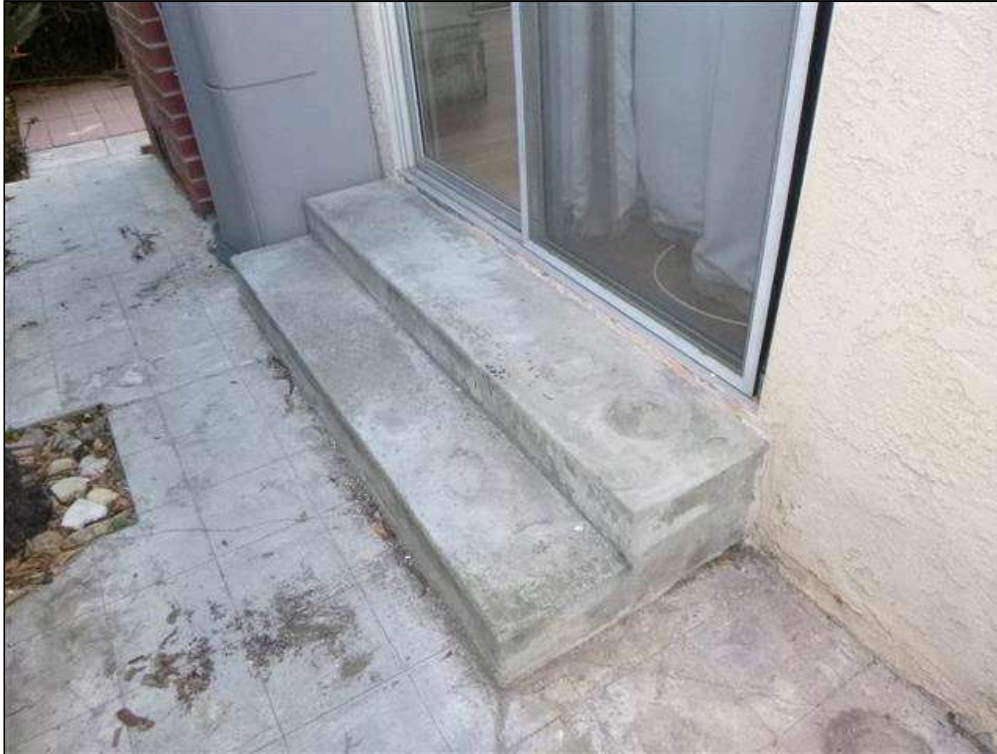
11.0 Item 1(Picture)

A potential trip/safety hazard was noted due an inadequate sized deck/landing prior to the step(s) (this is common for the age of the home/dwelling). Generally a 36" landing is required at any exterior door prior to any step(s). Suggest review by a licensed contractor for any repair/replacement costs as needed.
