General Summary

Ferguson Home Inspections

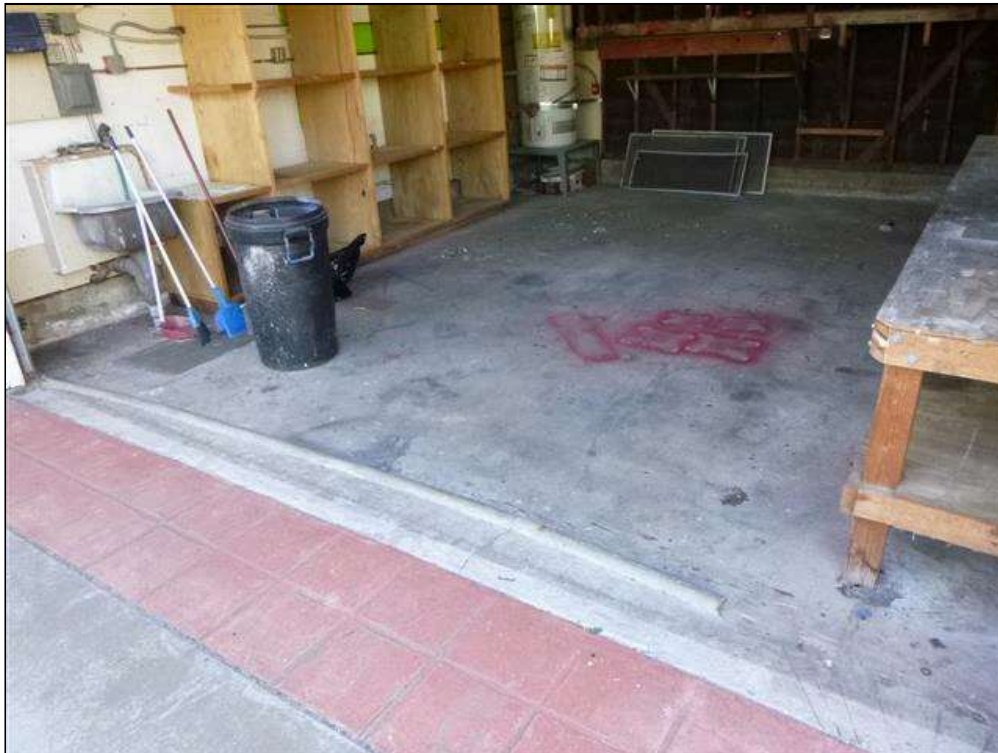
12.0 Item 2(Picture)

(3) Evidence of previous water intrusion into the garage was noted. See the driveway comment and suggest review with a licensed contractor for repair costs as needed.

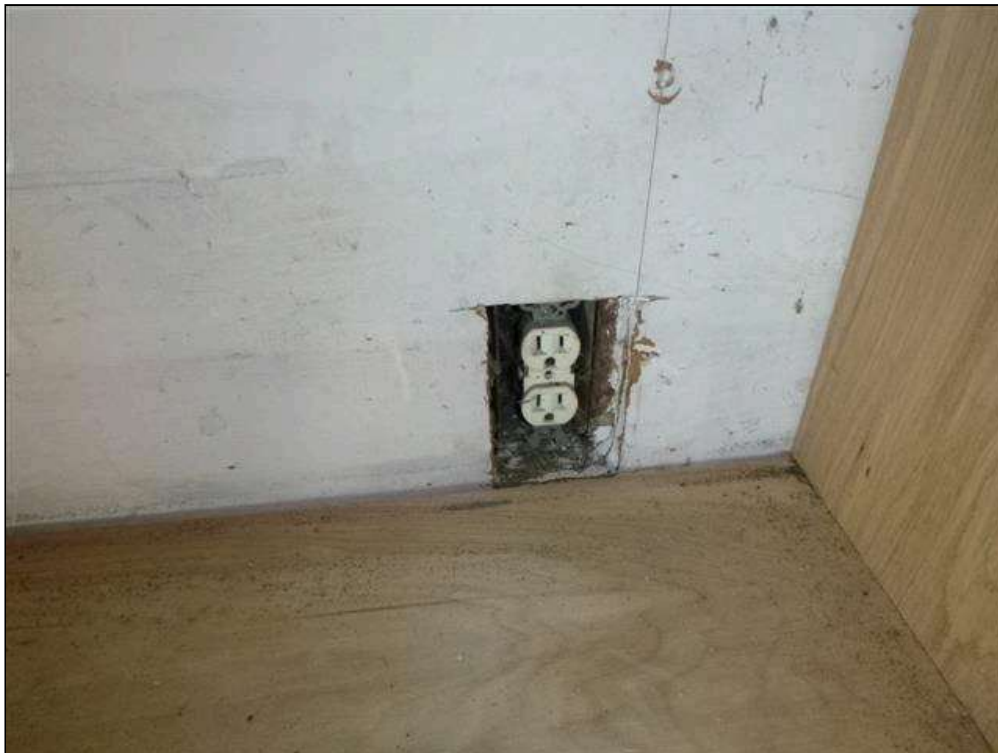
12.6 Item 1(Picture)

(1) Various outlet cover(s) are missing, suggest installation for safety.

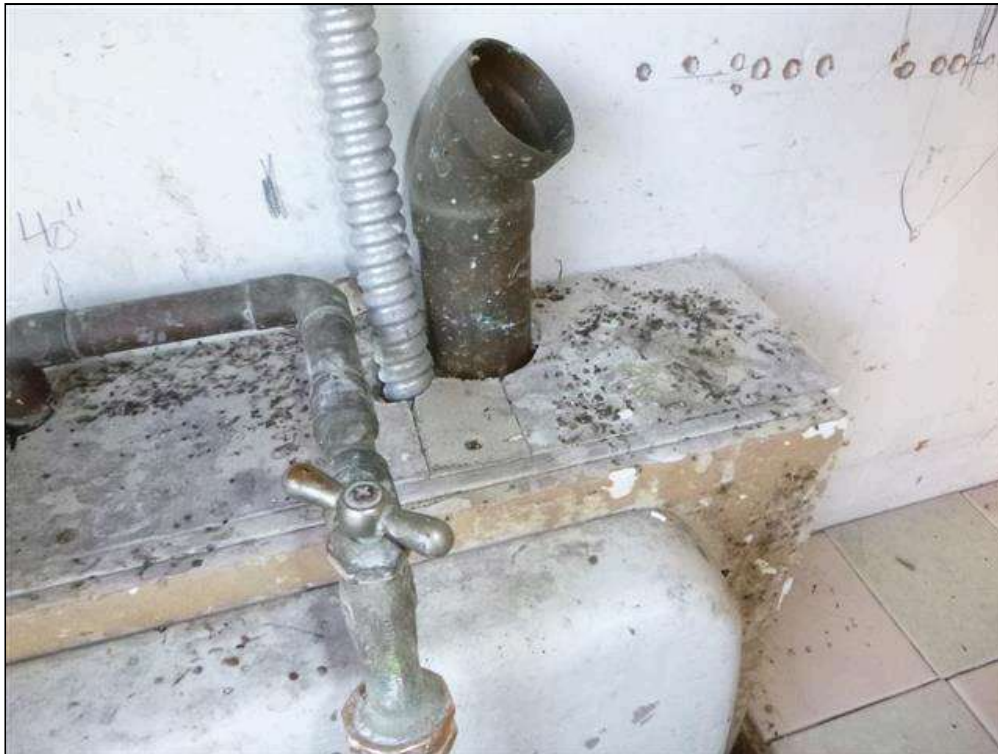
12.9 Item 1(Picture)

Excessive pest droppings noted within the garage area. Suggest review with a qualified pest control company and/or a licensed contractor for removal costs of the droppings as needed.

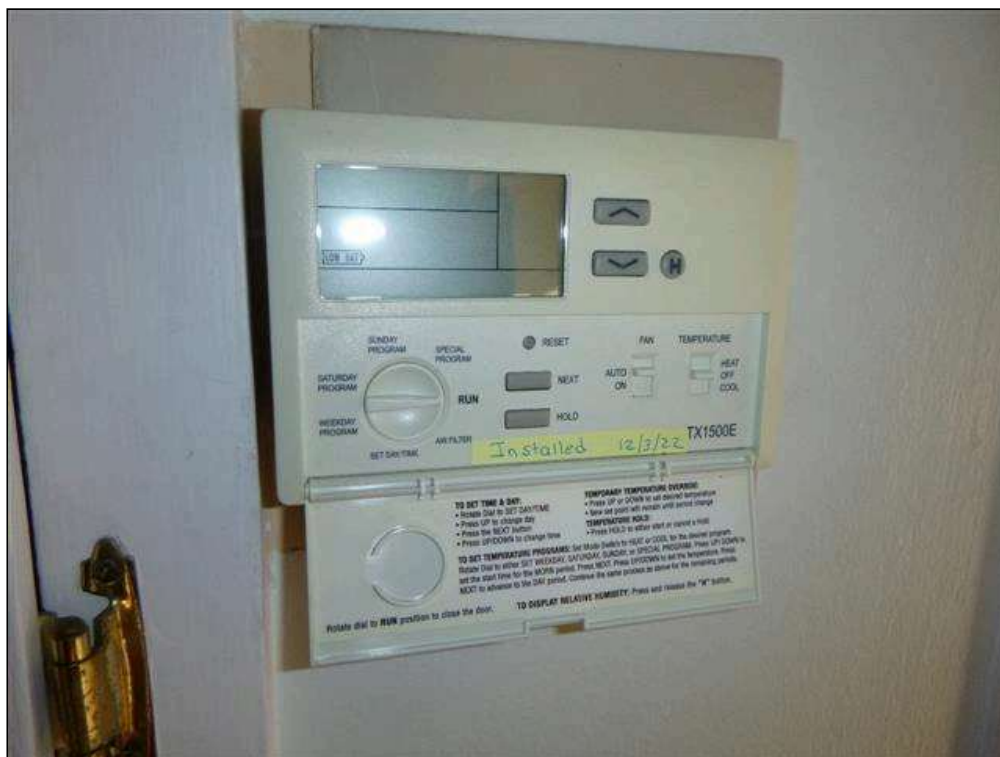
13.0 Item 2(Picture)

(1) The inspector was unable to test the heating system as the thermostat was inoperable at the time of the inspection. Suggest review by the Gas Company and/or a licensed heating company for review to determine if the unit is operational, any repair/replacement costs and confirm correct operation as needed.

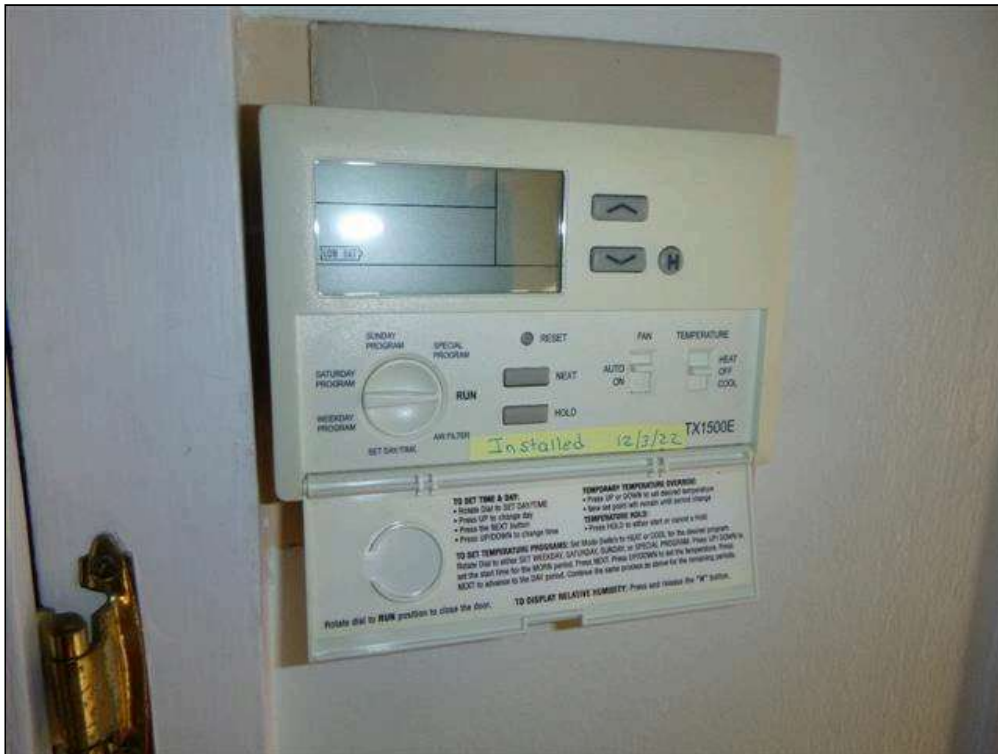
13.2 Item 1(Picture)

Unable to test/operate the thermostat at the time of the inspection, see the heating comments.

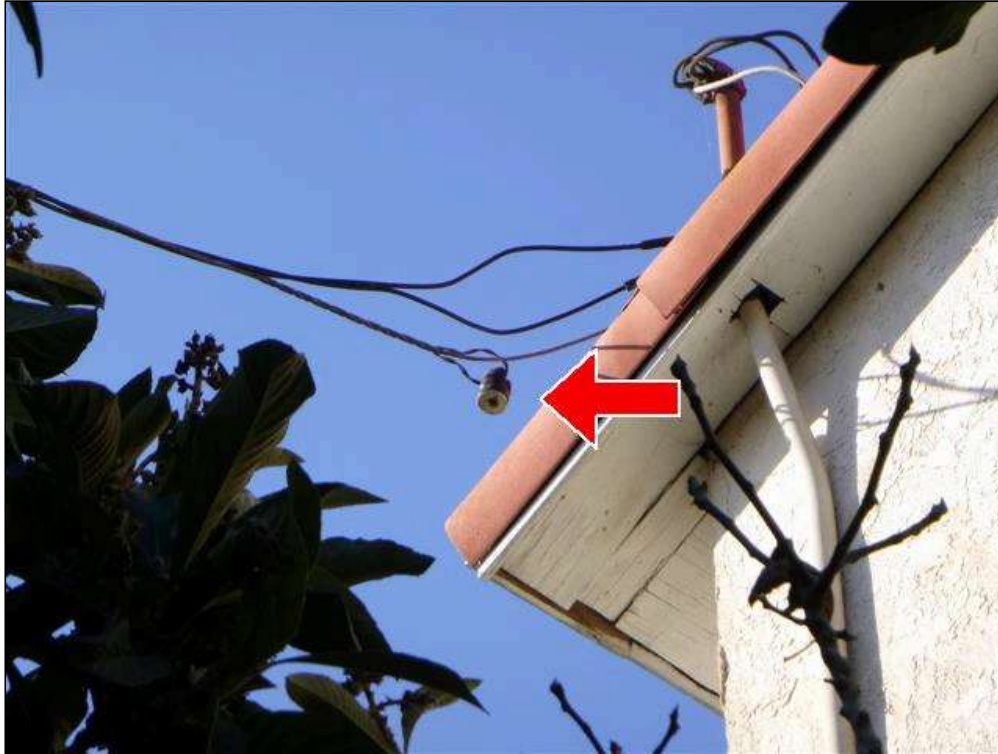
14.0 Item 1(Picture)

The electrical service wiring mount is broken and detached from the roof, this is a potential safety hazard. Suggest review with a licensed electrician and/or the local utility company for repair/replacement costs as required for safety.

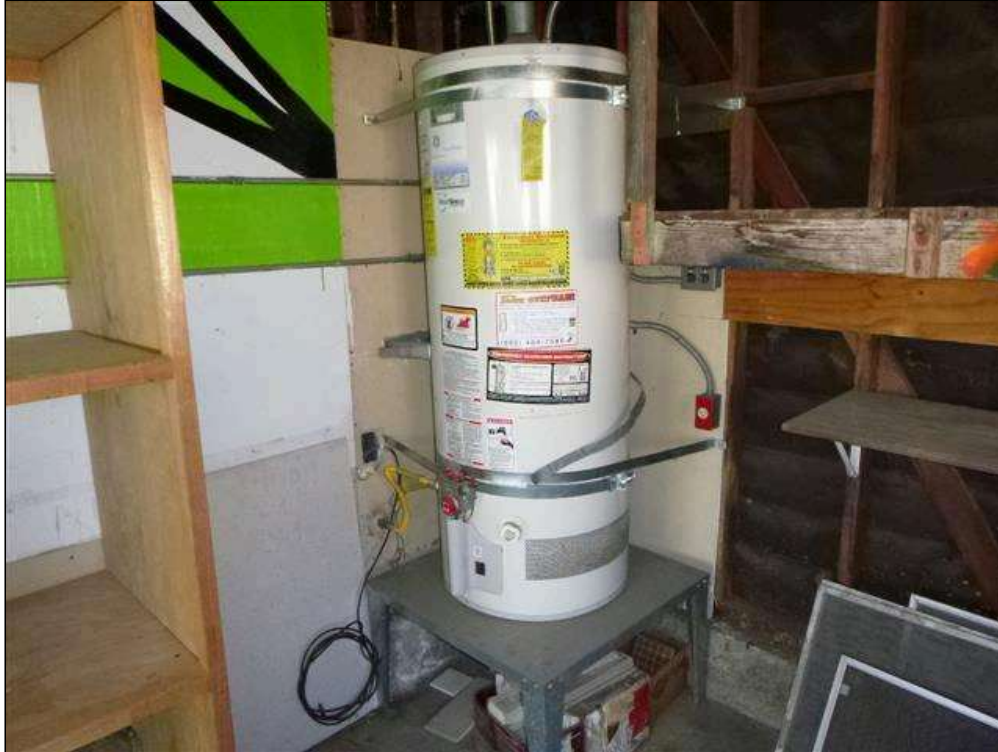
17.0 Item 1(Picture)

(1) Due to the age of this unit, suggest review with a licensed plumber for replacement costs as it has exceeded it's intended life span (12-15 years).

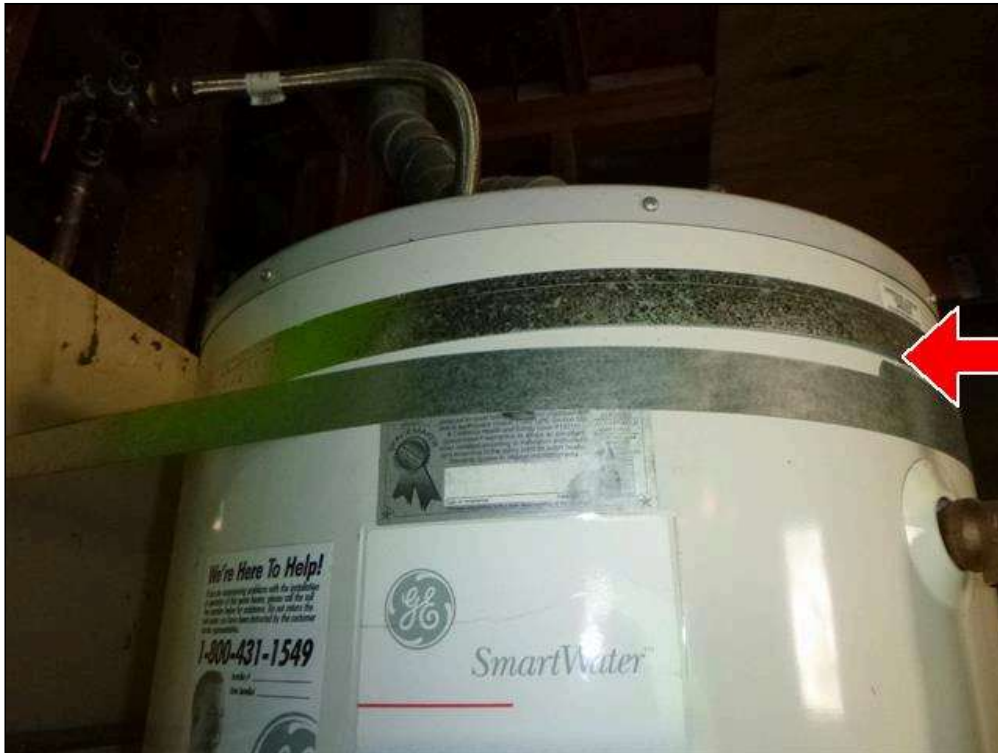
17.0 Item 3(Picture)

(4) The earthquake strapping has been installed incorrectly, the upper strap is required to be 1/3 down from the top of the tank. Suggest review with a licensed plumber and repair as required for safety.

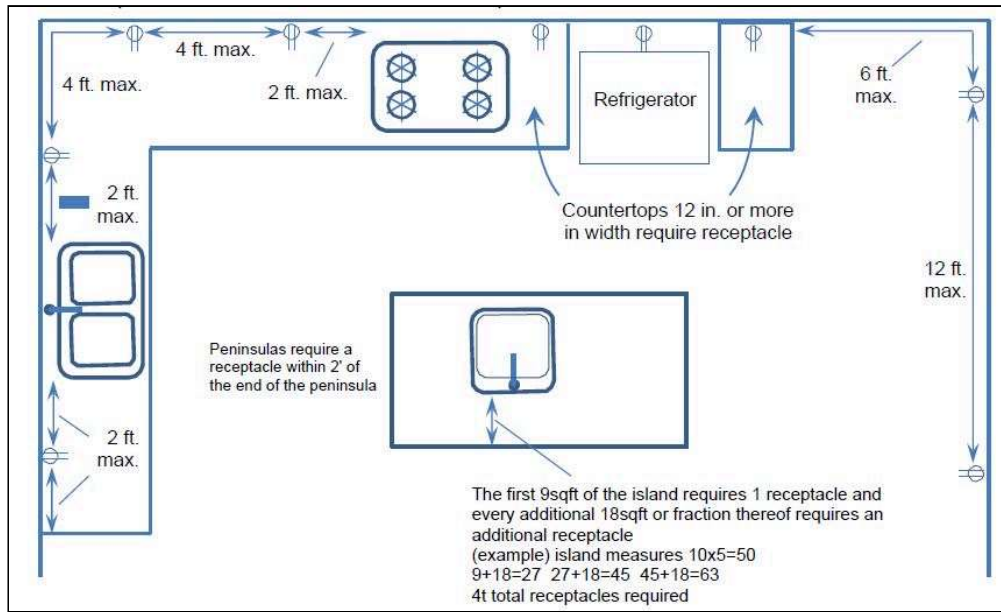
18.7 Item 3(Picture) Kitchen outlets

(2) Inadequate/incorrectly installed countertop/appliance outlets/circuits were noted, suggest review with a licensed electrician for installation costs as needed/required.

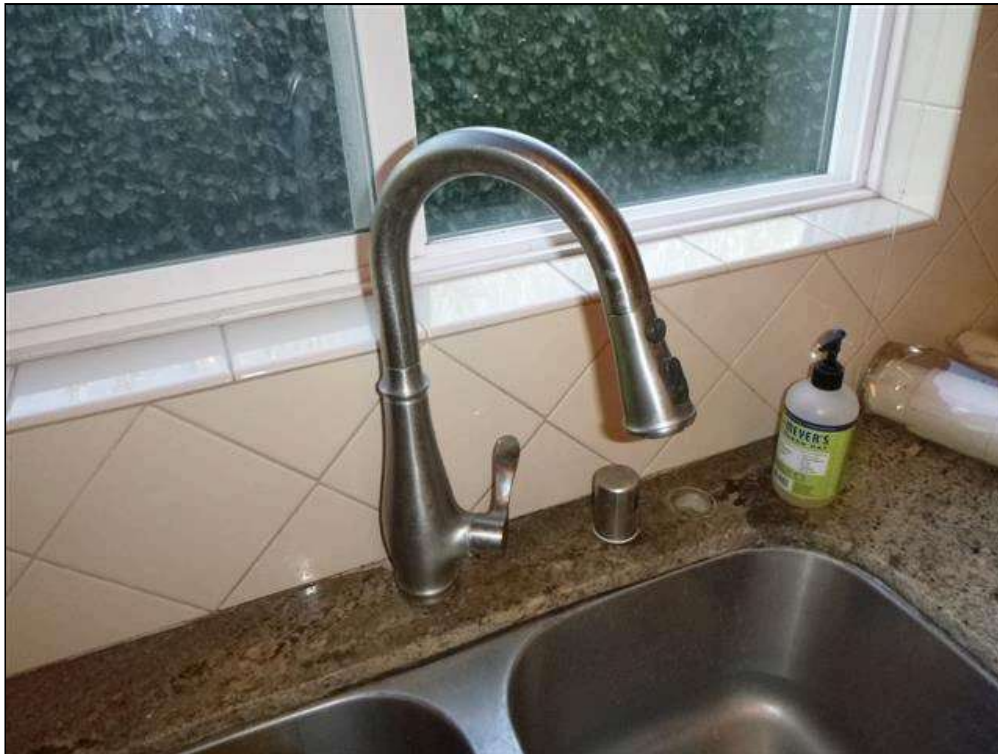
18.9 Item 1(Picture)

Unable to test the faucet as the water was either off or inoperable at this area. Suggest review with a licensed plumber for any repair/replacement costs as needed.

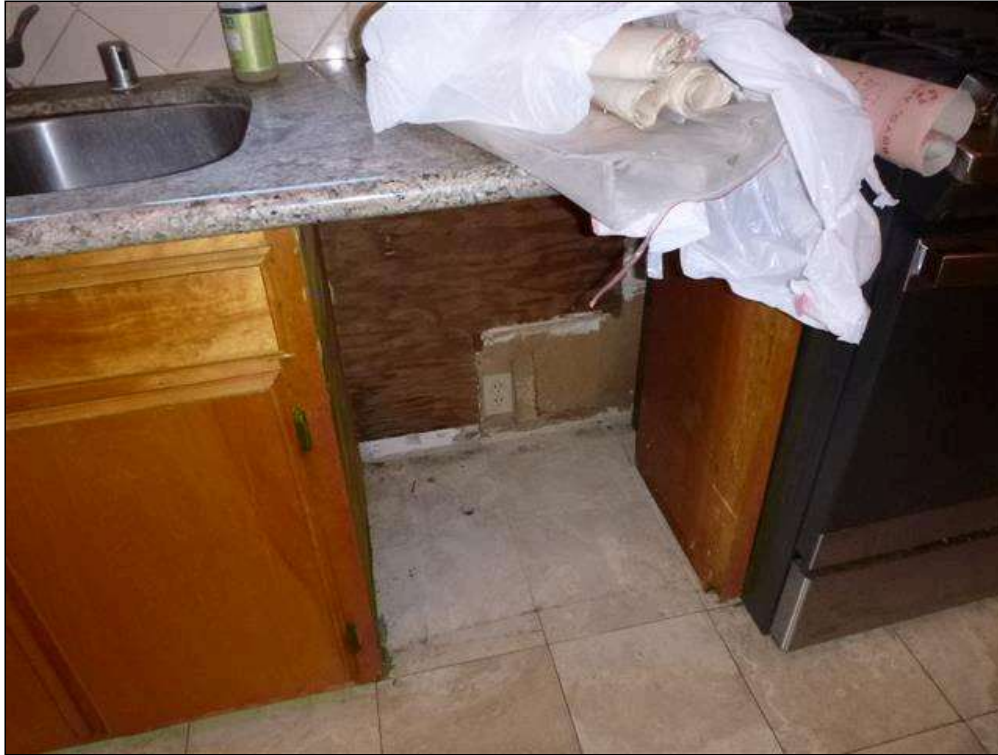
18.11 Item 1(Picture)

No dishwasher was installed at the time of the inspection. Suggest review with the seller and/or a licensed contractor for installation costs as needed.

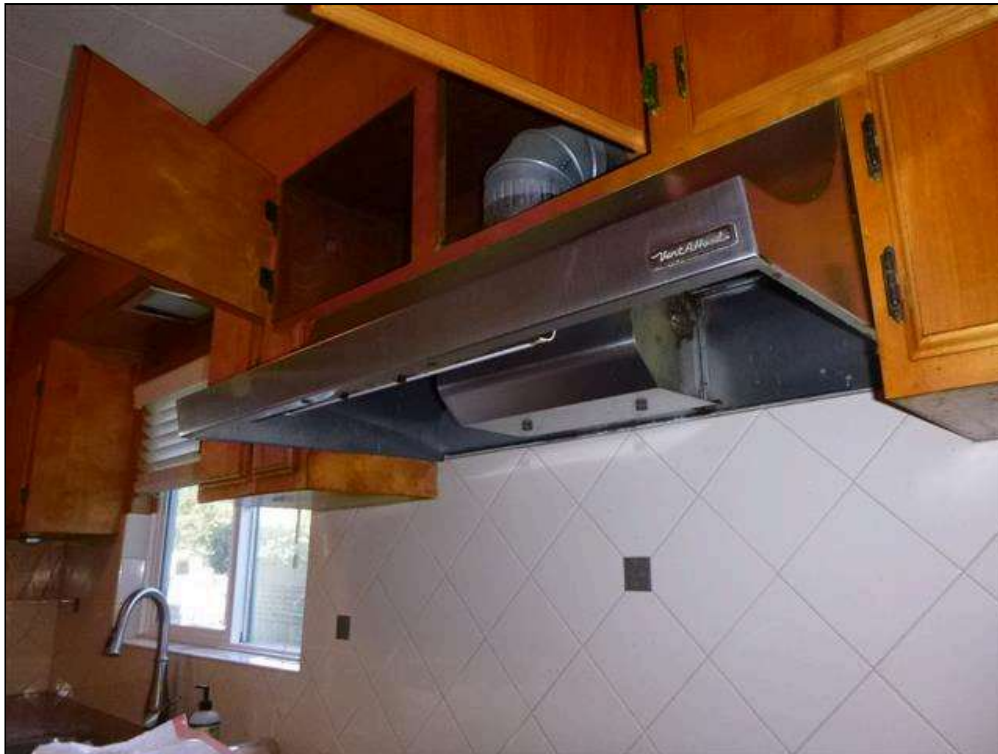
18.14 Item 1(Picture)

The range/hood vent is inoperable at the time of the inspection, suggest review with a licensed contractor and repair/replace as required for safety.

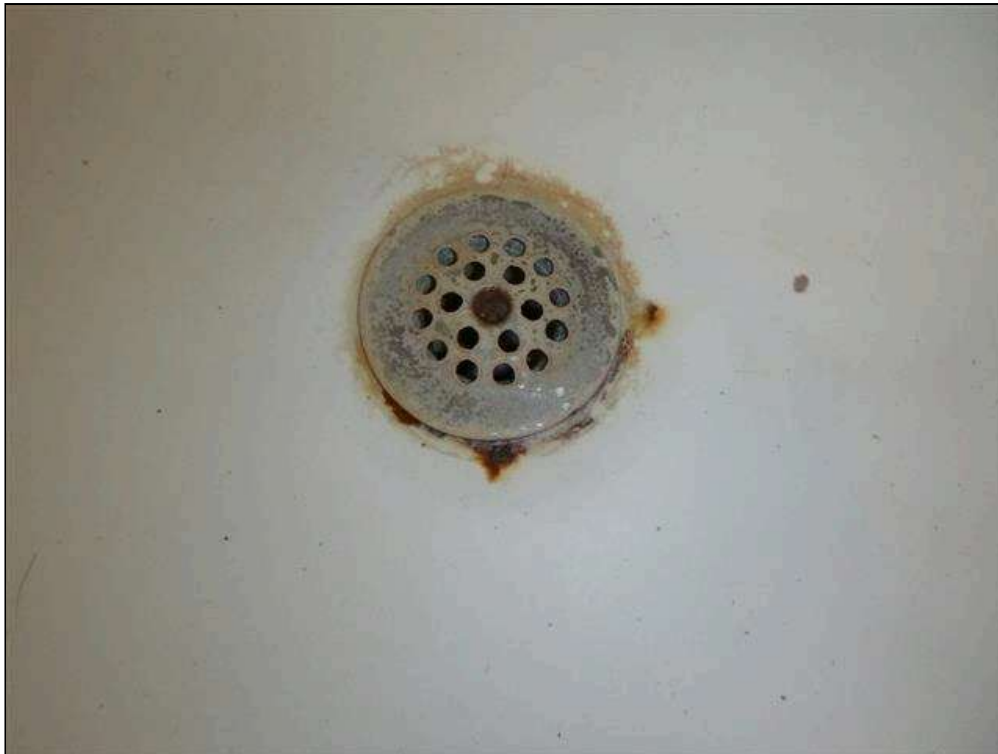
19.9 Item 1(Picture)

Minor deterioration and rust noted at the tub and surround, no visible evidence of leakage noted at the time of the inspection. Suggest repair/replace as needed.

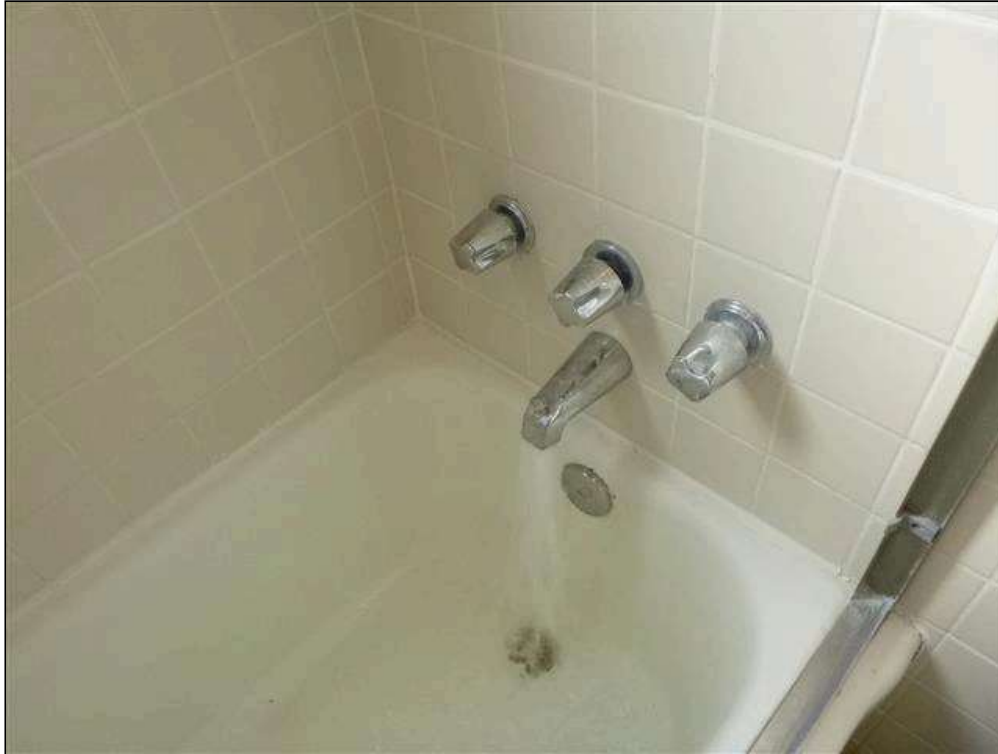
19.10 Item 1(Picture)

The existing tub faucet is not a low-flow system as required. Suggest review with a licensed plumber for costs to replace the existing tub faucet with a low flow faucet (2.2 gallons per minute) as required by the State of California as of January 1st, 2017. See the plumbing system comments for further details and a link to the State of California plumbing ordinance. Most retrofit companies/cities do not enforce the low flow tub faucet requirements due to it can take an excessive amount of time to fill the tub (you will use the same amount of water irrelevant of how long it takes to fill the tub).

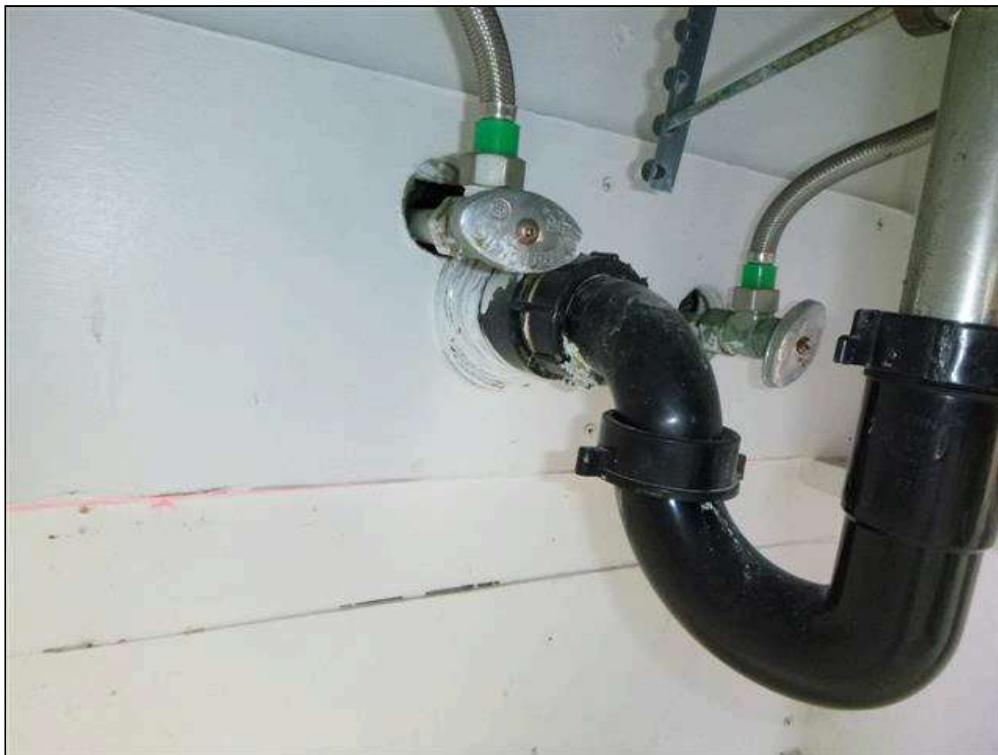
20.15 Item 1(Picture)

(1) Corrosion/stains noted at the sink drain and angle valve(s), no leaking noted at the time of the inspection. Suggest review by a licensed plumber for repair/replacement costs as needed.

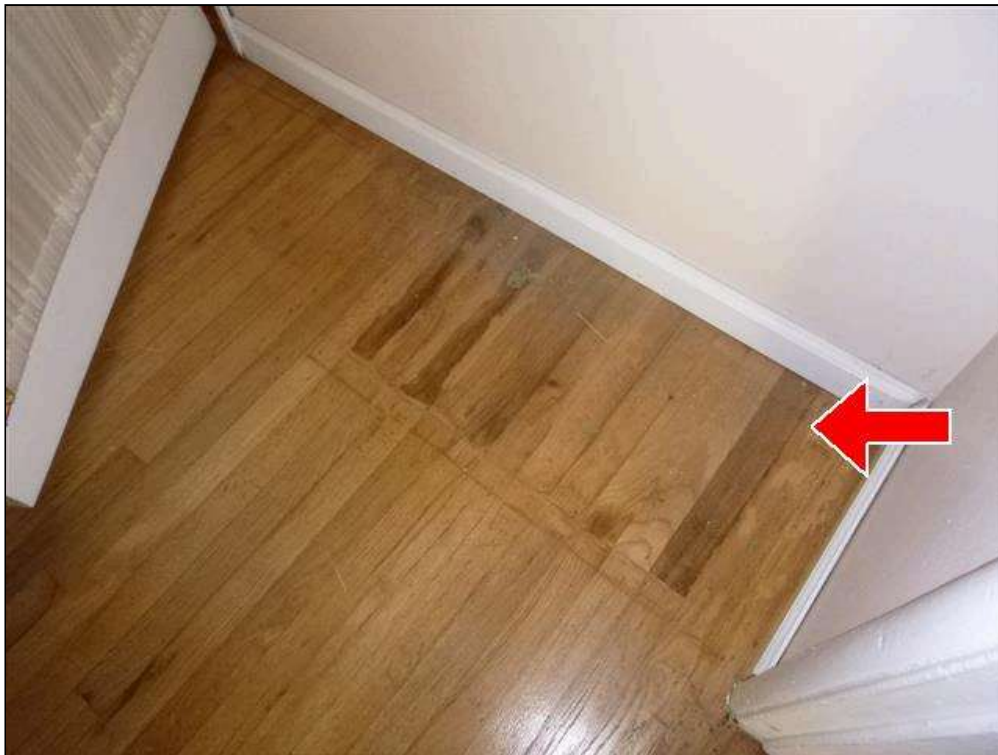
23.0 Item 1(Picture)

- (1) Floor slope, squeaky/noisy and uneven floors noted, suggest repairs as needed.
- (2) Patched areas of the floor were noted at the original floor heater location. Suggest repair/replace as needed.

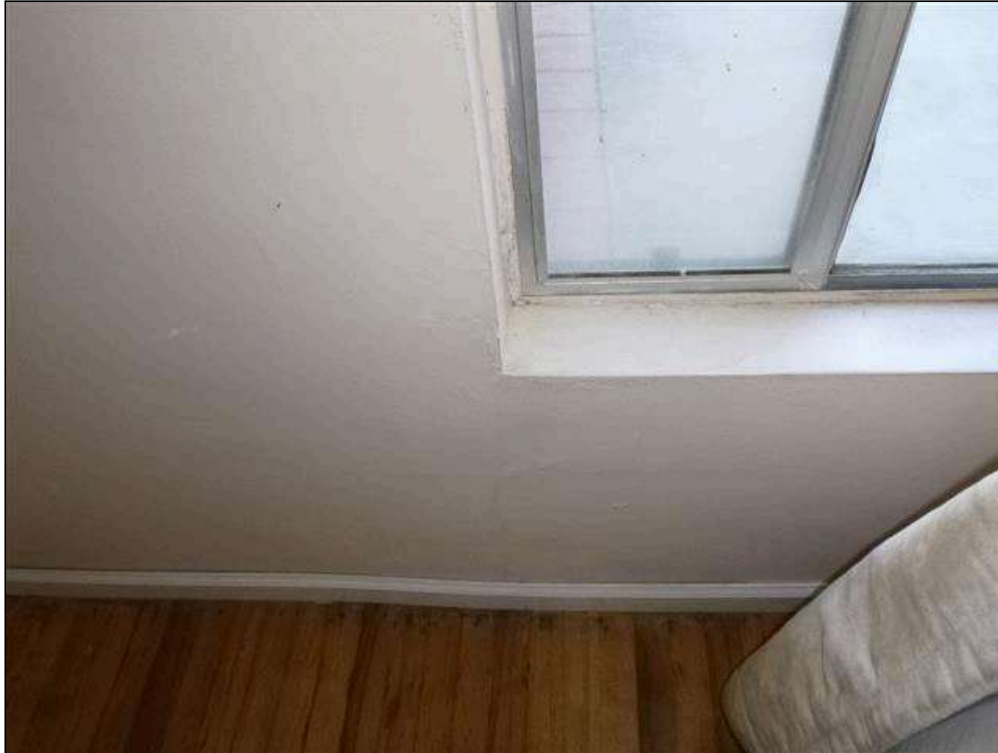
23.1 Item 1(Picture)

Patched areas of the walls were noted, suggest review with the seller for the cause and any repairs needed. Suggest review with a licensed contractor for any repair/removal/replacement costs as needed.

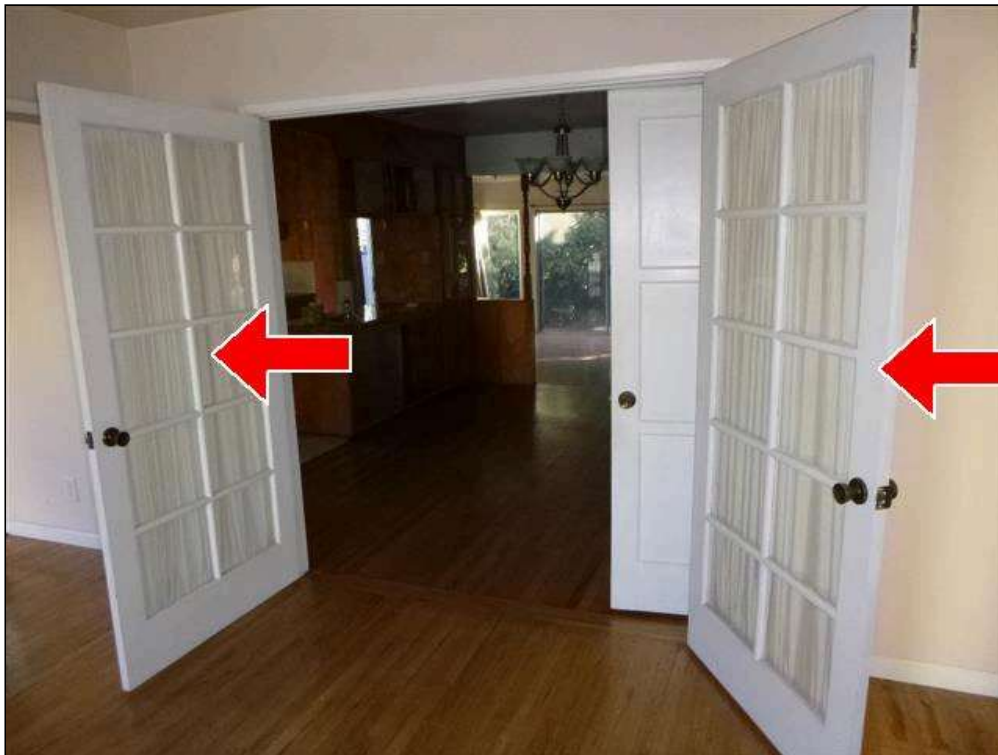
23.3 Item 1(Picture)

- (1) Suggest installation of door stops to prevent damage to the walls and/or surrounding area.
- (2) The inspector was unable to verify/determine if tempered/safety glass is installed at the window/door glass at this area (no labelling/etching is visible). Windows and doors with glass 18 inches off the floor area or windows within doors should have safety glass. Suggest review of these areas for possible costs to upgrade for safety.

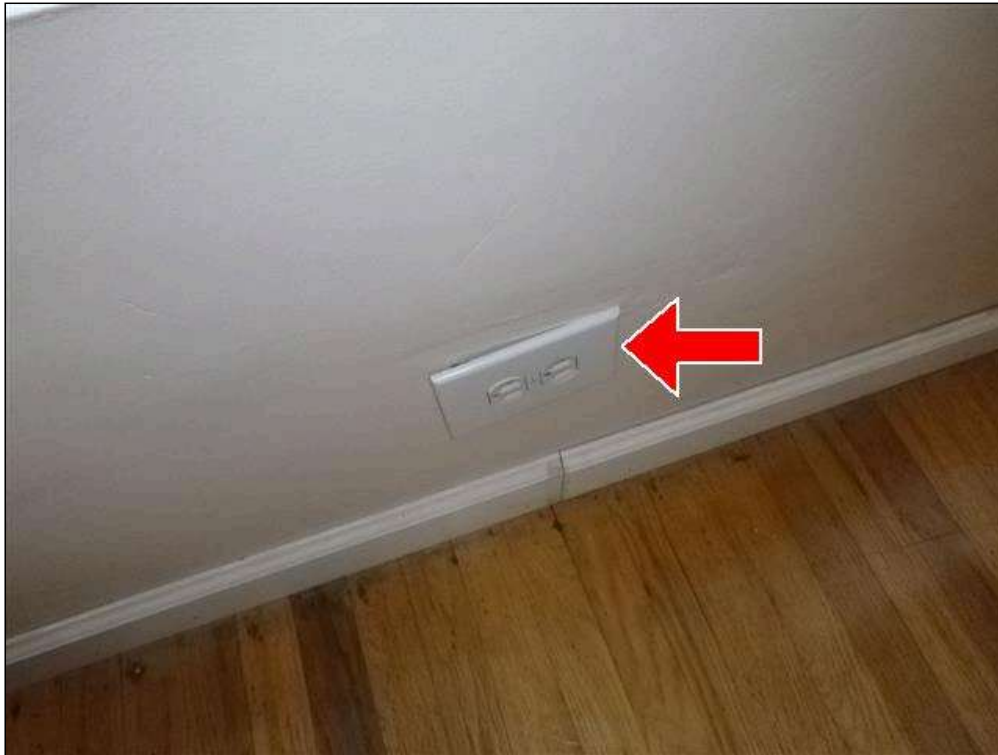
23.6 Item 1(Picture)

The outlet at the front wall is loose at the wall mount, suggest review with a licensed electrician for repair/replacement costs as needed.

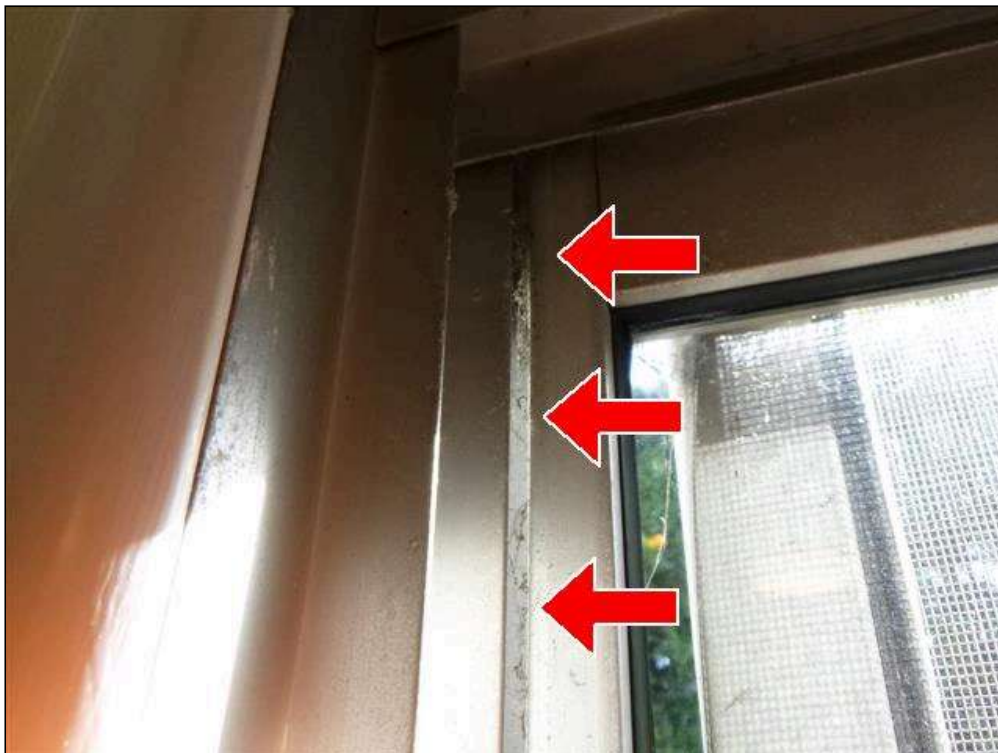
25.3 Item 1(Picture)

(1) The fixed section of the rear sliding door is not currently installed level with the frame and excessive gaps were noted. Suggest review with a licensed contractor for any repair/replacement costs as needed to prevent future water, draft and insect intrusion at this area.

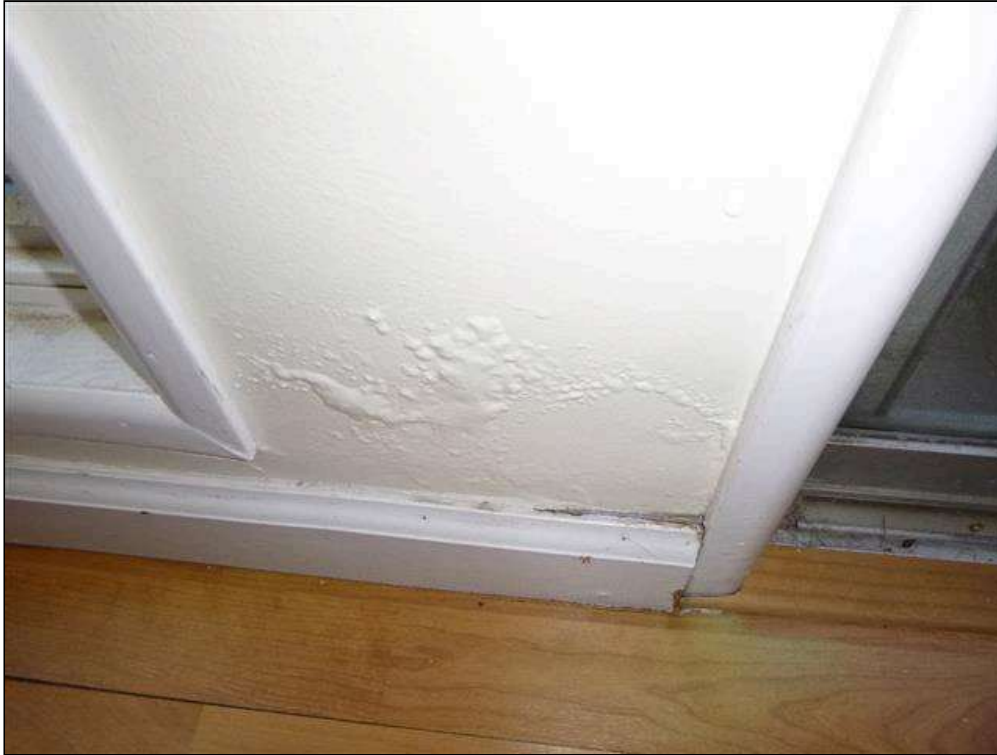
25.3 Item 2(Picture)

(2) Evidence of previous and possible on-going water intrusion was noted at the door(s) to the exterior. Suggest review with a licensed contractor for repair/replacement costs as needed.

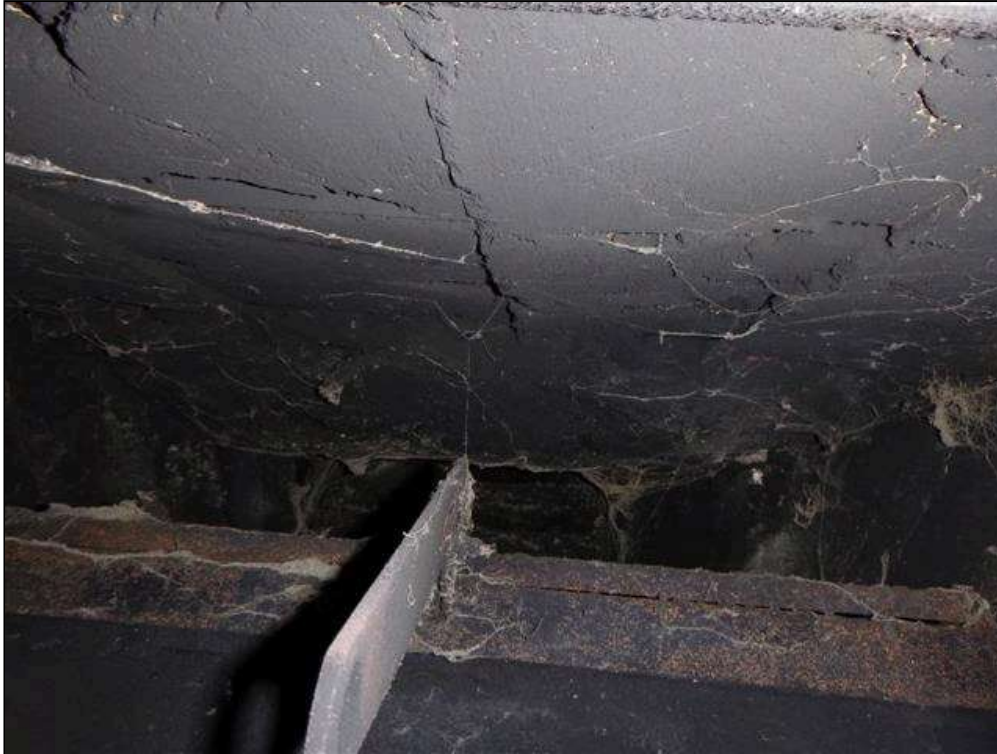
25.7 Item 3(Picture)

(2) Minor creosote noted within the firebox, smoke chamber or chimney areas. Creosote build-up can cause chimney fires if not removed from voids, open seams or open mortar joints within the fireplace and chimney. This inspection is a 'Level 1' inspection and is limited to visible and accessible areas only. 'Level 2' and 'Level 3' inspections are invasive inspections performed by qualified personnel only with equipment designed for fireplace/chimney inspections, cleaning or repairs. Suggest periodic cleaning of the fireplace/chimney and remove the creosote and debris within the fireplace and chimney. Suggest review by a professional chimney sweep for estimates, repairs or cleaning.

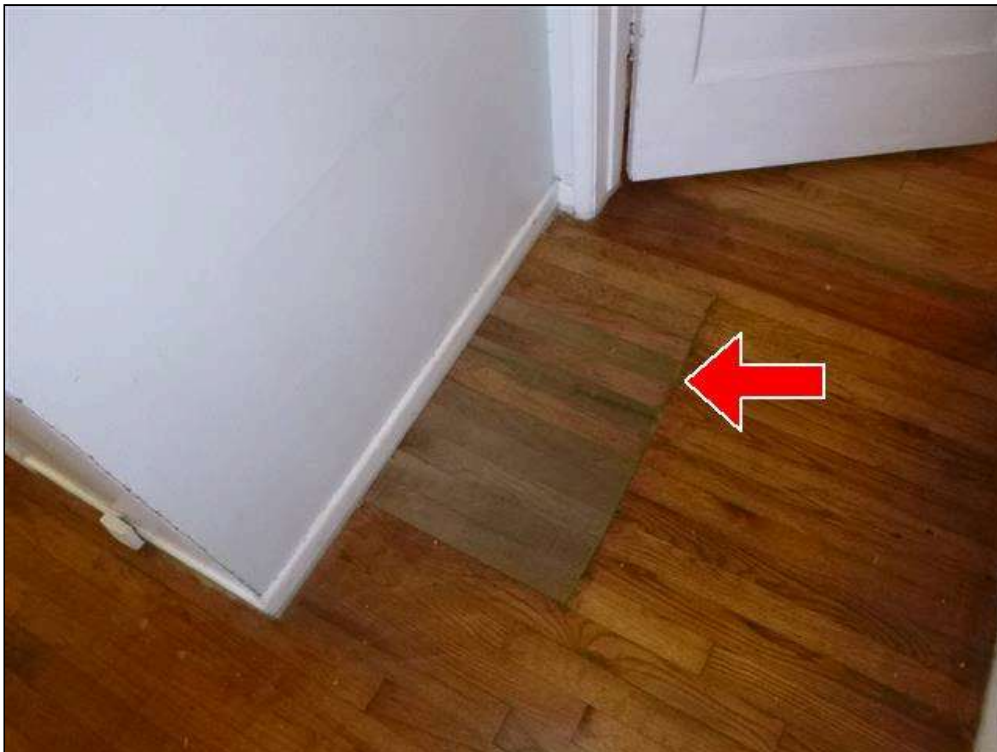
26.0 Item 1(Picture)

- (1) Floor slope, squeaky/noisy and uneven floors noted, suggest repairs as needed.
- (2) Patched areas of the floor were noted at the original floor heater location. Suggest repair/replace as needed.

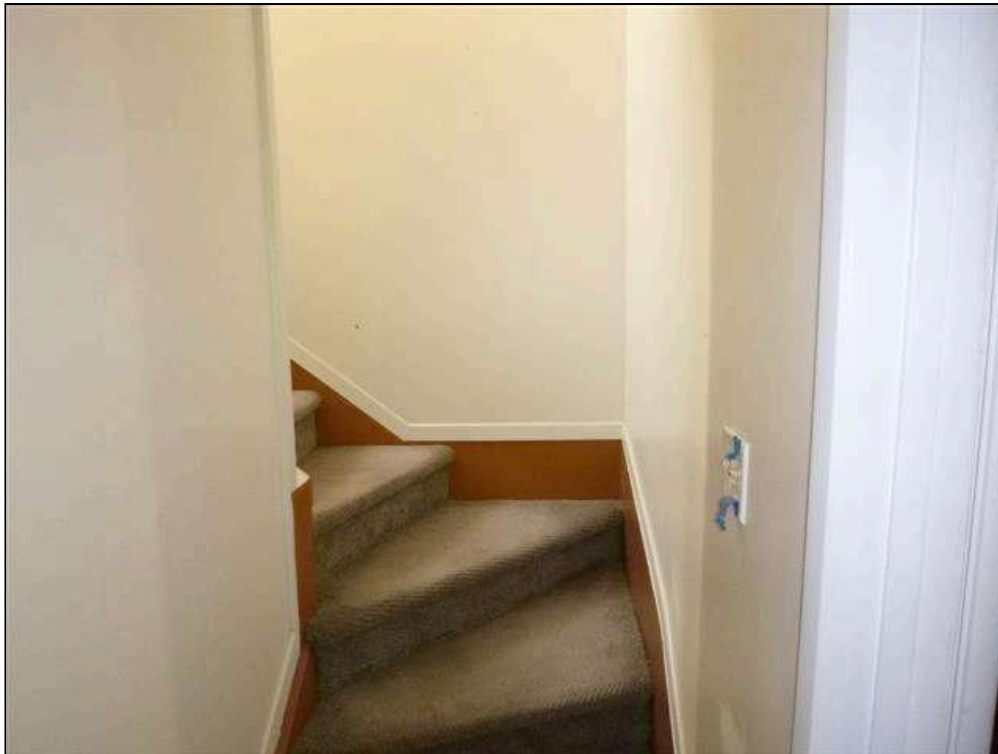
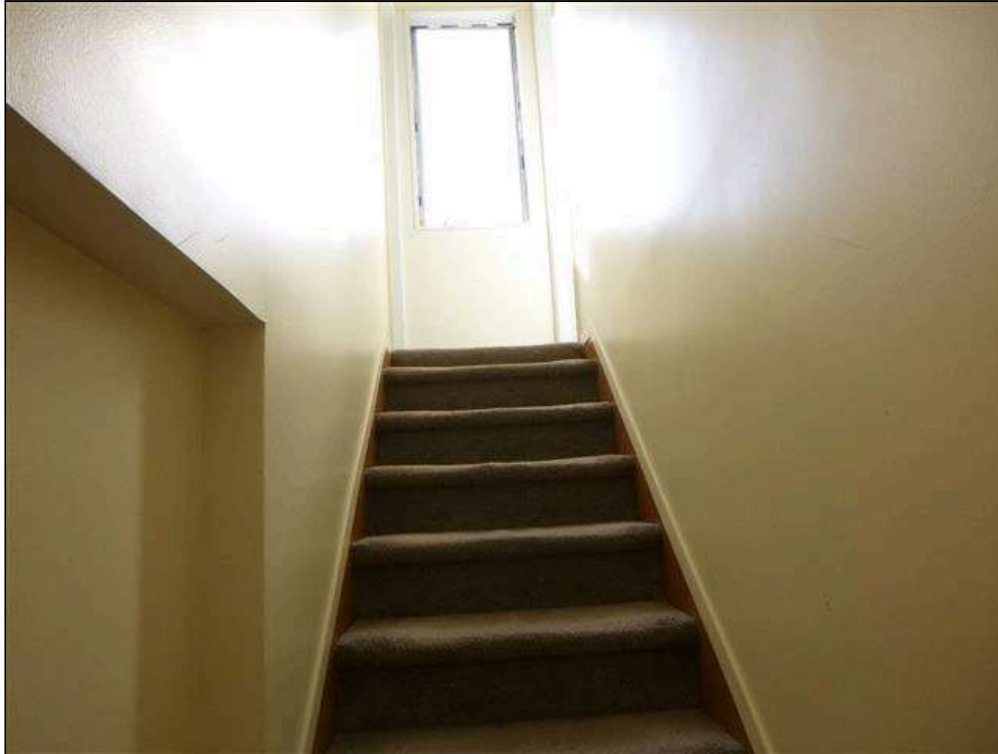
(1) No graspable hand railing(s) installed at the stair area(s). Suggest review with a licensed contractor for costs to install graspable railing(s) to current standards as required for safety.

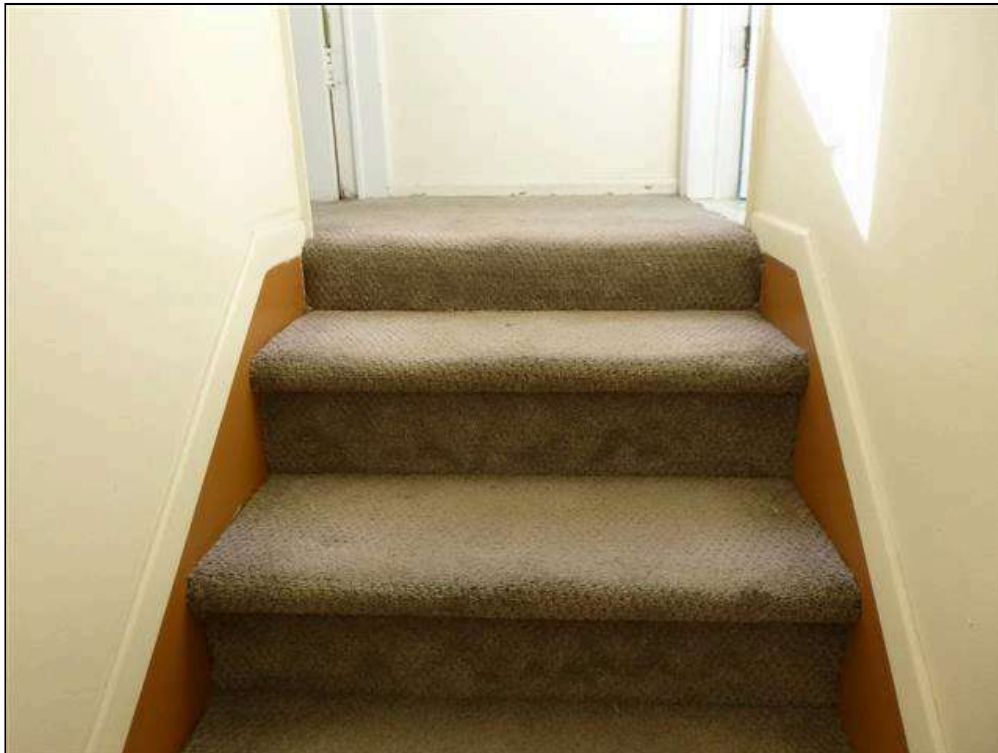
28.7 Item 3(Picture)

(2) A potential trip hazard was noted due to the uneven rise height at various steps. Suggest review with a licensed contractor for any repair/replacement costs as needed.

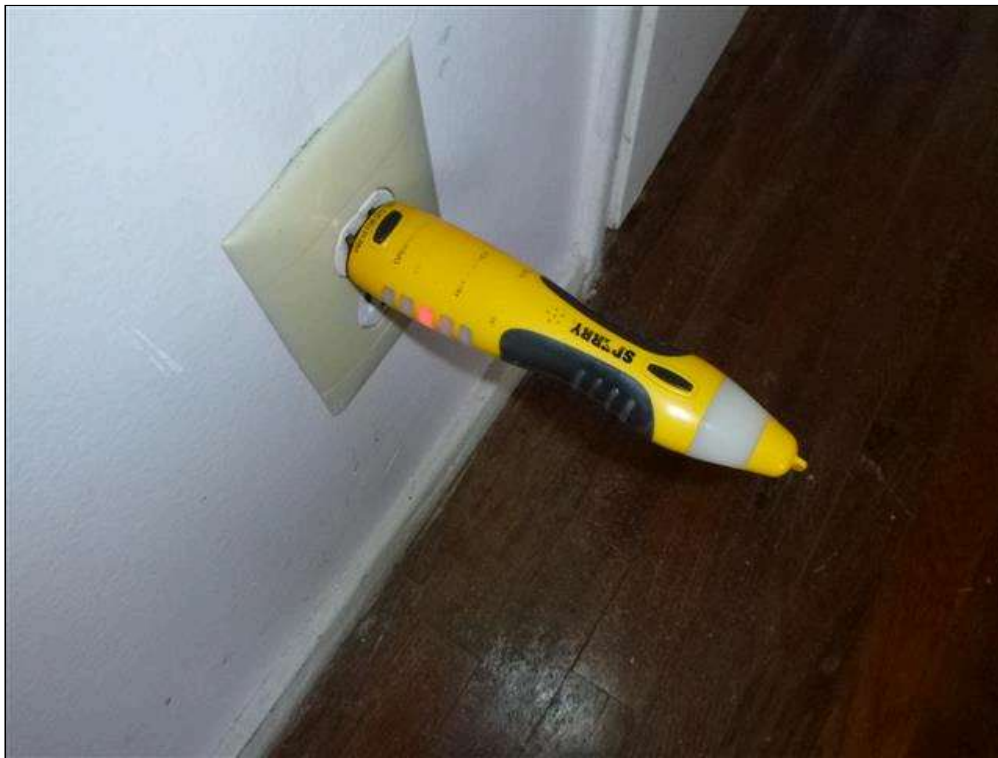
30.6 Item 2(Picture)

(3) Reversed polarity noted at various outlets. Reversed polarity, hot and ground reversed and other terms used for electric outlets are usually easily corrected by minor wiring adjustments at the specified item. Suggest review with a licensed electrician for repair/replacement costs and confirm correct operation as needed.
