General Summary

Ferguson Home Inspections

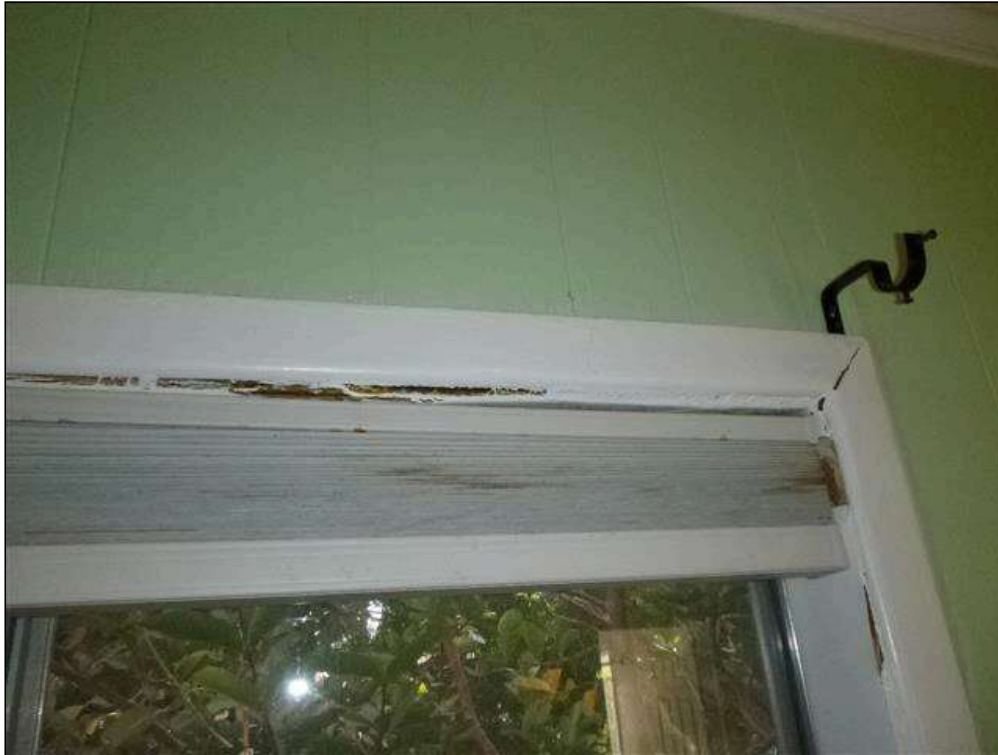
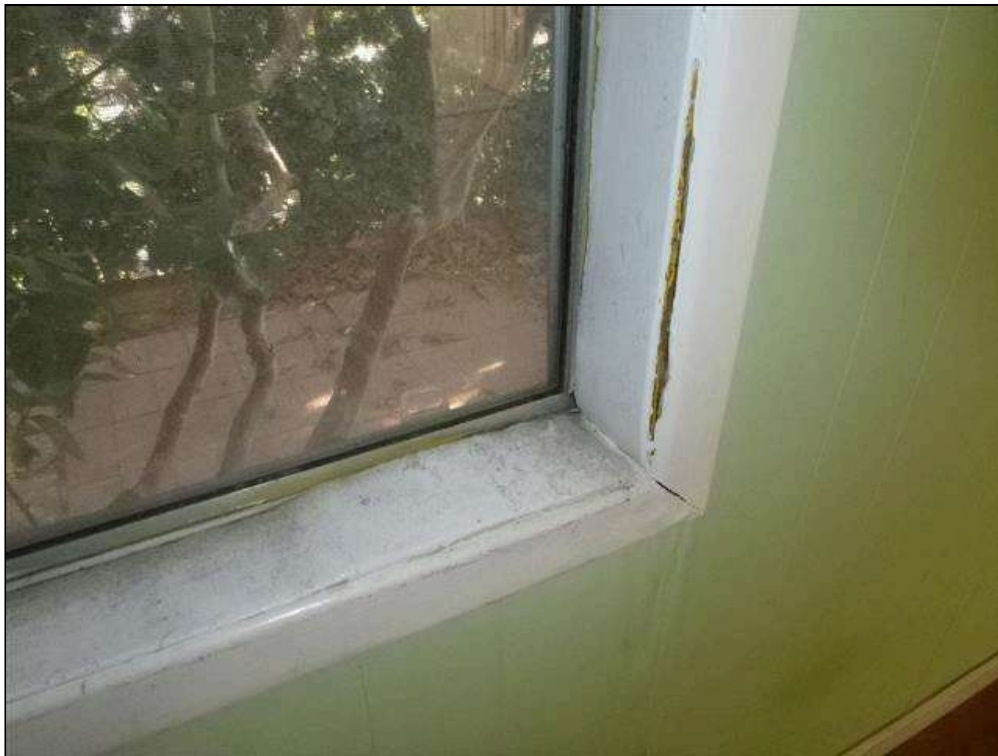
Stained, patched and damaged areas of the walls were noted at the windows (evidence of previous/on-going water intrusion was noted). Suggest review with the seller for the cause and any repairs needed. Suggest review with a licensed contractor for any repair/removal/replacement costs as needed.

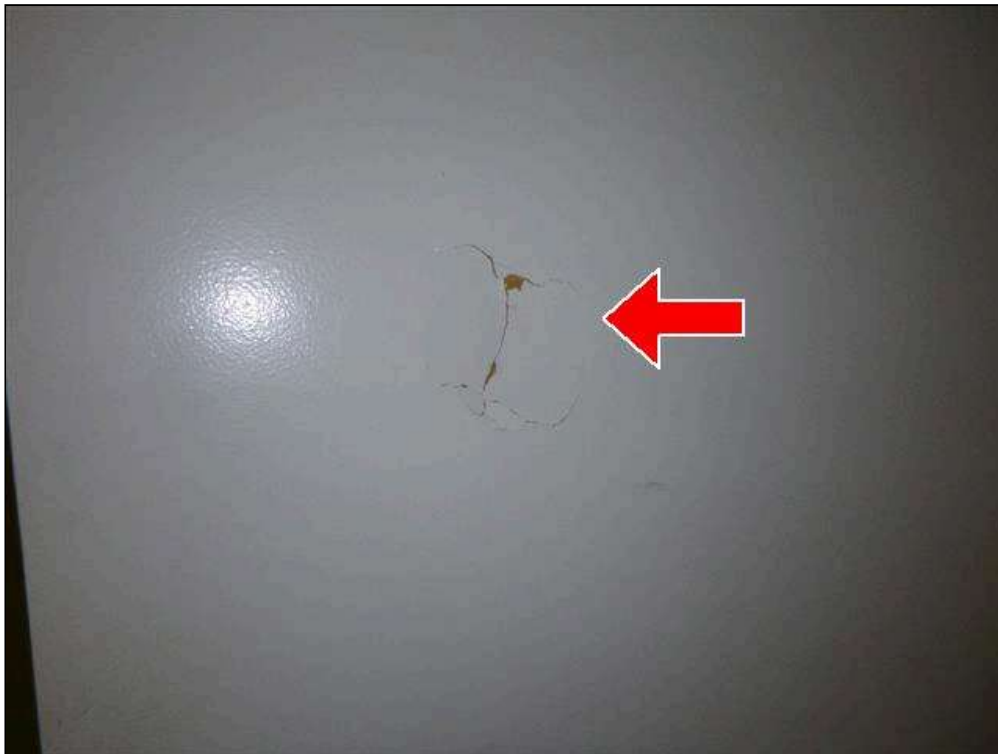
31.3 Item 2(Picture)

(2) The door to the hallway is damaged/holes noted, suggest repair as needed.

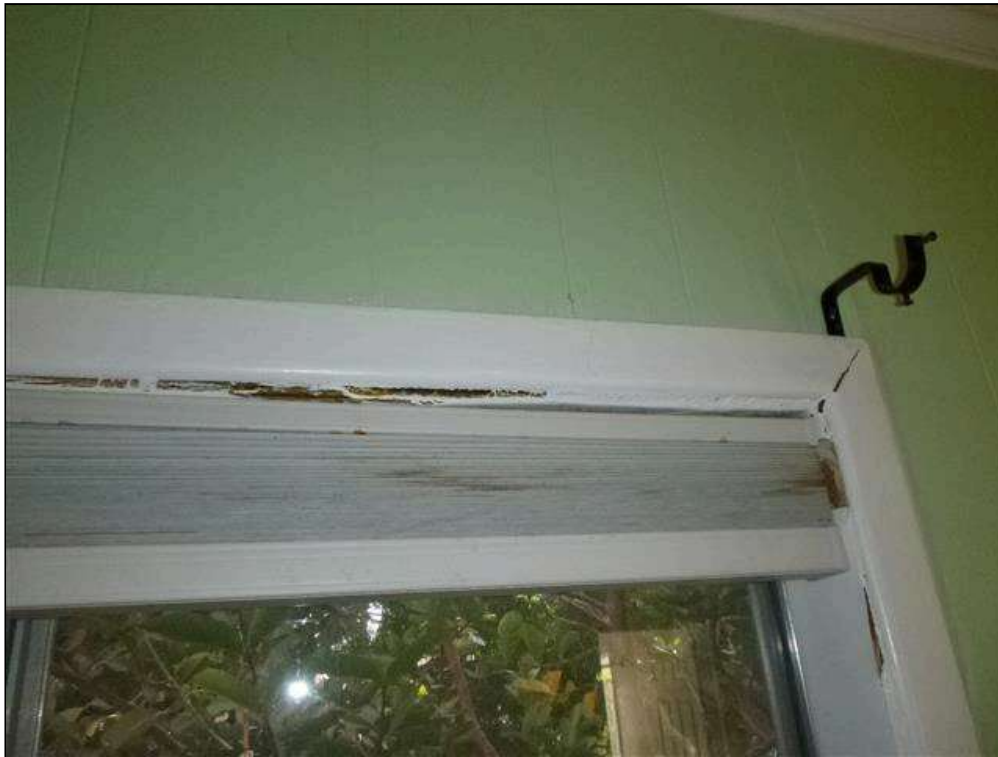
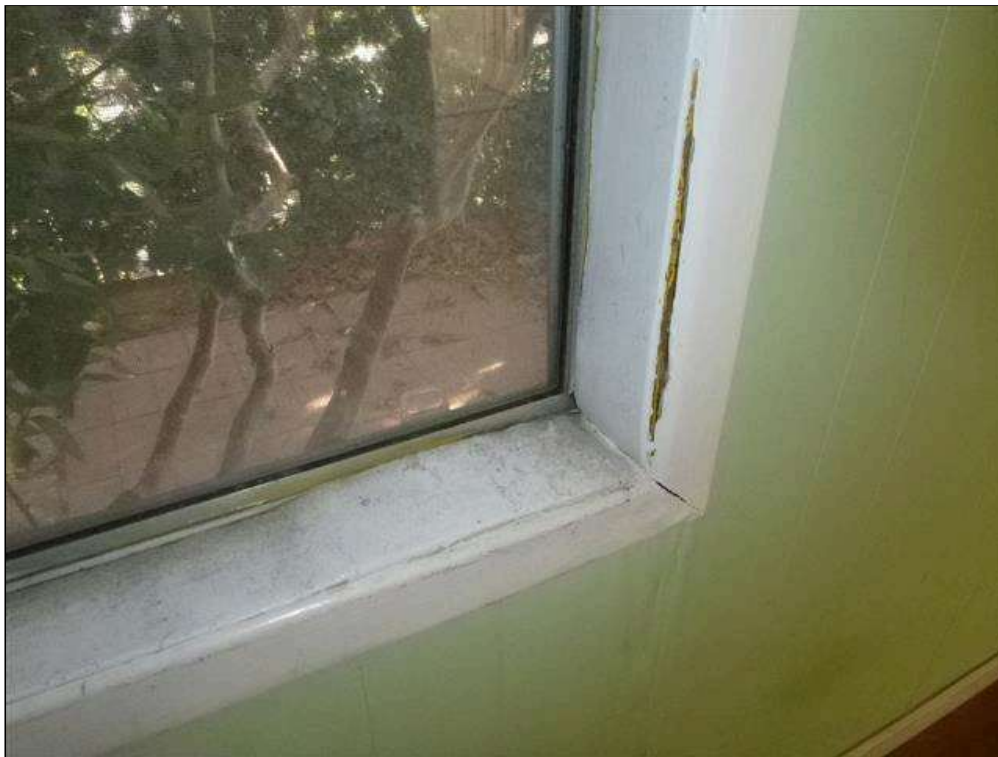
(2) Excessive deterioration, satins and evidence of previous/on-going leakage was noted at the windows. Suggest review with a licensed contractor for any repair/replacement costs as needed.

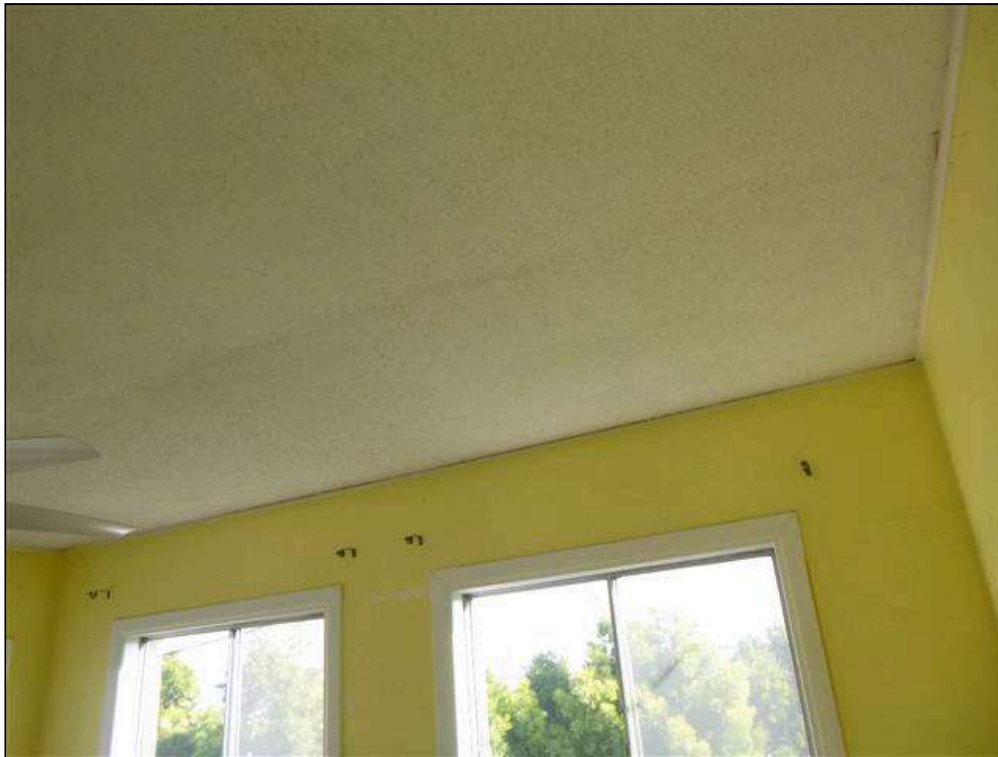
32.2 Item 1(Picture)

Patched and uneven areas of the ceiling was noted, suggest review with the seller on the cause and any repairs needed. Suggest review with a licensed contractor for any repair/removal/replacement costs as needed.

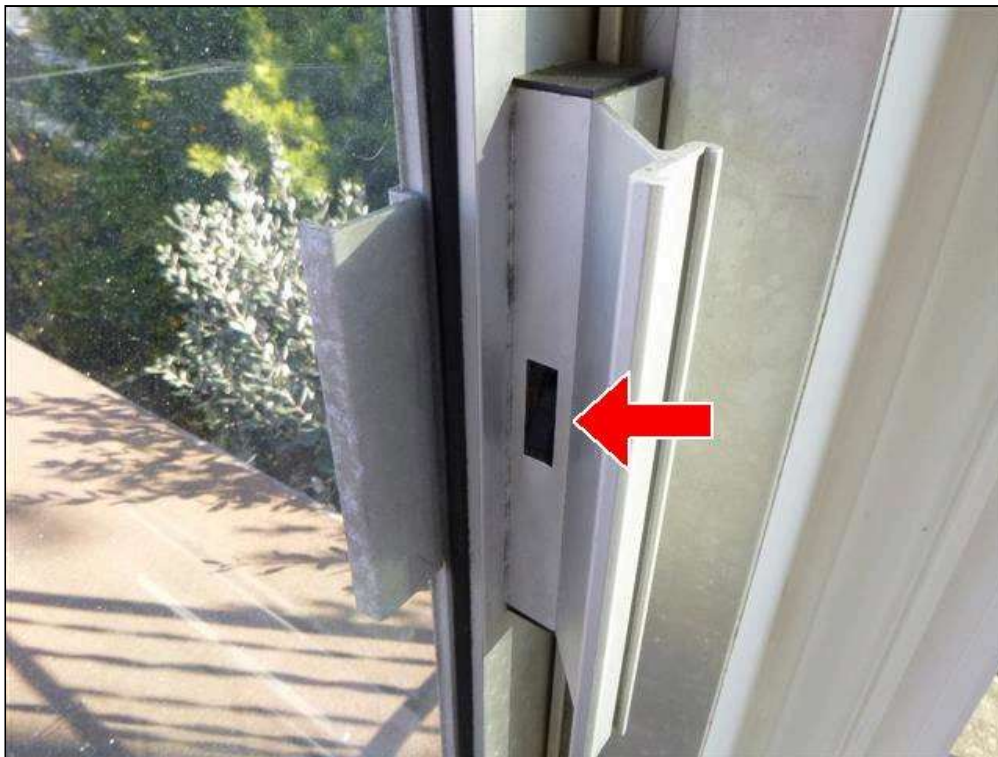
32.3 Item 1(Picture)

- (1) Suggest installation of door stops to prevent damage to the walls and/or surrounding area.
- (2) The sliding door lock handle is broken/damaged, suggest repair/replace as needed.

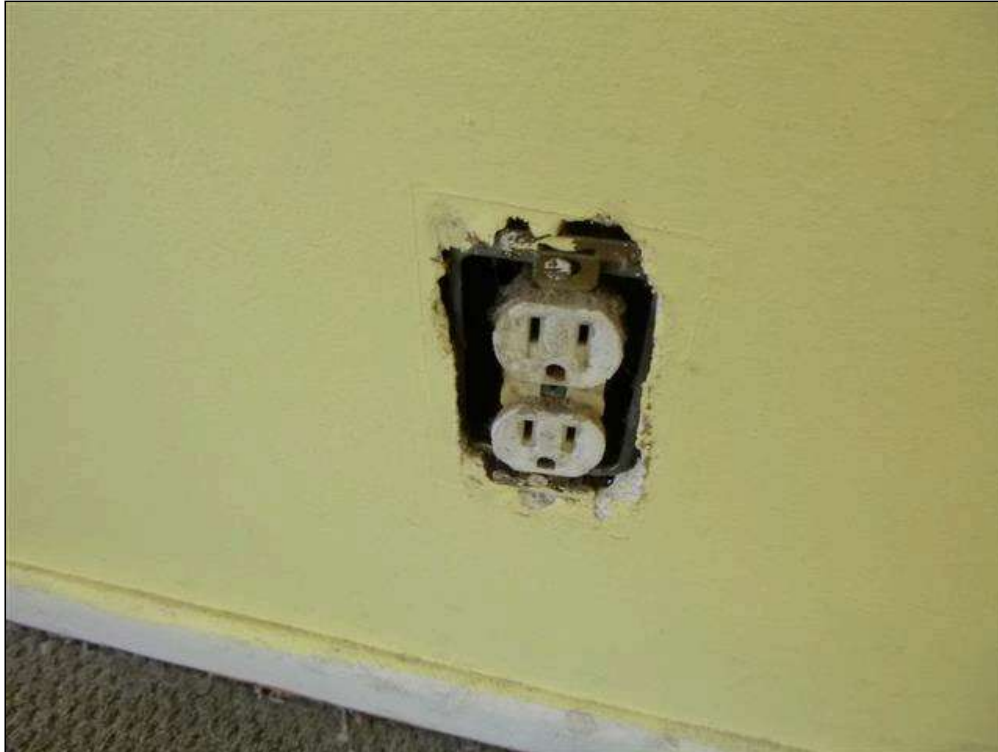
32.6 Item 1(Picture)

(1) Various outlet cover(s) are missing, suggest installation for safety.

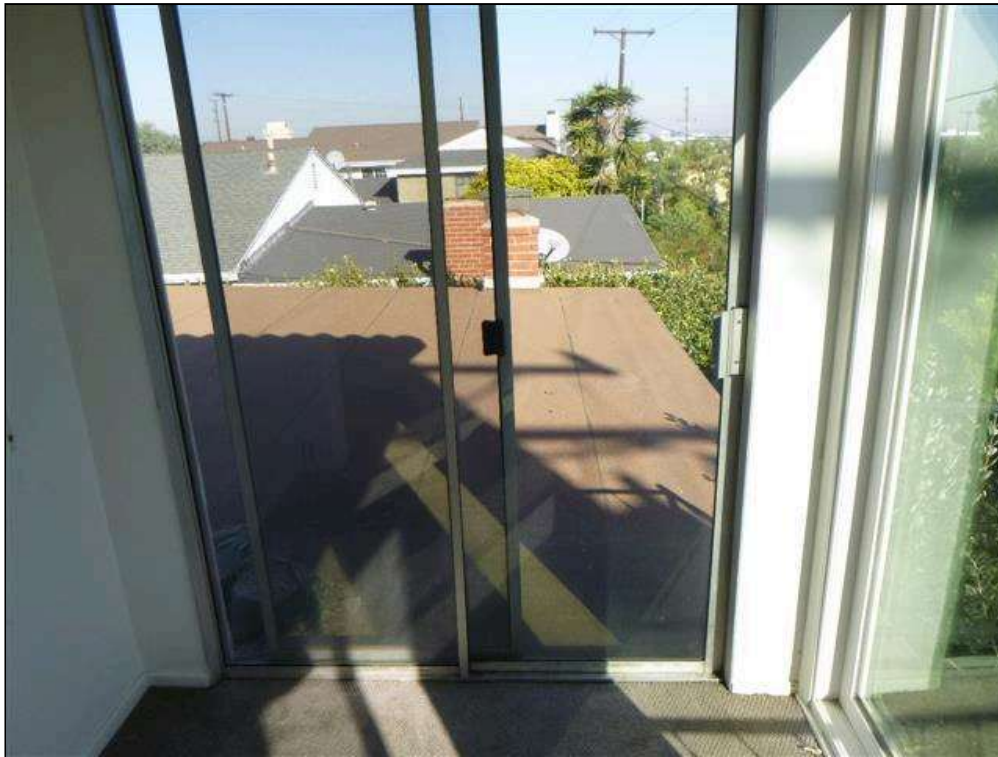
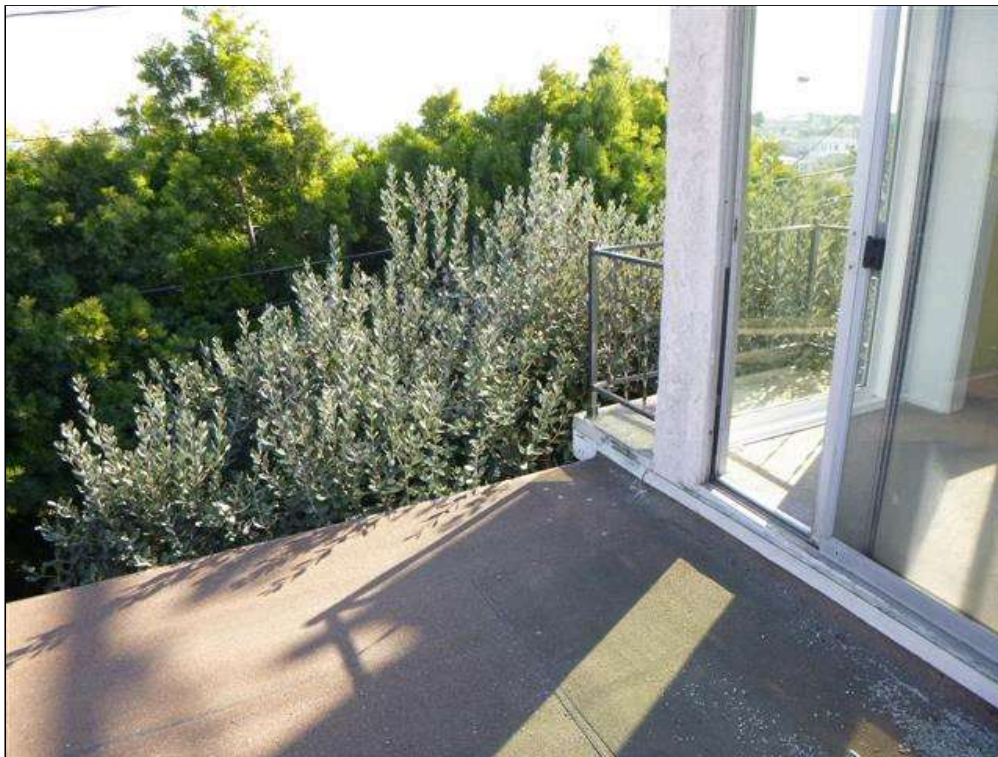
(2) A potential safety/fall hazard was noted due to the sliding door exits/leads out to the sloped roof area (no railing is installed at the roof area). Suggest review with a licensed contractor to seal/screw the door closed to prevent access to the roof area as needed.
