## SUMMARY

33525 Binnacle Dr, Dana Point CA  
92629  
David & Lesley Midkiff  
July 1, 2021

Randall Meadows  
InterNACHI CPI #19012717  
FOCUS Home Inspection Authority  
949-945-0111  
[focusinspectionauthority@gmail.com](mailto:focusinspectionauthority@gmail.com)

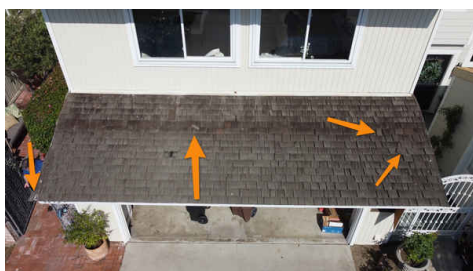
Front First Story Elevation over Garage

Roof coverings showed moderate damage in various areas, due to age and weathering, including curling, cracking, granule loss and fiberglass mat base showing/reveal. Roof is approaching natural end of life. Recommend a qualified roofing professional evaluate and repair/replace as indicated. This item should be budgeted in for a anticipated future replacement.

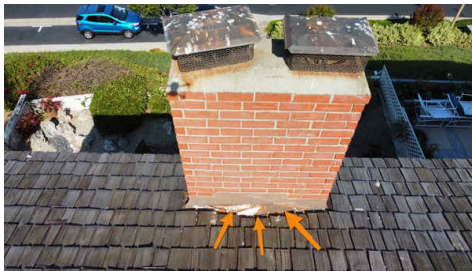
Cricket Flashing

CHIMNEY FLASHING DEFECT - I observed a defect at the chimney flashing. Prone to water leaking at this area.

Recommendation  
Contact a qualified roofing professional.

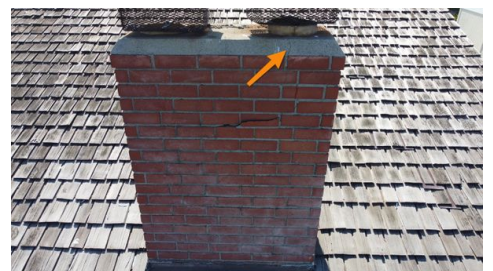
Chimney crown or cap was cracked and loose. Properly sealed crown/cap is important to maintain to protect from moisture intrusion and protect the chimney. Recommend a qualified roofer or chimney sweep to repair or replace.

Recommendation  
Contact a qualified professional.

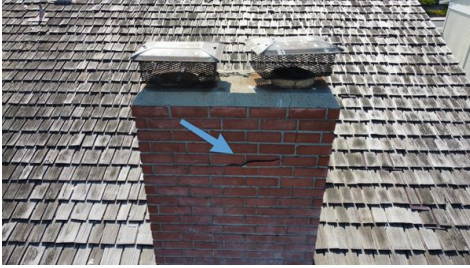
Observed horizontal chimney crack below crown. Should be further evaluated for repair.

Recommendation  
Contact a qualified professional.

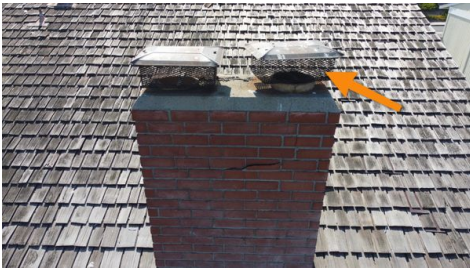
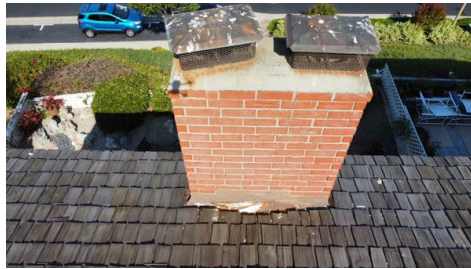
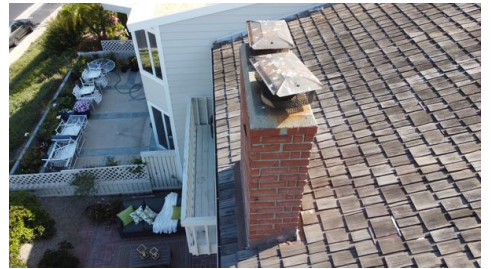
Observed one or more chimney caps/cover that appear to be loose and should be checked & re-secured

Recommendation  
 Contact a qualified professional.

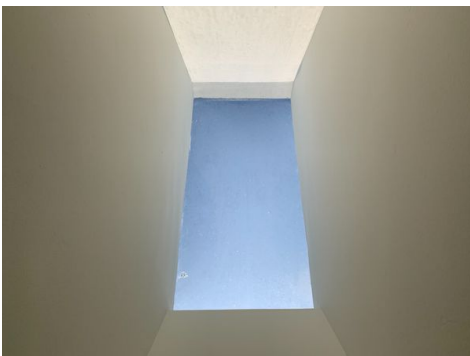
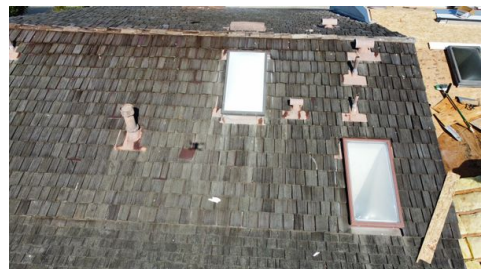
Small cracks or crazing were observed in one or more skylight features. Crazing is caused by weathering and UV exposure over time. Eventually the small cracks can widen due to sudden temperature change or slight impact. Hazing can also occur and the plastic can become brittle. Recommend monitoring and further evaluation for potential replacement needs by qualified professional.

Recommendation  
 Contact a qualified professional.

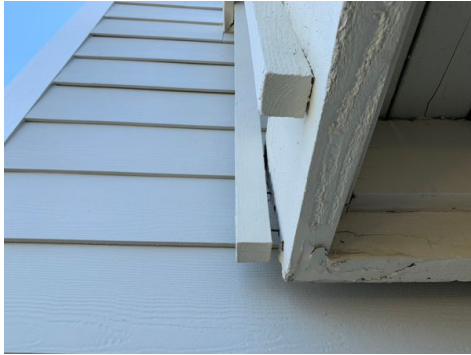
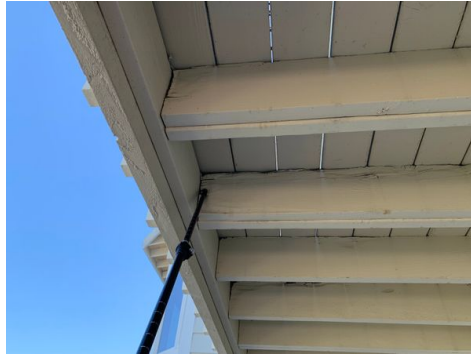
Wood rot was noted at the bottom ends and top rail of Balcony. Rot was also observed on one beam support under the decking. Recommend further evaluation for repair or replacement.

Contact a qualified professional.

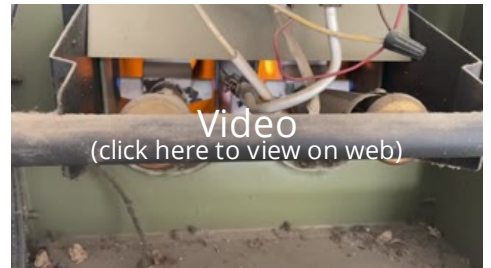
A blue steady flame in the burner compartment is a sign your furnace is producing complete combustion. If the flame is yellow or yellowish orange, it may indicate incomplete combustion or the possibility of a breach in the systems sealed heat exchanger. Recommend further evaluation by qualified HVAC technician.

Contact a qualified professional.

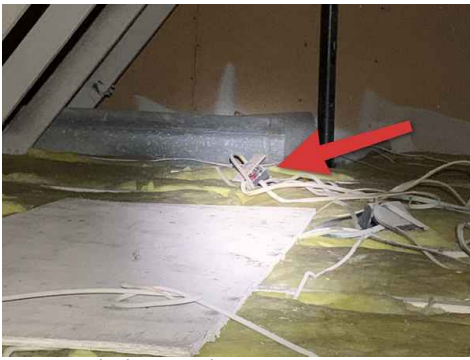
Exposed Electrical

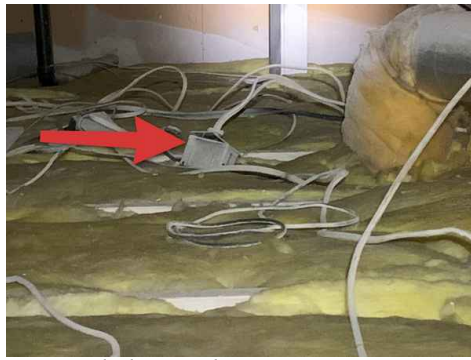
Exposed Electrical

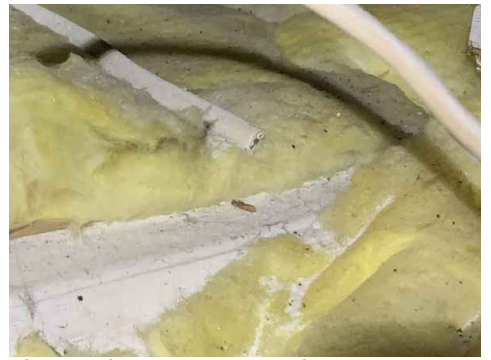
Electrical Wire Not Capped

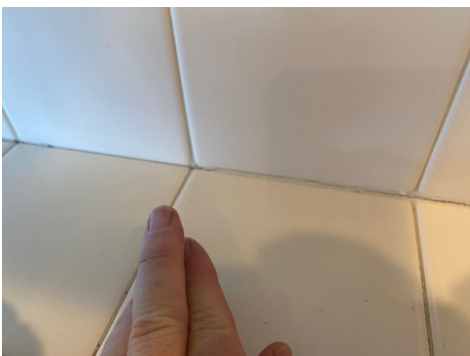
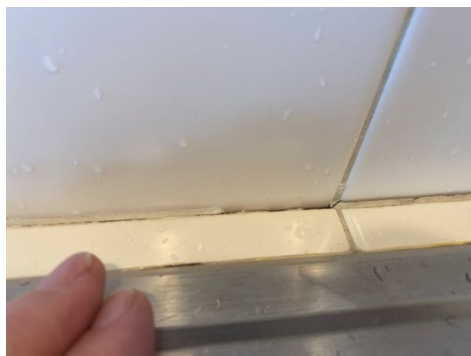
Observed one or more areas requiring grout touch up along counter backsplash.

Recommendation  
Contact a qualified professional.

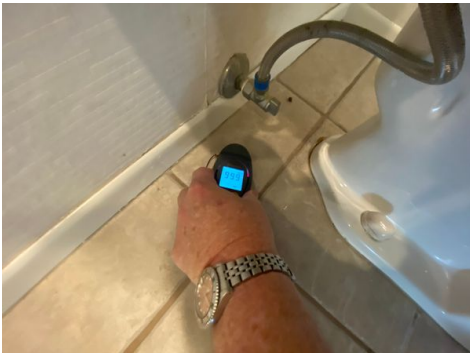
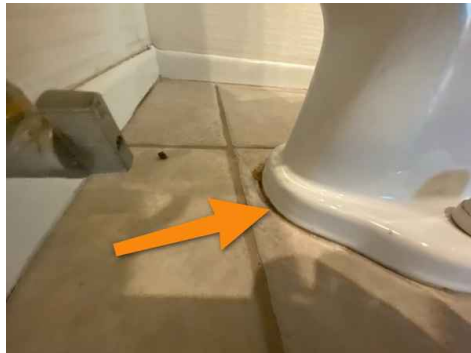
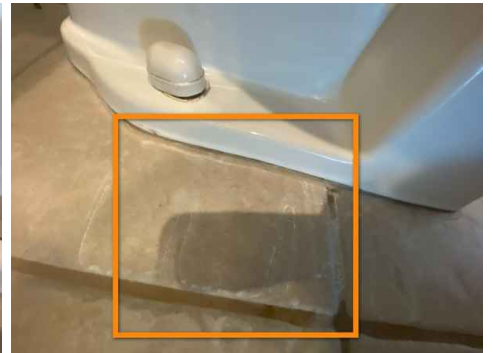
Noted high moisture reading at base of toilet area. Recommend further evaluation by qualified contractor/qualified plumber, to determine cause of high reading. This may be due to wax seal breach from the toilet or other deficiency.

Recommendation  
Contact a qualified professional.
