Del Fine Home Inspections

Property Inspection Report

Property address: **6432 Via Canada
Rancho Palos Verdes, CA 90275**

Inspection date: **Friday, July 19, 2024**

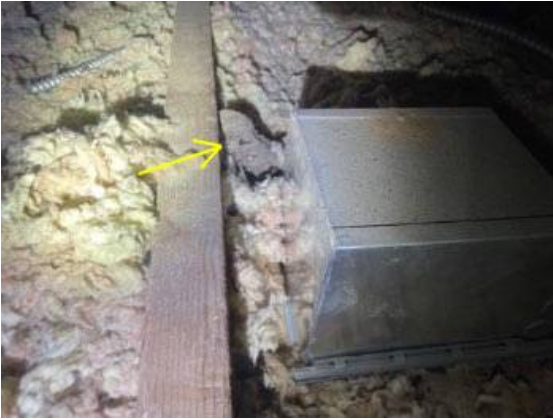
Photo 1-1

One or more hornet, bee or wasp nests were found in the attic. These can pose a safety hazard. A qualified person should remove nests or exterminate as necessary.

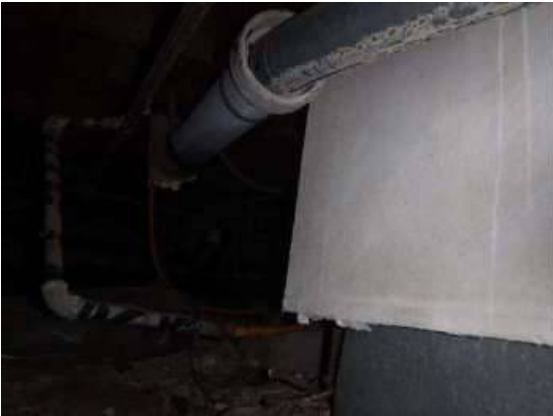
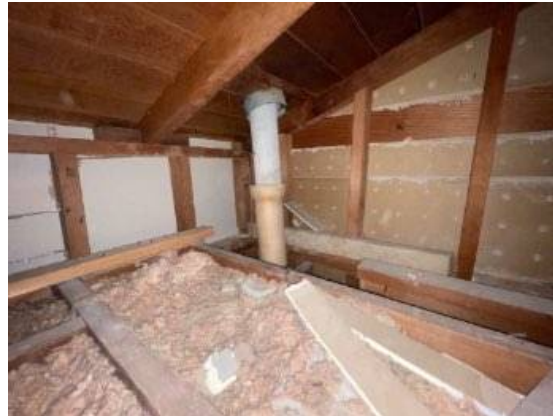
Structures built prior to the mid 1980s may contain lead and/or asbestos. Lead is commonly found in paint and in some plumbing components. The EPA does not recognize newer coats of paint as encapsulating older coats of lead-based paint. Asbestos is commonly found in various building materials such as insulation, siding, and/or floor and ceiling tiles. Laws were passed in 1978 to prohibit usage of lead and asbestos, but stocks of materials containing these substances remained in use for a number of years thereafter. Both lead and asbestos are known health hazards. Evaluating for the presence of lead and/or asbestos is beyond the scope of this inspection. Any mention of these materials in this report is made as a courtesy only, and meant to refer the client to a specialist. Consult with specialists as necessary, such as industrial hygienists, professional labs and/or abatement specialists for this type of evaluation. For information on lead, asbestos and other hazardous materials in homes, visit:

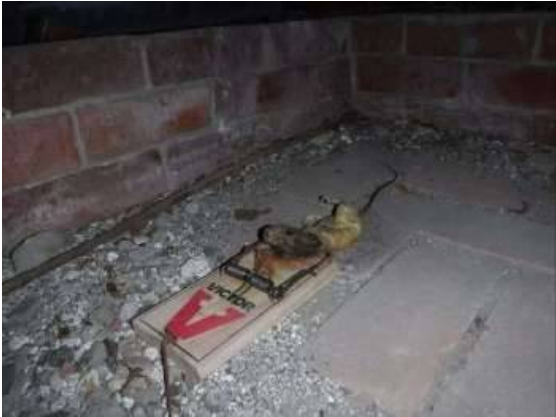
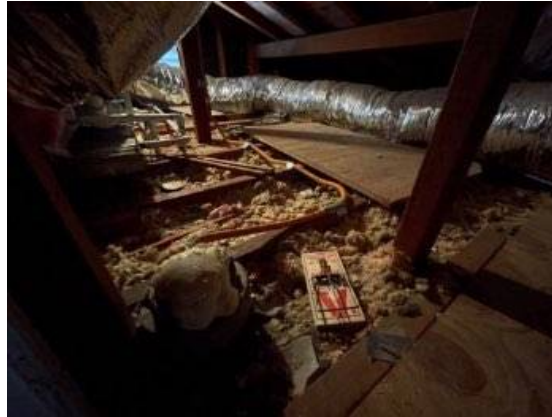
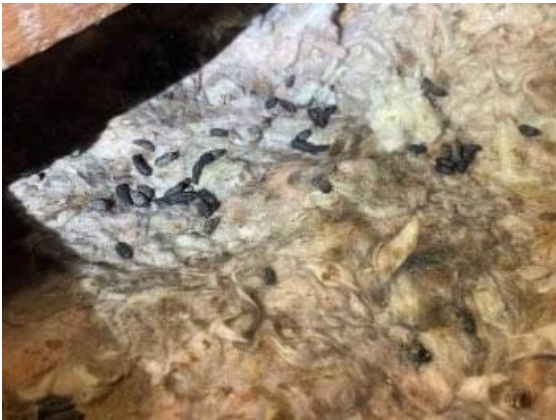
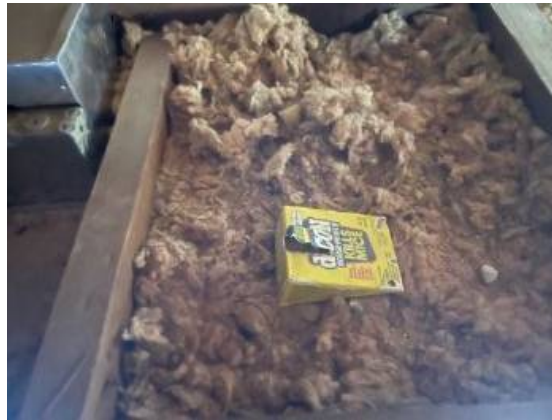
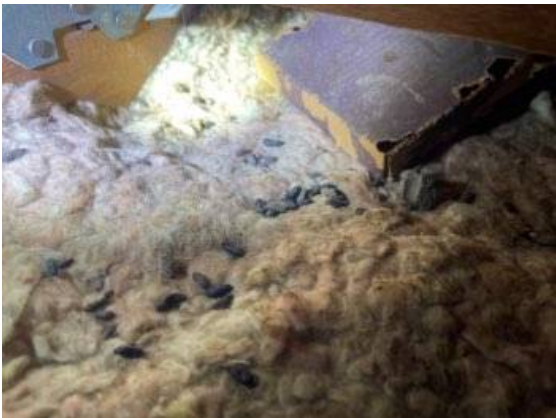
Evidence of rodent infestation was found in the form of feces, urine stains, traps and/or dead rodents in the attic and/or crawl space. Consult with the property owner about this. A qualified person should make repairs to seal openings in the structure, set traps, and clean rodent waste as necessary. Recommend following guidelines in these Center for Disease Control articles:

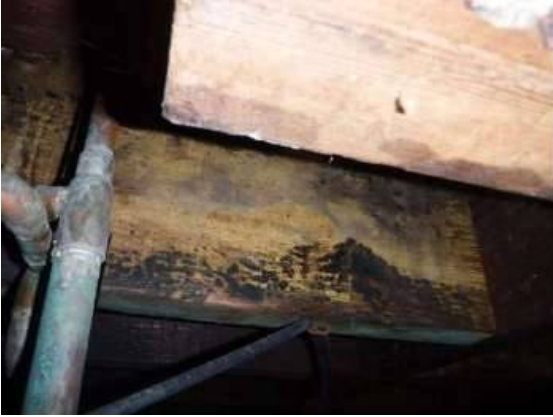
Photo 4-1

Microbial growths were found at one or more locations in the crawlspace. It is beyond the scope of this inspection to identify what substance or organism this staining is. However such staining is normally caused by excessively moist conditions, which in turn can be caused by plumbing or building envelope leaks and/or substandard ventilation. These conducive conditions should be corrected before making any attempts to remove or correct the staining. Normally affected materials such as drywall are removed, enclosed affected spaces are allowed to dry thoroughly, a mildewcide may be applied, and only then is drywall reinstalled. For evaluation and possible mitigation, consult with a qualified industrial hygienist or mold/moisture mitigation specialist. For more information, visit:

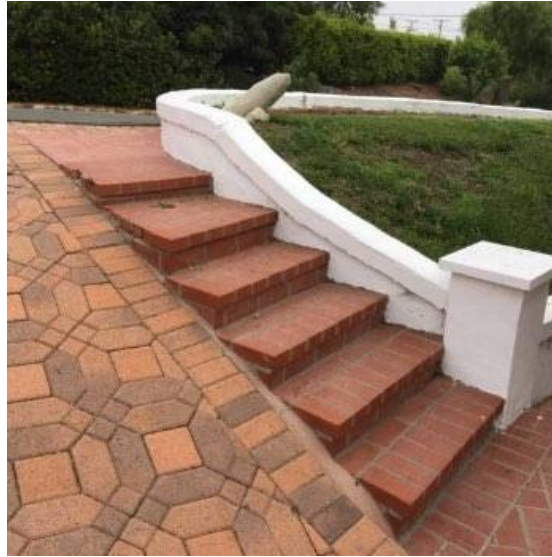
Photo 8-2

Handrails at one or more flights of stairs were missing. This is a potential fall hazard. Handrails should be installed at stairs with four or more risers or where stairs are greater than 30 inches high. Recommend that a qualified contractor install handrails where missing and per standard building practices.

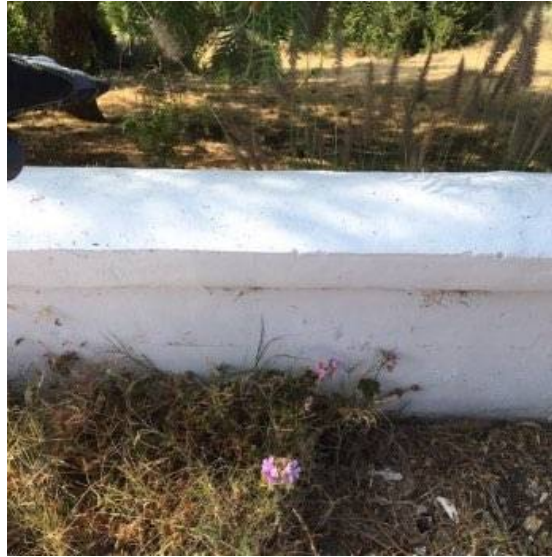
Photo 10-2

Guardrails at one or more locations with drop-offs higher than 30 inches were too low. This poses a fall hazard. Guardrails should be at least 36 inches in height. Recommend that a qualified contractor replace or repair guardrails per standard building practices.

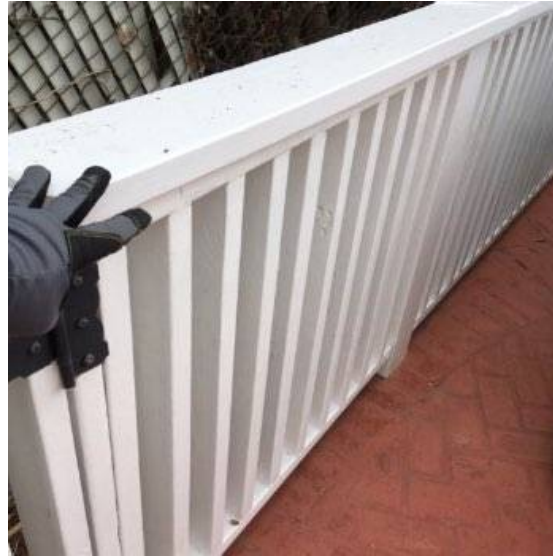
Photo 13-2

13) 🛠️ Guardrails at one or more locations with drop-offs higher than 30 inches were wobbly, and pose a fall hazard. Recommend that a qualified person repair guardrails as necessary.

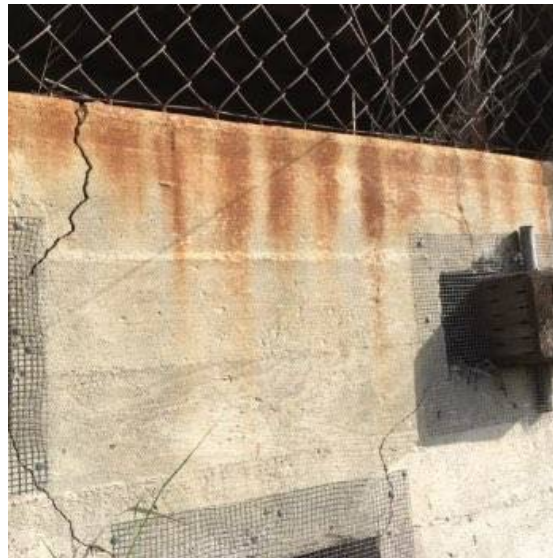
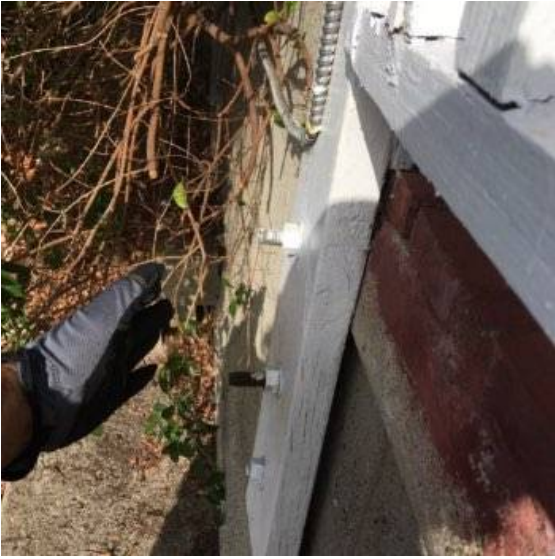
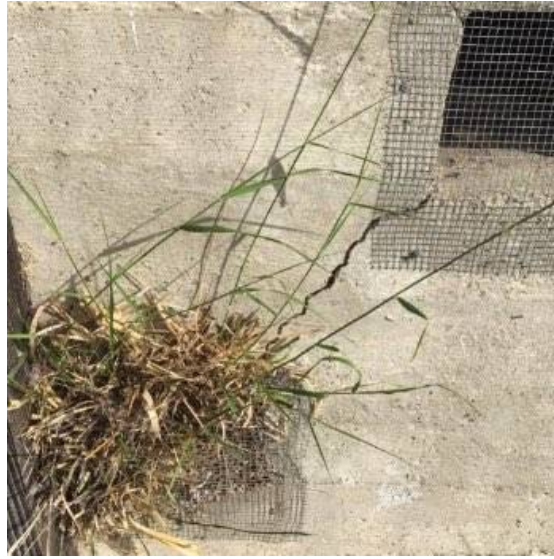
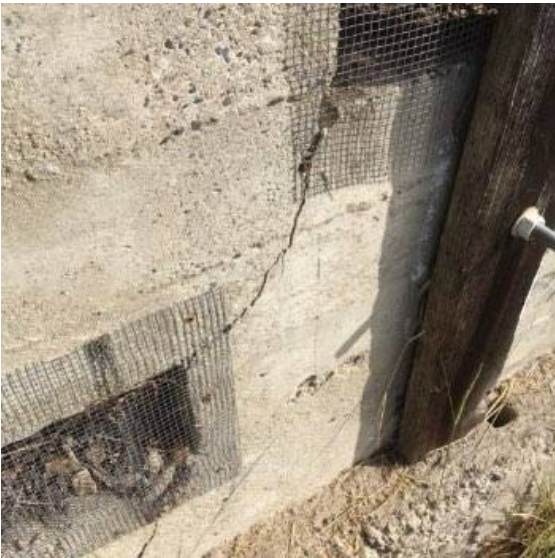
Cracks, deterioration, leaning and/or bowing were found in one or more retaining walls. Recommend that a qualified contractor evaluate and repair as necessary. Note that some retaining walls, based on their height or size, may require evaluation by a structural engineer.

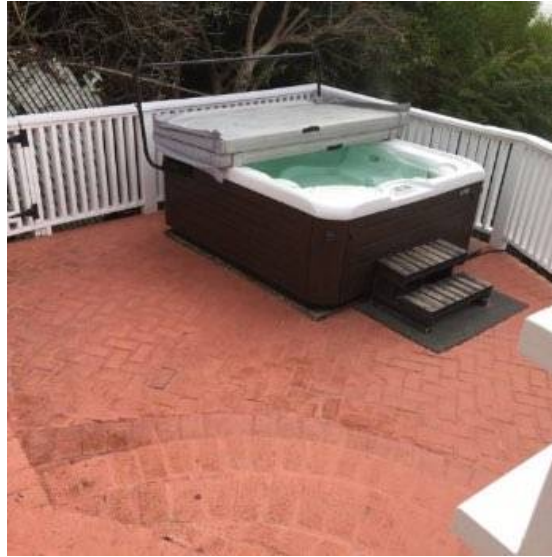
Photo 17-2

17) 🔧🔍 A hot tub was installed. Hot tubs, related equipment and supply hookups are specialty systems and are excluded from this inspection. Comments in this report related to this system are made as a courtesy only and are not meant to be a substitute for a full evaluation by a qualified specialist. Regular maintenance is required, and safety issues may exist. Recommend that a qualified specialist evaluate and, if needed, maintain or repair.

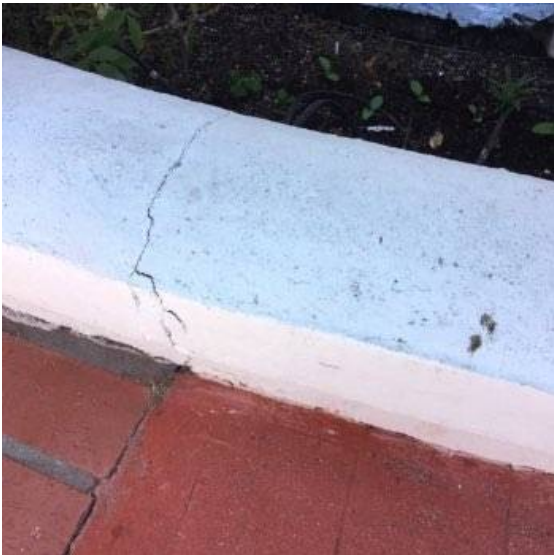
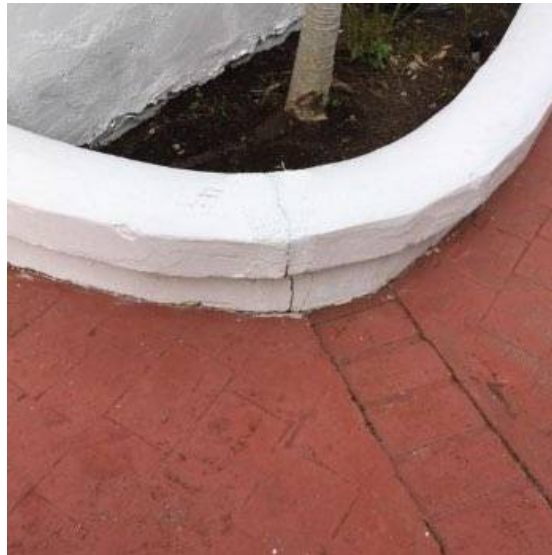
21) One or more planters were damaged or deteriorated. Recommend that a qualified person remove, repair or replace planters as necessary.

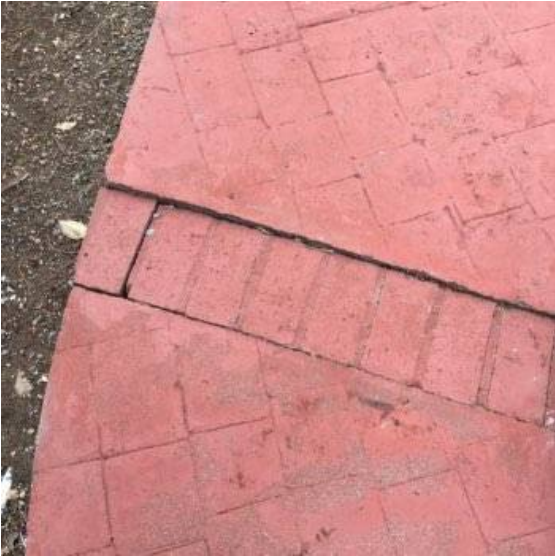
Photo 23-2

23) 🛠️ Cracks, holes, settlement, heaving and/or deterioration were found in sidewalks and/or patios. Recommend that qualified contractor repair as necessary.

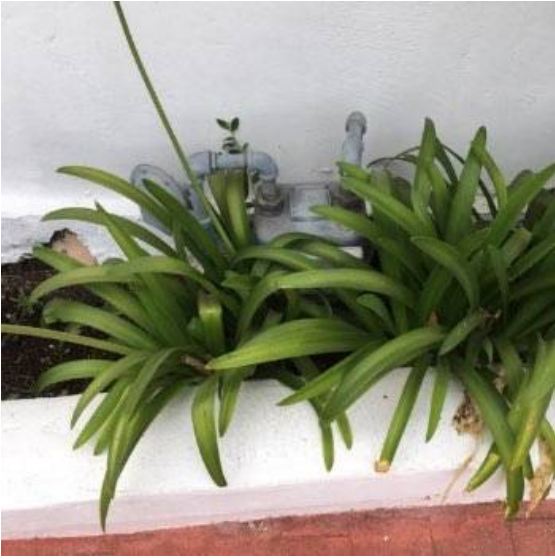
Photo 25-1

25) 🌿 Vegetation was overgrown around equipment for one or more utilities such as gas or electric meters. Vegetation should be pruned or removed as necessary to allow unobstructed access.

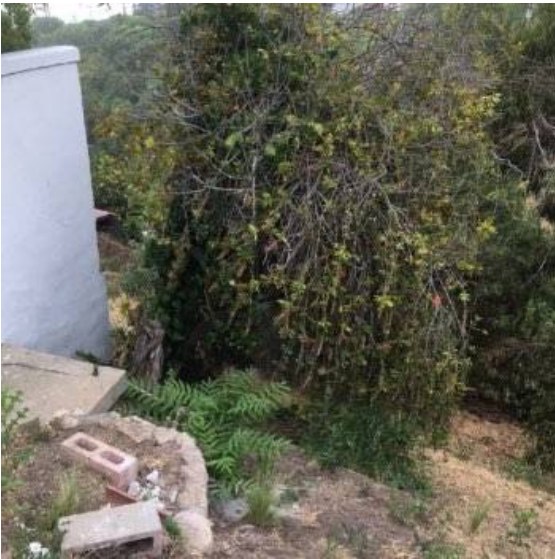
Photo 26-1

Client may want to consider having a qualified geotechnical engineer evaluate soils around the building for possible stability issues due to the building being close to a cliff, a ravine and/or a steep or vertical drop.

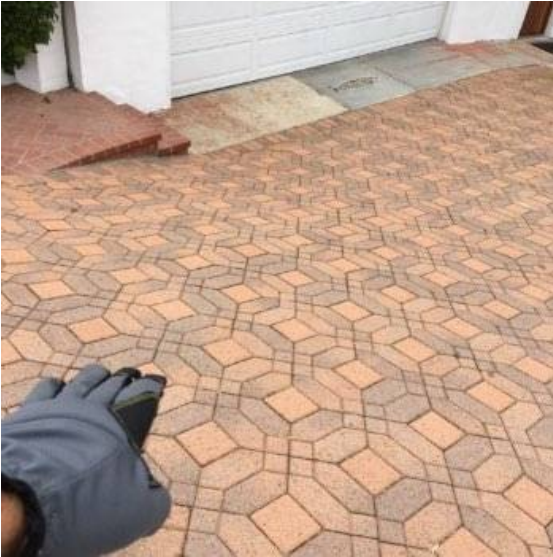
Photo 28-1

The driveway sloped down towards the garage or house. This may result in water accumulating in the garage, around building foundations or underneath buildings, and is a conducive condition for wood-destroying organisms. Monitor these areas in the future, especially during and after periods of rain. If significant amounts of water are found to accumulate, then recommend that a qualified contractor evaluate and repair as necessary. For example, by installing drain(s) or removing and installing new pavement.

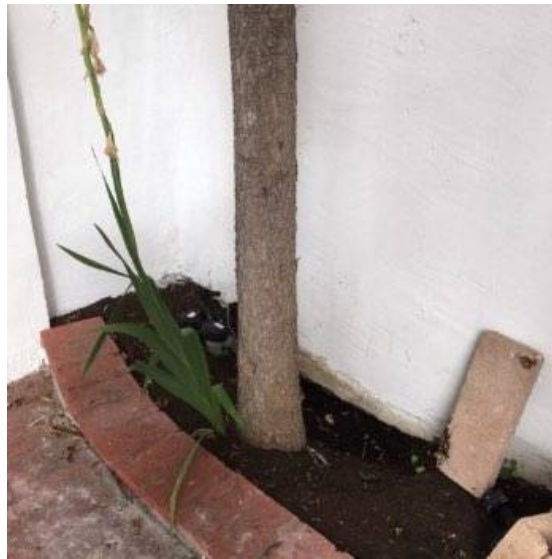
Photo 31-2

31) 🛠️ One or more large trees were very close to the foundation. Tree roots can cause significant structural damage to foundations. Recommend that a qualified tree service contractor or certified arborist remove trees as necessary to prevent damage to foundations.

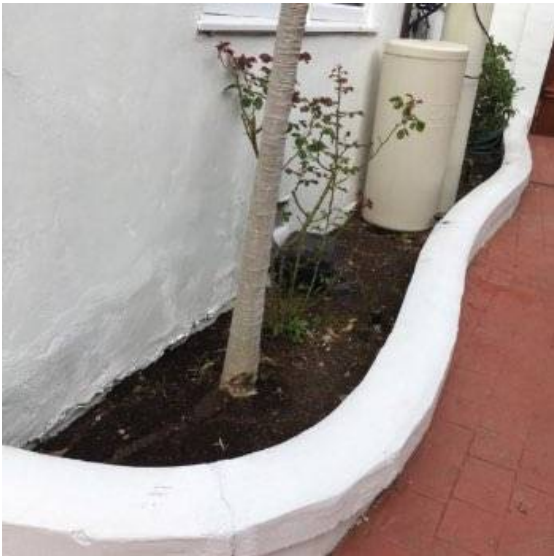
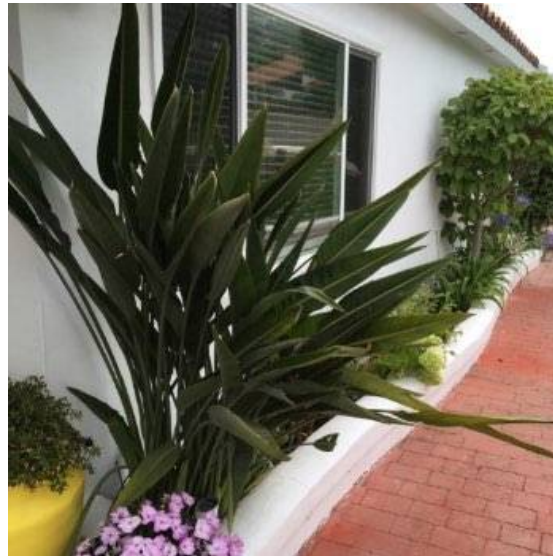
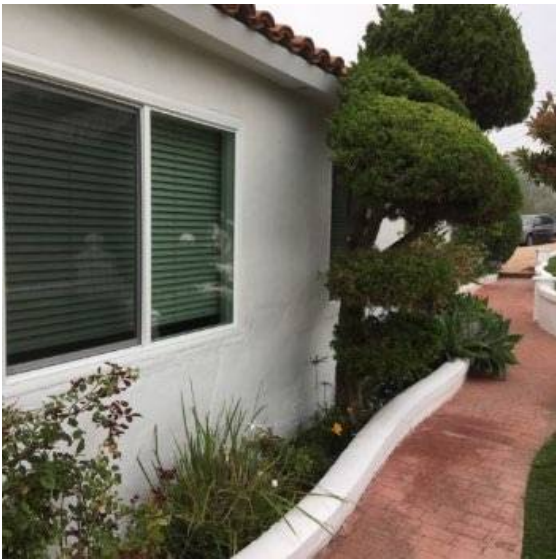
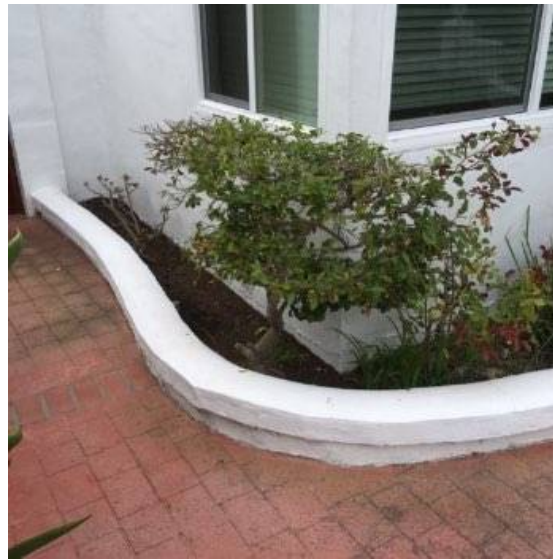
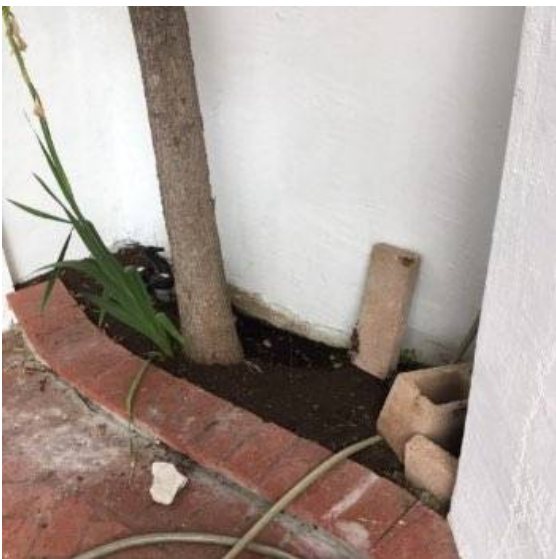
34) 🪴 One or more planters were attached to the building exterior. This can result in high levels of moisture at the building exterior near planters. It is a conducive condition for wood-destroying organisms. Recommend removing planters, or repairing so there is a gap of at least 2 inches between planters and the building exterior for better airflow and to allow building exteriors to dry quickly.

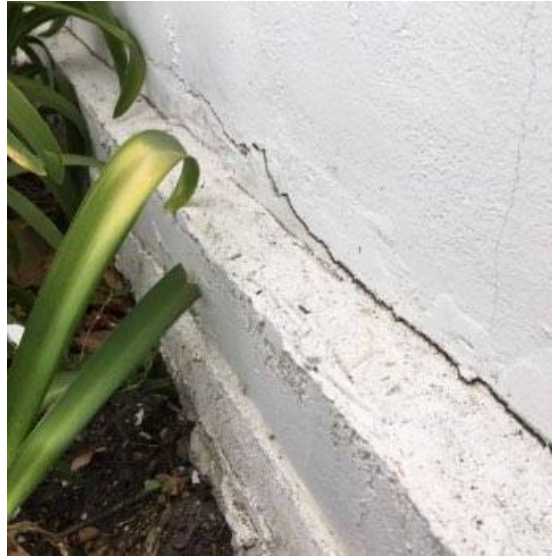
Photo 35-2

35) 🛠️ Cracks, deterioration and/or damage were found in one or more areas of the exterior stucco finish. In damp climates, moisture may enter cracks or damaged areas and further deteriorate the stucco. Also the wall behind the stucco may become damaged from moisture. Note that areas behind the stucco are inaccessible and excluded from this inspection. Recommend that a qualified contractor repair or replace stucco as necessary.

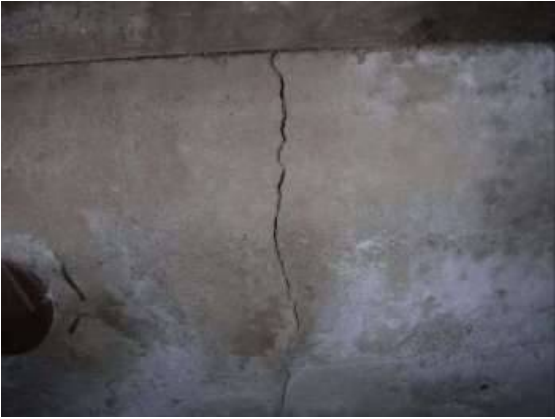
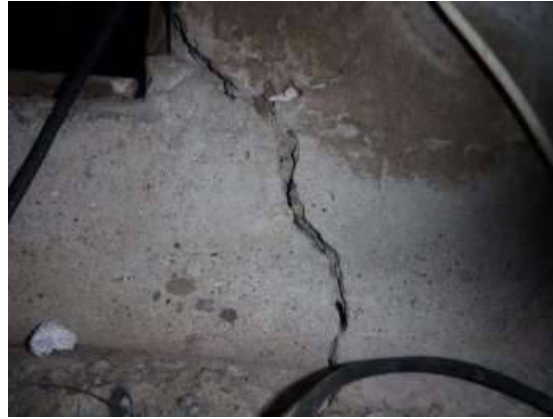
37) 🛠️ One or more cracks (1/8 inch - 1/4 inch) were found in the foundation. Recommend a qualified contractor repair as necessary. At a minimum, recommend sealing cracks to prevent water infiltration. Numerous products exist to seal such cracks including hydraulic cement, resilient caulks and epoxy sealants.

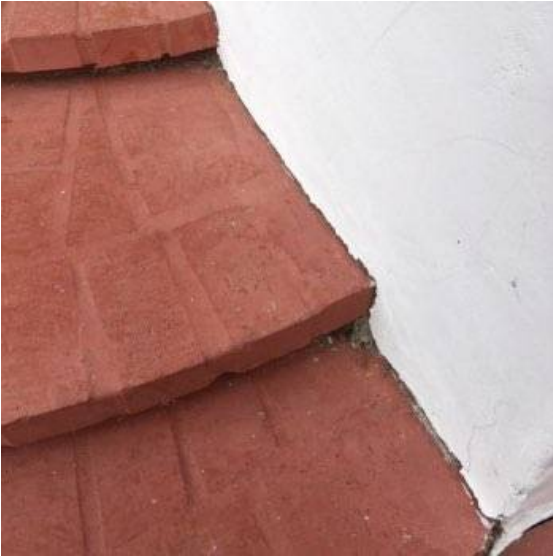
Photo 40-1

40) 🚧 Caulk was missing in some areas. For example, where walkways meet structure. Recommend that a qualified person renew or install caulk as necessary. Where gaps are wider than 1/4 inch, an appropriate material other than caulk should be used. For more information, visit: <https://www.reporthost.com/?CAULK>

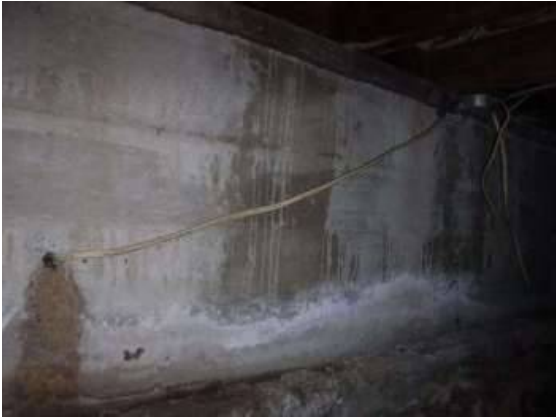
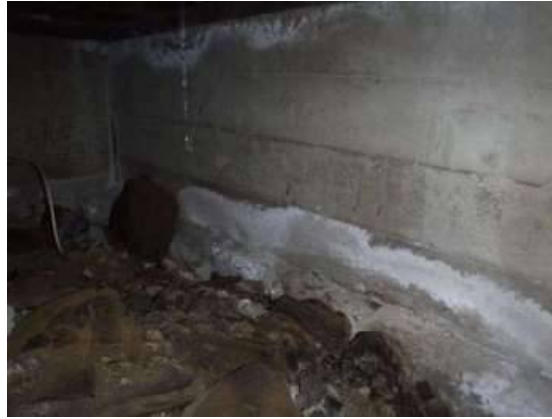
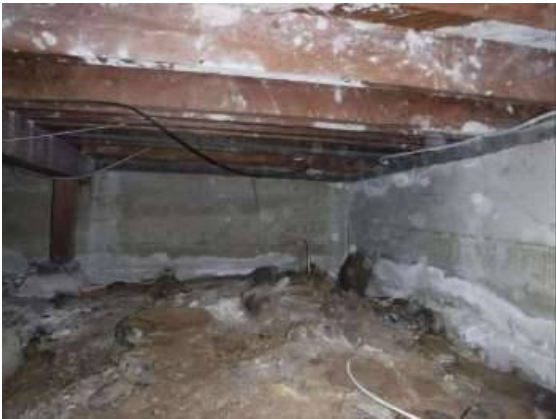
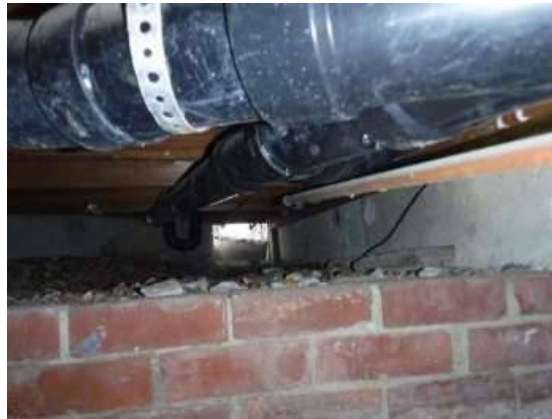
- 43) **🔍🚰🚰** Evidence of prior water intrusion or accumulation was found in one or more sections of the crawl space. For example, sediment stains on the vapor barrier or foundation, and/or efflorescence on the foundation. Accumulated water is a conducive condition for wood-destroying organisms and should not be present in the crawl space. Recommend that the client review any disclosure statements available and ask the property owner about past accumulation of water in the crawl space. The crawl space should be monitored in the future for accumulated water, especially after heavy and/or prolonged periods of rain. If water is found to accumulate, then recommend that a qualified contractor who specializes in drainage issues evaluate and repair as necessary. Typical repairs for preventing water from accumulating in crawl spaces include:

- Repairing, installing or improving rain run-off systems (gutters, downspouts and extensions or drain lines)
- Improving perimeter grading
- Repairing, installing or improving underground footing and/or curtain drains

Ideally, water should not enter crawl spaces, but if water must be controlled after it enters the crawl space, then typical repairs include installing trenches, gravity drains and/or sump pump(s) in the crawl space.

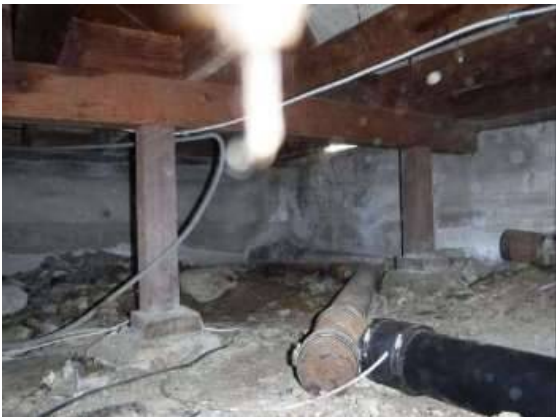
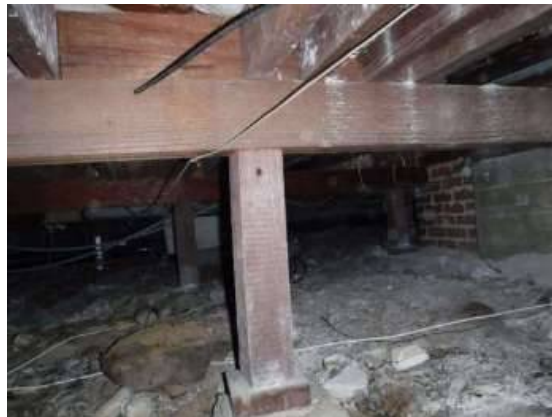
One or more support posts were not positively secured to the beam above. While this is common in older homes, current standards require positive connections between support posts and beams above for earthquake reinforcement. Recommend that a qualified contractor repair per standard building practices. For example, by installing metal plates, plywood gussets or dimensional lumber connecting posts and beams.

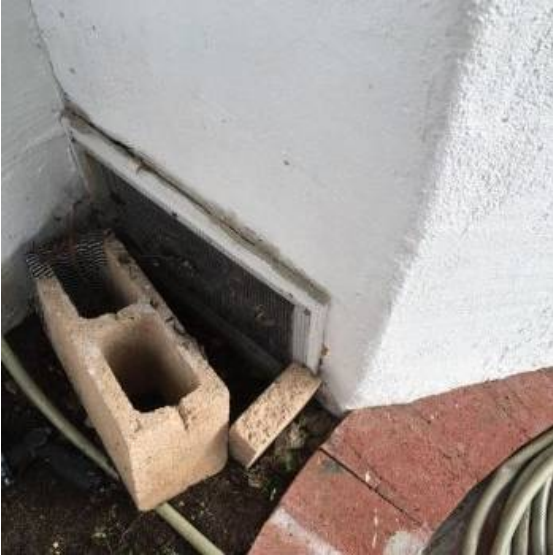
Photo 49-1

49) 🛠️ One or more outdoor crawl space access hatches or doors were missing, damaged, deteriorated or substandard. Water and/or vermin can enter the crawl space. Recommend that a qualified person replace, install or repair hatches or doors where necessary.

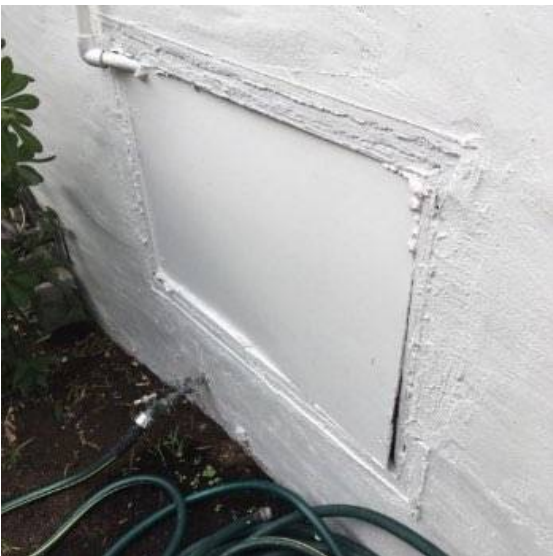
Photo 52-1

52) 📌🔍 One or more crawl space vents were intentionally blocked (e.g. removable panels, rigid foam). This restricts ventilation in the crawl space and can result in increased levels of moisture inside. This is a conducive condition for wood-destroying organisms. Such vents should be left open at all times except during severe freezing weather. Recommend removing materials or items blocking vents as necessary.

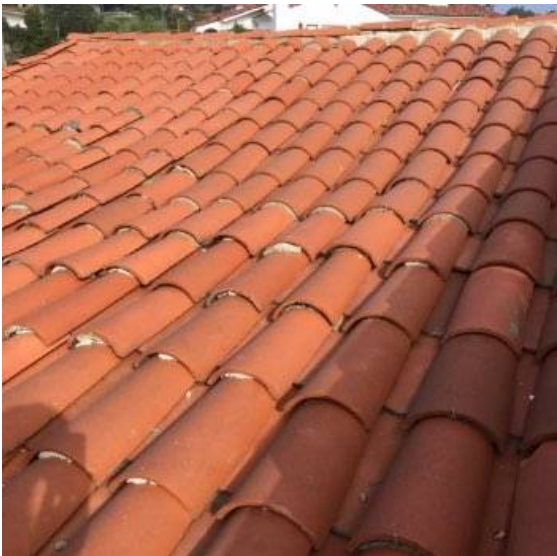
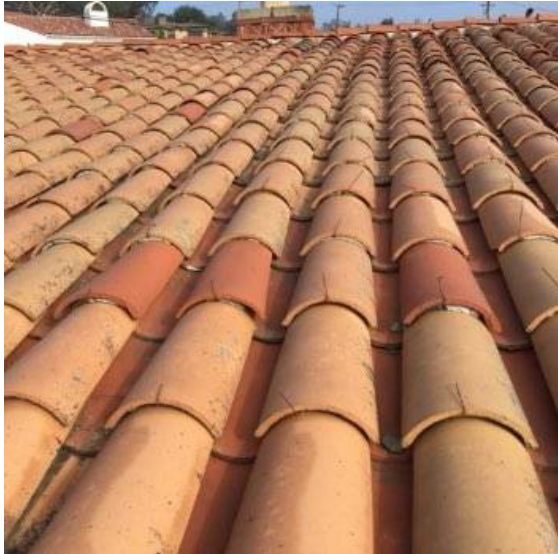
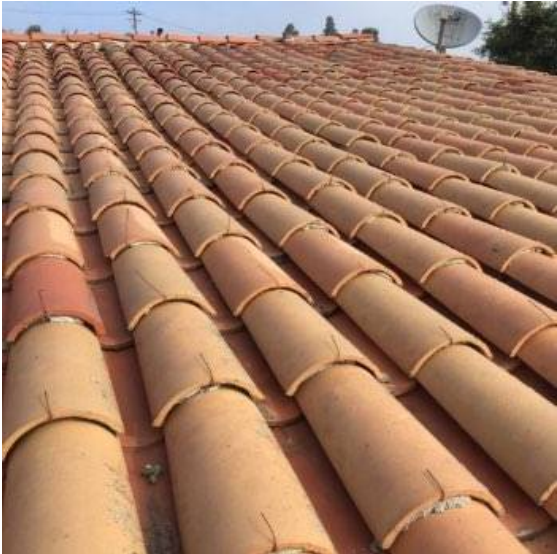
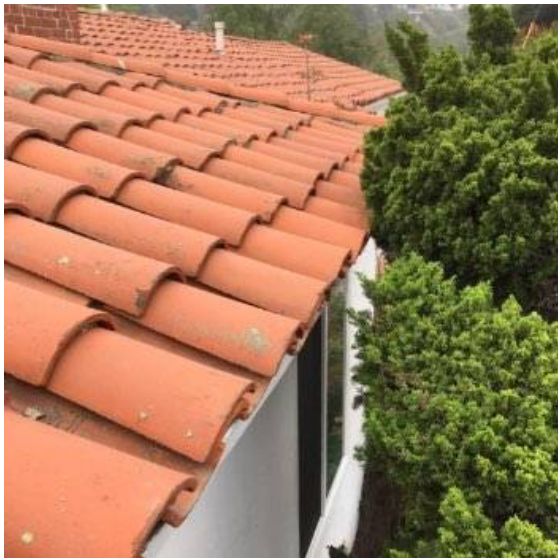
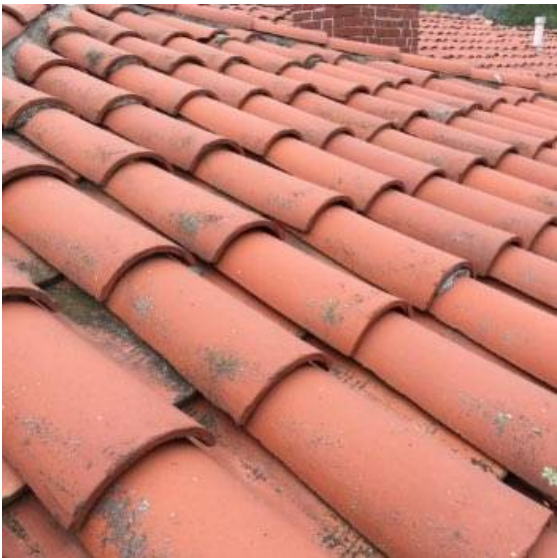
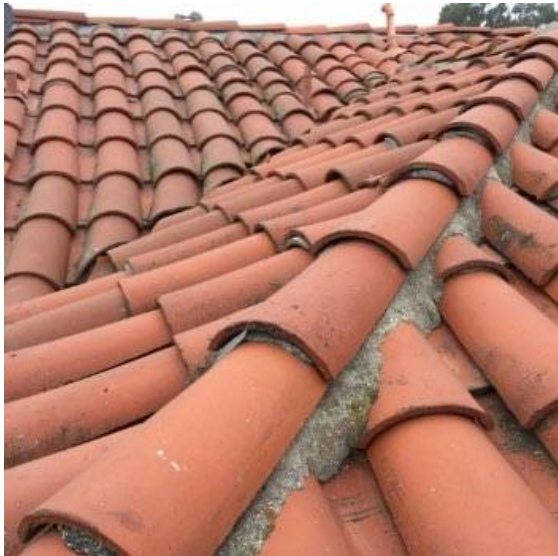
The roof was inspected and will require repair by a qualified roofer. The client may also wish to consider having a qualified contractor attempt to issue a "roof certificate" once all repairs have been made. No prediction of future performance or warranties can be offered.

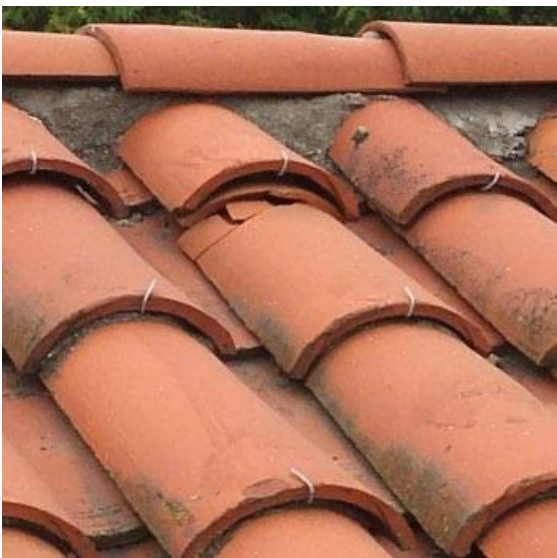
Photo 57-1

Some roof tiles were cracked, broken, loose and/or damaged. Leaks may occur as a result. This is a conducive condition for wood-destroying organisms. Recommend that a qualified person replace tiles or make repairs as necessary.

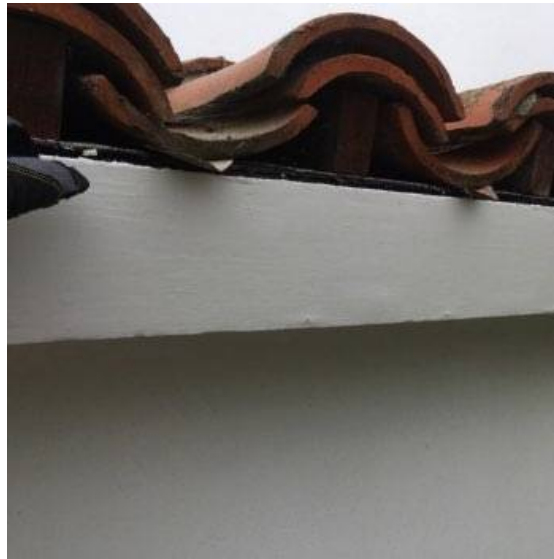
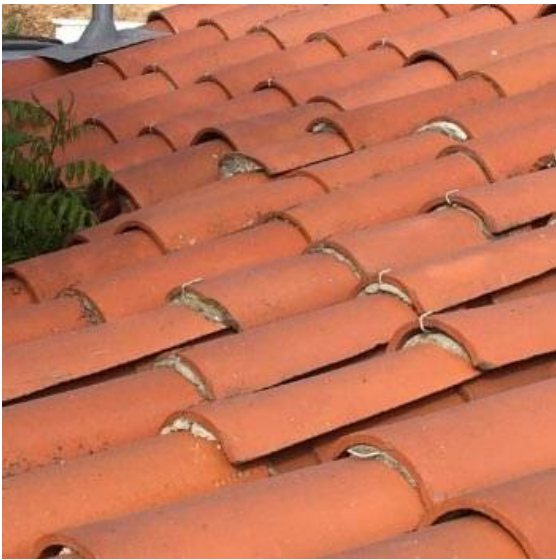
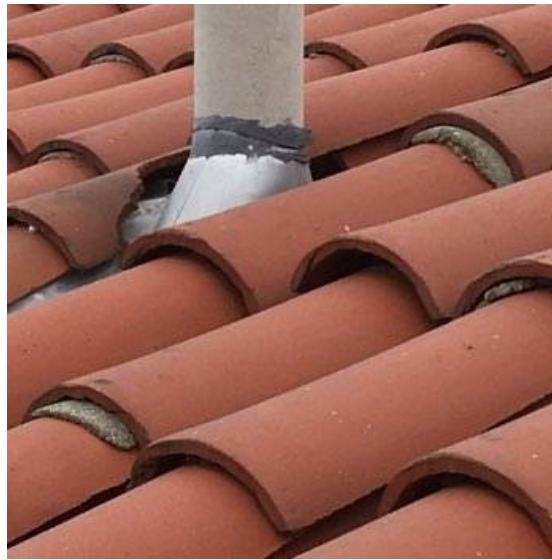
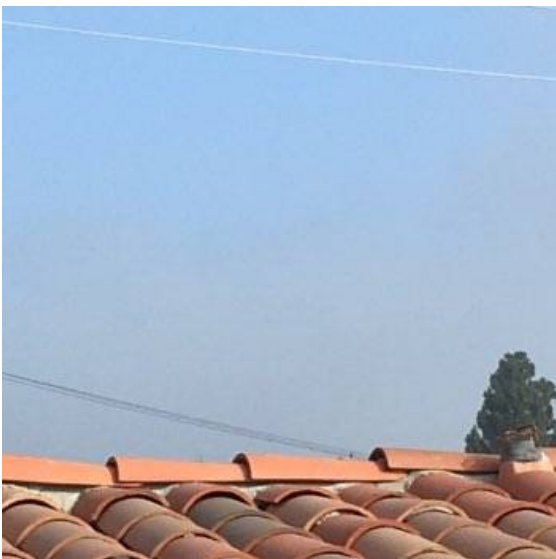
59) 🛠️ One or more roof flashings were lifting, substandard, missing and/or deteriorated. Leaks can occur as a result. This is a conducive condition for wood-destroying organisms. Recommend that a qualified person repair as necessary.

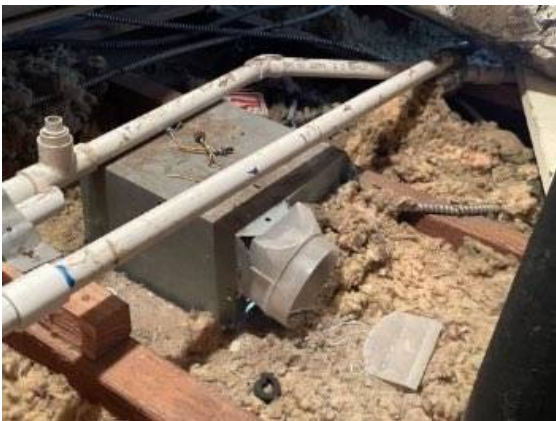
Photo 64-1

One or more exhaust fans in the attic had no duct to route the exhaust air outside. As a result, conditioned air will enter the attic when the fan is operated. This can result in excessive moisture in the attic. Recommend that a qualified contractor install ducting per standard building practices. Typically, this includes a duct with R-4 rated insulation permanently attached to a vent hood or cap installed on the roof or at an exterior wall.

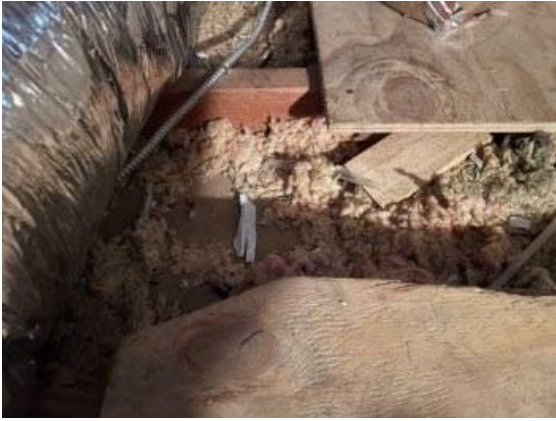
Photo 66-1

The ceiling insulation in one or more areas of the attic was compacted or uneven, missing and/or substandard. Heating and cooling

costs may be higher due to reduced energy efficiency. Recommend that a qualified person repair, replace or install insulation as necessary and per standard building practices (typically R-38).

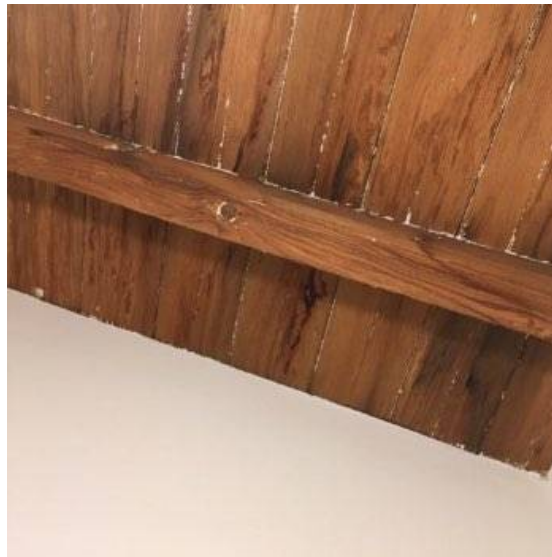
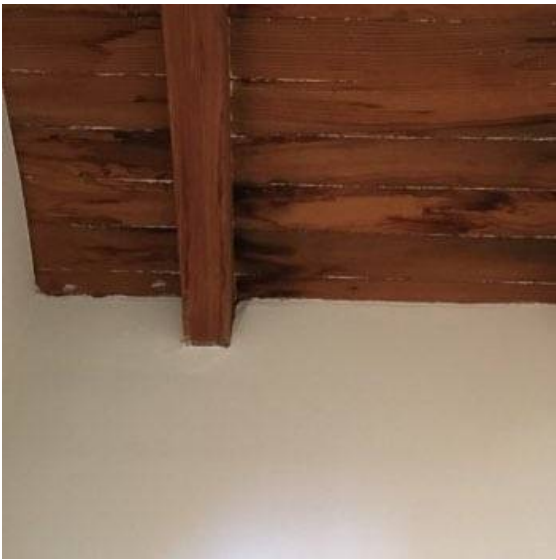
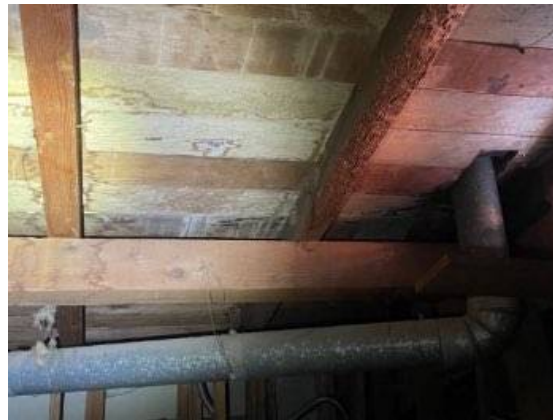
What appeared to be past water stains were visible on the roof structure at one or more locations. However, no elevated levels of moisture were found at these stains during the inspection. The stains may have been caused by a past leak. Recommend asking the property owner about past leaks. Monitor these areas in the future, especially after heavy rains to determine if active leaks exist. If leaks are found, recommend that a qualified contractor evaluate and repair as necessary.

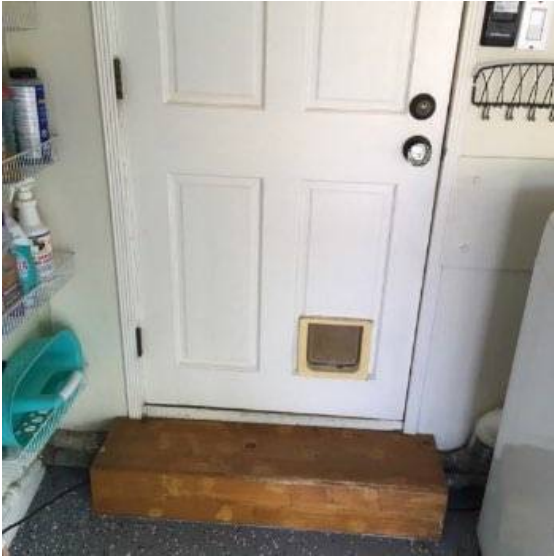
Photo 70-1

The door between the garage and the house has been modified with a pet door, and is no longer fire-resistant. This is a potential safety hazard. House to garage doors, to prevent fire and fumes from spreading from the garage into interior living space, should be constructed of fire-resistant materials. Doors, generally considered to be suitable for the purpose, are solid core wood, steel, honeycomb steel or a door that has been factory labeled as fire rated. Recommend that a qualified contractor replace or repair the door and, at that time, make any other corrections that might be required to provide suitable fire resistance between the garage and the dwelling per standard building practices. For more information, visit:

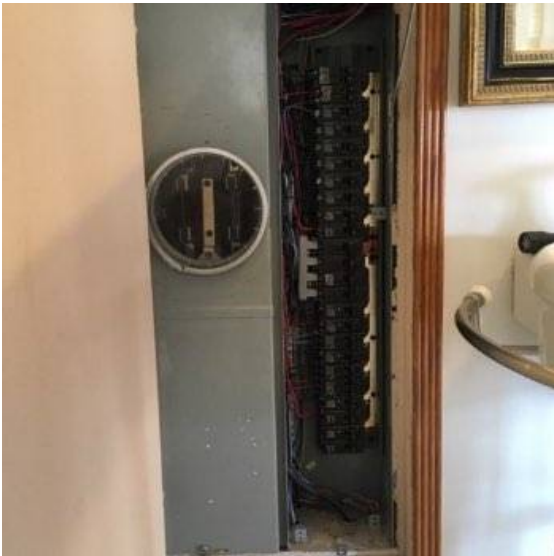
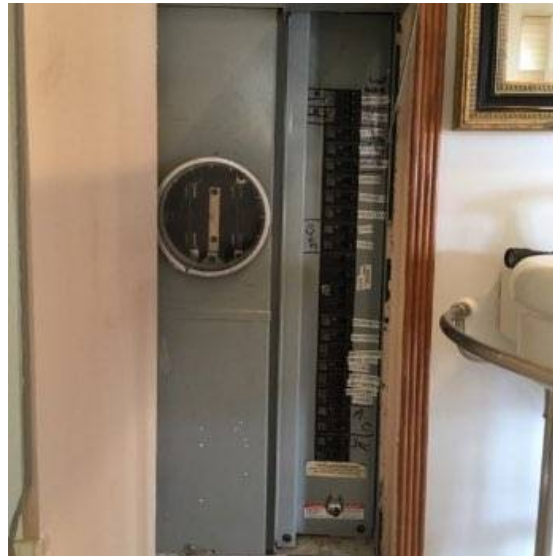
Panel(s) #B were located in a bathroom and/or a closet. This is not an approved location for electric panels. Recommend that a qualified electrician move the panel(s) or make repairs per standard building practices.

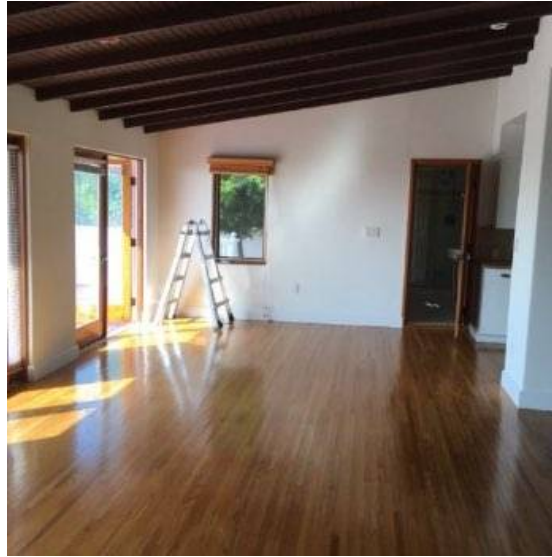
Photo 81-2

One or more modern, 3-slot electric receptacles were found with an open ground. This is a shock hazard when appliances that require a ground are used with these receptacles. Examples of such appliances include computers and related hardware, refrigerators, freezers, portable air conditioners, clothes washers, aquarium pumps, and electrically operated gardening tools. Recommend that a qualified electrician repair as necessary so all receptacles are grounded per standard building practices.

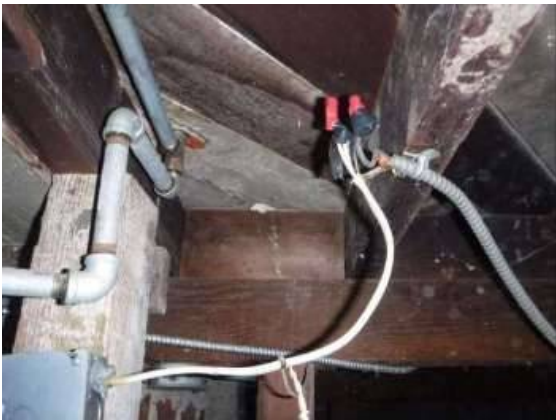
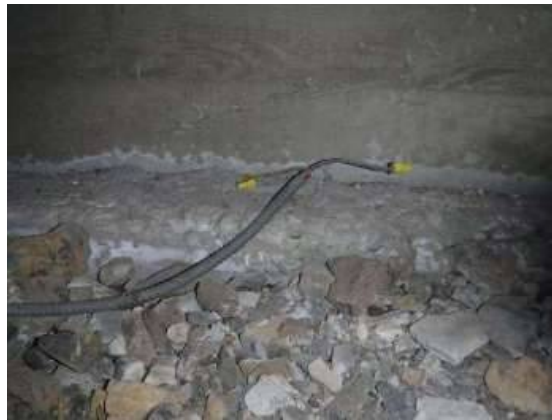
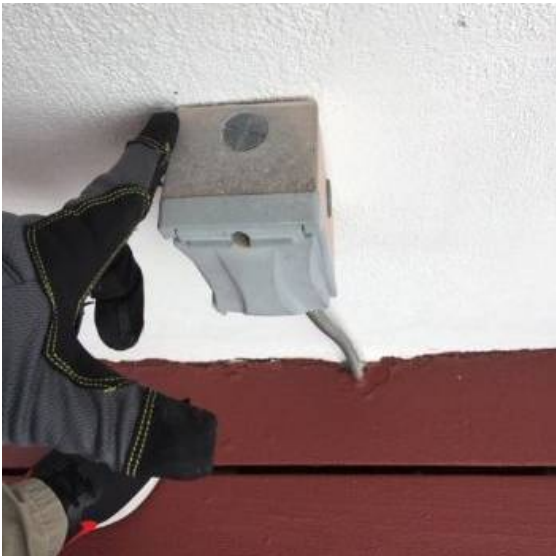
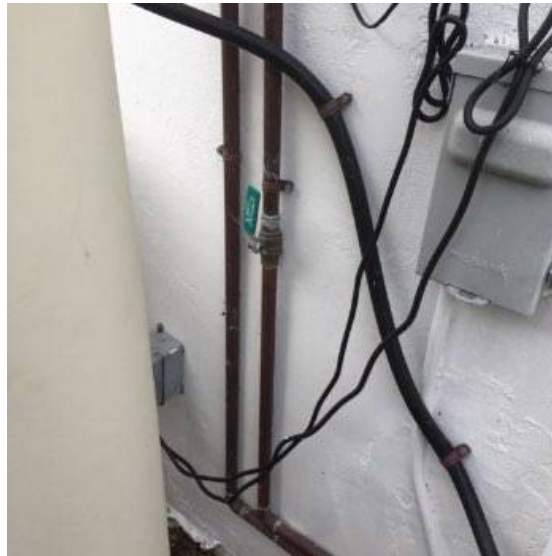
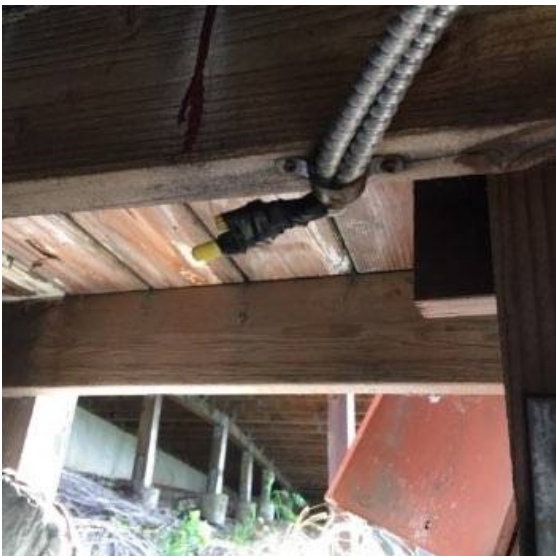
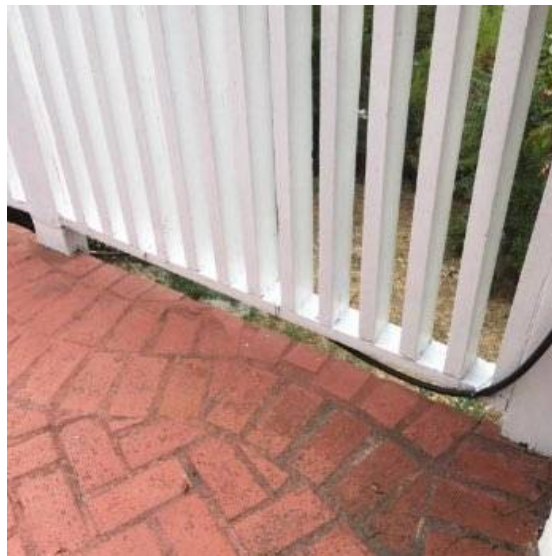
83) 🔍🛠️ Substandard wiring was found at the building exterior and/or crawl space. For example, exposed wiring, loose wiring, unterminated wires, exposed splices and/or missing conduit. This is a safety hazard. Recommend that a qualified electrician evaluate and repair as necessary and per standard building practices.
