Del Fine Home Inspections

Property Inspection Report

Property address: **6432 Via Canada
Rancho Palos Verdes, CA 90275**

Inspection date: **Friday, July 19, 2024**

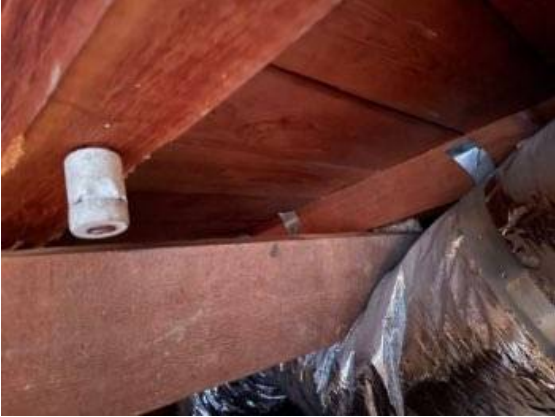
Photo 84-1

84) 🚨 🔍 "Knob and tube" wiring or related components such as porcelain insulators were found. This type of wiring was commonly installed prior to 1950. It is ungrounded, and considered unsafe by today's standards. Over time, the wire's insulation can become brittle and fall apart or wear thin, resulting in exposed conductors and a risk of shock and/or fire. This wiring is also easily damaged by covering it with

The inspector did not find any energized knob and tube wiring during the inspection. However, this is no indication that all the knob and tube wiring has been abandoned. It is not within the scope of this inspection to determine what percentage of this property's wiring is of the knob-and-tube type, or to determine what percentage of the knob and tube wiring is energized versus abandoned. Recommend that a qualified electrician evaluate this wiring and make repairs or replace wiring as necessary.

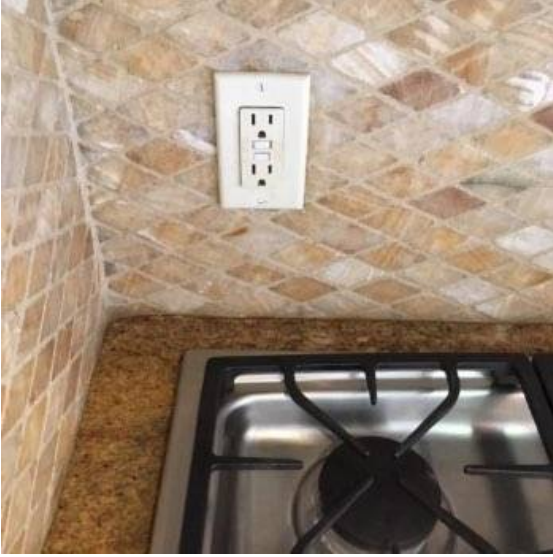
Photo 86-1

One or more receptacles or wiring were near cook top. This is a potential hazard. Recommend that a qualified electrician repair as necessary.

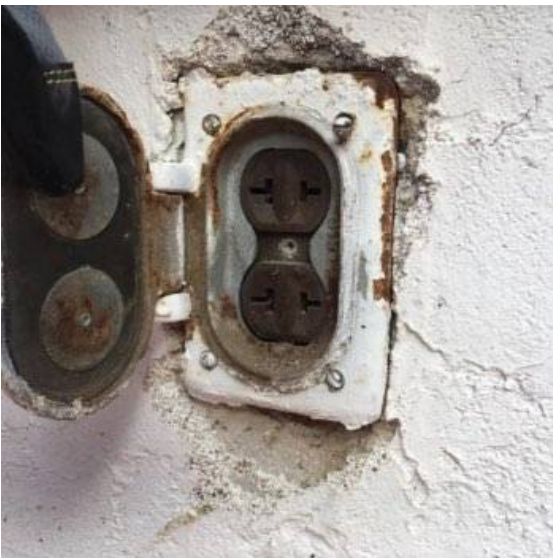
2-slot receptacles rather than 3-slot, grounded receptacles were installed in one or more areas. These do not have an equipment ground and are considered unsafe by today's standards. Appliances that require a ground should not be used with 2-slot receptacles. Examples of such appliances include computers and related hardware, refrigerators, freezers, portable air conditioners, clothes washers, aquarium pumps, and electrically operated gardening tools. The client should be aware of this limitation when planning use for various rooms, such as an office. Upgrading to grounded receptacles typically requires installing new wiring from the main service panel or sub-panel to the receptacle(s), in addition to replacing the receptacle(s). Consult with a qualified electrician about upgrading to 3-wire, grounded circuits.

Photo 88-1 One location

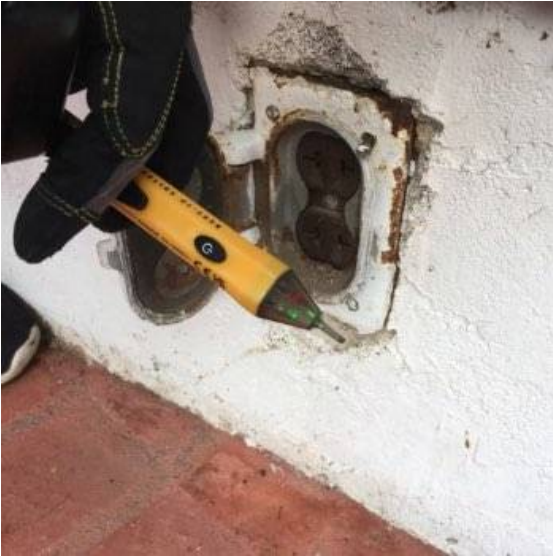
One or more electric receptacles appeared to have no power. Recommend asking the property owner about this. Switches may need

to be operated or GFCI/AFCI protection may need to be reset to make some receptacles energized. If necessary, recommend that a qualified electrician evaluate and repair.

Photo 89-1 One location

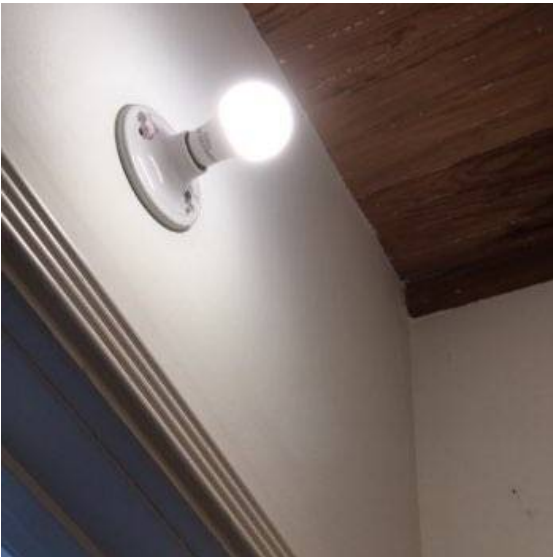
Photo 90-1

One or more globes or covers for light fixtures were missing or damaged. Recommend replacing as necessary to avoid exposed bulbs. With closet lighting or where flammable stored objects are near light fixtures, missing or broken covers can be a fire hazard.

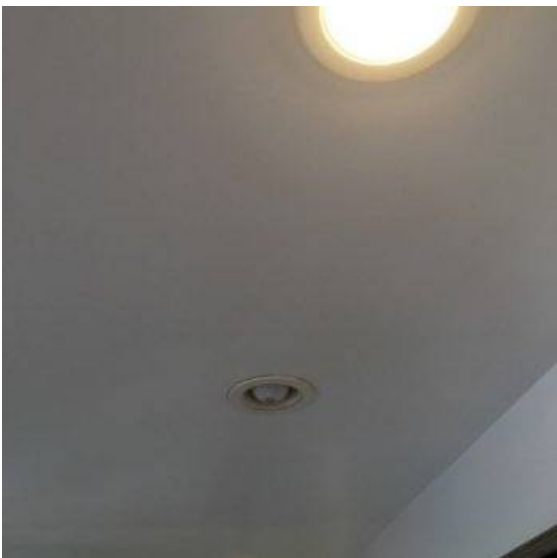
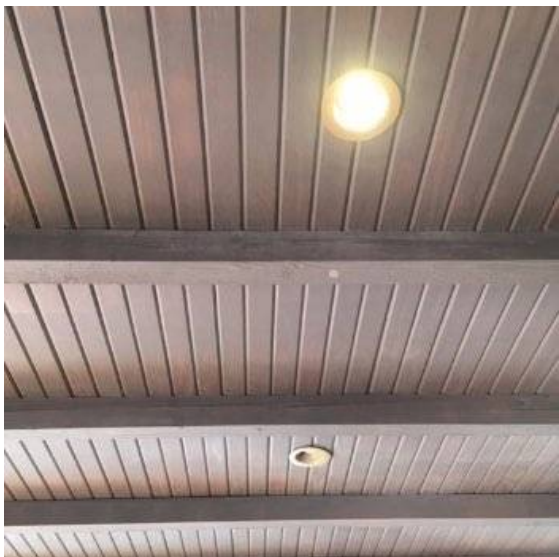
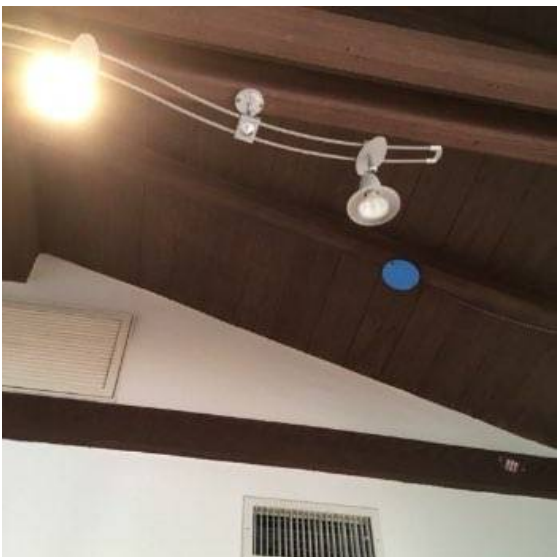
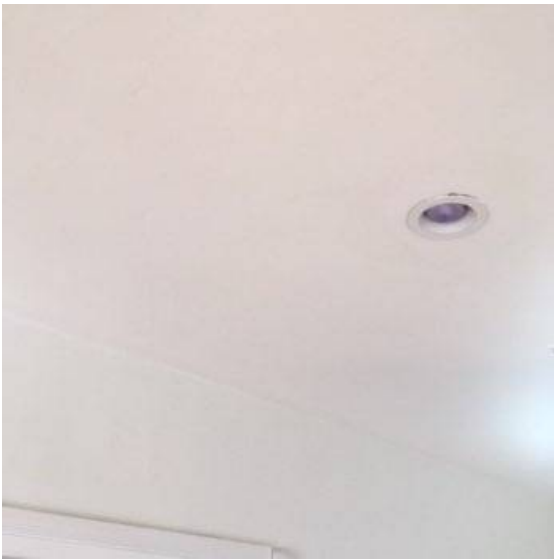
94) 🔍 One or more exterior light fixtures were inoperable (didn't turn on when nearby switches were operated). Recommend further evaluation by replacing bulbs and/or consulting with the property owner. If replacing bulbs doesn't work and/or no other switch(es) can be found, then recommend that a qualified electrician evaluate and repair or replace light fixtures as necessary.

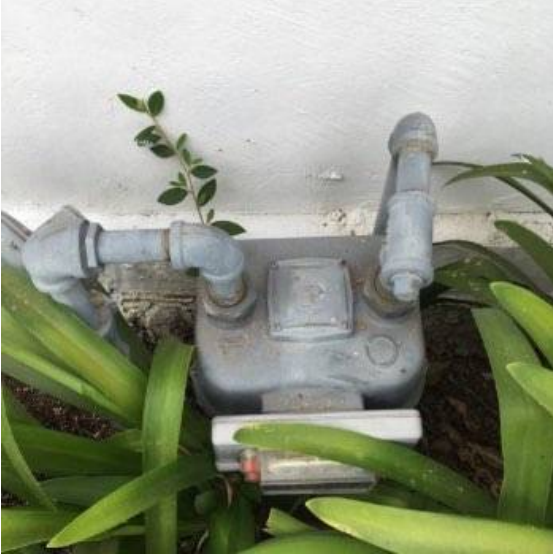
Photo 98-1

In an earthquake, the shaking of a home can cause damage to gas piping and appliances. This damage can result in release of natural gas that can lead to fires or even explosions. Recommend the installation of an approved Automatic Gas Shut Off Valve by a state licensed plumber or contact the local gas utility company for guidance.

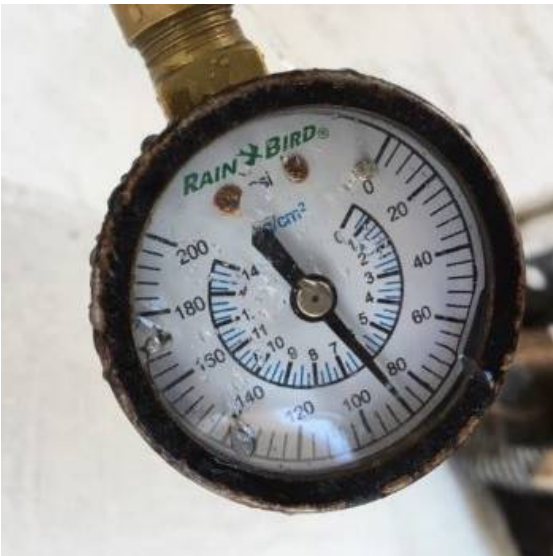
Photo 99-1

The water supply pressure was greater than 80 pounds per square inch (PSI). Pressures above 80 PSI may void warranties for some appliances such as water heaters or washing machines. Flexible supply lines to washing machines are likely to burst with higher pressures. 40-80 PSI is considered the normal range for water pressure in a home, and most plumbers recommend 50-60 PSI. Typically, the pressure cannot be regulated at the water meter. Recommend that a qualified plumber evaluate and make modifications to reduce the pressure to below 80 PSI. Installing a pressure reducing valve on the main service pipe is a common solution to this problem. If one exists, then it should be adjusted, repaired or replaced as necessary to maintain lower pressures. Note that installing a pressure reducing valve creates a "closed system," which may require installing an expansion tank at the water heater if one is not already installed.

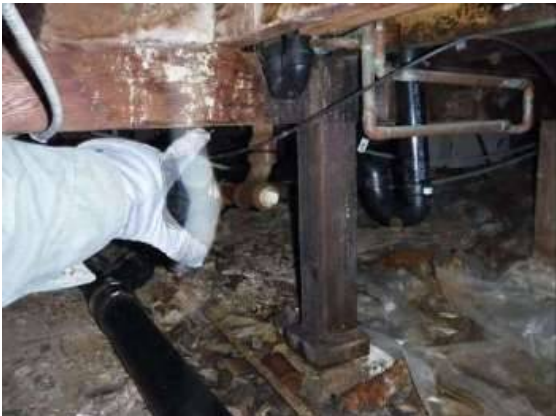
Photo 102-1

One or more leaks were found in drain and/or waste pipes or fittings. A qualified plumber should evaluate and repair as necessary.

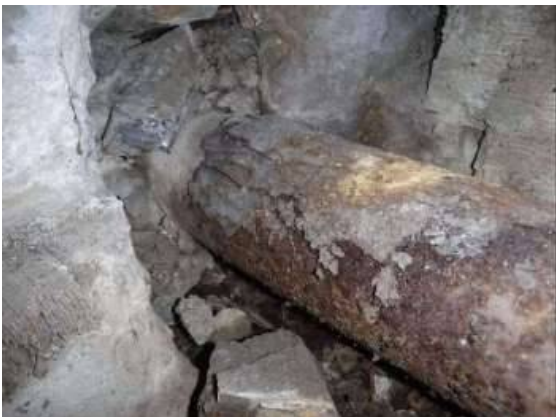
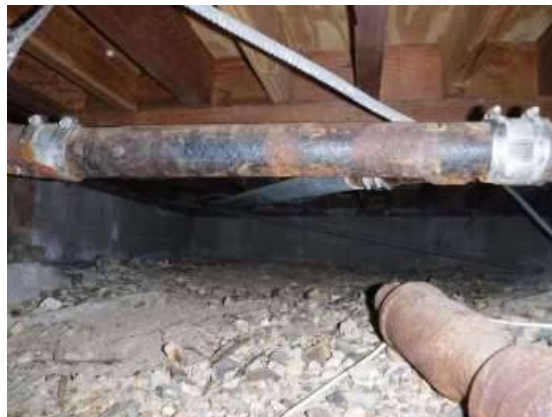
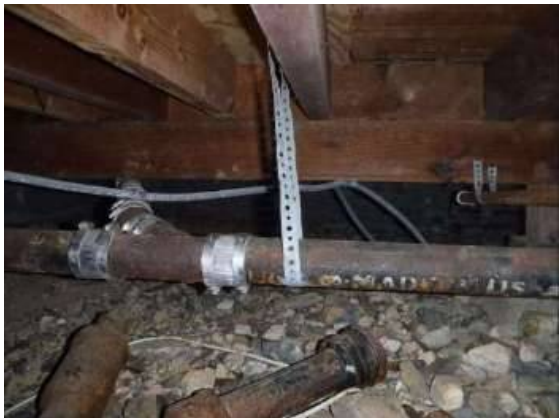
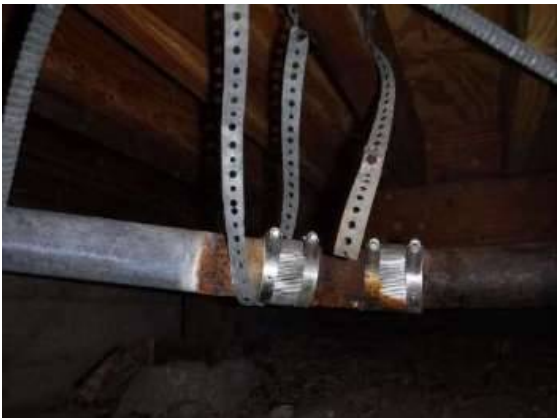
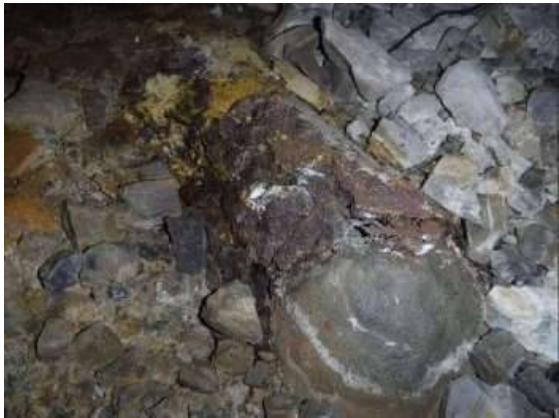
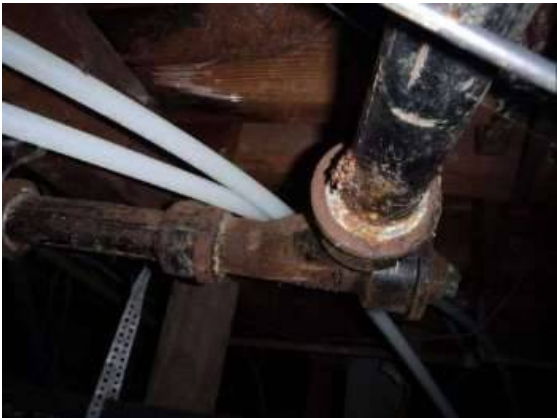
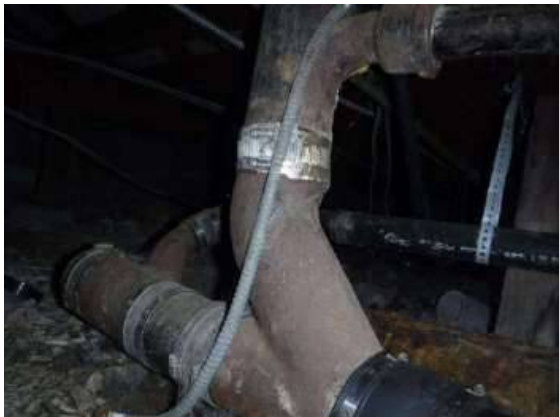
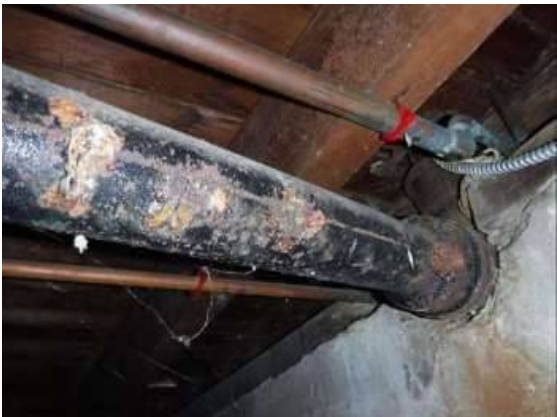
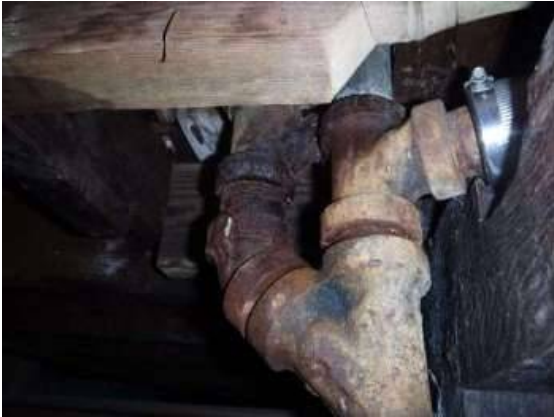
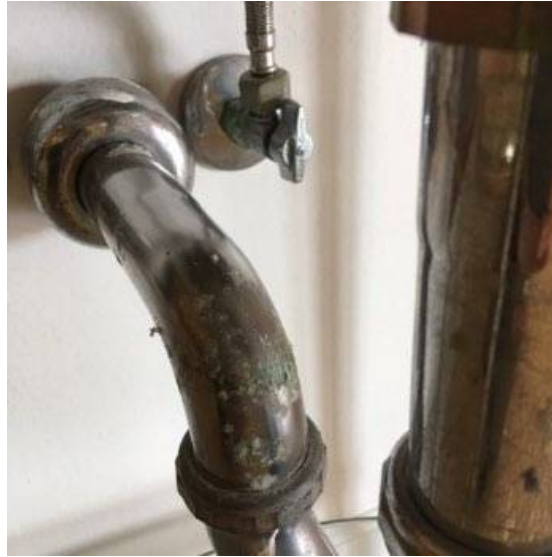
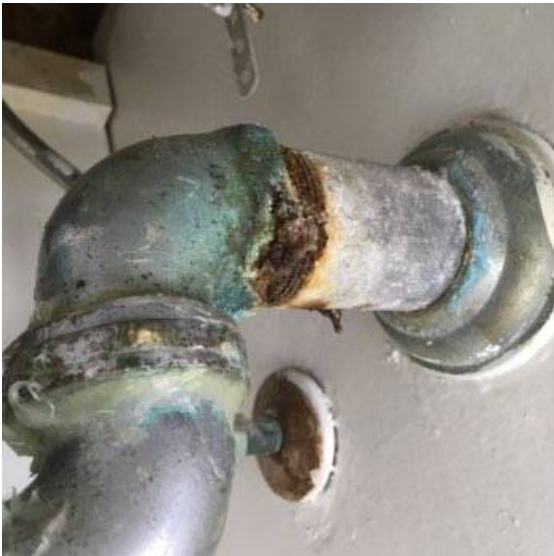
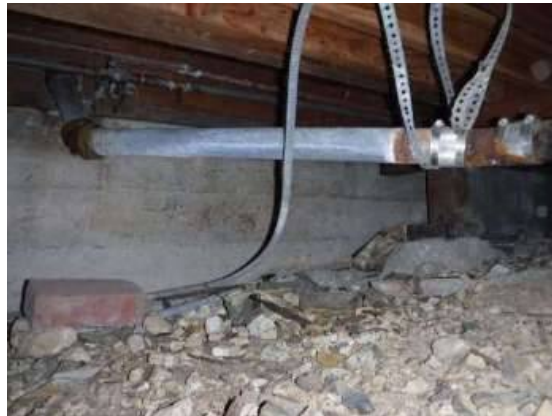
Significant corrosion, deterioration, cracks or damage was found in many drain and/or waste pipes or fittings. This can indicate past leaks, or that leaks are likely to occur in the future. Recommend that a qualified plumber evaluate and repair as necessary.

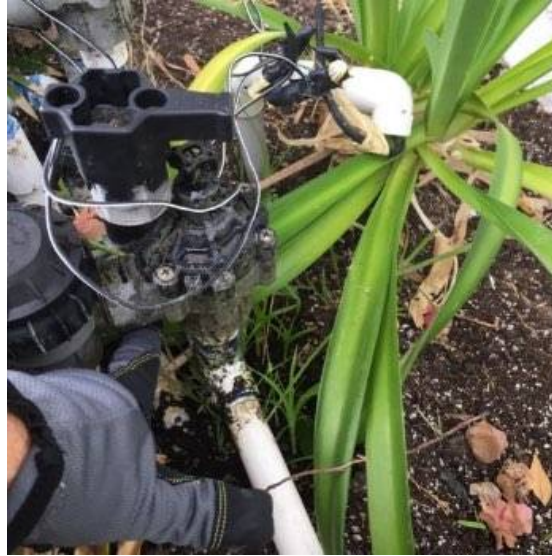
Photo 108-1 Sprinklers were located in planter boxes. Significant amount of water may stand in boxes and cause deterioration or damage. Recommend having a qualified person repair as necessary.

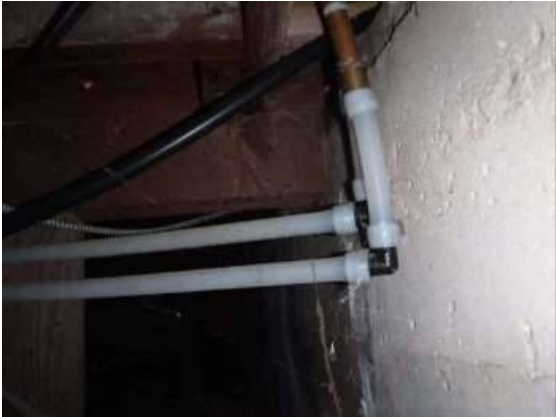
Photo 109-1

One or more sections of cross-linked polyethylene (PEX) water supply piping was in contact with concrete. PEX piping can be

damaged. Recommend that a qualified person protect PEX tubing where necessary.

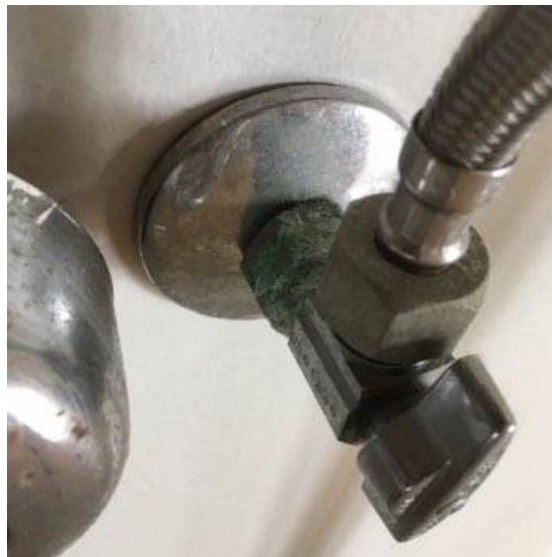
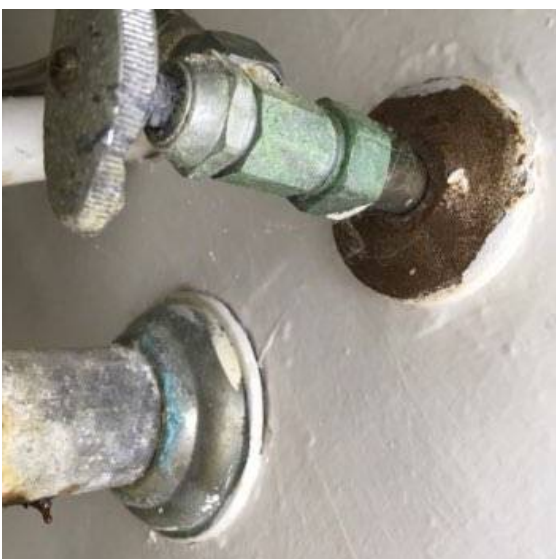
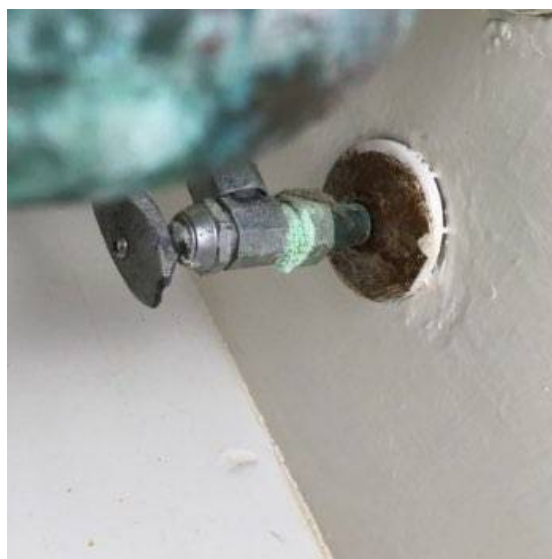
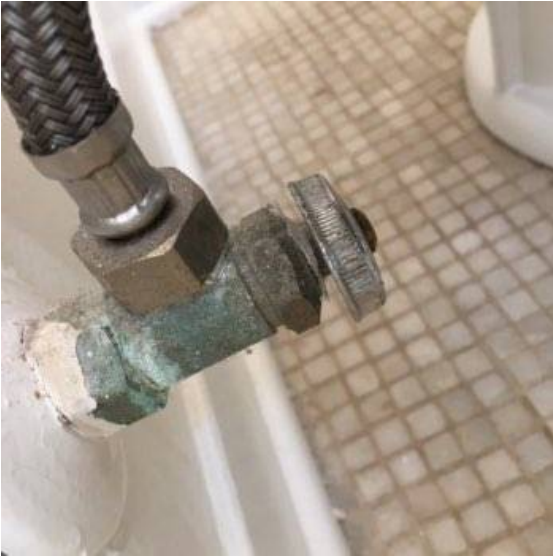
Corrosion or rust was found at one or more water supply valves. This can indicate past leaks, or that leaks are likely to occur in the future. Recommend that a qualified plumber repair as necessary. For example, by replacing valves or fittings.

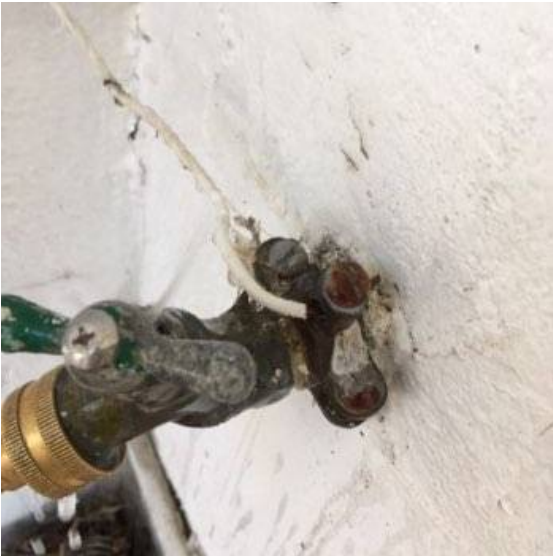
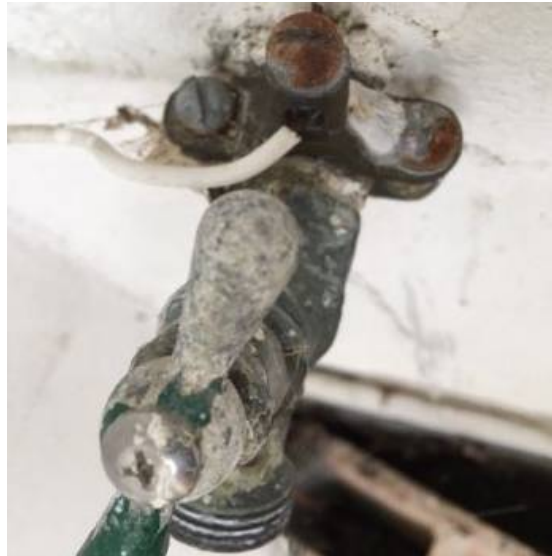
One or more hose bibs leaked when tested. When hose bibs leak while turned off, it's often caused by a worn valve seat or a loose bonnet. When hose bibs leak while turned on, it may be due to worn "packing" around the stem or a defective backflow prevention device. Recommend that a qualified plumber repair as necessary.

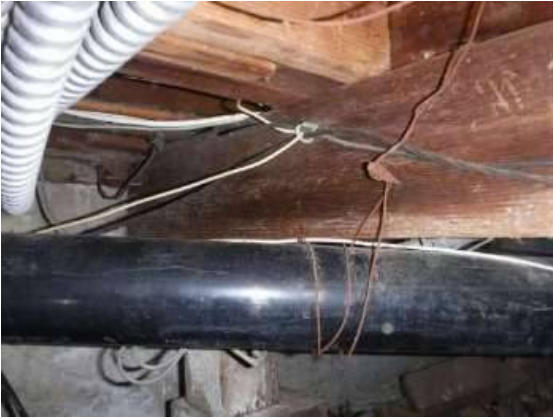
Photo 112-1

One or more waste or drain pipes had substandard support or were loose. Leaks can occur as a result. Recommend that a qualified person install hangers or secure pipes per standard building practices.

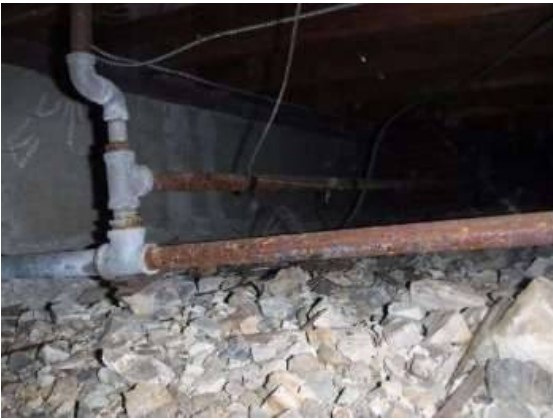
Photo 113-1

Steel piping for the gas service was corroded. Gas leaks can result. Recommend evaluation by a qualified contractor to determine if piping needs replacing. If not, then a qualified person should prep and paint lines as necessary with a rust-preventative paint. Very corroded pipes should be replaced by a qualified contractor.

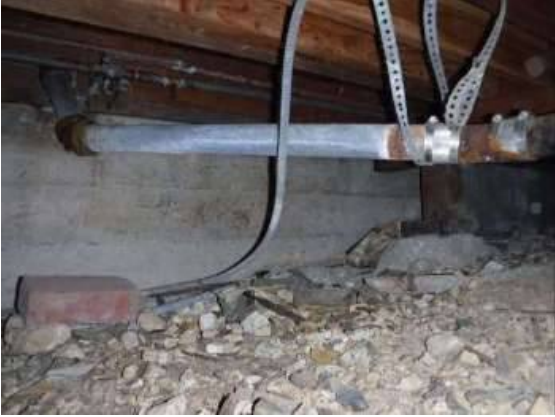
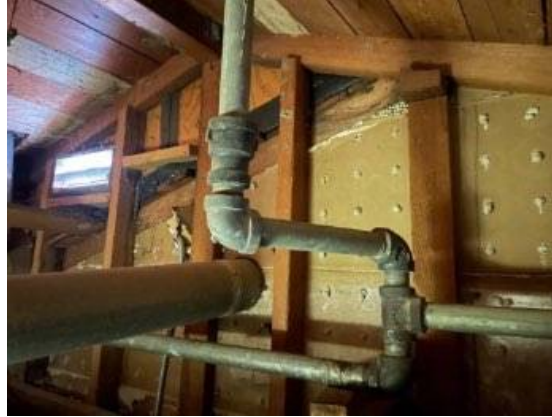
Some galvanized steel drain or vent pipes were found. Based on the age of this structure and the 40-60 year useful life of this piping, it will likely need replacing in the future. Leaks can develop, flooding and/or water damage may occur, flow can be restricted due to scale accumulating inside the piping, and water may be rusty. Note that it is beyond the scope of this inspection to determine what percentage of the piping is older, galvanized steel, as much of it is concealed in wall, floor and/or ceiling cavities. Recommend the following:

- That a qualified plumber evaluate to better understand or estimate the remaining life
- Consulting with a qualified plumber about replacement options and costs
- Budget for replacement in the future
- Monitor these pipes for leaks and decreased flow in the future
- Consider replacing old, galvanized steel piping proactively

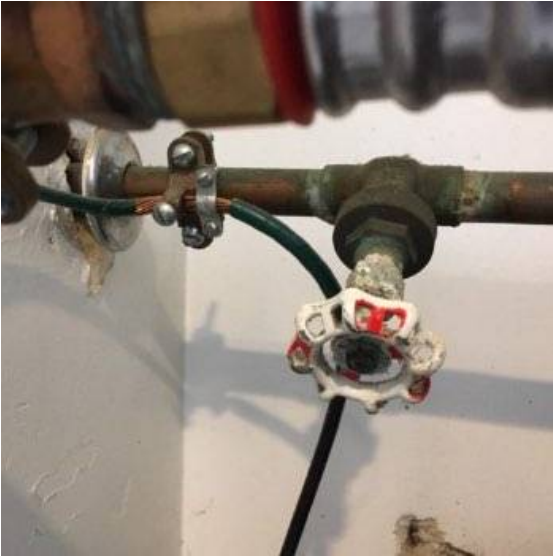
Photo 121-1

121) 🔧🔍 Significant corrosion or rust was found at the supply pipes or fittings and/or shut-off valve. This can indicate past leaks, or that leaks are likely to occur in the future. Recommend that a qualified plumber evaluate and replace components or make repairs as necessary.

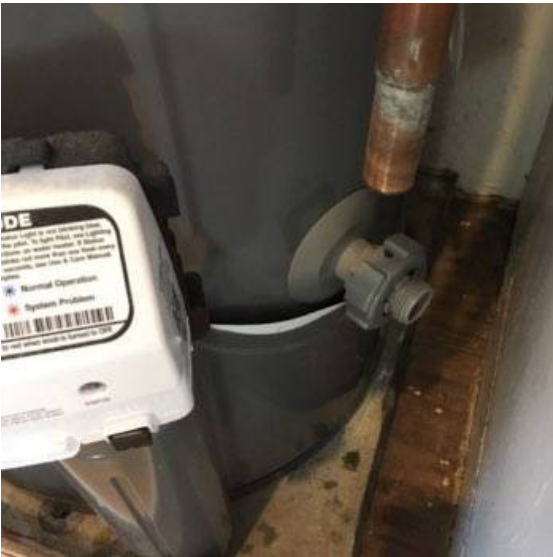
Photo 122-1

122) 🛠️🔍 Drain line was installed for the temperature-pressure relief valve, but was not drained to outside. Drain lines are normally installed to prevent water from accumulating if/when the valve eventually leaks, and to prevent scalding if someone is standing next to the water heater when the valve opens. Recommend that a qualified plumber install a drain line so it drains outside and per standard building practices.

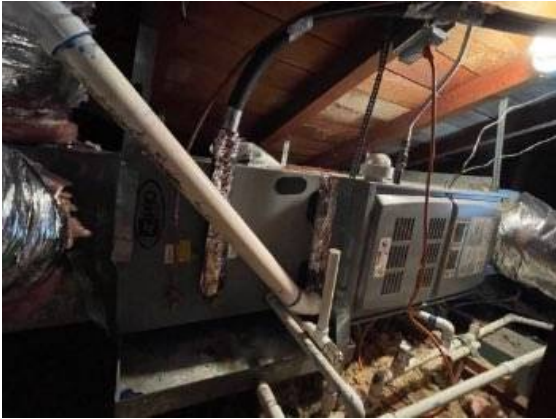
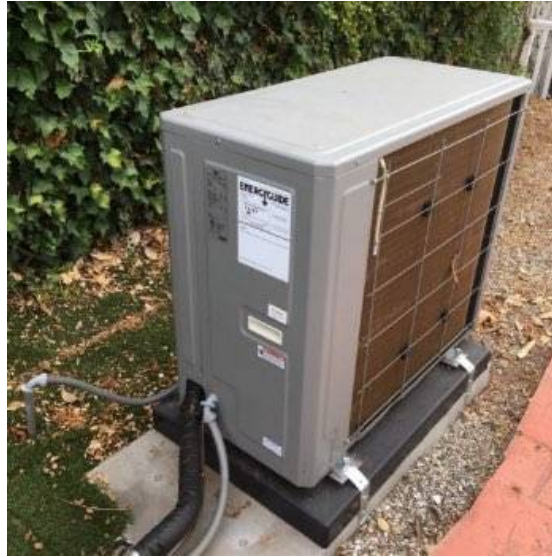
The last service date of the forced air heating/cooling system appeared to be more than 1 year ago, or the inspector was unable to determine the last service date. Ask the property owner when it was last serviced. If unable to determine the last service date, or if this system was serviced more than 1 year ago, recommend that a qualified HVAC contractor service this system and make repairs if necessary. Because this system has a compressor and refrigerant system, this servicing should be performed annually in the future. Any needed repairs noted in this report should be brought to the attention of the contractor when it's serviced.

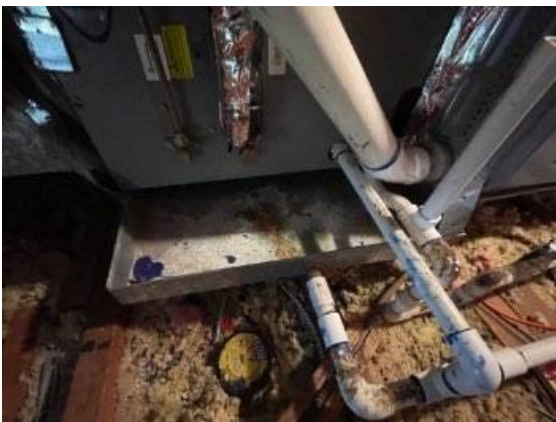
Photo 126-1

The pan had significant amounts of corrosion or rust. Holes may develop and leaks may occur. Recommend that a qualified HVAC contractor repair as necessary.

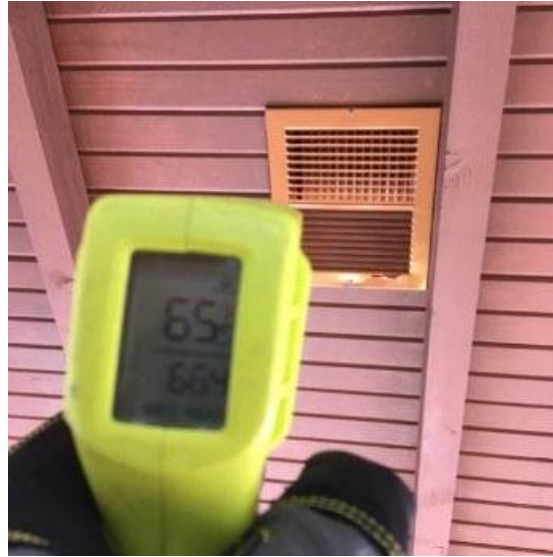
Photo 127-2

Supply air from the air conditioning or heat pump cooling system was not cool enough. Recommend that a qualified HVAC contractor repair as necessary.

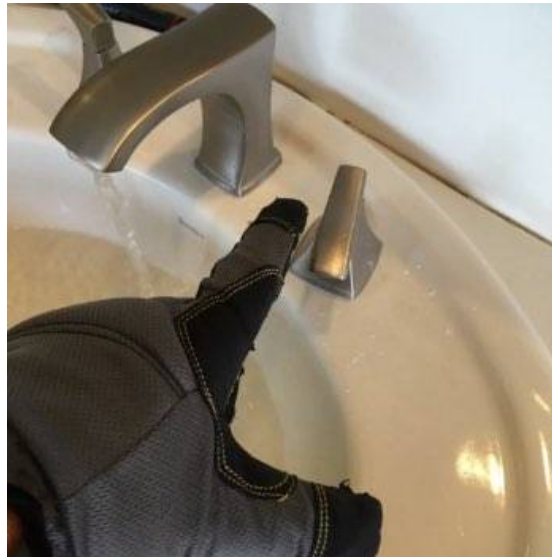
Photo 141-2

The hot and/or cold water supply flow for the sink at location(s) #B was low or inoperable. Recommend that a qualified plumber evaluate and repair as necessary.

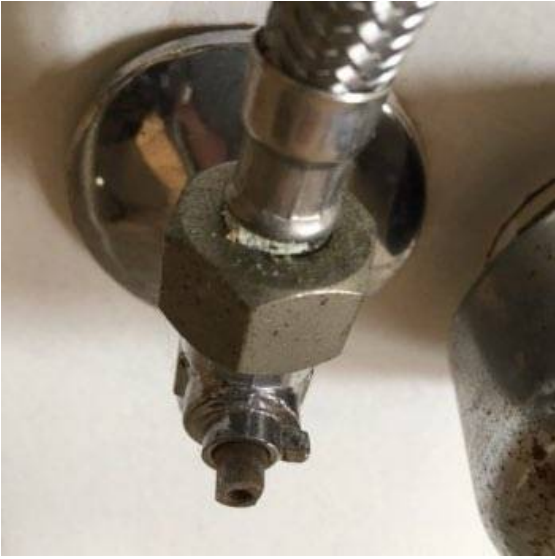
Photo 142-1

The handle for the toilet shut-off valve at location(s) #B was missing. Recommend that a qualified person replace or repair handles as necessary.

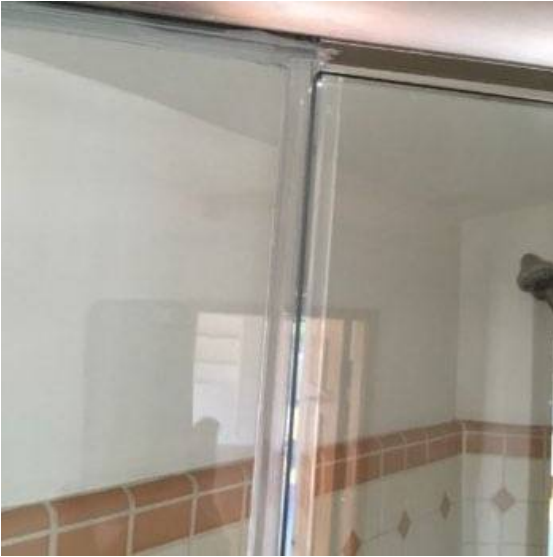
Photo 144-1

The shower door at location(s) #B was difficult to open or close. Recommend that a qualified person repair as necessary.

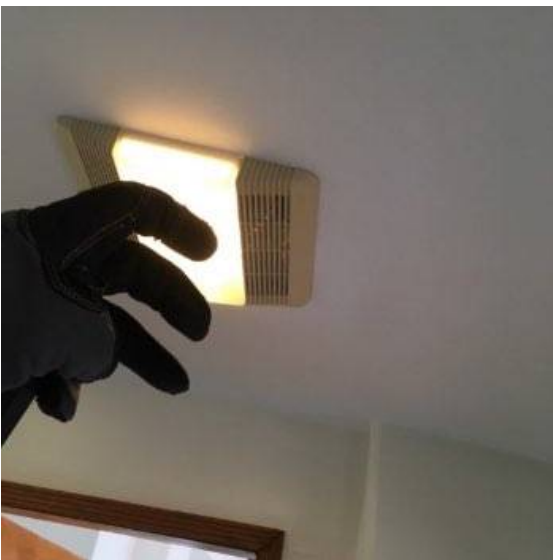
Photo 145-1

The exhaust fan at location(s) #B was noisy or vibrated excessively. Moisture may accumulate and result in mold, bacteria or fungal growth. Recommend that a qualified person clean, repair or replace fans as necessary.

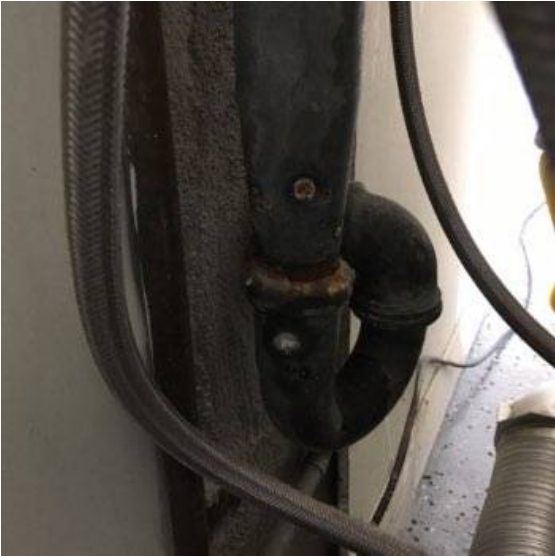
Photo 146-1

The clothes washer drain standpipe was deteriorated or substandard. Standard building practices require that the stand pipe be:

- A minimum of 2 inches in diameter
- At least 33 inches tall for a top-loading clothes washer
- At least 24 inches tall for a front-loading clothes washer

Recommend that a qualified person repair as necessary per standard building practices.

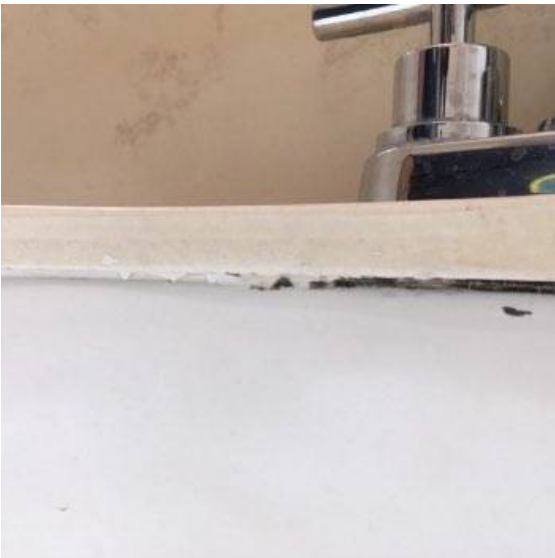
Photo 147-1

Gaps, no caulk, or substandard caulking were found between countertops and backsplashes and/or around the sink at location(s) #A. Water can penetrate these areas and cause damage. Recommend that a qualified person repair as necessary. For example, by installing or replacing caulk.

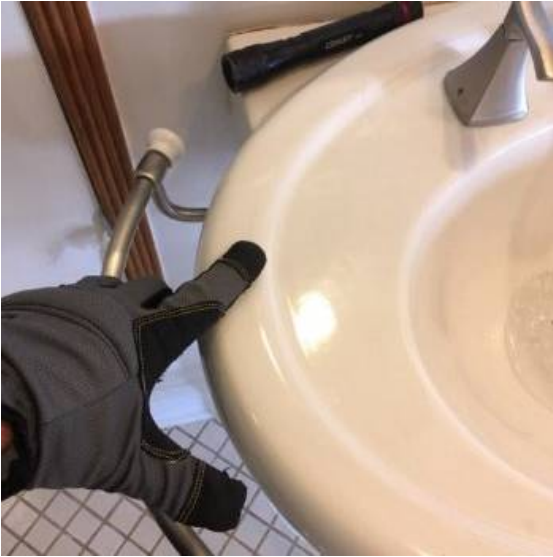
Photo 148-1

The sink at location(s) #B were not securely fastened to the wall. An adequate number of appropriate fasteners should be used. Recommend that a qualified person repair as necessary.

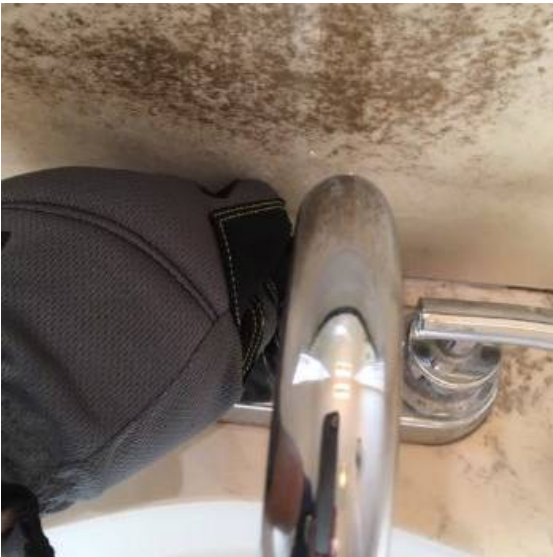
Photo 149-1

149) 🛠️ The sink faucet controls at location(s) #A was difficult to operated, damaged or deteriorated.

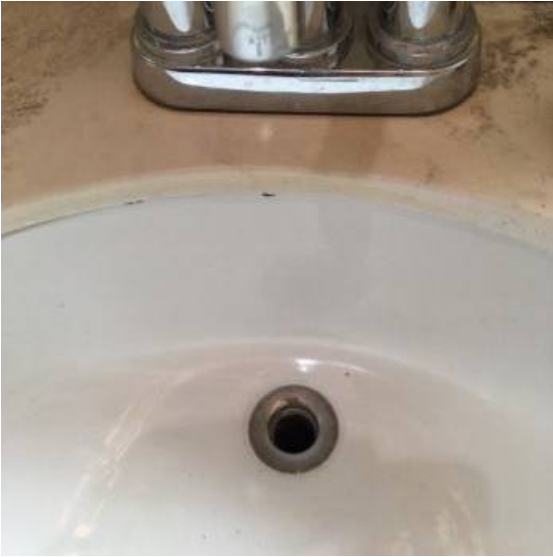
Photo 150-1

150) 🛠️ The sink drain stopper mechanism at location(s) #A was missing. Recommend that a qualified person repair or replace as necessary.

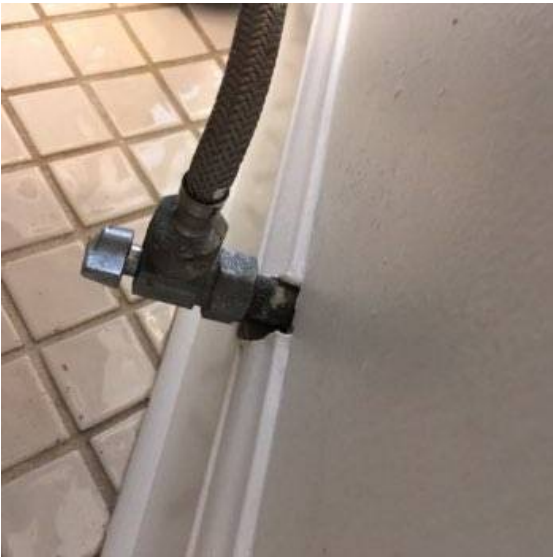
Photo 151-1

151) 🛠️ Escutcheon plate(s) were missing at one or more locations. Recommend having a qualified person repair.

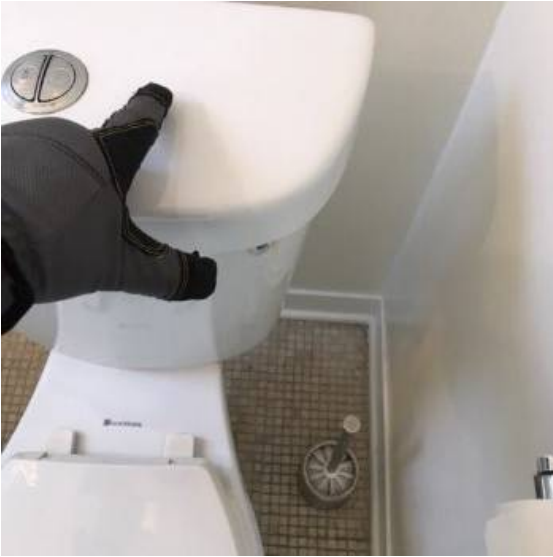
**Photo 152-1**

152) 🛠️ The toilet tank at location(s) #A was loose. Leaks can occur. Recommend that a qualified person repair as necessary.

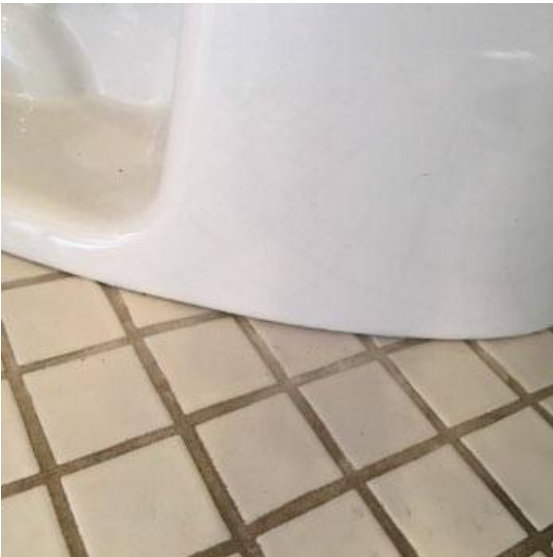
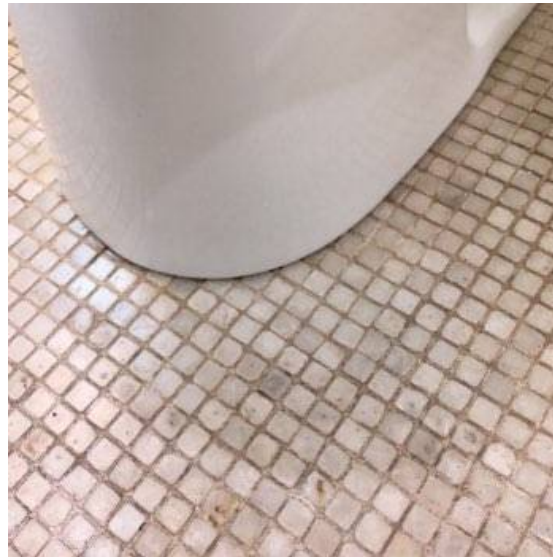
Caulk around the base of the toilet at location(s) #A and B was missing, substandard and/or deteriorated. Modern standards require caulk to be installed around the entire toilet base where it meets the floor for sanitary reasons. Without it, soiled water can soak into flooring and sub-floor materials if the toilet overflows. Condensation from the toilet can also soak into the flooring. Recommend that a qualified person caulk around toilet bases per standard building practices.

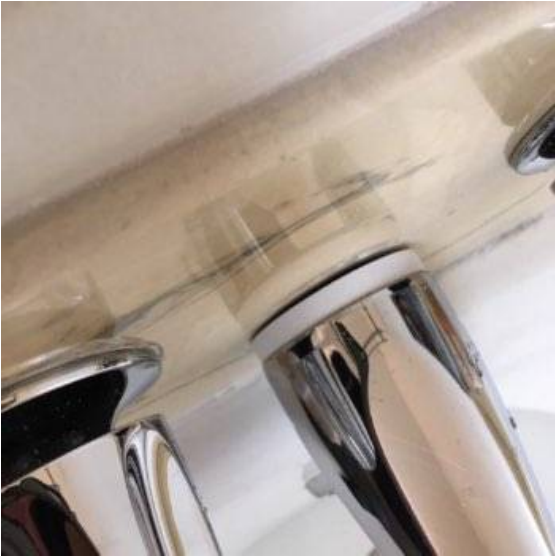
Photo 154-1

Caulk was missing around the base of the bathtub spout, or there was a gap behind it, at location(s) #A. Water may enter the wall structure behind the bathtub. Recommend that a qualified person repair as necessary to eliminate the gap. For example, by installing or replacing caulk if the gap is small enough. For larger gaps, a shorter spout nipple or an escutcheon plate can be installed.

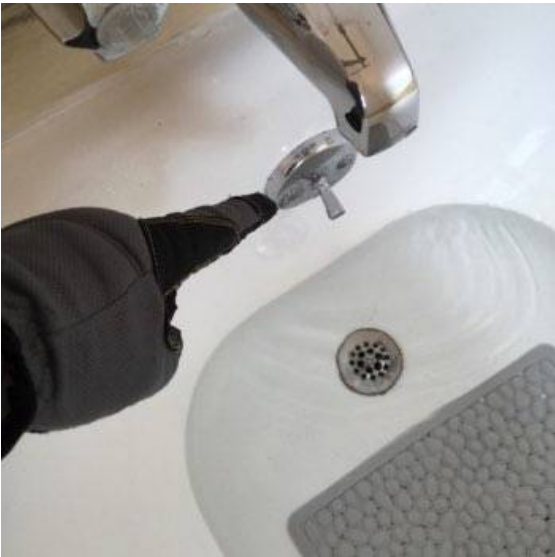
Photo 156-1

The bathtub drain stopper mechanism at location(s) #A was inoperable and/or difficult to operate. Recommend that a qualified person repair or replace as necessary.

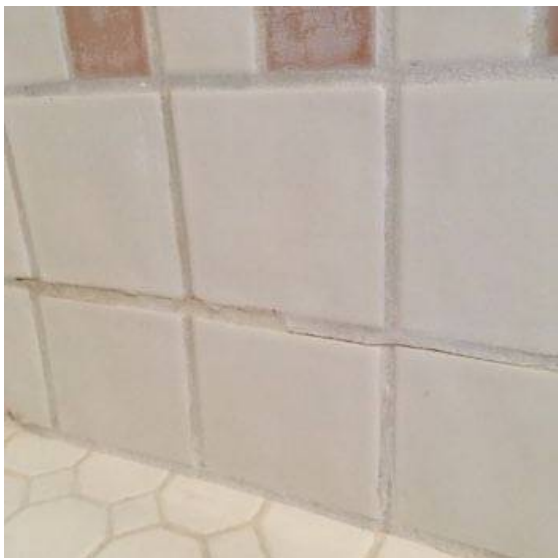
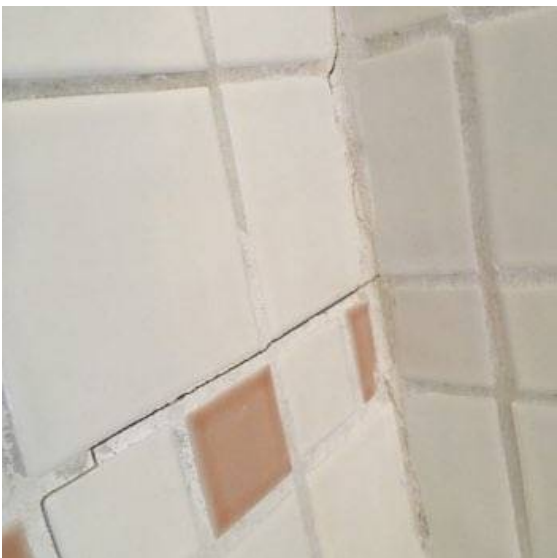
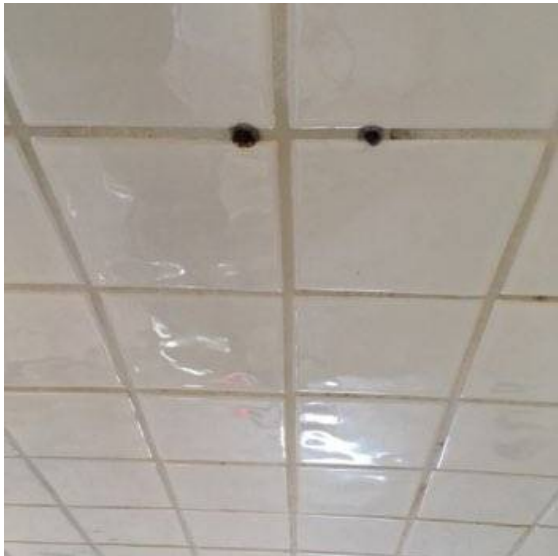
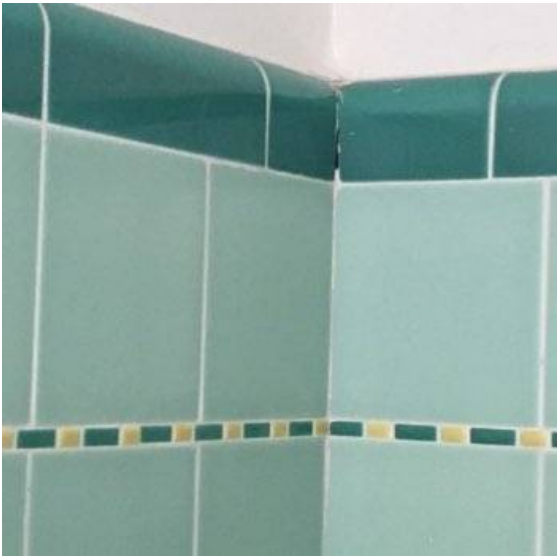
Tile and/or grout in the shower enclosure at location(s) #A and B were deteriorated (e.g. loose or cracked tiles, missing grout) or substandard. Water can damage the wall structure as a result. Recommend that a qualified contractor repair as necessary.

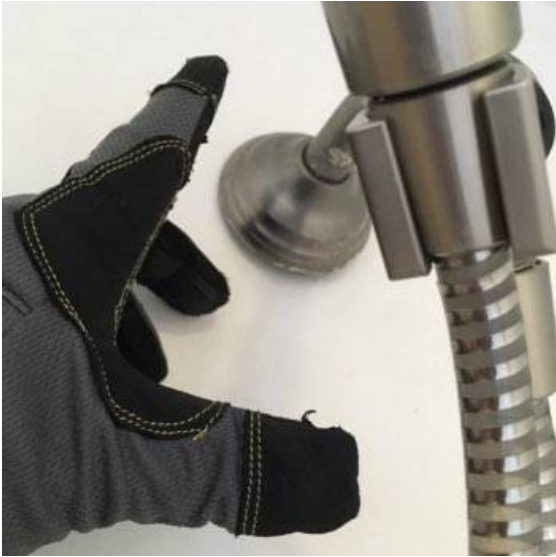
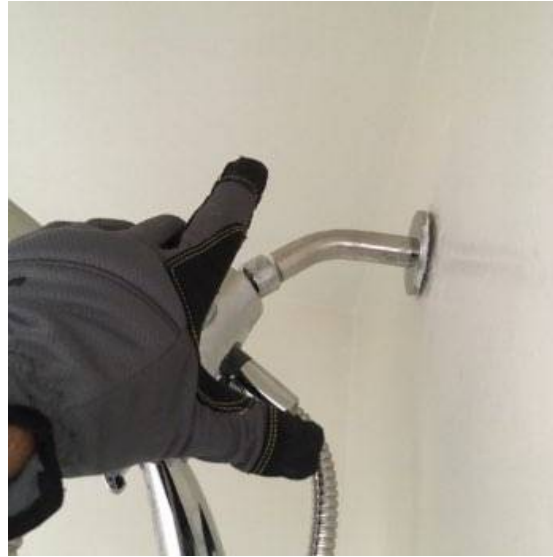
158) 🛠️ The shower arm at location(s) #A and B was loose. Recommend that a qualified person repair as necessary.

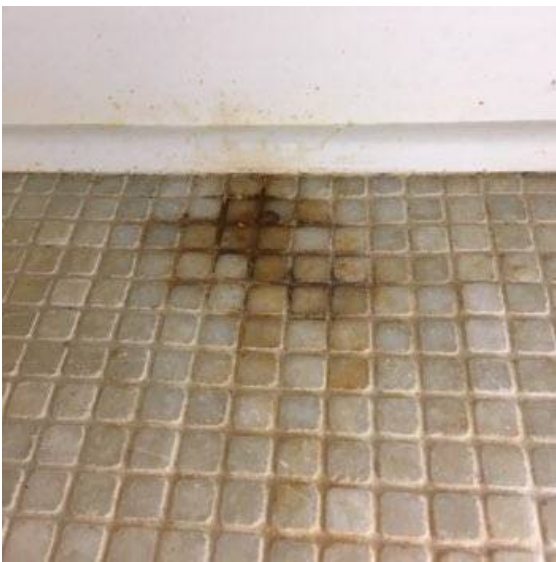
Photo 159-1

Stains were found below the sink at location(s) #A. Plumbing leaks may have occurred in the past. Consult with the property owner about this, and if necessary that a qualified person evaluate and repair.

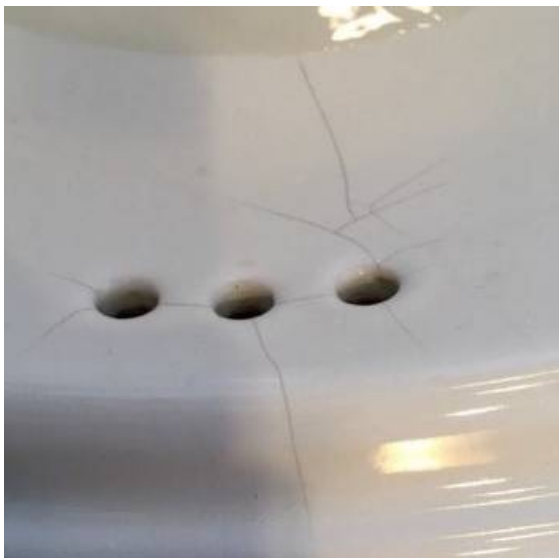
Photo 160-1

The sink at location(s) #B was worn, blemished or deteriorated.

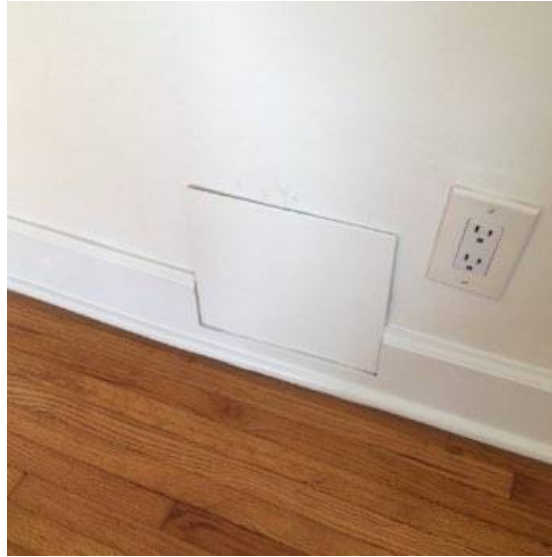
Photo 161-4 Plumbing access was sealed shut. Recommend having a qualified person repair as plumbing is easily accessible.
