Del Fine Home Inspections

Property Inspection Report

Property address: **6432 Via Canada
Rancho Palos Verdes, CA 90275**

Inspection date: **Friday, July 19, 2024**

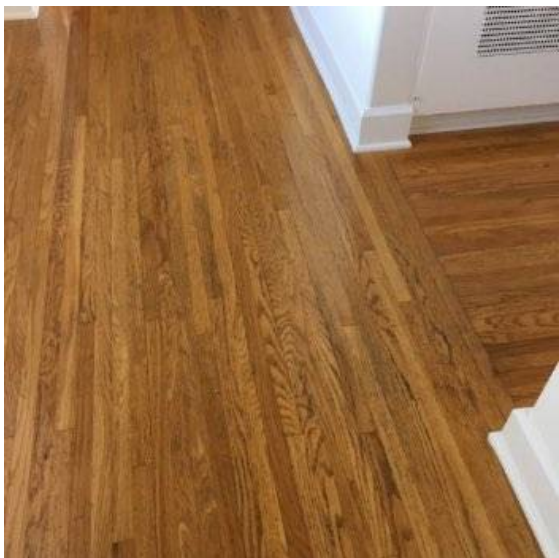
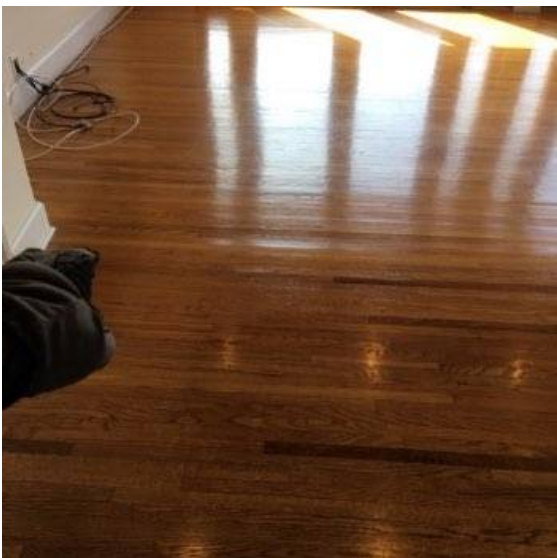
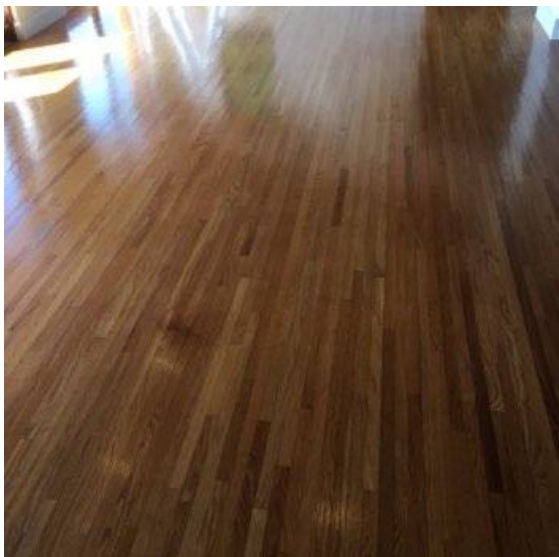
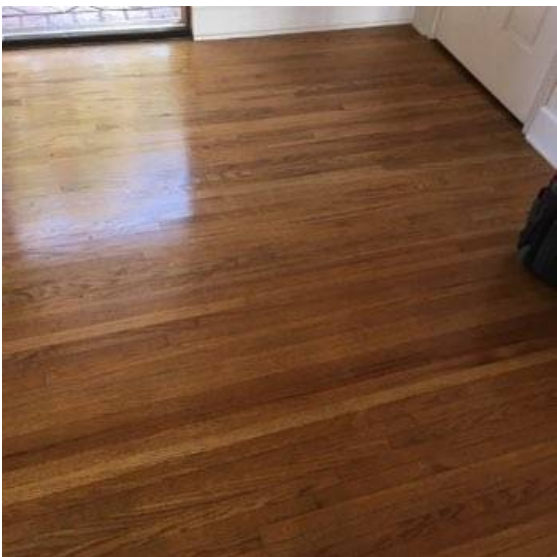
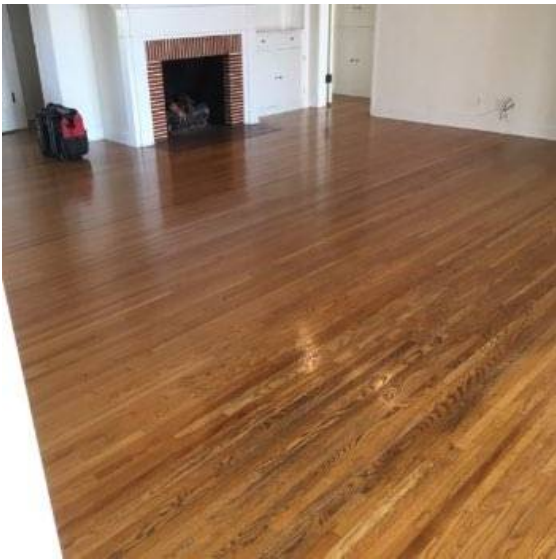
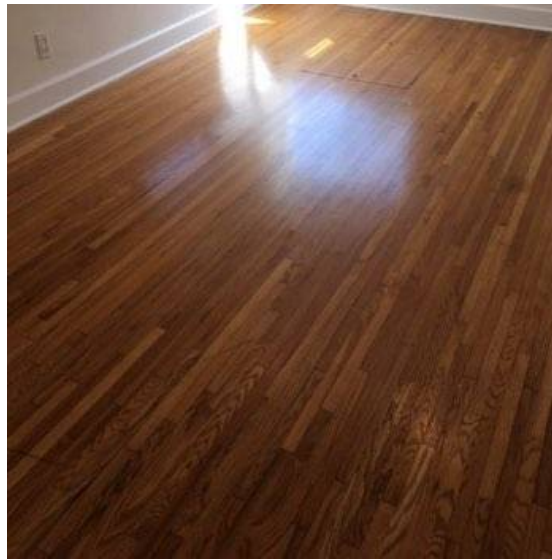
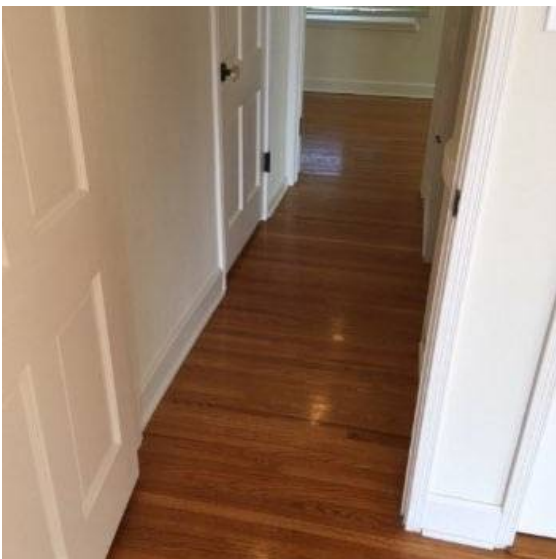
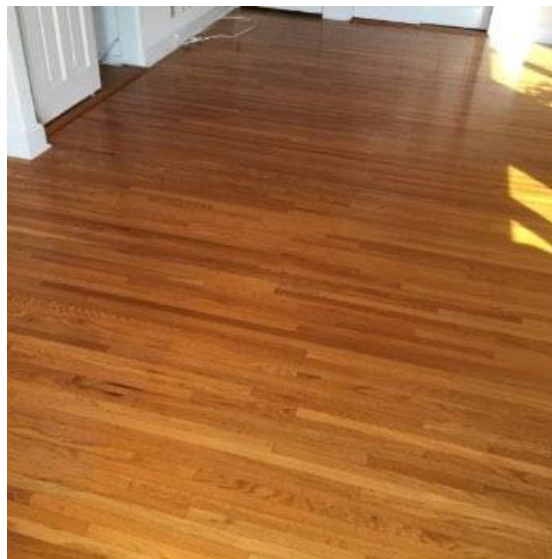
Floors in one or more areas were not level. Significant repairs may be needed to make floors level. Recommend that a qualified contractor evaluate and repair as necessary.

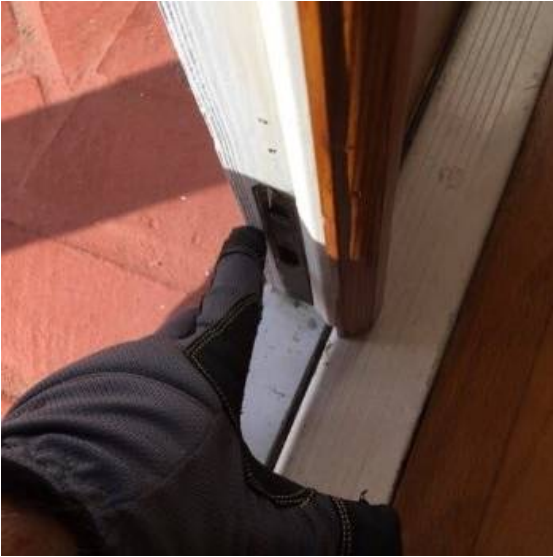
Photo 164-1

164) 🔧 One or more exterior doors were difficult to open or close and/or were difficult to latch. Recommend that a qualified person repair as necessary.

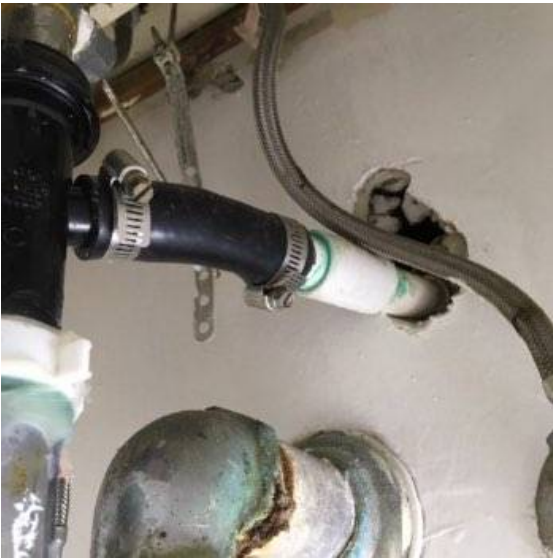
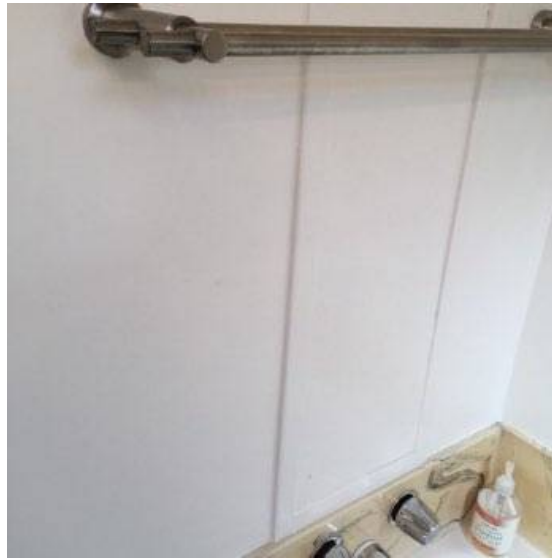
One or more walls and/or ceilings were damaged, were cracked and/or had substandard repairs. Recommend that a qualified person repair as necessary.

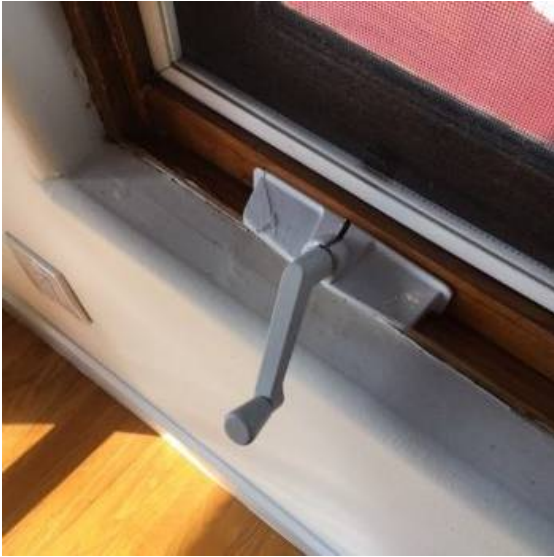
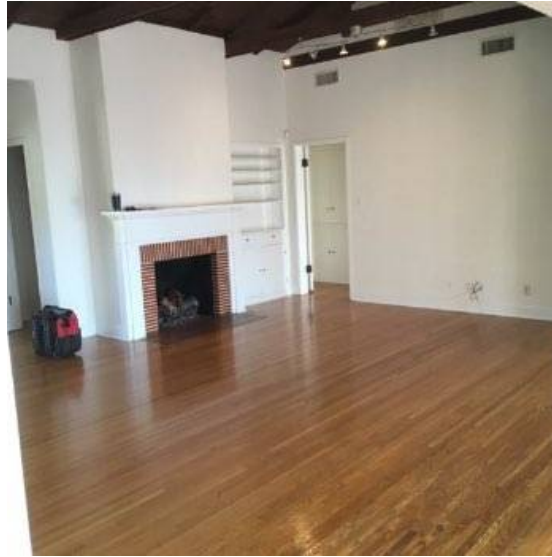
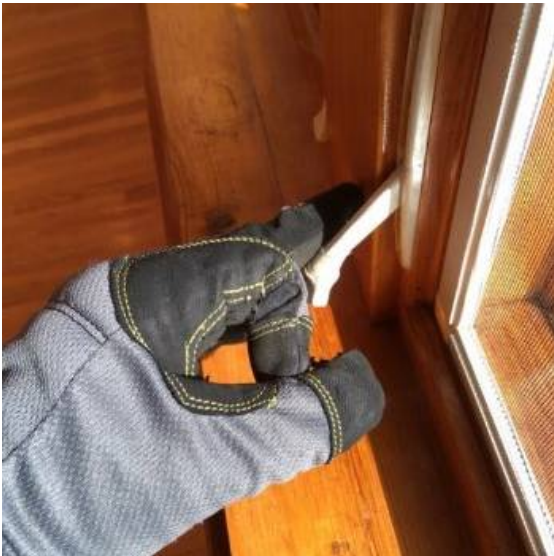
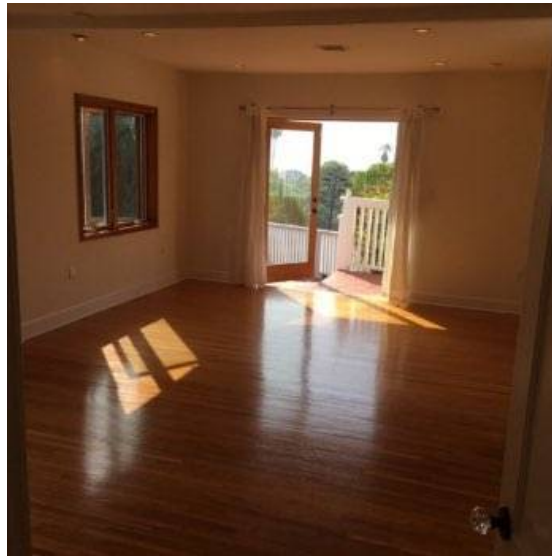
Crank handles or latches at some windows were deteriorated or damaged. Recommend that a qualified person repair as necessary.

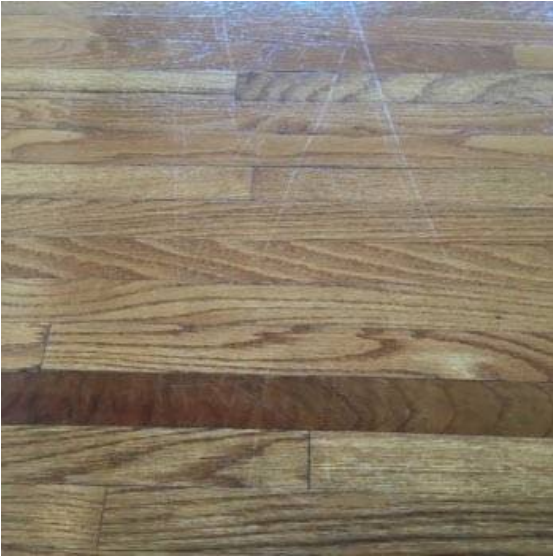
Photo 168-1

168) 🛠️ Flooring in one or more areas was blemished, worn, deteriorated or damaged. Recommend that a qualified person repair as necessary.
