## Confidential Inspection Report

LOCATED AT:  
579 Crane Blvd  
Los Angeles, California 90065

INSPECTED ON:  
Thursday, April 24, 2025

Inspector, Jerry Holt  
Brooke and Sons Inspections

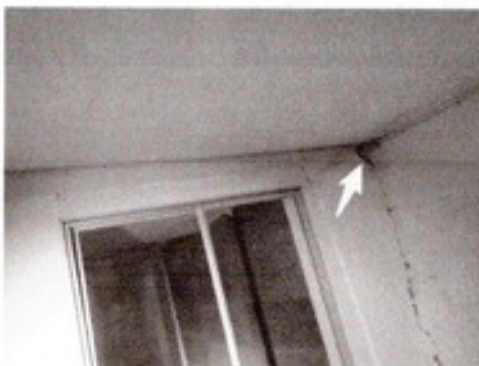
**s-50:** General water stains seen in various areas that are more than like due to previous roof leak issues. Some of the darker stains should be evaluated and tested by an environmental agency. This would determine on whether or not any special remediation procedures would need to be followed.

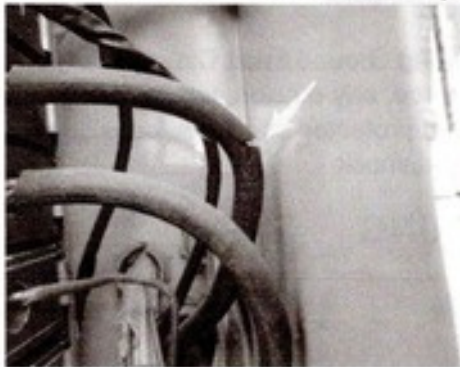
**s-90:** Action Necessary - Electrical circuitry wiring in the power panel shows some condition that calls for the immediate action of a qualified licensed electrician.

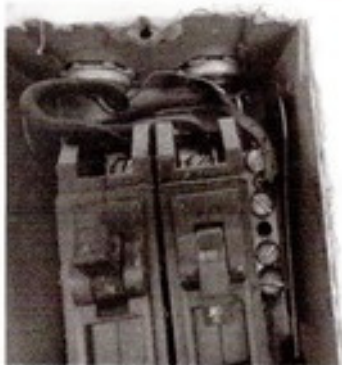
**s-96:** Attention needed: Sub panels antiqued. Upgrades needed.

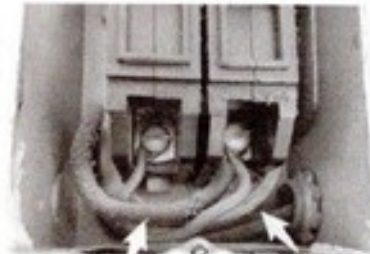
**s-98:** Attention needed: It looks as though that some of the wiring is of the older cloth insulation. This type of insulation wears and breaks off with age. Most electricians in the industry will recommend upgrades to newer plastic insulated conductors for safety reasons. We recommend that a qualified licensed and insured contractor do further inspection and evaluation of any cloth covered wiring.

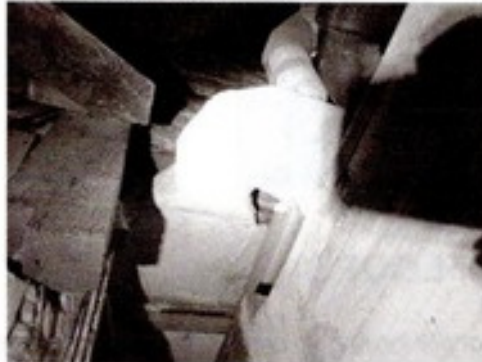
**s-128:** The original duct work that appears to be of asbestos product that is compromised and or in poor condition . Further testing and removal needed.

You need to be aware that some buyers are concerned about asbestos materials in relation to health considerations as well as cost to remove the materials should conditions of the materials or remodeling call for it. Further information can be obtained by environmental agency.

Contact a qualified asbestos abatement agency for further evaluation

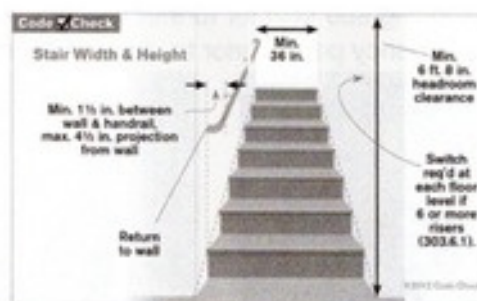
**s-160:** Attention: Stairway width not to today's standards. Further evaluation by licensed general contractor.

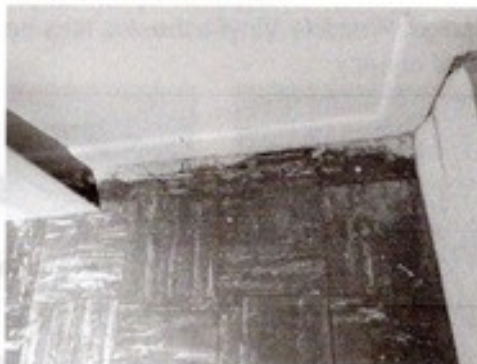
**s-189:** Horizontal cracks were noted in at least one exterior wall.

**s-191:** These conditions warrant further investigation by a Professional Engineer or qualified licensed foundation contractor. Seek bids to remedy the condition from at least three (3) Licensed Professional Foundation Contractors.

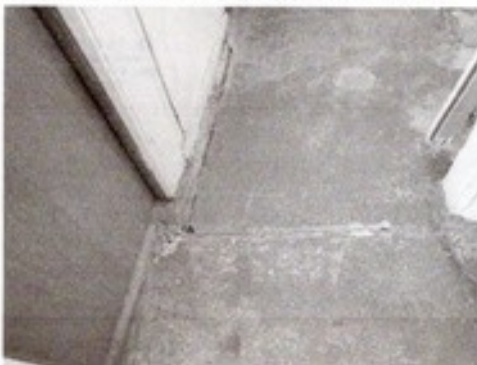
**s-192:** Uneven areas of sub floor noted. These uneven areas warrant further investigation by a licensed foundation contractor. Make arrangements with seller or pertinent party to have floor covering removed exposing sub slab for further viewing. All further investigations should be done during inspection contingency period prior to close of escrow or transfer of title.

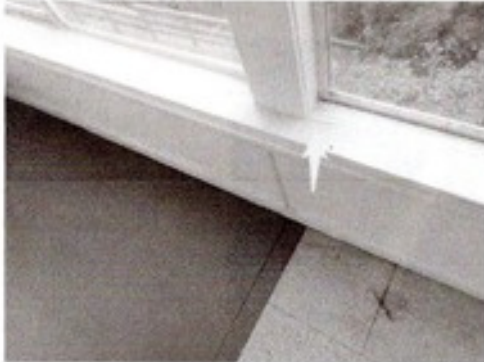
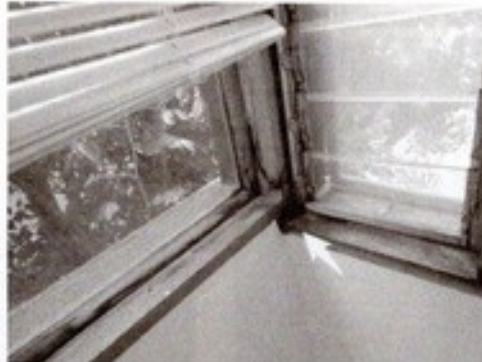
**42:** Attention needed: There is evidence of leakage. There is wet trim noted from the interior of the wall cavity.

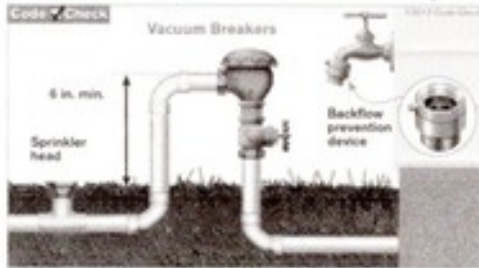
**59:** There are no backflow preventer valves installed. Under current standards, backflow preventer valves are required. It would be a good investment to have them installed.

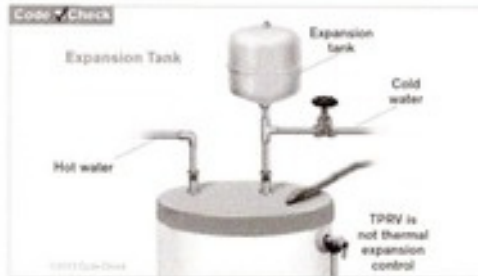
**68:** The 2012 International Residential Code (P2903.4.2) requires the installation of an expansion tank on a hot water tank where thermal expansion may cause an increase in pressure. The tank or device shall be sized in accordance with the manufacturer's recommendation.

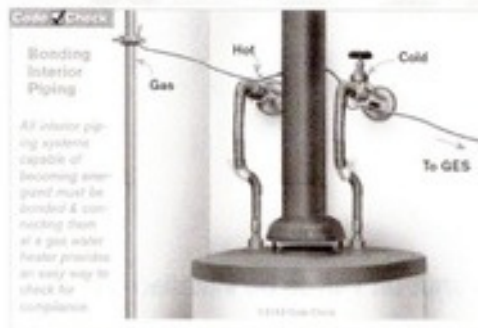
**72:** The water piping is not bonded to the electrical system ground which is now standard practice. The water heater is an easy location to accomplish this. We recommend the hot and cold supply connections be bonded to the electrical system ground.

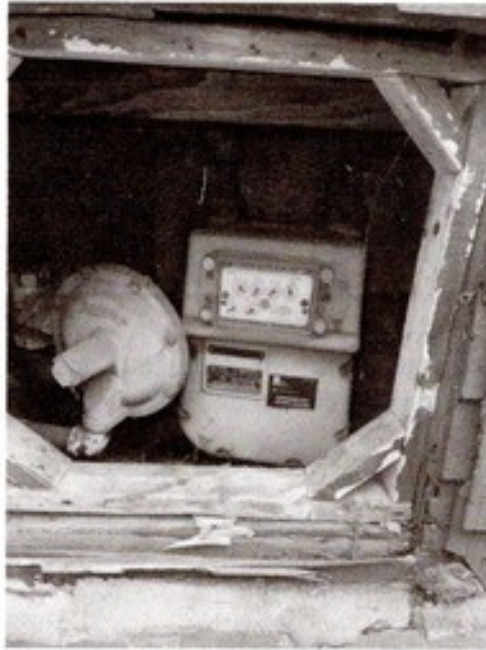
**78:** Right side

**79:** An automatic seismic gas shut off valve is not installed  
Los Angeles City Ordinance 174478 requires that seismic gas shut-off valves be installed on designated buildings within the City. Seismic gas shut-off valves are designed to automatically shut off the supply of natural gas to a building to prevent a fire or explosion due to accumulation of gas in the building in the event of a major earthquake.

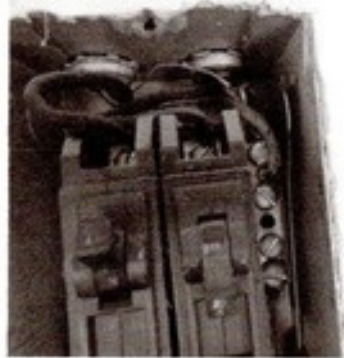
**96:** Attention needed: Sub panels antiqued. Upgrades needed.

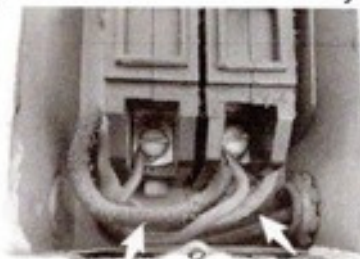
**98:** Attention needed: It looks as though that some of the wiring is of the older cloth insulation. This type of insulation wears and breaks off with age. Most electricians in the industry will recommend upgrades to newer plastic insulated conductors for safety reasons. We recommend that a qualified licensed and insured contractor do further inspection and evaluation of any cloth covered wiring.

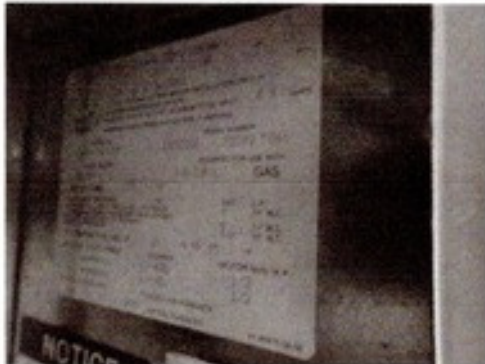
**111:** 33 years old 50,000btu natural gas fired. The typical service life for a forced air natural gas furnace is 18 - 20 years.

**112:** Furnace is an older unit that has a very limited service life.

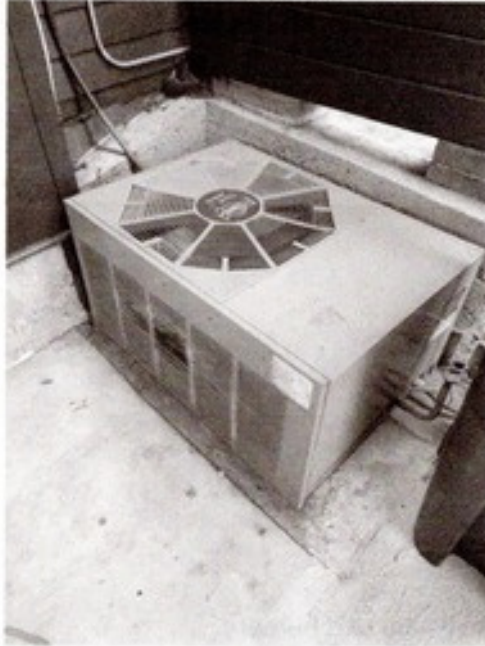
120: Condenser unit Location- carport

121: 32 years old, 3 ton. The typical service life for an AC unit is 12 - 15 years.  
Each ton provides conditioning for approximately 500-600 square feet of area.

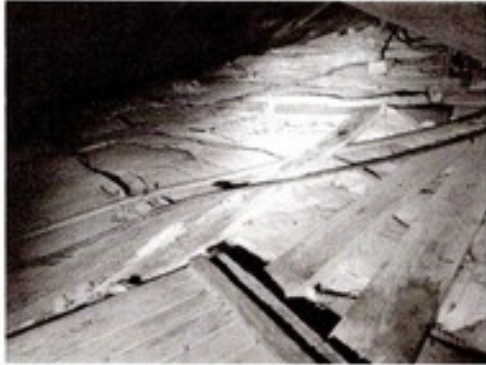
**144:** Attention Needed - The attic insulation appears not to be correctly installed or needs attention. Paper exposed on insulation is not to industry standards. Manufactures Installation instructions requires paper to be covered by a non combustible material such as sheetrock or using insulation with non flammable backing..

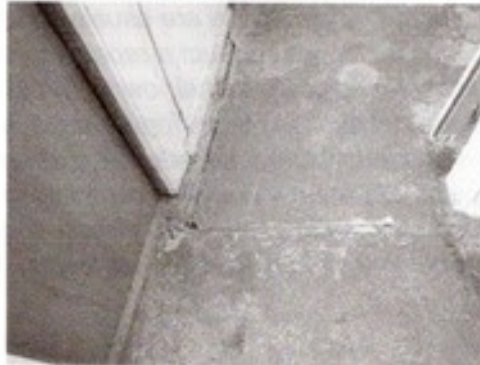
**157:** Unsatisfactory- Flooring is deteriorated throughout. Extensive repairs will be needed. Contact a licensed contractor for further evaluation as to extent of damage as well as cost.

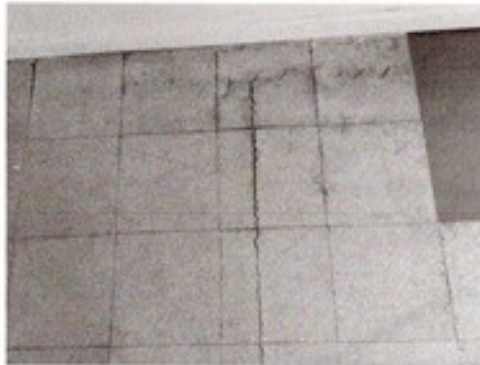
**159:** Attention needed: Possible Vinyl asbestos tiles noted in areas. Further evaluation by licensed environmental agency.

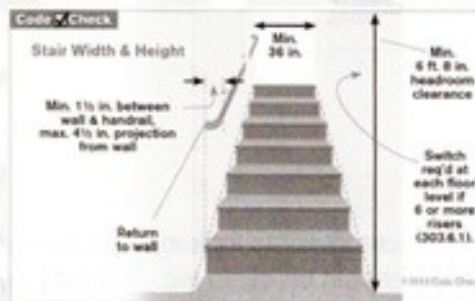
**160:** Attention: Stairway width not to today's standards. Further evaluation by licensed general contractor.

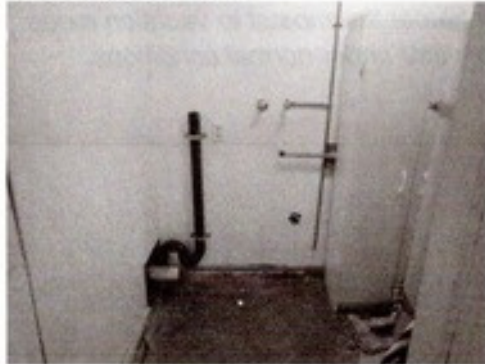
173: Laundry room

174: This laundry room does not have a Ground Fault Circuit Interrupt outlet installed. The age of the structure may predate the required installation. However, for safety considerations, it is strongly suggested that one be installed at any location within 6 feet of a water source.

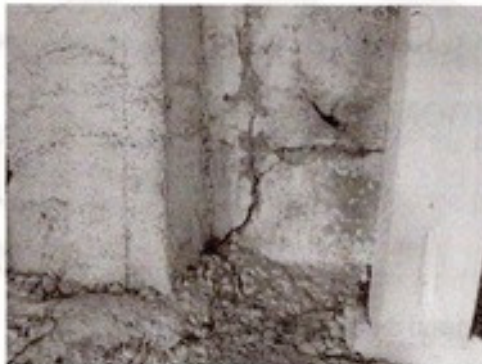
**192:** Uneven areas of sub floor noted. These uneven areas warrant further investigation by a licensed foundation contractor. Make arrangements with seller or pertinent party to have floor covering removed exposing sub slab for further viewing. All further investigations should be done during inspection contingency period prior to close of escrow or transfer of title.

**193:** Significant cracks were noted that warrant further inspection by a licensed foundation expert or licensed structural engineer.

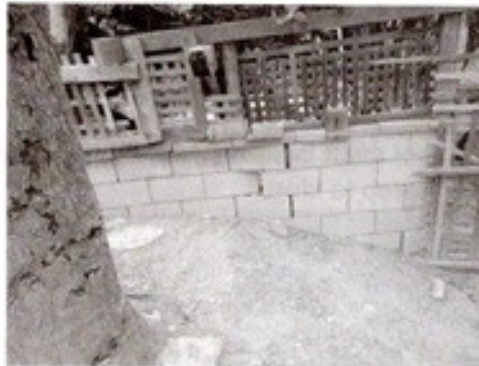
**204:** Attention Needed - The fencing needs to be repaired.

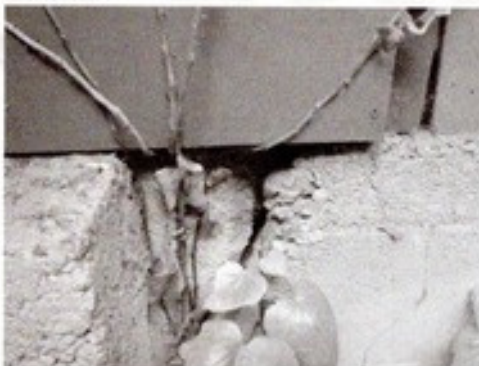
**207:** Attention needed: The retaining wall requires some repair or replacement which is due either to movement or deteriorated materials.

Further evaluation by licensed masonry contractor.

**208:** A qualified licensed and insured engineer or licensed and insured masonry contractor should be contacted for further evaluation to determine extent of damage as well as cost of repairs.
