HENRY
HOME
INSPECTIONS LLC

Inspection Report

4924 Shelby Lane, Clearlake, California 95422

AP-381-001786

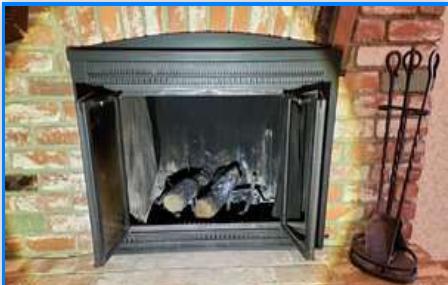
Location: LIVING ROOM

7.1.1 Wood burner/pellet/fireplace inspection

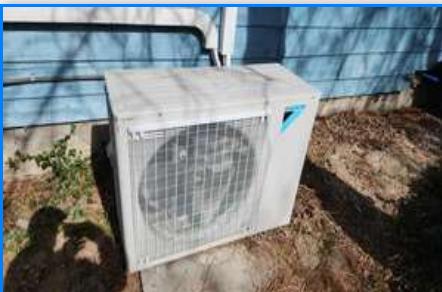
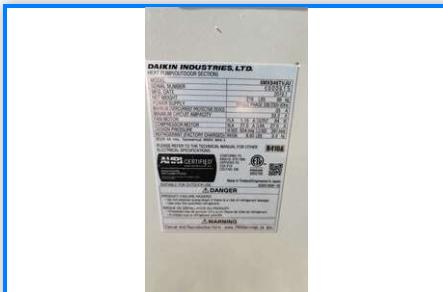
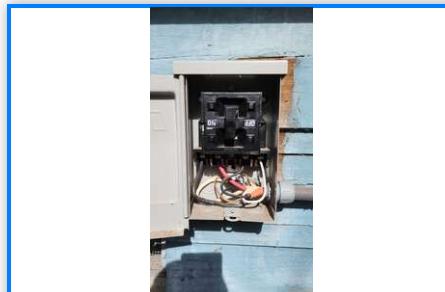
Service is recommended on all HVAC units unless recent service records are available.

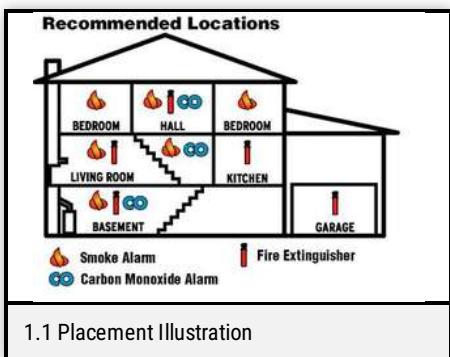
1.1 Placement Illustration

Smoke alarms were missing in one or more locations. Smoke alarms should be replaced as necessary and installed per standard building practices (e.g. in hallways leading to bedrooms, in each bedroom, on each floor). We recommend installing photoelectric type smoke detectors / alarms. Note: Homes built prior to 1992 were not required to have smoke detectors installed in each bedroom, only hallways. Regardless, calfire.ca.gov recommends installing smoke detectors in each bedroom for increased safety.

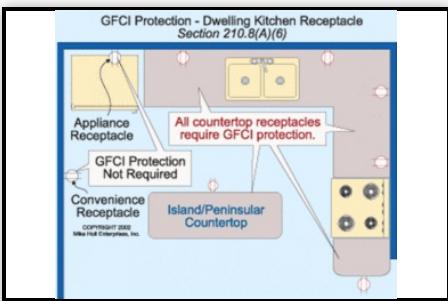
1.1 GFCI placement illustration

GFCI outlets were not installed located within 6 feet of a plumbing fixture or on kitchen counters. The Inspector recommends upgrading to GFCI protected outlets as a safety precaution.
