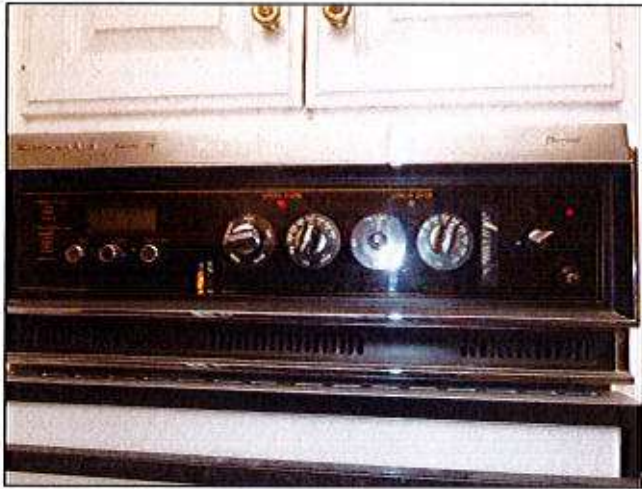
17.14 Item 1 (Picture)

(2) The gas was turned off to the stove top, suggest review with the seller and the gas company as needed.

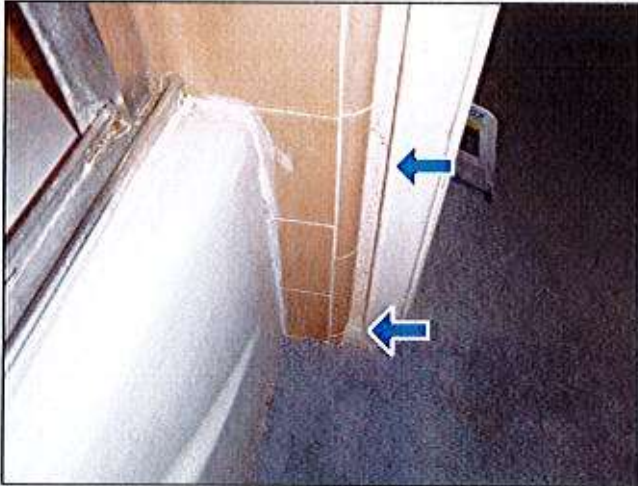
18.1 Item 1 (Picture)

Deteriorated wall & trim around the shower door/screen area, this is probably due to water splashing/leaking from shower area. This area tested dry at the time of the inspection. Suggest repair/replace as needed.

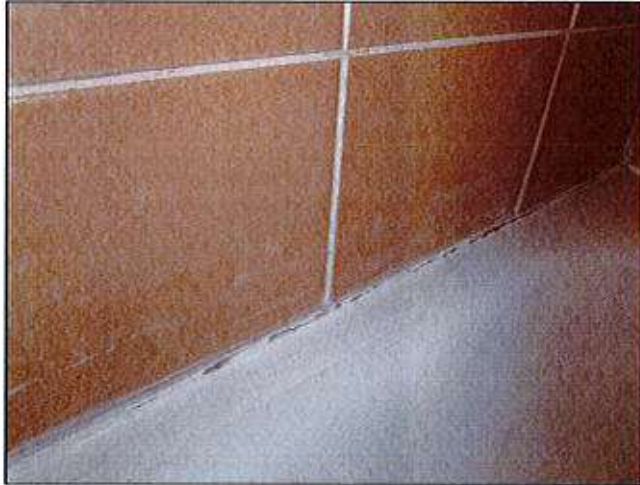
18.9 Item 1 (Picture)

Suggest caulking or re-grout as needed. The edges of the tub walls should be caulked to prevent moisture penetration. Failure to keep walls sealed can cause deterioration and extensive moisture damage to the interior walls, which is not always visible.

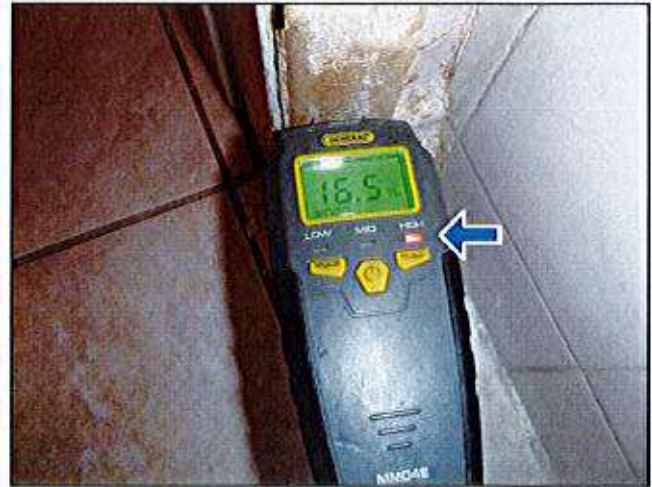
19.1 Item 2 (Picture)

(1) Wet and deteriorated wall & trim around the shower door/screen area. This area tested positive for moisture at time of the inspection. Unable to determine the cause of the moisture, suggest review by a licensed contractor to determine the cause of the moisture and for removal/repair/replacement costs as needed.

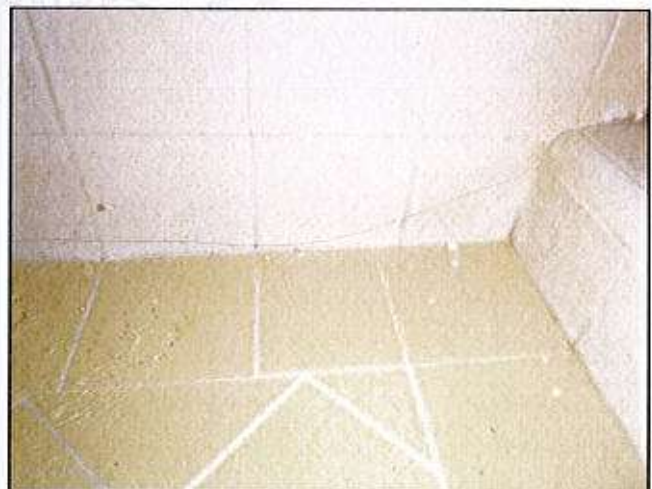
19.6 Item 2 (Picture)

Cracked tiles noted at the shower area, suggest review with a licensed contractor for repair/replacement costs as needed.

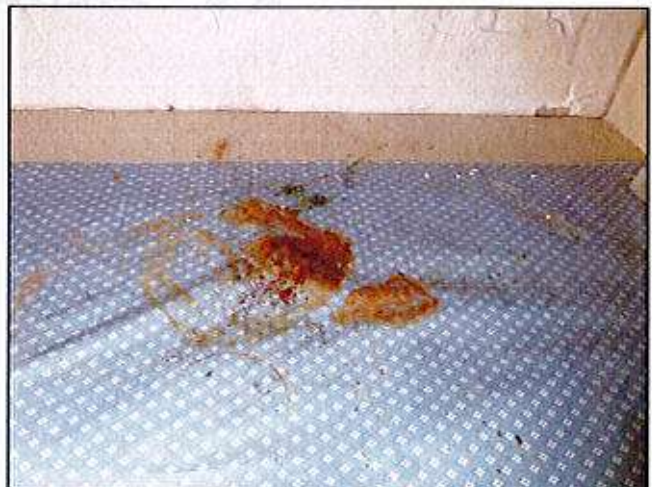
19.10 Item 2 (Picture)

Excessive corrosion noted at the sink drain, see the main sewer/waste system comments and review with a licensed plumber and repair/replace as needed.

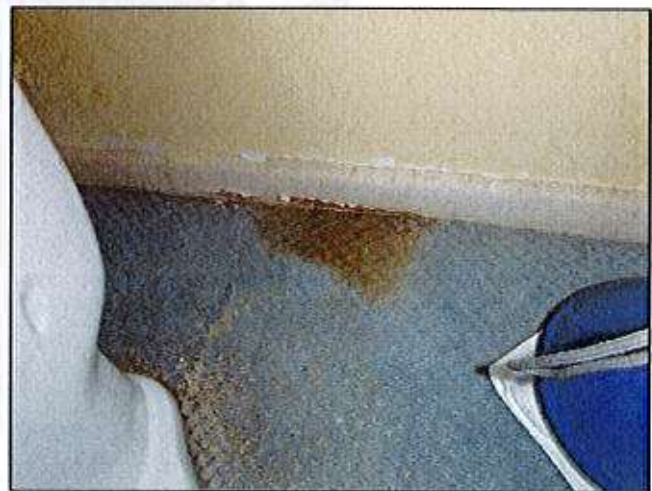
20.0 Item 2 (Picture)

Soft areas of the flooring were noted, suggest review with a licensed contractor for removal/repair/replacement costs as needed.

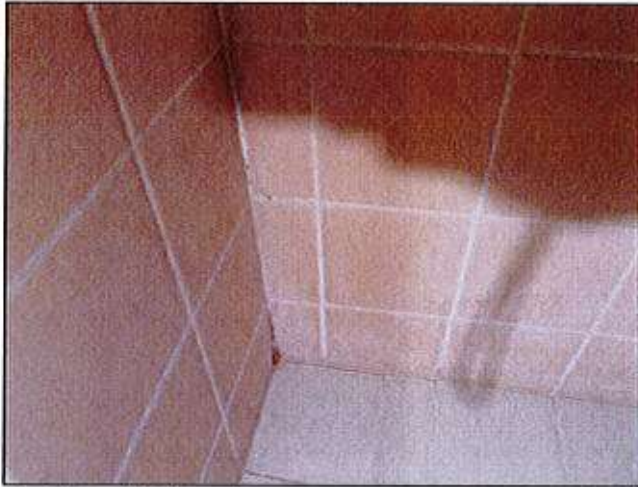
20.8 Item 1 (Picture)

(1) Worn/missing grout noted at the shower base tiles, suggest maintenance/repair/replace as needed.

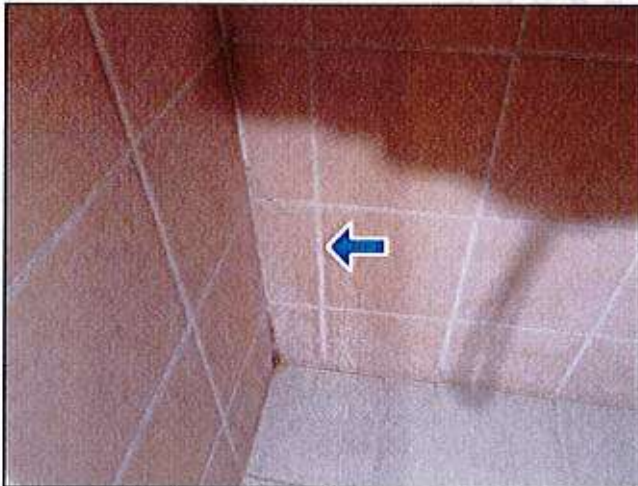
20.8 Item 2 (Picture)

(2) Cracked tiles noted at the shower area, suggest review with a licensed contractor for repair/replacement costs as needed.

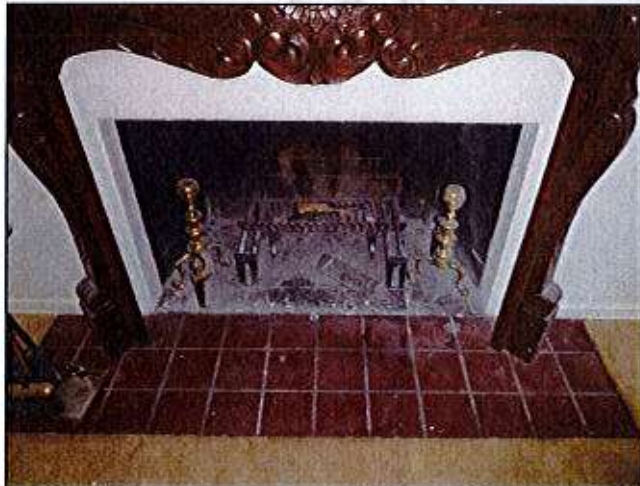
22.6 Item 2 (Picture)

(2) Excessive creosote noted within the firebox, smoke chamber or chimney areas. Creosote build-up can cause chimney fires if not removed from voids, open seams or open mortar joints within the fireplace and chimney. This inspection is a 'Level 1' inspection and is limited to visible and accessible areas only. 'Level 2' and 'Level 3' inspections are invasive inspections performed by qualified personnel only with equipment designed for fireplace/chimney inspections, cleaning or repairs. Suggest periodic cleaning of the fireplace/chimney and remove the creosote and debris within the fireplace and chimney. Suggest review by a professional chimney sweep for estimates, repairs or cleaning.

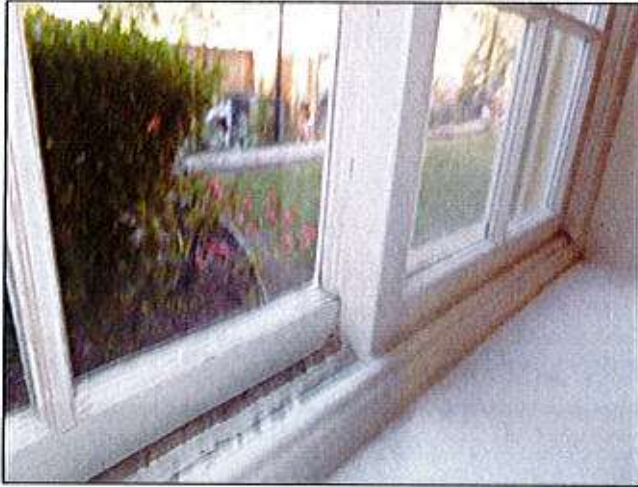
24.4 Item 1 (Picture)

The wood trim/frames are peeling paint at various windows, further deterioration may occur if not repaired. Suggest review by a licensed contractor and repair/replace as needed.

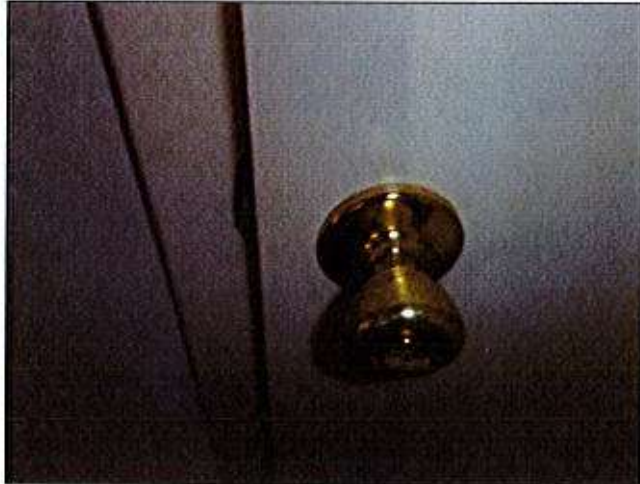
28.3 Item 1 (Picture)

The door will not close and latch correctly, suggest repair as needed.

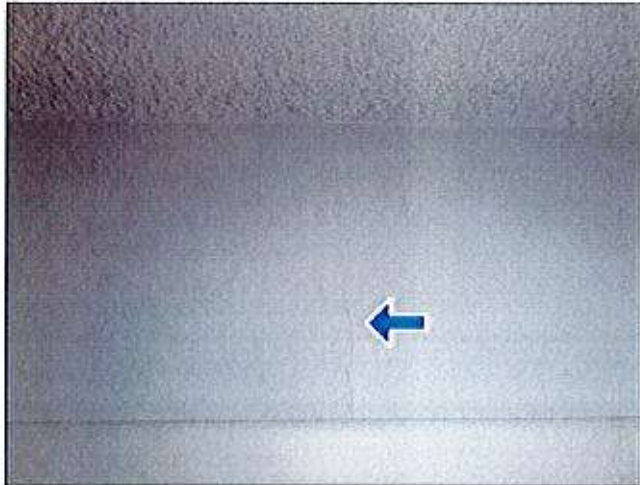
29.1 Item 1 (Picture)

- (1) See the door comments and repair as needed.
- (2) Settling cracks and patching was noted, suggest repair as needed.

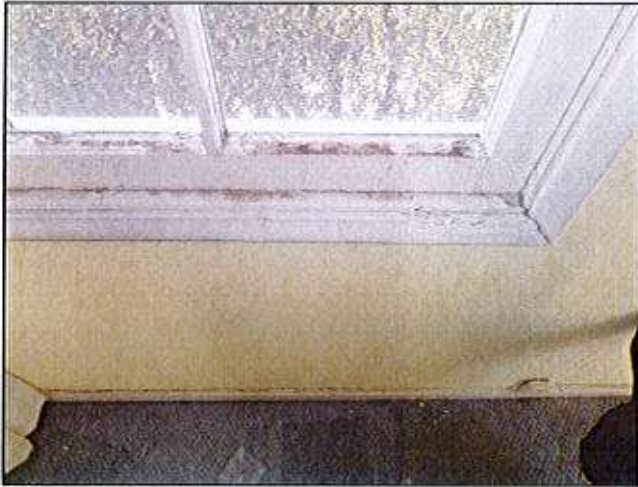
31.4 Item 1 (Picture)

The wood trim/frames are excessively peeling paint at various windows, further deterioration may occur if not repaired. Suggest review by a licensed contractor and repair/replace as needed.

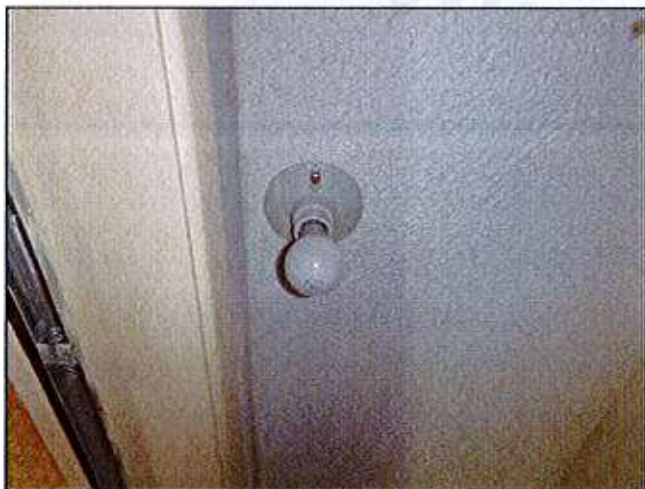
31.6 Item 2 (Picture)

(2) Various light fixtures were inoperable, possible bulbs out. Suggest replacing the bulbs as needed.
