Del Fine Home Inspections

Property Inspection Report

Property address: **1936 Homeworth Dr
Rancho Palos Verdes, CA 90275**

Inspection date: **Wednesday, November 19, 2025**

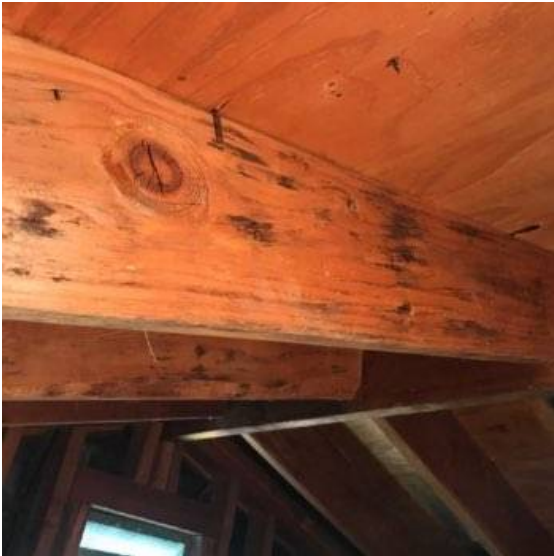
Photo 2-1

2) **🔍** Microbial growths were found at one or more locations in the attic. It is beyond the scope of this inspection to identify what substance or organism this staining is. However such staining is normally caused by excessively moist conditions, which in turn can be caused by plumbing or building envelope leaks and/or substandard ventilation. These conducive conditions should be corrected before making any attempts to remove or correct the staining. Normally affected materials such as drywall are removed, enclosed affected spaces are allowed to dry thoroughly, a mildewcide may be applied, and only then is drywall reinstalled. For evaluation and possible mitigation, consult with a qualified industrial hygienist or mold/moisture mitigation specialist. For more information, visit:

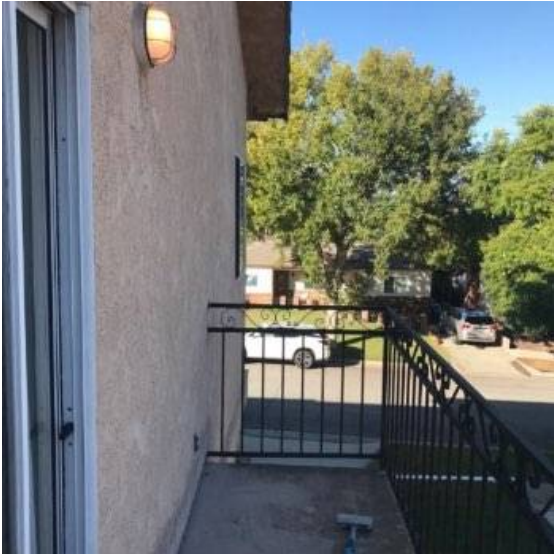
Photo 7-1

Guardrails at one or more locations with drop-offs higher than 30 inches had gaps that were too large. This poses a safety hazard for children (e.g. falling, getting stuck in railing). Guardrails should not have gaps or voids that allow passage of a sphere equal to or greater than 4 inches in diameter, or 6 inches in diameter at triangular spaces between stair edges and guardrails. At a minimum, the client should be aware of this hazard. Recommend that a qualified contractor repair or replace guardrails per standard building practices.

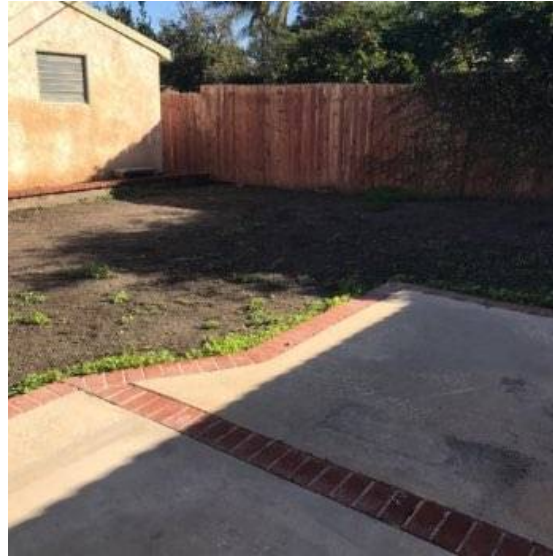
Significant amounts of standing water or evidence of past accumulated water were found at one or more locations in the yard or landscaped areas, and no drain was visible. If evidence of past water was found (e.g. silt accumulation or staining), monitor these areas in the future during periods of heavy rain. If standing water exists, recommend that a qualified person repair as necessary. For example, installing one or more drains, or grading soil.

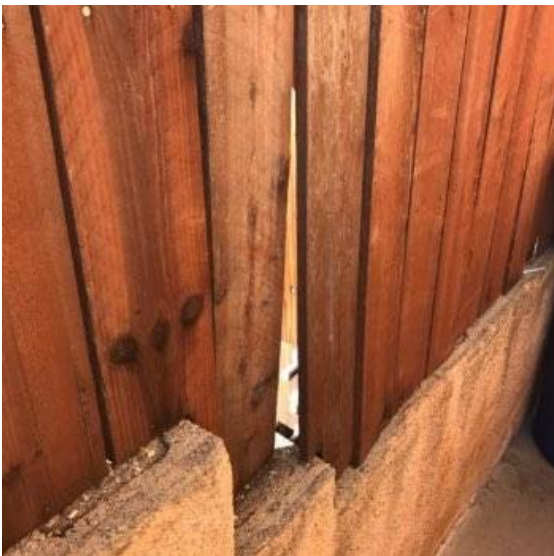
Photo 13-1

13) 🛠️ One or more fences and/or gates were damaged or deteriorated and need repair.

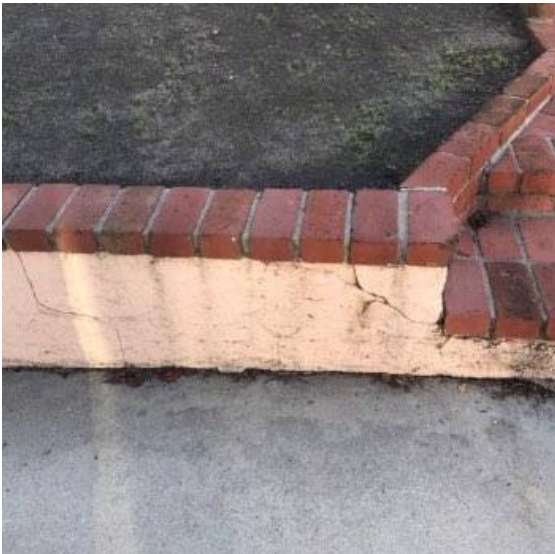
Photo 14-2

14) 🛠️ Cracks and/or deterioration were found in one or more walls. Recommend that a qualified person repair as necessary.

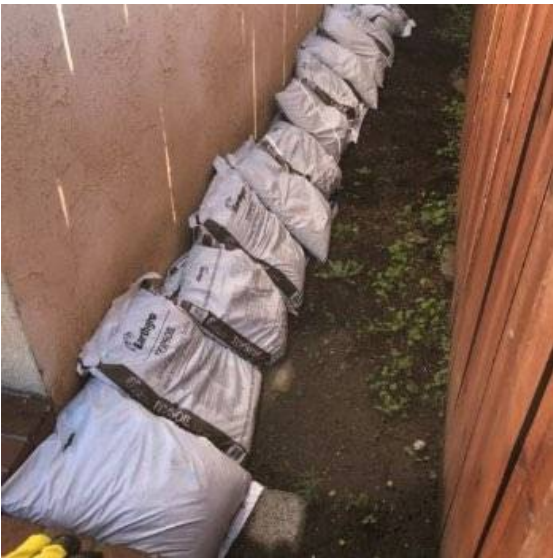
Photo 15-1

The soil or grading sloped down towards building perimeters in one or more areas. This can result in water accumulating around building foundations or underneath buildings. It can be a conducive condition for wood-destroying organisms. Recommend grading soil so it slopes down and away from buildings with a slope of at least 1 inch per horizontal foot for at least 6 feet out from buildings.

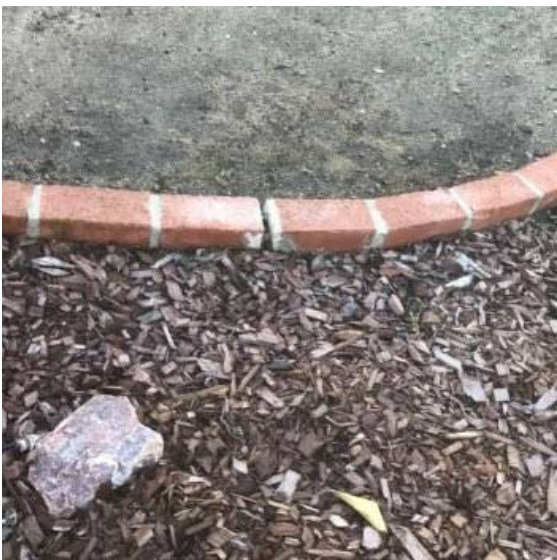
Photo 16-2

One or more planters were damaged or deteriorated. Recommend that a qualified person remove, repair or replace planters as necessary.

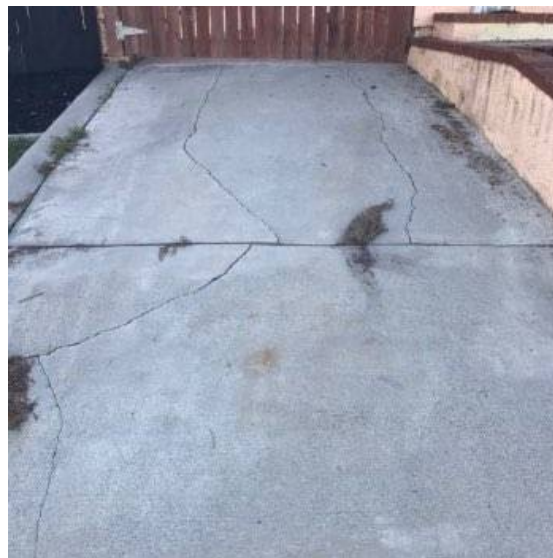
Photo 17-2

Cracks, holes, settlement, heaving and/or deterioration were found in the driveway. Recommend that qualified contractor repair as necessary.

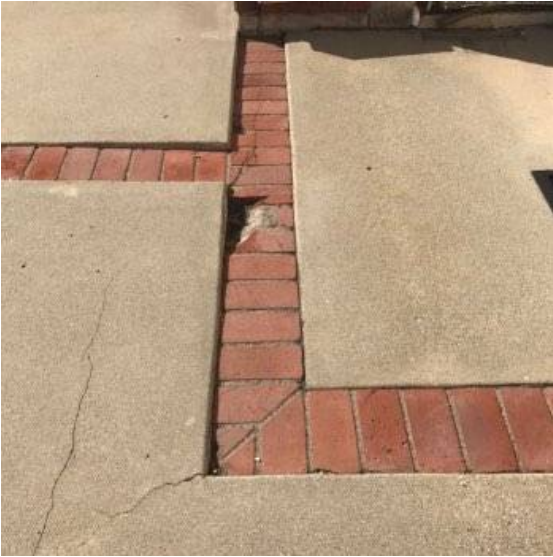
Photo 18-3

18) 🛠️ Cracks, holes, settlement, heaving and/or deterioration were found in sidewalks and/or patios. Recommend that qualified contractor repair as necessary.

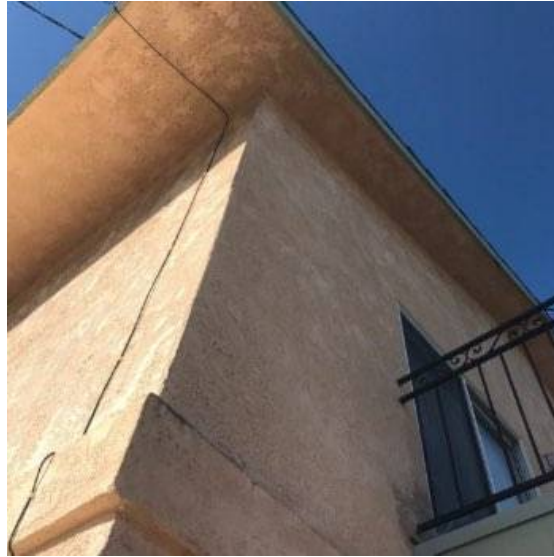
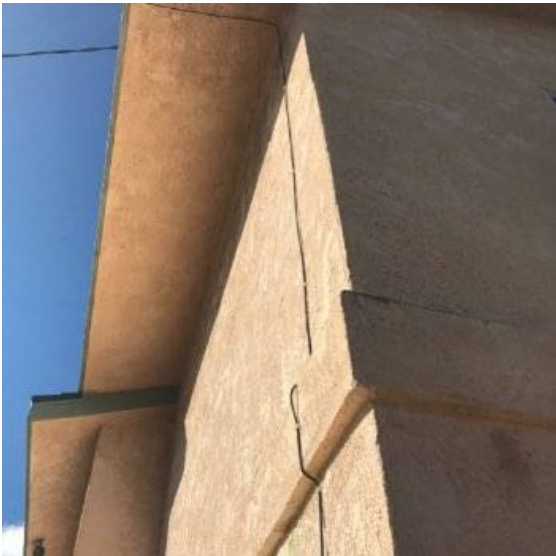
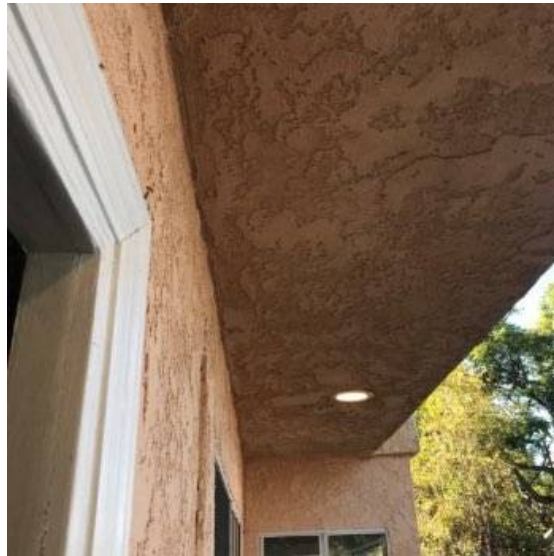
25) 🔧🔍 One or more soffits, pop-outs or cantilevered sections of the exterior were not vented. This may result in moisture accumulation. This is a conducive condition for wood-destroying organisms. Recommend that a qualified contractor evaluate and repair as necessary.

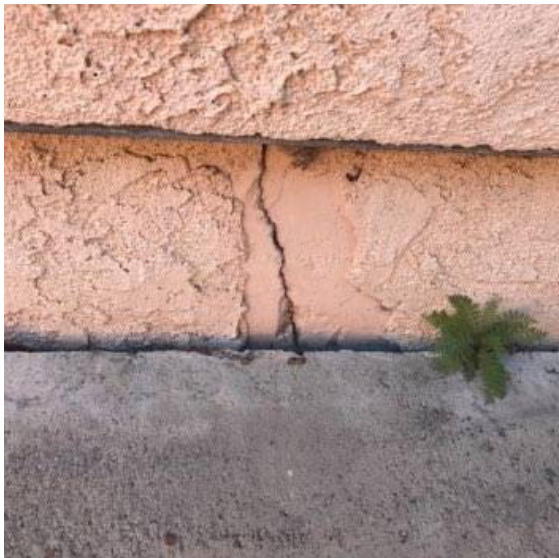
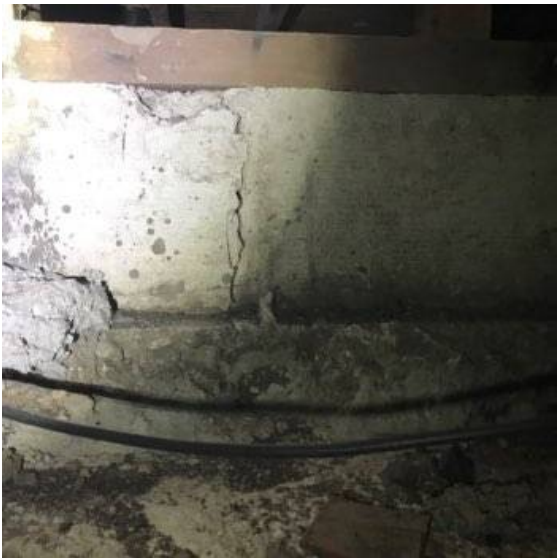
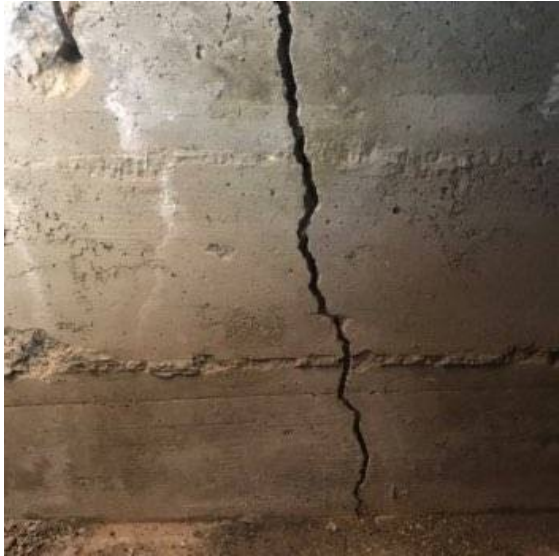
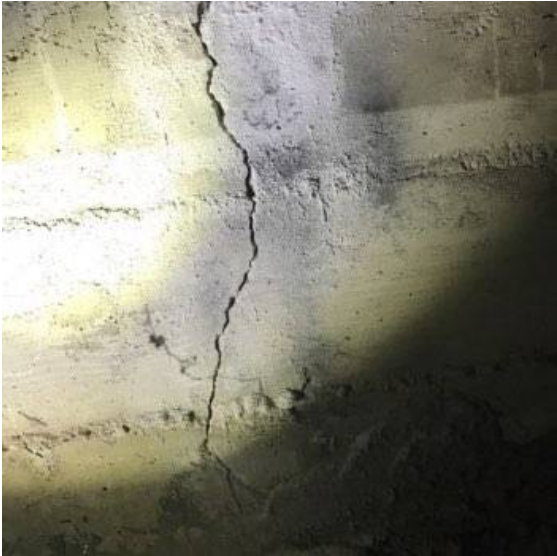
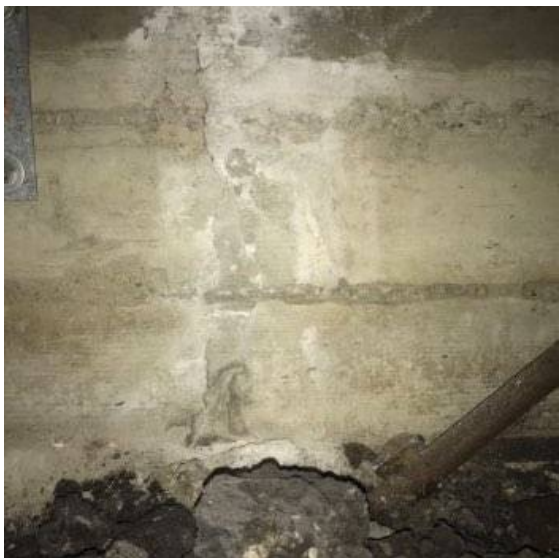
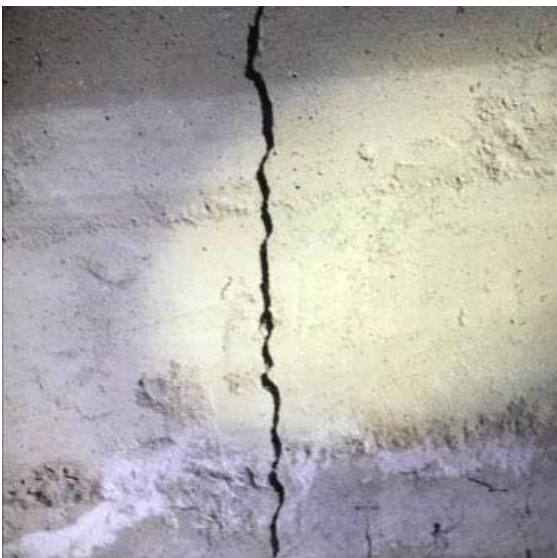
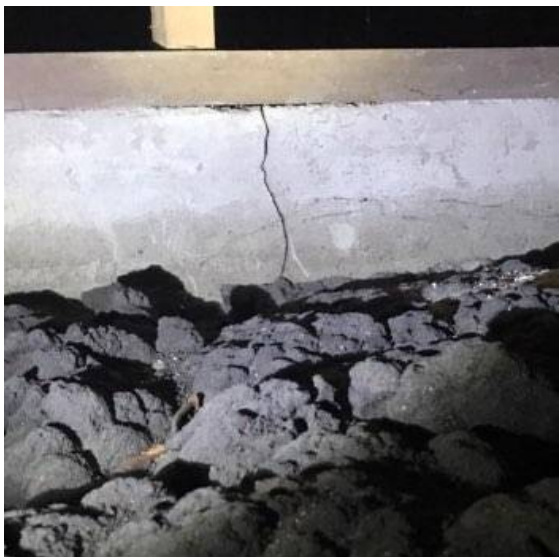
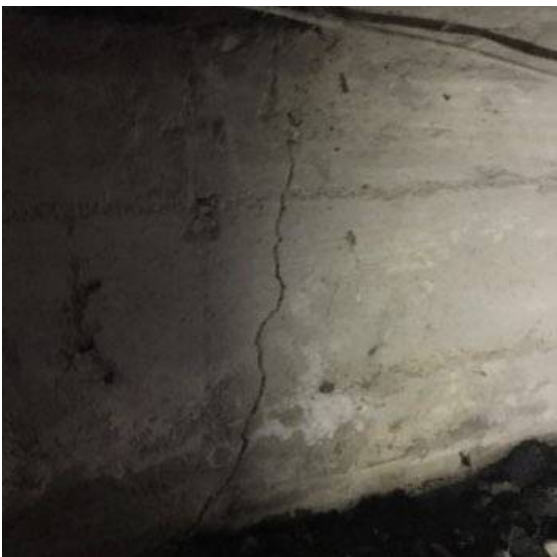
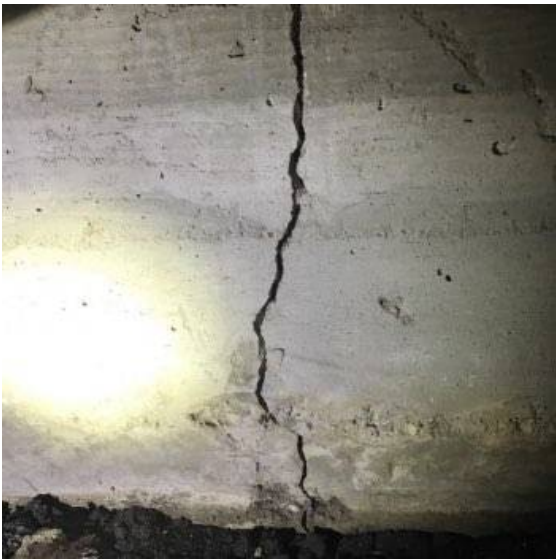
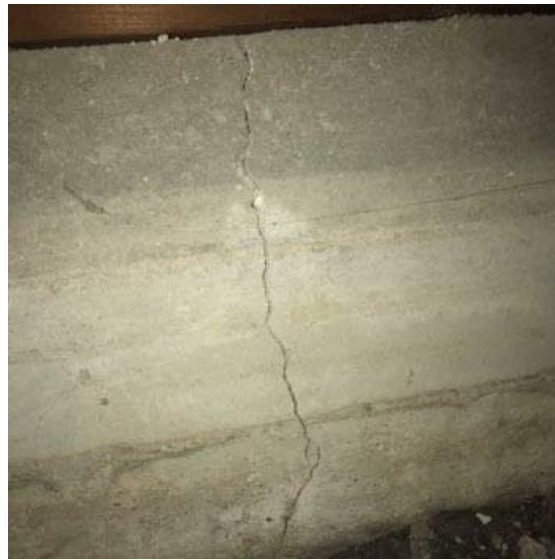
One or more cracks (1/8 inch - 1/4 inch) were found in the foundation. Recommend a qualified contractor evaluate and repair as necessary.

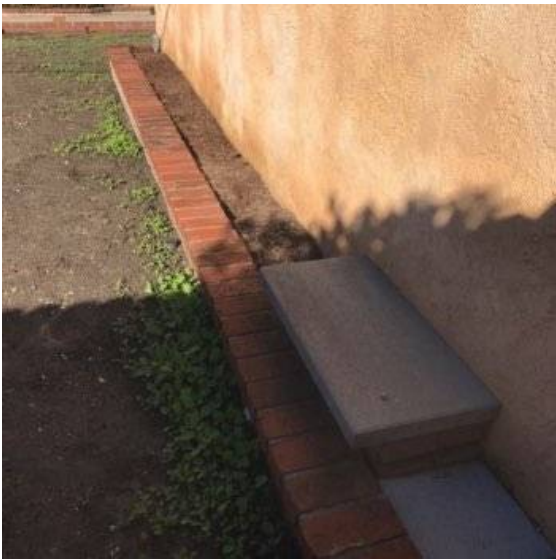
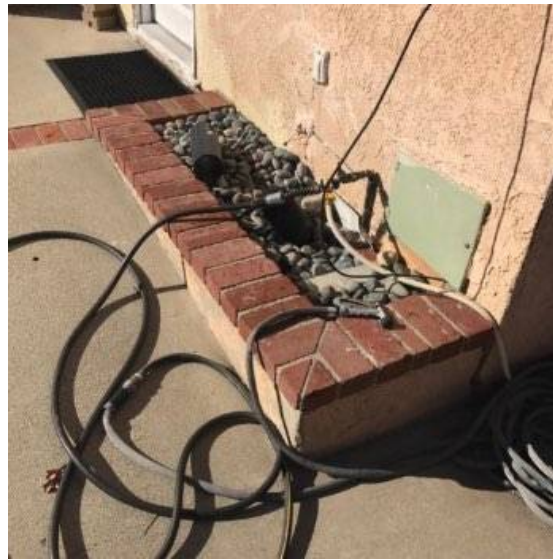
28) 🛠️ One or more planters were attached to the building exterior. This can result in high levels of moisture at the building exterior near planters. It is a conducive condition for wood-destroying organisms. Recommend removing planters, or repairing so there is a gap of at least 2 inches between planters and the building exterior for better airflow and to allow building exteriors to dry quickly.

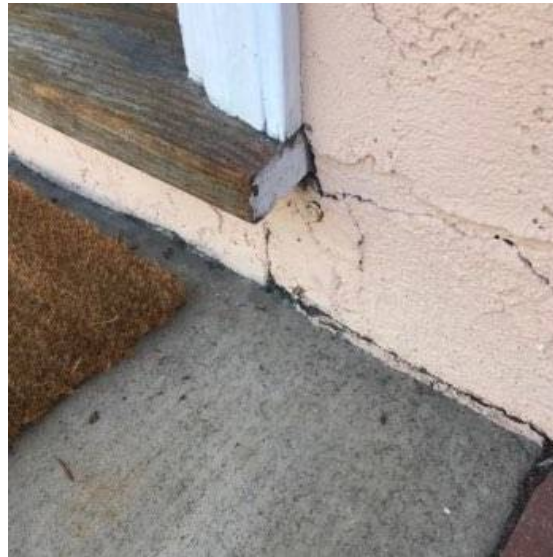
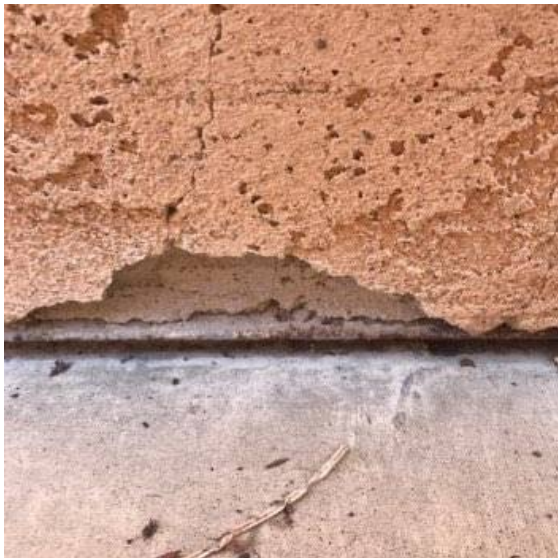
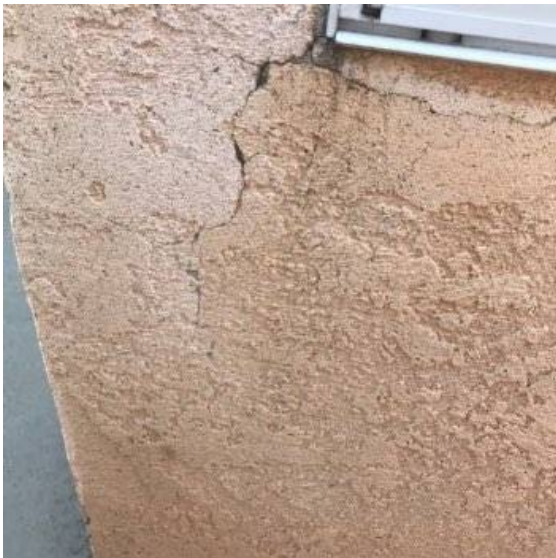
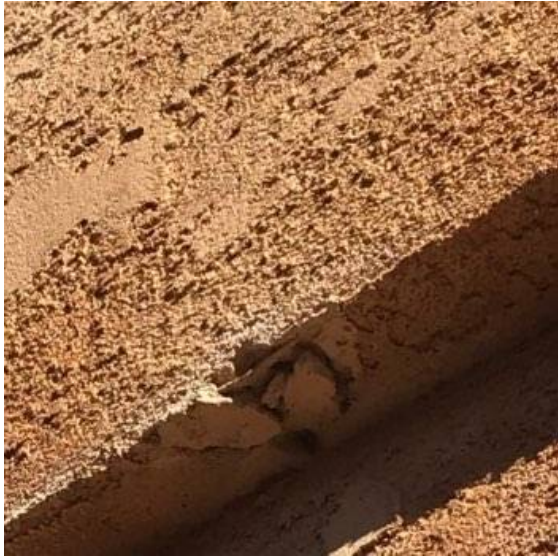
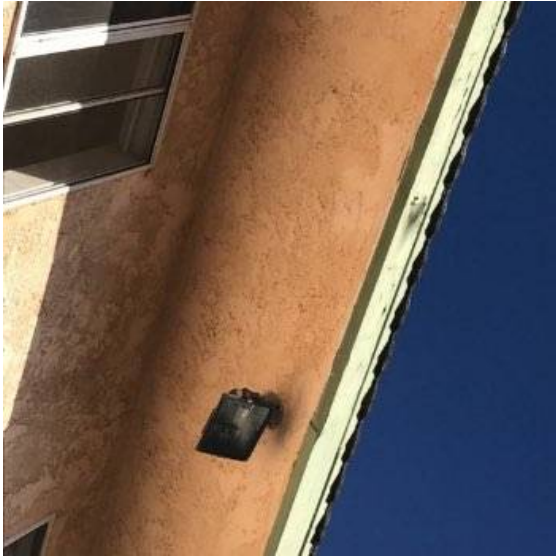
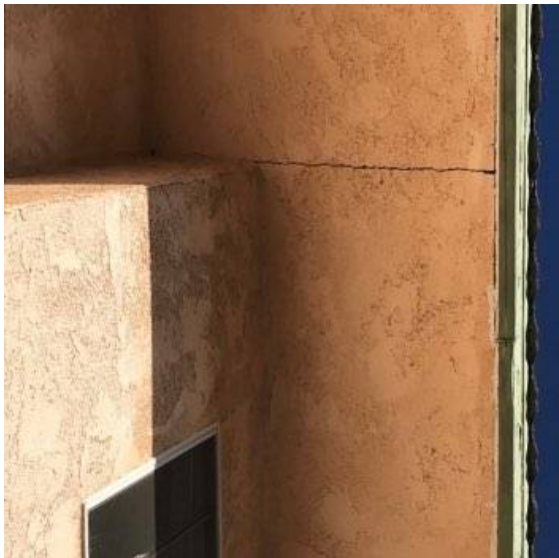
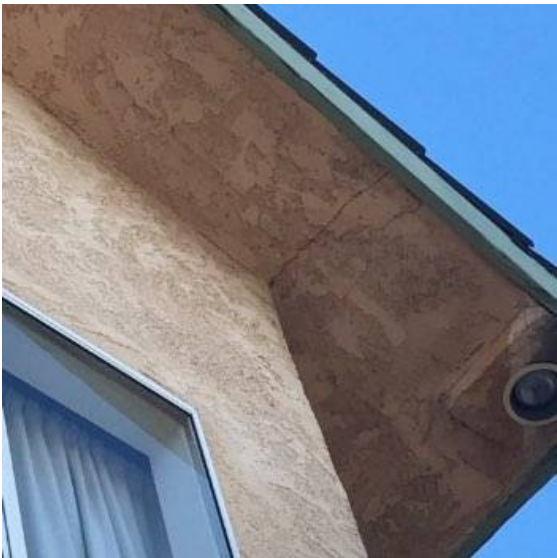
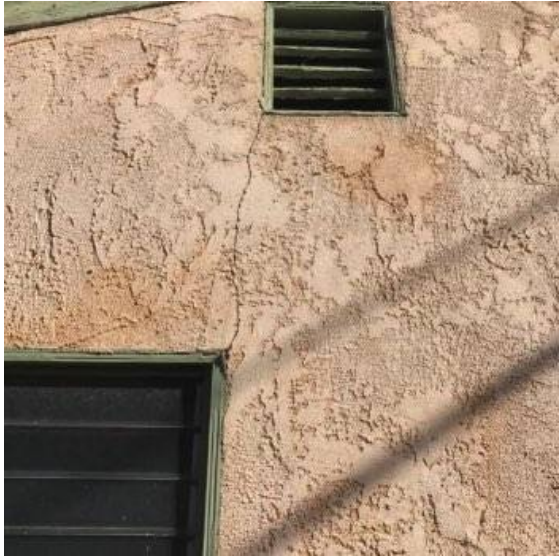
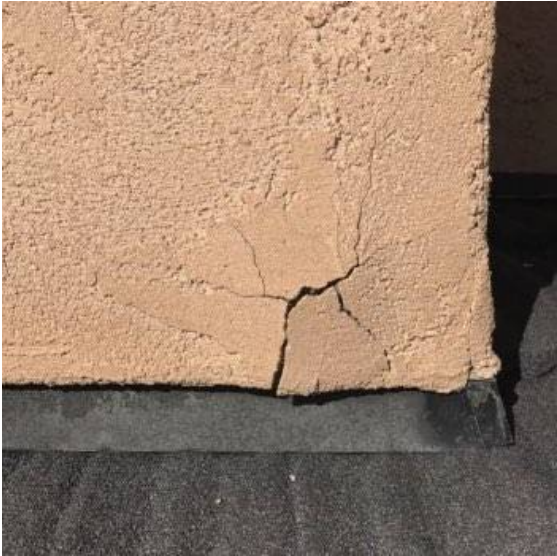
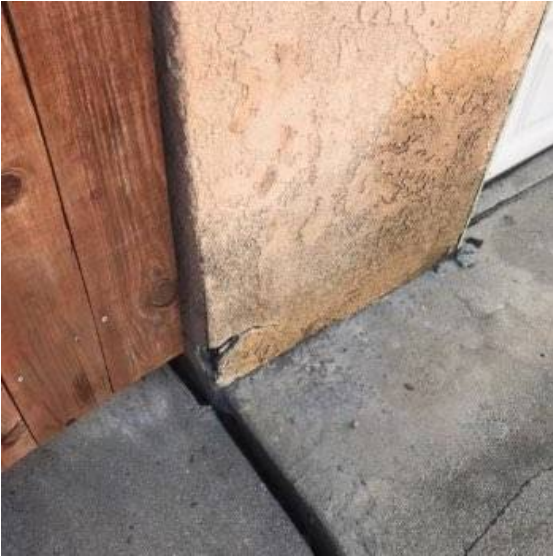
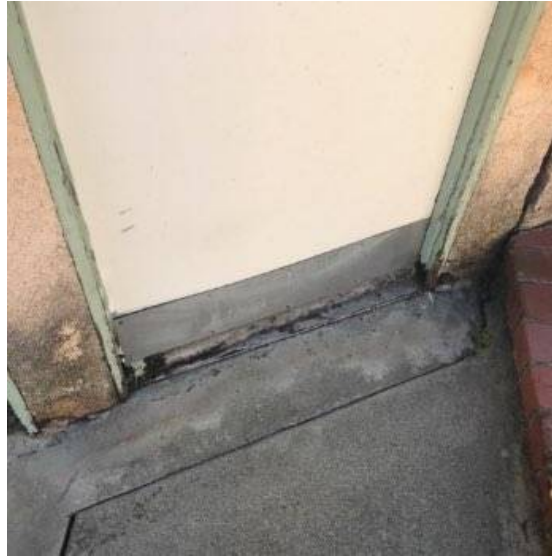
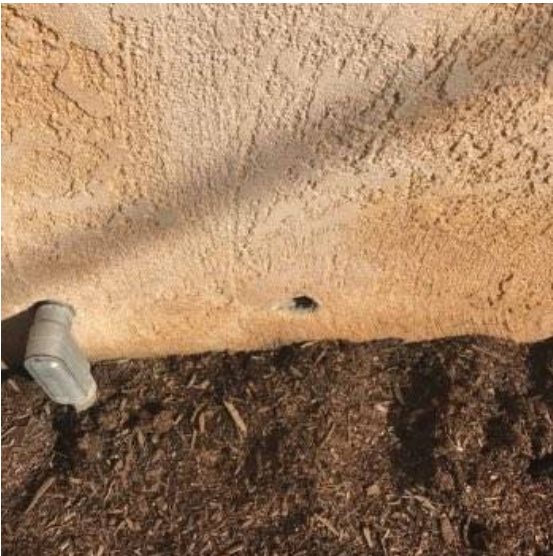
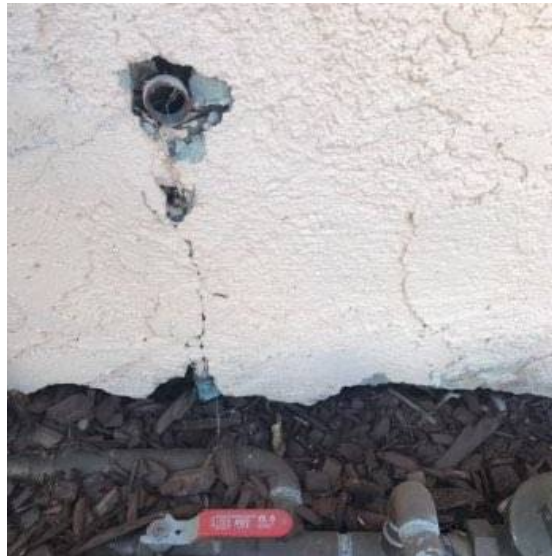
29) 🛠️ Cracks, deterioration and/or damage were found in one or more areas of the exterior stucco finish. In damp climates, moisture may enter cracks or damaged areas and further deteriorate the stucco. Also the wall behind the stucco may become damaged from moisture. Note that areas behind the stucco are inaccessible and excluded from this inspection. Recommend that a qualified contractor repair or replace stucco as necessary.

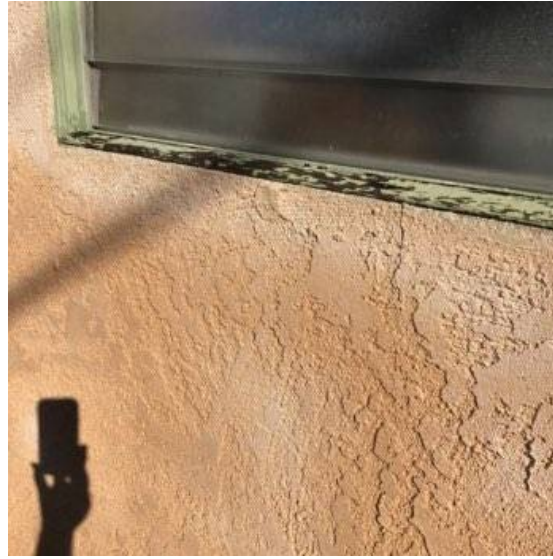
33) 🗑️ Some areas of the exterior paint or stain finish were incomplete and/or substandard (e.g. primed only, too few coats). Recommend that a qualified contractor prep (e.g. clean, scrape, sand, prime, caulk) and repaint or restain the exterior where necessary and per standard building practices. Any repairs needed to the siding or trim should be made prior to this.

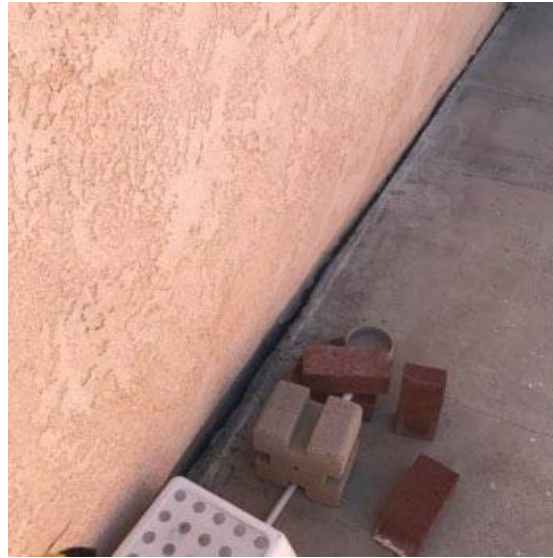
Caulk was missing in some areas. For example, where sidewalk meets structure. Recommend that a qualified person renew or install caulk as necessary. Where gaps are wider than 1/4 inch, an appropriate material other than caulk should be used. For more information, visit: <https://www.reporhost.com/?CAULK>

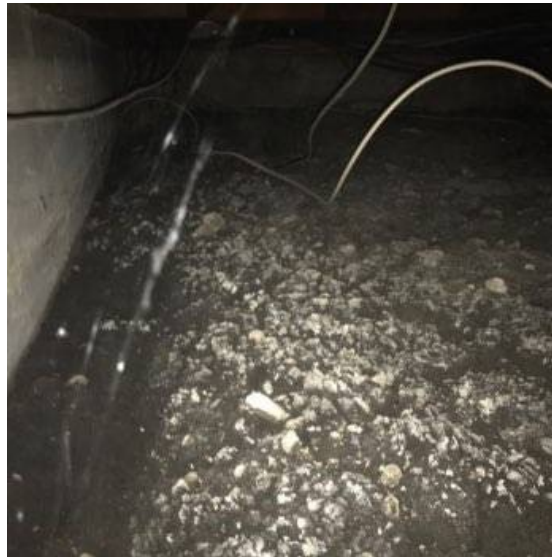
Evidence of prior water intrusion or accumulation was found in one or more sections of the crawl space. For example, sediment stains on the vapor barrier or foundation, and/or efflorescence on the foundation. Accumulated water is a conducive condition for wood-destroying organisms and should not be present in the crawl space. Recommend that the client review any disclosure statements available and ask the property owner about past accumulation of water in the crawl space. The crawl space should be monitored in the future for accumulated water, especially after heavy and/or prolonged periods of rain. If water is found to accumulate, then recommend that a qualified contractor who specializes in drainage issues evaluate and repair as necessary. Typical repairs for preventing water from accumulating in crawl spaces include:

- Repairing, installing or improving rain run-off systems (gutters, downspouts and extensions or drain lines)
- Improving perimeter grading
- Repairing, installing or improving underground footing and/or curtain drains

Ideally, water should not enter crawl spaces, but if water must be controlled after it enters the crawl space, then typical repairs include installing trenches, gravity drains and/or sump pump(s) in the crawl space.

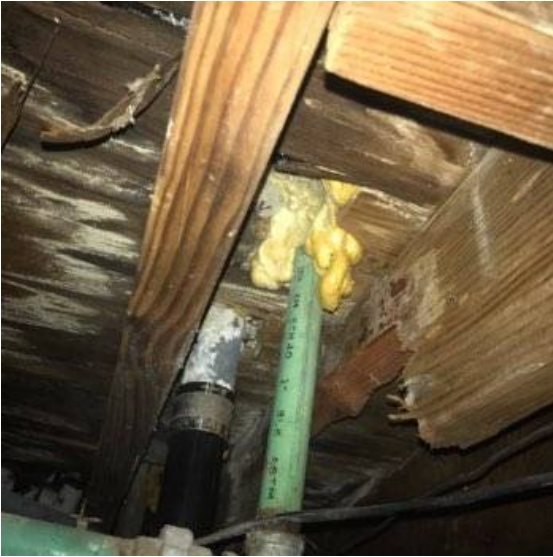
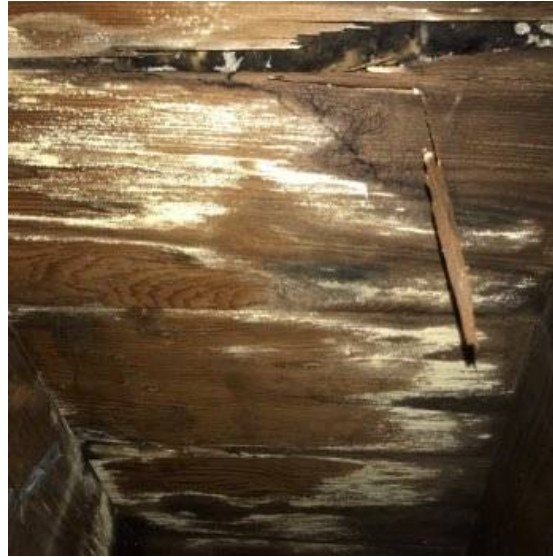
Staining was found at one or more joists and/or sections of floor sheathing. Recommend that a qualified contractor evaluate and repair as necessary. Any rotten wood should be replaced.

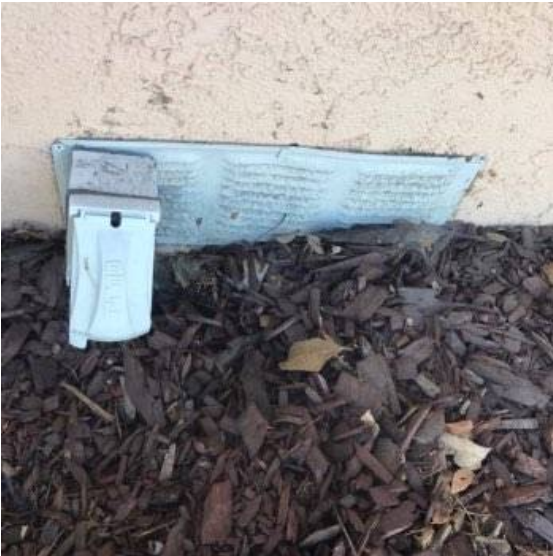
Photo 41-1

One or more crawl space vents were below grade, and either no wells were installed, or wells were substandard. Vent wells should be installed when vents are at or near grade to prevent debris from blocking vents and/or water from entering vents. This is a conducive condition for wood-destroying organisms. Recommend that a qualified person install, replace or repair vent wells per standard building practices.

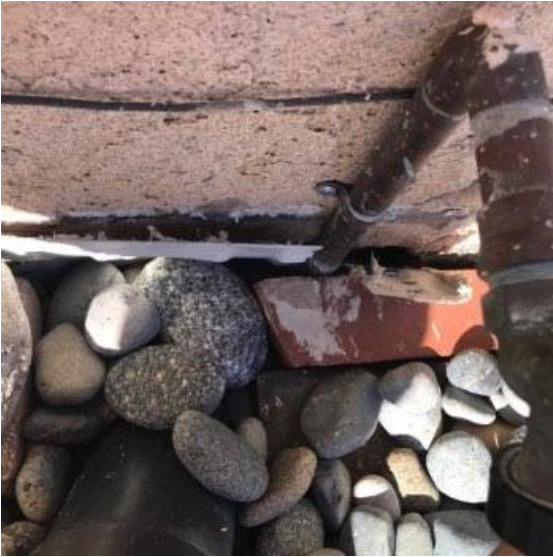
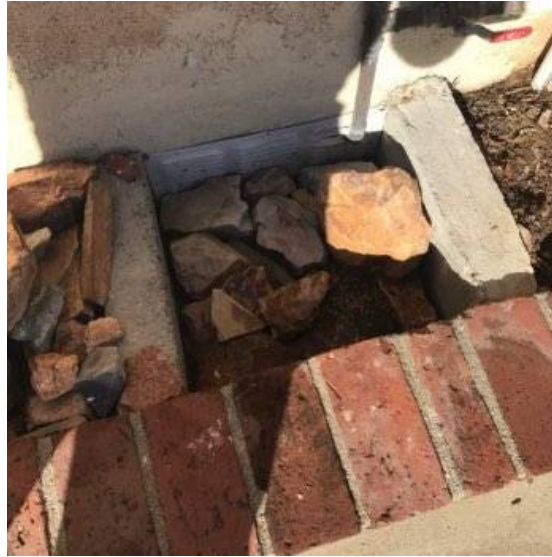
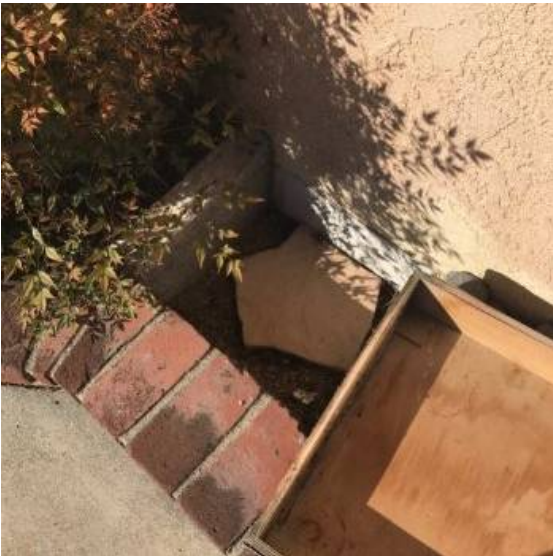
One or more crawl space vents were blocked by stored items. This restricts ventilation in the crawl space and can result in increased levels of moisture inside. This is a conducive condition for wood-destroying organisms. Materials or items blocking vents should be removed as necessary.

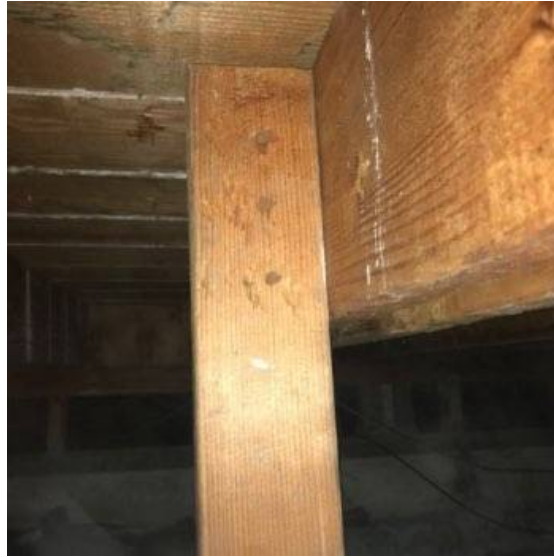
Photo 46-2

One or more beams, joist, post and/or pier were damaged, non-standard or substandard. Floors and/or the structure can deflect, resulting in non-level floors or damage to the structure. Recommend that a qualified contractor evaluate and repair per standard building practices.

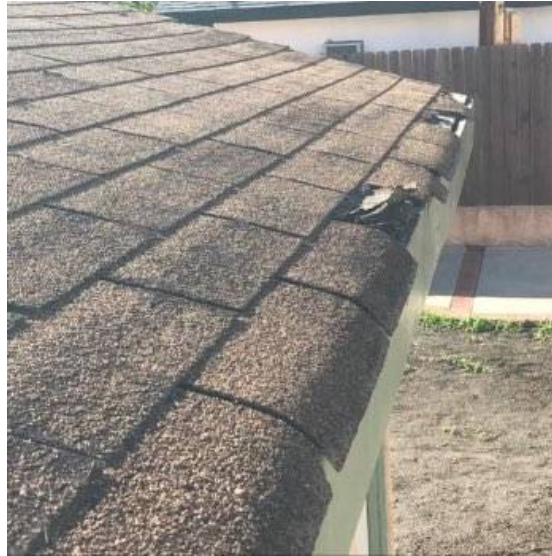
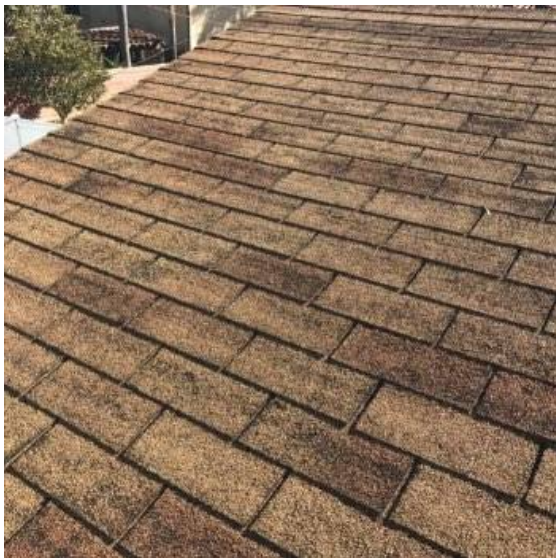
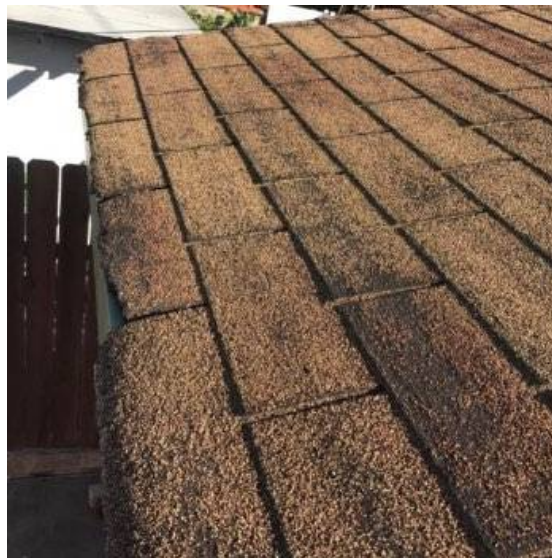
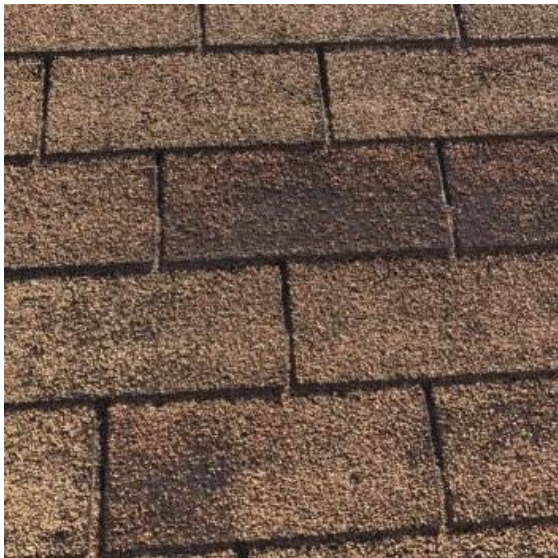
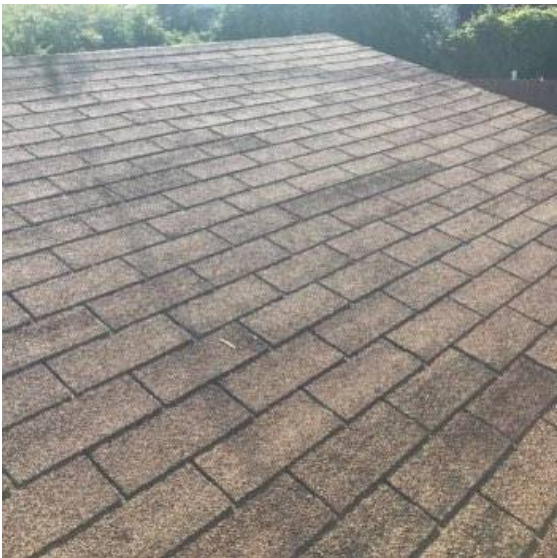
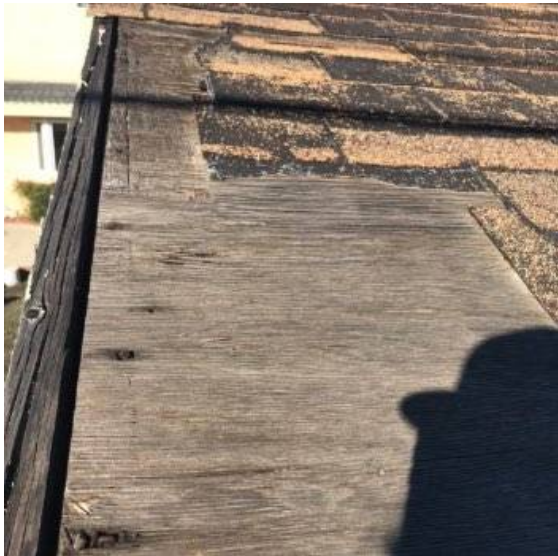
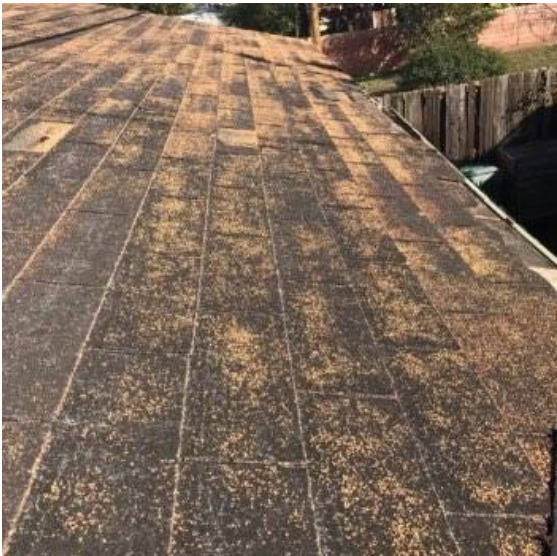
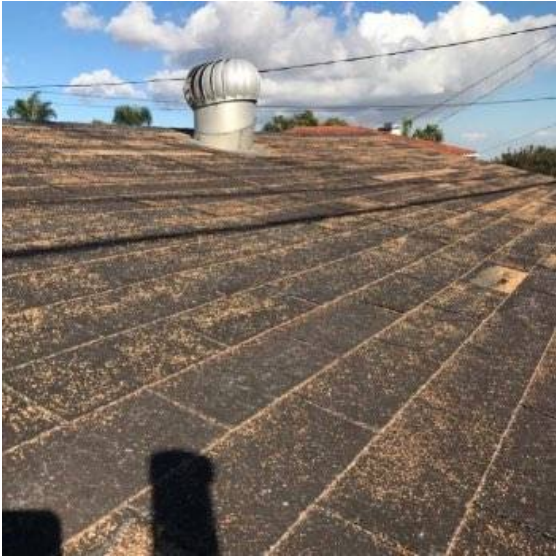
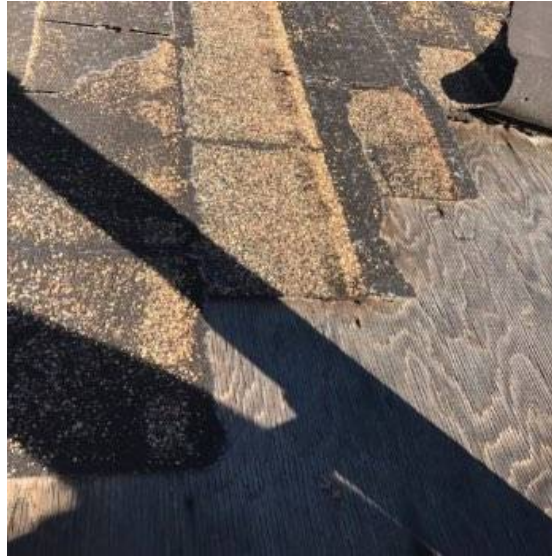
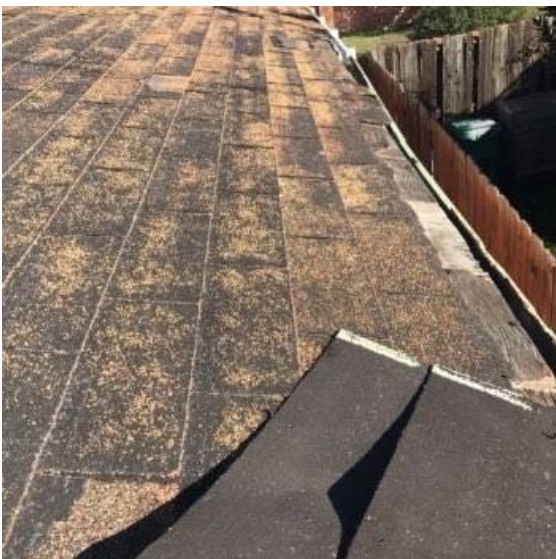
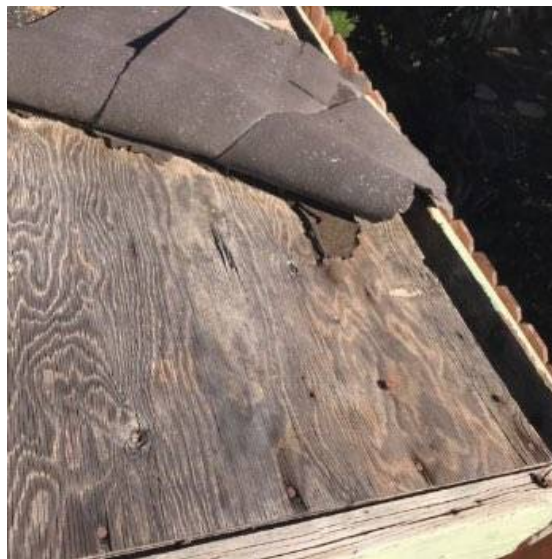
(Garage) The roof surface was significantly deteriorated and appeared to be at or beyond its service life. It needs replacing now. This is a conducive condition for wood-destroying organisms. Consult with a qualified contractor to determine replacement options. Note that some structural repairs are often needed after old roof surfaces are removed and the structure becomes fully visible. Related roofing components such as flashings and vents should be replaced or installed as needed and per standard building practices. No prediction of future performance or warranties can be offered.

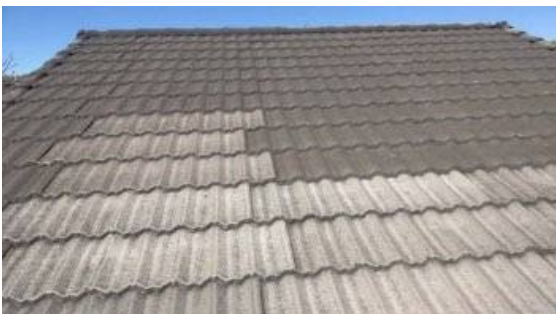
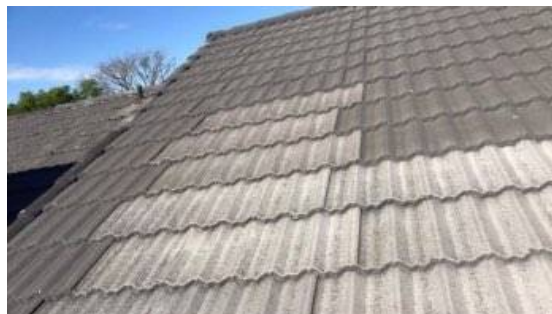
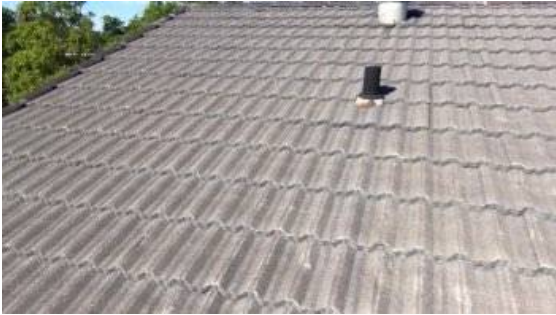
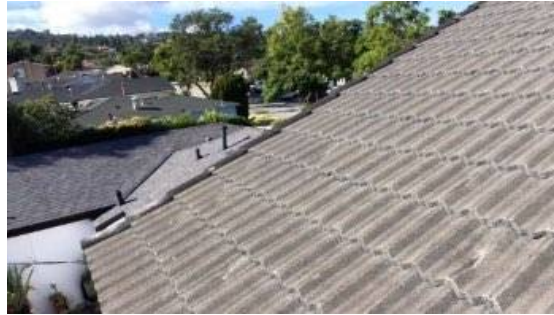
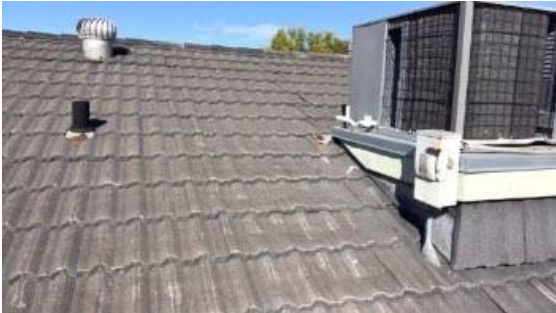
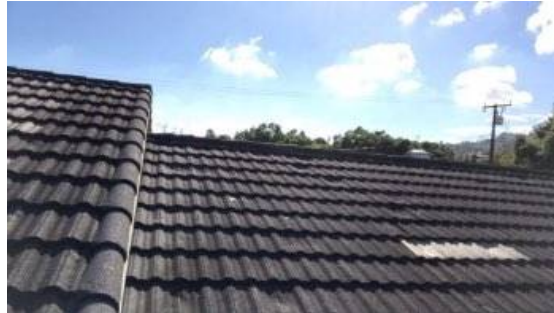
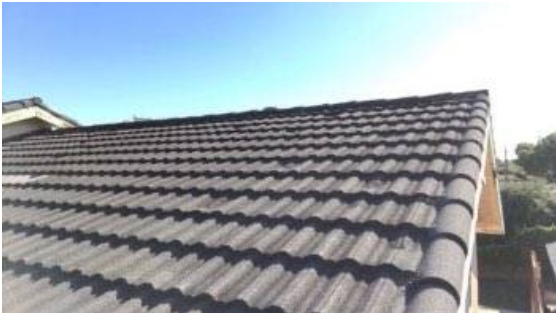
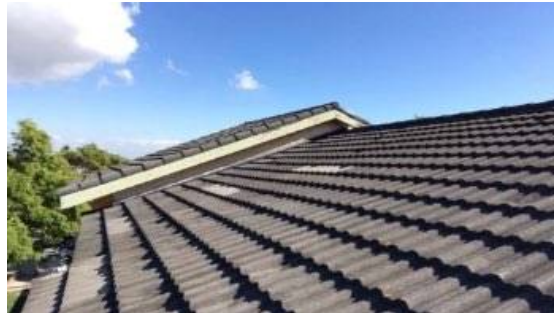
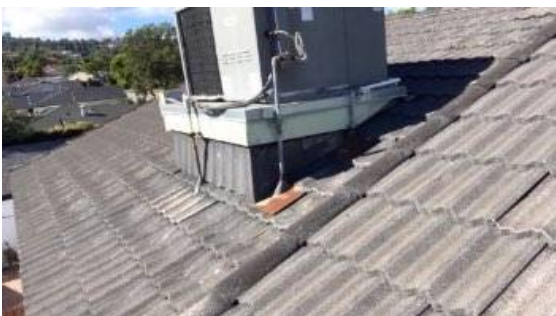
52)

The roof surface appeared to be near the end of its service life and will likely need replacing in the near future. Recommend discussing replacement options with a qualified contractor, and budgeting for a replacement roof surface in the near future. The client may also wish to consider having a qualified contractor attempt to issue a "roof certificate." No prediction of future performance or warranties can be offered.

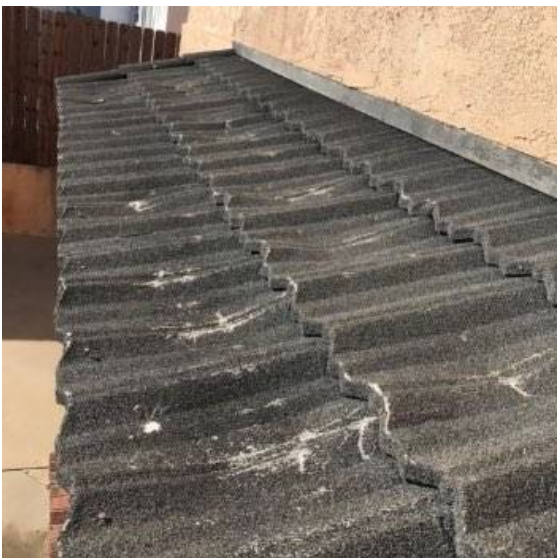
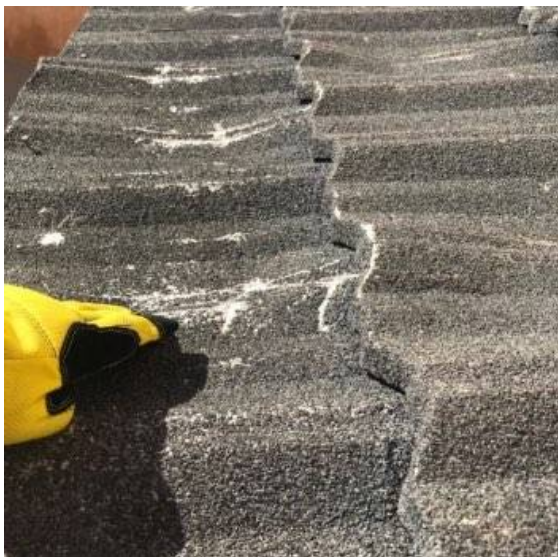
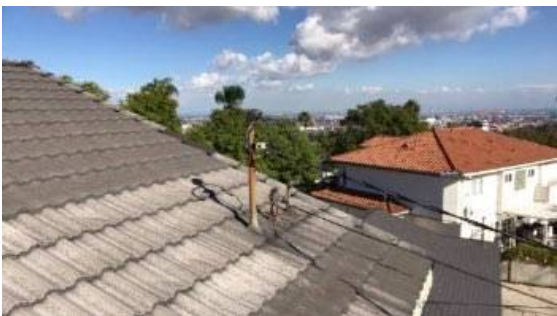
53)

Many metal roof tiles were dented and/or damaged. Leaks may occur as a result. Recommend that a qualified contractor repair as necessary.
