Del Fine Home Inspections

Property Inspection Report

Property address: **1936 Homeworth Dr
Rancho Palos Verdes, CA 90275**

Inspection date: **Wednesday, November 19, 2025**

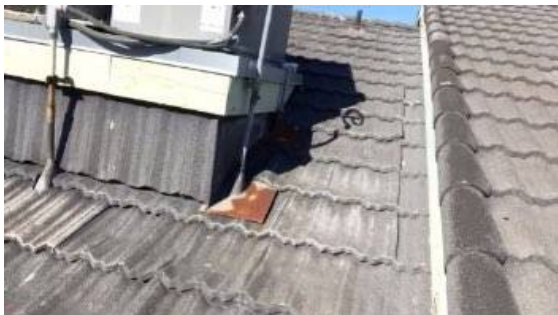
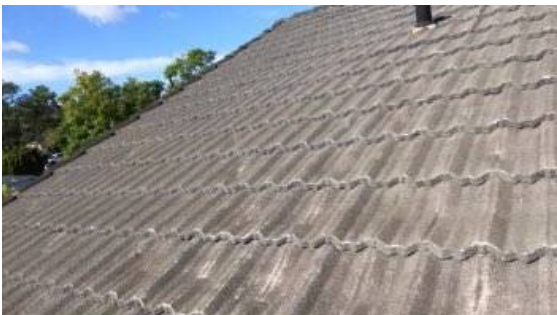
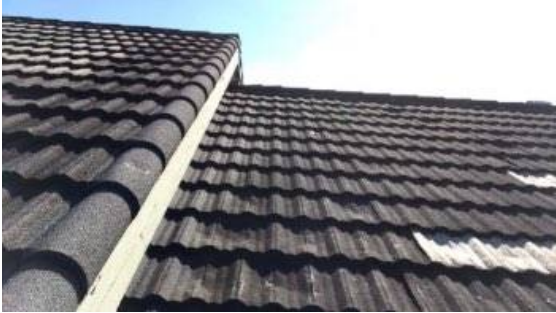
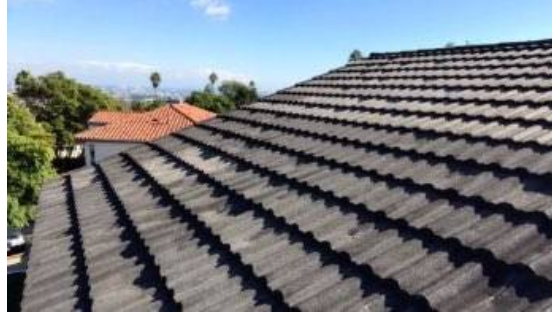
Many metal roof tiles were dented and/or damaged. Leaks may occur as a result. Recommend that a qualified contractor repair as necessary.

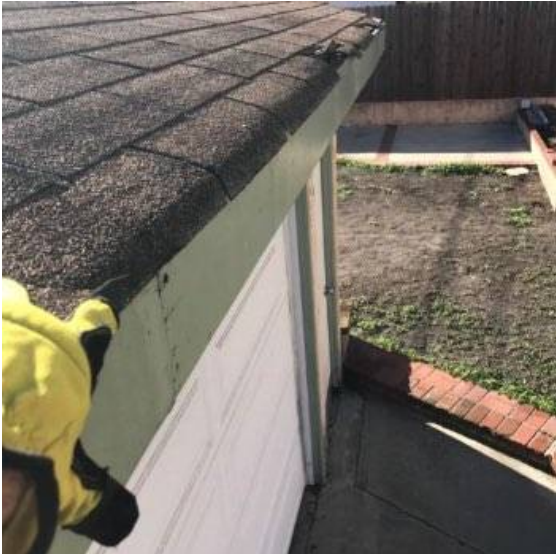
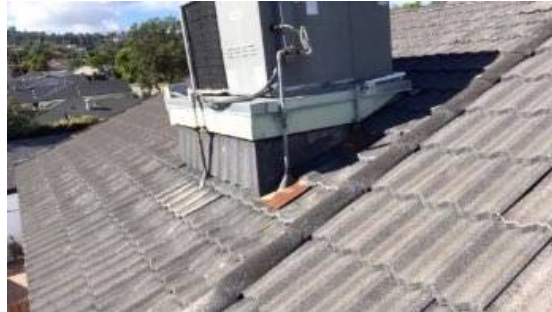
One or more roof flashings were missing, lifting or corroded. Leaks can occur as a result. This is a conducive condition for wood-destroying organisms. Recommend that a qualified person repair as necessary.

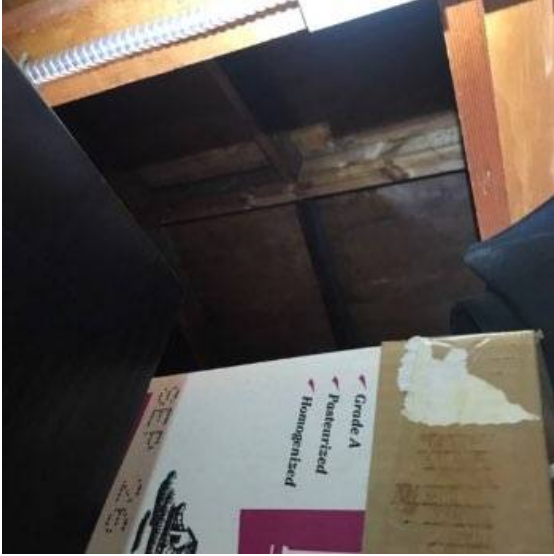
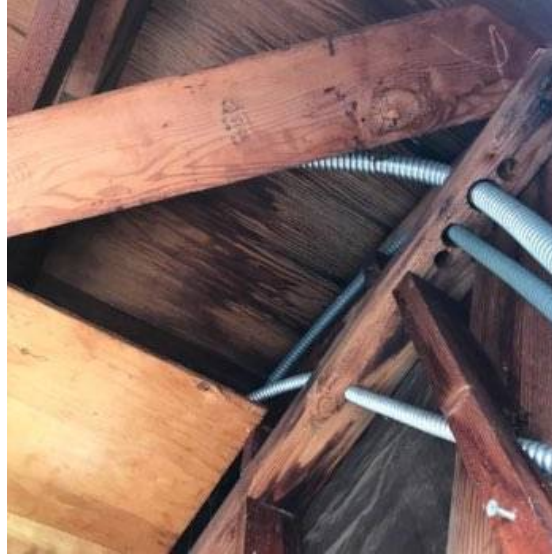
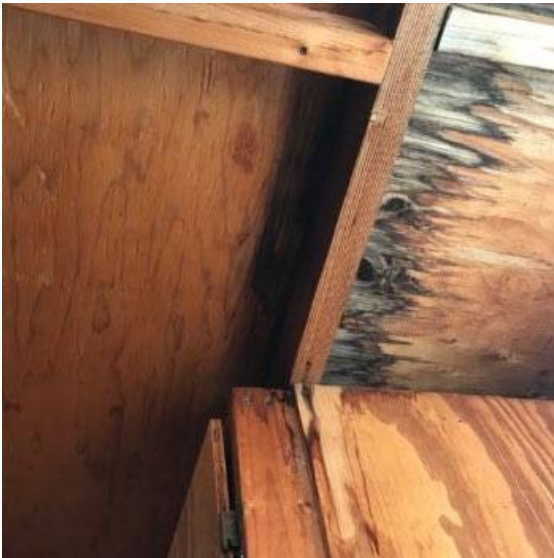
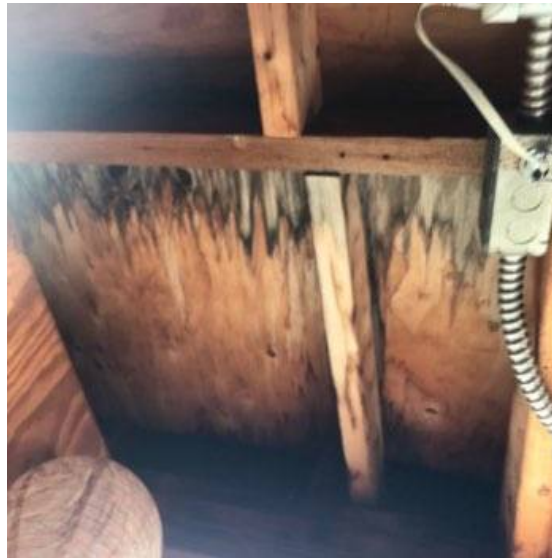
What appeared to be past water stains were visible on the roof structure at one or more locations. The stains may have been caused by a past leak. Recommend asking the property owner about past leaks. Monitor these areas in the future, especially after heavy rains to determine if active leaks exist. If leaks are found, recommend that a qualified contractor evaluate and repair as necessary.

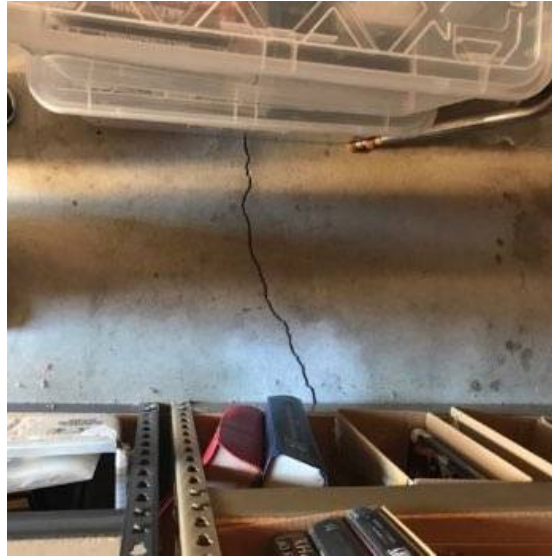
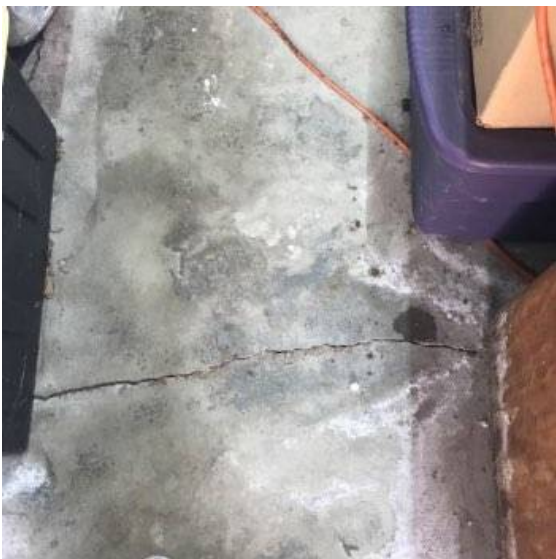
Cracks, heaving and/or settlement were found in one or more sections of concrete slab floors. Recommend that a qualified contractor repair as necessary.

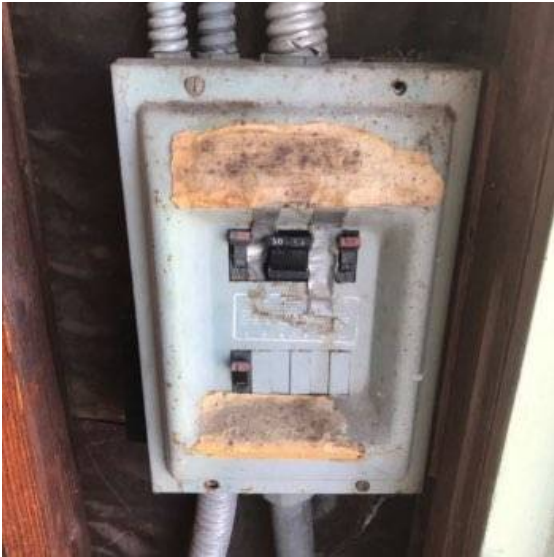
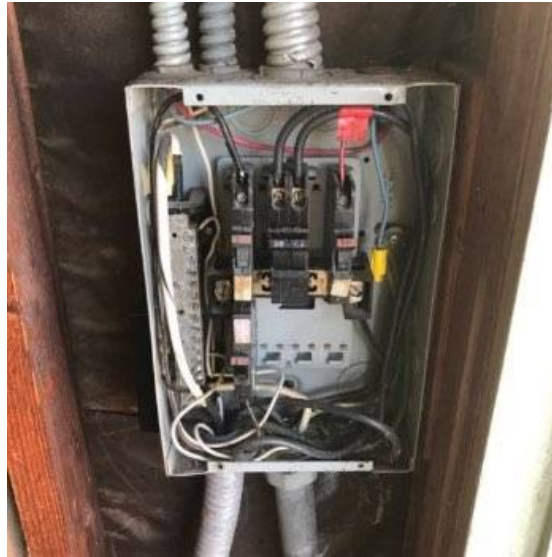
Panel(s) #C were manufactured by the Federal Pacific Electric company and used "Stab-Lok" circuit breakers. There is significant evidence that both double and single pole versions of these circuit breakers fail by not tripping when they are supposed to. However, in 2011 the Consumer Products Safety Commission (CPSC) closed an investigation into this product because they did not have enough data to establish that the circuit breakers pose a serious risk of injury to consumers. Regardless, and due to other evidence of safety issues, recommend that a qualified electrician carefully evaluate all Federal Pacific panels and make repairs as necessary. Consider replacing Federal Pacific panels with modern panels that offer more flexibility for new, safer protective technologies like ground fault circuit interrupters (GFCIs) and arc fault circuit interrupters (AFCIs). For more information, visit:

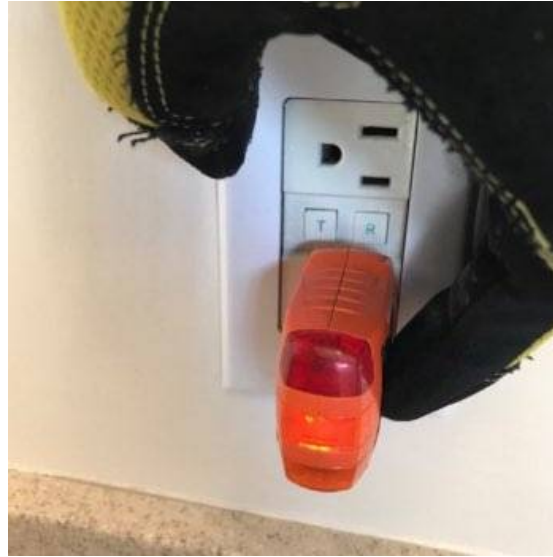
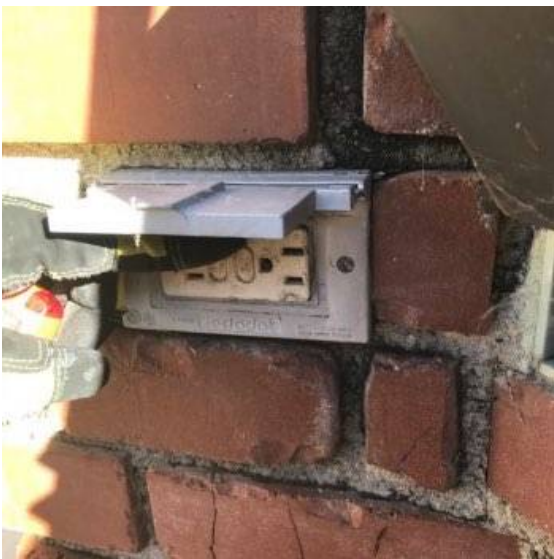
One or more ground fault circuit interrupter (GFCI) devices protecting receptacles at the building exterior or bathroom would not reset or trip when tested. This is a potential shock hazard. Recommend that a qualified electrician evaluate and repair as necessary.

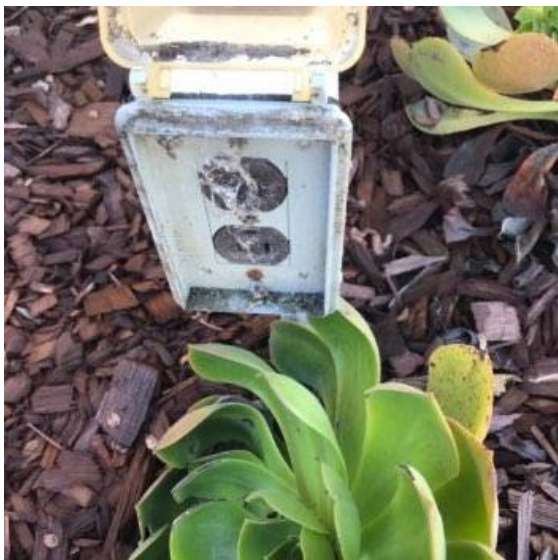
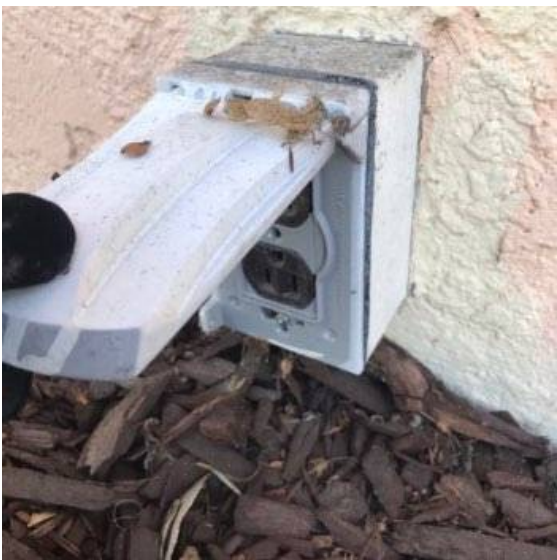
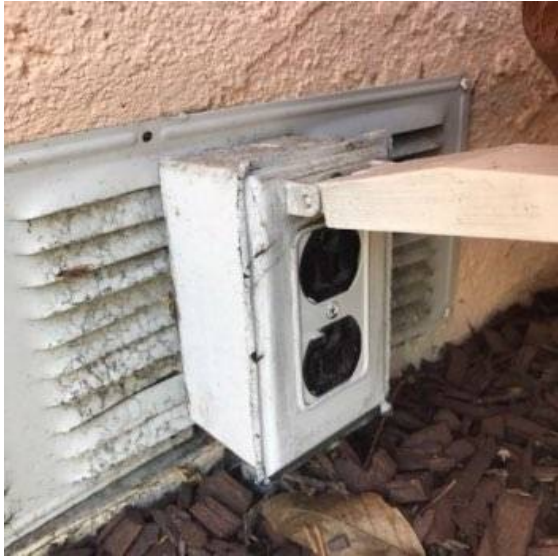
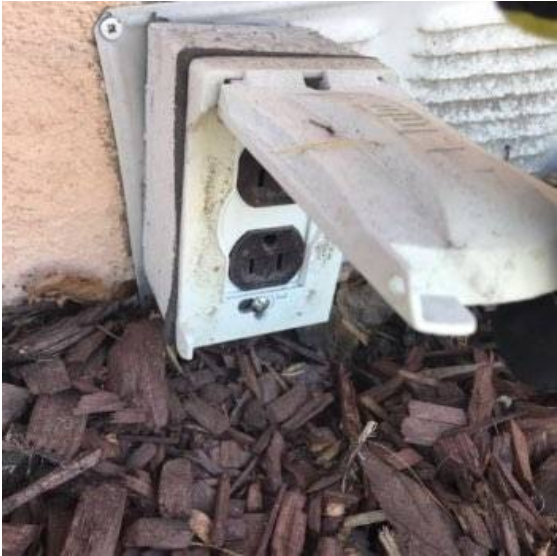
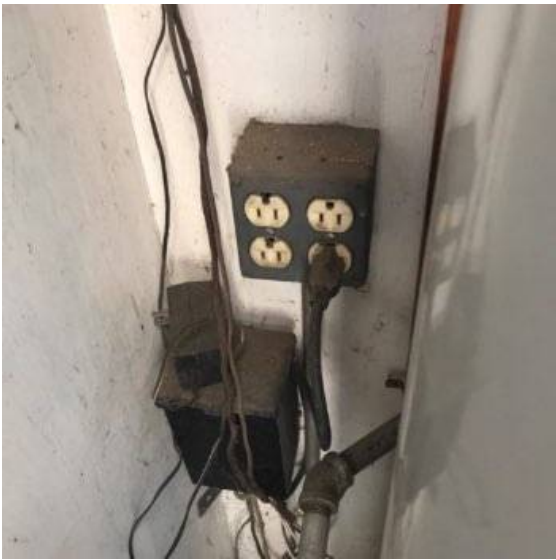
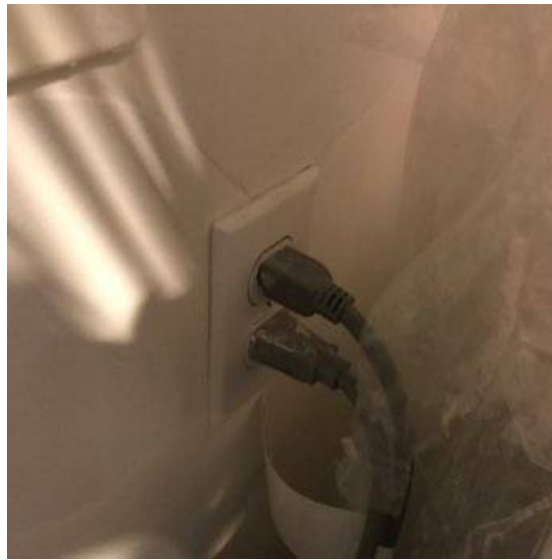
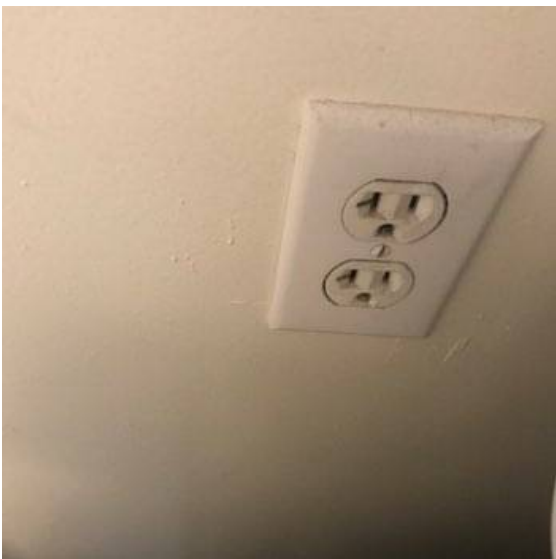
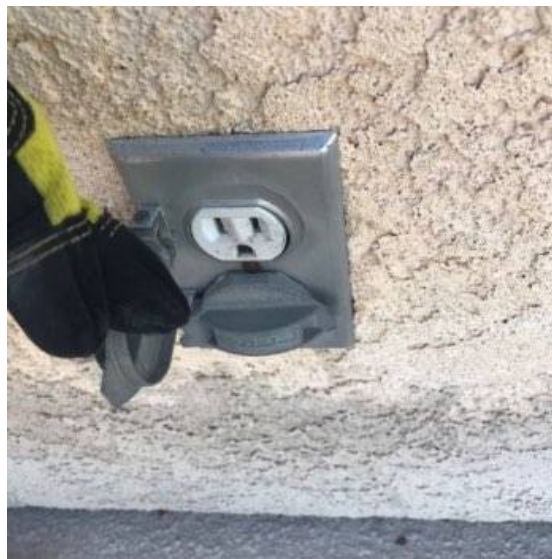
One or more electric receptacles at the laundry area and/or exterior had no visible ground fault circuit interrupter (GFCI) protection, or the inspector was unable to determine if GFCI protection was present. If not GFCI-protected, receptacles in wet areas pose a shock hazard. Recommend that a qualified electrician evaluate and install GFCI protection if necessary and per standard building practices. General guidelines for GFCI-protected receptacles include the following locations:

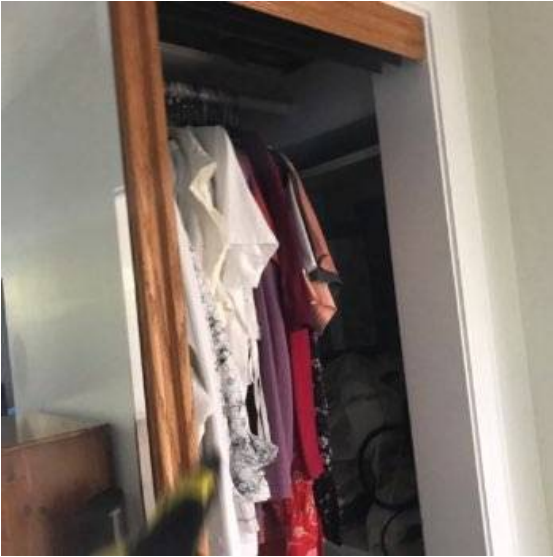
Photo 71-1

Panel(s) #B were located in a closet. This is not an approved location for electric panels. Recommend that a qualified electrician move the panel(s) or make repairs per standard building practices.

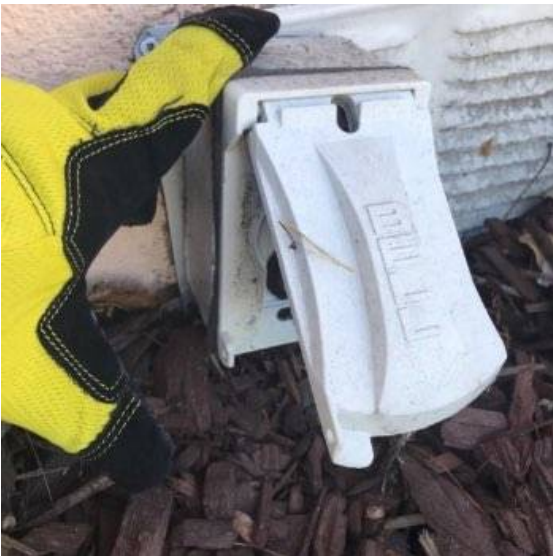
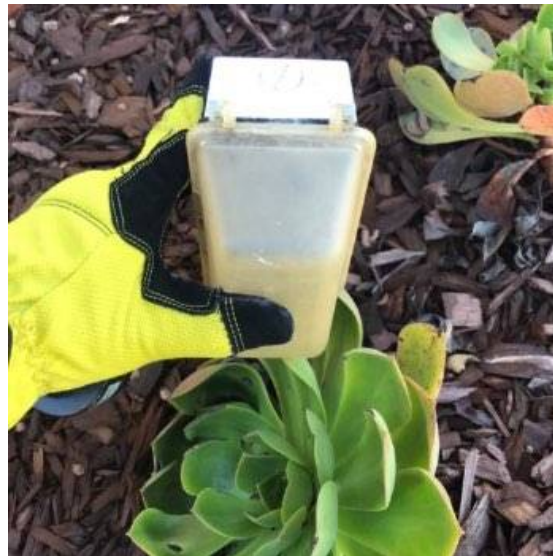
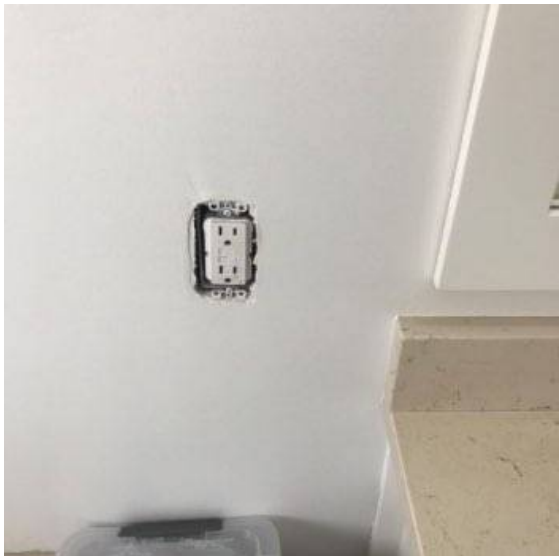
Substandard wiring was found at the building exterior, attic, crawl space and/or interior rooms. For example, exposed wiring, loose wiring, unterminated wires, exposed splices, missing or broken cover plates, loose boxes, missing conduit and/or loose receptacle. This is a safety hazard. Recommend that a qualified electrician evaluate and repair as necessary and per standard building practices.

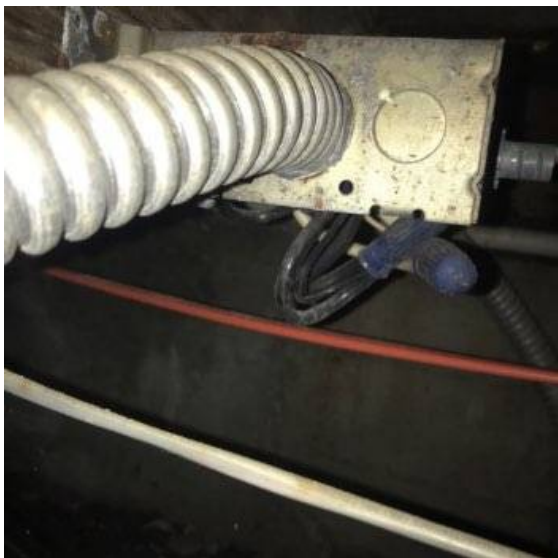
Photo 75-6 Crawl space

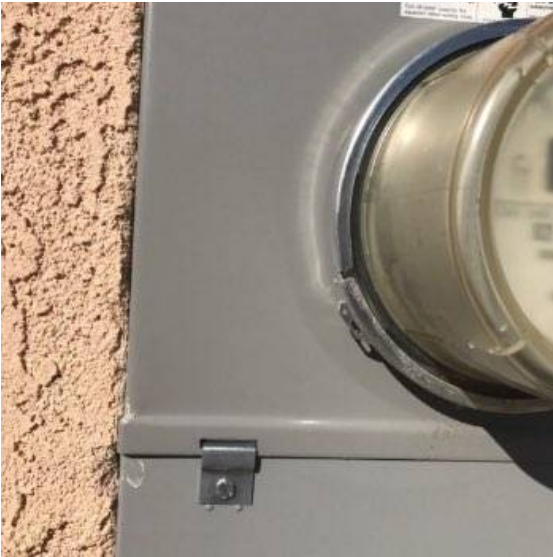
Photo 80-1

The electric meter seal was missing. The utility company installs these seals to prevent tampering with the meter or tapping into the electric supply before the meter. Consult with the property owner about this and/or contacting the utility company to have the seal reinstalled.

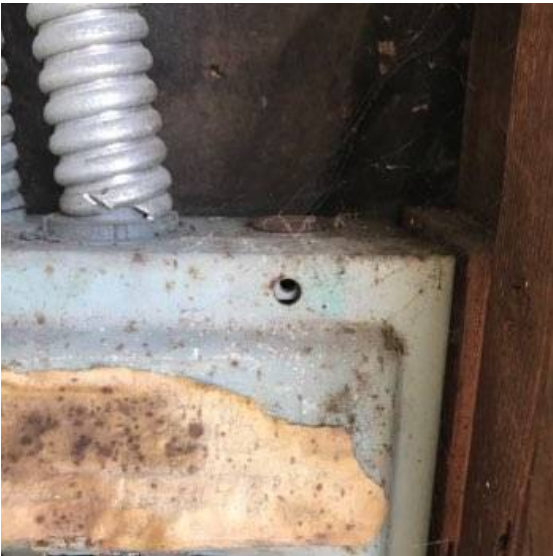
Photo 81-1

One or more screws that attach the cover or dead front to panel(s) #C were missing or not installed. Recommend installing screws where missing so the cover or dead front is secure. Only screws with blunt tips approved for this purpose should be installed, so wiring inside the panel is not damaged. Because energized wires may be located directly behind screw holes, the client should consider having a qualified electrician replace missing screws.

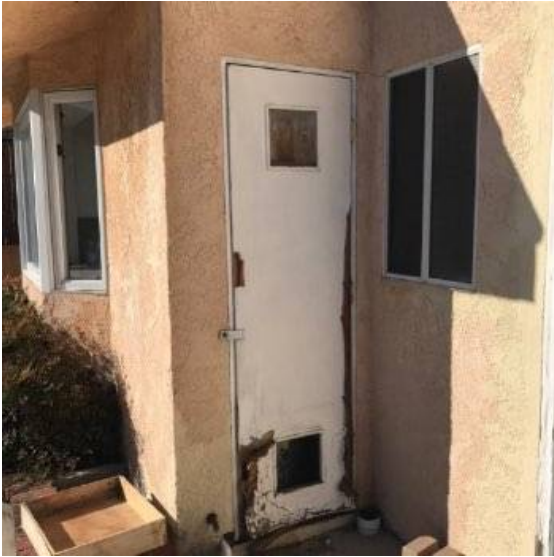
Photo 94-1

94) 🛠️ The water heater door was damaged. Recommend having a qualified contractor repair as necessary.

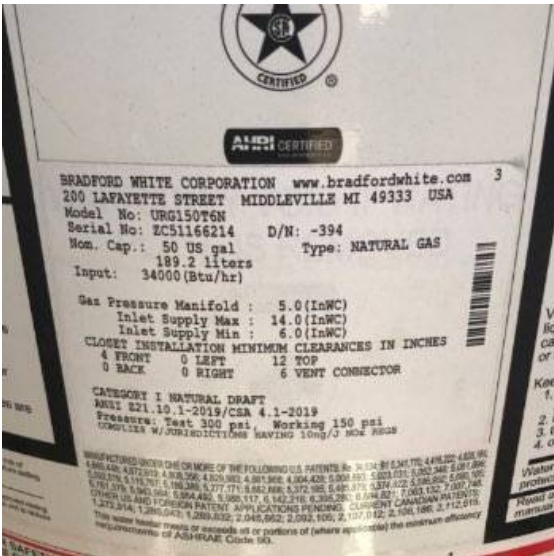
Photo 95-1 MFG 2023

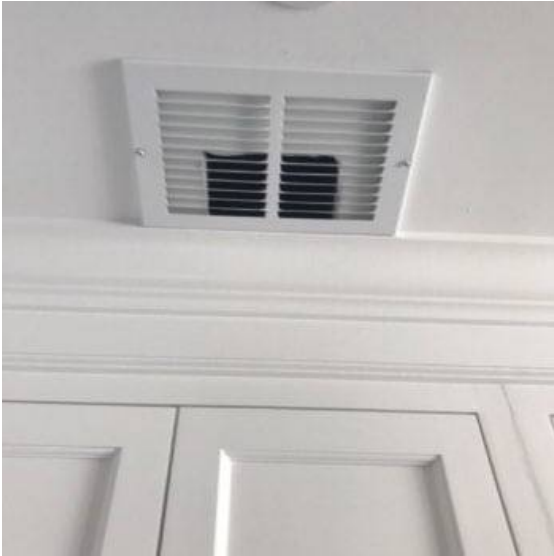
Photo 96-1

One or more air supply registers were installed in a non-standard or substandard way. Recommend that a qualified person repair as necessary.

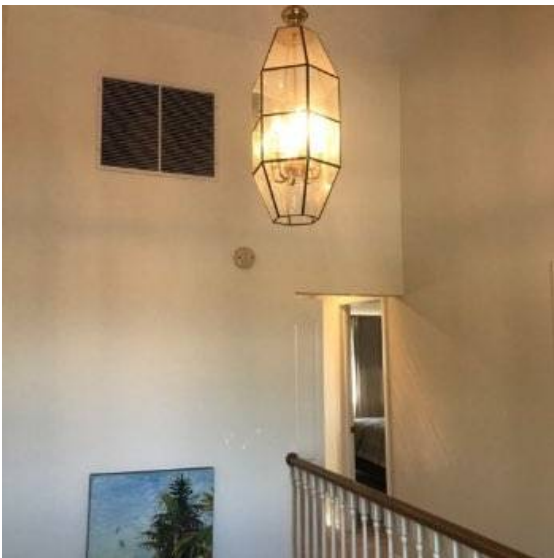
Photo 97-1

Air filters for the heating and/or cooling system were missing at one or more locations where they should have been installed. Indoor air quality will be reduced as a result. Recommend installing good quality filters at intended locations (e.g. in or at the air handler, behind return air grills). Filters should be sized correctly to minimize air gaps. Many types of filters are available. Recommend installing pleated filters or better rather than the cheapest disposable kind. For more information, visit:

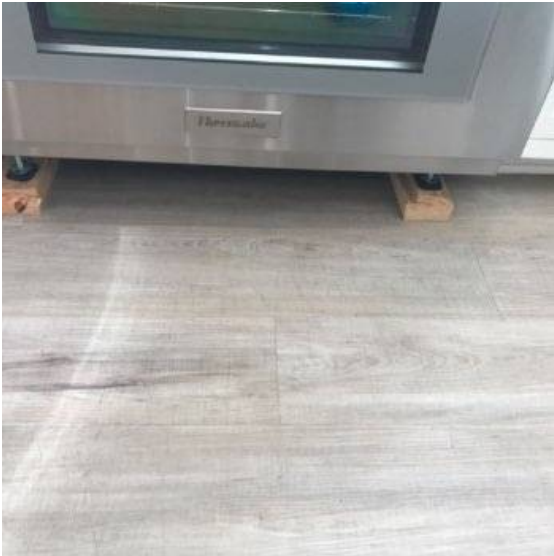
Photo 100-1

The range was placed on supports. Consult with the property owner. If necessary, a qualified person should repair.

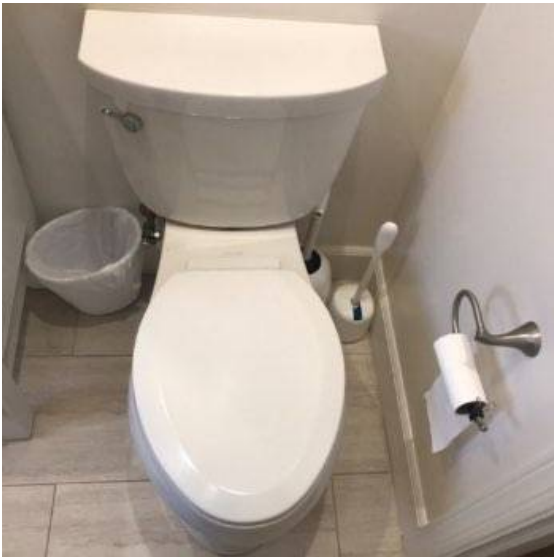
Photo 103-1

The toilet at location(s) #C was loose where it attached to the floor. Leaks can occur. Flooring, the sub-floor or areas below may get damaged. Sewer gases can enter living spaces. Recommend that a qualified contractor remove the toilet(s) for further evaluation and repair if necessary. A new wax ring should be installed and toilet(s) should be securely anchored to the floor to prevent movement and leaking.

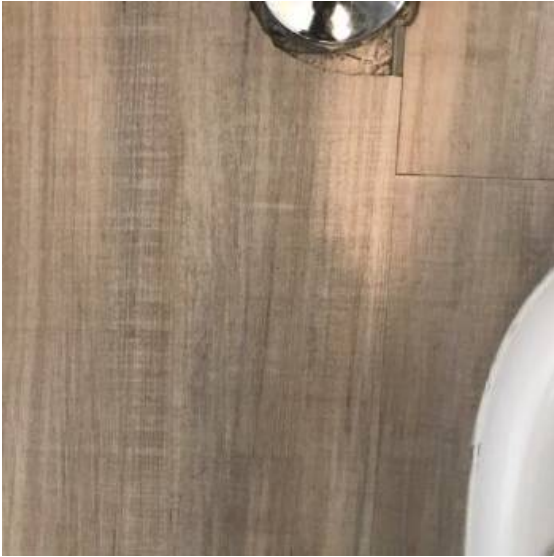
**Photo 104-1**

Flooring in the bathroom at location(s) #D was deteriorated. Water can damage the sub-floor as a result. Recommend that a qualified contractor repair flooring as necessary.

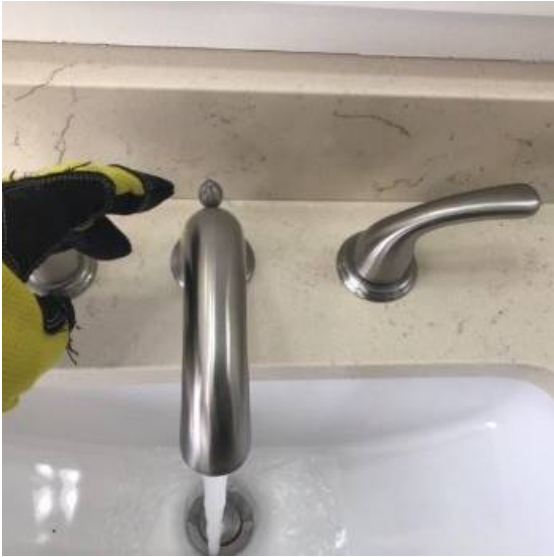
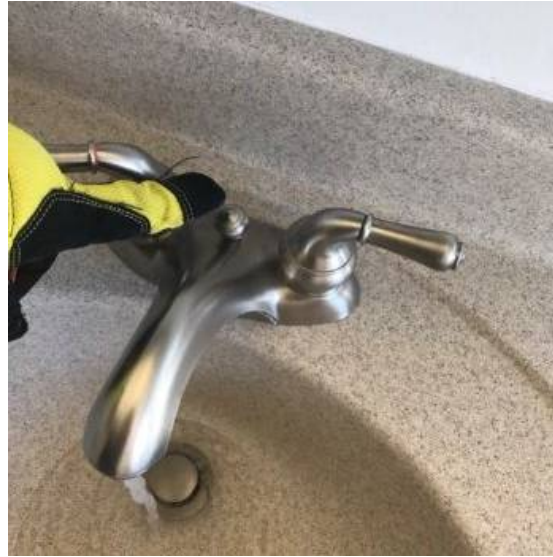
The sink drain stopper mechanism at location(s) #A and B was inoperable, loose and/or difficult to operate. Recommend that a qualified person repair or replace as necessary.

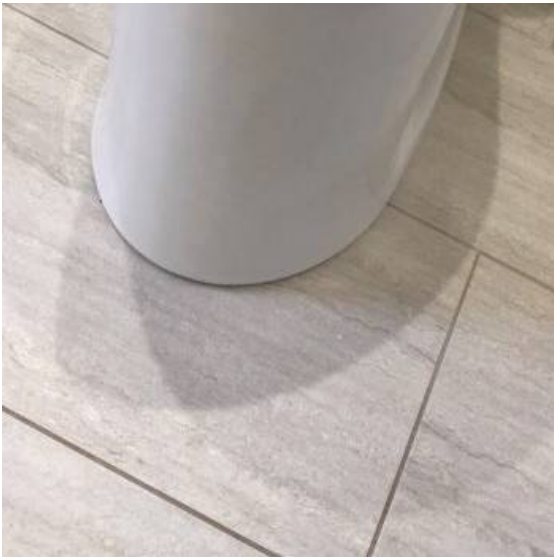
Photo 112-1

Caulk around the base of the toilet at location(s) #C was missing, substandard and/or deteriorated. Modern standards require caulk to be installed around the entire toilet base where it meets the floor for sanitary reasons. Without it, soiled water can soak into flooring and sub-floor materials if the toilet overflows. Condensation from the toilet can also soak into the flooring. Recommend that a qualified person caulk around toilet bases per standard building practices.

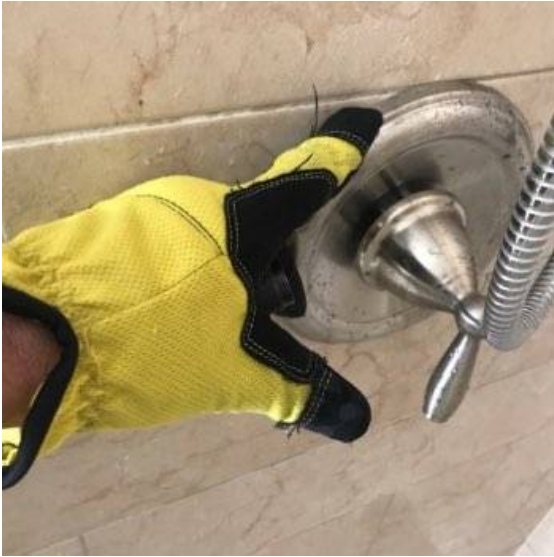
Photo 116-1

116) 🛠️ The shower trim or plumbing at location(s) #A was loose. Recommend that a qualified person repair as necessary.

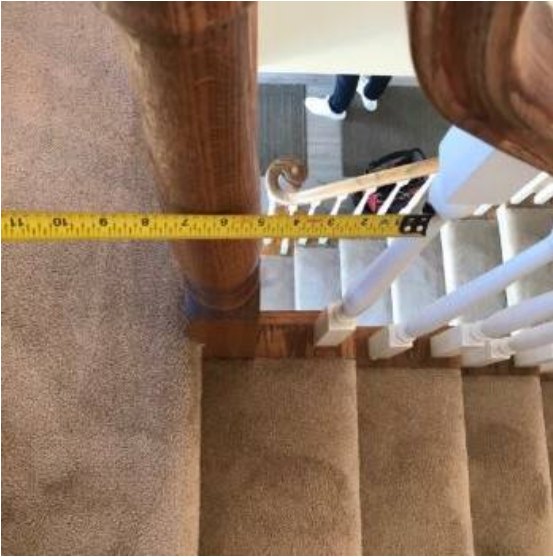
Photo 120-1

120) + 🛠️ Guardrails at one or more locations with drop-offs higher than 30 inches had gaps that were too large. This poses a safety hazard for children (e.g. falling, getting stuck in railing). Guardrails should not have gaps or voids that allow passage of a sphere equal to or greater than 4 inches in diameter, or 6 inches in diameter at triangular spaces between stair edges and guardrails. At a minimum, the client should be aware of this hazard. Recommend that a qualified contractor repair or replace guardrails per standard building practices.

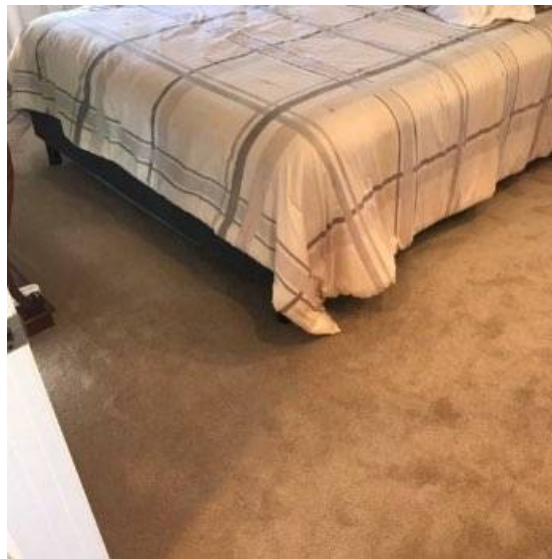
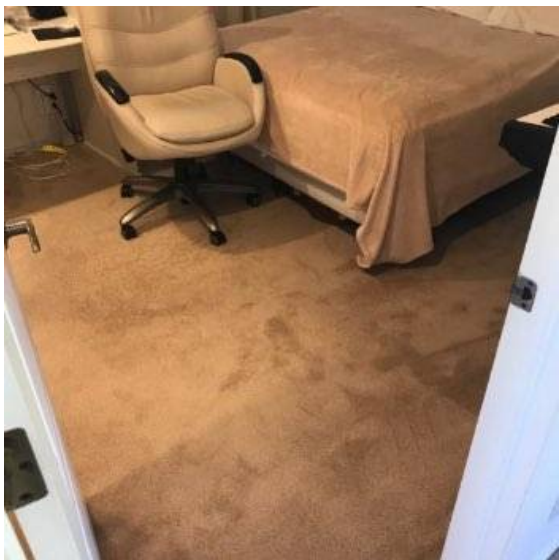
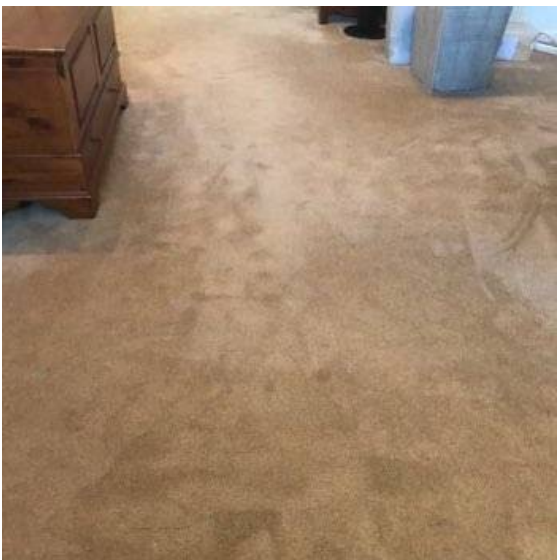
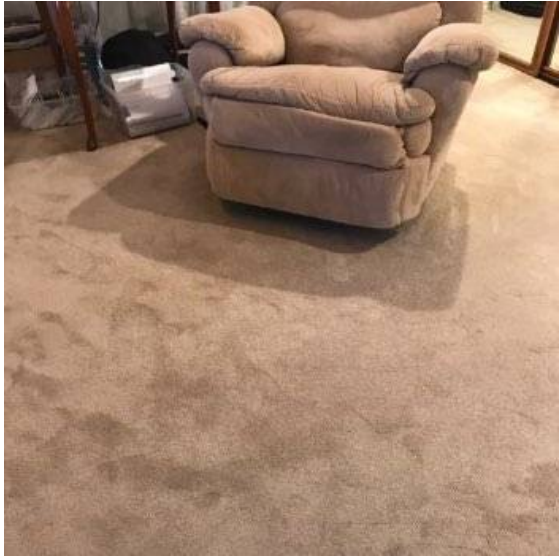
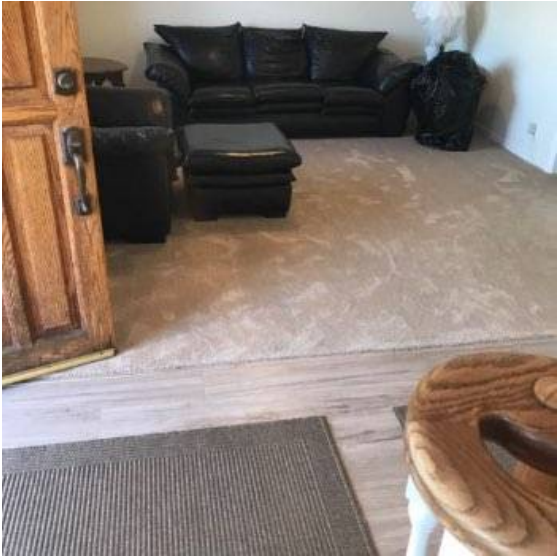
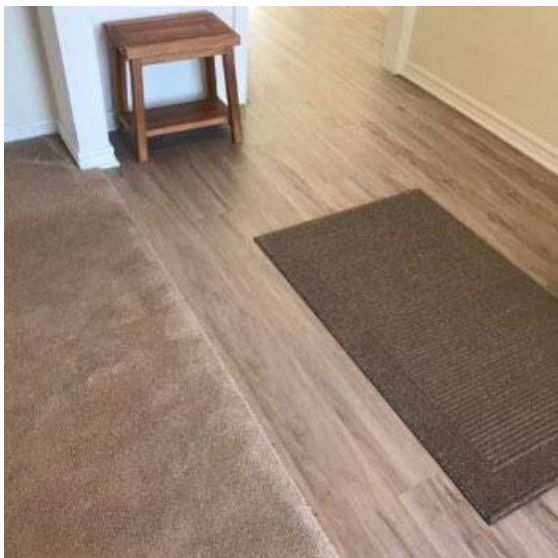
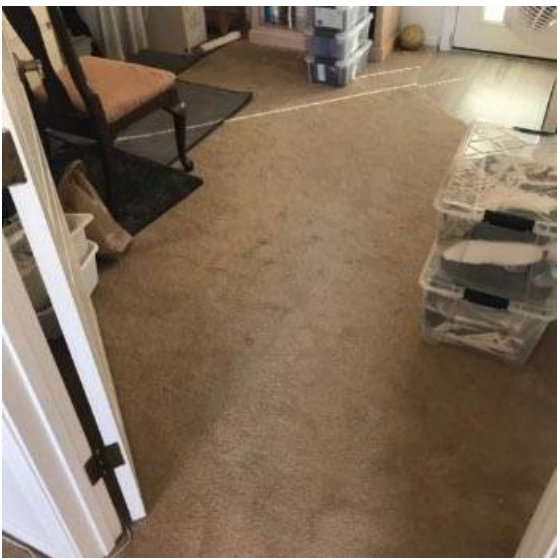
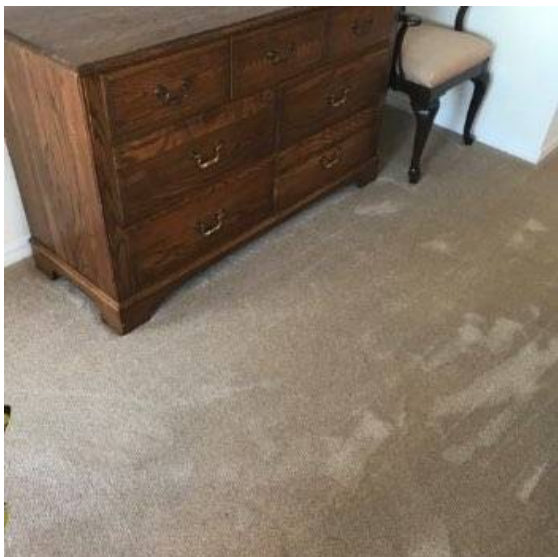
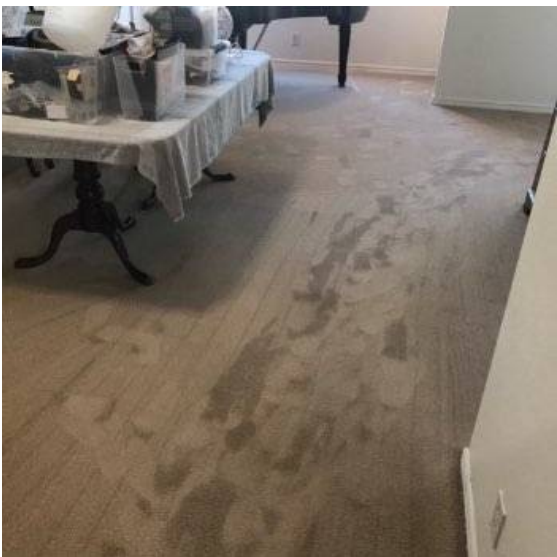
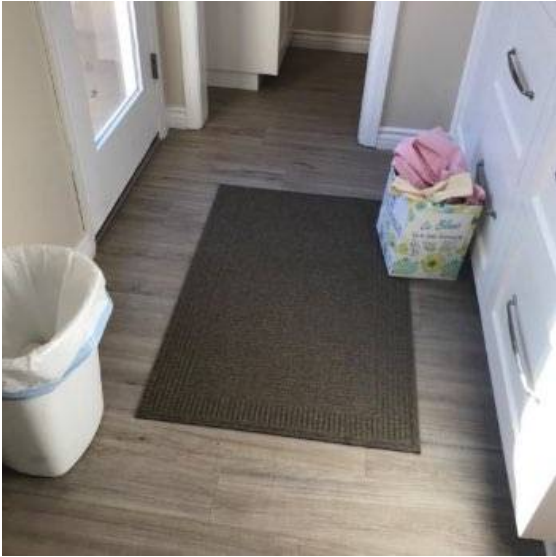
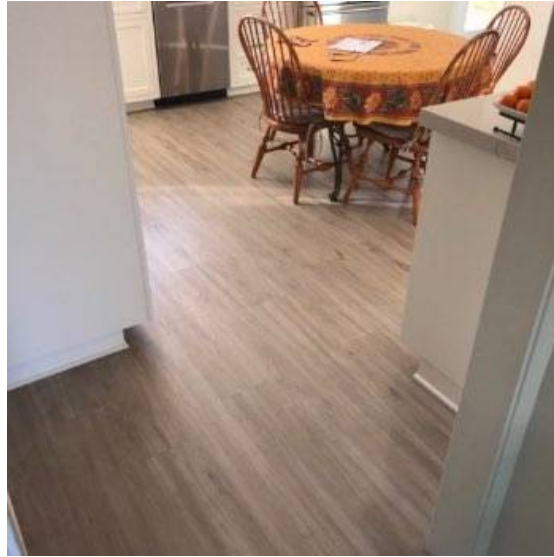
Floors in one or more areas were not level. Recommend that a qualified contractor evaluate and repair as necessary.

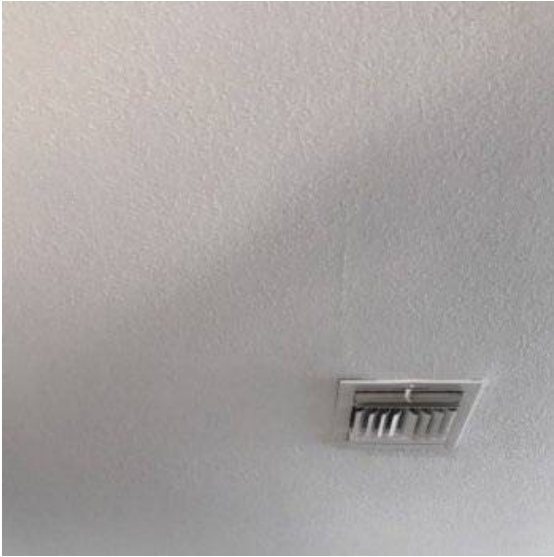
Photo 124-1

124) 🛠️ One or more ceilings were cracked. Recommend that a qualified person repair as necessary.

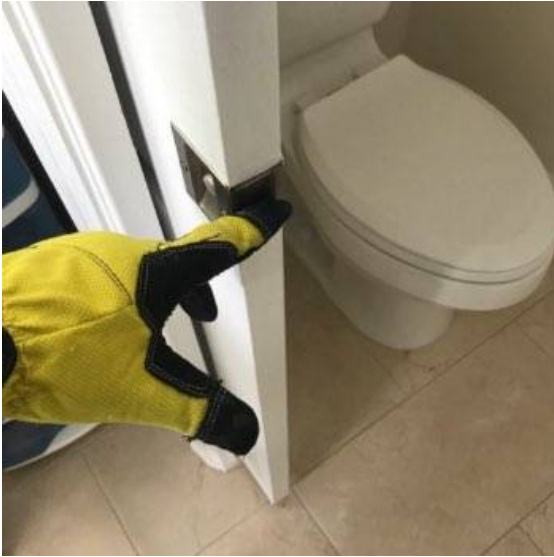
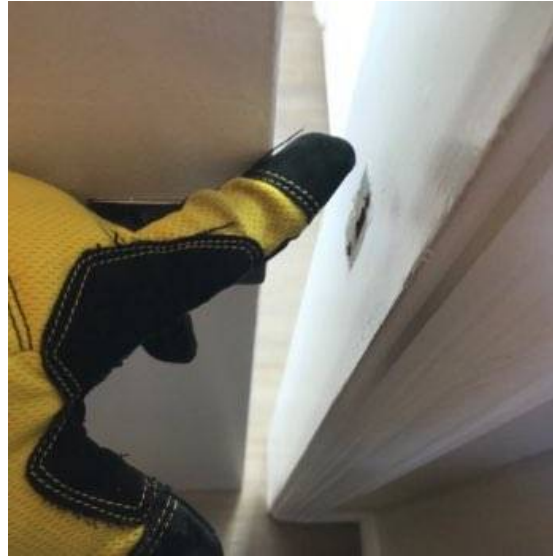
128) 🛠️ One or more interior doors wouldn't latch or were difficult to latch. Recommend that a qualified person repair as necessary. For example, by adjusting latch plates or locksets.

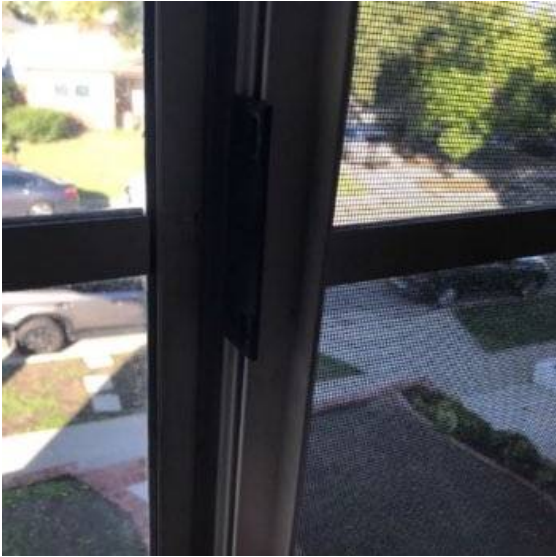
Photo 130-1

Lock mechanisms on one or more windows were difficult to operate. This can pose a security risk. Recommend that a qualified person repair as necessary.

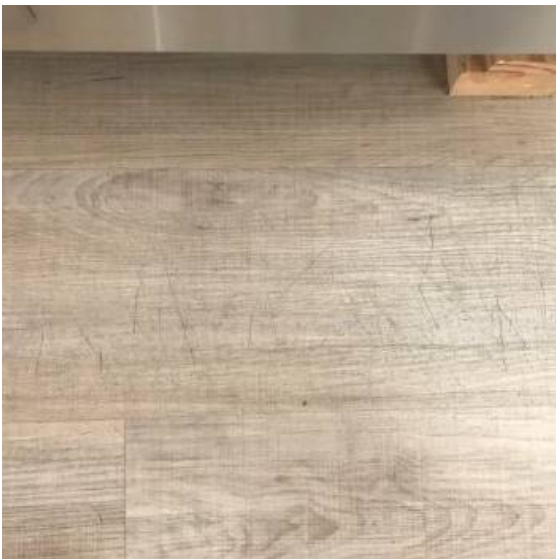
Photo 131-1

131) 🛠️ Flooring in one or more areas was worn, deteriorated or damaged. Recommend that a qualified contractor repair as necessary.

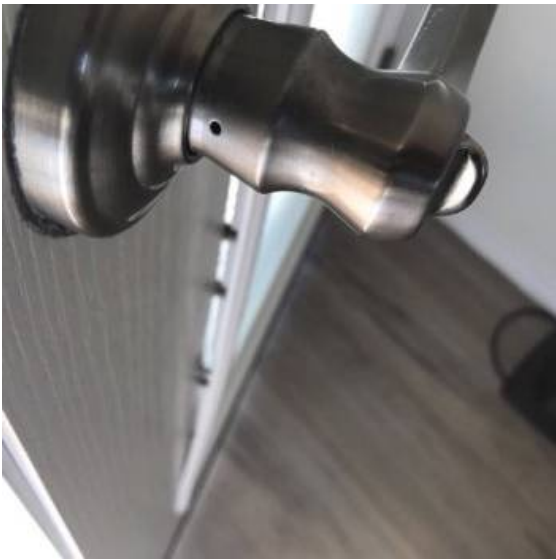
Photo 132-1

132) ⓘ One or more exterior doors had minor damage and/or deterioration. Although serviceable, the client may wish to repair or replace such doors for appearances' sake.
