Inspection Report

Property Address:
618 Prospect Ave
Hermosa Beach CA 90254

Ferguson Home Inspections

Date: 10/13/2022	Time: 02:00 PM	Report ID: 10132022Prospect
Property: 618 Prospect Ave Hermosa Beach CA 90254	Customer: Wendy & Scott Fletcher	Real Estate Professional: Amy Teitelbaum

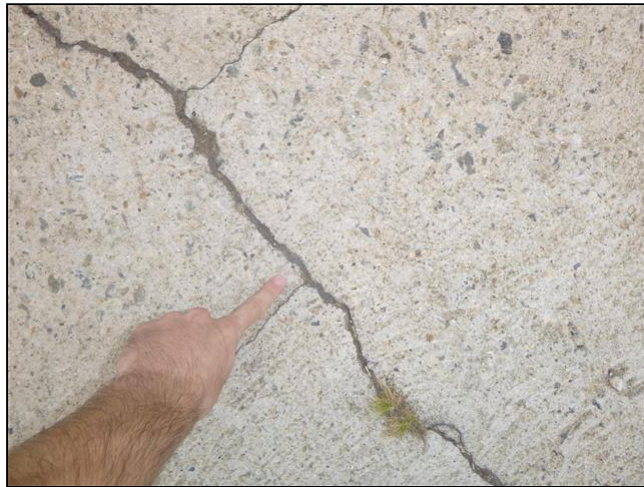
1.0 Item 1 (Picture)

1.0 (1) Settling, expansion cracks and heaving noted at various areas. Suggest review with a licensed contractor for repair/replacement costs as needed.

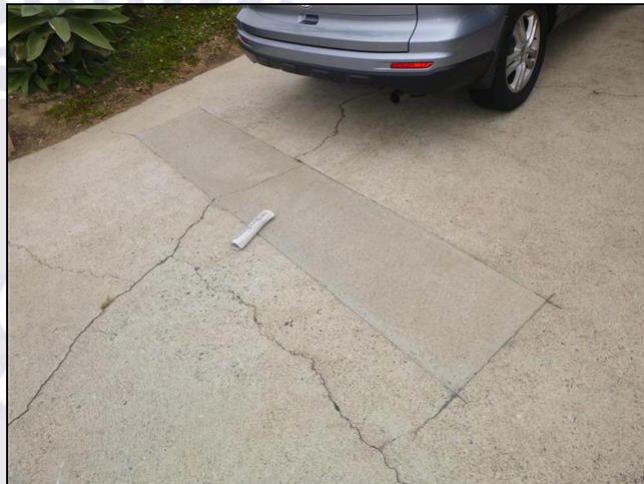
1.0 Item 2 (Picture)

1.0 (2) Patched and repaired areas of the driveway was noted. Suggest review with the seller on the cause and any repairs needed. Suggest repair as needed.

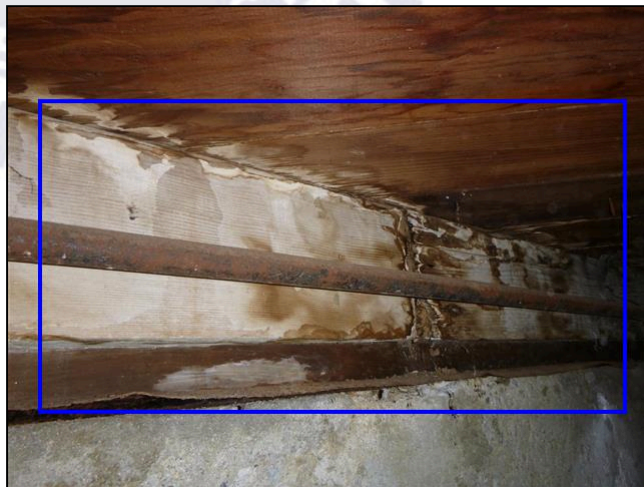
1.1 Item 1 (Picture)

1.1 (1) There is a negative slope towards the rear of the dwelling. This area does not appear to drain water away from home/foundation (water damage was noted in the crawl space at the rear of the dwelling due to the walkway's slope toward the rear of the dwelling), suggest regrading and/or the addition of sub-surface drainage as needed.

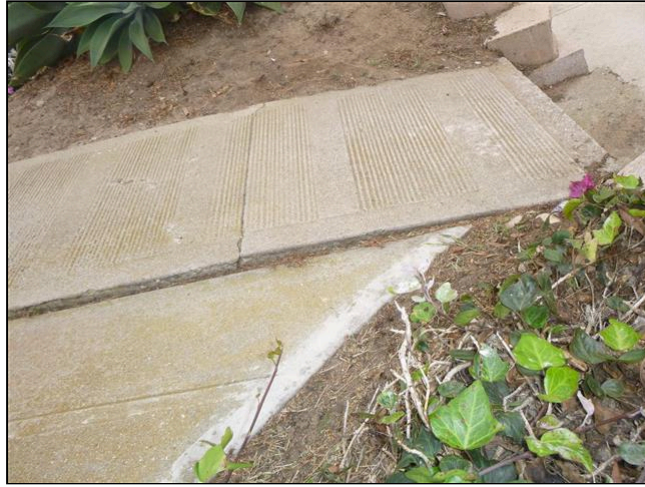
1.1 Item 2 (Picture)

1.1 (2) Settling and heaving noted at various areas, this is a potential trip hazard. Suggest review with a licensed contractor for repair/replacement costs as needed.

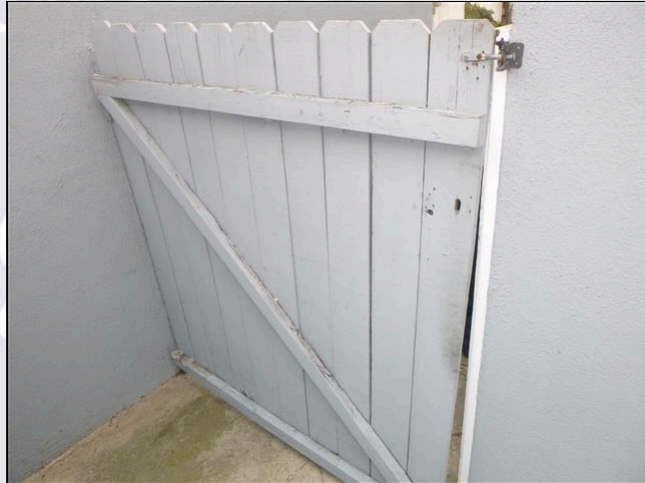
1.3 Item 1 (Picture)

1.3 The gates are deteriorated, suggest repair/replace as needed.

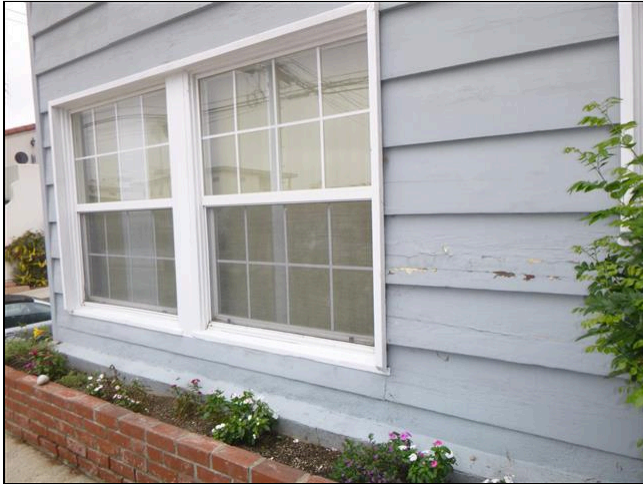
1.4 Item 1 (Picture)

1.4 (1) Paint blistering, peeling and wood deterioration noted at various wood siding areas. Suggest review with a licensed termite company and/or a licensed contractor for repair/replacement costs as needed.

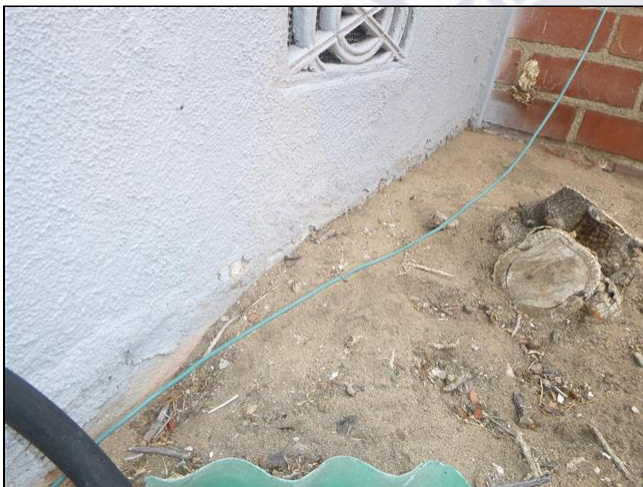
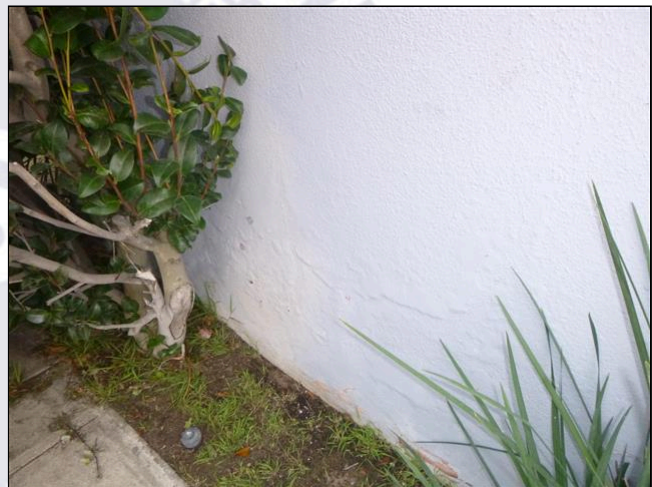
1.4 (2) Deteriorated and blistering stucco noted at various areas. See the Lot/Drainage comments and review with a licensed contractor to repair as needed and divert water away from the foundation areas.

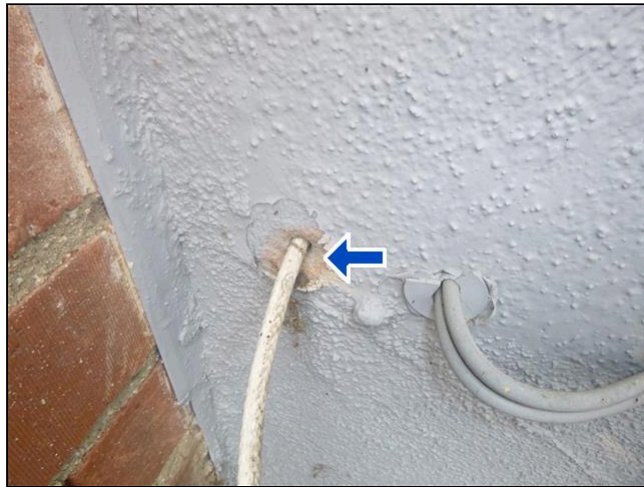
1.4 Item 5 (Picture)

1.4 (3) Suggest sealing around the siding penetration's to prevent future water/insect/rodent intrusion at these areas.

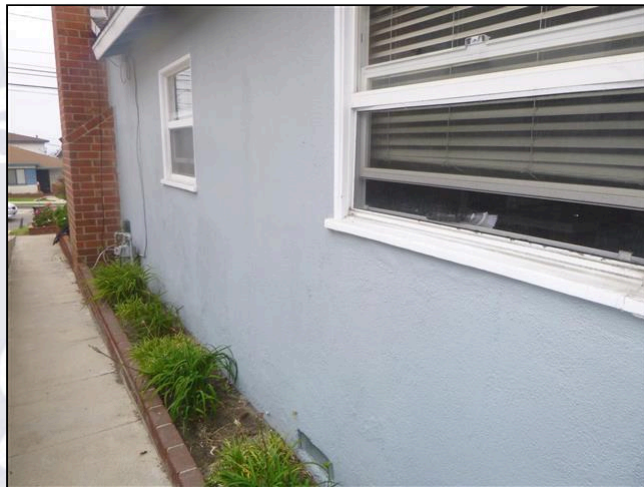
1.4 Item 6 (Picture)

1.4 (4) Various areas of the siding have been patched, suggest review with the seller on the cause and any repairs needed.

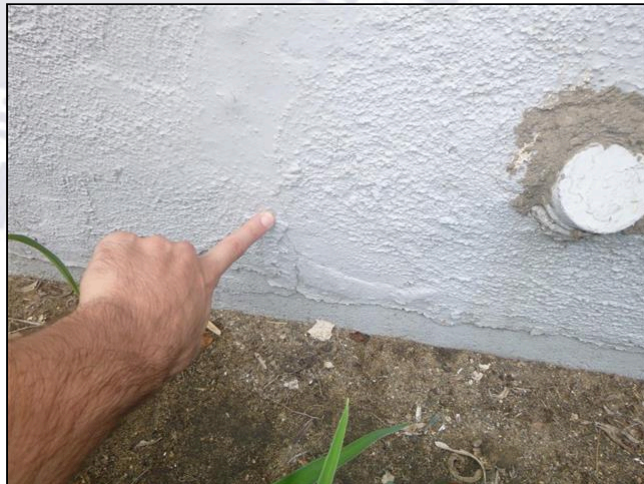
1.4 Item 7 (Picture)

1.4 (5) Common settling cracks noted at various areas of the stucco siding, suggest maintenance as needed.

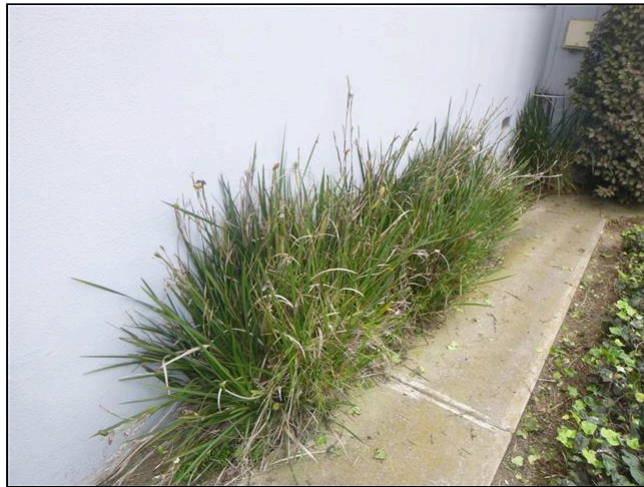
1.4 Item 8 (Picture)

1.4 (6) Multiple trees and bushes are in contact with the siding. Suggest trimming them away from the siding to prevent any future damage.

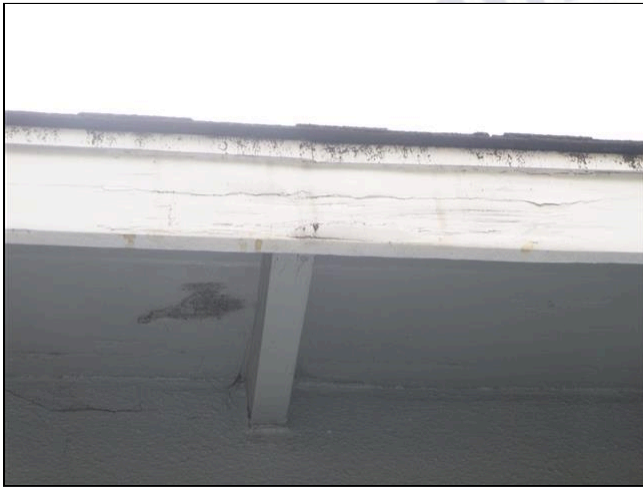
1.5 Item 1 (Picture)

1.5 Wood deterioration noted at various trim areas. Suggest review with termite company and/or a licensed contractor and repair/replace as needed.

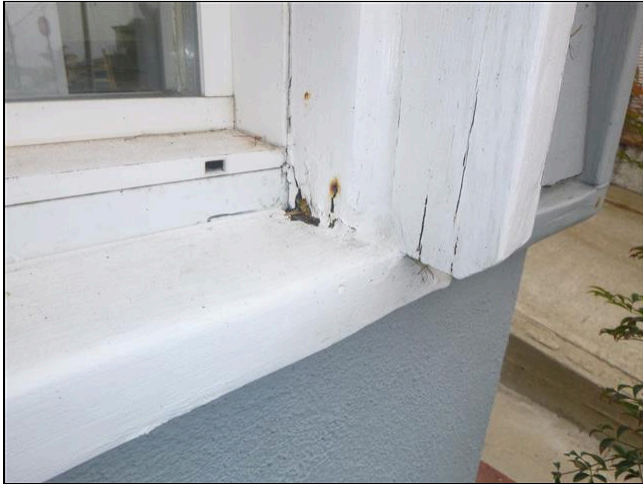
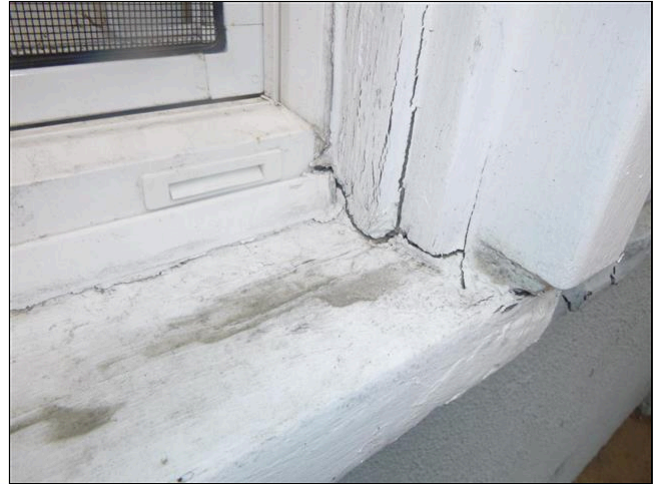
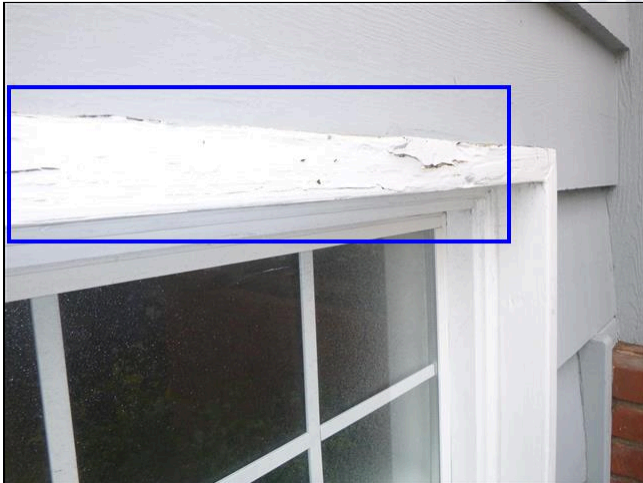
1.6 (1) Wood deterioration noted at various window frames. Suggest review with termite company and/or a licensed contractor and repair/replace as needed.

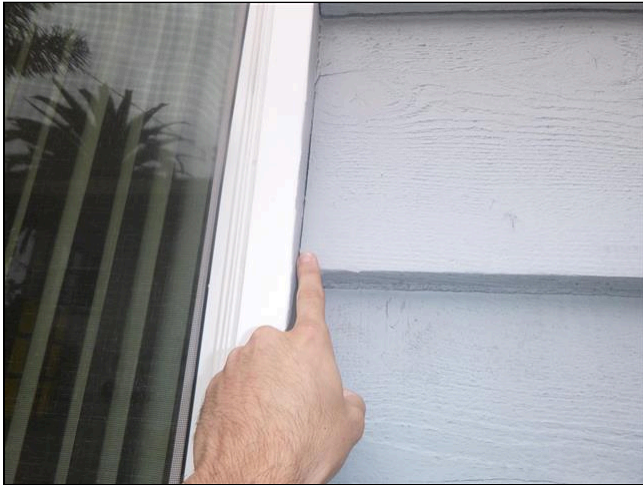
1.6 Item 4 (Picture)

1.6 (2) Various windows have not been fully sealed/flushed to the sills/siding as required and/or the sealant has deteriorated leaving extensive voids. Suggest review with a licensed contractor for costs to seal/flash the windows as required to prevent future water leakage and/or insect intrusion at these areas.

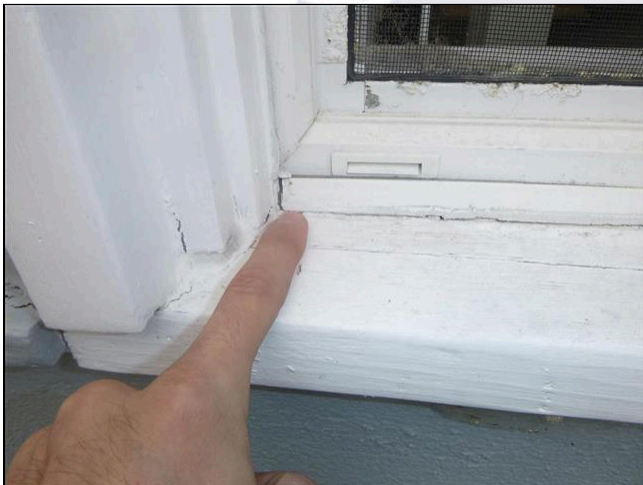
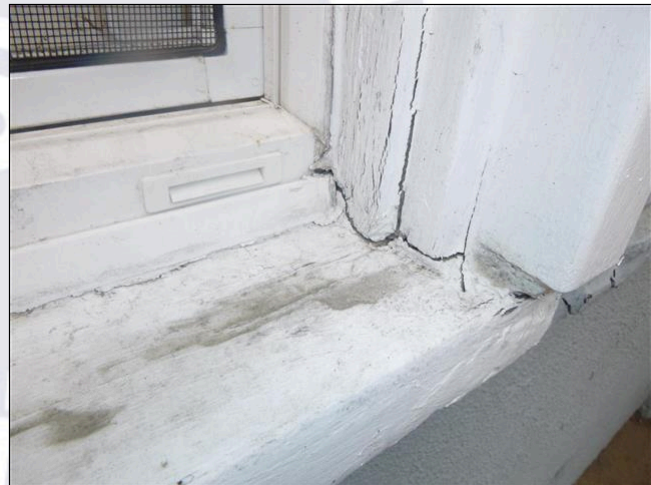
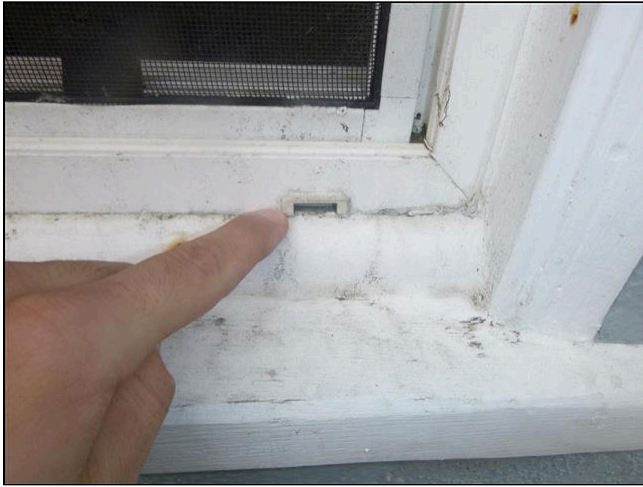
1.6 (3) The weep holes at the base of various windows are incorrect. The weep holes are either blocked or have seams/gaps to adjacent trims that will allow water to weep/seep into the interior of the dwelling. Evidence of water intrusion/damage was noted at multiple areas/rooms. Suggest review with a licensed contractor for removal/repair/ replacement costs as needed.

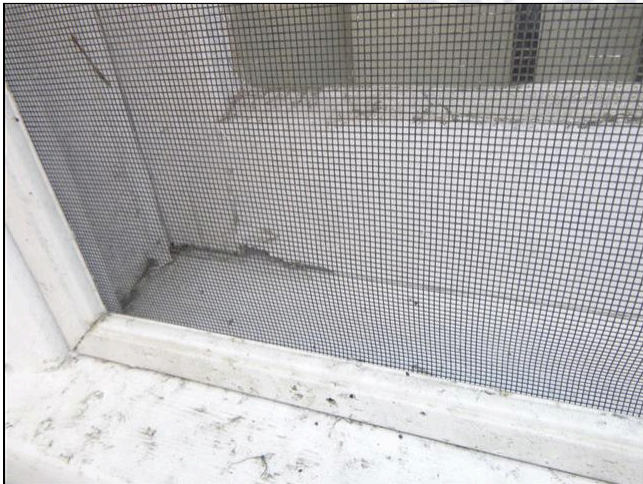
1.6 Item 9 (Picture)

1.6 (4) Wood deterioration noted at various wood windows. Suggest review with termite company and/or a licensed contractor and repair/replace as needed.

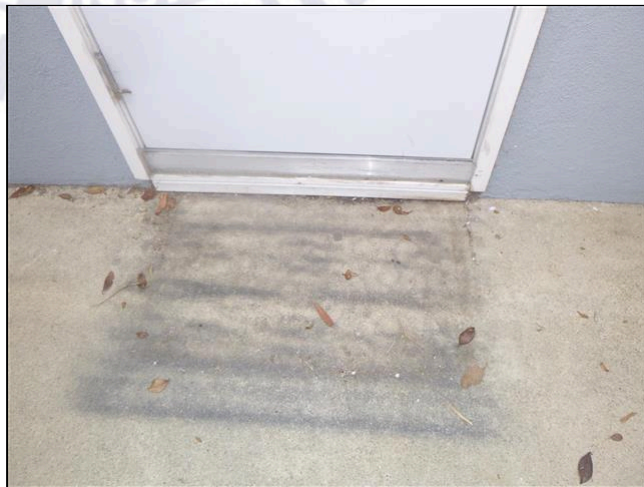
1.7 Item 1 (Picture)

1.7 Evidence of water intrusion was noted below the rear laundry door into the crawl space area. Suggest review with a licensed contractor for repair/ replacement costs as needed.

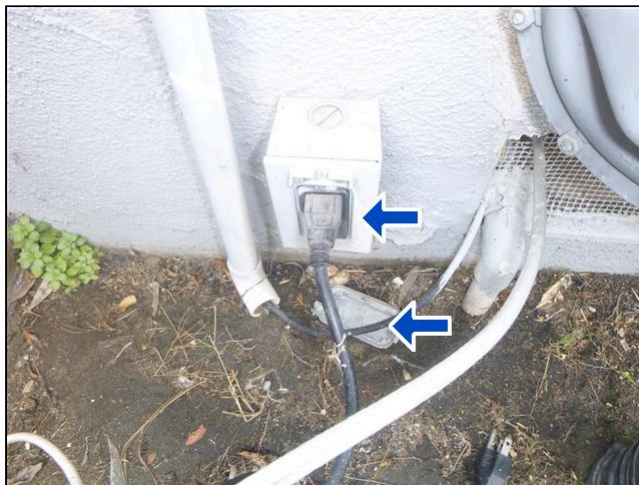
1.8 Item 1 (Picture)

1.8 The exterior outlet(s) weather cover(s) are damaged. Suggest repair for safety and as required.

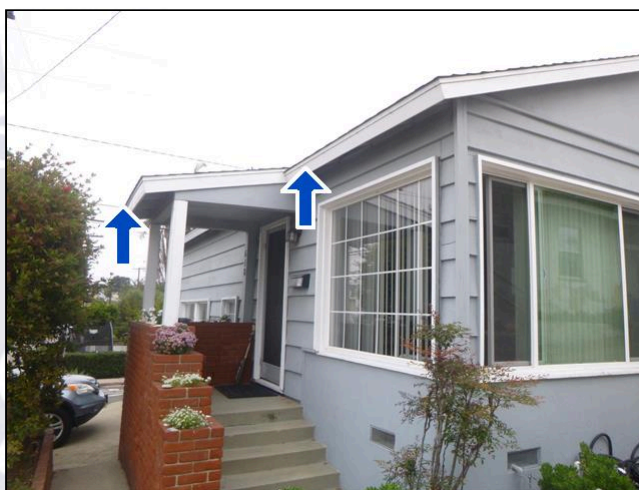
1.9 Item 1 (Picture)

1.9 Suggest installation of gutters throughout all eave areas and installation of an area drainage system to divert the water away from the foundation to the street as an upgrade.

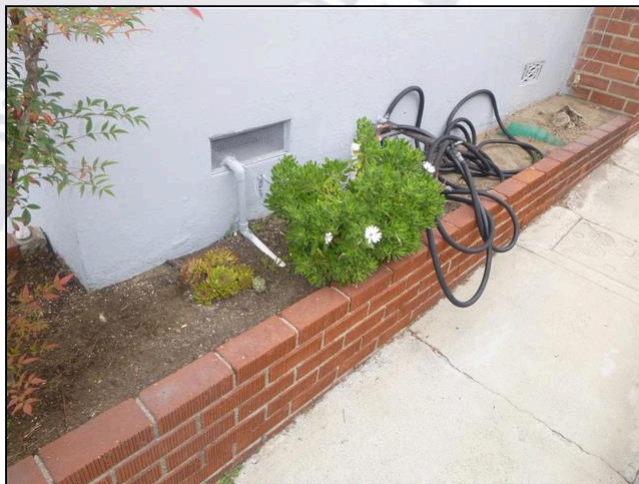
1.11 Item 1 (Picture)

1.11 (1) No drain holes noted in the planter(s). Suggest installing drain holes and/or removal of the planters to reduce/eliminate the water intrusion into the foundation/crawl space as needed.

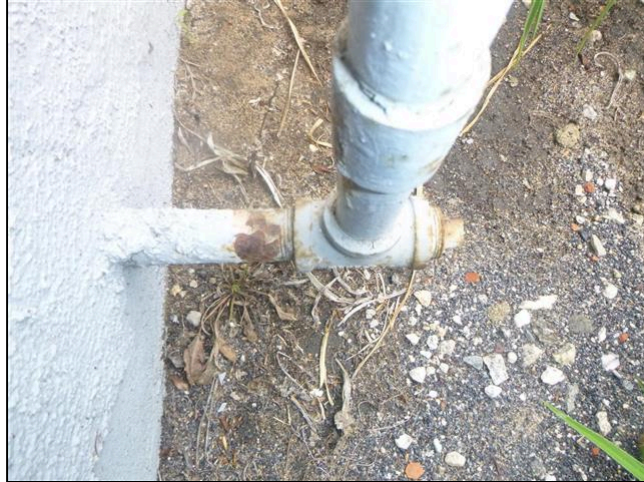
1.12 Item 1 (Picture)

1.12 Suggest painting or wrapping the exposed galvanized gas line to prevent excessive rusting.

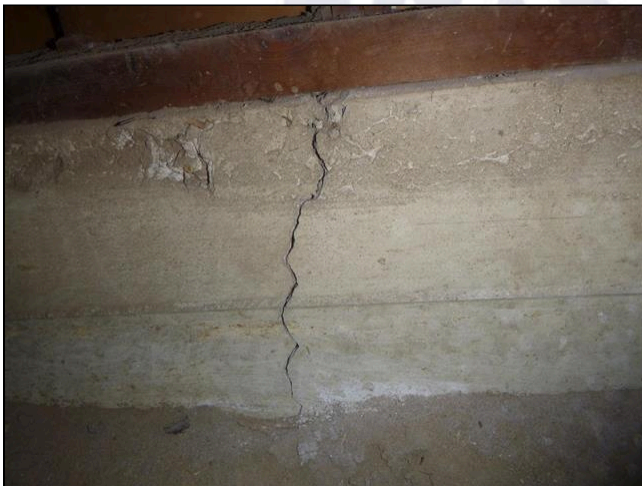
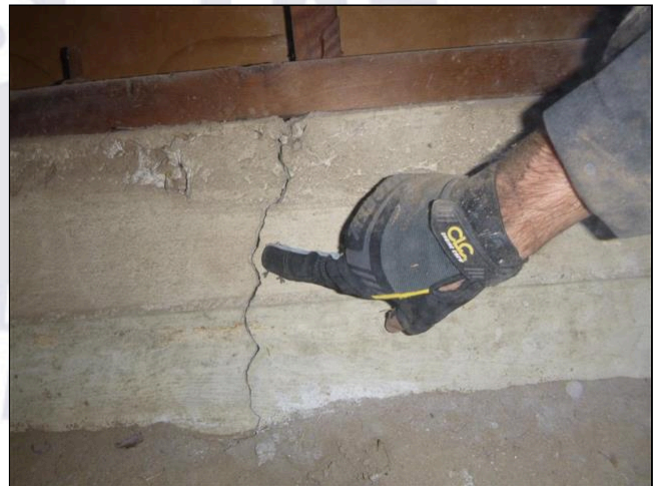
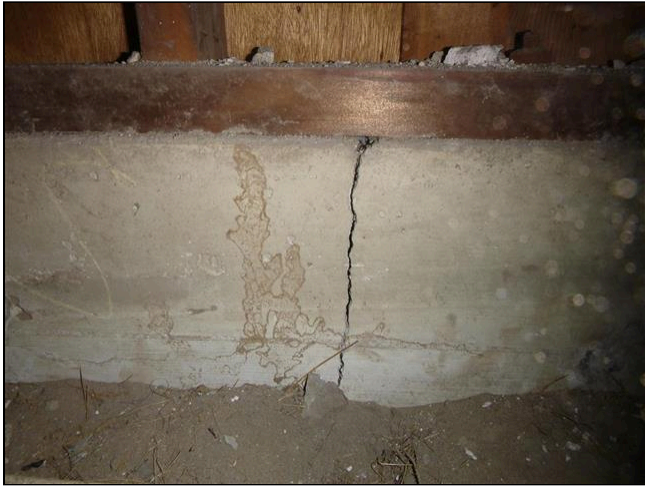
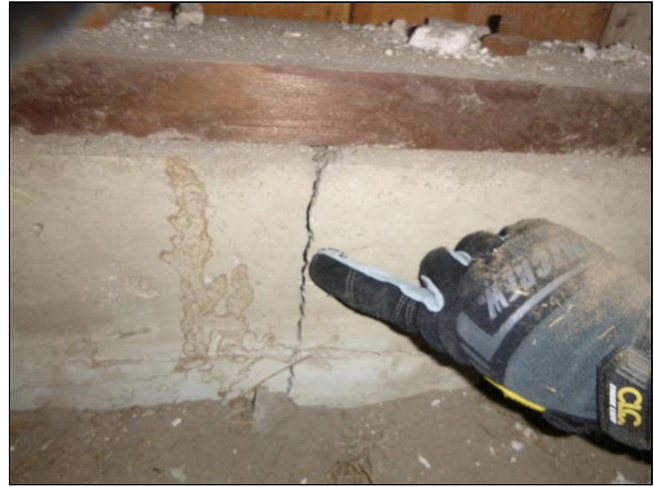
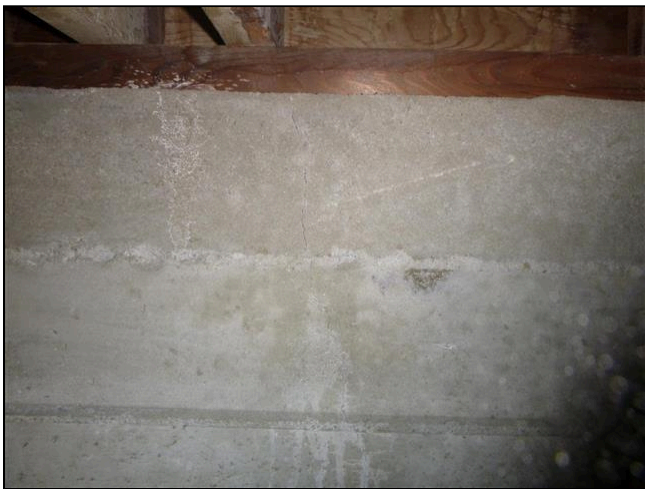
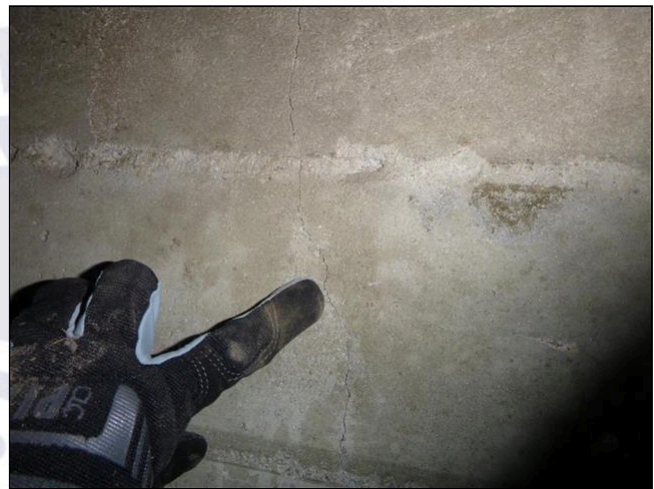
2.0 (1) Suggest installation of gutters throughout all eave areas and installation of an area drainage system to divert the water away from the foundation to the street as an upgrade.

2.0 (2) Re-grading where needed is recommended to assure all water drains away from the home's foundation. The inadequate drainage has caused minor settling/cracking/movement to the foundation, suggest review with a licensed contractor for installation of perimeter concrete walkways/barriers, rain gutters and an area drainage system to divert all the water away from the foundation.

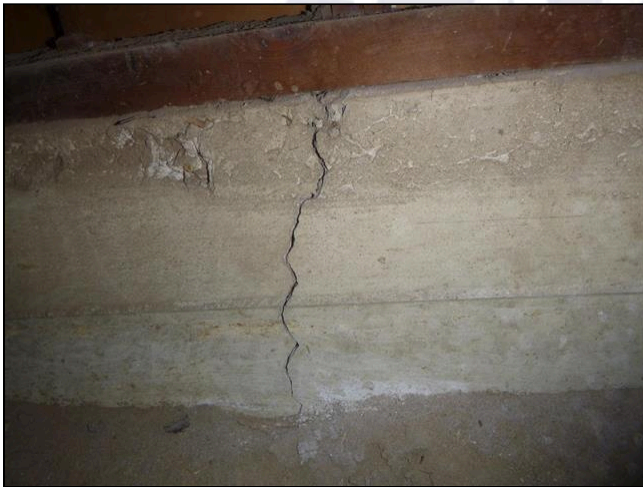
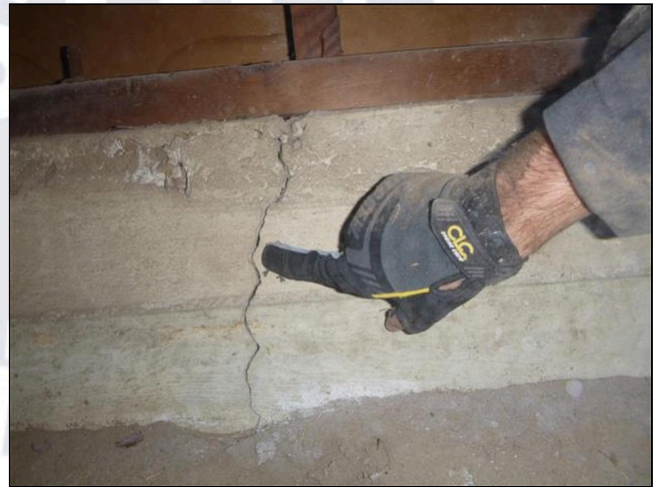
3.0 (1) Re-grading where needed is recommended to assure all water drains away from the home's foundation. The inadequate drainage has caused minor settling/cracking/movement to the foundation, suggest review with a licensed contractor for installation of perimeter concrete walkways/barriers, rain gutters and an area drainage system to divert all the water away from the foundation.

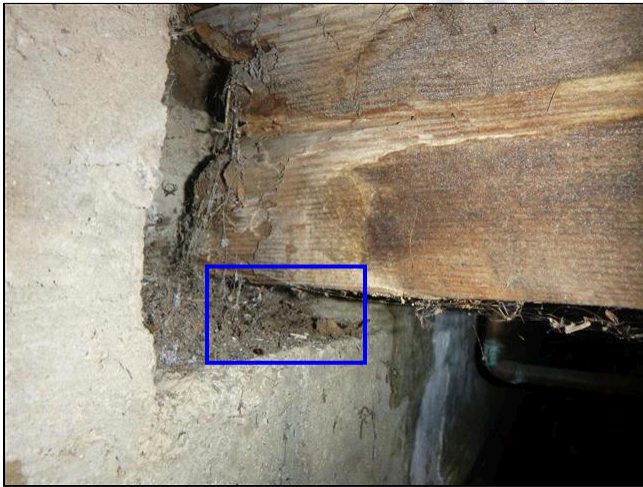
3.1 Item 1 (Picture)

3.1 (1) Various interior floor girders have settled, cracked and are missing the lower shims, suggest review with a licensed contractor for repairs as needed to prevent ongoing settling of the foundation.

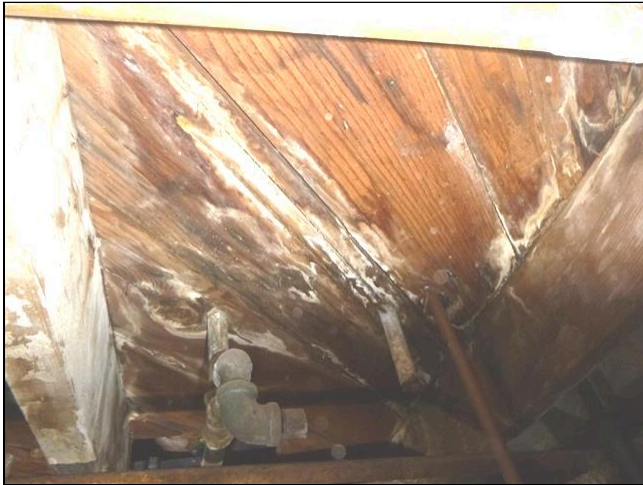
3.1 Item 3 (Picture)

3.1 (2) Wet areas, stains and excessive wood deterioration noted at various flooring and supports from ongoing leaks and water intrusion from the exterior. Suggest review with a termite company and/or a licensed contractor and repair/replace as needed.

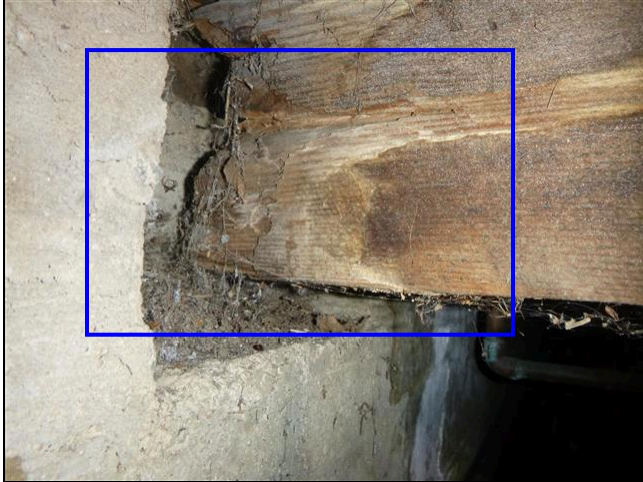
3.1 Item 7 (Picture)

3.1 (3) Wood deterioration noted at various flooring and supports. Suggest review with a termite company and/or a licensed contractor and repair/replace as needed.

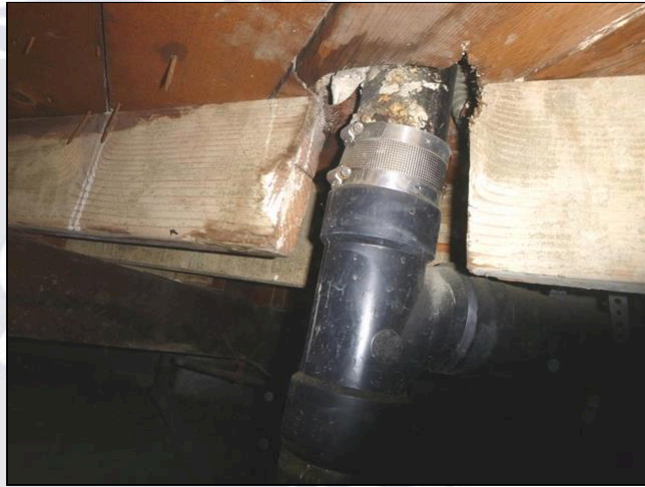
3.1 Item 9 (Picture)

3.1 (4) Excessive cutting and notching of various floor joists due to drainage installation. Suggest review by a licensed contractor for repair costs as needed.

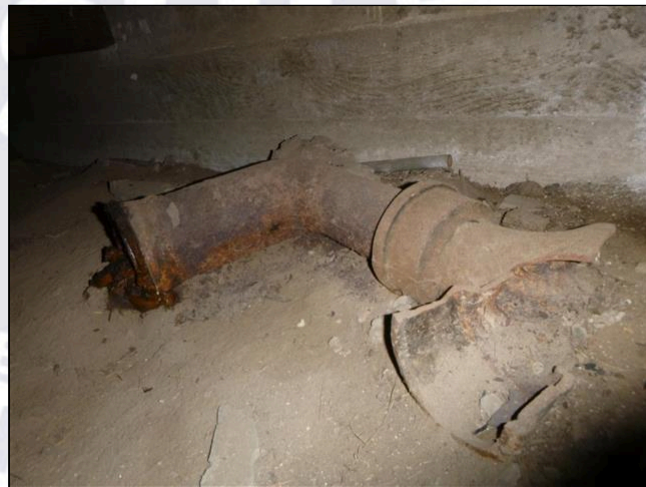
4.0 Item 1 (Picture)

4.0 (1) Suggest removal of debris and construction items from the crawl area.

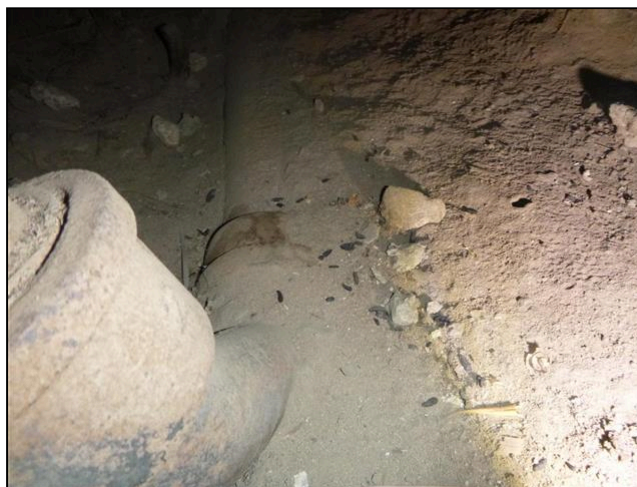
4.0 Item 2 (Picture)

4.0 (2) Pest droppings noted throughout the crawl space. Suggest review with a qualified pest control company.

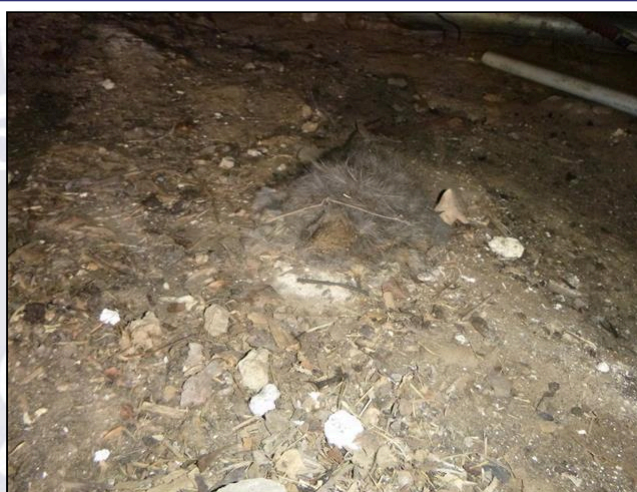
4.0 Item 3 (Picture)

4.0 (3) A decomposing animal/rodent was noted in the crawl space. Suggest review with a qualified pest control company for removal.

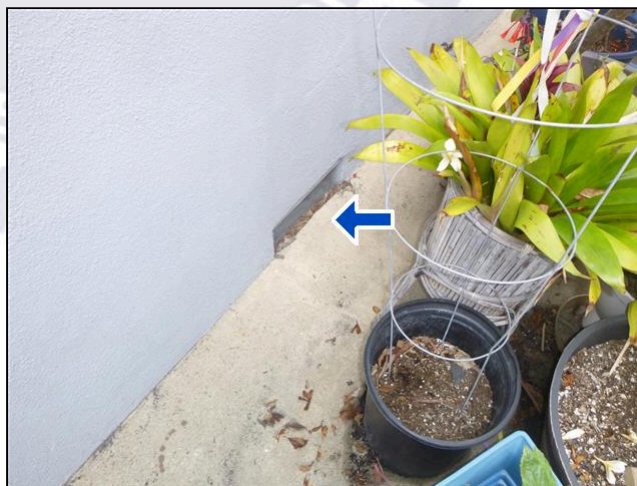
4.1 Item 1 (Picture)

4.1 Multiple crawl vents are below the exterior grade, suggest review by a licensed contractor and install a berm to reduce the water intrusion into the crawl area.

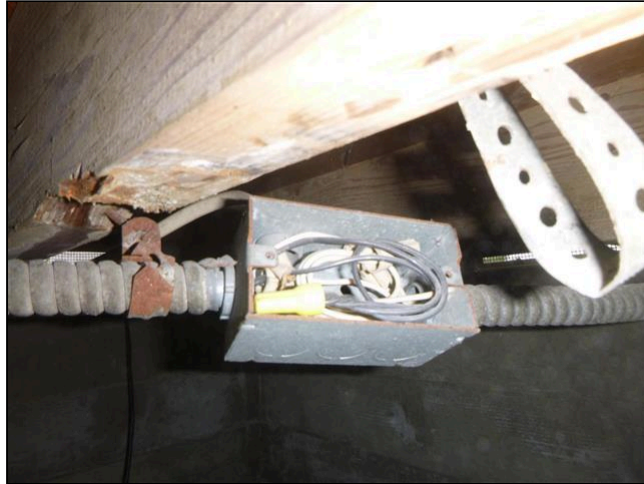
4.2 Item 1 (Picture)

4.2 Open junction boxes were noted. This is a safety concern. Whenever an electrical wire is cut and re-connected, the 'splice' should be encased in a covered junction box to prevent shocks and separation of the splice. Suggest review by a licensed electrician and repair as needed.

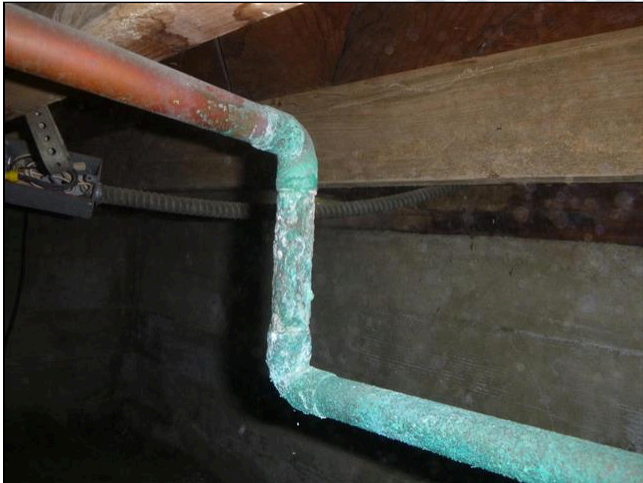
4.3 Item 1 (Picture)

4.3 (1) Excessive blue staining/deterioration was noted at the copper plumbing supply lines in the crawl space area. This type of staining/deterioration is a pre-cursor to pin hole leaks. Suggest review with a licensed plumber to evaluate the copper supply line(s) in the dwelling/crawl space and for repair/replacement costs as needed.

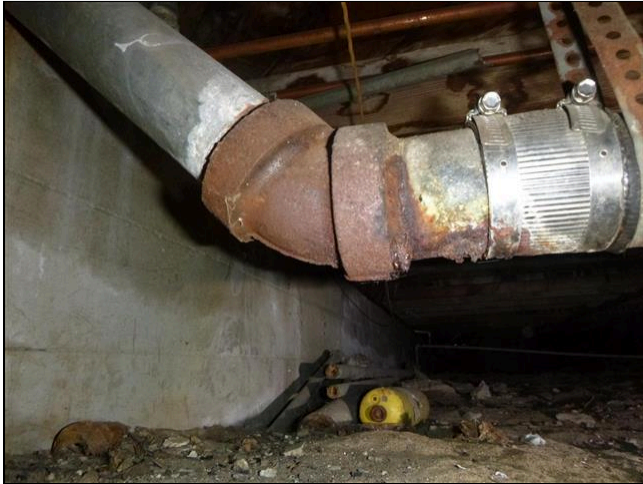
4.3 Item 4 (Picture)

4.3 (2) Excessive rust and seepage/deterioration noted at various cast iron drain lines within the crawl space.

Suggest review by a licensed plumbing contractor for replacement costs as needed to prevent leakage at the crawl area.

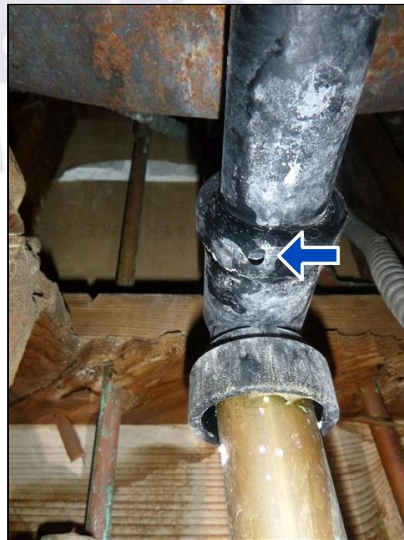
4.3 Item 8 (Picture)

4.3 (3) An actively leaking ABS drain line was noted at the rear hallway bathroom tub drain. The leaking drain line has caused saturation of the soil in the crawl area. Suggest review by a licensed plumbing contractor for replacement costs as needed to prevent on-going leakage at the crawl area.

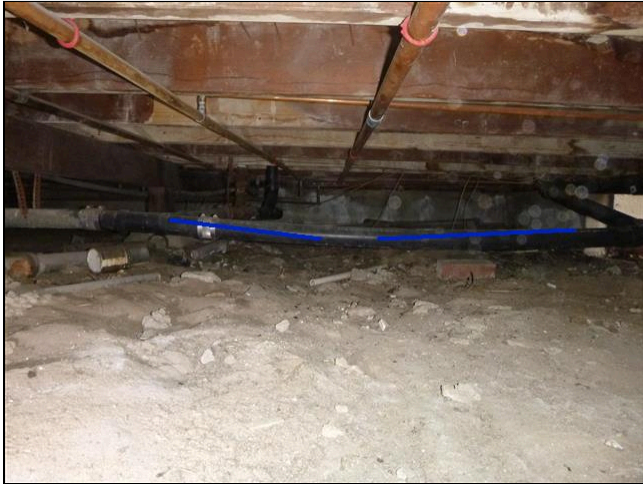
4.3 Item 9 (Picture)

4.3 (4) Inadequate slope noted at various drains in the crawl area, suggest review with a licensed plumber for costs to re-slope the drains as required/needed.

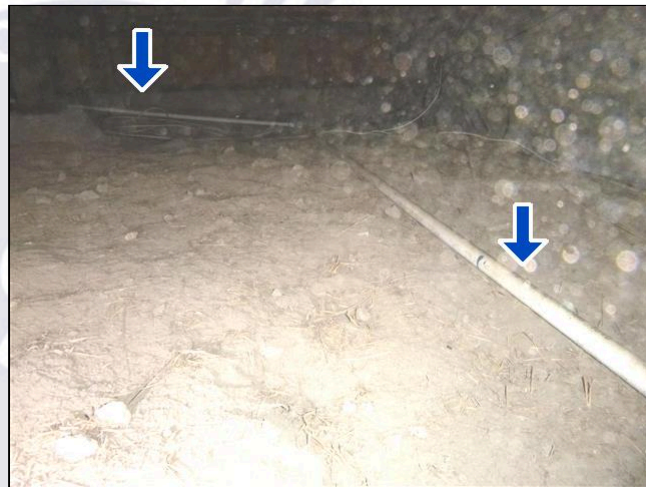
4.3 Item 11 (Picture)

4.3 (5) Plastic PVC plumbing for the irrigation system noted transferring through the crawl area. Suggest review by a licensed plumber for removal of the PVC from the crawl area as this product is not suitable or allowable in this area.

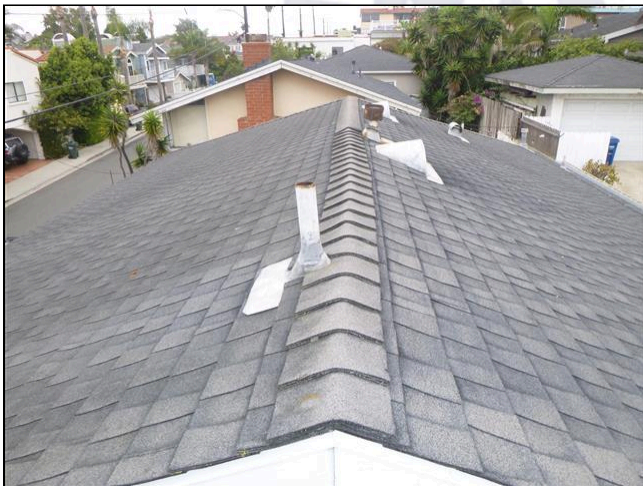
5.0 Item 1 (Picture)

5.0 (1) Minor deterioration of the roofing was noted, suggest review with a licensed roofing contractor for repairs, periodic maintenance and to determine the remaining life expectancy of the roof.

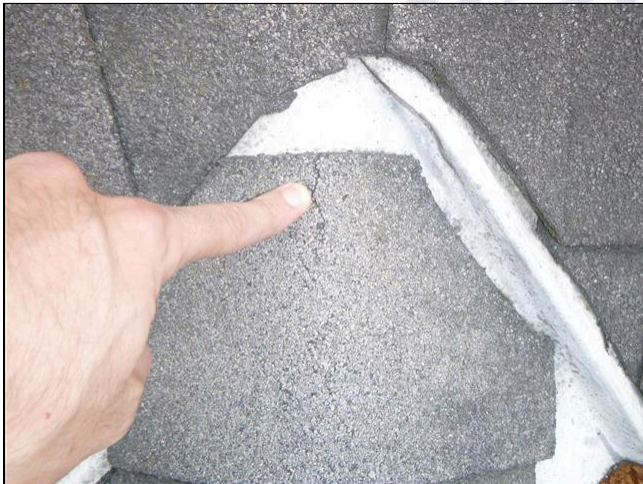
5.0 Item 5 (Picture)

5.0 (2) Deteriorated ridge caps noted at the pitched roof, suggest review by licensed roofer for replacement costs and replace as needed.

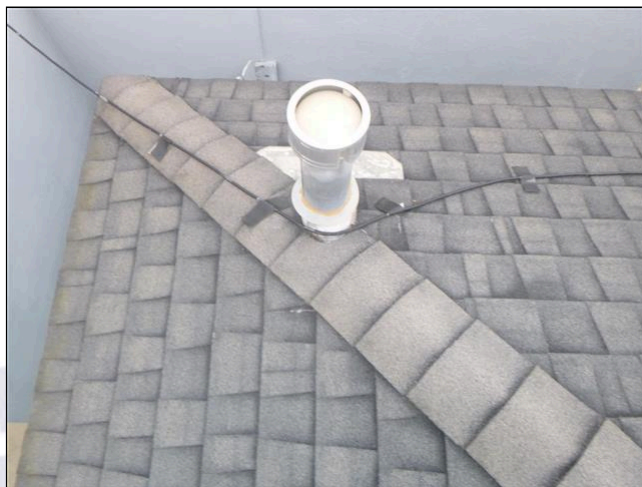
5.1 Item 2 (Picture)

5.1 (2) Two flashings are incorrectly installed on the ridge (penetrations should not be installed on a ridge). Suggest review with a licensed roofer for repair/relocation costs as needed to prevent future leakage.

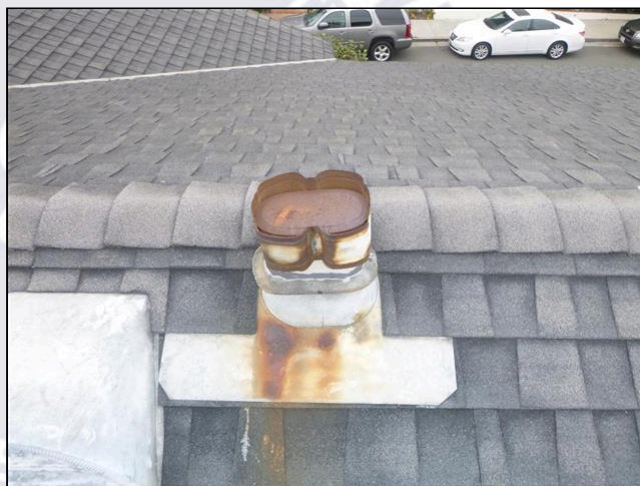
5.1 Item 3 (Picture)

5.1 (3) Rusted flashings noted at various areas, suggest review with a licensed roofer for repairs as needed.

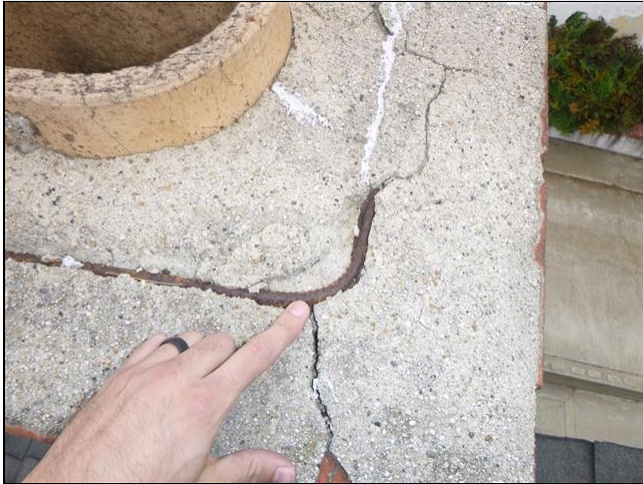
5.2 Item 1 (Picture)

5.2 (1) Excessive cracks and exposed rebar was noted at the chimney crown, suggest repairs/sealing as needed to prevent future water intrusion and deterioration.

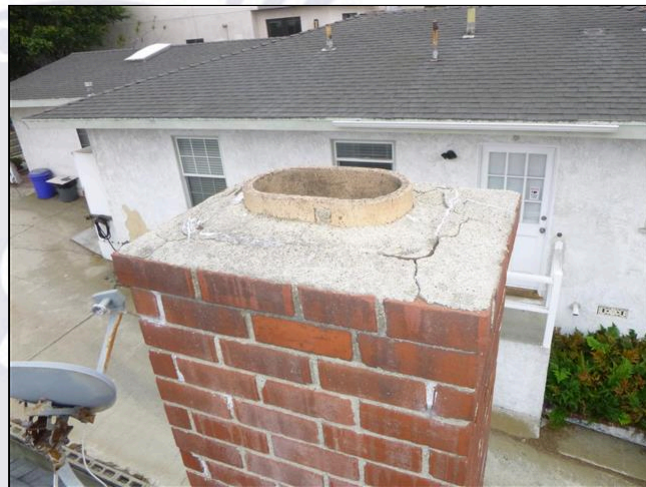
5.2 Item 3 (Picture)

5.2 (2) The chimney has no rain cap or spark arrestor. Suggest installation of a rain cap and a spark arrestor to prevent water intrusion and a potential fire spread hazard.

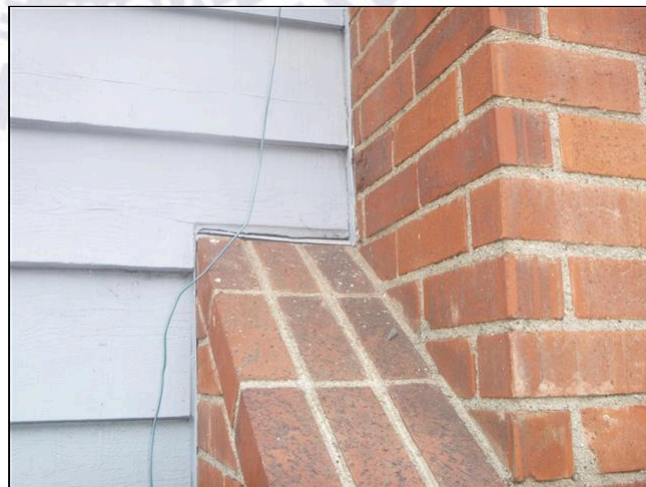
5.2 Item 4 (Picture)

5.2 (3) The chimney flashing to the siding is open at various areas, suggest sealing to prevent water and insect intrusion.

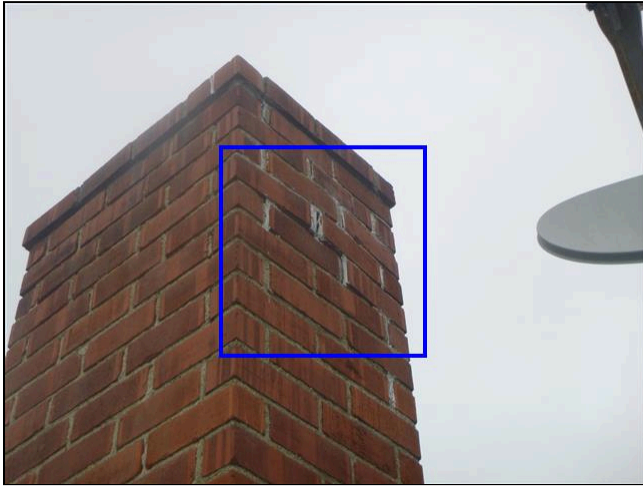
5.2 Item 5 (Picture)

5.2 (4) Cracks/bulging was noted at the chimney bricks at the top section, suggest repairs and sealing to prevent

future water intrusion and deterioration.

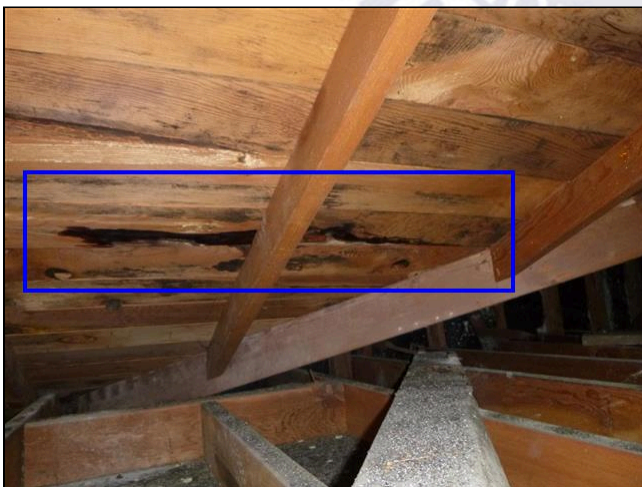
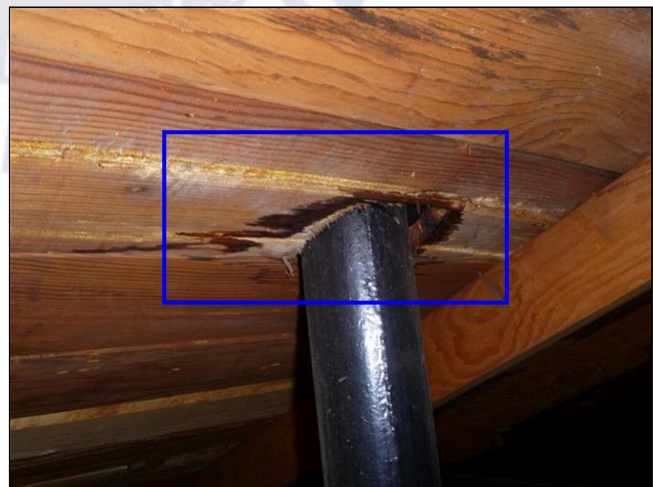
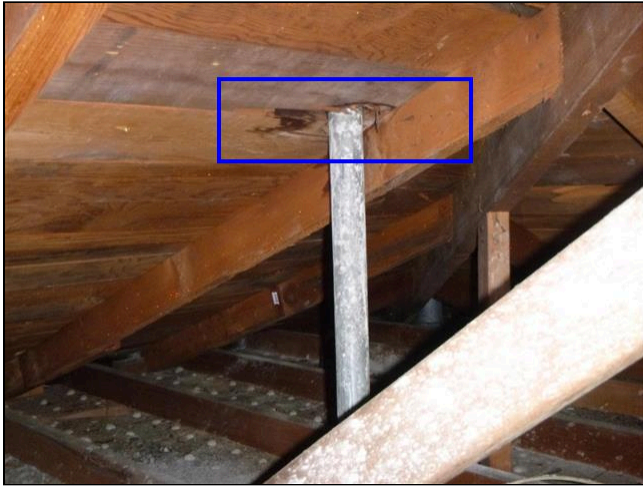
6.0 (1) Moisture stains noted at various areas of the attic sheathing/framing, unable to determine if the staining is past or present. Suggest review with the seller and a licensed roofer as needed.

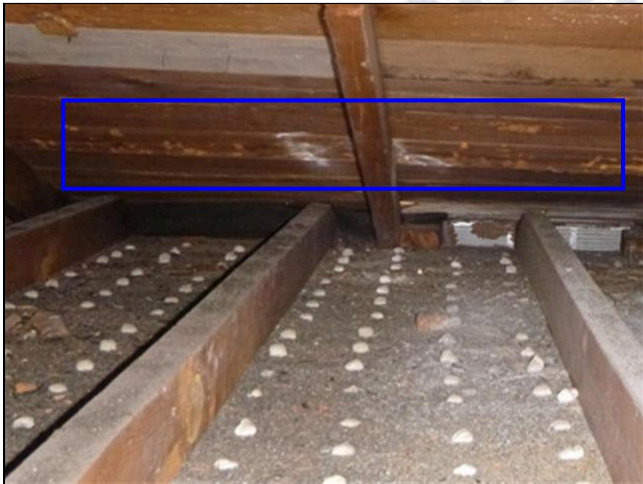
6.0 Item 4 (Picture)

6.0 (2) Wood deterioration noted at various areas of the roof framing, suggest review with a termite company and/or a licensed contractor for repairs as needed.

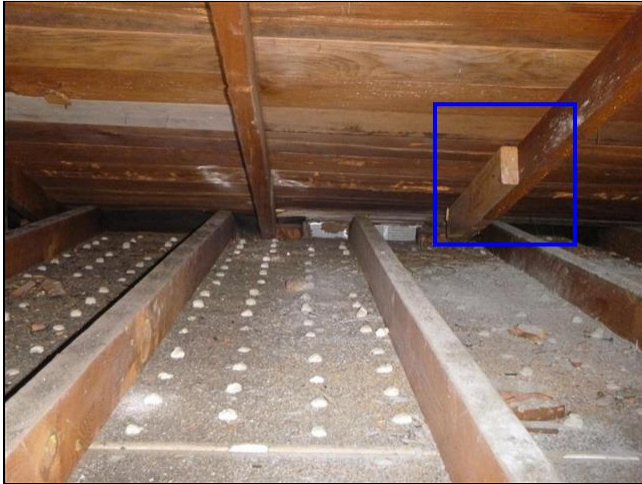
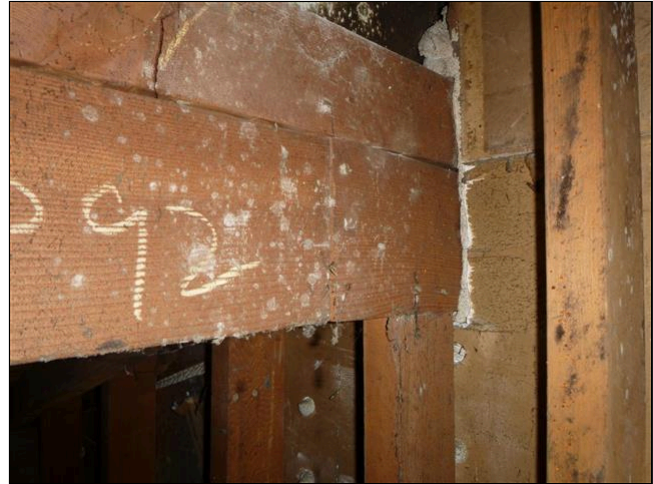
6.0 (3) Repaired roof rafters and additional beams/framing/ceiling supports noted at various areas within the attic. Suggest review with the seller/city and/or a licensed contractor/structural engineer on this installation as needed.

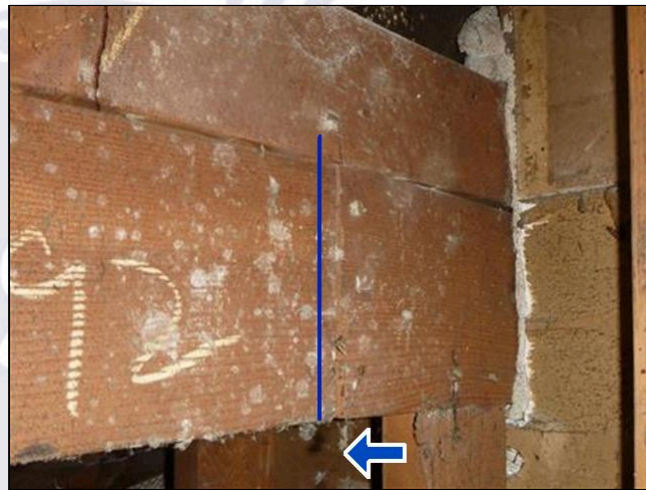
6.0 Item 8 (Picture)

6.0 (4) Typically, wood support members should have vertical supports at any splice/joint (this area does not), suggest review with a licensed contractor and for re-supporting costs as/if needed.

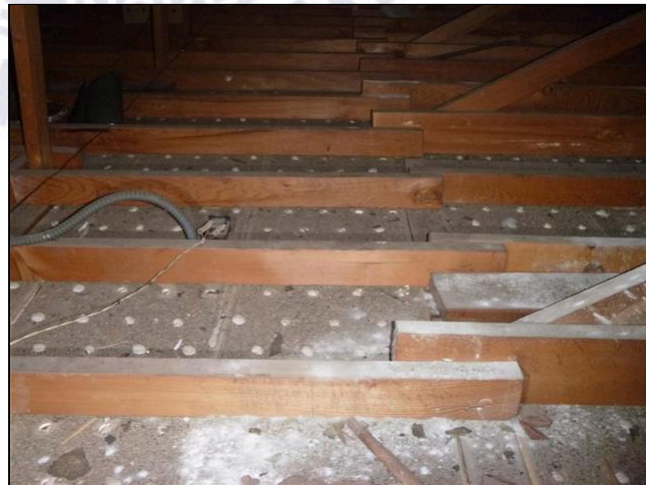
6.1 Item 1 (Picture)

6.1 No Insulation installed at the attic area, this is common for the original age of the home. Suggest review by a licensed contractor for installation costs as an upgrade.
