Inspection Report

Property Address:
618 Prospect Ave
Hermosa Beach CA 90254

Ferguson Home Inspections

Date: 10/13/2022	Time: 02:00 PM	Report ID: 10132022Prospect
Property: 618 Prospect Ave Hermosa Beach CA 90254	Customer: Wendy & Scott Fletcher	Real Estate Professional: Amy Teitelbaum

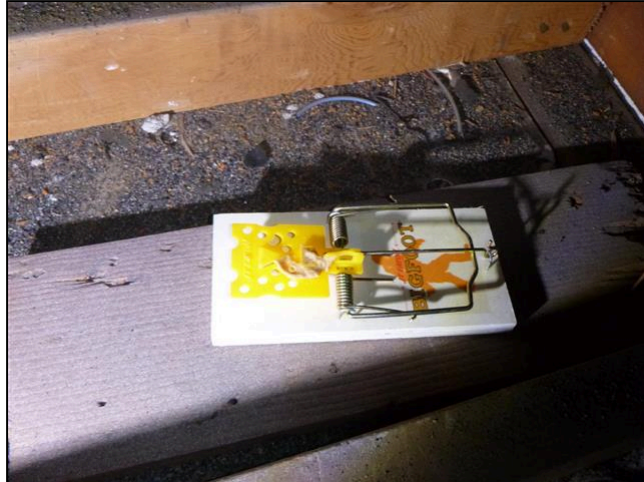
6.4 Item 1 (Picture)

6.4 (1) Pest droppings/traps noted within the attic. Suggest review with a qualified pest control company and/or a licensed contractor for removal costs of the droppings, re-screening of the vents and any removal/replacement of the attic insulation as needed.

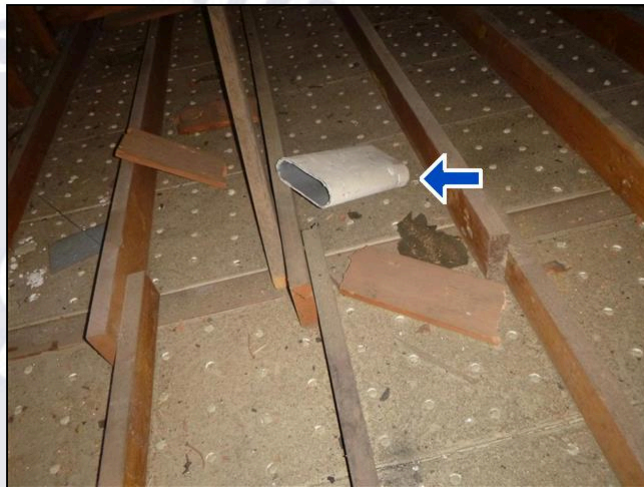
6.4 Item 2 (Picture)

6.4 (2) Abandoned asbestos vent pipes noted in the attic area, suggest review with a licensed contractor for removal costs as needed.

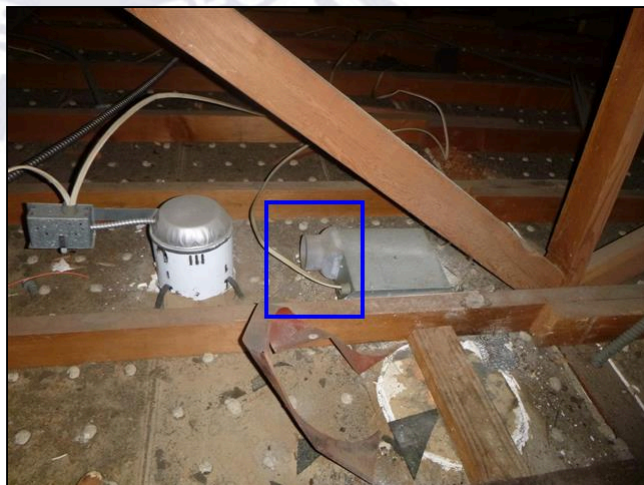
6.4 Item 3 (Picture)

6.4 (3) The kitchen's exhaust vents into attic, suggest review by a licensed contractor to vent to the exterior as required.

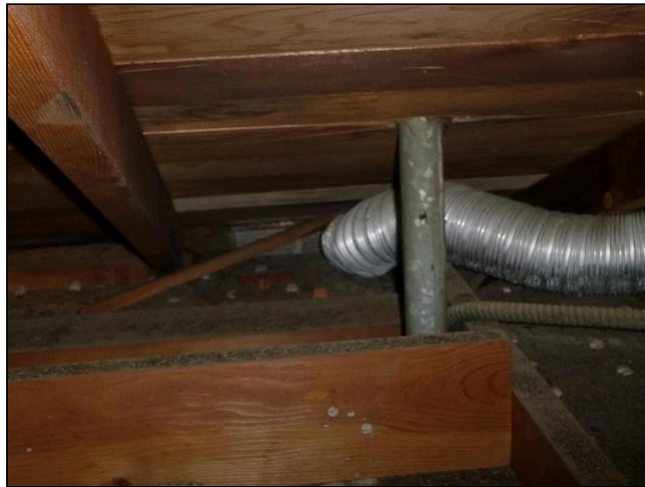
6.4 Item 4 (Picture)

6.4 (4) The exhaust fan systems for both bathrooms are currently venting into attic, suggest review by a licensed contractor to vent to the exterior as required.

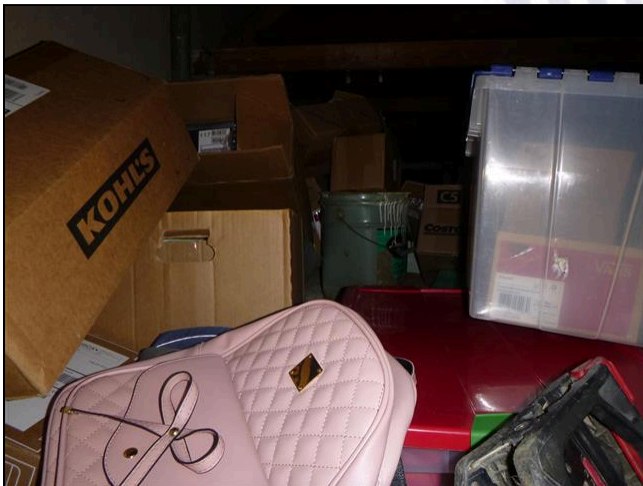
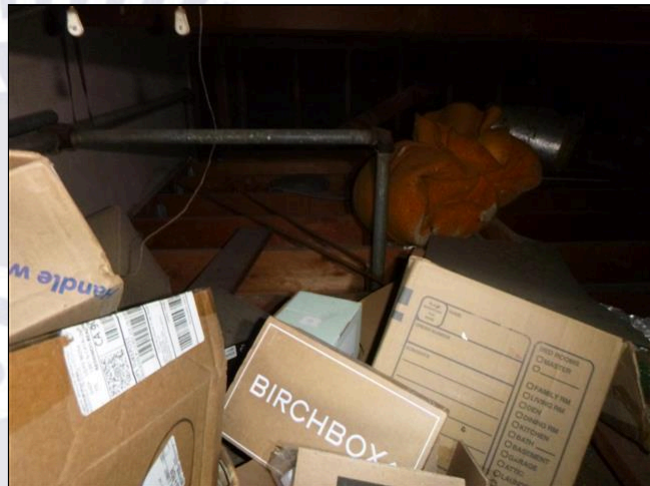
6.4 (5) Access within the front left master attic was severely limited due to the restrictive clearances/personal effects.

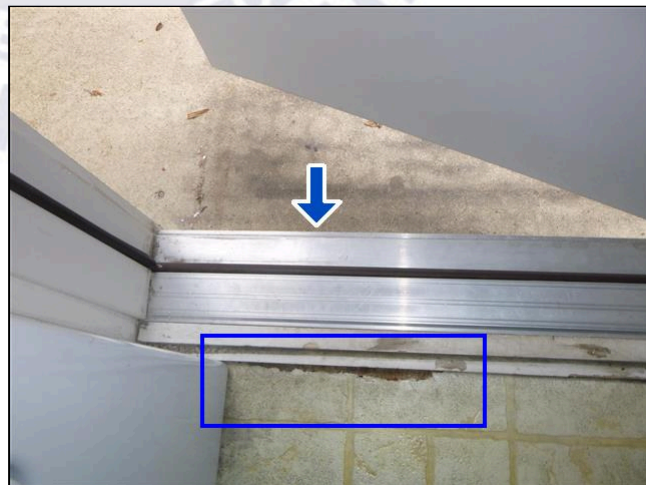
7.0 Item 1 (Picture)

7.0 The flooring is deteriorated and lifting. Water intrusion was noted below the door into the crawl space and has damaged the subflooring and sill plate. Suggest review with a licensed contractor for removal/repair/ replacement costs as needed.

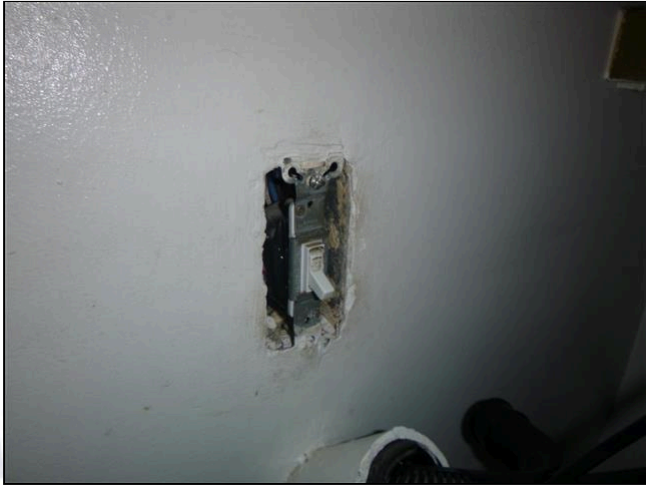
7.4 Item 1 (Picture)

7.4 (1) Various wall switch covers are missing, suggest installation for safety.

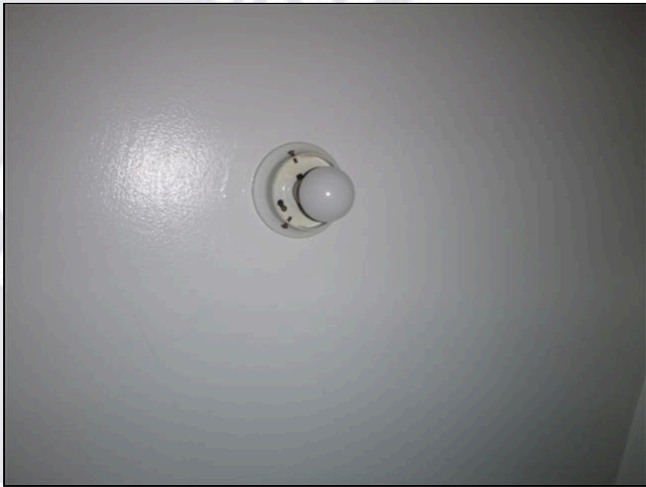
7.4 Item 2 (Picture)

7.4 (2) The cover globe(s) are missing at light fixture(s) at the time of the inspection. Suggest replacing the missing cover globe(s) for safety.

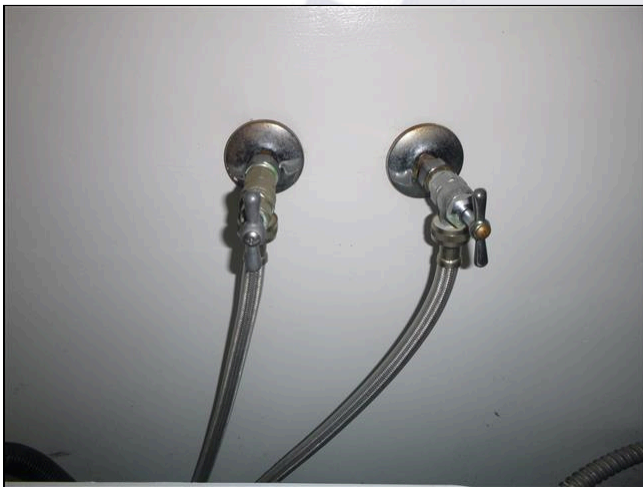
7.5 Suggest upgrading with 'hammer valve' plumbing supply systems if a water sensor/efficient/smart washing machine is to be installed at this area.

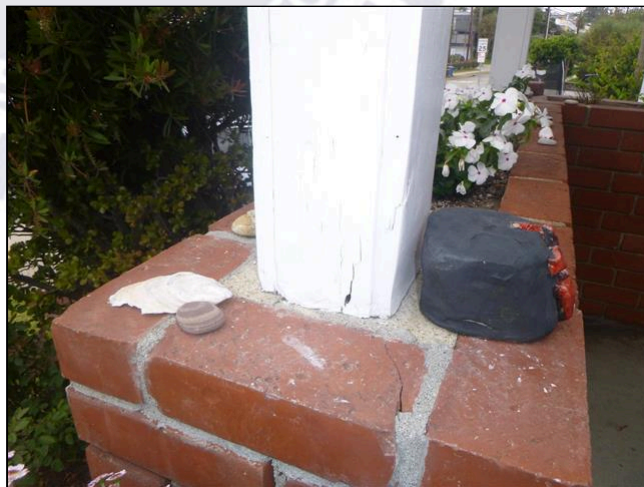
8.0 Item 1 (Picture)

8.0 Wood deterioration noted at various areas. Suggest review with termite company and/or review with a licensed contractor for repair/replacement costs as needed.

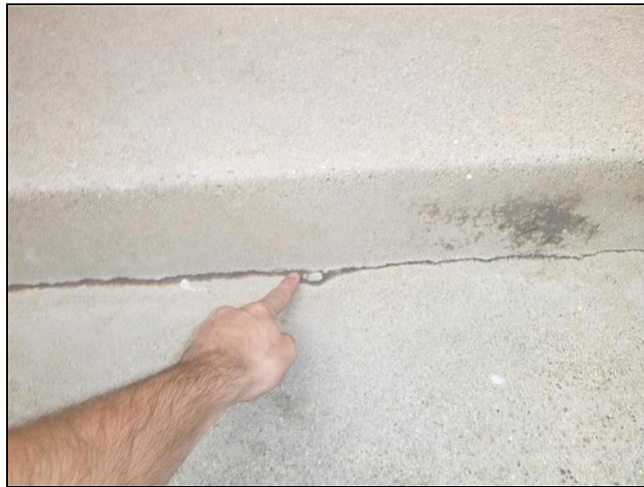
8.1 Item 1 (Picture)

8.1 Minor movement and settling noted at the patio, this is common for the original age of the dwelling. Suggest review with a licensed contractor for repairs as needed.

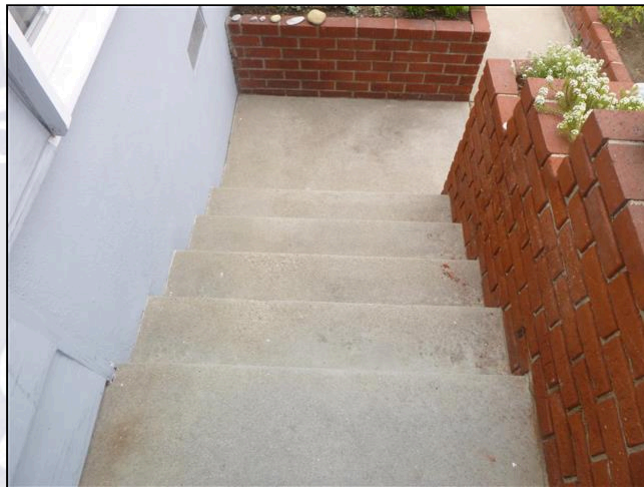
8.2 Item 1 (Picture)

8.2 No railing installed at the front steps at the time of the inspection. Common for the age of the property. Possible safety hazard. Suggest installation of railing to current standards to enhance safety.

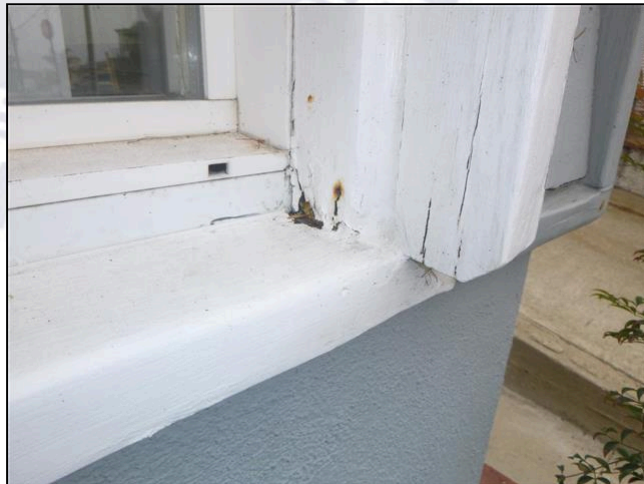
8.4 Item 1 (Picture)

8.4 Wood deterioration noted at various window frames. Suggest review with termite company and/or a licensed contractor and repair/replace as needed.

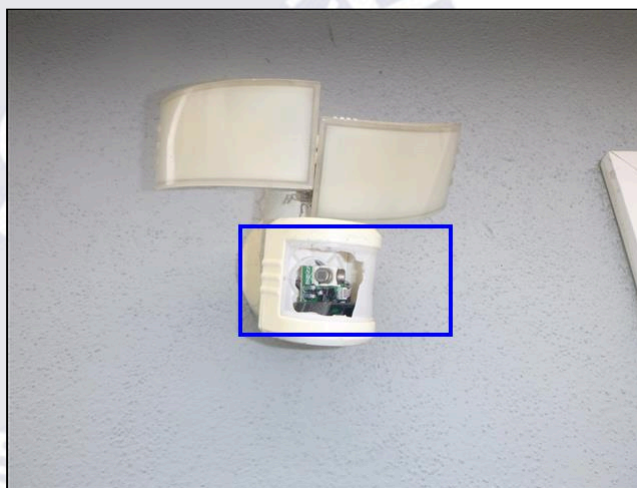
9.2 Item 1 (Picture)

9.2 The light fixture sensor was deteriorated. Suggest repair/replace as needed.

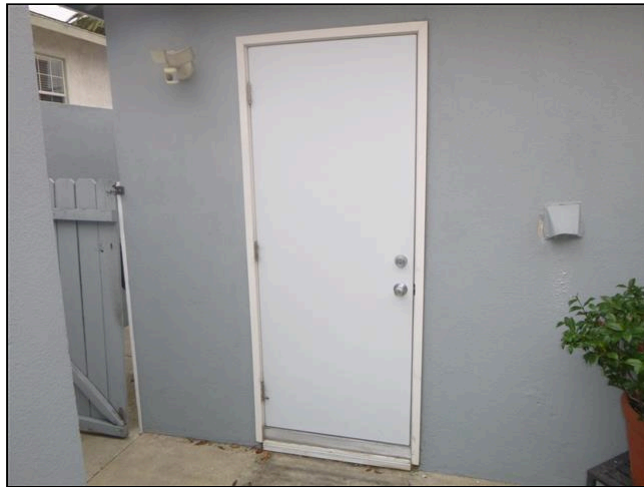
9.3 Item 1 (Picture)

9.3 (1) The existing door currently opens out from the dwelling. Generally exterior doors are required to open into the dwelling for safety. Suggest review with a licensed contractor to re-hang the door to open in as needed.

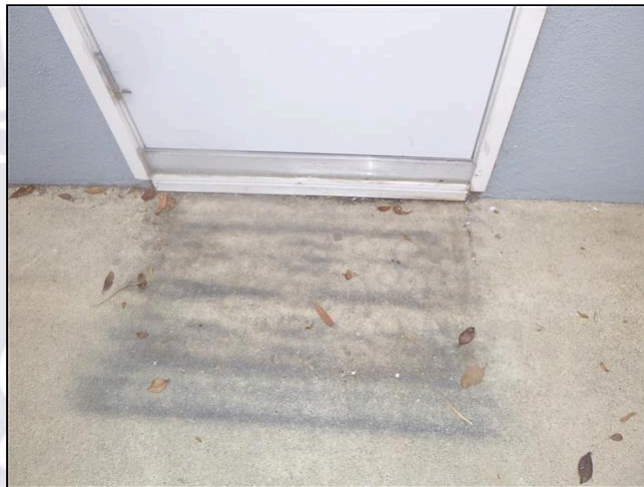
9.3 Item 2 (Picture)

9.3 (2) Evidence of previous and ongoing water intrusion noted at the door(s) to the interior. Deteriorated and stained flooring/wood members noted. Suggest review with a licensed contractor for repair/replacement costs as needed to prevent further and future water intrusion at this area.

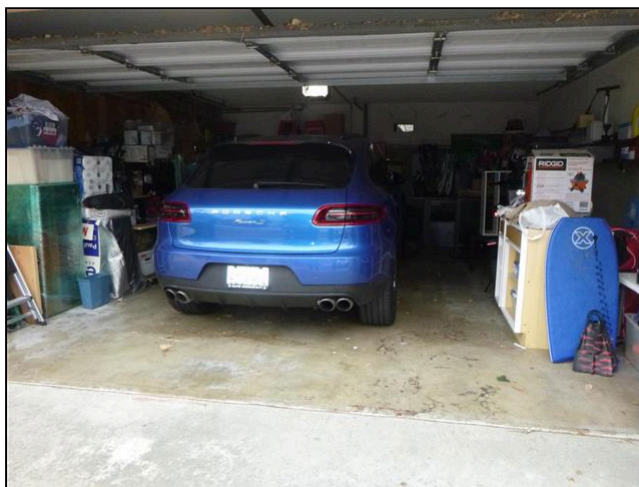
10.0 Item 1 (Picture)

10.0 (1) Access within this area was blocked or severely limited at the time of the inspection. An inspection of this area can be performed by appointment and at an additional cost when the area is made accessible.

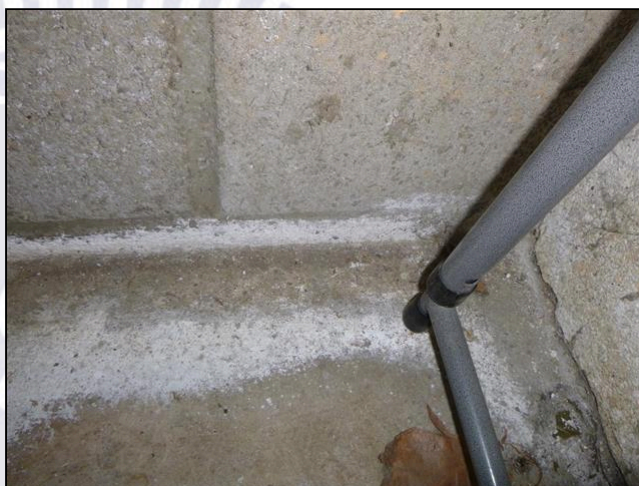
10.0 Item 2 (Picture)

10.0 (2) White efflorescence (powder substance) on foundation footings indicates prior, and possibly ongoing, excessive moisture build up at the exterior of the foundation. Ongoing water intrusion at the foundations can, in some cases, cause the steel in the foundations to rust, called spalling, which can lead to horizontal cracking of the foundation (currently there are no major horizontal cracks visible at the foundation). Any future horizontal cracking/damage can be an expensive repair as the foundation would be considered structurally weak and susceptible to horizontal movement. Suggest review of the Lot/Grade and drainage systems, including rain gutters, to reduce and prevent further and future water buildup at the exterior of the dwellings foundations.

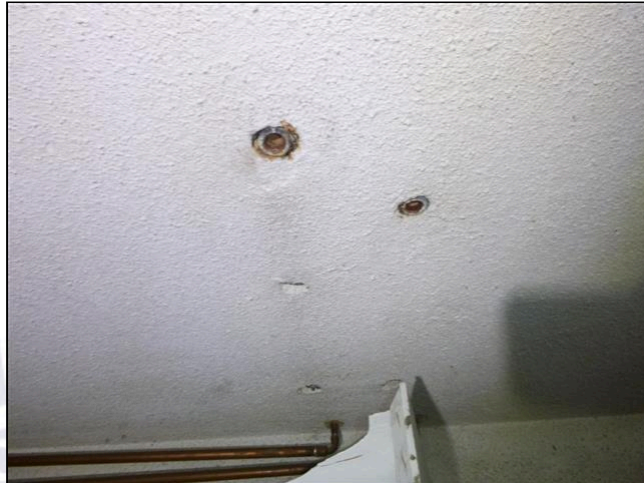
10.4 Item 1 (Picture)

10.4 (2) Holes and unfinished sections of firewall and ceiling were noted, this is a potential fire spread hazard. 5/8 inch sheetrock may be installed as a minimum standard material and as a requirement for a one hour burn through rating for firewall. Suggest review by licensed contractor for repair/installation costs as needed.

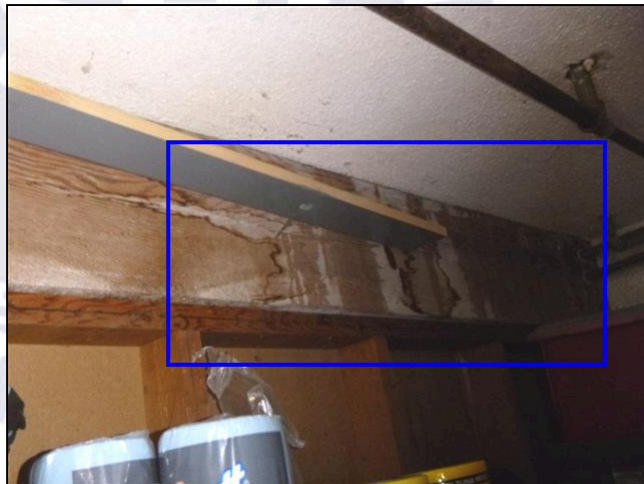
10.4 Item 2 (Picture)

10.4 (4) Water staining/damage was noted from the unit above, suggest repairs as needed.

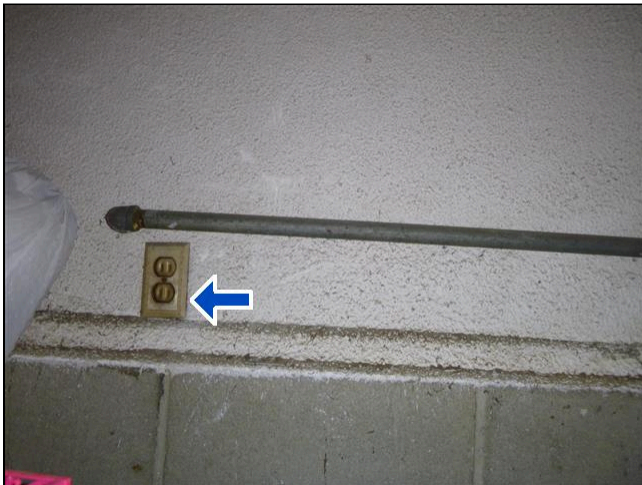
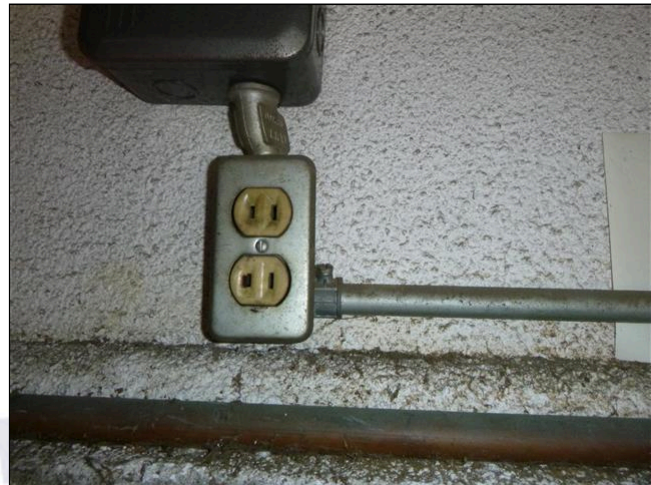
10.5 (1) Two wire and two prong electrical receptacles noted. At the time of the original construction this type of system was the acceptable standard and appears to be intact. If three prong and GFCI receptacles are desired a ground source is required. Suggest review with a licensed electrician for costs to ground the outlets as needed as an upgrade and/or protected the outlet(s) on a GFCI circuit where recommended.

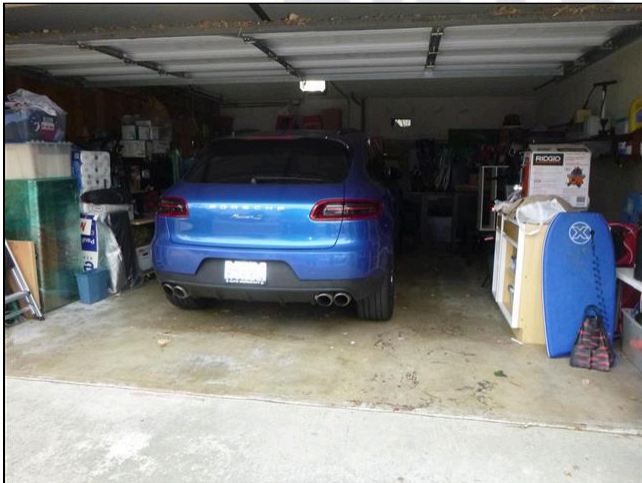
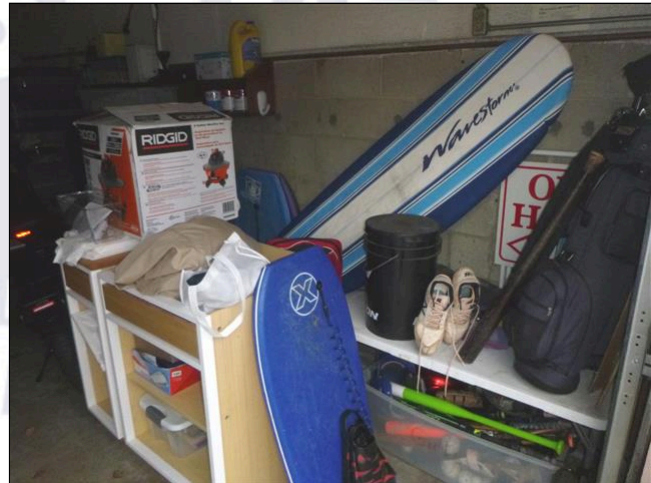
10.6 Access within this area was blocked or severely limited at the time of the inspection. An inspection of this area can be performed by appointment and at an additional cost when the area is made accessible.

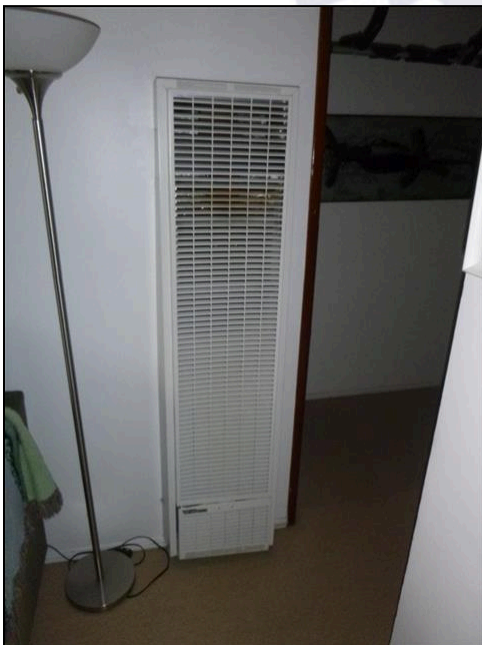
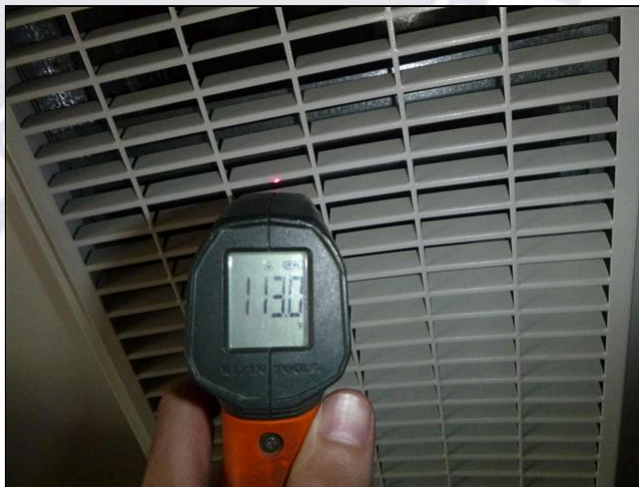
11.0 The heating unit was tested and was operational at the time of the inspection.

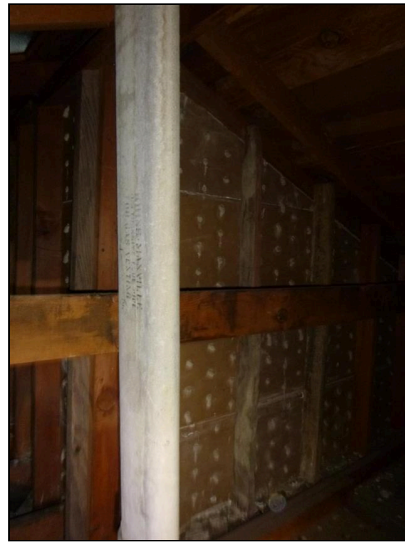
11.1 Item 1 (Picture)

11.1 (1) Asbestos-like material transite pipe/vent noted. Common for the age of the dwelling. No damage visible at the transite pipe at the time of the inspection.

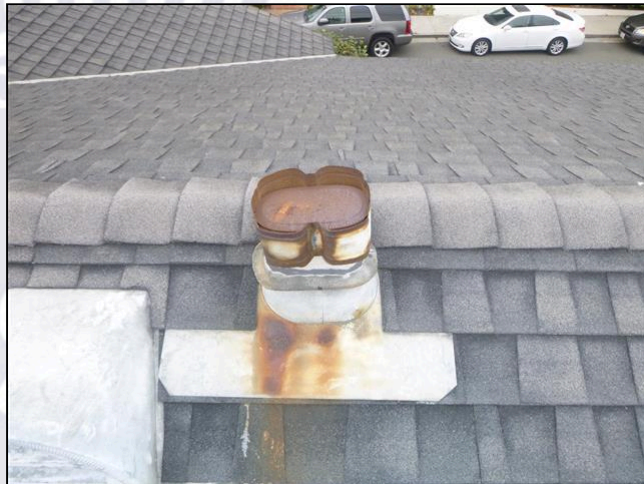
11.1 Item 2 (Picture)

11.1 (2) The heater's vent cap is rusted, suggest review with a licensed roofer for repairs as needed.

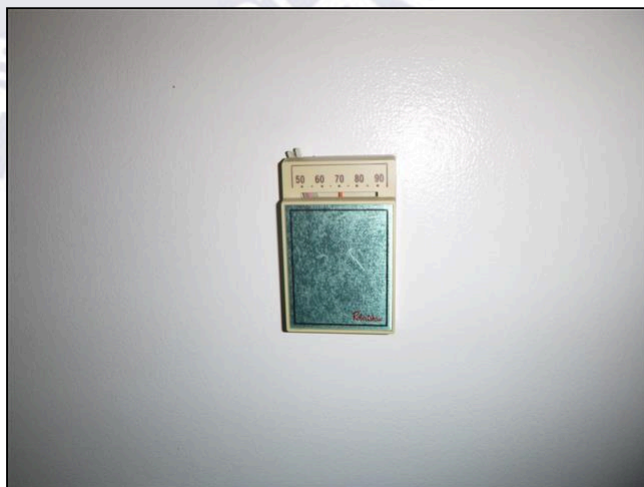
11.2 Item 1 (Picture)

11.2 Suggest upgrading with digital programmable thermostat if desired.

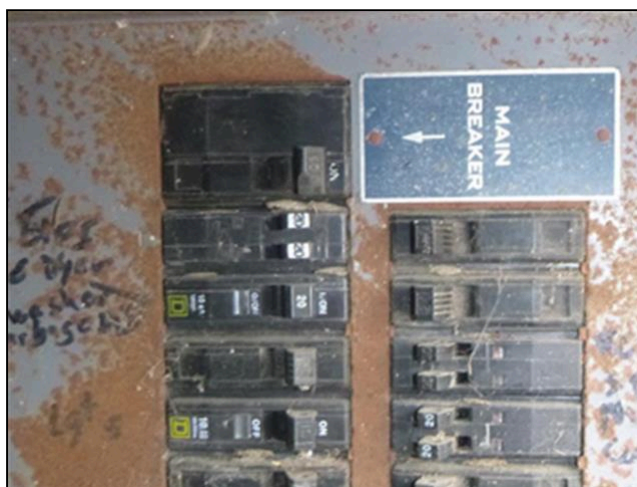
12.1 Item 1 (Picture)

12.1 (1) The main electrical panel is a Square D brand electrical panel. There are problems with these panels that can, in some cases, be serious. Some of the main electrical panels have been recalled, with other problems including counterfeit circuit breakers and faulty GFCI and AFCI breakers. Also, please be aware that various insurance companies will not insure homes with this style of electrical panel. Suggest review by a licensed electrician for review and repair/replacement costs as needed.

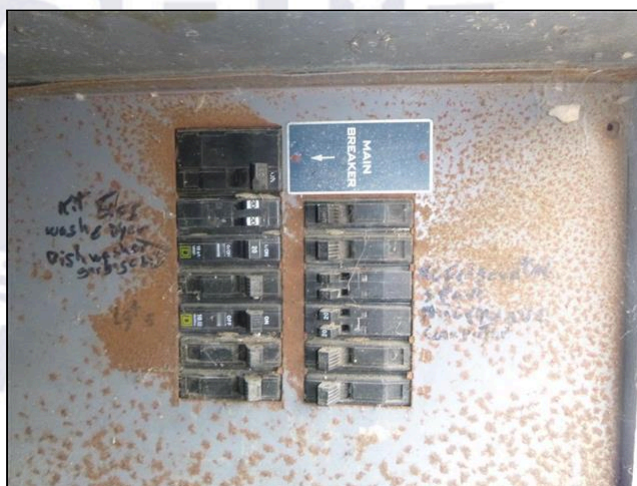
12.1 Item 2 (Picture)

12.1 (2) Suggest adding correct/complete indexing/labelling to all breakers for identification of each circuit for safety.

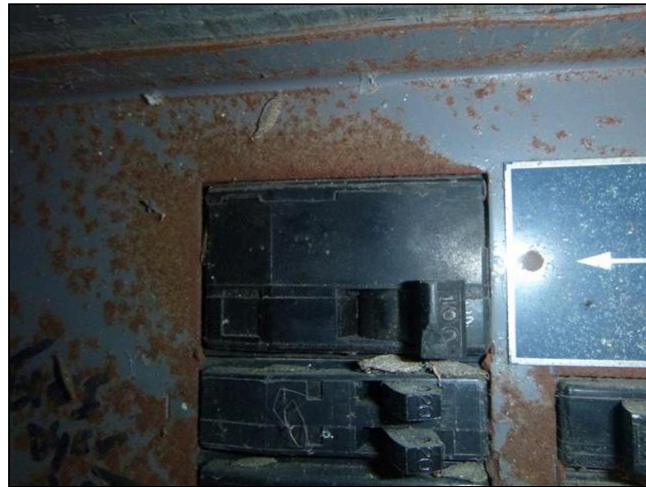
12.1 Item 3 (Picture)

12.1 (3) Due to the age and size/overall amperage of this system relative to the square footage of the dwelling, suggest review with a licensed electrician for replacement cost to upgrade the electrical panel, increase the overall amperage and install additional circuits to the interior of the dwelling as needed/ desired.

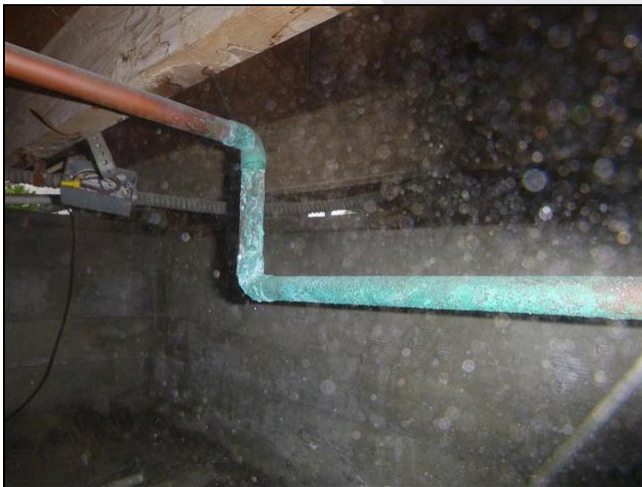
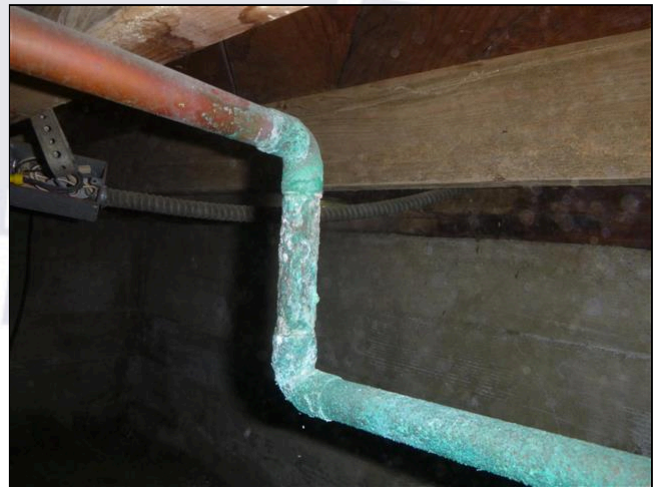
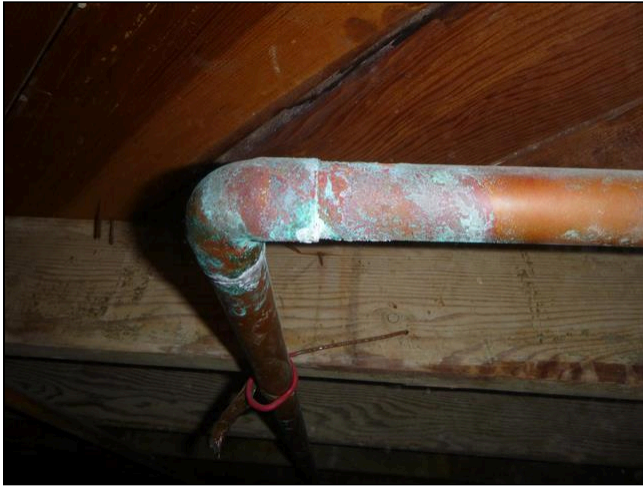
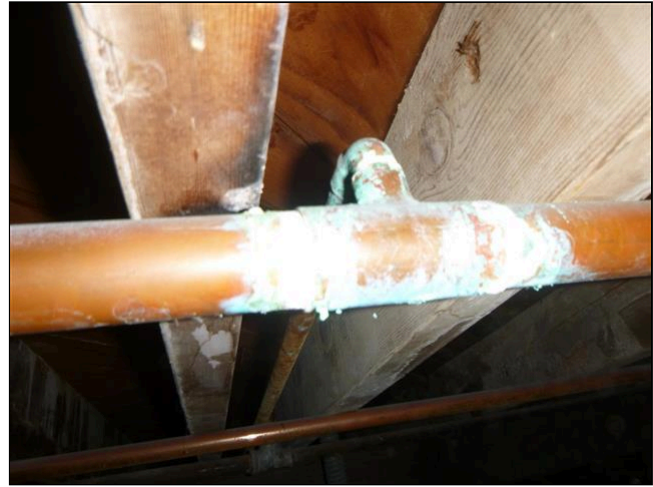
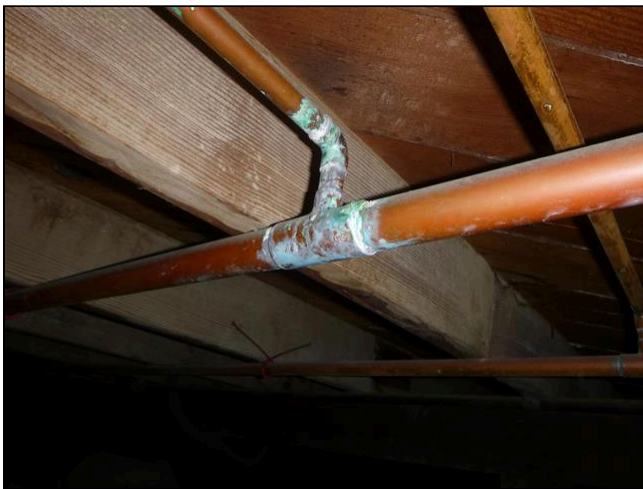
13.0 (1) See the crawl space comments and repair as needed.

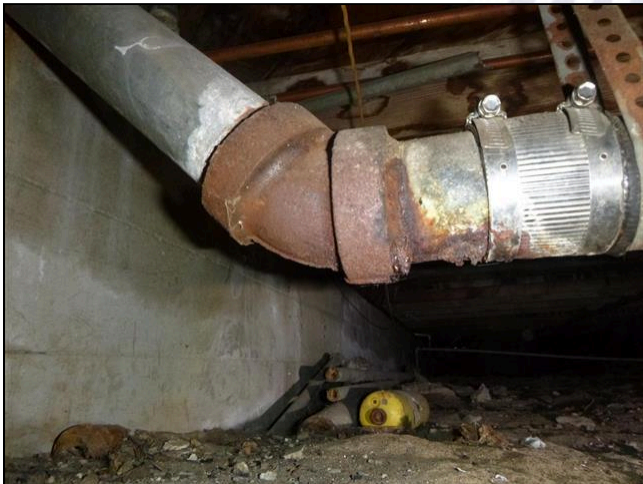
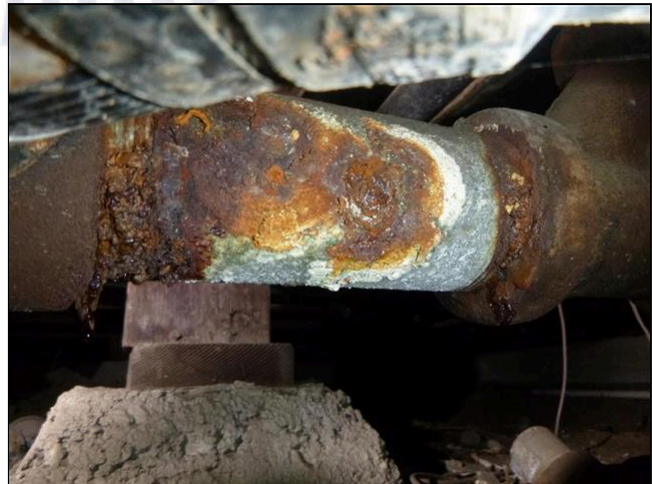
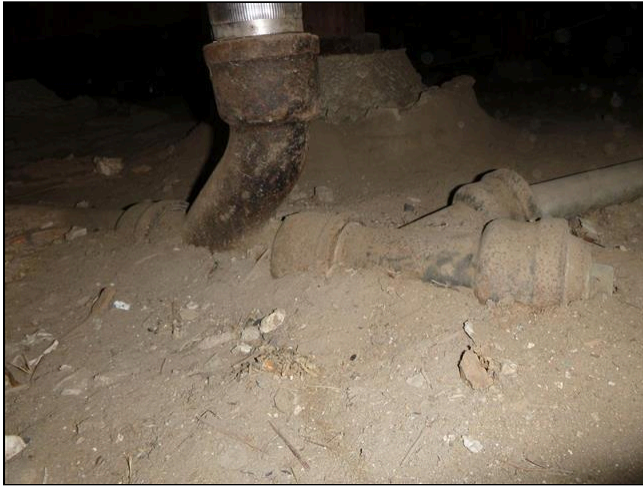
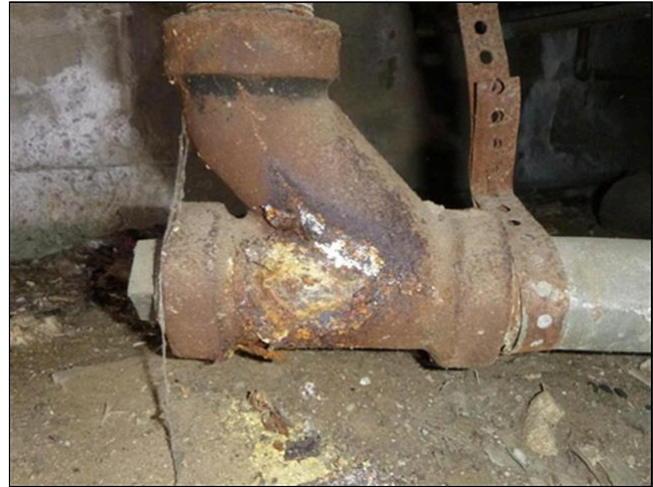
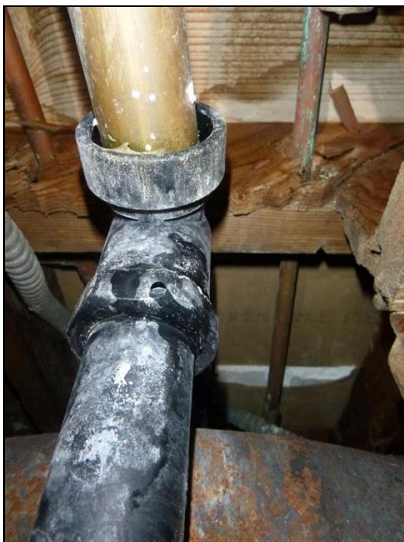
14.0 (3) See the crawl space comments due to the excessively corroded and leaking drains. Suggest review by licensed plumber for repair/replacement costs.

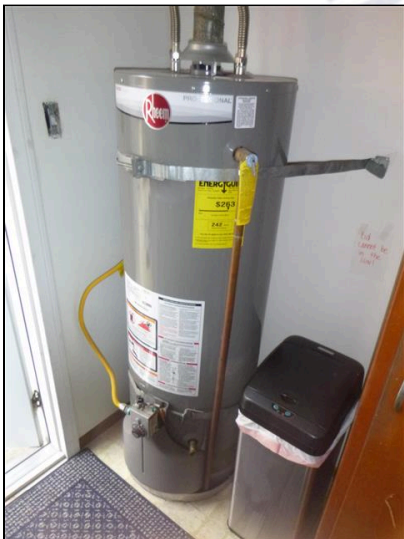
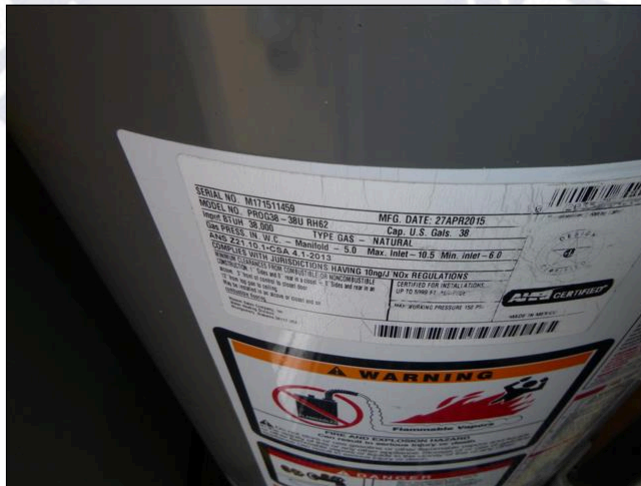
15.0 (1) The water heater was operational at the time of the inspection.

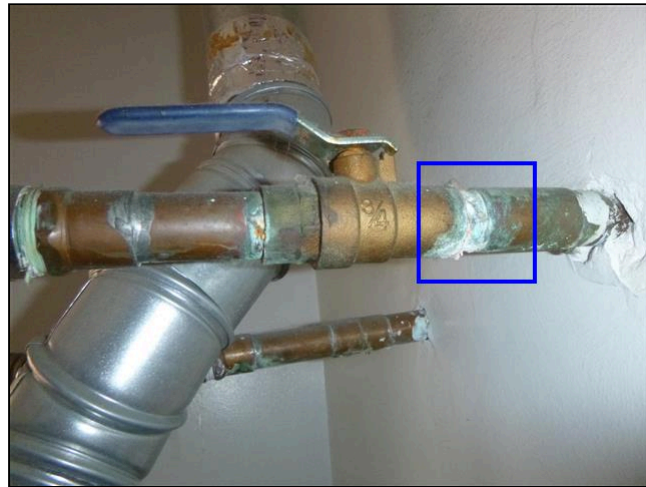
15.0 Item 3 (Picture)

15.0 (2) Rust and corrosion was noted at the cold water shut off, no leaking was visible at the time of the inspection. Suggest review by a licensed plumber for repair/replacement costs as needed.

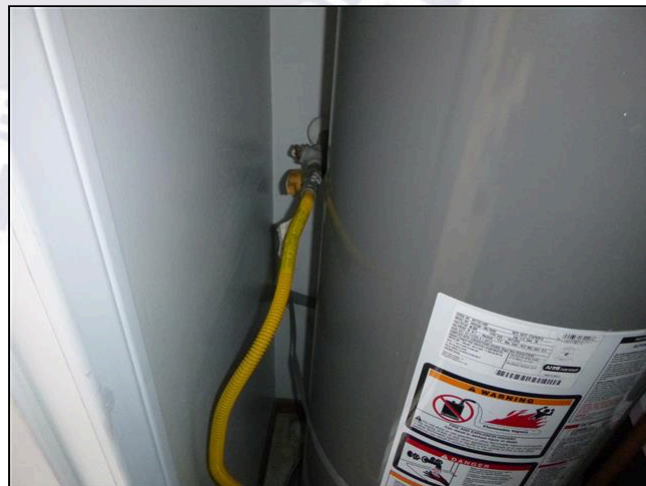
15.0 Item 5 (Picture)

15.0 (4) Currently no gas supply line drip leg/sediment trap is installed, please be aware that various cities do not enforce/require this installation. Suggest review with the local City Building Department and/or with a licensed plumbing contractor for installation costs as needed.

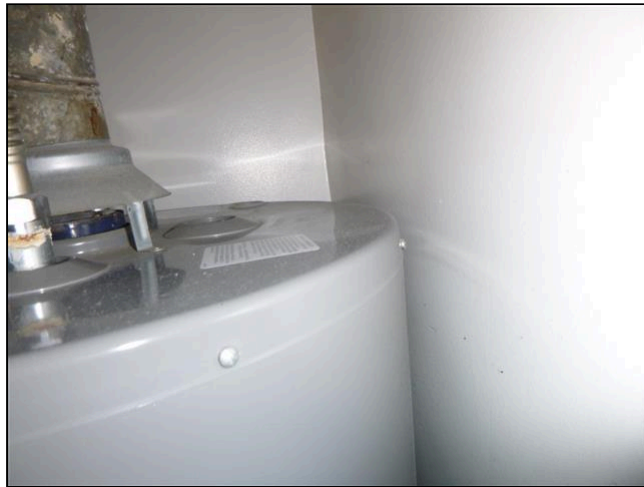
15.0 Item 6 (Picture)

15.0 (5) The water heating strapping is missing the rear bracing at the time of the inspection, suggest review by licensed plumber for installation costs as required.

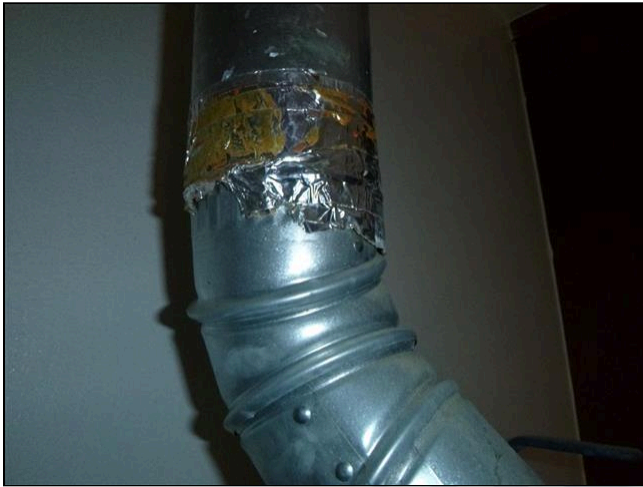
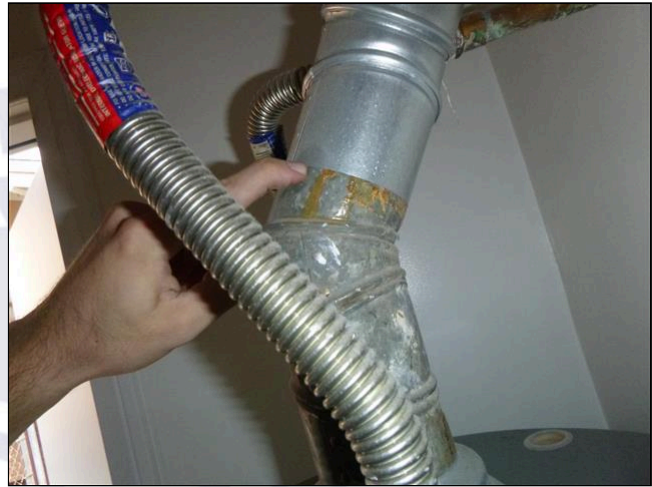
15.1 (1) Asbestos-like material transite pipe/vent noted. Common for the age of the dwelling. No damage visible at the transite pipe at the time of the inspection.

15.1 (2) The fittings do not have the required screws installed, suggest installation as needed to prevent dislodging.

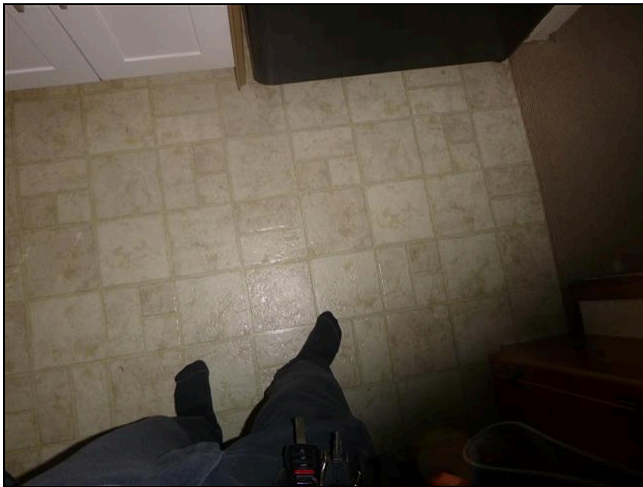
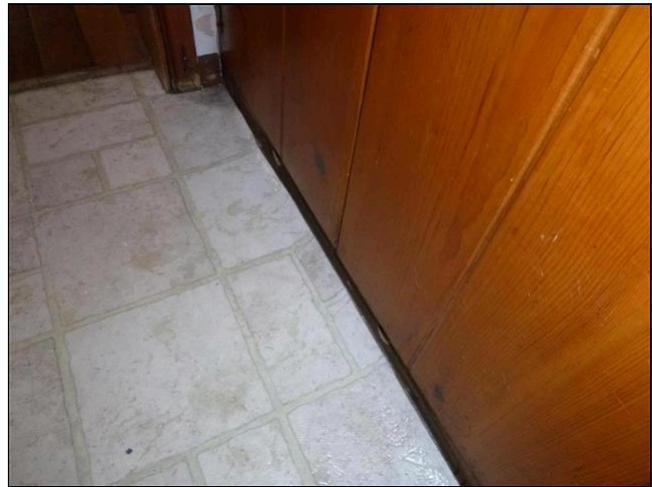
16.0 (1) Floor slope and uneven flooring noted.

16.0 (2) The flooring in the kitchen is soft, deteriorated and lifting, suggest review with a licensed contractor for

removal/repair/replacement costs as needed.

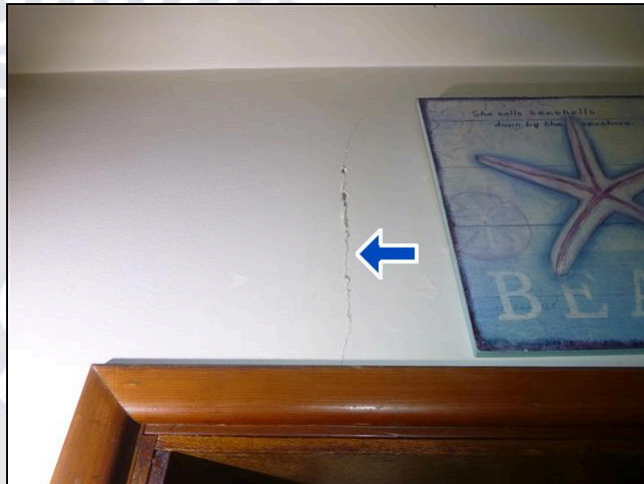
16.1 Item 1 (Picture)

16.1 Excessive settling cracks noted, see the foundation and Lot/Drainage comments. Suggest review with a licensed contractor for repair/replacement costs as needed.

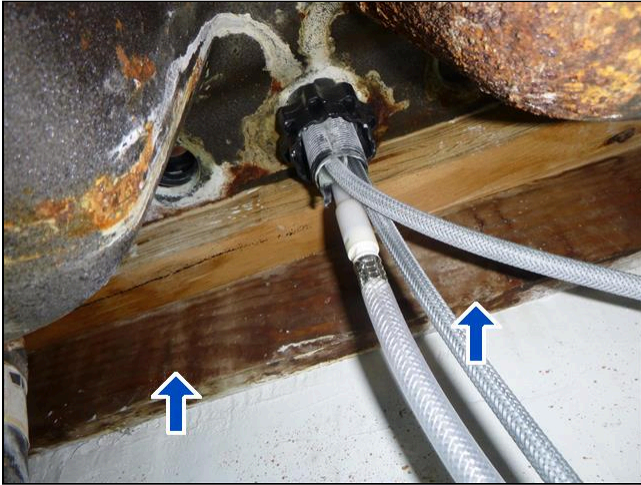
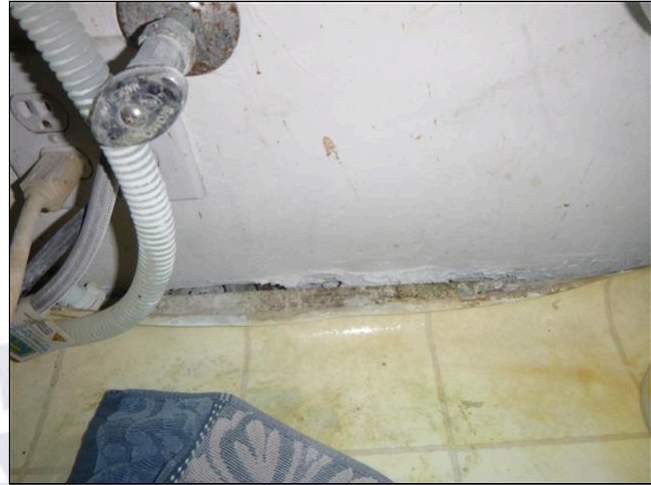
16.6 (1) The base cabinet under the sink is deteriorated/stained from leaks, suggest repair/replace as needed.

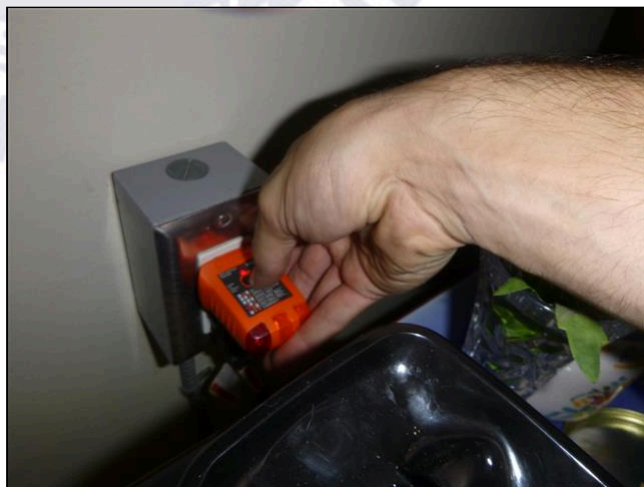
16.8 Item 1 (Picture)

16.8 (2) Various countertop outlets are not GFCI protected as required. Countertop GFCI outlet(s)/protection has been required within six feet of the sink since 1987 and all countertop outlets since 1996. Suggest review by a licensed electrician for installation costs as required for safety.

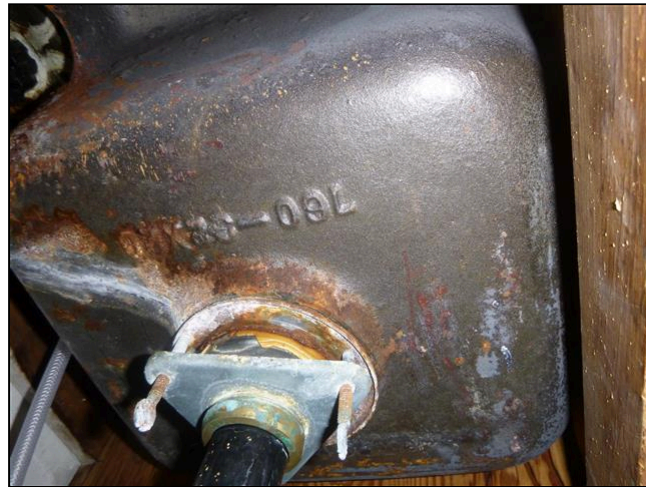
16.9 Item 1 (Picture)

16.9 Excessive rusting and deteriorated areas of the sink was noted, suggest repair/replace as needed.

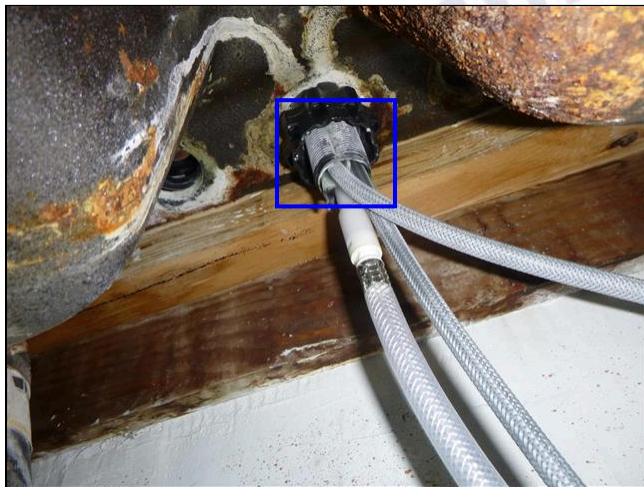
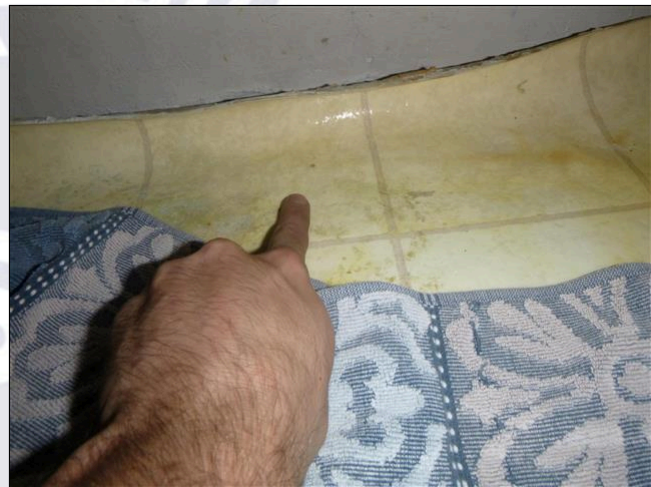
16.10 The sink faucet leaks, suggest repair/replace as needed to prevent future and further leaking water from damaging the cabinet base and surrounding areas.

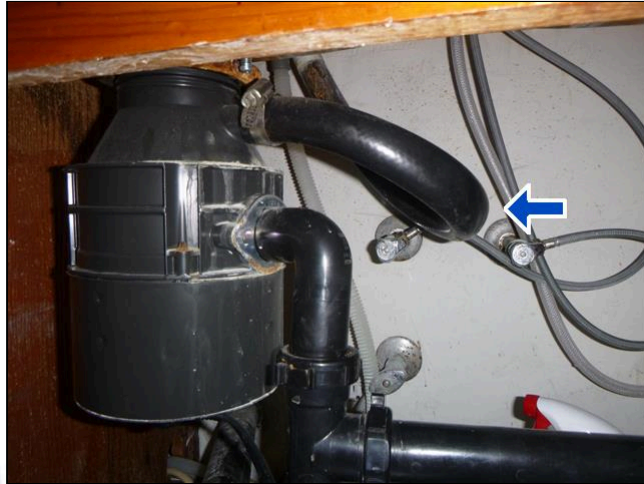
16.12 Item 1 (Picture)

16.12 Suggest review with a licensed plumber for costs to reduce the length of the drain from the air gap to the disposal as this has created a trap in the drainage system.

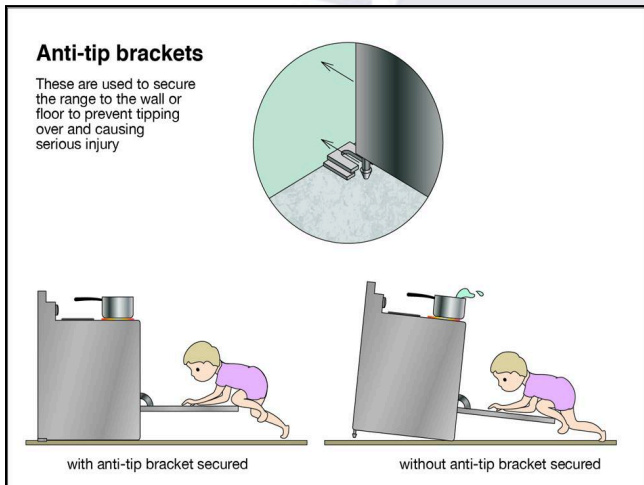
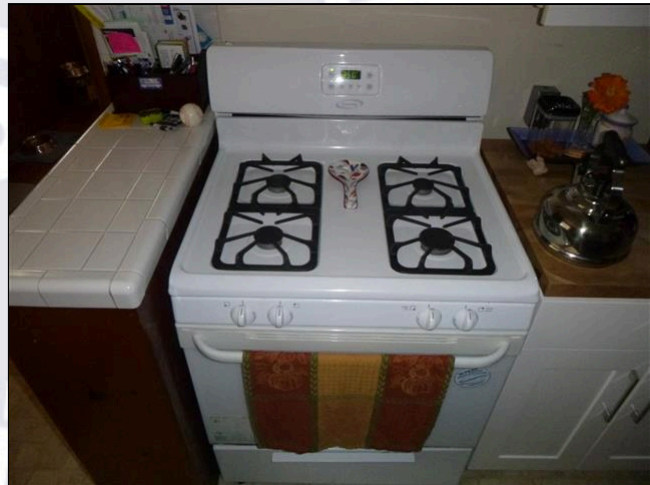
16.14 (1) The anti-tip bracket is not currently installed. An anti-tip bracket is usually installed on the floor and against the wall (towards the back of the stove) for one of the rear legs to slide into. Its purpose is to prevent the stove from tipping when a heavy load is placed on the door (possible child) or slide-out racks upsetting the center of gravity. Suggest installation for safety as required since 1991.

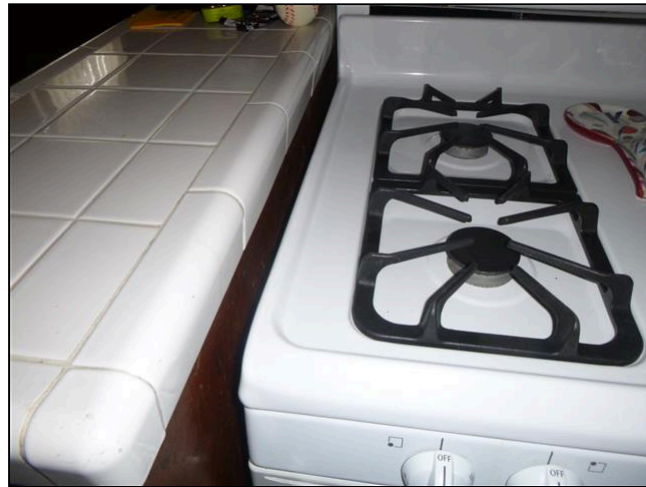
16.14 Item 3 (Picture)

16.14 (2) Potential fire spread hazard due to the stove is currently below the countertop height. Suggest review with a licensed contractor for cost to raise and level the stove to above the countertop height as required for safety.

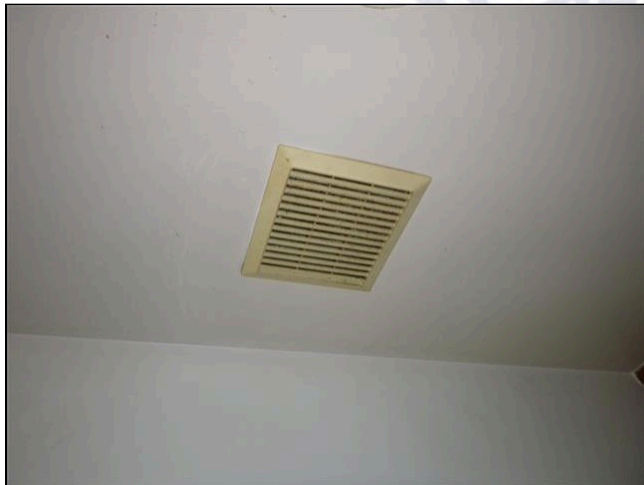
16.15 Item 1 (Picture)

16.15 (1) The exhaust fan system over the gas range is the incorrect style (this style is typically seen in a bathroom/ laundry room) and is not located within 36-42 inches of the stove top. Suggest review with a licensed contractor for replacement costs as needed for safety.

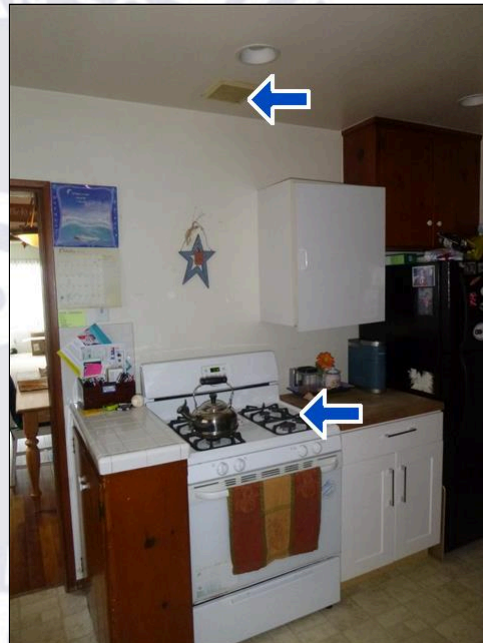
16.15 Item 2 (Picture)

16.15 (2) The range hood currently vents into the attic area, this is a potential fire safety hazard. Suggest review by a licensed contractor and vent to the exterior as required.
