Inspection Report

Property Address:
618 Prospect Ave
Hermosa Beach CA 90254

Ferguson Home Inspections

Date: 10/13/2022	Time: 02:00 PM	Report ID: 10132022Prospect
Property: 618 Prospect Ave Hermosa Beach CA 90254	Customer: Wendy & Scott Fletcher	Real Estate Professional: Amy Teitelbaum

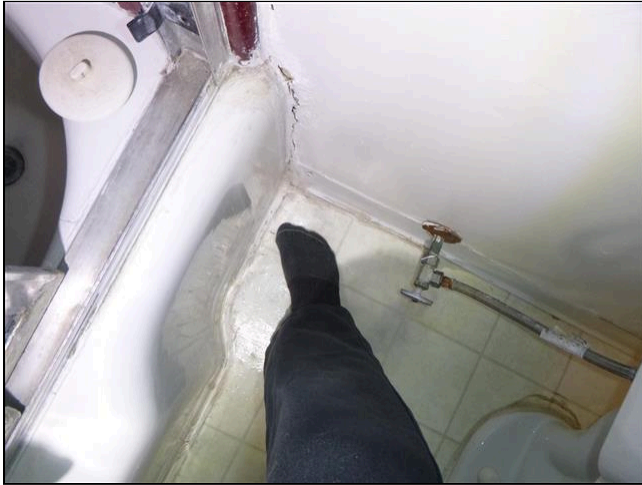
17.0 Item 1 (Picture)

17.0 The flooring is soft and deteriorated near the shower, this is due to water leaking from the shower area and damaging the subflooring. Suggest review with a licensed contractor for removal/repair/replacement costs as needed.

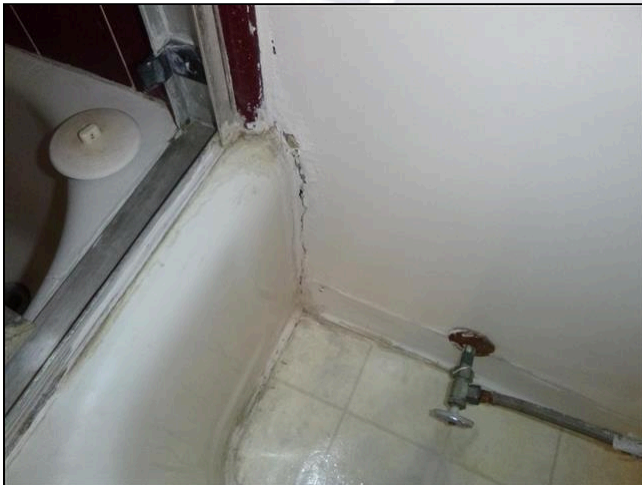
17.1 Item 1 (Picture)

17.1 (1) Excessive moisture was detected at the walls adjacent to the shower. Water damage/deterioration was noted at the walls and the area below in the crawl space. Suggest review with the seller and/or a licensed mold/contractor for repair/replacement/removal costs as needed.

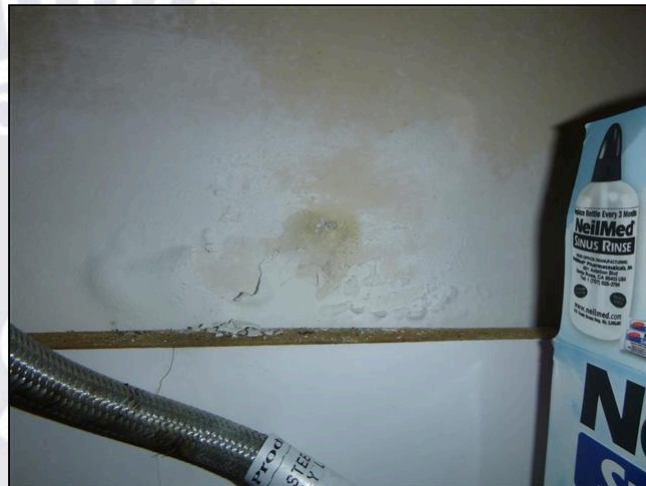
17.1 Item 5 (Picture)

17.1 (2) Old water stains/damage was noted under the sink area, suggest removal/repair/replacement costs as needed.

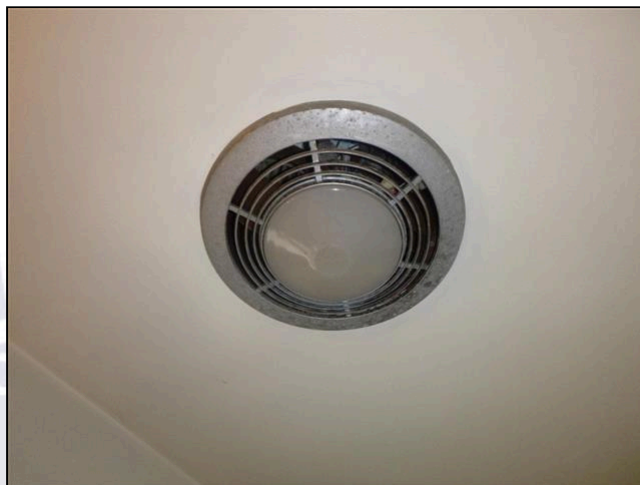
17.7 Item 1 (Picture)

17.7 (2) The exhaust fan is excessively noisy, suggest review with a licensed contractor for repair/replacement costs as needed.

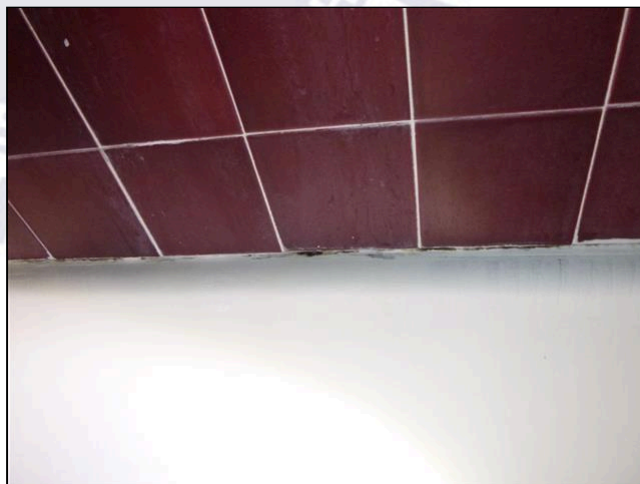
17.9 Item 1 (Picture)

17.9 (1) Suggest caulking or re-grout as needed. The edges of the tub walls should be caulked to prevent moisture penetration. Failure to keep walls sealed can cause deterioration and extensive moisture damage to the interior walls, which is not always visible.

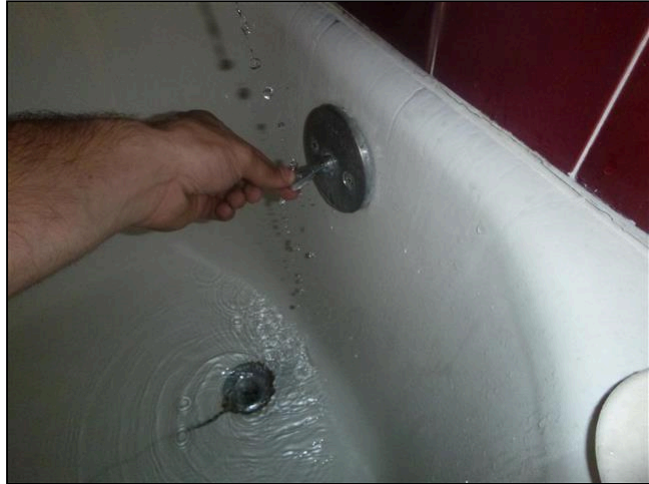
17.9 Item 2 (Picture)

17.9 (2) The tub stopper was inoperable at the time of the inspection, suggest repair/replace as needed.

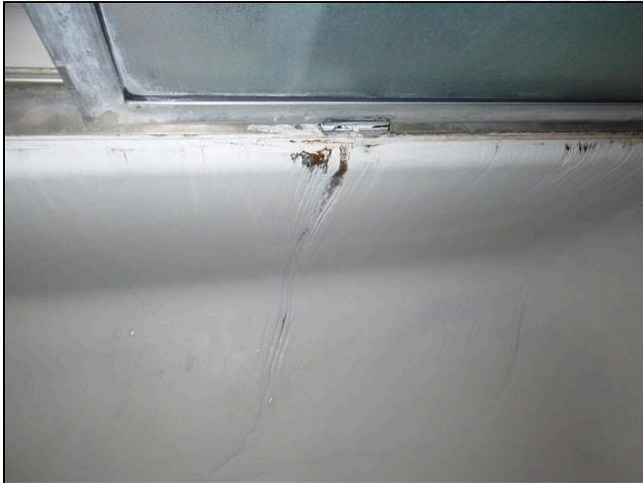
17.9 Item 3 (Picture)

17.9 (3) Excessive wear/rusting/deterioration was noted at the tub and surround. Suggest repair/replace as needed.

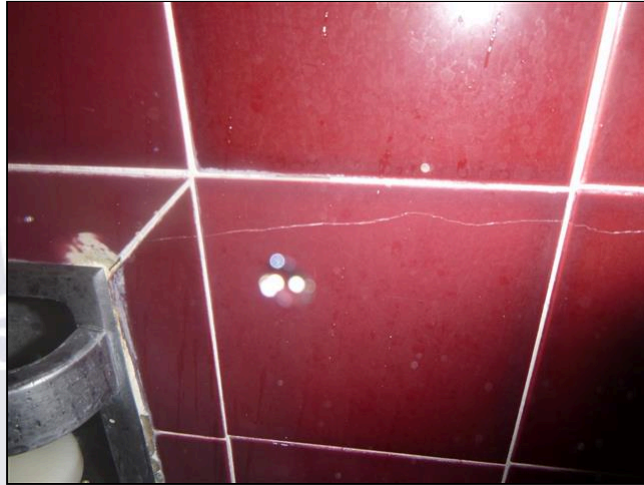
17.11 Item 1 (Picture)

17.11 (2) Cracked tiles noted at the shower area, suggest review with a licensed contractor for repair/ replacement costs as needed.

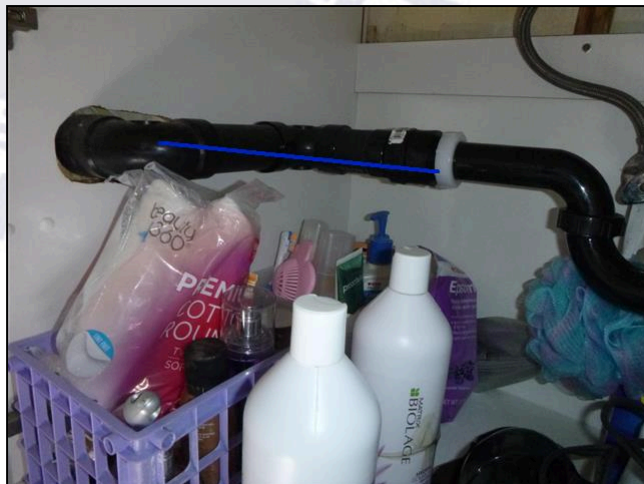
17.16 Item 1 (Picture)

17.16 Incorrect sloping was noted at the sink drain, suggest re-sloping as needed.

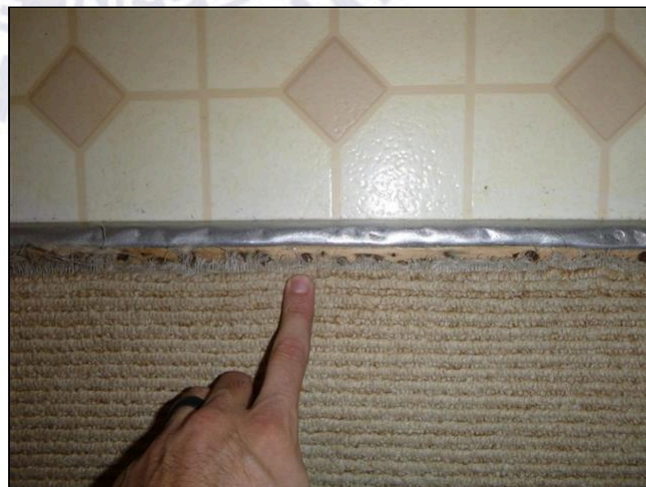
18.0 Item 1 (Picture)

18.0 The flooring transition is deteriorated, suggest repairs as needed.

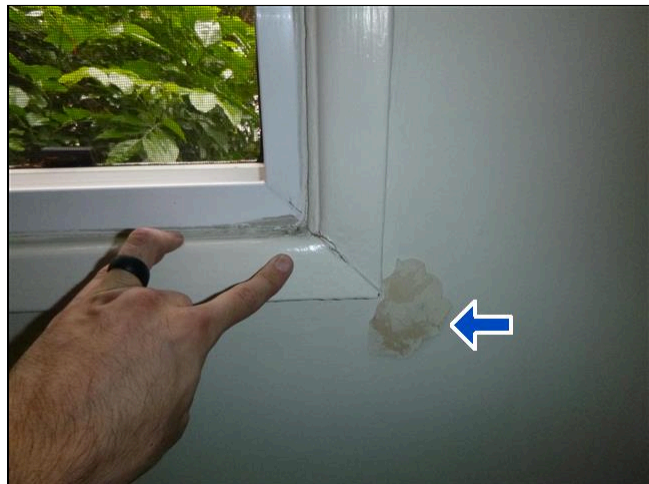
18.1 Item 1 (Picture)

18.1 Stains, deterioration and water damage noted at the walls near the window. Suggest review of the exterior window comments and review with a licensed contractor for repair/removal/replacement costs as needed.

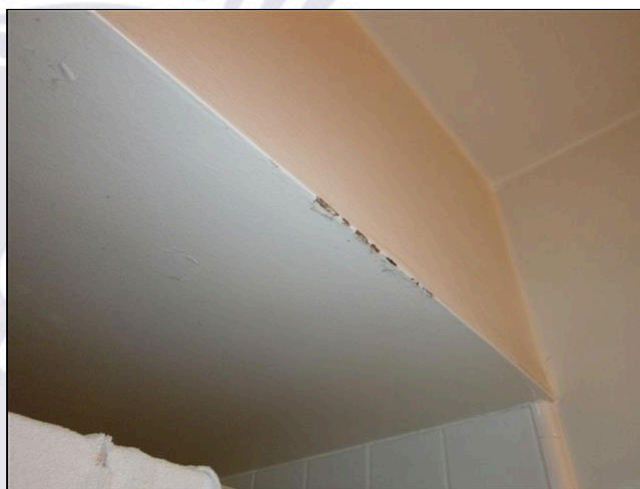
18.2 Item 1 (Picture)

18.2 Blistering and deterioration noted at the ceiling due to inadequate ventilation. See the exhaust fan comment and repair/install as needed.

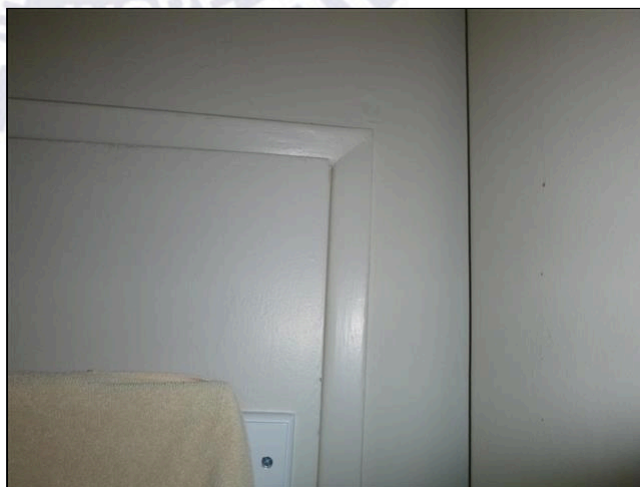
18.3 Item 1 (Picture)

18.3 The door sticks on the jamb when operating. Suggest maintenance and repairs as necessary.

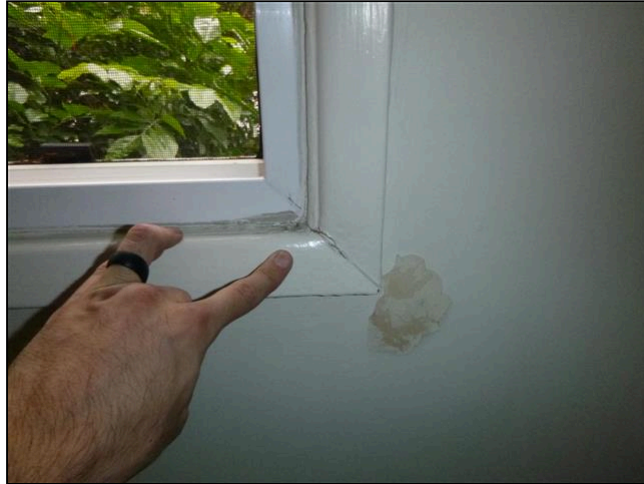
18.4 Item 1 (Picture)

18.4 Multiple stains and evidence of on-going leakage at various windows, suggest review with a licensed contractor for repair/replacement costs as needed.

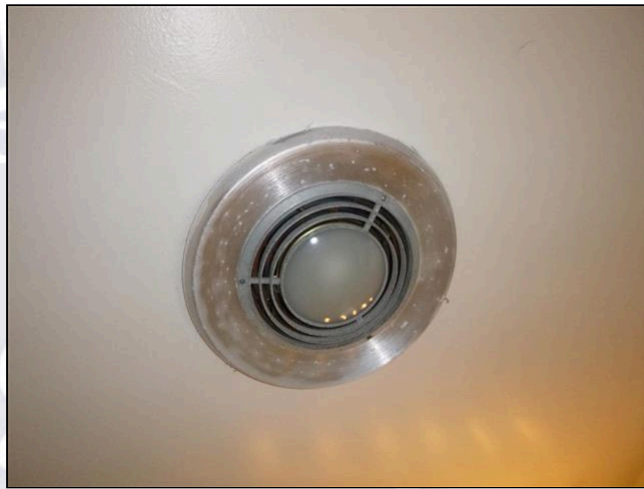
18.6 Item 1 (Picture)

18.6 Various light fixtures were inoperable, possible bulbs out. Suggest replacing the bulbs as needed.

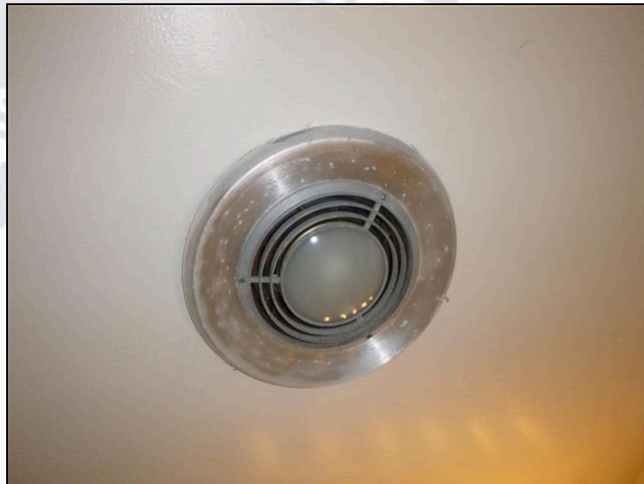
18.7 Item 1 (Picture)

18.7 (1) The exhaust vent is inoperable, suggest review with a licensed contractor for repair/replacement costs as required for ventilation at this area.

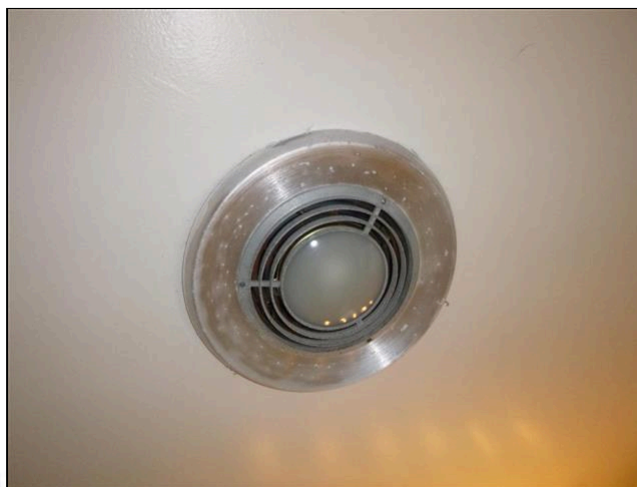
18.8 Item 1 (Picture)

18.8 The ceiling heat coil system was inoperable at the time of the inspection, suggest repair/replace as needed.

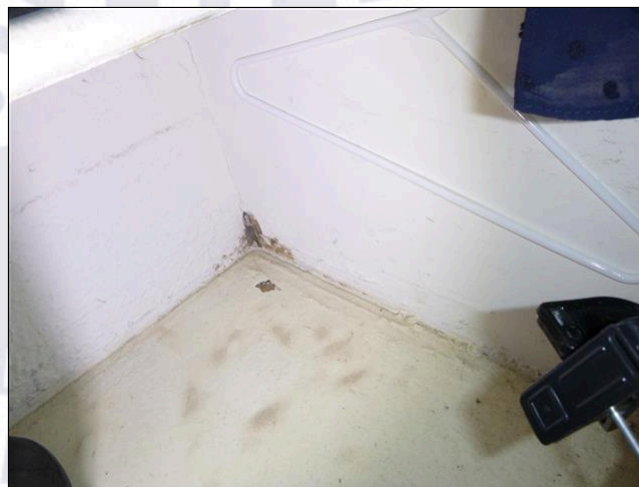
18.9 Item 2 (Picture)

18.9 Suggest caulking or re-grout as needed. The edges of the tub walls should be caulked to prevent moisture penetration. Failure to keep walls sealed can cause deterioration and extensive moisture damage to the interior walls, which is not always visible. However, water damage/deterioration was noted in the master bedroom's closet which is directly behind the shower/tub area which indicates that there is likely leakage from this shower/tub enclosure. Suggest review with a licensed contractor to verify/confirm and for removal/repair/replacement costs as needed.

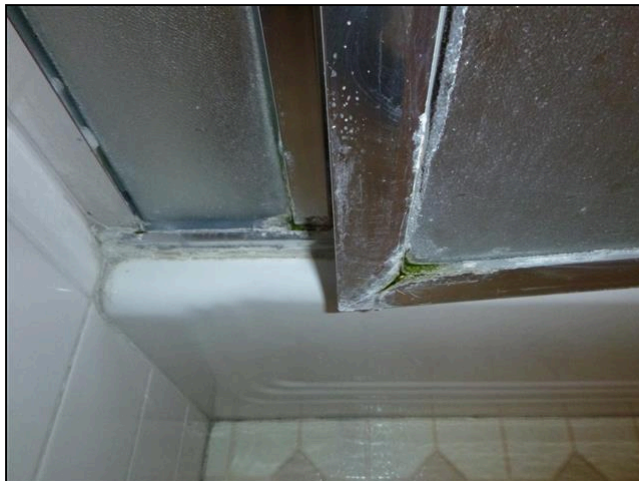
18.12 Item 1 (Picture)

18.12 Excessive corrosion was noted at the shower enclosure, suggest repair/replace as needed.

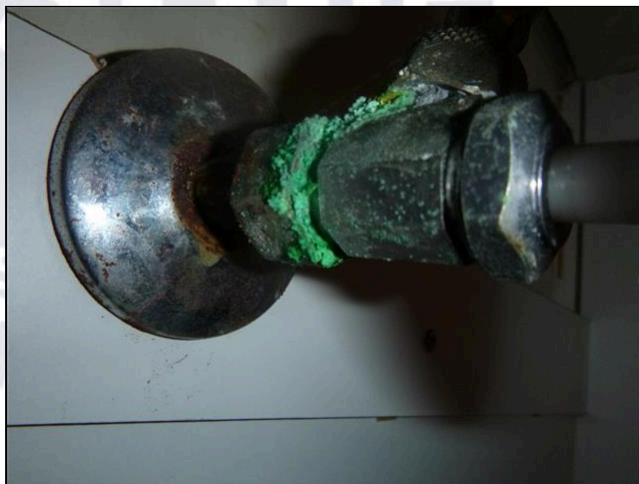
18.16 Item 1 (Picture)

18.16 Corrosion noted at the sink drain and angle valve(s), no leaking noted at the time of the inspection. Suggest review by a licensed plumber and repair/replace as needed.

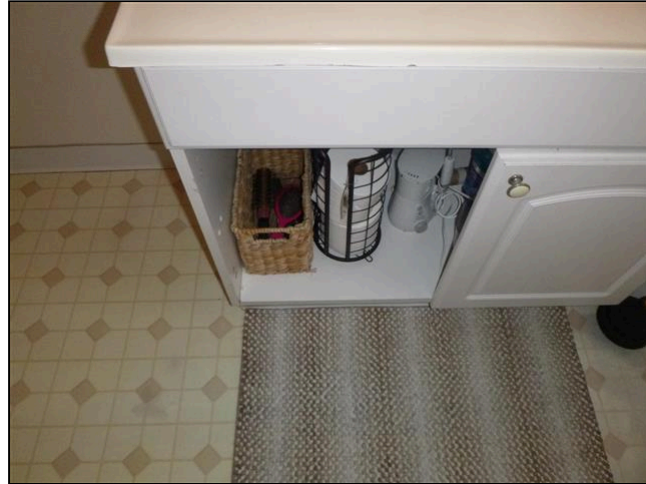
18.18 Item 1 (Picture)

18.18 A cabinet door is damaged/
missing. Suggest repair/replace as
needed.

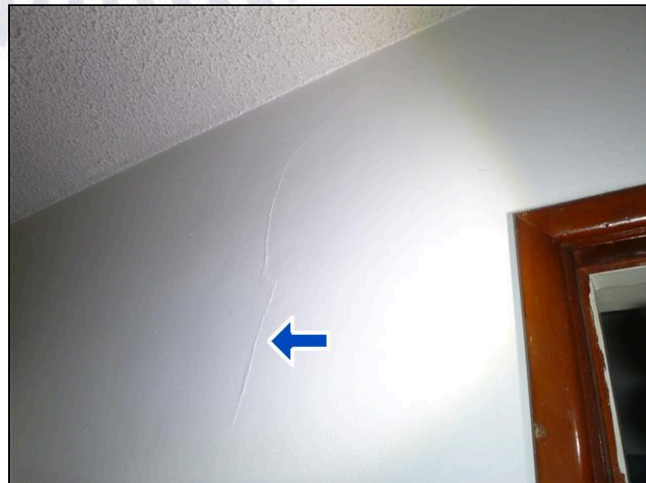
19.1 Item 1 (Picture)

19.1 (1) Excessive settling cracks noted, see the foundation and Lot/ Drainage comments. Suggest review with a licensed contractor for repair/ replacement costs as needed.

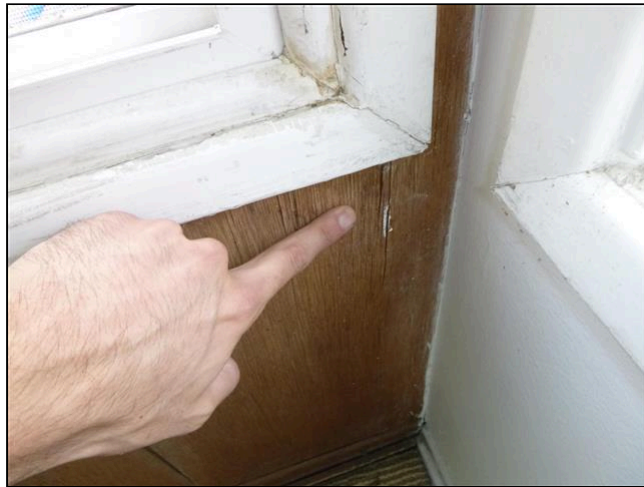
19.1 Item 2 (Picture)

19.1 (2) Stains, deterioration and water damage noted at the walls near the window. Suggest review of the exterior window comments and review with a licensed contractor for repair/removal/replacement costs as needed.

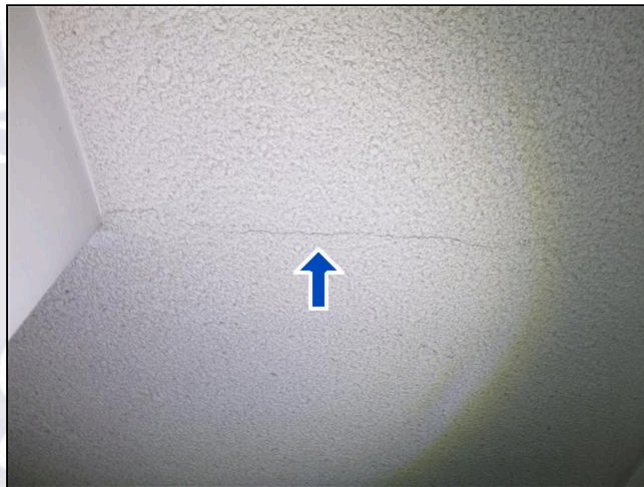
19.2 Item 1 (Picture)

19.2 Settling cracks and patching was noted, suggest repair as needed.

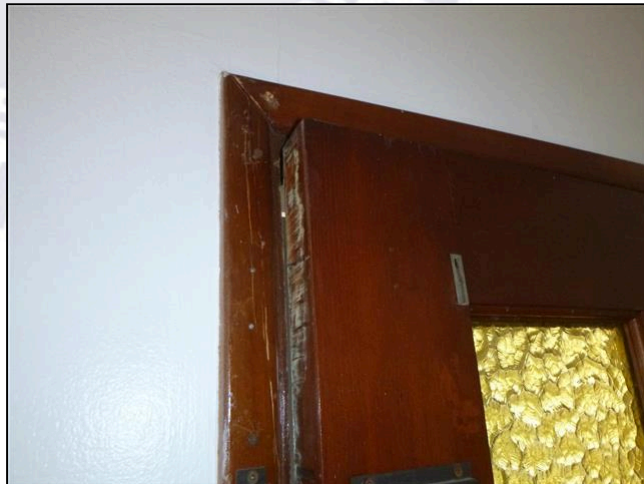
19.3 Item 1 (Picture)

19.3 (1) The door sticks on the jamb when operating. Suggest maintenance and repairs as necessary.

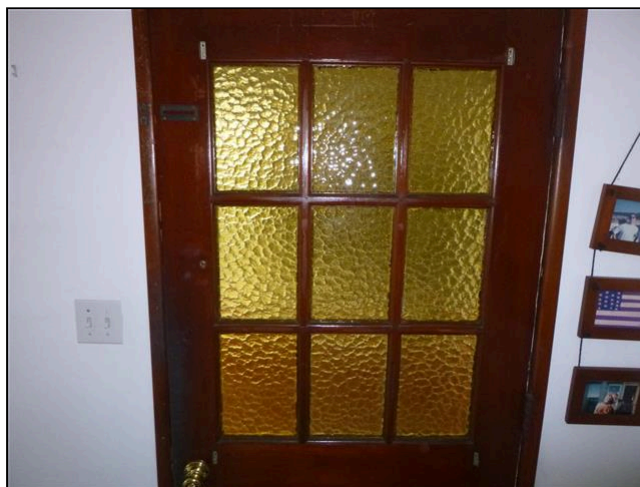
19.3 Item 2 (Picture)

19.3 (2) Unable to determine if tempered glass is installed at the window/door glass at this area (no labelling/etching is visible). Windows and doors with glass 18 inches off the floor area or windows within doors should have safety glass. Suggest review of these areas for possible costs to upgrade for safety.

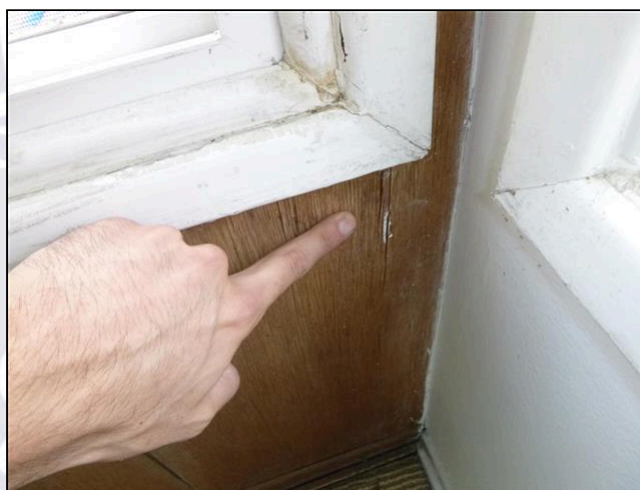
19.4 Item 1 (Picture)

19.4 Multiple stains and evidence of on-going leakage at various windows, suggest review with a licensed contractor for repair/replacement costs as needed.

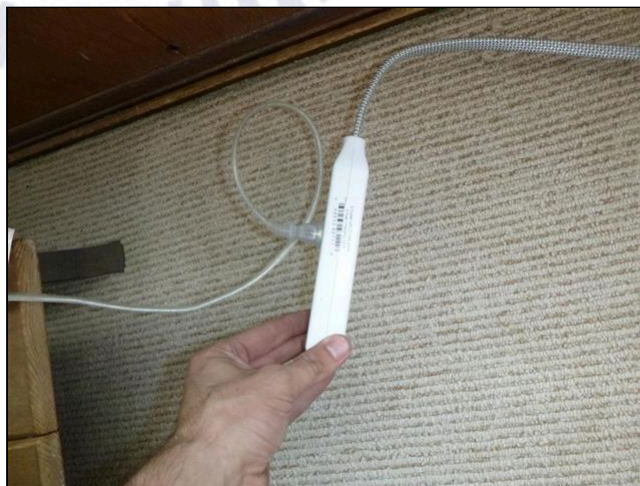
19.6 Item 1 (Picture)

19.6 (2) Excessive use of electrical plugs strips/extension cords used at this area, this is a potential fire safety hazard. Suggest review with a licensed electrician for additional electrical circuits/outlets costs as needed for safety.

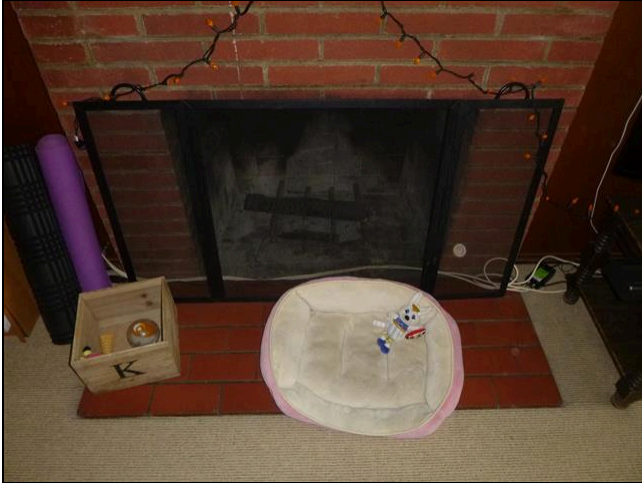
19.7 Item 1 (Picture)

19.7 (1) Excessive creosote noted within the firebox, smoke chamber or chimney areas. Creosote build-up can cause chimney fires if not removed from voids, open seams or open mortar joints within the fireplace and chimney. This inspection is a 'Level 1' inspection and is limited to visible and accessible areas only. 'Level 2' and 'Level 3' inspections are invasive inspections performed by qualified personnel only with equipment designed for fireplace/chimney inspections, cleaning or repairs. Suggest periodic cleaning of the fireplace/chimney and remove the creosote and debris within the fireplace and chimney. Suggest review by a professional chimney sweep for estimates, repairs or cleaning.

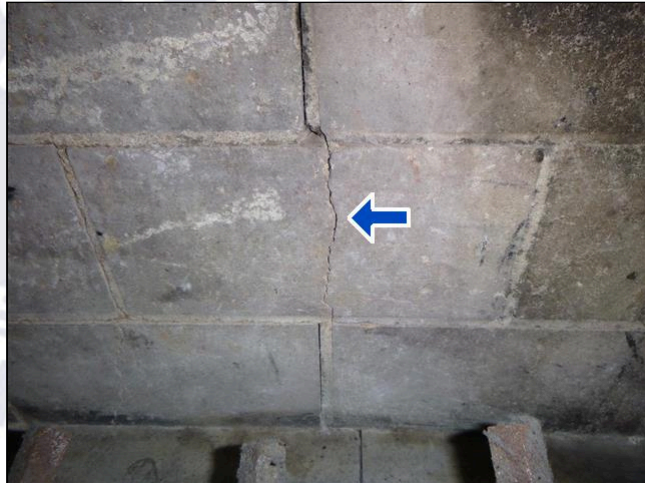
19.7 Item 3 (Picture)

19.7 (2) Surface cracks noted at the rear firebrick, suggest review with a licensed chimney sweep/contractor for repairs/replacement as needed.

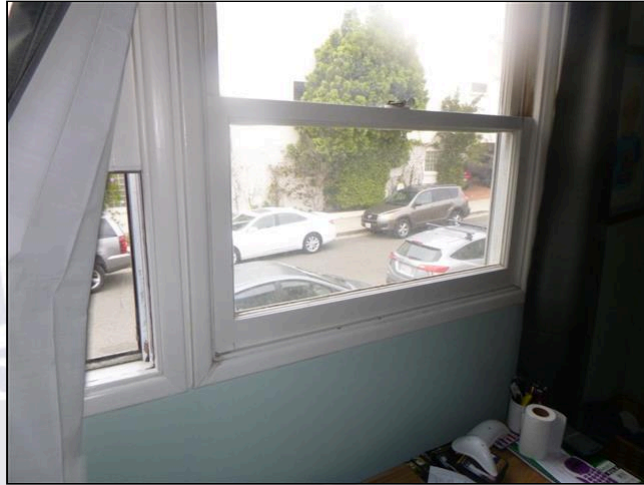
22.4 Item 1 (Picture)

22.4 (1) The windows are difficult to operate, suggest repair/replacement as needed/required to allow for emergency exit/egress and ventilation.

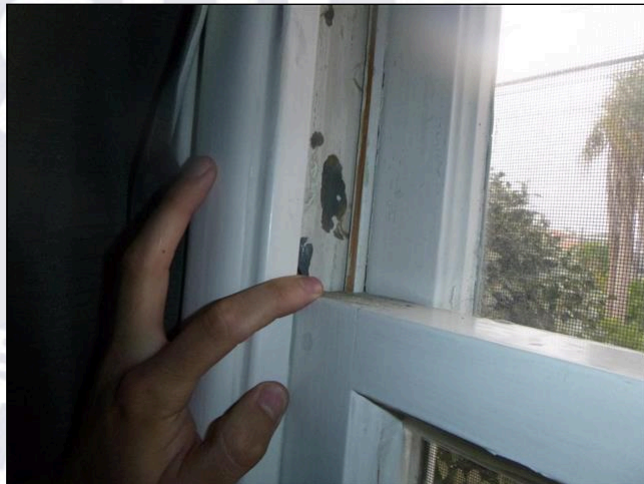
22.4 Item 2 (Picture)

22.4 (2) Broken sash/wire/cord noted on the window frame(s), this is a possible safety concern as the sash/wire/cord should hold the window in an open position. Suggest review with a licensed contractor for repair/replacement costs and confirm correct operation as needed.

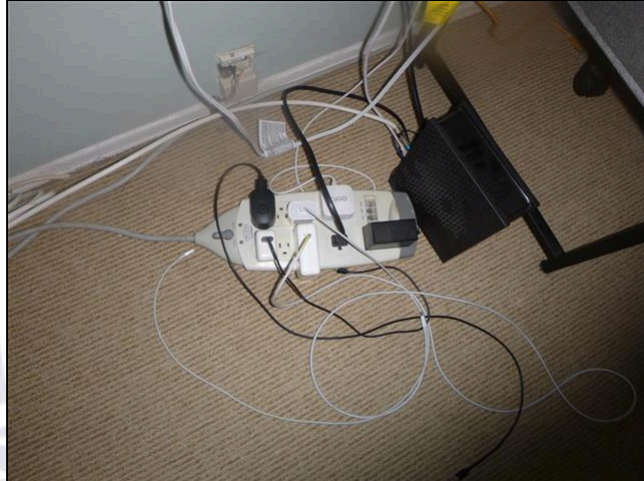
22.6 Item 1 (Picture)

22.6 (2) Excessive use of electrical plugs strips/extension cords used at this area, this is a potential fire safety hazard. Suggest review with a licensed electrician for additional electrical circuits/outlets costs as needed for safety.

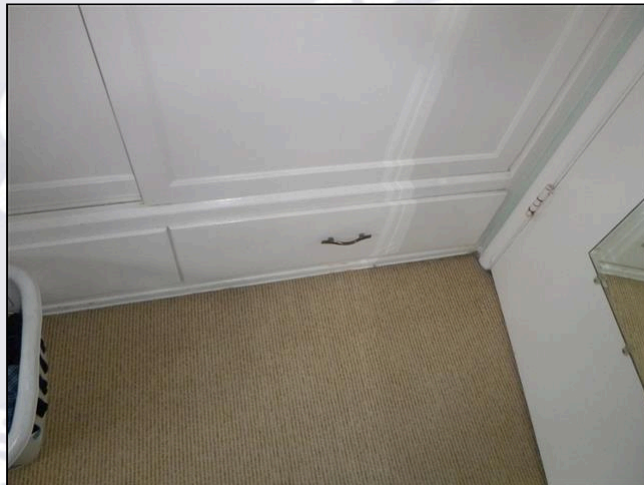
22.7 Item 1 (Picture)

22.7 Minor deterioration and worn/stuck areas noted at various cabinets, suggest repair/replace as needed.

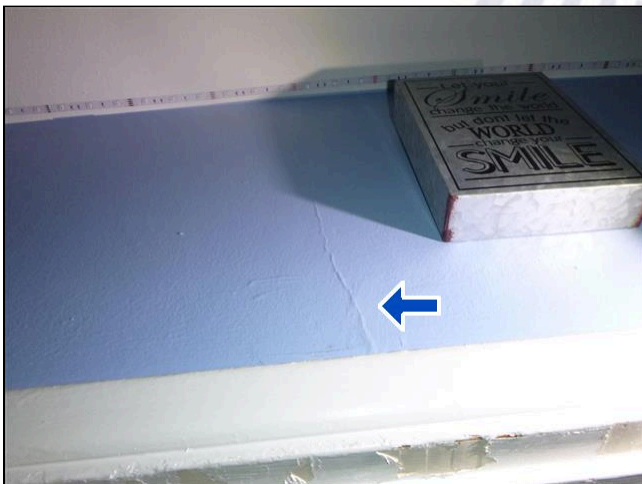
23.1 Item 1 (Picture)

23.1 Settling cracks and minor damage was noted, suggest repair as needed.

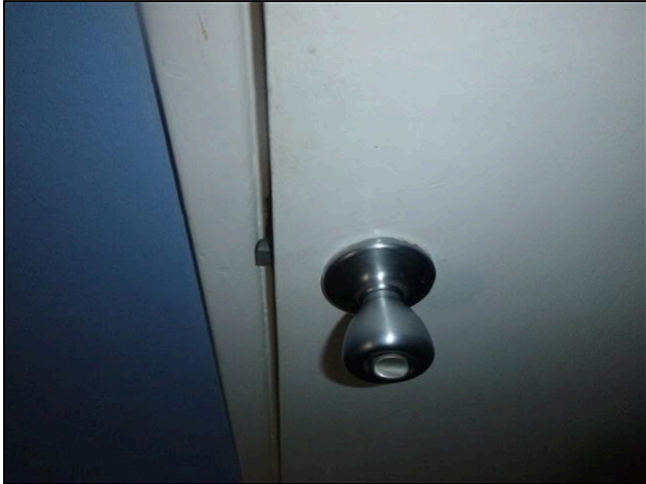
23.3 Item 1 (Picture)

23.3 The door will not close and latch correctly, suggest repair as needed.

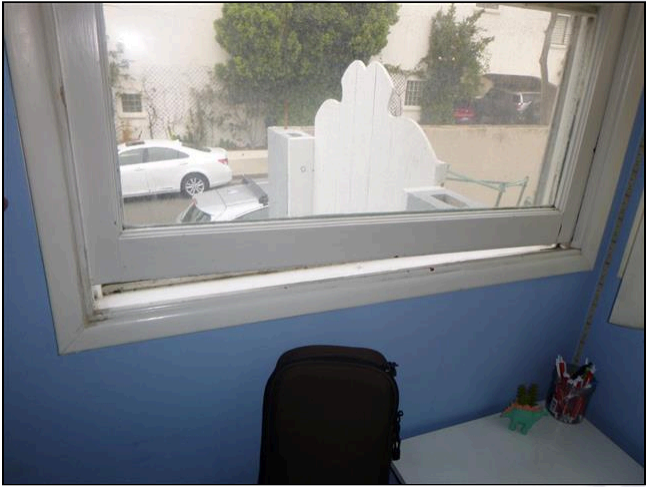
23.4 Item 1 (Picture)

23.4 (1) The windows are difficult to operate, suggest repair/replacement as needed/required to allow for emergency exit/egress and ventilation.

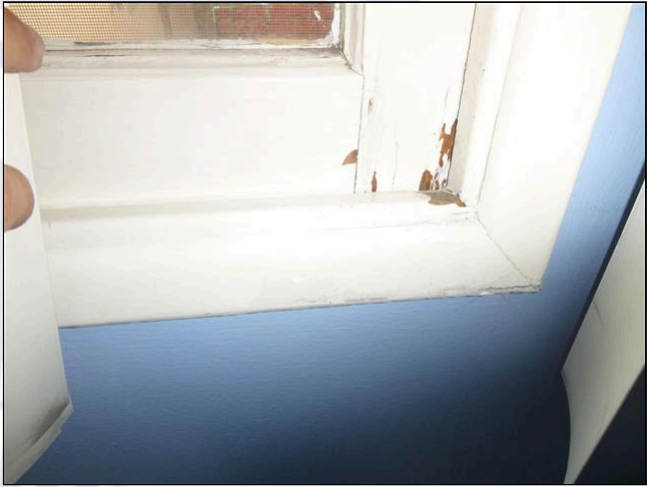
23.4 Item 2 (Picture)

23.4 (2) The wood windows are deteriorated and are slanted/off track in the frame, suggest review with a licensed contractor for repair/replacement costs as needed.

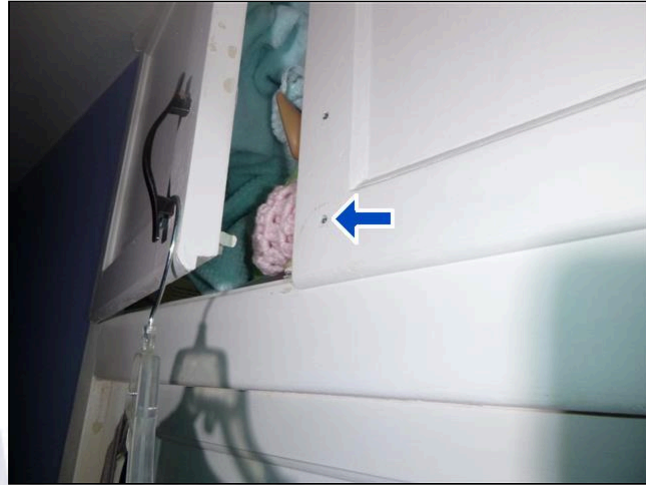
23.7 Item 1 (Picture)

23.7 The door pull(s) are missing.
Suggest repair/replace as needed.

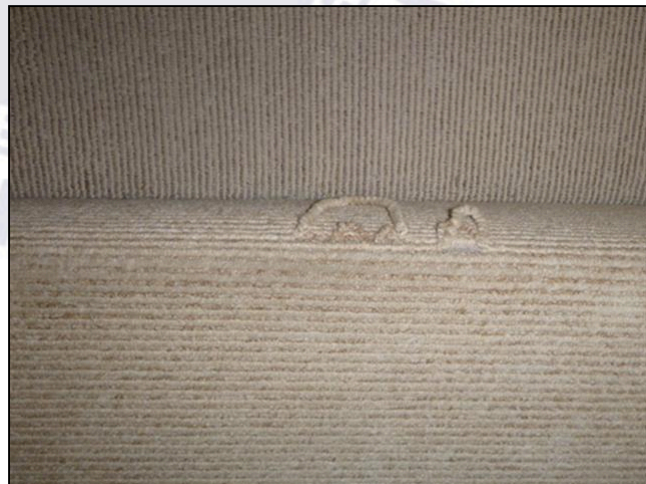
24.0 Item 1 (Picture)

24.0 Deteriorated areas were noted at the carpet, suggest repairs as needed.

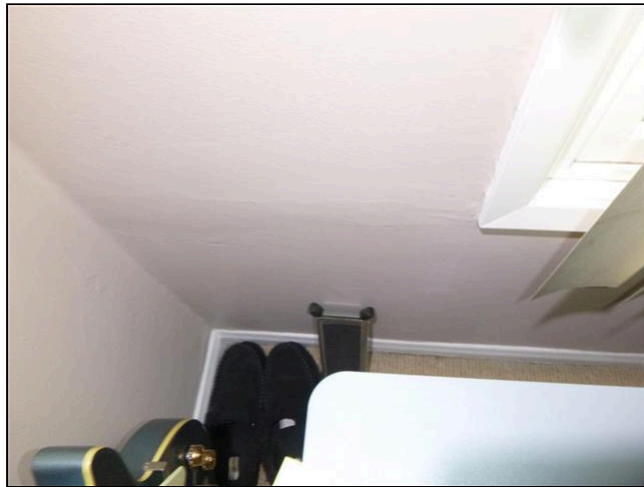
24.1 Item 1 (Picture)

24.1 (1) Settling cracks and patching was noted, suggest repair as needed.

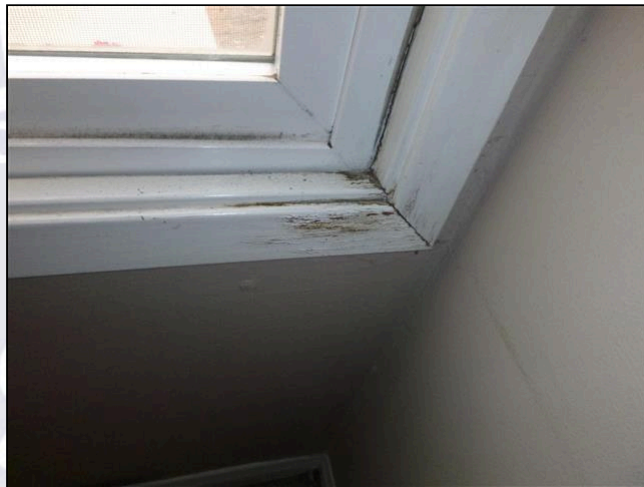
24.1 Item 2 (Picture)

24.1 (2) Stains, deterioration and water damage noted at the walls near the window. Suggest review of the exterior window comments and review with a licensed contractor for repair/removal/replacement costs as needed.

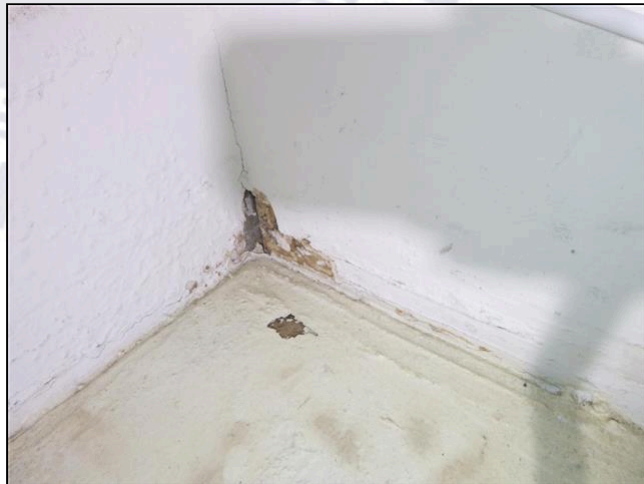
24.1 Item 3 (Picture)

24.1 (3) Water damage was noted at the walls in the closet that is adjacent to the master bathroom shower area. Suggest review of the master bathroom comments and review with a licensed contractor for repair/removal/replacement costs as needed.

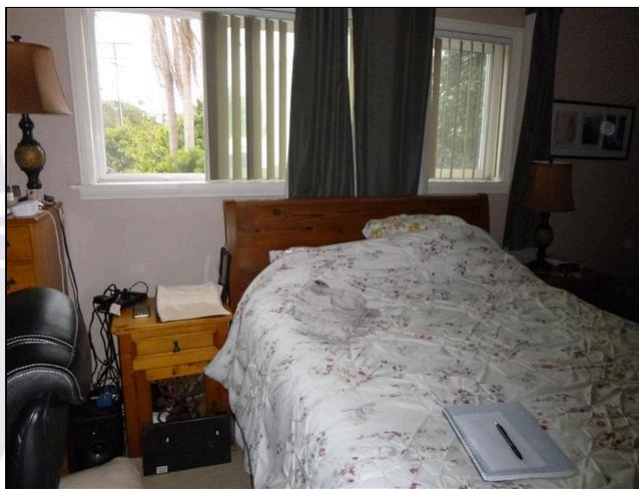
24.4 Item 1 (Picture)

24.4 (4) The replacement windows sill height is above 44" as required for a bedroom for Egress/Emergency exit. This is not uncommon for the age of the dwelling as the windows may have been replaced without getting a city permit. Suggest review with the city and/or a licensed contractor for replacement costs if desired or concerned.

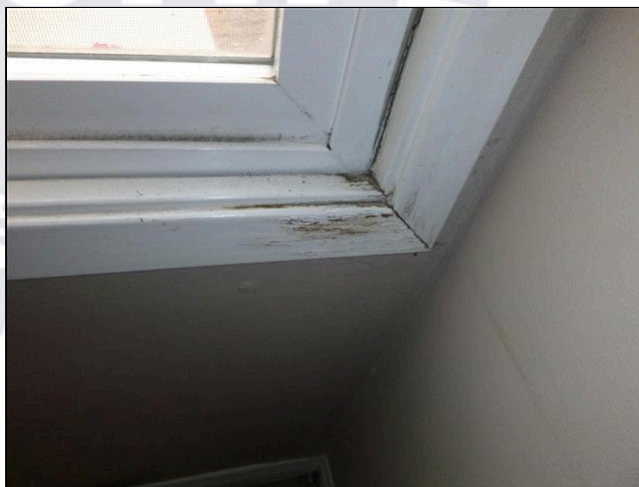
24.4 Item 2 (Picture)

24.4 (5) Multiple stains and evidence of on-going leakage at various windows, suggest review with a licensed contractor for repair/replacement costs as needed.

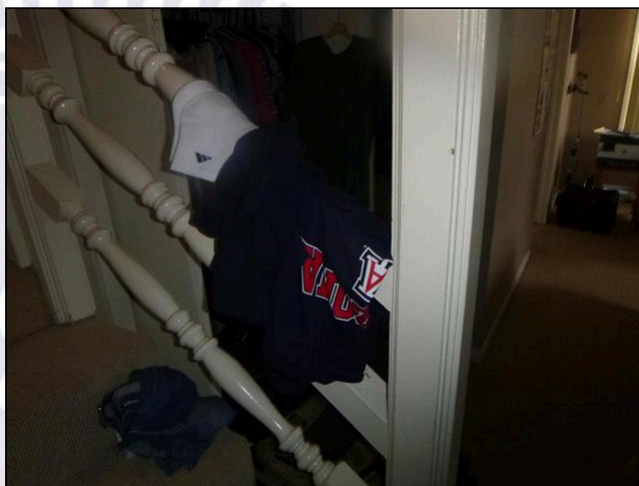
24.8 Item 1 (Picture)

24.8 (2) A non graspable handrail was noted at this area, this is a potential safety hazard. Suggest review with a licensed contractor for costs to upgrade to current standards for safety and/or as needed.

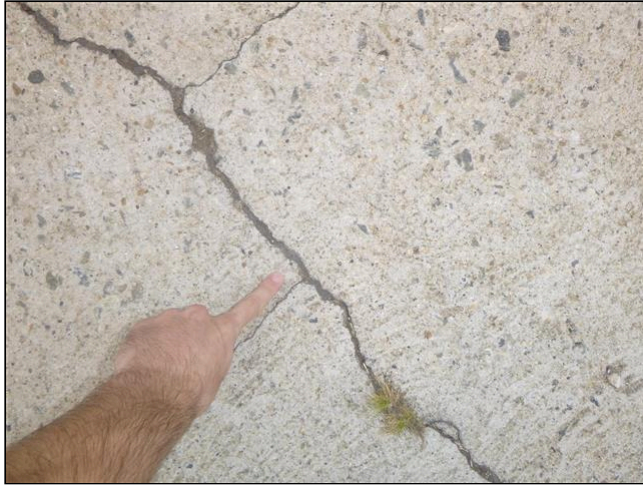
1.0 Item 1 (Picture)

(1) Settling, expansion cracks and heaving noted at various areas. Suggest review with a licensed contractor for repair/replacement costs as needed.

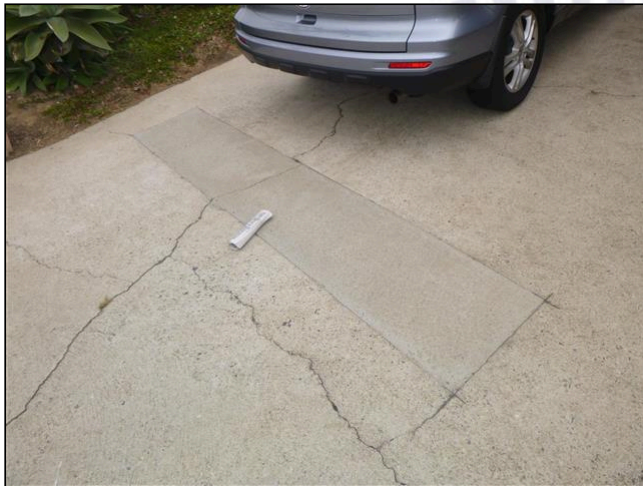
1.0 Item 2 (Picture)

(2) Patched and repaired areas of the driveway was noted. Suggest review with the seller on the cause and any repairs needed. Suggest repair as needed.

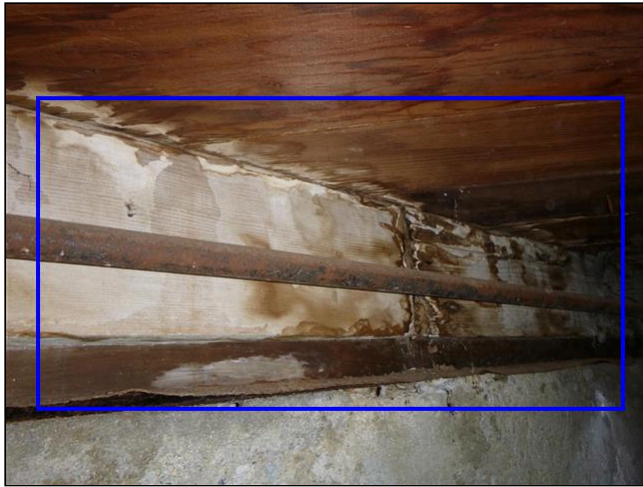
1.1 Item 1 (Picture)

(1) There is a negative slope towards the rear of the dwelling. This area does not appear to drain water away from home/foundation (water damage was noted in the crawl space at the rear of the dwelling due to the walkway's slope toward the rear of the dwelling), suggest regrading and/or the addition of sub-surface drainage as needed.

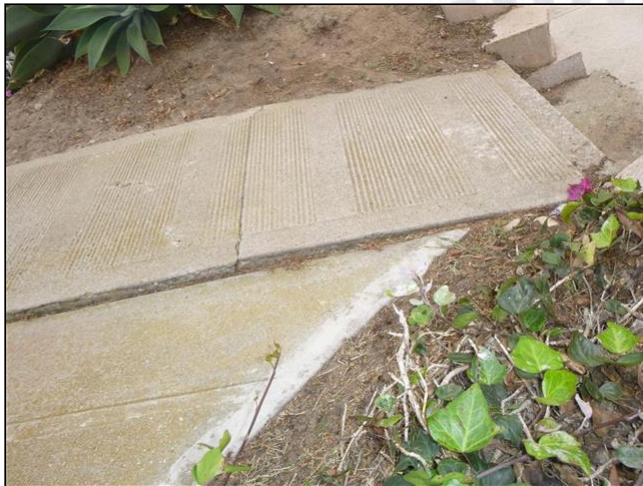
1.1 Item 2 (Picture)

(2) Settling and heaving noted at various areas, this is a potential trip hazard. Suggest review with a licensed contractor for repair/replacement costs as needed.

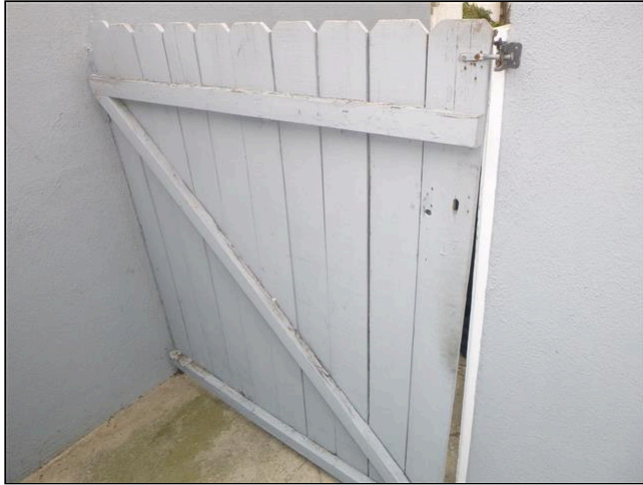
1.3 Item 1 (Picture)

The gates are deteriorated, suggest repair/replace as needed.

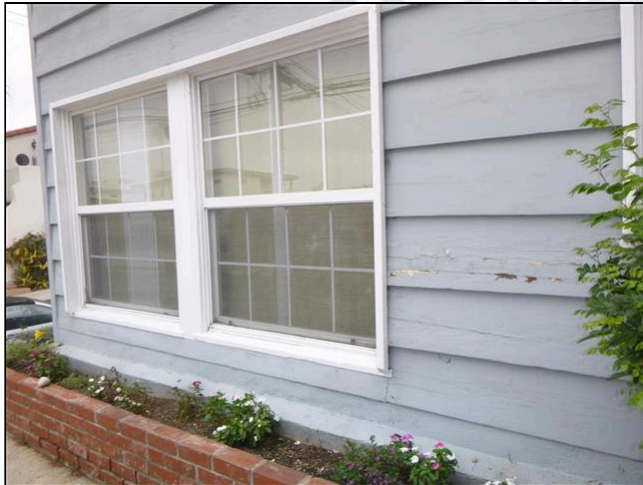
1.4 Item 1 (Picture)

(1) Paint blistering, peeling and wood deterioration noted at various wood siding areas. Suggest review with a licensed termite company and/or a licensed contractor for repair/replacement costs as needed.

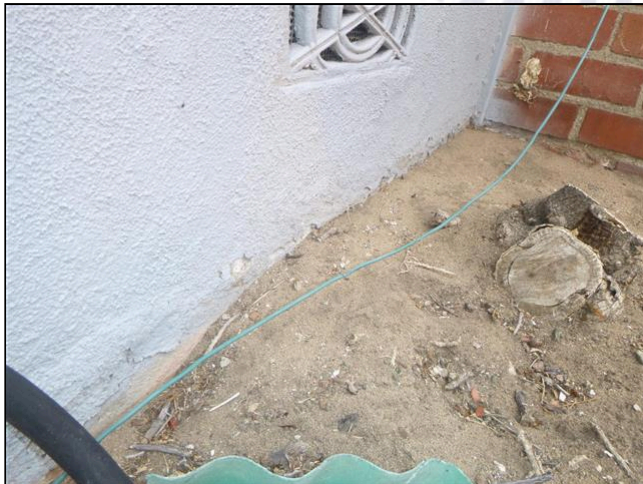
1.4 Item 3 (Picture)

(2) Deteriorated and blistering stucco noted at various areas. See the Lot/Drainage comments and review with a licensed contractor to repair as needed and divert water away from the foundation areas.

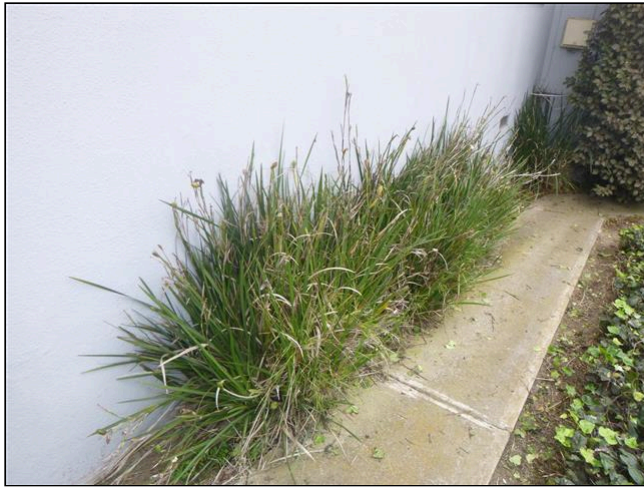
1.4 Item 8 (Picture)

(6) Multiple trees and bushes are in contact with the siding. Suggest trimming them away from the siding to prevent any future damage.

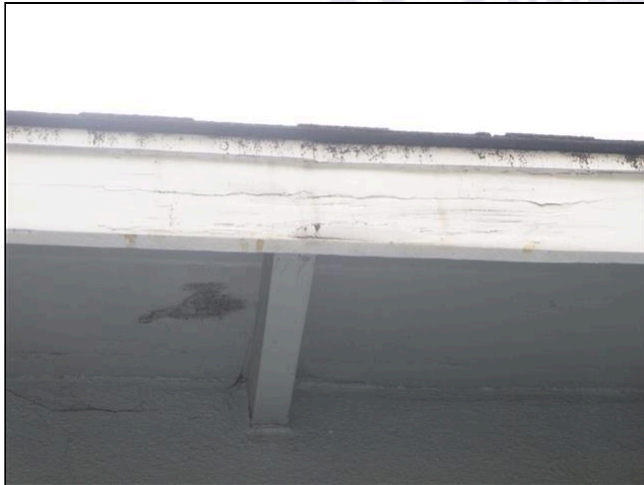
1.5 Item 1 (Picture)

Wood deterioration noted at various trim areas. Suggest review with termite company and/or a licensed contractor and repair/replace as needed.

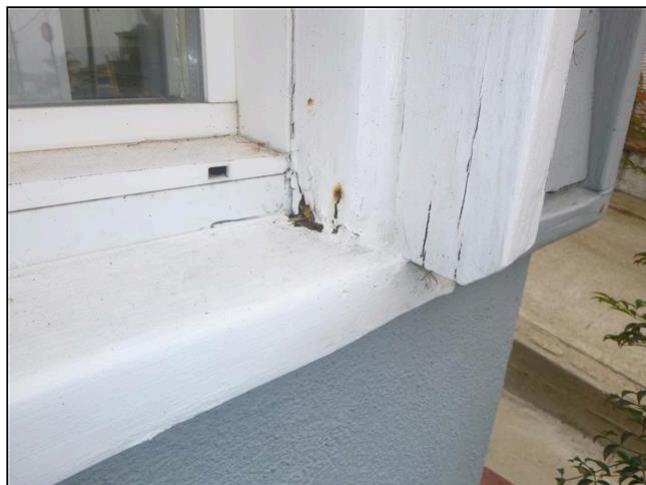
1.6 Item 1 (Picture)

(1) Wood deterioration noted at various window frames. Suggest review with termite company and/or a licensed contractor and repair/replace as needed.

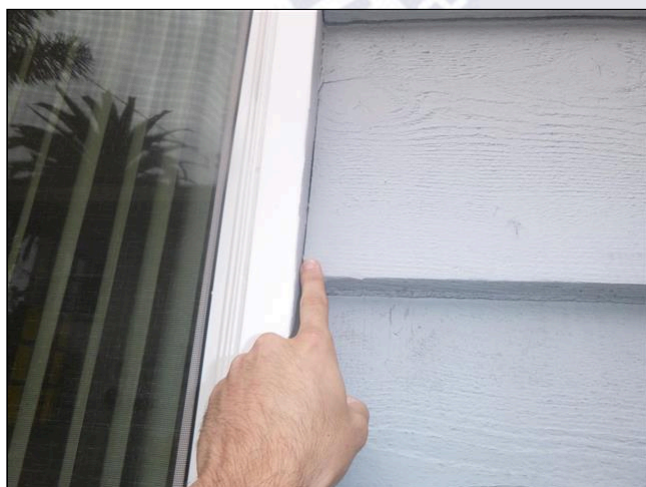
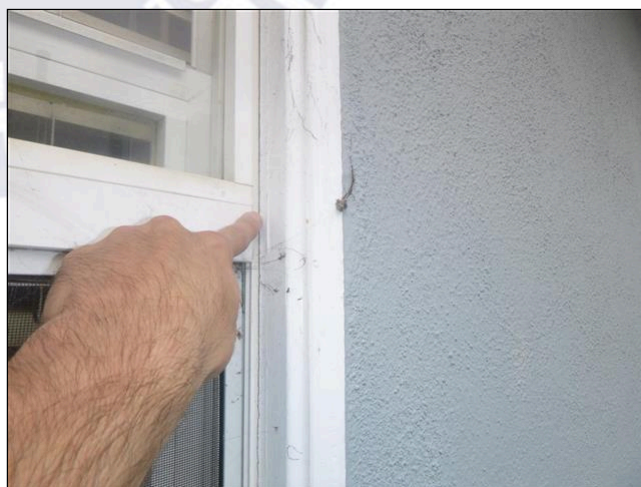
(2) Various windows have not been fully sealed/flushed to the sills/siding as required and/or the sealant has deteriorated leaving extensive voids. Suggest review with a licensed contractor for costs to seal/flash the windows as required to prevent future water leakage and/or insect intrusion at these areas.

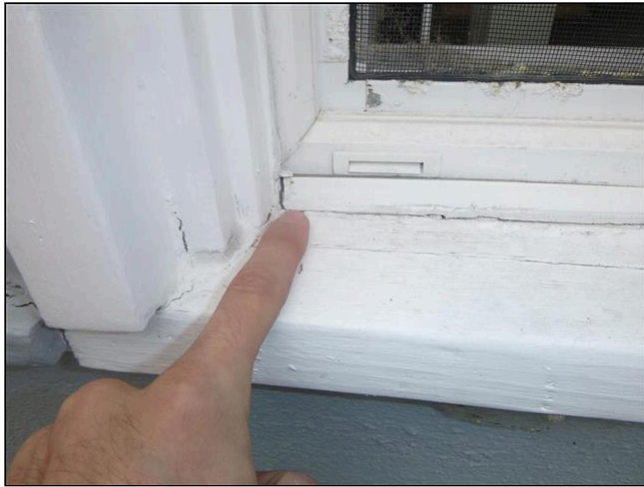
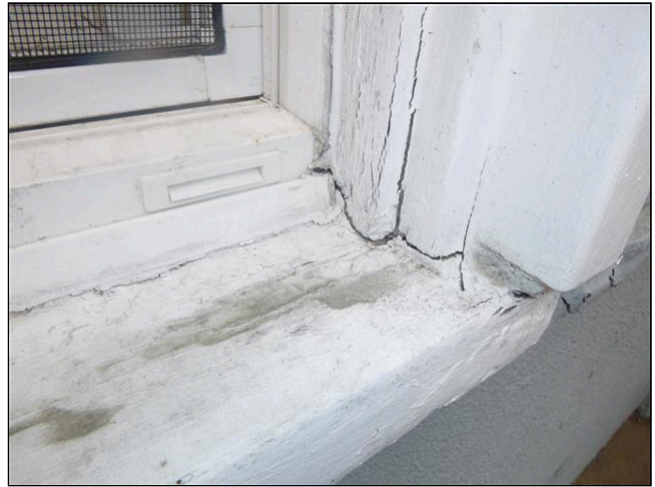
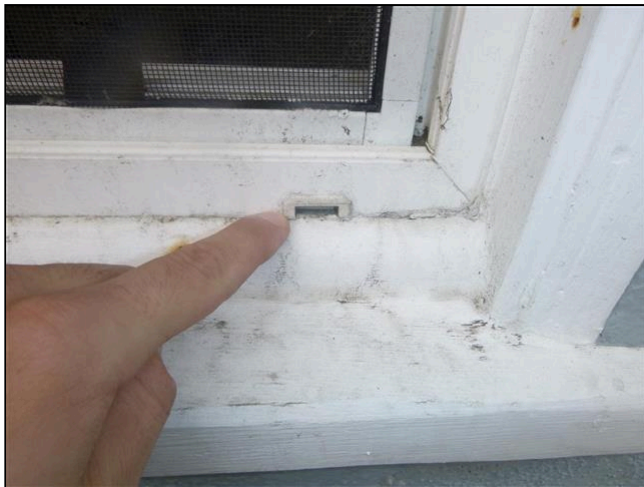
(3) The weep holes at the base of various windows are incorrect. The weep holes are either blocked or have seams/gaps to adjacent trims that will allow water to weep/seep into the interior of the dwelling. Evidence of water intrusion/damage was noted at multiple areas/rooms. Suggest review with a licensed contractor for removal/repair/ replacement costs as needed.
